# Forest River Park Pool Evaluation

City of Salem, Massachusetts  
93 Washington Street  
Salem, MA 01970

October 2017

## **ENGINEER'S REPORT**

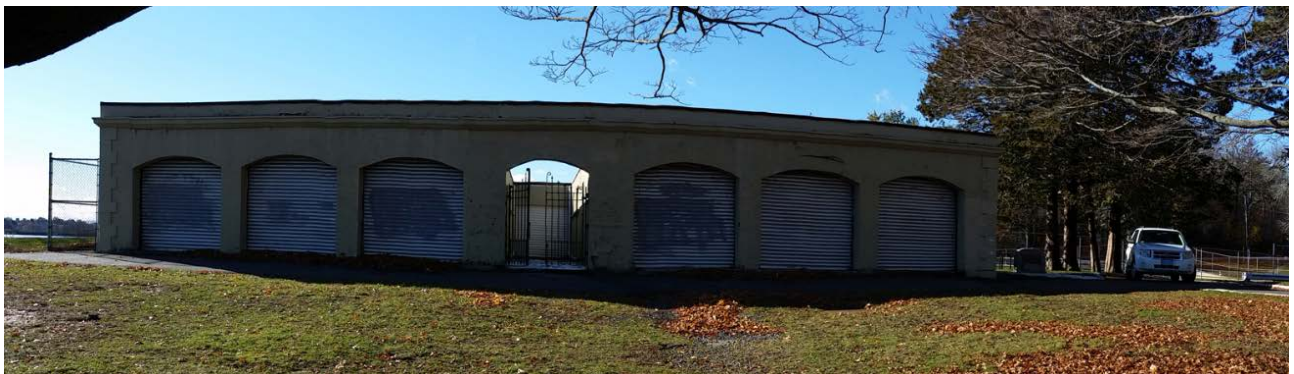
Figure A: Front of Bath House Building

The bathhouse building was built the same time as the pool in 1901. Maintenance renovations have been regularly performed by the city throughout its lifetime. This includes painting, fixture upgrades, ADA compliance upgrades, and new roofing. Figure A below shows a view of the existing building.

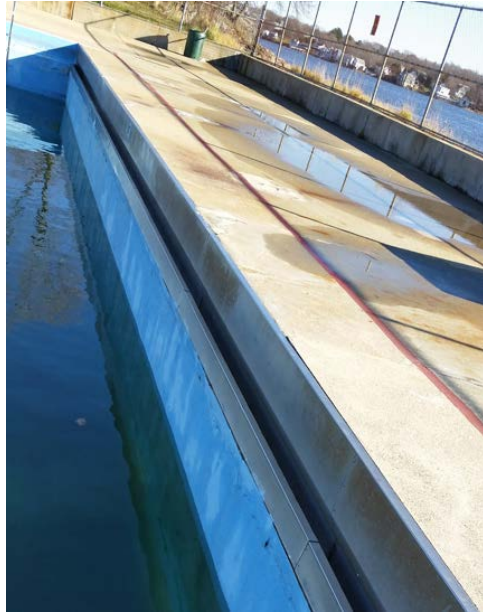
The pool shell consists of a reinforced cast in place concrete walls and floor. The pool was originally constructed to be a flow through pool using salt water. Adverse effects of sodium chloride have been seen on the walls of the pool.

There were no expansion joints or construction joints found in the concrete structure. There was no available information on the structure of the pool to determine wall and floor thicknesses and reinforcing. However, given several visible and leaking cracks in the pool wall along with significant daily water loss, structural failure has occurred.

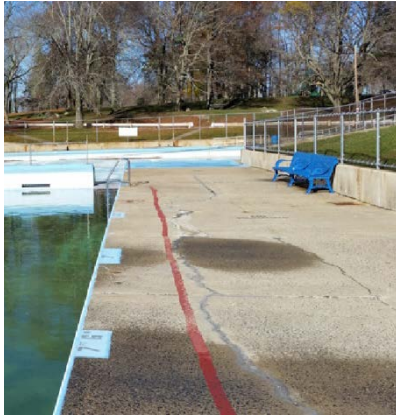
Figure E: Existing Pool Deck

The main swimming pool has an impervious concrete deck around the perimeter of the pool extending approximately 10 to 20 feet from the pool edge in some locations. There is an expansion joint between the edge of the pool wall and the edge of the concrete deck, as well as other various locations around the deck.

It appears that during the life span of the pool the deck has been repaired and patched in various locations. Painted depth markers are located around the edge of the perimeter of the pool.

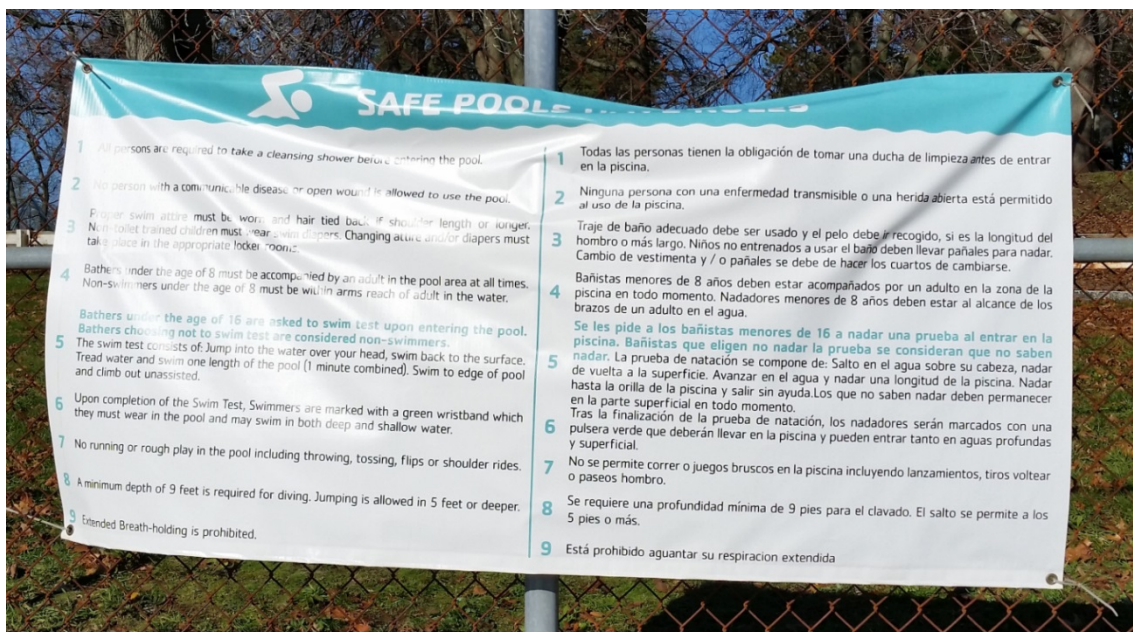
Existing Pool Rules Signage

Health and safety signs that are required by code, with specific language are not found in the bath house or at the facility. The existing banner signage contains some, but not all of the required language.

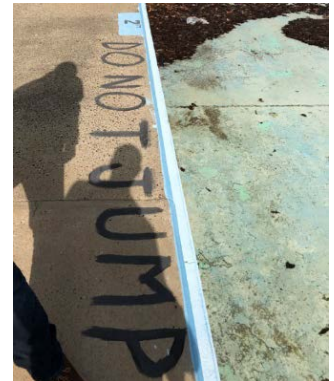
In all depths less than 5-feet, “NO DIVING” international symbol needs to be present at every point where there is a water depth marker. Currently, painted ‘Do not jump’ or ‘No diving’ markings are painted on the deck in shallow locations. These do not conform to the code requirements. Also, there is no 4” contrasting color band and rope line found at the 4 FT mark in the pool. This would need to be installed.

Depth markers shall be replaced on the wall faces and on the pool deck. The spacing between depth markers shall not exceed 25 linear feet or a change in direction.

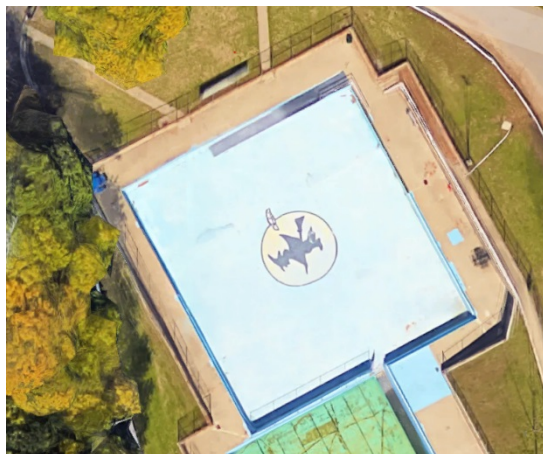
In the center of the wading pool section of the pool, and in the deep end of the lap pool is a picture of a witch, the Salem High School mascot. The witch contains colors that are not light or white in color. The witch graphic shall be removed from the bottom of the pool, or a graphic that has been reviewed and approved by the Board of Health should be installed. (As of the writing of this report, the witch was being painted over with the blue paint to match the rest of the pool color.)

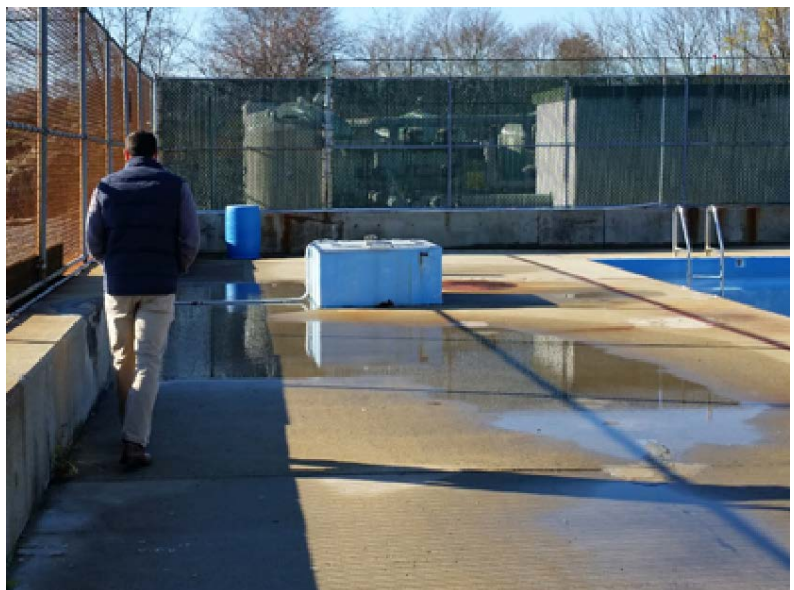
The concrete deck has settled in various locations. The concrete deck settled between ½ to 2 inches in locations, resulting in standing water on the deck. Standing water on the deck is a health and a safety hazard. In accordance with Code 306.5.1, “Maximum Gaps”, from the International Swimming Pool and Spa Code states, “The difference in vertical elevation between the pool deck and adjoining sidewalk shall be not greater than ¼-inch.”

The deck has settled or shifted around the perimeter of the pool. In some locations, there is a vertical elevation change of ½ to 6 inches. The settled deck has created a trip hazard around the perimeter of the pool.

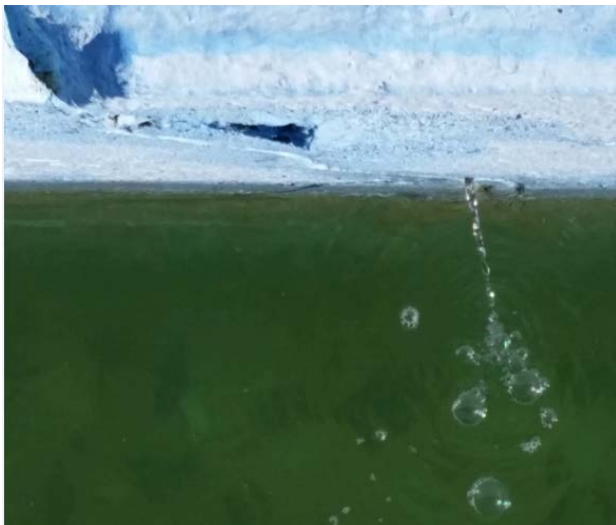
The source of water loss is found in the structural cracks and failures in the pool shell, which were visible during inspection. High water table during inspection resulted in ground water leaking back into the pool, since the pool was empty.

A majority of the loss of water can be contributed to the structural failures in pool shell. The failures stem from the deterioration of the structural shell. In discussions with the staff, when they have

attempted to make repairs, they have been unsuccessful because the block wall has deteriorated beyond the point where it will hold an anchor or be structurally strong.

The shell is approximately 45 years old, which is a normal end of lifespan for a facility such as this. Because of the site grading and location adjacent to salt water bay, years of salt water operation and chlorine have allowed sodium chlorides to penetrate the concrete and breakdown the structure. Additionally, flood and storm events have surely contributed to structural deterioration and subbase erosion.

The cracks and gaping holes are a result of hydrostatic pressure and the absence of control joints and expansion joints. The pool shell has exceeded its service life.

The code compliance issues stated in the above section need to be corrected in order to legally operate the pool. The structural repairs should be a high priority as they are creating unsafe and unacceptable conditions for the patrons and the environment. Given the age and condition of the existing structure, Weston & Sampson recommends the replacement of this pool.

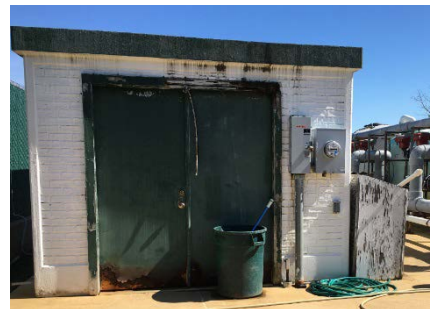
The filter building is a precast concrete building. The building contains some louvers and a 6'-0" door. Condition of the building is fair, but is showing some aging due to a chlorine environment and moist environment.
