Bertram Fieldhouse

Renovation Study
June 9, 2013

This is a study of the Bertram Fieldhouse to document the existing conditions and develop a complete scope of renovations and cost estimate.

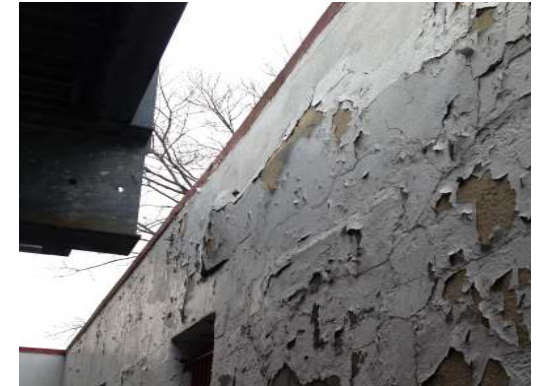
Exterior wall

1. The exterior walls are composed of concrete masonry units with painter stucco finish on the exterior and painted interior.
2. Several locations on the exterior the paint and stucco has deteriorated as well as the back-up masonry.

1. Remove all loose and deteriorated stucco and replace with new stucco.
2. Repair back-up masonry.
3. Paint facade.

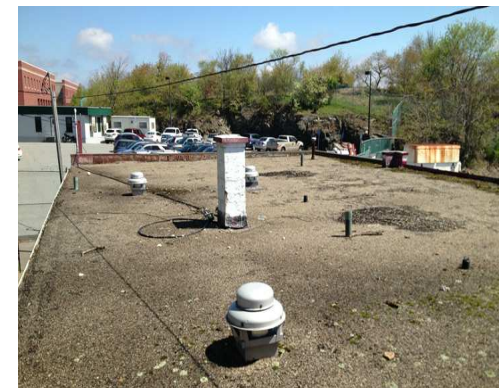
Roof

1. The existing roof is tar and gravel built up roof over a wood deck. The roof may be over 30 years old and has

indications of many repair over the years.

3. Side wall parapets are covered with copper flashing and a precast cap stone. This flashing appeared in poor condition. The cap stones are in reasonably good condition.

1. Replace the existing roof, with new built up system including flashings.
2. Repair water damaged wood decking.
3. Replace capstones with metal cap and gravel stop.
4. Replace rear gutter.

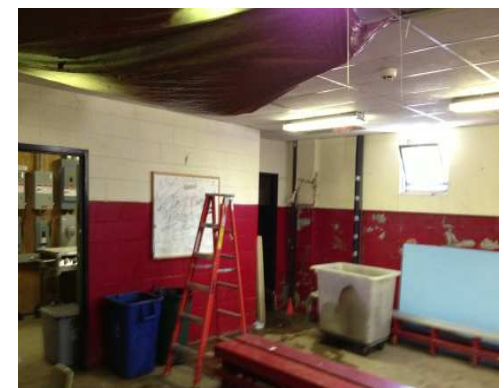
Interior ceilings and walls

1. The ceilings are hung acoustical tile. It appears that these are not the moisture resistant type. Some have been damaged through roof leaks.

1. Replace all ceilings with new hung gypsum type ceilings

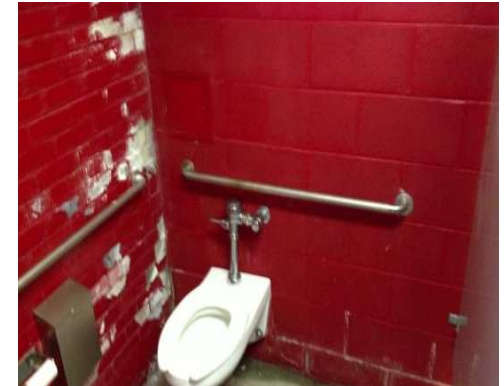
Walls at toilet

2. The lavatories are older, in good condition but with differing, non-sensing, faucet types. The waste lines beneath the lavatories are not protected as required for accessible toilet rooms.

1. Replace existing toilets and urinals with high efficiency fixtures including flush valves with sensors.
2. Provide new ADA compliant sensor faucets for existing lavatories.
3. Provide proper protection for lavatory waste lines.
4. Remove all obsolete, abandoned gas piping. The furnace and water heater are the only gas appliances which should be piped.

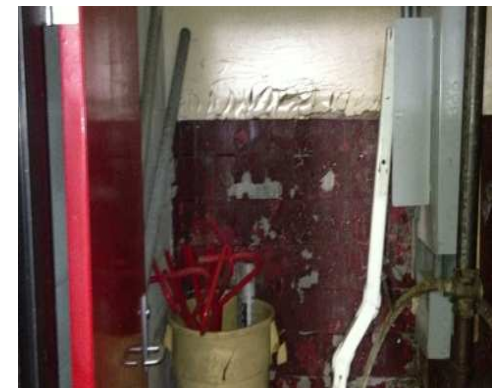
Electric panel room

b. Team Room Locker facility electric service is 240/120V, 1 phase 3 wire, 200A with individually metered overhead service cables. Main service entrance Panel is located in a corner closet. Water was present in the closet creating a hazardous condition. Service entrance panel Panel is old FPE with discontinued parts. Most of the outgoing branch circuits from FPE panel are old.

4. Replace existing service entrance FPE panel with new panel and circuit breakers.

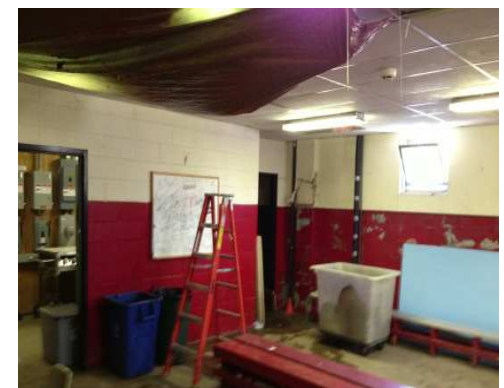
Water leaking locker room A

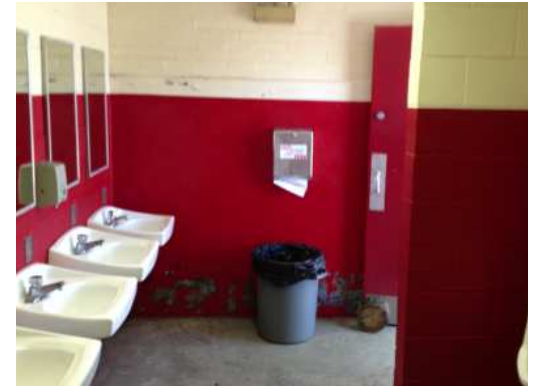
Public toilet

1. The building toilets and urinals are older, not high efficiency, but in good condition. The fixtures are wall mounted and code compliant.

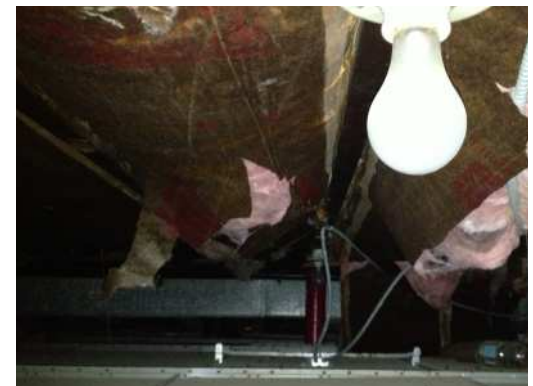
Partial insulation above ceiling

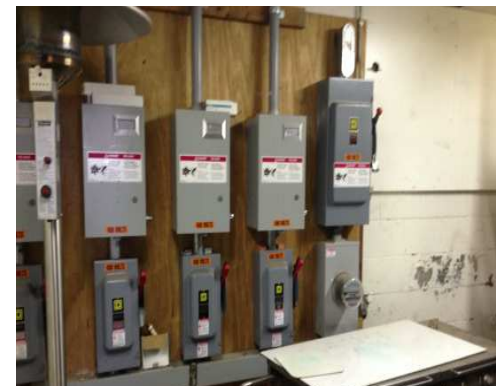
Panel room

a. Sports field flood light electric service is 480/277V 3 phase, 4 Wire, 200A fed from a 75 kVA pole mount transformer with overhead service cables and pipe. Main 200A service disconnect switch has sub distribution feeders for four sports field flood light poles each sized at 60A. Main and four sub-feed disconnects are housed within team locker room facility in a dedicated room.
