COLUMBUS AVENUE SEAWALL

PROJECT REVIEW - NEIGHBORHOOD SUBCOMMITTEE MEETING JULY 28, 2020

GZA GeoEnvironmental, Inc.

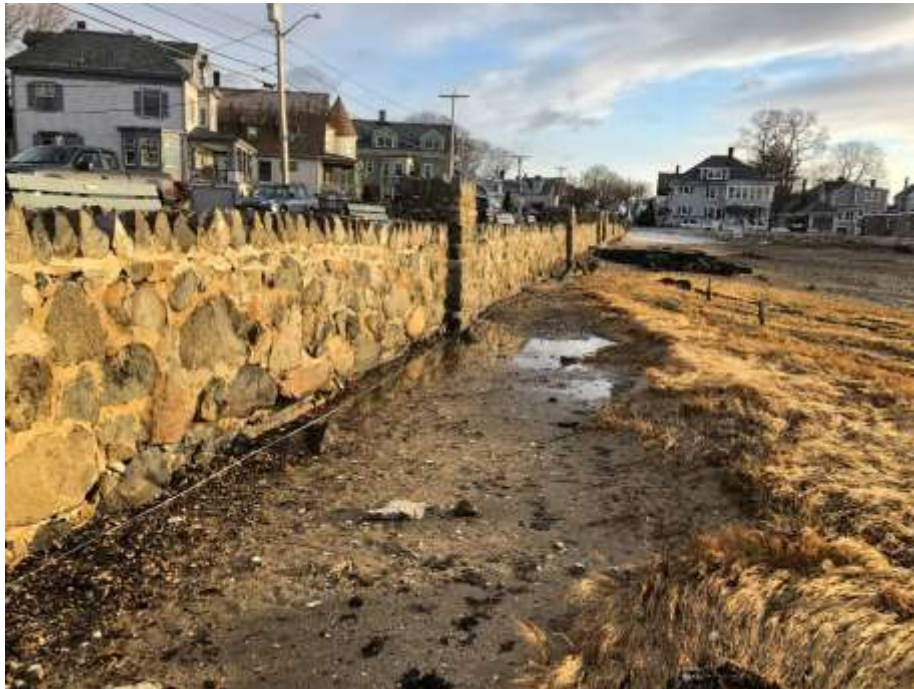
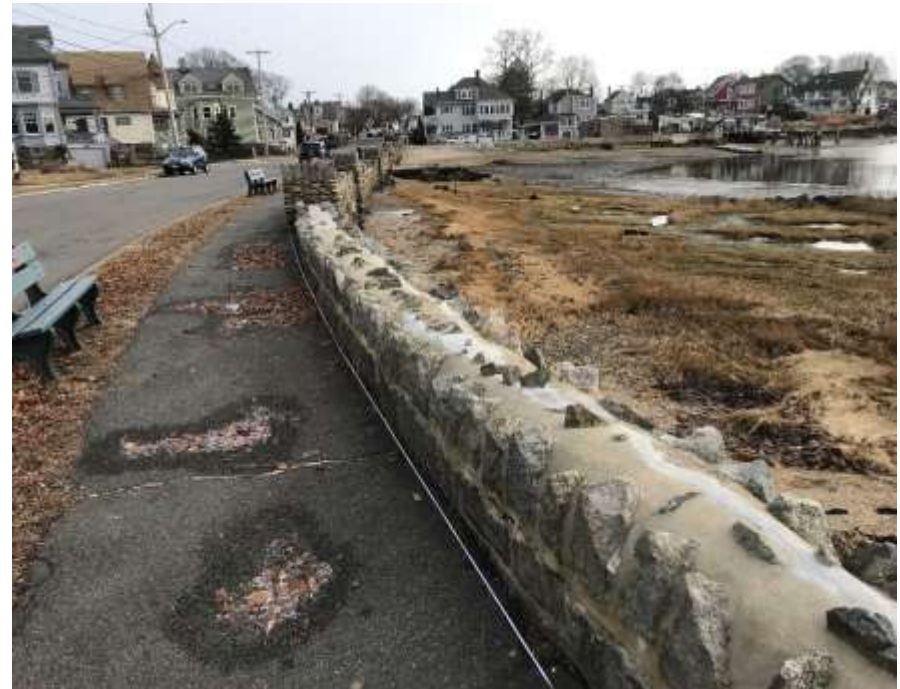
- Observed to be in overall FAIR to POOR Condition
 - Loose/missing stones,
 - Deteriorated and missing mortar/cracks

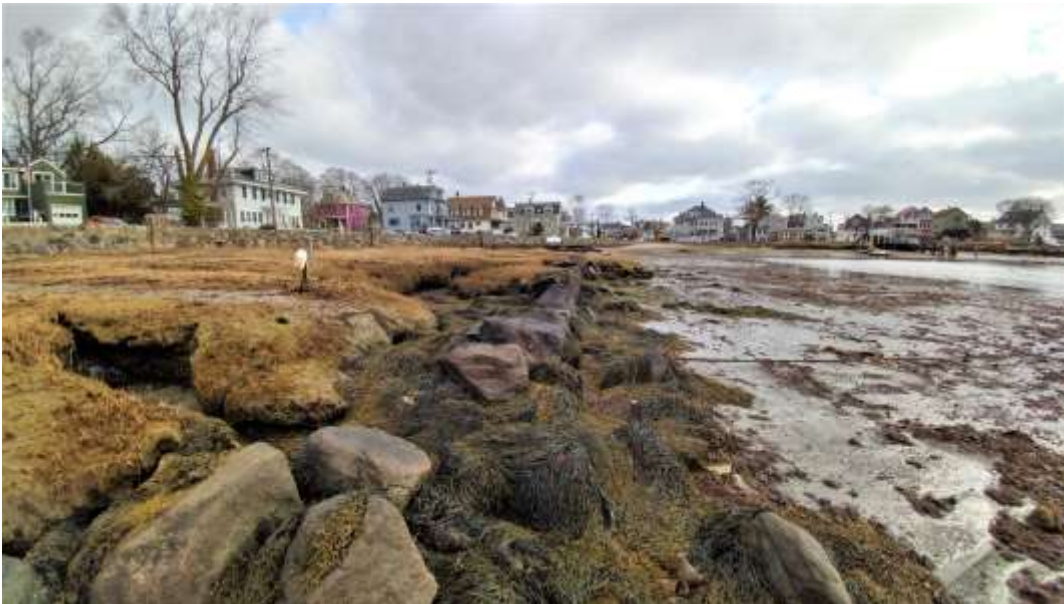
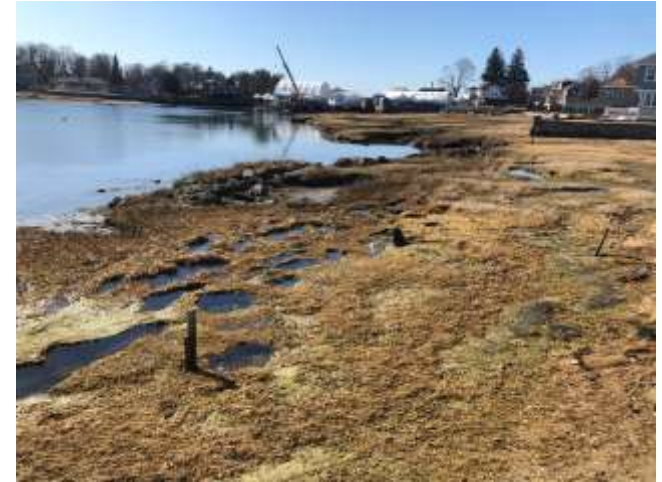
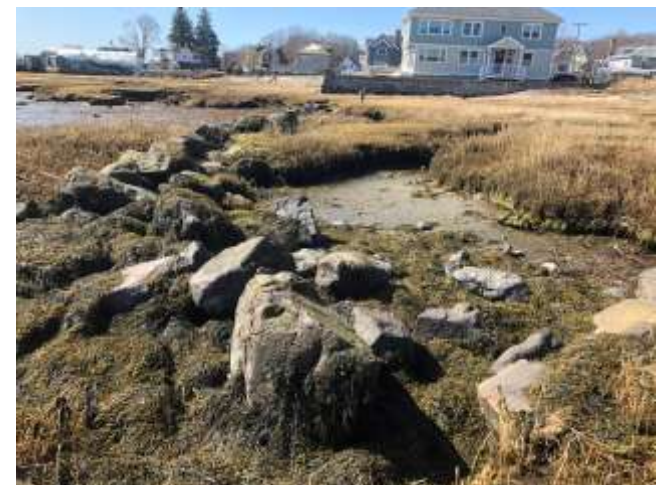
- Partly desiccated with “pockmark” voids throughout
- Erosion and undermining along seaward edge

- New seaward sill
- Sand nourishment fill to raise grades and fill voids
- New and supplemental salt marsh plantings (*Spartina patens* and *Spartina alterniflora*)
