## FOREST RIVER CONSERVATION AREA TRAIL ASSESSMENT

Produced for the Conservation Commission  
of the City of Salem, MA

February 2016

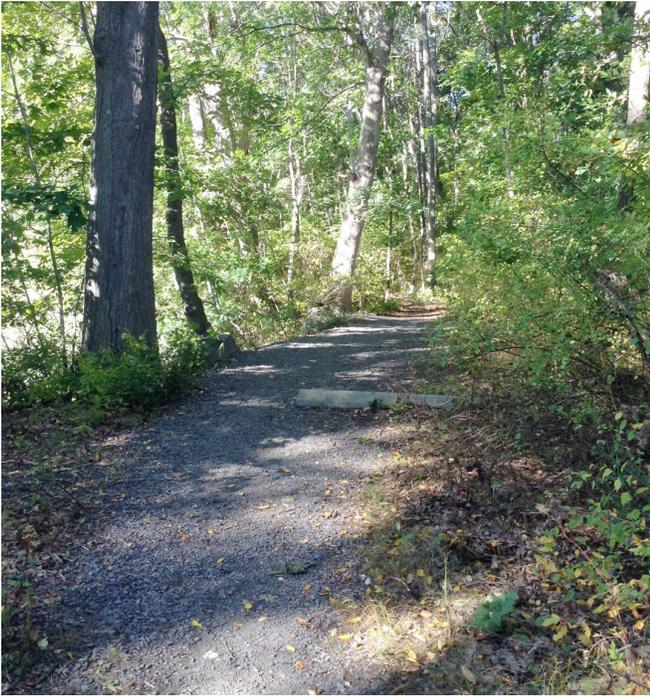
**Good Condition**

*The concrete wheel stop should be removed, but this trail is otherwise in good condition.*

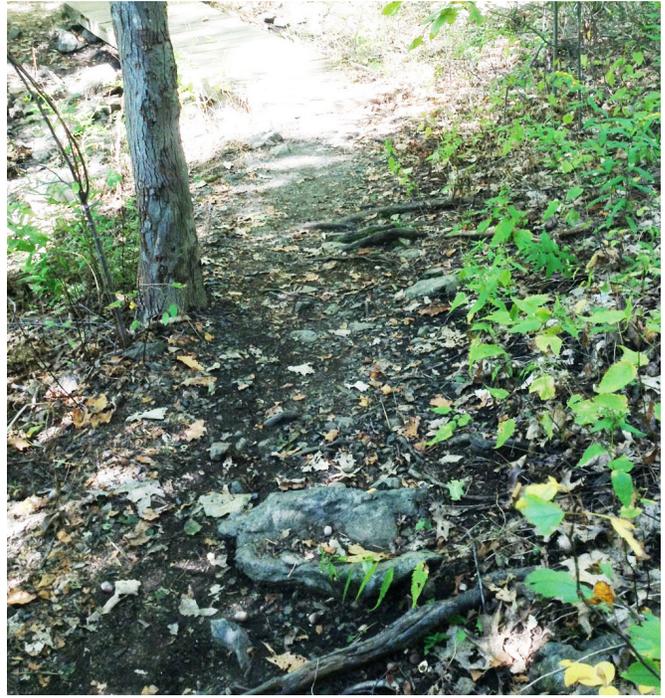
**Fair Condition**

*Loose rocks and exposed roots contribute to a fair condition rating for this trail segment.*

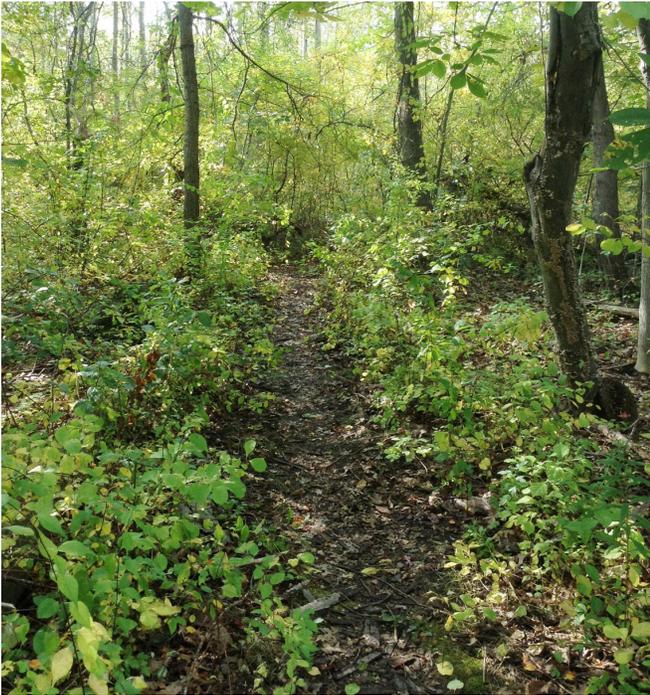
**Fair Condition**

*The trail edges here are quickly being overtaken by plants such as catbrier, which is thorny and spreads aggressively.*

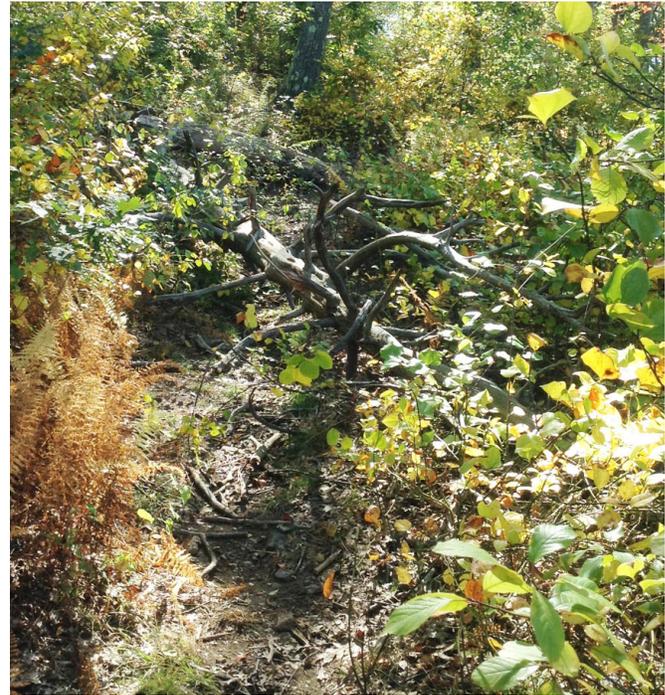
**Poor Condition**

*This trail is obstructed by a fallen tree, covered in loose rocks and twigs, and shrubs are obscuring the path.*

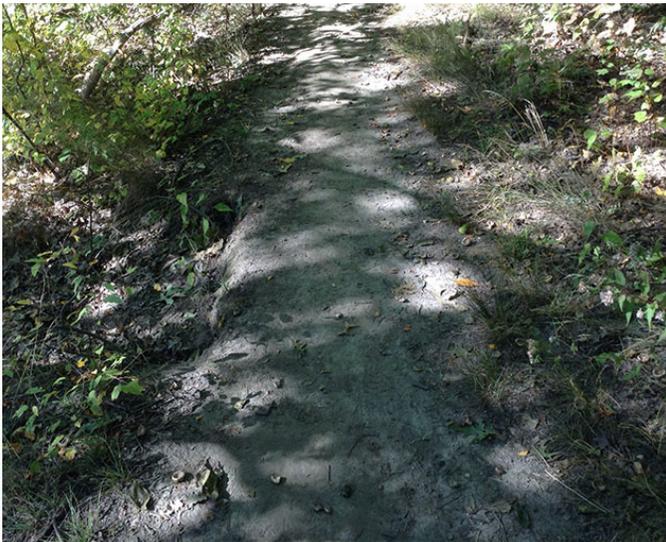
*Crushed stone trail erosion*

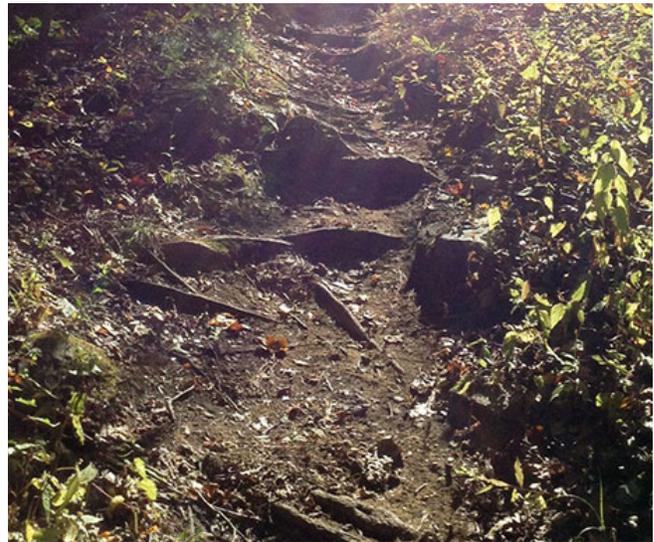
*Erosion on slope*

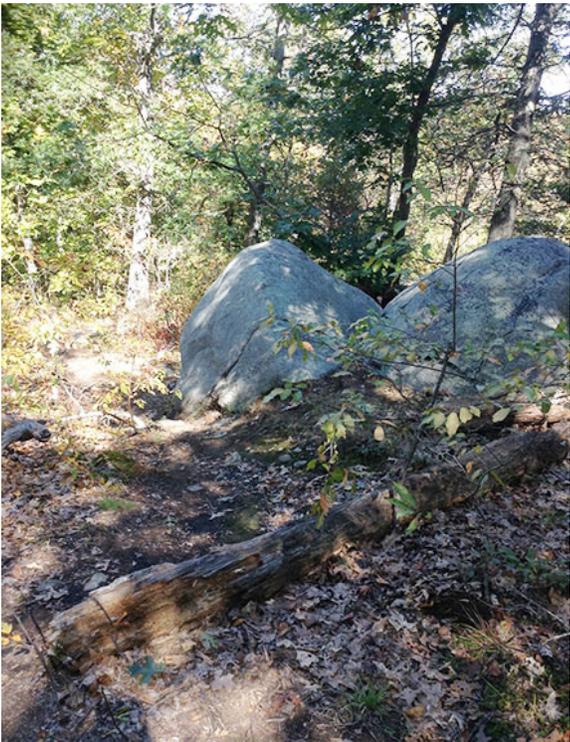
*The boulders are not obstacles, but the fallen limb, when combined with other factors, reduces the condition of the trail.*

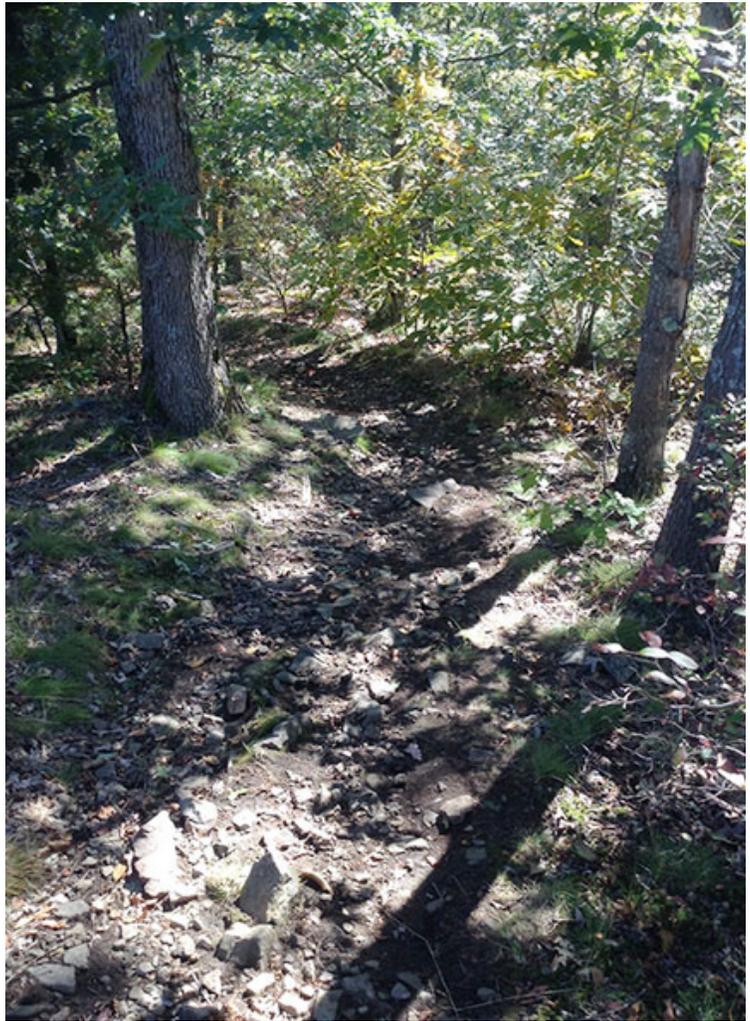
*Many loose small rocks make this trail surface less stable under foot.*

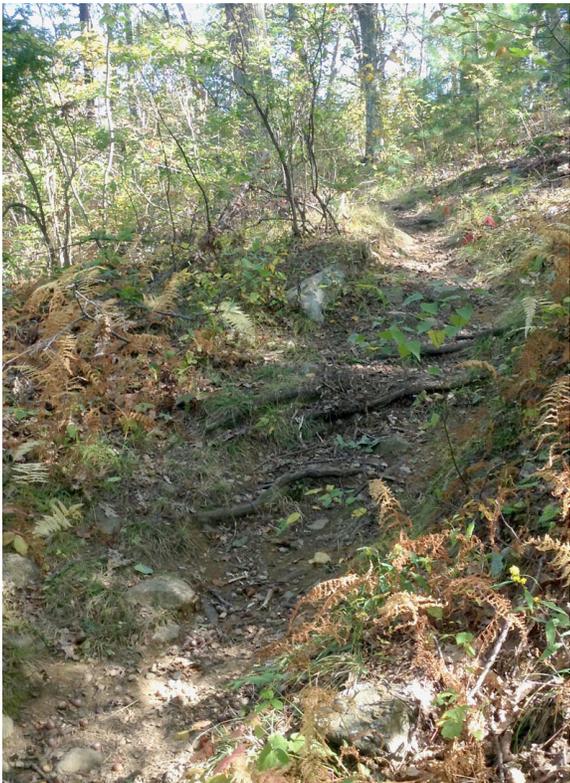
*Multiple exposed roots and loose soil are a sign of erosion. The combination creates unstable walking surfaces.*

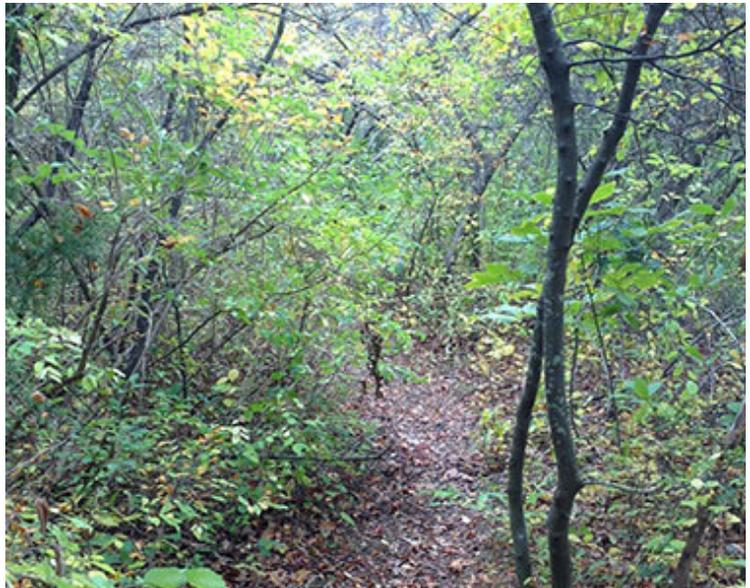
*Low canopy is pleasant and interesting, but too low and walkers must constantly duck and push vegetation away.*

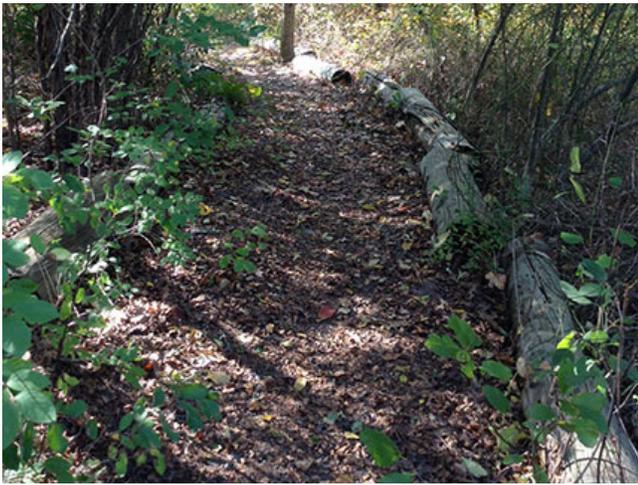
*Utility poles lining path running to Pickman Road*

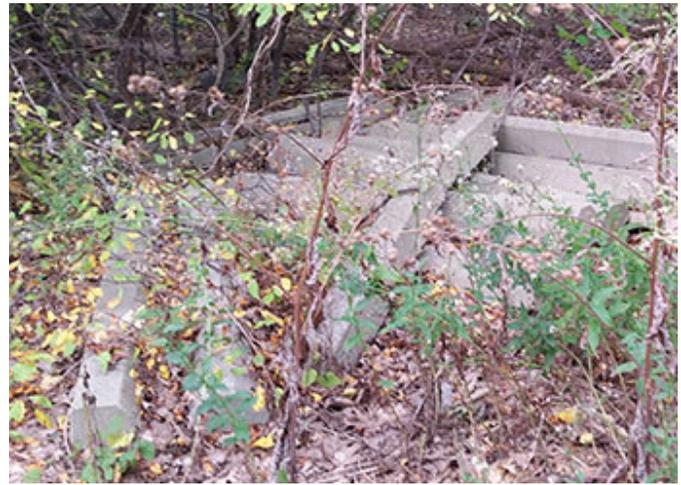
*Concrete wheel stops near the salt marsh*

Notably, concrete wheel stops, or bumper blocks, are visible in a few locations along the FRCA trails. One blocks the entry path along the salt marsh, while a couple groups have been placed off the side of the trail elsewhere near the salt marsh. More than 10 wheel stops can be found lining the slope in one location on Eagle Hill, while others appear to have fallen or been pushed downhill. According to documents provided by the City of Salem, these wheel stops were placed to prevent erosion and stabilize the Eagle Hill slope, but most appear to have been moved and, therefore, serve no purpose.

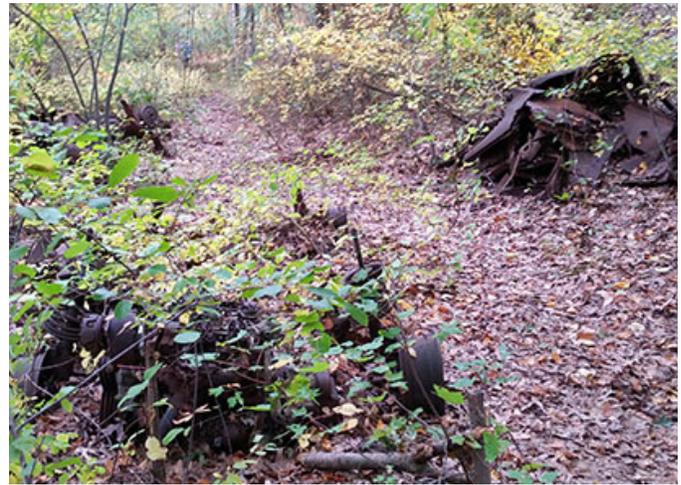
*Car parts near railroad on northern side of river*

Some visitors may consider the rusted vehicle parts near the railroad tracks to be junk, but others might consider these interesting site features. Oxidized iron is not toxic, and the parts have minimal to no impact on the surrounding forest and wildlife, so removal is a matter of preference alone and is not accounted for within cost estimates.

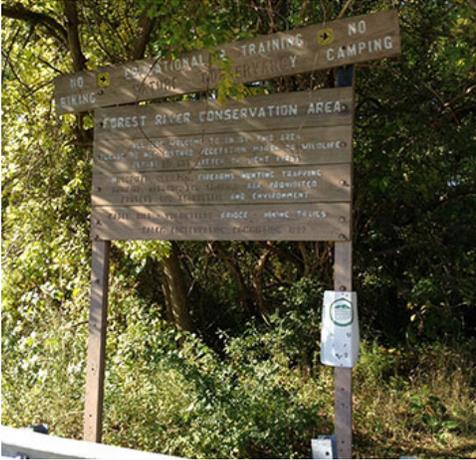
### Salem State Entry & Volunteers Bridge Signs

From 1997, the large (~8') entry sign at the Salem State parking lot is in disrepair. It is hard to read due to loss of paint, and the top board is misaligned. Vegetation is beginning to cover the top of the sign as well. The position of the sign is somewhat awkward as the sign faces outward and parallel to the parking lot, when it would be more legible if angled inward toward the trail. This is a minor issue only.

The Conservation Commission could either repair the existing sign or replace it. In repairing the existing, it should be cleaned, the top board refastened, rusted washers replaced, and the letters should be repainted. Remove/replace the damaged Land and Water Conservation Fund attachment. Also consider moving the sign so it angles in toward the trail rather than toward vehicles.

Optionally, replace the existing wood sign with something more legible and which will require less maintenance over time. Different materials could be mixed for the frame and panel, but the sign should include the site name, rules, and a new map with updated trail routes.

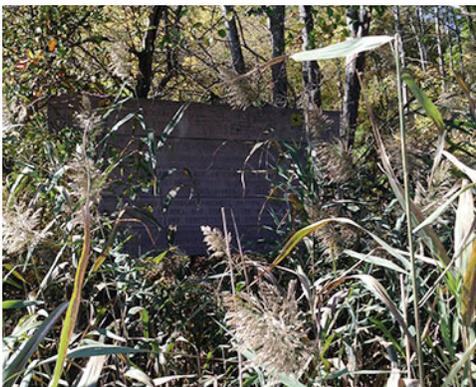
The Volunteers Bridge sign is hardly legible due to vegetation almost covering it and due to the wear on the sign. The sign is positioned at the southern, or far, end of the boardwalk, when it might make more sense to position a sign at the beginning, northern end of the boardwalk.

Currently the Volunteers Bridge sign is oddly located and repeats information stated on the Salem State entry sign. While basic repairs could be made to the sign, consider reconfiguring the Volunteers Bridge sign to make it smaller and refer only to the bridge. Place it at the northern side of the boardwalk so visitors are sure to see it. Rules do not need to be added to this sign. Optionally, remove the sign entirely or replace it with a smaller identification sign.

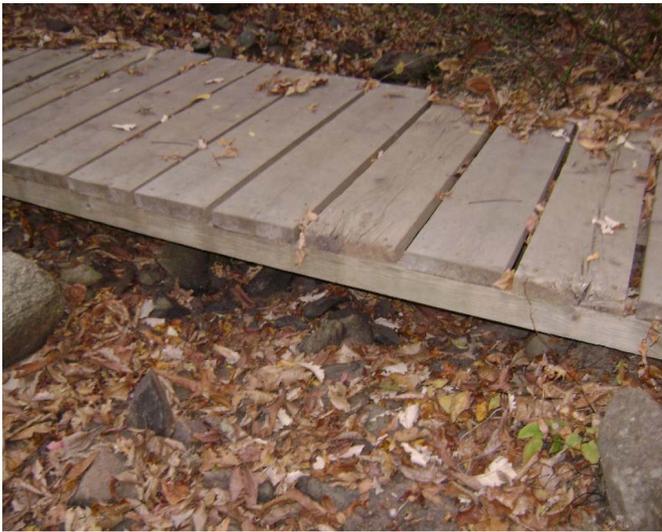
### Cub Scout Bridge

The bridge is approximately 16' long at the deck and is four feet wide. It's of timber construction. Deck elements are 10" nominal wide and 3" nominal (2+ inch full). There are three longitudinal 4"x4" stringers. It appears there are at least 3-20 penny spikes at each stringer. Some dry rot was observed in the deck planks. The deck flex under load is significant due to the lack of depth of the stringers. There are no handrails on the bridge. Due to the large deflection under load the bridge would not meet current building code standards.

This bridge is framed opposite the normal framing, i.e., planks run longitudinally along the bridge structure and are supported transversely. The majority of the bridge is supported on "bents" originally comprised of 4" posts supporting a transverse post ap (4"x4" or 4"x6"). The post bents were located 4-5' on center. The ends of the bridge, close to the ground, are supported on "sleeper" logs laid right on the ground and there is fair amount of deterioration observable. The sleepers are also approximately 5 feet on-center. The main body of the bridge goes over a marsh and through some cattails.

As funding allows, each of the boardwalks should be replaced with a long-lasting structure that includes a guardrail to meet building code. The Cub Scout Bridge and Volunteers Bridge are priorities. Signage, vegetation clearing, and grading at bridge entries all need to be considered as part of bridge construction projects. Educational and artistic uses/opportunities should also be contemplated in the design of each boardwalk, particularly Volunteers Bridge.

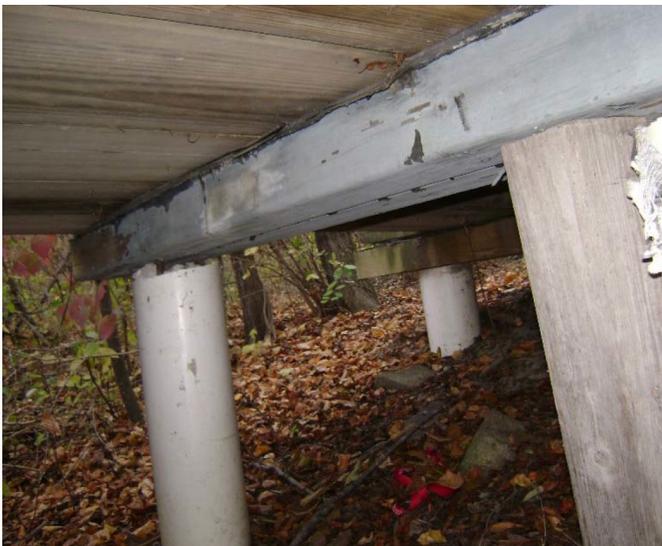
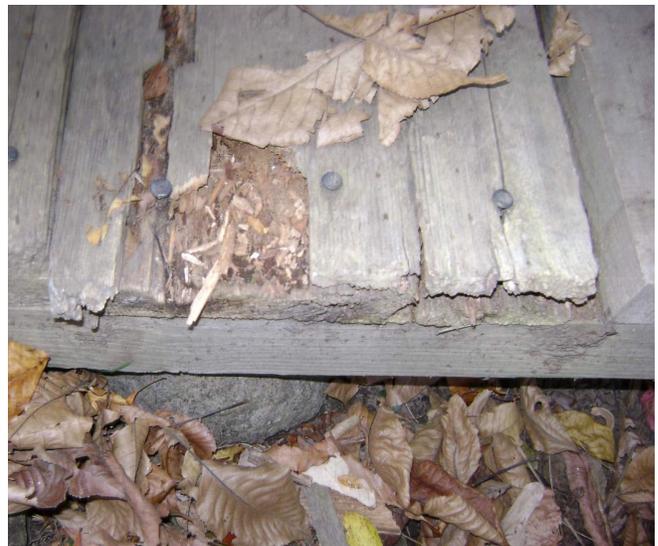
It appears many of the original timber posts rotted and were replaced (functionally) with grout filled PVC pipes. Again significant deterioration on the decking was noted and there are several "soft spots" as one walked over the bridge. The bridge deck is 4-5' above the marsh surface and the bridge doesn't have guard rails. Bridge runs a zig zag path from one shore to the other. Similar issues with regard to deterioration and lack of guard rail. This bridge would not meet current code. The Volunteer Bridge is approximately 5'-10' wide and approximately 210 feet from first post cap to last post cap.

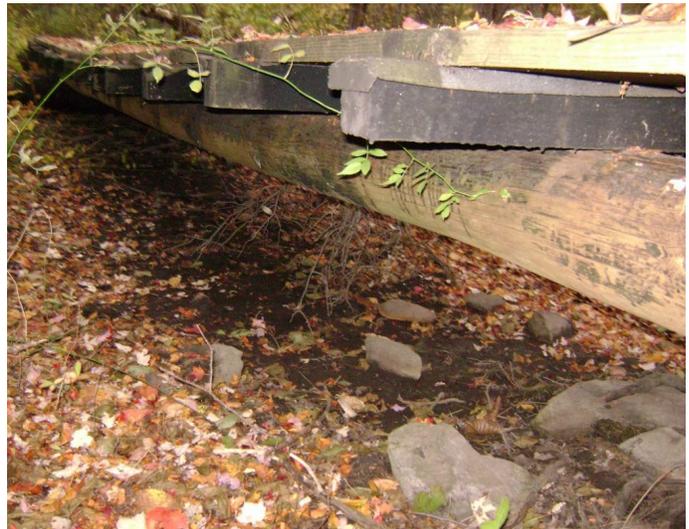
### **Eagle Scout Bridge**

This bridge is also framed with the decking running longitudinally. The decking is supported by 4"x4" and 4"x6" transverse members. These transverse members are supported by 2 9-10" logs spanning between the log abutments. This is sturdier construction than the Cub Scout and the Volunteer due to the heavier longitudinal structure. Decking has a bit of rot which is typical of several bridges. The abutments are a pair of logs placed transversely. The main span length is approximately 22 feet and there is some bounciness but not significant. Code issues also exist with regard to the lack of railing.

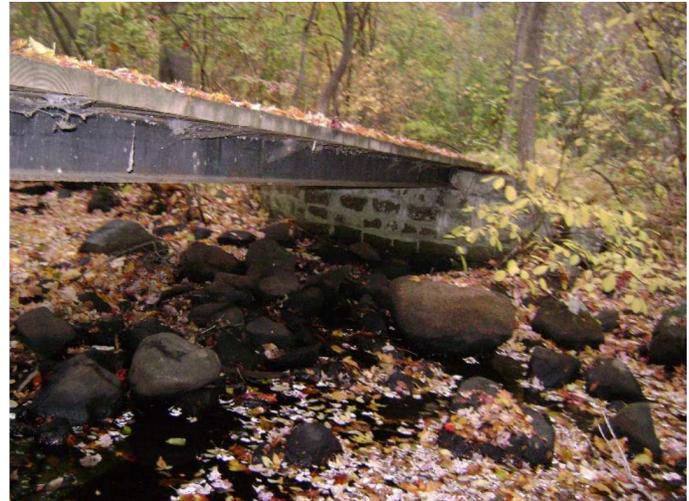
### **College Student Bridge**

Deck construction is 3"x12"s transverse. This bridge uses a couple of railroad rails or wide flange beams to span between stone and mortar abutments. The Student Bridge is 5 feet wide by approximately 20 feet long. With the exception of having no guard rails this bridge might meet current code.

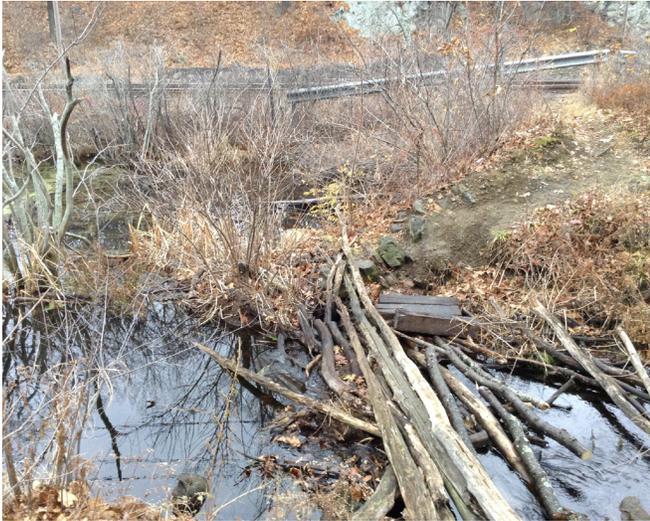
Two crossing areas currently exist, with the crossing to the south being blocked only by a guardrail. Here visitors must cross a bridge made of branches. This crossing is lined at its sides by a fence in need of repair. No signage is visible here. The other crossing, to the north, includes both a guardrail and fence directly lining it, though the fence is jogged in toward the guardrail, which seems to encourage a natural funneling of users to this spot. The fence lining the guardrail has been ripped back out of place, and signage is only visible far to the sides of the crossing.

*Southern railroad crossing*

At the southern crossing add 20 feet of fence near the guardrail. Repair 50 feet of fence frames currently without chain link. At the more northern crossing the Conservation Commission might consider constructing a 10 foot section of fence closer to the tracks and more in line with the rest of the fence at this spot to stop what seems like a funnel attracting visitors in or out. The Commission might also consider encouraging some catbrier to grow in this location.

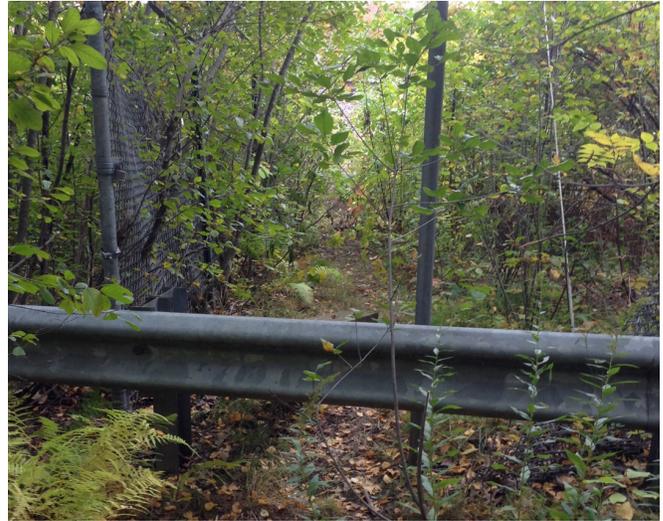
*Northern railroad crossing*

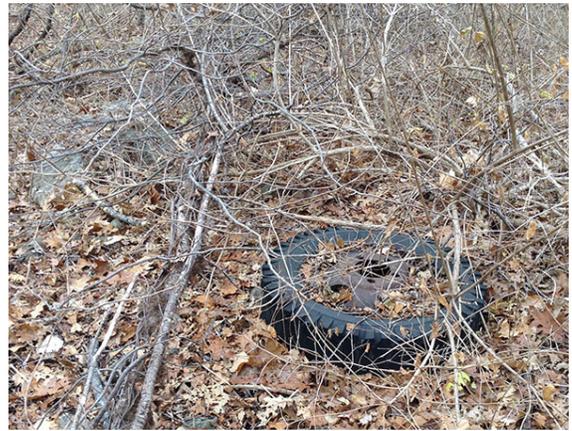
*Dumped trash and encroachment*
