**City of Salem,  
Massachusetts**

December 2019

# Salem City Hall

## City of Salem ADA Transition Plan

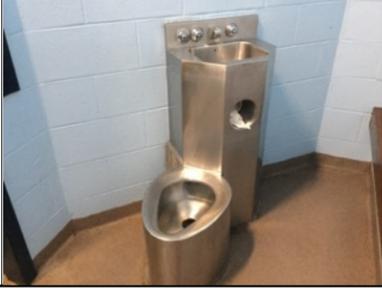
Mobility cell lacks access to accessible toilet/lavatory	-	Ensure an accessible toilet room is provided.	1	0	\$0
<b>Toilet &amp; Bathing Rooms</b>												
<b>Overall Access</b>												
26	Women's Toilet Room and Men's Toilet Room	1		Overall Access	Toilet Room

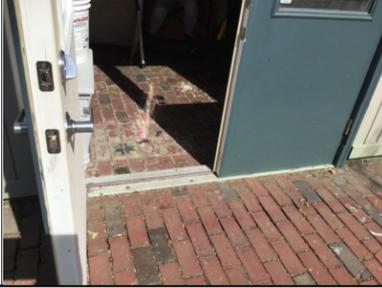
Clear width at door is < 32" Threshold not beveled	29"3/4 -	Keep both doors open as needed to provide program access. Bevel threshold.  See Catalog for Artist's Row #5 for egress sign.	1	113	\$113

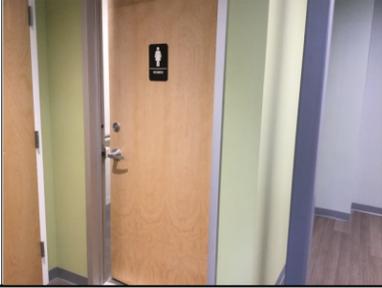
International Symbol of Acc. not provided	-	Provide a sign with the International Symbol of Accessibility.	1	174	\$174
<b>Dispensers</b>												
31	Men's	1		Dispensers	Paper Towel Dispenser

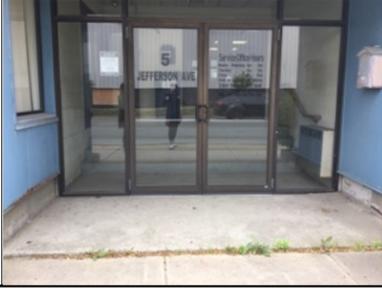
Directional sign to accessible entrance not provided	-	Provide a directional sign indicating the location of the nearest accessible entrance.	1	260	\$260
<b>Emergency Exit</b>												
6	5 Jefferson Street Egress After Stairs	1		Emergency Exit	N/A

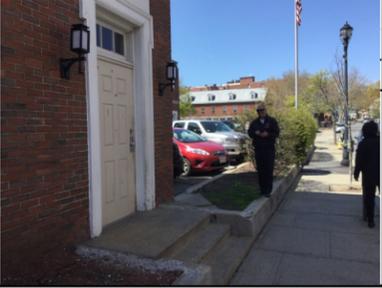
Entrance not on an accessible route Directional sign to accessible entrance not provided Hardware not operable with a closed fist	- - -	Provide a directional sign indicating the location of the nearest accessible entrance. Provide hardware that can be operable with one hand and not require tight grasping, pinching, or twisting of the wrist.	1	623	\$623
<b>Emergency Exit</b>												
7	Main Entrance and Exit to Staff Parking	1	101	Emergency Exit	N/A

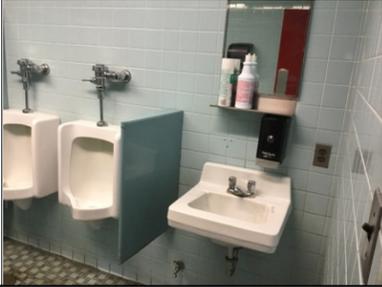
Plumbing underneath is exposed Mirror above lavatory w/reflective surface > 40"	- 53"	Insulate or otherwise configure pipes to prevent contact, for at least one lavatory. Lower mirror so that the bottom surface is at 40" max. above finished floor.	1	261	\$261
<b>Urinal</b>												
15	Men's Toilet Room	1		Urinal	N/A

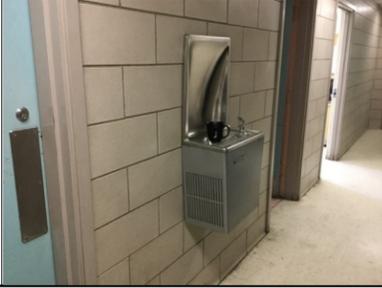
No drinking fountain provided for seated users	-	Provide an additional drinking fountain for seated users.  (Cost based on a new low wall mounted drinking fountain.)	1	3021	\$3021

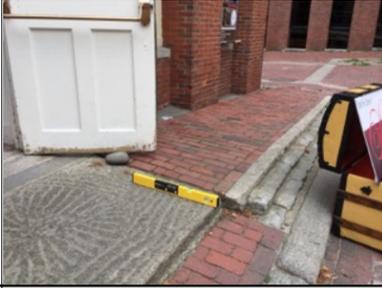
Exterior route < 36" wide	-	Ensure the right leaf is closed to maintain 36" min. width at the accessible route.	1	-	\$0
2	Old Town Hall - North Side	Ext.		Exterior Access Route	Sidewalk

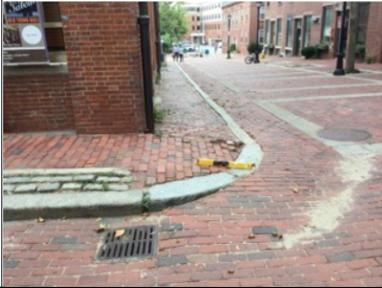
Route not maintained in operable working condition	-	Ensure the accessible route is maintained in operable working conditions.	1	-	\$0
<b>Access to Goods and Services</b>												
<b>Means of Egress</b>												
3	Exit - Near Elevator	1		Means of Egress	N/A

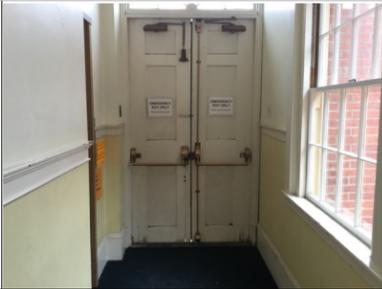
Emergency exit not on an accessible route Directional sign to accessible emergency exit not provided	- -	Provide a directional sign indicating the location of the nearest emergency exit.	2	174	\$348

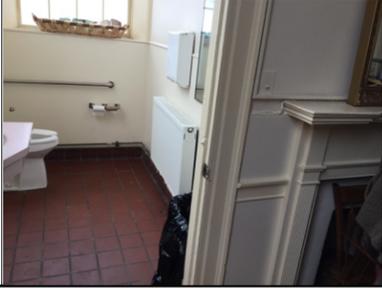
Not provided	-	Provide a sign with raised characters duplicated in braille. Locate sign on the wall adjacent to the latch side of the door. Add the International Symbol of Accessibility (ISA).	1	174	\$174
<b>Assembly Area</b>												
16	Great Hall	2		Assembly Area	N/A

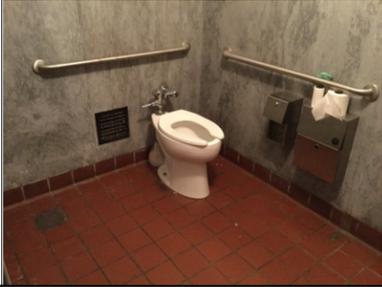
Door has malfunctioning self-closing hinge	-	Repair hinge.	1	Labor	\$0
<b>Dispensers</b>												
20	Women's Toilet Room	B		Dispensers	Tampon Dispenser

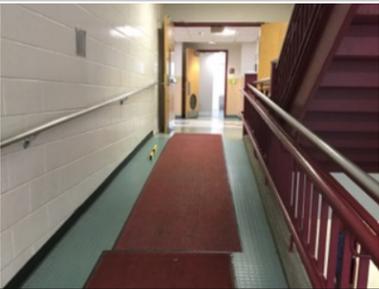
Running slope >1:12 (8.33%) Mat not securely attached	9.8% -	Repair to this ramp might be technically infeasible. Securely attach mat.	1	Labor	\$0

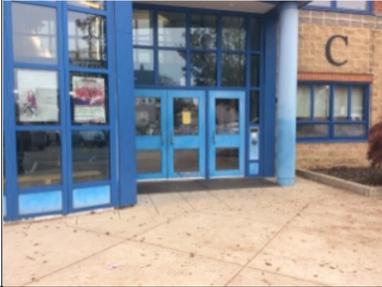
Mat not securely attached Automatic door opener not operable	- -	Securely attach mat. Ensure automatic door opener is on and maintained in operable working condition.	1	Labor	\$0

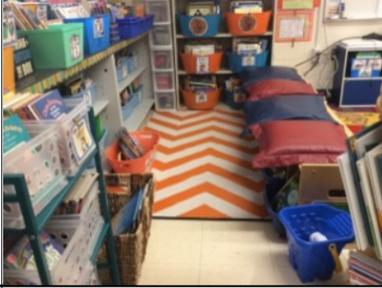
Route < 36" wide Mat not securely attached	26.25" -	Ensure that a clear width of 36" min. is maintained at the accessible route. Securely attach mat.	1	Labor	\$0
16	Main Office	1	164	Interior Access Route	N/A

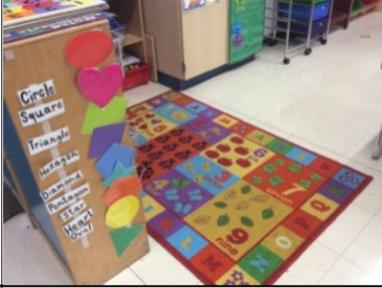
Mat not securely attached	-	Securely attach mat.	4	Labor	\$0
21	Inclusion Classroom	2	260	Interior Access Route	N/A

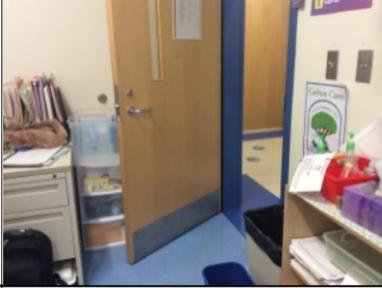
Maneuvering clearance(s) not provided	-	Remove clutter behind door and in the maneuvering clearance.	1	Labor	\$0
31	Classrooms Throughout School	1	127, 252, 227, 222	Doors, Doorways, & Gates	Classroom

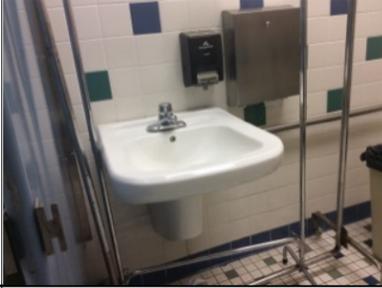
Clear floor space not provided at lavatory	-	Provide at least one lavatory with a 30" min. by 48" min. clear floor space positioned for a forward approach. Relocate stored items/coat rack.	1	Labor	\$0
61	Boys' Toilet Room	1		Lavatory	N/A

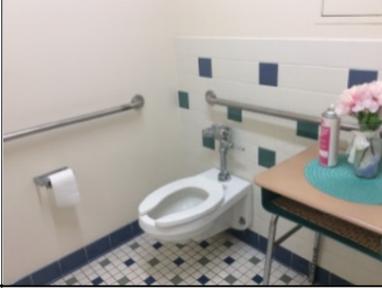
Clearance at toilet < 60" clear width	-	Provide a clear floor space that is 60" wide min. and/or provide sign to accessible toilet. (Relocate desk.)	1	Labor	\$0
66	Women's Staff Toilet Room	2		Single-User Toilet	N/A

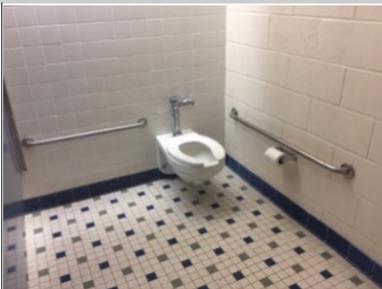
Door has malfunctioning self-closing hinge Rear grab bar < 42" long	- 30"	Repair hinge. Provide a rear wall grab bar that is 42" long min. and extends from the toilet 12" min. on one side and 24" min. on the other side (open side).  <b>Note:</b> The rear grab bar is not compliant but is usable.	1	Labor	\$0

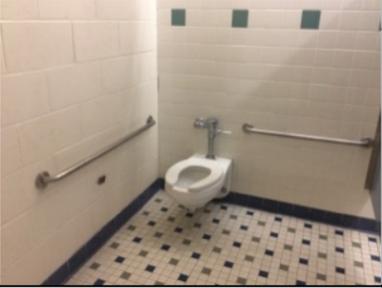
Door has malfunctioning self-closing hinge Rear grab bar < 42" long	- 30"	Repair hinge. Provide a rear wall grab bar that is 42" long min. and extends from the toilet 12" min. on one side and 24" min. on the other side (open side).  <b>Note:</b> The rear grab bar is not compliant but is usable.	1	Labor	\$0
71	Girls' Toilet Room	2		Toilet Compartment	Accessible Compartment

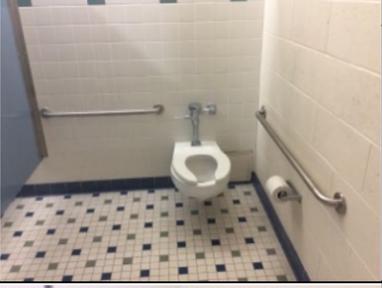
Door has malfunctioning self-closing hinge Rear grab bar < 42" long	- 30"	Repair hinge. Provide a rear wall grab bar that is 42" long min. and extends from the toilet 12" min. on one side and 24" min. on the other side (open side).  <b>Note:</b> The rear grab bar is not compliant but is usable.	1	Labor	\$0
72	Boys' Toilet Room in Gym	1	157	Toilet Compartment	Accessible Compartment

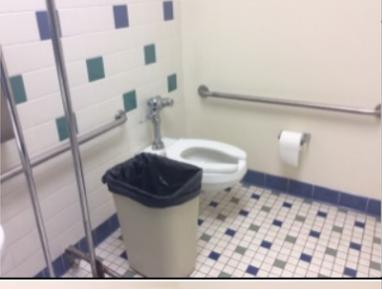
Door has malfunctioning self-closing hinge Clearance at toilet < 60" clear width	- -	Repair hinge. Relocate trash can and coat rack out of clear floor space at toilet.  <b>Note:</b> Where a flushometer prevents the location of a 42 inch grab bar, a 36" grab bar is permitted under 521 CMR (MAAB) 30.8.2. The rear grab bar in this instance is 36" long and therefore is compliant.	1	Labor	\$0

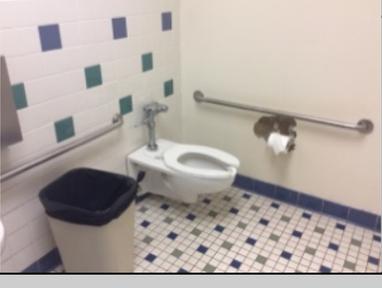
Door has malfunctioning self-closing hinge Clearance at toilet < 60" clear width	- -	Repair hinge. Relocate trash can out of clear floor space at toilet.  <b>Note:</b> Where a flushometer prevents the location of a 42 inch grab bar, a 36" grab bar is permitted under 521 CMR (MAAB) 30.8.2. The rear grab bar in this instance is 36" long and therefore is compliant.	1	Labor	\$0
<b>Shower Compartment</b>												
74	Health Suite, Bathing Room	1	170	Shower Compartment	Roll-In Type

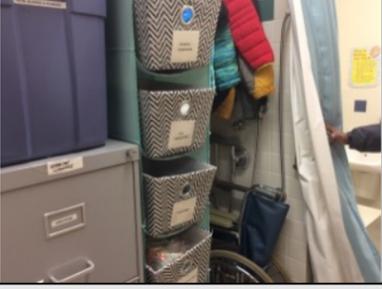
Not maintained in operable working condition	-	Ensure shower compartment is maintained in operable working condition. Relocate storage.	1	Labor	\$0
<b>Toilet Rooms for Children</b>

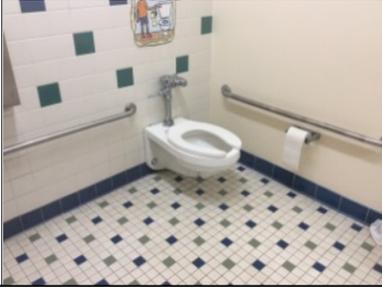
Side or rear grab bar < 42" long	36"	<b>Note:</b> Where a flushometer prevents the location of a 42 inch grab bar, a 36" grab bar is permitted under 521 CMR (MAAB) 30.8.2. The rear grab bar in this instance is 36" long and therefore is compliant.	1	0	\$0
<b>Additional Access</b>												
<b>Drinking Fountains</b>												
76	Gym	1	157	Drinking Fountains	N/A

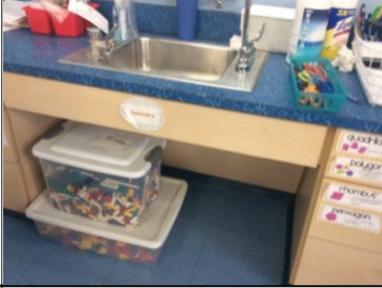
Clear floor space not provided at sink Toe and knee clearances not provided	- 23.5"	Provide a 30" by 48" clear floor space positioned for a forward approach by removing clutter. Ensure there is a 25" knee clearance positioned for a forward approach.	1	1265	\$1265
80	Art Room	2	213	Sink	Classroom

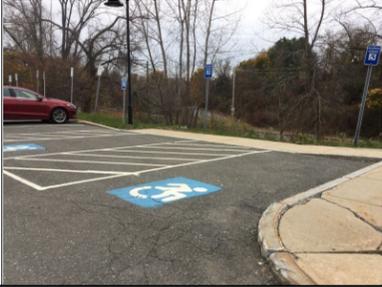
Total # of parking Total # of designated accessible parking spaces Sign does not have the designation "Van Accessible"	79 3 -	Provide One additional car parking space. Add the designation "Van Accessible" to the sign located at the van accessible space.	1	925	\$925
<b>Entrance</b>												
7	Robert J. Geswell Athletic Field	Ext		Entrance	Gate

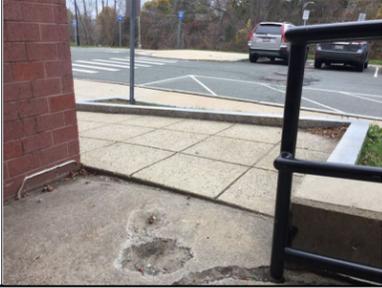
Level changes > 1/4"	-	Alter change in level to be 1/4" high max.	1	155	\$155
<b>Access to Goods and Services</b>												
<b>Means of Egress</b>												
12	Exit #10, Near Room 172	1		Means of Egress	N/A

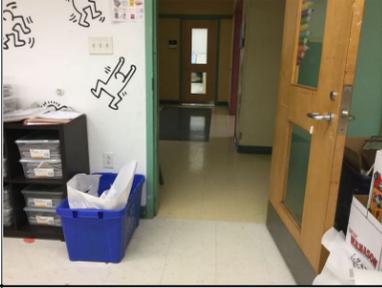
Maneuvering clearance(s) not provided	-	Relocate trash bin to maintain the maneuvering clearance at the door.	1	Labor	\$0
37	Occupational Therapists Office	3	366	Doors, Doorways, & Gates	Office

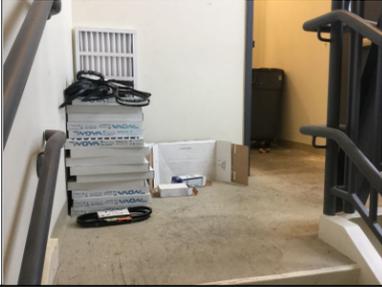
Not maintained in operable working condition	-	Ensure stairs are maintained in operable working condition.	1	Labor	\$0
<b>Elevator</b>												
47	Elevator	1		Elevator	Interior

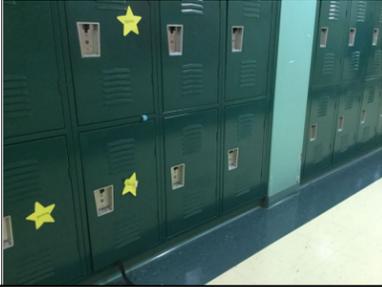
Total # of locker Total # of accessible locker 2% of lockers are not accessible	612 0 -	Provide at least 1 accessible locker (or ensure 2% of all lockers are accessible) .	1	330	\$330
<b>Picnic Tables</b>												
72	Near Garden	Ext		Picnic Tables	N/A

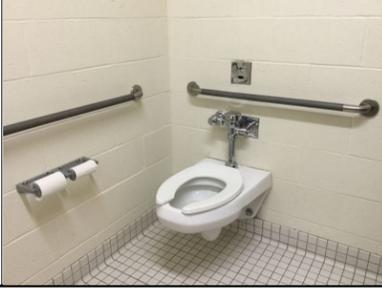
Side grab bar < 42" long Rear grab bar < 42" long	38" 39"	Provide a side wall grab bar that is 42" long min. located 12" max. from the rear wall. Provide a rear wall grab bar that is 42" long min. and extends from the toilet 12" min. on one side and 24" min. on the other side (open side).	2	674	\$1348
<b>Toilet Compartment</b>												
81	Boys' Multi-User Toilet Room <b>No Door</b>	3		Toilet Compartment	Accessible Compartment

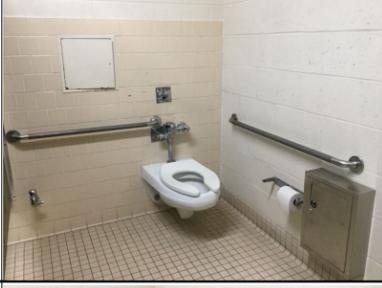
Door has non-compliant hardware Door has malfunctioning self-closing hinge	- -	Provide hardware that can be operable with one hand and not require tight grasping, pinching, or twisting of the wrist. Repair hinge.	1	18	\$18

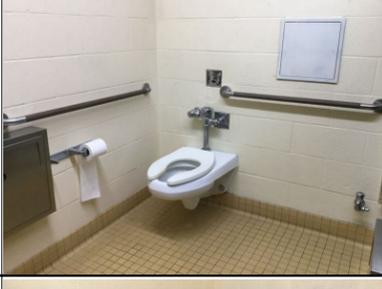
Door has malfunctioning self-closing hinge	-	Repair hinge.	1	Labor	\$0
84	Girls' Multi-User Toilet Room	3		Toilet Compartment	Accessible Compartment

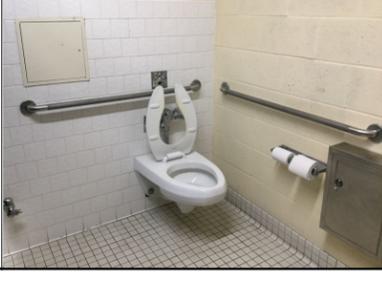
Door has malfunctioning self-closing hinge	-	Repair hinge.	1	Labor	\$0

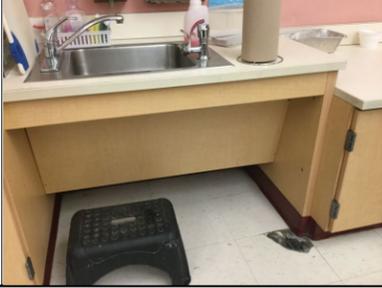
Parallel clear space not provided (5 yrs. old or younger)	-	Relocate step stool to maintain the clear floor space at the sink.	1	Labor	\$0
<b>Play and Sport Areas</b>												
<b>Play Areas</b>												
105	Playground Southeast Side of School	Ext		Play Areas	N/A

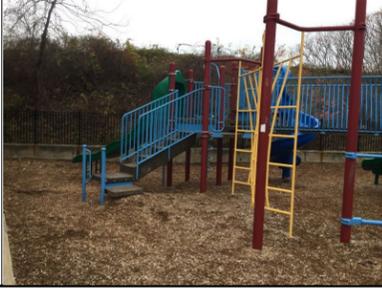
Not connected to an accessible route	-	Provide an accessible route around the playground.  (Cost based on 210' of 4' wide asphalt path around playground.)	1	5355	\$5355
<b>Benches</b>												
110	Playground Near Kindergarten Wing	Ext		Benches	N/A

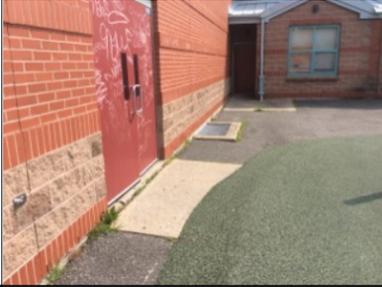
Maneuvering clearance(s) not provided Threshold > 1/2" high	- 2.5"	While not technically compliant, this exit could still be usable if the threshold is altered. Alter threshold to be 1/2" high max.	1	155	\$155
17	Exit #21	Ext.		Emergency Exit	N/A

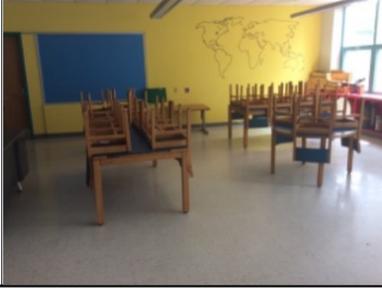
Knee or toe clearance not provided	23"	Provide at least 1 work surface with 25" min. knee and toe clearance.	1	525	\$525
<b>Picnic Tables</b>												
67	Near Playground West Side	Ext.		Picnic Tables	N/A

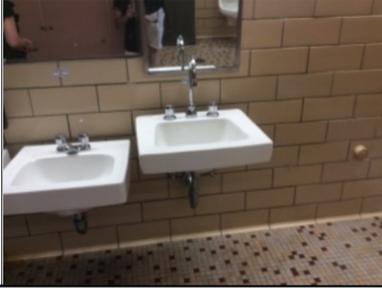
Plumbing underneath is exposed Mirror above lavatory w/reflective surface > 40"	- 43"	Insulate or otherwise configure pipes to prevent contact, for at least one lavatory. Lower mirror so that the bottom surface is at 40" max. above finished floor.	1	261	\$261
<b>Single-User Toilet</b>												
77	Women's Toilet Room Near Library	1		Single-User Toilet	N/A

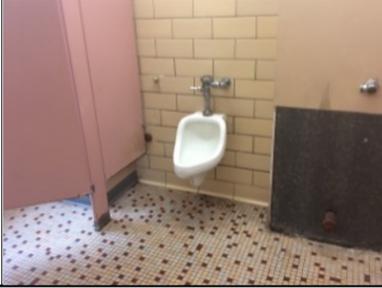
Rim > 15" high (MAAB)	20"	Provide at least one urinal with the rim no higher than 15" above the finished floor.	1	2436	\$2436
<b>Toilet Rooms for Children</b>												
<b>Single-User Toilet</b>												
87	Girls' Toilet Room in Classroom	1	B115	Single-User Toilet	N/A

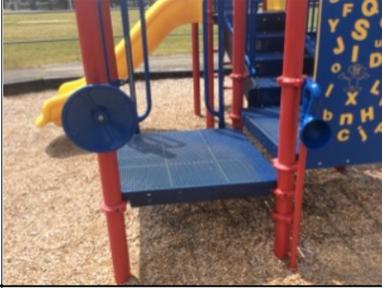
No compliant transfer system	-	Alteration might be technically infeasible.	1	-	\$0
101	Kindergarten Playground	Ext.		Play Areas	N/A

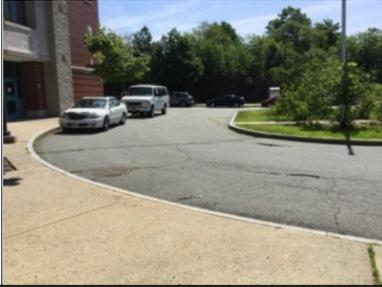
Zone not connected to an accessible route		Ensure the passenger loading zone is connected to an accessible route.	1	2800	\$2800
<b>Entrance</b>												
11	Exit #13 - West Side	Ext.		Entrance	Secondary Entrance

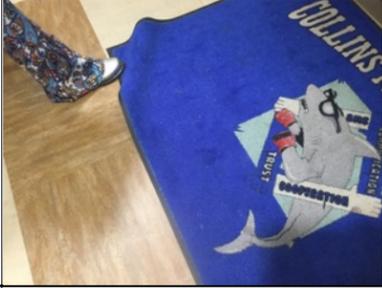
Mat not securely attached	-	Ensure walk-off mat is securely attached.	1	Labor	\$0
40	Classroom	3	301	Interior Access Route	N/A

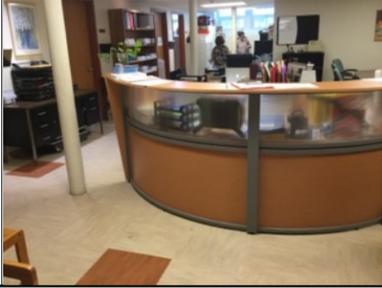
Counter > 36" high	44.5"	Provide a counter that is 36" max. above the ground or finished floor.	1	660	\$660
<b>Dining or Work Surfaces</b>												
79	Classroom	4	434	Dining or Work Surfaces	Work Surface

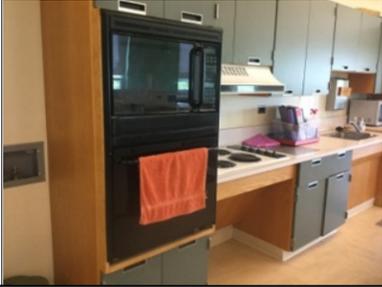
Retractable bread board not provided	-	Provide a retractable bread board adjacent to the door.	1	305	\$305
<b>Toilet &amp; Bathing Rooms</b>												
<b>Overall Access</b>												
98	Boys' Toilet Room - Near Cafeteria	1		Overall Access	Toilet Room

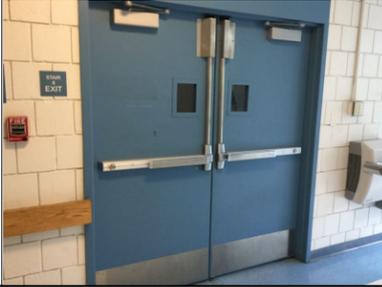
Directional sign to accessible emergency exit not provided	-	Provide directional signs indicating the location of the nearest emergency exits.	30	174	\$5220
<b>Interior Access Route</b>												
72	Latin Classroom, Route to Connecting Classroom	3	335	Interior Access Route	N/A

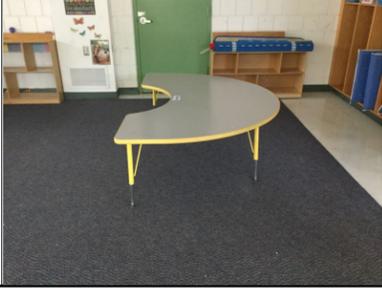
Mat not securely attached	-	Securely attach mat.	1	Labor	\$0
<b>Doors, Doorways, &amp; Gates</b>												
107	Door Between Rooms 328 and 329	3	328-329	Doors, Doorways, & Gates	Circulation

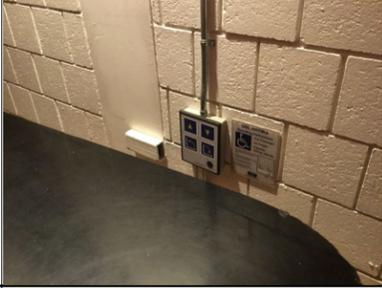
Visual characters < 40" above ground	37"	Mount visual sign so that the baseline of the lowest character is 40" min. above finished floor.	1	Labor	\$0
182	Instructional Media Center	3	355	Signage	Designation

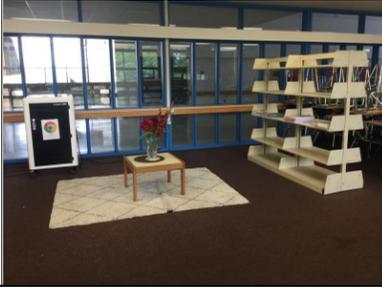
Card catalogs and magazine displays > 48" high	55"	Locate card catalogs and magazine displays 48" max. above the finished floor.	1	530	\$530
<b>Check-Out Aisles &amp; Retail Areas</b>												
292	School Store	2	251	Check-Out Aisles & Retail Areas	N/A

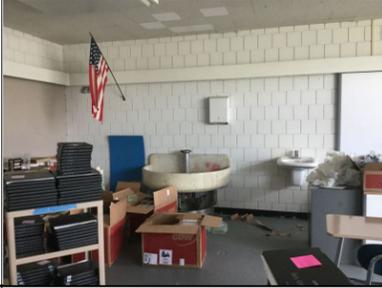
Dispenser not within reach range	-	Relocate dispenser 48" max. above the finished floor or ground.	1	530	\$530
371	Wood Shop	1	174	Sink	Classroom

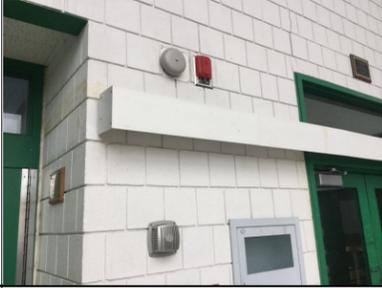
No visible fire alarm provided within room	-	When fire system is updated, ensure that a visible fire alarm is installed in each room.	1	519	\$519
381	Speech	2	256	Fire Alarms	Classroom
