# Phase II Report for the South River Drainage Improvement Project

Project No: 218953.02  
April 2011

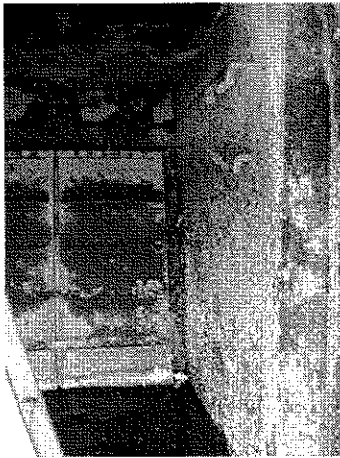
**Photo 3 – South Tide Gate Spall:** A small concrete spall was present at the north edge of the south tide gate. The surrounding concrete appeared to be sound.

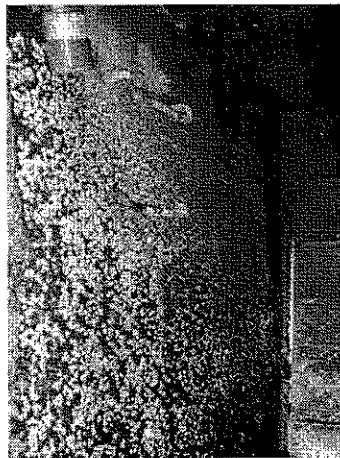
**Photo 4 – Climbing Rungs at South Tide Gate:** The climbing rungs from the upper hatch to the tide gates are damaged and unusable.

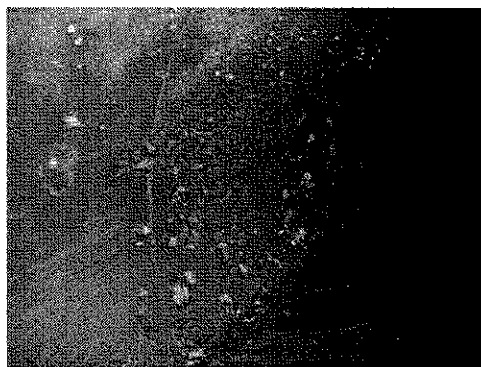
**Photo 9 – Crack on Header Above North Tide Gate:** A crack in the concrete starts at the upper left corner of the header and extends down and to the right looking at Photo #9.

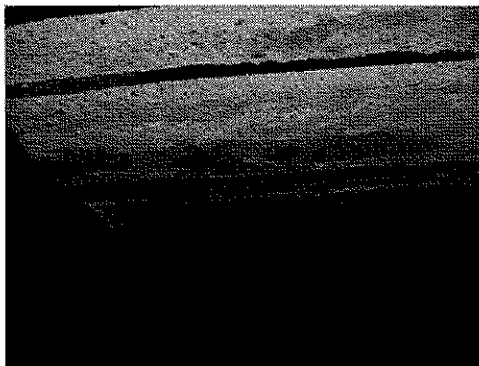
**Photo 10 – Concrete Fines Washout at 72" Diameter Pipe Behind Tide Gates**

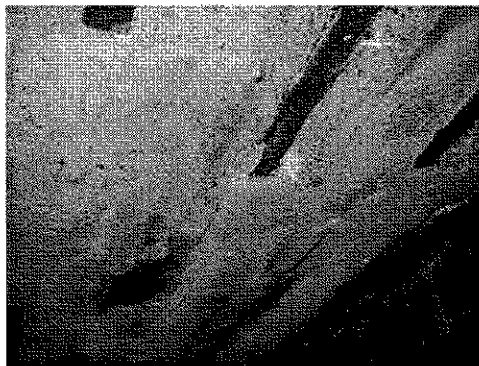
**Photo 12 – Overall Photo of Chamber Roof Behind Tide Gates:** Approximately half of the ceiling surface is spalled. The remaining surface exhibits staining and shadows of the embedded steel sections contained within the concrete. The staining could indicate active corrosion of the embedded steel sections.

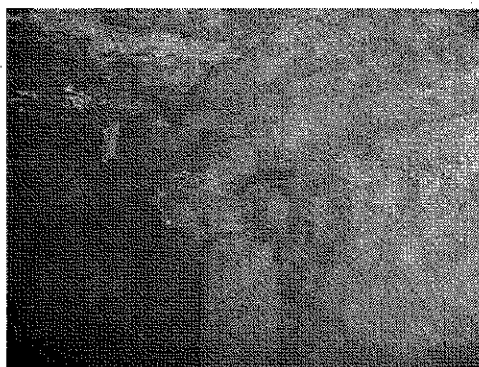
**Photo 13 – Typical Condition of the Bottom Surface of the Chamber Ceiling:** Heavy corrosion of the steel sections has occurred and substantial pieces of concrete hang from the ceiling.

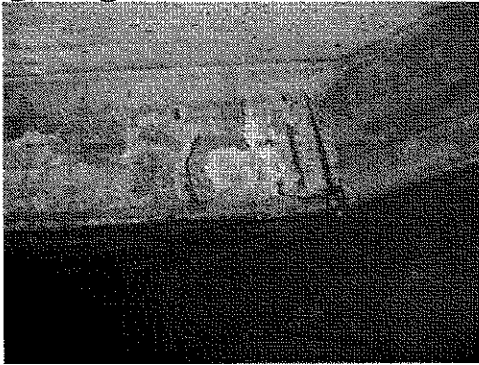
**Photo 14 – Typical Timber Beam:** The purpose of the existing timbers is unknown and the timbers are exhibiting varying levels of decay.

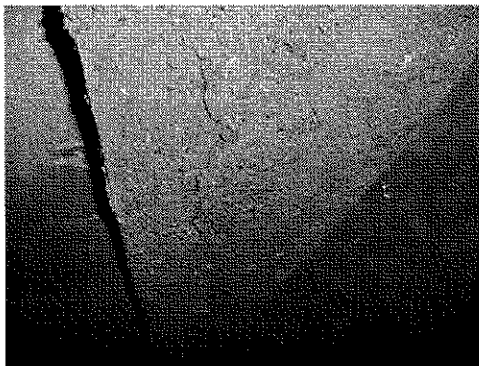
**Photo 15 – Exposed Reinforcing Bars on Cast in Place Concrete Roof Beams:**  
Inadequate concrete cover appears to be the cause of the initiated corrosion on the bars.

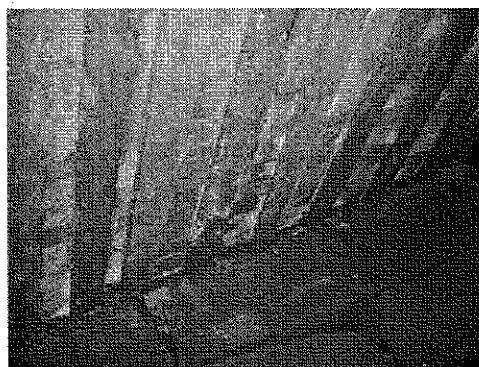
**Photo 17 – Fallen Granite Stones**

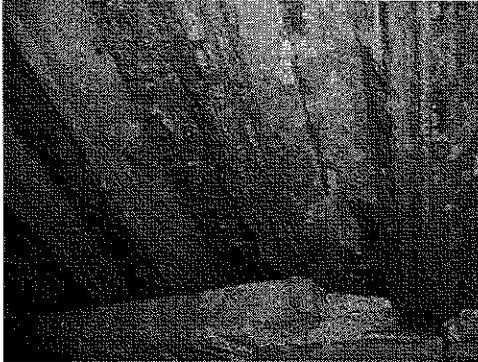
**Photo 18 – Corroding Steel Roof Beams with Red Brick Infill**

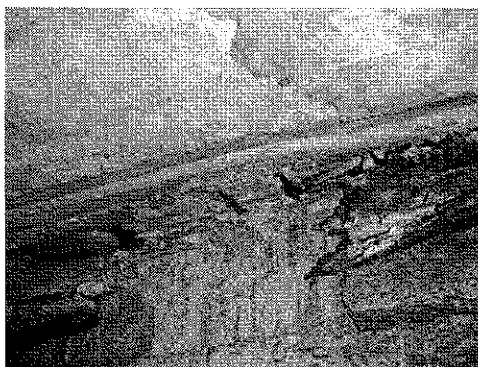
**Photo 21 – Corroding Embedded Steel at Station 14+60:** Although the steel sections have lost significant area due to corrosion the concrete infill appears to be sound.
