SALEM WILLOWS EXISTING CONDITIONS REPORT: HISTORIC RESOURCES

This report accompanies Phase One of the Salem Willows Park Existing Conditions Analysis prepared by HATCH, and includes:

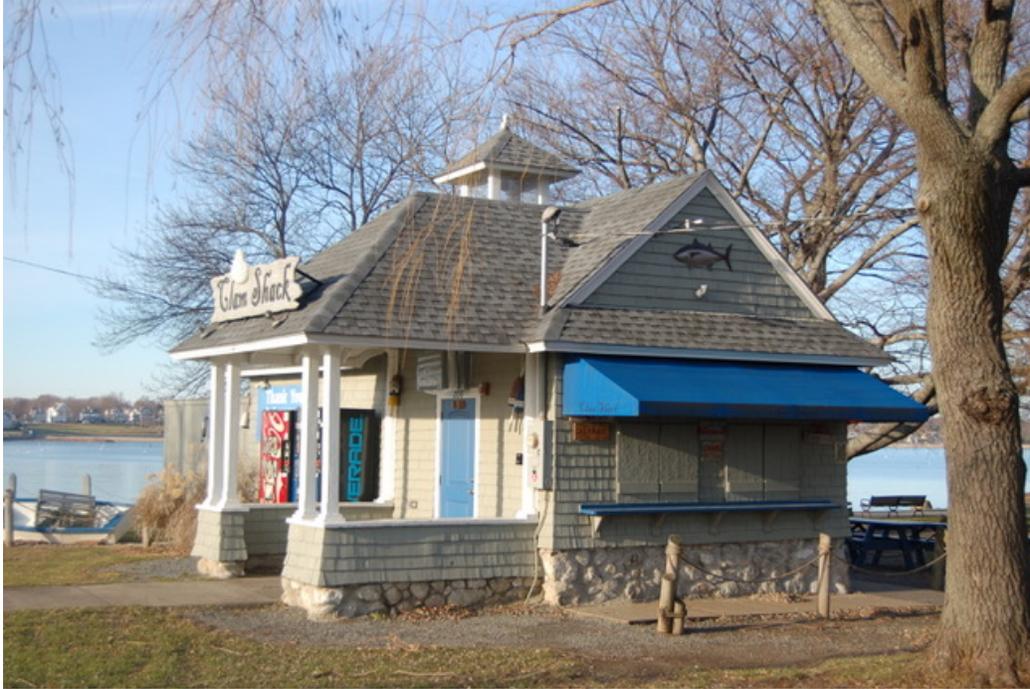
The interior was gutted for the new commercial use. Exterior modifications include changes to the east elevation windows, removal of the south windows, and the addition of a fabric canopy. The rubble foundation is original, as are the columns and cupola. Some shingles have likely been replaced over time, and the roof has been replaced several times.

Clam Shack, looking northwest. 2018

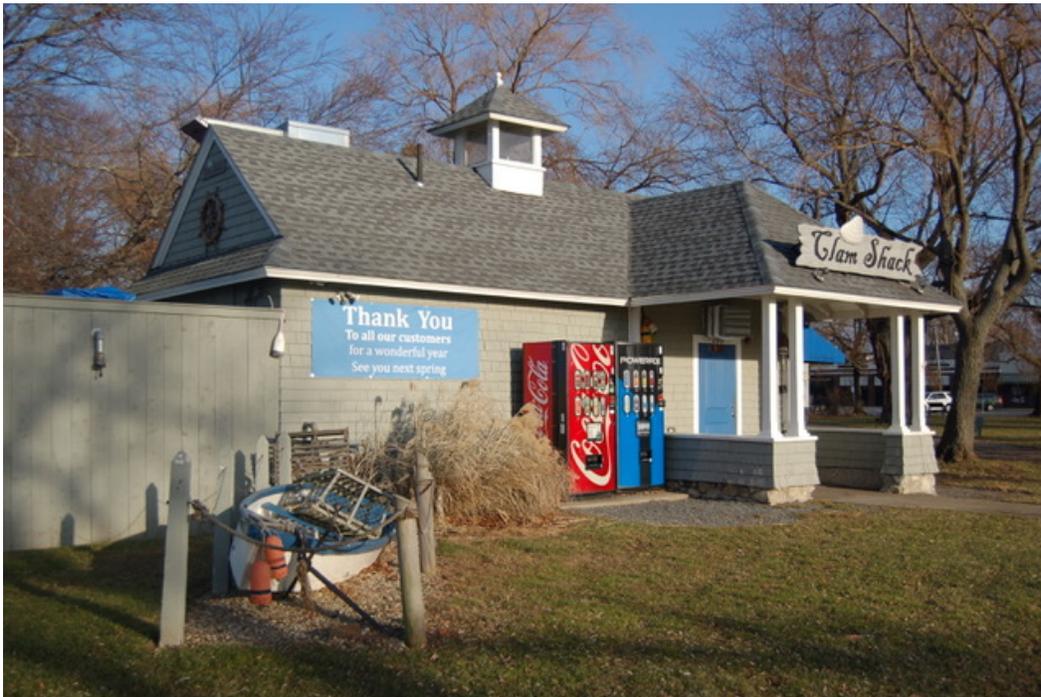
Notable are the exterior colors (taupe cladding with bright blue canopy and door) which depart from the historic dark green with white trim color scheme of the former Ladies Cottage and the Pavilions. Addition of commercial vending machines on the prominent south façade detracts from the visual integrity of the historic building.

South façade of Clam Shack, looking northeast. 2018

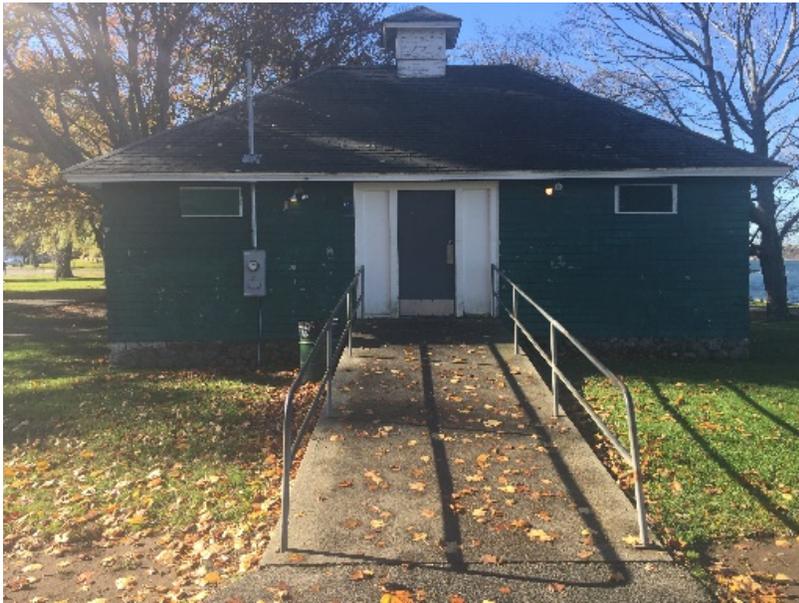
North elevation. In the 1950’s, glass block sidelights (now boarded up) were added on either side of the main entrance. A recently added concrete ramp with metal railings provides accessibility. 2018

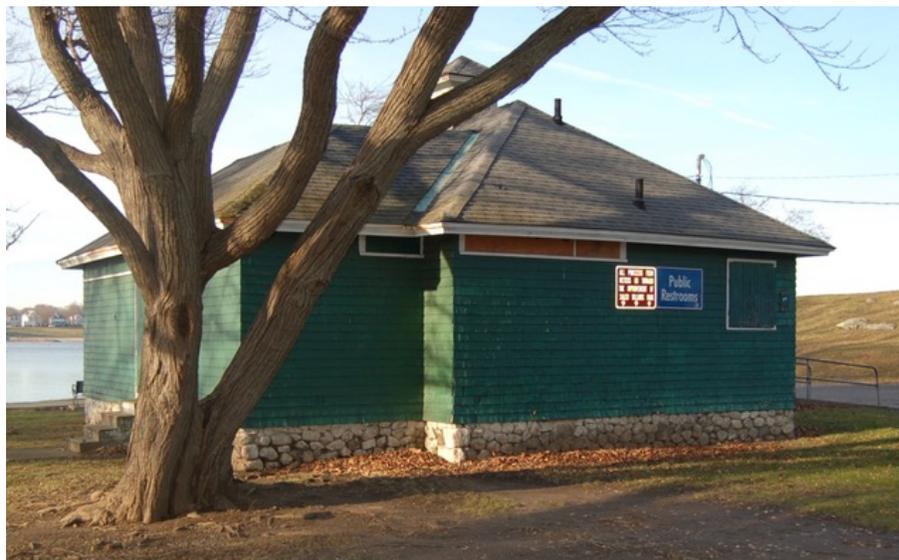
A 1924 extension to the south accommodated ten additional toilets. The addition was given the same foundation, cladding, window and hip roof treatment as the original. 2018

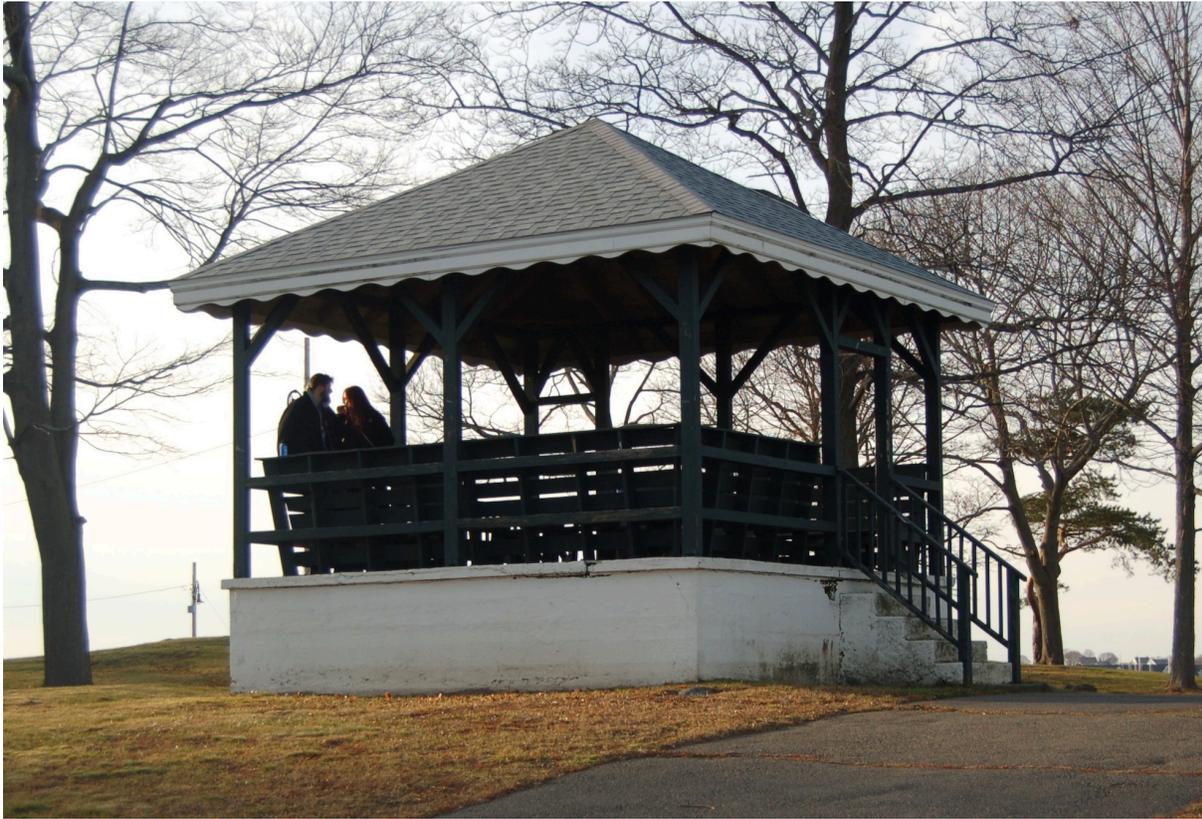
Currently, the pavilions maintain their original footprints, rooflines and Stick style construction. Replacement trim at the roofline attempts to replicate the historic 'sawtooth' style, but the current effect creates a less crisp reveal and punctuated silhouette. The pavilions have been repeatedly repaired and painted and re-roofed. The framing members have been replaced in kind.

The most significant alteration to the pavilions was the replacement of the wood floors with concrete, which necessitated concrete block footings to support new concrete floors. Originally, the wood structures sat directly on the ground on their framing posts, the floor raised slightly above the undulating ground of the hilly area of the Park, appearing lightly perched on the terrain. The heavy concrete foundations set into the landscape negate the airy, informal feeling of the all wood pavilions. The feeling of concrete underfoot, rather than floorboards, also affects an experience that was akin to the feeling of a "summer house." Open riser wood steps have been replaced with solid concrete block or poured steps.

6. Pavilion "B" (bandstand) with built in benches, modified 'pennant' trim, concrete floor and foundation, concrete steps and iron handrails. 2018

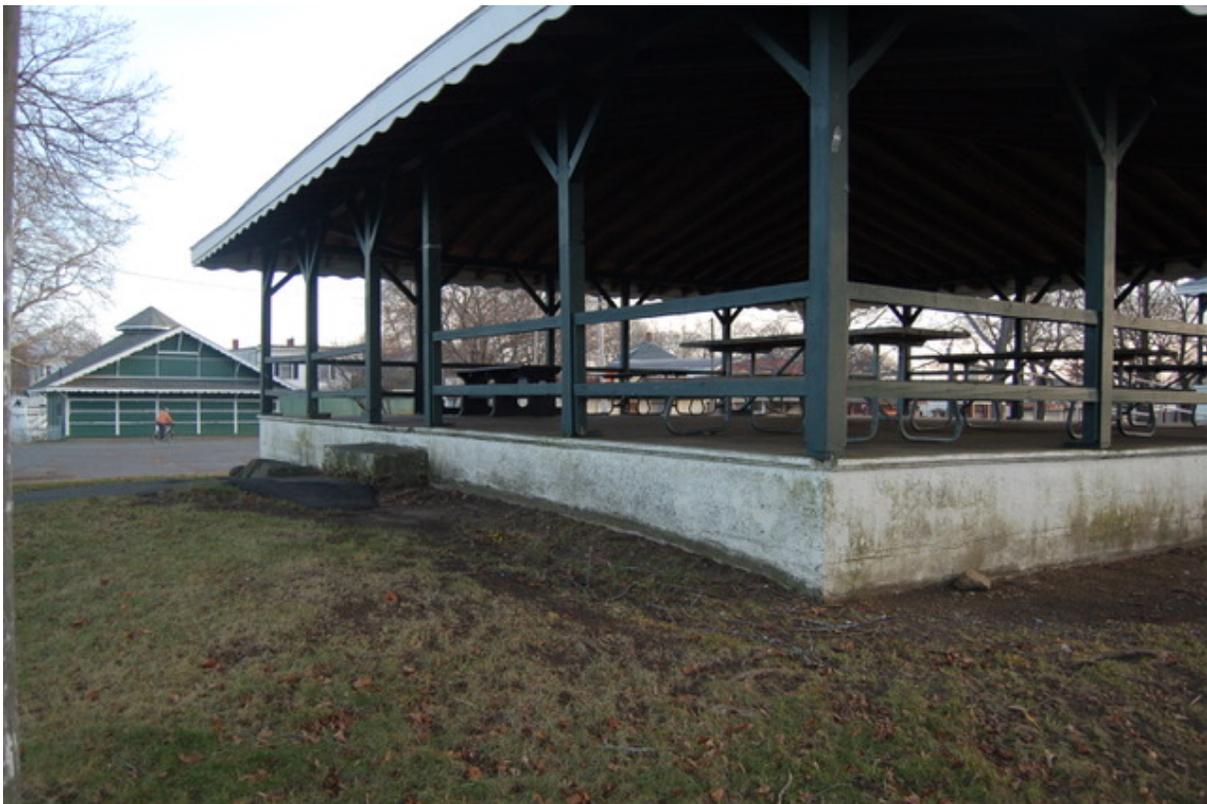
7. Pavilion "C"; detail of dripline surrounding base of Pavilion. 2018

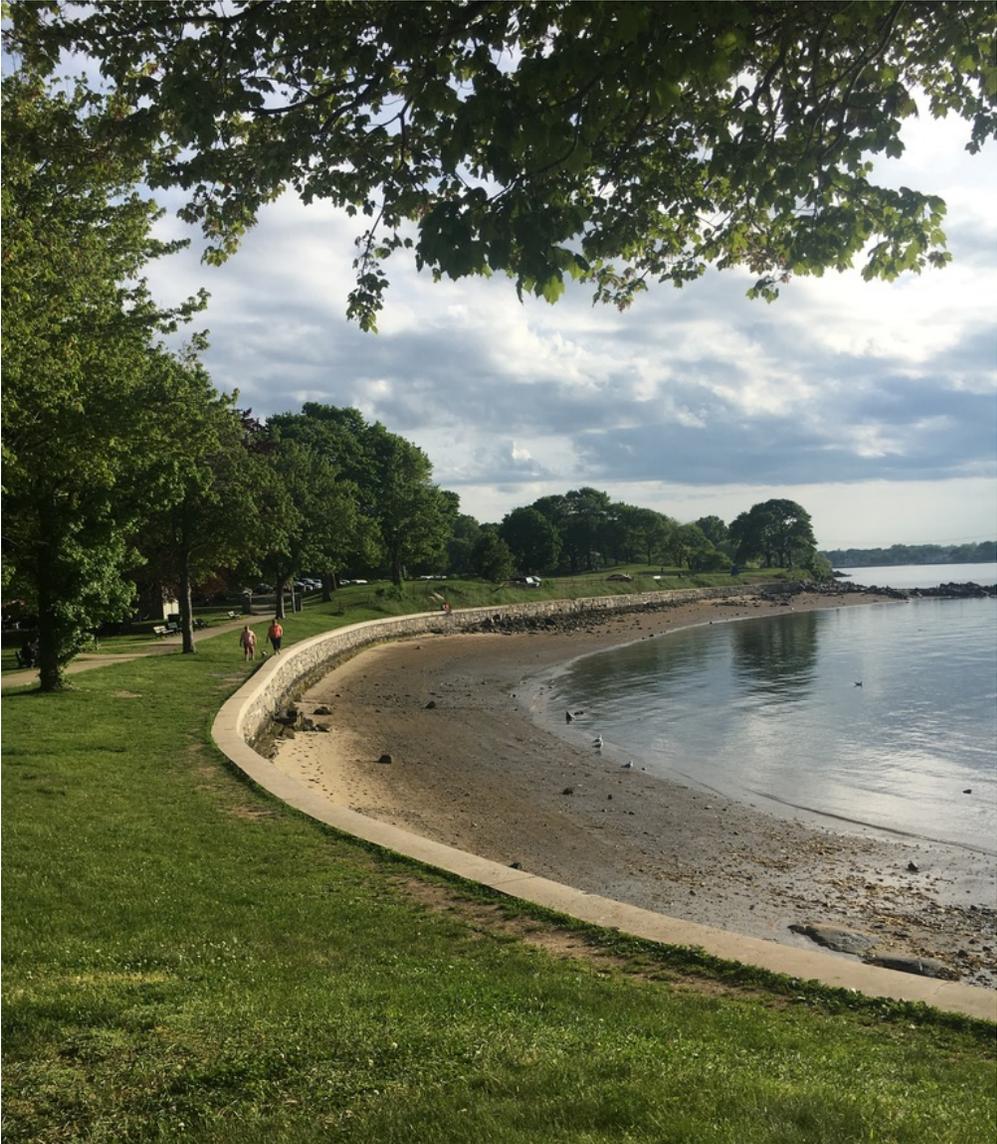
Sea Wall "B" looking south. 2018

2. Sea Wall "B": Clam Shack Beach. (ca. 1901) A mortared stone retaining wall which follows the curve of the shoreline, creating a defined waterfront edge. The historic wall is largely intact with some modifications including the addition of a concrete cap along the northern section. Historic mortared stone cap has been replaced at northern end with concrete cap. Stairs have been removed.

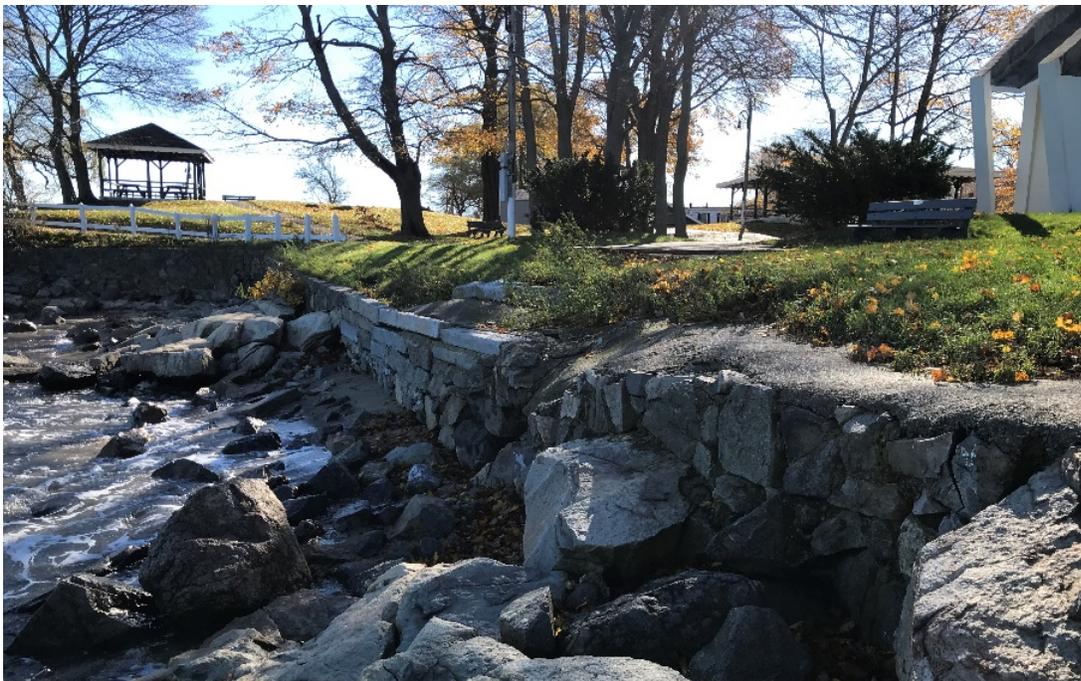
Sea Wall "C". 2018 Hatch

Sea Wall "C" is in a location which was historically a beach where boats landed and visitors gained access to the Park by water. Sea Wall "C" was likely created at a point in time when a hard edge retaining wall was needed to prevent erosion encroaching into the park from the wave action and tides in the most exposed point of the Park.

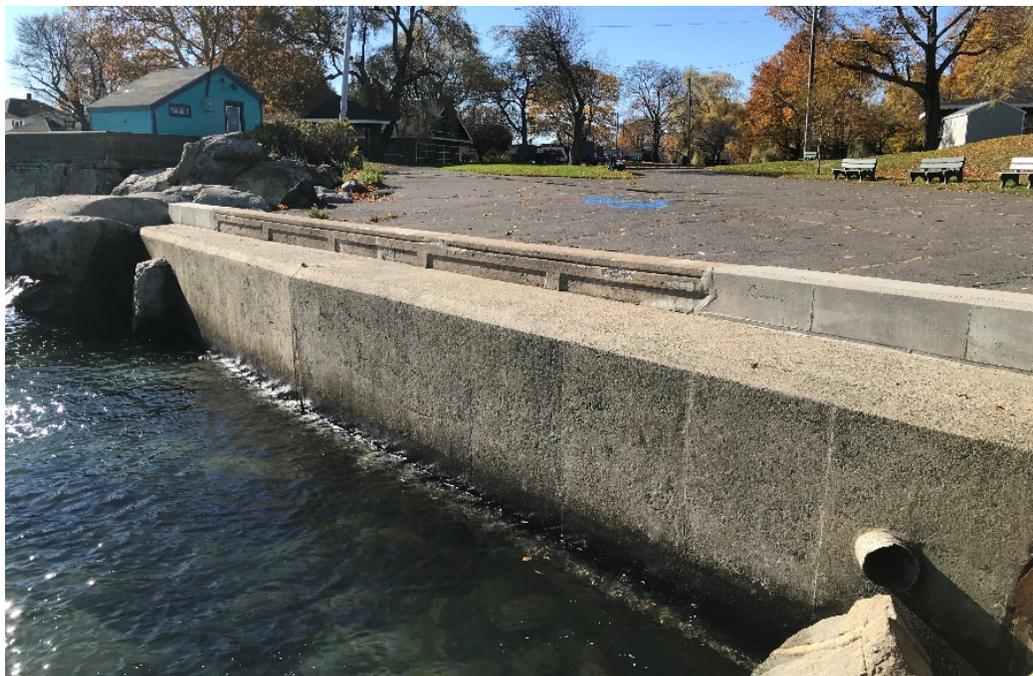
Sea Wall "D". 2018 HATCH

4. Sea Wall "D": Pier (1942) Originally a poured in place concrete wall with recessed panels (perhaps an attempt to replicate design of Sea Wall "E"), the wall has been extensively altered by extensions and widening with a series of concrete additions which have largely cover the original decorative concrete design.

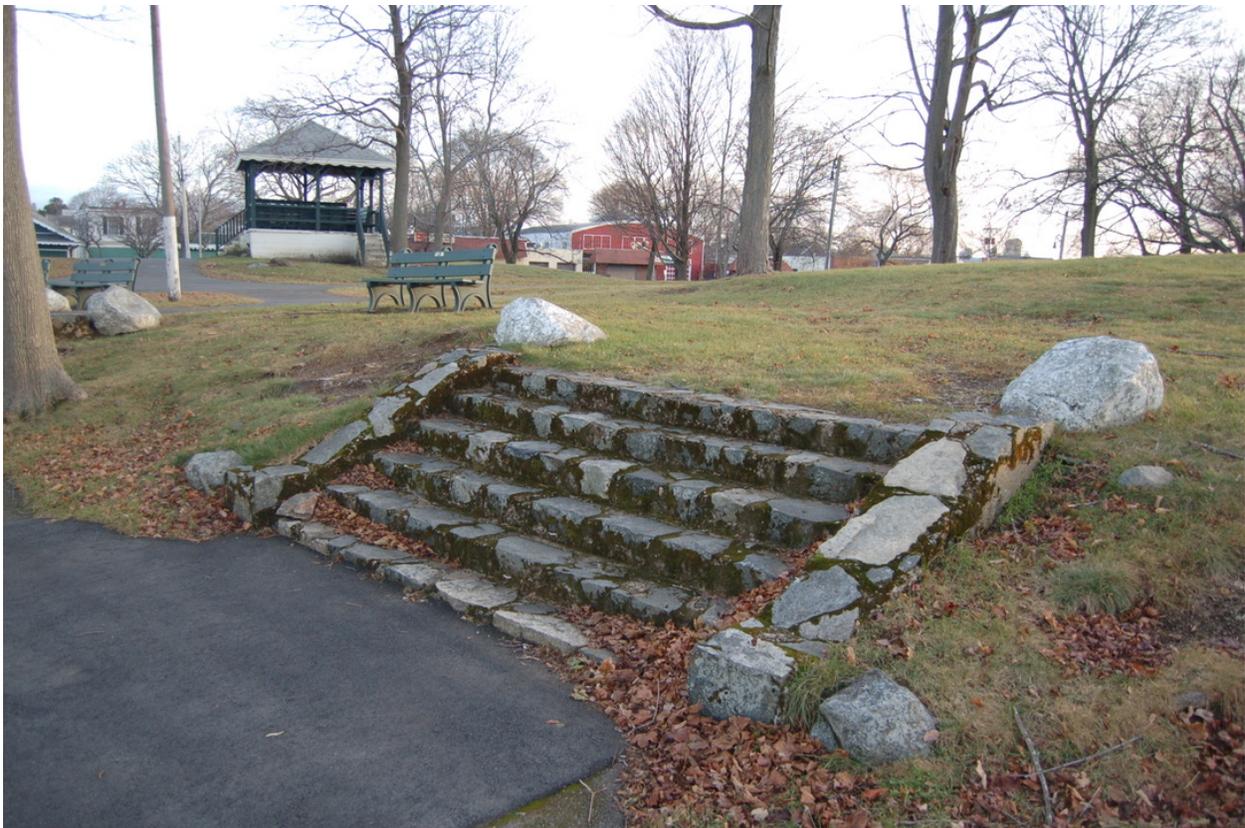
In 1923 a new outdoor amphitheatre/stage was built in the northwest portion of the site. A leveled area was created to accommodate audiences for the outdoor amphitheatre toward the northeast corner of the site. Two sets of dry-laid granite steps were built into the low slope at the outside the edge of the seating area. Steps are barely visible in the far left of historic postcard view, below. The granite steps are in excellent condition. Boulders painted white have been placed at the edges of the top of the steps to increase visibility.

Granite steps at perimeter of amphitheatre seating (one of a pair of steps.) 2018

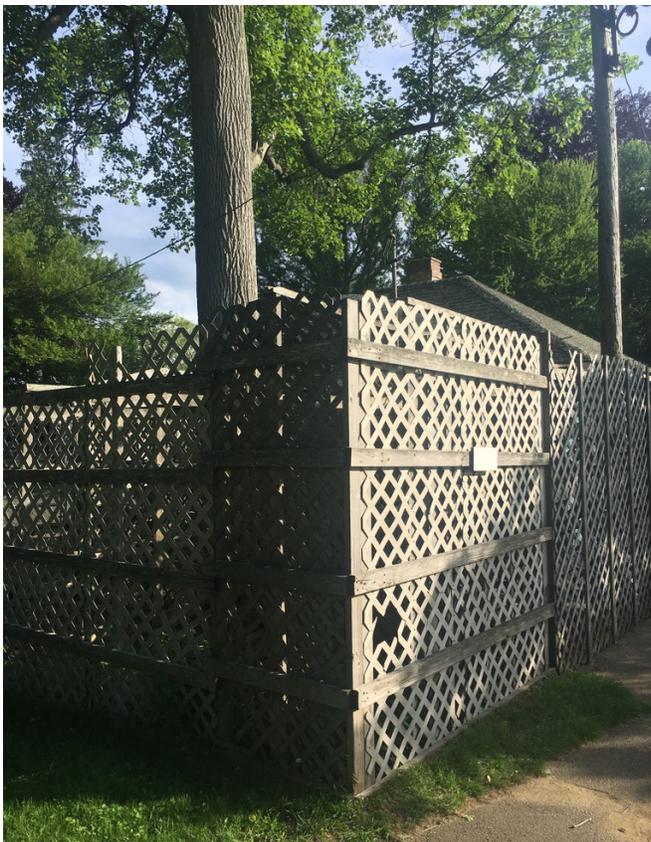
On the north side of the maintenance shed, a series of vertical lattices frame a storage area. 2018

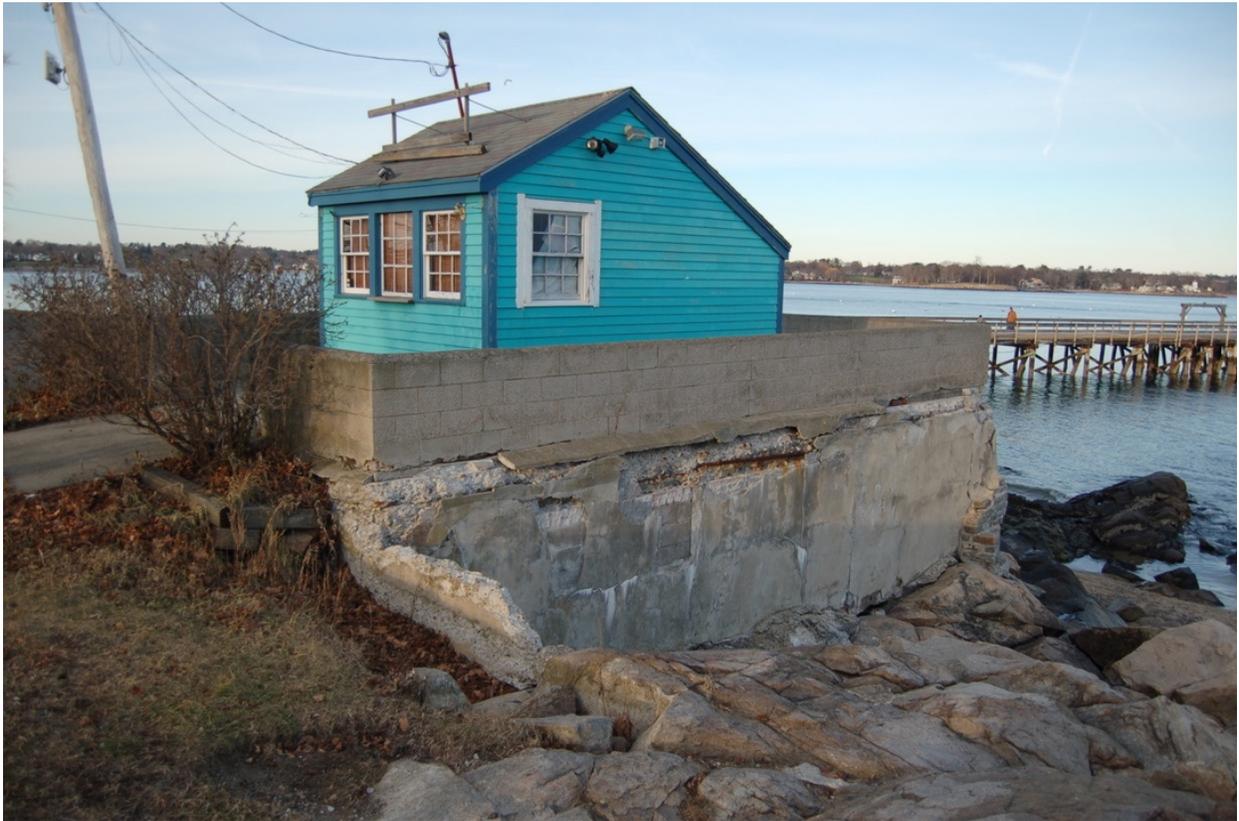
Looking northwest, south east corner of Hut; remains of bathhouse foundation. 2018

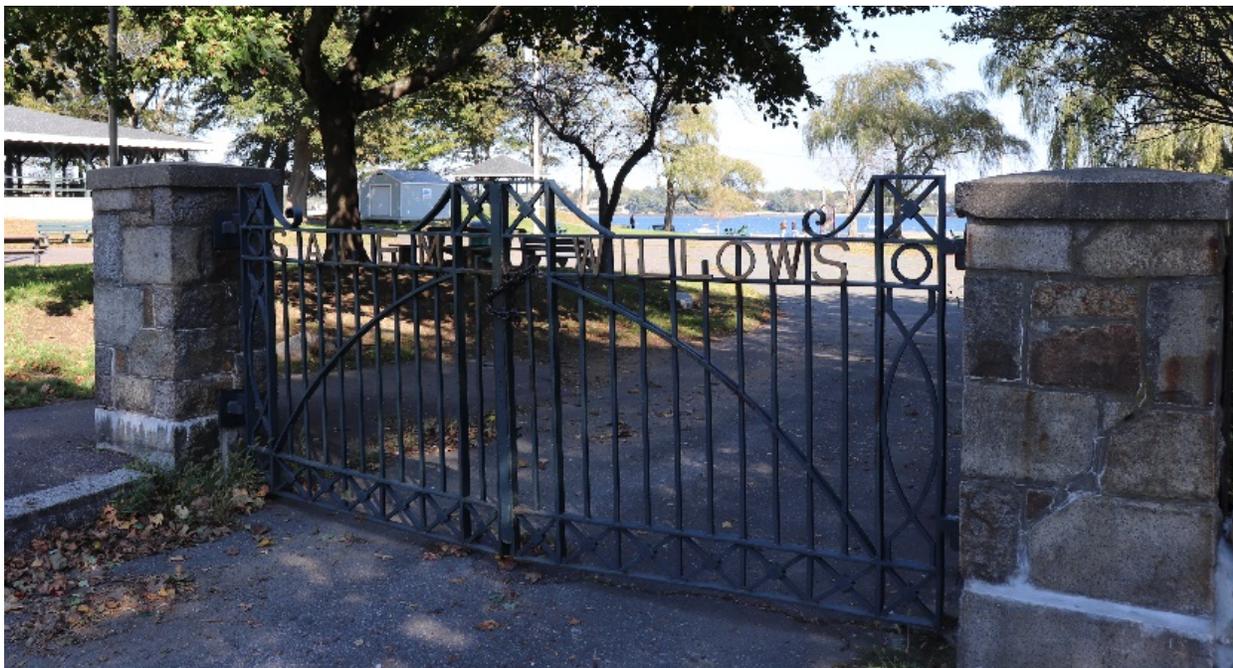
The five-foot high wrought iron gates are set between five-foot high concrete capped mortared fieldstone piers. The gates were erroneously listed as built in 1909 on the 1994 NRDIS

Gate, looking north, showing inconsistent treatment of mortars over time. 2018
