# Forest River Park Pool Evaluation-DRAFT

City of Salem, Massachusetts  
93 Washington Street  
Salem, MA 01970

JUNE 2017

## **ENGINEER'S REPORT**

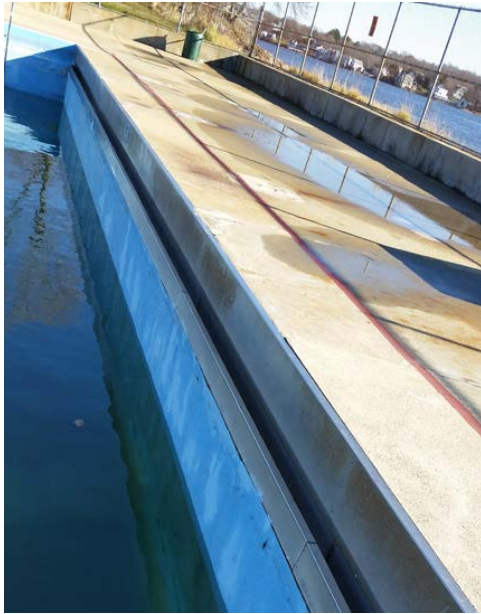
Figure D: Current Wall Conditions  
loss, structural failure has occurred.

There were no expansion joints or construction joints found in the concrete structure. There was no available information on the structure of the pool to determine wall and floor thicknesses and reinforcing. However, given several visible and leaking cracks in the pool wall along the reported water

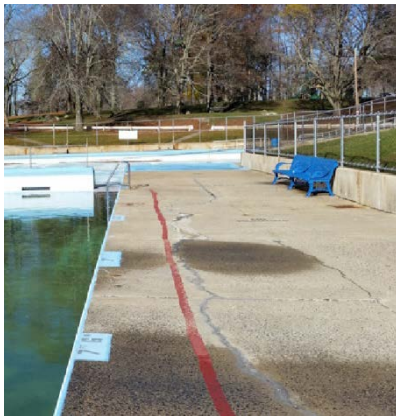
Figure E: Existing Pool Deck

The main swimming pool has an impervious concrete deck around the perimeter of the pool extending approximately 10 to 20 feet from the pool edge in some locations. There is an expansion joint between the edge of the pool wall and the edge of the concrete deck, as well as other various locations around the deck.

It appears that during the life span of the pool the deck has been repaired and patched in various locations. Painted depth markers are located around the edge of the perimeter of the pool.

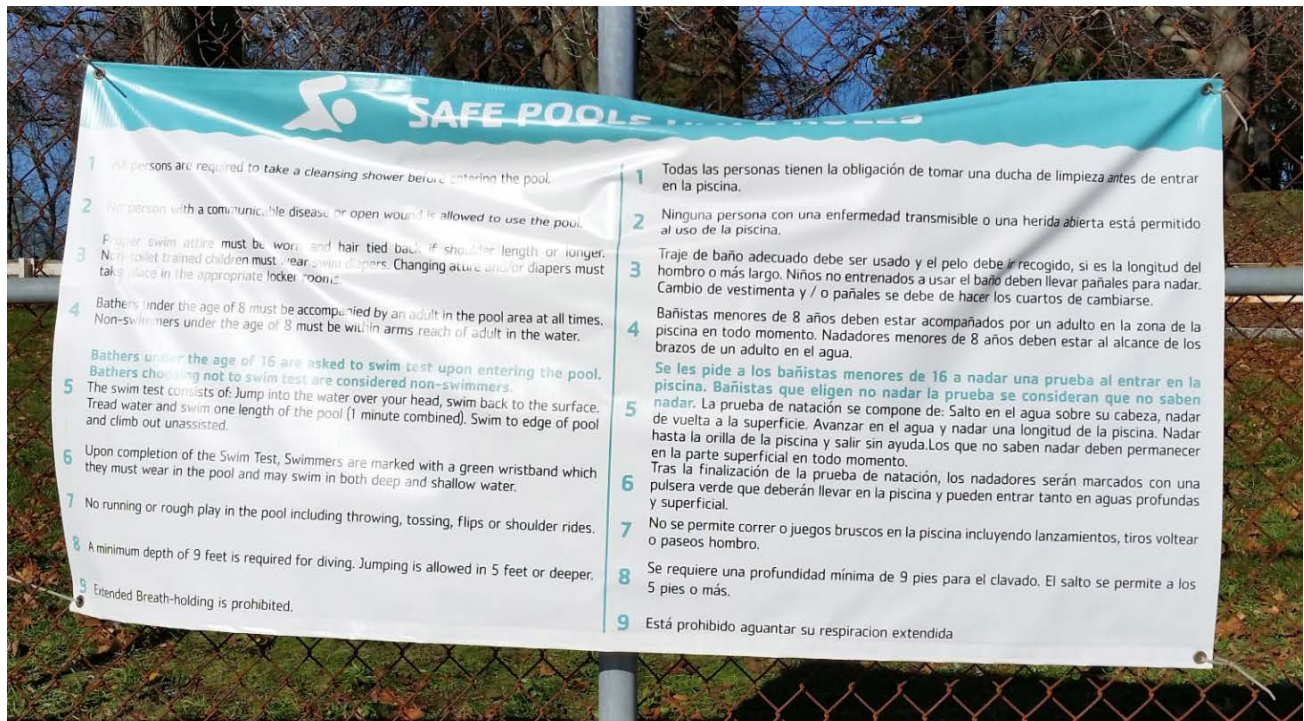
Existing Pool Rules Signage

Health and safety signs that are required by code, with specific language are not found in the bath house or at the facility. The existing banner signage contains some, but not all of the required language.

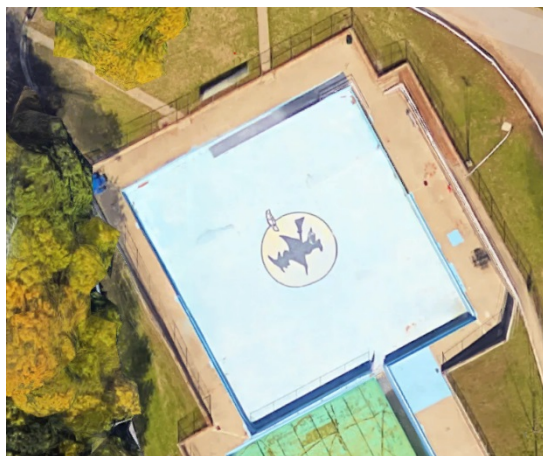
- In accordance with Code 435.05, “Location, Structural Stability, Finish (4)”, states, “the finish of the walls and floors of every swimming, special purpose and wading pool shall be of concrete, cement, mortar, tile, paint, vinyl liner, fiberglass or other inert and impervious material, shall be reasonably enduring, shall be moderately smooth and free from cracks, and shall be of light color.”

In the center of the wading pool section of the pool is a picture of a witch. The witch contains colors that are not light or white in color. The witch shall be removed from the bottom of the pool, or a graphic that has been reviewed and approved by the Board of Health should be installed. As of the writing of this report the witch was being painted over with the blue paint to match the rest of the pool color.
