SALEM TRIAL COURT  
EXISTING CONDITION SURVEY - Window & Frame Analysis  
Goody Clancy Project Number 6290

Date Aug 9&10, 2005 Surveyor: Jonathan Tudan

Salem Probate and Family Court Building Existing Conditions Survey

## **Appendix**

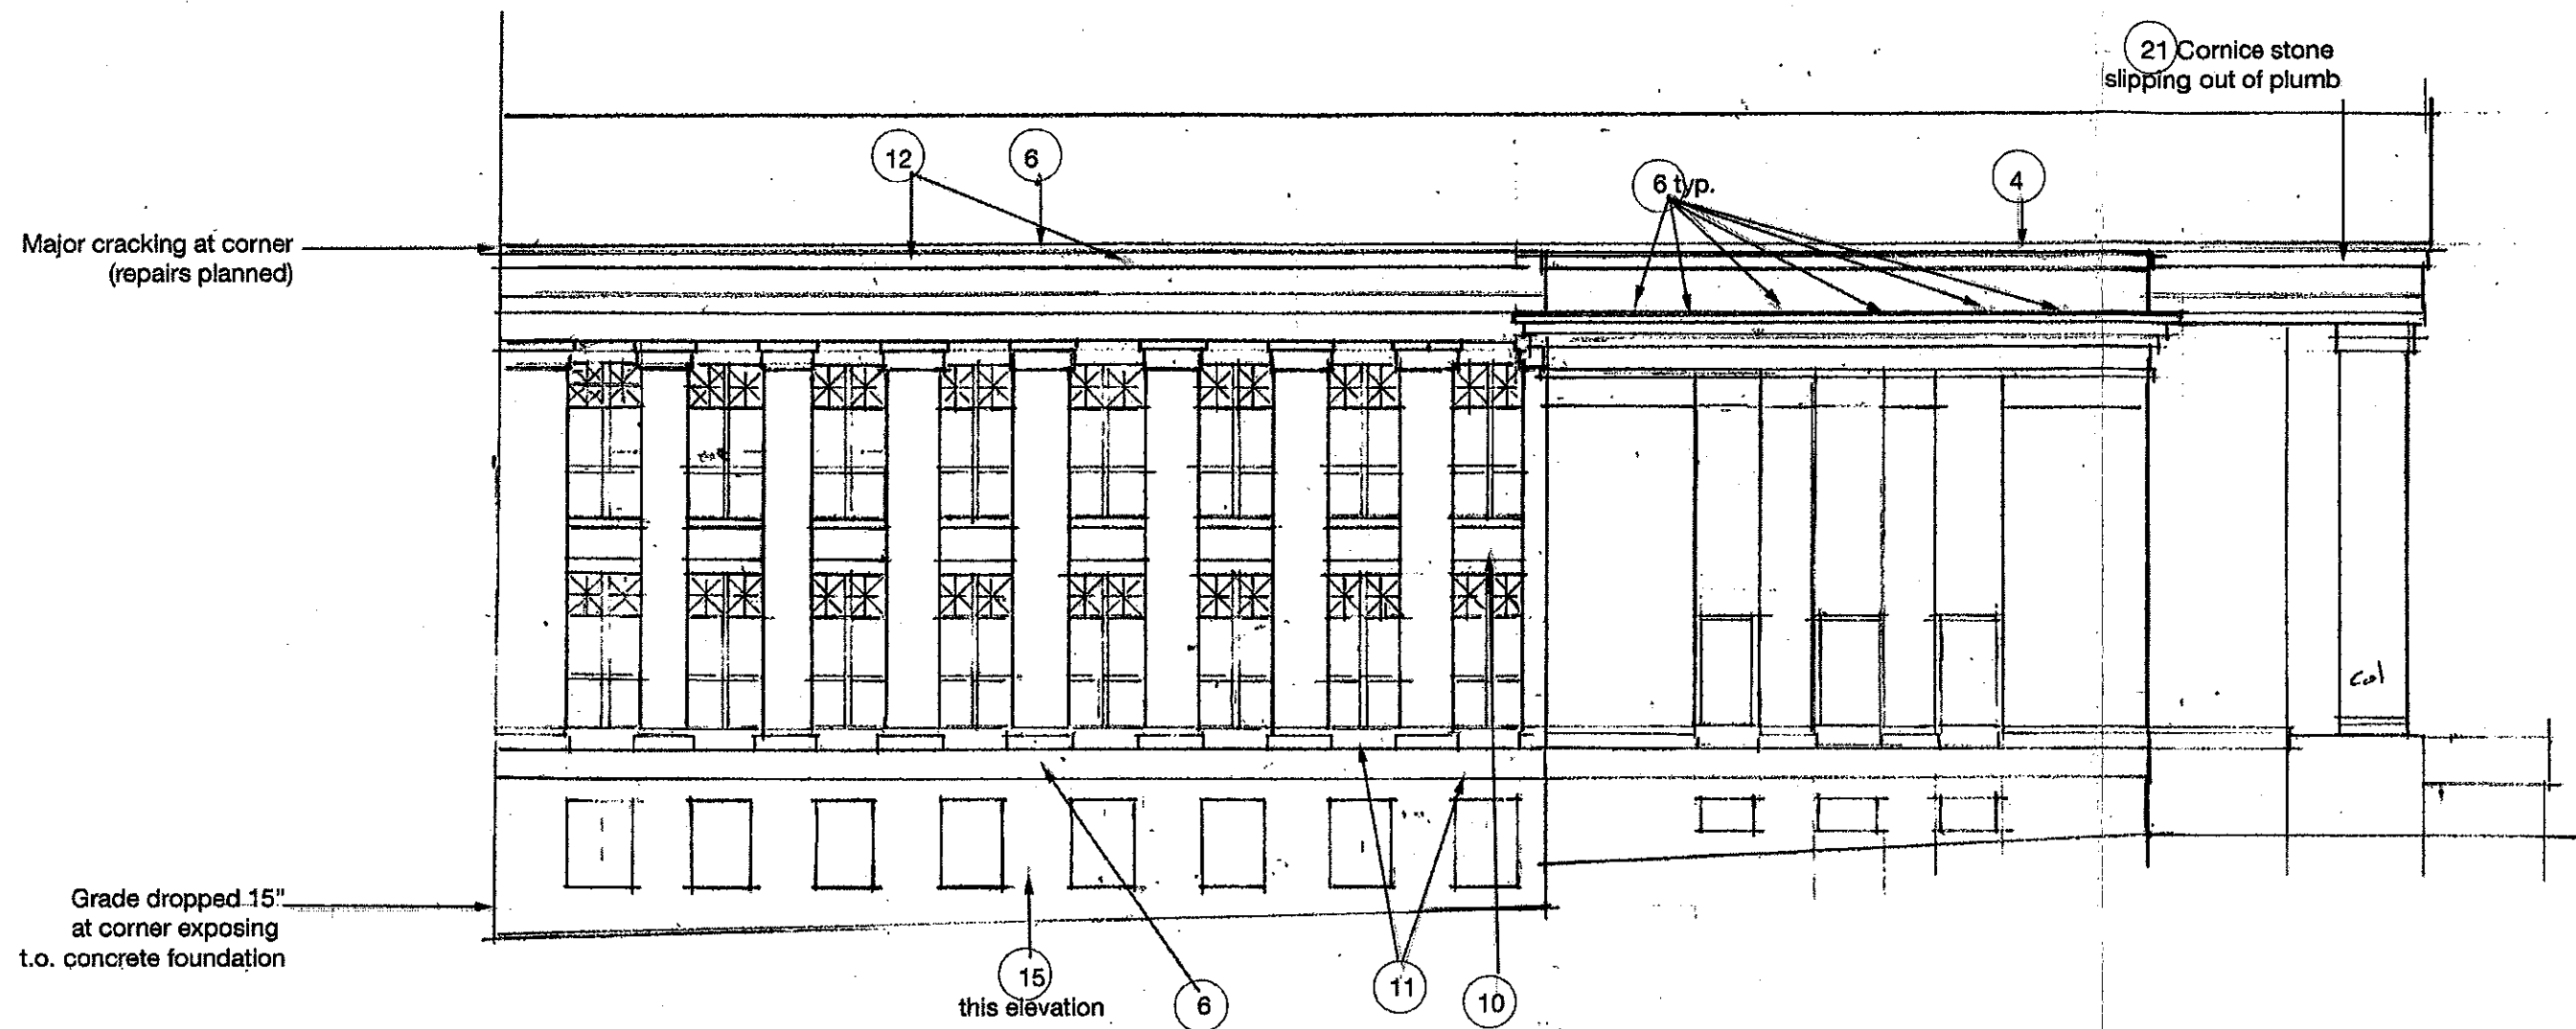
| 1 | Plywood cap (bird proofing) above capital at pilasters and columns, and at cornice and frieze moldings. | 12 | Joint sealant failure. |
| 2 | Not used | 13 | Wood window sill at grade; partially covered by landscape mulch. |
| 3 | Stainless steel dowel bolts used to pin broken cornice. | 14 | Open mortar joints and efflorescence at underside of flat masonry arch/window head. |
| 6 | Open mortar joints. | 17 | Extensive crack at cornice stone (repairs were in process at the time of this survey) |
| 7 | Sheet metal flashing used as bird proofing. | 18 | Guano heavy in this area resulting in staining of affected materials. |
| 8 | Not used | 19 | Failure of glazing compound and perimeter sealant. |
| 9 | Section of stone spalled and loose | 20 | Stained and dirty wood coffered ceiling at porch. Electrical fixtures removed at bays; canopies remain in place. |
| 11 | Iron oxide and carbon staining on masonry. | | |

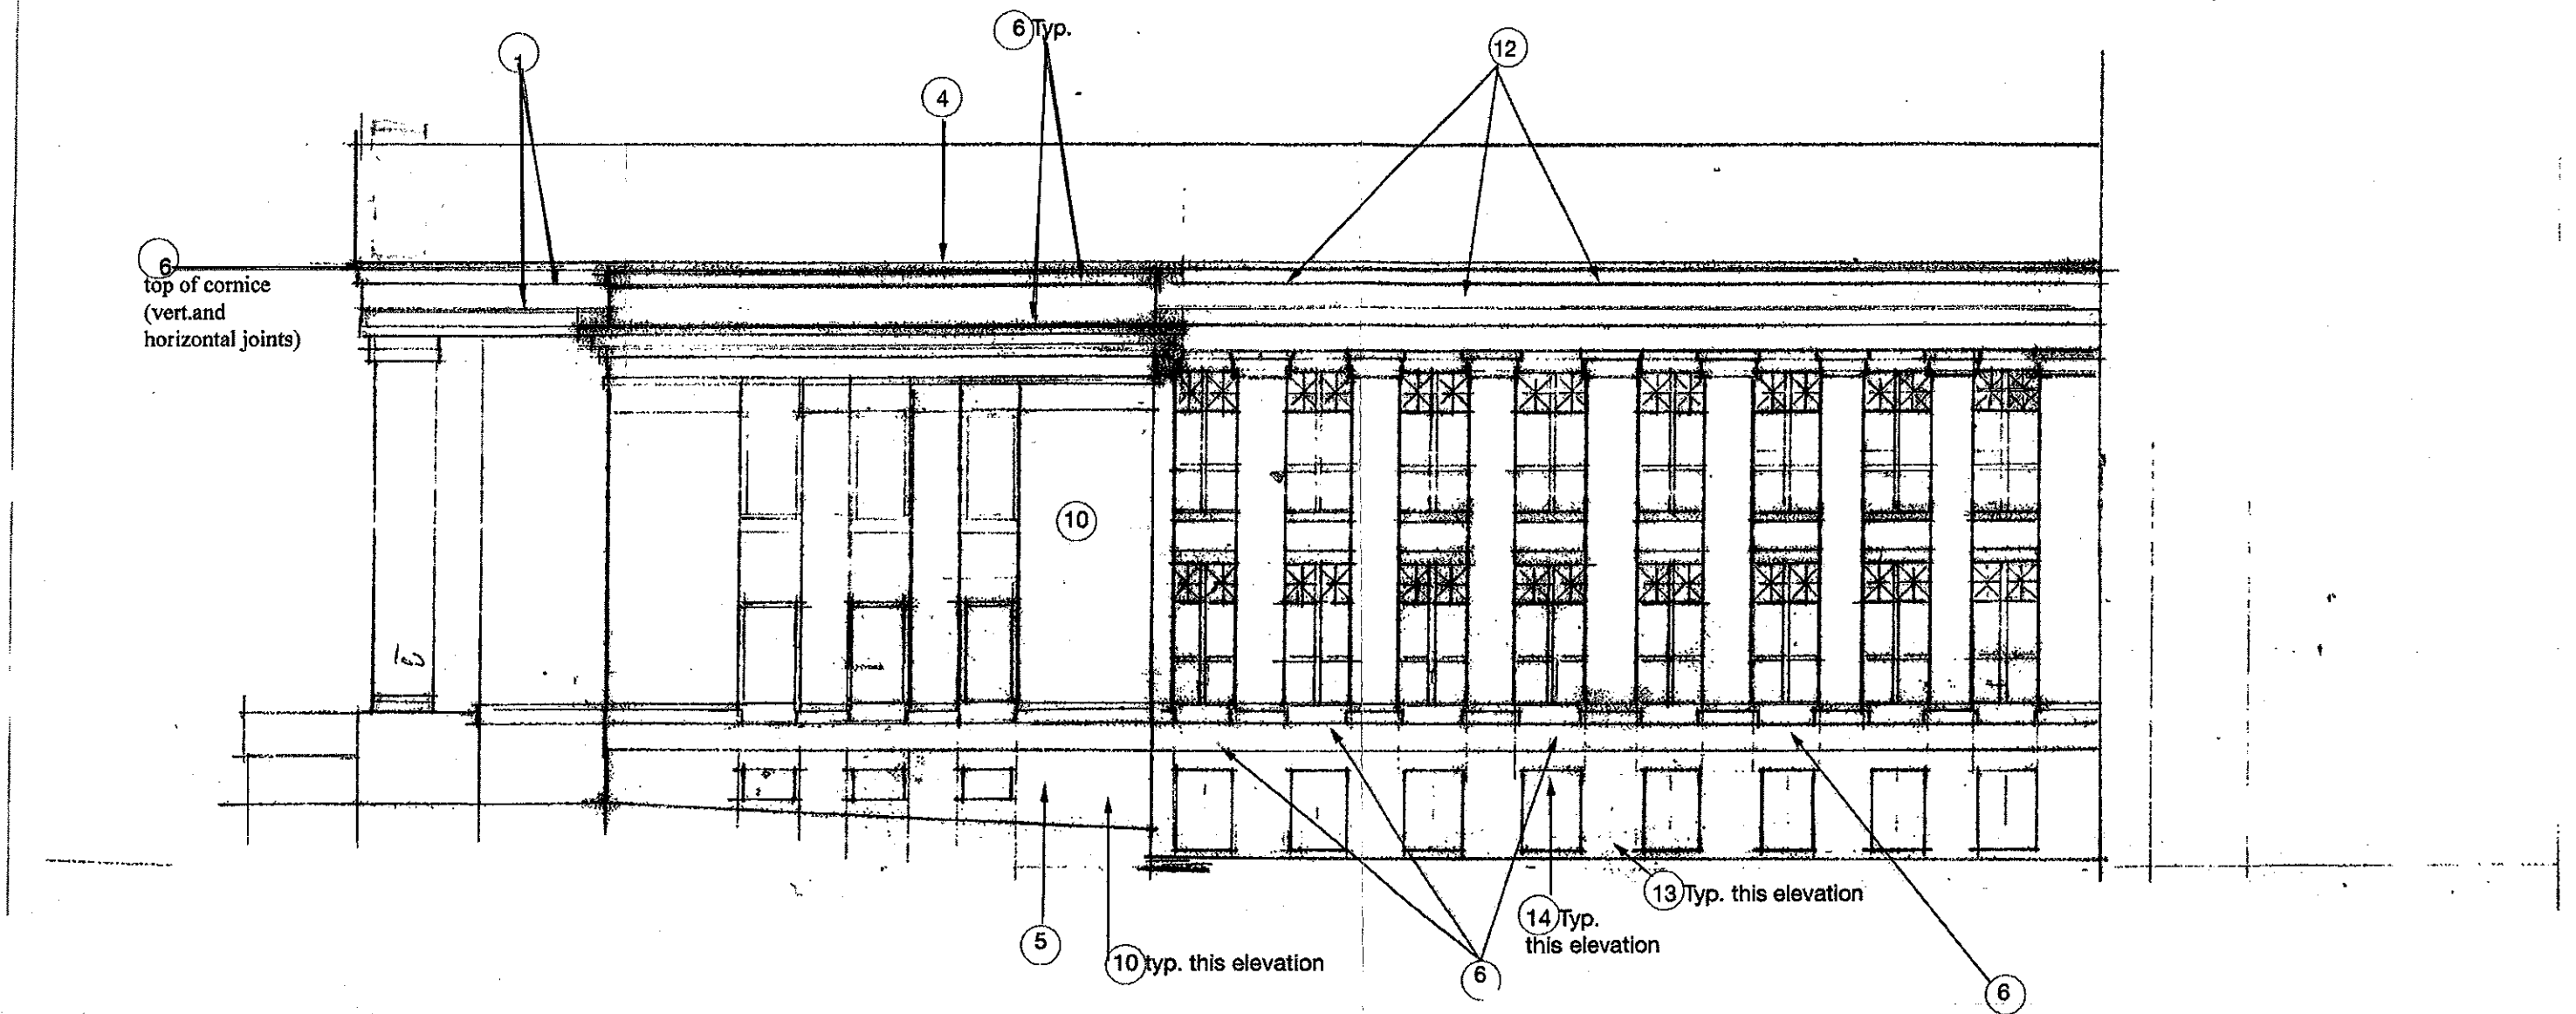
## WEST ELEVATION

| 1 | Plywood cap (bird proofing) above capital at pilasters and columns, and at cornice and frieze moldings. | 12 | Joint sealant failure. |
| 2 | Not used | 13 | Wood window sill at grade; partially covered by landscape mulch. |
| 3 | Stainless steel dowel bolts used to pin broken cornice. | 14 | Open mortar joints and efflorescence at underside of flat masonry arch/window head. |
| 6 | Open mortar joints. | 17 | Extensive crack at cornice stone (repairs were in process at the time of this survey) |
| 7 | Sheet metal flashing used as bird proofing. | 18 | Guano heavy in this area resulting in staining of affected materials. |
| 8 | Not used | 19 | Failure of glazing compound and perimeter sealant. |
| 9 | Section of stone spalled and loose | 20 | Stained and dirty wood coffered ceiling at porch. Electrical fixtures removed at bays; canopies remain in place. |
| 11 | Iron oxide and carbon staining on masonry. | | |

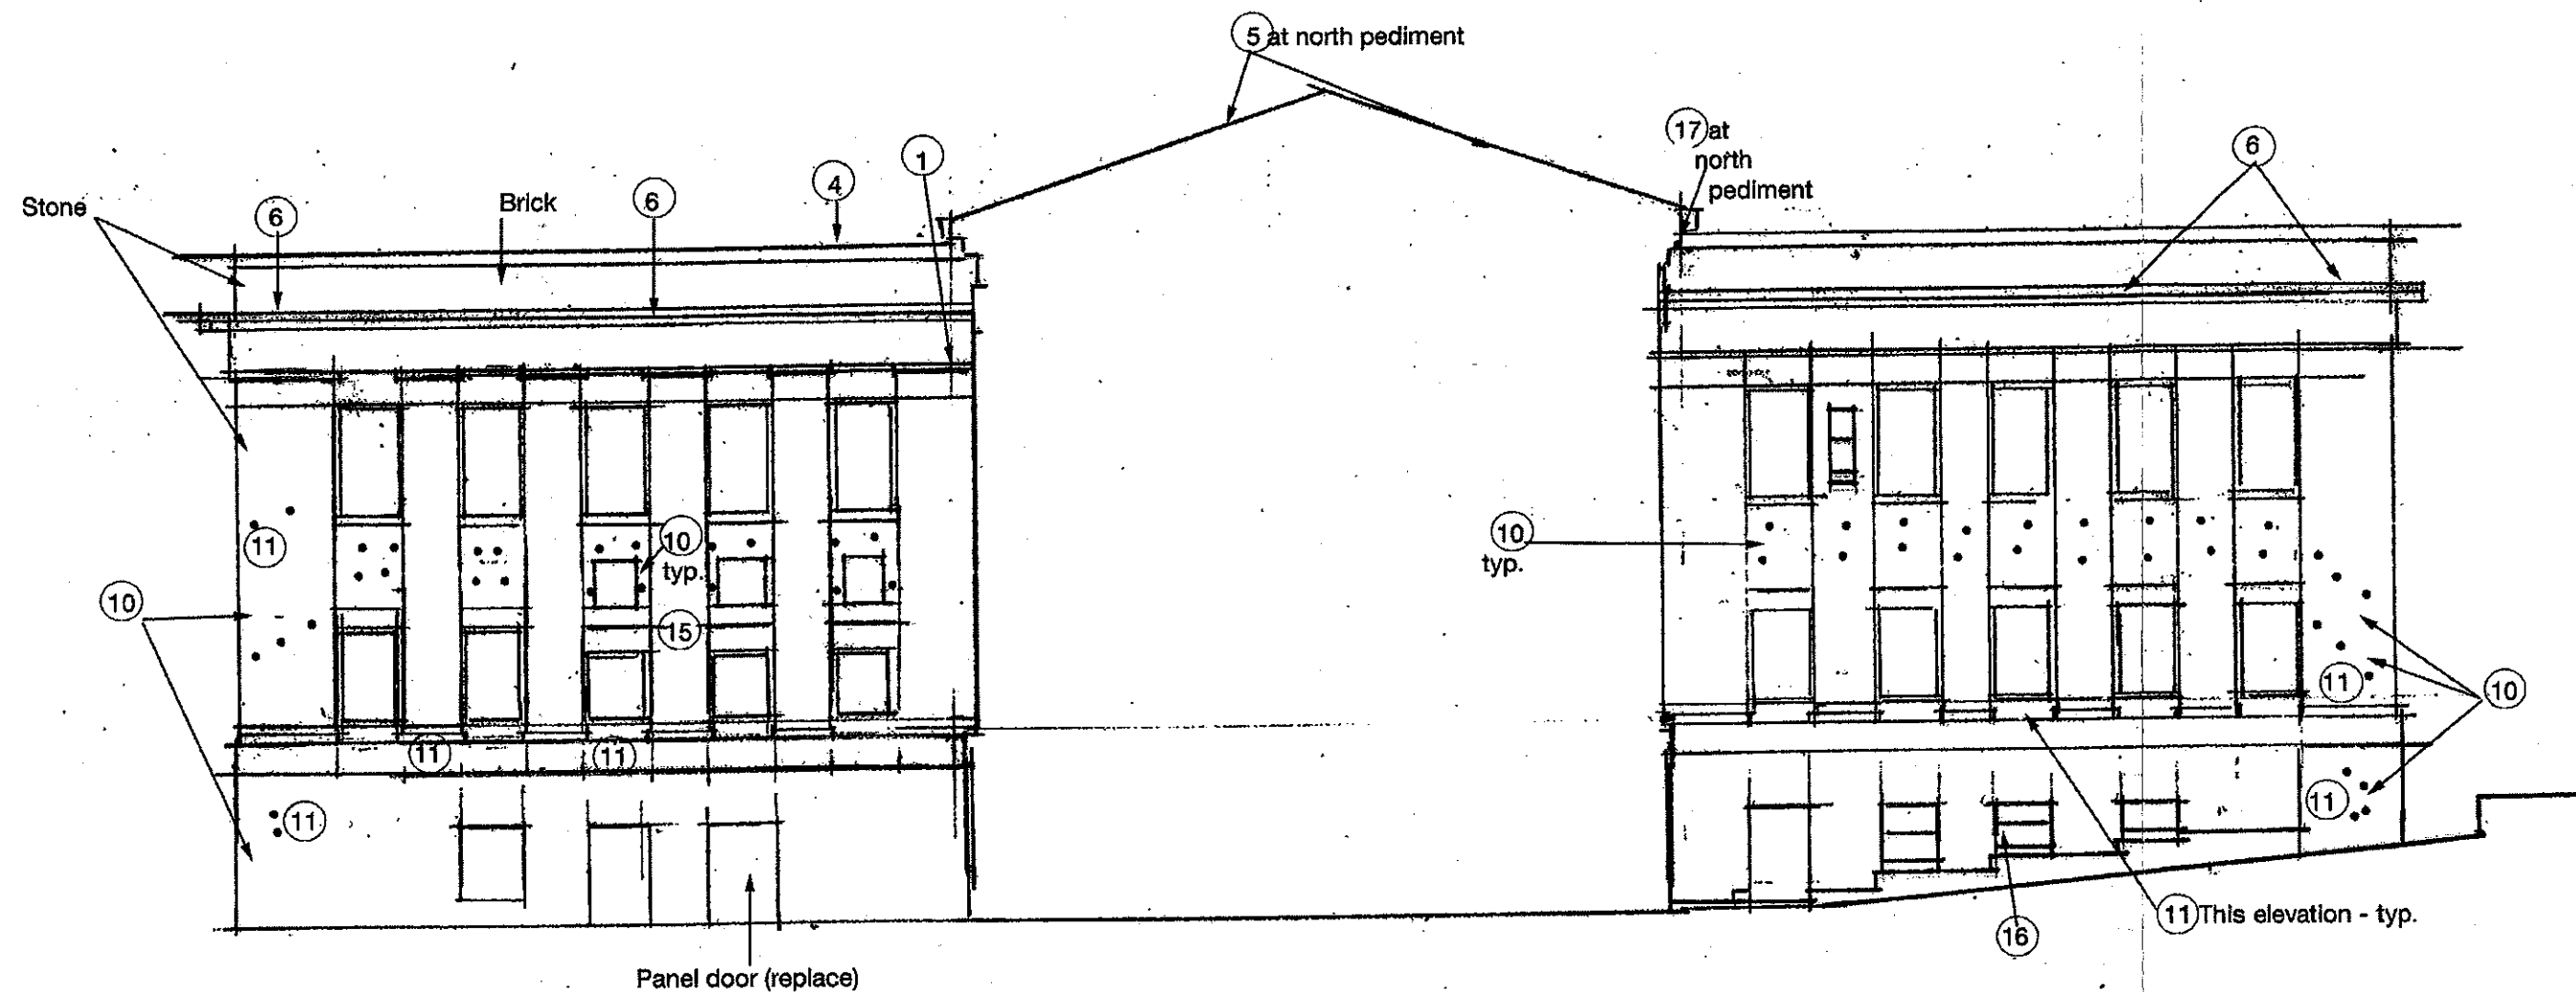
## EAST ELEVATION

| 1 | Plywood cap (bird proofing) above capital at pilasters and columns, and at cornice and frieze moldings. | 12 | Joint sealant failure. |
| 3 | Stainless steel dowel bolts used to pin broken cornice. | 14 | Open mortar joints and efflorescence at underside of flat masonry arch/window head. |
| 6 | Open mortar joints. | 17 | Extensive crack at cornice stone (repairs were in process at the time of this survey) |
| 7 | Sheet metal flashing used as bird proofing. | 18 | Guano heavy in this area resulting in staining of affected materials. |
| 8 | Not used | 19 | Failure of glazing compound and perimeter sealant. |
| 9 | Section of stone spalled and loose | 20 | Stained and dirty wood coffered ceiling at porch. Electrical fixtures removed at bays; canopies remain in place. |
| 11 | Iron oxide and carbon staining on masonry. | | |

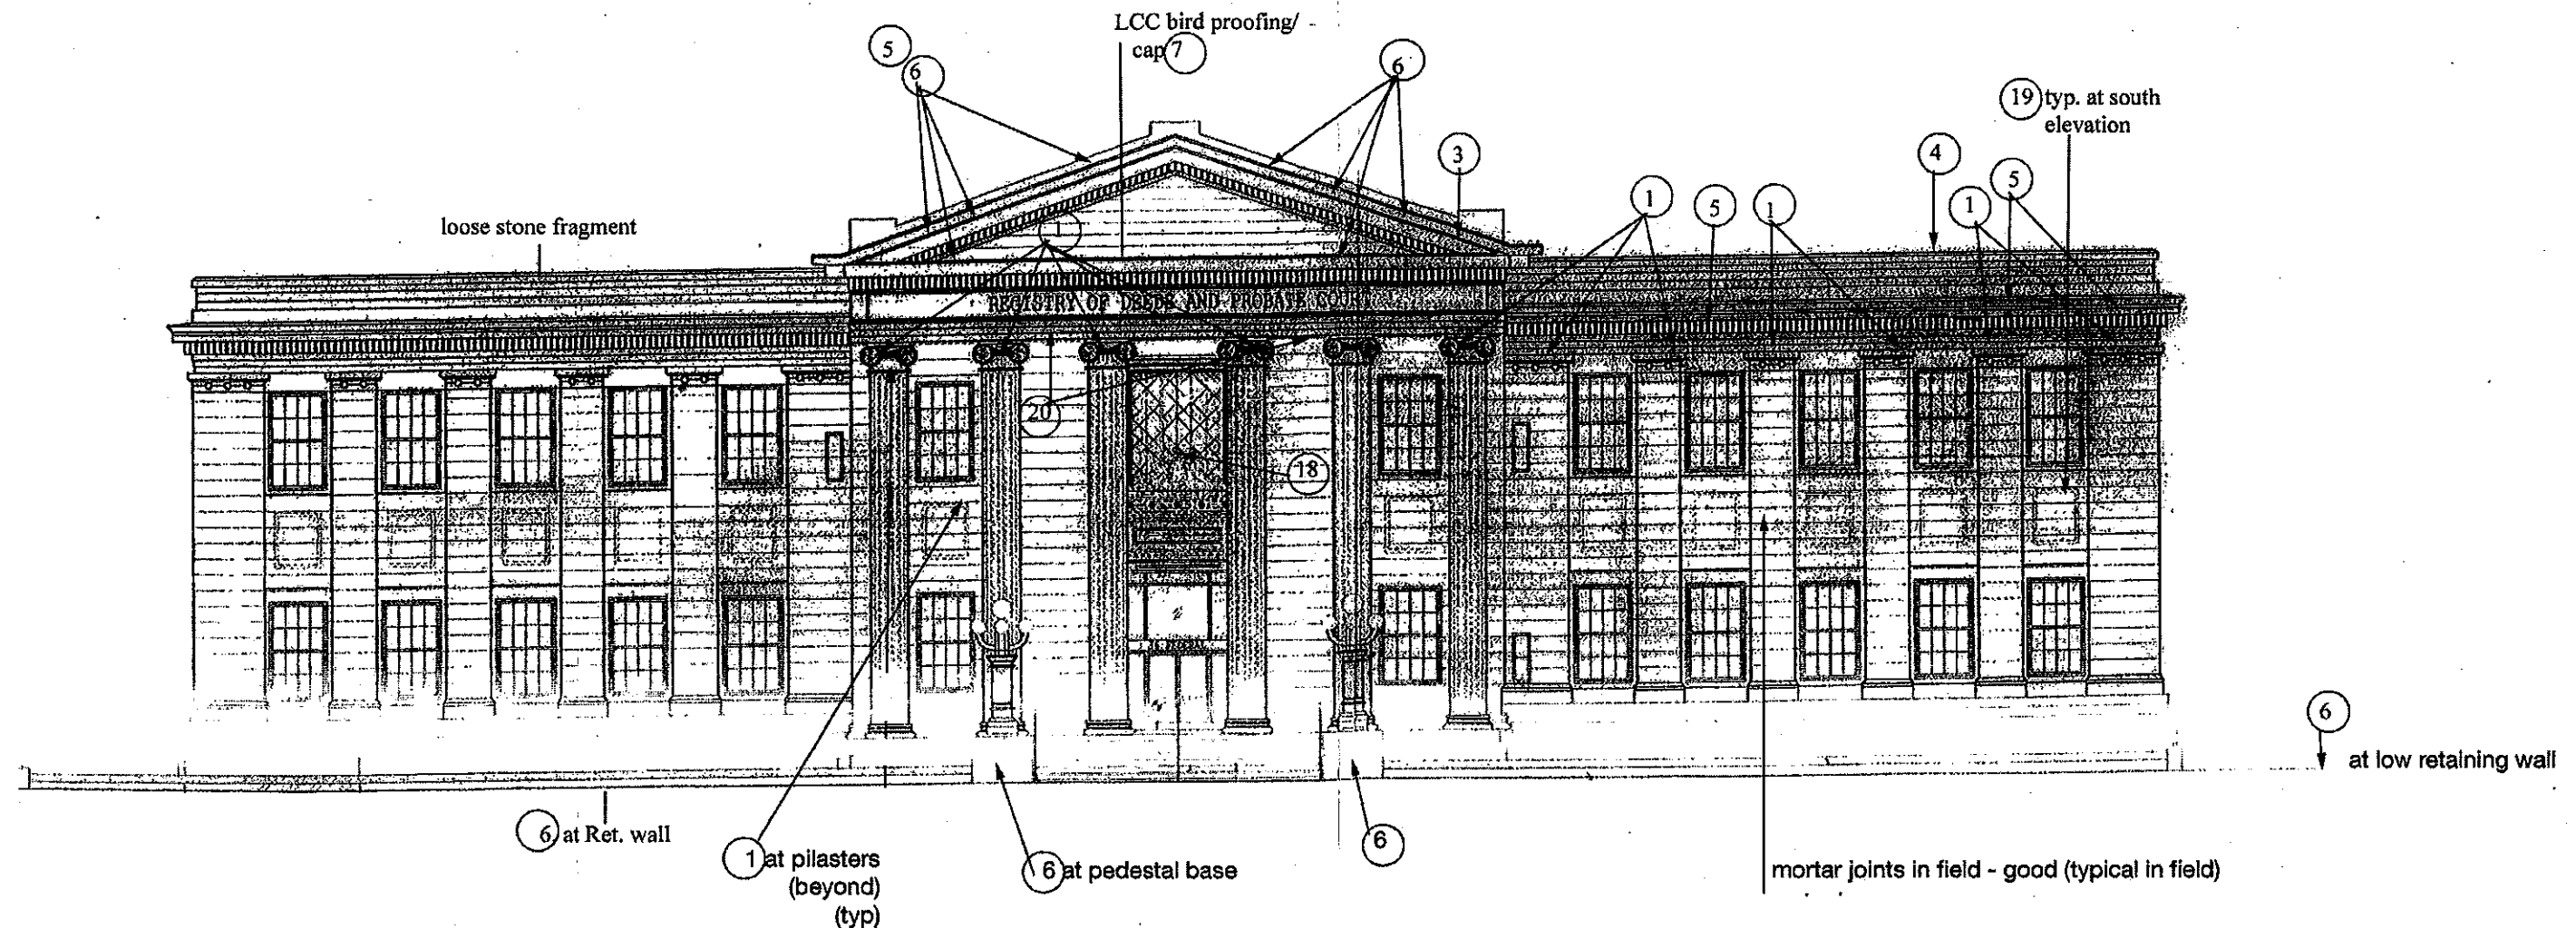
## NORTH ELEVATION

| 1 | Plywood cap (bird proofing) above capital at pilasters and columns, and at cornice and frieze moldings. | 12 | Joint sealant failure. |
| 2 | Not used | 13 | Wood window sill at grade; partially covered by landscape mulch. |
| 3 | Stainless steel dowel bolts used to pin broken cornice. | 14 | Open mortar joints and efflorescence at underside of flat masonry arch/window head. |
| 6 | Open mortar joints. | 17 | Extensive crack at cornice stone (repairs were in process at the time of this survey) |
| 7 | Sheet metal flashing used as bird proofing. | 18 | Guano heavy in this area resulting in staining of affected materials. |
| 8 | Not used | 19 | Failure of glazing compound and perimeter sealant. |
| 9 | Section of stone spalled and loose | 20 | Stained and dirty wood coffered ceiling at porch. Electrical fixtures removed at bays; canopies remain in place. |
| 11 | Iron oxide and carbon staining on masonry. | | |

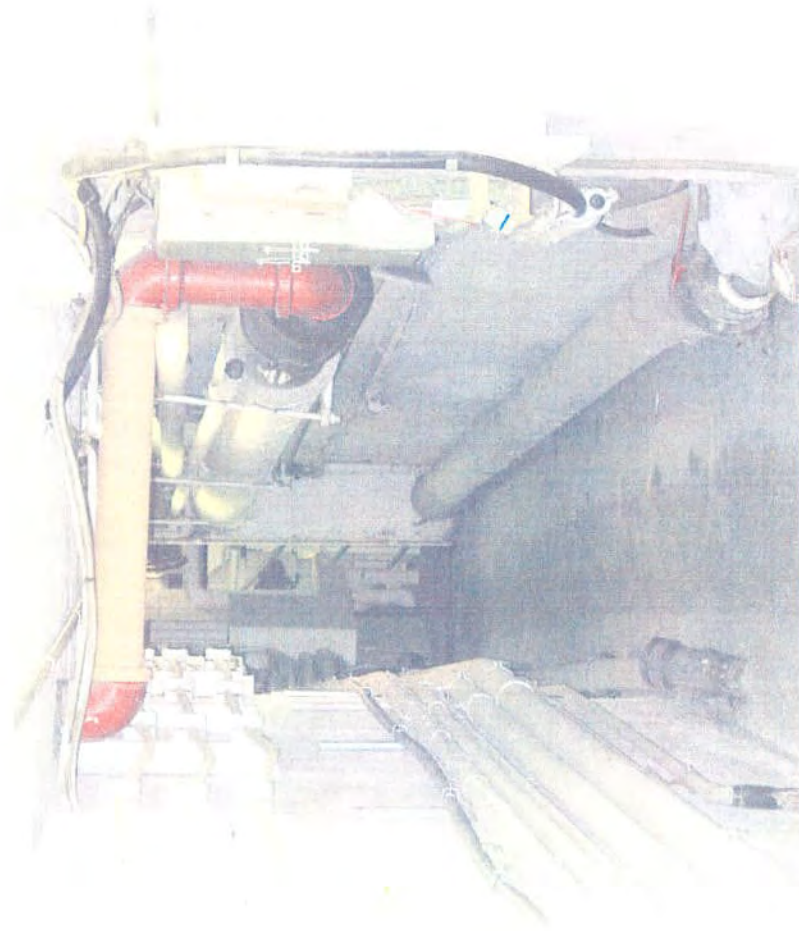
B-M1  
Steam Tunnel from Probate Building to boiler room

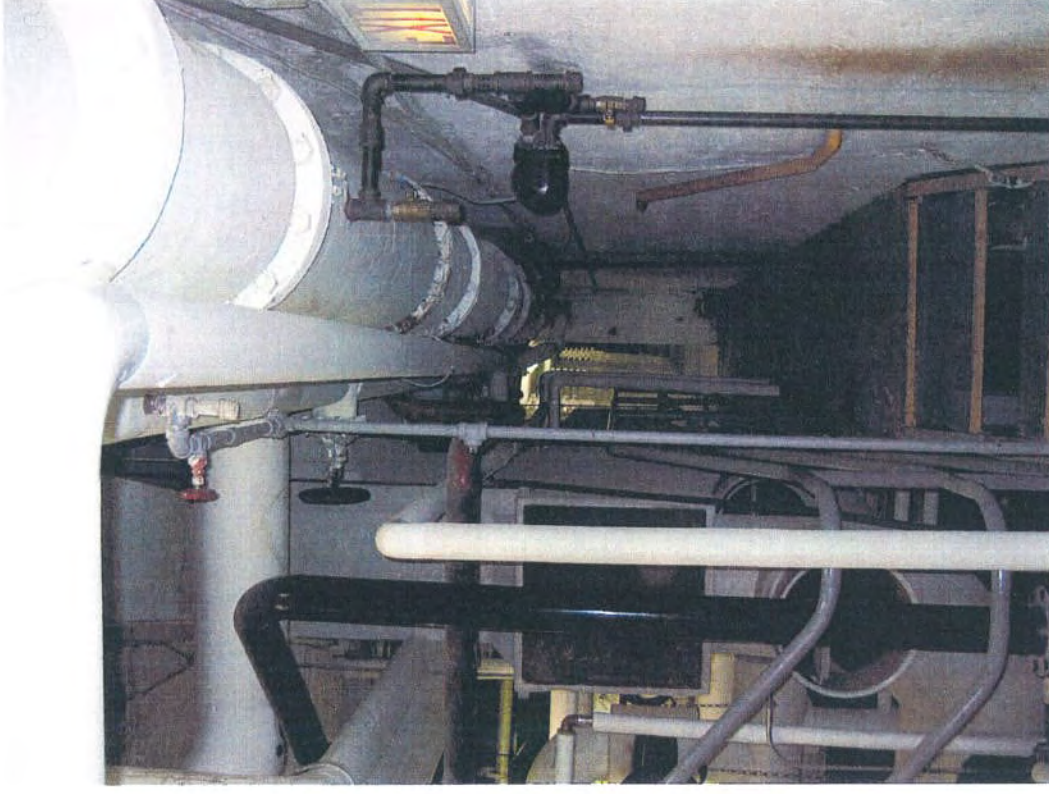
B-M2  
Steam tunnel at boiler room noting steam header on right and rectangular boiler breaching on left.

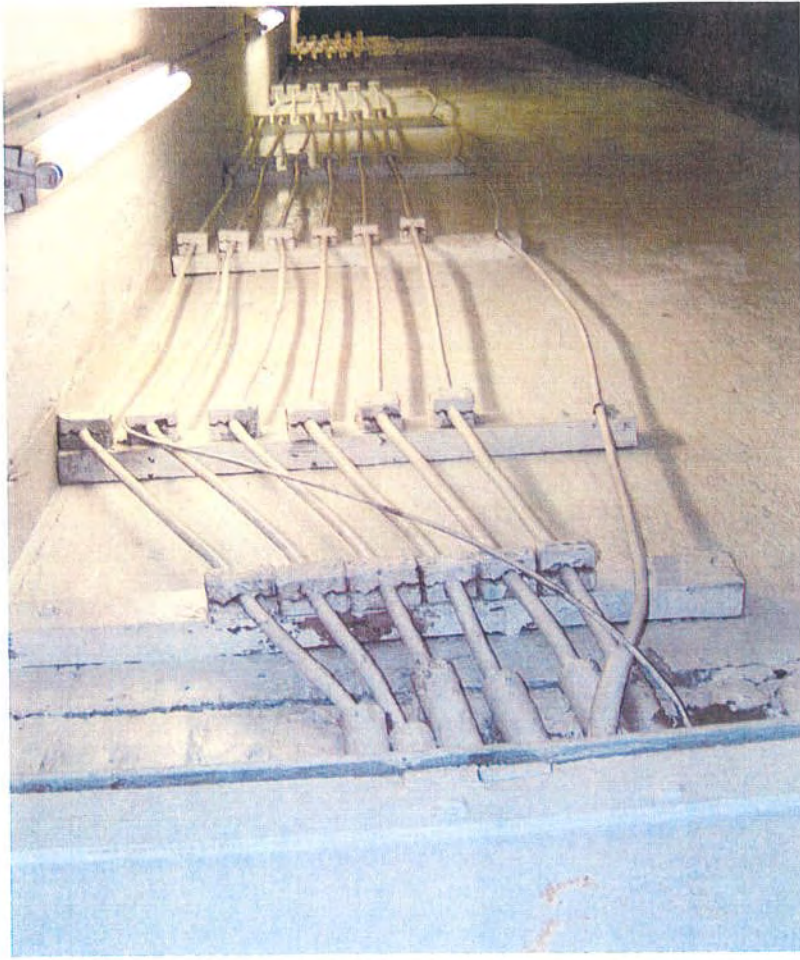
B-M4

Steam tunnel from boiler room to Superior Court Building  
feeders

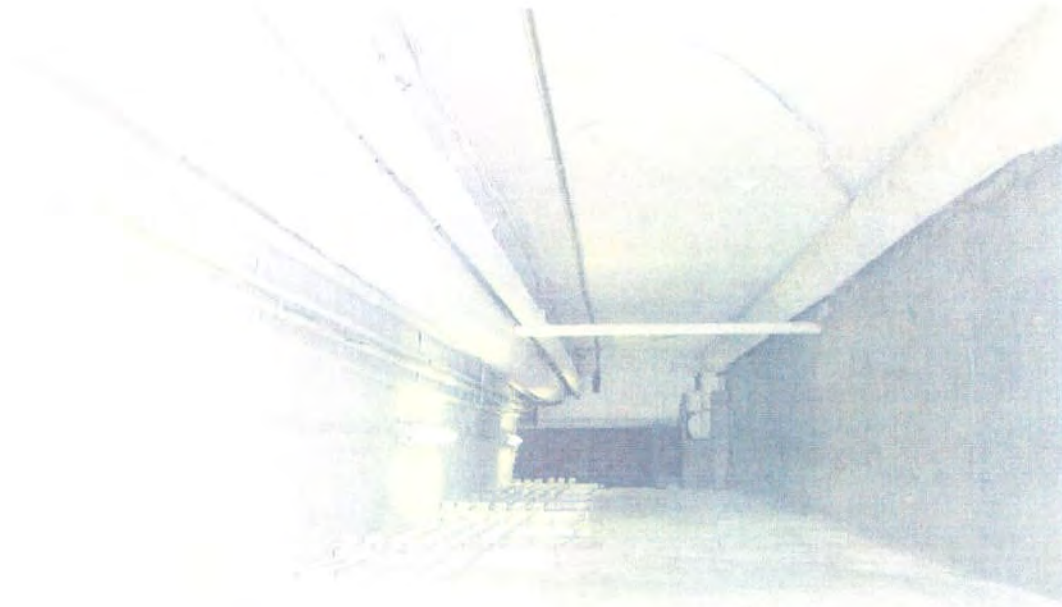
B-M3

Steam tunnel from boiler room to Superior Court Building

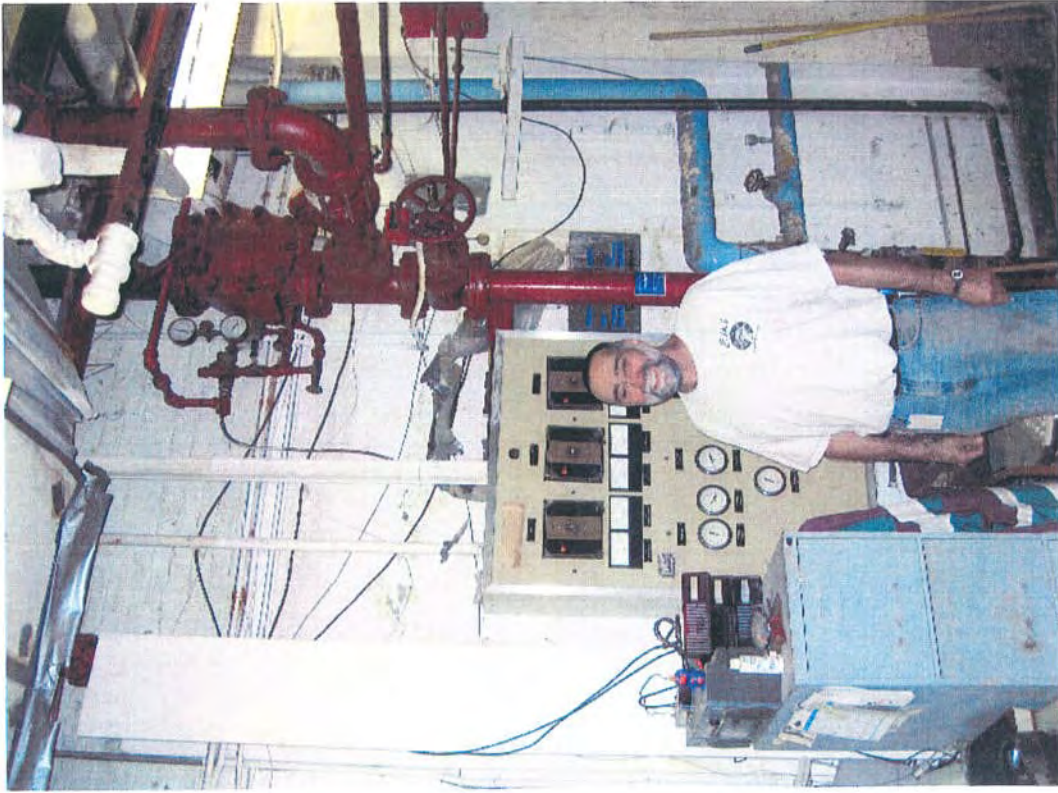
B-M5

Boiler room with temperature control panel and fire flow valve

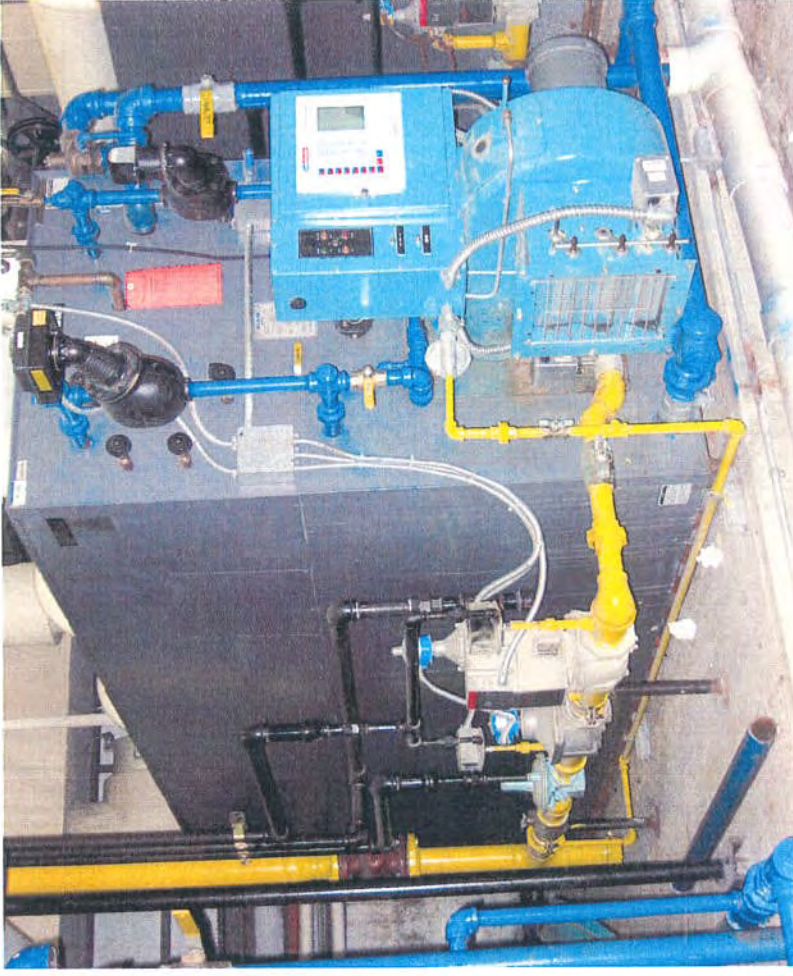
B-M6

Boiler room, gas fired steam boilers, 1 of 3

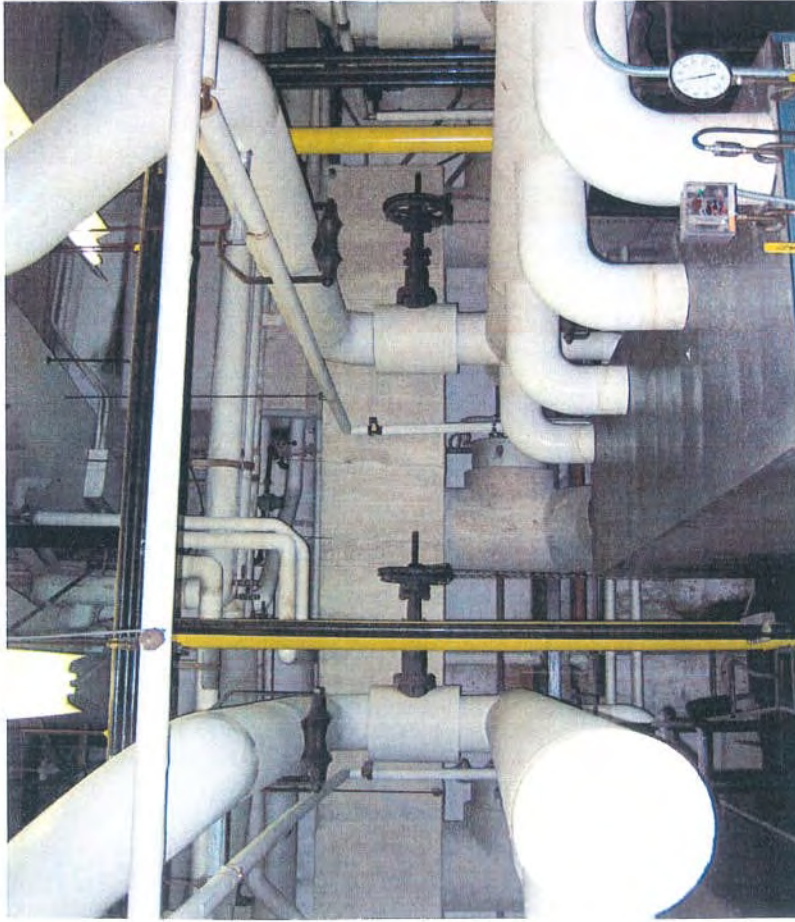
B-M7

Boiler room, noting steam headers and boiler breeching off back

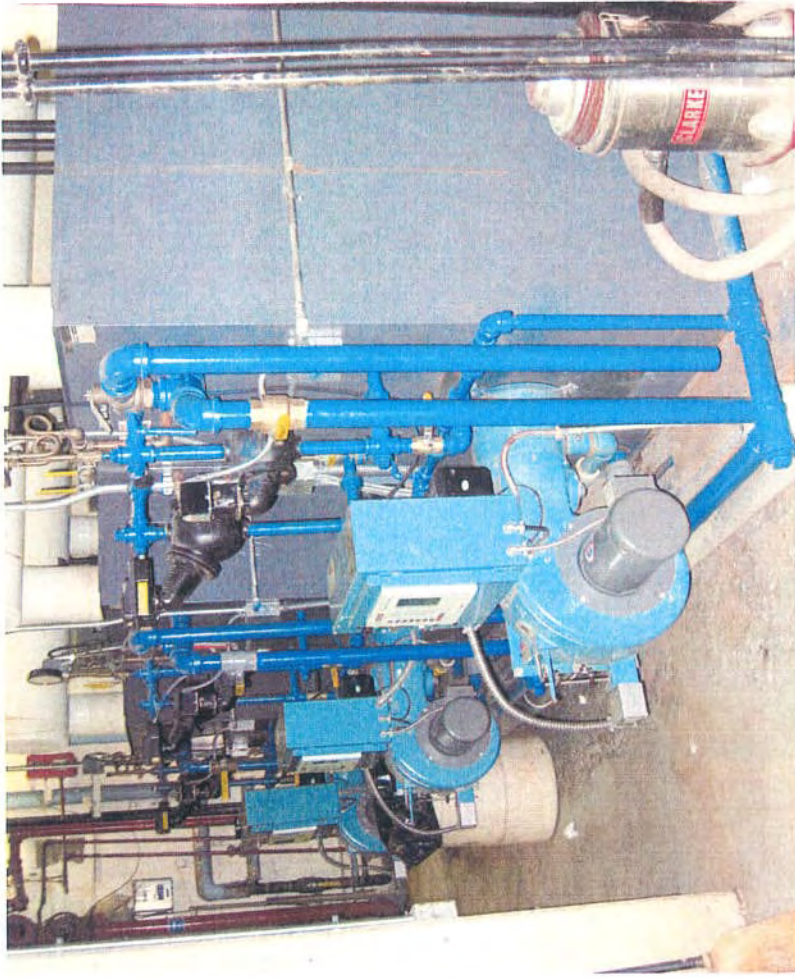
B-M8

Boiler room, gas fired steam boilers

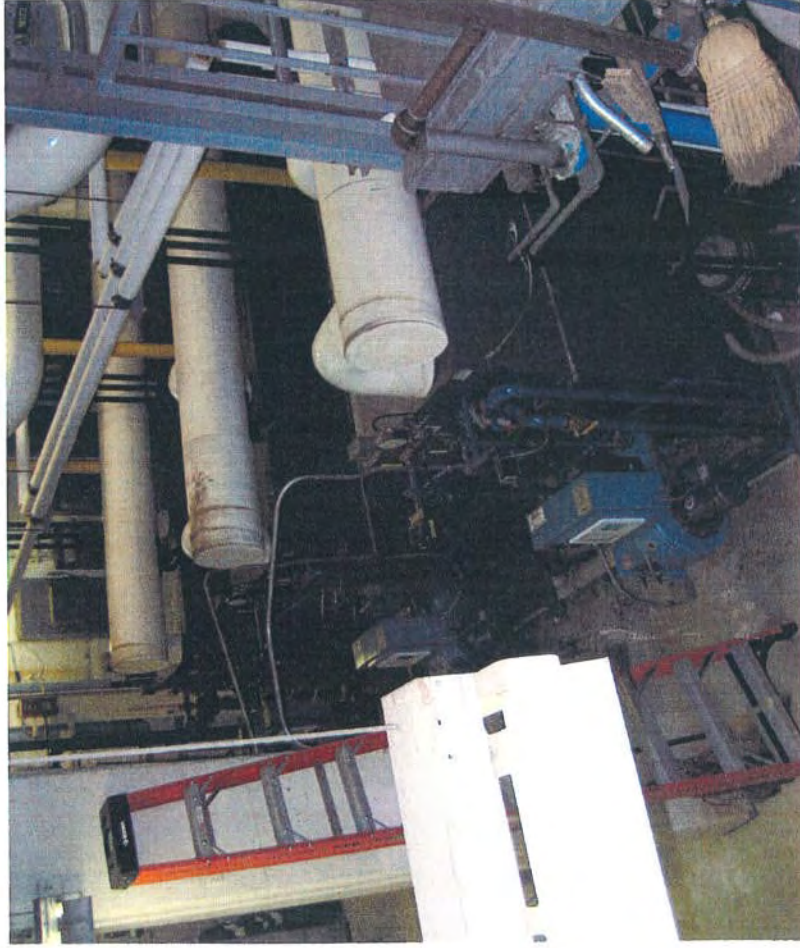
B-M9

Boiler room, noting steam headers off boilers

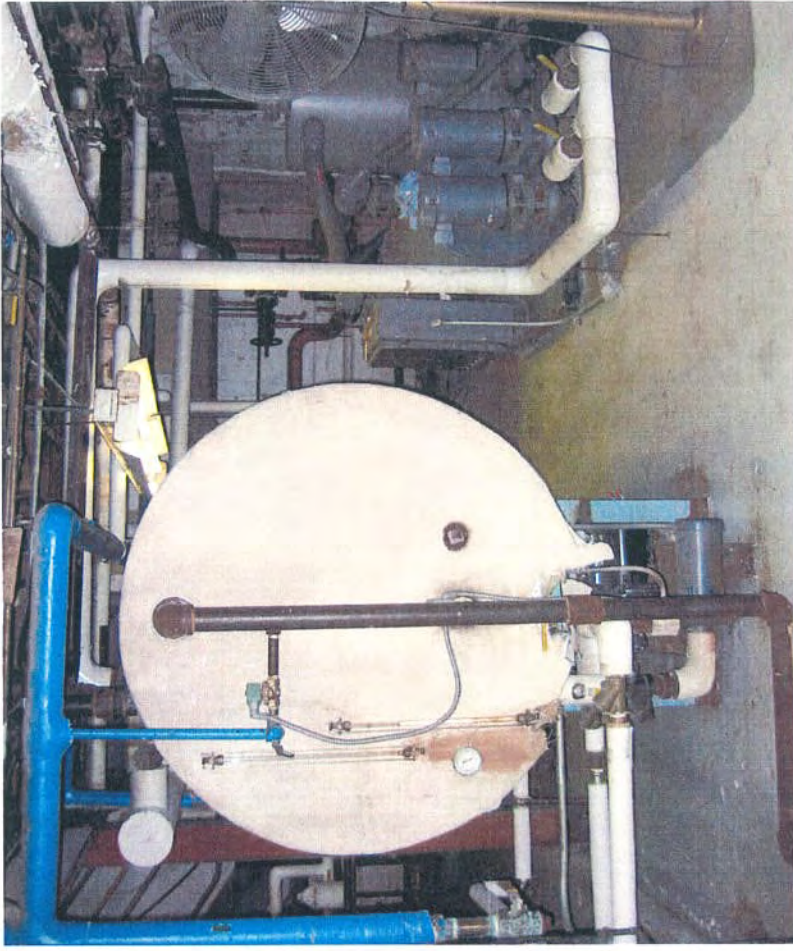
B-M10

Boiler room, noting boiler feedwater tank on left and condensate receiver and pumps on the right

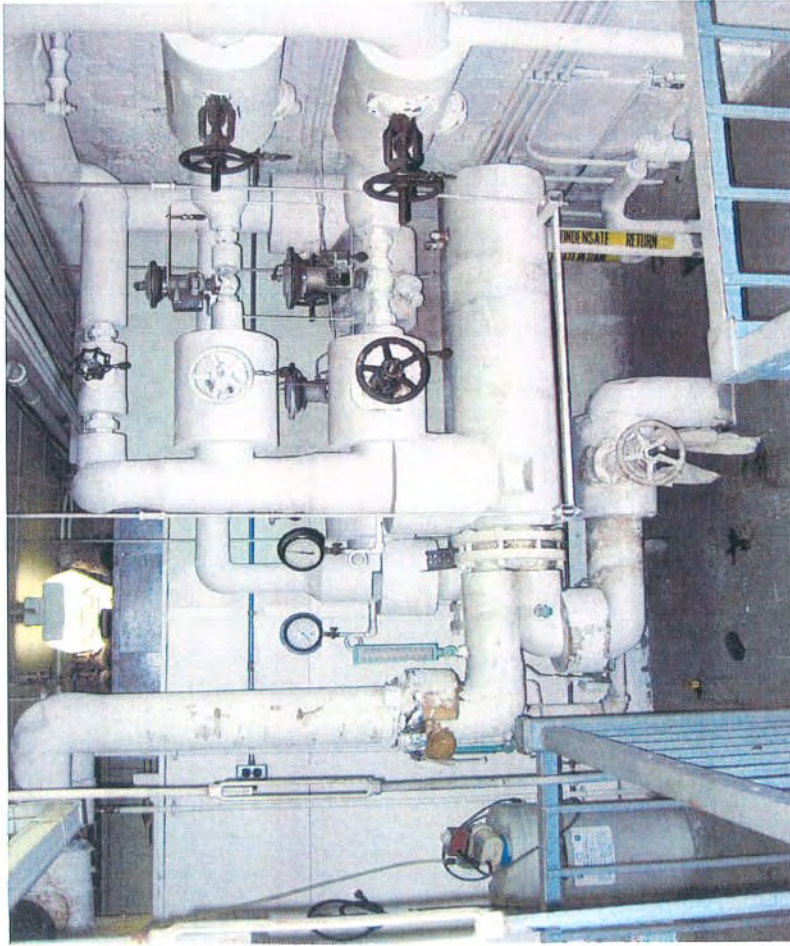
B-M11

Boiler room mezzanine, noting steam to hot water converters for 1977 building addition

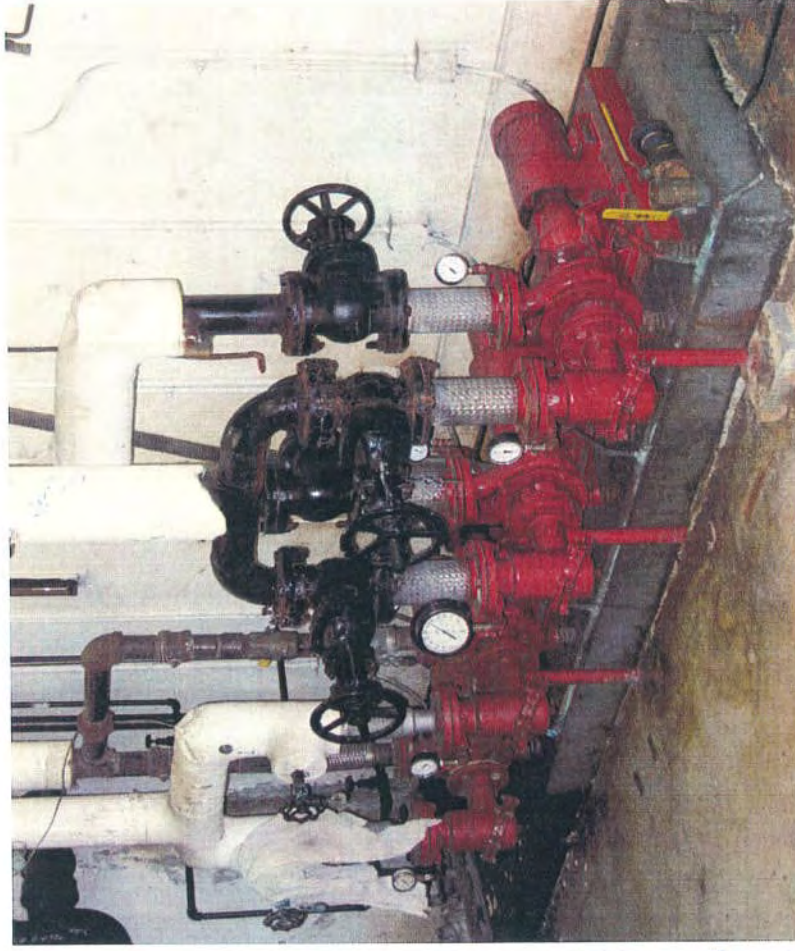
B-M12

Boiler room, noting heating hot water pumps for 1977 building addition

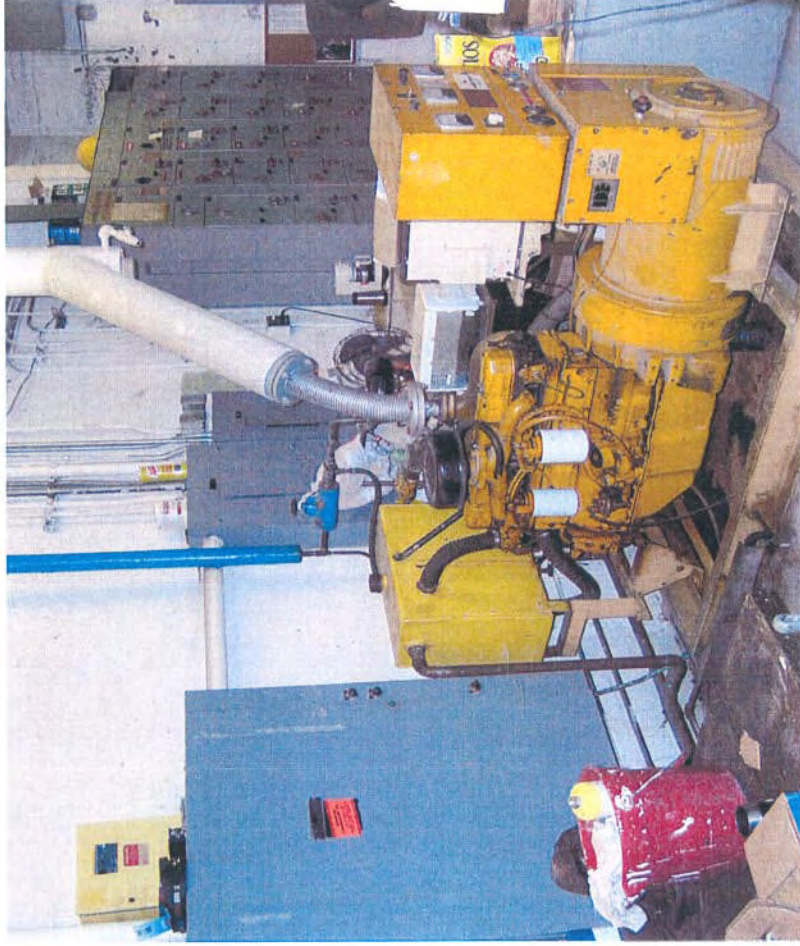
B-M13

Boiler room, noting electrical generator

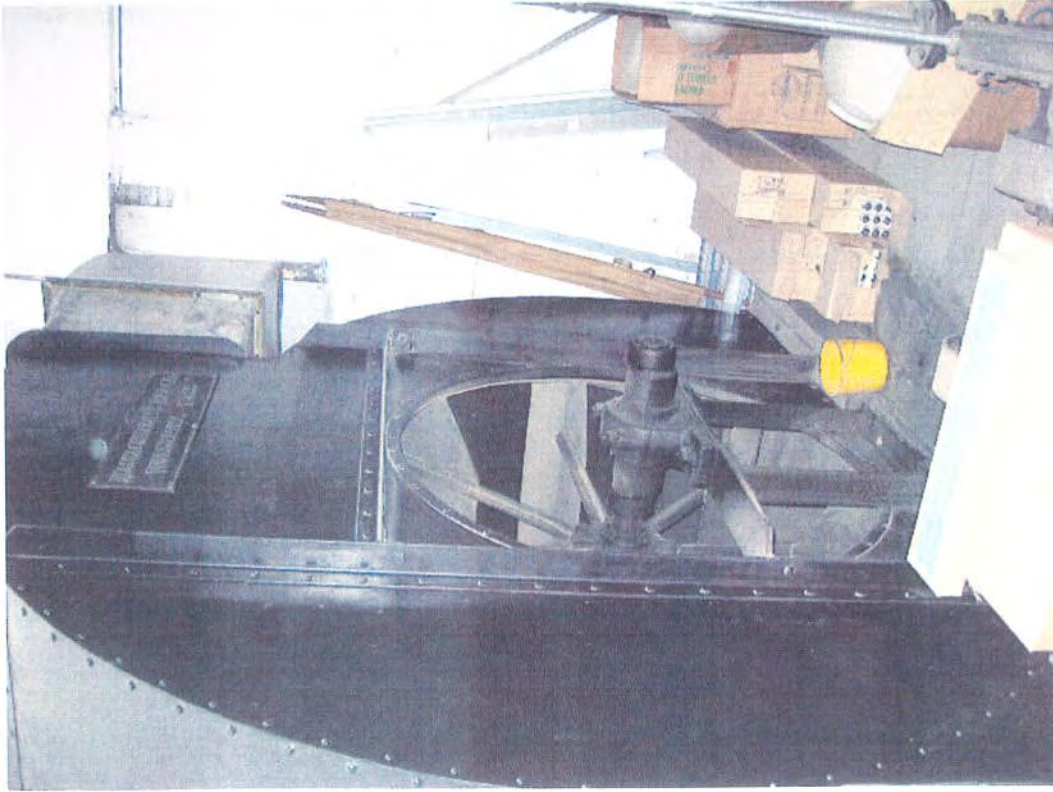
P-M1

Building main supply air fan with dual discharge, top and bottom

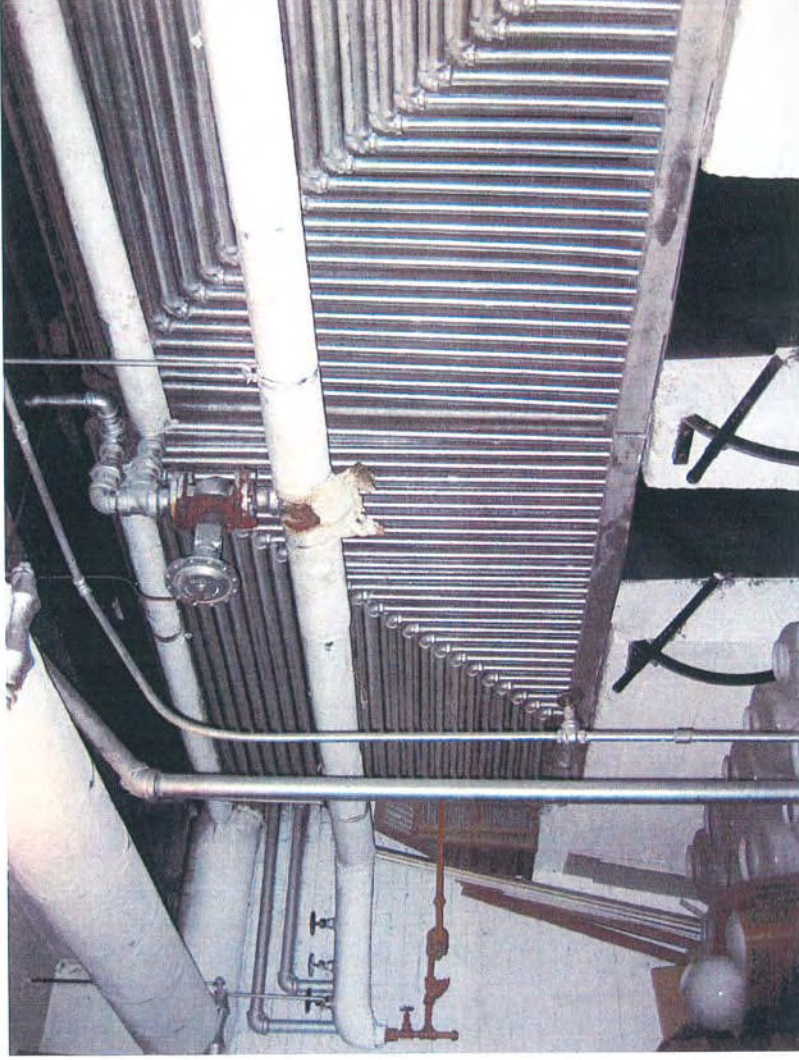
P-M2

Building main air handling unit, steam heating coil
