i. Scope of Existing Condition Survey

iii. Room Inventory & Inspection; Window Inventory & Inspection; Architectural Photos and Annotated Drawings

SALEM TRIAL COURT
EXISTING CONDITION SURVEY - Room Inventory & Inspection

Goody Clancy Project Number 6290

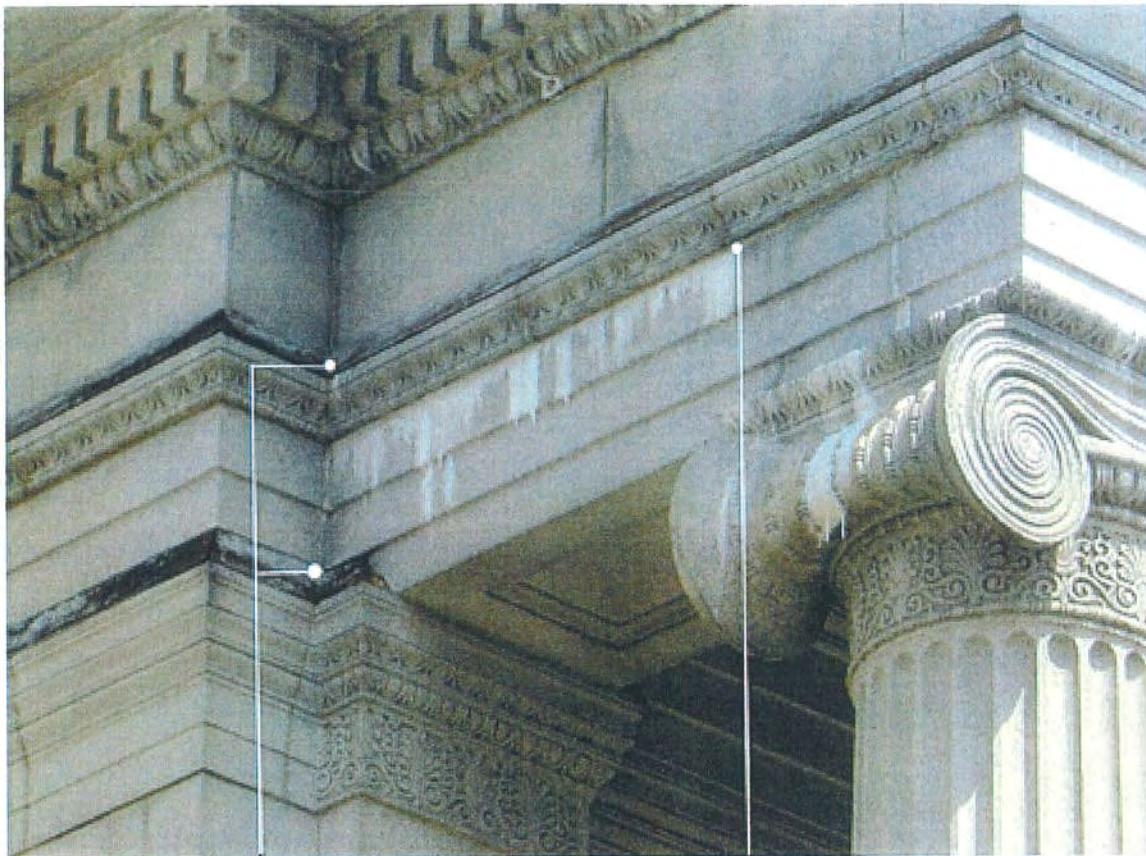
Photo #E-1

Plywood Bird Proofing

Staining from open mortar joints
above cove

Entablature Southeast Corner

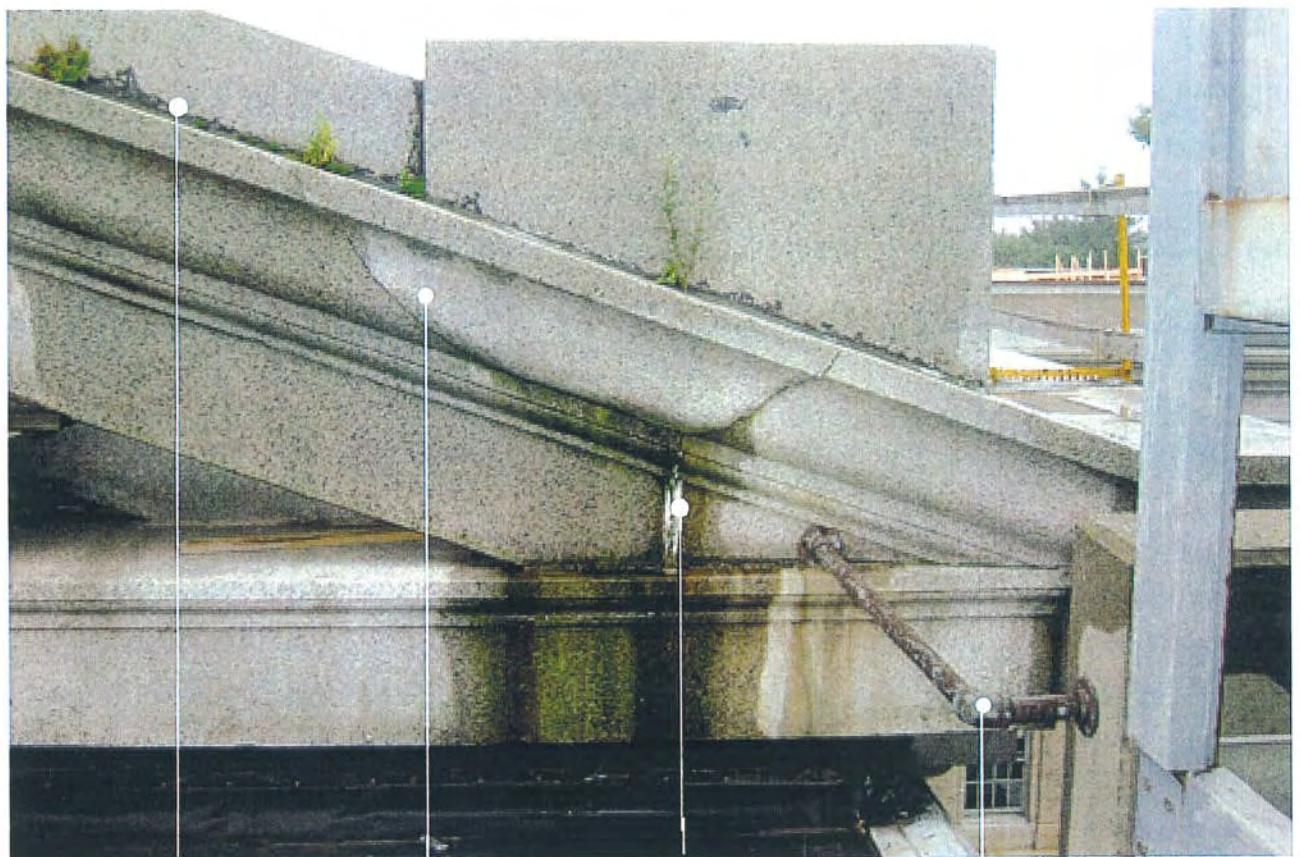
Photo #E-2

Moss and Vegetation
At Joint

Recent Stone
Repair

Open Joints

Structural Anchor

Pediment - North Elevation West Corner

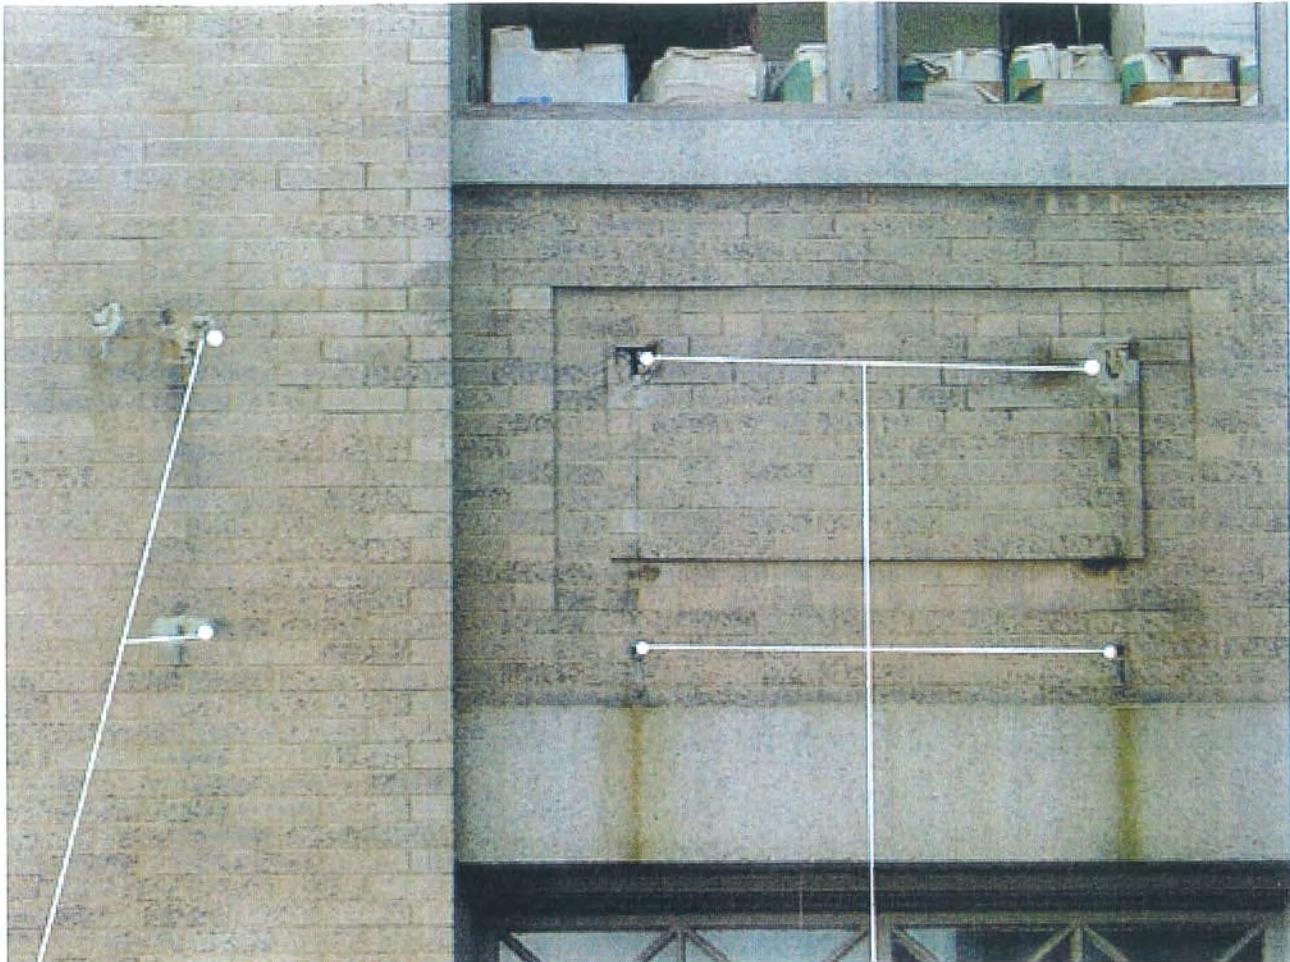
Photo #E-3

Open Holes from Fire Escape Anchors

Steel Sections Remain from Removal of Fire Escape

Mortar Elevation - East Wing

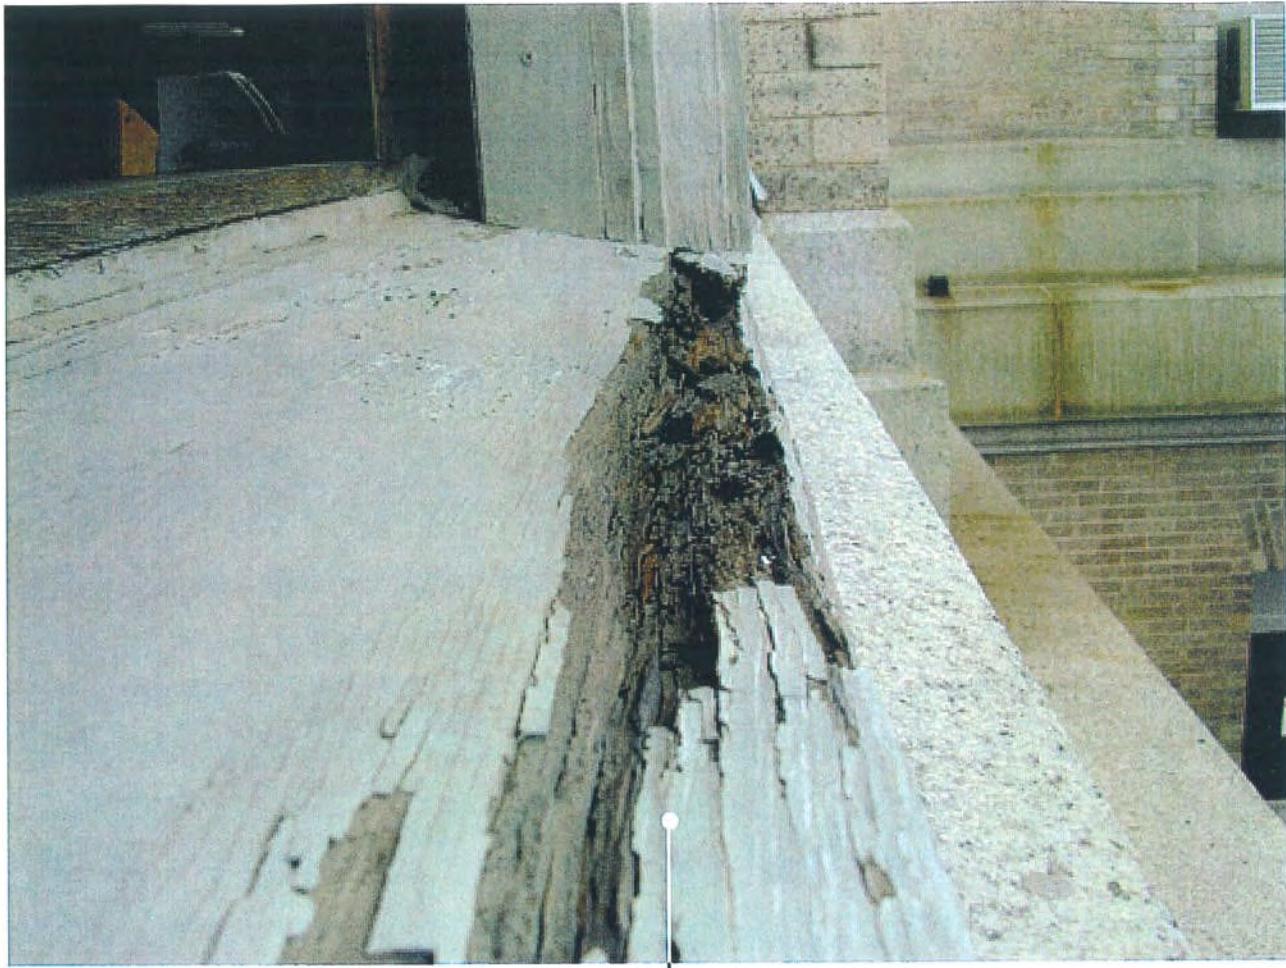
Photo #E-4

Rotted Sill

North Elevation East Wing - Second Story

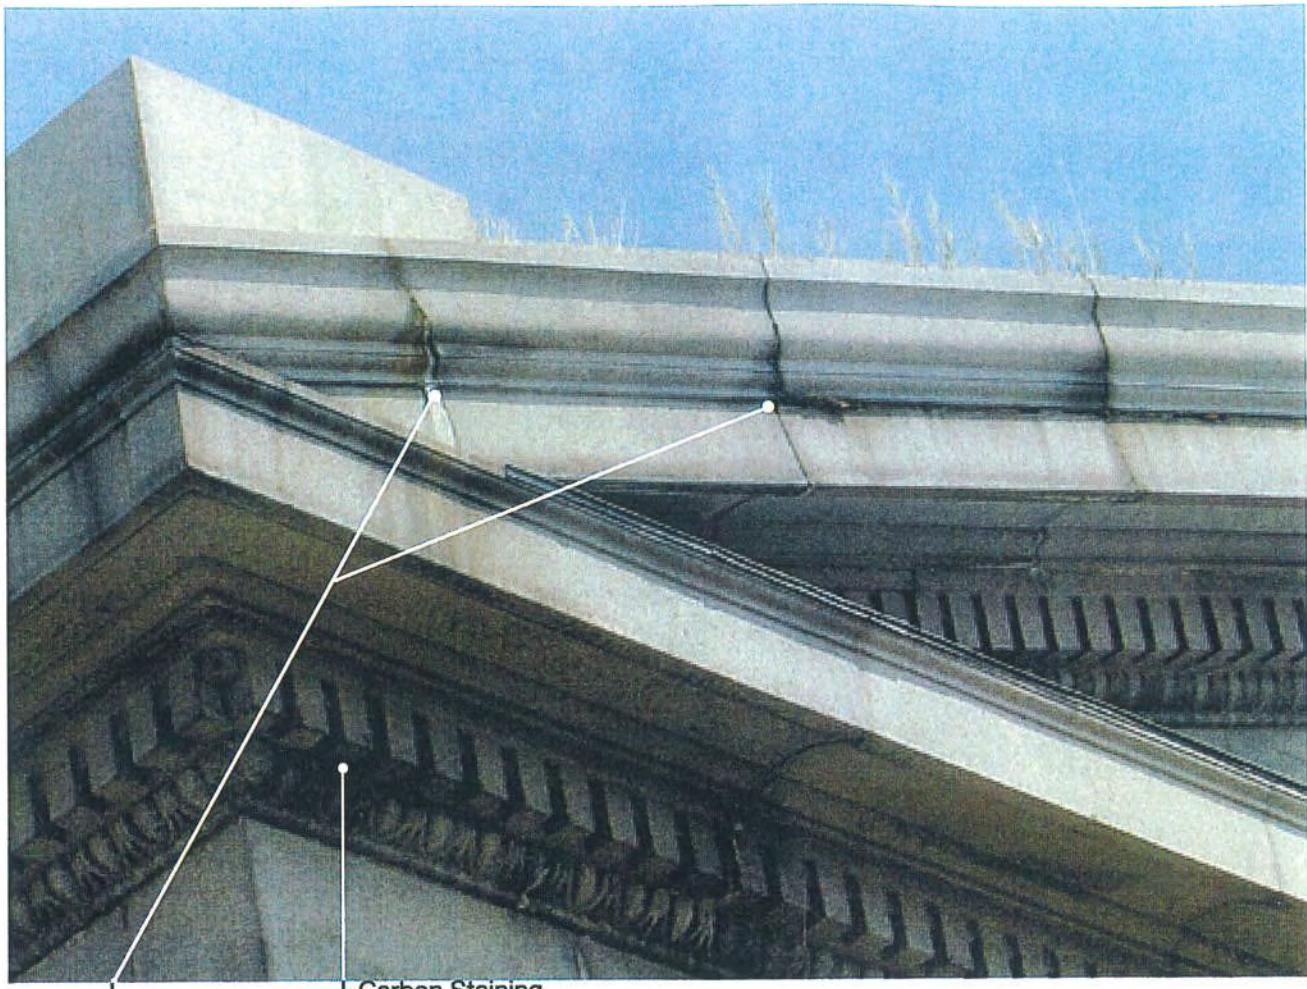
Photo #E-5

Carbon Staining

Open Mortar Joints. Moss in Joints at bottom cove.
Vegetation in joint at top of cove.

South Elevation Pediment - West Corner

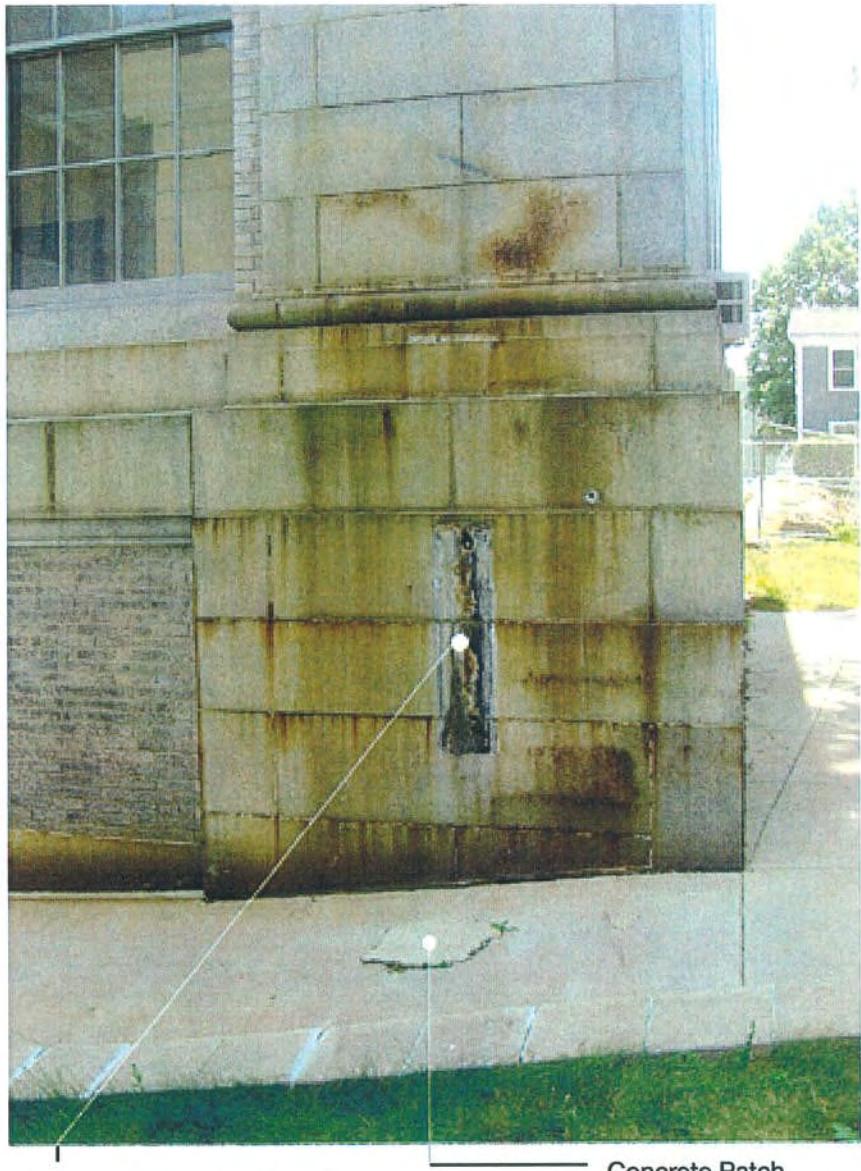
Photo #E-6

Anchors Support removed
from spiral stair/
fire escape

Concrete Patch
former anchorage for
center pole at
fire escape/spiral stair

North Elevation West Wing

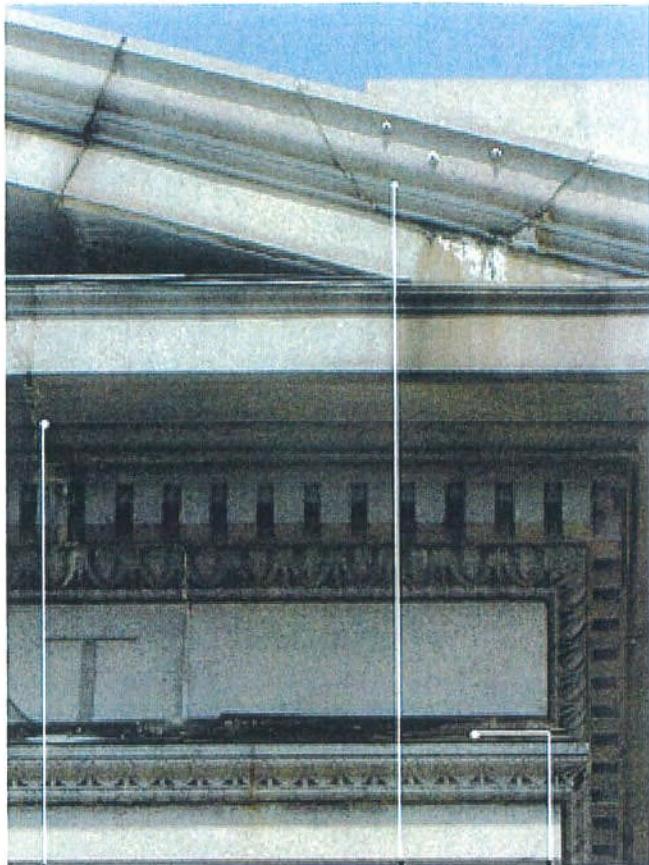
Photo #E-7

Open Joints

Plywood Birdproofing

Improper Stone Repair

South Elevation Pediment East Corner

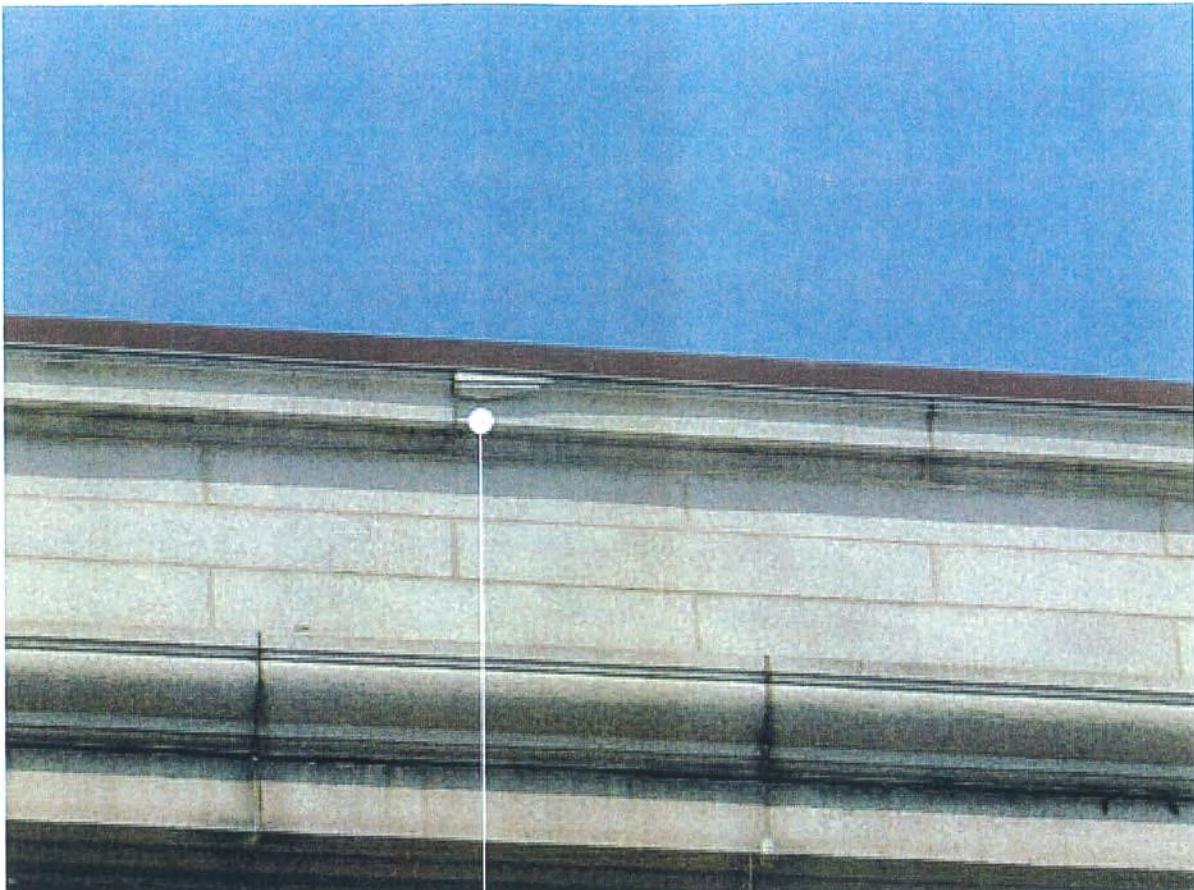
Photo #E-8

Loose Stone Fragments

Cornice: West Wing South Elevation

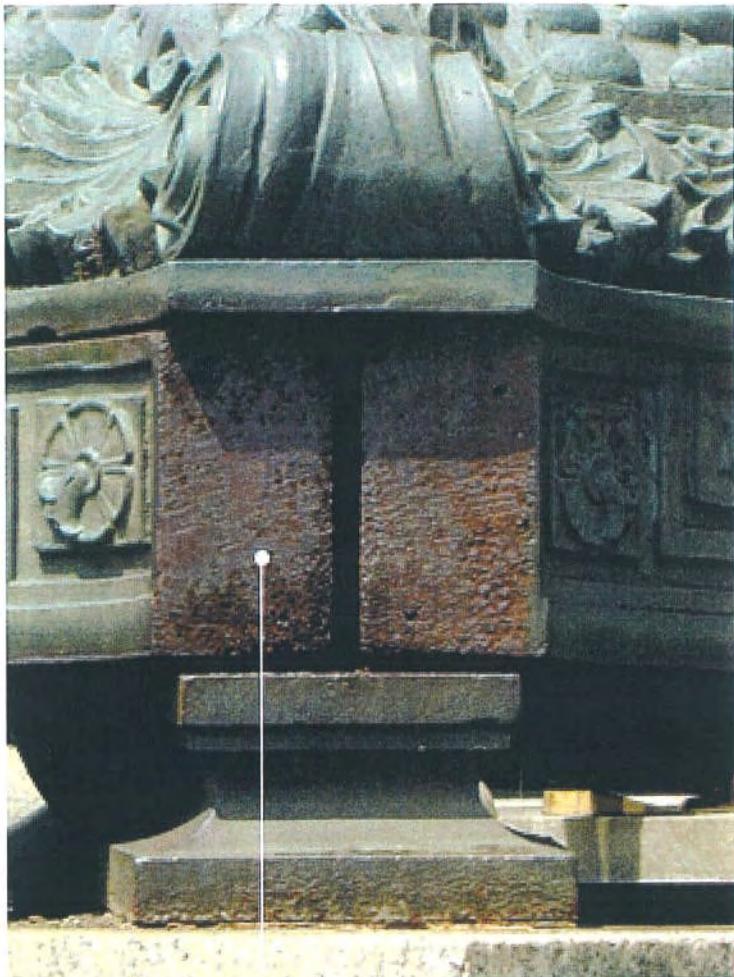
Photo #E-9

Missing Medallion

Cast Iron Light Standard

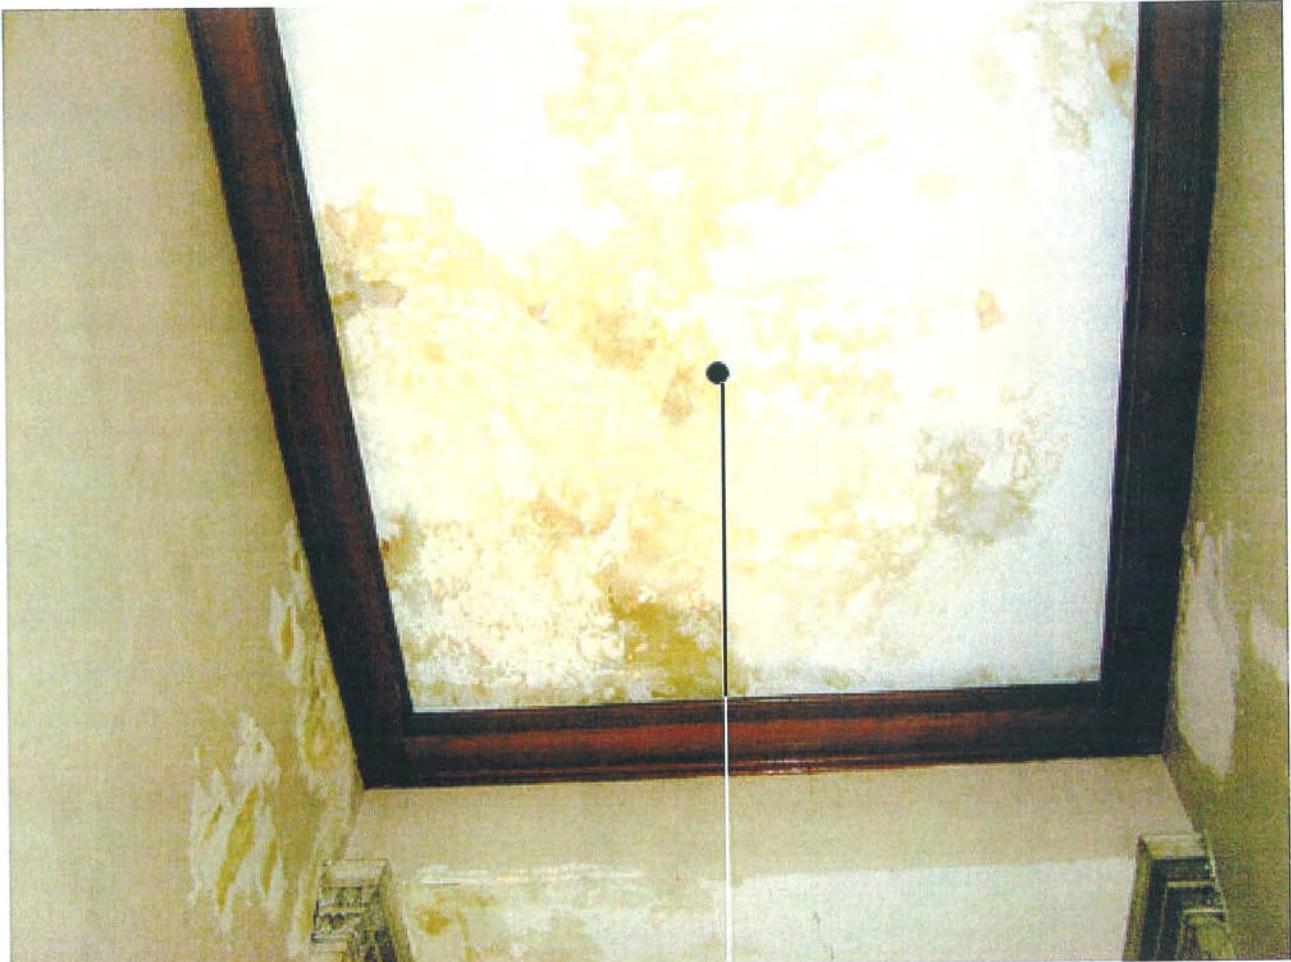
Photo #I-10

Water Damage Plaster Ceiling

Second Floor West End Corridor

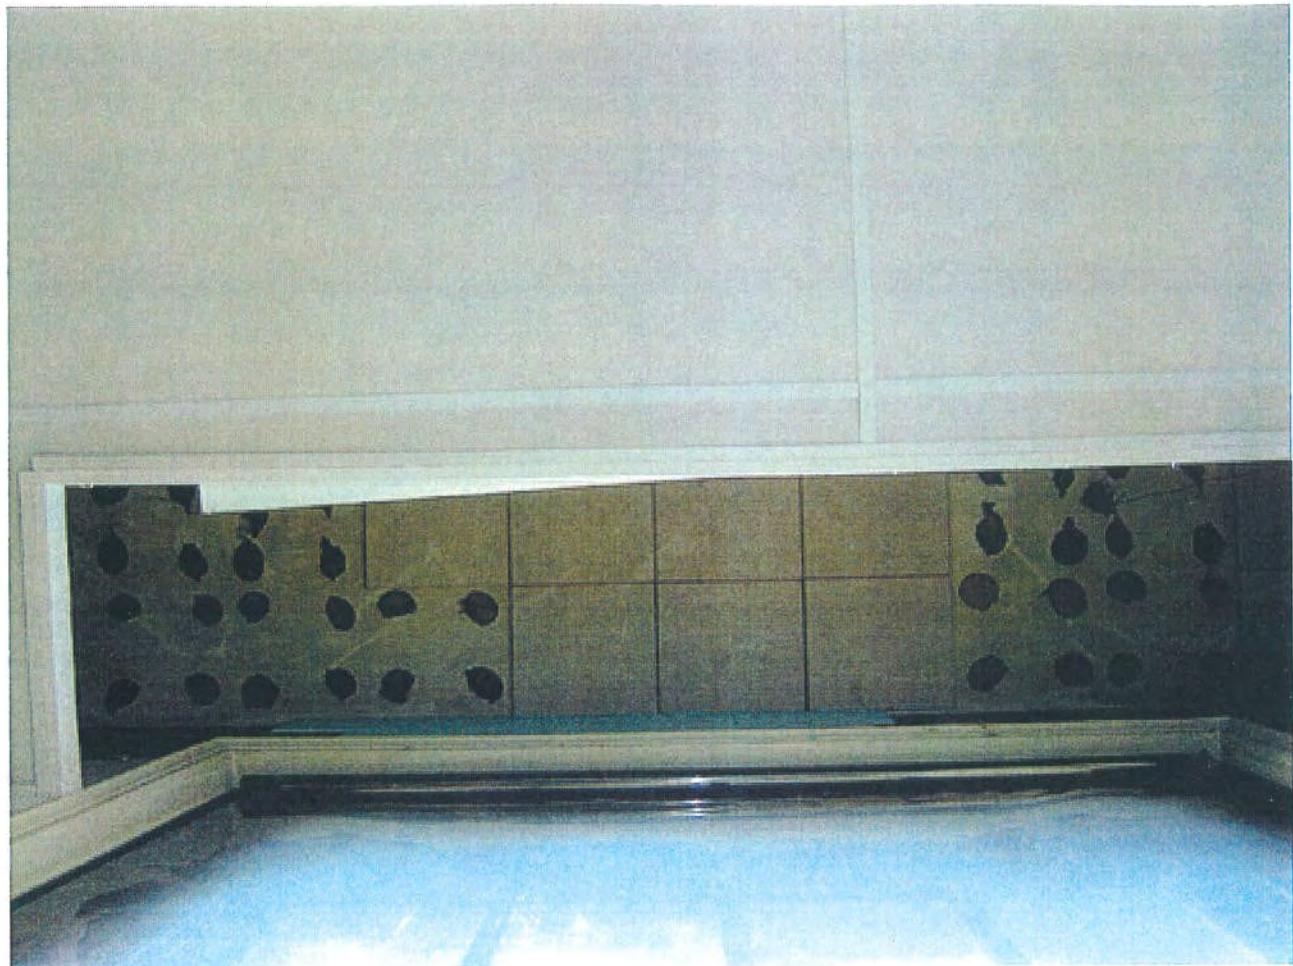
Photo #I-11

Multiple Ceilings

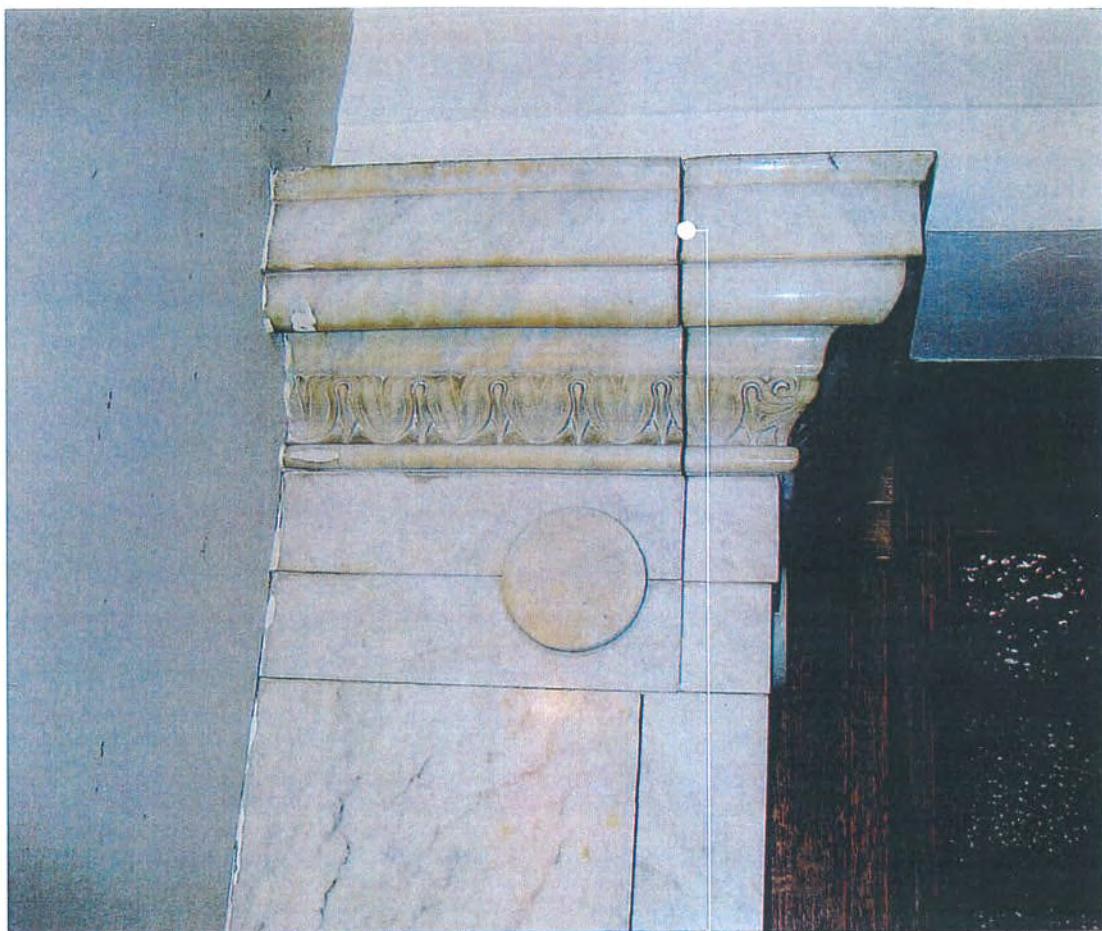
Photo #I-13

Open Joint

MARBLE PILASTER

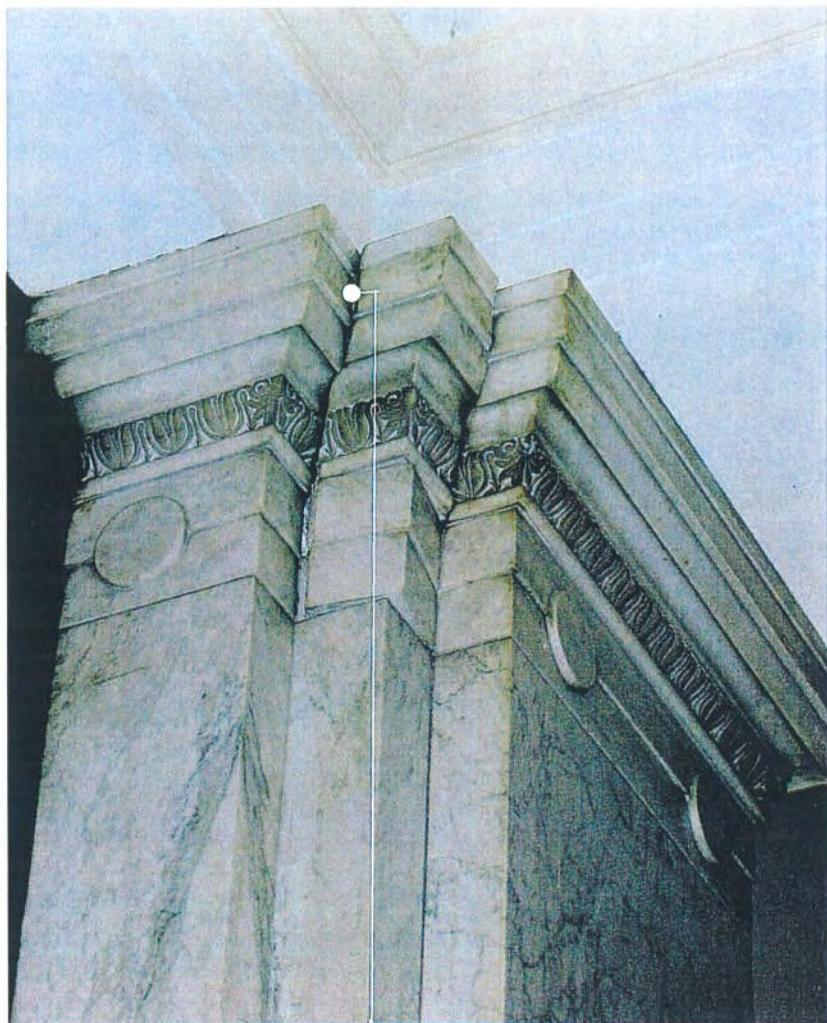
Photo #I-14

Open Joint

MARBLE PILASTER

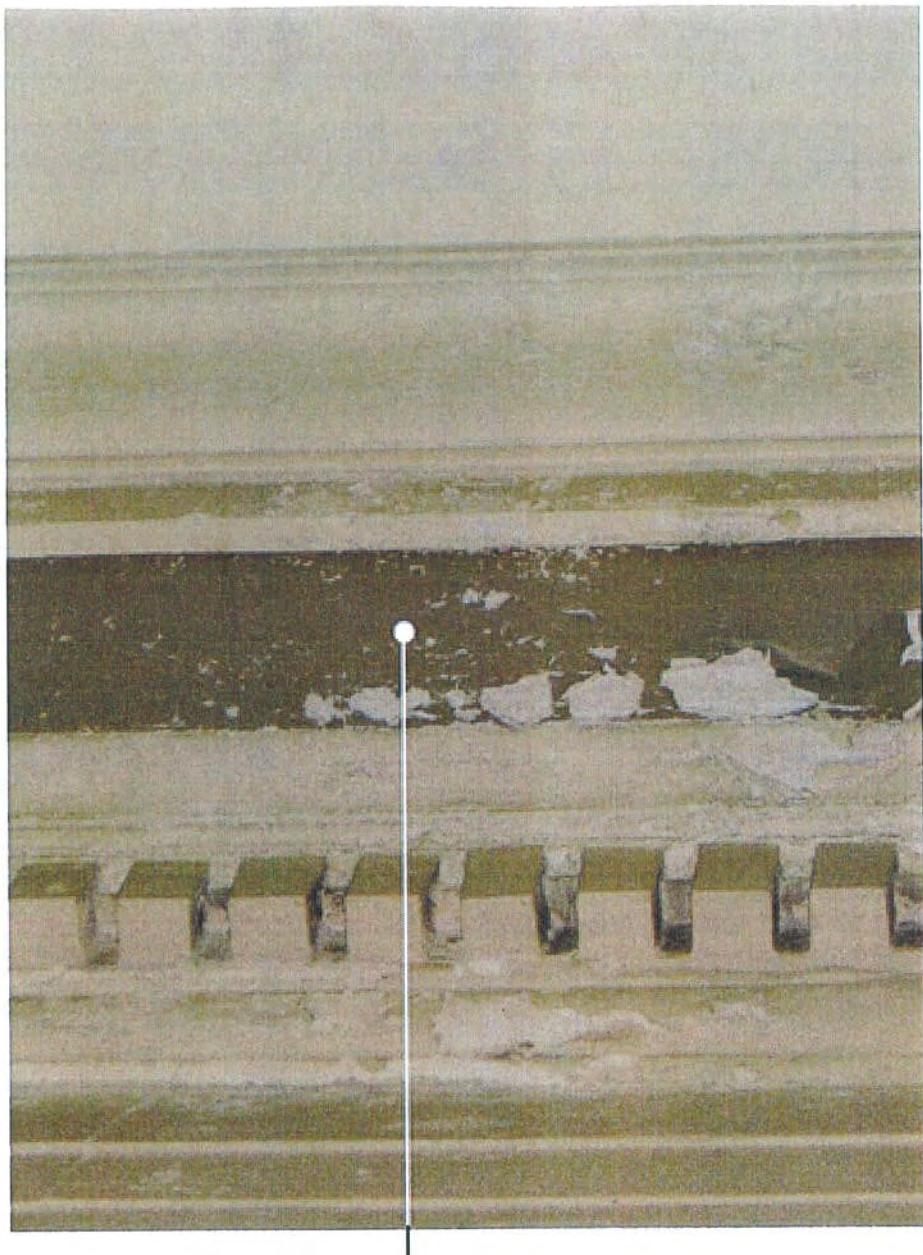
Photo #I-17

Water Damage to Plaster Details
at face of wall/coffer ceiling

Second Floor - Lobby

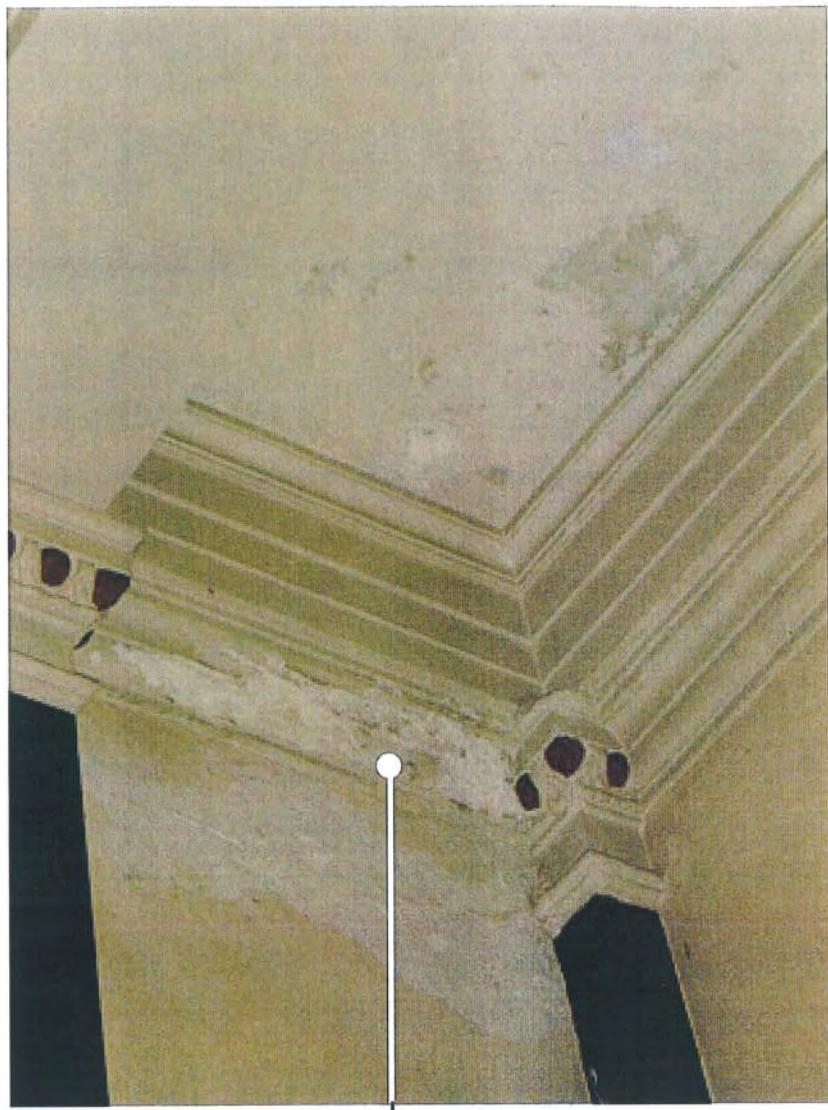
Photo #I-21

Water Damage

Plaster, Coffered Ceiling
