**Fort Lee and Fort Pickering
Conditions Assessment, Cultural Resources Survey, and
Maintenance and Restoration Plan**

City of Salem

Massachusetts Historic Commission

2003

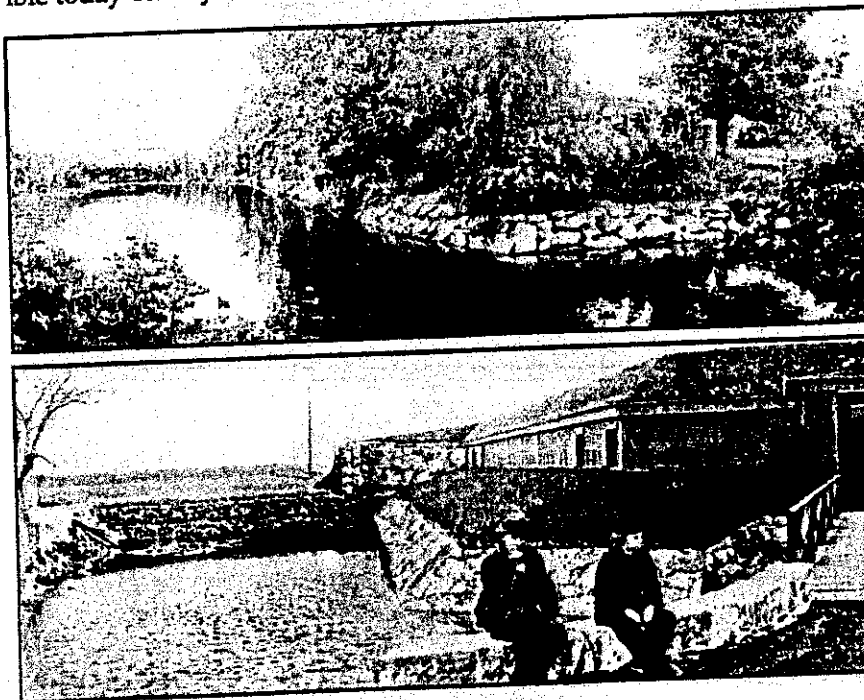
Fig. 48: Current appearance of north rampart, north moat, and entry to fort (extreme right). The dry laid stone rip rap on the edge of the moat and the stone wall visible at the end of the moat are largely intact to their original appearance and are in serviceable condition. The north rampart is completely obscured by vegetation, but has also lost all its detailing except its general mass. See Fig. 49 below for c. 1860's appearance of this view.

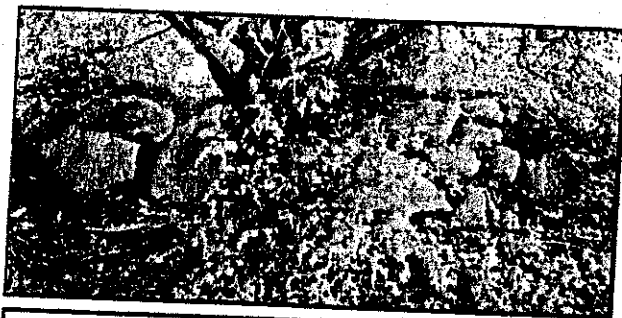
Fig. 50: Current typical appearance of dry laid stone wall that originally served as the back of the rifle gallery. The top of the rampart lies just above and behind the stone wall. The wall is dishevelled with substantial soil erosion above and below it.

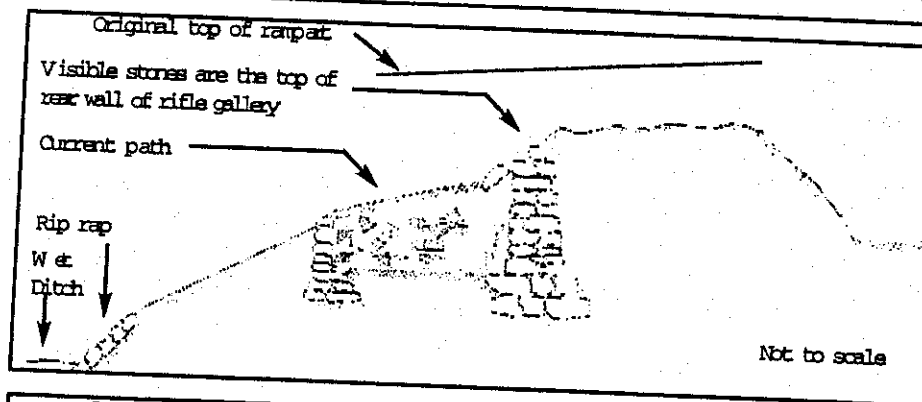
Fig. 52: Section of current condition of north rampart with remains of collapsed rifle gallery buried by the soil that was originally on its roof. Height of rampart has likely been reduced by erosion (red line indicates original height)

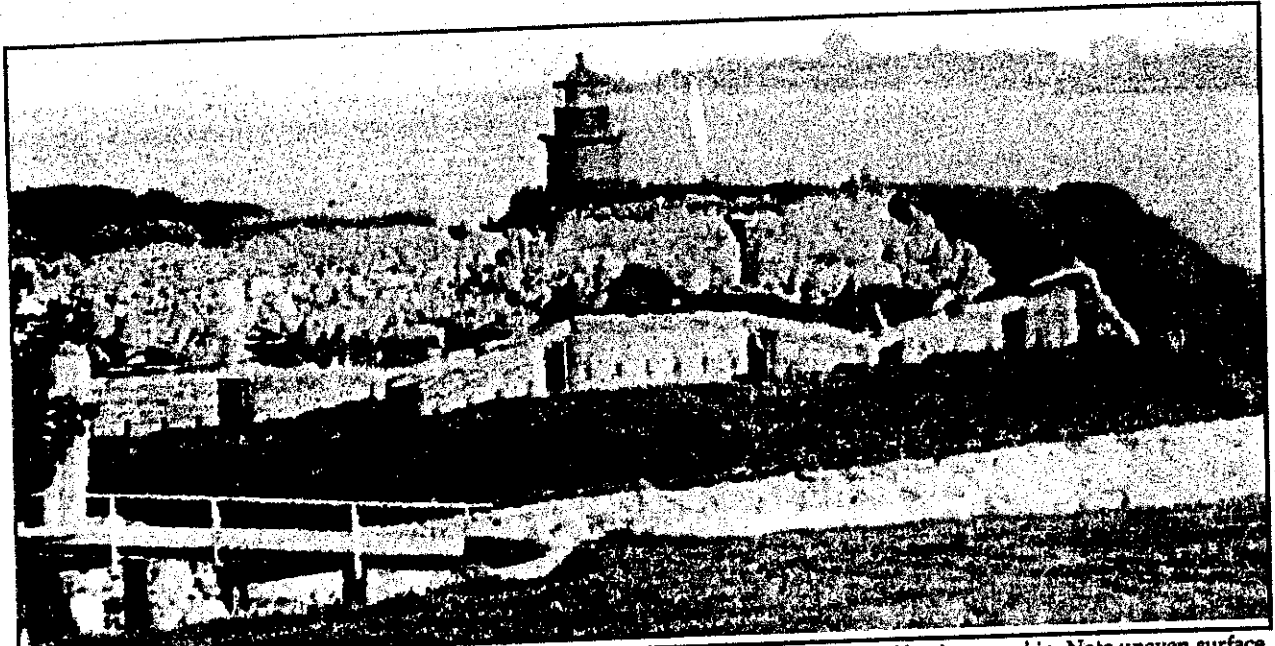
Fig. 54: C. 1900 photo of west rampart showing rifle gallery in partial collapse with the roof having caved in. Note uneven surface and erosion to top and face of remaining rampart. Photos courtesy of PEM.C.

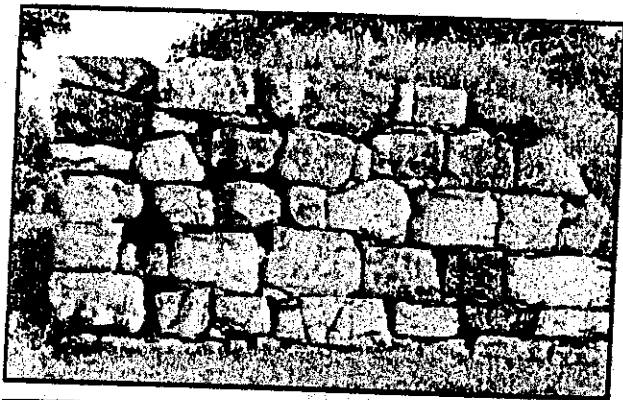
Fig. 55: Main entry wall at north Rampart (west face) showing voids to be chinked, especially on left side. The right side should be used as a model for the repair, rechinking and rebuilding of other dry stone walls.

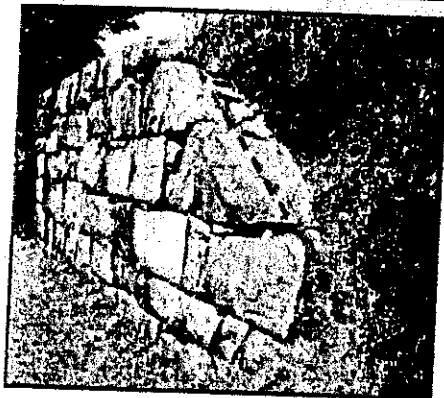
Fig. 56: Parade side flank of entry wall showing soil erosion. Soil should be restored to cover to the red line.

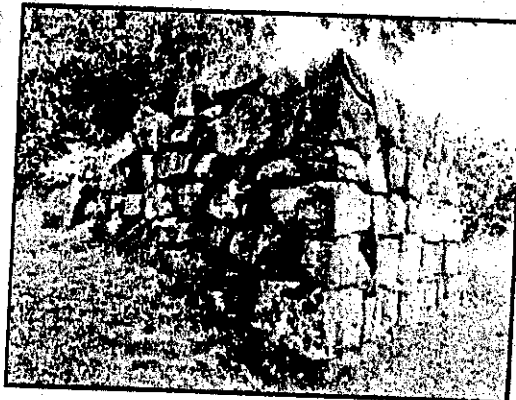
Fig. 57: Entry wall becomes more disheveled on its wet ditch side face, and needs partial rebuilding and chinking.

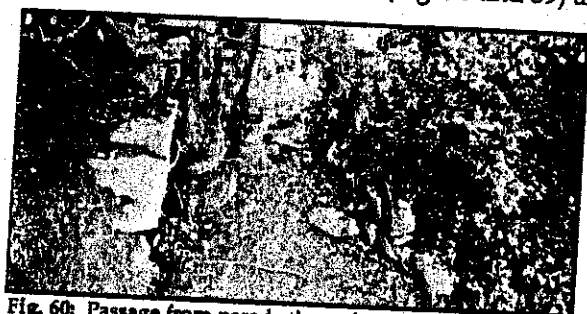
Fig. 60: Passage from parade through rampart into north rifle gallery, looking from parade. This was a bomb proof passage with a timber roof covered with soil. The roof collapsed and is presumably buried beneath the surface of the cut. The large tree threatens the wall remaining below grade and obscures the visible feature. It should be removed above grade with its roots left in the ground to decay naturally. There is substantial soil erosion occurring to the rampart on each side of the cut.

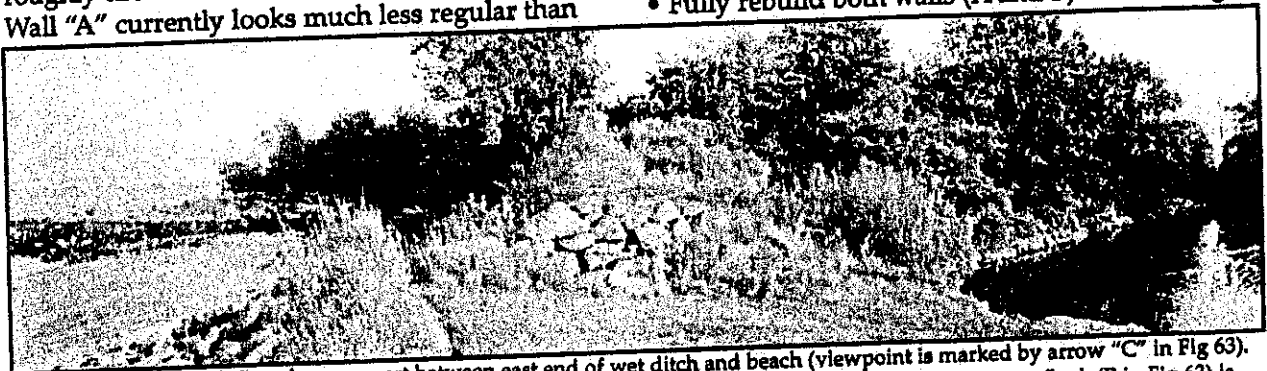
Fig. 62: Looking south from low rampart between east end of wet ditch and beach (viewpoint is marked by arrow "C" in Fig 63). Wall marked "A" has lost height, its uniform appearance, and is threatened by erosion from path. Its return flank (B in Fig 63) is concealed by vegetation, but likely is in similar poor condition.

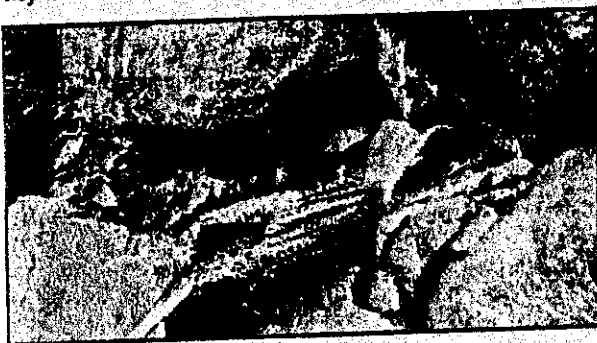
Fig. 67: Remains of beam end that was part of rifle gallery construction embedded in wall. Additional pieces remain in place at this height at irregular intervals across the wall. After being stabilized, the wall and related archeological features in the ground in front of it should be interpreted with signage explaining the former rifle gallery.

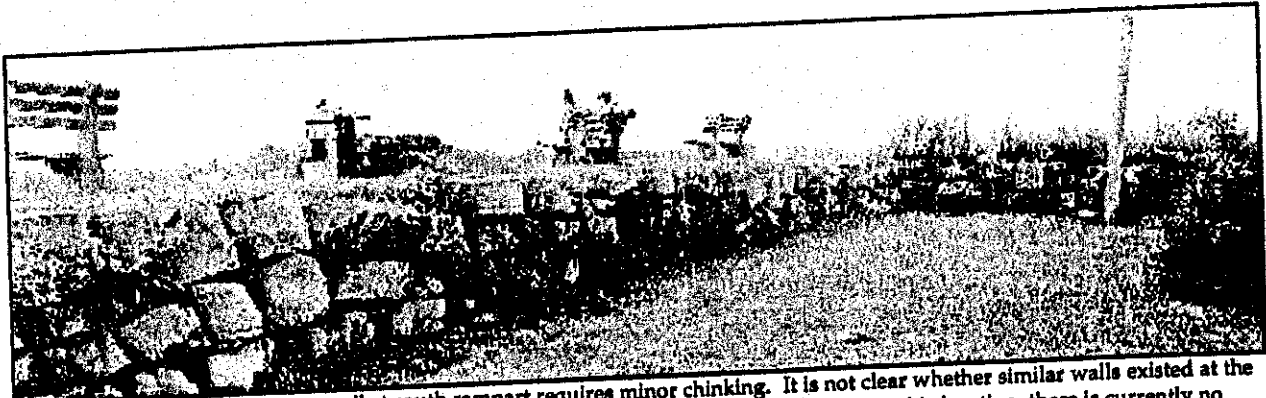
Fig. 68: Well organized parapet wall at south rampart requires minor chinking. It is not clear whether similar walls existed at the top of the terraplein behind all the ramparts. Although the 1864 plans show an embrasure at this location, there is currently no sign of it. Perhaps the rampart top was reworked c. 1900.

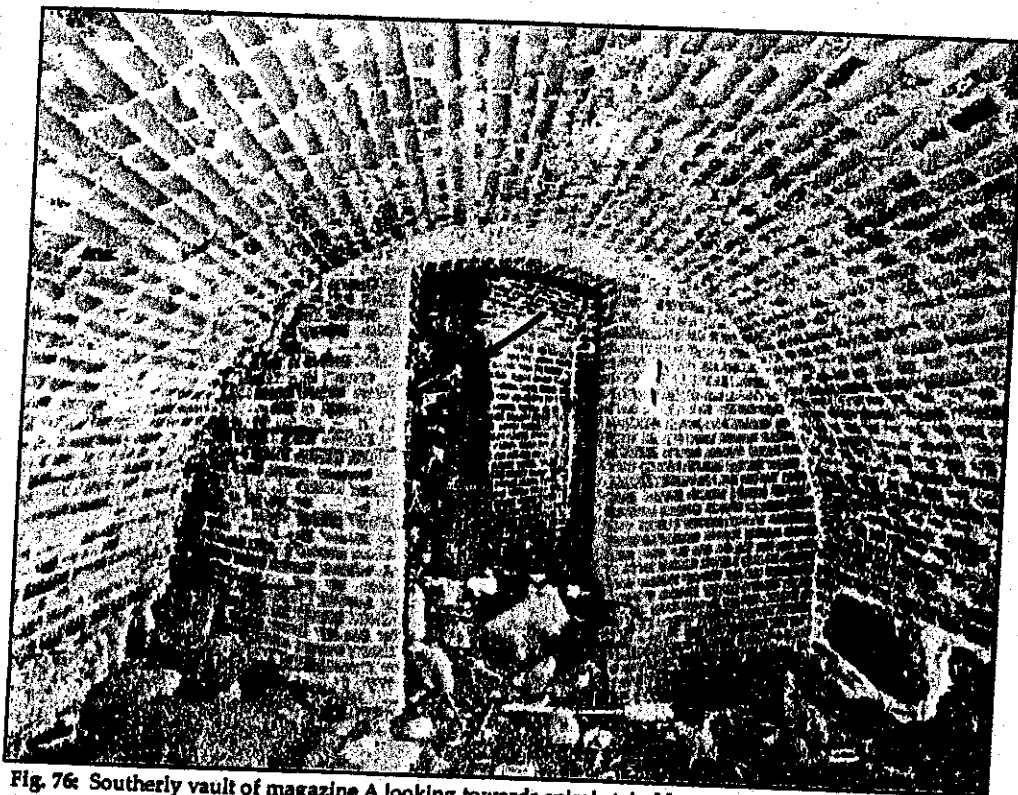
Fig. 76: Southerly vault of magazine A looking towards spiral stair. Note missing newel at stair and adjacent brick that is dark from water draining down the stairs (Arrow).

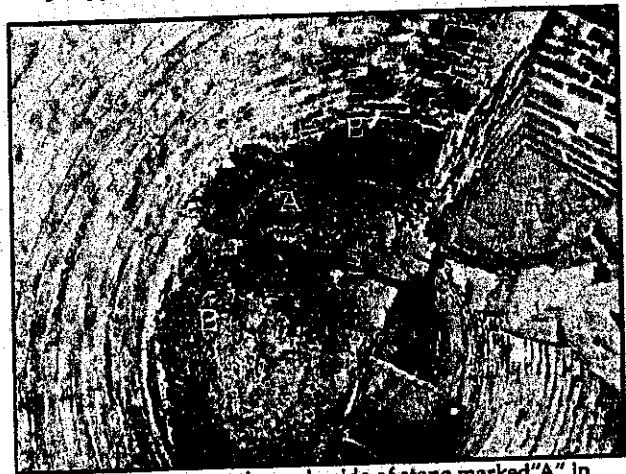
Fig. 82: Looking up at the underside of stone marked "A" in fig. 80. Stone marked "B" extends completely over top of "A" and is supported by the brick perimeter walls. This stone forms the entry landing of the spiral stair.

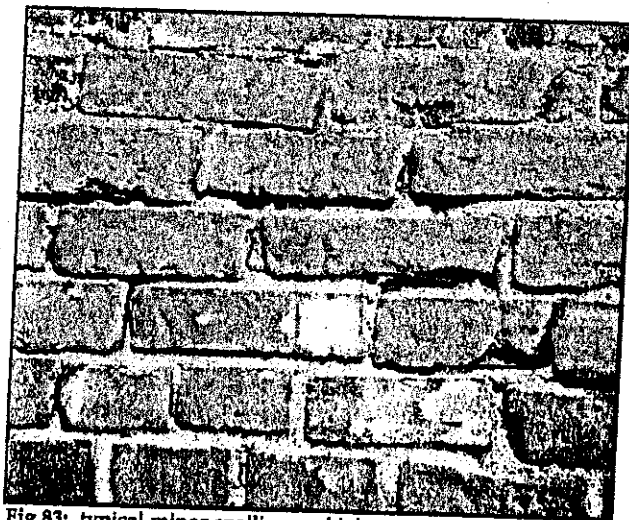
Fig.83: typical minor spalling and joint erosion in staircase. brick joints in upper section have been poorly repointed many years ago.

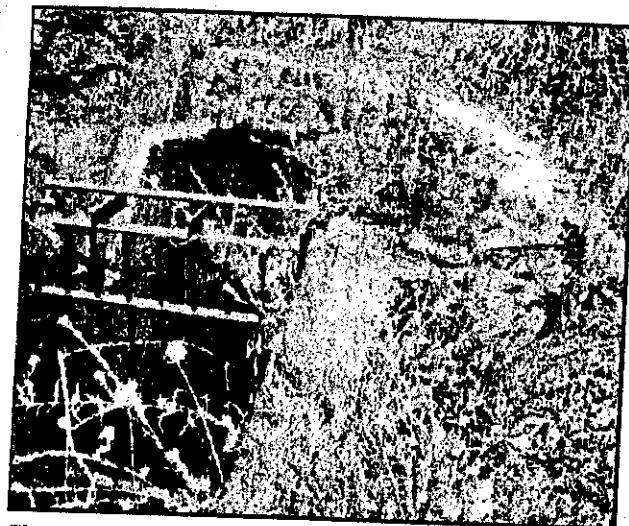
Fig.84: Top entry to magazine A showing missing stone lintel that further exacerbates the drainage problem at the stair.

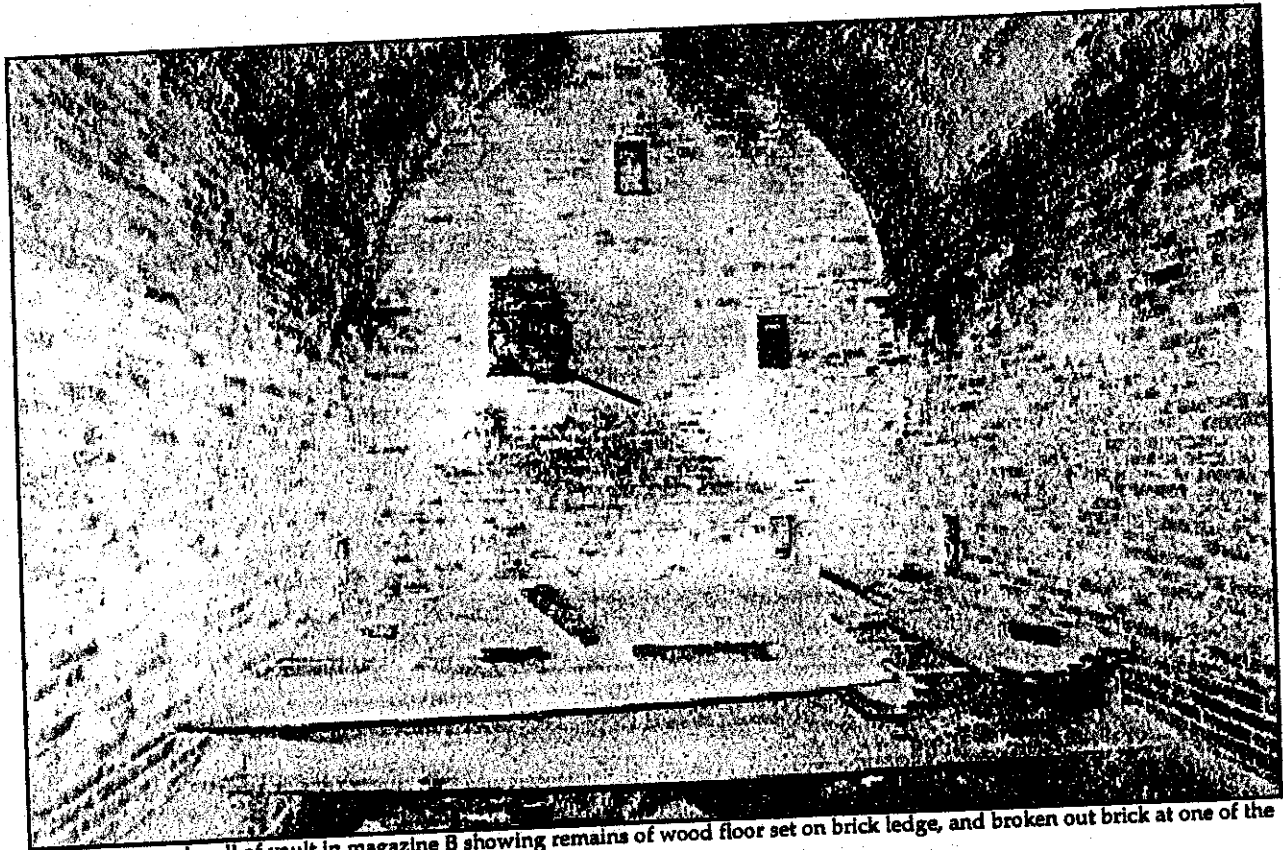
Fig.85: Rear end wall of vault in magazine B showing remains of wood floor set on brick ledge, and broken out brick at one of the ventilation slots (arrow).

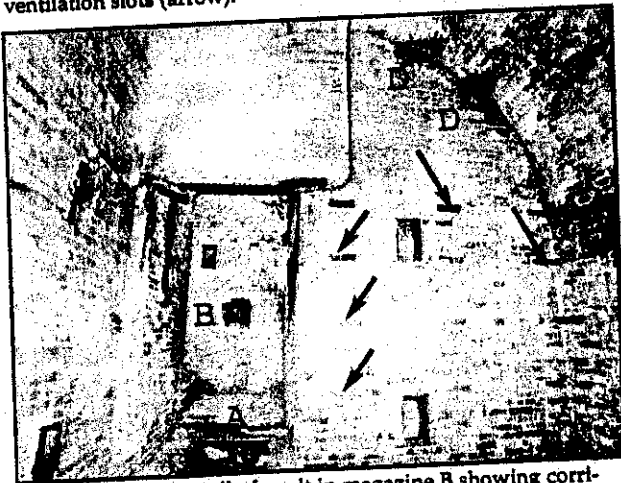
Fig.86: Front end wall of vault in magazine B showing corridor at base of staircase with wood landing that needs to be rebuilt (A) and ventilation slot with broken out brick (B). Dark spots at edge of ceiling marked "D" may indicate dampness from roof seepage. Arrows mark some of the typical original wood nailers set in brick that may have been for centering to construct the arch.

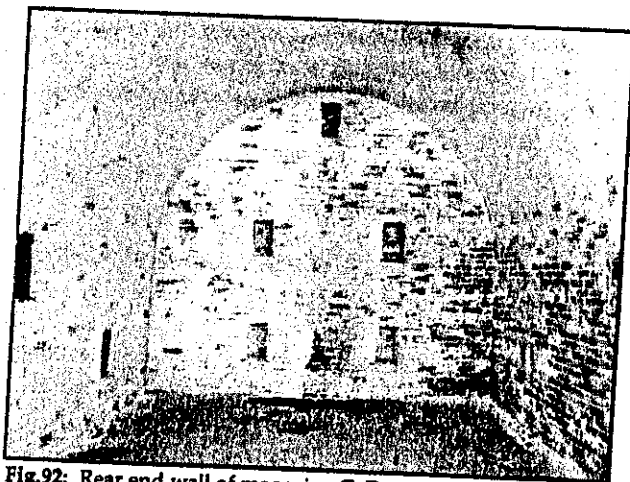
Fig. 92: Rear end wall of magazine C. Exposed red brick at right has areas of minor spalling indicating there is chronic dampness in this area.

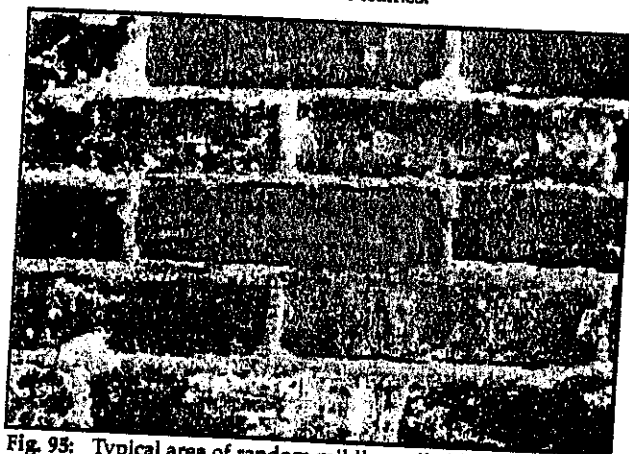
Fig. 95: Typical area of random mildly spalled brick where the whitewash has been pushed off by dampness.

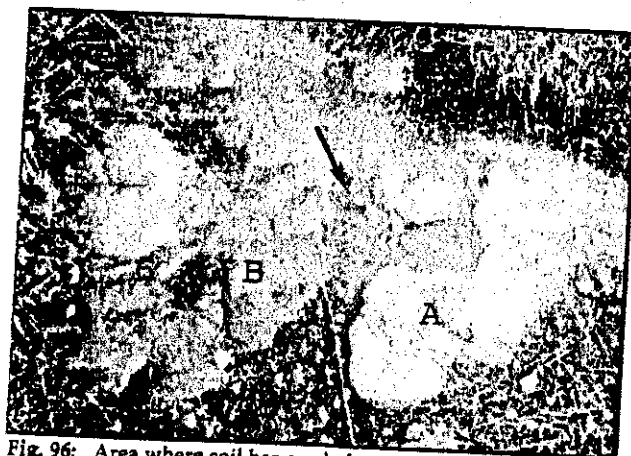
Fig. 96: Area where soil has eroded to expose the top of the entry corridor vault. Arrow indicates tar waterproofing over brick, "A" marks thin rubblestone and mortar covering over brick, and "B" indicates Brick.

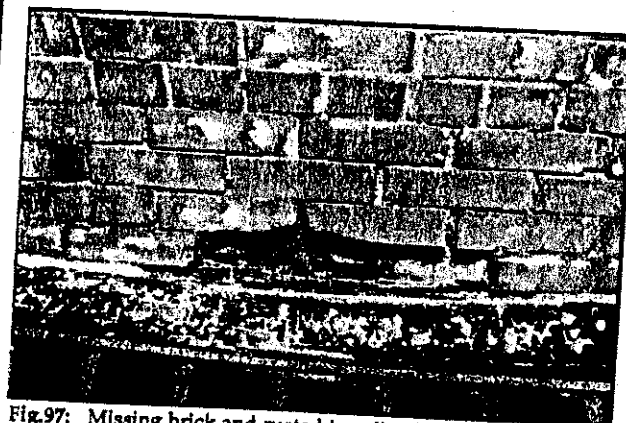
Fig. 97: Missing brick and rusted iron lintel bar over inner doorway to magazine C.

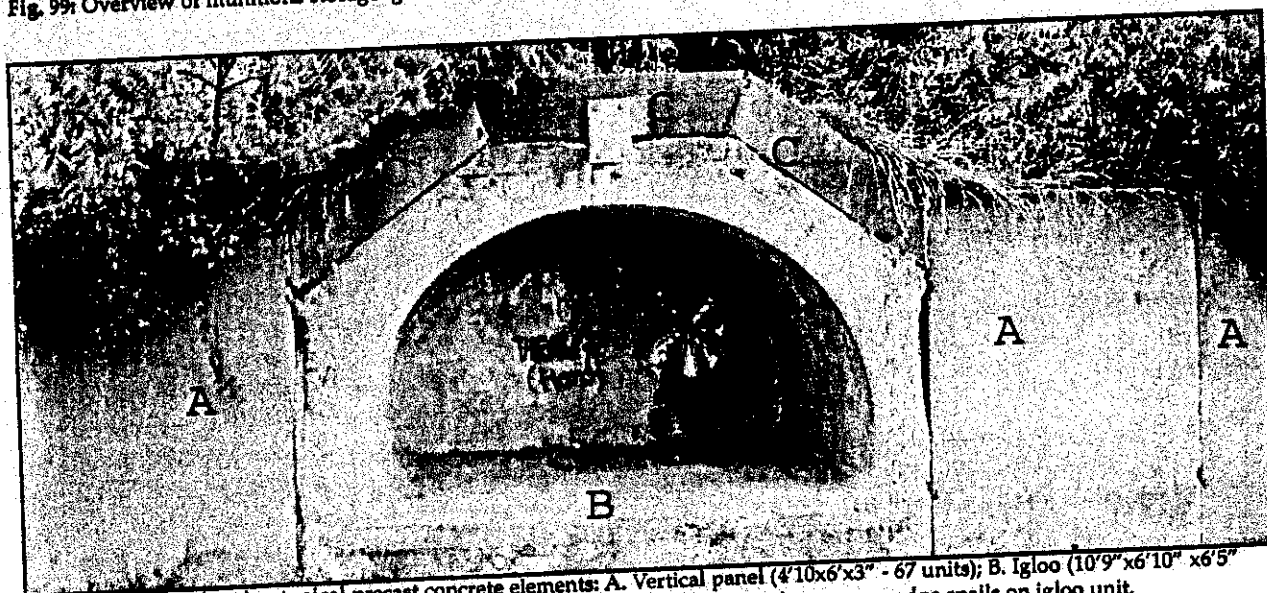
Fig. 100: Igloo #1 showing typical precast concrete elements: A. Vertical panel (4'10"x6'x3" - 67 units); B. Igloo (10'9"x6'10" x6'5" deep- 10 units); C. Igloo top panels (4'x1'x4" - 30 units). Note recent graffiti and numerous edge spalls on igloo unit.

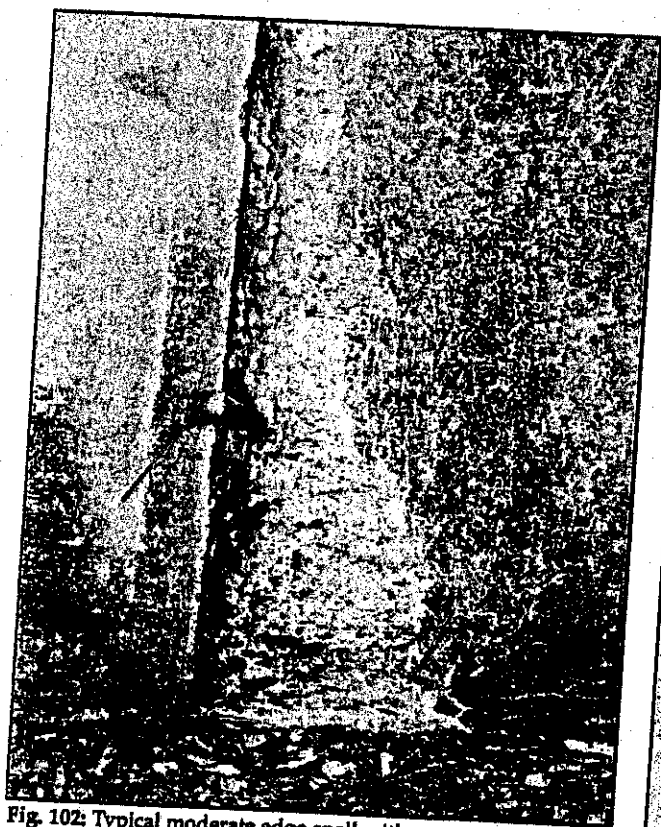
Fig. 102: Typical moderate edge spall without visible rebar. Arrow indicates bronze clip joining panels. Repair patch should not bond the adjacent panels together.

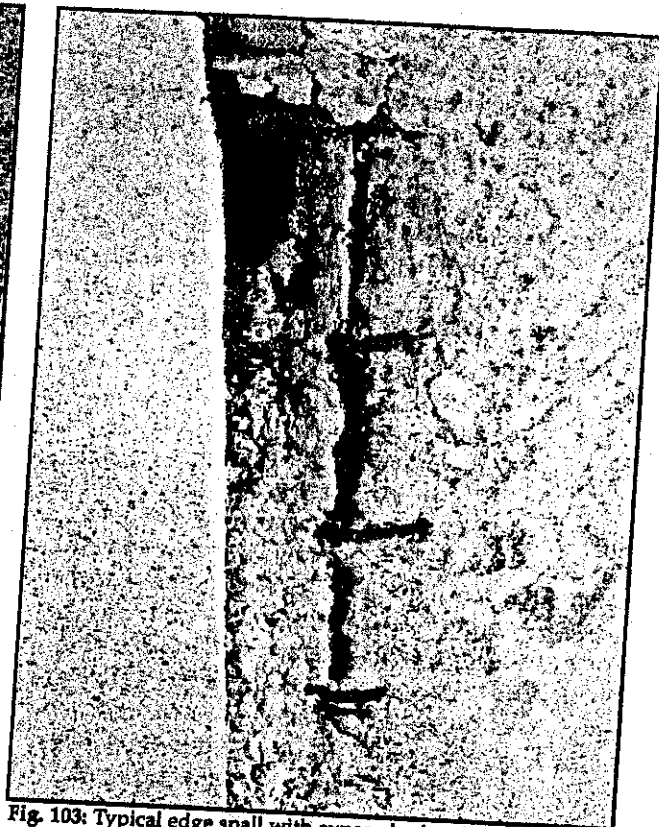
Fig. 103: Typical edge spall with exposed rebar. Rust must be removed from rebar as part of the patching process.

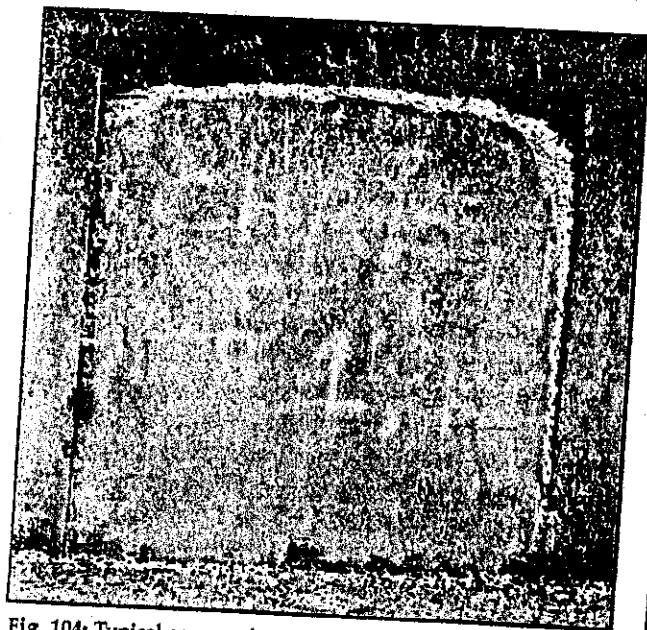
Fig. 104: Typical severe edge spall; Complete replacement of the panel with a matching new precast panel is recommended.

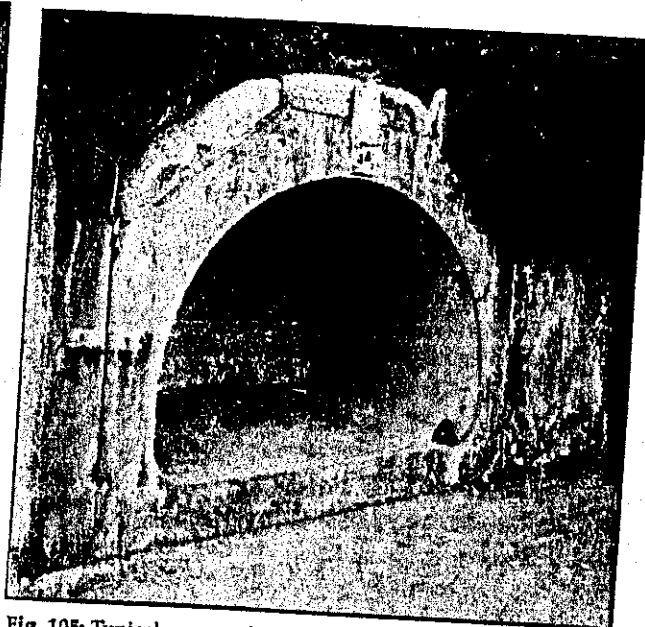
Fig. 105: Typical severe edge spall at igloo top panels; Complete replacement of the panels with a matching new precast panels is recommended.

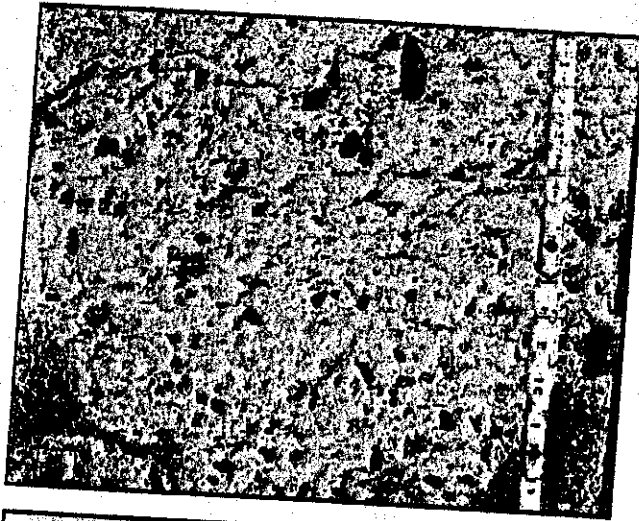
Fig. 106: Typical surface spall without exposed rebar that can be repaired with plastic patching. This condition occurs primarily on east wall panels, with each panel having several sizeable areas of spalling totaling 8-12 square feet of surface area.

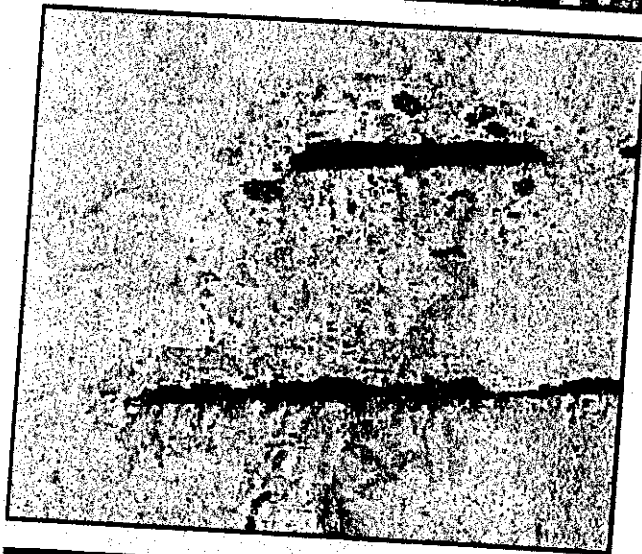
Fig. 107: Typical surface spall with exposed rebar. This condition occurs mostly on the inner faces of some igloo niches and results from the rebar being much too close to the surface. The exposed rebar should be cut out in conjunction with applying a plastic patch.

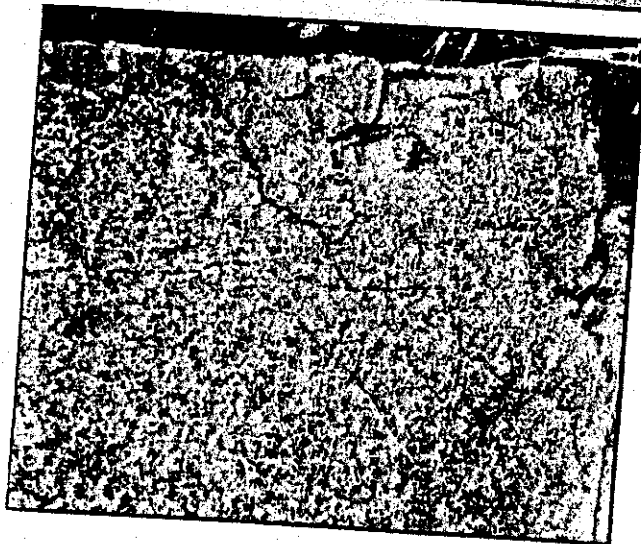
Fig. 108: Typical incipient spall at the top corner of a vertical panel. The visible cracks are the initial phase in developing a full spall. Repair can be postponed until active spalling occurs. Although the survey only noted 5 areas of incipient spalling, there are probably many more that were not observed due to overhanging foliage.

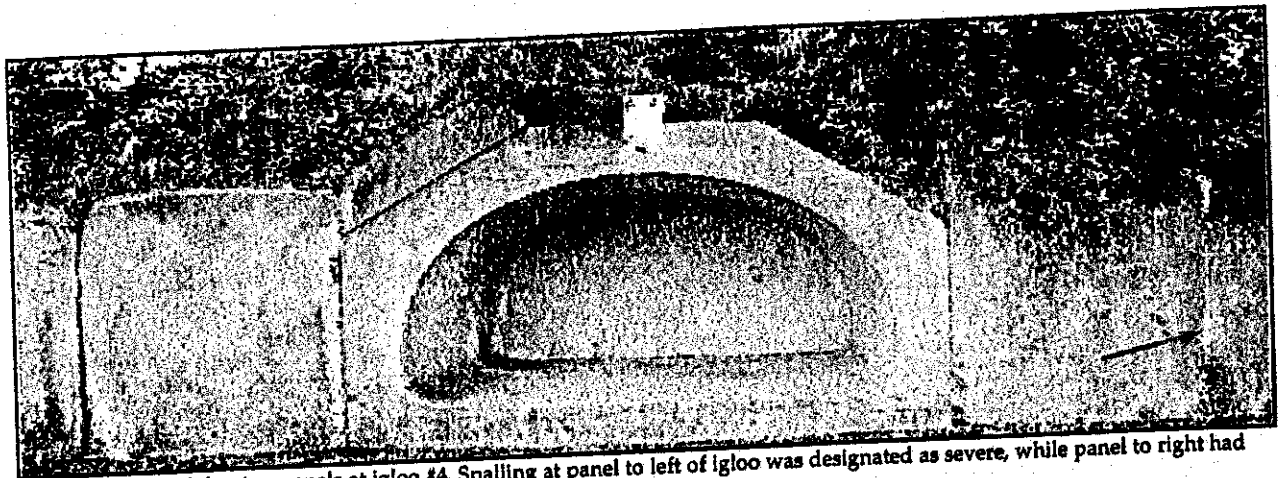
Fig. 109: Missing igloo top panels at igloo #4. Spalling at panel to left of igloo was designated as severe, while panel to right had moderate spall (arrow) and incipient spalling at the top.
