Feasibility Study for 5 Broad Street, Salem, MA

Preliminary Findings: November 4th, 2009

Existing Building: Architectural Critical Evaluation: Exterior

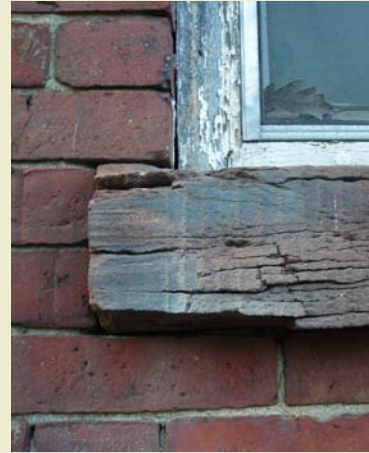
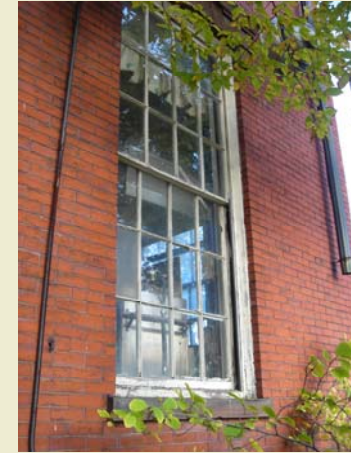
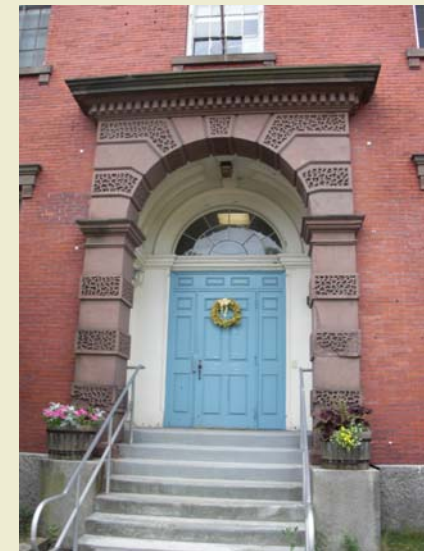
- The building condition – Fair to poor.
- Stone foundations should be waterproofed
- Repair and/or replace deteriorated concrete ramp and railings.
- Reset and re-pointed exterior brick as needed
- Replace/Restore deteriorated brownstone details.
- Restore single pane double hung windows at first and second floors-add storm windows.
- Replace failing newer third floor windows.

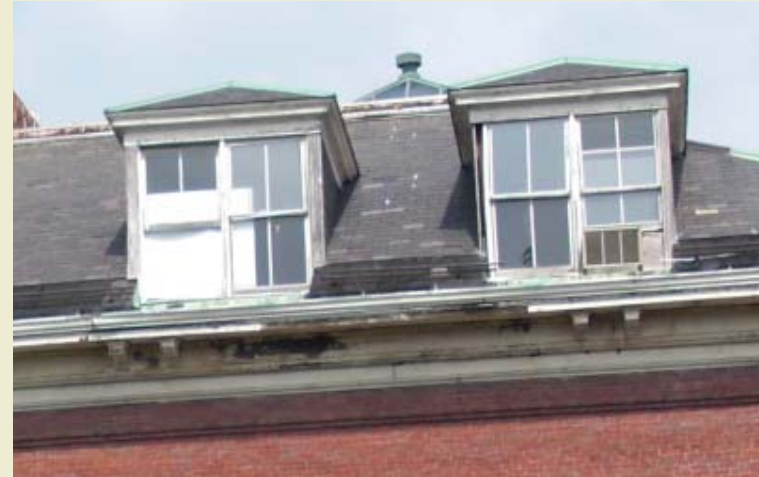
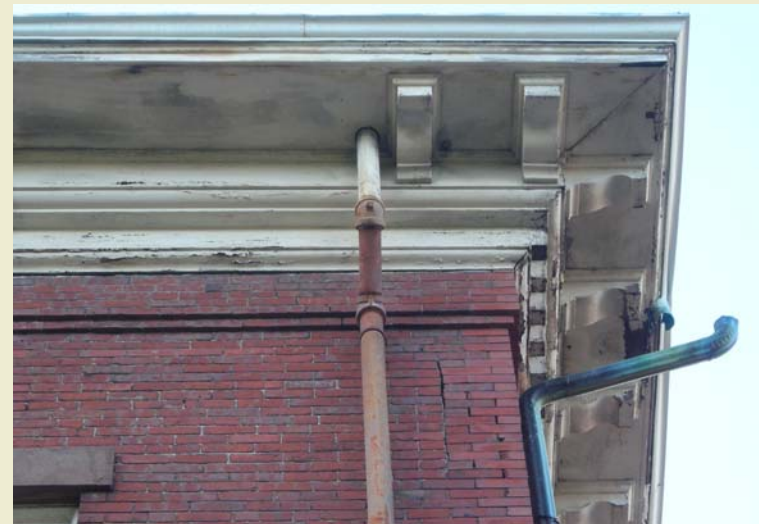
- Repair deteriorated wood trim at the eave line & windows and doors.
- Replace copper gutters.
- Replace downspouts and make proper connection at roof and grade.
- Copper snow guards and soffit pans are coated with tar and should be replaced.
- Slate roof appears to be in good shape, but requires up-close evaluation. Some water damage was observed at the third floor ceiling.

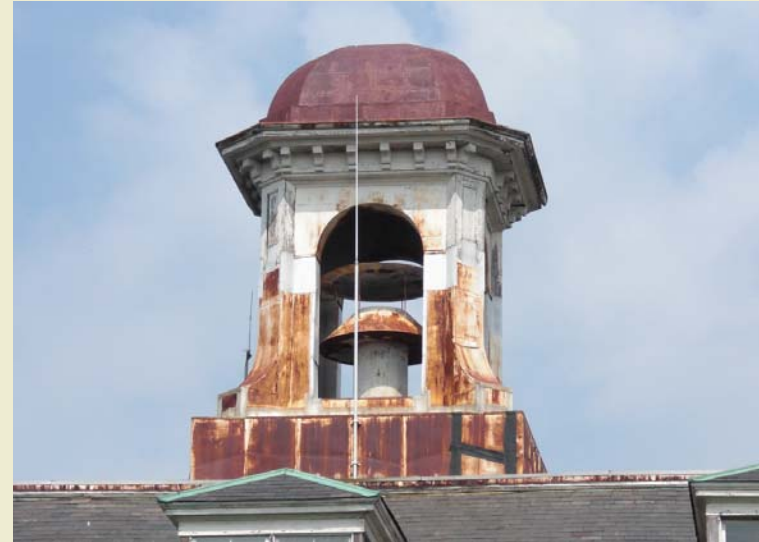
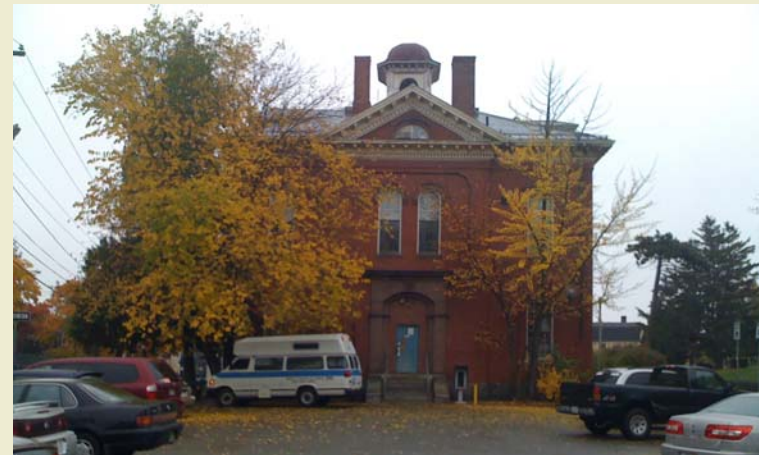
- Repair/restore cupola including copper roofing, copper flashing, wood detailing.
- A vent stack exists in the cupola and it's current function is unclear. We recommend removal and cap if not serving a useful purpose.
- Power wash and paint entire building.
- Trim/remove random overgrown trees and shrubs.
- Confirm stormwater drainage management. Repair and replace as needed.
- Repair asphalt parking surfaces

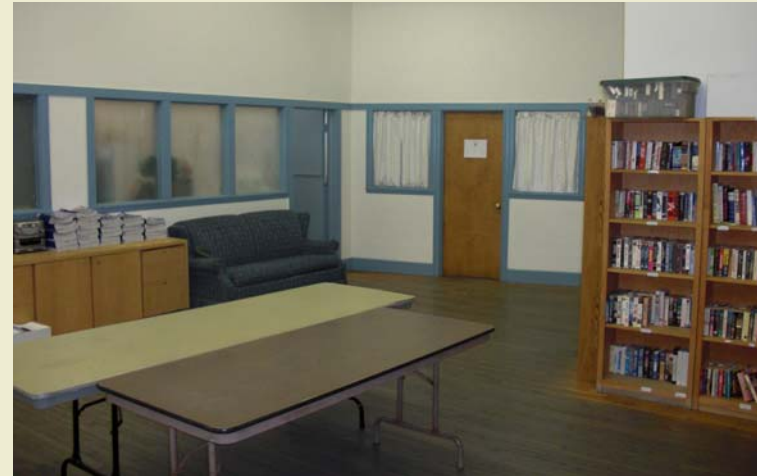
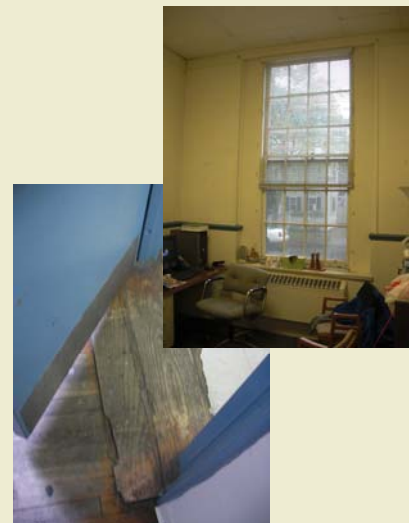
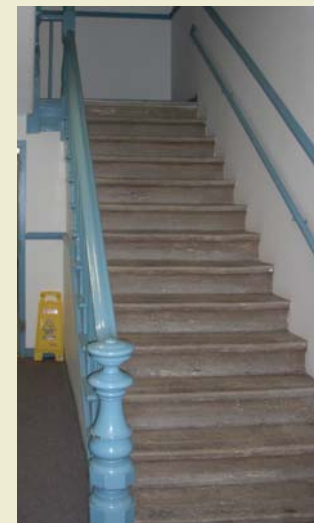
- General finish appearance is institutional in character.
- Condition is fair to poor.
- Original, potentially historic details to be reviewed:
 - Stair railings, balusters and newel posts
 - Window trim on the first and second floors
 - Some Hardwood flooring
- Determine presence of lead paint on interior trim.

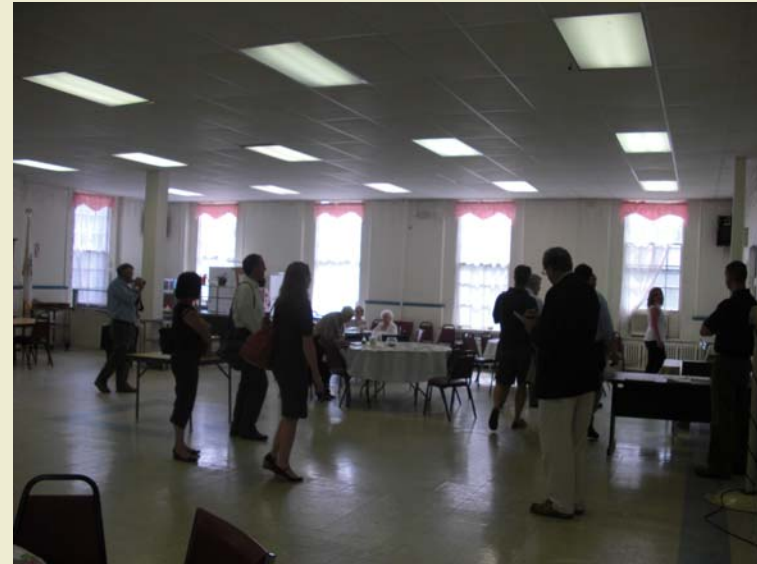
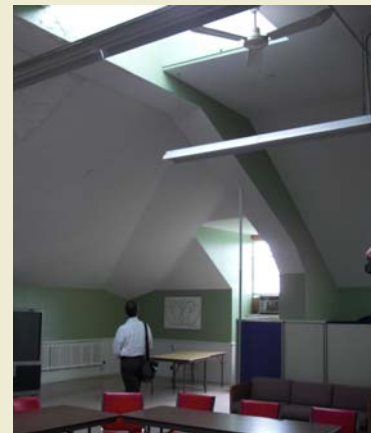
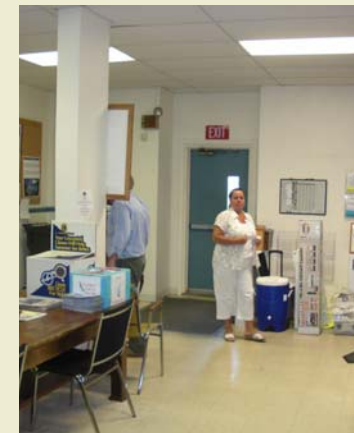
- Flooring is a mix of carpet, hardwood, vinyl tile and ceramic tile.
- Newer ceiling finishes in fair condition.
- Interior plaster cracks and water damage indicate exterior envelope water penetrations issues to be repaired.
- The building appears to be partially insulated.
- Copper framed skylights should be restored and made weather tight.
- Hydraulic elevator is in fair condition but does not meet current code requirements.

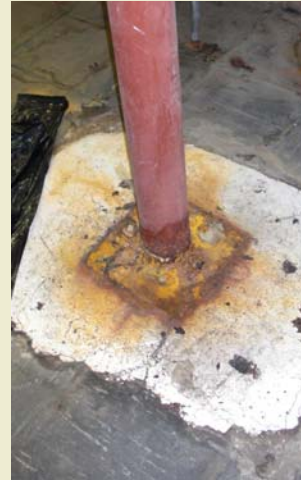
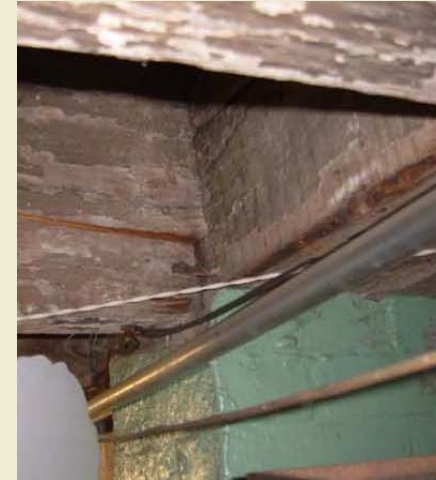
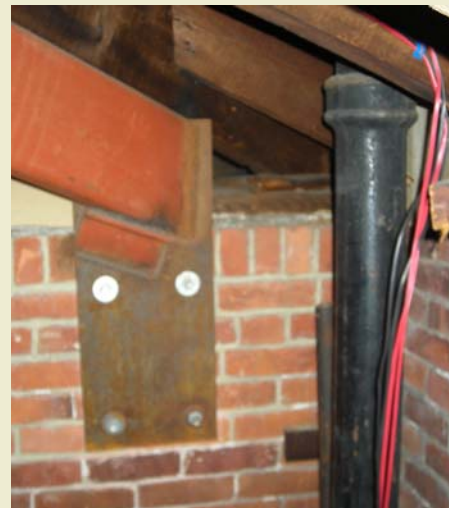
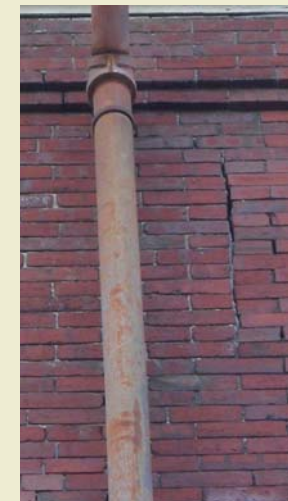
Structural

- There is no evidence of major structural distress - the building appears to be in fair condition
- There are many framing deficiencies that need addressing on all floors
- Some masonry piers in basement need rebuilding.
- Joist hangers need to be installed for all flush framing conditions on all floors
- Deflection in upper floor framing is noticeable and should be reinforced.
- Exterior cracks located around perimeter of envelope need re-pointing and replacement
- Any addition to building over 10% of it's floor area will need extensive seismic upgrade

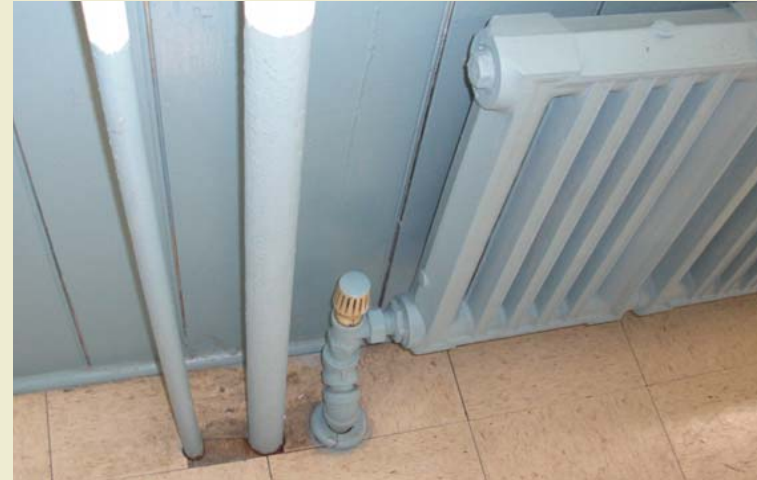
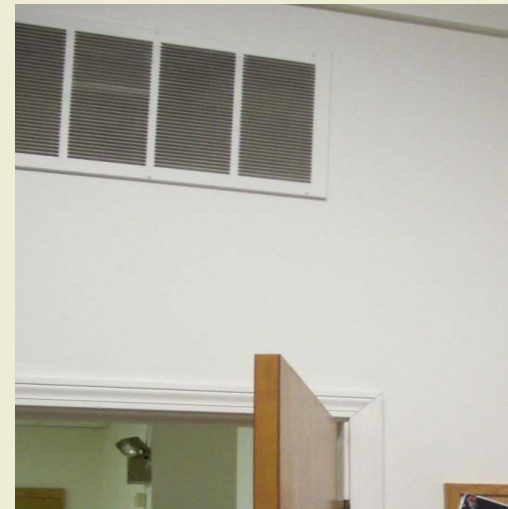
- Overall the delivery system is in poor condition and needs to be replaced
- Oil-fired boiler is ~5 years old and in good condition
- The building currently has only one zone and should have more zones to deal with the daily changes in temperature and solar orientation.
- No mechanical ventilation; should be provided to support occupants.
- No Mechanical exhaust in bathrooms or kitchens; mechanical exhaust must be provided for all bathrooms as well as kitchen appliances.
- No Central air conditioning system.
- No energy conservation systems in place.

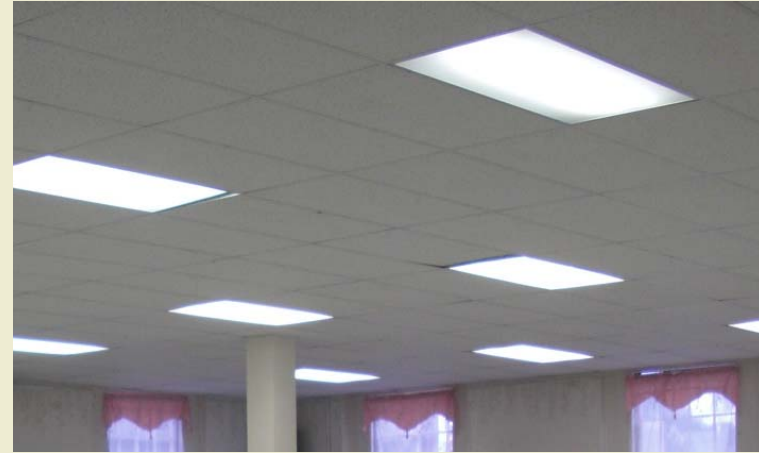
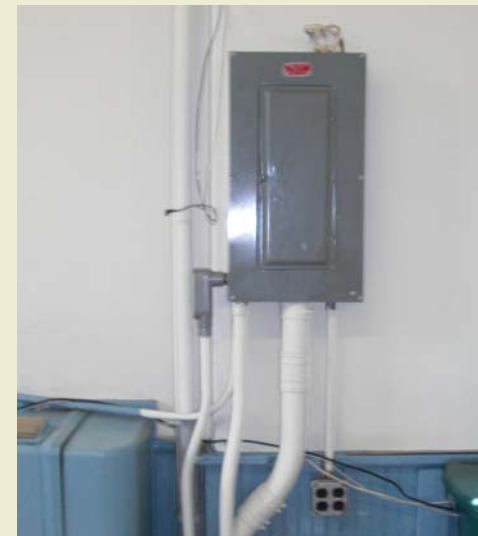
Electrical

- Current 400 amp service is undersized.
- The main disconnect & distribution panels are outdated and should be replaced.
- Any renovation should include replacement of lighting controls.
- Fuse type load centers throughout the building need to be replaced.
- Wiring in the building will need to be brought up to code.
- Most lighting fixtures throughout are inefficient except for third floor.
- Exterior lighting is inefficient and in poor condition.

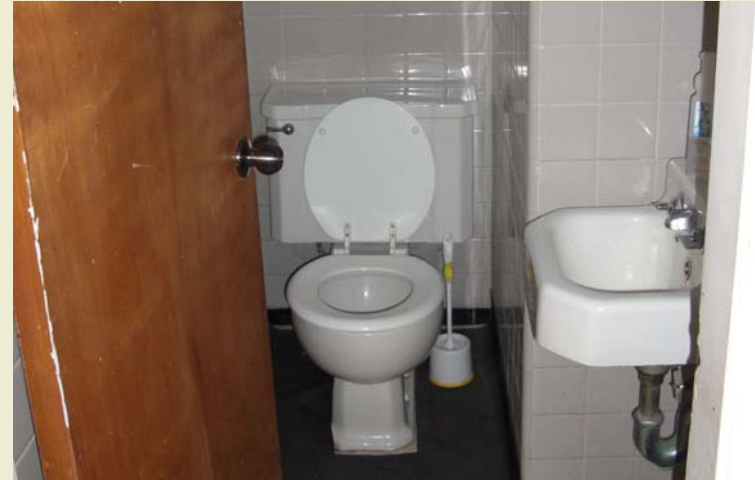
Plumbing

- The water piping from the meter to the building is undersized by current code and needs to be replaced.
- The oil fired water heater is inefficient but appears to be in good condition.
- Any renovation requires replacing non code compliant plumbing fixtures.

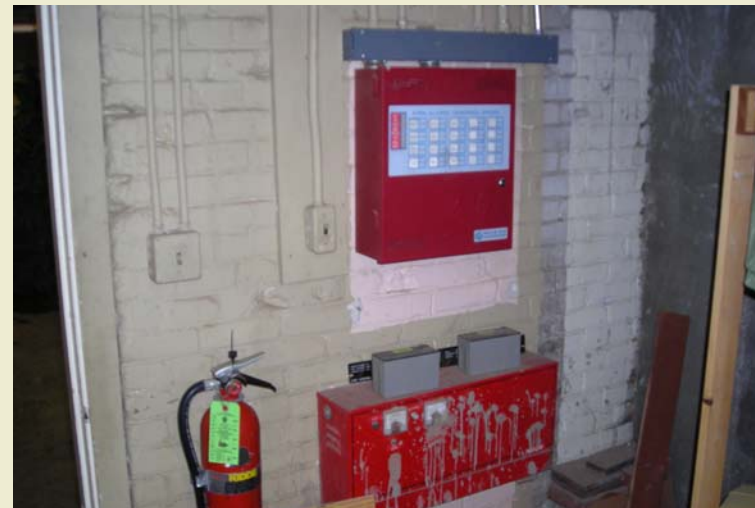
Fire Protection

- Current Fire Alarm system is not addressable. Any renovation requires replace existing alarm system.
- Any renovation requires an automatic sprinkler system.
