# St. Joseph's Parcel Reuse Study

**2.7 Acre Site  
135 Lafayette Street  
Salem, Massachusetts**

**Prepared by  
Crosswhite Property Advisors  
6 Beacon Street Suite 215  
Boston, MA 02108**

**November 2005**

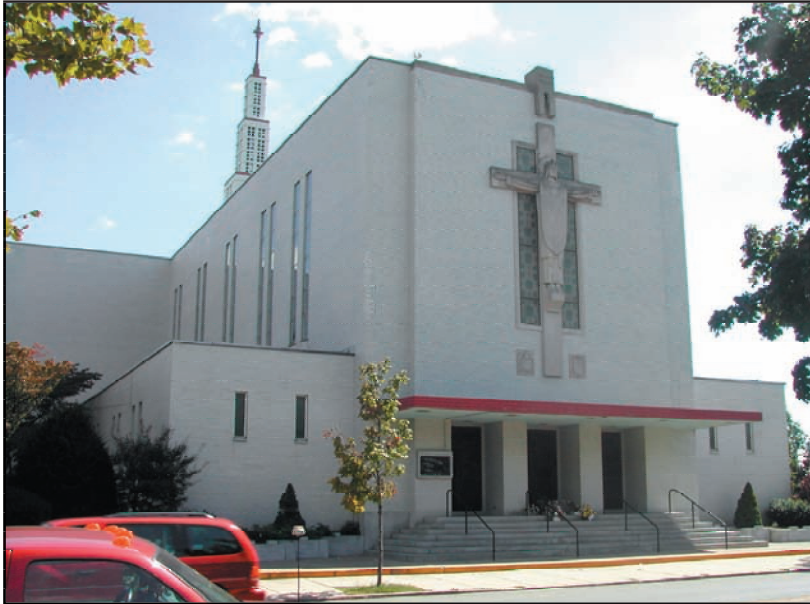
At every vertical corner of the building, a long, deep vertical crack has occurred approximately 4" from the corner on both faces. The face-brick (white glazed) has not demonstrated compatibility with either the brick or concrete back-up material.

The brick over the windows is supported by embedded steel lintels, of which the bottom flanges can be seen from the exterior. Stress lines can be seen in the form of horizontal cracks and movement in and near the joint in which the lintel sits, often for long stretches of wall such as the north and south elevations, which have repetitive closely spaced windows that share the same top elevation. The cause of the cracking and movement is most likely the corrosion of the steel lintels and subsequent rust jacking.

There are thermal cracks at the north and south facing walls to the east of the transept. These relatively short walls are rigidly attached via the roof structure to the longer walls on the west side of the transept. When thermal expansion and contraction occurs in the roof structure, it creates a "tug of war" between the two respective sections of, causing diagonal shear cracks to occur in the shorter ones.

The chimney near the northeast corner of the building is in a cracked and somewhat fragmented condition. While it remains serviceable at present, it will eventually need to be reconstructed.

The steel structure within the tower is rusting. *The steel structure will need to be cleaned and painted if the tower is to be retained.*

Water is entering the interior of the structure through the exterior envelope at several scattered locations, as is evident in staining on the interior surfaces of walls.

*Prior to any repairing of the corners of the face brick, an investigation and analysis will have to be performed to demonstrate that the ties between the backup brick and the face brick have retained their structural integrity.*

*To halt further damage to the building facade, veneer brick should be stripped off the existing lintels, which should then be removed and replaced with new, corrosion-resistant galvanized steel. If it is evident that the corrosion is only occurring on the outside face of a given steel lintel, it may be possible to remove the rust and corrosion-protect the steel from the outside. Cracks caused by rust jacking should be pinned, knitted back together or repointed as necessary, depending upon the situation.*

*Thermal effects of this nature are unavoidable in this type and scale of construction and can best be accommodated by the introduction of sawcut control joints in the brickwork that will allow the stresses caused by these movements to be relieved.*

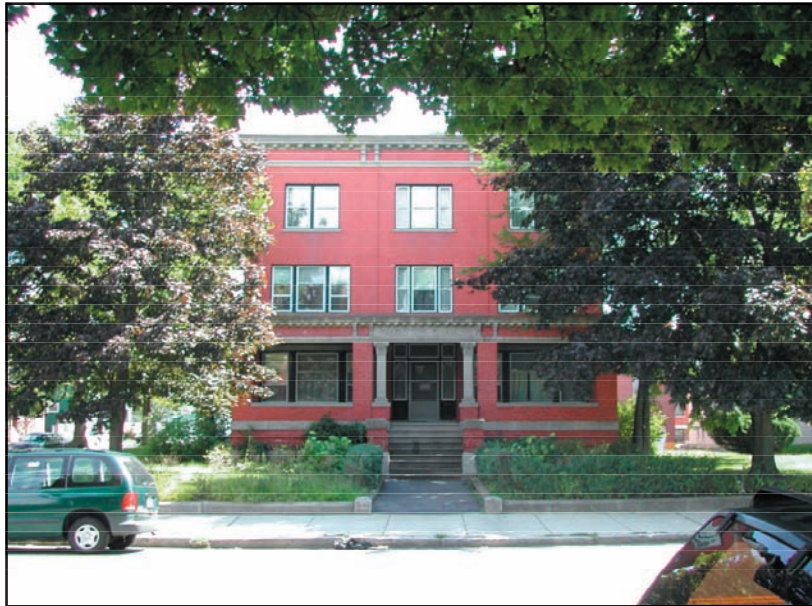
The exterior brick seems well fired and the mortar appropriate for the brick. That being the case, we have still noted significant damage (most likely due to the use of concealed headers) which is described below.

This condition specifically occurs on all three sides of the west facing (front) porch and entry steps. The piers at the bottom of the steps show significant movement as well as cracks in the lower concrete foundation wall. The south-east porch (south wall), south facing porched entrance canopy housing stairs up to the first floor, and the north facing porch have also all incurred movements due to the instability of the brick banding.

The brick over the windows is supported by embedded steel lintels, of which the bottom flanges can be seen from the exterior. Most of the steel lintels are currently deflected (sagging in the middle), and stress lines can be seen in the form of horizontal cracks in the joint that the lintel sits in, or step cracks originating at the top corner of the window and projecting diagonally upward.

The cause of the sagging of the lintels and adjacent cracking is directly attributable to corrosion of the steel lintel and subsequent rust jacking.

One of the cast stone units in the north façade's string course has spalled and is about to fall to the single-story roof below, possibly damaging it or rebounding onto the sidewalk. The spalled piece of stone should be removed and stored.

There are several cracks and spalls in the cast-in-place concrete steps *that should be repaired using standard concrete restoration methods such as adhesive-injecting cracks, exposing and corrosion-treating embedded steel (if any) and applying formed or trowel-grade restoration mortar to spalls.*

*The resultant bowing of the lower bricks caused by the redistribution of support is in and of itself a potentially unstable arrangement that will increase in magnitude as mortar joints naturally weather and erode losing their tensile strength. The outer wythe (10 courses) of the single story segments of wall between the belt course and the foundation would need to be sequentially disassembled and rebuilt using galvanized or stainless steel brick anchors to stabilize the projecting bands.*

*To halt further damage to the facade of the building, veneer brick should be stripped off at the lintels and the lintels should be removed and replaced with new galvanized steel. If it is evident that the corrosion is only occurring on the outside face of the steel lintel, it may be possible to remove the rust and corrosion and protect the steel from the outside. Cracks caused by rust jacking should be individually assessed, and pinned, knitted back together or repointed as necessary.*

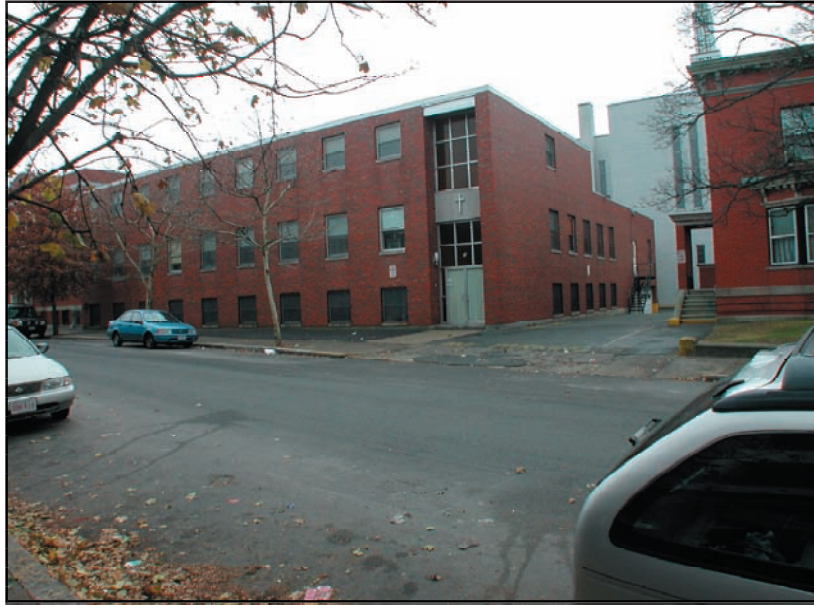
Typically the masonry appears tightly bonded and sound. The mortar is in adequate condition and no re-pointing is necessary for the foreseeable future.

The brick over the windows is supported by embedded steel lintels, the bottom flanges of which can be seen from the exterior. The masonry on either side of the window is revealing early signs of lintel corrosion and rust jacking illustrated by short lengths of mortar being pushed out of the joint common to that containing the flange of the lintel. The required repair would include dismantling veneer brick to access lintels, removing the rust and corrosion protecting the steel from the outside. Local repointing at damaged joints would also be required as part of the lintel repair.

There is a large garage door opening on the west facing façade of the building, the masonry over which is supported by a steel W-flange beam with a full-wall thickness steel plate welded to the bottom flange (visible from the opening). The top surface of the plate is rusting and jacking itself downward away from the beam.

*The repair would include: shoring of the garage door opening, removal of the bottom plate and subsequent repair and corrosion-protection of the beam flange and replacement of the bottom plate using galvanized steel.*

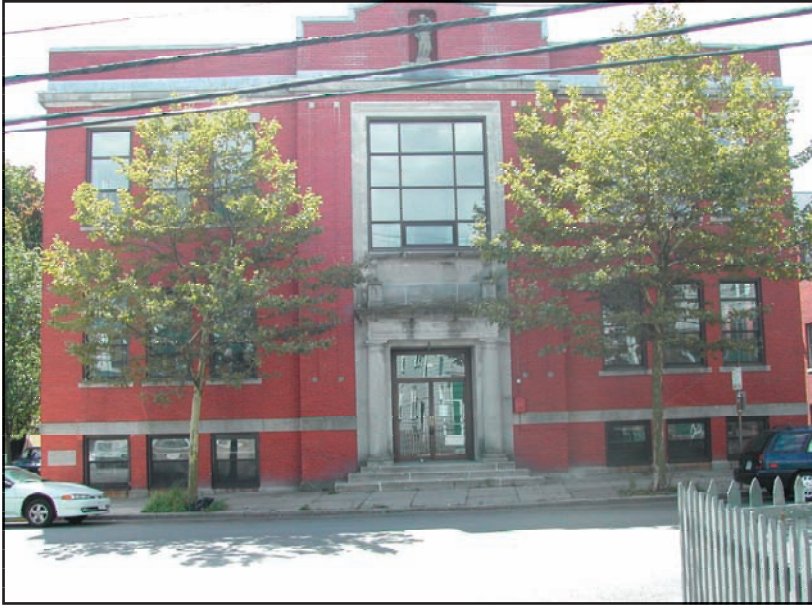
The exterior brick seems well fired and the mortar appropriate for the brick. However, the south pediment on the west-facing wall is showing signs of local shifting in the masonry, and the north pediment on the east-facing wall has seen some step-cracking. Also, the north corner of the east facing wall appears to have eroded mortar joints between the top of the wall and the “cornice” / top cast stone belt course.

Damage has occurred in a few locations in the cast stone belt course between the basement and 1<sup>st</sup> floors on the west facing elevation. Specifically, the cast stone has cracked along the central segment of the wall toward the south and at the very south end of the wall. The cast stone has also spalled on the south segment. *Commonly this type of damage occurs due to embedded metal pipe in the cast stone that corrodes and causes rust jacking. The presence of embedded steel pipe should be verified, and removed if present. The belt course should be patched with similar material.*

*All five of the pediments appear to be in need of repointing, at a minimum. The pediments will need to be more closely inspected via aerial lift to determine the extent of rebuilding and re-pointing, and to pinpoint any causes of local movement and cracking such as embedded corroding metal.*
