Charter Street Cemetery, Salem MA

# Charter Street Cemetery, Salem MA

The initial assessment identified 23 priority 1 and 1.5 markers to be conserved and are listed in the table to the left. Upon excavating markers C7.2 and J10.1 their condition was found to be un-restorable.

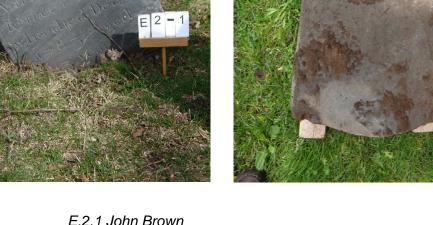
18th century markers often have as much below the ground as above. Only upon excavating this marker for resetting does the below grade portion becomes apparent.

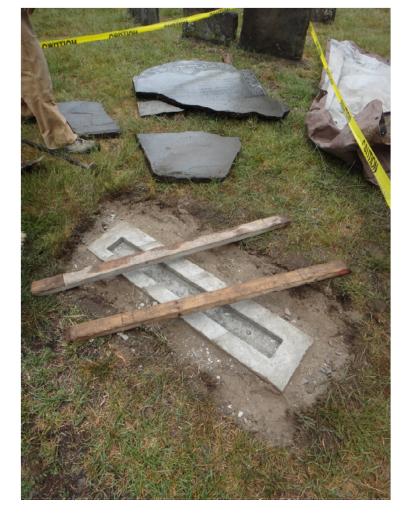
H.7.4 Capt Robert Seldon Form removed, ready for resetting marker

Concrete poured, with form for setting slot in place

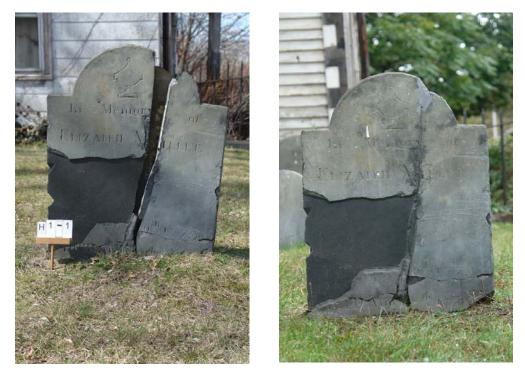
#H.1.1 Elizabeth Millet (before and After) with loss filled with pigmented Jahn M70 mortar

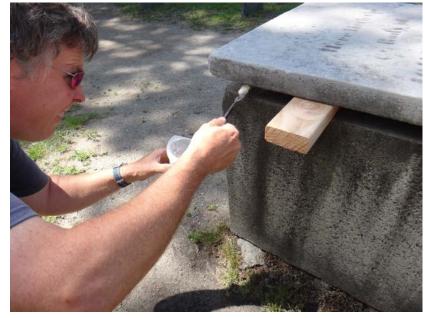
F1.1 Fisk Tomb This loose top can be secured to the solid granite base with a structural adhesive . There is little reason for it to ever be removed.

Loose table tops have been moved by inquisitive visitors, and they also can become a hazard. Tops which are set on solid bases where there is little or no likelihood of ever having to remove the top in the future, were secured in their proper orientation using a structural adhesive (Abatron 55-22).

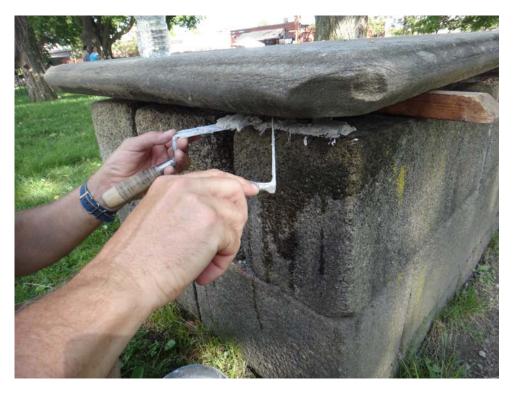
F2.2 Derby Tomb This loose top was secured to the granite block base with a soft mortar. If the granite blocks have to be reset in the future the top will be more easily detached.

If it if likely that the tomb will be taken apart sometime in the future a pigmented pozzolanic hydraulic lime mortar (typically #600 PHLc70 by Voidspan) was used to set the ledger top.

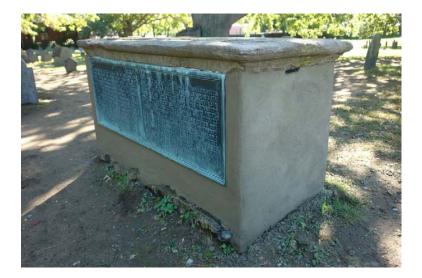
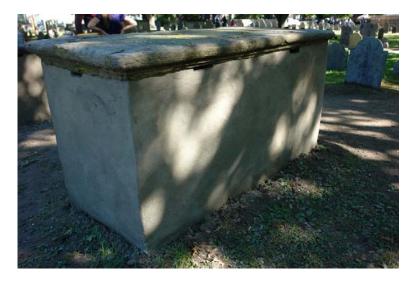
*l6.1 Bradstreet Tomb . Before and after*

There are a number of tombs exhibiting typical conditions of deteriorating stucco.

All existing loose, failing or spalling stucco was to be removed and a bonding agent applied to all surfaces. Applications of stucco (1:1:6 with masonry sand) are applied and repeated when required.

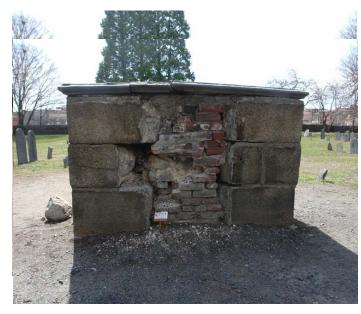
*G7.1 Lynde Tomb Failing stucco. Missing brickwork. Note fallen granite stone on ground to left*

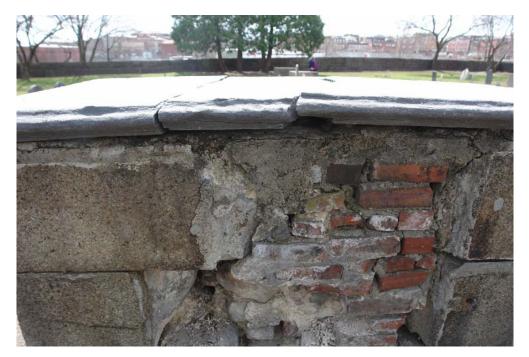
*G7.1 Lynde Tomb (Before) Ledger top with multiple fractures and old repairs. Ledger fragments were firmly attached and set askew*

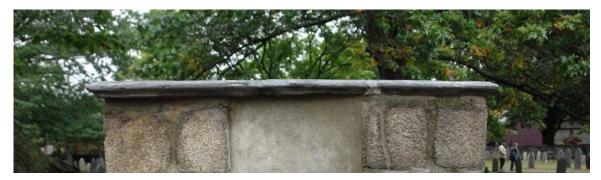
G7.1 Lynde Tomb (After) Ledger top level and secure

When cured, joints were filled with a pigmented Jahn restoration mortar.

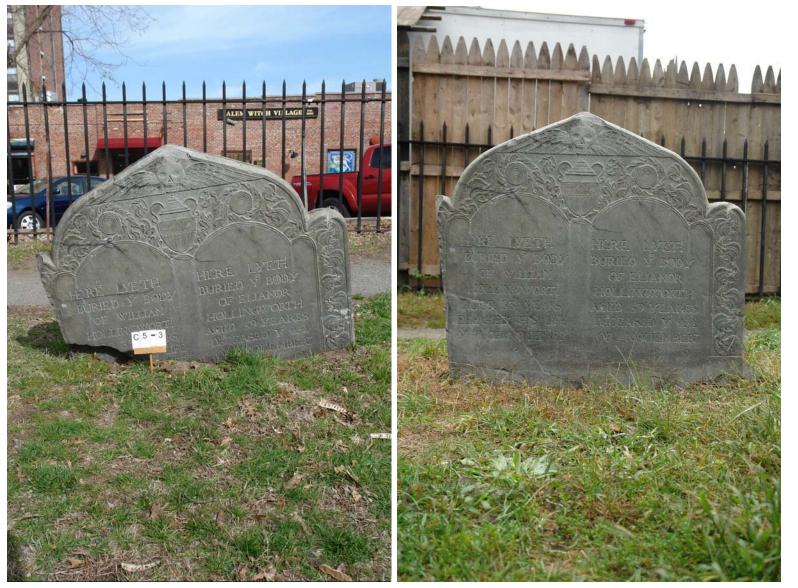
#### **Charter Street Cemetery** Cemetery: NAME ON MARKER William & Elianor Hollingworth Death Date: 11/7/1688 Marker Type: Headstone Condition of Inscription: Legible Material:Slate **EXISTING CONDITIONS CONSERVATION STRATEGY** Attach fragments with structural Fractured Tilted adhesive Reset plumb Possible new below base 1) Hazardous, immediate action 2) Unstable- asap **CONSERVATION PRIORITY 1.5** 3) Ongoing deterioration, treat 2-5 years 4) Stable A) Artistic H) Historical P) Visually prominent M) Monitor Date(s) of treatment 6/24-9/6/2016 TREATMENT 1. Marker fragments excavated and setting area excavated for new below grade cast concrete base sized minimum of 12 inches deep, 12 inches greater in thickness and 6 inches wider than the stone. 2. Mating surfaces cleaned and fragments attached with structural adhesive, brace and clamp until cured.

# Comments: Adhesive repair and reset in 1993

6. Cracks and losses filled with pigmented cementitious Jahn products.

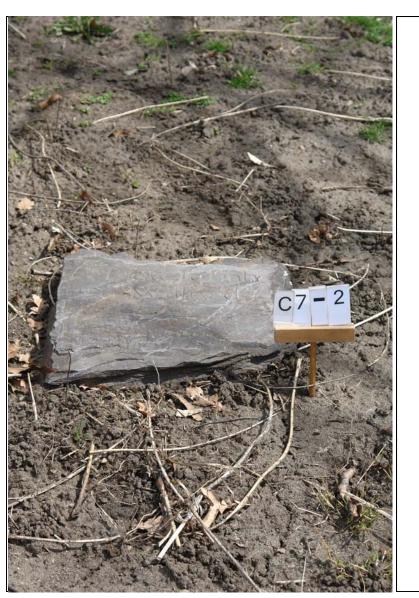
Cemetery: **Charter Street Cemetery** NAME ON MARKER Dea. Josiah Willard Death Date: Marker Type: Footstone? Material: Slate Condition of Inscription: Missing, illegible EXISTING CONDITIONS CONSERVATION STRATEGY Investigate- restorable? Fallen Reset plumb Fragment Possible new below base 1) Hazardous, immediate action 2) Unstable- asap CONSERVATION PRIORITY 1.5 3) Ongoing deterioration, treat 2-5 years 4) Stable A) Artistic H) Historical P) Visually prominent M) Monitor TREATMENT Date(s) of treatment Area probed and no additional fragments discovered. Fragment found to be not restorable In 1998 listed to be reset into new base

Not restorable

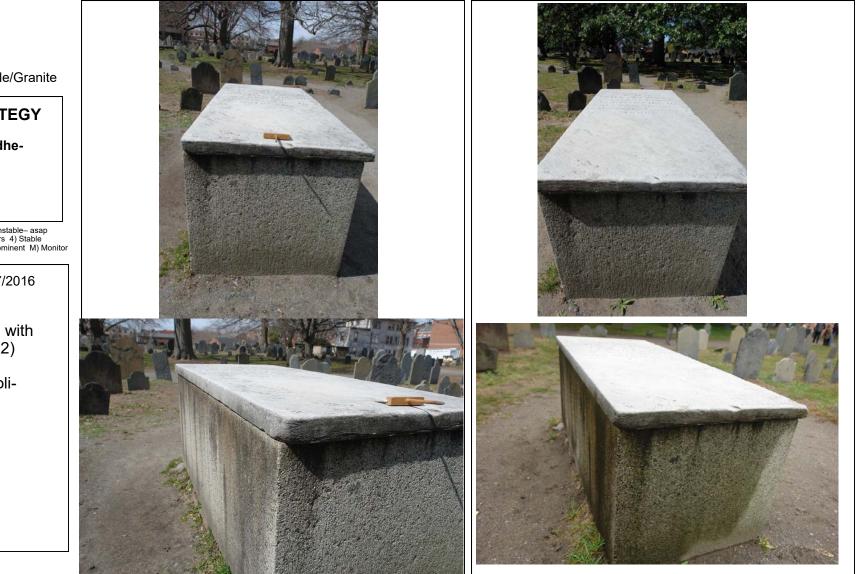
Cemetery: **Charter Street Cemetery** NAME ON MARKER **Turner Tomb** Death Date: Marker Type: Tomb Condition of Inscription: Decipherable Material: Marble/Granite **EXISTING CONDITIONS** CONSERVATION STRATEGY Top loose and out of plane Secure top with structural adhewith base sive. Treat top with HCT Weathered ledger 1) Hazardous, immediate action 2) Unstable- asap **CONSERVATION PRIORITY 1** 3) Ongoing deterioration, treat 2-5 years 4) Stable A) Artistic H) Historical P) Visually prominent M) Monitor TREATMENT Date(s) of treatment 6/6-6/27/2016 1. Top positioned in line with granite base and attached with structural adhesive placed around edge. (Abatron 55-22) 2. Top treated with 3 saturating applications of HCT, (Prosoco) a hydoxylating conversion treatment to consolidate the surface

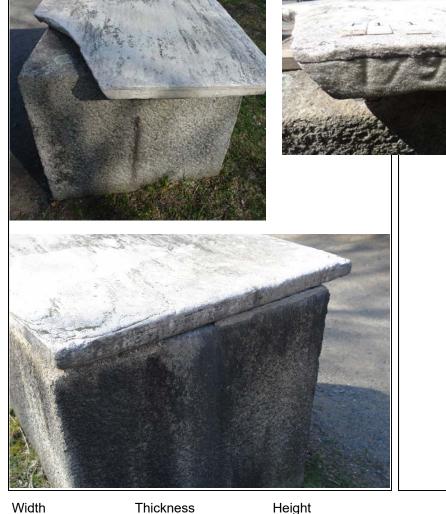
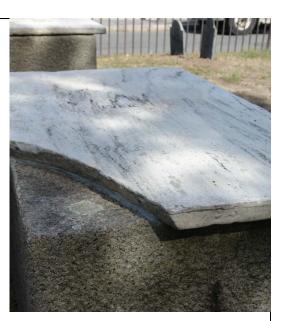
Cemetery: **Charter Street Cemetery** NAME ON MARKER **Fisk Tomb** Marker Type: Death Date: Tomb Condition of Inscription: Illegible Material: Marble/Granite **EXISTING CONDITIONS** CONSERVATION STRATEGY Top loose and out of plane Secure top with structural adhewith base sive. Treat top with HCT Weathered ledger Missing fragment 1) Hazardous, immediate action 2) Unstable- asap **CONSERVATION PRIORITY 1** 3) Ongoing deterioration, treat 2-5 years 4) Stable A) Artistic H) Historical P) Visually prominent M) Monitor TREATMENT Date(s) of treatment 6/6/-6/27/2016 1. Top positioned in line with granite base and attached with structural adhesive placed around edge. (Abatron 55-22) 2. Top treated with 3 saturating applications of HCT, (Prosoco) a hydoxylating conversion treatment to consolidate the surface 3. Perimeter was tuck-filled with Voidspan mortar binder and clean sand. Note: Corner fragment is missing. Unless it is found no replacement work to be done

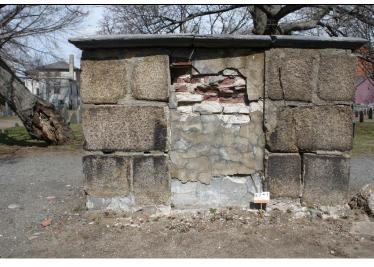
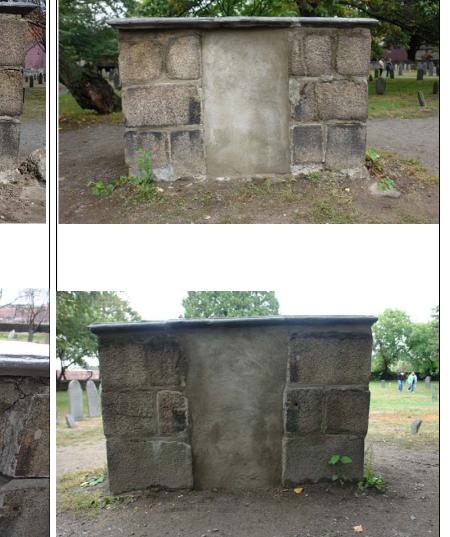
**Charter Street Cemetery** Cemetery: NAME ON MARKER Lynde Tomb Tomb Death Date: Marker Type: Condition of Inscription: Illegible Material: Marble/Granite **EXISTING CONDITIONS** CONSERVATION STRATEGY Attach ledger with structural ad-**Top ledger fractured** Missing bronze plaques hesive and reset to base. Loose granite block and open Replace loose block and repoint. Fill plaque areas with stucco joints **Repoint mortar joints** 1) Hazardous, immediate action 2) Unstable- asap **CONSERVATION PRIORITY 1** 3) Ongoing deterioration, treat 2-5 years 4) Stable A) Artistic H) Historical P) Visually prominent M) Monitor TREATMENT Date(s) of treatment 9/20-103/2016 1. Fragmented marble ledger dismantled and fragments attached with structural adhesive (Abatron 55-22), clamped and braced until cured. 2. Voids filled with pigmented Voidspan PHLc injection grout, keep damp for min 3 days. When cured, larger areas filled with pigmented Jahn mortar. 3. Top was tuck pointed around perimeter 4. Loose granite block reset and all mortar joints repointed 5. Loose bricks stabilized and bricks added where missing. 6. Plague areas on both sides were stuccoed with masonry mortar mix.

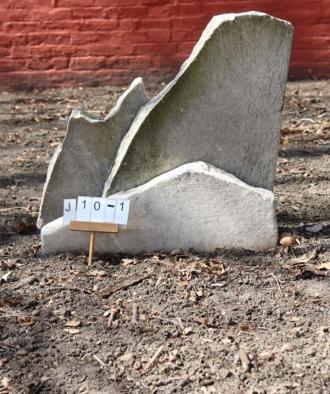
Cemetery: **Charter Street Cemetery** NAME ON MARKER n.a. Death Date: Marker Type: Headstone Condition of Inscription: Illegible Material: Marble **EXISTING CONDITIONS CONSERVATION STRATEGY** Investigate- Restorable? Fragmented Reset plumb Attach fragments with structural adhesive Possible new below base 1) Hazardous, immediate action 2) Unstable- asap **CONSERVATION PRIORITY 1.5** 3) Ongoing deterioration, treat 2-5 years 4) Stable A) Artistic H) Historical P) Visually prominent M) Monitor TREATMENT Date(s) of treatment Not restorable

Not restorable
