Winter Island Barracks Building Re-Use Feasibility Study

SALEM, MASSACHUSETTS

Submitted to:
City of Salem

Submitted by:
Vine Associates, Inc.

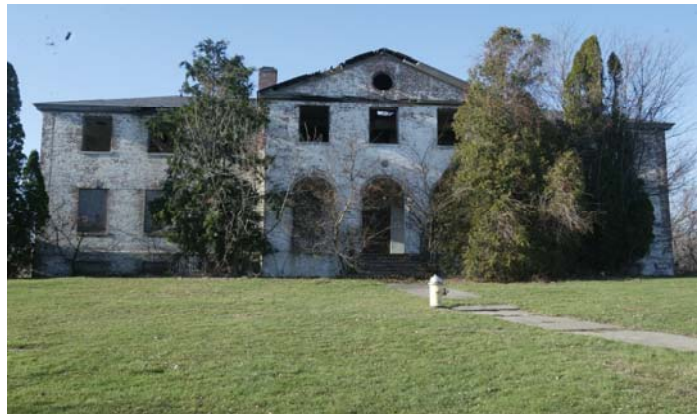
East Elevation

East Elevation: Due to its classical Palladian portico and its prominence in the landscape, the view of the building from the east is the most important. From an aesthetic point of view as well as a functional point of view, the main entry to the building wants to be from this direction. Also, this façade commands ones attention when arriving at the Hangar and the main parking lot some 300-feet away. From that distance, a person can judge the proportions of the building and see all its features, including the massive chimneys.

The primary east façade contains nine bays. It is centered on a 10-foot wide, three bay, projecting frontispiece that serves as a vestibule for the main entrance. The first story contains three open arches on the front and one on each side, all with header brick surrounds and cast stone keystones. Three standard window openings that originally contained 8 over 8

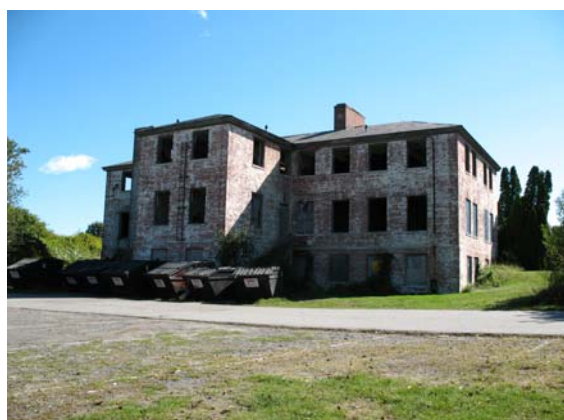
West Elevation

The west elevation has little architectural merit: the wing is disproportionate, the chimney off balance, and the fire escape utilitarian looking. If alterations to this side of the building are necessary, such alterations would have minor ramifications on historical or architectural character.

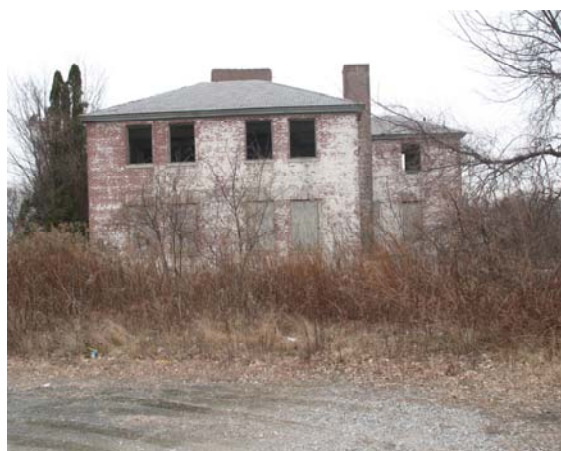
North Elevation and South Elevation: These facades fare a little better than the west facade. From the north, the fenestration of the wing is more composed than the south fenestration where the stairs can be seen and the doors seem disproportionate. Fortunately, the view from the south is not prominent. However, the North elevation can be seen from the entrance to the site, and hence should be treated with sensitivity. On this side of the building, historical and architectural character should be maintained.

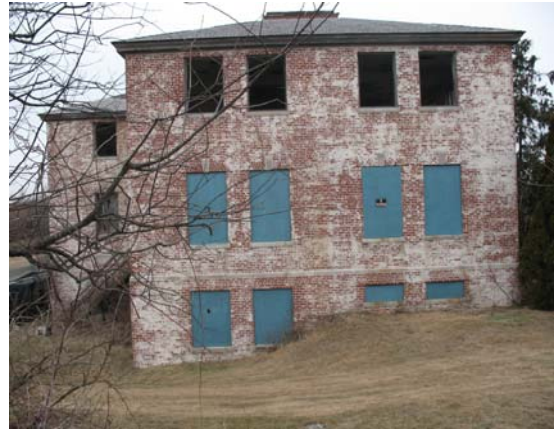
South Elevation

The South elevation contains four windows arranged in groups of two at all three stories. The eastern pair of basement windows are narrow due to the higher grade. The north end is similar.

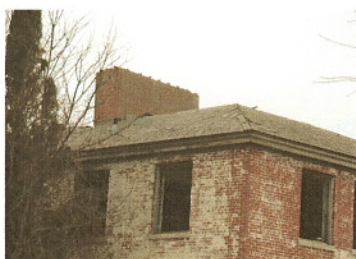
Roof East and Northeast

Structure: Although exposed to the elements for many years, the steel trusses looked pretty good, in spite of the rust and scaling. A more detailed inspection is necessary to determine if they are sound, although they appear adequate at this time. If they are retained, they will need fire proofing to meet the code. The board sheathing and the wood rafters are in poor condition. Much of the sheathing is missing. The roof should be replaced.

Slates: The slates were in very good shape, but there appeared to be many missing. There is no reason not to expect that they can be salvaged and re-used. An as yet undetermined number are missing and have to be replaced.

The entire roof needs to be replaced. Currently water enters through the roof and freezes in the joints between the concrete floors and the walls causing damage to the structure.

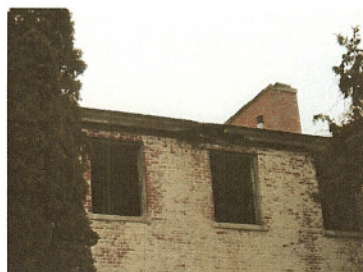
Roof Trim and Chimney Northeast

The visual inspection revealed minimal structural problems except for the roof which needs to be replaced. There are some problem areas including the timber framing supporting the ornamental chimneys which has deteriorated to the point that it presents hazard for chimney collapse. Both chimneys seem to be out of plumb, need coping stones, and could have water damage. Whether these will have to be removed and rebuilt or only repaired depends on the condition of the roof structure. Recommended approach is to remove and replace with lighter materials of the same size and appearance.

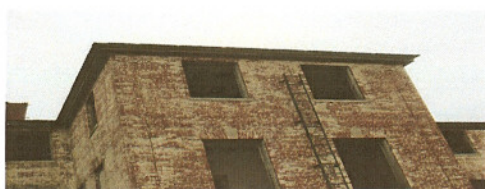
West Roof Trim

Exterior Trim: Consistent with this building type, the cornice trim is visually fairly heavy, but probably made up of stock sections. Although some of it looks in good shape, it should be assumed that all of it will need to be replicated and replaced. There may also have been some special features and trim on the pediment (it appears that the full overhang was molded) that may need to be replicated and replaced such as the circular window and medallion. (See also Doors and Windows.)

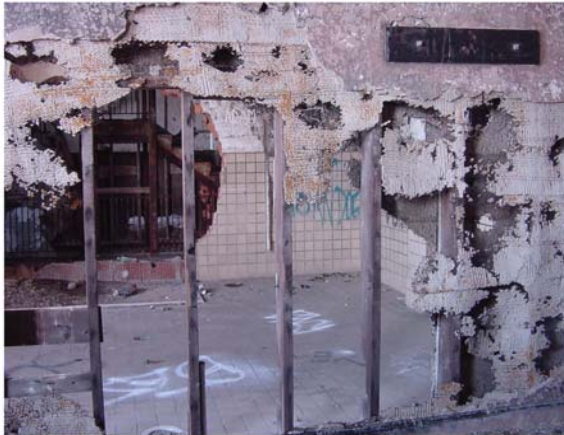
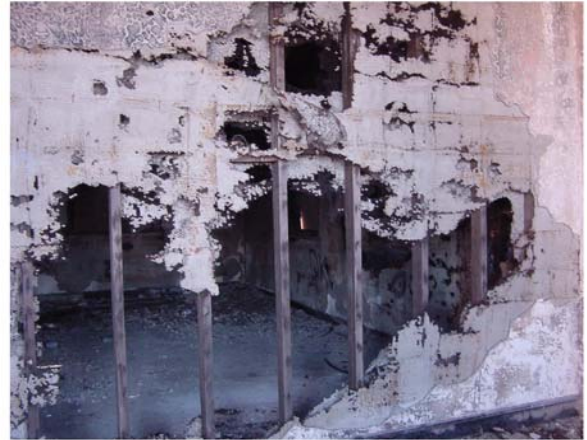
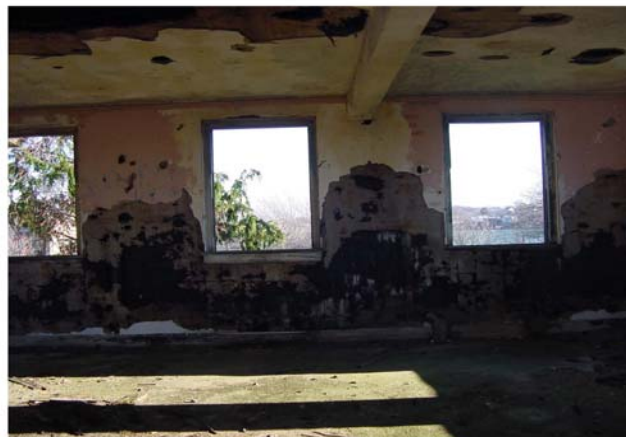
Barracks Building 2007 Interior Walls and Ceiling

Interior walls: There are not any reusable wall surfaces. All existing wood stud/plaster partitions should be taken down to the studs. Where they are retained, the brick and the clay tile/plaster walls should be individually evaluated as to whether all plaster is removed or plaster is repaired. Strapping and plaster should be removed from the interior of the exterior walls.

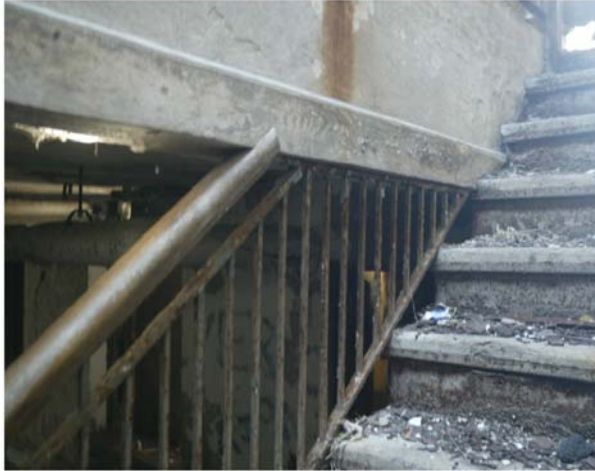
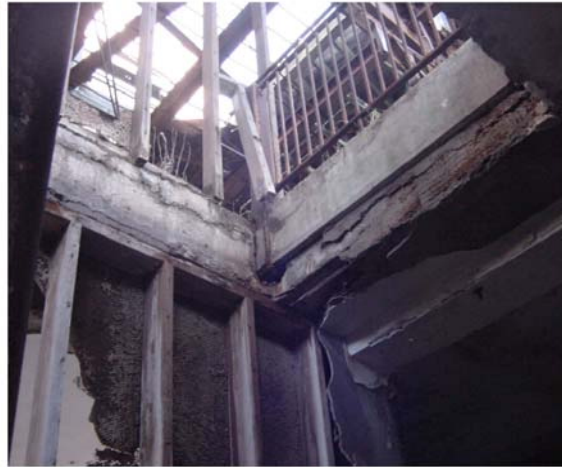
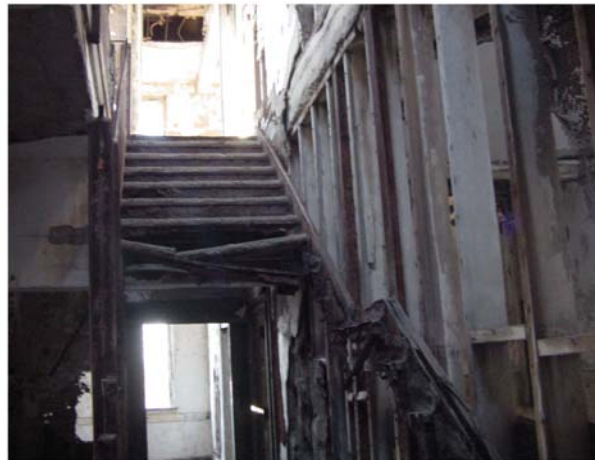
Barracks Building 2007 Interior Stair

The building has been vacant since the City took ownership in 1972 and has experienced significant vandalism over the years. As noted earlier in this report, there are no windows, no interior doors, the interior stairways are dilapidated, the interior trim and molding has been removed and there is nothing in the interior of any historic significance. Currently the upper floor windows on all sides and the first floor windows on the rear side are open to the elements and there are holes in the roof allowing water to penetrate the structure. The basement contains at least one foot of water.
