Greenlawn Chapel, Salem, Mass.

City of Salem- Dickson Memorial Chapel Restoration 2016
Department of Planning and Community Development
By: Erin Schaeffer, Staff Planner

Phase I: Municipal Restoration
2016-2017

Existing Conditions and Project Scope

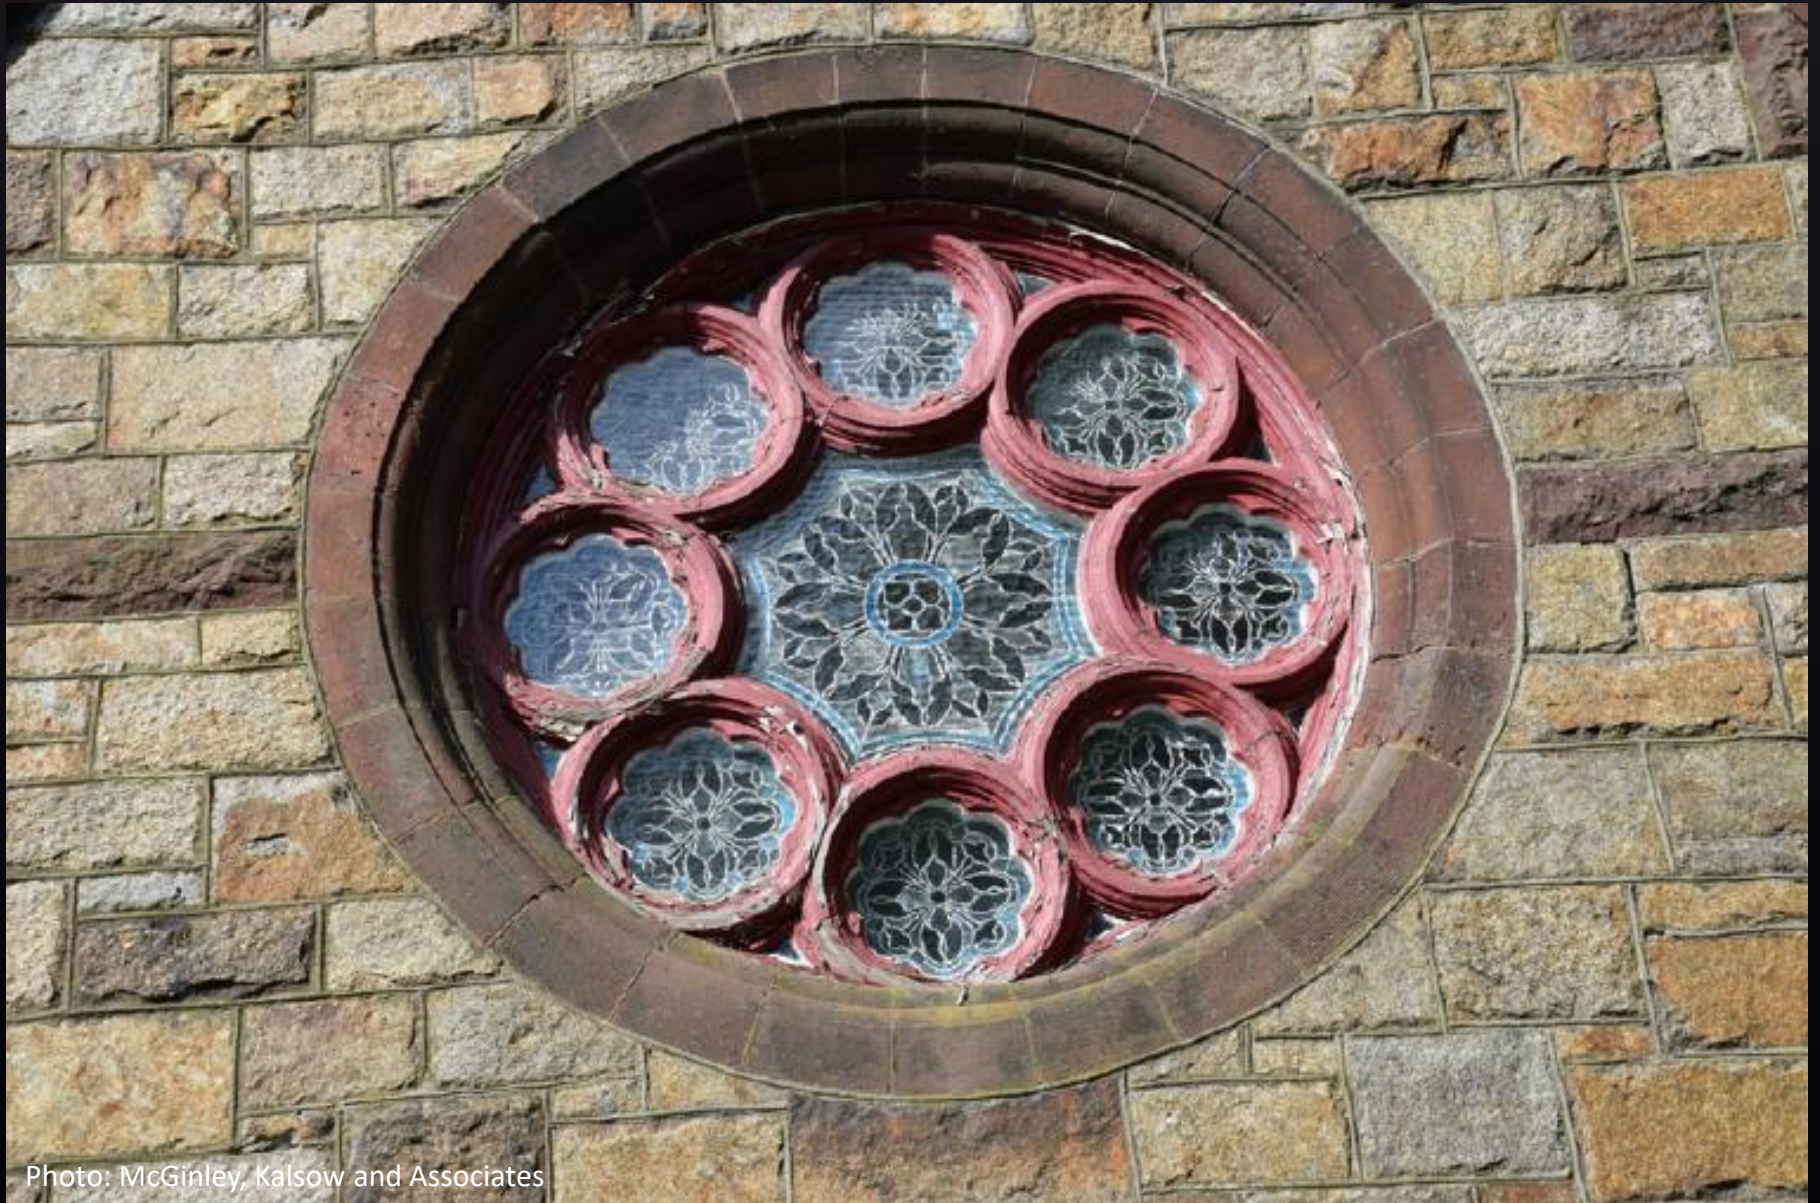
Existing Conditions- East Rose Window

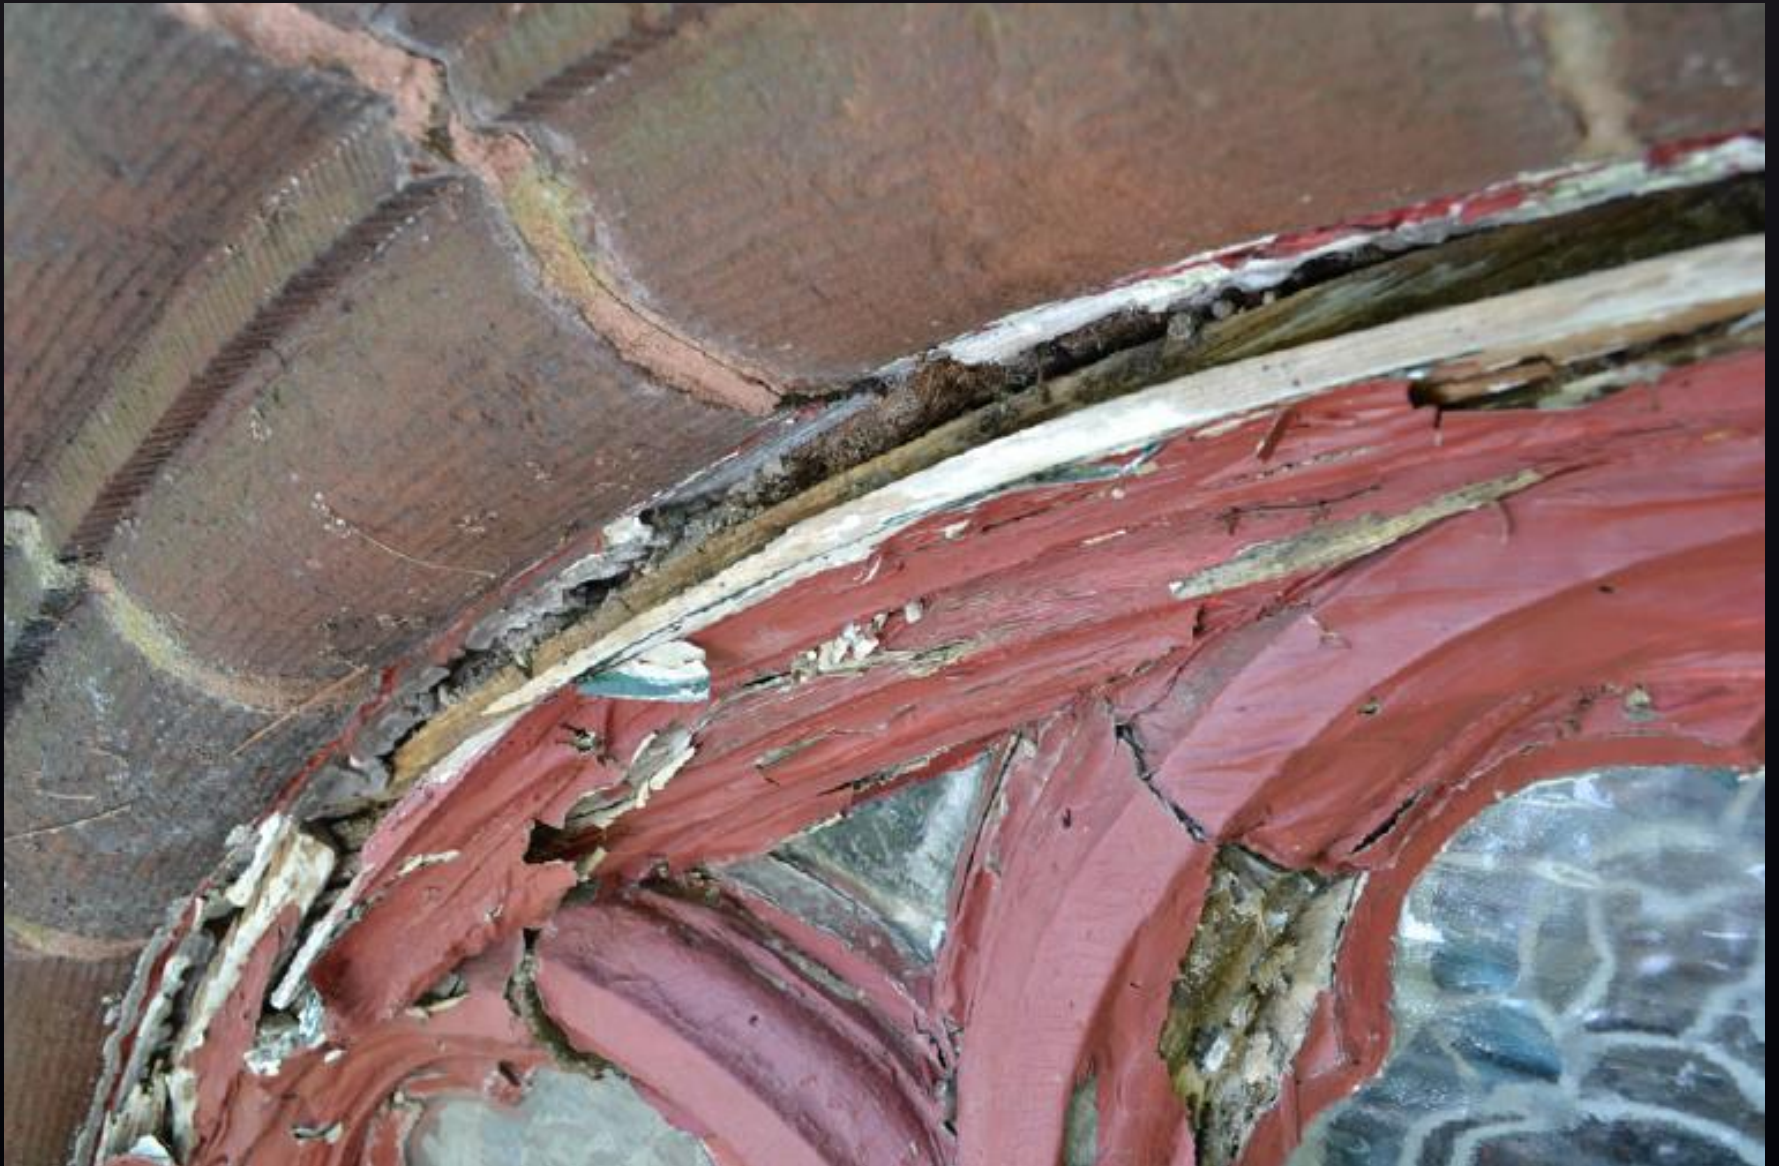
Existing Conditions – East Rose Window

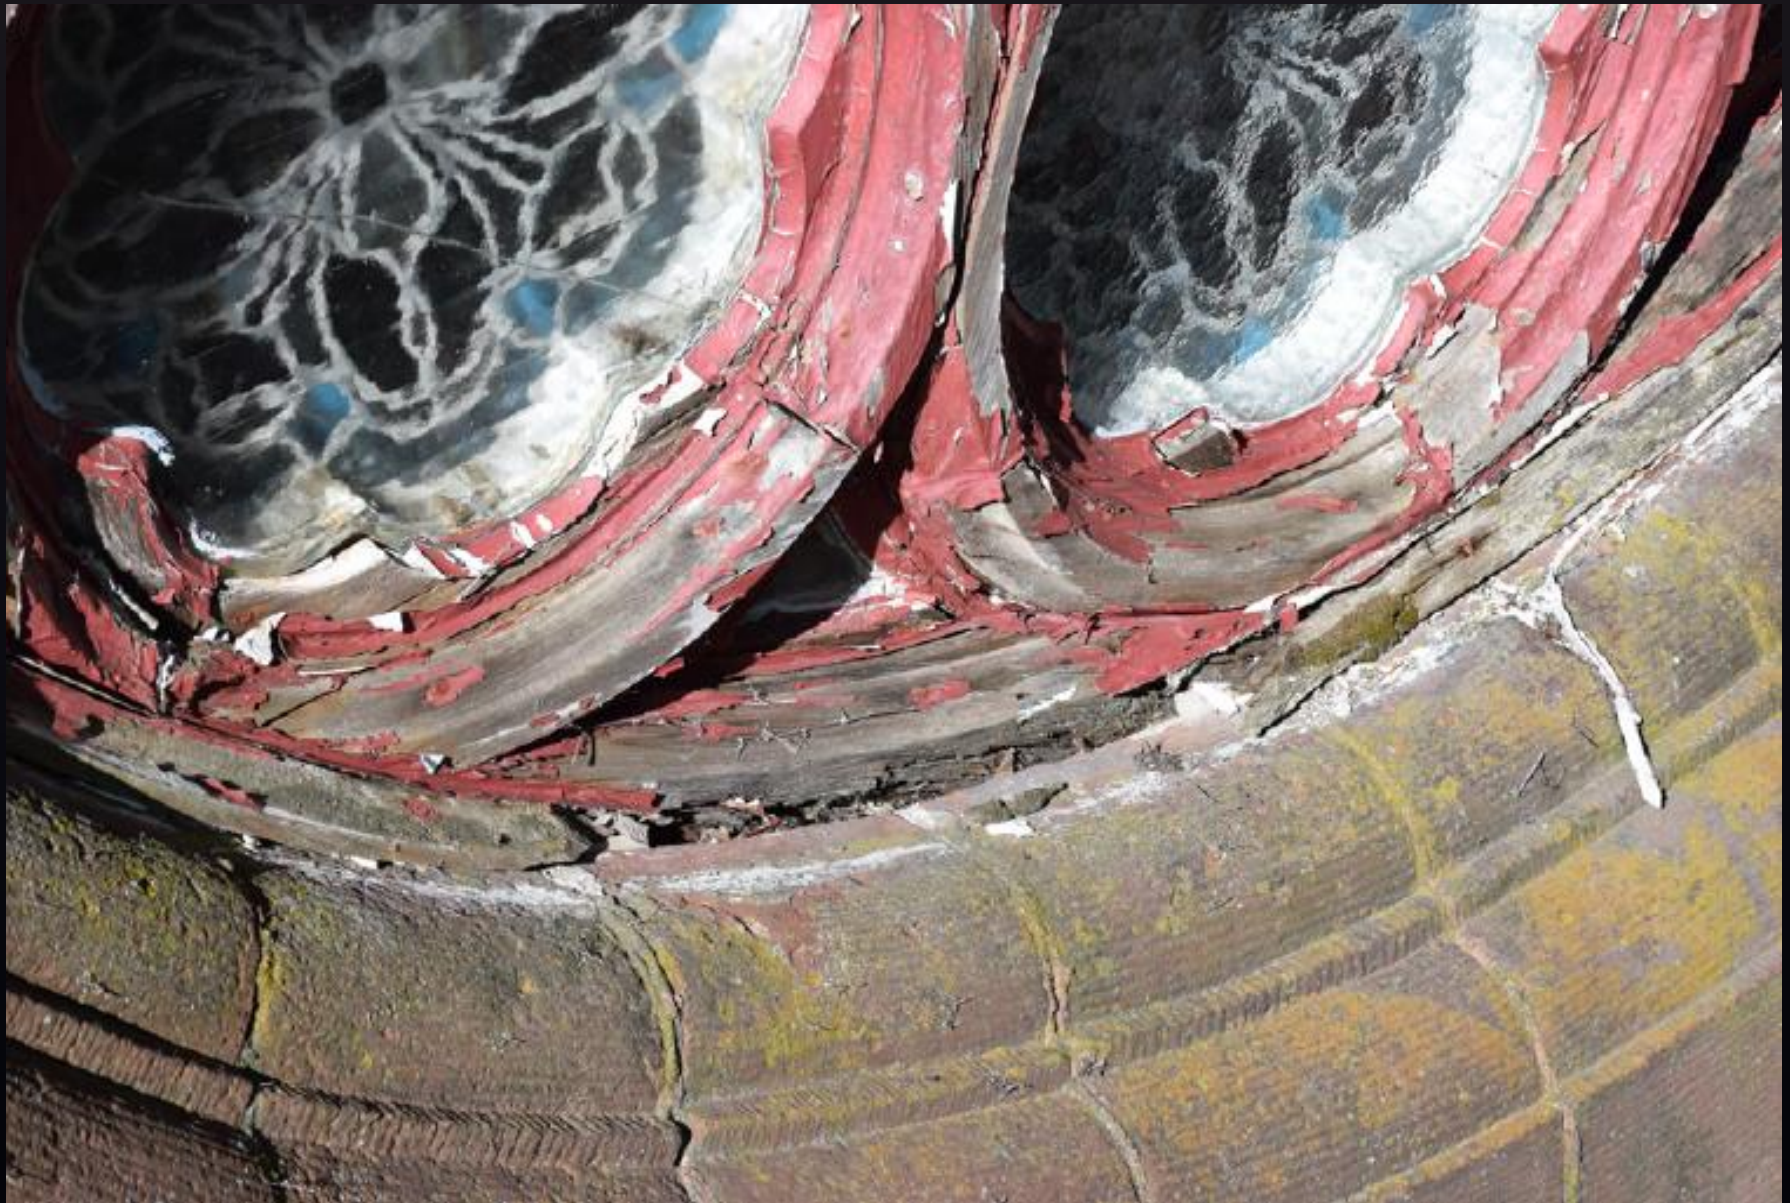
Existing Conditions- East Rose Window

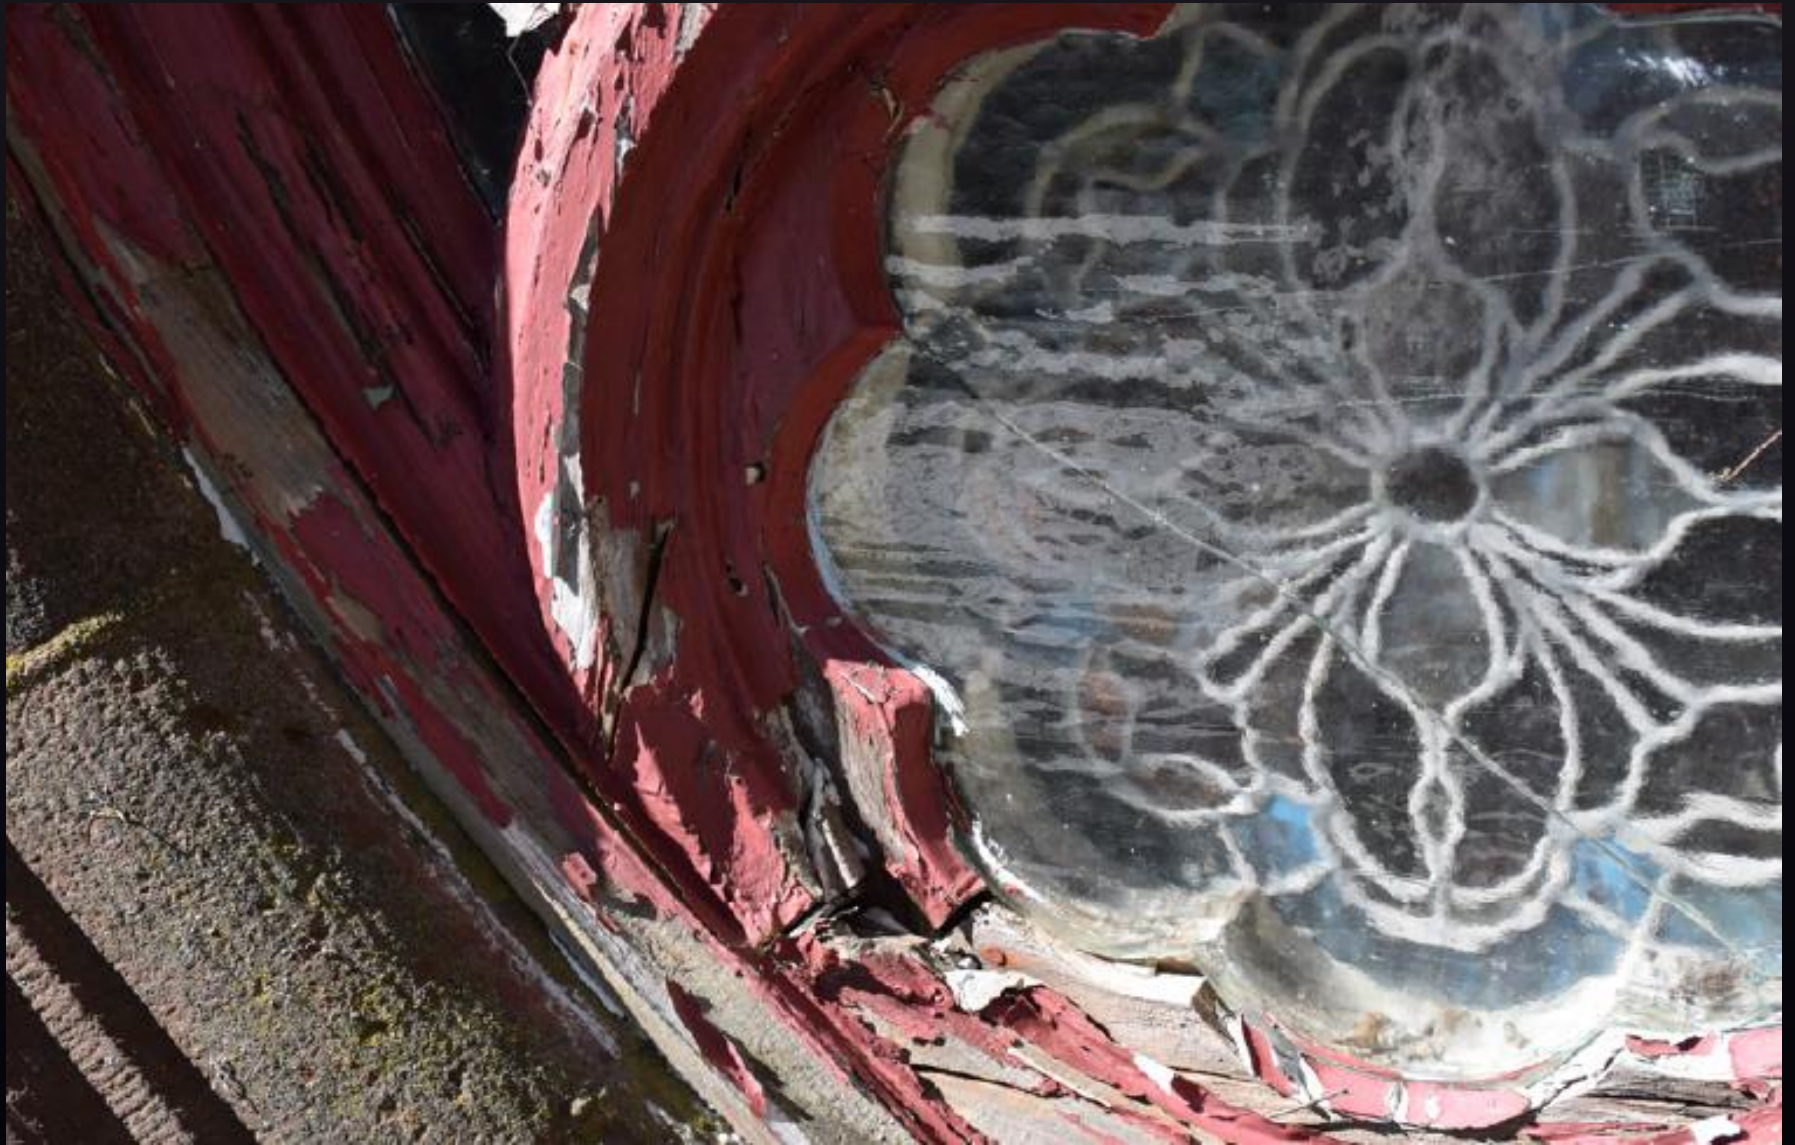
Existing Conditions- East Rose Window

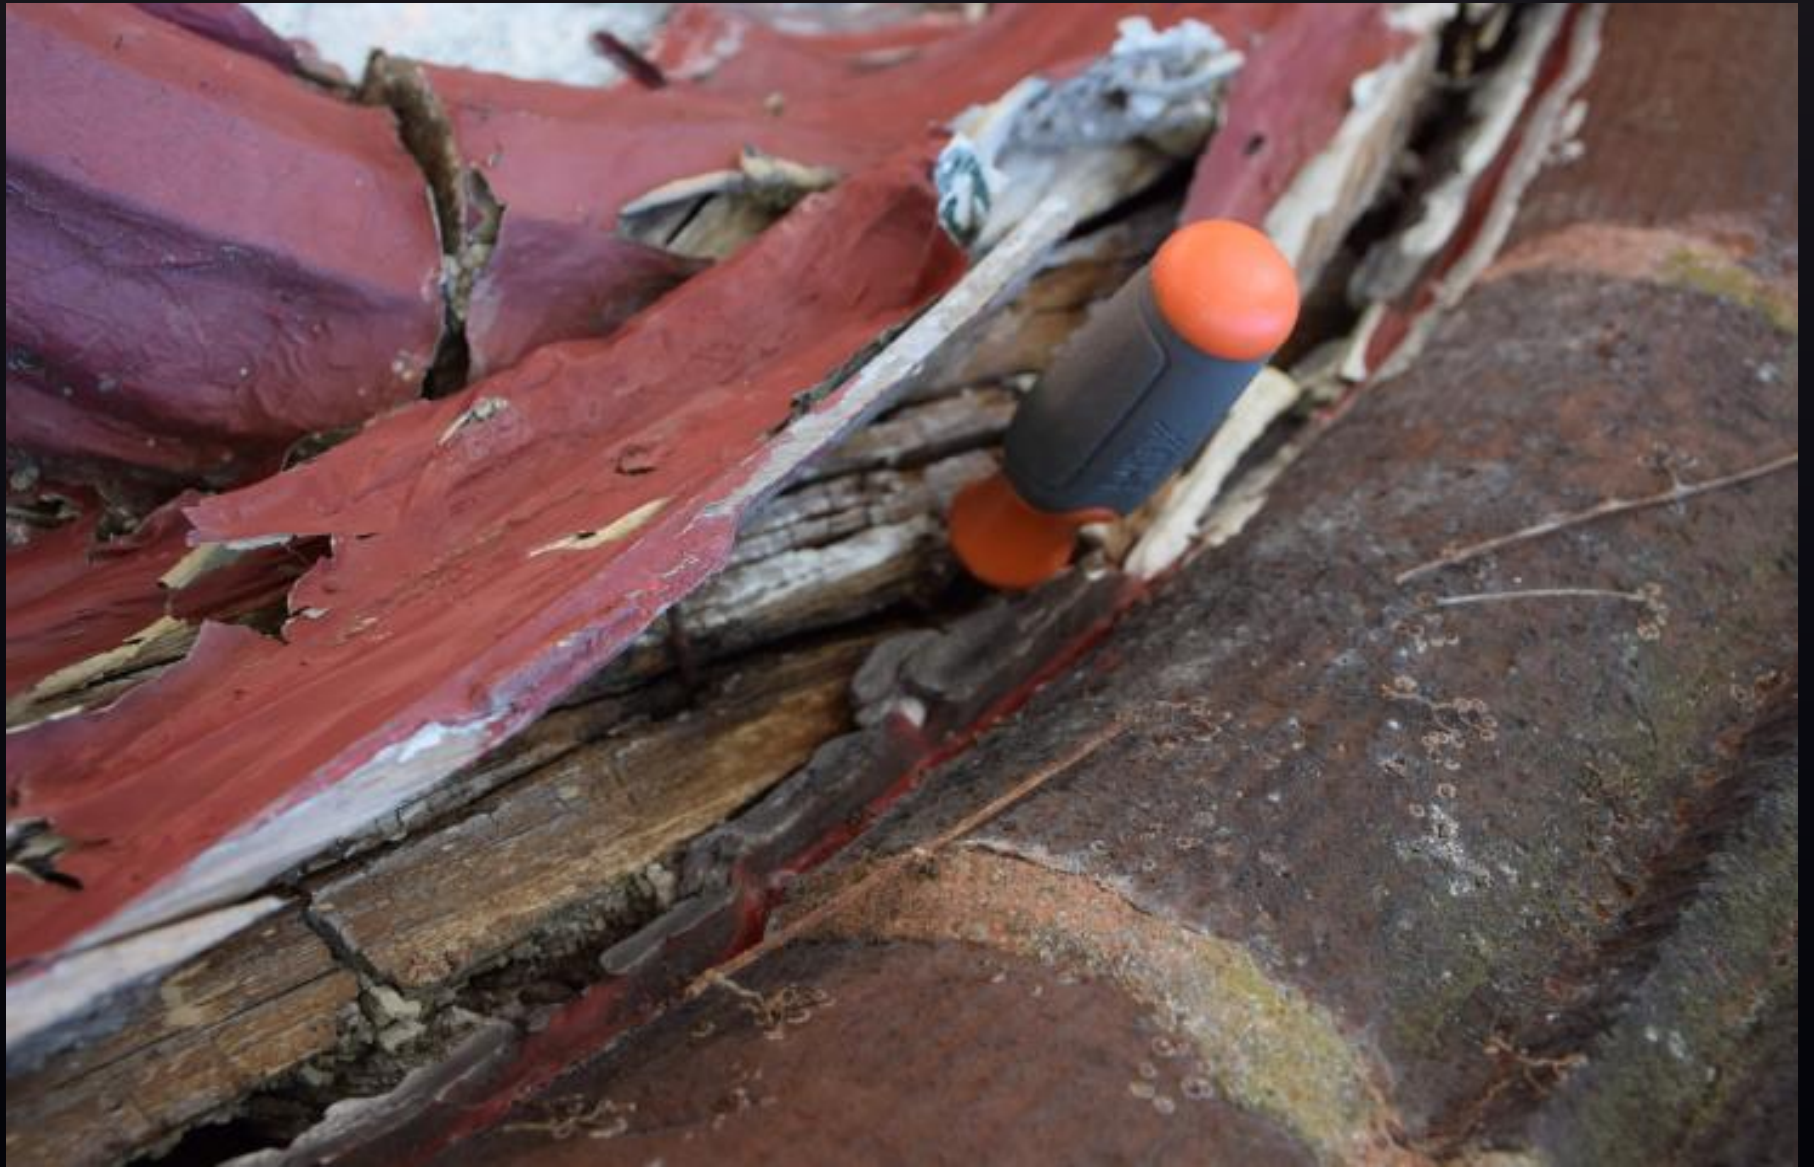
Existing Conditions- East Rose Window

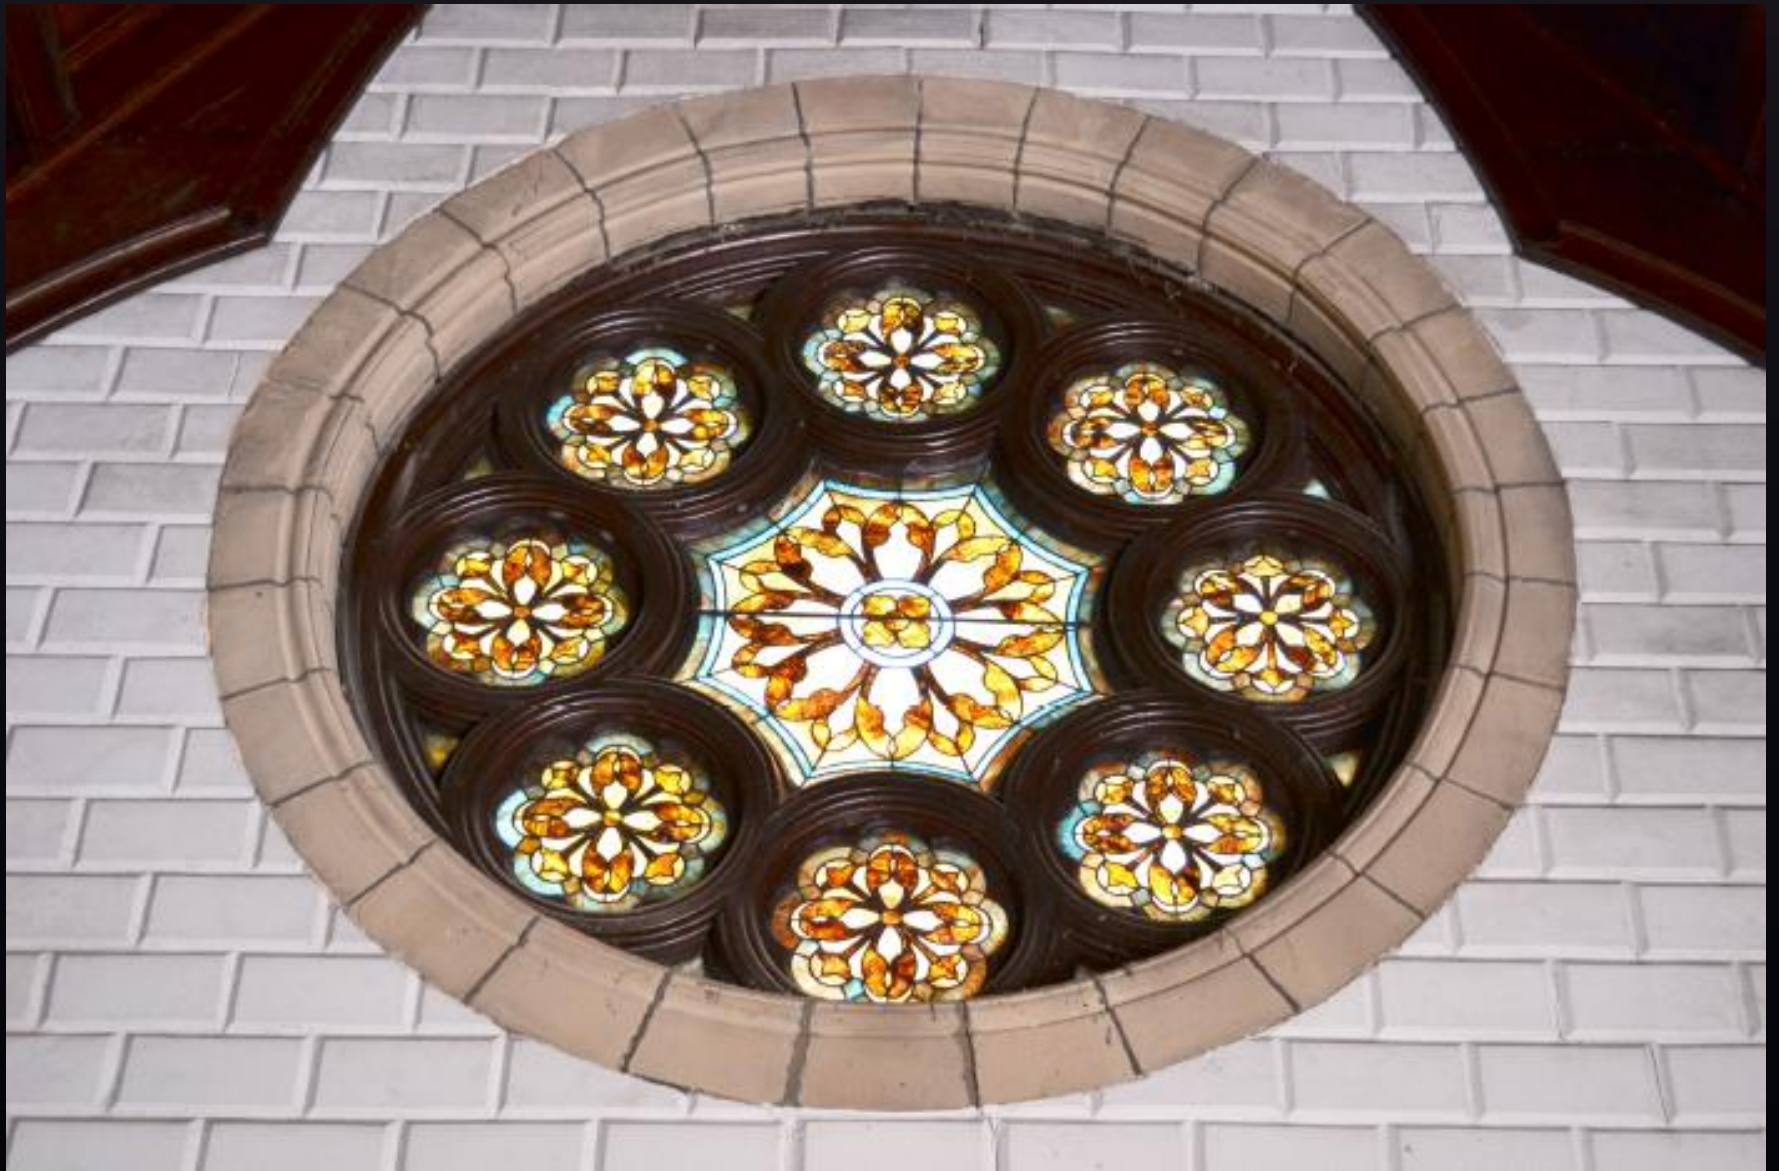
Existing Conditions- East Rose Window

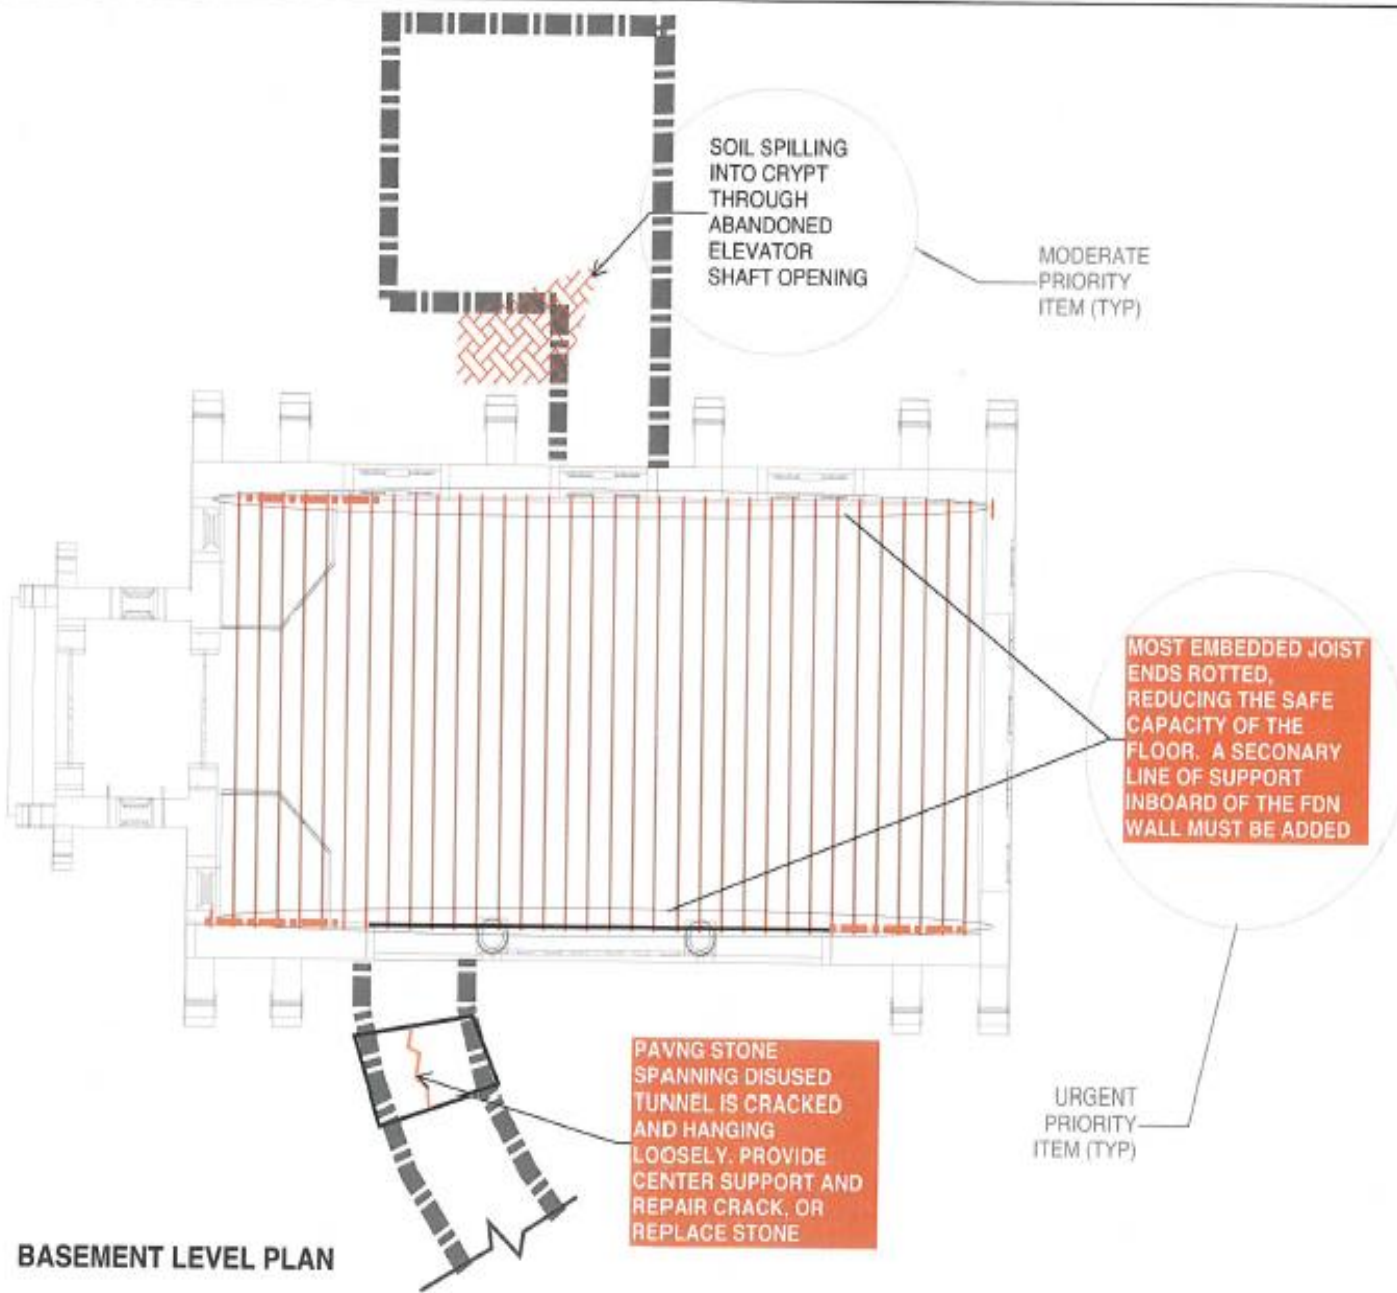
No.
S1.1

Floor Joist Restoration

68 Floor Joist Ends

Installation of secondary line of support inside of the foundation wall to be added

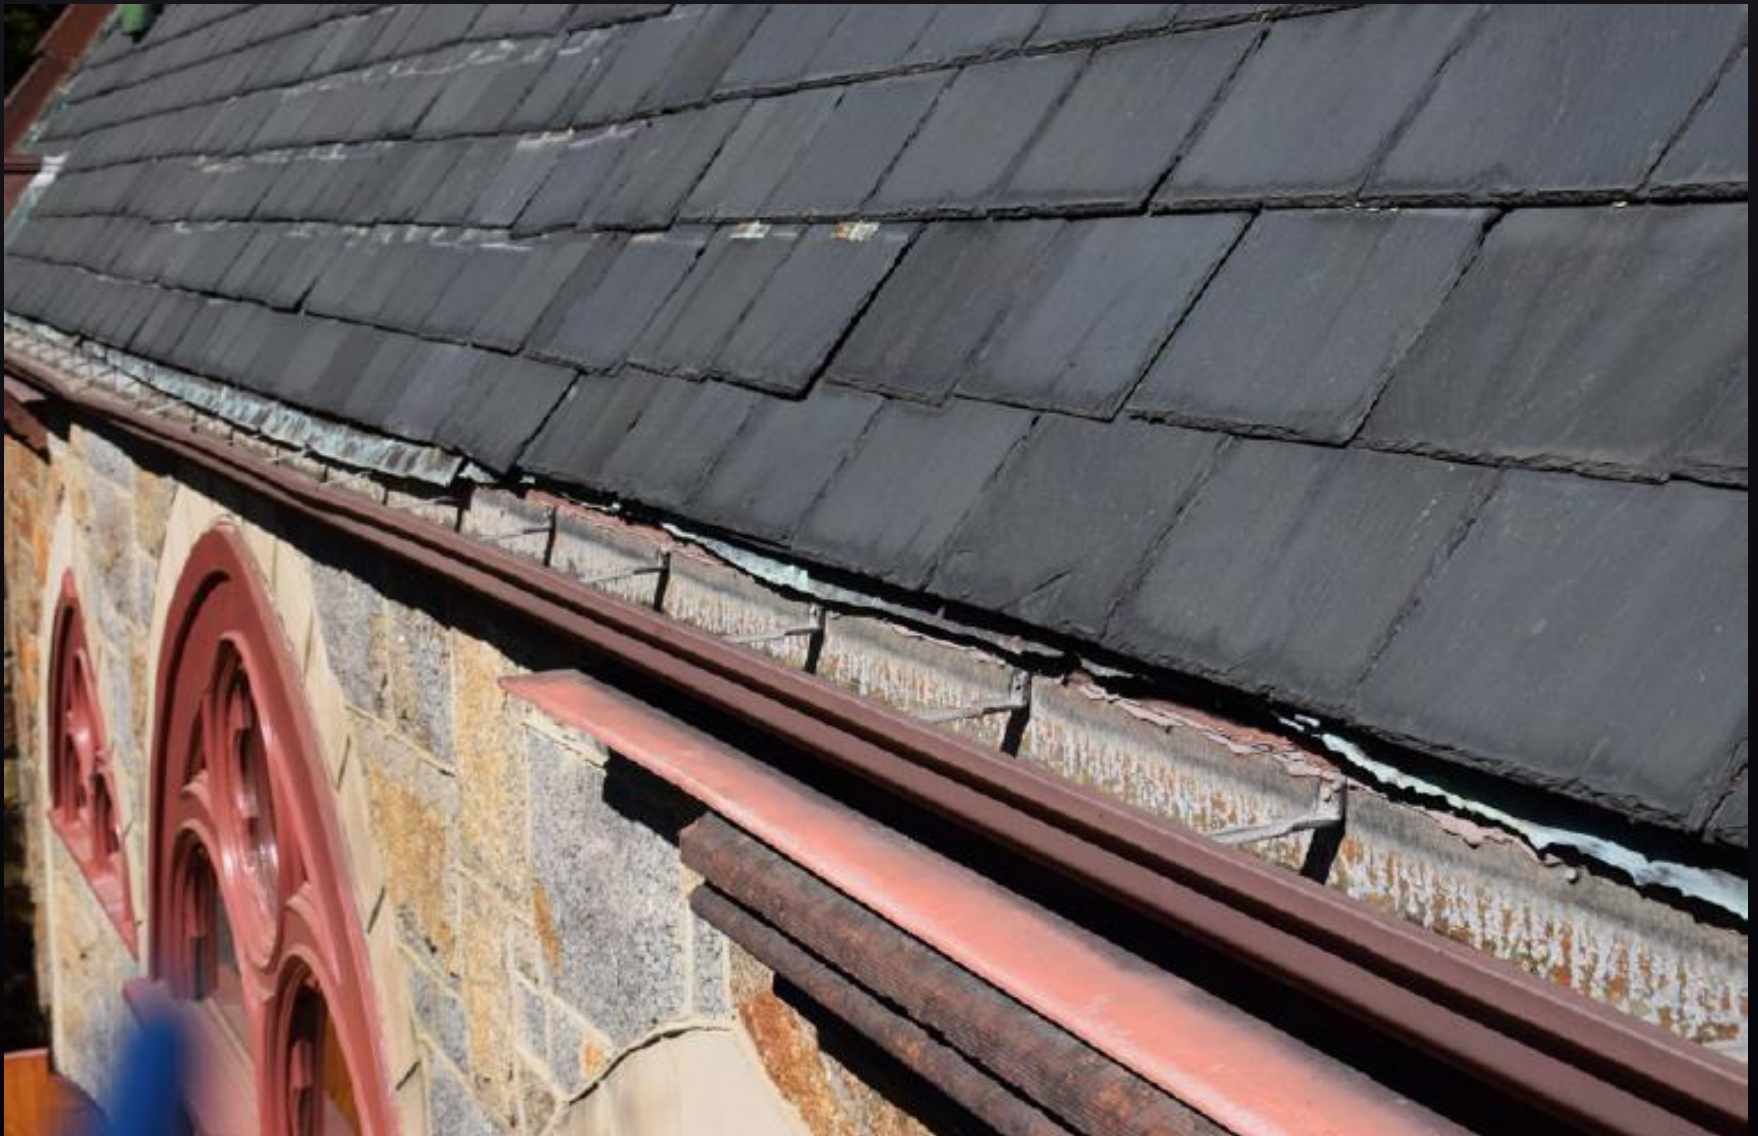
Existing Conditions- Gutters and Downspouts South Façade Alternate #2

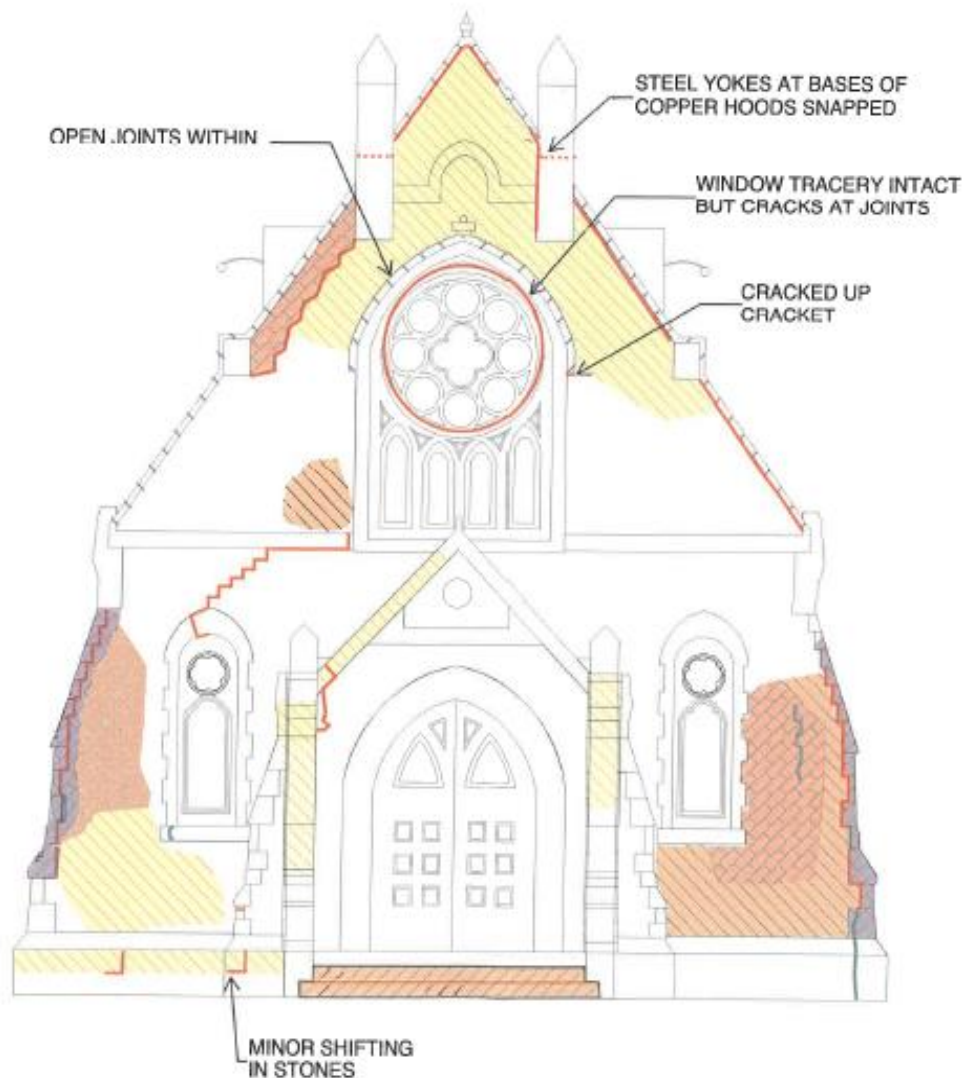
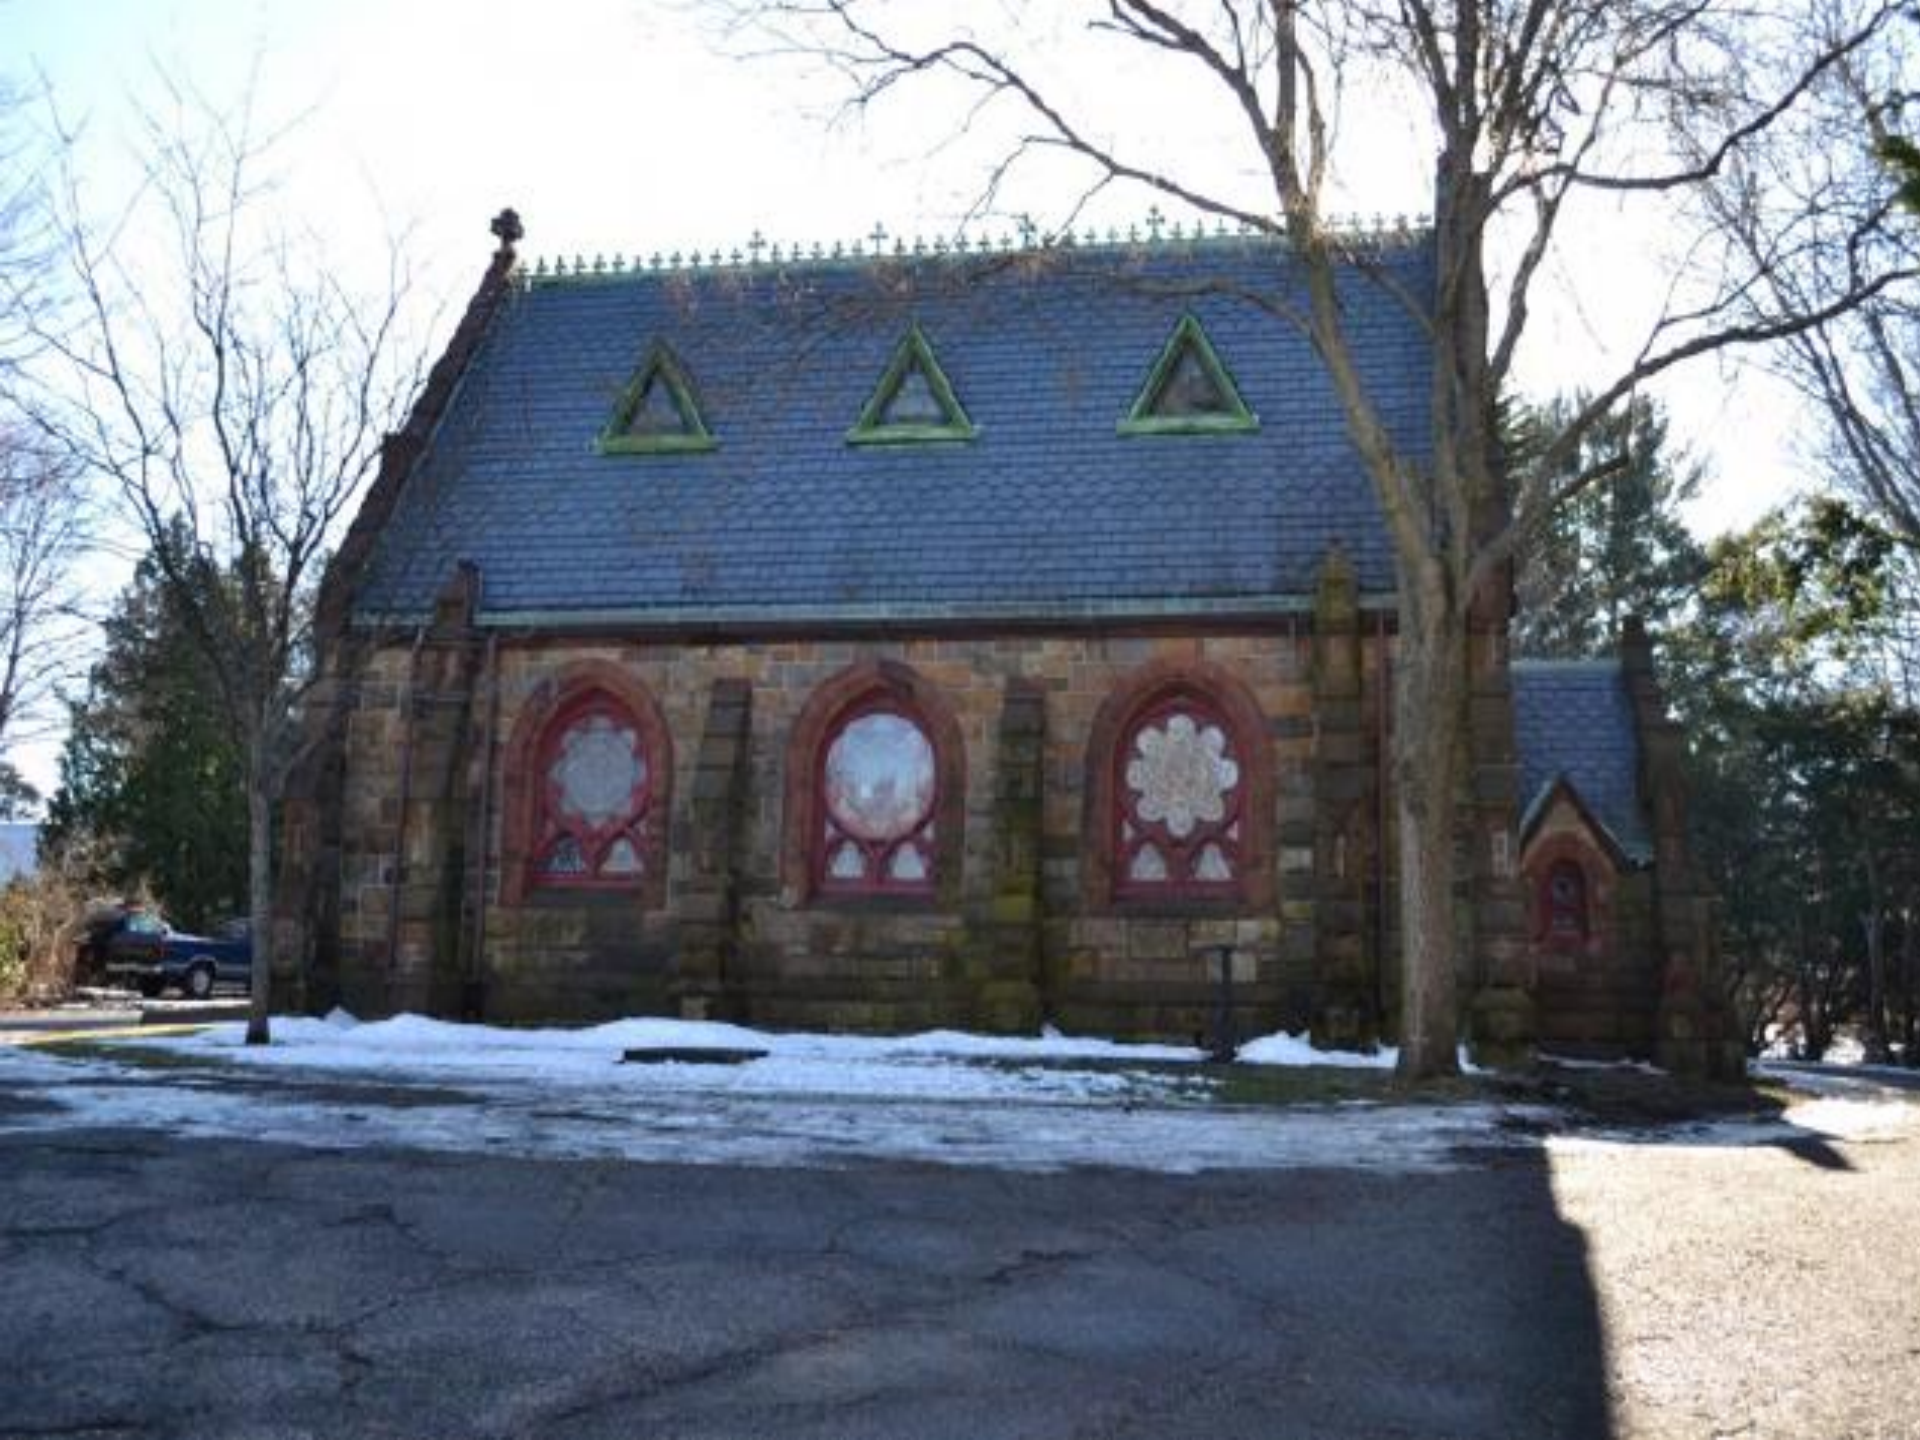
S2.1

WEST ELEVATION/ EXTERIOR

ITEM #6: EFFLORESCENT DEPOSITS, SIGN OF DAMNNESS OR LEAKAGE

ITEM #1: ERODED MORTAR JOINTS- MUST BE CUT AND POINTED

ITEM #2: DEEPLY ERODED MORTAR JOINTS, MUST DEEPLY CUT AND POINT, RE-SET STONES THAT LOOSEN DURING CUTTING

ITEM #3: BULGED OR SHIFTED FLAT MASONRY, MUST BE REMOVED AND RE-SET

ITEM #4: BULGED OR SHIFTED PROJECTING MASONRY, MUST BE DISMANTLED AND RECONSTRUCTED FROM 3-SIDES

ITEM #5: DAMAGED INTERIOR MASONRY UNITS, MUST BE REPLACED

ITEM #7: CRACK THROUGH MORTAR JOINTS, EXCAVATE, POINT AND GROUT, RE-SET STONES ALONG CRACK THAT HAVE LOOSENED

ITEM #8: CRACK THROUGH UNIT, REPLACE OR REPAIR

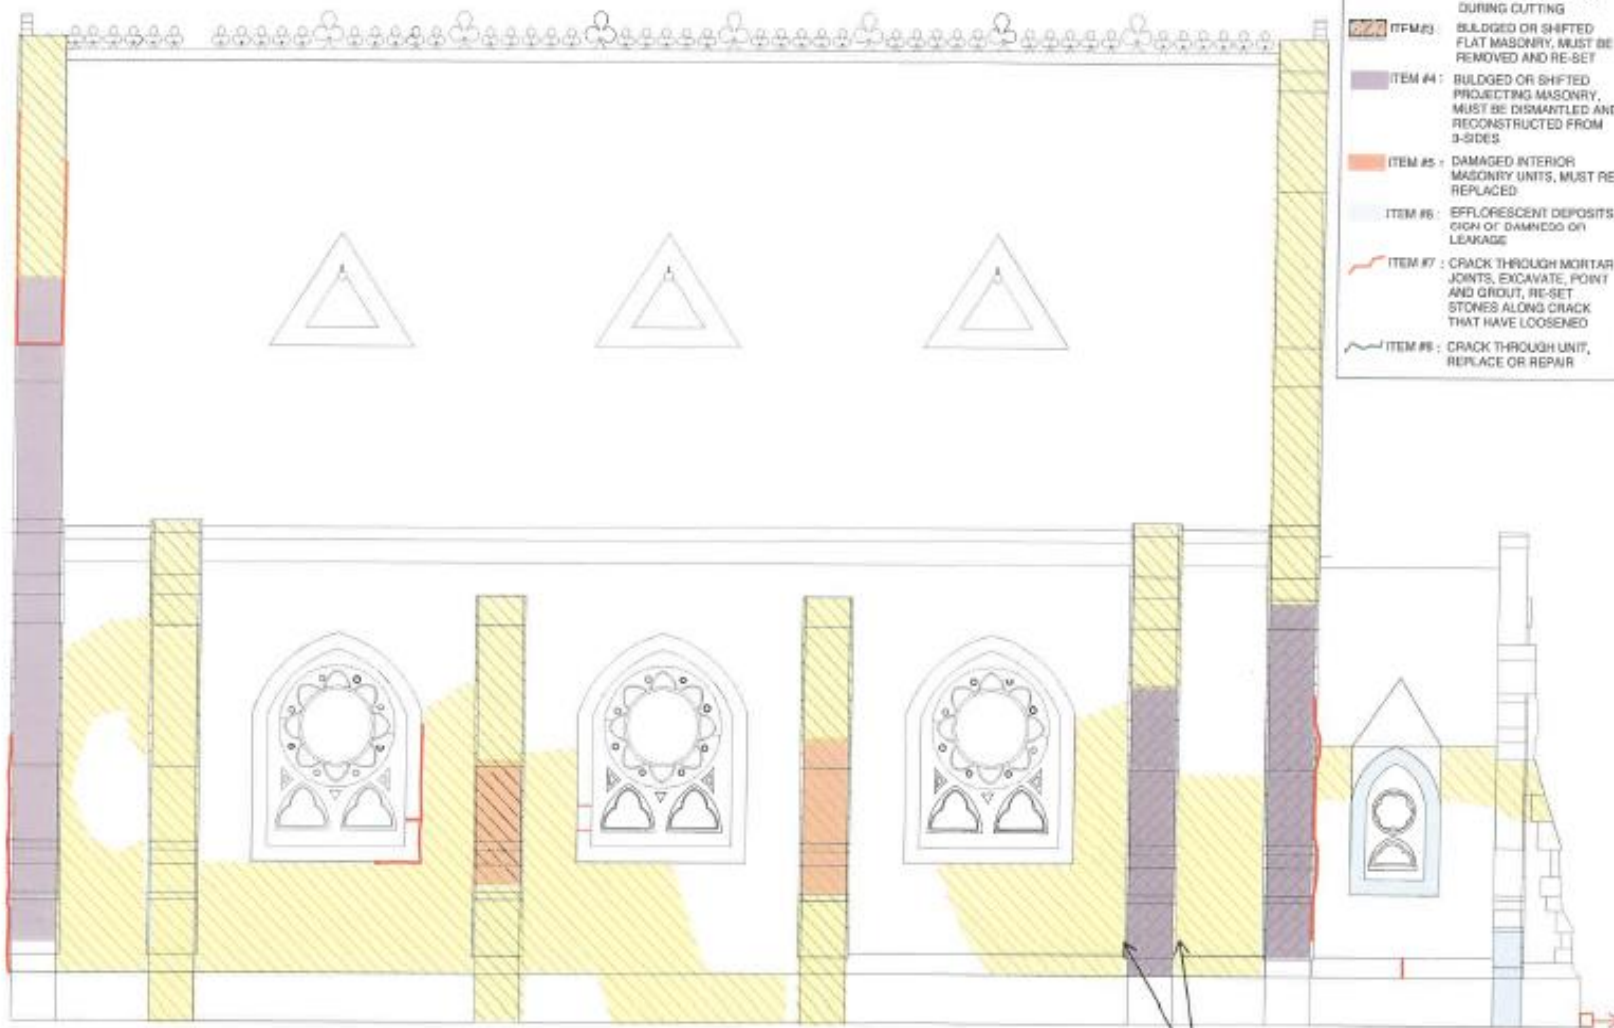
No.
S2.2

NORTH ELEVATION/ EXTERIOR

SAME CONDITION
ON THE SIDES
(TYPICAL)

- ITEM #1 : ERODED MORTAR JOINTS, MUST BE CUT AND POINTED
- ITEM #2 : DEEPLY ERODED MORTAR JOINTS, MUST DEEPLY CUT AND POINT, RE-SET STONES THAT LOOSEN DURING CUTTING
- ITEM #3 : BULGED OR SHIFTED FLAT MASONRY, MUST BE REMOVED AND RE-SET
- ITEM #4 : BULGED OR SHIFTED PROJECTING MASONRY, MUST BE DISMANTLED AND RECONSTRUCTED FROM 3-SIDES
- ITEM #5 : DAMAGED INTERIOR MASONRY UNITS, MUST RE PLACED
- ITEM #6 : EFFLORESCENT DEPOSITS, SIGN OF DAMNAGE OR LEAKAGE
- ITEM #7 : CRACK THROUGH MORTAR JOINTS, EXCAVATE, POINT AND GROUT, RE-SET STONES ALONG CRACK THAT HAVE LOOSENED
- ITEM #8 : CRACK THROUGH UNIT, REPLACE OR REPAIR
