Greenlawn Chapel, Salem, Mass.

City of Salem- Dickson Memorial Chapel Restoration 2016
Department of Planning and Community Development
By: Erin Schaeffer, Staff Planner

Phase I: Municipal Restoration
2016-2017

Existing Conditions and Project Scope

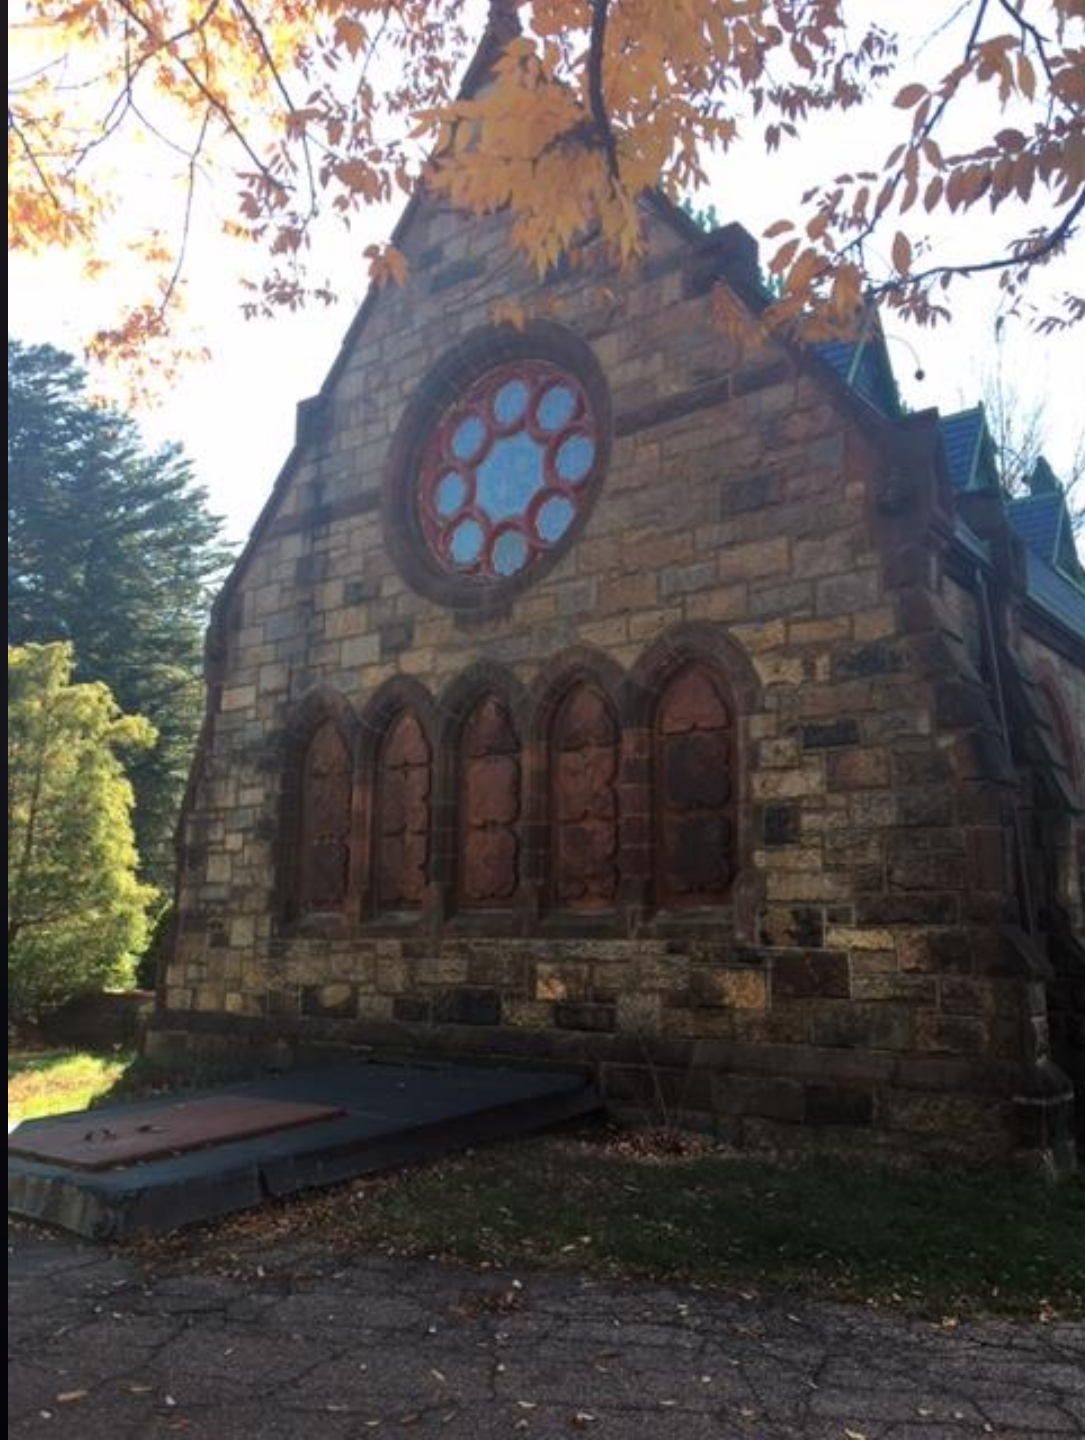
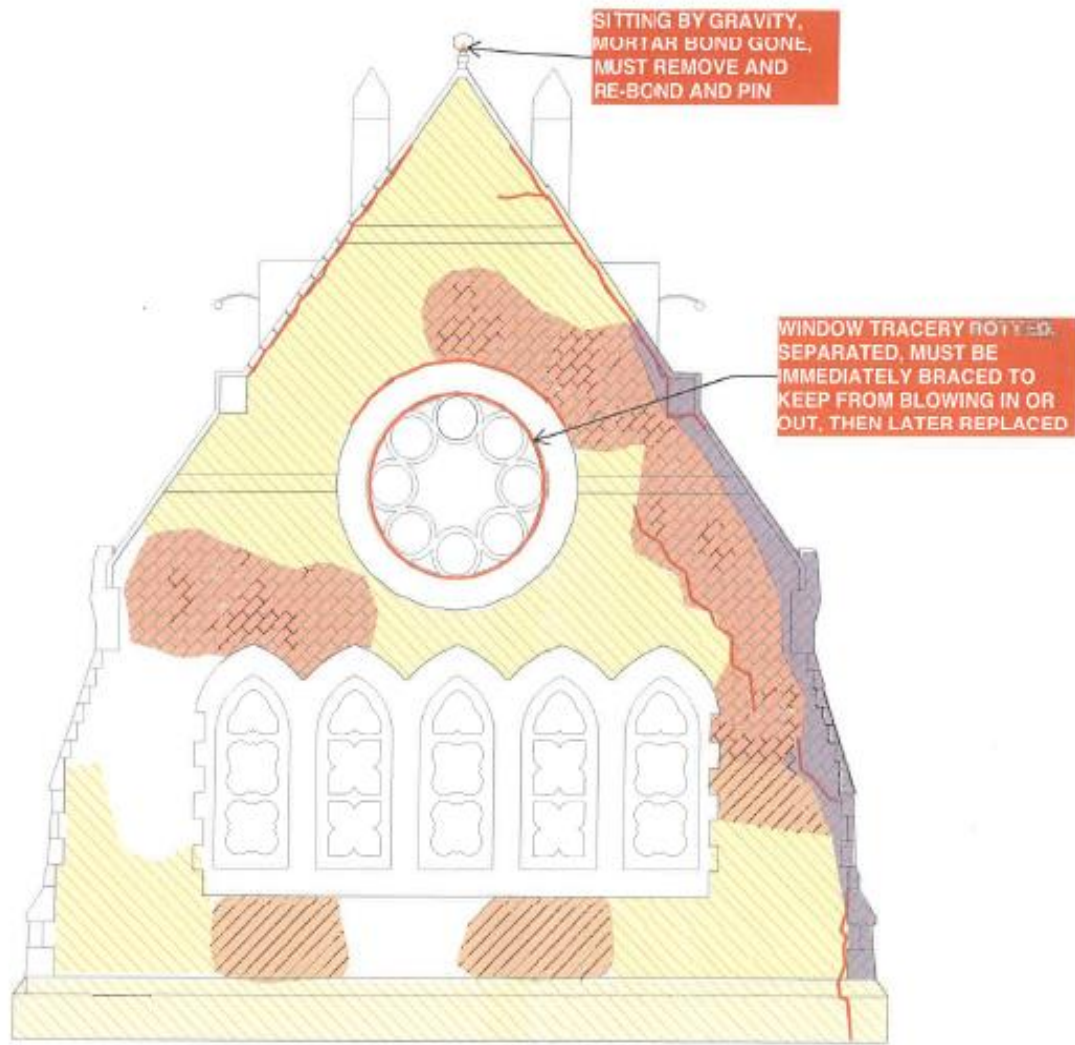
No.
S2.3

EAST ELEVATION/ EXTERIOR

- ITEM #1: ERODED MORTAR JOINTS. MUST BE CUT AND POINTED
- ITEM #2: DEEPLY ERODED MORTAR JOINTS. MUST DEEPLY CUT AND POINT, RE-SET STONES THAT LOOSEN DURING CUTTING
- ITEM #3: BULGED OR SHIFTED FLAT MASONRY. MUST BE REMOVED AND RE-SET
- ITEM #4: BULGED OR SHIFTED PROJECTING MASONRY. MUST BE DISMANTLED AND RECONSTRUCTED FROM 3-SIDES
- ITEM #5: DAMAGED INTERIOR MASONRY UNITS. MUST BE REPLACED
- ITEM #6: EFFLORESCENT DEPOSITS, SIGN OF DAMNNESS OR LEAKAGE
- ITEM #7: CRACK THROUGH MORTAR JOINTS, EXCAVATE, POINT AND GROUT, RE-SET STONES ALONG CRACK THAT HAVE LOOSENED
- ITEM #8: CRACK THROUGH UNIT, REPLACE OR REPAIR

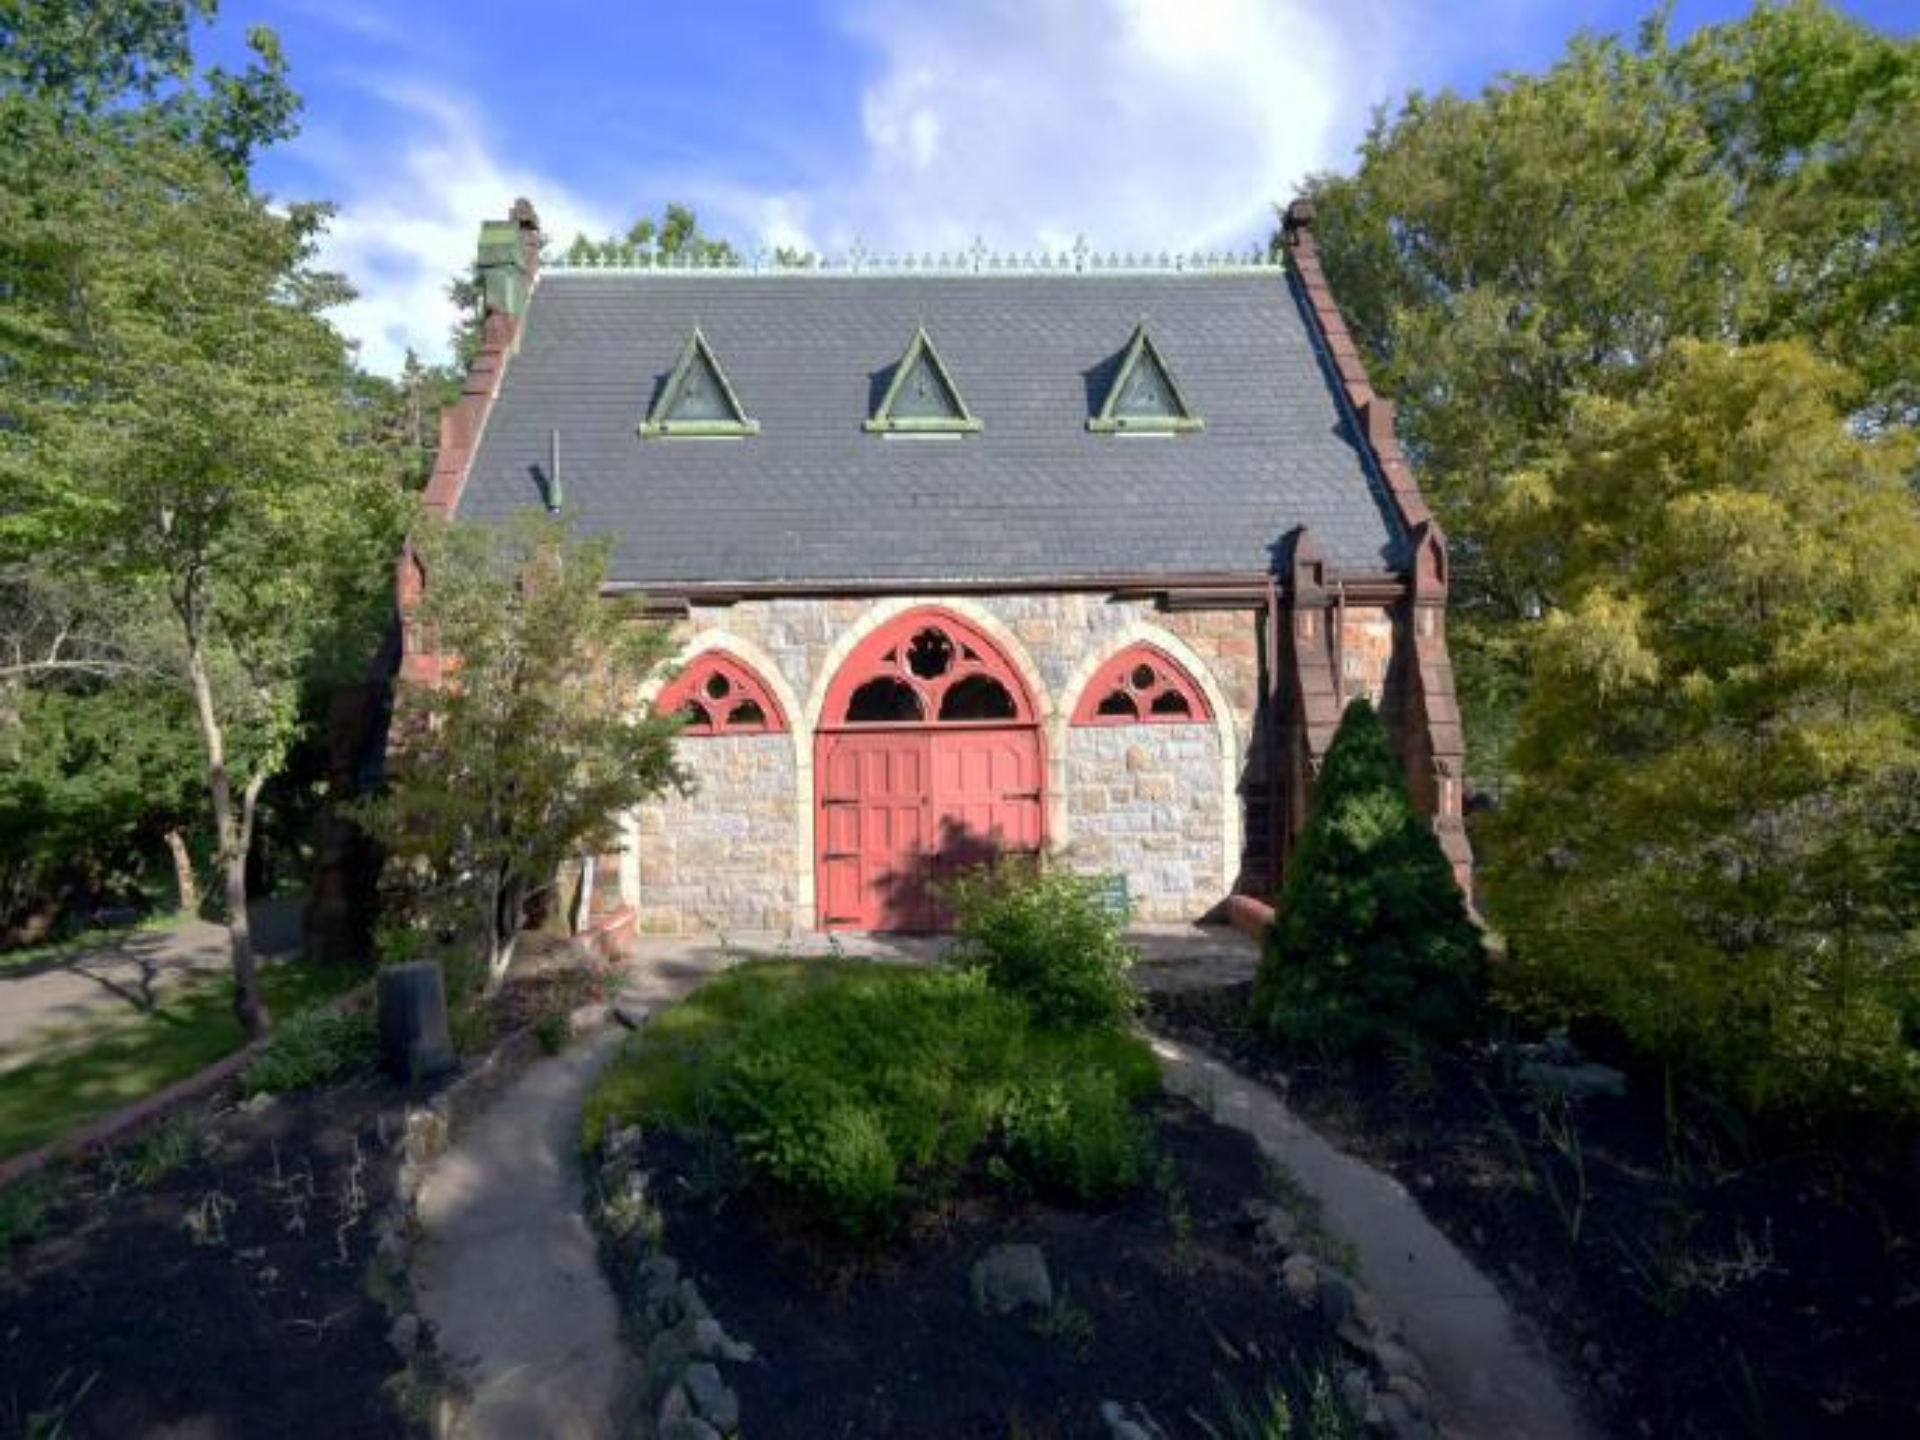
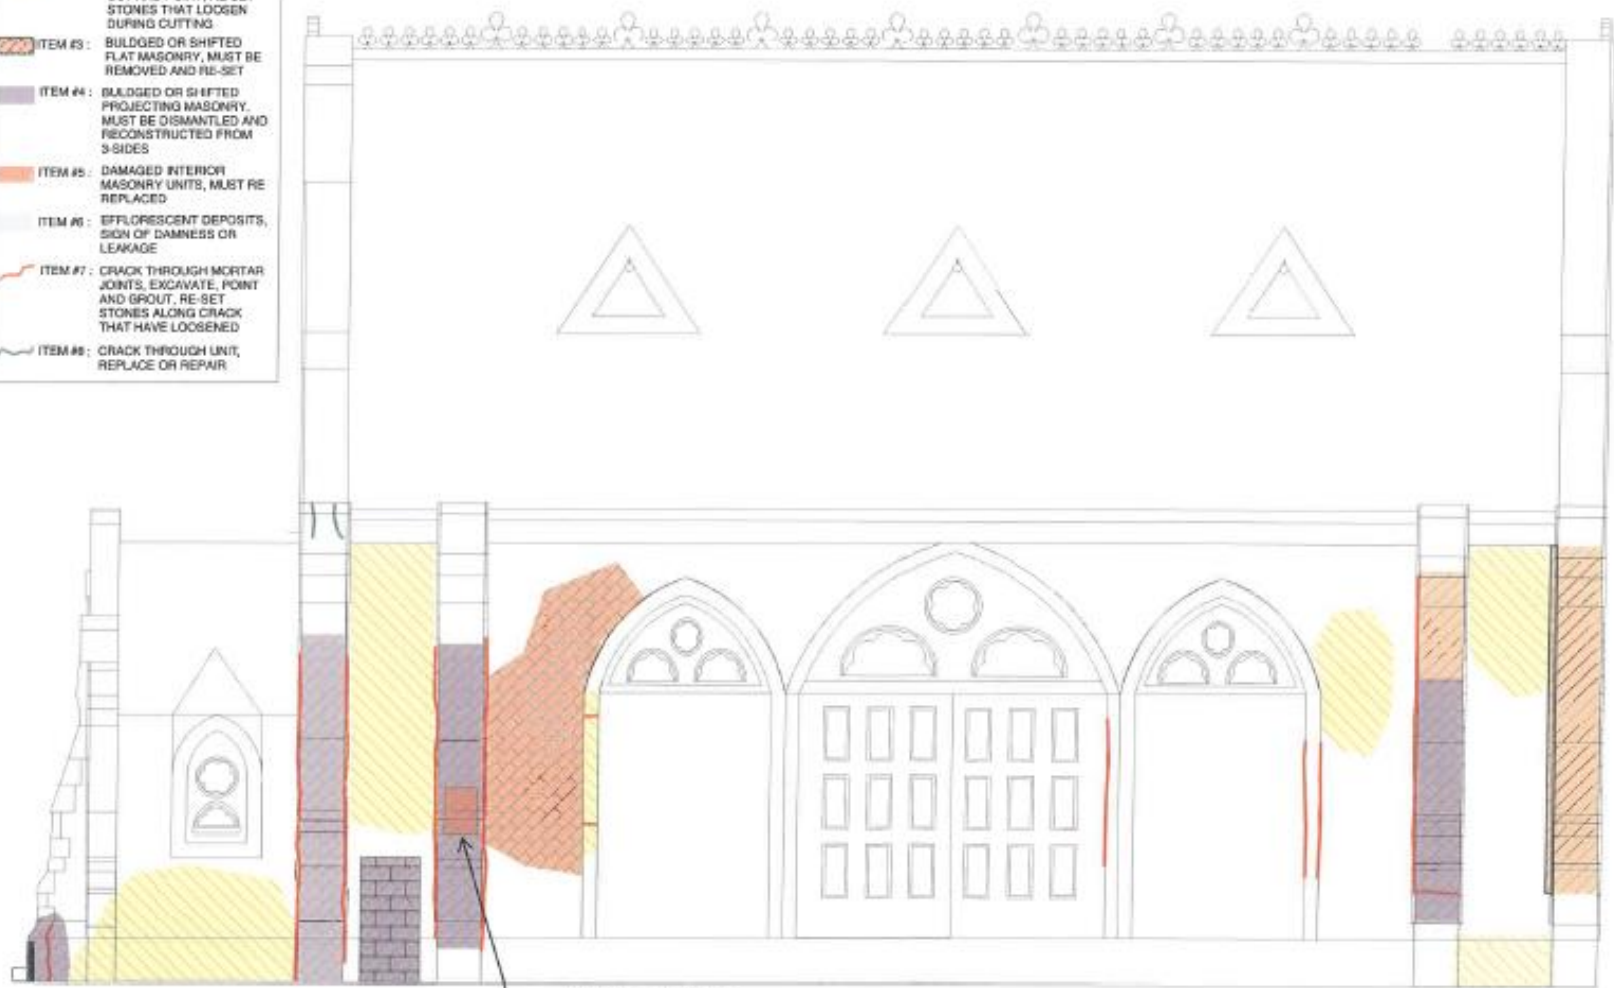
No.
S2.4

MISSING STONES
DEEP REPAIR

SOUTH ELEVATION/ EXTERIOR

- ITEM #1: ERODED MORTAR JOINTS- MUST BE CUT AND POINTED
- ITEM #2: DEEPLY ERODED MORTAR JOINTS, MUST DEEPLY CUT AND POINT, RE-SET STONES THAT LOOSEN DURING CUTTING
- ITEM #3: BULGED OR SHIFTED FLAT MASONRY, MUST BE REMOVED AND RE-SET
- ITEM #4: BULGED OR SHIFTED PROJECTING MASONRY, MUST BE DISMANTLED AND RECONSTRUCTED FROM 3-SIDES
- ITEM #5: DAMAGED INTERIOR MASONRY UNITS, MUST BE REPLACED
- ITEM #6: EFFLORESCENT DEPOSITS, SIGN OF DAMNERS OR LEAKAGE
- ITEM #7: CRACK THROUGH MORTAR JOINTS, EXCAVATE, POINT AND GROUT, RE-SET STONES ALONG CRACK THAT HAVE LOOSENED
- ITEM #8: CRACK THROUGH UNIT, REPLACE OR REPAIR
