# SALEM WILLOWS

## Existing Conditions Report - Buildings & Structures

*Observed: November 07, 2018*

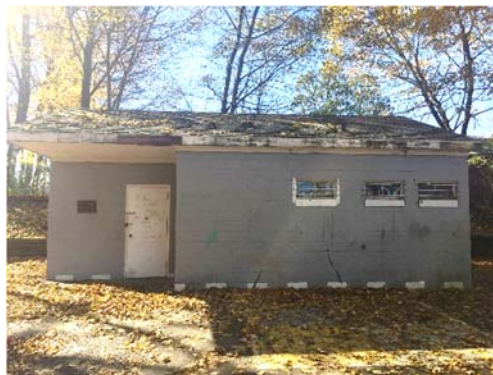
### 1- Waterfront Park – Activity Center

**Conditions** – *Poor, but stable.* There are no apparent structural concerns, but there is a good deal of material degradation and there is a buildup of leaves, dirt and debris throughout. Specific items to be addressed:

- \* Roof and fascia should be replaced.
- Steel doors and frames are rusting and should be stripped, zinc treated, patched, and repainted.
- \* The wiring in the building is draped loosely in the rafters and should be secured and brought up to code.
- The ceiling tiles are missing from the drop ceiling system.
- Missing door hardware on storage room door to be replaced.
- \* Main entry door hardware is an inaccessible knob type – switch out for lever-type.
- \* Bathrooms are marked as accessible, but fixture types and clearances are non-compliant:
  - o Sinks = 28 ½” AFF.
  - o Toilets = 13” centerline from wall
  - o Only one grab bar provided per room
- Repaint structure

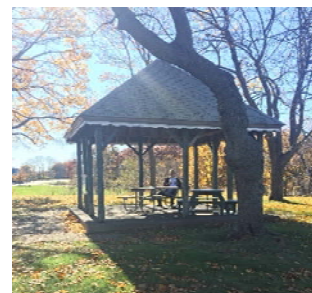
### 2- Pavilion A

**Conditions** – *Good.* Structure is in good shape but needs maintenance.

- This structure is not currently on an accessible route.
- \* Slab is 8”-10” above grade; the approach from one side should be graded up to the elevation of the slab.
- Roof is missing some shingles.
- \* Rot at most post bases and anchors. (See earlier recommendation.)
- Repaint structure

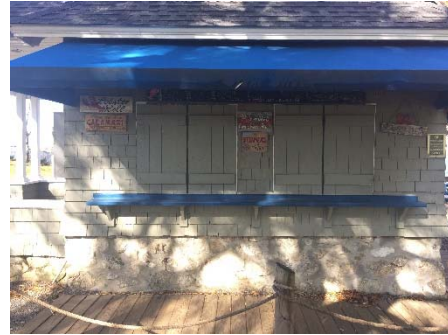
### 3- Clam Shack

**Conditions** – Good. Structure is in good shape but needs maintenance

- \* One of the serving windows, preferable the standalone on the north side, should be dropped to 34” for accessible service.
- There appears to be some wood rot at the cupola that should be replaced.
- New paint at exterior, especially at fascia boards and cupola.

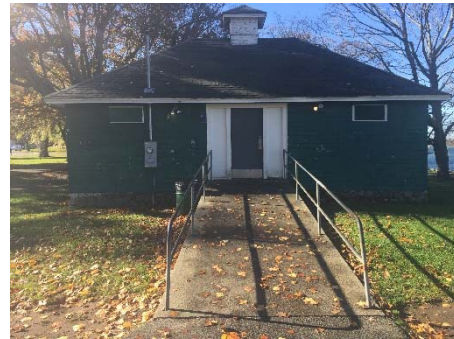
### 4- Public Restrooms

**Conditions** – Fair. Structure is in good shape but needs maintenance. Interiors need repair and refinishing.

- \* Exterior ramp slope is too steep and requires a 60” landing at the top of ramp at exterior door. Length of ramp would extend further down the path and will require new compliant handrails and guards.

- \* Exterior restroom signage - with braille – should be relocated / replaced to 60” above the top of landing on the latch side of the door.
- Exterior wood sill, adjacent to the entry door, is rotted and should be replaced.

- \* Smoke detector missing.
- \* Floor tiles are missing at entry threshold and should be replaced to prevent tripping.
- Steel doors and frames are rusting and should be stripped, zinc treated, patched, and repainted.

- Broken glass at high windows which are currently boarded up:
  - o Replace with glass or plexiglass, in kind.
  - o Replace with glass or screens and provide exterior awning that can be latched when not in use.

- Toilet partitions are all rusted, graffitied, and pulled off walls in some places. Recommend replacement with new vandal resistant partitions.
- \* Rear door only 30” wide, though not required for egress. Keep locked and mark “NOT AN EXIT”.

- Replace damaged exterior shingles.
- Stone foundation should be packed with new grout where deteriorated.
- Repaint structure

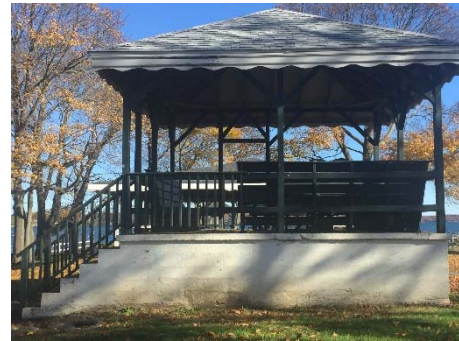
## 6- Pavilion B (Elevated)

**Conditions** – *Fair.* Repair needed to concrete and fascia.

- \* Repair spalling at pad edges and side walls.
- Some rot at fascia, repair and replace.
- \* Section of guard pickets missing adjacent to north stair.
- Repaint structure

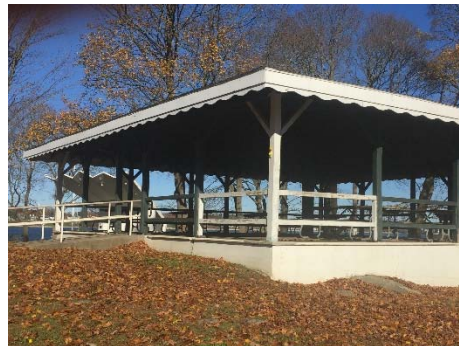
## 7- Pavilion C (Picnic)

**Conditions** – *Good.* Structure is in good shape but needs maintenance

- Repair cracks in slab
- \* Stair has a 9" and a 12" riser with no handrails. Provide three risers at 7" and compliant handrails.
- \* East side of pavilion is more than 30" above grade and requires a compliant guard. Recommend bringing grade up approximately 12" on this side to maintain character of existing rail.
- Repaint structure.

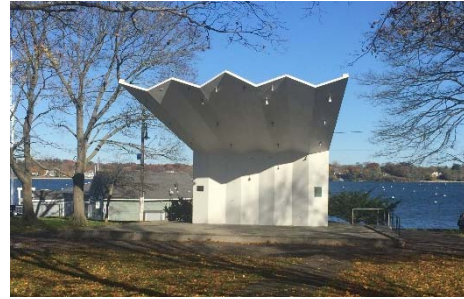
## 8- Amphitheater

**Conditions** – *Good*. Concrete spalling and in need of repair and maintenance.

- \* Roof should be sealed with penetrating crystalline waterproofing to protect rebar and further deterioration of concrete, likely from saturation and freeze/thaw cycles
- Treat and paint exposed rebar and repair damaged concrete.
- Steel doors and frames are rusting and should be stripped, zinc treated, patched, and repainted.
- \* WSA agrees with EMG assessment that wood ramp should be replaced and recommend replacing with concrete for even surface and long-term durability. Ramp needs required width and compliant handrails on both sides.
- Stair has spalled riser and also needs compliant handrails
- Repaint structure.

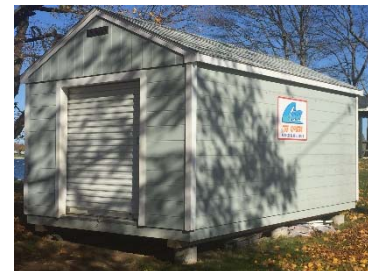
## 9- SUP Hut

**Conditions** – *Excellent*. Structure is in excellent condition but is temporary in nature and inaccessible. Primary use is for storage of kayaks and paddleboards, not occupancy.

- Door is two feet above grade. Consider building stairs for improved access vs. reach-in.

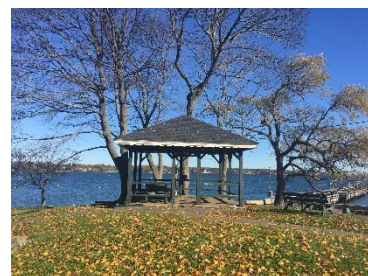
## 10- Pavilion D

**Conditions** – *Good*. Structure is in good shape but needs maintenance

- \* Rot at some post bases.
- Repair cracked slab
- \* Repair concrete spall under corner post.
- Repaint structure

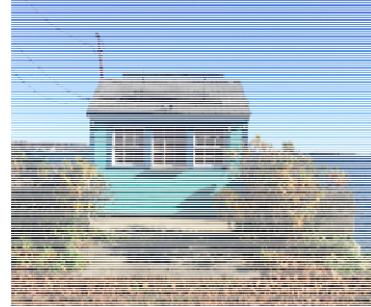
## 11- Hut

**Conditions** – *Good*. Structure is in good shape but needs maintenance.

- \* Seawall CMU is only 36" above exterior walkway. Recommend adding additional metal top-rail at 42" to meet code for guards.
- \* Portions of seawall need to be rebuilt and repaired. Open to underneath structure.
- Wood rot on window trim and portions of siding.
- Repaint structure

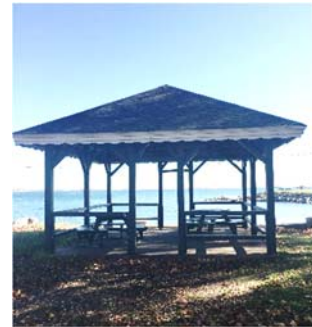
## 12- Pavilion E

**Conditions** – *Good*. Structure is in good shape but needs maintenance

- \* Rot at some post bases
- Rot at fascia / Loose fascia
- Repair cracked slab
- \* Missing and damaged rails
- Repaint structure
