MARCH 2018, NOR-EASTER STORM DAMAGE SEAWALL ASSESSMENTS

Salem, Massachusetts

Columbus Avenue Seawall

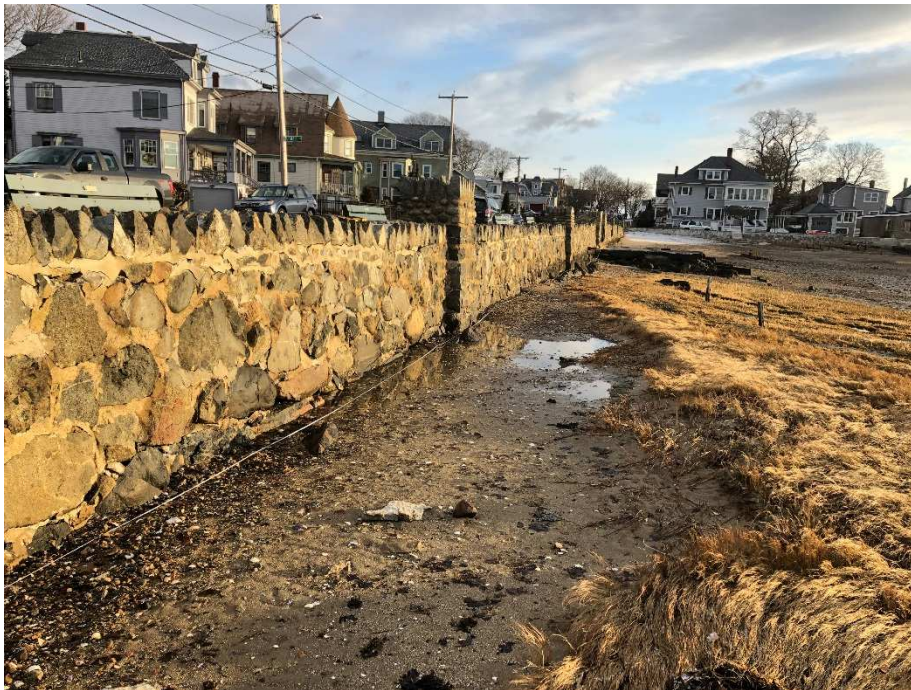
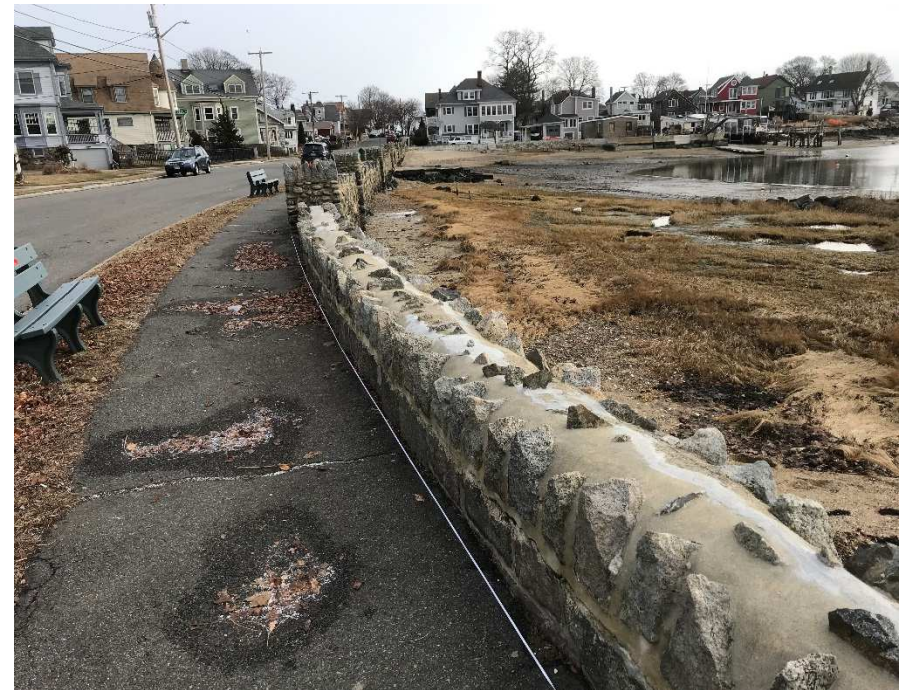
➤ Observed to be in overall FAIR to POOR Condition

- Loose/missing stones,
- Deteriorated and missing mortar/cracks

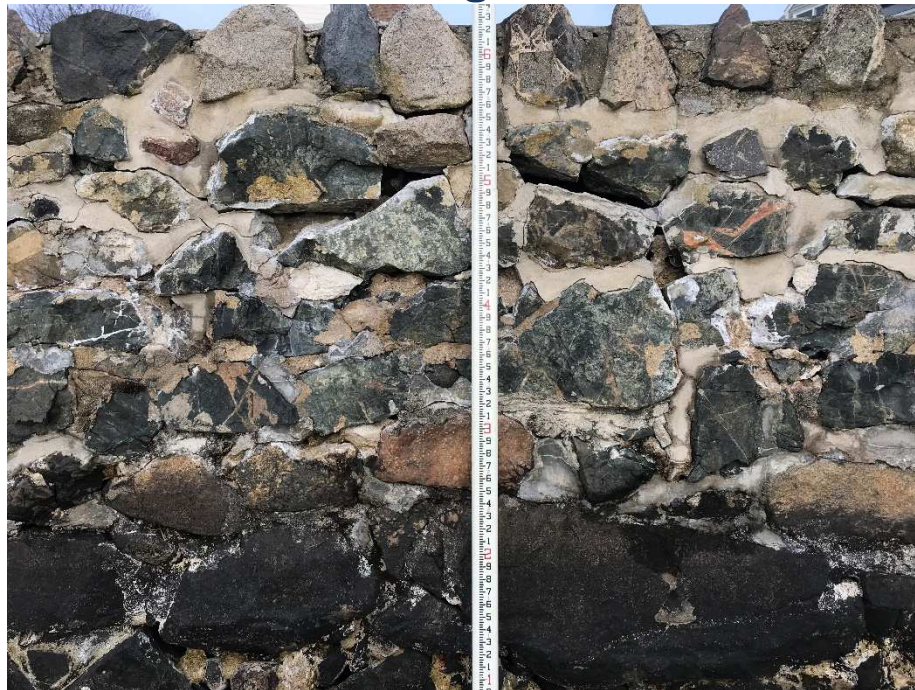
Typical voids and missing mortar along seaward face.

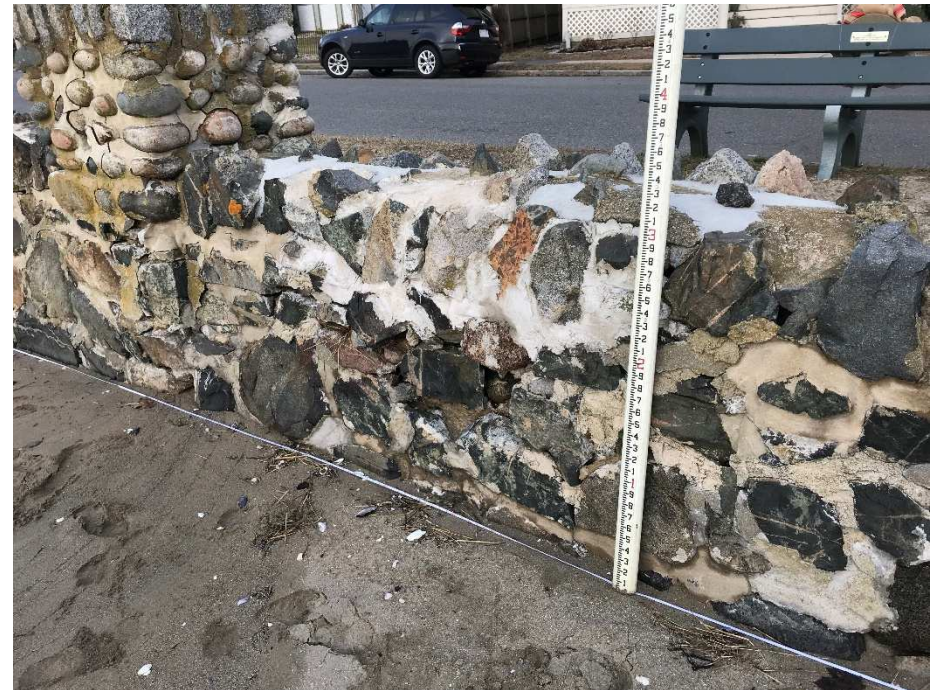
Missing face stones and typical recent mortar repair.

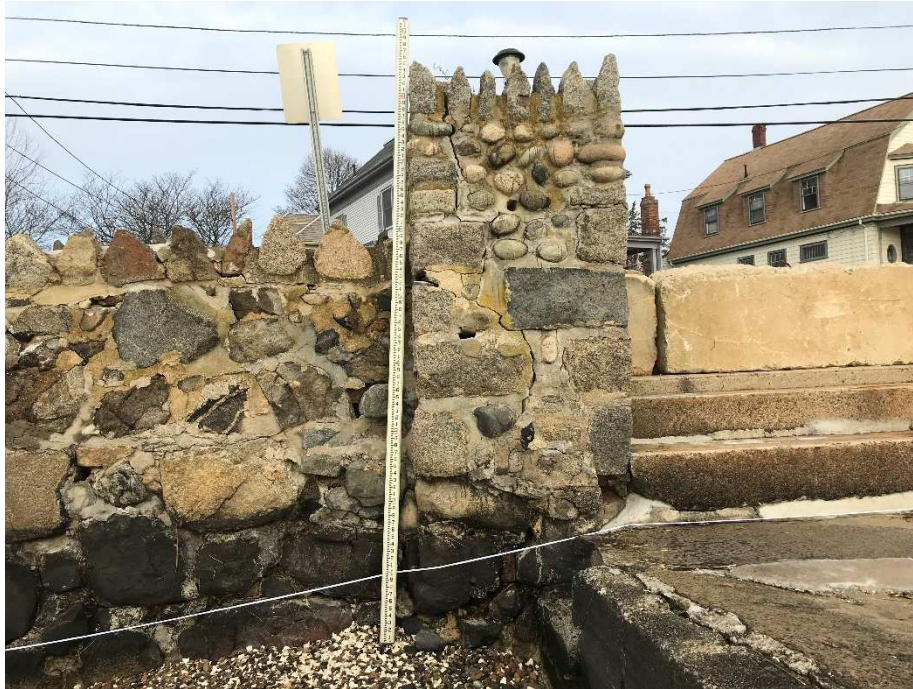
Typical voids and deteriorated and missing mortar/cracks in seaward face.

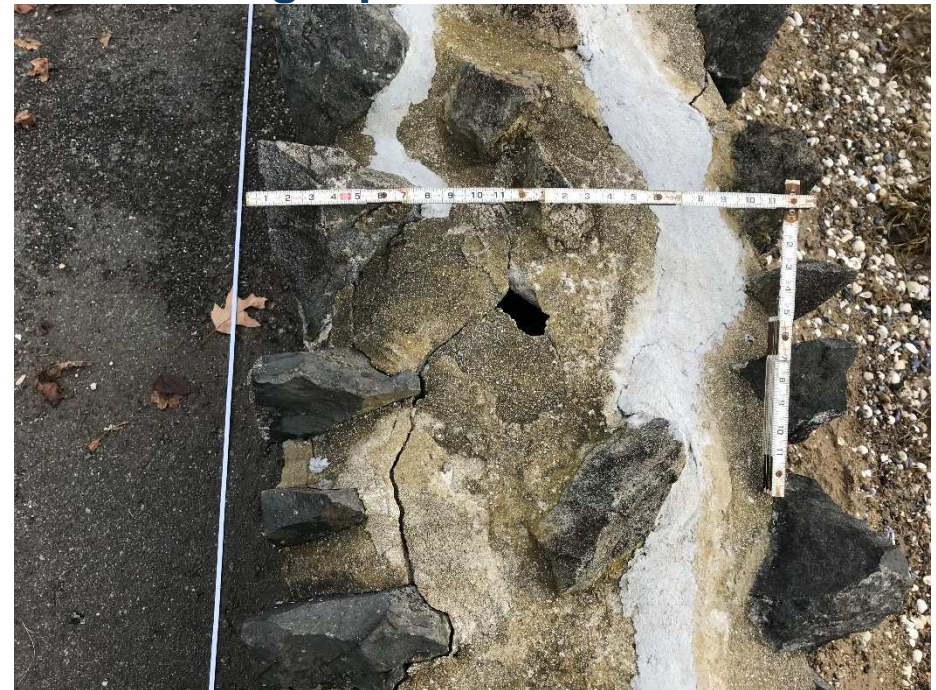
Typical voids and deteriorated and missing mortar/cracks along top of wall.

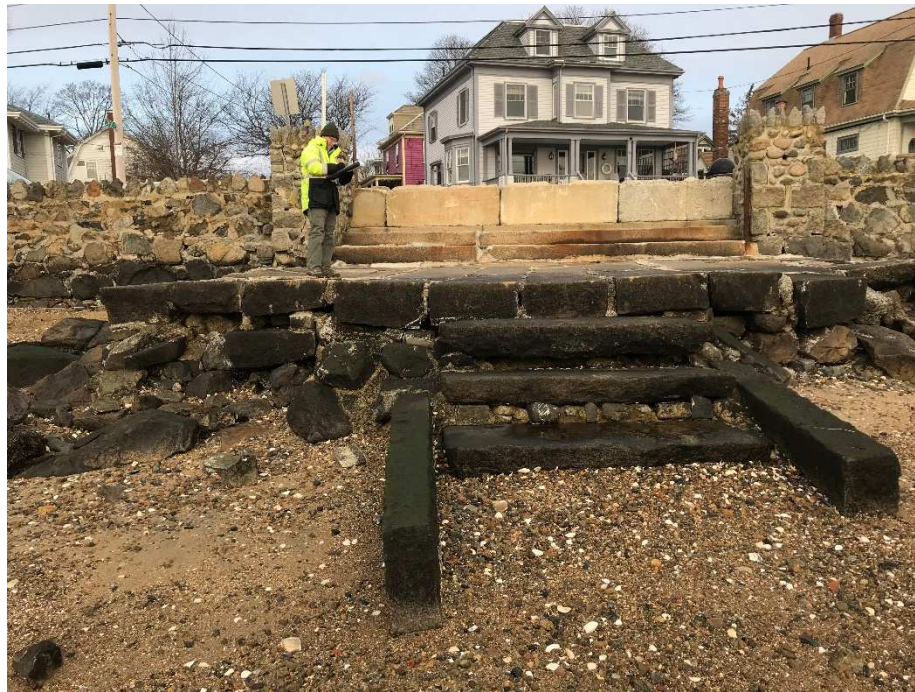
**Granite block landing
with loss of fill material
below top course.**

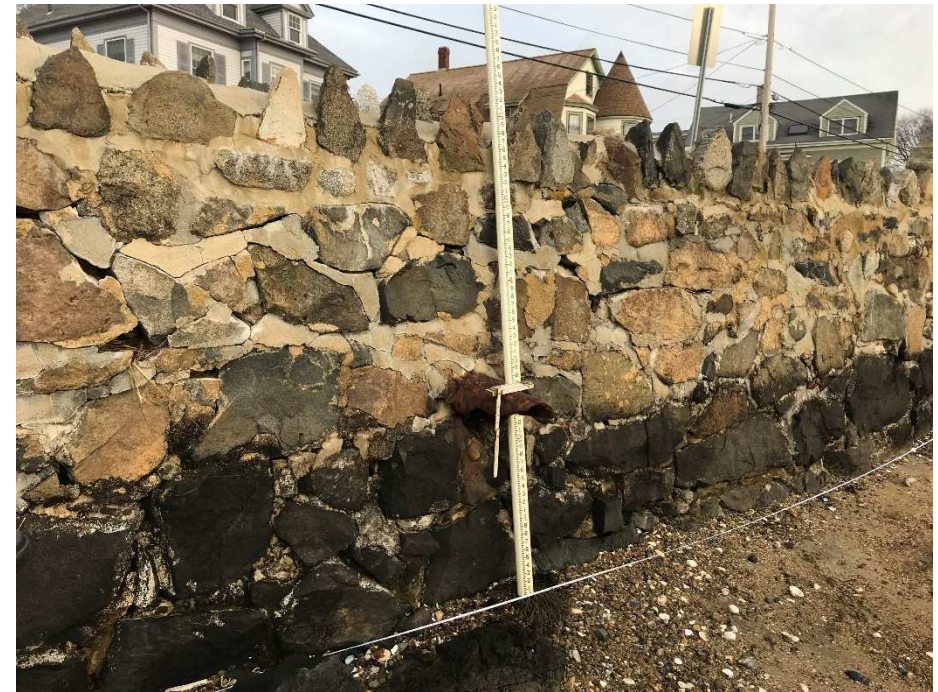
**Typical corroded pipe
weep hole and voids
along seaward face.**
