FOREST RIVER CONSERVATION AREA **TRAIL ASSESSMENT**

SALEM CONSERVATION COMMISSION MEETING NOV 12, 2015

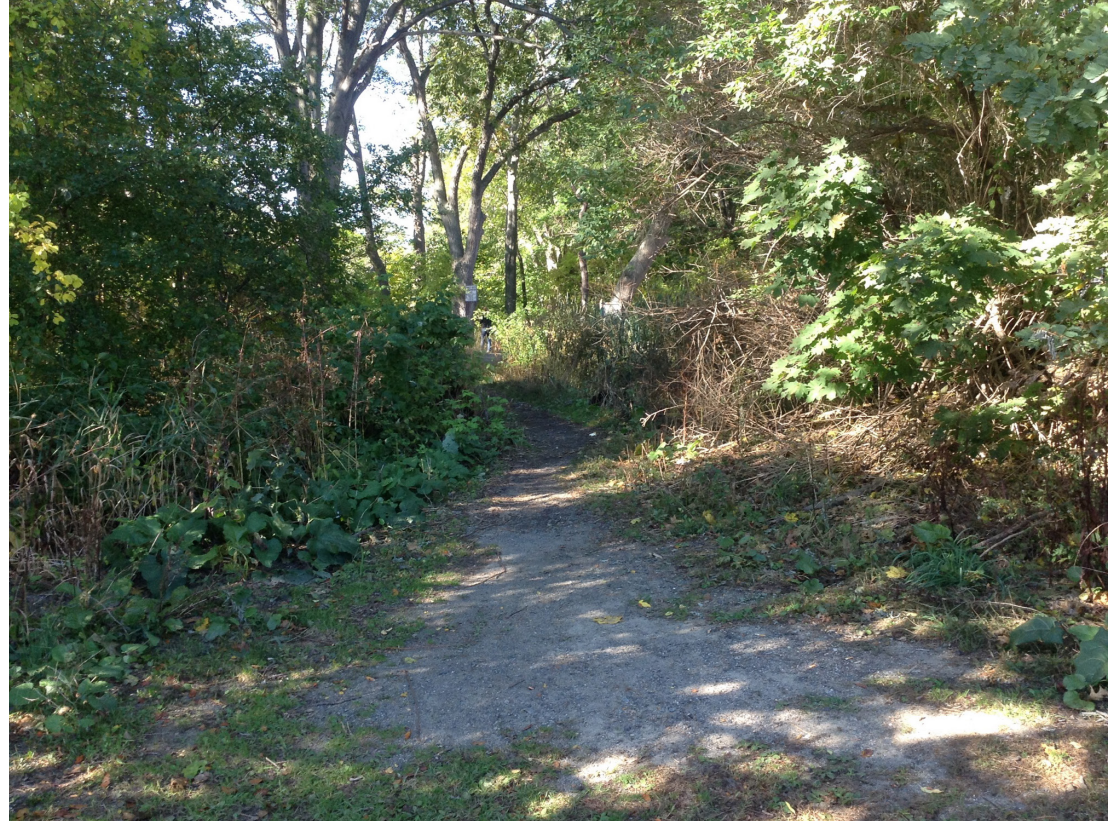
SALEM STATE ENTRANCE

- No ADA parking
- Signage needs repair
- Entry trail somewhat messy and overgrown

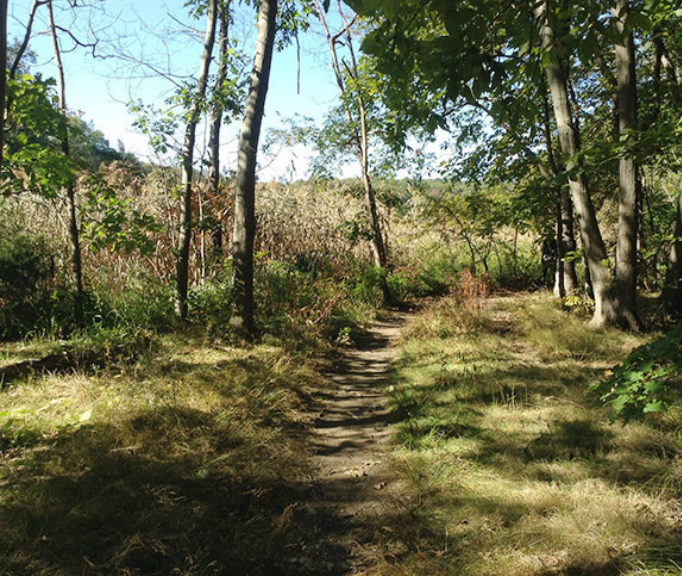
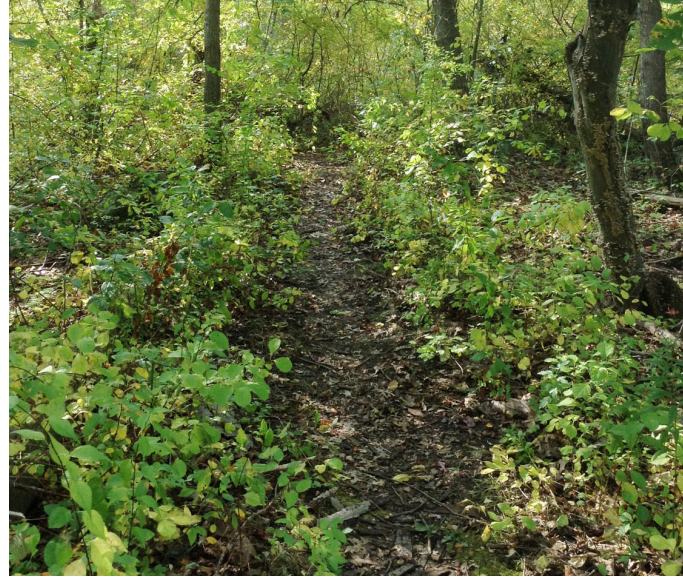
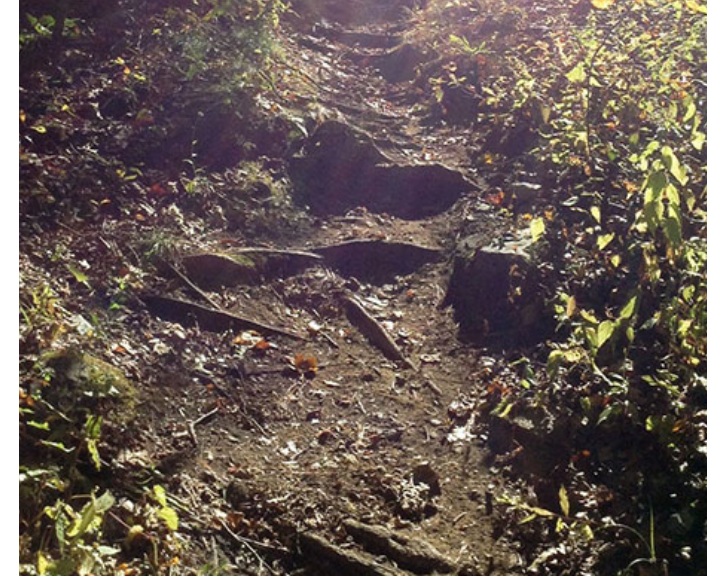
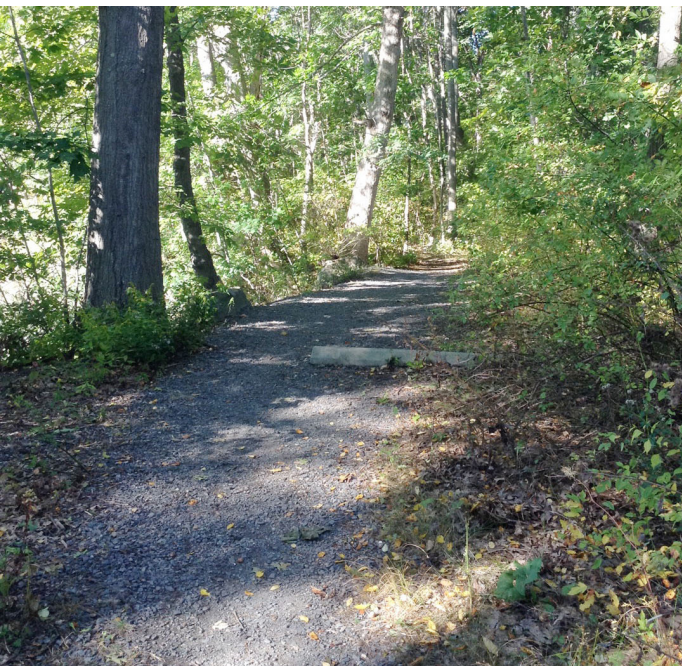
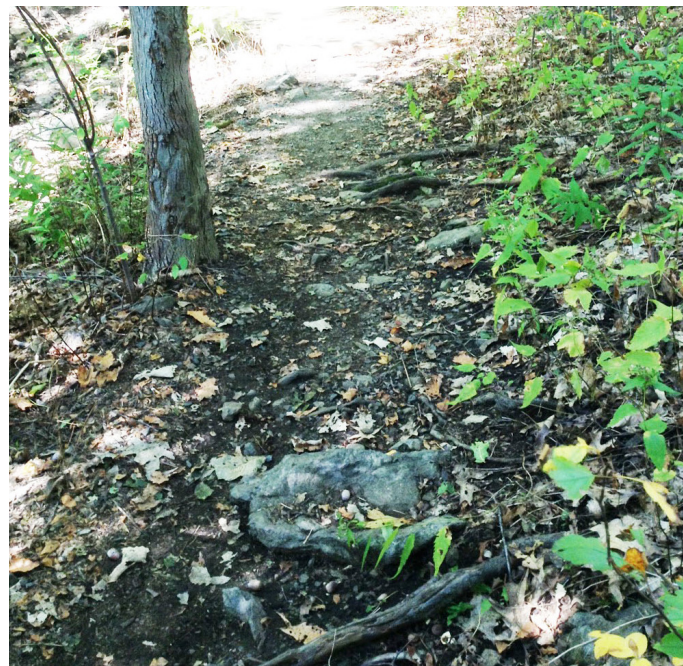
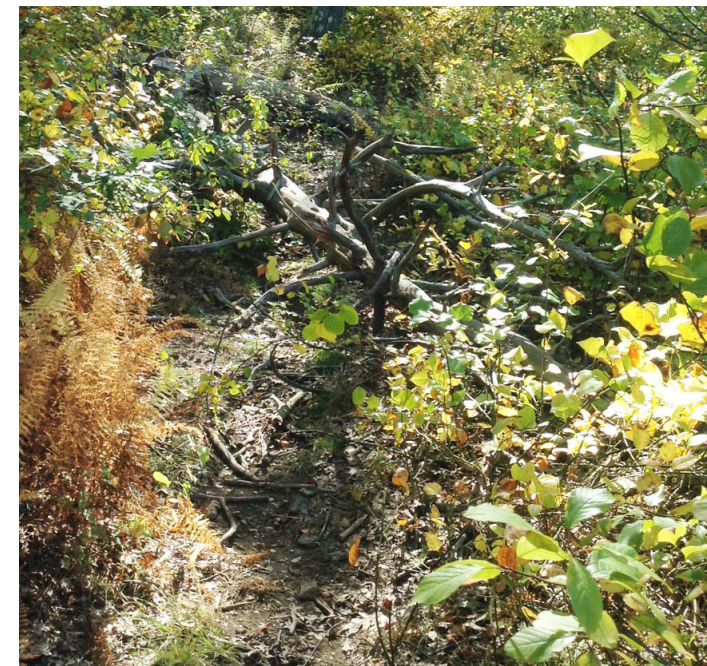
Good Condition

- Minimal to No Obstructions
- Minimal to No Overgrowth
- Minimal to No Erosion

Fair Condition

- Noticeable surface obstructions such as exposed tree roots and small rocks
- Some overgrowth
- Some erosion

Poor Condition

- Large-sized or large quantity of obstructions on walking surface or overhead
- Much erosion

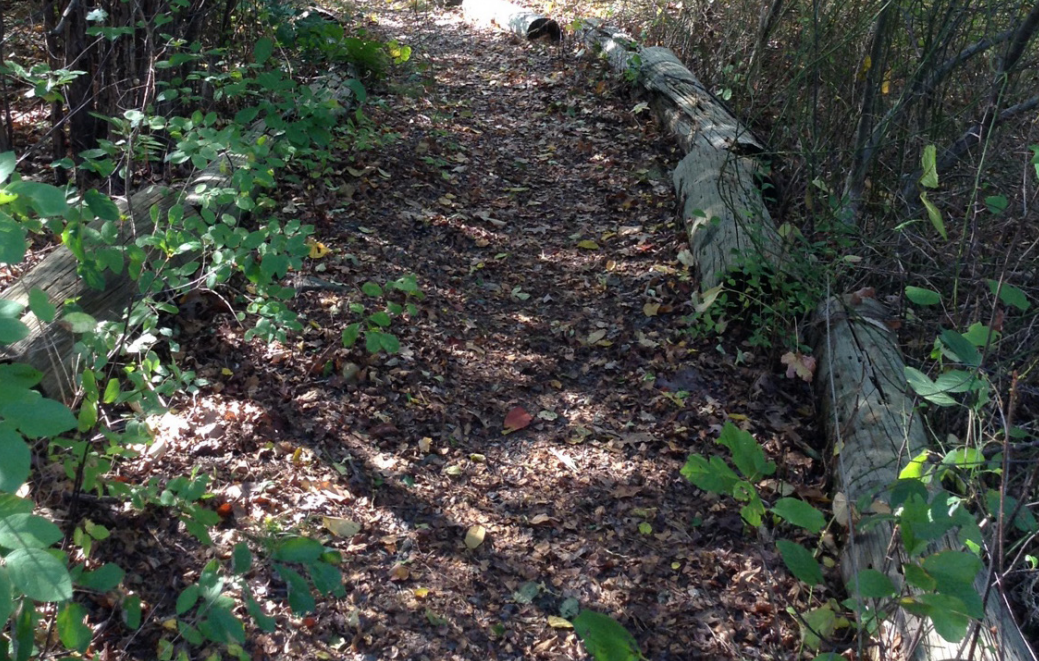
Utility poles lining path running to Pickman Road

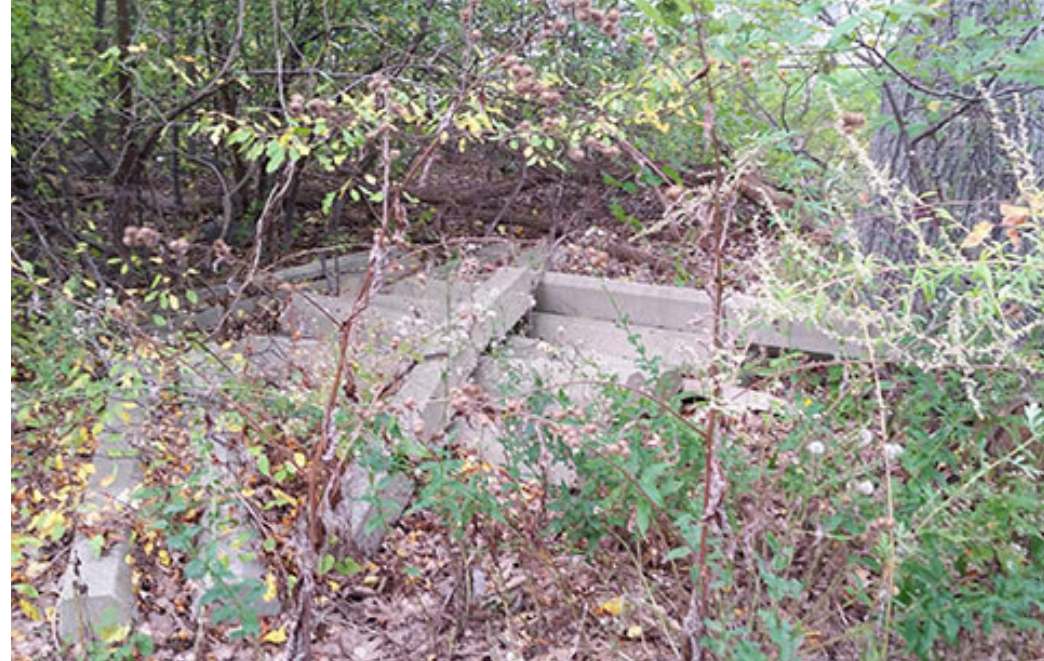
Concrete wheel stops near the salt marsh

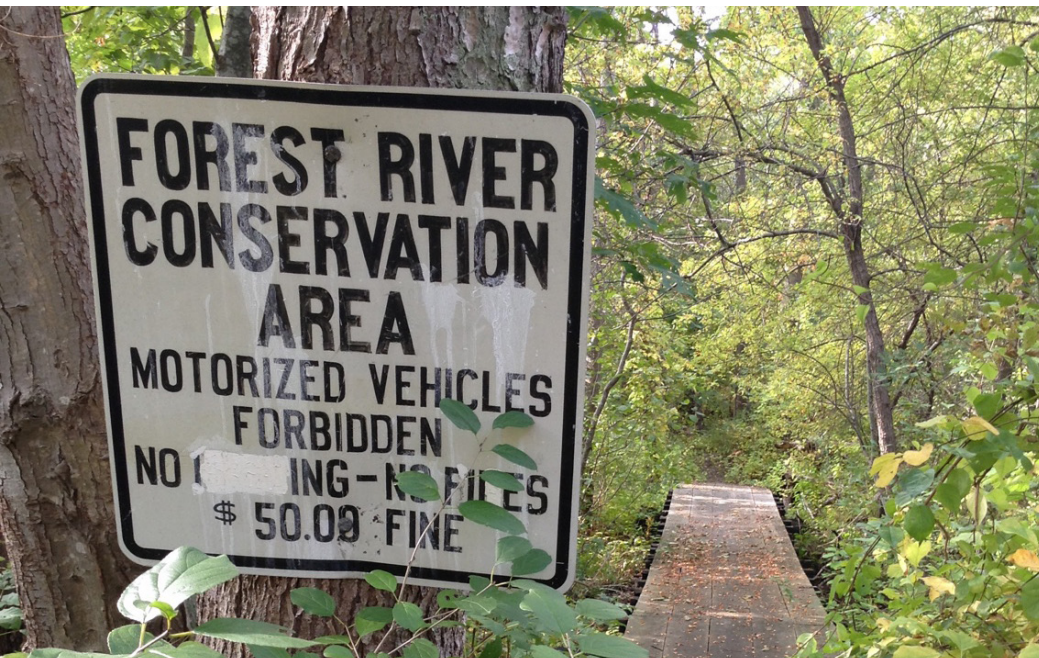
One of several signs advertising fines & vandalized

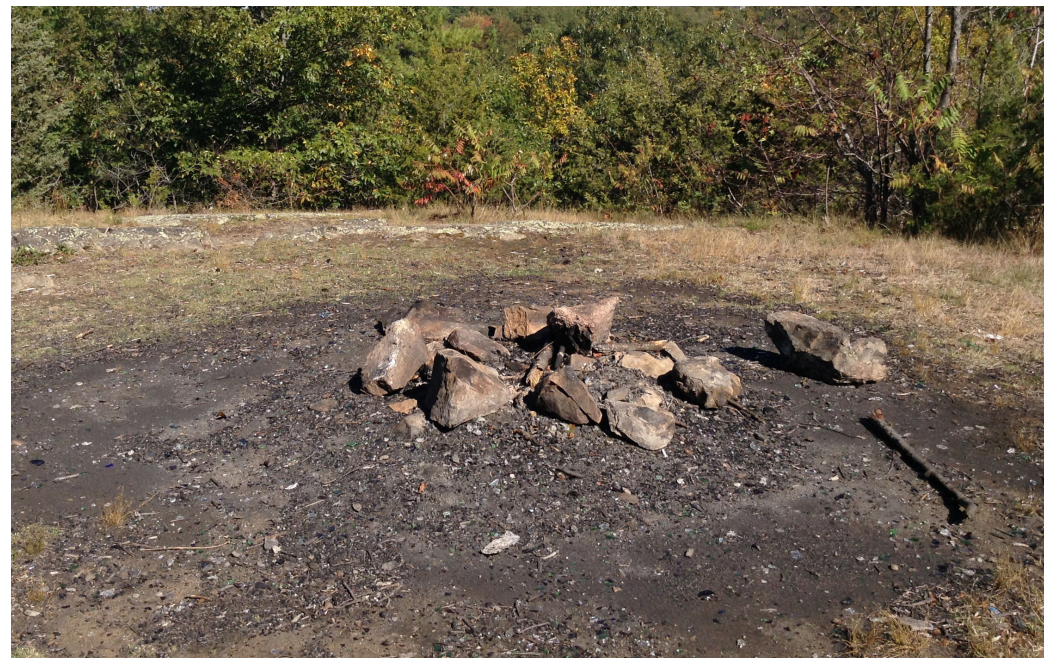
Fire pit at top of Eagle Hill

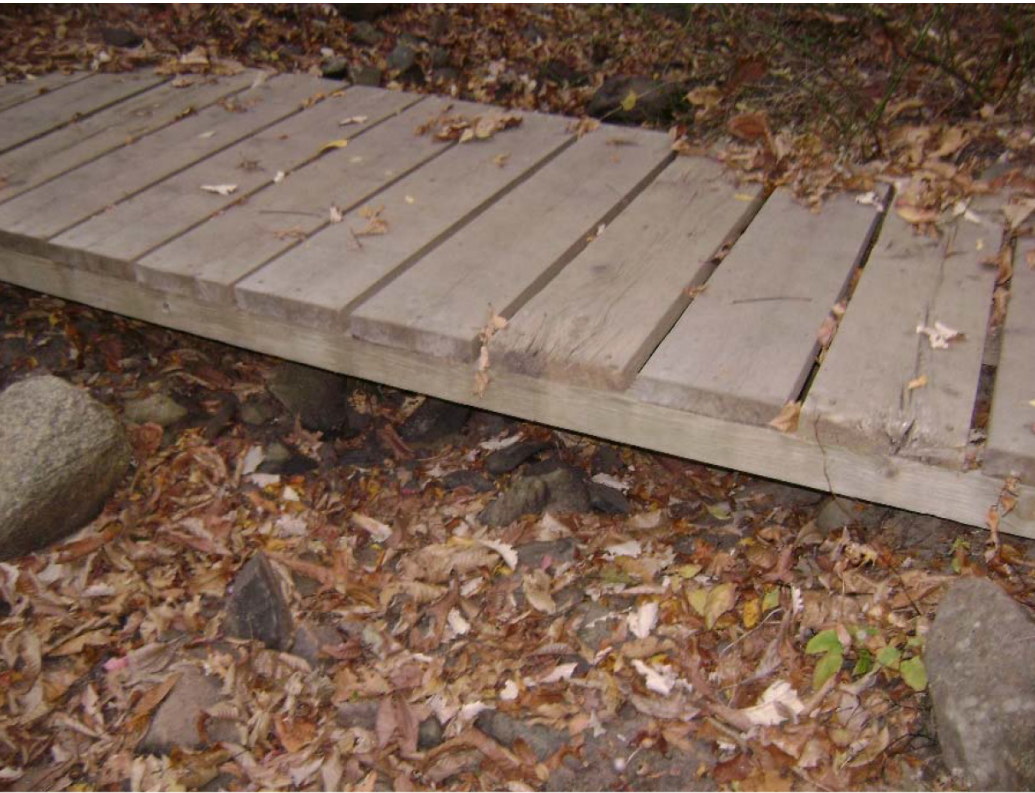
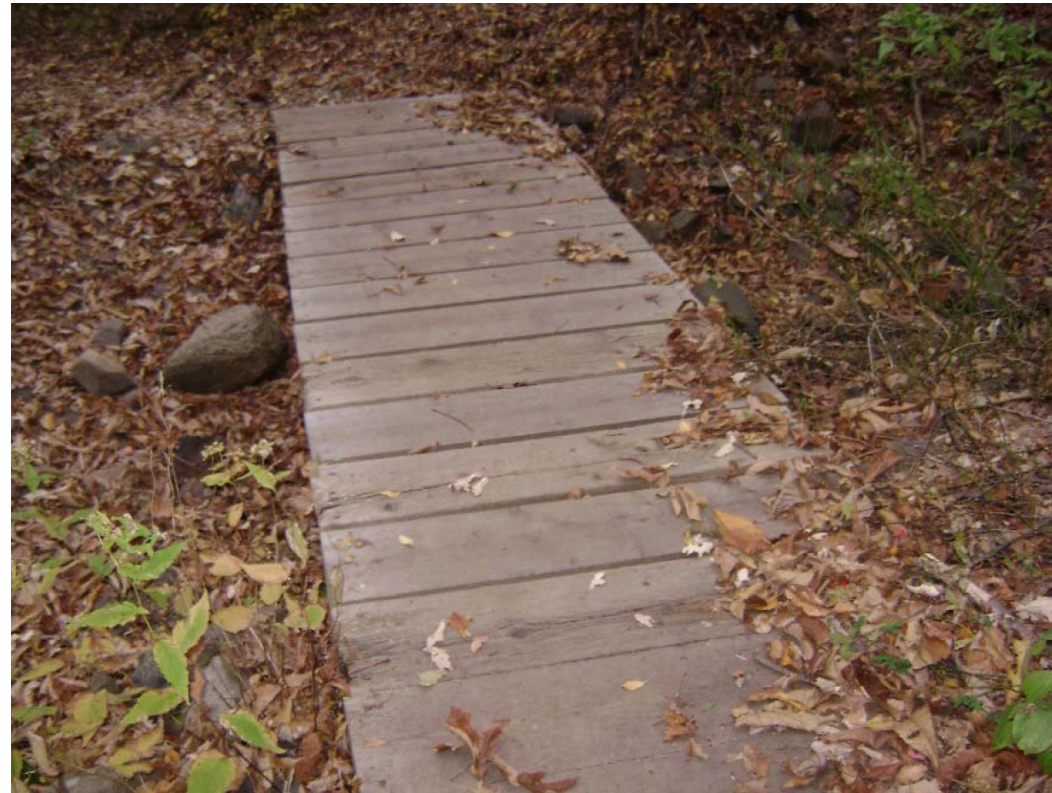
CUB SCOUT BRIDGE

- 16' long x 4' wide
- 3 longitudinal 4" x 4" stringers
- dry rot in deck planks
- deck flex
- no handrails

DOES NOT MEET CODE

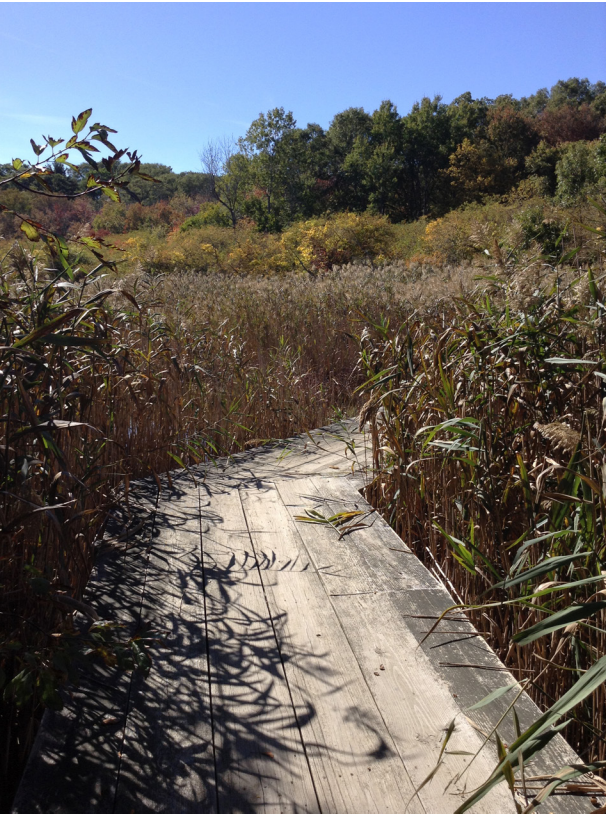
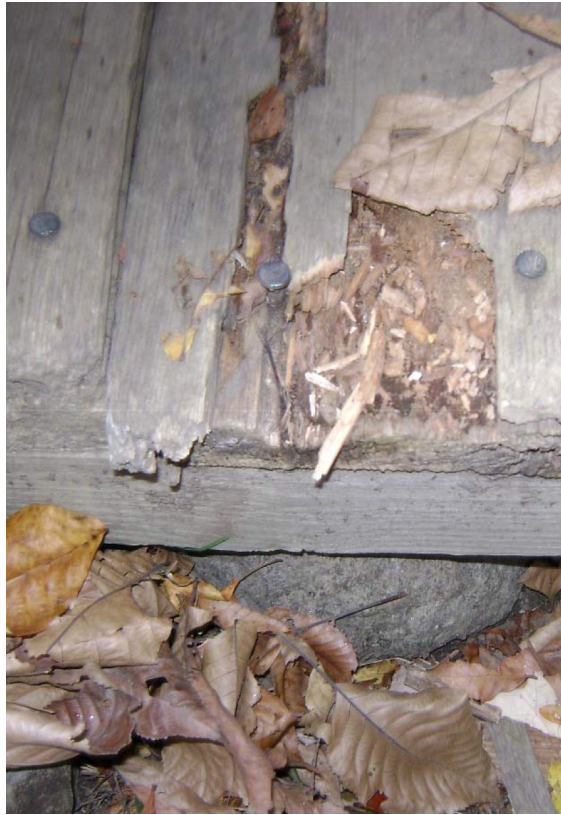
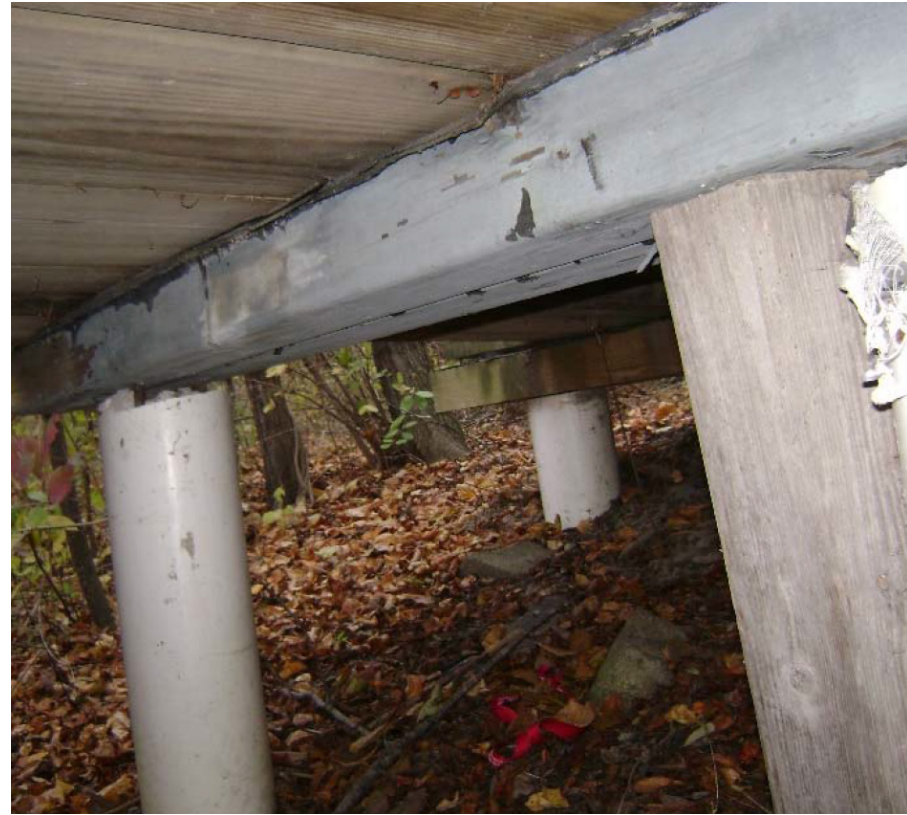
VOLUNTEER BRIDGE

- 210' long x 5'-10" wide
- deck 4-5' above marsh surface
- planks run longitudinally
- post and transverse cap supports, timber and grout-filled PVC
- deck deterioration
- no guard rails

DOES NOT MEET CODE

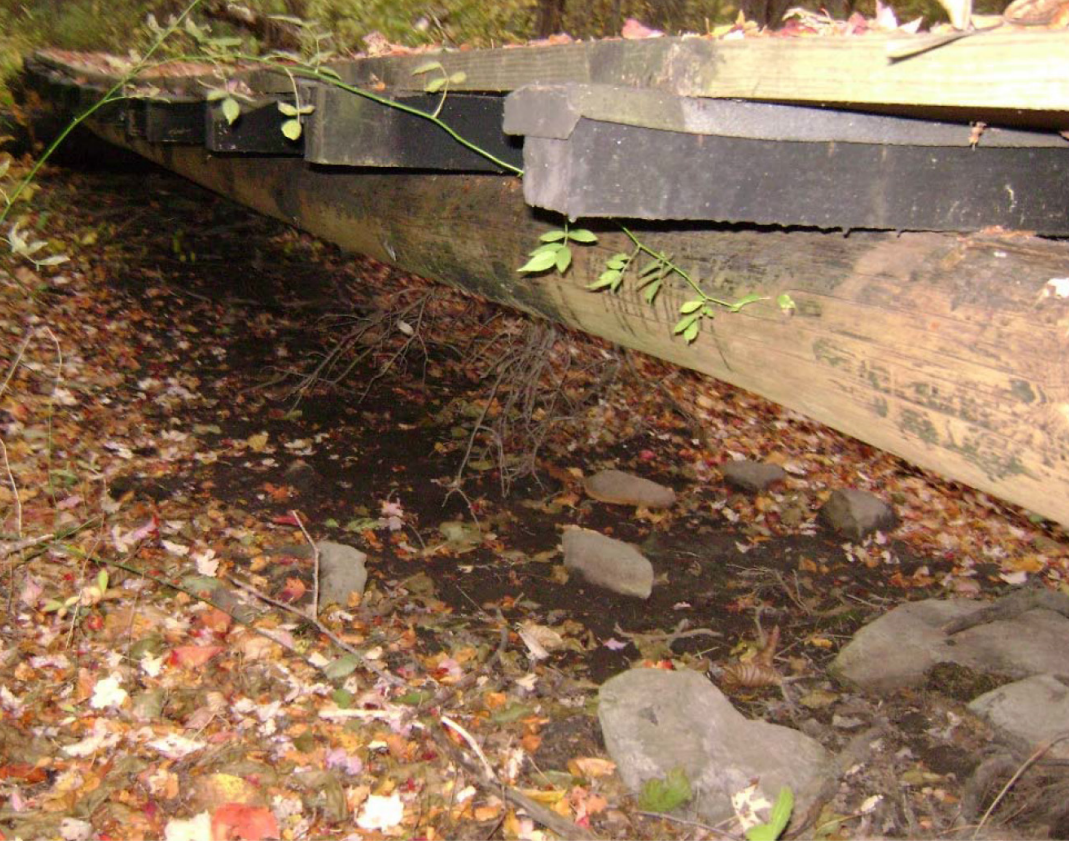
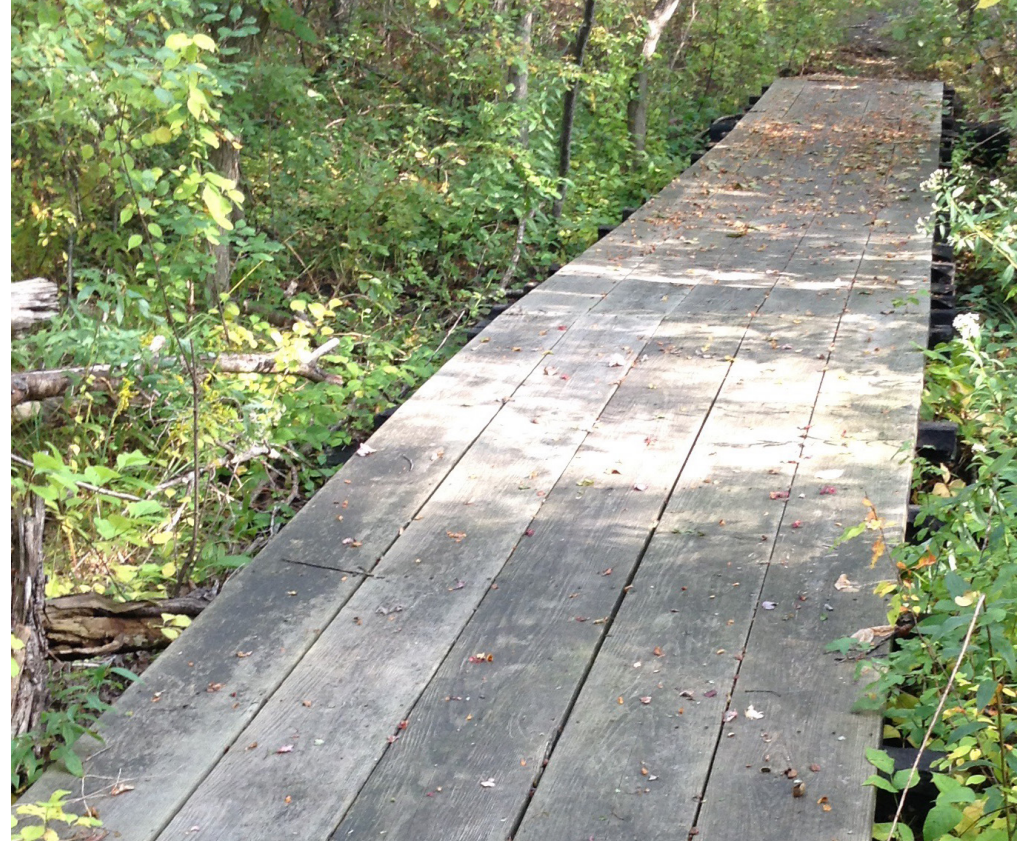
EAGLE SCOUT BRIDGE

- 22' long x 5' wide
- 4"x4" and 4"x6" transverse members supported by logs
- sturdier construction than previous two bridges
- post and transverse cap supports, timber and grout-filled PVC
- some deck rot & limited bounciness
- no guard rails

DOES NOT MEET CODE

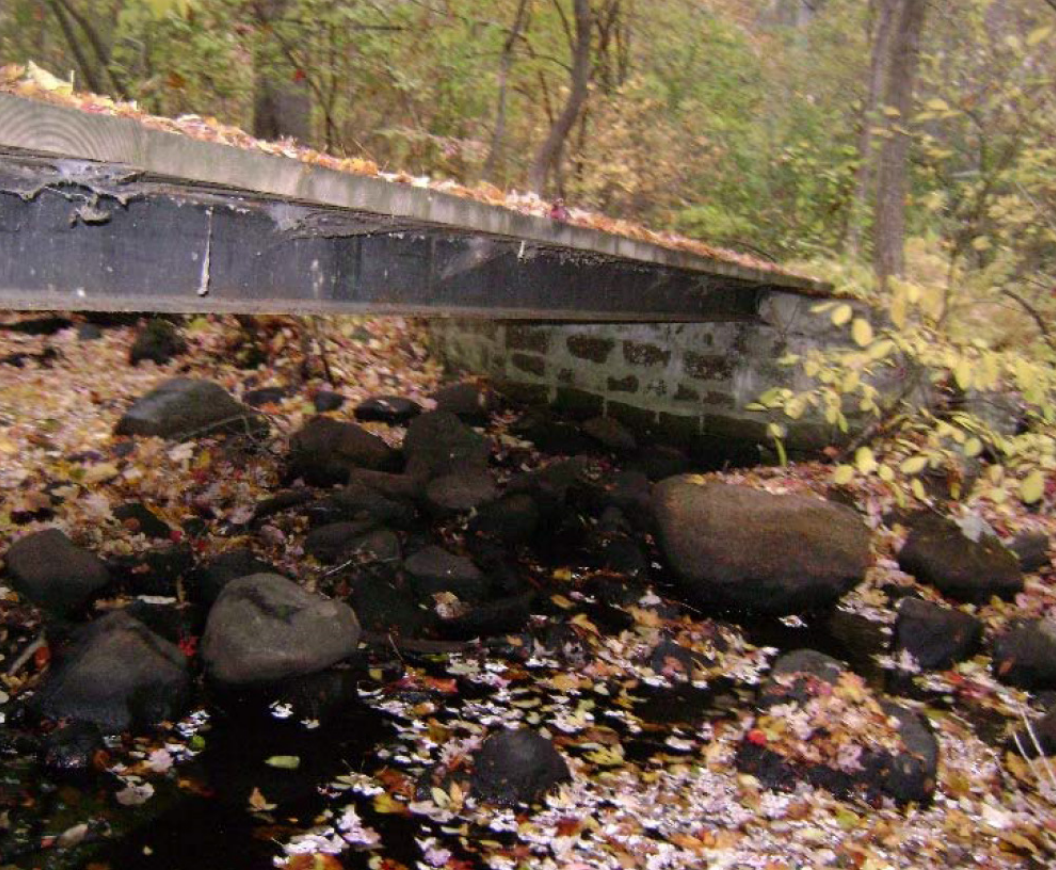
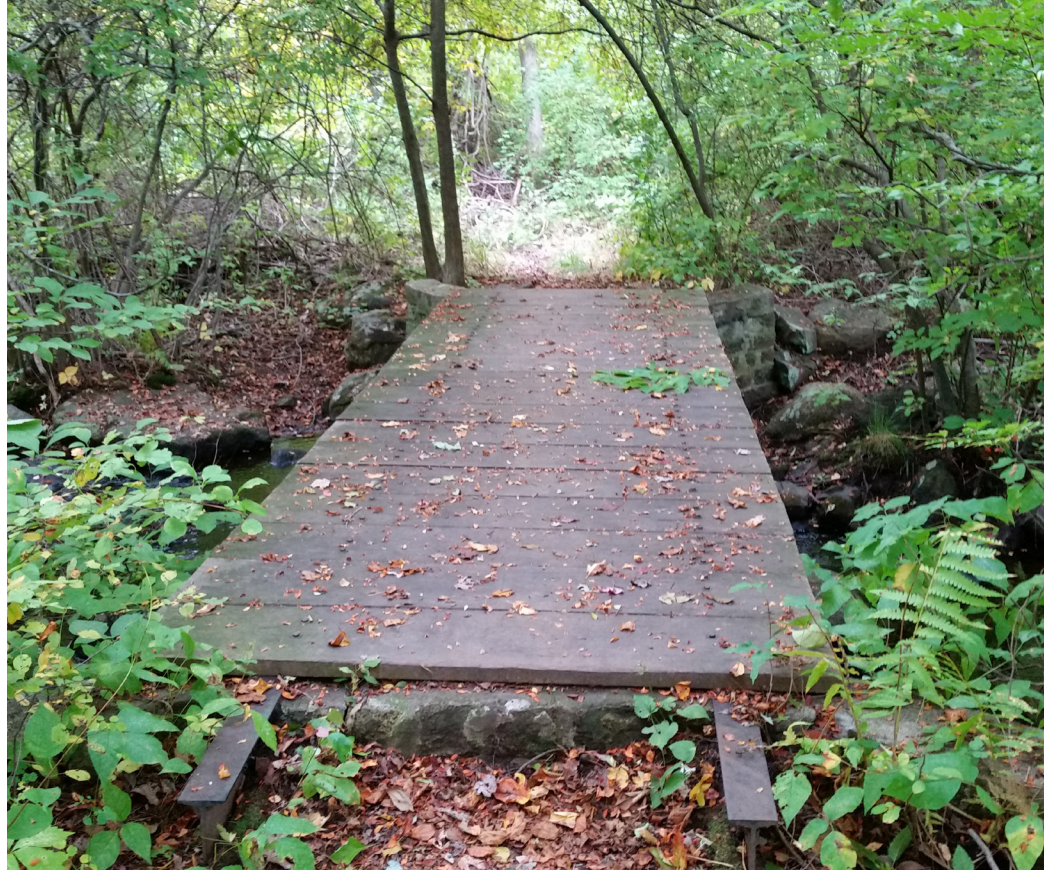
COLLEGE STUDENT BRIDGE

- 20' long x 5' wide
- railroad rails/wide flange beams span between stone and mortar abutments
- good condition overall
- no guard rails

DOES NOT MEET CODE
