Fort Lee and Fort Pickering Conditions Assessment, Cultural Resources Survey, and Maintenance and Restoration Plan

This study was prepared by Gray Architects Inc., Crane Morrison Archaeology, Leslie C. Shaw the Native American Specialist and Finch and Rose Architectural Preservationists. The statements and recommendations are those of these consultants and have been prepared to pro-

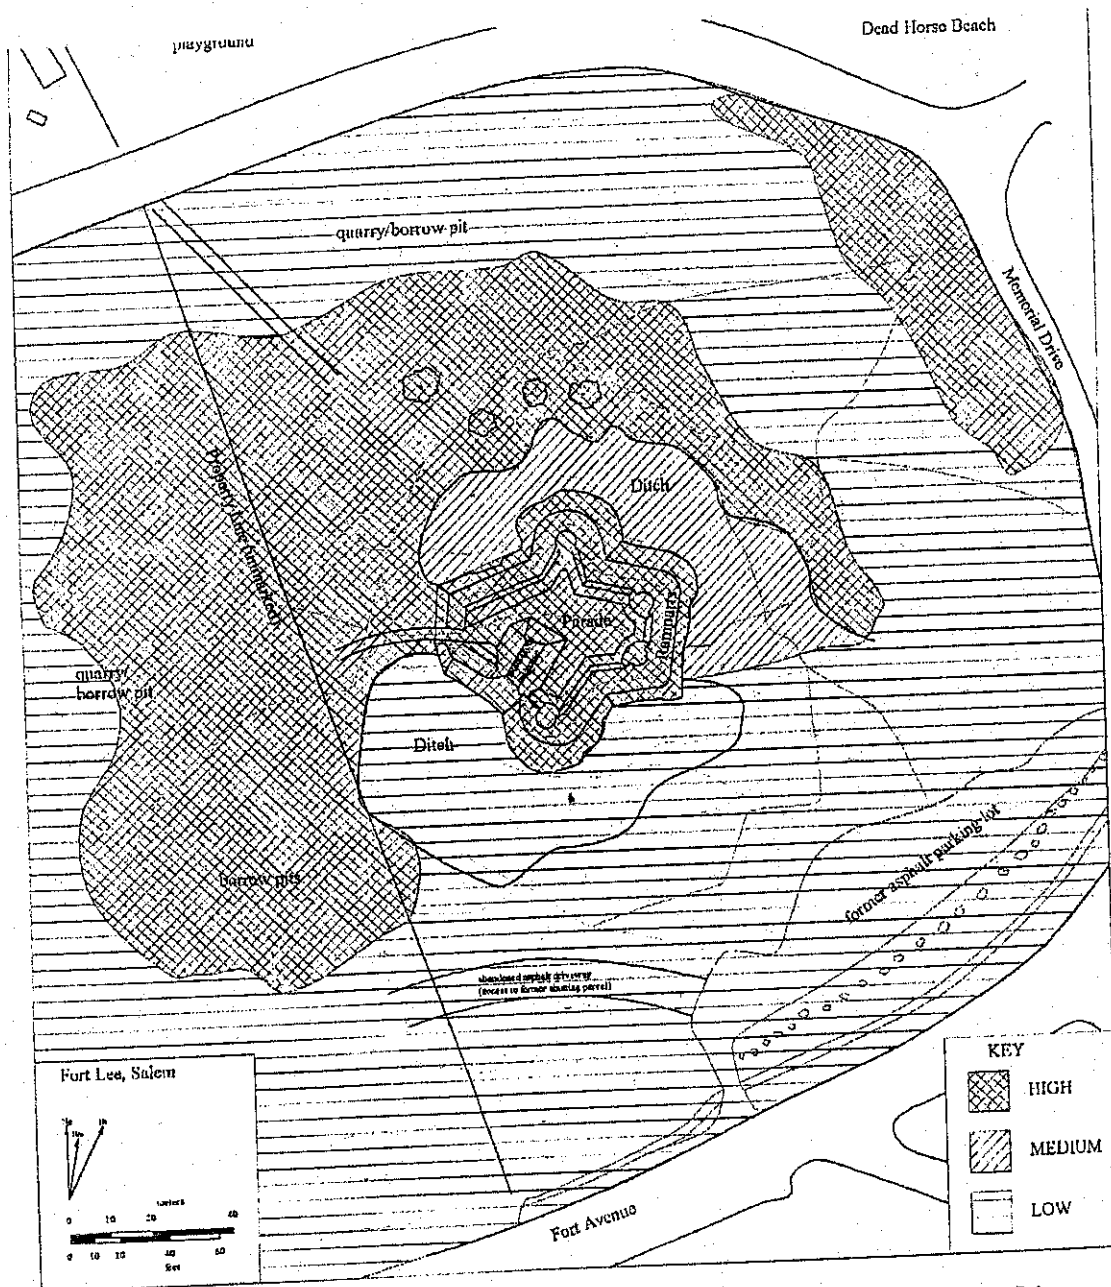
Sensitivity Map Archaeological Resources at Fort Lee

Figure 5.12. Sensitivity map ranking the potential for finding historical archaeological resources at Fort Lee, Salem, Massachusetts. Historical resources are believed on the relatively level areas at and near the hill's top and bottom. Sites are less likely on the relatively steep hill side. Absence of buried resources can also be anticipated in areas of severe documented disturbances, as in borrow pits and quarries, and in some areas of the ditch. Archaeological testing has partially borne out this model.

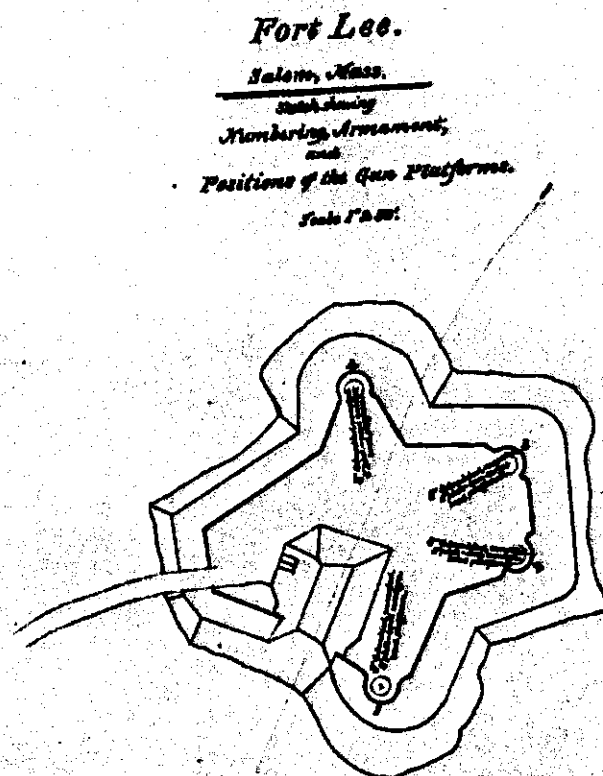
Fig. 120: Fort Lee showing numbering, armaments and positions of the gun platforms, 1869. RG 77 Dr 259 Sh 10. National Archives and Records Administration.

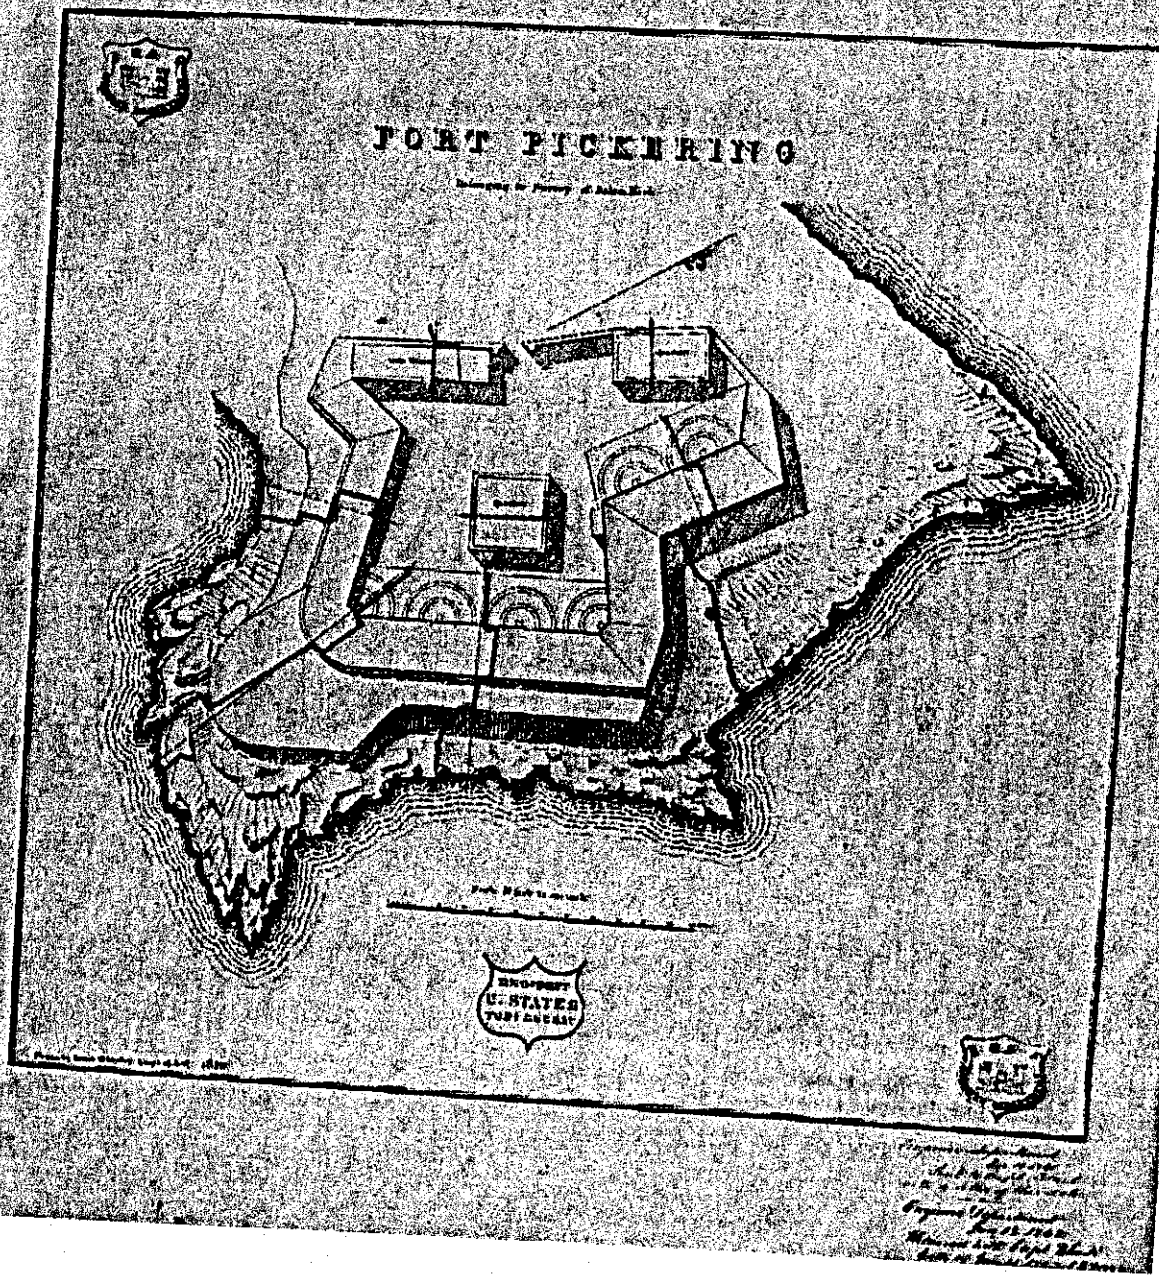
Fig.121: Plan of Fort Pickering recorded during the Engineering Department's survey of Salem Neck and Winter Island. The quarters at the upper right predates Rochefontain's work of 1794. RG 77 Dr 18 Sh 13. National Archives and Records Administration Fort Lee and Fort Pickering Conditions Assessment, Cultural Resources Survey, and Maintenance and Restoration Plan

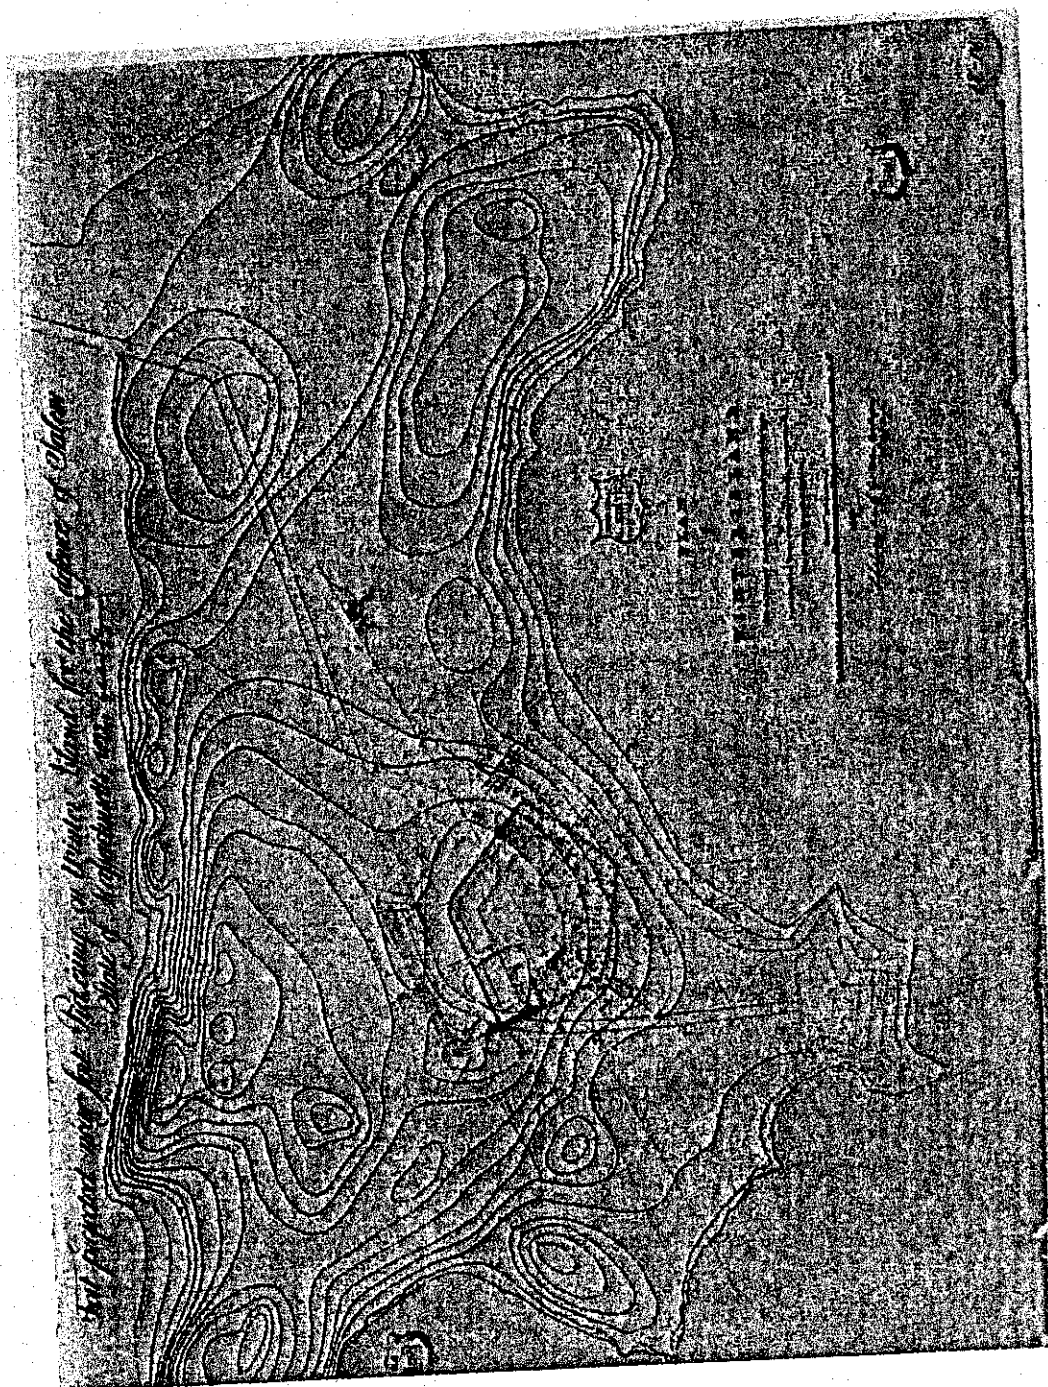
Fig.133:1822 plan for the construction of a casmated masonry fortification to replace the earthwork fort of 1794 and earlier. The new fort was never built. National Archives and Records Administration.

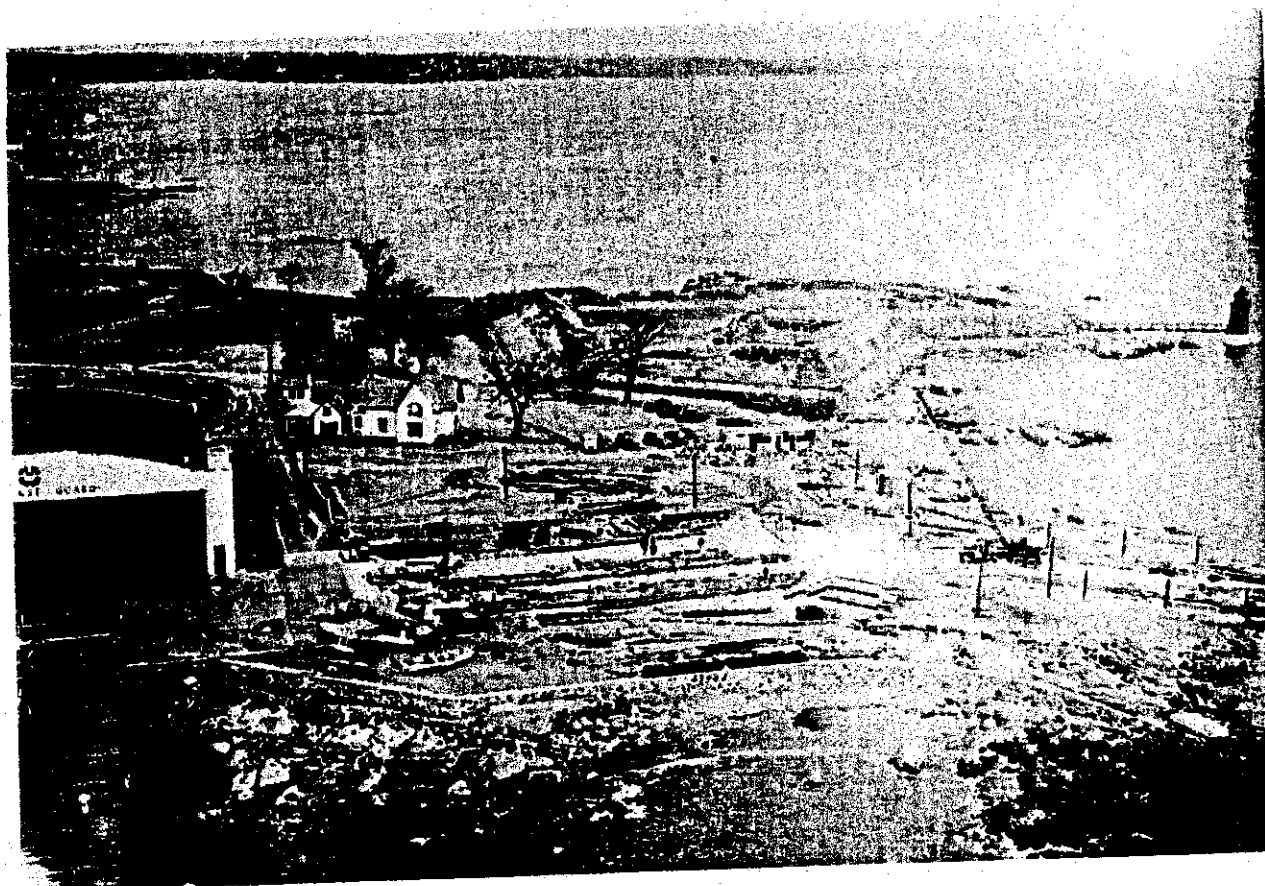
Figure 138 Portion of an aerial photograph of Fort Pickering

Fig. 138: Portion of an aerial photograph taken April 1, 1942. Richard C. Kelsey photograph on file Office of Planning and Community Development, City of Salem.

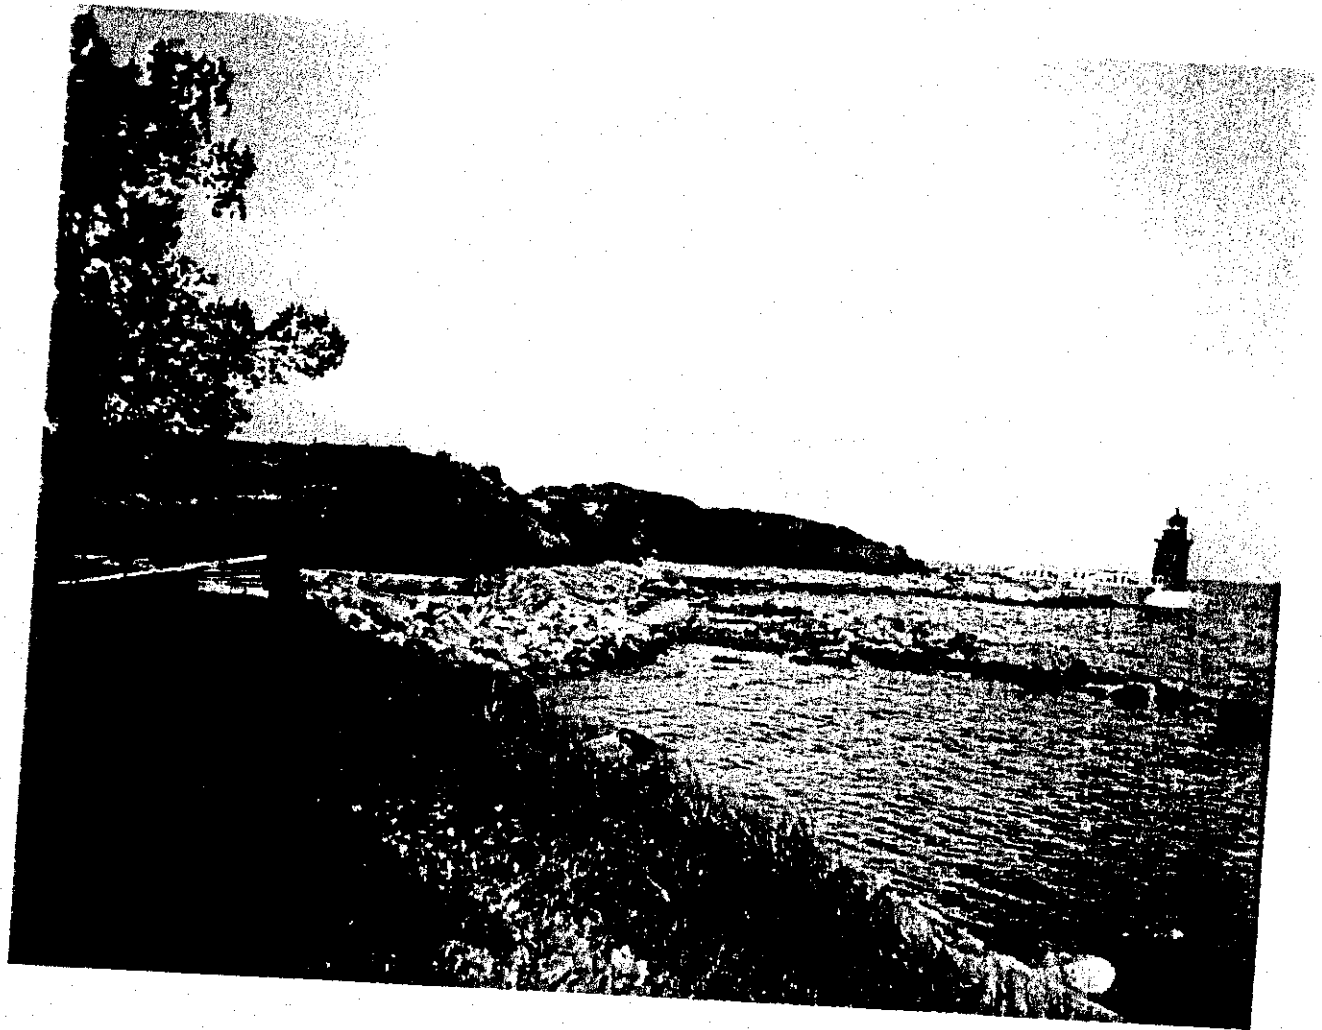
Figure 142 South side of Fort Pickering and the Lighthouse

Fig. 142: South side of Fort Pickering and the lighthouse, date unknown. Courtesy, Peabody Essex Museum, Salem, MA.
