City of Salem, Massachusetts

PART A – Executive Summary

Part A – Executive Summary

Introduction

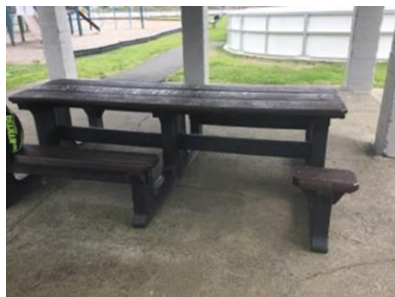
Picnic Table - Collins Cove Park

Salem has some excellent amenities such as accessible picnic tables with integrated seating spaces or accessible hockey rinks that IHCD recommends the City use in other locations to ensure that people with disabilities can participate in all the outdoor programs

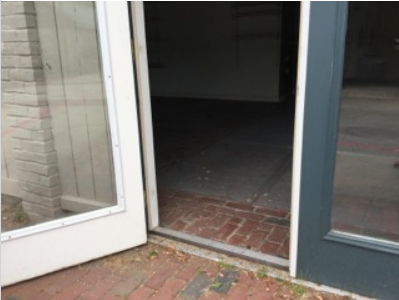
Clear width at door is < 32" Threshold not beveled	- -	Keep both doors open as needed to provide program access. Bevel threshold.	1	113	\$113
2	Artist's Row	1		Signage	Egress

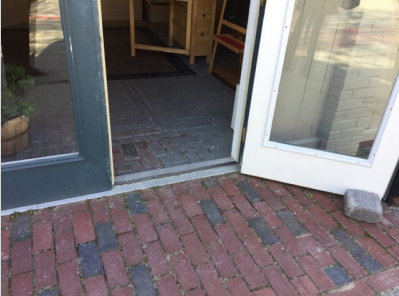
Threshold not beveled	-	Bevel threshold. See Catalog for Artist Row #5 for egress sign.	1	113	\$113
2	Building #2	1		Service Counter	N/A

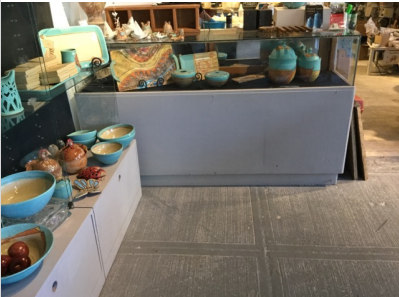
Counter > 36" high	40"	Provide a counter that is 36" max. above the ground or finished floor.	1	660	\$660
3	Route From Parking Lot	Ext.		Exterior Access Route	Walkway

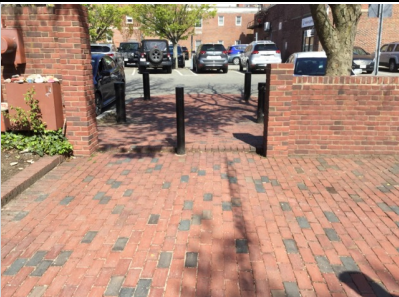
Level changes > 1/4"	2"	Alter change in level to be 1/4" high max.	1	-	\$0

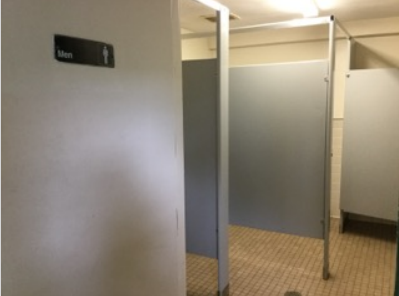
Raised characters not provided Braille not provided Sign not located on the latch side of the door	- - -	Provide text with raised characters duplicated in braille. Locate sign at permanent rooms alongside the door on the latch side.	1	174	\$174
2	Women's Toilet Room	1		Signage	Designation

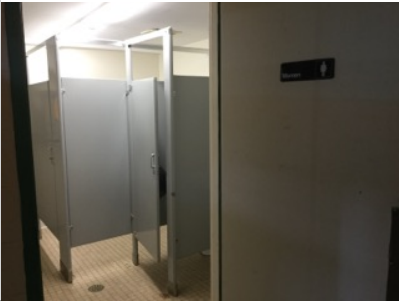
Raised characters not provided Braille not provided Sign not located on the latch side of the door	- - -	Provide text with raised characters duplicated in braille. Locate sign at permanent rooms alongside the door on the latch side.	1	174	\$174
Toilet & Bathing Rooms												
Lavatory												
3	Men's Toilet Room			Lavatory	N/A

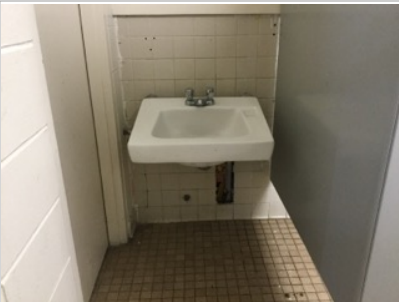
Route < 36" wide Toe or knee clearances not provided Plumbing underneath is exposed	31" 24" -	Remove partition to ensure that a clear width of 36" min. is maintained at the accessible route to the lavatory. Provide a lavatory with knee and toe clearance positioned for a forward approach. Insulate or otherwise configure pipes to prevent contact at lavatory.	1	1526	\$1526

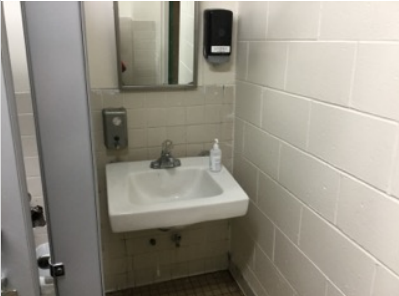
Route < 36" wide Toe or knee clearances not provided Plumbing underneath is exposed Mirror above lavatory w/reflective surface > 40"	- 24" 47.5"	Relocate partition to ensure that a clear width of 36" min. is maintained at the accessible route. Provide a lavatory with knee and toe clearance positioned for a forward approach. Insulate or otherwise configure pipes to prevent contact at lavatory. Lower mirror so that the bottom surface is at 40" max. above finished floor.	1	1718	\$1718

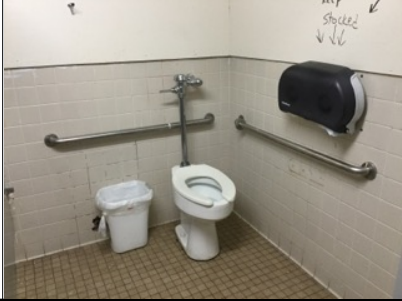
Door has malfunctioning self-closing hinge Side or rear grab bar < 33" or >36" high Non-compliant toilet paper dispenser Coat hook > 48"	- 30" - 60"	Repair hinge. Locate grab bars between 33"- 36" above the finished floor. Relocate toilet paper so that it is 15" min. high, located under the grab bar, and between 7" and 9" from the front of the toilet below the side grab bar. Lower coat hook so that it is no higher than 48".	1	1237	\$1237
6	Women's Toilet Room	1		Toilet Compartment	Accessible Compartment

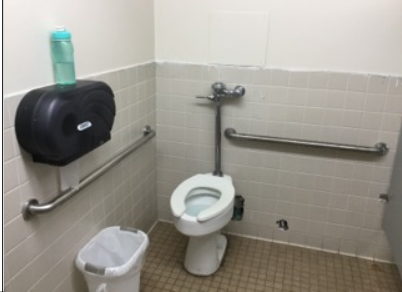
Side or rear grab bar < 33" or >36" high Flush control not on open side Non-compliant toilet paper dispenser Coat hook > 48"	30" - - 63"	Locate grab bars between 33"- 36" above the finished floor. Provide the flush control on the open side of the toilet (transfer side). Relocate toilet paper so that it is 15" min. high, located under the grab bar, and between 7" and 9" from the front of the toilet below the side grab bar. Lower coat hook so that it is no higher than 48".	1	1518	\$1518

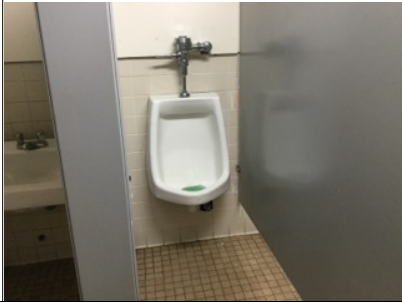
Rim > 17" high Flush control is > 44" high or not properly located Urinal recessed > 24" deep has < 36" clear width	20" 47" 25"	Provide an urinal with the rim no higher than 17" above the finished floor. Mount flush control at 44" max. above the finished floor. Remove partition to ensure there is a clear width of 36".	1	2628	\$2628
Dispensers												
8	Men's Toilet Room			Dispensers	Other

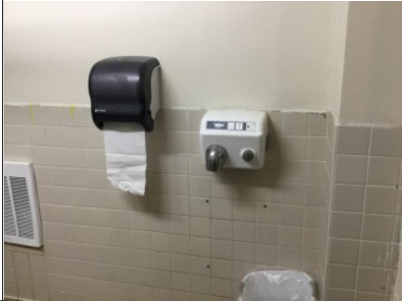
Controls > 42" high Dispenser acts as a protruding object	44" -	Relocate so the operable part is 42" max. above the finished floor. Ensure paper towel dispenser does not protrude into the circulation path.	1	530	\$530
9	Women's Toilet Room	1		Dispensers	Paper Towel Dispenser

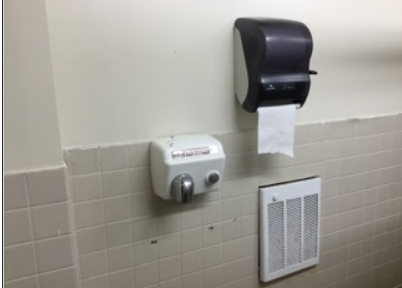
Controls > 42" high Dispenser acts as a protruding object	58" -	Relocate so the operable part is 42" max. above the finished floor. Ensure paper towel dispenser does not protrude into the circulation path.	1	530	\$530

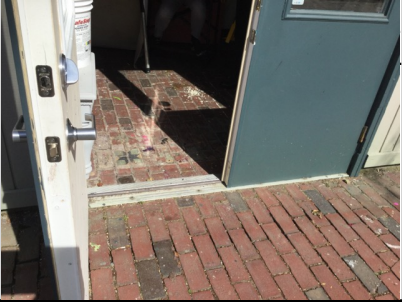
Clear width at door is < 32" Threshold not beveled	29"3/4 -	Keep both doors open as needed to provide program access. Bevel threshold. See Catalog for Artist's Row #5 for egress sign.	1	113	\$113

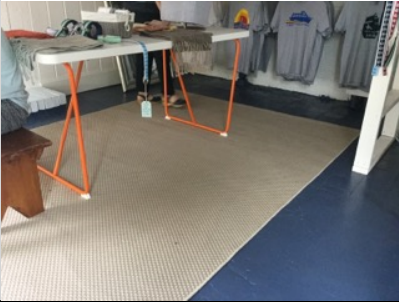
Mat not securely attached		Ensure mat is securely attached.	1	Labor	\$0
2	Entrance/Exit	1		Signage	Egress

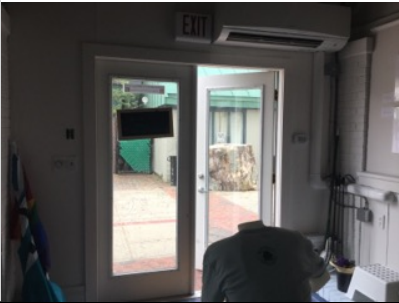
Raised characters not provided Braille not provided	- -	Provide a sign with raised characters duplicated in braille. Ensure sign is locate alongside the door on the latch side. (Applies to all buildings.)	4	174	\$696
3	Main Entrance	1		Entrance	Main Entrance

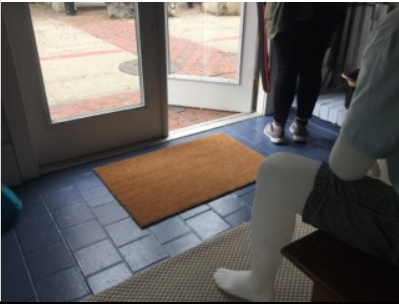
Mat not securely attached	-	Ensure mat is securely attached.	1	Labor	\$0

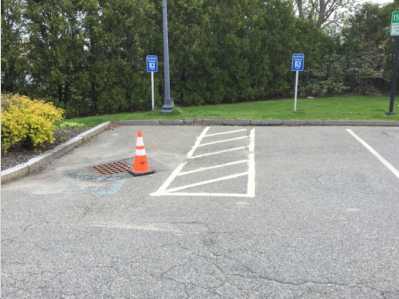
Vehicle space < 96" wide at car space Access aisle < 96" wide at van space Sign does not have the designation "Van Accessible" Sign bottom < 60" above finished grade Sign top > 96" above finished grade	80" 62" - 51"	Provide an accessible space that is at least 96" wide with a marked access aisle that is at least 96" wide. Add the designation "Van Accessible" to the sign located at the van accessible space. Locate sign with between 60" and 96" above the ground.	1	600	\$600
Entrance												
2	Main Entrance	Ext.		Entrance	Main Entrance

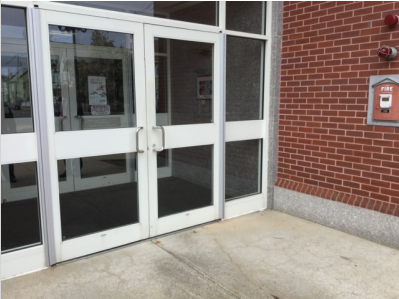
Door requires >15 lbs. of force to open	18 lbs	Adjust closers so doors do not require more than 15 pounds of force.	1	Labor	\$0

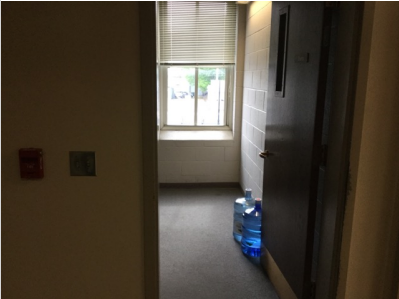
Tactile exit sign not provided	-	Ensure tactile exit signs with raised characters and braille are provided at exit doors. Mount signs between 48"- 60" above finish floor located on the latch side of the door.	1	174	\$174
4	Stairway	1		Means of Egress	N/A

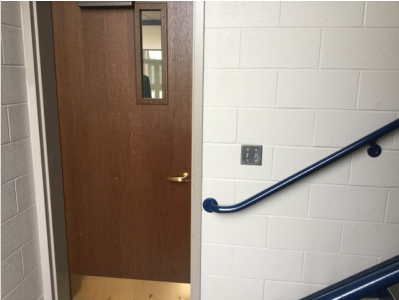
Tactile exit sign not provided	-	Ensure tactile exit signs with raised characters and braille are provided at exit doors. Mount signs between 48"- 60" above finish floor located on the latch side of the door.	1	174	\$174

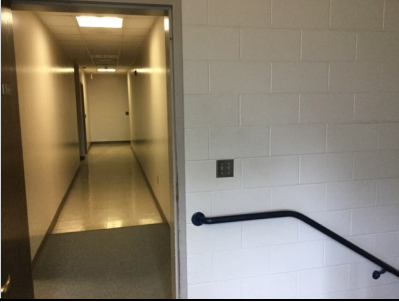
ID	Location	Floor	Room	Element	Type	Photo	Issues	Current Measure	Recommendations	Quantity	Price	Cost Estimation
5	Stairway	2		Means of Egress	N/A

Tactile exit sign not provided	-	Ensure tactile exit signs with raised characters and braille are provided at exit doors. Mount signs between 48"- 60" above finish floor located on the latch side of the door.	1	174	\$174
6	Stairway	2		Means of Egress	N/A

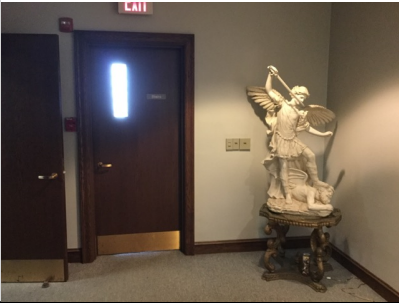
Tactile exit sign not provided	-	Ensure tactile exit signs with raised characters and braille are provided at exit doors. Mount signs between 48"- 60" above finish floor located on the latch side of the door.	1	174	\$174
7	Stairway	2		Means of Egress	N/A

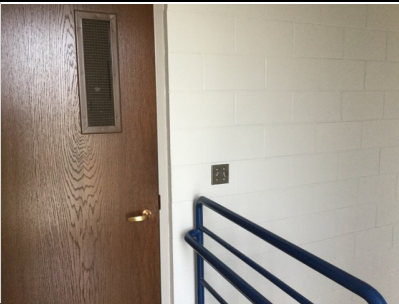
Tactile exit sign not provided	-	Ensure tactile exit signs with raised characters and braille are provided at exit doors. Mount signs between 48"- 60" above finish floor located on the latch side of the door.	1	174	\$174
Interior Access Route

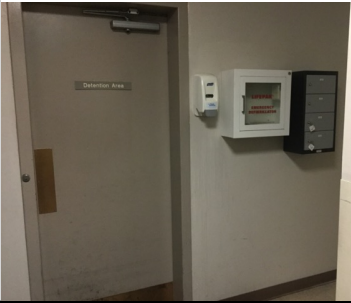
8	Detention Area	1		Interior Access Route	N/A

Obstructed by protruding objects	-	Relocate AED cabinet.	1	192	\$192
Doors, Doorways, & Gates												
9	Licensing Office	1		Doors, Doorways, & Gates	Office

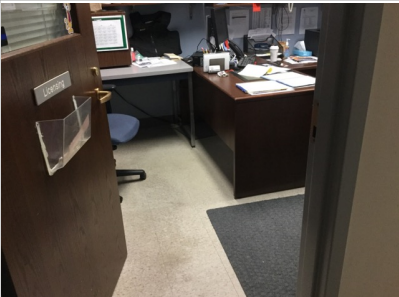
Clear width at door < 32"	-	Ensure door opens 90 degrees.	1	Labor	\$0

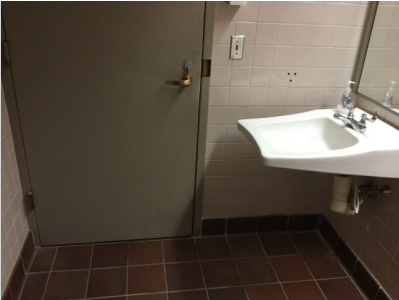
Maneuvering clearance(s) not provided	-	See ID #12	1	0	\$0
11	Women's Toilet Room	1		Doors, Doorways, & Gates	Toilet Room

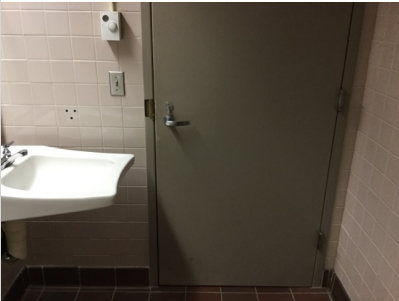
Maneuvering clearance(s) not provided	-	See ID #12	1	0	\$0
12	Women's Toilet Room	1		Doors, Doorways, & Gates	Toilet Room

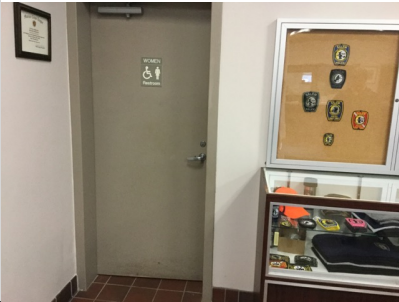
Maneuvering clearance not provided at recess > 6"	10"	Install an automatic door opener.	2	2295	\$4590
13	Main Entrance	1		Doors, Doorways, & Gates	Other

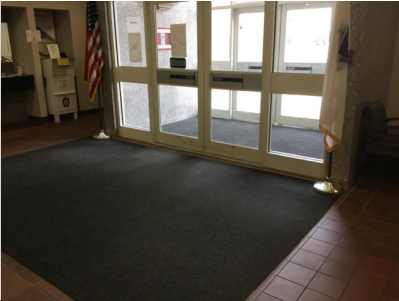
Mat not securely attached Door requires > 5 lbs. of force to open	- 17 lbs	Install an ADA-compliant walk-off mat. Adjust closers so doors do not require more than 5 pounds of force to open.	1	486	\$486
Elevator												
14	Lobby	1		Elevator	Interior

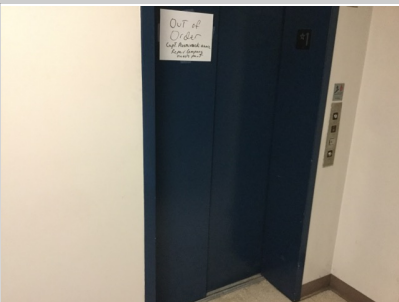
Elevator not maintained in operable working condition	-	Ensure elevator is maintained in operable working condition.	1	0	\$0

Note: IHCD team only surveyed the areas used by the public. The day of the survey, the elevator was not in operable working condition. IHCD team was told that it has been that way for quite some time.

- Cost to repair the elevator is not provided.
- Cost for providing accessible holding cells (male, female and juvenile) is not provided. (See attached document from the Department of Justice regarding requirements for accessible holding cells).

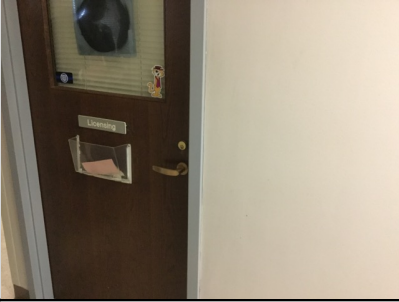
Raised characters not provided Braille misplaced Sign not located on the latch side of the door	- - -	Provide text with raised characters duplicated in braille. Position braille below the corresponding text. If text is multi-lined place braille below the entire text. Locate sign alongside the door on the latch side.	1	174	\$174
16	Interview Room	1		Signage	Designation

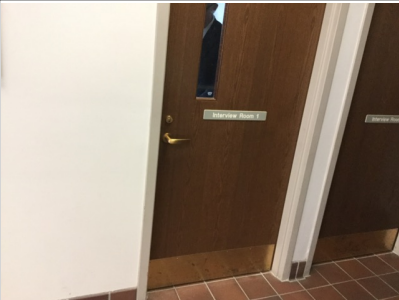
Braille not provided Sign not located on the latch side of the door	- -	Provide braille. Locate sign alongside the door on the latch side.	2	174	\$348
17	Men's Toilet Room & Women's Toilet Room	1		Signage	Designation

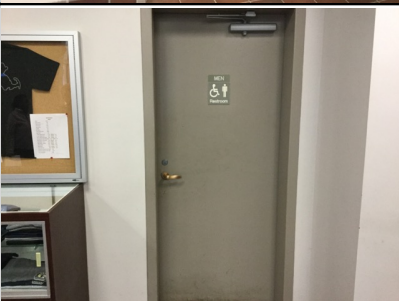
Braille not provided Sign not located on the latch side of the door	- -	Provide braille. Locate sign alongside the door on the latch side.	2	174	\$348

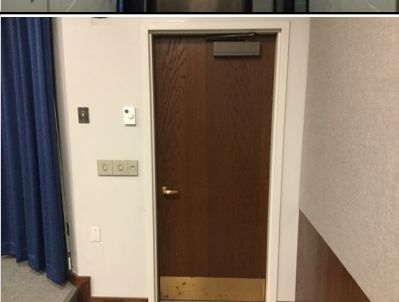
Not provided	-	Locate sign on the latch side.	1	174	\$174

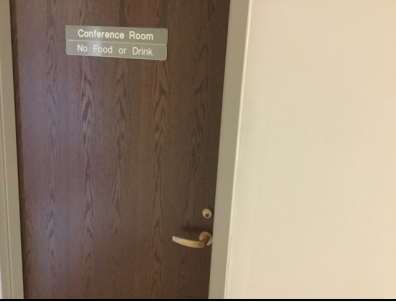
Raised characters not provided Braille not provided Sign not located on the latch side of the door	- - -	Provide text with raised characters duplicated in braille. Locate signs alongside the door on the latch side.	1	174	\$174
21	Chief Police	2		Signage	Designation

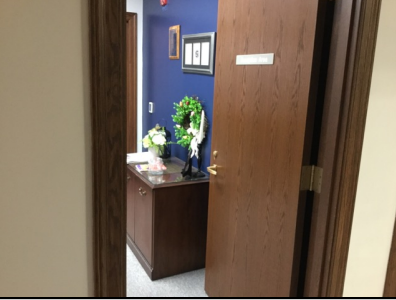
Raised characters not provided Braille not provided Sign not located on the latch side of the door	- - -	Provide text with raised characters duplicated in braille. Locate sign alongside the door on the latch side.	1	174	\$174
Assembly Area												
22	Auditorium	2		Assembly Area	N/A

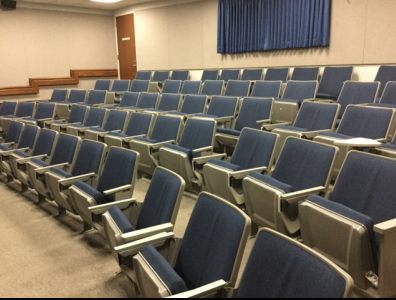
Number of seats Number of designated wheelchair spaces Minimum # wheelchair spaces not provided Assistive listening devices not provided	60 - - -	Provide four (4) wheelchair spaces; two (2) in the middle and one (1) at each end of the front row. If audible communication is integral to the use of the space, provide an assistive listening system.	1	10143	\$10143

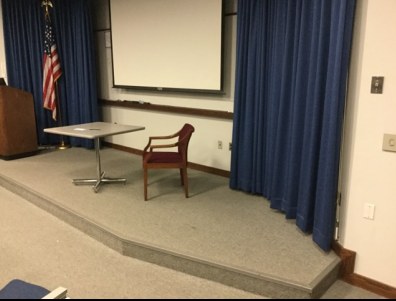
23	Auditorium	2		Assembly Area	N/A

Accessible route to stage not provided	-	Provide a portable ramp as needed.	1	450	\$450
Detention Facilities												
24	Holding Cell	1		Detention Facilities	Men's

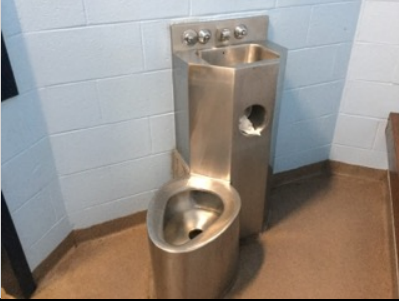
Mobility cell lacks access to accessible toilet/lavatory	-	Ensure an accessible toilet room is provided.	1	0	\$0
Toilet & Bathing Rooms												
Overall Access												
26	Women's Toilet Room and Men's Toilet Room	1		Overall Access	Toilet Room

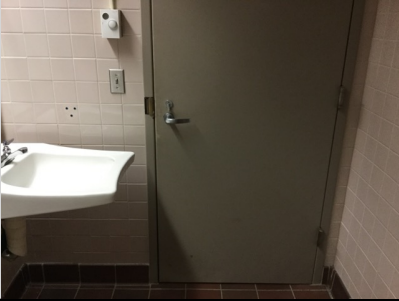
Audible and visible alarms not provided	-	When fire system is updated, ensure that a visible and audible fire alarm is installed.	2	519	\$1038
Single-User Toilet												
27	Women's Toilet Room	1		Single-User Toilet	N/A

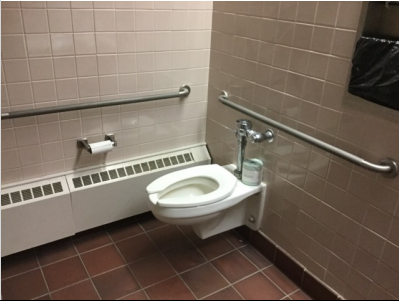
Flush control not on open side	-	Relocate the flush control to the open side.	1	281	\$281
28	Men's Toilet Room	1		Single-User Toilet	N/A

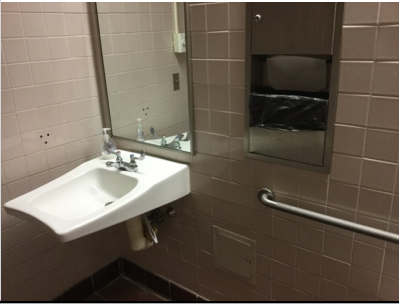
Controls > 42" high	56"	Relocate paper towel dispenser so the operable part is 42" max. above the finish floor.	2	530	\$1060

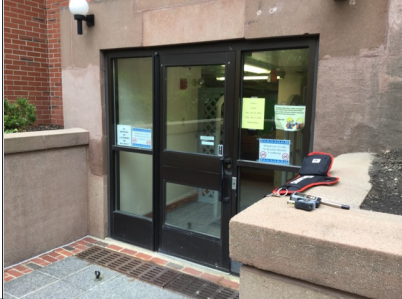
International Symbol of Accessibility not provided	-	Provide the International Symbol of Accessibility.	1	260	\$260
Emergency Exit												
2	Emergency Exit	G		Emergency Exit	N/A

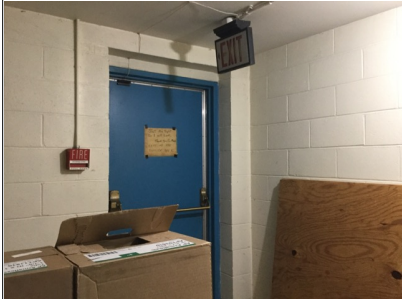
Directional sign to accessible emergency exit not provided	-	Provide a directional sign indicating the location of the nearest accessible emergency exit.	1	174	\$174
Access to Goods and Services												
Means of Egress												
3	Emergency Exit to Children's Area	G		Means of Egress	N/A

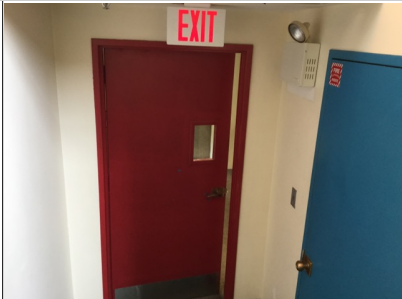
Tactile exit sign not provided	-	Ensure tactile exit signs with raised characters and braille are provided at exit doors. Mount signs between 48"- 60" above finish floor located on the latch side of the door.	1	174	\$174

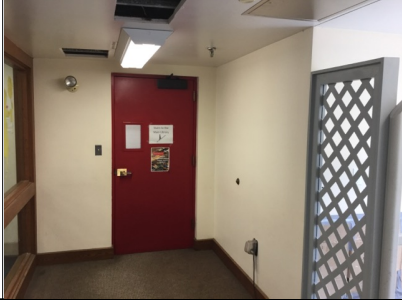
4	Emergency Exit	G		Means of Egress	N/A

Tactile exit sign not provided	-	Ensure tactile exit signs with raised characters and braille are provided at exit doors. Mount signs between 48"- 60" above finish floor located on the latch side of the door.	1	174	\$174

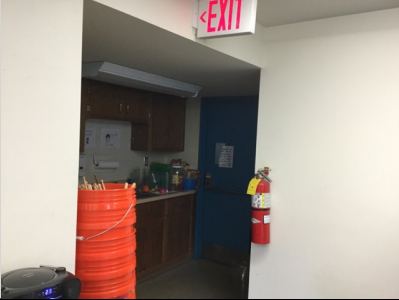
Tactile exit sign not provided	-	Ensure tactile exit signs with raised characters and braille are provided at exit doors. Mount signs between 48"- 60" above finish floor located on the latch side of the door.	1	174	\$174
6	Children Emergency Exit	G		Means of Egress	N/A

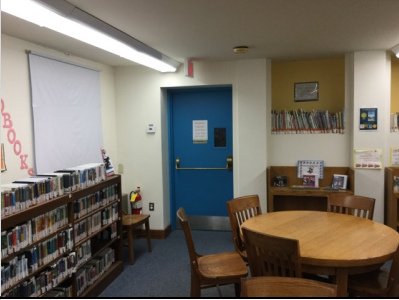
Tactile exit sign not provided	-	Ensure tactile exit signs with raised characters and braille are provided at exit doors. Mount signs between 48"- 60" above finish floor located on the latch side of the door.	1	174	\$174
7	First Floor Stacks Exit to Stairs	1		Means of Egress	N/A

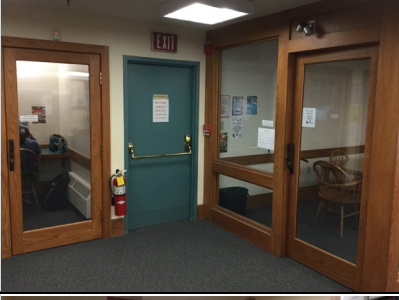
8	Exit Near Study Room	2		Means of Egress	N/A

Tactile exit sign not provided	-	Ensure tactile exit signs with raised characters and braille are provided at exit doors. Mount signs between 48"- 60" above finish floor located on the latch side of the door.	1	116	\$116
9	Exit Behind Reference	2		Means of Egress	N/A

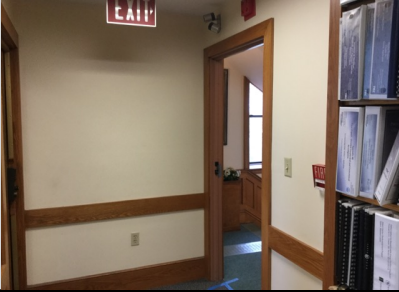
Tactile exit sign not provided	-	Ensure tactile exit signs with raised characters and braille are provided at exit doors. Mount signs between 48"- 60" above finish floor located on the latch side of the door.	1	174	\$174

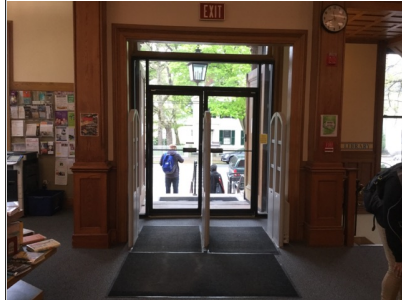
Tactile exit sign not provided	-	Ensure tactile exit signs with raised characters and braille are provided at exit doors. Mount signs between 48"- 60" above finish floor located on the latch side of the door.	1	174	\$174
Interior Access Route												
11	Children	G		Interior Access Route	N/A

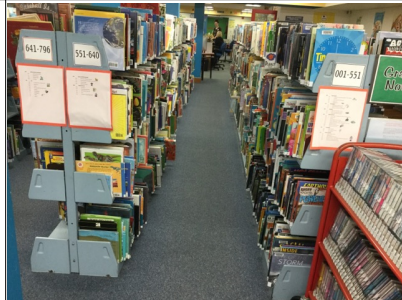
Route < 36" wide	33"	Ensure that a clear width of 36" min. is maintained at the accessible route.	1	Labor	\$0
12	Children Near Sink	G		Interior Access Route	N/A

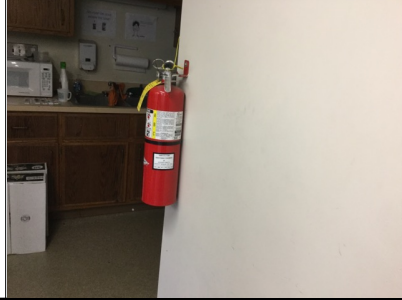
Obstructed by protruding objects	33.5"	Relocate fire extinguisher out of circulation path, lower extinguisher to 27" max. above the finished floor or provide a cane detectable barrier.	1	230	\$230
13	Emergency Exit	G		Interior Access Route	N/A

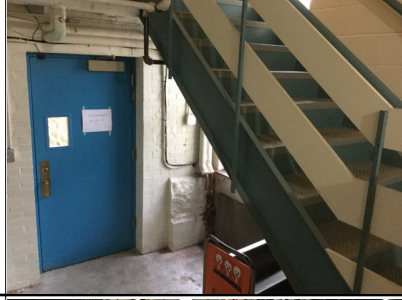
Obstructed by protruding objects	-	Provide a cane detectable barrier under stairs. (Cost for a 6'x4' pipe rail under stairs.)	1	720	\$720

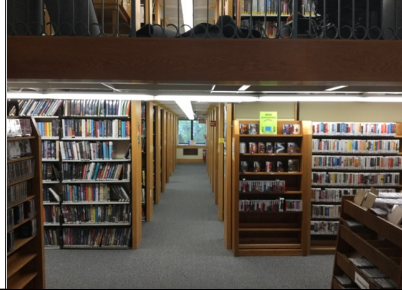
14	Floor 1	1		Interior Access Route	N/A

Obstructed by protruding objects	77"	Provide color contrast and / or padding.	1	Labor	\$0

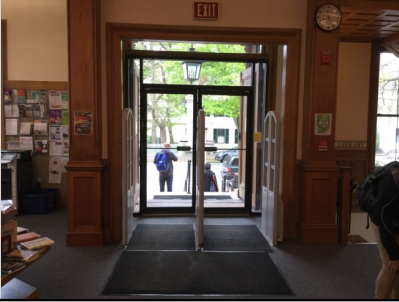
Mat not securely attached	-	Securely attach walk-off mat.	1	Labor	\$0
16	Ground Floor Exit to Ramp	G		Doors, Doorways, & Gates	Emergency Egress

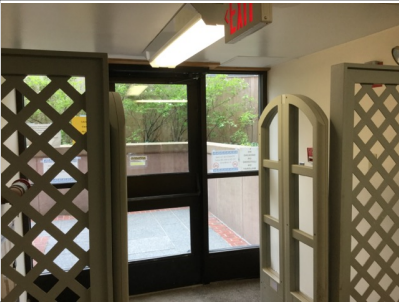
Mat not securely attached Illuminated International Symbol of Accessibility (ISA) not provided	-	Securely attach walk-off mat. Provide an illuminated International Symbol of Accessibility (ISA) sign.	1	150	\$150
17	Exit Towards Ramp	G		Doors, Doorways, & Gates	Emergency Egress

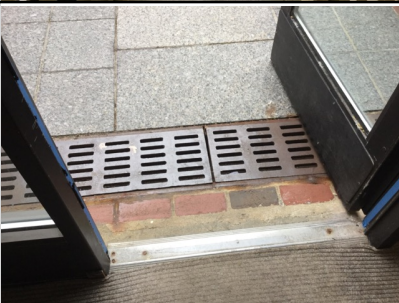
Threshold > 1/2" high	1"	Alter threshold to be 1/2" high max.	1	113	\$113
18	Single-User Toilet Room	1	E	Doors, Doorways, & Gates	Toilet Room

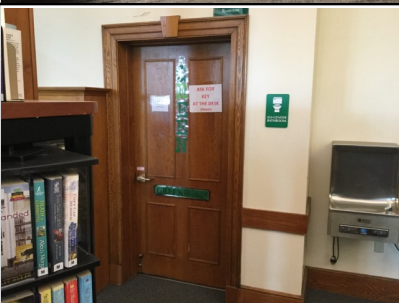
Door requires > 5 lbs. of force to open	18 lbs.	Adjust closers so doors do not require more than 5 pounds of force to open.	1	Labor	\$0

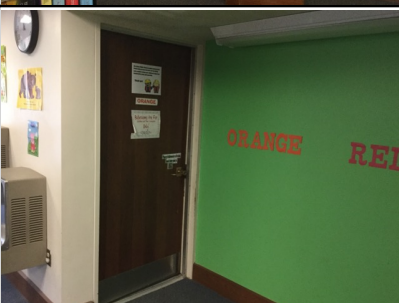
19	Orange Single-User Toilet Room	G		Doors, Doorways, & Gates	Toilet Room

Door requires > 5 lbs. of force to open	20 lbs.	Adjust closers so doors do not require more than 5 pounds of force to open.	1	Labor	\$0

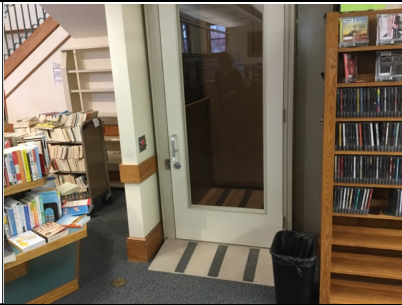
Door requires > 5 lbs. of force to open	17 lbs.	Adjust closers so doors do not require more than 5 pounds of force to open.	1	Labor	\$0
21	Single-User Toilet Room by Elevator	1		Doors, Doorways, & Gates	Toilet Room

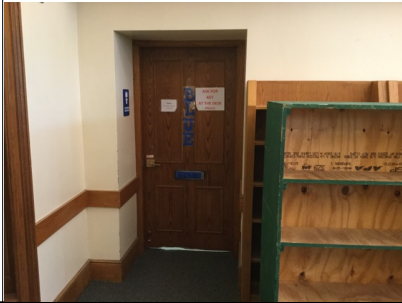
Door requires > 5 lbs. of force to open	15 lbs.	Adjust closers so doors do not require more than 5 pounds of force to open.	1	Labor	\$0
Ramps												
22	Ramp	2		Ramps	Interior

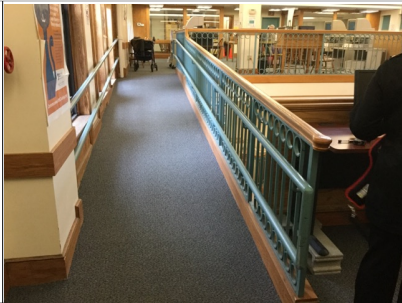
No lower handrail 18"-20" high provided Handrails not continuous where required	-	Provide continuous handrails for the length of ramp runs. (Provide continuous lower and upper handrails on one side. (Cost based on two 5' sections of metal handrail at \$56 a foot.)	1	560	\$560
23	Exterior Ramp	G		Ramps	Exterior

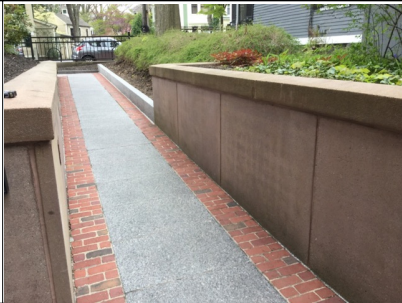
Handrails not provided	-	Provide upper handrails between 34"- 38" high above the ground and lower handrails between 18" to 20" above the ground on both sides of ramp, all with 1 1/4"- 2" circular cross sections or a 4"- 6 1/4" non-circular cross sections. (Cost based and 4 30' sections of metal railing.)	1	6660	\$6660

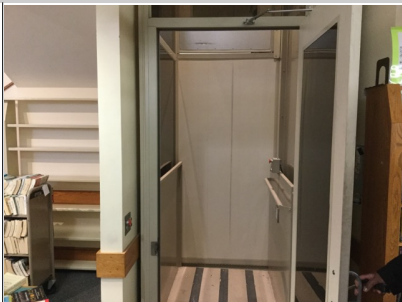
Platform Lift or LULA Elevator												
24	Lift to Mezzanine	G		Platform Lift or LULA Elevator	Interior

36" x 48" clear floor space not provided (if end door)	34"	Providing a 36" by 48" clear floor space might be technically infeasible. (34"x46" provided). Not compliant, but usable.	1	-	\$0
Toilet & Bathing Rooms

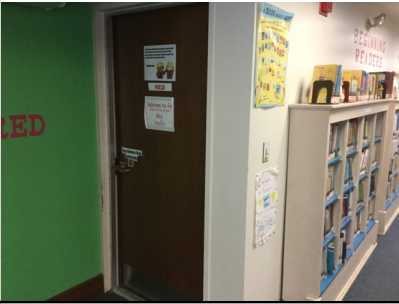
International Symbol of Acc. not provided	-	Provide a sign with raised characters and braille and the International Symbol of Accessibility mounted on the latch side of the door.	1	174	\$174
26	Orange Single-User Toilet Room	G		Overall Access	Toilet Room

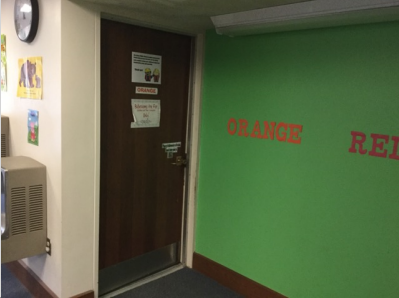
International Symbol of Acc. not provided	-	Provide a sign with raised characters and braille and the International Symbol of Accessibility mounted on the latch side of the door.	1	174	\$174
Lavatory												
27	Orange Single-User Toilet Room	G		Lavatory	N/A

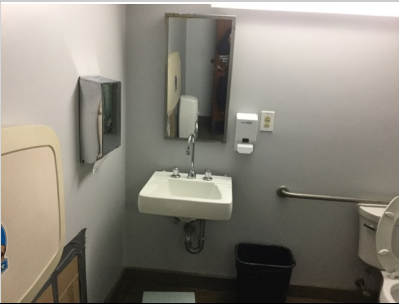
Plumbing underneath is exposed	-	Insulate or otherwise configure pipes to prevent contact, for at least one lavatory.	1	69	\$69
28	Red Single-User Toilet Room	G		Lavatory	N/A

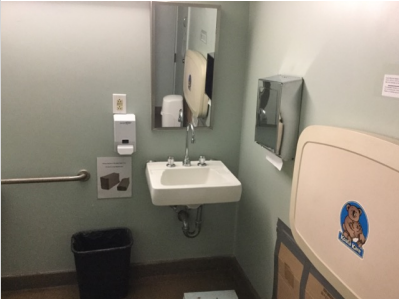
Plumbing underneath is exposed	-	Insulate or otherwise configure pipes to prevent contact, for at least one lavatory.	1	69	\$69

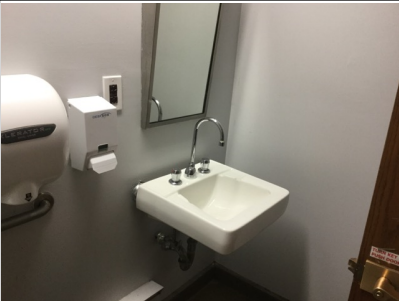
29	Single-User Toilet Room by Elevator	1		Lavatory	N/A

Plumbing underneath is exposed	-	Insulate or otherwise configure pipes to prevent contact, for at least one lavatory.	1	69	\$69

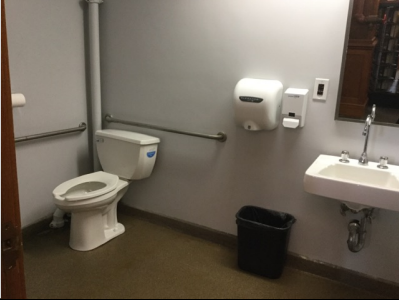
ID	Location	Floor	Room	Element	Type	Photo	Issues	Current Measure	Recommendations	Quantity	Price	Cost Estimation
30	Single-User Toilet Room	1	E	Lavatory	N/A

Plumbing underneath is exposed Mirror above lavatory w/reflective surface > 40"	- 42"	Insulate or otherwise configure pipes to prevent contact, for at least one lavatory. Lower mirror so that the bottom surface is at 40" max. above finish floor.	1	261	\$261
Single-User Toilet												
31	Single-User Toilet Room	1	E	Single-User Toilet	N/A

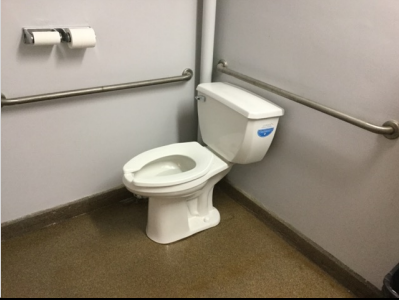
Flush control not on open side Side or rear grab bar < 33" or > 36" high Toilet paper dispenser is not compliant	- 30.5" -	Relocate the flush control to the open side. Mount grab bars 33"- 36" above the floor. Relocate toilet paper so that it is 15" min high, located under the grab bar, and between 7" and 9" from the front of the toilet. Replace dispenser if it does not allow continuous paper flow.	1	1003	\$1003

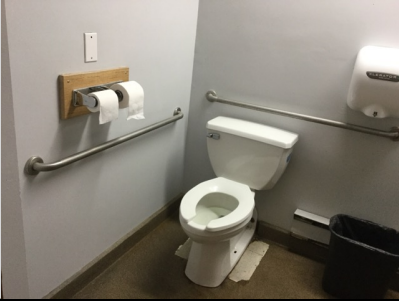
32	Single-User Toilet Room by Elevator	1		Single-User Toilet	N/A

Flush control not on open side Clearance at toilet < 60" clear width Toilet paper dispenser is not compliant	- - -	Relocate the flush control to the open side. Provide a clear floor space that is 60" wide min. (Relocate trash can and hand dryer.) Relocate toilet paper dispenser so that it is 15" min high, located under the grab bar, and between 7" and 9" from the front of the toilet.	1	1341	\$1341
33	Red Single-User Toilet Room	G		Single-User Toilet	N/A

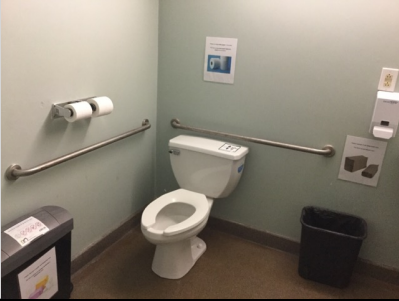
Flush control not on open side Toilet paper dispenser is not compliant	- -	Relocate the flush control to the open side. Relocate toilet paper so that it is 15" min high, located under the grab bar, and between 7" and 9" from the front of the toilet. Replace dispenser if it does not allow continuous paper flow.	1	811	\$811
34	Orange Single-User Toilet Room	G		Single-User Toilet	N/A

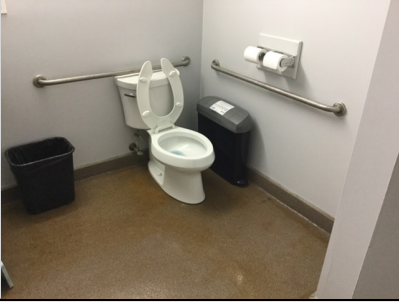
Toilet paper dispenser is not compliant	-	Relocate toilet paper so that it is 15" min high, located under the grab bar, and between 7" and 9" from the front of the toilet. Replace dispenser if it does not allow continuous paper flow.	1	530	\$530

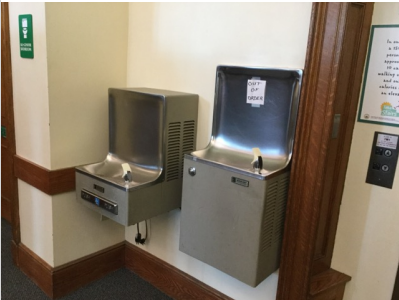
ID	Location	Floor	Room	Element	Type	Photo	Issues	Current Measure	Recommendations	Quantity	Price	Cost Estimation
Drinking Fountains												
35	Water Fountains Near Toilet Room	1		Drinking Fountains	N/A

Knee or toe clearance not provided	20"	Provide knee and toe clearance, 27" min. high at both drinking fountains. (Cost based on a new Hi-Lo fountain.)	1	3162	\$3162
36	Near Orange Toilet Room	G		Drinking Fountains	N/A

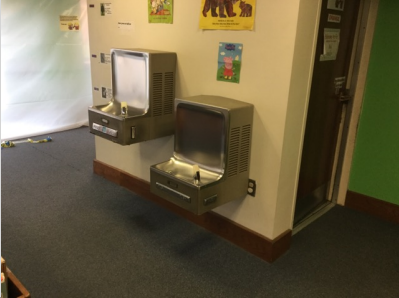
Knee or toe clearance not provided	16"	Provide knee and toe clearance, 27" min. high at both drinking fountains. (Cost based on a new Hi-Lo fountain.)	1	3162	\$3162
37	By Second Floor Interior Ramp	2		Drinking Fountains	N/A

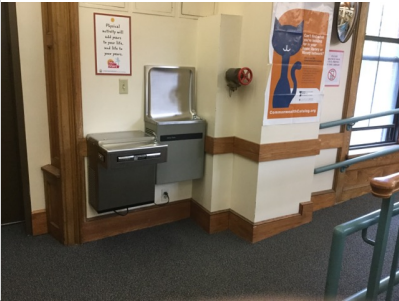
Knee or toe clearance not provided	9"	Provide knee and toe clearance, 27" min. high at both drinking fountains. (Cost based on a new Hi-Lo fountain.)	1	3162	\$3162

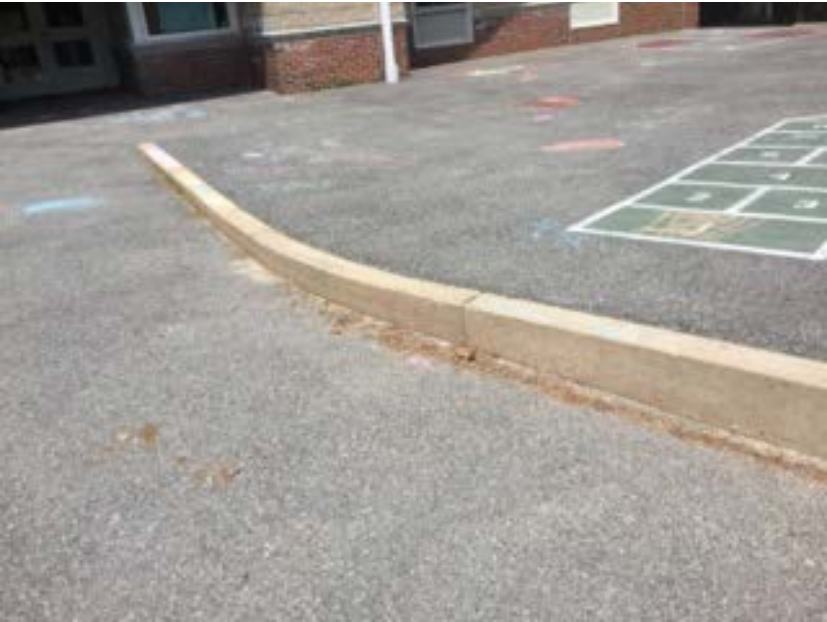
The north playground, near the basketball courts, lacks a route around the playground as well as an impact resistant route to each of the play components. This playground also lacks a compliant transfer station. The south playground is technically compliant, but an issue was brought to the IHCD survey team’s attention by a concerned parent. It seems as though the curbs that cut through the middle of the playground act as a serious tripping and safety hazard (see Fig. 1). As it is in the middle of the playground, children might be running from one side to the other and could fall if they

are not fully aware of the curbs. IHCD strongly recommends looking into a possible solution to this issue, such as redesigning the area or using more poured in place rubber.

Fig. 1 Tripping Hazard on South Playground

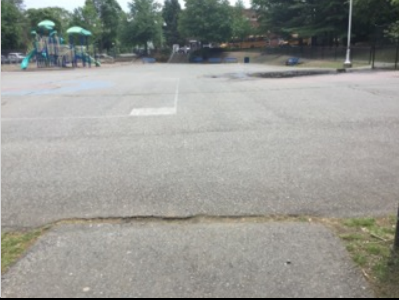
ID	Location	Floor	Room	Element	Type	Photo	Issues	Current Measure	Recommendations	Quantity	Price	Cost Estimation
Approach and Entrance												
Exterior Access Route												
1	Route to Basketball Court 2	Ext.		Exterior Access Route	Exterior

Surface openings > 1/2"	3"	Repair surface.	1	27	\$27
2	Bike Rack Near Basketball Court 1	Ext.		Exterior Access Route	Exterior

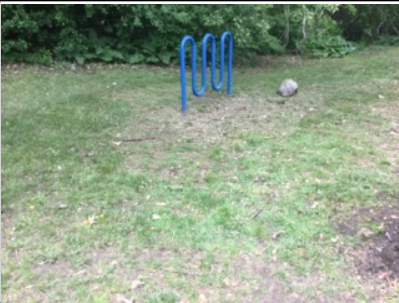
Accessible route not provided	-	Ensure an accessible route is provided. (Cost based on 15' by 4' wide asphalt route to bike rack.)	1	383	\$383
Curb Ramp												
3	Southeast Corner of School	Ext.		Curb Ramp	N/A

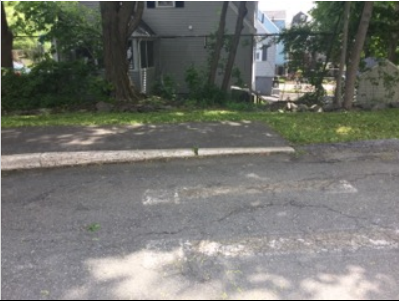
Curb ramp not provided	-	Provide a curb ramp at intersection.	1	2800	\$2800
Off-Street Parking Lot or Garage												
4	Parking Lot on West Side of School	Ext.		Off-Street Parking Lot or Garage	N/A

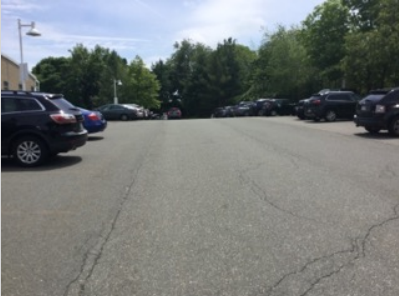
Total # of parking Total # of designated accessible parking spaces Access aisle not provided Sign not provided Sign does not have the designation "Van Accessible"	58 0 - - -	Provide two (2) car accessible spaces and one (1) van accessible space. Provide a marked access aisle that is at least 60" wide. for the car spaces to share and one that is 96" wide for the van space. Provide a sign with the bottom of the sign 60" min. above the ground and the top 96" max. above the ground. Add the designation "Van Accessible" at the van accessible space.	3	1388	\$4164

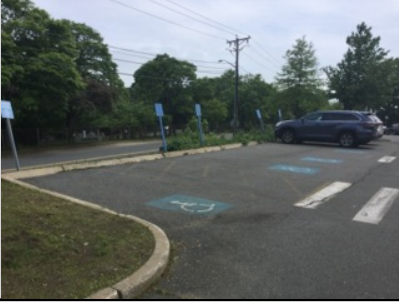
ID	Location	Floor	Room	Element	Type	Photo	Issues	Current Measure	Recommendations	Quantity	Price	Cost Estimation
5	Accessible Parking Spaces Near Main Entrance	Ext.		Off-Street Parking Lot or Garage	N/A

Access aisle < 96" wide at van space Sign does not have the designation "Van Accessible"	93" -	Provide a marked access aisle that is at least 96" wide. Add the designation "Van Accessible" to the sign located at the van accessible space.	1	600	\$600
Entrance												
6	Stairs to Basketball Courts and Playground on North Side of School	Ext.		Entrance	N/A

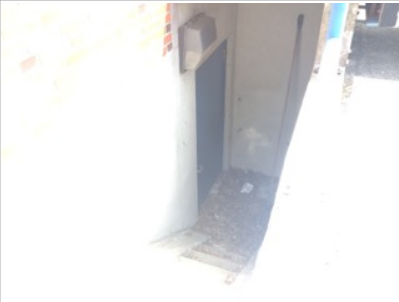
Tactile exit sign not provided Directional sign to accessible emergency exit not provided	- -	Ensure tactile exit signs on the interior of the door have raised characters and braille are provided at exit doors. Mount signs between 48"- 60" above finished floor located on the latch side of the door. Provide a directional sign on the inside indicating the location of the nearest accessible emergency exit.	1	348	\$348

- At Emergency Exit #10, consider providing an informational sign on the inside of the door indicating the conditions of the exit on the exterior (stairs leading away from building).

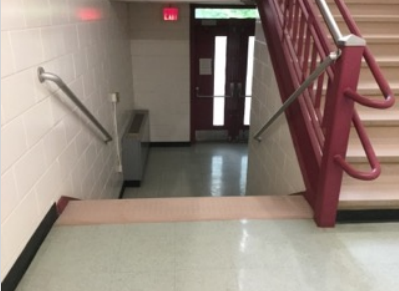
Tactile exit sign not provided Directional sign to accessible emergency exit not provided	- -	Ensure tactile exit signs with raised characters and braille are provided at exit doors. Mount signs between 48"- 60" above finished floor located on the latch side of the door. Provide a directional sign indicating the location of the nearest accessible emergency exit.	1	348	\$348

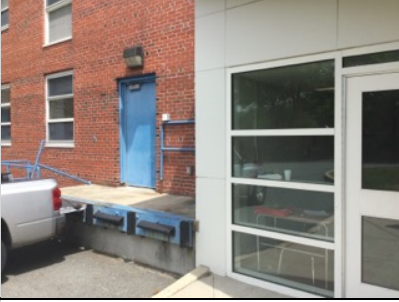
ID	Location	Floor	Room	Element	Type	Photo	Issues	Current Measure	Recommendations	Quantity	Price	Cost Estimation
10	Emergency Exit 8	Ext.		Means of Egress	N/A

Tactile exit sign not provided Illuminated exit sign lacks International Symbol of Accessibility.	- -	Ensure tactile exit signs on the interior of the door have raised characters and braille are provided at exit doors. Mount signs between 48"- 60" above finished floor located on the latch side of the door. Ensure illuminated exit sign inside contains the International Symbol of Accessibility (ISA).	1	274	\$274
11	Emergency Exit 15	Ext.		Means of Egress	N/A

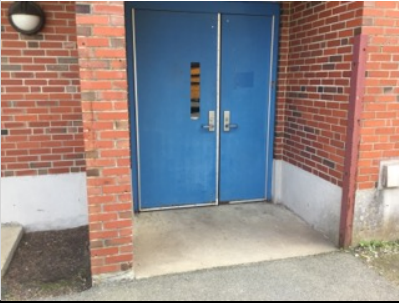
Tactile exit sign not provided Illuminated exit sign lacks International Symbol of Accessibility.	- -	Ensure tactile exit signs on the interior of the door have raised characters and braille are provided at exit doors. Mount signs between 48"- 60" above finished floor located on the latch side of the door. Ensure illuminated exit sign inside contains the International Symbol of Accessibility (ISA).	1	274	\$274

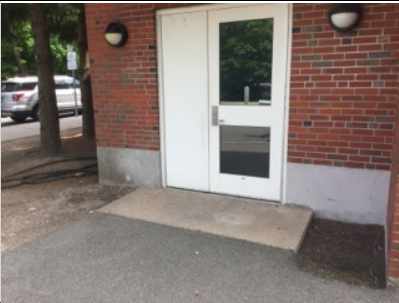
12	Emergency Exit 16	Ext.		Means of Egress	N/A

Tactile exit sign not provided Illuminated exit sign lacks International Symbol of Accessibility.	- -	Ensure tactile exit signs on the interior of the door have raised characters and braille are provided at exit doors. Mount signs between 48"- 60" above finished floor located on the latch side of the door. Ensure illuminated exit sign inside contains the International Symbol of Accessibility (ISA).	1	274	\$274
13	Emergency Exit 11	B	012	Means of Egress	N/A

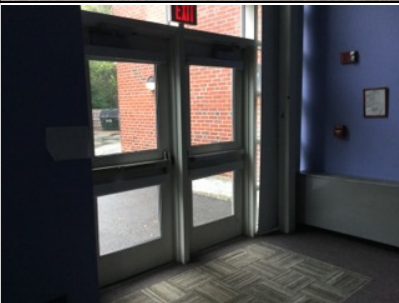
Tactile exit sign not provided Illuminated exit sign lacks International Symbol of Accessibility.	- -	Ensure tactile exit signs with raised characters and braille are provided at exit doors. Mount signs between 48"- 60" above finished floor located on the latch side of the door. Ensure illuminated exit sign contains the International Symbol of Accessibility (ISA).	1	274	\$274
14	Emergency Exit 12, Near Stage	B		Means of Egress	N/A

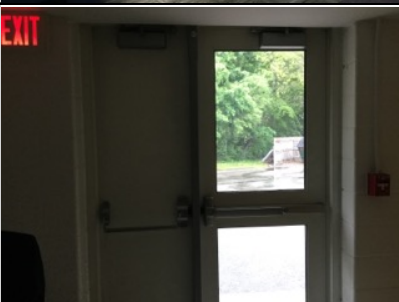
Tactile exit sign not provided Illuminated exit sign lacks International Symbol of Accessibility.	- -	Ensure tactile exit signs with raised characters and braille are provided at exit doors. Mount signs between 48"- 60" above finished floor located on the latch side of the door. Ensure illuminated exit sign contains the International Symbol of Accessibility (ISA).	1	274	\$274

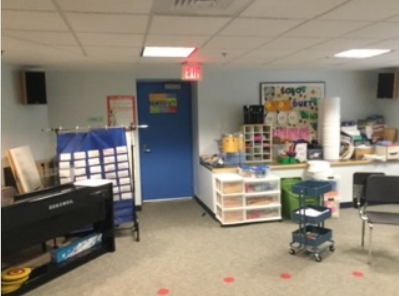
ID	Location	Floor	Room	Element	Type	Photo	Issues	Current Measure	Recommendations	Quantity	Price	Cost Estimation
15	Emergency Exit 10, in Music Room	1	130	Means of Egress	N/A

Tactile exit sign not provided Illuminated exit sign lacks International Symbol of Accessibility.	- -	Ensure tactile exit signs with raised characters and braille are provided at exit doors. Mount signs between 48"- 60" above finished floor located on the latch side of the door. Ensure illuminated exit sign contains the International Symbol of Accessibility (ISA).	1	274	\$274
16	Emergency Exit 7	1		Means of Egress	N/A

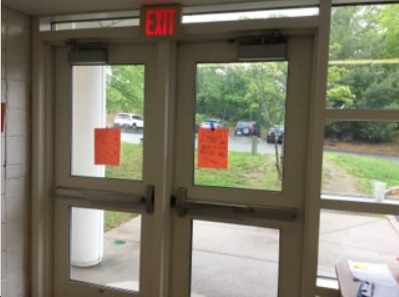
Tactile exit sign not provided Illuminated exit sign lacks International Symbol of Accessibility.	- -	Ensure tactile exit signs with raised characters and braille are provided at exit doors. Mount signs between 48"- 60" above finished floor located on the latch side of the door. Ensure illuminated exit sign contains the International Symbol of Accessibility (ISA).	1	274	\$274

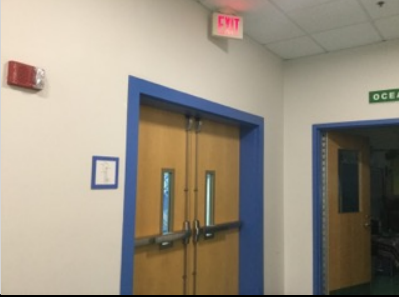
17	Route to Emergency Exit 5	1		Means of Egress	N/A

Tactile exit sign not provided Illuminated exit sign lacks International Symbol of Accessibility.	- -	Ensure tactile exit signs with raised characters and braille are provided at exit doors. Mount signs between 48"- 60" above finished floor located on the latch side of the door. Ensure illuminated exit sign contains the International Symbol of Accessibility (ISA).	1	274	\$274
18	Emergency Exit 5	1		Means of Egress	N/A

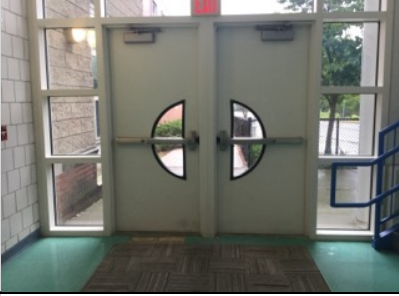
Tactile exit sign not provided Illuminated exit sign lacks International Symbol of Accessibility.	- -	Ensure tactile exit signs with raised characters and braille are provided at exit doors. Mount signs between 48"- 60" above finished floor located on the latch side of the door. Ensure illuminated exit sign contains the International Symbol of Accessibility (ISA).	1	274	\$274
19	Emergency Exit 6	1		Means of Egress	N/A

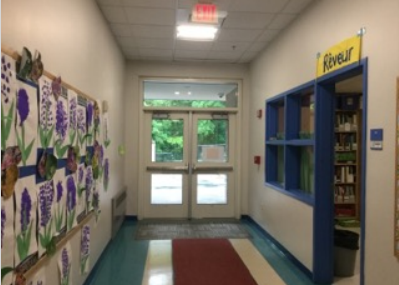
Tactile exit sign not provided Illuminated exit sign lacks International Symbol of Accessibility.	- - -	Ensure tactile exit signs with raised characters and braille are provided at exit doors. Mount signs between 48"- 60" above finished floor located on the latch side of the door. Ensure illuminated exit sign contains the International Symbol of Accessibility (ISA).	1	274	\$274

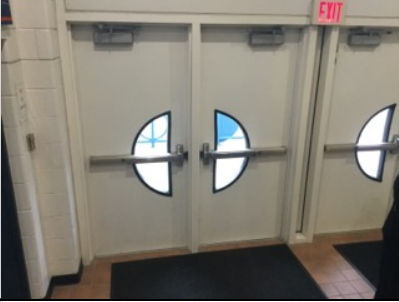
ID	Location	Floor	Room	Element	Type	Photo	Issues	Current Measure	Recommendations	Quantity	Price	Cost Estimation
20	Main Entrance, Exit 1	1		Means of Egress	N/A

Tactile exit sign not provided Illuminated exit sign lacks International Symbol of Accessibility.	- -	Ensure tactile exit signs with raised characters and braille are provided at exit doors. Mount signs between 48"- 60" above finished floor located on the latch side of the door. Ensure illuminated exit sign contains the International Symbol of Accessibility (ISA).	1	274	\$274
21	Exit From Gym to Emergency Exit 12 in Basement	1		Means of Egress	N/A

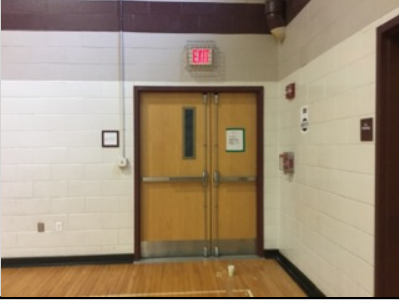
Directional sign to accessible emergency exit not provided	-	Provide a directional sign indicating the location of the nearest accessible emergency exit.	1	174	\$174
Interior Access Route												
22	Classroom, Book Nook	2	202	Interior Access Route	N/A

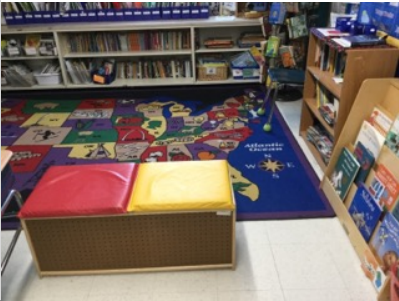
Route < 36" wide	30" -	Ensure that a clear width of 36" min. is maintained at the accessible route.	1	Labor	\$0

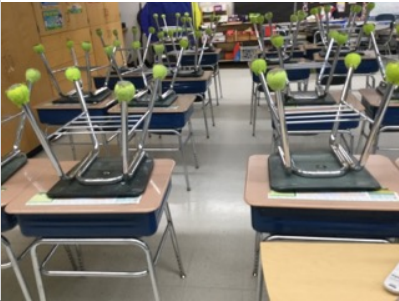
23	Classroom	2	202	Interior Access Route	N/A

Route < 36" wide	19"	Ensure that a clear width of 36" min. is maintained at the accessible route.	1	Labor	\$0
24	Classroom	2	205	Interior Access Route	N/A

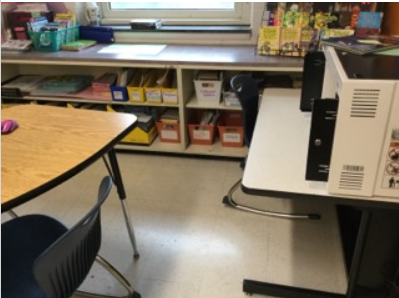
Route < 36" wide	17.5"	Ensure that a clear width of 36" min. is maintained at the accessible route.	1	Labor	\$0

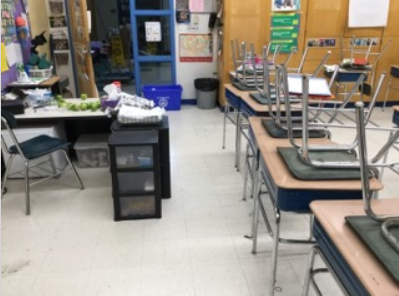
ID	Location	Floor	Room	Element	Type	Photo	Issues	Current Measure	Recommendations	Quantity	Price	Cost Estimation
25	Classroom, Fifth Grade	2	210	Interior Access Route	N/A

Route < 36" wide	25"	Ensure that a clear width of 36" min. is maintained at the accessible route.	1	Labor	\$0
26	Classroom	2	209	Interior Access Route	N/A

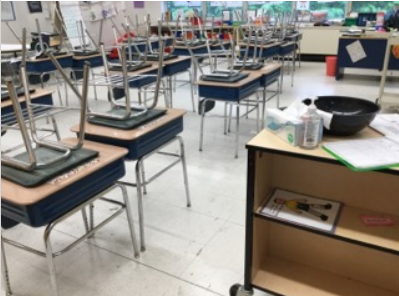
Route < 36" wide	28"	Ensure that a clear width of 36" min. is maintained at the accessible route.	1	Labor	\$0
27	Classroom, Fourth Grade	2	217	Interior Access Route	N/A

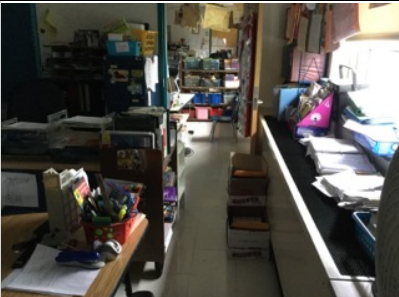
Route < 36" wide	28"	Ensure that a clear width of 36" min. is maintained at the accessible route.	1	Labor	\$0
28	ELA Classroom	2	206	Interior Access Route	N/A

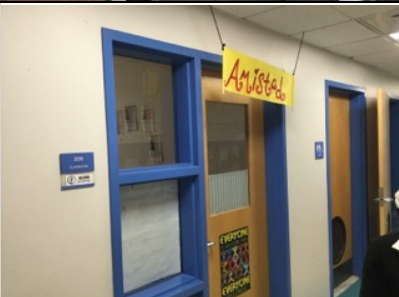
Obstructed by protruding objects	76"	Relocate sign in doorway so that it is at least 80" above the finished floor.	1	Labor	\$0
29	Main Office	1	100	Interior Access Route	N/A

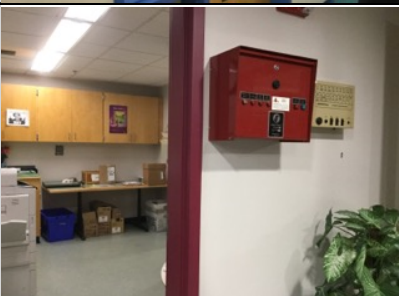
Obstructed by protruding objects	7"	Relocate object out of circulation path.	1	530	\$530

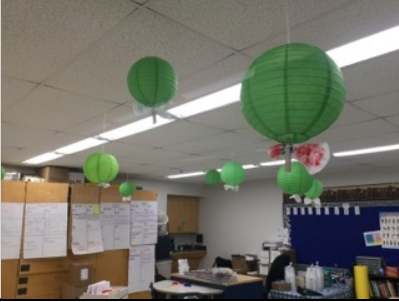
ID	Location	Floor	Room	Element	Type	Photo	Issues	Current Measure	Recommendations	Quantity	Price	Cost Estimation
30	Classroom	1	107	Interior Access Route	N/A

Obstructed by protruding objects	69"	Relocate lanterns so that that are at least 80" above the finished floor.	1	Labor	\$0
31	Classrooms Throughout School	2, 1, B	203, 205, 209, 213, 215, 217, 05, 104, 107, 110	Interior Access Route	N/A

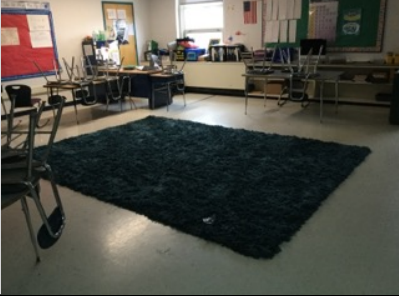
Mat not securely attached	-	Securely attach mats.	16	Labor	\$0
Doors, Doorways, & Gates												
32	Main Office Into Hallway	1	100	Doors, Doorways, & Gates	N/A
