City of Salem, Massachusetts

PART A – Executive Summary

Part A – Executive Summary

Introduction

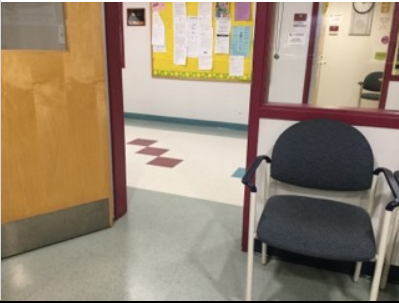
Maneuvering clearance(s) not provided	-	Remove the chair away from the required maneuvering clearance at the door.	1	Labor	\$0
33	Health Suite	1	127	Doors, Doorways, & Gates	N/A

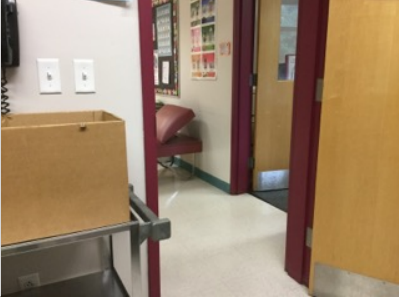
Maneuvering clearance(s) not provided	-	Relocate the cart away from the required maneuvering clearance at the door.	1	Labor	\$0
34	Toilet Room Near 127	1		Doors, Doorways, & Gates	Toilet Room

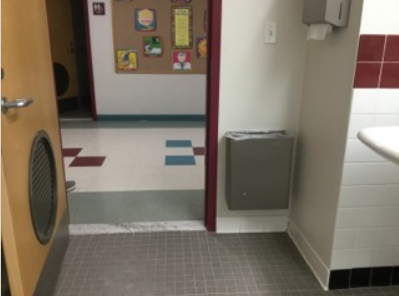
Maneuvering clearance(s) not provided	-	Relocate trash can to another wall at the same height away from the required maneuvering clearance at the door.	1	530	\$530

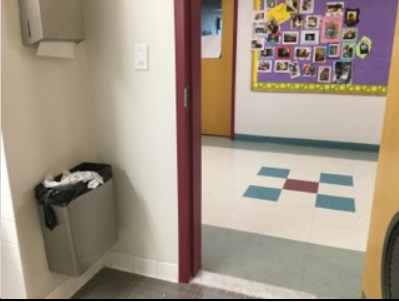
ID	Location	Floor	Room	Element	Type	Photo	Issues	Current Measure	Recommendations	Quantity	Price	Cost Estimation
35	Toilet Room Near 127	1		Doors, Doorways, & Gates	Toilet Room

Maneuvering clearance(s) not provided	14"	While not technically compliant, this doorway is still usable.	1	-	\$0
36	Classroom	1	104	Doors, Doorways, & Gates	Classroom

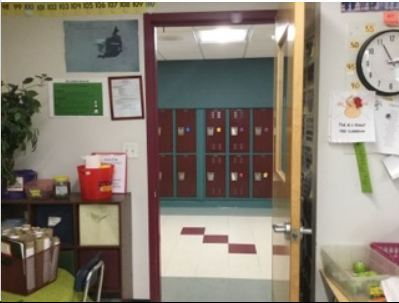
Maneuvering clearance(s) not provided	-	Relocate the cabinet away from the required maneuvering clearance at the door.	1	Labor	\$0
37	Classroom, First Grade	1	119	Doors, Doorways, & Gates	Classroom

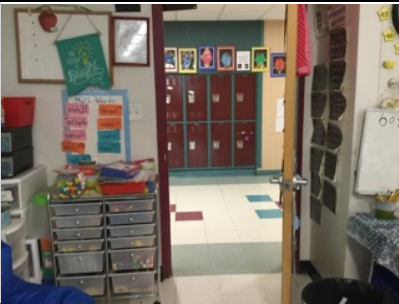
Maneuvering clearance(s) not provided	-	Relocate the cabinet away from the required maneuvering clearance at the door.	1	Labor	\$0
38	Locker Room Entrance	1		Doors, Doorways, & Gates	N/A

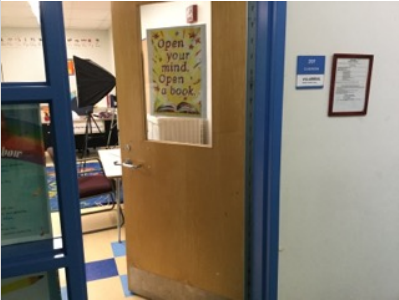
Sign not located on the latch side of the door	-	Locate sign at permanent rooms alongside the door on the latch side.	1	Labor	\$0
42	Art Room	2	208	Signage	Designation

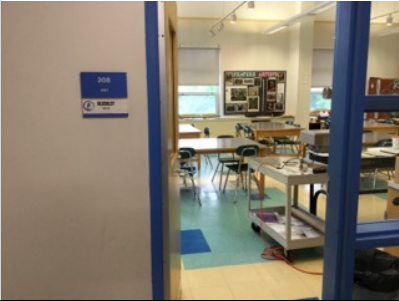
Sign not located on the latch side of the door	-	Locate sign at permanent rooms alongside the door on the latch side.	1	Labor	\$0
43	Art Room to Kiln Room	2	208	Signage	Designation

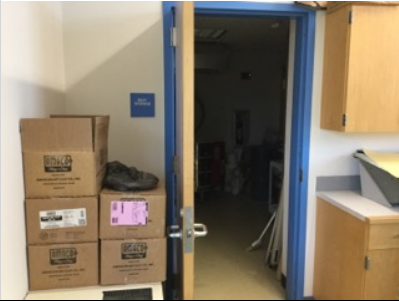
Sign not located on the latch side of the door	-	Locate sign at permanent rooms alongside the door on the latch side.	1	Labor	\$0

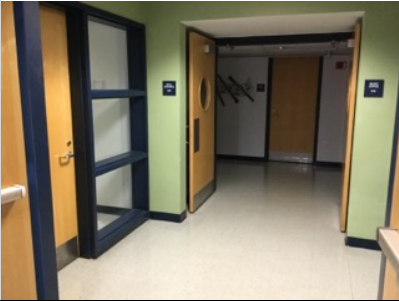
44	Music Ensemble Room and Music Office	B	009, 013	Signage	Designation

Sign not located on the latch side of the door	-	Locate sign at permanent rooms alongside the door on the latch side.	2	Labor	\$0

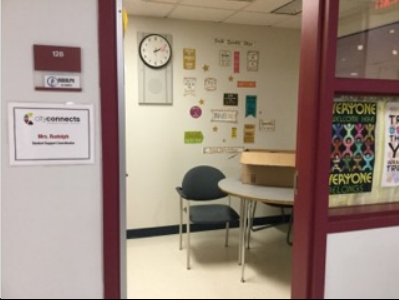
ID	Location	Floor	Room	Element	Type	Photo	Issues	Current Measure	Recommendations	Quantity	Price	Cost Estimation
45	Office	1	128	Signage	Designation

Sign not located on the latch side of the door	-	Locate sign at permanent rooms alongside the door on the latch side.	1	Labor	\$0
46	Boys' Toilet Room	1		Signage	Designation

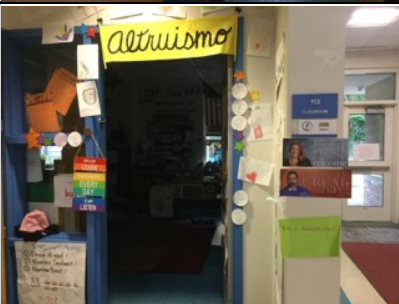
Sign not located on the latch side of the door	-	Locate sign at permanent rooms alongside the door on the latch side.	1	Labor	\$0
48	Classroom	1	108	Signage	Designation

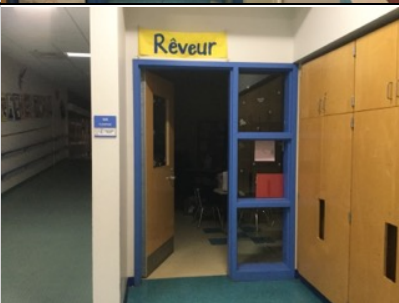
Sign not located on the latch side of the door	-	Locate sign at permanent rooms alongside the door on the latch side.	1	Labor	\$0
Service Counter												
49	Main Office	1	100	Service Counter	N/A

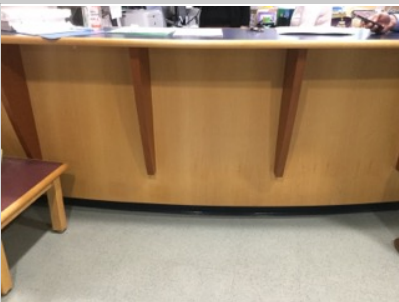
Counter > 36" high	42"	Provide a counter that is 36" max. above the ground or finished floor.	1	660	\$660

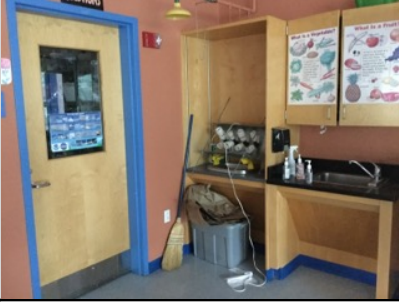
ID	Location	Floor	Room	Element	Type	Photo	Issues	Current Measure	Recommendations	Quantity	Price	Cost Estimation
Operable Parts												
50	Emergency Shower	2	211	Operable Parts	Other

Clear floor space is not provided	-	Provide a 30" min. by 48" min. clear floor space at emergency eye wash station.	1	Labor	\$0
51	Classroom, Book Nook	2	202	Operable Parts	Other

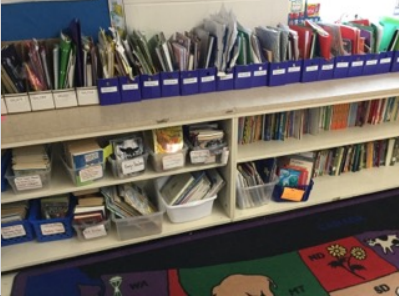
Reach < 15" or > 48"(forward/side approach)	5"	Relocate books so that controls are between 15"- 48" above finished floor.	1	Labor	\$0
52	Classroom	2	209	Operable Parts	Other

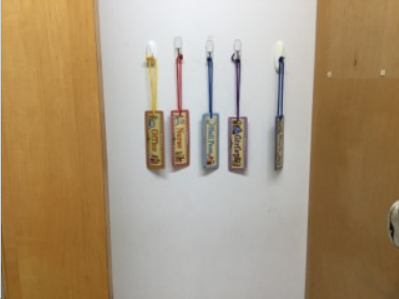
Reach < 15" or > 48"(forward/side approach)	64"	Relocate hooks so that controls are between 15"- 48" above finished floor.	1	Labor	\$0
53	Classroom, Third Grade	2	213	Operable Parts	Other

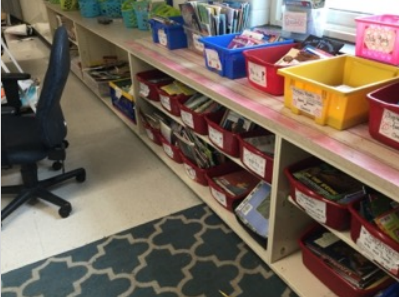
Reach < 15" or > 48"(forward/side approach)	5"	Relocate books so that controls are between 15"- 48" above finished floor.	1	Labor	\$0
54	Classroom, Fourth Grade	2	215	Operable Parts	Other

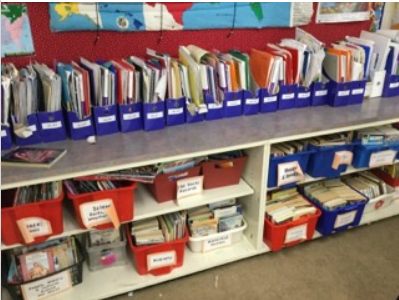
Reach < 15" or > 48"(forward/side approach)	5"	Relocate books so that controls are between 15"- 48" above finished floor.	1	Labor	\$0

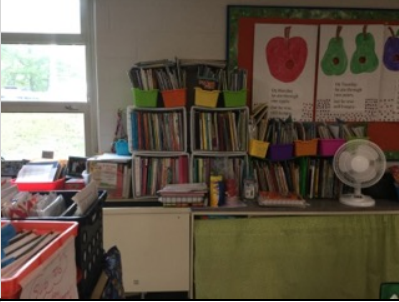
ID	Location	Floor	Room	Element	Type	Photo	Issues	Current Measure	Recommendations	Quantity	Price	Cost Estimation
55	Classroom, First Grade	1	119	Operable Parts	Other

Reach < 15" or > 48"(forward/side approach)	68"	Relocate books so that controls are between 15"- 48" above finished floor.	1	Labor	\$0
56	Boys' and Girls' Locker Rooms	1		Operable Parts	Other

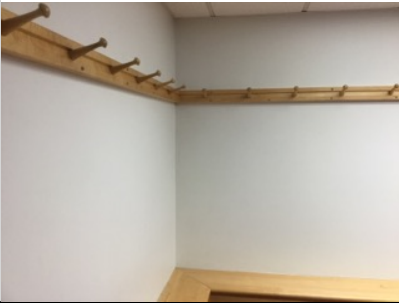
Reach < 15" or > 48"(forward/side approach)	66.5"	Relocate at least one hook per room so that controls are between 15"- 48" above finished floor.	2	192	\$384
Dining or Work Surfaces												
57	Classrooms Throughout School	2, 1, B	202, 210, 213, 215, 217, 005	Dining or Work Surfaces	Work Surface

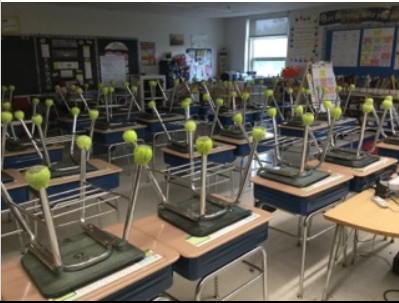
At least one or 5% accessible tables not provided	-	Ensure that at least one work surface per room is accessible with 27" minimum knee and toe clearance.	6	525	\$3150
58	Classrooms Throughout School	2, 1	203, 124, 104, 118, 107	Dining or Work Surfaces	Work Surface

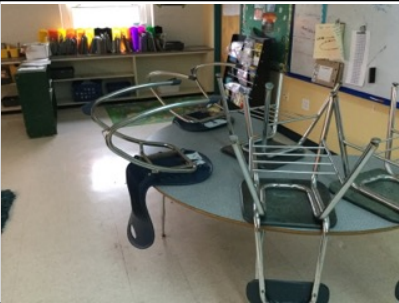
Knee or toe clearance not provided	24"	Adjust at least 1 work surface per room so that they have 27" min. knee and toe clearance.	5	Labor	\$0

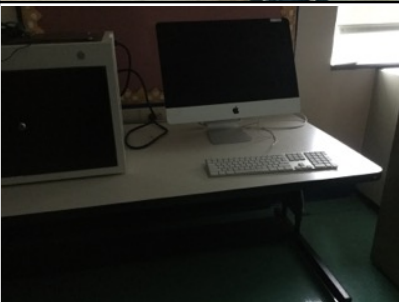
59	Classroom	1	110	Dining or Work Surfaces	Work Surface

Knee or toe clearance not provided	22.5"	Adjust work surface so that it has 27" min. knee and toe clearance.	1	Labor	\$0

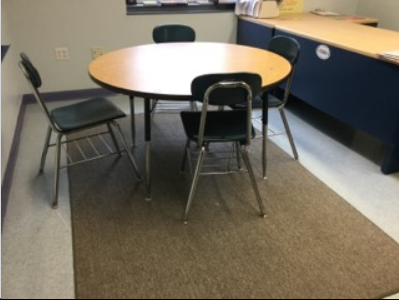
ID	Location	Floor	Room	Element	Type	Photo	Issues	Current Measure	Recommendations	Quantity	Price	Cost Estimation
60	Assistant Principle's Office	1	126	Dining or Work Surfaces	Work Surface

Knee or toe clearance not provided Mat not securely attached	26" -	Adjust table so that is has minimum 27" knee clearance underneath. Securely attach mat.	1	Labor	\$0
Picnic Tables												
61	North Side of School	Ext.		Picnic Tables	N/A

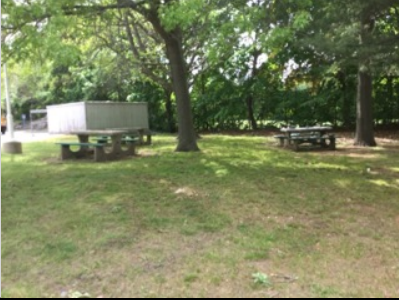
At least 5% accessible spaces not provided Picnic table not on an accessible route	- -	Ensure that at least 5% (minimum one) of dining surfaces are accessible. Ensure that the dining surface is connected to an accessible route. (Cost based on an accessible picnic table and a 15' by 4' wide asphalt path to the picnic area.)	1	1433	\$1433
Toilet & Bathing Rooms												
Lavatory												
62	Girls' Toilet Room	1		Lavatory	N/A

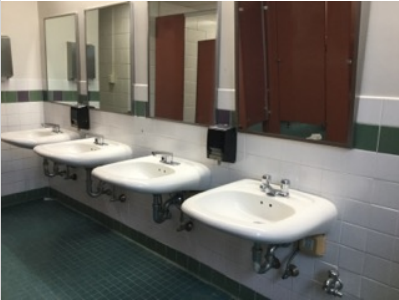
Toe or knee clearances not provided Plumbing underneath is exposed	25" -	Provide at least one lavatory with knee and toe clearance positioned for a forward approach. Insulate or otherwise configure pipes to prevent contact, for at least one lavatory.	1	1334	\$1334

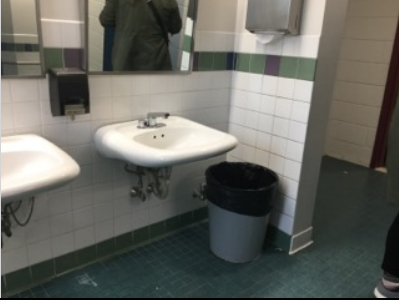
63	Boys' Toilet Room	1		Lavatory	N/A

Toe or knee clearances not provided Plumbing underneath is exposed	24.5" -	Provide at least one lavatory with knee and toe clearance positioned for a forward approach. Insulate or otherwise configure pipes to prevent contact, for at least one lavatory.	1	1334	\$1334
64	Toilet Room Near 109	1	113	Lavatory	N/A

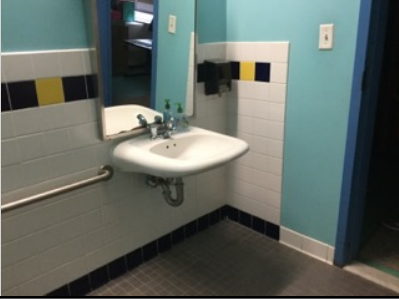
Toe or knee clearances not provided Plumbing underneath is exposed	25.5" -	Provide at least one lavatory with knee and toe clearance positioned for a forward approach. Insulate or otherwise configure pipes to prevent contact, for at least one lavatory.	1	1334	\$1334

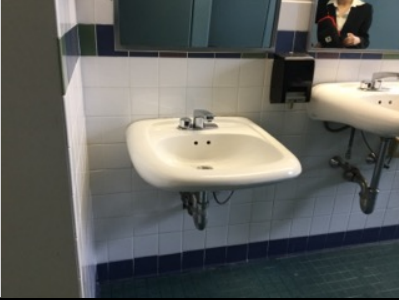
Plumbing underneath is exposed	-	Insulate or otherwise configure pipes to prevent contact, for at least one lavatory.	1	69	\$69
66	Boys' Toilet Room	2		Lavatory	N/A

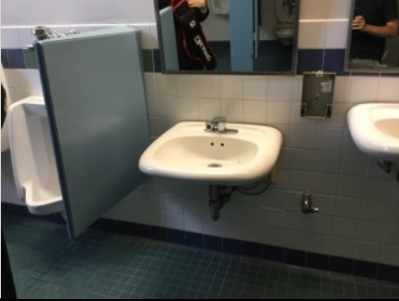
Plumbing underneath is exposed	-	Insulate or otherwise configure pipes to prevent contact, for at least one lavatory.	1	69	\$69
67	Girls' Toilet Room	B		Lavatory	N/A

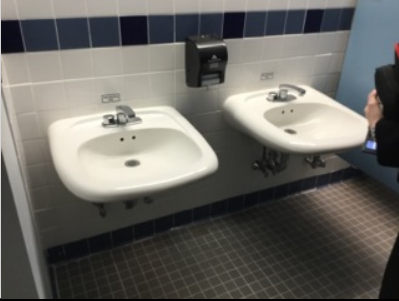
Plumbing underneath is exposed	-	Insulate or otherwise configure pipes to prevent contact, for at least one lavatory.	1	69	\$69
68	Health Suite, Toilet Room	1	127	Lavatory	N/A

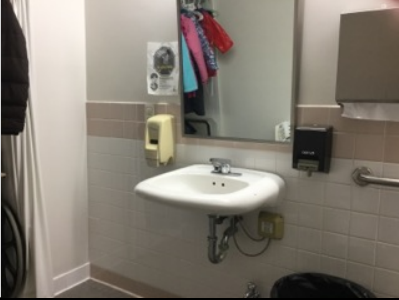
Plumbing underneath is exposed	-	Insulate or otherwise configure pipes to prevent contact, for at least one lavatory.	1	69	\$69
69	Toilet Room in 116	1	116	Lavatory	N/A

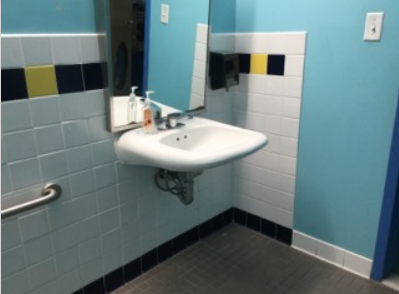
Plumbing underneath is exposed	-	Insulate or otherwise configure pipes to prevent contact, for at least one lavatory.	1	69	\$69

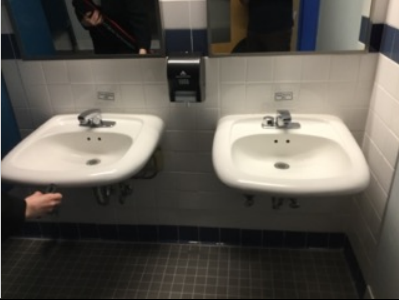
Plumbing underneath is exposed Mirror above lavatory w/reflective surface > 40"	- 42"	Insulate or otherwise configure pipes to prevent contact, for at least one lavatory. Lower mirror so that the bottom surface is at 40" max. above finished floor.	1	261	\$261
71	Women's Toilet Room Near 218	2		Lavatory	N/A

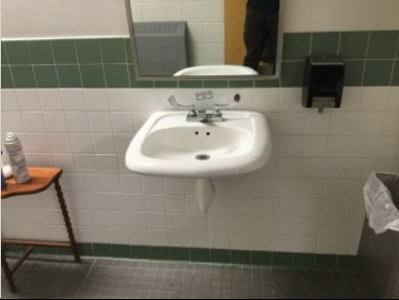
Mirror above lavatory w/reflective surface > 40"	42"	Lower mirror so that the bottom surface is at 40" max. above finished floor.	1	192	\$192
72	Men's Toilet Room Near 218	2		Lavatory	N/A

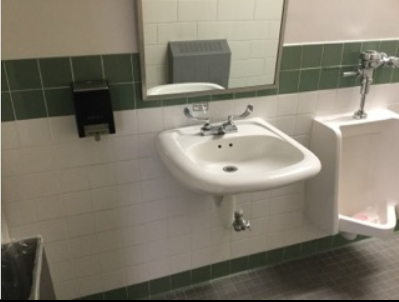
Mirror above lavatory w/reflective surface > 40"	42"	Lower mirror so that the bottom surface is at 40" max. above finished floor.	1	192	\$192
Single-User Toilet												
73	Women's Toilet Room Near 218	2		Single-User Toilet	N/A

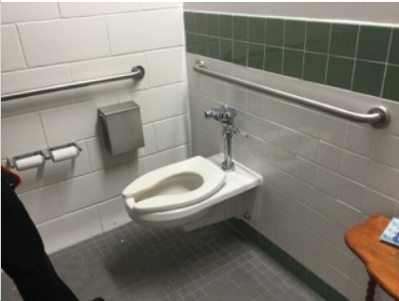
Centerline < or > 18" (MAAB)	20"	Relocate toilet so that the centerline is 18" from the side wall.	1	2121	\$2121

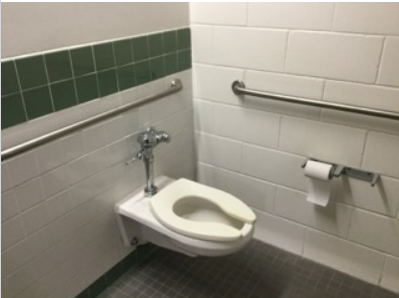
74	Men's Toilet Room Near 218	2		Single-User Toilet	N/A

Centerline < or > 18" (MAAB)	20"	Relocate toilet so that the centerline is 18" from the side wall.	1	2121	\$2121

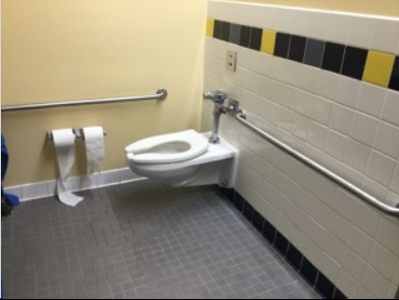
Centerline < or > 18" (MAAB) Side or rear grab bar < 33" or > 36" high	15" 22"	Relocate toilet so that the centerline is 18" from the side wall. Mount grab bars 33"- 36" above the floor.	1	2313	\$2313
76	Toilet Room in 115	1	115	Single-User Toilet	N/A

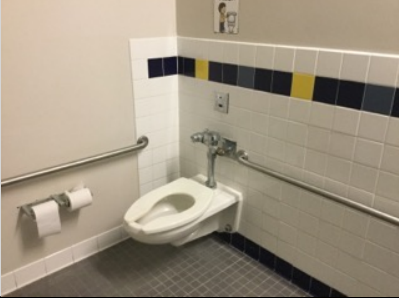
Centerline < or > 18" (MAAB) Side or rear grab bar < 33" or > 36" high	15" 22"	Relocate toilet so that the centerline is 18" from the side wall. Mount grab bars 33"- 36" above the floor.	1	2313	\$2313
77	Toilet Room in 116	1	116	Single-User Toilet	N/A

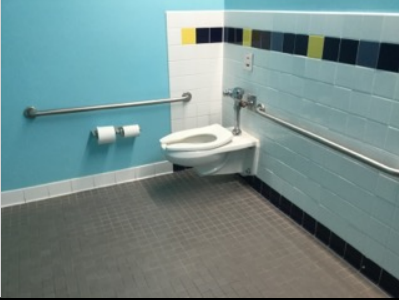
Centerline < or > 18" (MAAB) Side or rear grab bar < 33" or > 36" high	15" 24"	Relocate toilet so that the centerline is 18" from the side wall. Mount grab bars 33"- 36" above the floor.	1	2313	\$2313
Toilet Compartment

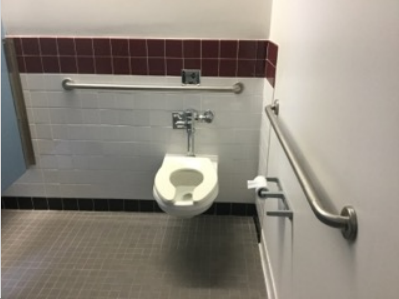
78	Girls' Locker Room Toilet Room	1		Toilet Compartment	Accessible Compartment

Door has malfunctioning self-closing hinge	-	Repair hinge.	1	Labor	\$0
79	Boys' Toilet Room	B		Toilet Compartment	Accessible Compartment

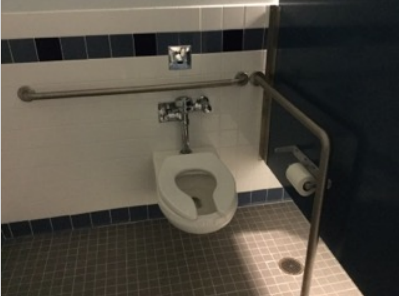
Side grab bar < 42" long	30"	Provide a side wall grab bar that is 42" long min. located 12" max. from the rear wall.	1	674	\$674

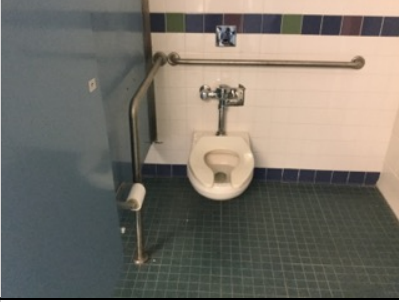
Side grab bar < 42" long Non-compliant toilet paper dispenser	30" -	Provide a side wall grab bar that is 42" long min. located 12" max. from the rear wall. Relocate toilet paper so that it is 15" min. high, located under the grab bar, and between 7" and 9" from the front of the toilet. Replace dispenser if it does not allow continuous paper flow.	1	1204	\$1204
81	Boys' Toilet Room	2		Toilet Compartment	Accessible Compartment

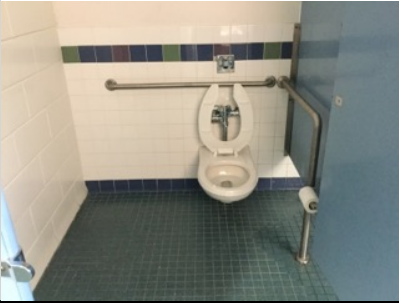
Side grab bar < 42" long Non-compliant toilet paper dispenser	30" -	Provide a side wall grab bar that is 42" long min. located 12" max. from the rear wall. Relocate toilet paper so that it is 15" min. high, located under the grab bar, and between 7" and 9" from the front of the toilet. Replace dispenser if it does not allow continuous paper flow.	1	1204	\$1204

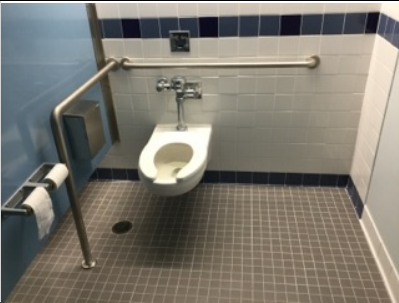
82	Girls' Toilet Room	B		Toilet Compartment	Accessible Compartment

Side grab bar < 42" long Non-compliant toilet paper dispenser	30" -	Provide a side wall grab bar that is 42" long min. located 12" max. from the rear wall. Relocate toilet paper so that it is 15" min. high, located under the grab bar, and between 7" and 9" from the front of the toilet. Replace dispenser if it does not allow continuous paper flow.	1	1204	\$1204
83	Girls' Toilet Room	1		Toilet Compartment	Accessible Compartment

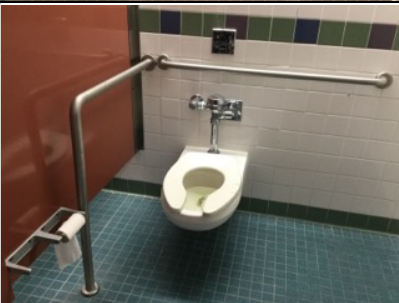
Side grab bar < 42" long Non-compliant toilet paper dispenser	31" -	Provide a side wall grab bar that is 42" long min. located 12" max. from the rear wall. Relocate toilet paper so that it is 15" min. high, located under the grab bar, and between 7" and 9" from the front of the toilet. Replace dispenser if it does not allow continuous paper flow.	1	1204	\$1204
84	Boys' Toilet Room	1		Toilet Compartment	Accessible Compartment

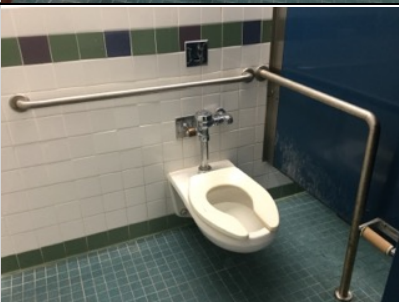
Side grab bar < 42" long Non-compliant toilet paper dispenser	31" -	Provide a side wall grab bar that is 42" long min. located 12" max. from the rear wall. Relocate toilet paper so that it is 15" min. high, located under the grab bar, and between 7" and 9" from the front of the toilet. Replace dispenser if it does not allow continuous paper flow.	1	1204	\$1204

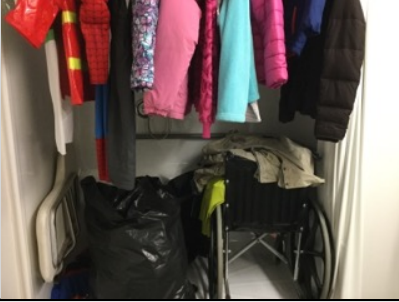
Accessible shower not provided	-	Provide at least one accessible shower by ensuring it is maintained in operable working condition and is free of clutter.	1	Labor	\$0
Additional Access												
Drinking Fountains												
86	Gym	1		Drinking Fountains	High

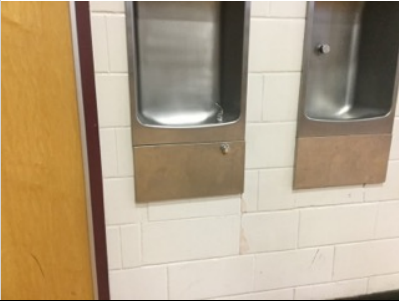
Inadequate water flow No drinking fountain provided for seated users	- -	Install a Hi-Lo drinking fountain.	1	3162	\$3162
87	Drinking Fountains Near Main Staircase	B	005	Drinking Fountains	Hi-Lo

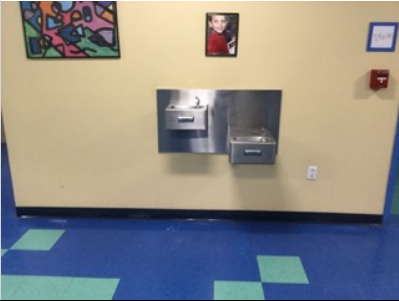
Standing height fountain does not have cane protection	-	Provide a cane-detectable barrier skirt under the high unit.	1	668	\$668
Sink												
88	Classroom	2	202	Sink	Classroom

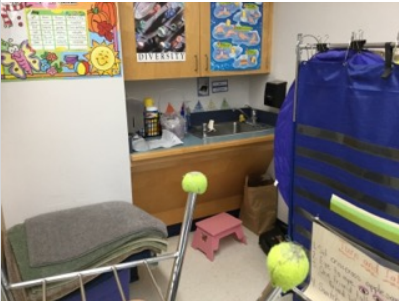
Clear floor space not provided at sink Sink not on a accessible route	- -	Provide a 30" by 48" clear floor space positioned for a forward approach. Ensure the sink is on an accessible route.	1	Labor	\$0

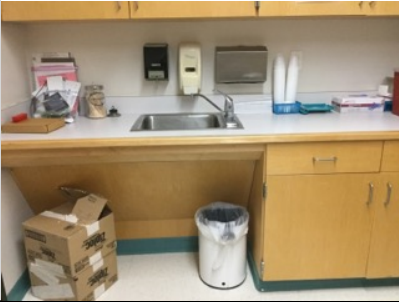
Toe and knee clearances not provided	-	Ensure there is a 27" knee clearance positioned for a forward approach by removing clutter.	2	Labor	\$0
90	Classrooms Throughout School	2, 1	210, 208, 213, 215, 130, 104, 119, 118	Sink	Classroom

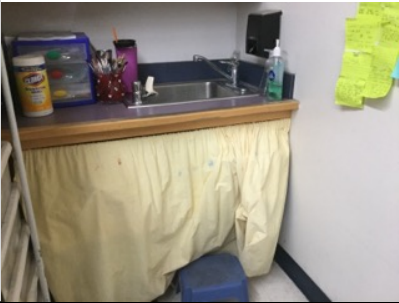
Toe and knee clearances not provided	-	Ensure there is a 27" knee clearance positioned for a forward approach by removing storage and other clutter under the sink. Ensure sinks have a minimum 30" by 48" clear floor space as well.	8	Labor	\$0
91	Bilingual Reading Room	2	207	Sink	Classroom

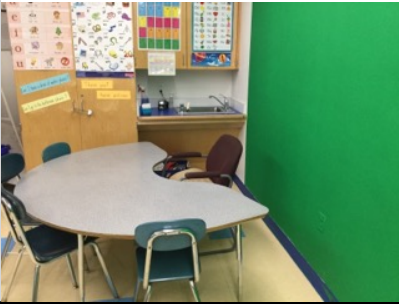
Sink not on a accessible route	-	Ensure the sink is on an accessible route.	1	Labor	\$0
Play and Sport Areas												
Play Areas												
92	Playground on North Side of School	Ext.		Play Areas	N/A

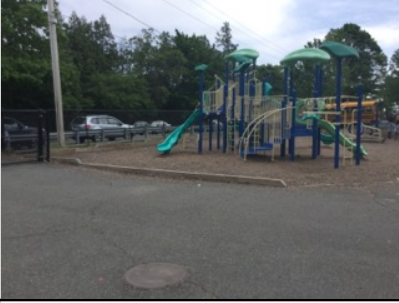
The north playground, near the basketball courts, lacks a route around the playground as well as an impact resistant route to each of the play components. This playground also lacks a compliant transfer station. The south playground is technically compliant, but an issue was brought to the IHCD survey team’s attention by a concerned parent. It seems as though the curbs that cut through the middle of the playground act as a serious tripping and safety hazard (see Fig. 1). As it is in the middle of the playground, children might be running from one side to the other and could fall if they

Accessible route not provided to ground level play components	-	Ensure an accessible route is provided to one of each type of ground level play components (Cost based on 250' by 4' wide asphalt route around playground as well as 1880' by 5' wide poured in place rubber route to play components.)	1	25275	\$25275

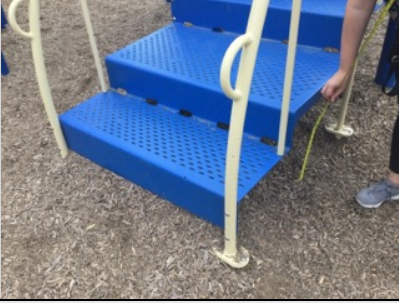
93	Playground on North Side of School	Ext.		Play Areas	N/A

No compliant transfer system	-	Alteration might be technically infeasible.	1	-	\$0
Best Practice

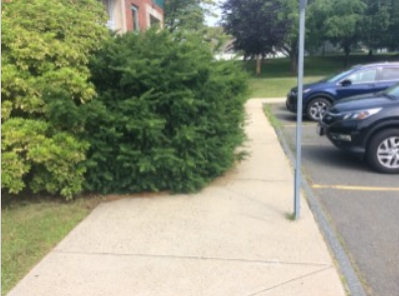
Exterior route < 48" wide	25"	Ensure that a clear width of 48" min. is maintained at the accessible route by trimming trees.	1	Labor	\$0
2	Crossing at Exit to Early Childhood Drop Off Area, Along Memorial Drive	Ext.		Exterior Access Route	Exterior

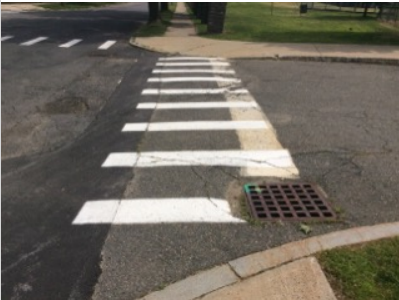
Surface openings > 1/2"	-	Replace or reposition so that openings are 1/2" max. and the long opening dimension is perpendicular to the dominant direction of travel.	1	1238	\$1238
3	Exit #3	Ext.		Exterior Access Route	Exterior

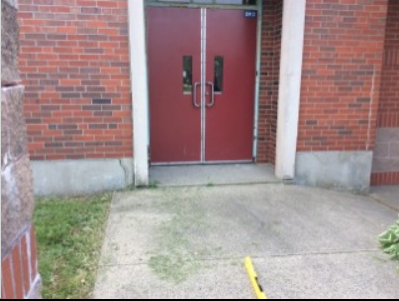
Level changes > 1/4"	1.5"	Alter change in level to be 1/4" high max.	1	155	\$155
4	Route to Parking Lot From Memorial Drive	Ext.		Exterior Access Route	Exterior

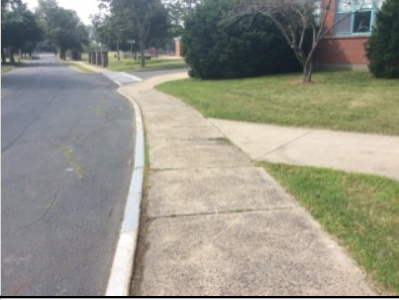
Level changes > 1/4"	2"	Alter change in level to be 1/4" high max. (Cost based on 20' of concrete.)	1	690	\$690

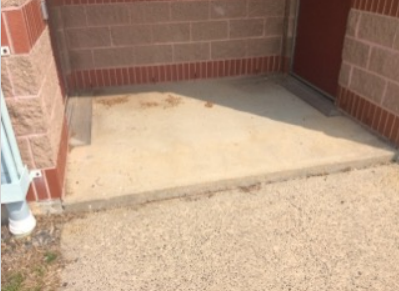
5	Exits #10 and #11	Ext.		Exterior Access Route	Exterior

Level changes > 1/4"	3"	Alter change in level to be 1/4" high max.	1	155	\$155

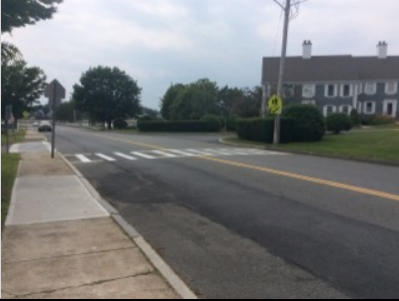
Curb ramp not provided	-	Provide a curb ramp at intersection.	2	2800	\$5600
12	Main Entrance, Exit #2	Ext.		Curb Ramp	N/A

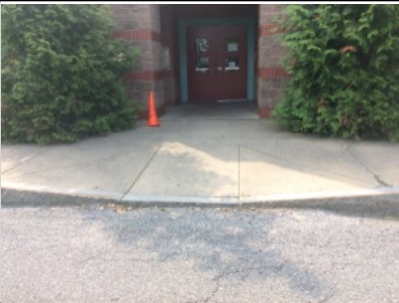
Transition from curb ramp to street not flush	3"	Ensure transition from curb ramp to street is flush or free of changes in level.	1	128	\$128
Off-Street Parking Lot or Garage												
13	Parking Lot Northeast Side	Ext.		Off-Street Parking Lot or Garage	N/A

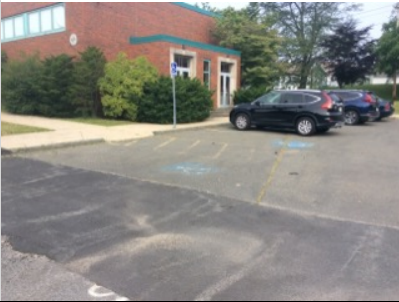
Total # of parking Total # of designated accessible parking spaces Total # of designated van accessible spaces Access aisle < 96" wide at van space Sign not provided Sign does not have the designation "Van Accessible"	23 2 0 90" - -	Provide a marked access aisle that is at least 96" wide. Provide a sign with the bottom of the sign 60" min. above the ground and the top 96" max. above the ground. Add the designation "Van Accessible" to the sign located at the van accessible space.	1	600	\$600

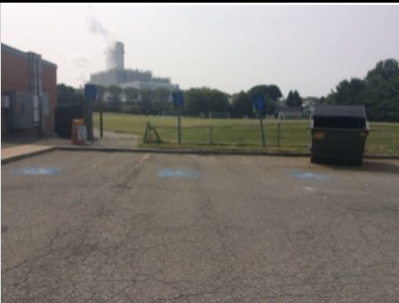
14	Parking Lot West Side	Ext.		Off-Street Parking Lot or Garage	N/A

Total # of parking Total # of designated accessible parking spaces Total # of designated van accessible spaces Access aisle < 96" wide at van space Sign does not have the designation "Van Accessible" Surface not stable, firm, and slip-resistant	75 3 0 48" - -	Provide a marked access aisle that is at least 96" wide. Add the designation "Van Accessible" to the sign located at the van accessible space. Relocate dumpster.	1	600	\$600
Passenger Loading Zones												
15	Early Childhood Center Drop Off Zone	Ext.		Passenger Loading Zones	N/A

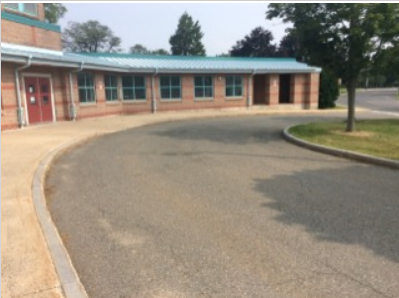
Zone not connected to an accessible route	-	Ensure the passenger loading zone is connected to an accessible route by providing curb ramp.	1	2800	\$2800

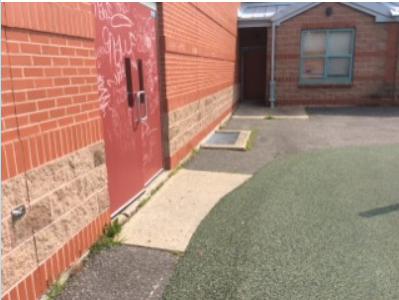
Maneuvering clearance(s) not provided Threshold > 1/2" high	- 2.5"	While not technically compliant, this exit could still be usable if the threshold is altered. Alter threshold to be 1/2" high max.	1	155	\$155
17	Exit #21	Ext.		Emergency Exit	N/A

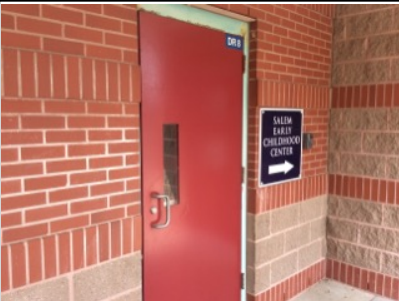
19	Exit #8	Ext.		Means of Egress	N/A

Illuminated exit sign not provided Tactile exit sign not provided	- -	Ensure illuminated exit signs on the interior of the door contain the International Symbol of Accessibility (ISA). Ensure tactile exit signs with raised characters and braille are provided at the interior of exit doors. Mount signs between 48"- 60" above finished floor located on the latch side of the door.	1	274	\$274
20	Exit #9	Ext.		Means of Egress	N/A

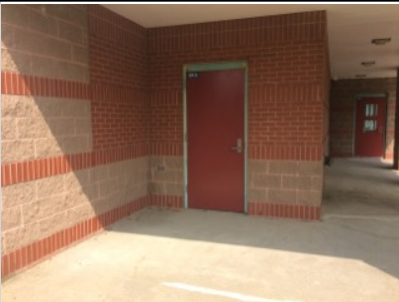
Illuminated exit sign not provided Tactile exit sign not provided	- -	Ensure illuminated exit signs on the interior of the door contain the International Symbol of Accessibility (ISA). Ensure tactile exit signs with raised characters and braille are provided at the interior of exit doors. Mount signs between 48"- 60" above finished floor located on the latch side of the door.	1	274	\$274

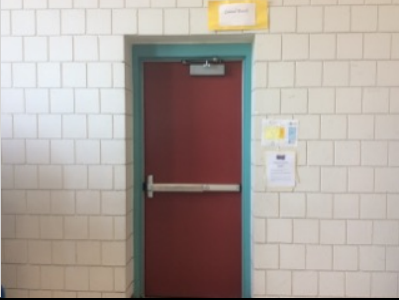
Illuminated exit sign not provided Tactile exit sign not provided	- -	Ensure illuminated exit signs contain the International Symbol of Accessibility (ISA). Ensure tactile exit signs with raised characters and braille are provided at exit doors. Mount signs between 48"- 60" above finished floor located on the latch side of the door.	1	274	\$274
22	Exit #20 From Gym	1		Means of Egress	N/A

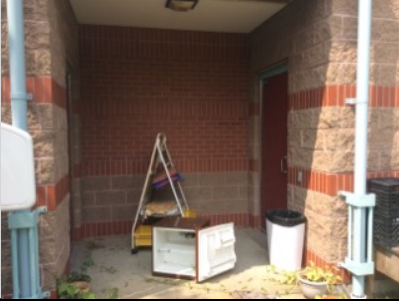
Illuminated exit sign not provided Tactile exit sign not provided	- -	Ensure illuminated exit signs on the interior of the door contain the International Symbol of Accessibility (ISA). Ensure tactile exit signs with raised characters and braille are provided at the interior of exit doors. Mount signs between 48"- 60" above finished floor located on the latch side of the door.	12	274	\$3288

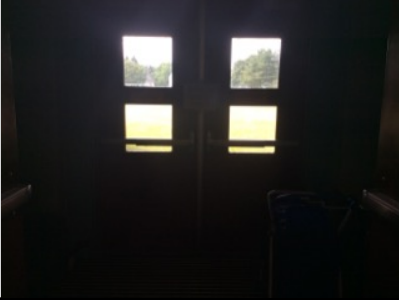
24	Exit #14	1		Means of Egress	N/A

Illuminated exit sign not provided Tactile exit sign not provided	- -	Ensure illuminated exit signs contain the International Symbol of Accessibility (ISA). Ensure tactile exit signs with raised characters and braille are provided at exit doors. Mount signs between 48"- 60" above finished floor located on the latch side of the door.	1	274	\$274
25	Emergency Exits #10, #11, #12, #13, #15, #16, #17, #18 in Classrooms	1	04	Means of Egress	N/A

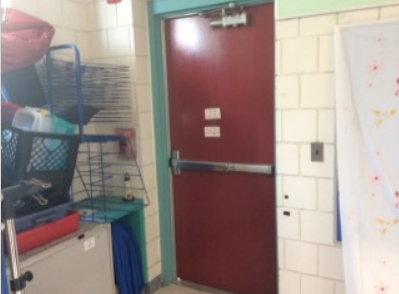
Illuminated exit sign not provided Tactile exit sign not provided	- -	Ensure illuminated exit signs contain the International Symbol of Accessibility (ISA). Ensure tactile exit signs with raised characters and braille are provided at exit doors. Mount signs between 48"- 60" above finished floor located on the latch side of the door.	8	274	\$2192

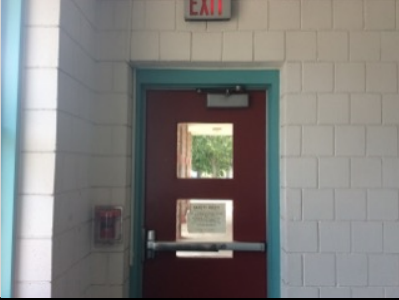
Illuminated exit sign not provided Tactile exit sign not provided	- -	Ensure illuminated exit signs contain the International Symbol of Accessibility (ISA). Ensure tactile exit signs with raised characters and braille are provided at exit doors. Mount signs between 48"- 60" above finished floor located on the latch side of the door.	1	274	\$274
27	Exit #6	1		Means of Egress	N/A

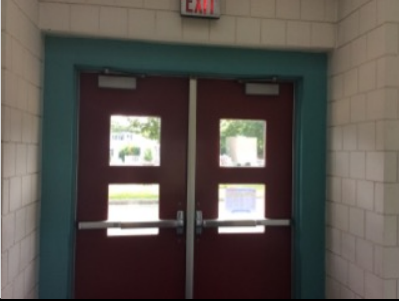
Illuminated exit sign not provided Tactile exit sign not provided	- -	Ensure illuminated exit signs contain the International Symbol of Accessibility (ISA). Ensure tactile exit signs with raised characters and braille are provided at exit doors. Mount signs between 48"- 60" above finished floor located on the latch side of the door.	1	274	\$274
28	Exit #5	1		Means of Egress	N/A

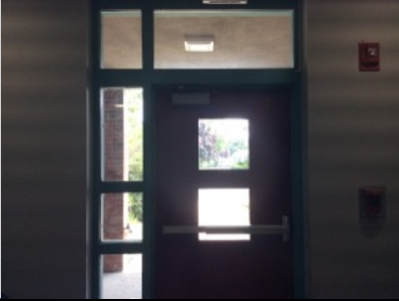
Illuminated exit sign not provided Tactile exit sign not provided	- -	Ensure illuminated exit signs contain the International Symbol of Accessibility (ISA). Ensure tactile exit signs with raised characters and braille are provided at exit doors. Mount signs between 48"- 60" above finished floor located on the latch side of the door.	1	274	\$274

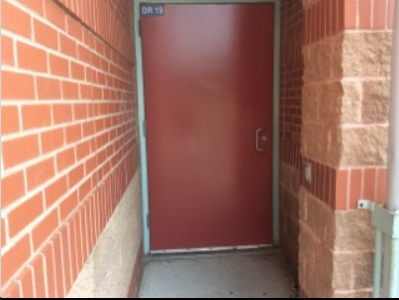
29	Exit #19	1	119	Means of Egress	N/A

Illuminated exit sign not provided Tactile exit sign not provided	- -	Ensure illuminated exit signs on the interior of the door contain the International Symbol of Accessibility (ISA). Ensure tactile exit signs with raised characters and braille are provided at the interior of exit doors. Mount signs between 48"- 60" above finished floor located on the latch side of the door.	1	274	\$274
30	Exit #22	1		Means of Egress	N/A

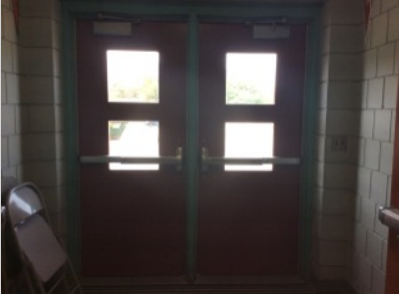
Illuminated exit sign not provided Tactile exit sign not provided Threshold > 1/2" high	- - 2"	Ensure illuminated exit signs contain the International Symbol of Accessibility (ISA). Ensure tactile exit signs with raised characters and braille are provided at exit doors. Mount signs between 48"- 60" above finished floor located on the latch side of the door. Alter threshold to be 1/2" high max.	1	487	\$487

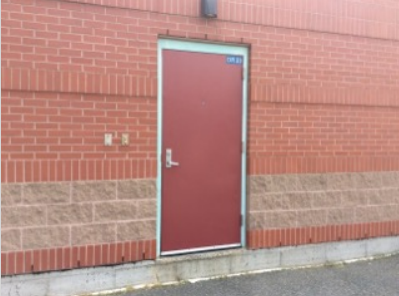
Tactile exit sign not provided Emergency exit not on an accessible route	- -	Ensure tactile exit signs with raised characters and braille are provided at the interior of exit doors. Mount signs between 48"- 60" above finished floor located on the latch side of the door. Provide a directional sign inside indicating the location of the nearest accessible emergency exit.	1	348	\$348
32	Library Exits 4	1		Means of Egress	N/A

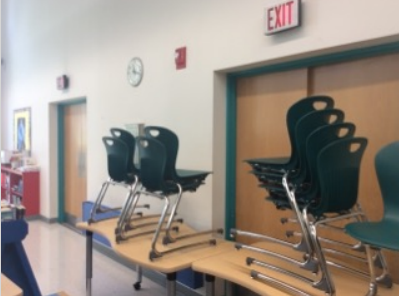
Tactile exit sign not provided Emergency exit not on an accessible route	- -	Ensure tactile exit signs with raised characters and braille are provided at exit doors. Mount signs between 48"- 60" above finished floor located on the latch side of the door. Provide a directional sign indicating the location of the nearest accessible emergency exit.	1	348	\$348

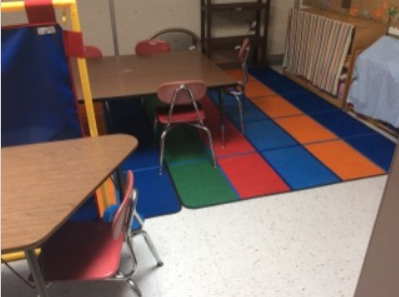
Mat not securely attached		Ensure mats in classrooms throughout the school are securely attached.	6	Labor	\$0
35	OT/PT Room	1	125	Interior Access Route	N/A

clear width required. Additionally, mats throughout the school are not securely attached and act as tripping hazards.

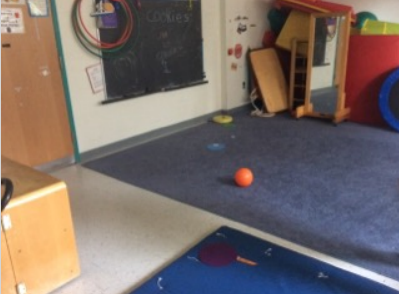
Mat not securely attached	-	Securely attach mat.	1	Labor	\$0

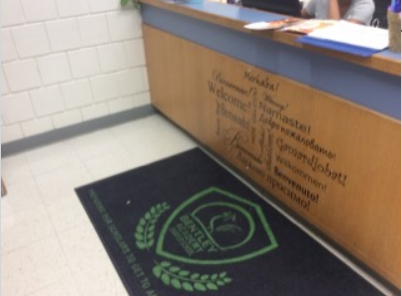
Mat not securely attached	-	Securely attach mat.	1	Labor	\$0
37	Reading Specialist	1	132	Interior Access Route	N/A

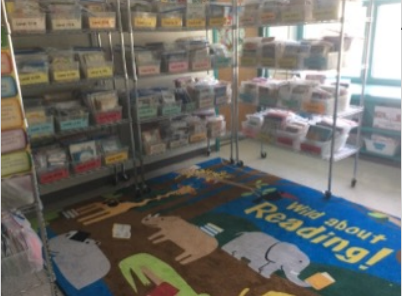
Mat not securely attached	-	Securely attach mat.	1	Labor	\$0
Doors, Doorways, & Gates												
38	OT/PT Room Office	1	125	Doors, Doorways, & Gates	Office

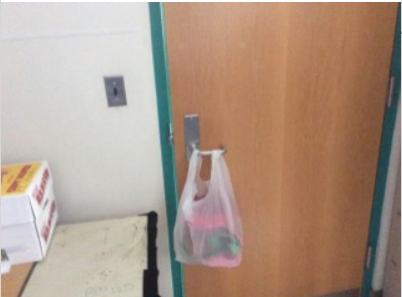
Maneuvering clearance(s) not provided	-	Relocate furniture.	1	Labor	\$0
39	Music Room	1	120	Doors, Doorways, & Gates	Classroom

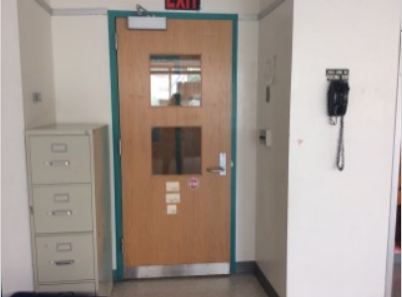
Maneuvering clearance not provided at recess > 8"	29"	Install an automatic door opener.	1	2295	\$2295
40	Classroom	2	219	Doors, Doorways, & Gates	Classroom

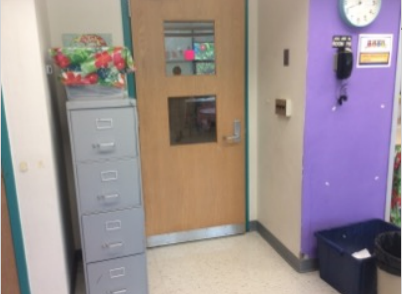
Maneuvering clearance not provided at recess > 8"	29"	Install an automatic door opener.	1	2295	\$2295

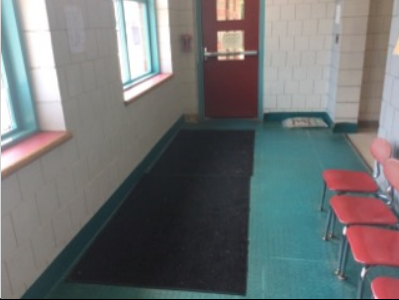
Mat not securely attached	-	Securely attach mat.	2	Labor	\$0
42	Exit #6	1		Doors, Doorways, & Gates	Emergency Egress

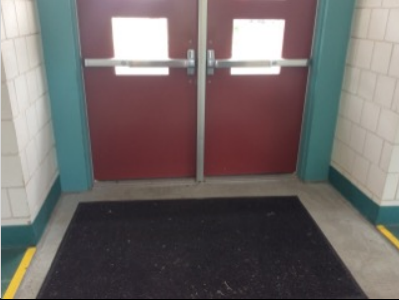
Mat not securely attached	-	Securely attach mat.	1	Labor	\$0
Signage												
43	City Connects Coordinator	1	123	Signage	Designation

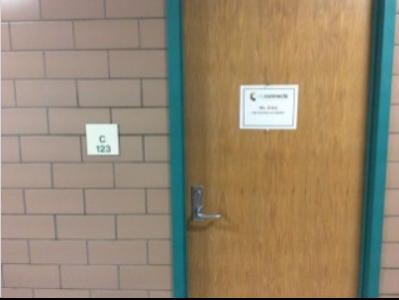
Raised characters not provided Braille not provided	- -	Provide text with raised characters duplicated in braille.	1	174	\$174
44	EOC Office	1	106	Signage	Designation

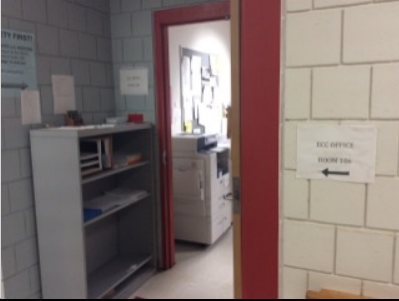
Raised characters not provided Braille not provided Sign not located on the latch side of the door	- - -	Provide text with raised characters duplicated in braille. Locate sign at permanent rooms alongside the door on the latch side.	1	174 Labor	\$174
45	Main Office	1		Signage	Designation

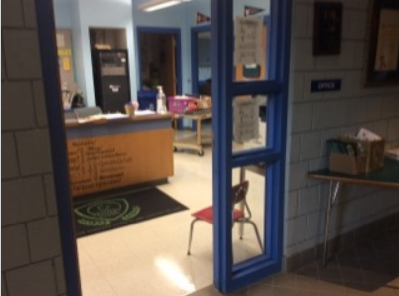
Braille not provided	-	Provide braille.	1	174	\$174

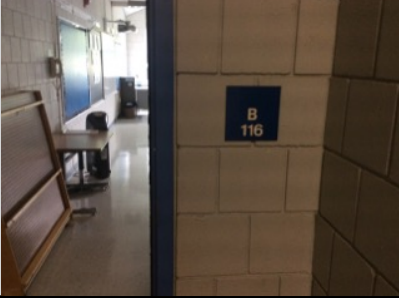
Braille not provided	-	Provide braille.	44	174	\$7656
50	Boys' Toilet Room in Classroom	1	B115	Signage	Designation

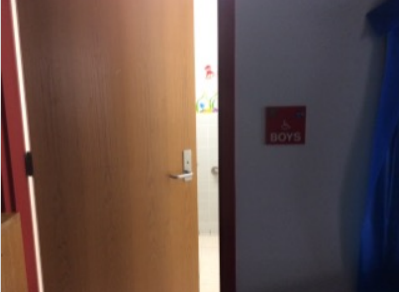
Braille not provided	-	Provide braille.	1	174	\$174

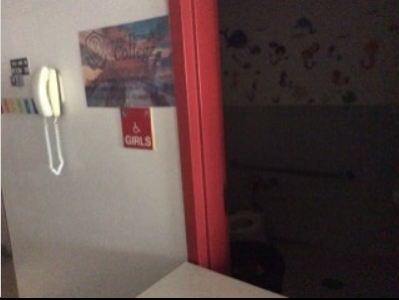
Braille not provided	-	Provide braille.	1	174	\$174
52	Health Office	1	127	Signage	Designation

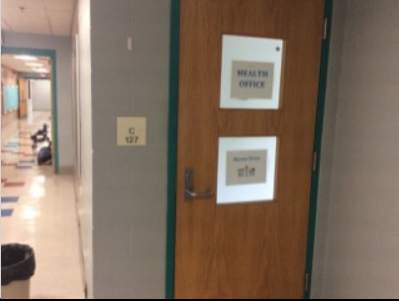
Braille not provided	-	Provide braille.	1	174	\$174
53	Chairperson's Office	1	129	Signage	Designation

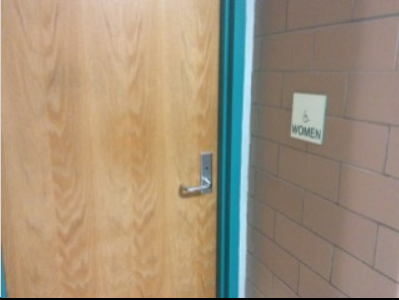
Braille not provided	-	Provide braille.	1	174	\$174
55	Men's Toilet Room Near Library	1		Signage	Designation

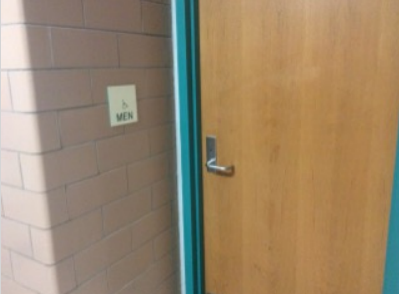
Braille not provided	-	Provide braille.	1	174	\$174

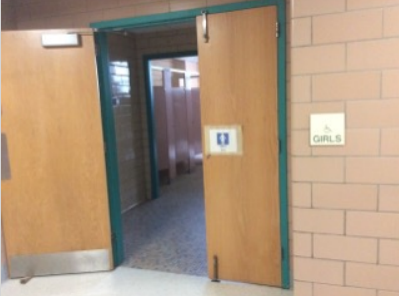
Braille not provided	-	Provide braille.	1	174	\$174
57	Reading Specialist	1	132	Signage	Designation

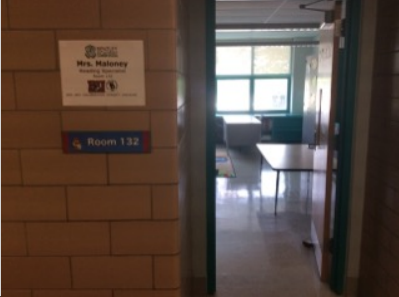
Braille not provided	-	Provide braille.	1	174	\$174
58	Health Office	1	119	Signage	Designation

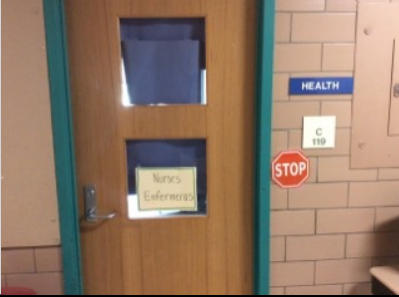
Braille not provided	-	Provide braille.	1	174	\$174
59	Music Room	1	120	Signage	Designation

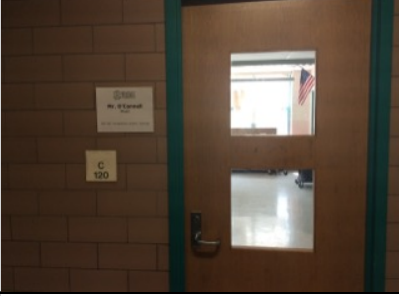
Braille not provided	-	Provide braille.	1	174	\$174
60	Art Room	2	217	Signage	Designation

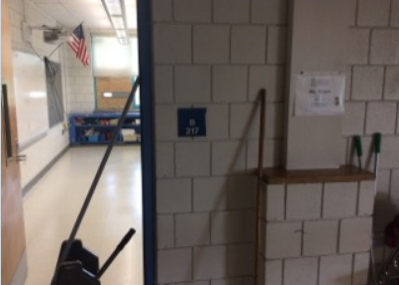
Braille not provided	-	Provide braille.	1	174	\$174

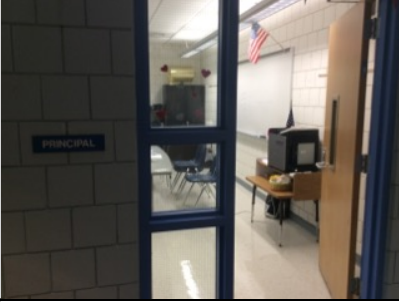
ID	Location	Floor	Room	Element	Type	Photo	Issues	Current Measure	Recommendations	Quantity	Price	Cost Estimation
61	Principal's Office	1		Signage	Designation

Braille not provided Sign not located on the latch side of the door	- -	Provide braille. Locate sign at permanent rooms alongside the door on the latch side.	1	174 Labor	\$174
62	Boys' Multi-User Toilet Room Near Library	1		Signage	Designation

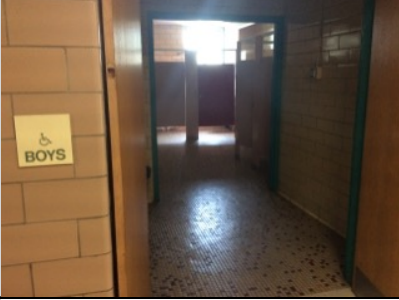
Braille not provided Sign not located on the latch side of the door	- -	Provide braille. Locate sign at permanent rooms alongside the door on the latch side.	1	174 Labor	\$174
63	Girls' Multi-User Toilet Room Second Floor	2		Signage	Designation

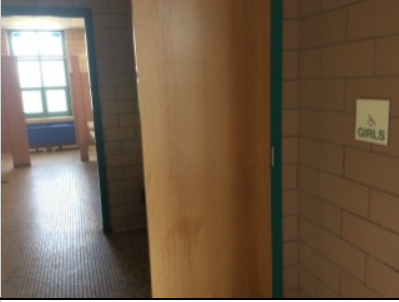
Braille not provided Sign not located on the latch side of the door	- -	Provide braille. Locate sign at permanent rooms alongside the door on the latch side.	1	174 Labor	\$174
64	Girls' Toilet Room in Gym	1		Signage	Designation

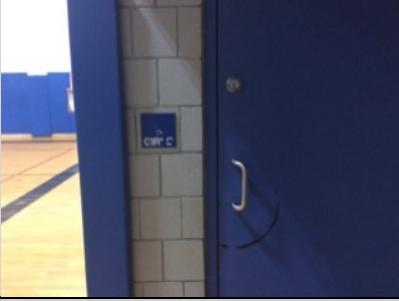
Braille not provided International Symbol of Acc. not compliant	- -	Provide braille. Replace sign with a sign containing the International Symbol of Accessibility.	1	174	\$174

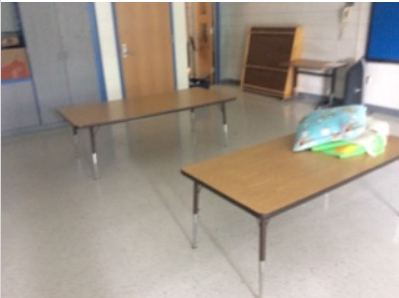
Dining or Work Surfaces												
65	Classrooms Throughout School	1		Dining or Work Surfaces	Work Surface

Knee or toe clearance not provided	21"	Adjust at least 1 work surface per classroom per grade to provide 25" min. knee and toe clearance.	6	Labor	\$0

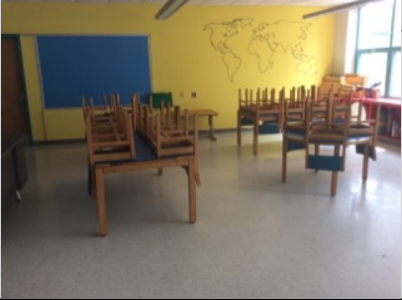
ID	Location	Floor	Room	Element	Type	Photo	Issues	Current Measure	Recommendations	Quantity	Price	Cost Estimation
66	Music Room	1	120	Dining or Work Surfaces	Work Surface

Knee or toe clearance not provided	23"	Provide at least 1 work surface with 25" min. knee and toe clearance.	1	525	\$525
Picnic Tables												
67	Near Playground West Side	Ext.		Picnic Tables	N/A

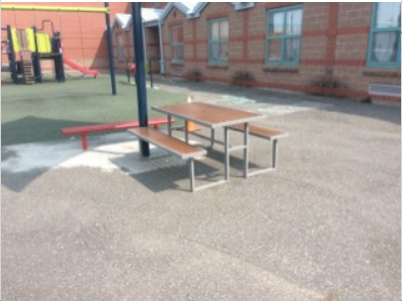
At least 5% accessible spaces not provided	-	Ensure that at least 5% (minimum one) of dining surfaces are accessible.	1	1050	\$1050
Toilet & Bathing Rooms												
Lavatory												
68	Women's Toilet Room Near Library	1		Lavatory	N/A

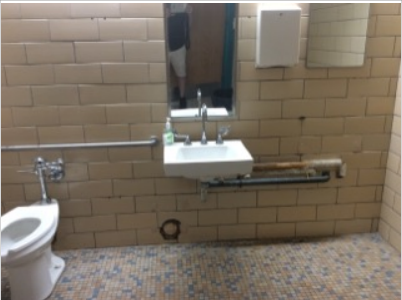
Plumbing underneath is exposed	-	Insulate or otherwise configure pipes to prevent contact, for at least one lavatory.	1	69	\$69
69	Men's Toilet Room Near Library	1		Lavatory	N/A

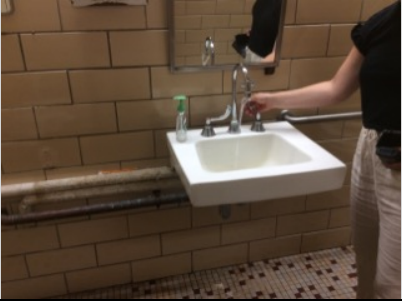
Plumbing underneath is exposed	-	Insulate or otherwise configure pipes to prevent contact, for at least one lavatory.	1	69	\$69

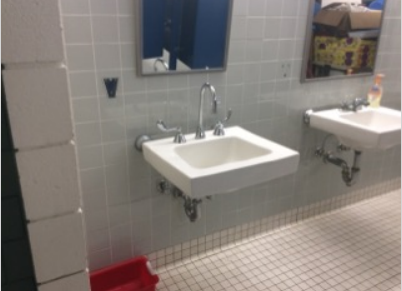
70	Girls' and Boys' Toilet Rooms in Gym	1		Lavatory	N/A

Plumbing underneath is exposed Mirror above lavatory w/reflective surface > 40"	- 42"	Insulate or otherwise configure pipes to prevent contact, for at least one lavatory. Lower mirror so that the bottom surface is at 40" max. above finished floor.	2	261	\$522

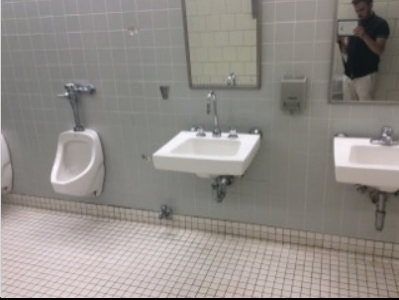
ID	Location	Floor	Room	Element	Type	Photo	Issues	Current Measure	Recommendations	Quantity	Price	Cost Estimation
71	Men's Toilet Room Near Main Entrance	1		Lavatory	N/A

Plumbing underneath is exposed Mirror above lavatory w/reflective surface > 40"	- 42"	Insulate or otherwise configure pipes to prevent contact, for at least one lavatory. Lower mirror so that the bottom surface is at 40" max. above finished floor.	1	261	\$261
72	Women's Toilet Room Near Main Entrance	1		Lavatory	N/A

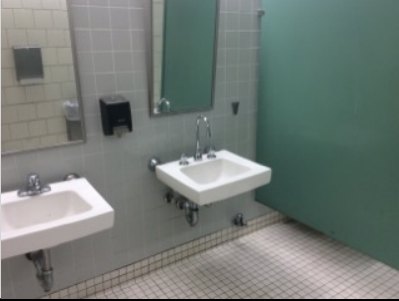
Plumbing underneath is exposed Mirror above lavatory w/reflective surface > 40"	- 42"	Insulate or otherwise configure pipes to prevent contact, for at least one lavatory. Lower mirror so that the bottom surface is at 40" max. above finished floor.	1	261	\$261
73	Girls' Multi-User Toilet Room Near Library	1		Lavatory	N/A

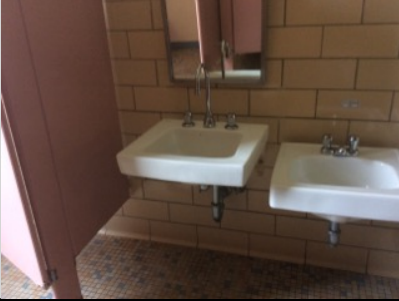
Plumbing underneath is exposed Mirror above lavatory w/reflective surface > 40"	- 42"	Insulate or otherwise configure pipes to prevent contact, for at least one lavatory. Lower mirror so that the bottom surface is at 40" max. above finished floor.	1	261	\$261

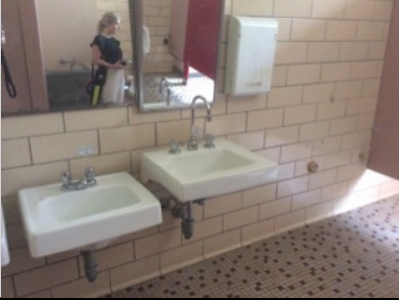
74	Boys' Multi-User Toilet Room Near Library	1		Lavatory	N/A

Plumbing underneath is exposed Mirror above lavatory w/reflective surface > 40"	- 42"	Insulate or otherwise configure pipes to prevent contact, for at least one lavatory. Lower mirror so that the bottom surface is at 40" max. above finished floor.	1	261	\$261
75	Girls' Multi-User Toilet Room Second Floor	2		Lavatory	N/A
