City of Salem, Massachusetts

PART A – Executive Summary

Part A – Executive Summary

Introduction

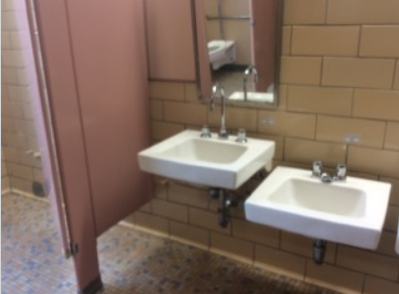
Plumbing underneath is exposed Mirror above lavatory w/reflective surface > 40"	- 42"	Insulate or otherwise configure pipes to prevent contact, for at least one lavatory. Lower mirror so that the bottom surface is at 40" max. above finished floor.	1	261	\$261
75	Girls' Multi-User Toilet Room Second Floor	2		Lavatory	N/A

Plumbing underneath is exposed Mirror above lavatory w/reflective surface > 40"	- 43"	Insulate or otherwise configure pipes to prevent contact, for at least one lavatory. Lower mirror so that the bottom surface is at 40" max. above finished floor.	1	261	\$261

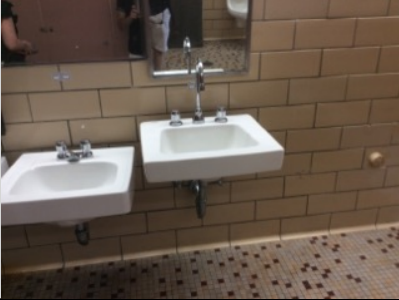
ID	Location	Floor	Room	Element	Type	Photo	Issues	Current Measure	Recommendations	Quantity	Price	Cost Estimation
76	Boys' Multi-User Toilet Room Second Floor	2		Lavatory	N/A

Plumbing underneath is exposed Mirror above lavatory w/reflective surface > 40"	- 43"	Insulate or otherwise configure pipes to prevent contact, for at least one lavatory. Lower mirror so that the bottom surface is at 40" max. above finished floor.	1	261	\$261
Single-User Toilet												
77	Women's Toilet Room Near Library	1		Single-User Toilet	N/A

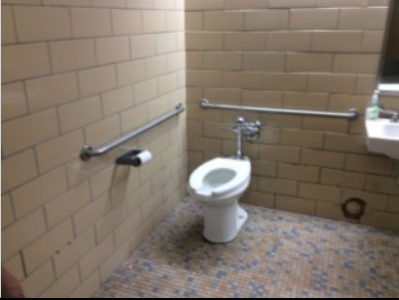
Flush control not on open side	-	Relocate the flush control to the open/transfer side.	1	281	\$281
Toilet Compartment												
78	Girls' and Boys' Toilet Rooms in Gym	1		Toilet Compartment	Accessible Compartment

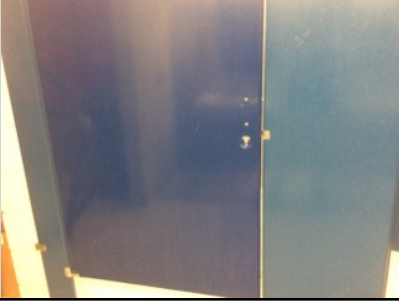
Door has non-compliant hardware	-	Provide hardware that can be operable with one hand and not require tight grasping, pinching, or twisting of the wrist.	2	18	\$36

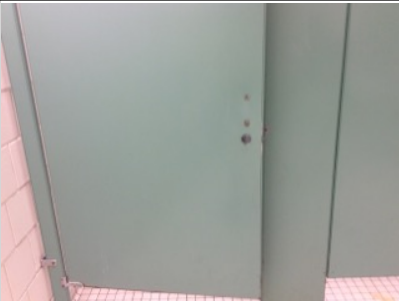
79	Men's Toilet Room Near Main Entrance	1		Toilet Compartment	Accessible Compartment

Door has non-compliant hardware	-	Provide hardware that can be operable with one hand and not require tight grasping, pinching, or twisting of the wrist.	1	18	\$18
80	Girls' and Boys' Multi-User Toilet Rooms Second Floor	2		Toilet Compartment	Accessible Compartment

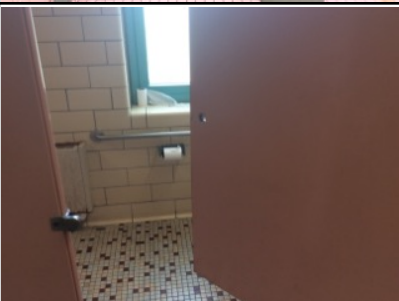
Door has non-compliant hardware	-	Provide hardware that can be operable with one hand and not require tight grasping, pinching, or twisting of the wrist.	1	18	\$18

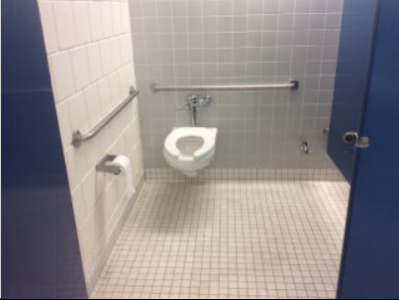
ID	Location	Floor	Room	Element	Type	Photo	Issues	Current Measure	Recommendations	Quantity	Price	Cost Estimation
81	Girls' and Boys' Toilet Rooms in Gym	1		Toilet Compartment	Accessible Compartment

Toilet seat <17" or > 19" high Side or rear grab bar < 33" or >36" high Flush control not on open side	21" 31" -	Install a toilet with a seat height 17"- 19" above the floor. Locate grab bars between 33"- 36" above the finished floor. Provide the flush control on the open side of the toilet (transfer side).	2	2098	\$4196
82	Boys' Multi-User Toilet Room Near Library	1		Toilet Compartment	Accessible Compartment

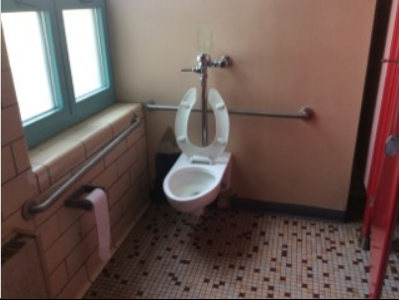
Side or rear grab bar < 33" or >36" high Flush control not on open side	29" -	Locate grab bars between 33"- 36" above the finished floor. Provide the flush control on the open side of the toilet (transfer side).	1	473	\$473
83	Boys' Multi-User Toilet Room Second Floor	2		Toilet Compartment	Accessible Compartment

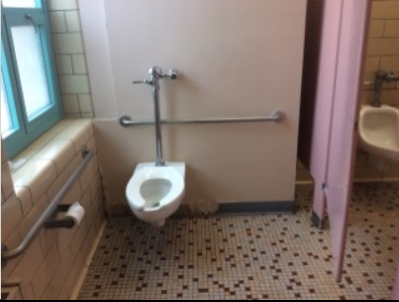
Side or rear grab bar < 33" or >36" high Flush control not on open side	29" -	Locate grab bars between 33"- 36" above the finished floor. Provide the flush control on the open side of the toilet (transfer side).	1	473	\$473

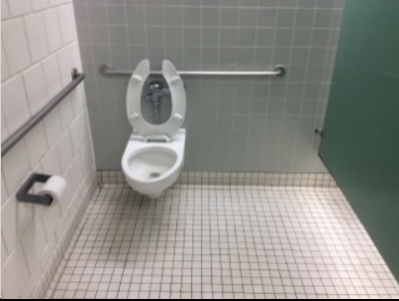
84	Men's Toilet Room Near Main Entrance	1		Toilet Compartment	Accessible Compartment

Flush control not on open side	-	Provide the flush control on the open side of the toilet (transfer side).	1	281	\$281
Urinal												
85	Boys' Multi-User Toilet Room Near Library	1		Urinal	N/A

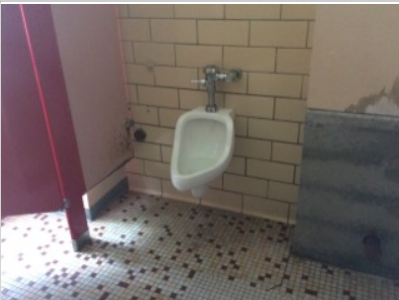
Rim > 15" high (MAAB)	20"	Provide at least one urinal with the rim no higher than 15" above the finished floor.	1	2436	\$2436

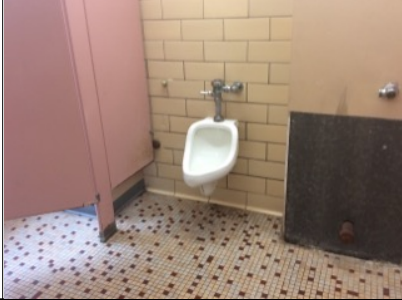
ID	Location	Floor	Room	Element	Type	Photo	Issues	Current Measure	Recommendations	Quantity	Price	Cost Estimation
86	Boys' Multi-User Toilet Room Second Floor	2		Urinal	N/A

Rim > 15" high (MAAB)	20"	Provide at least one urinal with the rim no higher than 15" above the finished floor.	1	2436	\$2436
Toilet Rooms for Children												
Single-User Toilet												
87	Girls' Toilet Room in Classroom	1	B115	Single-User Toilet	N/A

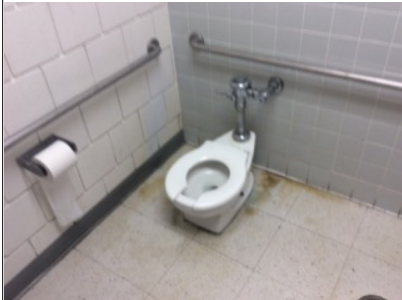
Flush control not on open side Centerline < or > 11" (Pre-K) Side or rear grab bar < 18" or > 20" high (Pre-K)	- 19" 25"	Move the flush control to the open/transfer side. Mount flush control between 20" - 30" above the floor. Relocate toilet so that the centerline is 11" from the side wall. Locate grab bar between 18"- 20" above the floor.	1	2594	\$2594
88	Boys' Toilet Room in Classroom	1	B115	Single-User Toilet	N/A

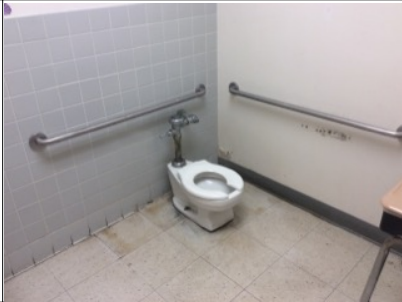
Centerline < or > 11" (Pre-K) Side or rear grab bar < 18" or > 20" high (Pre-K)	19" 25"	Relocate toilet so that the centerline is 11" from the side wall. Locate grab bar between 18"- 20" above the floor.	1	2313	\$2313

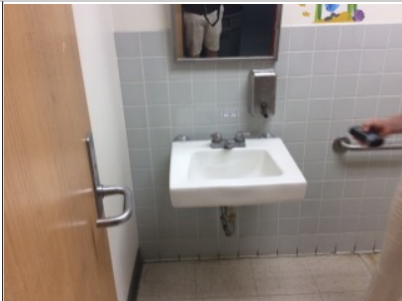
Lavatory												
89	Boys' Toilet Room in Classroom	1	B115	Lavatory	N/A

Exposed plumbing underneath Mirror above lavatory w/reflective surface > 31"	- 43"	Insulate or otherwise configure pipes to prevent contact, for at least one lavatory. Lower mirror so that the bottom surface is at 31" above finished floor.	1	261	\$261
90	Girls' Toilet Room in Classroom	1	B115	Lavatory	N/A

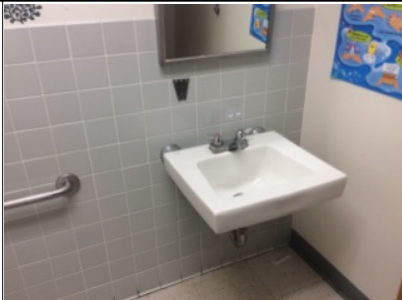
Exposed plumbing underneath Mirror above lavatory w/reflective surface > 31"	- 41"	Insulate or otherwise configure pipes to prevent contact, for at least one lavatory. Lower mirror so that the bottom surface is at 31" above finished floor.	1	261	\$261

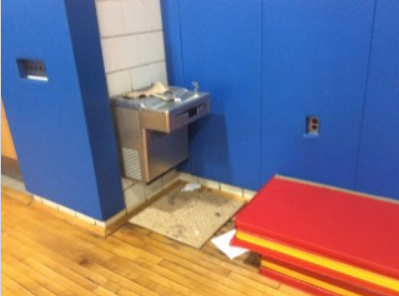
ID	Location	Floor	Room	Element	Type	Photo	Issues	Current Measure	Recommendations	Quantity	Price	Cost Estimation
Additional Access												
Drinking Fountains												
91	Gym	1		Drinking Fountains	Low

Clear floor space not provided No drinking fountain provided for standing users	- -	Provide a 30" by 48" clear floor space positioned for a forward approach by removing clutter. Provide an additional drinking fountain for standing users or install a Hi-Lo drinking fountain.	1	Labor 3021	\$3021
92	Near Main Entrance	1		Drinking Fountains	Low

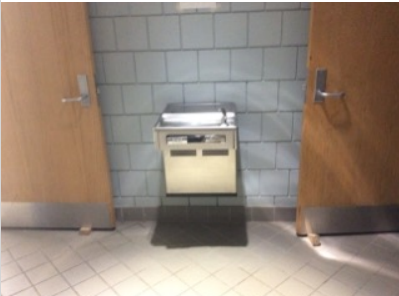
No drinking fountain provided for standing users	-	Provide an additional drinking fountain for standing users or install a Hi-Lo drinking fountain.	1	3021	\$3021
93	Near Room 110	1		Drinking Fountains	Low

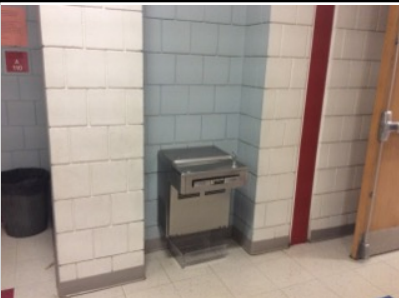
No drinking fountain provided for standing users	-	Provide an additional drinking fountain for standing users or install a Hi-Lo drinking fountain.	1	3162	\$3162

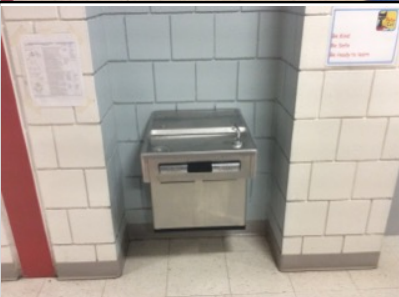
94	Near Early Childhood Center Office	1		Drinking Fountains	Low

No drinking fountain provided for standing users	-	Provide an additional drinking fountain for standing users or install a Hi-Lo drinking fountain.	1	3162	\$3162
95	Near Library	1		Drinking Fountains	Low

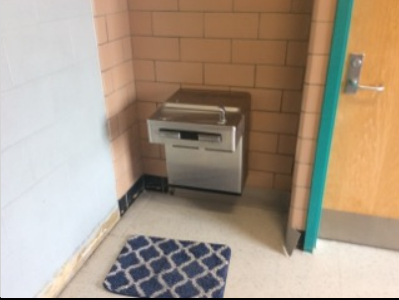
ID	Location	Floor	Room	Element	Type	Photo	Issues	Current Measure	Recommendations	Quantity	Price	Cost Estimation
96	Near Toilet Rooms on Second Floor	2		Drinking Fountains	Low

No drinking fountain provided for standing users	-	Provide an additional drinking fountain for standing users or install a Hi-Lo drinking fountain.	1	3162	\$3162
Sink												
97	Health Office	1	119	Sink	N/A

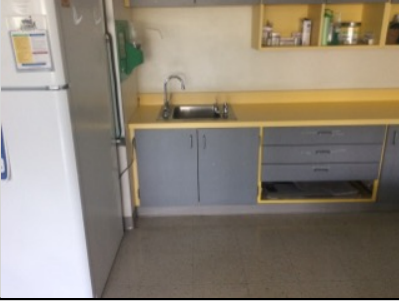
Toe and knee clearances not provided	-	Ensure there is a 27" knee clearance positioned for a forward approach.	1	1265	\$1265
Sinks for Children's Use												
98	Music Room	1	120	Sinks for Children's Use	Classroom

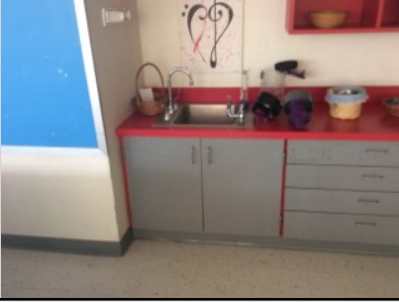
Knee or toe clearance not provided	-	Provide at least one sink with 25" knee and toe clearance positioned for a forward approach.	1	1265	\$1265
Play and Sport Areas												
Play Areas												
99	Kindergarten Playground	Ext.		Play Areas	N/A

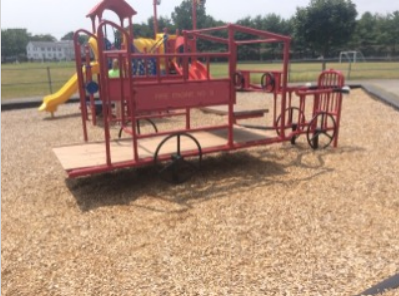
Accessible route not provided to ground level play components Not connected to an accessible route	- -	Ensure an accessible route is provided to one of each type of ground level play components Provide an accessible route to and around play areas. (Cost based on 80' by 5' wide poured in place rubber routes to play components.)	1	8400	\$8400

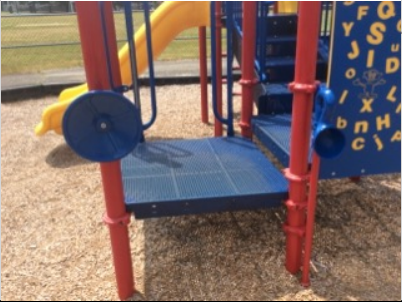
No compliant transfer system	-	Alteration might be technically infeasible.	1	-	\$0
101	Kindergarten Playground	Ext.		Play Areas	N/A

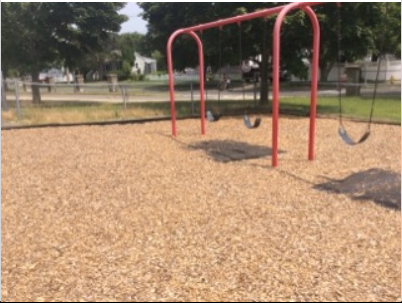
Not connected to an accessible route Accessible route not provided to ground level play components	- -	Ensure an accessible route is provided to swings. Provide an accessible route to play areas. (Cost based on 115' by 4' wide asphalt around play area and 55' by 5' wide poured in place rubber route to swings.)	1	8708	\$8708

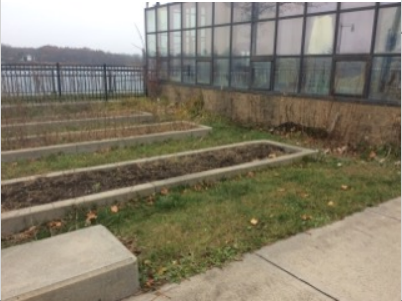
Accessible route not provided	-	Ensure an accessible route is provided. (Cost based on 45' by 4' wide stone dust path to and around community garden.)	1	1080	\$1080
Off-Street Parking Lot or Garage												
2	Parking Lot	Ext.		Off-Street Parking Lot or Garage	N/A

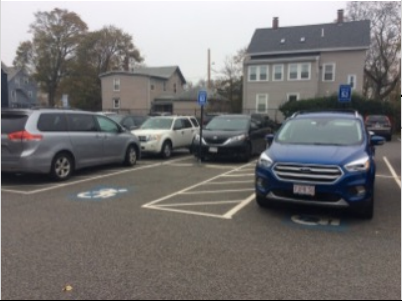
Total # of parking Total # of designated accessible parking spaces Sign does not have the designation "Van Accessible" Total # of designated van accessible spaces	50 2 1 -	Add the designation "Van Accessible" to the sign located at the van accessible space.	1	375	\$375
Entrance												
3	Main Entrance	Ext.		Entrance	Main Entrance

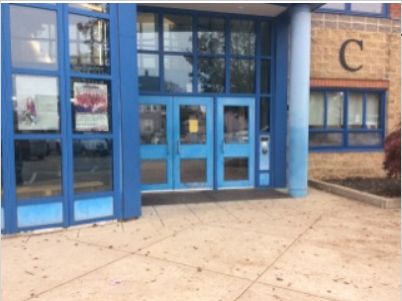
Mat not securely attached Automatic door opener not operable	- -	Securely attach mat. Ensure automatic door opener is on and maintained in operable working condition.	1	Labor	\$0

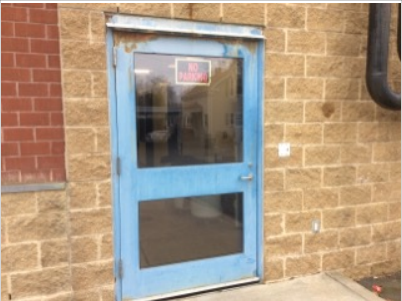
Illuminated exit sign not provided	-	Ensure illuminated exit sign on the interior of the door contains the International Symbol of Accessibility (ISA).	1	150	\$150

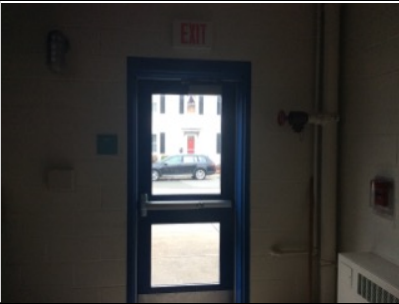
Illuminated exit sign not provided	-	Ensure illuminated exit signs contain the International Symbol of Accessibility (ISA).	1	150	\$150
6	Exit #3 in Kindergarten Classroom	1	109	Means of Egress	N/A

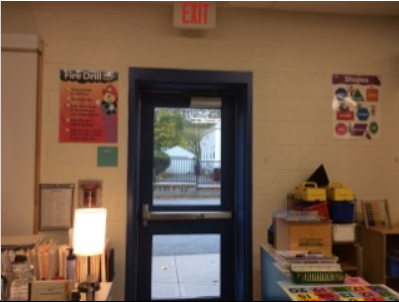
Illuminated exit sign not provided	-	Ensure illuminated exit signs contain the International Symbol of Accessibility (ISA).	1	150	\$150
7	Exit #2 in Kindergarten Classroom	1	102	Means of Egress	N/A

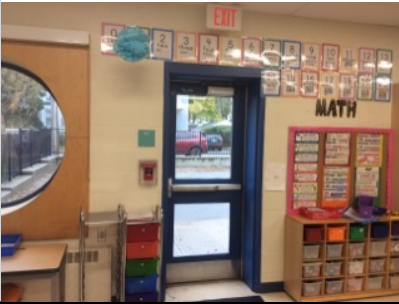
Illuminated exit sign not provided	-	Ensure illuminated exit signs contain the International Symbol of Accessibility (ISA).	1	150	\$150
8	Exit #5 in Greenhouse	1		Means of Egress	N/A

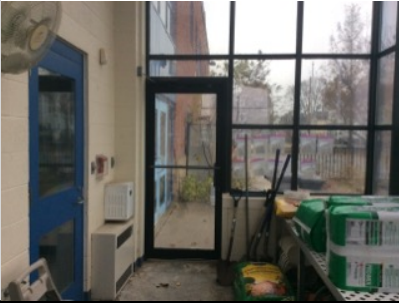
Illuminated exit sign not provided Tactile exit sign not provided	- -	Ensure illuminated exit signs are provided at exits and exit doors. Ensure it contains the International Symbol of Accessibility (ISA). Ensure tactile exit signs with raised characters and braille are provided at exit doors. Mount signs between 48"- 60" above finished floor located on the latch side of the door.	1	324	\$324

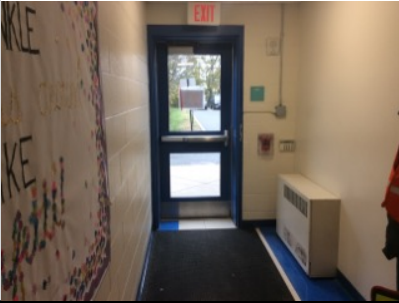
9	Exit #11	1		Means of Egress	N/A

Illuminated exit sign not provided Mat not securely attached	- -	Ensure illuminated exit signs contain the International Symbol of Accessibility (ISA). Securely attach mat.	1	150	\$150

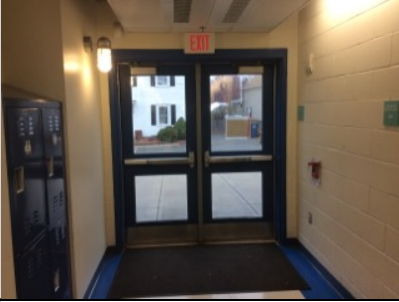
Illuminated exit sign not provided Mat not securely attached	- -	Ensure illuminated exit signs contain the International Symbol of Accessibility (ISA). Securely attach mat.	1	150	\$150
11	Exit #4 in Stair #1	1		Means of Egress	N/A

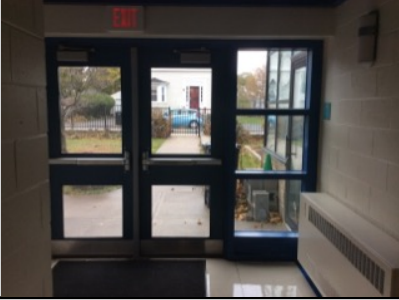
Illuminated exit sign not provided Mat not securely attached	- -	Ensure illuminated exit signs contain the International Symbol of Accessibility (ISA). Securely attach mat.	1	150	\$150
Interior Access Route												
12	Inclusion Classroom	2	260	Interior Access Route	N/A

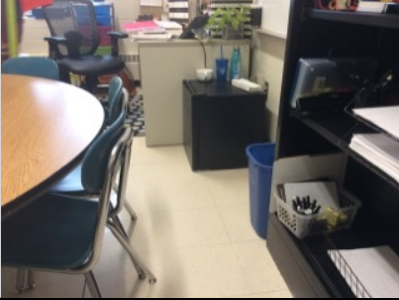
Route < 36" wide	22"	Ensure that a clear width of 36" min. is maintained at the accessible route.	1	Labor	\$0
13	Reading Room	2	261	Interior Access Route	N/A

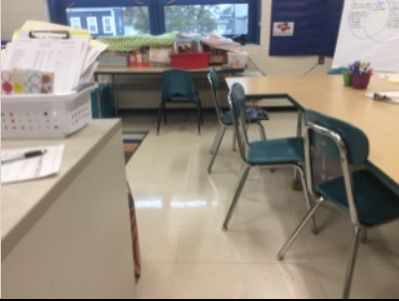
Route < 36" wide	29"	Ensure that a clear width of 36" min. is maintained at the accessible route.	1	Labor	\$0

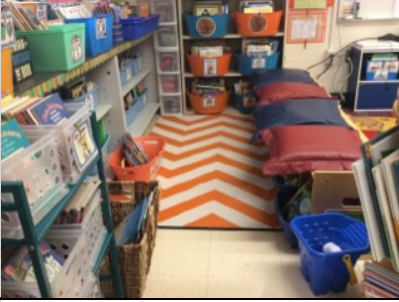
Route < 36" wide Mat not securely attached	26.25" -	Ensure that a clear width of 36" min. is maintained at the accessible route. Securely attach mat.	1	Labor	\$0
16	Main Office	1	164	Interior Access Route	N/A

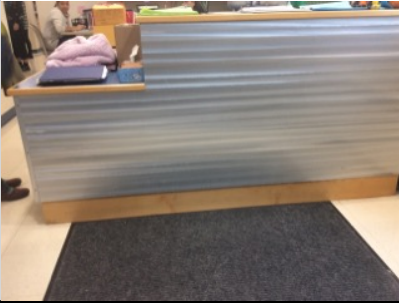
Mat not securely attached	-	Securely attach mat.	1	Labor	\$0
17	Special Education Room	1	175	Interior Access Route	N/A

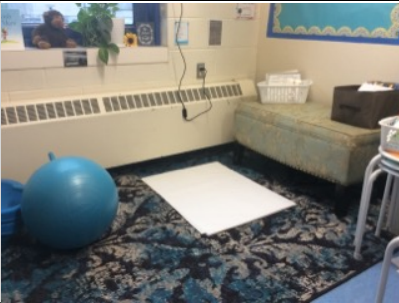
Mat not securely attached	-	Securely attach mat.	1	Labor	\$0
18	Classrooms Throughout the School	1	127, 222	Interior Access Route	N/A

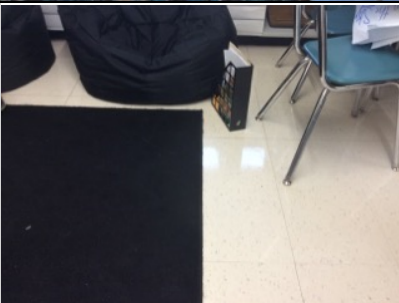
Mat not securely attached	-	Securely attach mats.	2	Labor	\$0
19	Math/Marine Environmental Lab	1	113	Interior Access Route	N/A

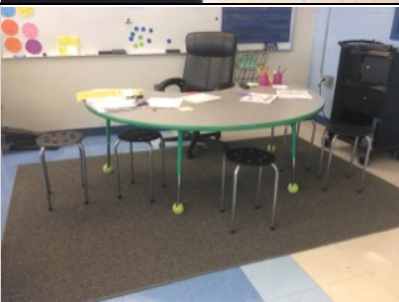
Mat not securely attached	-	Securely attach mat.	1	Labor	\$0

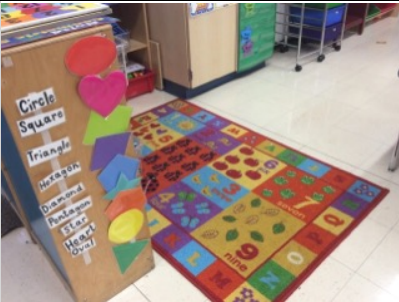
Mat not securely attached	-	Securely attach mat.	4	Labor	\$0
21	Inclusion Classroom	2	260	Interior Access Route	N/A

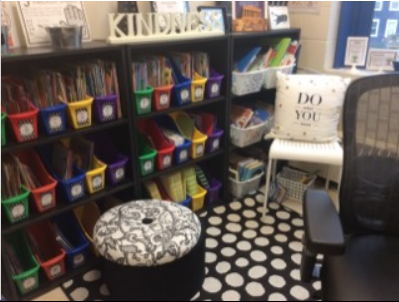
Mat not securely attached	-	Securely attach mat.	1	Labor	\$0
22	Reading Room	2	261	Interior Access Route	N/A

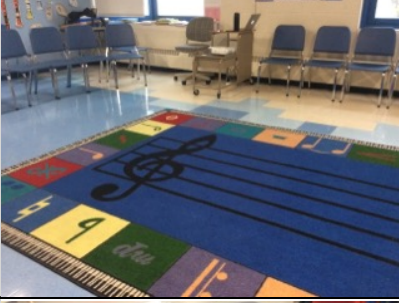
Mat not securely attached	-	Securely attach mat.	1	Labor	\$0
24	Facuty/ FLEX Room	2	235	Interior Access Route	N/A

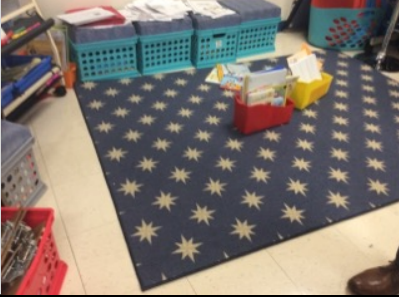
Mat not securely attached	-	Securely attach mat.	1	Labor	\$0

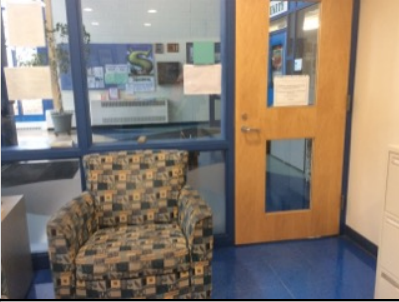
Maneuvering clearance(s) not provided	14.75"	Move chair to the left in this image so as to maintain maneuvering clearance of at least 18" on the pull side of the door.	1	Labor	\$0
26	Health Suite	1	170	Doors, Doorways, & Gates	Office

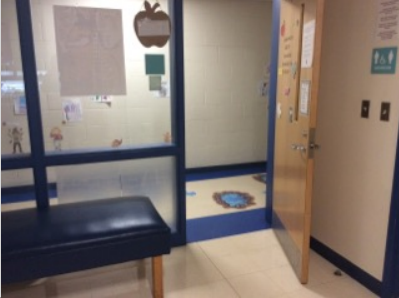
Maneuvering clearance(s) not provided	13.25"	Move bed to the left in this image so as to maintain maneuvering clearance of at least 18" on the pull side of the door.	1	Labor	\$0
27	Health Suite, Bathing Room	1	170	Doors, Doorways, & Gates	Toilet Room

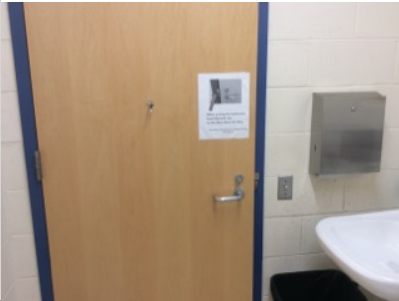
Maneuvering clearance(s) not provided	6"	Provide an automatic door opener.	1	2295	\$2295

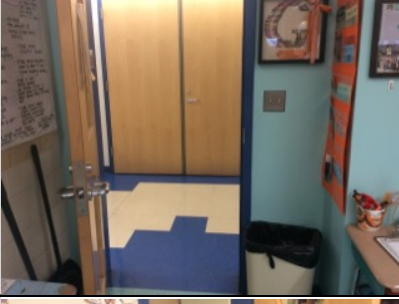
Maneuvering clearance(s) not provided	-	Relocate trash bin.	1	Labor	\$0
33	Kindergarten Classroom	1	109	Doors, Doorways, & Gates	Classroom

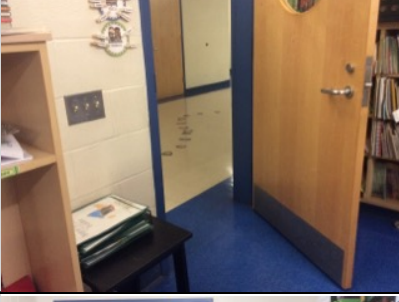
Maneuvering clearance(s) not provided	-	Relocate table.	1	Labor	\$0
34	Speech and Language Room	2	253	Doors, Doorways, & Gates	Office

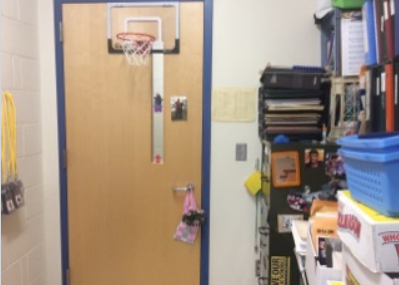
Maneuvering clearance(s) not provided	15.5"	Rearrange room so as to maintain maneuvering clearance of at least 18" on the pull side of the door.	1	Labor	\$0

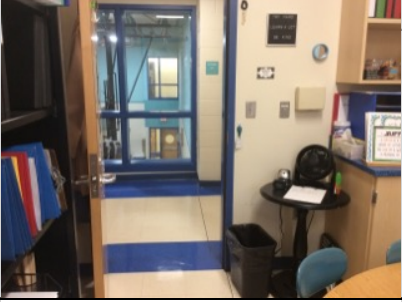
Maneuvering clearance(s) not provided	-	Relocate clutter so as to maintain maneuvering clearance of at least 18" on the pull side of the door.	1	Labor	\$0
36	Reading Room	2	261	Doors, Doorways, & Gates	Classroom

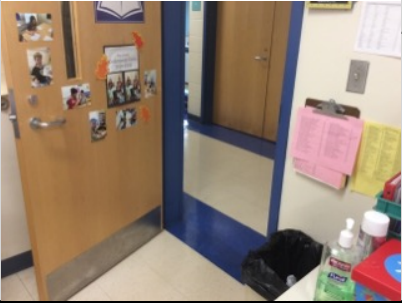
Maneuvering clearance(s) not provided	-	Rearrange room so as to maintain maneuvering clearance of at least 18" on the pull side of the door.	1	Labor	\$0
37	Literacy Coach	2	262	Doors, Doorways, & Gates	Classroom

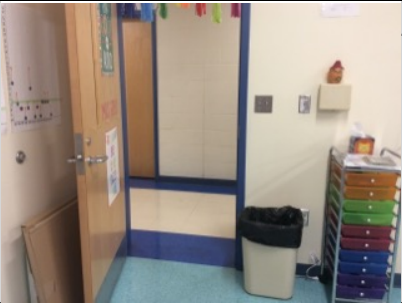
Maneuvering clearance(s) not provided	-	Relocate trash bin and storage bin.	1	Labor	\$0
38	OT Room	2	264	Doors, Doorways, & Gates	Classroom

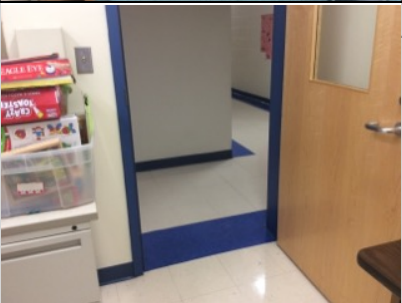
Maneuvering clearance(s) not provided	-	Rearrange room so as to maintain maneuvering clearance of at least 18" on the pull side of the door.	1	Labor	\$0

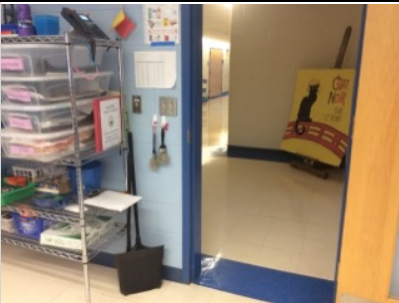
Maneuvering clearance(s) not provided	14.5"	Rearrange room so as to maintain maneuvering clearance of at least 18" on the pull side of the door.	1	Labor	\$0
42	Distance Learning Room	2	206	Doors, Doorways, & Gates	Classroom

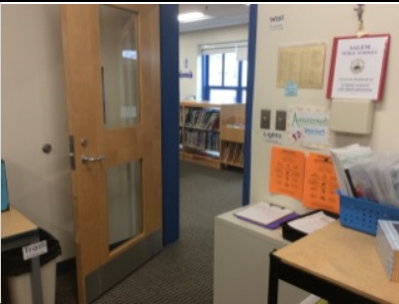
Maneuvering clearance(s) not provided	-	Rearrange room so as to maintain maneuvering clearance of at least 18" on the pull side of the door.	1	Labor	\$0
43	Music Room	2	270	Doors, Doorways, & Gates	Classroom

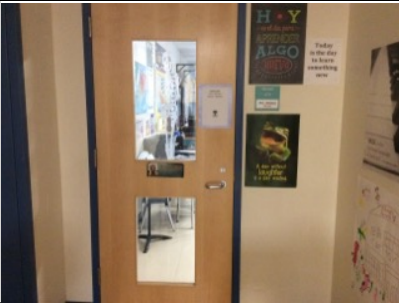
Door requires > 5 lbs. of force to open	11 lbs.	Adjust closers so doors do not require more than 5 pounds of force to open.	1	Labor	\$0

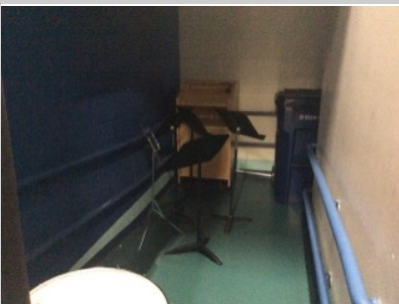
Not maintained in operable working condition	-	Ensure the ramp is maintained in operable working condition by remove stored items from ramp.	1	Labor	\$0

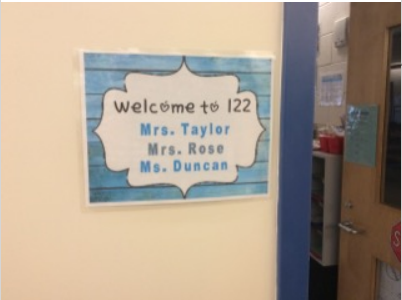
Raised characters not provided Braille not provided	- -	Provide text with raised characters duplicated in braille.	1	174	\$174
46	All Gender Toilet Room Near 223	2		Signage	Designation

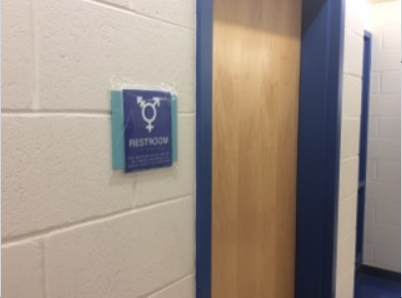
Raised characters not provided Braille not provided International Symbol of Acc. not compliant	- - -	Provide text with raised characters duplicated in braille for All Gender toilet room sign. Provide sign with raised characters and braille containing the International Symbol of Accessibility (ISA).	2	174	\$348
47	Practice Room in Music Room	2	272	Signage	Designation

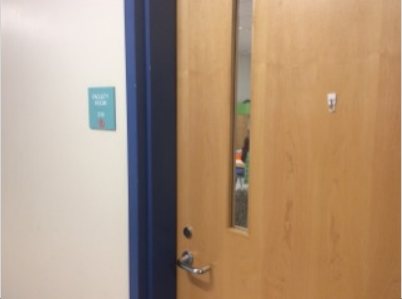
48	Faculty/ FLEX Room	2	235	Signage	Designation

Designation sign does not reflect current use		Provide accurate designation sign with raised characters and braille mounted on the latch side of the door. (Designation sign does not reflect long term use of room. It reads "Faculty", but the room is being used as a classroom for multiple grades.)	1	174	\$174
Operable Parts												
49	Near Main Entrance	Ext.		Operable Parts	Other

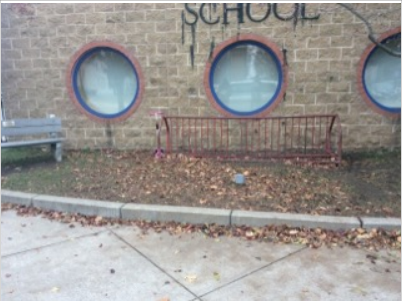
Element not on an accessible route	-	Ensure bike rack is located on an accessible route.	1	Labor	\$0

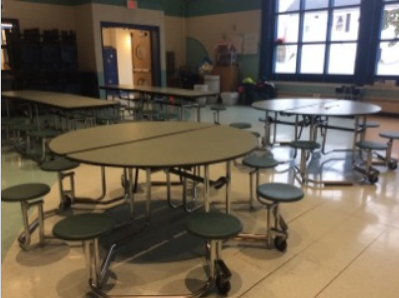
At least one or 5% accessible tables not provided	-	Ensure that at least one dining surface is accessible.	1	825	\$825
51	Grades 1 and 2 Classroom	1	127, 222	Dining or Work Surfaces	Work Surface

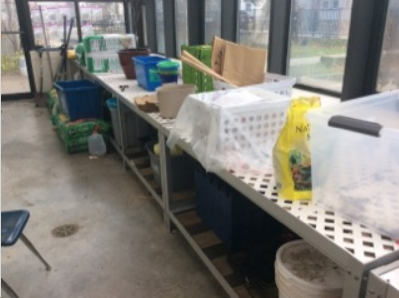
Knee or toe clearance not provided	-	Provide at least 1 work surface with 24" min. knee and toe clearance.	1	525	\$525
53	Kindergarten Classroom	1	109	Dining or Work Surfaces	Work Surface

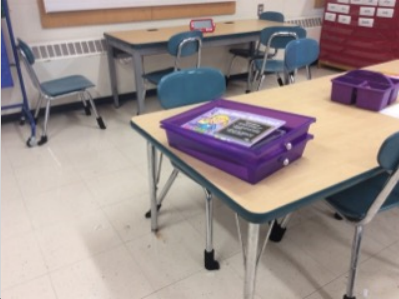
Knee or toe clearance not provided	19.75"	Adjust at least 1 work surface so that it has 24" min. knee and toe clearance.	1	Labor	\$0

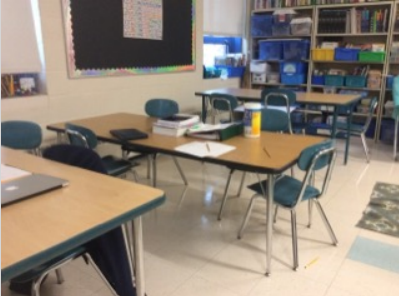
54	Small Classroom	2	252	Dining or Work Surfaces	Work Surface

Knee or toe clearance not provided	22.25"	Adjust at least 1 work surface so that it has 24" min. knee and toe clearance.	1	Labor	\$0

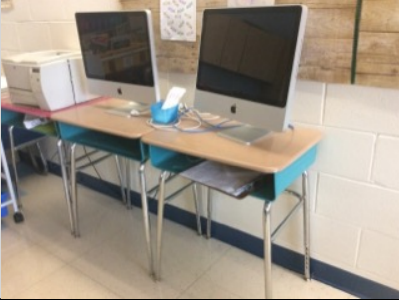
ID	Location	Floor	Room	Element	Type	Photo	Issues	Current Measure	Recommendations	Quantity	Price	Cost Estimation
55	Grades 4 and 5 Classroom	2	227	Dining or Work Surfaces	Work Surface

Knee or toe clearance not provided	23"	Provide at least 1 work surface with 24" min. knee and toe clearance.	1	525	\$525
56	Reading Area in Library	2	205	Dining or Work Surfaces	Work Surface

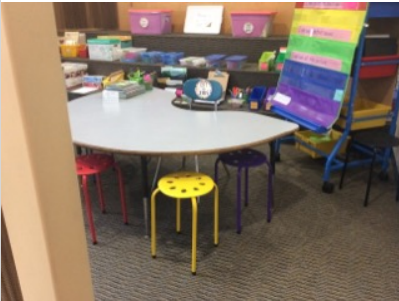
Knee or toe clearance not provided	23"	Adjust at least 1 work surface so that it has 24" min. knee and toe clearance.	1	Labor	\$0
Benches												
57	Near Main Entrance	Ext.		Benches	N/A

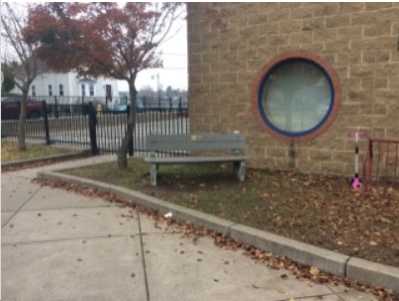
No accessible route to 20% of benches	-	Relocate 20% of benches (1) to an accessible route.	1	Labor	\$0
Toilet & Bathing Rooms												
Lavatory												
58	Men's Staff Toilet Room	1		Lavatory	N/A

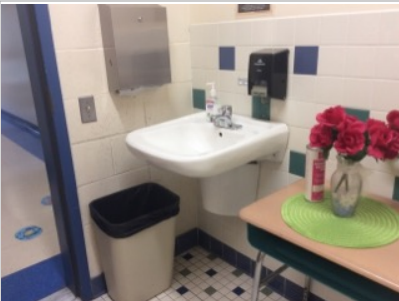
Clear floor space not provided at lavatory	-	Provide at least one lavatory with a 30" min. by 48" min. clear floor space positioned for a forward approach. Relocate clutter.	1	Labor	\$0

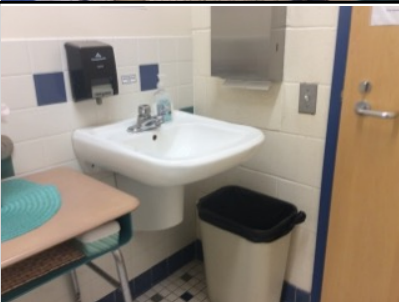
59	Women's Staff Toilet Room	1		Lavatory	N/A

Clear floor space not provided at lavatory	-	Provide at least one lavatory with a 30" min. by 48" min. clear floor space positioned for a forward approach. Relocate clutter.	1	Labor	\$0

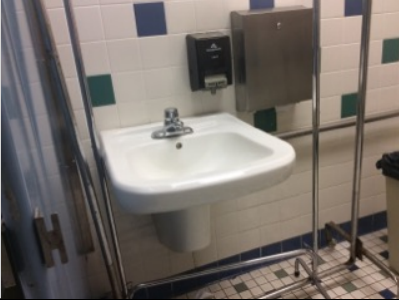
ID	Location	Floor	Room	Element	Type	Photo	Issues	Current Measure	Recommendations	Quantity	Price	Cost Estimation
60	Boys' Toilet Room in Gym	1	157	Lavatory	N/A

Clear floor space not provided at lavatory	-	Provide at least one lavatory with a 30" min. by 48" min. clear floor space positioned for a forward approach. Relocate stored items/coat rack.	1	Labor	\$0
61	Boys' Toilet Room	1		Lavatory	N/A

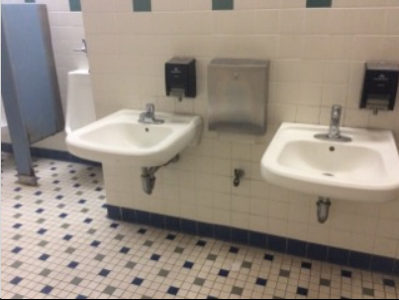
Plumbing underneath is exposed	-	Insulate or otherwise configure pipes to prevent contact, for at least one lavatory.	1	69	\$69
62	Girls' Toilet Room	1		Lavatory	N/A

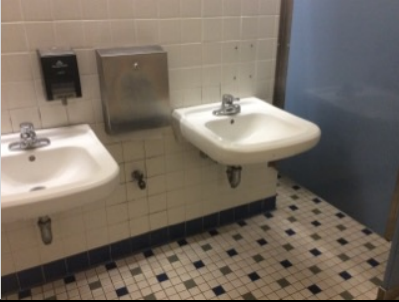
Plumbing underneath is exposed	-	Insulate or otherwise configure pipes to prevent contact, for at least one lavatory.	1	69	\$69
63	Girls' Toilet Room	2		Lavatory	N/A

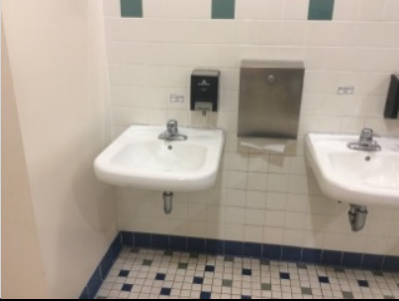
Plumbing underneath is exposed	-	Insulate or otherwise configure pipes to prevent contact, for at least one lavatory.	1	69	\$69
Single-User Toilet

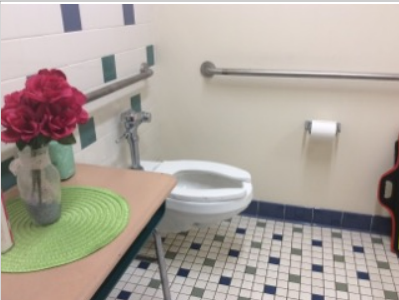
64	Men's Staff Toilet Room	1		Single-User Toilet	N/A

Clearance at toilet < 60" clear width	-	Provide a clear floor space that is 60" wide min. and/or provide sign to accessible toilet. (Relocate desk.)	1	Labor	\$0

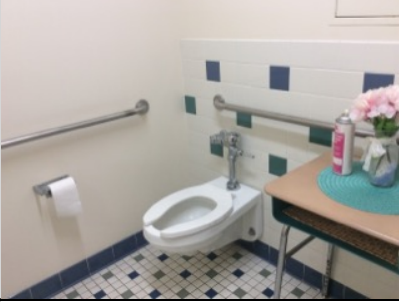
ID	Location	Floor	Room	Element	Type	Photo	Issues	Current Measure	Recommendations	Quantity	Price	Cost Estimation
65	Women's Staff Toilet Room	1		Single-User Toilet	N/A

Clearance at toilet < 60" clear width	-	Provide a clear floor space that is 60" wide min. and/or provide sign to accessible toilet. (Relocate desk.)	1	Labor	\$0
66	Women's Staff Toilet Room	2		Single-User Toilet	N/A

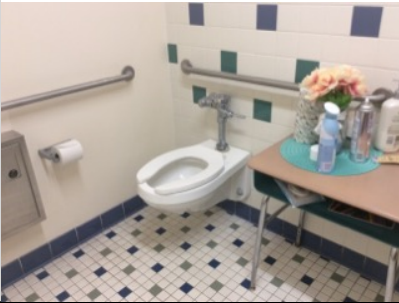
Clearance at toilet < 60" clear width	-	Provide a clear floor space that is 60" wide min. and/or provide sign to accessible toilet. (Relocate desk.)	1	Labor	\$0
67	All Gender Toilet Room Near 223	2		Single-User Toilet	N/A

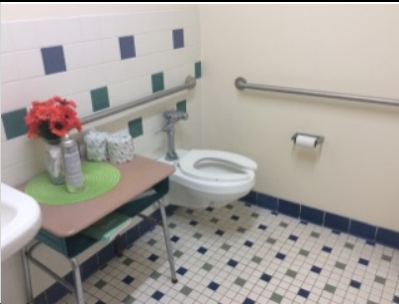
Clearance at toilet < 60" clear width	-	Provide a clear floor space that is 60" wide min. and/or provide sign to accessible toilet. (Relocate desk.)	1	Labor	\$0
68	Health Suite, Bathing Room	1	170	Single-User Toilet	N/A

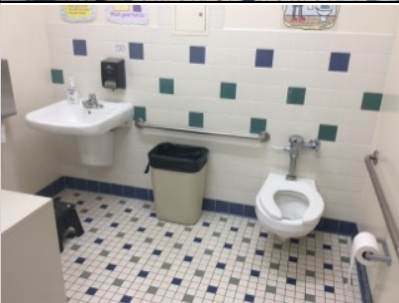
Clearance at toilet < 72" clear depth	49.5"	Remove storage unit.	1	Labor	\$0

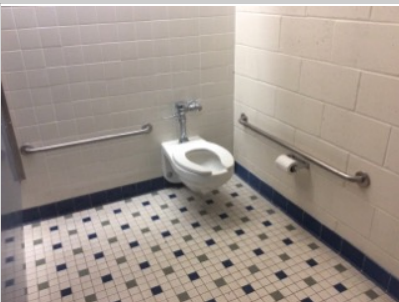
Toilet Compartment												
69	Girls' Toilet Room	1		Toilet Compartment	Accessible Compartment

Door has malfunctioning self-closing hinge Rear grab bar < 42" long	- 30"	Repair hinge. Provide a rear wall grab bar that is 42" long min. and extends from the toilet 12" min. on one side and 24" min. on the other side (open side). Note: The rear grab bar is not compliant but is usable.	1	Labor	\$0

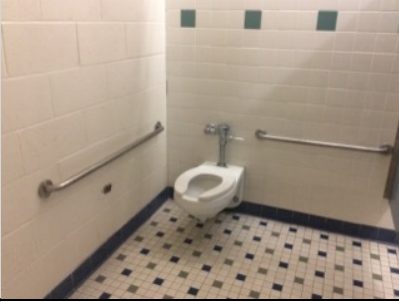
ID	Location	Floor	Room	Element	Type	Photo	Issues	Current Measure	Recommendations	Quantity	Price	Cost Estimation
70	Boys' Toilet Room	2		Toilet Compartment	Accessible Compartment

Door has malfunctioning self-closing hinge Rear grab bar < 42" long	- 30"	Repair hinge. Provide a rear wall grab bar that is 42" long min. and extends from the toilet 12" min. on one side and 24" min. on the other side (open side). Note: The rear grab bar is not compliant but is usable.	1	Labor	\$0
71	Girls' Toilet Room	2		Toilet Compartment	Accessible Compartment

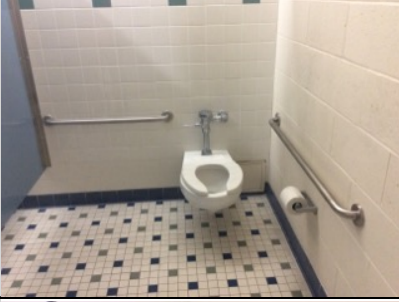
Door has malfunctioning self-closing hinge Rear grab bar < 42" long	- 30"	Repair hinge. Provide a rear wall grab bar that is 42" long min. and extends from the toilet 12" min. on one side and 24" min. on the other side (open side). Note: The rear grab bar is not compliant but is usable.	1	Labor	\$0
72	Boys' Toilet Room in Gym	1	157	Toilet Compartment	Accessible Compartment

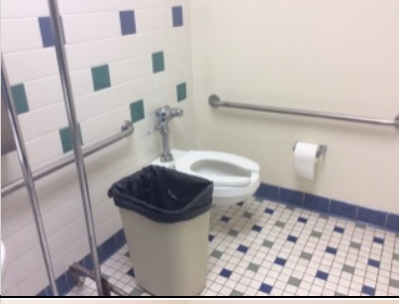
Door has malfunctioning self-closing hinge Clearance at toilet < 60" clear width	- -	Repair hinge. Relocate trash can and coat rack out of clear floor space at toilet. Note: Where a flushometer prevents the location of a 42 inch grab bar, a 36" grab bar is permitted under 521 CMR (MAAB) 30.8.2. The rear grab bar in this instance is 36" long and therefore is compliant.	1	Labor	\$0

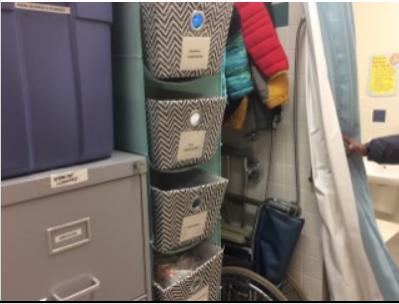
Not maintained in operable working condition	-	Ensure shower compartment is maintained in operable working condition. Relocate storage.	1	Labor	\$0
Toilet Rooms for Children

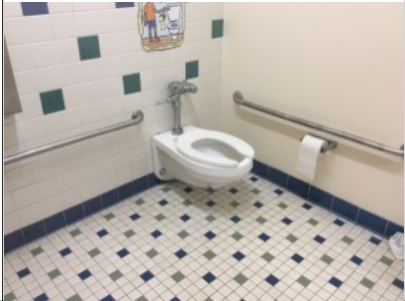
Side or rear grab bar < 42" long	36"	Note: Where a flushometer prevents the location of a 42 inch grab bar, a 36" grab bar is permitted under 521 CMR (MAAB) 30.8.2. The rear grab bar in this instance is 36" long and therefore is compliant.	1	0	\$0
Additional Access												
Drinking Fountains												
76	Gym	1	157	Drinking Fountains	N/A

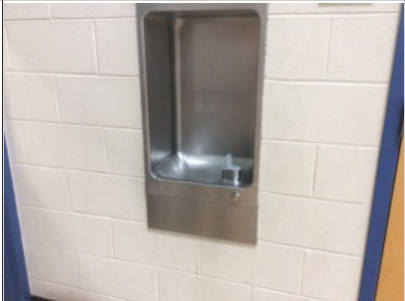
No drinking fountain provided for seated users	-	Provide an additional drinking fountain for seated users or install a Hi-Lo drinking fountain.	1	3021	\$3021
Sink												
77	Faculty/ FLEX Room	2	235	Sink	Classroom

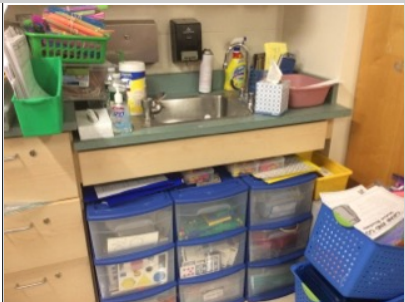
Clear floor space not provided at sink	-	Provide a 30" by 48" clear floor space positioned for a forward approach by removing clutter.	1	Labor	\$0

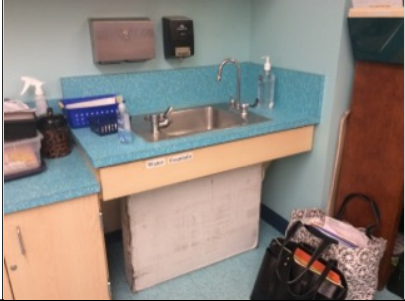
78	Classrooms Throughout School	1	127, 125, 227, 222	Sink	Classroom

Clear floor space not provided at sink Toe and knee clearances not provided	- 23.5"	Provide a 30" by 48" clear floor space positioned for a forward approach by removing clutter. Ensure there is a 25" knee clearance positioned for a forward approach.	4	1265	\$5060

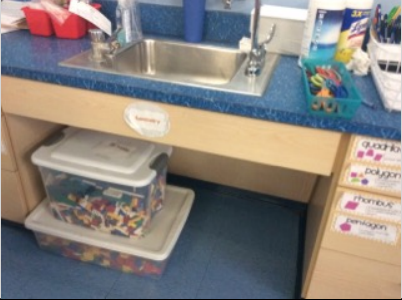
ID	Location	Floor	Room	Element	Type	Photo	Issues	Current Measure	Recommendations	Quantity	Price	Cost Estimation
79	Math/Marine Environmental Lab	1	113	Sink	Classroom

Clear floor space not provided at sink Toe and knee clearances not provided	- 23.5"	Provide a 30" by 48" clear floor space positioned for a forward approach by removing clutter. Ensure there is a 25" knee clearance positioned for a forward approach.	1	1265	\$1265
80	Art Room	2	213	Sink	Classroom

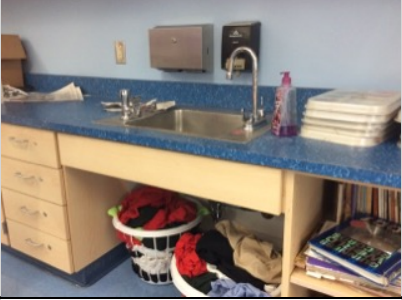
Clear floor space not provided at sink Toe and knee clearances not provided Exposed plumbing underneath sink	- 23.5" -	Provide a 30" by 48" clear floor space positioned for a forward approach by removing clutter. Ensure there is a 25" knee clearance positioned for a forward approach. Insulate or otherwise configure pipes at sink.	1	1334	\$1334
81	Music Room	2	270	Sink	Classroom

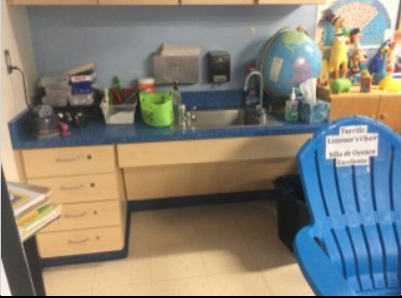
Toe and knee clearances not provided	23.5"	Ensure there is a 25" knee clearance positioned for a forward approach.	1	1265	\$1265

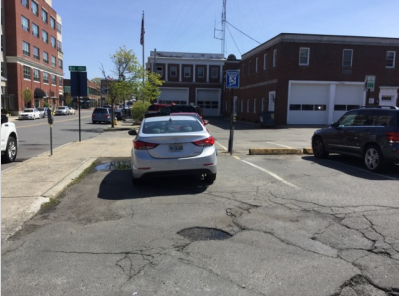
ID	Location	Floor	Room	Element	Type	Photo	Issues	Current Measure	Recommendations	Quantity	Price	Cost Estimation
Approach and Entrance												
Off-Street Parking Lot or Garage												
1	Klop Alley Parking Lot	1	101	Off-Street Parking Lot or Garage	Visitor

Total # of parking Total # of designated accessible parking spaces Total # of designated van accessible spaces Access aisle not provided Access aisle < 96" wide at van space Sign does not have the designation "Van Accessible"	26 2 - - - -	Provide a van accessible parking space 132" wide min. and a marked access aisle 60" wide min. Add the designation "Van Accessible" to the sign located at the van accessible space. (Cost based on a sign and re-striping.)	1	600	\$600
2	Employee Parking - Google Maps Image	1	101	Off-Street Parking Lot or Garage	Employee

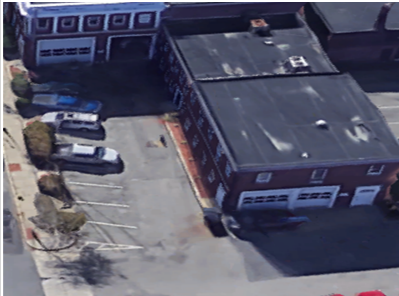
Total # of parking Total # of designated accessible parking spaces Total # of designated van accessible spaces Sign not provided Sign does not have the designation "Van Accessible"	10 - - - -	Provide a van accessible parking space 132" wide min. and a marked access aisle 60" wide min. at the shortest distance to the main entrance. Provide a sign with the International Symbol of Accessibility (ISA), add the designation "Van Accessible" to the sign located at the van accessible space.	1	1388	\$1388

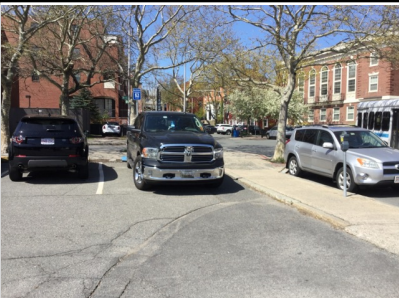
3	Klop Alley Parking Lot	1	101	Off-Street Parking Lot or Garage	Visitor

Access aisle not provided	-	Provide a marked access aisle that is at least 60" wide at the car accessible parking space. (Cost based on re-striping.)	1	225	\$225
Entrance												
4	Main Entrance at Parking	1	101	Entrance	Main Entrance

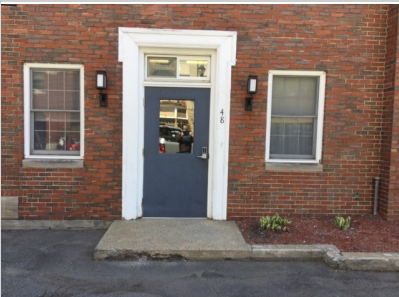
Entrance not on an accessible route ISA sign not provided.	6"	Provide a 48" wide min. x 6' long min. concrete walkway to door landing at main entrance. Ensure walkway has a running slope that does not exceed 1:20 (5.00%) and a cross slope that does not exceed 1:50 (2.00%). Provide sign with the International Symbol of Accessibility (ISA).	1	536	\$536
5	Lafayette and Newbury	Ext.		Entrance	Secondary Entrance

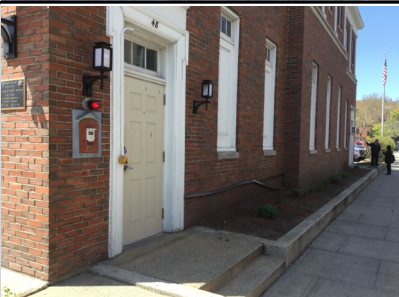
Entrance not on an accessible route Directional sign to accessible entrance not provided	- -	Provide a directional sign indicating the location of the nearest accessible entrance.	1	260	\$260

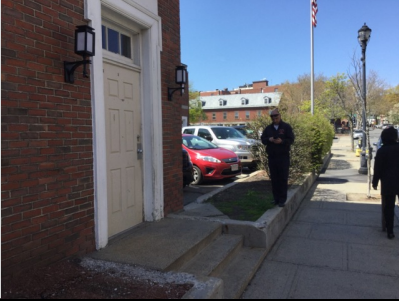
ID	Location	Floor	Room	Element	Type	Photo	Issues	Current Measure	Recommendations	Quantity	Price	Cost Estimation
6	Lafayette 1	Ext.		Entrance	Secondary Entrance

Entrance not on an accessible route Directional sign to accessible entrance not provided Hardware not operable with a closed fist	- - -	Provide a directional sign indicating the location of the nearest accessible entrance. Provide hardware that can be operable with one hand and not require tight grasping, pinching, or twisting of the wrist.	1	623	\$623
Emergency Exit												
7	Main Entrance and Exit to Staff Parking	1	101	Emergency Exit	N/A

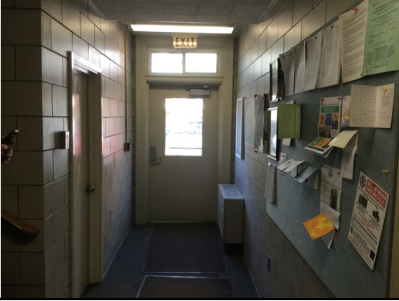
Maneuvering clearance(s) not provided Tactile exit sign not provided Illuminated ISA not provided.	-	Provide an automatic door opener. Ensure tactile exit signs with raised characters and braille are provided at exit doors. Mount signs between 48"- 60" above finished floor located on the latch side of the door. Add an illuminated International Symbol of Accessibility (ISA) to the illuminated exit sign.	1	2619	\$2619

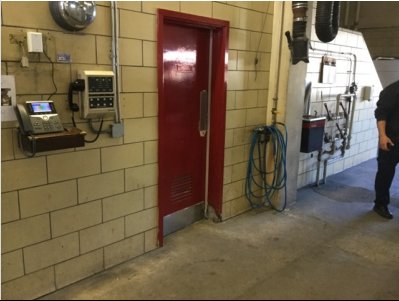
Access to Goods and Services												
Doors, Doorways, & Gates												
8	Men's Toilet Room	1		Doors, Doorways, & Gates	Toilet Room

International Symbol of Acc. not provided Clear width at door < 32"	28"	Widen the door so that there is 32" min. clear width. Provide a sign indicating toilet room is all gender. Also provide sign with the International Symbol of Accessibility (ISA) raised characters and braille mounted on the latch side of the door. (Cost based on widening door and providing a sign.)	1	2699	\$2699
9	Conference Room	2		Doors, Doorways, & Gates	Office

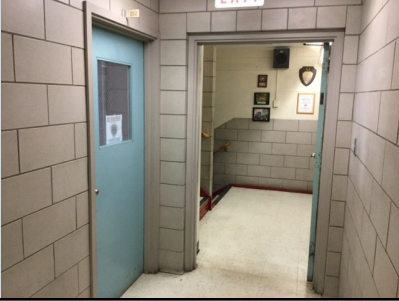
Hardware not operable with a closed fist Not provided Raised characters not provided	-	Provide hardware that can be operable with one hand and not require tight grasping, pinching, or twisting of the wrist. Locate signage alongside the door on the latch side. Provide text with raised characters duplicated in braille. (Cost based on accessible door hardware and sign.)	1	537	\$537

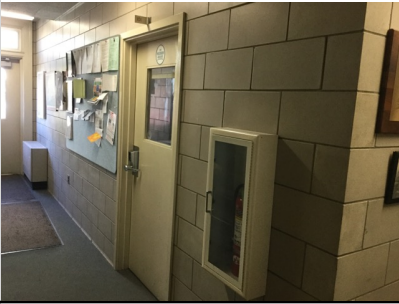
Not provided Raised characters not provided	- -	Locate signage alongside the door on the latch side. Provide text with raised characters duplicated in braille.	1	174	\$174
11	Conference Room	2		Signage	Designation

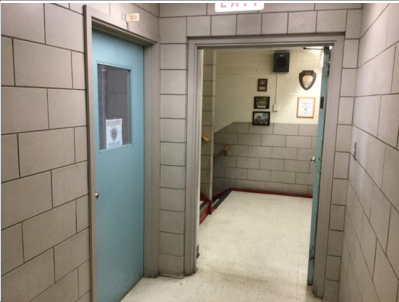
Not provided Raised characters not provided	- -	Locate signage alongside the door on the latch side. Provide text with raised characters duplicated in braille.	1	174	\$174
Service Counter												
12	Admin and Chief's Office	1	101	Service Counter	N/A

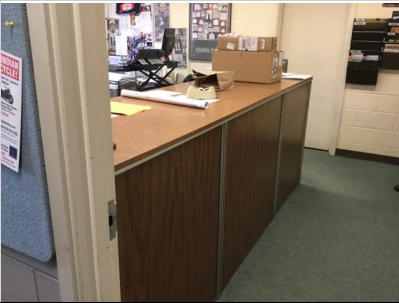
Counter > 36" high	-	Provide a counter that is 36" max. above the ground or finished floor.	1	660	\$660
Toilet & Bathing Rooms												
Overall Access												
13	Men's Toilet Room	1		Overall Access	Toilet Room

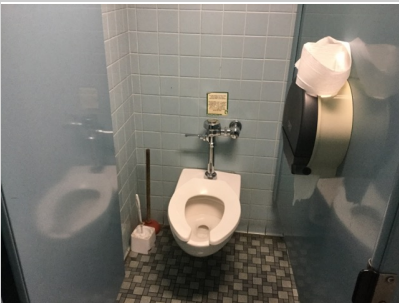
Accessible plumbing fixtures or stalls not provided	-	Provide one accessible wheelchair stall.	1	4637	\$4637

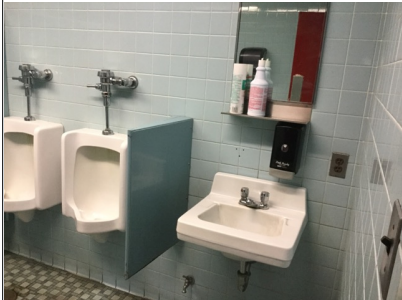
ID	Location	Floor	Room	Element	Type	Photo	Issues	Current Measure	Recommendations	Quantity	Price	Cost Estimation
Lavatory												
14	Men's Toilet Room	1		Lavatory	N/A

Plumbing underneath is exposed Mirror above lavatory w/reflective surface > 40"	- 53"	Insulate or otherwise configure pipes to prevent contact, for at least one lavatory. Lower mirror so that the bottom surface is at 40" max. above finished floor.	1	261	\$261
Urinal												
15	Men's Toilet Room	1		Urinal	N/A

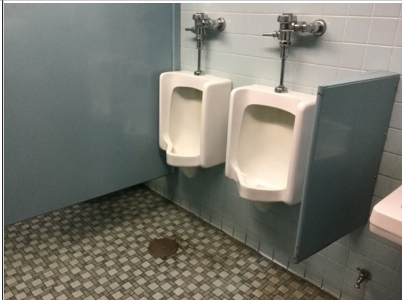
Rim > 15" high (MAAB)	24"	Provide at least one urinal with the rim no higher than 15" above the finished floor.	1	2436	\$2436
Dispensers												
16	Admin and Chief's Office	1		Dispensers	Paper Towel Dispenser

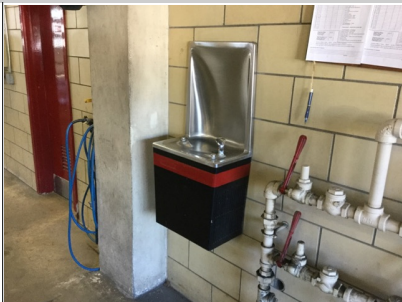
No drinking fountain provided for seated users	-	Provide an additional drinking fountain for seated users. (Cost based on a new low wall mounted drinking fountain.)	1	3021	\$3021

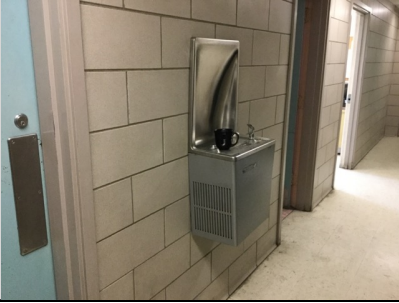
ID	Location	Floor	Room	Element	Type	Photo	Issues	Current Measure	Recommendations	Quantity	Price	Cost Estimation
18	Second Floor	2		Drinking Fountains	High

No drinking fountain provided for seated users	-	Provide an additional drinking fountain for seated users. (Cost based on a new low wall mounted drinking fountain.)	1	3021	\$3021

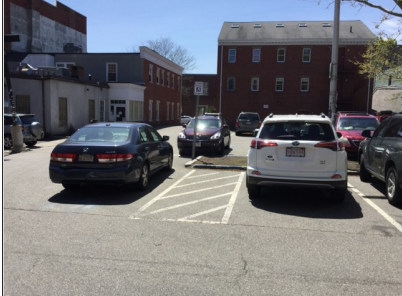
ID	Location	Floor	Room	Element	Type	Photo	Issues	Current Measure	Recommendations	Quantity	Price	Cost Estimation
Approach and Entrance												
Off-Street Parking Lot or Garage												
1	Parking By Annex	Ext		Off-Street Parking Lot or Garage	N/A

Total # of parking Total # of designated accessible parking spaces Total # of designated van accessible spaces Vehicle space < 132" wide at van space Sign does not have the designation "Van Accessible"	20 1 - - -	Provide a van accessible space that is 96" wide min. with an access aisle that is 96" wide min. Add the designation "Van Accessible" to the sign located at the van accessible space. Mount the sign 60" min. and 96" max. aff. (Cost for re-striping and a "Van Accessible" sign.)	1	600	\$600
2	Parking Sewell Street Lot	Ext		Off-Street Parking Lot or Garage	N/A
