City of Salem, Massachusetts

PART A – Executive Summary

Part A – Executive Summary

Introduction

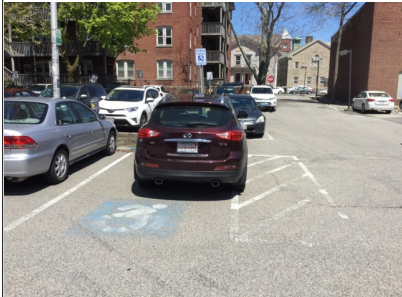
Total # of parking Total # of designated accessible parking spaces Total # of designated van accessible spaces	60 4 -	Provide a van accessible space that is 96" wide min. with an access aisle that is 96" wide min. Add the designation "Van Accessible" to the sign located at the van accessible space. Mount the sign 60" min. and 96" max. aff. (Cost for re-striping and a "Van Accessible" sign.)	1	600	\$600

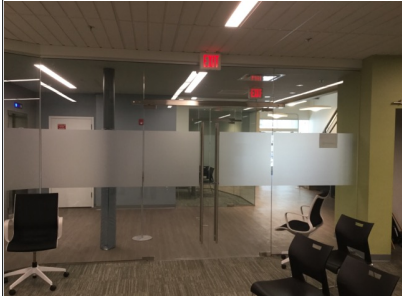
Tactile exit sign not provided	-	Ensure tactile exit signs with raised characters and braille are provided at exit doors. Mount signs between 48"- 60" above finish floor located on the latch side of the door.	1	174	\$174

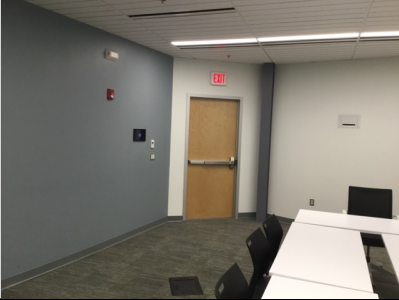
ID	Location	Floor	Room	Element	Type	Photo	Issues	Current Measure	Recommendations	Quantity	Price	Cost Estimation
5	Large Meeting Room	1	106	Means of Egress	N/A

Tactile exit sign not provided	-	Ensure tactile exit signs with raised characters and braille are provided at exit doors. Mount signs between 48"- 60" above finish floor located on the latch side of the door.	1	174	\$174
6	Planning	2		Means of Egress	N/A

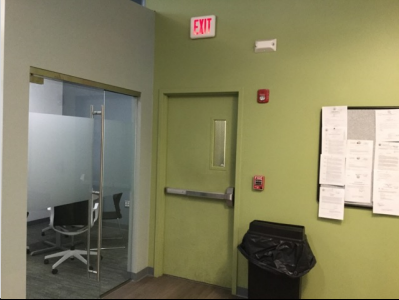
Tactile exit sign not provided	-	Ensure tactile exit signs with raised characters and braille are provided at exit doors. Mount signs between 48"- 60" above finish floor located on the latch side of the door.	1	174	\$174
7	Parking Entrance	1		Means of Egress	N/A

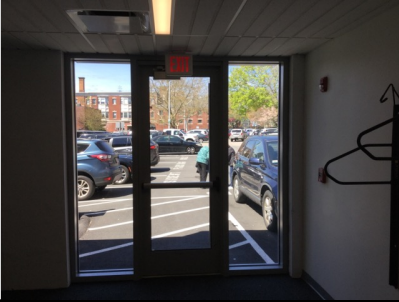
Tactile exit sign not provided International Symbol of Acc. not provided	-	Ensure tactile exit signs with raised characters and braille are provided at exit doors. Mount signs between 48"- 60" above finish floor located on the latch side of the door. Provide the International Symbol of Accessibility	1	174	\$174

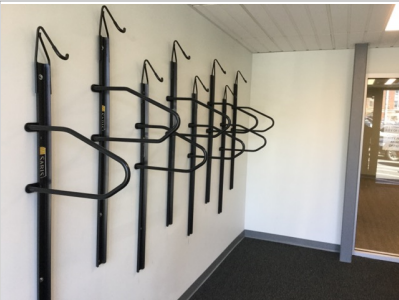
Obstructed by protruding objects	51"	Provide a cane detectable barrier 27" max. aff before the first / leading bike rack.	1	230	\$230

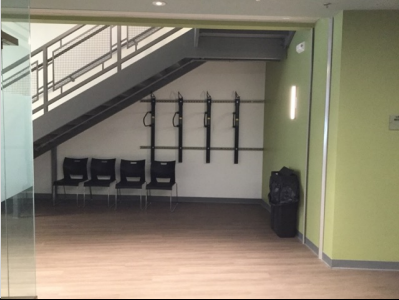
ID	Location	Floor	Room	Element	Type	Photo	Issues	Current Measure	Recommendations	Quantity	Price	Cost Estimation
10	Lobby	1		Interior Access Route	N/A

Obstructed by protruding objects	-	Relocate bike rack. (Descending stair less than 80" aff.) Provide a cane detectable barrier below stairs. (Cost bases on a 6' long 27" max. high pipe rail under stairs.)	1	720	\$720
Doors, Doorways, & Gates												
11	Egress to Parking	1		Doors, Doorways, & Gates	Emergency Egress

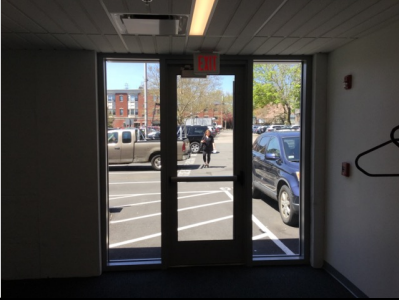
Door requires > 5 lbs. of force to open	25 lbs.	Adjust closers so doors do not require more than 5 pounds of force to open.	1	Labor	\$0
Stairways												
12	Entrance Lobby	1		Stairways	Interior

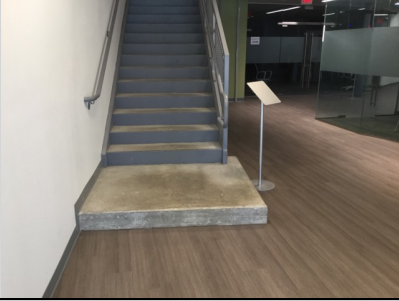
Handrails do not extend 12" from stairs Handrails not continuous where required	- -	Top: Ensure handrails extend horizontally above the landing for 12" min. beginning above the first riser nosing. Bottom: Ensure handrails extend to one tread depth beyond the last riser. Provide continuous handrails. (Cost based on one wall mounted and one free standing metal railing at landing.)	1	1074	\$1074

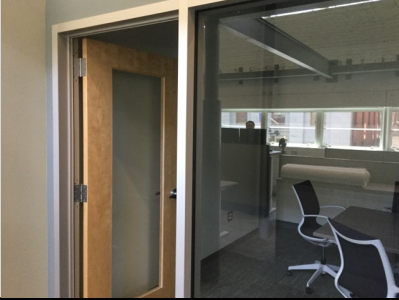
Signage												
13	Small Meeting Room	2		Signage	Designation

Not provided	-	Locate signage with raised characters and braille alongside the door on the latch side.	1	174	\$174
14	Engineering Conference Room	2		Signage	Designation

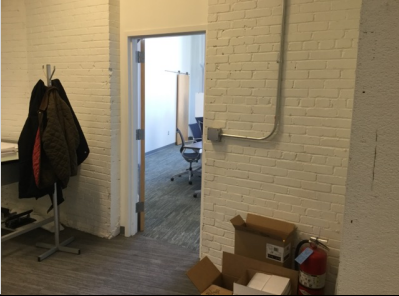
Not provided	-	Locate signage with raised characters and braille alongside the door on the latch side.	1	174	\$174

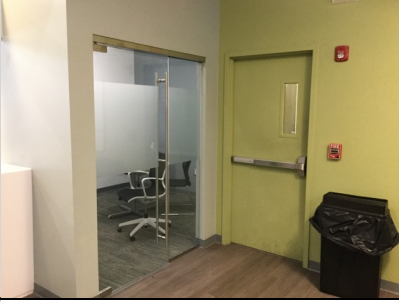
ID	Location	Floor	Room	Element	Type	Photo	Issues	Current Measure	Recommendations	Quantity	Price	Cost Estimation
15	Planning Lobby Conference Room	2		Signage	Designation

Not provided	-	Locate signage with raised characters and braille alongside the door on the latch side.	1	174	\$174
16	Health Conference Room	3		Signage	Designation

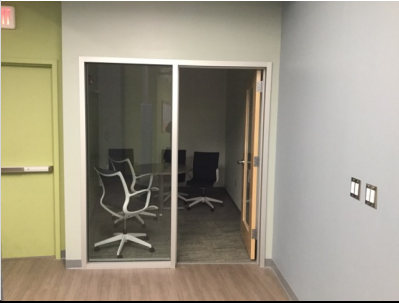
Not provided	-	Locate signage with raised characters and braille alongside the door on the latch side.	1	174	\$174
17	Conference Room	3		Signage	Designation

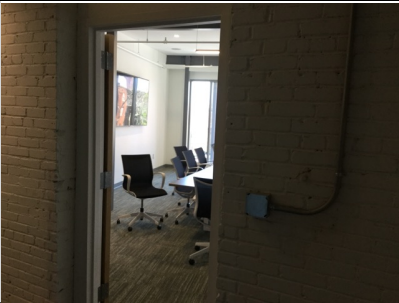
Not provided	-	Locate signage with raised characters and braille alongside the door on the latch side.	1	174	\$174
18	Large Meeting Room	1	106	Signage	Designation

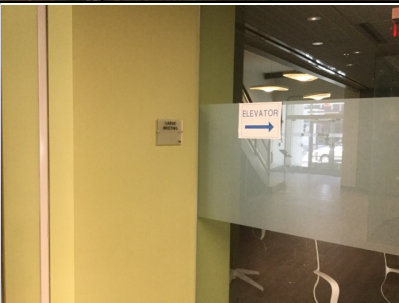
Raised characters not provided Braille not provided	- -	Mount signs so that the baseline of the lowest tactile character is 48" min. above finish floor and the baseline of the highest tactile character is 60" max. above finish floor. Provide braille for room number.	1	174	\$174

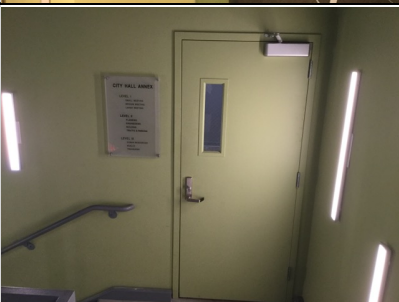
19	Floor 2 Stairwell	2		Signage	Designation

Raised characters not provided Braille not provided	- -	Provide text with raised characters duplicated in braille indicating floor number in stairwell. (Sign in photo is a directory.)	3	174	\$522

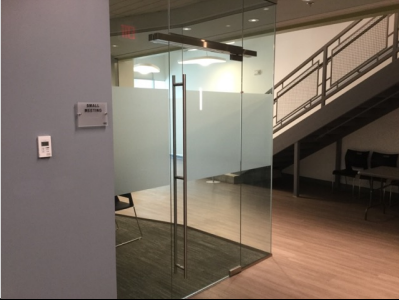
ID	Location	Floor	Room	Element	Type	Photo	Issues	Current Measure	Recommendations	Quantity	Price	Cost Estimation
20	Small Meeting Room	1	102	Signage	Designation

Raised characters < 48" or > 60" above ground Braille not provided	63.5" -	Mount signs so that the baseline of the lowest tactile character is 48" min. above finish floor and the baseline of the highest tactile character is 60" max. above finish floor. Provide braille for room number.	1	174	\$174
21	Medium Meeting Room	1	107	Signage	Designation

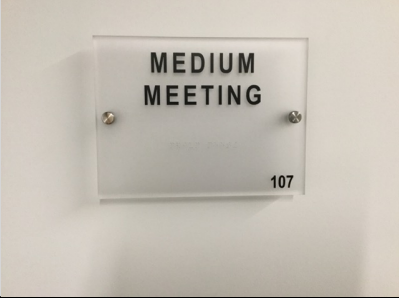
Braille not provided	-	Provide braille for room number.	1	174	\$174
22	Wellness Room	3		Signage	Designation

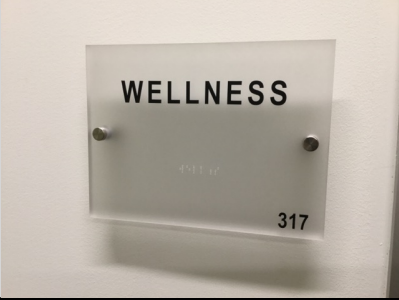
Braille not provided	-	Provide braille for room number.	1	174	\$174
Service Counter												
23	Health Reception	3		Service Counter	N/A

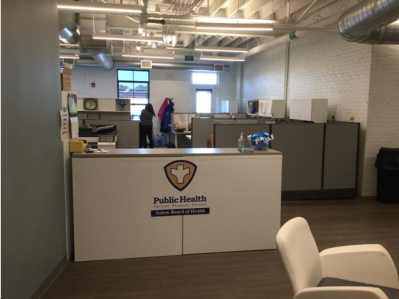
Counter > 36" high	42"	Provide a counter that is 36" max. above the ground or finish floor.	1	660	\$660
24	Planning	2		Service Counter	N/A

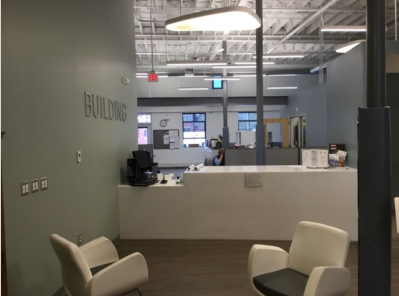
Service counter not clear and usable.		Keep accessible counter clear of stored objects.	1	Labor	\$0

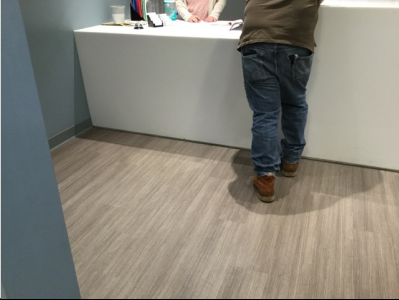
ID	Location	Floor	Room	Element	Type	Photo	Issues	Current Measure	Recommendations	Quantity	Price	Cost Estimation
25	Engineering	2		Service Counter	N/A

Service counter not clear and usable.		Keep accessible counter clear of stored objects.	1	Labor	\$0
Assembly Area												
26	Large Meeting Room	1	106	Assembly Area	N/A

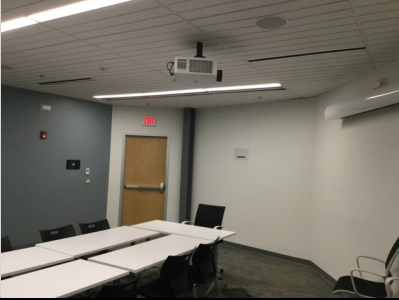
Assistive listening devices not provided	-	If audible communication is integral to the use of the space, provide an assistive listening system.	1	0	\$0
27	Medium Meeting Room	1	107	Assembly Area	N/A

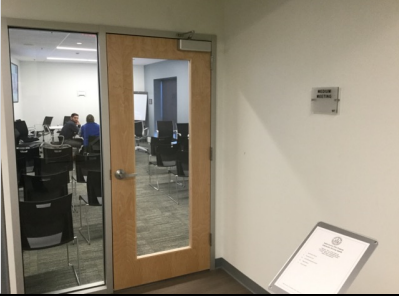
Assistive listening devices not provided	-	If audible communication is integral to the use of the space, provide an assistive listening system.	1	0	\$0
Toilet & Bathing Rooms												
Overall Access												
28	Men's and Women's	3		Overall Access	Toilet Room

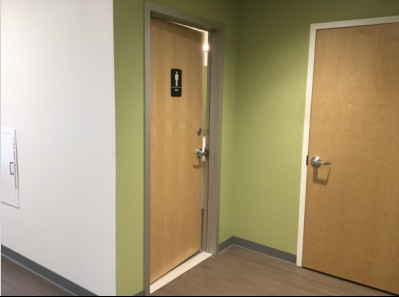
29	Men's	1		Overall Access	Toilet Room

International Symbol of Acc. not provided	-	Provide a sign with the International Symbol of Accessibility.	1	174	\$174

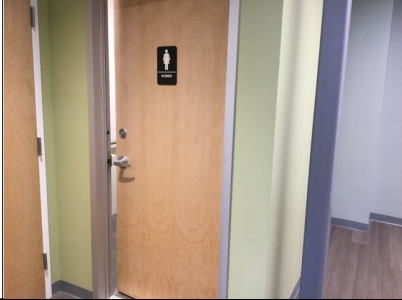
ID	Location	Floor	Room	Element	Type	Photo	Issues	Current Measure	Recommendations	Quantity	Price	Cost Estimation
30	Women's	1		Overall Access	Toilet Room

International Symbol of Acc. not provided	-	Provide a sign with the International Symbol of Accessibility.	1	174	\$174
Dispensers												
31	Men's	1		Dispensers	Paper Towel Dispenser

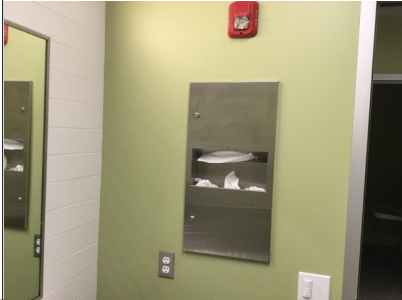
Controls > 42" high	60.5"	Relocate so the operable part is 42" max. above the finish floor. (Lower paper towel access.)	1	530	\$530
32	Women's	1		Dispensers	Paper Towel Dispenser

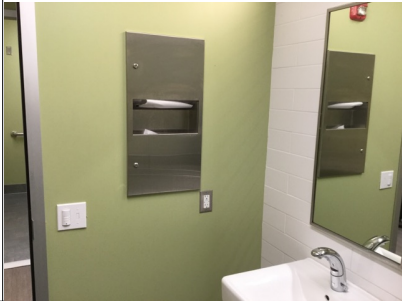
Controls > 42" high	61"	Relocate so the operable part is 42" max. above the finish floor. (Lower paper towel access.)	1	530	\$530
Additional Access												
Drinking Fountains												
33	Hallway	1		Drinking Fountains	Low

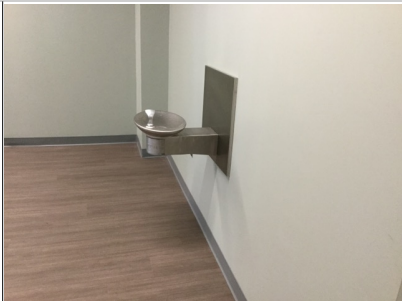
No drinking fountain provided for standing users	-	Provide an additional drinking fountain for standing users or install a hi-lo drinking fountain. (Cost for a new wall-mounted fountain for a standing user.)	1	3021	\$3021

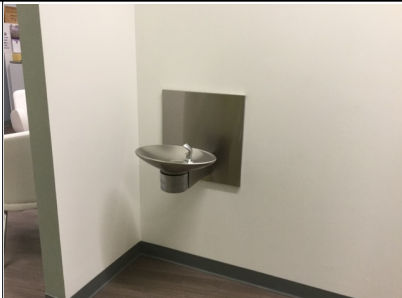
34	Near Wellness	3		Drinking Fountains	Low

No drinking fountain provided for standing users	-	Provide an additional drinking fountain for standing users or install a hi-lo drinking fountain. (Cost for a new wall-mounted fountain for a standing user.)	1	3021	\$3021

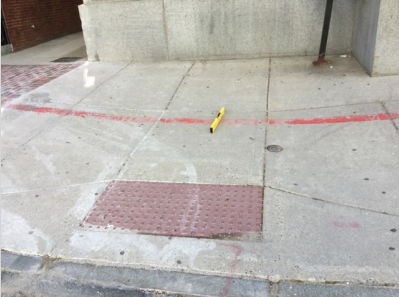
ID	Location	Floor	Room	Element	Type	Photo	Issues	Current Measure	Recommendations	Quantity	Price	Cost Estimation
Approach and Entrance												
Exterior Access Route												
1	Near Main Entrance	Ext.		Exterior Access Route	Sidewalk

Cross slope > 1:50 (2.00%)	5.2%	Reduce cross slope to be no steeper than 1:50 (2.00%).	1	648	\$648
2	Main Entrance	1		Exterior Access Route	Sidewalk

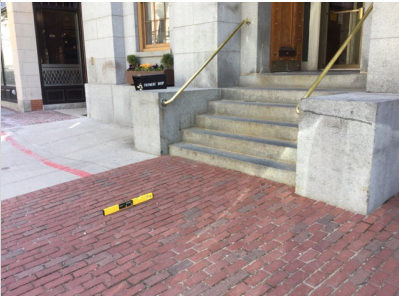
Cross slope > 1:50 (2.00%)	5.7%	Reduce cross slope to be no steeper than 1:50 (2.00%).	1	1125	\$1125
3	Near Main Entrance	Ext.		Exterior Access Route	Sidewalk

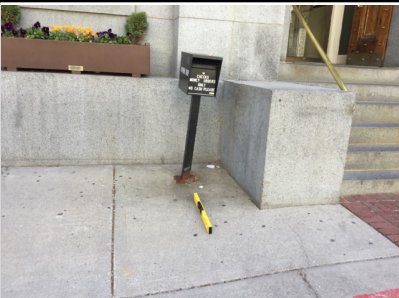
Running slope > 1:20 (5%)	9.9%	Reduce running slope to be no steeper than 1:20 (5.00%). See ID #2	1	0	\$0
Entrance												
4	Accessible Entrance	Ext.		Entrance	Secondary Entrance

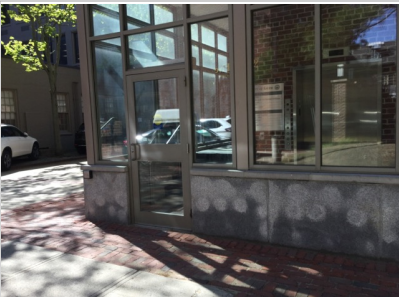
International Symbol of Accessibility not provided	-	Provide the International Symbol of Accessibility.	1	260	\$260
5	Towards City Hall Offices			Entrance	Secondary Entrance

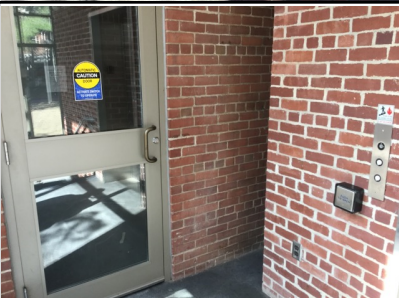
International Symbol of Accessibility not provided	-	Provide the International Symbol of Accessibility.	1	260	\$260

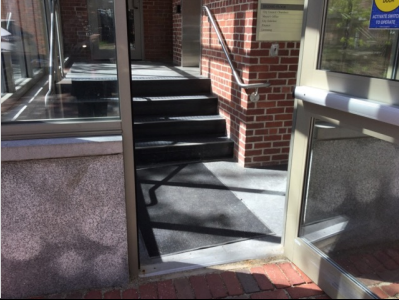
ID	Location	Floor	Room	Element	Type	Photo	Issues	Current Measure	Recommendations	Quantity	Price	Cost Estimation
6	Accessible Entrance	Ext.		Entrance	Secondary Entrance

Mat not securely attached	-	Install an ADA-compliant walk-off mat.	1	486	\$486
7	Main Entrance	1	2	Entrance	Main Entrance

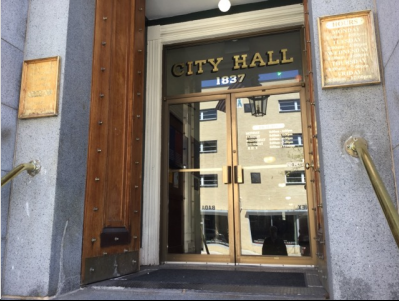
Mat not securely attached	-	Install an ADA-compliant walk-off mat.	1	486	\$486
Access to Goods and Services												
Interior Access Route												
8	Council's Chambers	2		Interior Access Route	N/A

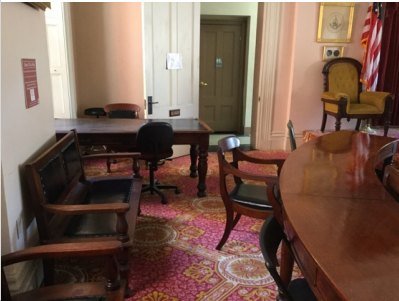
Route < 36" wide	31"	Relocate furniture to ensure a clear width of 36" min. is maintained at the accessible route.	1	Labor	\$0
9	Near Elevator			Interior Access Route	N/A

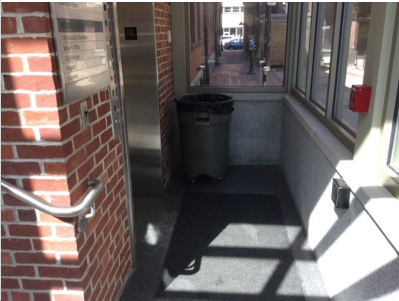
Mat not securely attached		Install an ADA-compliant walk-off mat.	1	486	\$486
Doors, Doorways, & Gates												
10	Towards City Hall Offices	1		Doors, Doorways, & Gates	Circulation

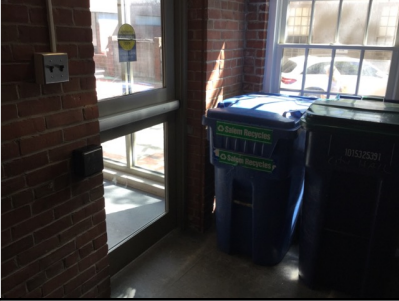
Clear width at door < 32"	31"	Relocate trash can to maintain the maneuvering clearance at the door.	1	Labor	\$0

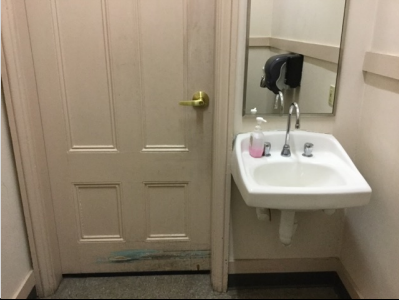
ID	Location	Floor	Room	Element	Type	Photo	Issues	Current Measure	Recommendations	Quantity	Price	Cost Estimation
11	Single-User Toilet Room	2		Doors, Doorways, & Gates	Toilet Room

Maneuvering clearance(s) not provided	-	Provide an automatic door opener.	1	2295	\$2295
12	City Council Ante Room	2		Doors, Doorways, & Gates	Office

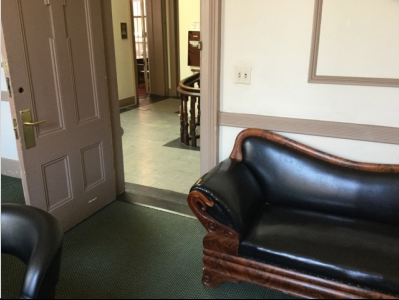
Maneuvering clearance(s) not provided	-	Relocate furniture to maintain the maneuvering clearance at the door.	1	Labor	\$0
13	Elections and Registrations Office	1	5	Doors, Doorways, & Gates	Office

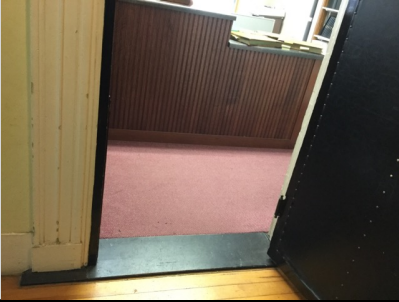
Threshold not beveled	-	Bevel threshold.	1	113	\$113
14	Legal Department	2	10	Doors, Doorways, & Gates	Office

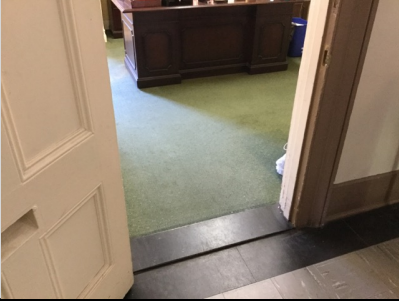
Threshold not beveled		Bevel threshold.	1	113	\$113
Signage												
15	Hearing Office	1	4	Signage	Designation

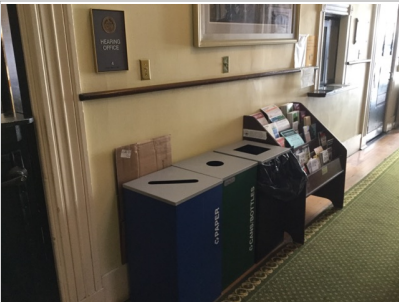
Clear floor space is not provided	-	Relocate trash cans to provide an 18" by 18" clear floor space at the sign.	1	Labor	\$0

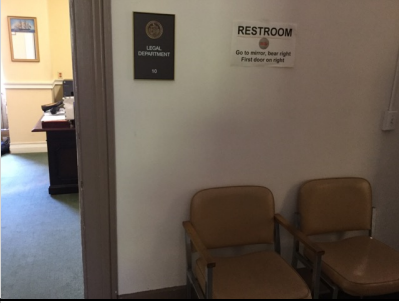
ID	Location	Floor	Room	Element	Type	Photo	Issues	Current Measure	Recommendations	Quantity	Price	Cost Estimation
16	Legal Department	2	10	Signage	Designation

Clear floor space is not provided		Relocate chairs to provide an 18" by 18" clear floor space at the sign.	1	Labor	\$0
17	Licensing Department	2	8	Signage	Designation

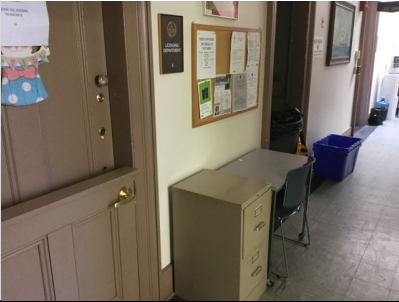
Clear floor space is not provided		Relocate cabinet to provide an 18" by 18" clear floor space at the sign.	1	Labor	\$0
18	Near Council's Chambers	2		Signage	Designation

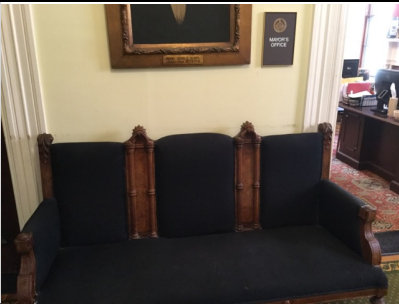
Clear floor space is not provided		Relocate chairs to provide an 18" by 18" clear floor space at the sign.	1	Labor	\$0
19	Assessor's Office	1	6	Signage	Designation

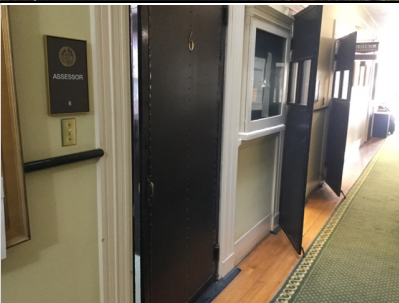
Raised characters < 48" or > 60" above ground	63"	Mount signs so that the baseline of the lowest tactile character is 48" min. above finish floor and the baseline of the highest tactile character is 60" max. above finish floor.	1	Labor	\$0

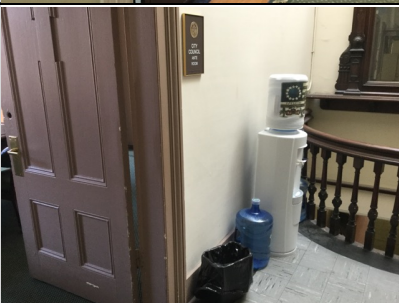
20	City Council Ante Room	2		Signage	Designation

Sign not located on the latch side of the door	- -	Locate sign at permanent rooms alongside the door on the latch side. Ensure an 18" by 18" clear floor space is maintained at the sign.	1	Labor	\$0

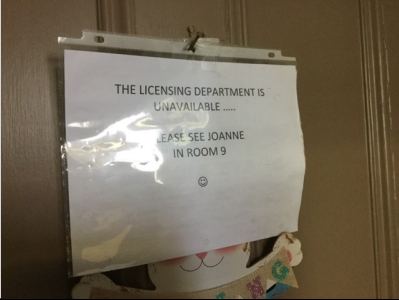
ID	Location	Floor	Room	Element	Type	Photo	Issues	Current Measure	Recommendations	Quantity	Price	Cost Estimation
21	Licensing Department	2	8	Signage	Informational

Non glare finish and contrast not provided	-	Provide signs with a non-glare finish with characters that have a high contrast to the background.	1	174	\$174
22	Council's Chambers	2		Signage	Informational

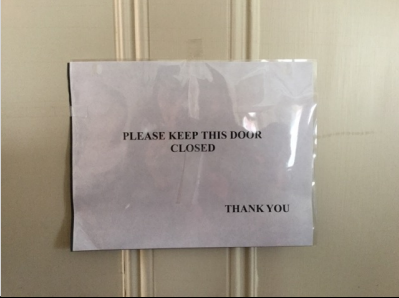
Non glare finish and contrast not provided	-	Provide signs with a non-glare finish with characters that have a high contrast to the background.	1	174	\$174
23	City Clerk - General Office	1	3	Signage	Directional

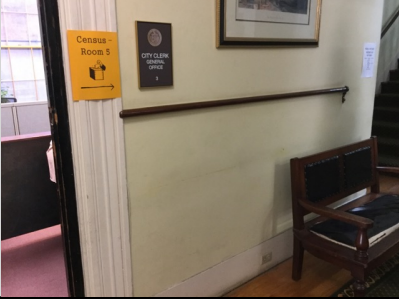
Text size non-compliant	-	Ensure that character size complies with the Character Height Table 703.5.5 in the ADA 2010 Standards.	1	174	\$174
24		2		Signage	Directional

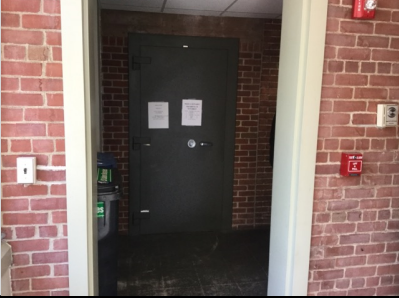
Text size non-compliant	-	Ensure that character size complies with the Character Height Table 703.5.5 in the ADA 2010 Standards.	1	174	\$174

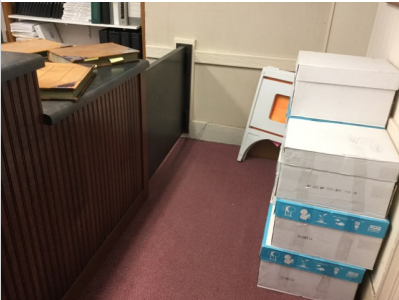
ID	Location	Floor	Room	Element	Type	Photo	Issues	Current Measure	Recommendations	Quantity	Price	Cost Estimation
Service Counter												
26	Elections and Registrations Office	1	5	Service Counter	N/A

Route < 36" wide	-	Remove boxes to maintain a clear width of 36" min. is maintained at the accessible route.	1	Labor	\$0
27	City Clerk - General Office	1	3	Service Counter	N/A

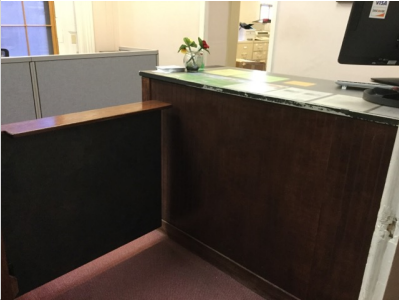
Counter > 36" high	41"	Provide a counter that is 36" max. above the ground or finish floor.	1	660	\$660
Operable Parts												
28	Across From Hearing Office	1		Operable Parts	Other

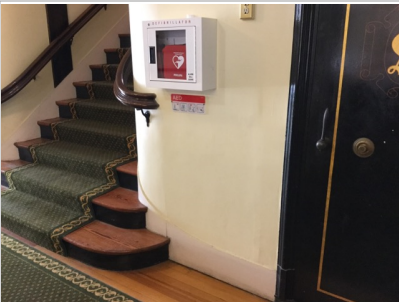
Reach < 15" or > 48"(forward/side approach)	59"	Relocate AED so that controls are 48" max. above finish floor.	1	192	\$192
Dining or Work Surfaces												
29	Council's Chambers	2		Dining or Work Surfaces	Work Surface

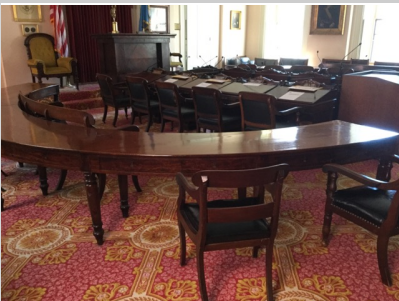
Knee or toe clearance not provided	23"	Provide a work surface with 27" min. knee clearance.	1	825	\$825

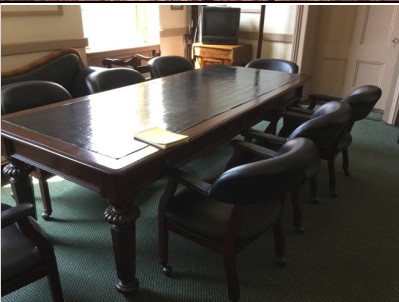
30	City Council Ante Room	2		Dining or Work Surfaces	Work Surface

Knee or toe clearance not provided	23"	Provide a work surface with 27" min. knee clearance.	1	825	\$825

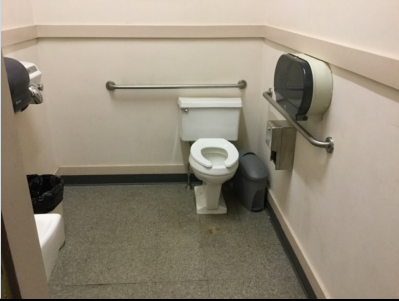
ID	Location	Floor	Room	Element	Type	Photo	Issues	Current Measure	Recommendations	Quantity	Price	Cost Estimation
Toilet & Bathing Rooms												
Single-User Toilet												
31	Single-User Toilet Room	2		Single-User Toilet	N/A

Toilet paper dispenser is not compliant	-	Relocate toilet paper dispenser so that it is 15" min. high, located below the grab bar, and between 7" and 9" from the front of the toilet.	1	530	\$530

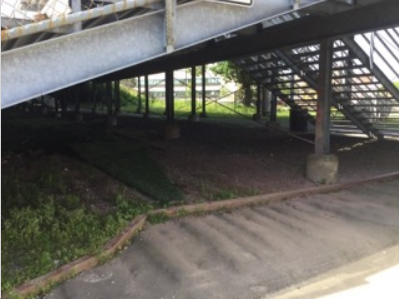
ID	Location	Floor	Room	Element	Type	Photo	Issues	Current Measure	Recommendations	Quantity	Price	Cost Estimation
Approach and Entrance												
Exterior Access Route												
1	Athletic Field, Route to Toilet Rooms			Exterior Access Route	Exterior

Accessible route not provided	-	Redesign this area to provide an accessible route to the lift.	1	-	\$0
2	Athletic Field, Route to Toilet Rooms			Exterior Access Route	Exterior

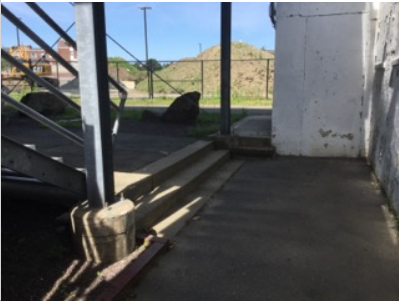
Accessible route not provided	-	Redesign this area to provide an accessible route to the lift.	1	-	\$0
Stairs												
3	Stairs Towards Broad Street	Ext.		Stairs	Exterior

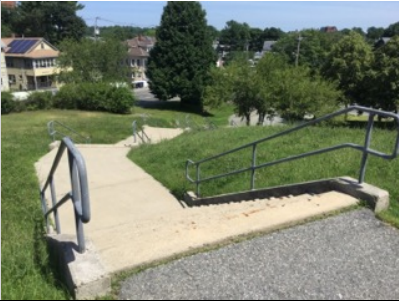
Stairs not maintained in operable working condition		Ensure stairs are maintained in operable working condition.	1	Labor	\$0
Curb Ramp												
4	Towards Playground	Ext.		Curb Ramp	N/A

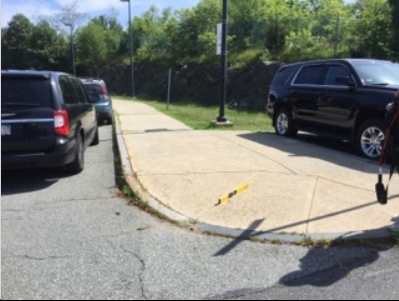
Running slope > 1:12 (8.33%)	13.5%	Reduce running slope to be no steeper than 1:12 (8.33%).	1	2800	\$2800

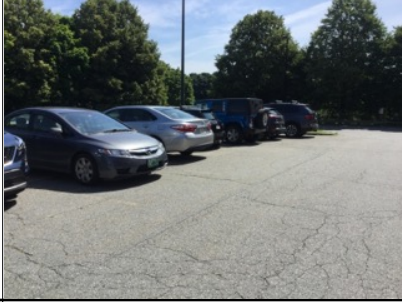
Total # of parking Total # of designated accessible parking spaces	24 -	Provide a van accessible space that is at least 96" wide with a marked access aisle that is at least 96" wide. Provide a sign with the bottom of the sign 60" min. above the ground and the top 96" max. above the ground. Add the designation "Van Accessible" to the sign.	1	1388	\$1388
6	Staff Parking Lot, South Side of School	Ext.		Off-Street Parking Lot or Garage	Employee

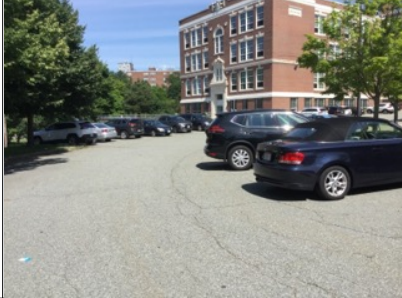
Total # of parking Total # of designated accessible parking spaces	20 -	Provide a van accessible space that is at least 96" wide with a marked access aisle that is at least 96" wide. Provide a sign with the bottom of the sign 60" min. above the ground and the top 96" max. above the ground. Add the designation "Van Accessible" to the sign.	1	1388	\$1388

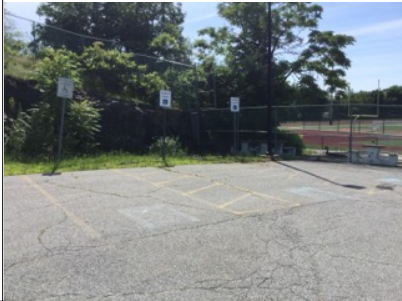
7	Parking Near Athletic Field	Ext.		Off-Street Parking Lot or Garage	Visitor

Total # of parking Total # of designated accessible parking spaces Access aisle < 96" wide at van space	59 3 64"	Provide two marked access aisle that are at least 96" wide.	1	225	\$225
8	Parking - North Side	Ext.		Off-Street Parking Lot or Garage	Employee

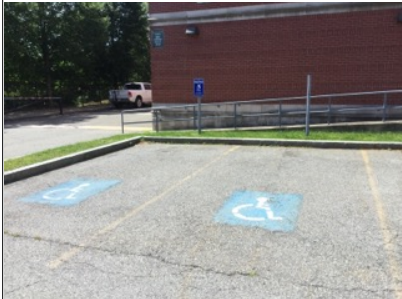
Access aisle not provided Sign bottom < 60" above finished grade	- 41"	Provide a marked access aisle that is at least 96" wide. Locate sign with the bottom of the sign 60" above the ground and the top 96" max. above the ground. Add the designation "Van Accessible" to the sign.	1	225	\$225
9	Staff Parking Lot	Ext.		Off-Street Parking Lot or Garage	Employee

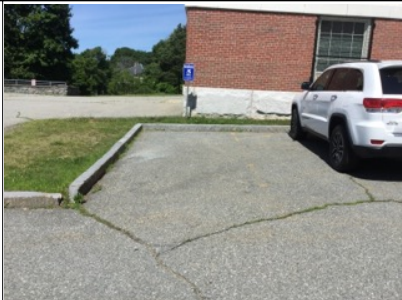
Access aisle < 96" wide at van space Sign bottom < 60" above finished grade	60" 45"	Provide a marked access aisle that is at least 96" wide. Locate sign with the bottom of the sign 60" above the ground and the top of the sign 96" above the ground.	1	225	\$225

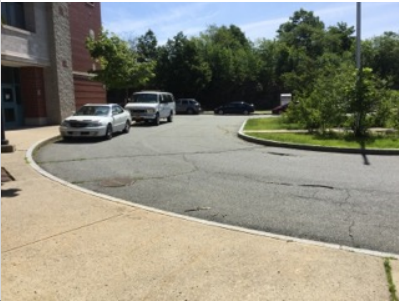
ID	Location	Floor	Room	Element	Type	Photo	Issues	Current Measure	Recommendations	Quantity	Price	Cost Estimation
Passenger Loading Zones												
10	Near Exit #7	Ext.		Passenger Loading Zones

Zone not connected to an accessible route		Ensure the passenger loading zone is connected to an accessible route.	1	2800	\$2800
Entrance												
11	Exit #13 - West Side	Ext.		Entrance	Secondary Entrance

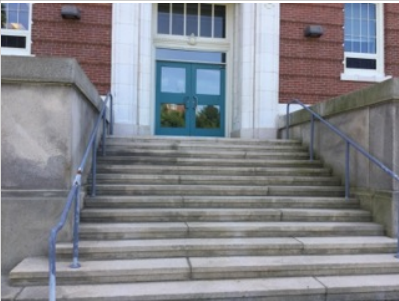
Entrance not on an accessible route Directional sign to accessible entrance not provided	- -	Provide a directional sign indicating the location of the nearest accessible entrance.	1	260	\$260
12	Main Entrance	Ext.		Entrance	Main Entrance

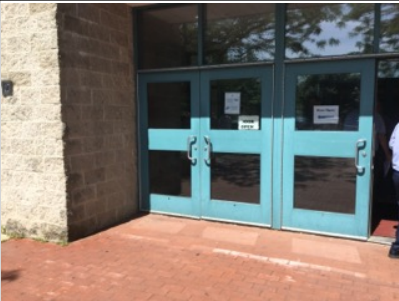
International Symbol of Accessibility not provided	-	Provide the International Symbol of Accessibility.	1	260	\$260
Stairs												
13	Stairs Towards Highland Avenue	Ext.		Stairs	N/A

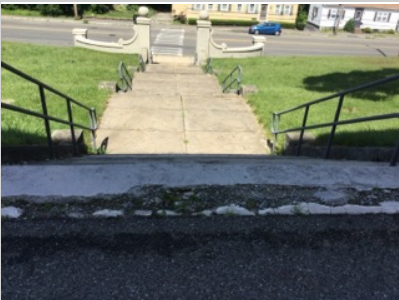
Not maintained in operable working condition	-	Ensure stairs are maintained in operable working condition.	1	-	\$0

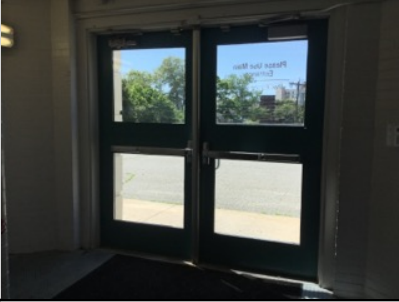
ID	Location	Floor	Room	Element	Type	Photo	Issues	Current Measure	Recommendations	Quantity	Price	Cost Estimation
Means of Egress												
14	Exit #11	1		Means of Egress	N/A

Illuminated exit sign not provided Tactile exit sign not provided	-	Ensure an illuminated exit sign with the International Symbol of Accessibility (ISA) is provided at exit door. Ensure a tactile exit sign with raised characters and braille is provided at exit door. Mount sign between 48"- 60" above finished floor located on the latch side of the door.	1	274	\$274
15	Main Entrance	1		Means of Egress	N/A

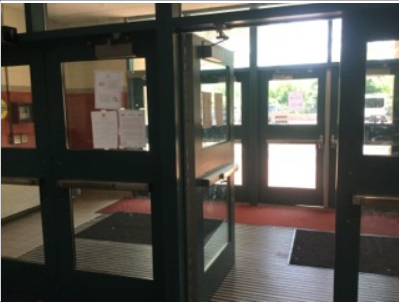
Illuminated exit sign not provided Tactile exit sign not provided	- -	Ensure an illuminated exit sign with the International Symbol of Accessibility (ISA) is provided at exit door. Ensure a tactile exit sign with raised characters and braille is provided at exit door. Mount sign between 48"- 60" above finished floor located on the latch side of the door.	1	274	\$274

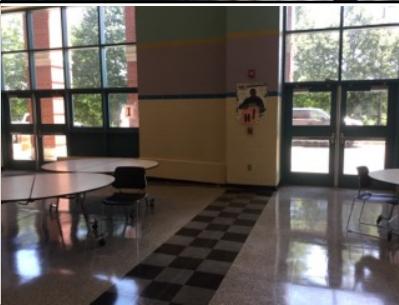
16	Exits #24 and #25 (Cafeteria)	1		Means of Egress	N/A

Illuminated exit sign not provided Tactile exit sign not provided	- -	Ensure illuminated exit signs with the International Symbol of Accessibility (ISA) are provided at exit doors. Ensure tactile exit signs with raised characters and braille is provided at exit door. Mount sign between 48"- 60" above finished floor located on the latch side of the door.	2	274	\$548
17	Exit #2	1		Means of Egress	N/A

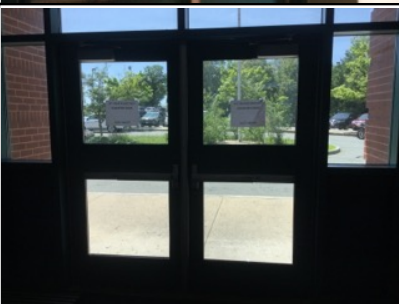
Illuminated exit sign not provided Tactile exit sign not provided	- -	Ensure an illuminated exit sign with the International Symbol of Accessibility (ISA) is provided at exit door. Ensure a tactile exit sign with raised characters and braille is provided at exit door. Mount sign between 48"- 60" above finished floor located on the latch side of the door.	1	274	\$274

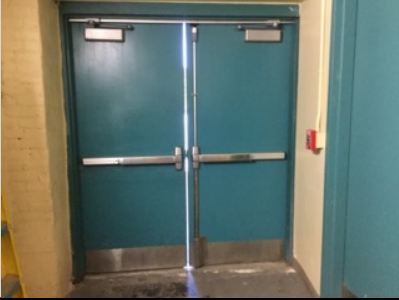
ID	Location	Floor	Room	Element	Type	Photo	Issues	Current Measure	Recommendations	Quantity	Price	Cost Estimation
19	Exit #18	1		Means of Egress	N/A

Illuminated exit sign not provided Tactile exit sign not provided	- -	Ensure an illuminated exit sign with the International Symbol of Accessibility (ISA) is provided at exit door. Ensure a tactile exit sign with raised characters and braille is provided at exit door. Mount sign between 48"- 60" above finished floor located on the latch side of the door.	1	274	\$274
20	Exit #17	Ext.		Means of Egress	N/A

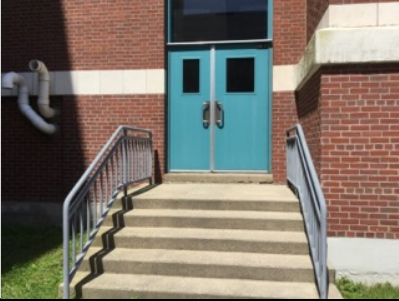
Emergency exit not on an accessible route		Provide a directional sign on the interior indicating the location of the nearest emergency exit. Ensure a tactile exit sign with raised characters and braille is provided at exit door. Mount sign between 48"- 60" above finished floor located on the latch side of the door.	1	174	\$174
21	Exit #16	1		Means of Egress	N/A

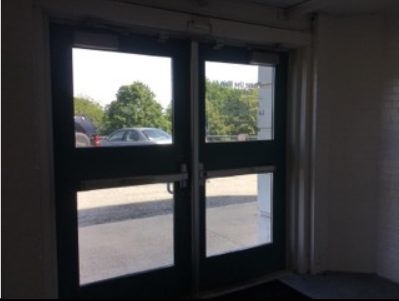
Emergency exit not on an accessible route Directional sign to accessible emergency exit not provided Tactile exit sign not provided	- - -	Provide a directional sign indicating the location of the nearest emergency exit. Ensure a tactile exit sign with raised characters and braille is provided at exit door. Mount sign between 48"- 60" above finished floor located on the latch side of the door.	1	174	\$174

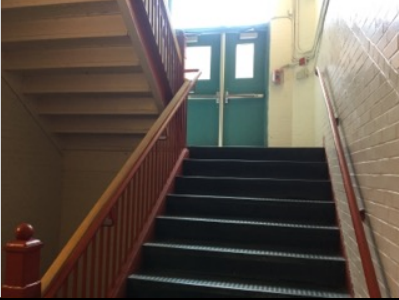
22	Stair F Exit #17	1	Stair F	Means of Egress	N/A

Emergency exit not on an accessible route Directional sign to accessible emergency exit not provided Tactile exit sign not provided	- - -	Provide a directional sign indicating the location of the nearest emergency exit. Ensure a tactile exit sign with raised characters and braille is provided at exit door. Mount sign between 48"- 60" above finished floor located on the latch side of the door.	1	174	\$174
23	Exit #14	1		Means of Egress	N/A

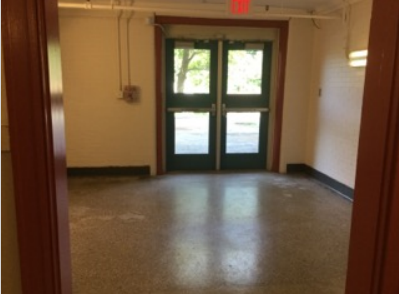
Emergency exit not on an accessible route Directional sign to accessible emergency exit not provided Tactile exit sign not provided	- - -	Provide a directional sign indicating the location of the nearest emergency exit. Ensure a tactile exit sign with raised characters and braille is provided at exit door. Mount sign between 48"- 60" above finished floor located on the latch side of the door.	2	174	\$348

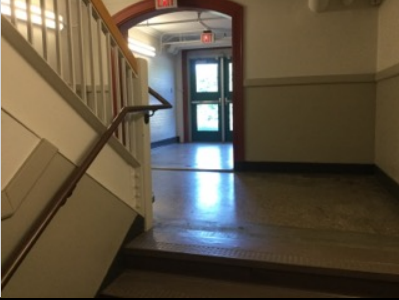
ID	Location	Floor	Room	Element	Type	Photo	Issues	Current Measure	Recommendations	Quantity	Price	Cost Estimation
24	Exit #12	1		Means of Egress	N/A

Emergency exit not on an accessible route Directional sign to accessible emergency exit not provided Tactile exit sign not provided		Provide a directional sign indicating the location of the nearest emergency exit. Ensure a tactile exit sign with raised characters and braille is provided at exit door. Mount sign between 48"- 60" above finished floor located on the latch side of the door.	1	174	\$174
25	Exit #10	1	117	Means of Egress	N/A

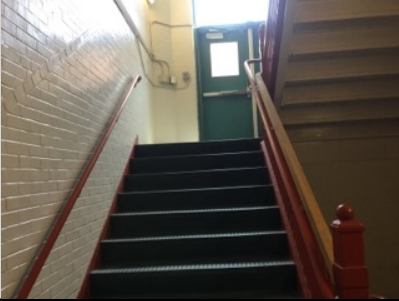
Emergency exit not on an accessible route Directional sign to accessible emergency exit not provided Tactile exit sign not provided		Provide a directional sign indicating the location of the nearest emergency exit. Ensure a tactile exit sign with raised characters and braille is provided at exit door. Mount sign between 48"- 60" above finished floor located on the latch side of the door.	1	174	\$174

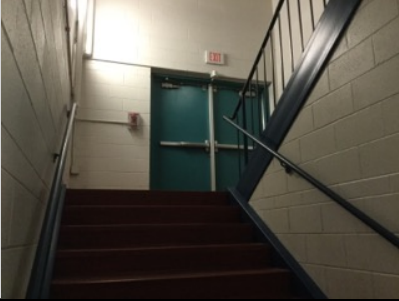
26	Exit #9	1		Means of Egress	N/A

Emergency exit not on an accessible route Directional sign to accessible emergency exit not provided Tactile exit sign not provided	- -	Provide a directional sign indicating the location of the nearest emergency exit. Ensure a tactile exit sign with raised characters and braille is provided at exit door. Mount sign between 48"- 60" above finished floor located on the latch side of the door.	1	174	\$174
27	Exit #9	2		Means of Egress	N/A

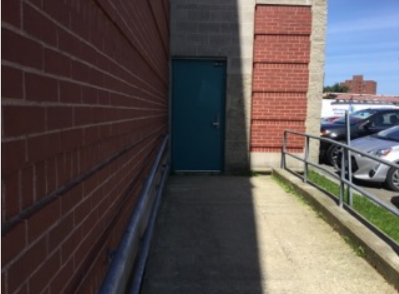
Tactile exit sign not provided	- -	Ensure a tactile exit sign with raised characters and braille is provided on the interior at exit door. Mount sign between 48"- 60" above finished floor located on the latch side of the door. Ensure an illuminated exit sign with the International Symbol of Accessibility (ISA) is provided at exit door.	1	274	\$274

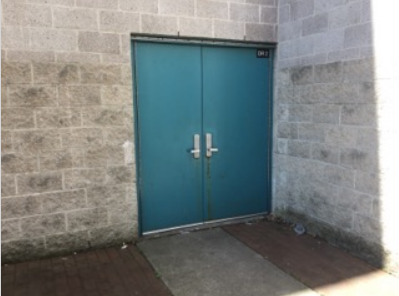
ID	Location	Floor	Room	Element	Type	Photo	Issues	Current Measure	Recommendations	Quantity	Price	Cost Estimation
29	Exit #2	Ext.		Means of Egress	N/A

Tactile exit sign not provided	-	Ensure tactile exit signs on the interior with raised characters and braille are provided at exit doors. Mount signs between 48"- 60" above finished floor located on the latch side of the door. Ensure an illuminated exit signs with the International Symbol of Accessibility (ISA) are provided at exit door.	1	274	\$274
30	Exits #3, #4, #5, and #6			Means of Egress	N/A

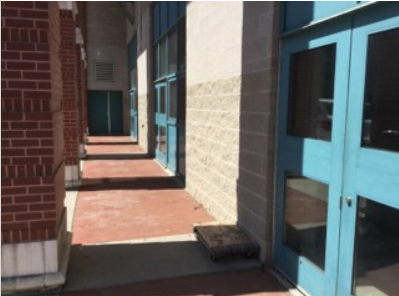
Tactile exit sign not provided	-	Ensure tactile exit signs on the interior with raised characters and braille are provided at exit doors. Mount signs between 48"- 60" above finished floor located on the latch side of the door. Ensure an illuminated exit signs with the International Symbol of Accessibility (ISA) are provided at exit door.	4	274	\$1096

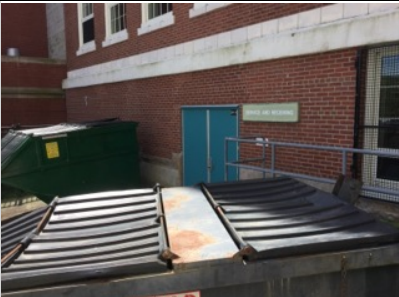
31	Exit #18			Means of Egress	N/A

Tactile exit sign not provided		Ensure a tactile exit sign on the interior with raised characters and braille is provided at exit door. Mount sign between 48"- 60" above finished floor located on the latch side of the door. Ensure an illuminated exit sign with the International Symbol of Accessibility (ISA) is provided at exit door.	1	274	\$274
32	Exits #19, #20			Means of Egress	N/A

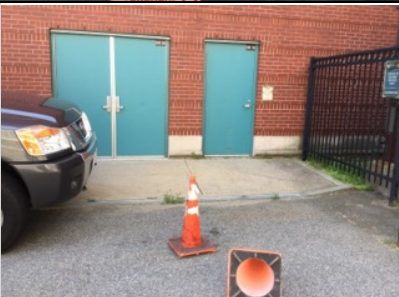
Tactile exit sign not provided	-	Ensure tactile exit signs with raised characters and braille are provided at exit doors. Mount signs between 48"- 60" above finished floor located on the latch side of the door. Ensure an illuminated exit signs with the International Symbol of Accessibility (ISA) are provided at exit doors.	2	274	\$548
33	Exit #21			Means of Egress	N/A

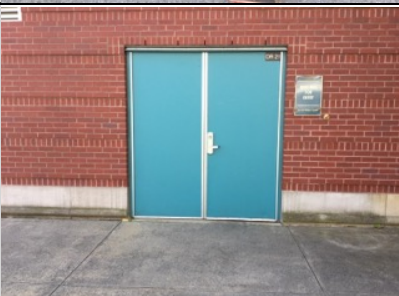
Tactile exit sign not provided	-	Ensure a tactile exit sign on the interior with raised characters and braille is provided at exit door. Mount sign between 48"- 60" above finished floor located on the latch side of the door. Ensure an illuminated exit sign with the International Symbol of Accessibility (ISA) is provided at exit door.	1	274	\$274

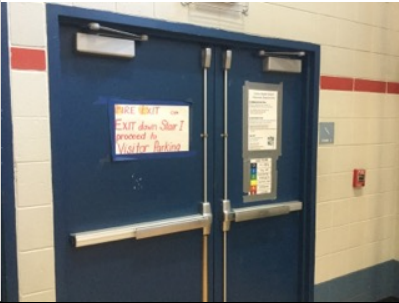
Directional sign to accessible emergency exit not provided	-	Provide a directional sign indicating the location of the nearest accessible emergency exit.	2	174	\$348
36	Stairwell H	2		Means of Egress	N/A

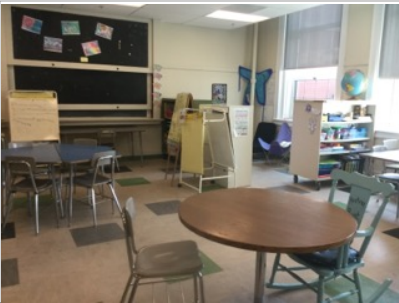
Interior Access Route												
37	Classroom	3	310	Interior Access Route

Route < 36" wide	29.75"	Ensure that a clear width of 36" min. is maintained at the accessible route.	1	Labor	\$0
38	Near Girls' Toilet Room	3		Interior Access Route	N/A

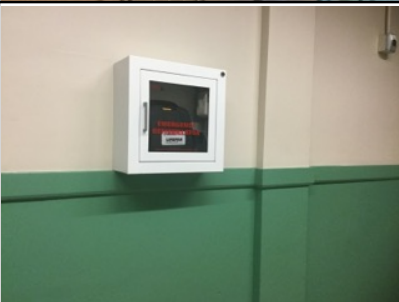
Obstructed by protruding objects	7"	Relocate AED so it does not protrude into the circulation path.	1	128	\$128

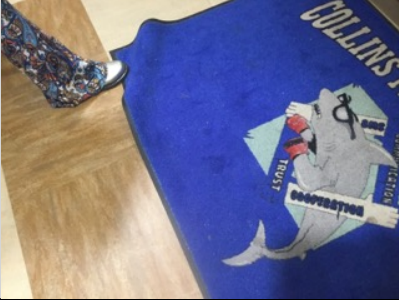
ID	Location	Floor	Room	Element	Type	Photo	Issues	Current Measure	Recommendations	Quantity	Price	Cost Estimation
39	Main Office	3		Interior Access Route	N/A

Mat not securely attached	-	Ensure walk-off mat is securely attached.	1	Labor	\$0
40	Classroom	3	301	Interior Access Route	N/A

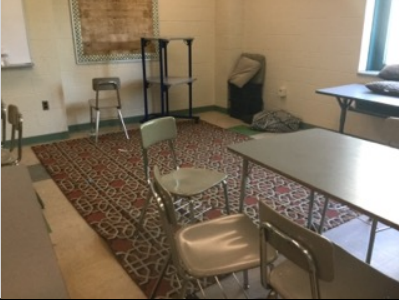
Mat not securely attached	-	Ensure walk-off mat is securely attached.	1	Labor	\$0
Doors, Doorways, & Gates												
41	Classroom	3	334	Doors, Doorways, & Gates	Classroom

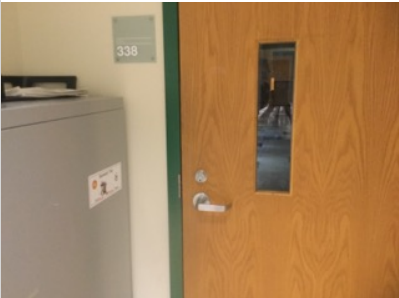
Maneuvering clearance(s) not provided	6"	Relocate cabinet to maintain the 18" min. maneuvering clearance at the door.	1	Labor	\$0

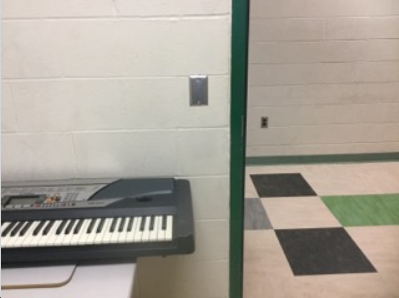
ID	Location	Floor	Room	Element	Type	Photo	Issues	Current Measure	Recommendations	Quantity	Price	Cost Estimation
44	Music Room	3	343	Doors, Doorways, & Gates	Classroom

Maneuvering clearance(s) not provided	-	Remove piano keyboard to maintain the maneuvering clearance at the door.	1	Labor	\$0
45	Assistant Superintendent's Office	2	226	Doors, Doorways, & Gates	N/A

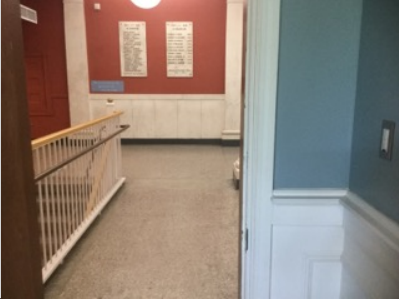
Maneuvering clearance(s) not provided		Keep door open as needed.	1	Labor	\$0
46	Assistant Superintendent's Office	2	226	Doors, Doorways, & Gates

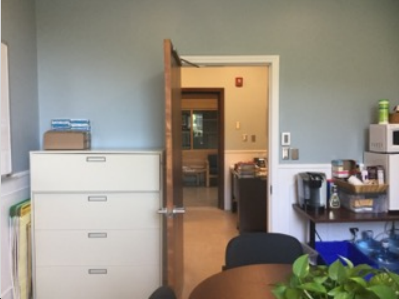
Maneuvering clearance(s) not provided	-	Relocate table to maintain the maneuvering clearance at the door.	1	Labor	\$0
47	Superintendent's Office	2	222	Doors, Doorways, & Gates	Office

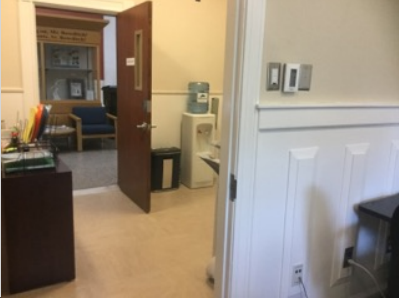
Maneuvering clearance(s) not provided	-	Relocate table to maintain the maneuvering clearance at the door.	1	Labor	\$0
48	Director of Nursing Office	1	129	Doors, Doorways, & Gates	Office

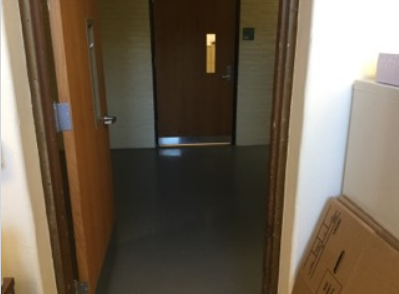
Maneuvering clearance(s) not provided	-	Ensure the maneuvering clearance is maintained at the door.	1	Labor	\$0

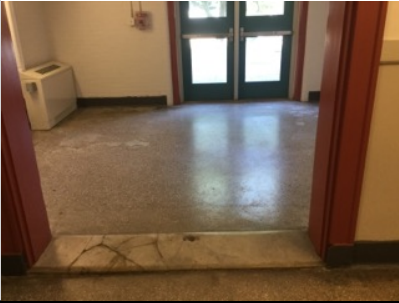
Threshold > 1/2" high	2"	Alter threshold to be 1/2" high max.	1	113	\$113
51	Classroom	4	431	Doors, Doorways, & Gates	Circulation

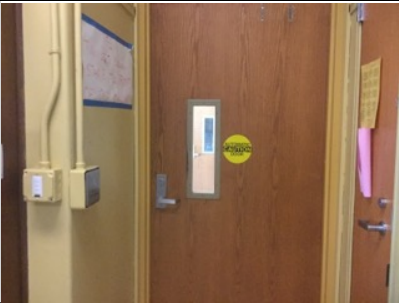
Automatic door opener not operable	-	Repair or replace the door opener.	1	2295	\$2295
52	Classroom	4	432	Doors, Doorways, & Gates

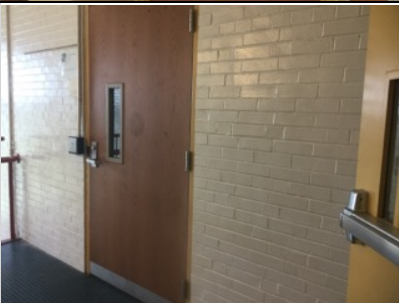
Automatic door opener not operable	-	Repair or replace the door opener.	1	2295	\$2295
53	Nurse's Room	3	317	Doors, Doorways, & Gates	Office

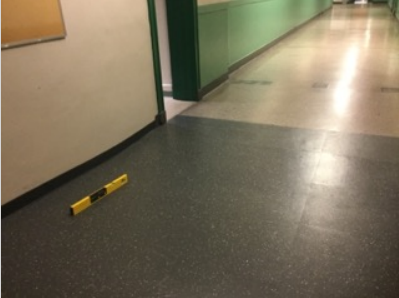
ID	Location	Floor	Room	Element	Type	Photo	Issues	Current Measure	Recommendations	Quantity	Price	Cost Estimation
Ramps												
54	Hallway - Near Room #337	3		Ramps	Interior

Handrails not provided at both sides if rise is > 6"	-	Provide handrails on both sides.	4	834	\$3336
55	Near Room #310	3		Ramps	Interior

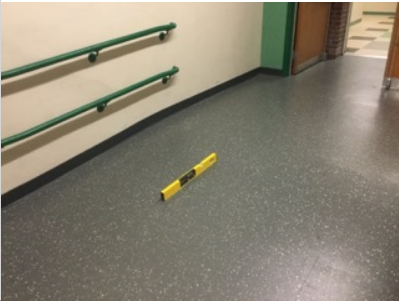
No lower handrail 18"-20" high provided	-	Provide a lower handrail between 18" to 20" high.	1	834	\$834
Stairways												
56	Towards Bleachers From Toilet Rooms	Ext		Stairways	Exterior

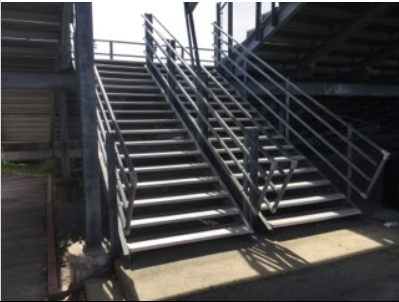
Stair has open risers	-	Ensure stairs have closed risers. (Cost for fill in of 16 risers.)	2	1968	\$3936
Elevator												
57	Elevator	3		Elevator	Interior

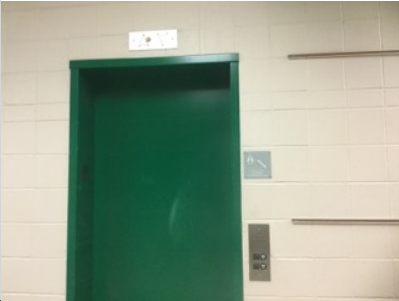
Elevator not independently operable (requires key)		Ensure elevator provides unassisted entry and exit.	1	-	\$0

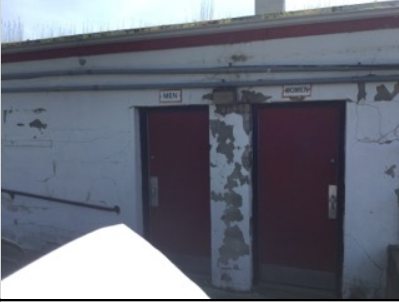
ID	Location	Floor	Room	Element	Type	Photo	Issues	Current Measure	Recommendations	Quantity	Price	Cost Estimation
Signage												
58	Men's and Women's Toilet Rooms	Ext.		Signage	Designation

Raised characters not provided Braille not provided Sign not located on the latch side of the door	- - -	Provide text with raised characters duplicated in braille. Locate sign alongside doors on the latch side.	2	260	\$520
59	Mechanical Drawing	1	103	Signage	Designation

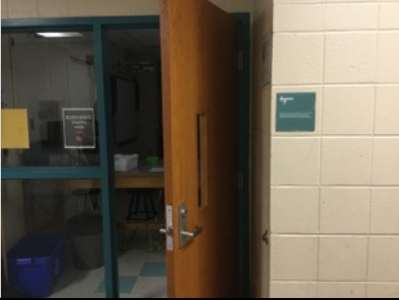
Raised characters not provided Braille not provided Sign not located on the latch side of the door	- - -	Provide text with raised characters duplicated in braille. Locate sign alongside the door on the latch side.	1	174	\$174
60	Classroom	3	334	Signage	Designation

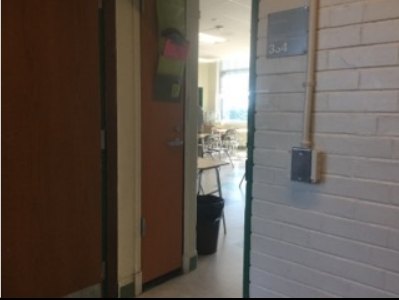
Braille not provided	-	Provide braille.	1	174	\$174
61	Classroom	4	422	Signage	Designation

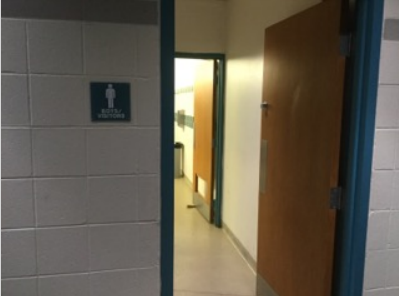
Braille not provided International Symbol of Acc. not provided	- -	Provide braille. Provide a sign with the International Symbol of Accessibility.	1	174	\$174

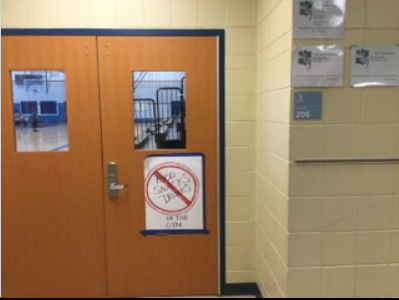
ID	Location	Floor	Room	Element	Type	Photo	Issues	Current Measure	Recommendations	Quantity	Price	Cost Estimation
63	Gym	2	206	Signage	Designation

Braille not provided Sign not located on the latch side of the door	- -	Provide braille. Locate sign at permanent rooms alongside the door on the latch side.	1	174	\$174
64	Classroom	4	423	Signage	Designation

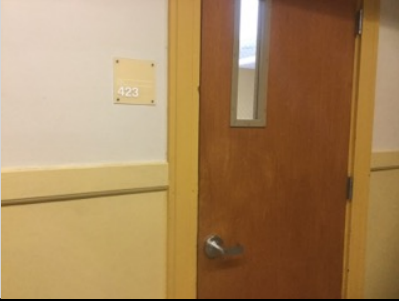
Braille misplaced	-	Position braille below the corresponding text. If text is multi-lined place braille below the entire text.	1	174	\$174
65	Girls' Toilet Room - Near Room #321	3		Signage	Designation

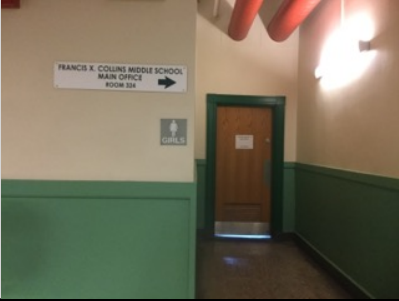
Braille misplaced	-	Position braille below the corresponding text. If text is multi-lined place braille below the entire text.	1	174	\$174
66	Stair B	3		Signage	Egress
