City of Salem, Massachusetts

PART A – Executive Summary

Part A – Executive Summary

Introduction

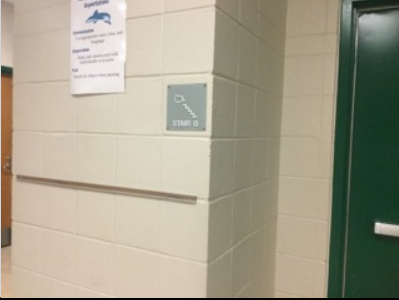
Braille misplaced	-	Position braille below the corresponding text. If text is multi-lined place braille below the entire text.	1	174	\$174
67	Boys' Toilet Room - Near Room #327	3		Signage	Designation

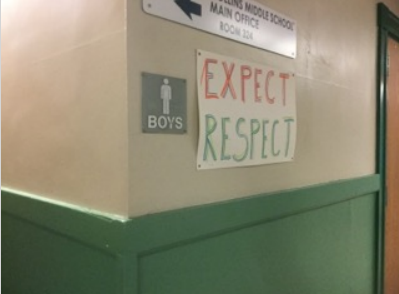
Braille misplaced Sign not located on the latch side of the door	- -	Position braille below the corresponding text. If text is multi-lined place braille below the entire text. Locate sign alongside the door on the latch side.	1	174	\$174

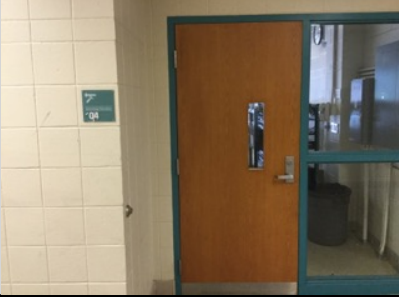
Sign not located on the latch side of the door	-	Locate sign alongside the door on the latch side.	1	Labor	\$0
70	Classroom	1	105	Signage	Designation

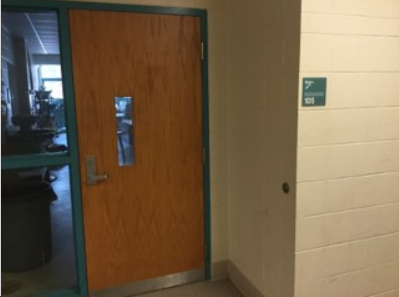
Sign not located on the latch side of the door	-	Locate sign alongside the door on the latch side.	1	Labor	\$0
71	Fitness Room	1	107	Signage	Designation

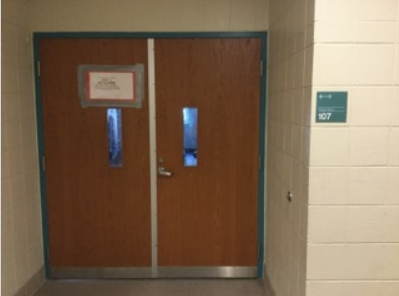
Sign not located on the latch side of the door	-	Locate sign at permanent rooms alongside the door on the latch side on the inactive leaf.	1	Labor	\$0
72	Computer Lab	2	225	Signage	Designation

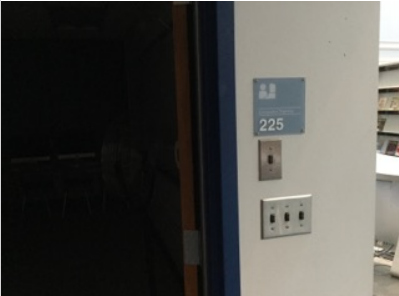
Sign not located on the latch side of the door	-	Locate sign alongside the door on the latch side.	1	Labor	\$0

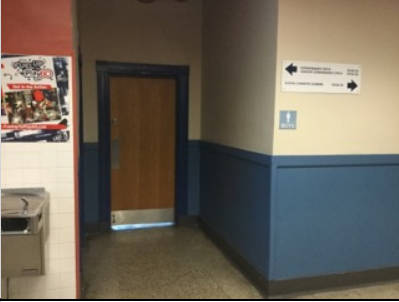
ID	Location	Floor	Room	Element	Type	Photo	Issues	Current Measure	Recommendations	Quantity	Price	Cost Estimation
73	Boys' and Girls' Toilet Rooms	2		Signage	Designation

Sign not located on the latch side of the door	-	Locate sign at permanent rooms alongside the door on the latch side.	2	Labor	\$0
74	Committee Chamber	2	227	Signage	Designation

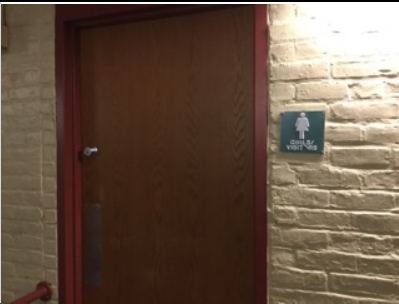
Sign not located on the latch side of the door International Symbol of Acc. not provided	- -	Locate sign at permanent rooms alongside the door on the latch side. Provide a sign with the International Symbol of Accessibility.	1	174	\$174
76	Green Room	1		Signage	Designation

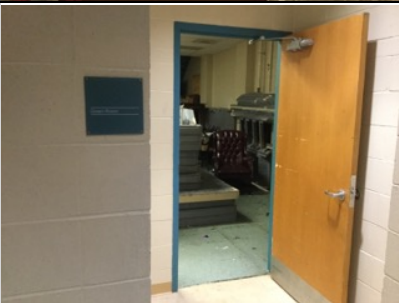
Sign not maintained in operable working condition	-	Provide a sign with raised characters duplicated in braille. Locate sign alongside doors on the latch side.	1	174	\$174

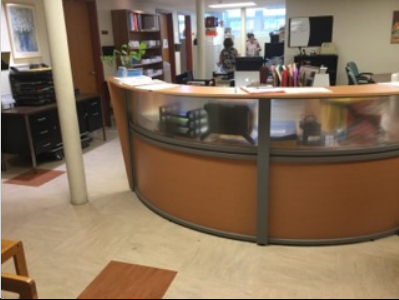
ID	Location	Floor	Room	Element	Type	Photo	Issues	Current Measure	Recommendations	Quantity	Price	Cost Estimation
78	Parent Information Center	1		Service Counter	N/A

Counter > 36" high	44.5"	Provide a counter that is 36" max. above the ground or finished floor.	1	660	\$660
Dining or Work Surfaces												
79	Classroom	4	434	Dining or Work Surfaces	Work Surface

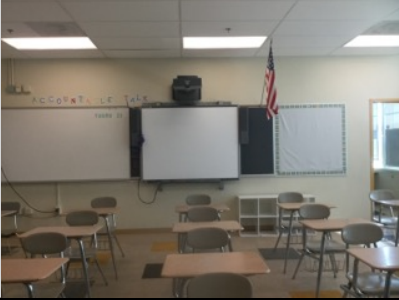
At least one or 5% accessible tables not provided Knee or toe clearance not provided	- -	Ensure that at least one dining or work surface is accessible. Provide at least 1 dining or work surface with 27" min. knee and toe clearance.	1	525	\$525
80	Classroom	4	433	Dining or Work Surfaces	Work Surface

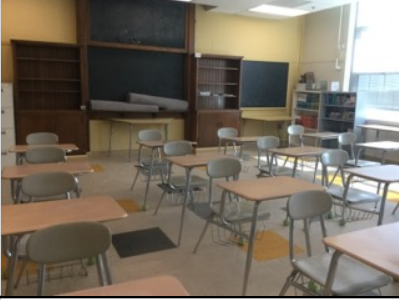
At least one or 5% accessible tables not provided Knee or toe clearance not provided	- -	Ensure that at least one dining or work surface is accessible. Provide at least 1 dining or work surface with 27" min. knee and toe clearance.	1	525	\$525

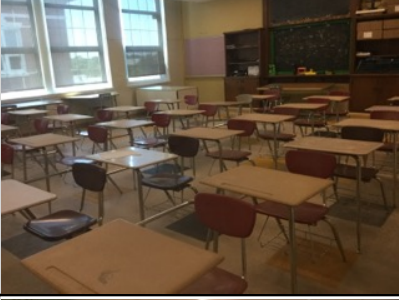
81	Classroom	4	430	Dining or Work Surfaces	Work Surface

At least one or 5% accessible tables not provided Knee or toe clearance not provided	- -	Ensure that at least one dining or work surface is accessible. Provide at least 1 dining or work surface with 27" min. knee and toe clearance.	1	525	\$525
82	Classroom	3	321	Dining or Work Surfaces	Work Surface

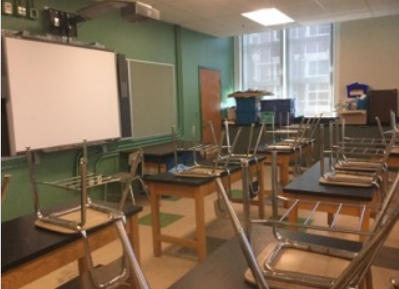
At least one or 5% accessible tables not provided Knee or toe clearance not provided	- 24"	Provide at least one work surface with 27" min. knee and toe clearance.	1	525	\$525

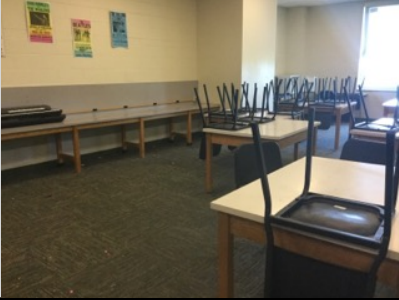
ID	Location	Floor	Room	Element	Type	Photo	Issues	Current Measure	Recommendations	Quantity	Price	Cost Estimation
83	Music Room	3	348	Dining or Work Surfaces	Work Surface

At least one or 5% accessible tables not provided Knee or toe clearance not provided	- 23.5"	Provide at least 1 work surface with 27" min. knee and toe clearance.	1	525	\$525
84	Computer Lab	2	225	Dining or Work Surfaces	Work Surface

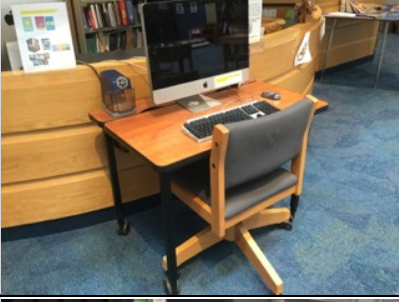
At least one or 5% accessible tables not provided Knee or toe clearance not provided	- 25"	Provide a work surface with 27" min. knee and toe clearance.	1	525	\$525
86	Library	2	238	Dining or Work Surfaces	Work Surface

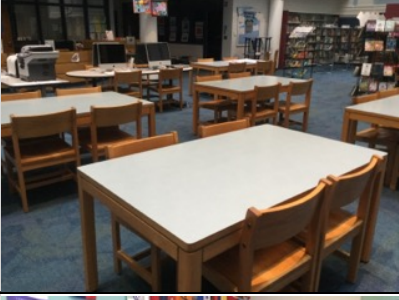
At least one or 5% accessible tables not provided Knee or toe clearance not provided	- 25"	Ensure that at least one work surface is accessible. Provide at least one work surface with 27" min. knee and toe clearance.	1	525	\$525

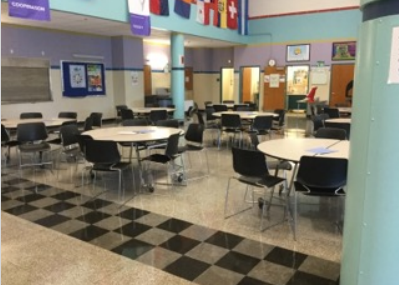
87	Cafeteria	1		Dining or Work Surfaces	Dining Surface

At least one or 5% accessible tables not provided Top of dining/work surface < 28" or > 34"	- 25"	Ensure that at least one dining surface is accessible. Provide at least one dining surface with top between 28"- 34" above the floor and 27" clear height underneath.	1	825	\$825

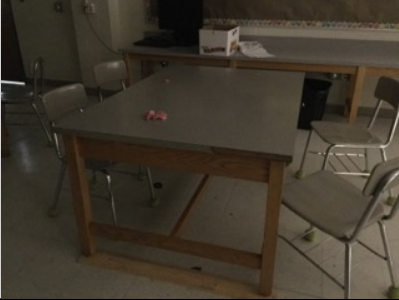
ID	Location	Floor	Room	Element	Type	Photo	Issues	Current Measure	Recommendations	Quantity	Price	Cost Estimation
88	Mechanical Drawing	1	103	Dining or Work Surfaces	Work Surface

At least one or 5% accessible tables not provided Top of dining/work surface < 28" or > 34"	- 23"	Ensure that at least one work surface is accessible. Provide at least one work surface with top between 28"- 34" above the floor and 27" clear height underneath.	1	525	\$525
89	Classroom	4	422 426	Dining or Work Surfaces	Work Surface

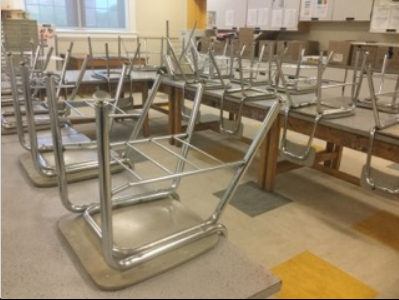
Knee or toe clearance not provided	23.75"	Provide at least 1 work surface with 27" min. knee and toe clearance.	2	525	\$1050
90	Research Room	3	323	Dining or Work Surfaces	Work Surface

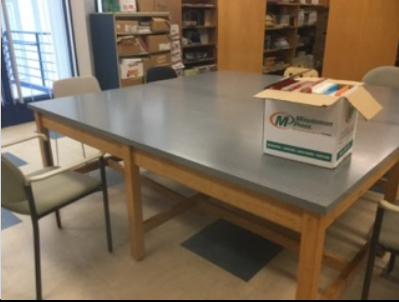
Knee or toe clearance not provided	23.5"	Provide at least one work surface with 27" min. knee and toe clearance.	1	525	\$525
Assembly Area												
91	Auditorium	2		Assembly Area	N/A

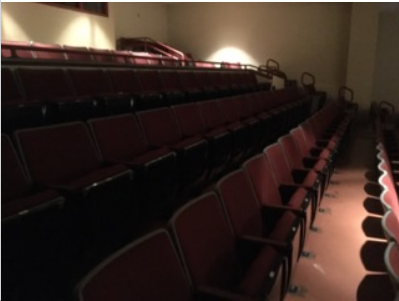
Number of seats Minimum # wheelchair spaces not provided Designated aisle seats < 5%	370 - -	Provide six (6) wheelchair accessible spaces. At least 5% of the total number of aisle seats provided must be identified by a sign or marker and have folding or retractable armrests. (Cost to remove six (6) seats.)	1	1152	\$1152

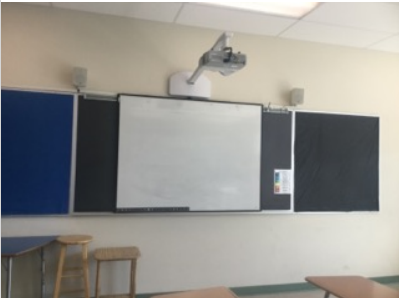
92	Classroom	3	334	Assembly Area	N/A

Assistive listening devices not provided	-	If audible communication is integral to the use of the space, provide an assistive listening system. (Cost for a capacity of 50 or less.)	1	1821	\$1821

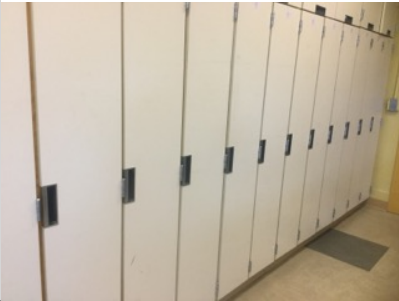
Total # of locker Total # of accessible locker	- -	Ensure that at least (5%) or one locker is accessible.	1	495	\$495
Emergency Shower												
95	Lab	3	321	Emergency Shower	N/A

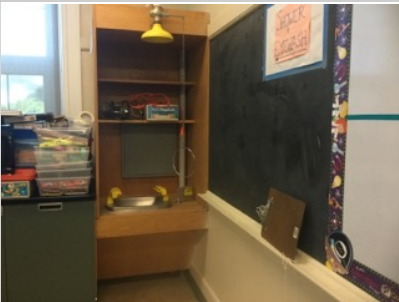
Emergency shower out of reach range	66"	Lower the shower pull to 48" max.	1	Labor	\$0
Picnic Tables												
96	North Side of Athletic Field	Ext.		Picnic Tables	N/A

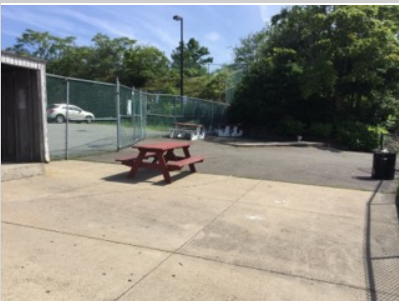
At least 5% accessible spaces not provided	-	Ensure that at least 5% (minimum one) of dining surfaces are accessible.	1	1050	\$1050

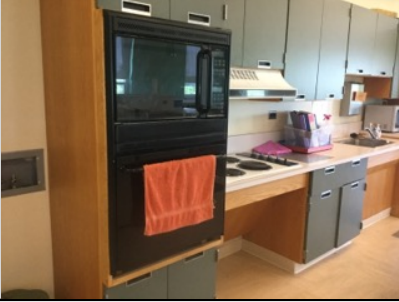
ID	Location	Floor	Room	Element	Type	Photo	Issues	Current Measure	Recommendations	Quantity	Price	Cost Estimation
Kitchens and Kitchenettes												
97	Kitchen Classroom	3	347	Kitchens and Kitchenettes	Classrooms

Retractable bread board not provided	-	Provide a retractable bread board adjacent to the door.	1	305	\$305
Toilet & Bathing Rooms												
Overall Access												
98	Boys' Toilet Room - Near Cafeteria	1		Overall Access	Toilet Room

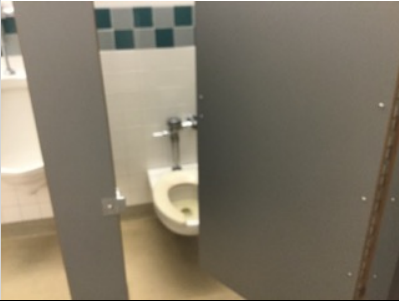
6 fixtures, but no ambulatory compartment provided	-	Provide one ambulatory accessible compartment.	1	2259	\$2259
Lavatory												
99	Girls' Toilet Room Near Cafeteria	1		Lavatory	N/A

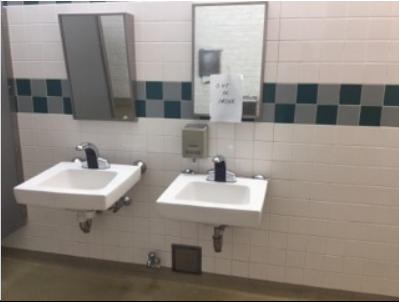
Toe or knee clearances not provided Mirror above lavatory w/reflective surface > 40"	22" 44.5"	Provide at least one lavatory with knee and toe clearance positioned for a forward approach. Lower mirror so that the bottom surface is at 40" max. above finished floor.	1	1457	\$1457

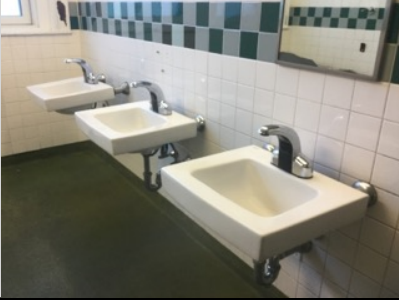
100	Boys' Toilet Room - Near Room #327	3		Lavatory	N/A

Plumbing underneath is exposed Mirror above lavatory w/reflective surface > 40"	- 44"	Insulate or otherwise configure pipes to prevent contact, for at least one lavatory. Lower mirror so that the bottom surface is at 40" max. above finished floor.	1	261	\$261

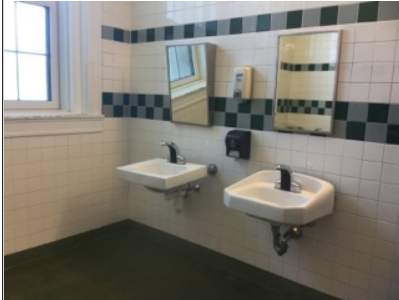
ID	Location	Floor	Room	Element	Type	Photo	Issues	Current Measure	Recommendations	Quantity	Price	Cost Estimation
101	Girls' Toilet Room - Near Room #321	3		Lavatory	N/A

Mirror above lavatory w/reflective surface > 40"	43"	Lower mirror so that the bottom surface is at 40" max. above finished floor.	1	192	\$192
Single-User Toilet												
102	Toilet Room - Nurse's Room	3	320	Single-User Toilet	N/A

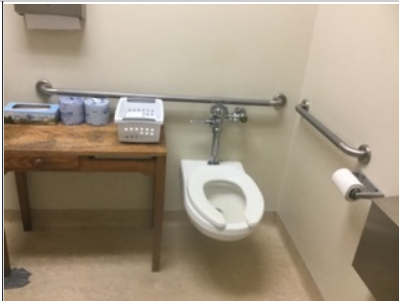
Clearance at toilet < 60" clear width	-	Remove table to maintain the 60" min. clear floor space at the toilet.	1	Labor	\$0
Toilet Compartment												
103	Girls' Toilet Room - Near Room #321	3		Toilet Compartment	Accessible Compartment

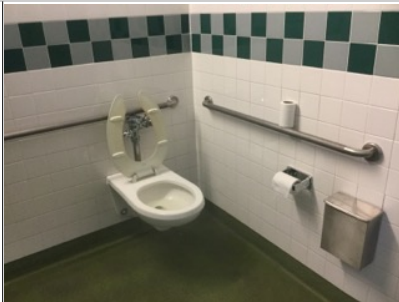
Door has malfunctioning self-closing hinge	-	Repair hinge.	1	Labor	\$0
104	Girls' Toilet Room - Near Room #302	3		Toilet Compartment	Accessible Compartment

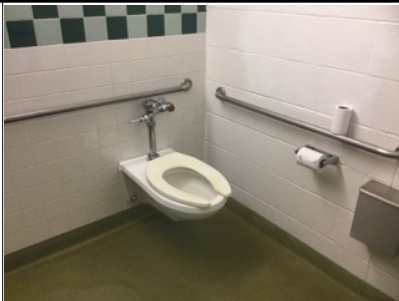
Door has malfunctioning self-closing hinge	-	Repair hinge.	1	Labor	\$0
105	Boys' Toilet Room - Near Room #302	3		Toilet Compartment	Accessible Compartment

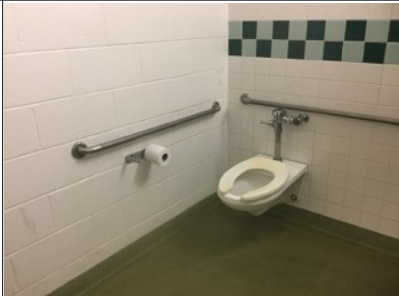
Door has malfunctioning self-closing hinge Flush control not on open side	- -	Repair hinge. Provide the flush control on the open side of the toilet (transfer side).	1	281	\$281

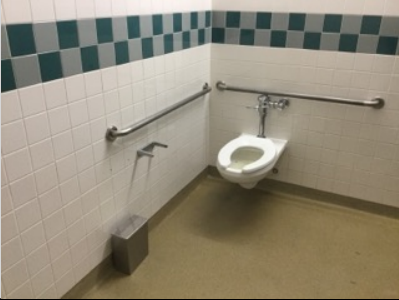
ID	Location	Floor	Room	Element	Type	Photo	Issues	Current Measure	Recommendations	Quantity	Price	Cost Estimation
106	Girls' Toilet Room Near Cafeteria	1		Toilet Compartment	Accessible Compartment

Flush control not on open side	-	Provide the flush control on the open side of the toilet (transfer side).	1	281	\$281
107	Girls' Toilet Room - Near Room #302	3		Toilet Compartment	Accessible Compartment

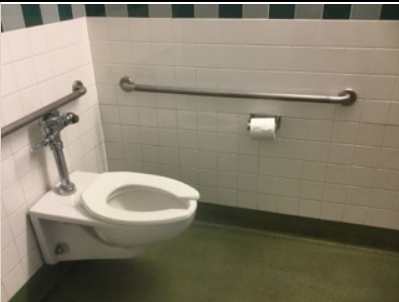
Centerline < or > 18" (MAAB)	19.5"	Relocate toilet so the centerline is 18" from the side wall.	1	2121	\$2121
Shower Compartment												
109	Toilet Room - Nurse's Room	3	320	Shower Compartment	Roll-In Type

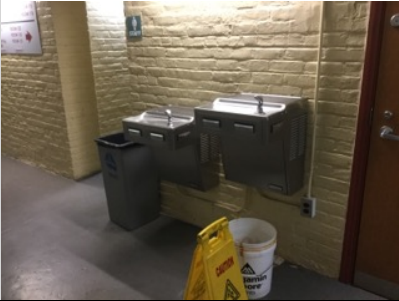
Additional Access												
Drinking Fountains												
110	Near Room #121	1		Drinking Fountains	N/A

Drinking fountains not maintained in operable working condition	-	Ensure drinking fountains are maintained in operable working condition.	1	-	\$0

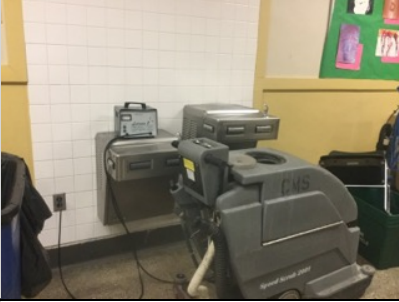
ID	Location	Floor	Room	Element	Type	Photo	Issues	Current Measure	Recommendations	Quantity	Price	Cost Estimation
111	Near Room #413	4		Drinking Fountains	Low

Spout > 36" high (wheelchair users)	38.5"	Lower drinking fountain for seated users so that the spout is 36" max. above the finished floor or ground.	1	1521	\$1521
112	Fountain Near Front Atrium	2	226	Drinking Fountains	Low

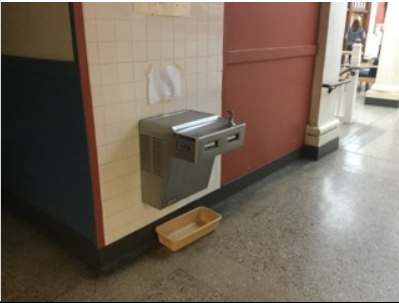
No drinking fountain provided for standing users	-	Provide an additional drinking fountain for standing users or install a Hi-Lo drinking fountain.	1	3021	\$3021
113	Near Room #127	1		Drinking Fountains	High

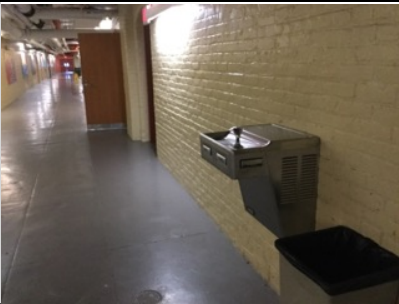
No drinking fountain provided for seated users	-	Provide an additional drinking fountain for seated users or install a Hi-Lo drinking fountain.	1	3021	\$3021
Sink												
114	Classroom	3	345	Sink	Classroom

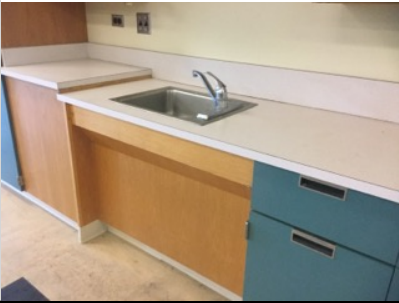
Toe and knee clearances not provided	-	Remove wooden panel to provide a 27" knee clearance positioned for a forward approach and insulate or otherwise configure pipes at sink.	1	930	\$930

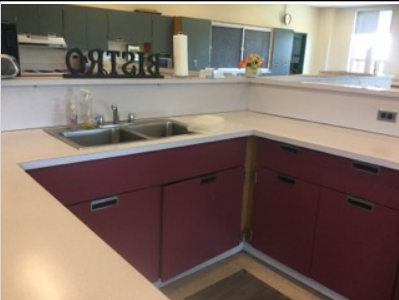
115	Kitchen Classroom	3	347	Sink

Toe and knee clearances not provided	-	Remove wooden panel to provide a 27" knee clearance positioned for a forward approach and insulate or otherwise configure pipes at sink.	1	930	\$930

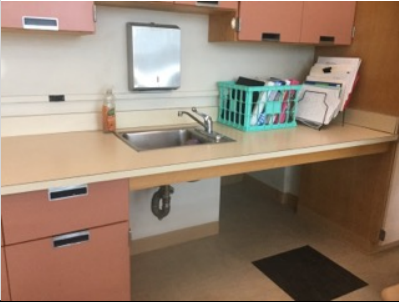
ID	Location	Floor	Room	Element	Type	Photo	Issues	Current Measure	Recommendations	Quantity	Price	Cost Estimation
116	Classroom	4	433	Sink	Classroom

Exposed plumbing underneath sink	-	Insulate or otherwise configure pipes at sink. (Insulate pipes at one sink per-grade.)	3	69	\$207
117	Band Room	3	340	Sink

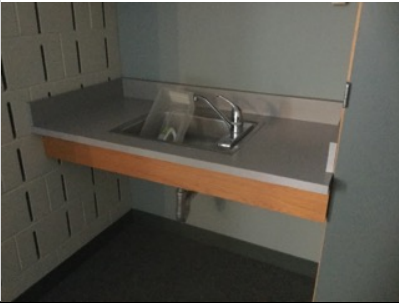
Exposed plumbing underneath sink	-	Insulate or otherwise configure pipes at sink.	1	69

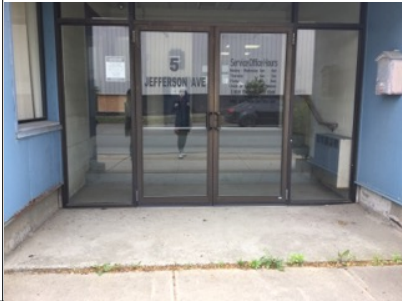
Level changes > 1/4"	-	Alter change in level to be 1/4" high max. (Cost based on a 3'x 9' concrete patch.)	1	464	\$464
Curb Ramp												
2	Crosswalk Near DPW at U-Haul	Ext.		Curb Ramp	N/A

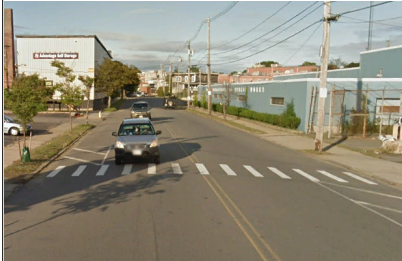
Curb ramp not provided	-	Provide a curb ramp at both sides of crosswalk. Note: Google Earth image. (Cost based on curb ramps in a concrete sidewalk.)	2	2800	\$5600
Off-Street Parking Lot or Garage												
3	Employee Parking	Ext.		Off-Street Parking Lot or Garage	Employee

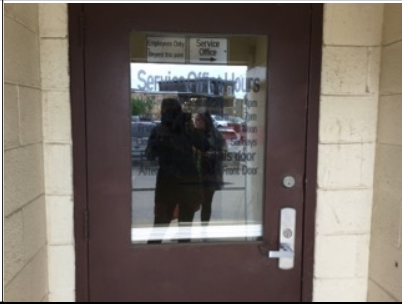
Entrance												
4	Northeast Entrance at Ramp	Ext.		Entrance	N/A

Entrance not on an accessible route when locked.	-	In order to provide program access at this entrance, which is the only accessible entrance and is locked after 3:-00 PM, either install an intercom system at this entrance, or keep this entrance open at all times that the office is open to the public.	1	Labor	\$0

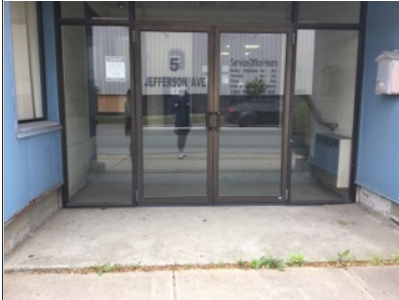
ID	Location	Floor	Room	Element	Type	Photo	Issues	Current Measure	Recommendations	Quantity	Price	Cost Estimation
5	5 Jefferson Street Entrance	Ext.		Entrance	Other

Directional sign to accessible entrance not provided	-	Provide a directional sign indicating the location of the nearest accessible entrance.	1	260	\$260
Emergency Exit												
6	5 Jefferson Street Egress After Stairs	1		Emergency Exit	N/A

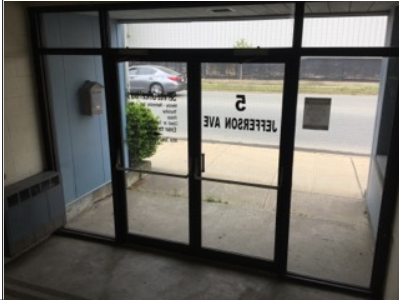
Emergency exit not on an accessible route Directional sign to accessible emergency exit not provided Tactile exit sign not provided	- -	Provide a directional sign indicating the location of the nearest accessible emergency exit. Ensure tactile exit signs with raised characters and braille are provided at exit doors. Mount signs between 48"- 60" above finished floor located on the latch side of the door. (Cost based on two (2) signs.)	2	174	\$348
Access to Goods and Services

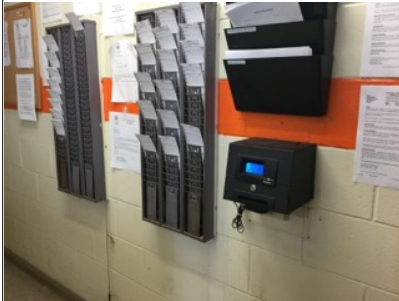
Obstructed by protruding objects	41"	Provide a cane-detectable barrier.	1	230	\$230

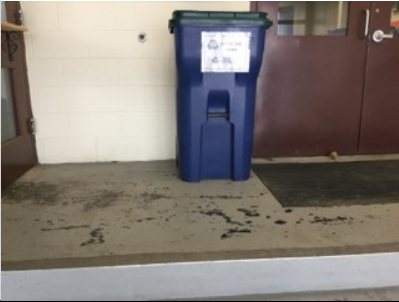
ID	Location	Floor	Room	Element	Type	Photo	Issues	Current Measure	Recommendations	Quantity	Price	Cost Estimation
9	Light Bulb Drop-Off	1		Interior Access Route	N/A

Accessible route not provided	-	Light bulb recycling bin not on an accessible route. Relocate bin to an accessible location or provide assistance with bulb disposal as needed.	1	Labor	\$0
Doors, Doorways, & Gates												
10	Service Office	1		Doors, Doorways, & Gates	Office

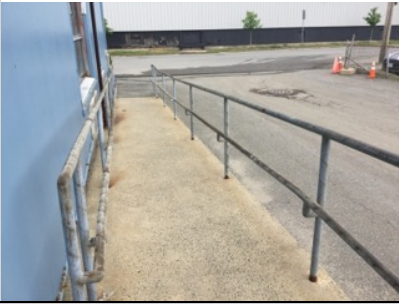
Ramp < 48" wide	40"	If ramp is renovated, widen ramp so that the clear width is 48" min. Ramp is usable but not compliant.	1	-	\$0
Stairways												
12	Interior at 5 Jefferson Street Entrance	1		Stairways	Interior

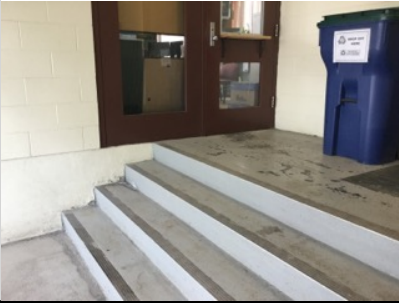
Handrail not provided on both sides	-	Provide handrail on one side. (Cost based on one (1) 6' long wall-mounted wooden handrail at \$33 a foot.)	1	198	\$198

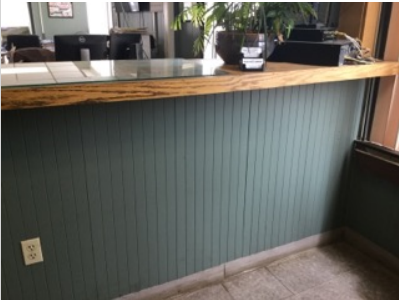
ID	Location	Floor	Room	Element	Type	Photo	Issues	Current Measure	Recommendations	Quantity	Price	Cost Estimation
Service Counter												
13	Service Counter	1		Service Counter	N/A

Counter > 36" high	45.5	Provide a counter that is 36" max. above the ground or finished floor.	1	660	\$660
Dining or Work Surfaces												
14	Service Office	1		Dining or Work Surfaces	Work Surface

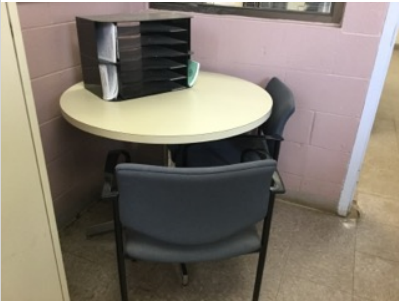
Knee or toe clearance not provided	-	Provide at least one (1) work surface with toe clearance. (Existing table does have sufficient knee clearance in excess of 27".)	1	525	\$525

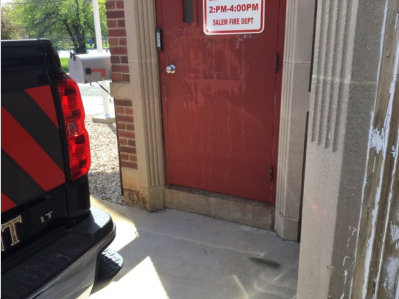
ID	Location	Floor	Room	Element	Type	Photo	Issues	Current Measure	Recommendations	Quantity	Price	Cost Estimation
Approach and Entrance												
Entrance												
1	Main Entrance	Ext.		Entrance	Main Entrance

Accessible entrance not provided	-		1		\$0
Access to Goods and Services												
Stairways												
2	From 1st Floor to 2nd Floor	2		Stairways	Interior

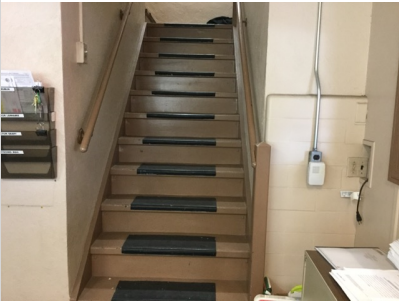
Accessible route not provided	-		1		\$0
Toilet & Bathing Rooms												
Overall Access												
3	Toilet Room	1		Overall Access	Toilet Room

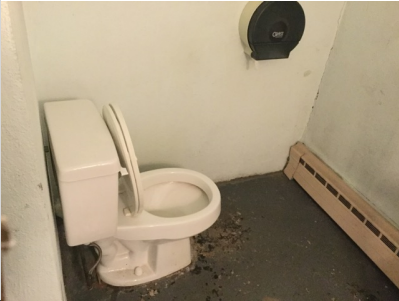
Accessible plumbing fixtures or stalls not provided	-	.	1	0	\$0
4	Toilet Room	2		Overall Access	Toilet Room

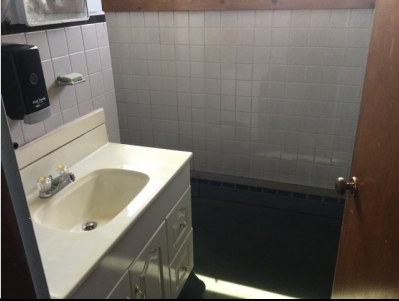
Accessible plumbing fixtures or stalls not provided	-		1	0	\$0

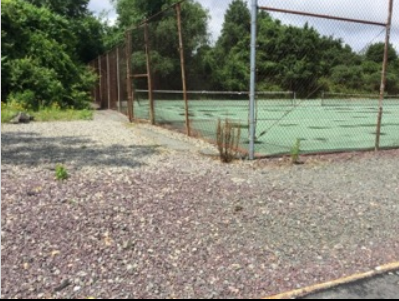
ID	Location	Floor	Room	Element	Type	Photo	Issues	Current Measure	Recommendations	Quantity	Price	Cost Estimation
Approach and Entrance												
Exterior Access Route												
1	Alternative Route to Tennis Court	Ext.		Exterior Access Route	Exterior

Area for alternative route to tennis courts.	1	-	\$0
2	Route to Field Across Doors From Gymnasium	Ext.		Exterior Access Route	Exterior

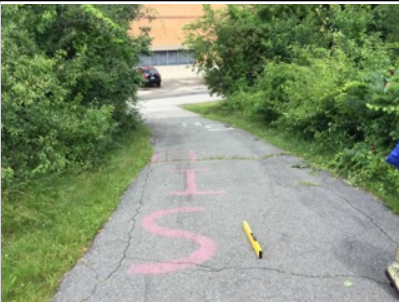
Cross slope > 1:50 (2.00%) Running slope > 1:20 (5%)	3.5% 10.6%	Reduce cross slope to be no steeper than 1:50 (2.00%). Reduce running slope to be no steeper than 1:20 (5%). (Cost based on 265' by 4" wide asphalt route to field.)	1	6758	\$6758
3	Route to Exits #4, #5, #6, #7	Ext.		Exterior Access Route	Exterior

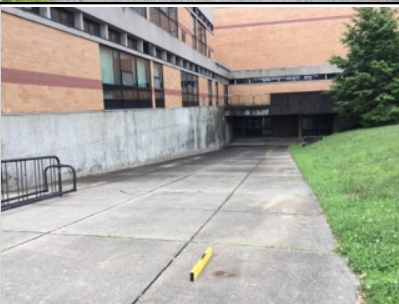
Running slope > 1:20 (5%)	9.8%	While not technically compliant, this area is still usable.	1	0	\$0
4	Tennis Courts	Ext.		Exterior Access Route	Exterior

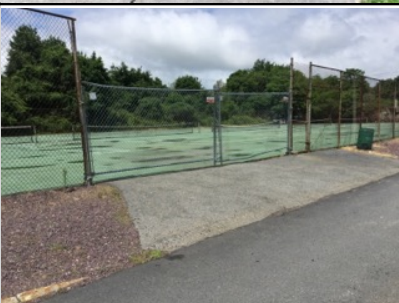
Running slope > 1:20 (5%)	14.1%	Provide an accessible route to the tennis courts that has a running slope no steeper than 1:20 (5%). See ID #1 for route placement. (Cost based on 65' by 4' wide asphalt route.)	1	1658	\$1658

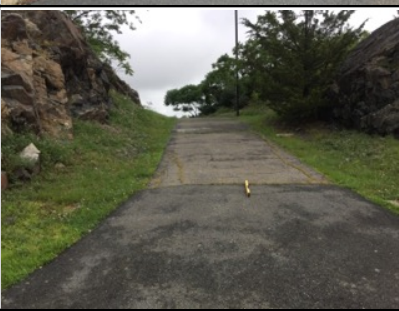
5	Route to Parking From Main Entrance	Ext.		Exterior Access Route	Exterior

Running slope > 1:20 (5%) Level changes > 1/4"	16.8% -	Provide signs indicating the direction of the nearest accessible route to the parking areas.	1	260	\$260

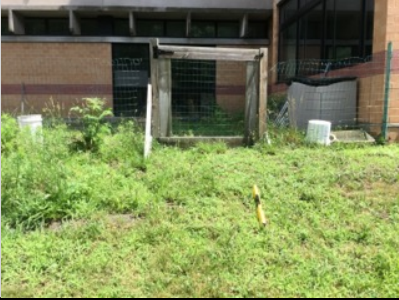
ID	Location	Floor	Room	Element	Type	Photo	Issues	Current Measure	Recommendations	Quantity	Price	Cost Estimation
6	Route to Community Garden	Ext.		Exterior Access Route	Exterior

Running slope > 1:20 (5%) Surface is not stable, firm, and slip-resistant	30% -	Create an alternative entrance on the north side of the community garden. See ID #9 for cost.	1	-	\$0
7	Route to Veteran's Memorial Fieldhouse	Ext.		Exterior Access Route	Exterior

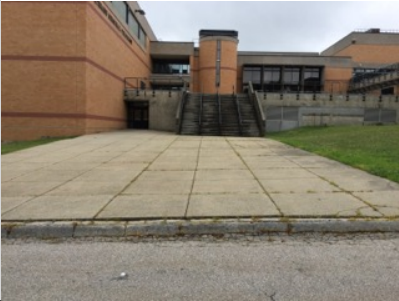
Level changes > 1/4"	6"	Alter change in level to be 1/4" high max.	1	155	\$155
8	Route to Exit #26	Ext.		Exterior Access Route	Exterior

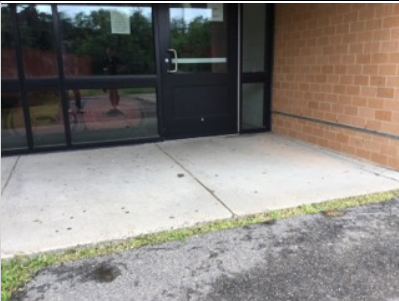
Level changes > 1/4"	3"	Alter change in level to be 1/4" high max.	1	155	\$155
9	Exit #37, Potential Route to Community Garden	Ext.		Exterior Access Route	Exterior

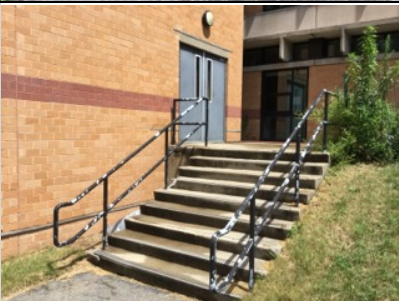
Surface is not stable, firm, and slip-resistant	-	Use this exit to provide an accessible route to the community garden. (Cost based on 15' asphalt path to community garden and new entry gate.)	1	483	\$483

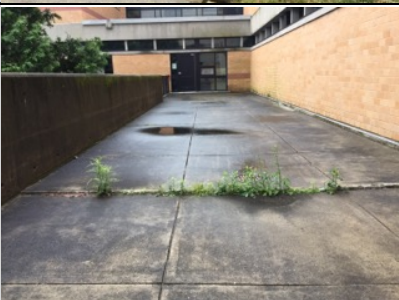
10	Route to Exit #3	Ext.		Exterior Access Route	Exterior

Does not prevent accumulation of water Route not maintained in operable working condition	- -	Repair surface. Ensure the accessible route is maintained in operable working conditions.	1	155	\$155

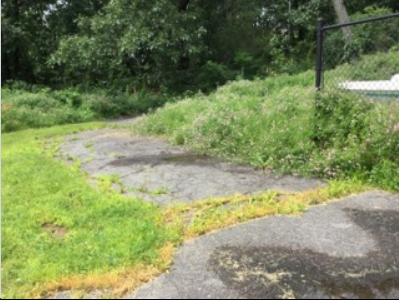
ID	Location	Floor	Room	Element	Type	Photo	Issues	Current Measure	Recommendations	Quantity	Price	Cost Estimation
11	Route to Basketball Court Near Veteran's Memorial Fieldhouse Parking Lot	Ext.		Exterior Access Route	Exterior

Route not maintained in operable working condition	-	Ensure the accessible route is maintained in operable working conditions. (Cost based on 185' by 4' wide asphalt route to basketball court.)	1	4718	\$4718
12	Route to Outdoor Classroom	Ext.		Exterior Access Route	Exterior

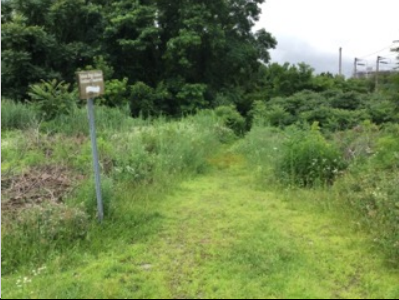
Accessible route not provided	-	Ensure an accessible route is provided. See ID #13 for cost.	1	-	\$0
13	Outdoor Classroom	Ext.		Exterior Access Route	Exterior

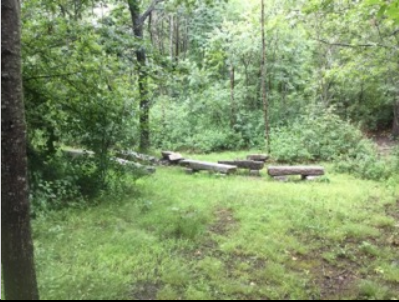
Accessible route not provided	-	Ensure an accessible route is provided. (Cost based on 300' by 4' wide stone dust route to outdoor classroom.)	1	7200	\$7200
14	Community Garden Near Exit #36	Ext.		Exterior Access Route	Exterior

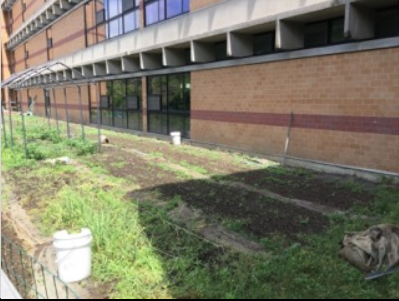
Accessible route not provided	-	Ensure an accessible route is provided. (Cost based on 90' by 4' wide stone dust route in garden.)	1	2160	\$2160

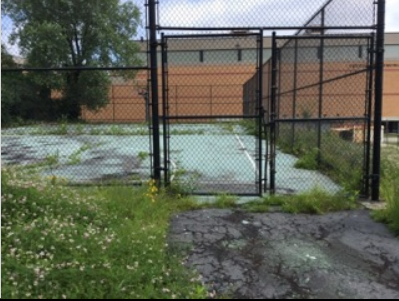
15	Basketball Court Near Veteran's Memorial Fieldhouse Parking Lot	Ext.		Exterior Access Route	613

Accessible route not provided	-	Ensure an accessible route is provided. See ID #11 for cost.	1	-	\$0

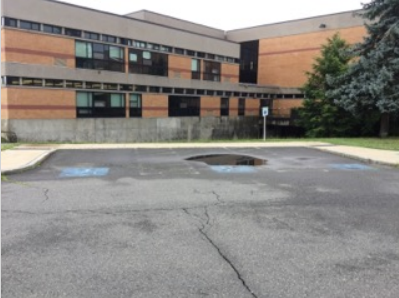
ID	Location	Floor	Room	Element	Type	Photo	Issues	Current Measure	Recommendations	Quantity	Price	Cost Estimation
Off-Street Parking Lot or Garage												
16	Accessible Parking Near Main Entrance	Ext.		Off-Street Parking Lot or Garage	N/A

Total # of parking Total # of designated accessible parking spaces Total # of designated van accessible spaces Vehicle space < 132" wide at van space Sign not provided Sign bottom < 60" above finished grade	3 3 0 118" - 53"	Provide a van accessible space that is at least 132" wide. Provide two (2) additional signs with the bottom of the sign 60" min. above the ground and the top 96" max. above the ground. Ensure sign at the van accessible space has the designation "Van Accessible." Locate existing sign with the bottom of the sign 60" above the ground.	1	975 Labor	\$975
17	Accessible Parking Near Exit #8	Ext.		Off-Street Parking Lot or Garage	N/A

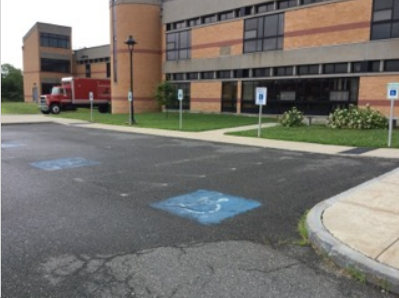
Total # of parking Total # of designated accessible parking spaces Total # of designated van accessible spaces Sign bottom < 60" above finished grade	5 4 1 47.75"	Locate sign with the bottom of the sign 60" above the ground.	1	Labor	\$0

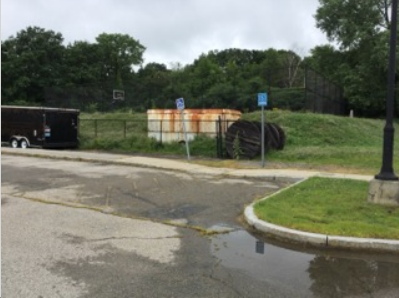
18	Veteran's Memorial Fieldhouse Parking Lot	Ext.		Off-Street Parking Lot or Garage	N/A

Total # of parking Total # of designated accessible parking spaces Total # of designated van accessible spaces Sign does not have the designation "Van Accessible"	85 3 0 -	Restripe parking lot so that accessible spaces and aisles are complaint with ADA 2010: 503. Ensure at least one of them is of a compliant van space size. Add the designation "Van Accessible" to the sign located at the van accessible space.	1	600	\$600
19	Parking Lot Near Tennis Courts	Ext.		Off-Street Parking Lot or Garage	N/A

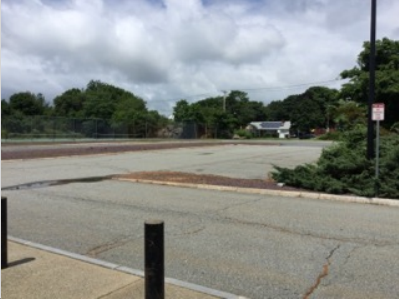
Total # of parking Total # of designated accessible parking spaces Access aisle not provided Sign not provided Sign does not have the designation "Van Accessible"	62 0 - - -	Provide two (2) car accessible spaces and one (1) van accessible space. Provide a marked access aisle that is at least 60" wide at the car space and 96" wide at the van space. Provide signs with the bottom of the sign 60" min. above the ground and the top 96" max. above the ground. Add the designation "Van Accessible" to the van accessible space.	3	1388	\$4164

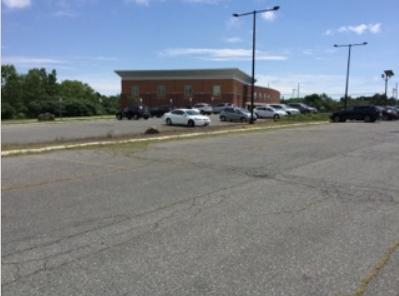
20	Parking Lot Near Main Entrance, Shared With Horace Mann School	Ext.		Off-Street Parking Lot or Garage	N/A

Total # of parking Total # of designated accessible parking spaces Access aisle not provided Sign not provided Sign does not have the designation "Van Accessible"	110 0 - - -	Provide four (4) car accessible spaces and one (1) van accessible space. Provide a marked access aisle that is at least 60" wide at the car spaces and 96" wide at the van space. Provide signs with the bottom of the sign 60" min. above the ground and the top 96" max. above the ground. Add the designation "Van Accessible" to the van accessible space.	4	1388	\$5552

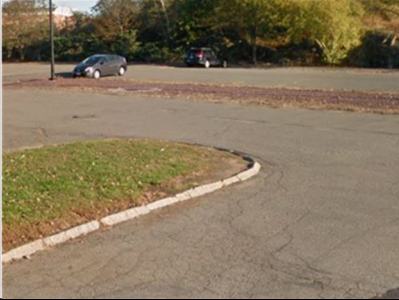
ID	Location	Floor	Room	Element	Type	Photo	Issues	Current Measure	Recommendations	Quantity	Price	Cost Estimation
21	Parking Lot on North Side of School	Ext.		Off-Street Parking Lot or Garage	N/A

Total # of parking Total # of designated accessible parking spaces Access aisle not provided Sign not provided Sign does not have the designation "Van Accessible"	106 0 - - -	Provide four (4) car accessible spaces and one (1) van accessible space. Provide a marked access aisle that is at least 60" wide at the car spaces and 96" wide at the van space. Provide signs with the bottom of the sign 60" min. above the ground and the top 96" max. above the ground. Add the designation "Van Accessible" to the van accessible space.	4	1388	\$5552
Entrance												
22	Storage Doors Off of Gymnasium	Ext.		Entrance	N/A

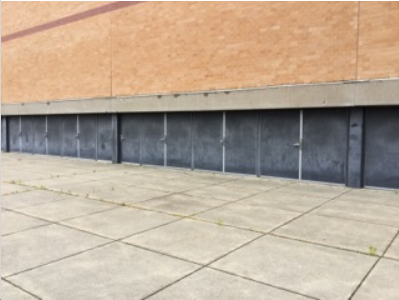
Directional sign to accessible entrance not provided	-	Provide a directional sign indicating the location of the nearest accessible entrance.	1	260	\$260

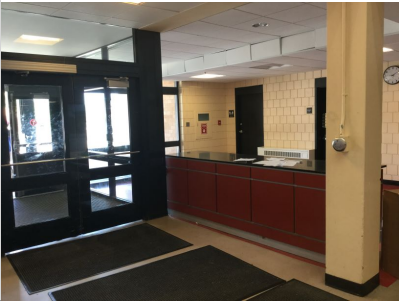
23	Main Lobby	1		Entrance	Main Entrance

Mat not securely attached Automatic door opener not operable Automatic door opener > 48" above the floor surface	- - 49"	Securely attach mat. Repair or replace the door opener. Lower automatic door opener to 48" max. above ground.	1	2295 Labor	\$2295
24	Playground Near Exit #44	Ext.		Entrance	Gate

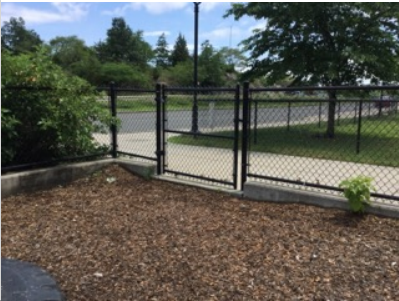
Threshold > 3/4" high	2"	Alter threshold to be 3/4" high max.	1	113	\$113
Emergency Exit												
25	Exits #11 and #12, Wood Shop	1	174	Emergency Exit	N/A

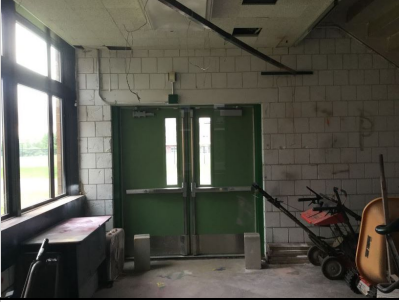
ID	Location	Floor	Room	Element	Type	Photo	Issues	Current Measure	Recommendations	Quantity	Price	Cost Estimation
26	Exit #13, in Stairwell 14	1	174	Emergency Exit	N/A

Illuminated exit sign not provided Tactile exit sign not provided Directional sign to accessible emergency exit not provided	- -	Ensure illuminated exit signs are provided at exits and exit doors. Ensure tactile exit signs with raised characters and braille are provided at exit doors. Mount signs between 48"- 60" above finished floor located on the latch side of the door. Provide a directional sign indicating the location of the nearest emergency exit.	1	448	\$448
27	Exits #4, #5, #6	Ext.		Emergency Exit	N/A

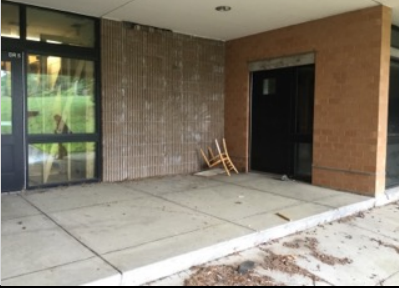
Emergency exit not on an accessible route	-	Renovate area so that there is an accessible route away from the building. (Cost based on 6' long ramp that is 48" wide and had handrails.)	1	1269	\$1269
28	Exit #38, in Stairwell 7	1		Emergency Exit	N/A

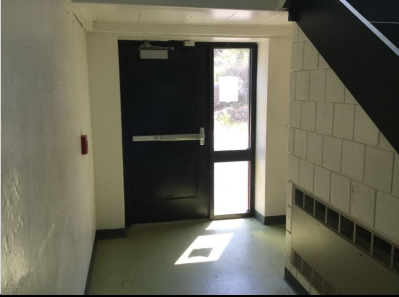
Emergency exit not on an accessible route Tactile exit sign not provided	- -	Provide a directional sign indicating the location of the nearest emergency exit. Ensure tactile exit signs with raised characters and braille are provided at exit doors. Mount signs between 48"- 60" above finished floor located on the latch side of the door.	1	348	\$348

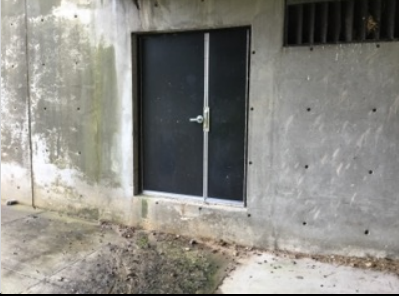
29	Exit #7	Ext.		Emergency Exit	N/A

Emergency exit not on an accessible route Tactile exit sign not provided	-	Provide a directional sign indicating the location of the nearest emergency exit on the interior of the door. Ensure tactile exit signs on the interior with raised characters and braille are provided at exit doors. Mount signs between 48"- 60" above finished floor located on the latch side of the door.	1	348	\$348
30	Veteran's Memorial Fieldhouse, Exit #22	Ext.		Emergency Exit	N/A

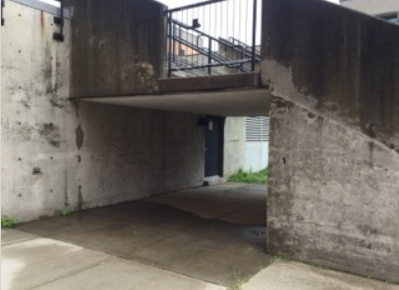
Emergency exit not on an accessible route Tactile exit sign not provided	- 6"	Provide a directional sign indicating the location of the nearest emergency exit on the interior of the door. Ensure tactile exit signs on the interior with raised characters and braille are provided at exit doors. Mount signs between 48"- 60" above finished floor located on the latch side of the door.	1	348	\$348

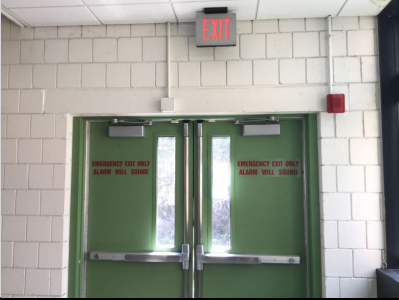
ID	Location	Floor	Room	Element	Type	Photo	Issues	Current Measure	Recommendations	Quantity	Price	Cost Estimation
31	Exit #36, in Stairwell 9	1		Emergency Exit	N/A

Illuminated exit sign lacks the International Symbol of Accessibility. Tactile exit sign not provided	- -	Ensure illuminated exit sign contains the International Symbol of Accessibility (ISA). Ensure tactile exit signs with raised characters and braille are provided at exit doors. Mount signs between 48"- 60" above finished floor located on the latch side of the door.	1	274	\$274
32	Exit #37, in Stairwell 8	1		Emergency Exit	N/A

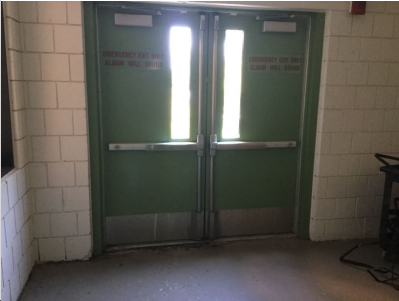
Illuminated exit sign lacks the International Symbol of Accessibility. Tactile exit sign not provided	- -	Ensure illuminated exit sign contains the International Symbol of Accessibility (ISA). Ensure tactile exit signs with raised characters and braille are provided at exit doors. Mount signs between 48"- 60" above finished floor located on the latch side of the door.	1	274

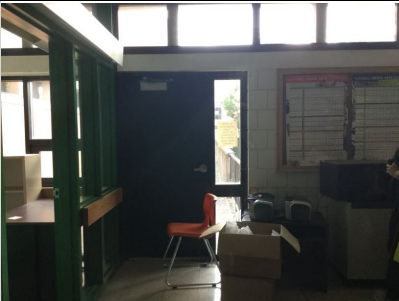
33	Exit #3, Faculty Lounge	1	185	Emergency Exit	N/A

Illuminated exit sign lacks the International Symbol of Accessibility. Tactile exit sign not provided Threshold > 3/4" high	- - 3"	Ensure illuminated exit sign contains the International Symbol of Accessibility (ISA). Ensure tactile exit signs with raised characters and braille are provided at exit doors. Mount signs between 48"- 60" above finished floor located on the latch side of the door. Alter threshold to be 3/4" high max.	1	387	\$387
34	Exit #14, Wood Shop	1	174	Emergency Exit	N/A

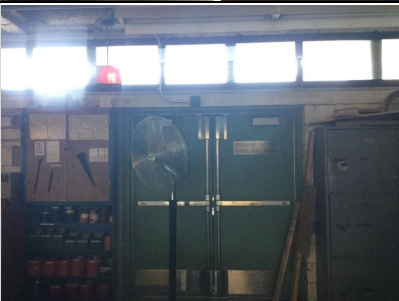
Illuminated exit sign lacks the International Symbol of Accessibility. Tactile exit sign not provided	- -	Ensure illuminated exit sign contains the International Symbol of Accessibility (ISA). Ensure tactile exit signs with raised characters and braille are provided at exit doors. Mount signs between 48"- 60" above finished floor located on the latch side of the door.	1	274	\$274

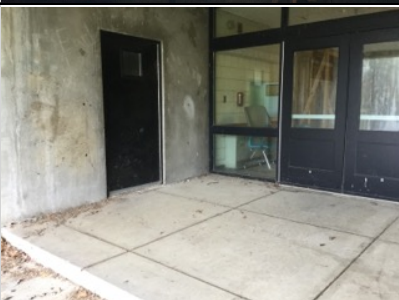
35	Exit #6	Ext.		Emergency Exit	N/A

Illuminated exit sign lacks the International Symbol of Accessibility. Tactile exit sign not provided	- -	Ensure illuminated exit sign on the interior contains the International Symbol of Accessibility (ISA). Ensure tactile exit signs on the interior with raised characters and braille are provided at exit doors. Mount signs between 48"- 60" above finished floor located on the latch side of the door.	1	274	\$274

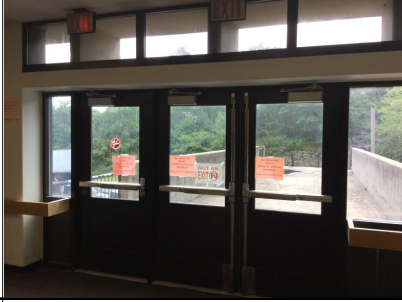
Tactile exit sign not provided Emergency exit not on an accessible route	- -	Ensure tactile exit signs with raised characters and braille are provided at exit doors. Mount signs between 48"- 60" above finished floor located on the latch side of the door. Provide a directional sign indicating the location of the nearest emergency exit.	1	274	\$274
37	Fitness Center - Exit #29	B	062	Emergency Exit	N/A

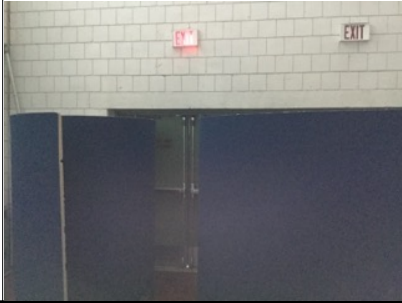
Tactile exit sign not provided Emergency exit not on an accessible route	- -	Ensure tactile exit signs with raised characters and braille are provided at exit doors. Mount signs between 48"- 60" above finished floor located on the latch side of the door. Provide a directional sign indicating the location of the nearest emergency exit.	1	348	\$348

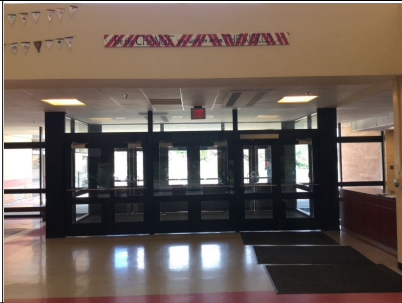
38	Exit #1, Main Lobby	1		Emergency Exit	N/A

Tactile exit sign not provided Illuminated exit sign lacks the International Symbol of Accessibility.	- -	Ensure tactile exit signs with raised characters and braille are provided at exit doors. Mount signs between 48"- 60" above finished floor located on the latch side of the door. Ensure illuminated exit sign contains the International Symbol of Accessibility (ISA).	1	274	\$274
39	Exit #48, Stair 2	1	Stair 2	Emergency Exit	N/A

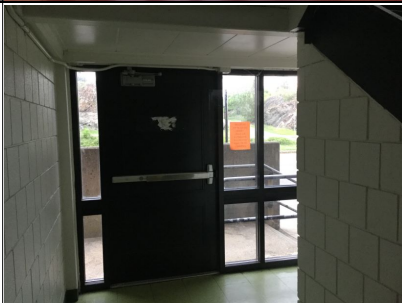
Tactile exit sign not provided Illuminated exit sign lacks the International Symbol of Accessibility.	- -	Ensure illuminated exit sign contains the International Symbol of Accessibility (ISA). Ensure tactile exit signs with raised characters and braille are provided at exit doors. Mount signs between 48"- 60" above finished floor located on the latch side of the door.	1	274	\$274
40	Exit #2, Auditorium	1	100	Emergency Exit	N/A

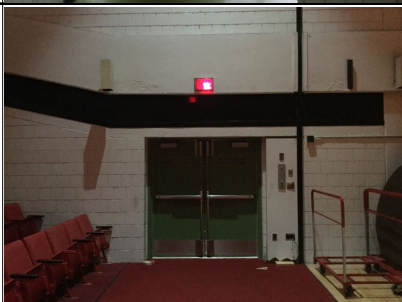
Tactile exit sign not provided Illuminated exit sign lacks the International Symbol of Accessibility. Threshold > 3/4" high	- - 3"	Ensure tactile exit signs with raised characters and braille are provided at exit doors. Mount signs between 48"- 60" above finished floor located on the latch side of the door. Ensure illuminated exit sign contains the International Symbol of Accessibility (ISA). Alter threshold to be 3/4" high max.	1	387	\$387

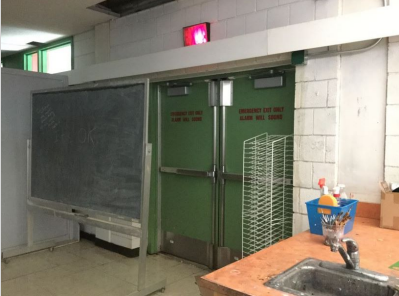
ID	Location	Floor	Room	Element	Type	Photo	Issues	Current Measure	Recommendations	Quantity	Price	Cost Estimation
41	Exit #20, Art Room	1	166	Emergency Exit	N/A

Tactile exit sign not provided Illuminated exit sign lacks the International Symbol of Accessibility.	- -	Ensure tactile exit signs with raised characters and braille are provided at exit doors. Mount signs between 48"- 60" above finished floor located on the latch side of the door Ensure illuminated exit sign contains the International Symbol of Accessibility (ISA).	1	274	\$274
42	Exits #8 and #9, in Stairwell 15 and Stairwell 16	1		Emergency Exit	N/A

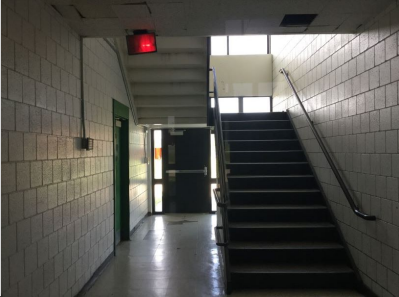
Tactile exit sign not provided Illuminated exit sign lacks the International Symbol of Accessibility.	- -	Ensure tactile exit signs with raised characters and braille are provided at exit doors. Mount signs between 48"- 60" above finished floor located on the latch side of the door. Ensure illuminated exit sign contains the International Symbol of Accessibility (ISA).	2	274	\$548

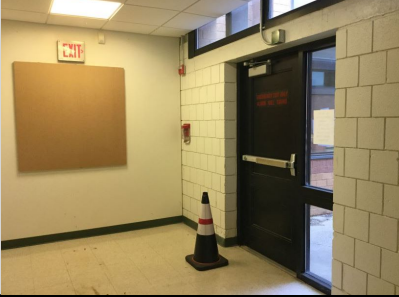
43	Exit #10, Hall by Wood Shop			Emergency Exit	N/A

Tactile exit sign not provided Illuminated exit sign lacks the International Symbol of Accessibility.	-	Ensure tactile exit signs with raised characters and braille are provided at exit doors. Mount signs between 48"- 60" above finished floor located on the latch side of the door. Ensure the illuminated exit sign contains the International Symbol of Accessibility (ISA).	1	274	\$274
44	Wood Shop, Route to Exit	1	174	Emergency Exit	N/A

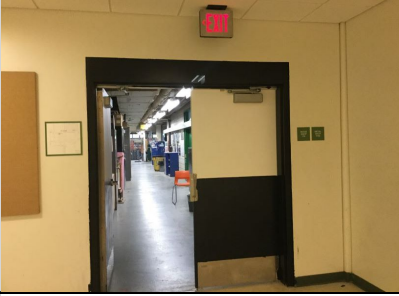
Tactile exit sign not provided Illuminated exit sign lacks the International Symbol of Accessibility.	-	Ensure tactile exit signs with raised characters and braille are provided at exit doors. Mount signs between 48"- 60" above finished floor located on the latch side of the door. Ensure illuminated exit sign contains the International Symbol of Accessibility (ISA).	1	274	\$274
45	Exit to Courtyard From Cafeteria, First Floor	1		Emergency Exit	N/A

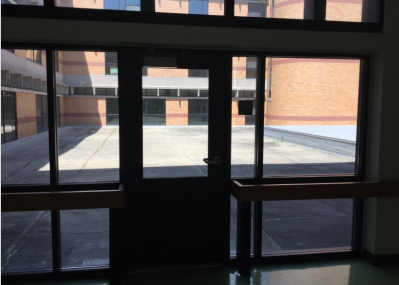
Tactile exit sign not provided Illuminated exit sign lacks the International Symbol of Accessibility.	-	Ensure tactile exit signs with raised characters and braille are provided at exit doors. Mount signs between 48"- 60" above finished floor located on the latch side of the door. Ensure illuminated exit sign contains the International Symbol of Accessibility (ISA).	1	274	\$274

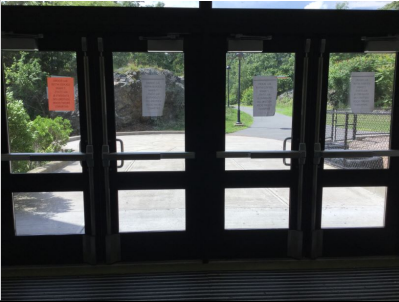
Tactile exit sign not provided Illuminated exit sign lacks the International Symbol of Accessibility.	- -	Ensure tactile exit signs with raised characters and braille are provided at exit doors. Mount signs between 48"- 60" above finished floor located on the latch side of the door. Ensure illuminated exit sign contains the International Symbol of Accessibility (ISA).	1	274

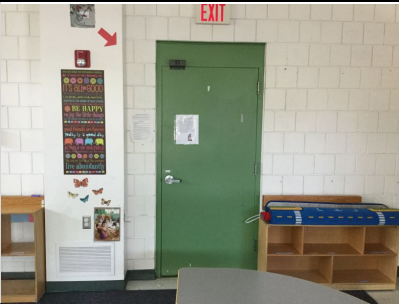
48	To Exit #45, Teen Parent Room/ Preschool	1	125	Emergency Exit	N/A

Tactile exit sign not provided Illuminated exit sign lacks the International Symbol of Accessibility.	- -	Ensure tactile exit signs with raised characters and braille are provided at exit doors. Mount signs between 48"- 60" above finished floor located on the latch side of the door. Ensure illuminated exit sign contains the International Symbol of Accessibility (ISA).	1	274	\$274
49	Exit #45, in Stairwell 5	1		Emergency Exit	N/A

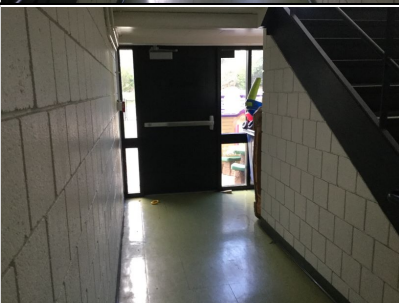
Tactile exit sign not provided Illuminated exit sign lacks the International Symbol of Accessibility.	- -	Ensure tactile exit signs with raised characters and braille are provided at exit doors. Mount signs between 48"- 60" above finished floor located on the latch side of the door. Ensure illuminated exit sign contains the International Symbol of Accessibility (ISA).	1	274	\$274
