City of Salem, Massachusetts

PART A – Executive Summary

Part A – Executive Summary

Introduction

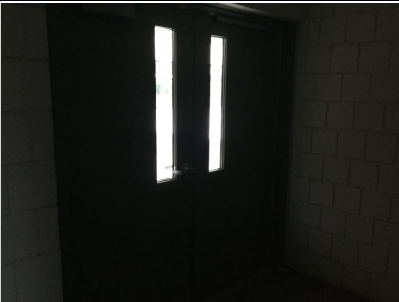
Tactile exit sign not provided Illuminated exit sign lacks the International Symbol of Accessibility.	- -	Ensure tactile exit signs with raised characters and braille are provided at exit doors. Mount signs between 48"- 60" above finished floor located on the latch side of the door. Ensure illuminated exit sign contains the International Symbol of Accessibility (ISA).	1	274	\$274
52	Exit #47	Ext.		Emergency Exit	N/A

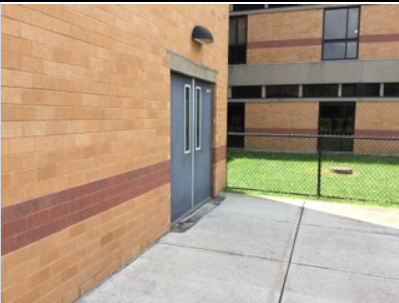
Tactile exit sign not provided Illuminated exit sign lacks the International Symbol of Accessibility.	- -	Ensure tactile exit signs on the interior with raised characters and braille are provided at exit doors. Mount signs between 48"- 60" above finished floor located on the latch side of the door. Ensure illuminated exit sign contains the International Symbol of Accessibility (ISA).	1	274	\$274

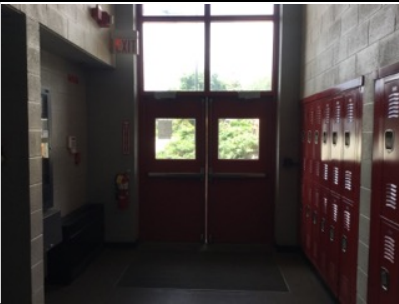
53	Automotive Technology Center, Main Entrance	1		Emergency Exit	N/A

Tactile exit sign not provided Illuminated exit sign lacks the International Symbol of Accessibility.	- -	Ensure tactile exit signs with raised characters and braille are provided at exit doors. Mount signs between 48"- 60" above finished floor located on the latch side of the door. Ensure illuminated exit sign contains the International Symbol of Accessibility (ISA).	1	274	\$274
54	Exit #31, Black Cat Cafe	B		Emergency Exit	N/A

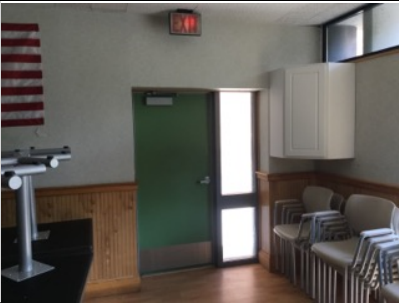
Tactile exit sign not provided Illuminated exit sign lacks the International Symbol of Accessibility.	- -	Ensure tactile exit signs with raised characters and braille are provided at exit doors. Mount signs between 48"- 60" above finished floor located on the latch side of the door. Ensure illuminated exit sign contains the International Symbol of Accessibility (ISA).	1	274	\$274
55	Exit #27, Gym	B		Emergency Exit	N/A

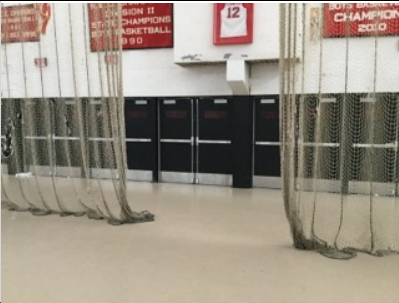
Tactile exit sign not provided Illuminated exit sign lacks the International Symbol of Accessibility.	- -	Ensure tactile exit signs with raised characters and braille are provided at exit doors. Mount signs between 48"- 60" above finished floor located on the latch side of the door. Ensure illuminated exit sign contains the International Symbol of Accessibility (ISA).	1	274	\$274

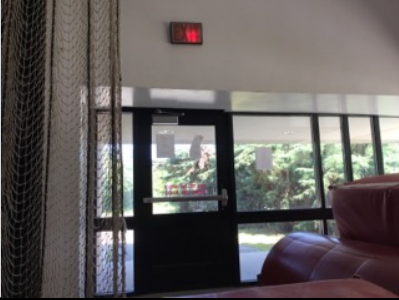
Tactile exit sign not provided Illuminated exit sign lacks the International Symbol of Accessibility.	- -	Ensure tactile exit signs with raised characters and braille are provided at exit doors. Mount signs between 48"- 60" above finished floor located on the latch side of the door. Ensure illuminated exit sign contains the International Symbol of Accessibility (ISA).	1	274	\$274
57	Exit #25	B		Emergency Exit	N/A

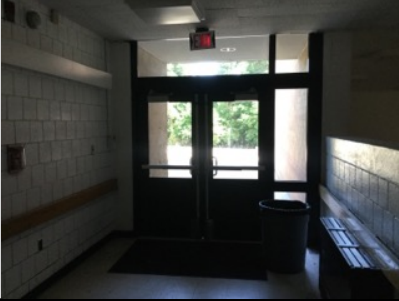
Tactile exit sign not provided Illuminated exit sign lacks the International Symbol of Accessibility.	- -	Ensure tactile exit signs with raised characters and braille are provided at exit doors. Mount signs between 48"- 60" above finished floor located on the latch side of the door. Ensure illuminated exit sign contains the International Symbol of Accessibility (ISA).	1	274	\$274

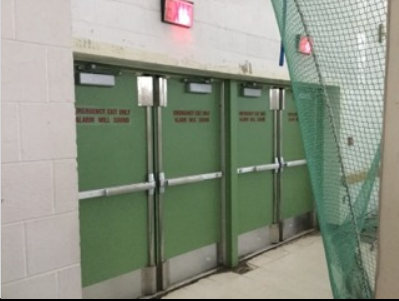
58	Exit #24, Gymnasium Balcony Area	1		Emergency Exit	N/A

Tactile exit sign not provided Illuminated exit sign lacks the International Symbol of Accessibility. Threshold > 3/4" high	- -	Ensure tactile exit signs with raised characters and braille are provided at exit doors. Mount signs between 48"- 60" above finished floor located on the latch side of the door. Ensure illuminated exit sign contains the International Symbol of Accessibility (ISA). Alter threshold to be 3/4" high max.	1	387	\$387
59	Exit #23	1		Emergency Exit	N/A

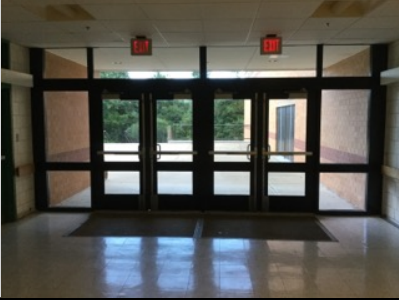
Tactile exit sign not provided Illuminated exit sign lacks the International Symbol of Accessibility.	- -	Ensure tactile exit signs with raised characters and braille are provided at exit doors. Mount signs between 48"- 60" above finished floor located on the latch side of the door. Ensure illuminated exit sign contains the International Symbol of Accessibility (ISA).	1	274	\$274

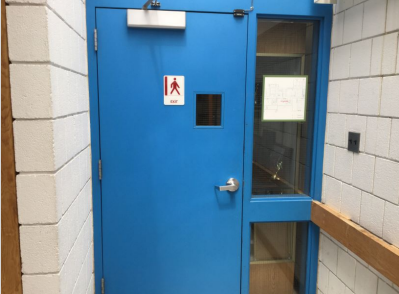
60	Exit From Main Office to Hallway	1	158C	Emergency Exit	N/A

Directional sign to accessible emergency exit not provided	-	Provide a directional sign indicating the location of the nearest emergency exit.	1	174	\$174

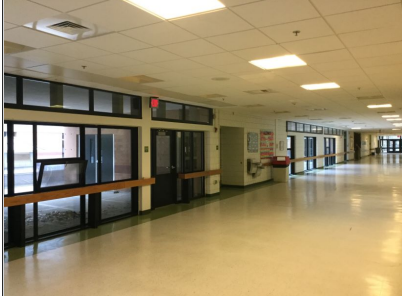
International Symbol of Acc. not provided Tactile exit sign not provided	- -	Ensure illuminated exit sign contains the International Symbol of Accessibility (ISA). Ensure tactile exit signs with raised characters and braille are provided at exit doors. Mount signs between 48"- 60" above finished floor located on the latch side of the door.	1	274	\$274
62	Exit #4, Electrical Class	B	087	Emergency Exit	N/A

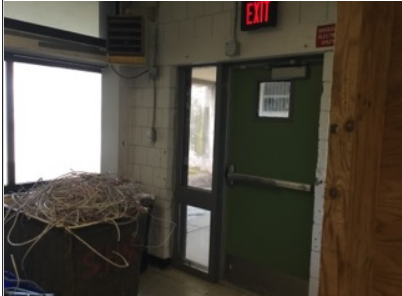
International Symbol of Acc. not provided Tactile exit sign not provided	- -	Ensure illuminated exit sign contains the International Symbol of Accessibility (ISA). Ensure tactile exit signs with raised characters and braille are provided at exit doors. Mount signs between 48"- 60" above finished floor located on the latch side of the door.	1	274

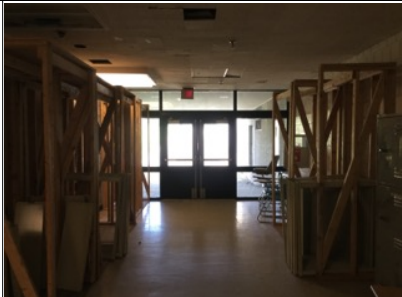
63	Exit #5	B		Emergency Exit	N/A

International Symbol of Acc. not provided Tactile exit sign not provided	- -	Ensure illuminated exit sign contains the International Symbol of Accessibility (ISA). Ensure tactile exit signs with raised characters and braille are provided at exit doors. Mount signs between 48"- 60" above finished floor located on the latch side of the door.	1	274	
64	Automotive Technology Center, Classroom	Ext.		Emergency Exit	N/A

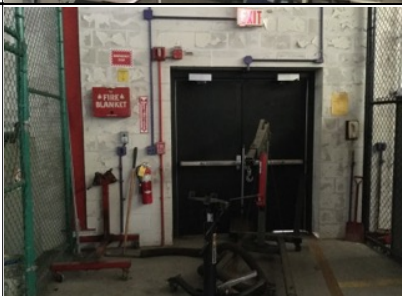
65	Automotive Technology Center, Garage Emergency Exit	1		Emergency Exit	N/A

Maneuvering clearance(s) not provided Tactile exit sign not provided Illuminated exit sign lacks the International Symbol of Accessibility.	- - -	Remove clutter in front of emergency exit. Ensure tactile exit signs with raised characters and braille are provided at exit doors. Mount signs between 48"- 60" above finished floor located on the latch side of the door. Ensure illuminated exit sign contains the International Symbol of Accessibility (ISA).	1	Labor 274

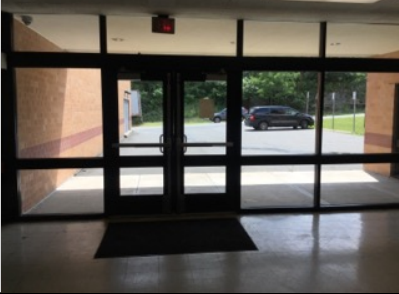
Mat not securely attached Tactile exit sign not provided Illuminated exit sign lacks the International Symbol of Accessibility.	- -	Securely attach mat. Ensure tactile exit signs with raised characters and braille are provided at exit doors. Mount signs between 48"- 60" above finished floor located on the latch side of the door. Ensure illuminated exit sign contains the International Symbol of Accessibility (ISA).	1	274	\$274

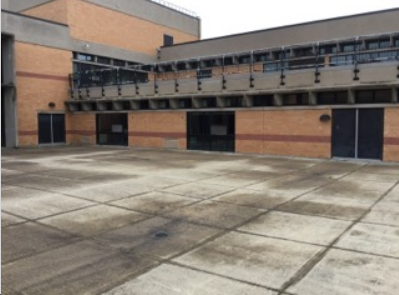
68	Exits #14, #16, #17, and #20 Emergency Exits at Top of Stairs at Veteran's Memorial Fieldhouse	Ext.		Emergency Exit	N/A

Threshold > 3/4" high	3"	Alter thresholds to be no more than 1/2" max.	4	113	\$452
69	Exit #38	Ext.		Emergency Exit	N/A

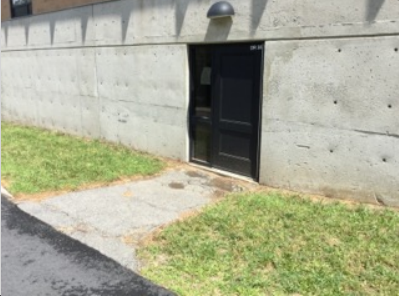
Threshold > 3/4" high	3"	Alter threshold to be no more than 1/2" max.	1	113	\$113
70	Exit #21 at Top of Stairs at Veteran's Memorial Fieldhouse	Ext.		Emergency Exit	N/A

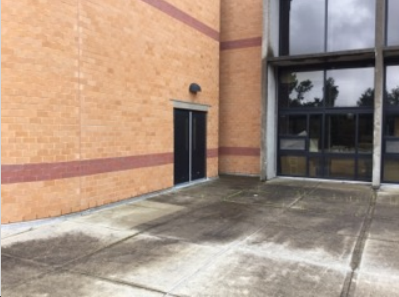
Threshold > 3/4" high Tactile exit sign not provided Illuminated exit sign lacks the International Symbol of Accessibility.	3" - -	Alter threshold to be 3/4" high max. Ensure tactile exit signs on the interior with raised characters and braille are provided at exit doors. Mount signs between 48"- 60" above finished floor located on the latch side of the door. Ensure illuminated exit sign contains the International Symbol of Accessibility (ISA).	1	387	\$387

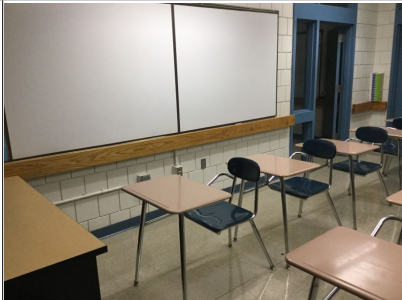
Route < 36" wide	31"	Ensure that a clear width of 36" min. is maintained at the accessible route.	1	Labor	\$0
73	Spanish Classroom	3	318	Interior Access Route	N/A

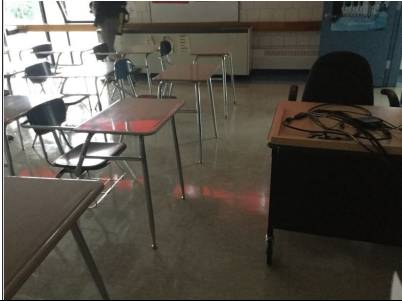
Route < 36" wide	21"	Ensure that a clear width of 36" min. is maintained at the accessible route.	1	Labor	\$0
74	French Classroom	3	319	Interior Access Route	N/A

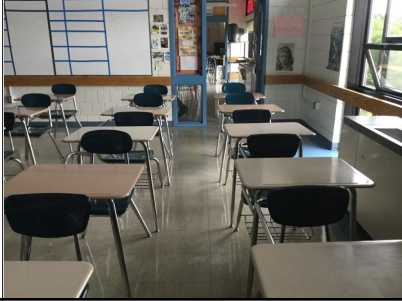
Route < 36" wide	27"	Ensure that a clear width of 36" min. is maintained at the accessible route.	1	Labor	\$0

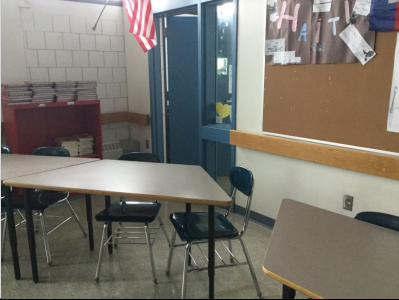
Route < 36" wide	9"	Ensure that a clear width of 36" min. is maintained at the accessible route.	1	Labor	\$0
77	Business Department Computer Lab	3	330	Interior Access Route	N/A

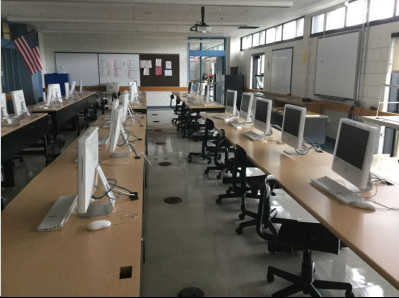
Route < 36" wide	34"	Ensure that a clear width of 36" min. is maintained at the accessible route.	1	Labor	\$0
78	Hydroponics Lab	3	348	Interior Access Route	N/A

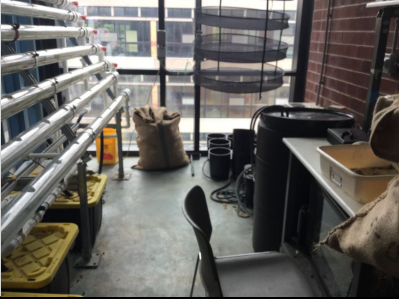
Route < 36" wide	22"	Ensure that a clear width of 36" min. is maintained at the accessible route.	1	Labor	\$0
79	Economics Class	2	232	Interior Access Route	N/A

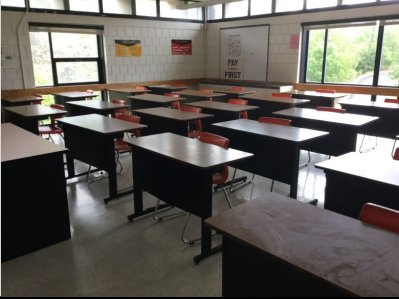
Route < 36" wide	21"	Ensure that a clear width of 36" min. is maintained at the accessible route.	1	Labor	\$0
80	Economics Class	2	232	Interior Access Route	N/A

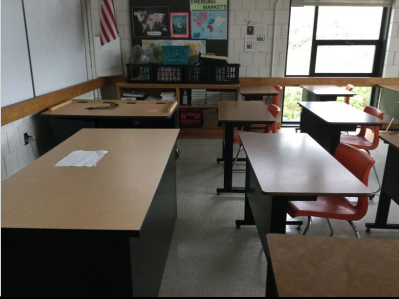
Route < 36" wide	18"	Ensure that a clear width of 36" min. is maintained at the accessible route.	1	Labor	\$0

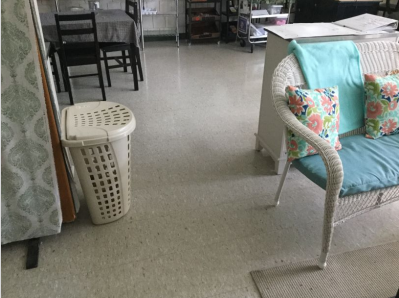
Route < 36" wide	28.5"	Ensure that a clear width of 36" min. is maintained at the accessible route.	1	Labor	\$0
82	Geometry and Calculus Classroom	1	134	Interior Access Route	N/A

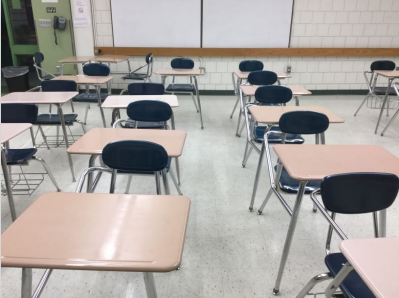
Route < 36" wide	28"	Ensure that a clear width of 36" min. is maintained at the accessible route.	1	Labor	\$0
83	Science Classroom	1	112	Interior Access Route	N/A

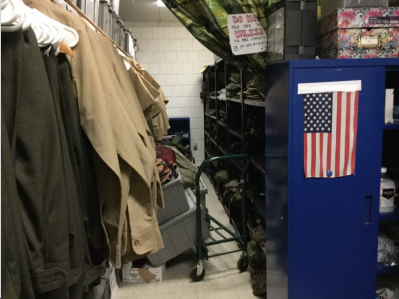
Route < 36" wide	33"	Ensure that a clear width of 36" min. is maintained at the accessible route.	1	Labor	\$0
85	ROTC - Bunker Room	1		Interior Access Route	N/A

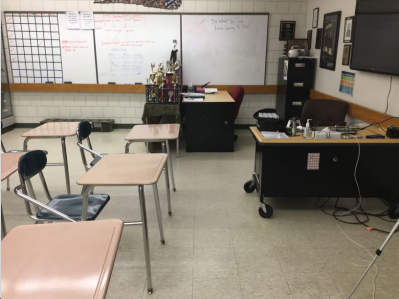
Route < 36" wide	28"	Ensure that a clear width of 36" min. is maintained at the accessible route by rearranging classroom set up.	1	Labor	\$0

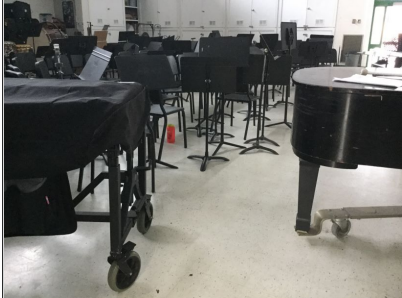
Route < 36" wide	31"	Ensure that a clear width of 36" min. is maintained at the accessible route.	1	Labor	\$0
87	Band Room	2	266	Interior Access Route	N/A

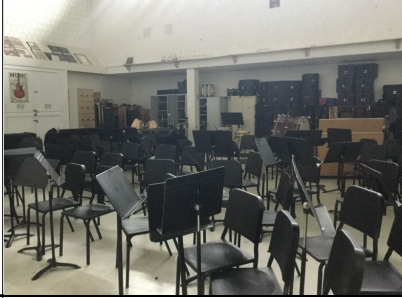
Route < 36" wide		Ensure that a clear width of 36" min. is maintained at the accessible route.	1	Labor	\$0
88	Auditorium	1	100	Interior Access Route	N/A

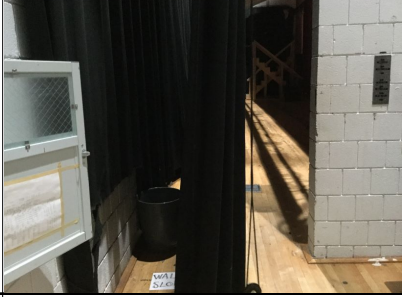
Route < 36" wide		Ensure that a clear width of 36" min. is maintained at the accessible route.	1	Labor	\$0
89	Wood Shop	1	174	Interior Access Route	N/A

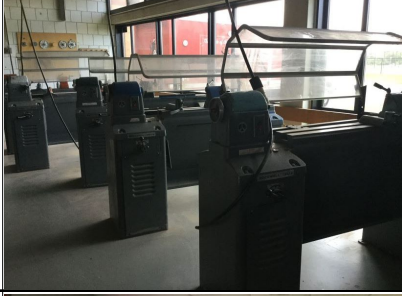
Route < 36" wide	30"	Ensure that a clear width of 36" min. is maintained at the accessible route.	1	Labor	\$0
90	Automotive Technology Center, Classroom	1	107	Interior Access Route	N/A

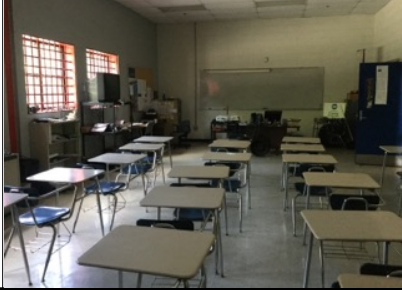
Route < 36" wide	22"	Ensure that a clear width of 36" min. is maintained at the accessible route.	1	Labor	\$0

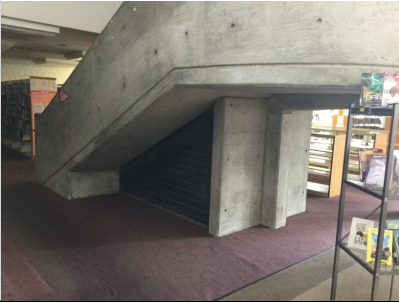
Obstructed by protruding objects	65"	Provide a cane-detectable barrier.	1	720	\$720
93	Mailbox Near Athletic Offices	1		Interior Access Route	N/A

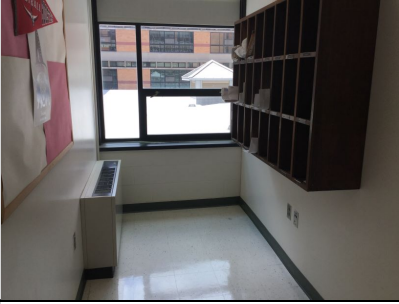
Obstructed by protruding objects	-	Provide a cane-detectable barrier.	1	230	\$230
94	ROTC Office Block	1	137	Interior Access Route	N/A

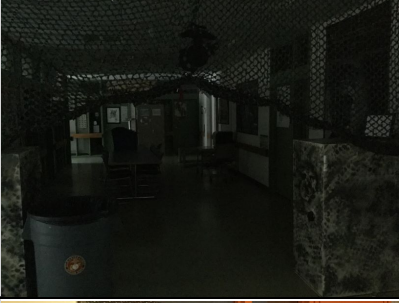
Obstructed by protruding objects	-	Remove netting on ceiling.	1	Labor	\$0
95	Classroom	2	212	Interior Access Route	N/A

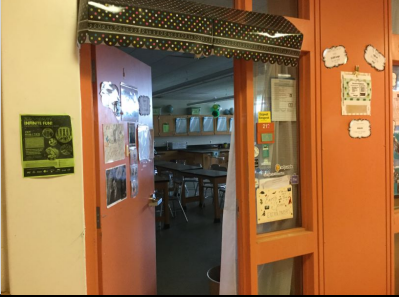
Obstructed by protruding objects	75"	Relocate paper border so that it is at least 80" above the finished floor.	1	Labor	\$0

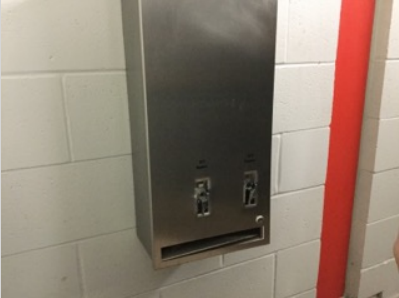
Obstructed by protruding objects	-	Remove tampon dispenser.	1	192	\$192
98	Visiting Team Room 2	B	074	Interior Access Route	N/A

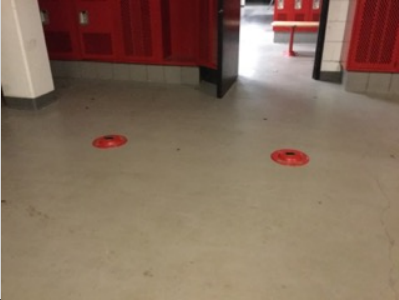
Level changes > 1/4"	-	Alter change in level to be 1/4" high max.	1	155	\$155
99	Laboratory	2	248	Interior Access Route	N/A

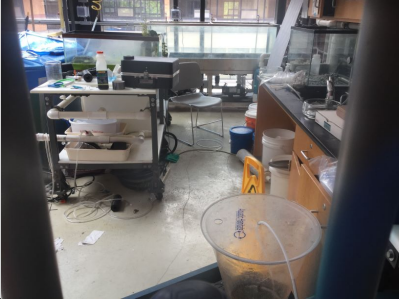
Surface not stable, firm, and slip-resistant	-	Relocate cables and other clutter.	1	Labor	\$0
100	Library	2	255	Interior Access Route	N/A

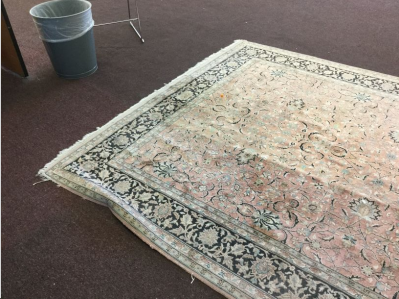
Surface not stable, firm, and slip-resistant	-	Remove rug or secure to floor.	1	Labor	\$0

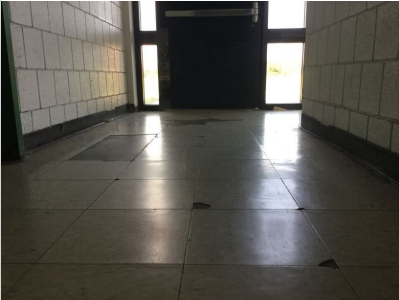
Surface not stable, firm, and slip-resistant		Repair surface.	1	155	\$155
102	ROTC Office	1	137G	Interior Access Route	N/A

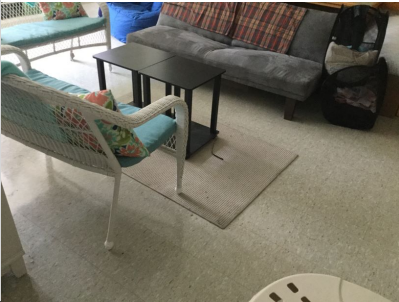
Mat not securely attached	-	Securely attach mat.	1	Labor	\$0
104	Home Economics/ Special Needs Classroom	1	141	Interior Access Route	N/A

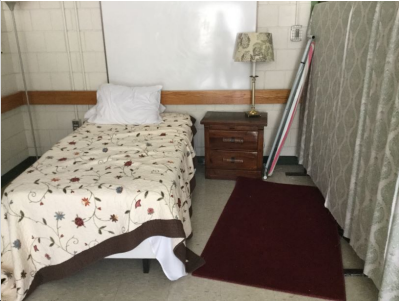
Mat not securely attached	-	Securely attach mat.	1	Labor	\$0
105	Life Skills/Post High School/ OT PT	1	131	Interior Access Route	N/A

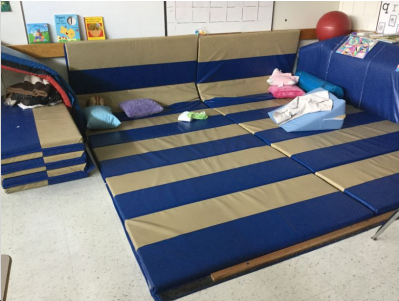
Mat not securely attached	-	Securely attach mat.	1	Labor	\$0

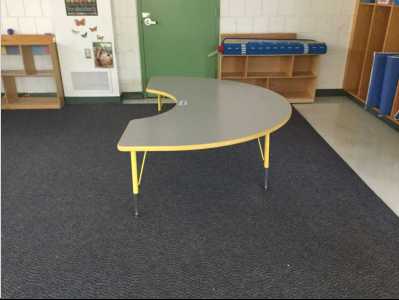
Mat not securely attached	-	Securely attach mat.	1	Labor	\$0
Doors, Doorways, & Gates												
107	Door Between Rooms 328 and 329	3	328-329	Doors, Doorways, & Gates	Circulation

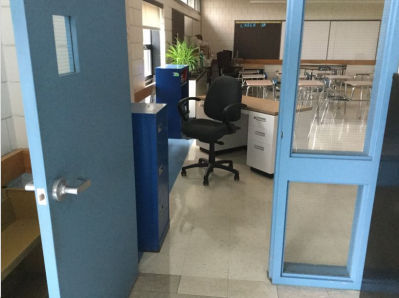
Clear width at door < 32"	30"	Ensure doorway is at least 32" wide be relocating cabinet.	1	Labor	\$0
108	Spanish 3 Classroom, Route to Room 326	3	325	Doors, Doorways, & Gates	Circulation

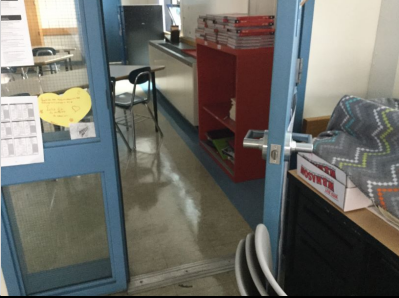
Clear width at door < 32"	28"	Remove obstructions.	1	Labor	\$0
109	Hydroponics Lab	3	348	Doors, Doorways, & Gates	Classroom

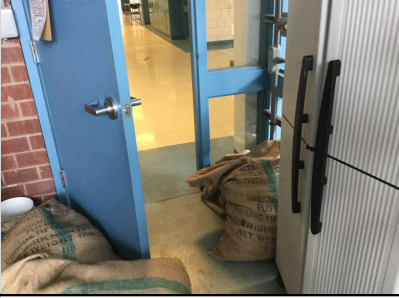
Clear width at door < 32"	18"	Remove obstructions.	1	Labor	\$0
110	ESL Classroom, Route to Room 233	2	240	Doors, Doorways, & Gates	Circulation

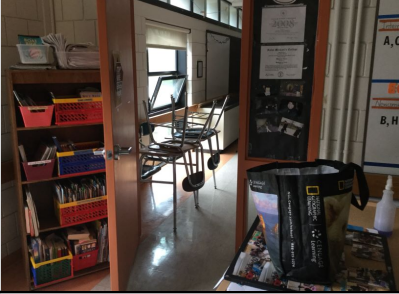
Clear width at door < 32"	24"	Remove obstructions.	1	Labor	\$0

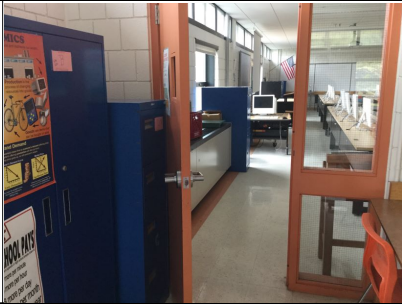
Clear width at door < 32"	30"	Remove obstructions	1	Labor	\$0
112	Door Between Rooms 140 and 134	1	140	Doors, Doorways, & Gates	Circulation

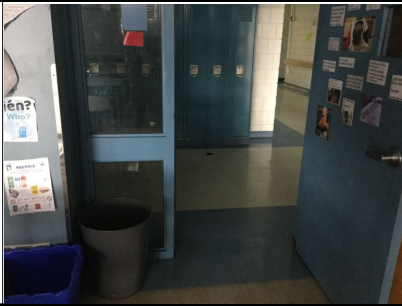
Maneuvering clearance(s) not provided	-	Remove the trash cans.	1	Labor	\$0
114	French 3 Classroom	3	326	Doors, Doorways, & Gates	Classroom

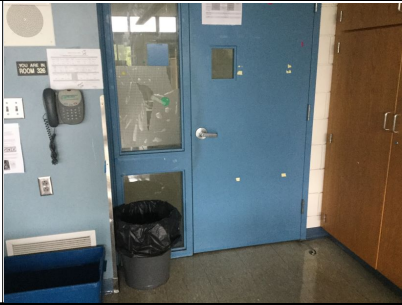
Maneuvering clearance(s) not provided	-	Remove the trash cans.	1	Labor	\$0
115	ESL Classroom	2	240	Doors, Doorways, & Gates	Classroom

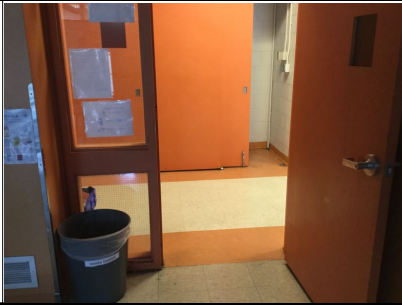
Maneuvering clearance(s) not provided	-	Remove the trash cans.	1	Labor	\$0

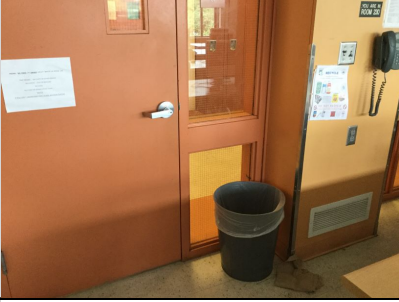
Maneuvering clearance(s) not provided	-	Remove the trash cans.	1	Labor	\$0
117	Exit From Instructional Media Center to Hallway	1	155	Doors, Doorways, & Gates	Other

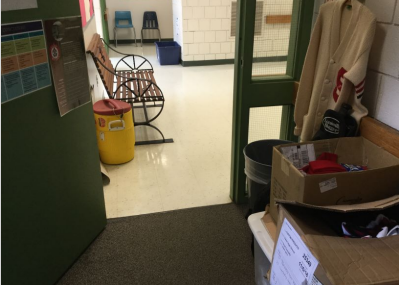
Maneuvering clearance(s) not provided	-	Remove the obstructions.	1	Labor	\$0

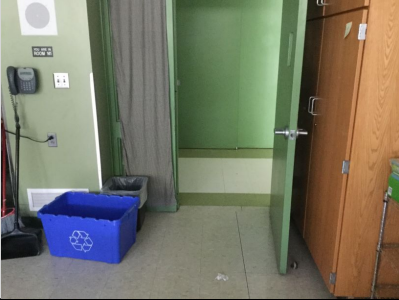
Maneuvering clearance(s) not provided	-	Remove the trash can.	1	Labor	\$0
122	Door Between Rooms 128 and 129	1	129	Doors, Doorways, & Gates	Circulation

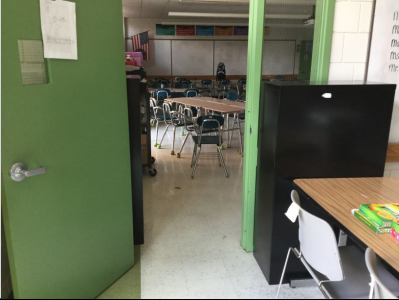
Maneuvering clearance(s) not provided	-	Remove the obstructions.	1	Labor	\$0
123	Teen Parent Room/ Preschool Toilet Room	1	125	Doors, Doorways, & Gates	Toilet Room

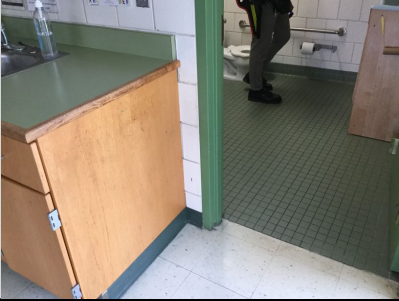
Maneuvering clearance(s) not provided	6"	Provide an automatic door opener.	1	2295	\$2295
124	Band Teacher's Office	2	279	Doors, Doorways, & Gates	Office

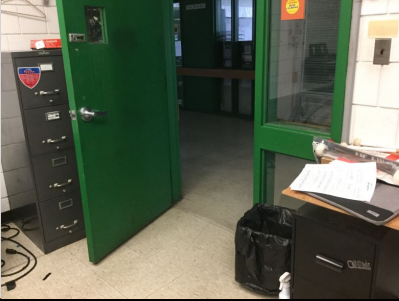
Maneuvering clearance(s) not provided		Remove trash can to provide at least 18" wide maneuvering clearance.	1	Labor	\$0
125	Orchestra	2	282	Doors, Doorways, & Gates	Classroom

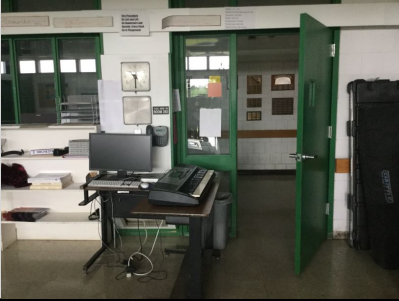
Maneuvering clearance(s) not provided		Remove the desk to provide at least 18" wide maneuvering clearance.	1	Labor	\$0

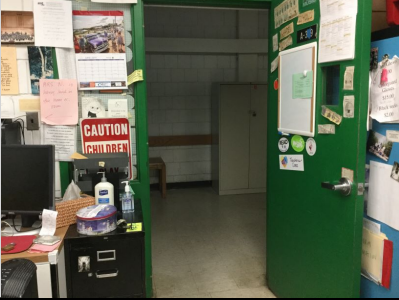
Maneuvering clearance(s) not provided		Remove the file cabinet to provide at least 18" wide maneuvering clearance.	1	Labor	\$0
127	Office	2	250B	Doors, Doorways, & Gates	Meeting Room

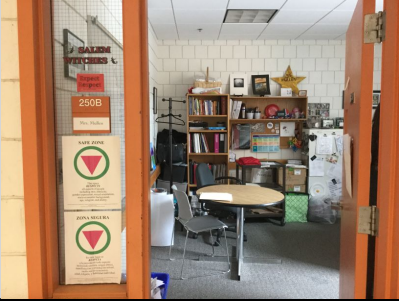
Maneuvering clearance(s) not provided	16"	Provide an automatic door opener.	1	2295	\$2295
128	Office	2	249F	Doors, Doorways, & Gates	Office

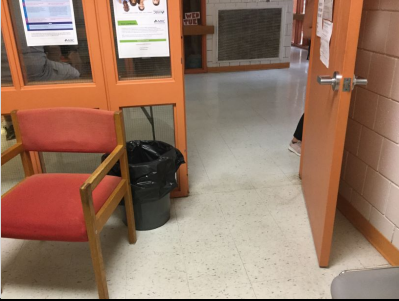
Maneuvering clearance(s) not provided		Remove trash can and chair to provide at least 18" wide maneuvering clearance.	1	Labor	\$0
129	Women's Toilet Room	2	Hall C	Doors, Doorways, & Gates	Toilet Room

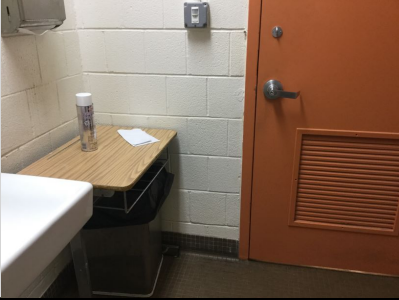
Maneuvering clearance(s) not provided	15"	Remove desk to provide at least 18" wide maneuvering clearance.	1	Labor	\$0
130	Classroom	2	210	Doors, Doorways, & Gates	Classroom

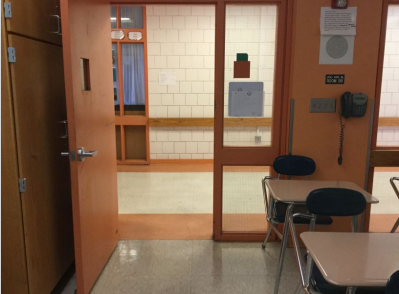
Maneuvering clearance(s) not provided	16"	Provide an automatic door opener.	1	2295	\$2295

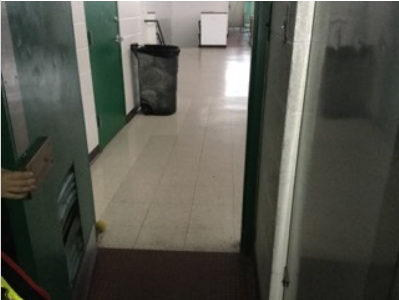
Maneuvering clearance(s) not provided	-	Provide an automatic door opener.	1	2295	\$2295
133	Science Classroom	2	216	Doors, Doorways, & Gates	Classroom

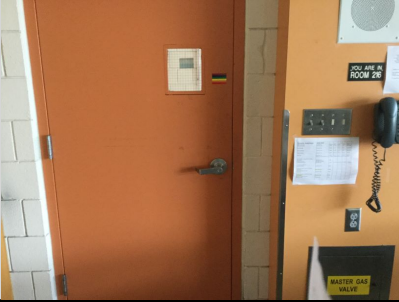
Maneuvering clearance not provided at recess > 8"	7"	Install an automatic door opener.	1	2295	\$2295
134	Color Guard Closet	2		Doors, Doorways, & Gates	Other

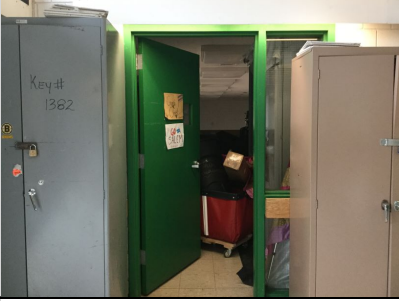
Maneuvering clearance not provided at recess > 8"	9"	Install an automatic door opener.	1	2295	\$2295
135	School Store	2	251	Doors, Doorways, & Gates	Other

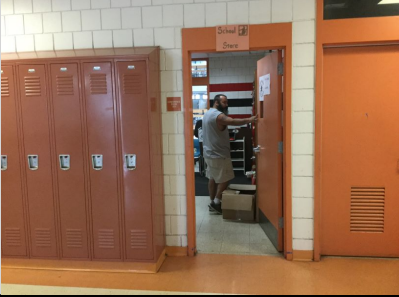
Maneuvering clearance not provided at recess > 8"	11"	Install an automatic door opener.	1	2295	\$2295

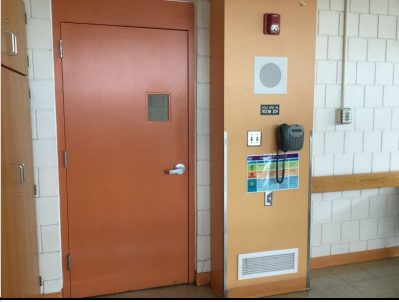
Maneuvering clearance not provided at recess > 8"	4"	Install an automatic door opener.	1	2295	\$2295
137	Lobby at Main Entrance, Women's Toilet Room	1		Doors, Doorways, & Gates	Toilet Room

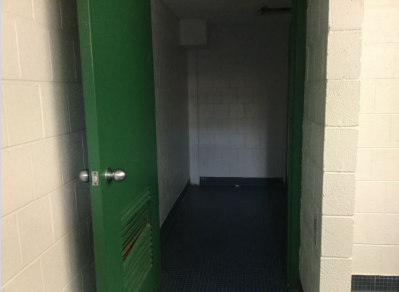
Hardware not operable with a closed fist	-	Provide hardware that can be operable with one hand and not require tight grasping, pinching, or twisting of the wrist.	1	363	\$363

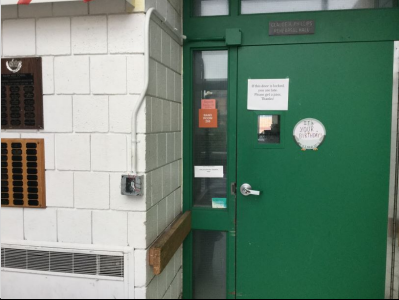
Automatic door opener not operable		Repair or replace the door opener.	1	2295	\$2295
142	Band Room (West Door)	2	266	Doors, Doorways, & Gates	Classroom

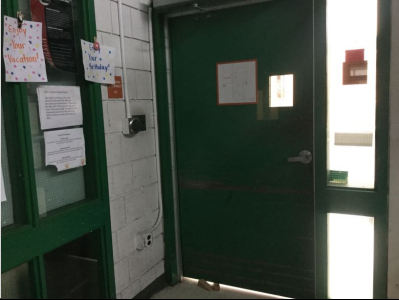
Automatic door opener > 48" above the floor surface	50"	Lower automatic door opener to 48" max. above ground.	1	Labor	\$0
143	Band Room (East Door)	2	266	Doors, Doorways, & Gates	Classroom

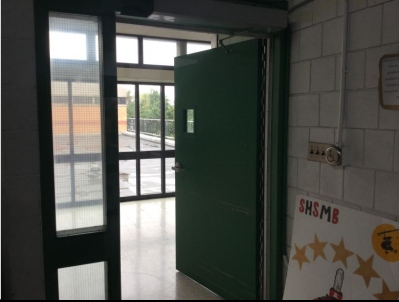
Automatic door opener > 48" above the floor surface	50"	Lower automatic door opener to 48" max. above ground.	1	Labor	\$0
Ramps												
144	Alternative Accessible Route to Gym Floor	B		Ramps	Interior

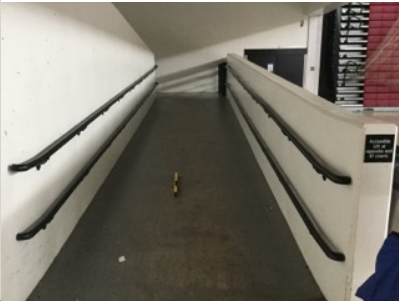
Running slope >1:12 (8.33%)	9.6%	Repair to this ramp might be technically infeasible.	1	0	\$0
Stairways												
145	Stairwell 2	2		Stairways	Interior

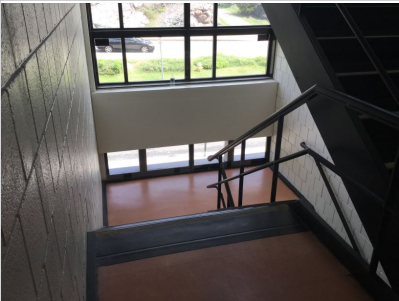
Handrail not provided on both sides	-	Provide handrail on one side.	1	1665	\$1665

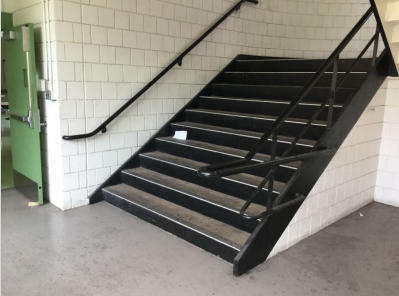
Handrails do not extend 12" from stairs	-	Ensure handrails extend to one tread depth beyond the last riser for the lower railing to ensure that the upper railing extension does not at as a protruding object.	1	600	\$600
147	Stairwell 8	1		Stairways	Interior

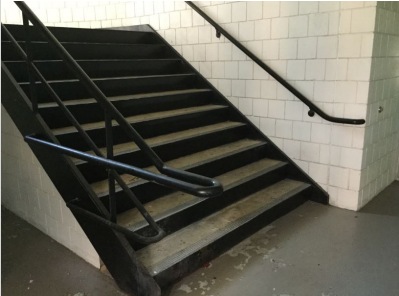
Handrails do not extend 12" from stairs	-	Ensure handrails extend to one tread depth beyond the last riser for the lower railing to ensure that the upper railing extension does not at as a protruding object.	1	600	\$600
148	Stairwell 7	1		Stairways	Interior

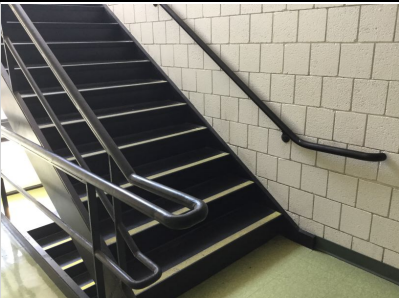
Handrails do not extend 12" from stairs	-	Ensure handrails extend to one tread depth beyond the last riser for the lower railing to ensure that the upper railing extension does not at as a protruding object.	1	600	\$600
149	Stairwell 7	1		Stairways	Interior

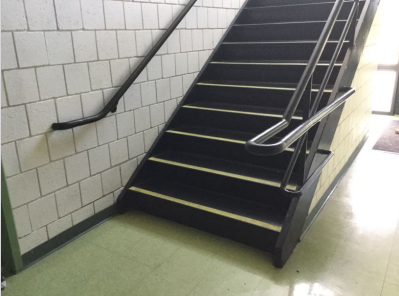
Handrails do not extend 12" from stairs	-	Ensure handrails extend to one tread depth beyond the last riser for the lower railing to ensure that the upper railing extension does not at as a protruding object.	1	600	\$600
152	Stairwell 5	1		Stairways	Interior

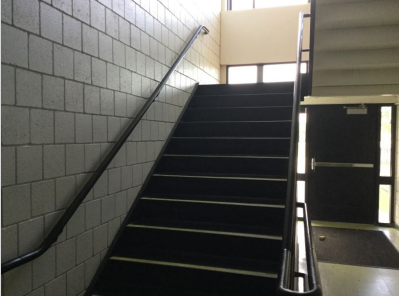
Handrails do not extend 12" from stairs	-	Ensure handrails extend to one tread depth beyond the last riser for the lower railing to ensure that the upper railing extension does not at as a protruding object.	1	600	\$600
153	Stairwell 4	1		Stairways	Interior

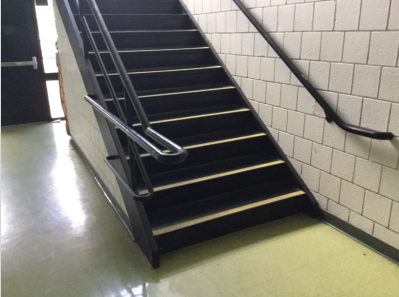
Handrails do not extend 12" from stairs	-	Ensure handrails extend to one tread depth beyond the last riser for the lower railing to ensure that the upper railing extension does not at as a protruding object.	1	600	\$600
154	Stairwell 4	1		Stairways	Interior

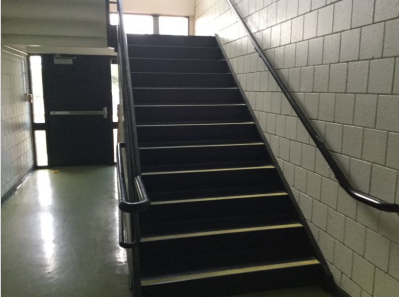
Handrails do not extend 12" from stairs	-	Ensure handrails extend to one tread depth beyond the last riser for the lower railing to ensure that the upper railing extension does not at as a protruding object.	1	600	\$600

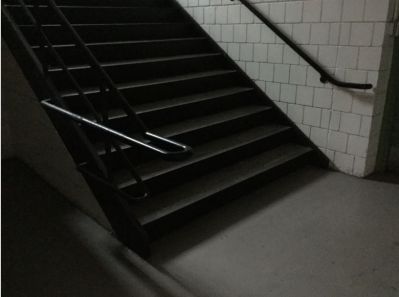
155	Stairwell 10	1		Stairways	Interior

Handrails do not extend 12" from stairs	-	Ensure handrails extend to one tread depth beyond the last riser for the lower railing to ensure that the upper railing extension does not at as a protruding object.	1	600	\$600

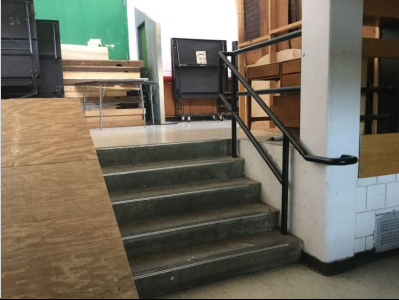
Handrails do not extend 12" from stairs	-	Ensure handrails extend horizontally above the landing for 12" min. beginning above the first riser nosing.	1	107	\$107
157	Auditorium	1	100	Stairways	Interior

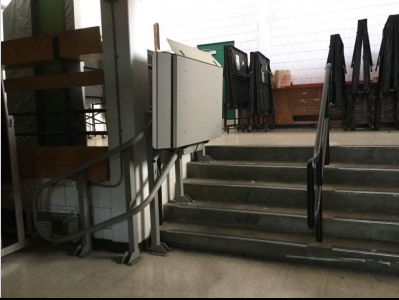
Not in operable working condition		Ensure lift is maintained in operable working condition.	1	Labor	\$0
159	Auditorium	1	100	Platform Lift or LULA Elevator	Interior

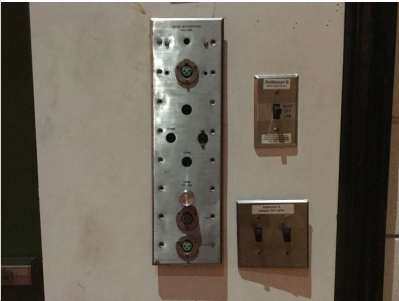
Not independently operable	-	Adjust controls to be independently operable or provide a new lift.	1	Labor	\$0
Elevator

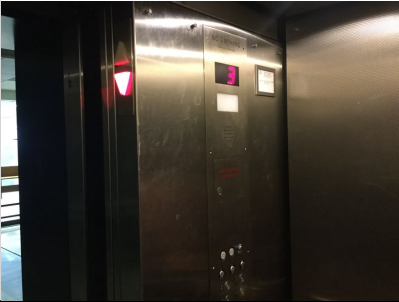
Audible hall signals not provided		Add audible hall signals. Note: Audible hall signals exist but were very faint and may not be audible to people who are deaf or are hard of hearing.	1	1329	\$1329
Signage												
162	Office	1		Signage	Designation

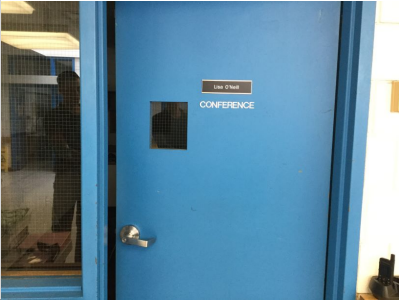
Not provided	-	Locate signage in raised characters in braille alongside the door on the latch side. Ensure it matches the long term use of this room.	1	174	\$174
163	Conference Room	1	158G	Signage	Designation

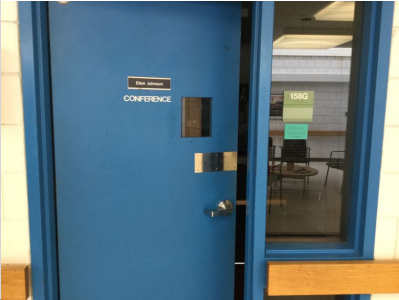
Not provided	-	Locate signage in raised characters and braille alongside the door on the latch side. Ensure it matches the long term purpose of the room.	1	174	\$174
164	Additional Entrance to Main Office Area	1		Signage	Designation

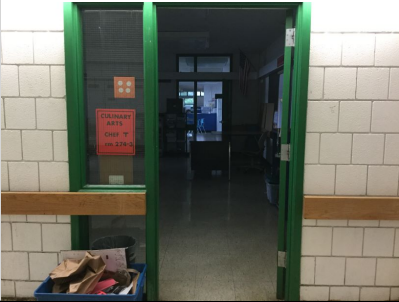
165	Culinary Arts Classroom	2	280	Signage	Designation

Not provided		Locate signage alongside the door on the latch side.	1	174	\$174

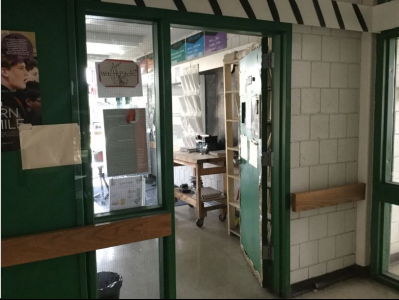
Not provided		Locate signage alongside the door on the latch side.	1	174	\$174
167	Donation Room	1	109	Signage	Designation

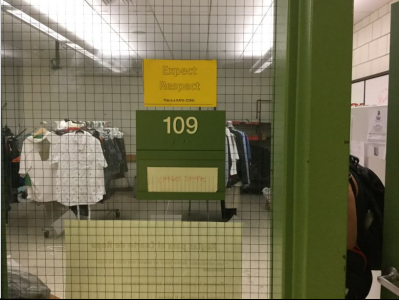
Not provided		Locate signage with correct information alongside the door on the latch side.	1	174	\$174
168	Principal's Office	1	158D	Signage	Designation

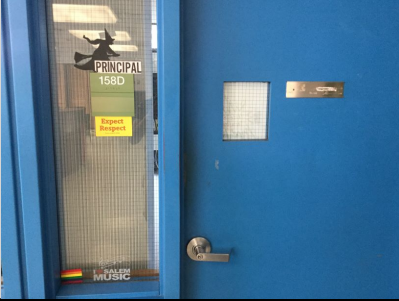
Raised characters not provided	-	Provide text with raised characters duplicated in braille. Ensure sign reflects the long term usage of this room.	1	174	\$174
169	Office	1		Signage	Designation

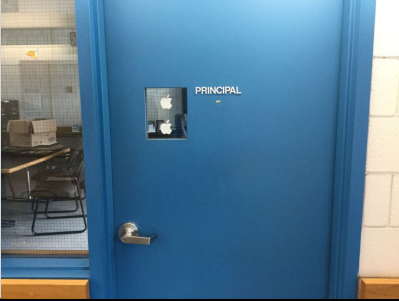
Raised characters not provided Braille not provided Sign not located on the latch side of the door	<ul style="list-style-type: none">---	Provide text with raised characters duplicated in braille. Locate sign at permanent rooms alongside the door on the latch side. Ensure signage reflects the long term use of this room.	1	174	\$174

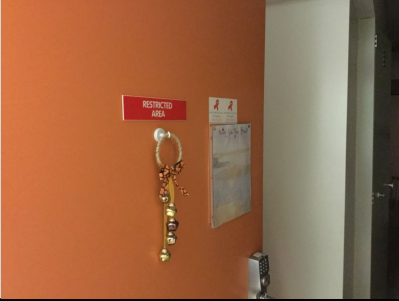
170	Environmental Science Closet	2	215	Signage	Informational

Raised characters not provided Braille not provided Sign not located on the latch side of the door	<ul style="list-style-type: none">---	Provide text with raised characters duplicated in braille. Locate sign at permanent rooms alongside the door on the latch side.	1	174 Labor	\$174

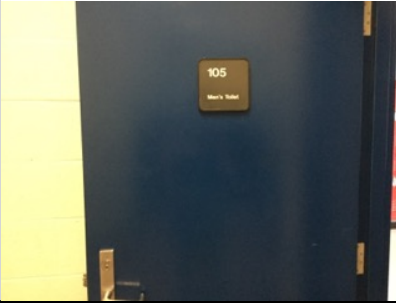
Raised characters not provided Braille not provided Sign not located on the latch side of the door International Symbol of Acc. not compliant	- - - -	Provide text with raised characters duplicated in braille. Locate sign at permanent rooms alongside the door on the latch side. Replace sign with a sign containing the International Symbol of Accessibility.	1	174	\$174

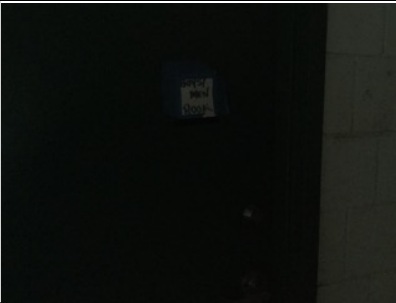
173	Gymnasium Area, Men's Public Toilet Room	B		Signage	Designation

Raised characters not provided Braille not provided Sign not located on the latch side of the door International Symbol of Acc. not compliant	- - - -	Provide text with raised characters duplicated in braille. Locate sign at permanent rooms alongside the door on the latch side. Replace sign with a sign containing the International Symbol of Accessibility.	1	174	\$174
174	Conference Room	1	158E	Signage	Designation

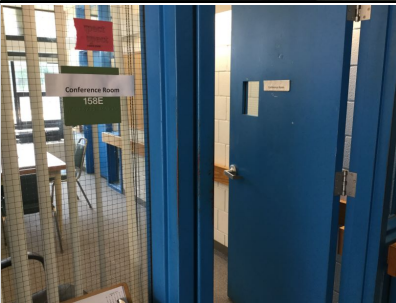
Raised characters not provided Braille misplaced	- -	Provide text with raised characters duplicated in braille. Ensure braille and raised characters match the long term purpose of this room.	1	174	\$174
175	Office	2	284	Signage	Designation

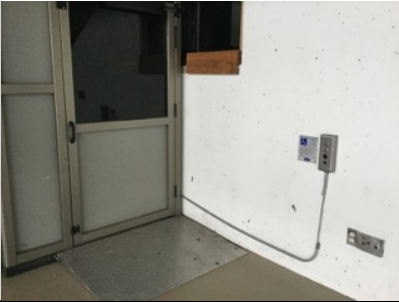
ID	Location	Floor	Room	Element	Type	Photo	Issues	Current Measure	Recommendations	Quantity	Price	Cost Estimation
176	Gymnasium Area, Access to Gym Floor	B		Signage	N/A

Braille not provided	-	Provide braille.	1	174	\$174
177	Projection Room	3		Signage	Designation

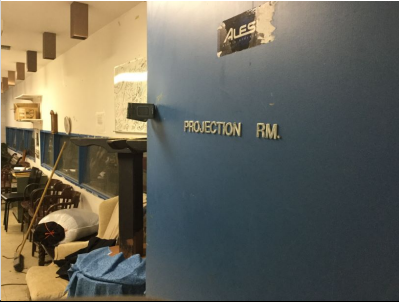
Braille not provided Sign not located on the latch side of the door	- -	Provide braille. Locate all signage at permanent rooms alongside the door on the latch side.	1	174 Labor	\$174
178	Conference Room	1	158E	Signage	Designation

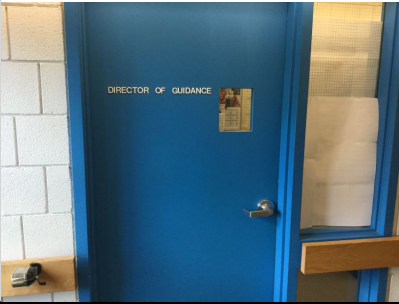
Braille not provided Sign not located on the latch side of the door	- -	Provide braille. Locate sign at permanent rooms alongside the door on the latch side.	1	174	\$174
179	Gymnasium Balcony Area, Women's Toilet Room	1		Signage	Designation

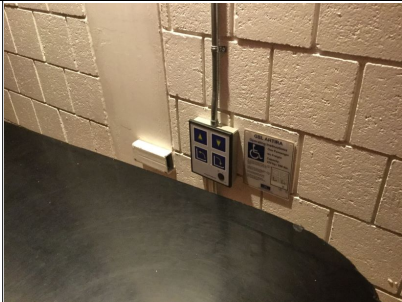
Visual characters < 40" above ground	37"	Mount visual sign so that the baseline of the lowest character is 40" min. above finished floor.	1	Labor	\$0
182	Instructional Media Center	3	355	Signage	Designation

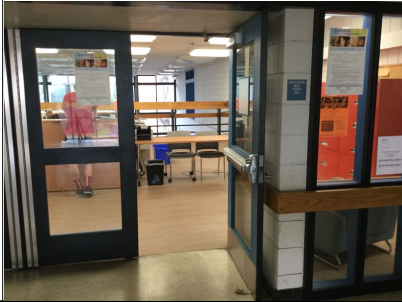
Sign not located on the latch side of the door	-	Locate sign at permanent rooms alongside the door on the latch side.	1	Labor	\$0
183	Instructional Media Center	1	155	Signage	Designation

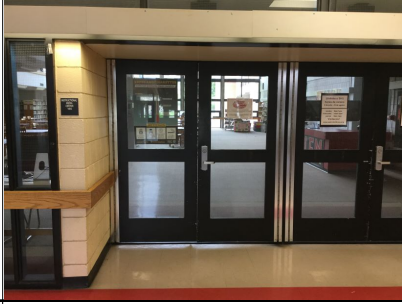
Sign not located on the latch side of the door	-	Locate sign at permanent rooms alongside the door on the latch side.	1	Labor	\$0
184	Culinary Arts/Medical Assistance Classroom	2	270	Signage	Designation

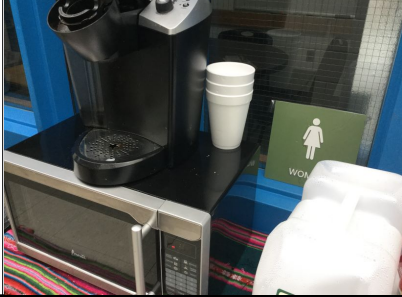
Sign not located on the latch side of the door		Locate sign at permanent rooms alongside the door on the latch side.	1	Labor	\$0

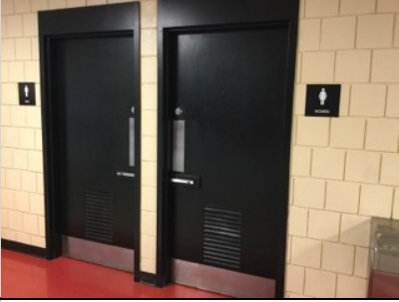
ID	Location	Floor	Room	Element	Type	Photo	Issues	Current Measure	Recommendations	Quantity	Price	Cost Estimation
186	Lobby at Main Entrance, Women's Toilet Room	1		Signage	Designation

Sign not located on the latch side of the door International Symbol of Acc. not compliant	- -	Locate sign at permanent rooms alongside the door on the latch side. Replace sign with a sign containing the International Symbol of Accessibility.	1	Labor 174	\$174
187	Lobby at Main Entrance, Men's Toilet Room	1		Signage	Designation

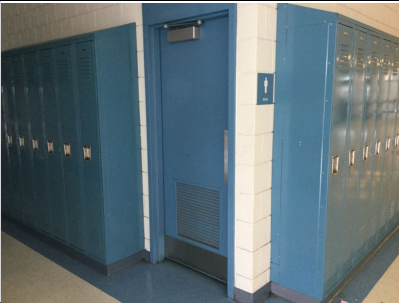
Sign not located on the latch side of the door Directional sign to access. toilet not provided	- -	Locate sign at permanent rooms alongside the door on the latch side. Provide a sign indicating the location of the nearest accessible toilet room.	1	Labor 174	\$174

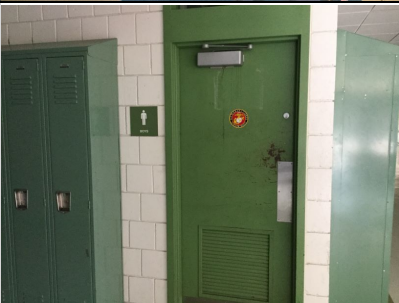
189	Boys' Toilet Room Near Teen Health Center	1		Signage	Designation

Sign not located on the latch side of the door Directional sign to access. toilet not provided	- -	Locate sign at permanent rooms alongside the door on the latch side. Provide a sign indicating the location of the nearest accessible toilet room.	1	Labor 174	\$174
190	Cafeteria, Third Floor	3	343	Signage	Designation

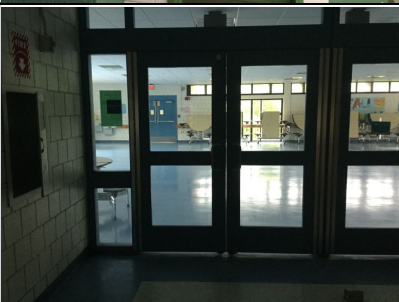
Sign not located on the latch side of the door	-	Ensure designation sign is located on the right side of this set of doors.	1	Labor	\$0

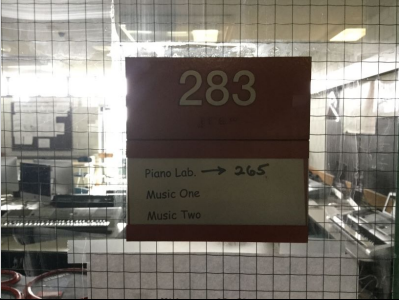
ID	Location	Floor	Room	Element	Type	Photo	Issues	Current Measure	Recommendations	Quantity	Price	Cost Estimation
191	Music Classroom	2	283	Signage	Designation

Text size non-compliant		Ensure that character size complies with the Character Height Table 703.5.5 in the ADA 2010 Standards.	1	174	\$174
Service Counter												
192	Instructional Media Center	3	355	Service Counter	N/A

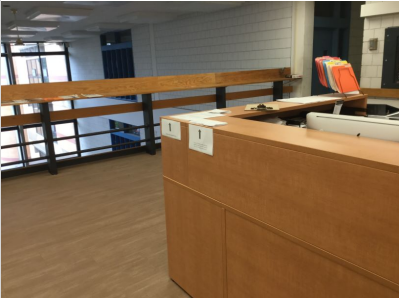
Counter > 36" high	44"	Provide a counter that is 36" max. above the ground or finished floor.	1	660	\$660
193	Instructional Media Center	1	155	Service Counter	N/A

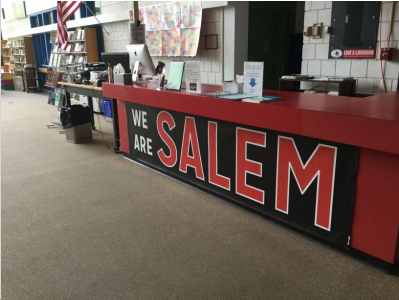
Counter > 36" high	40"	Provide a counter that is 36" max. above the ground or finished floor.	1	660	\$660
194	Speech	2	256	Service Counter	N/A

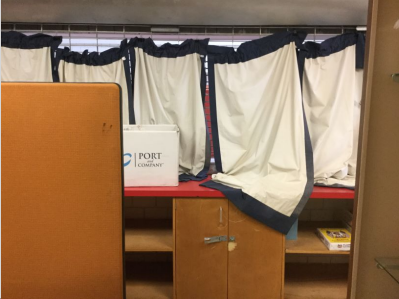
Counter > 36" high	37"	Provide a counter that is 36" max. above the ground or finished floor.	1	660	\$660
195	Hallway by Speech Room	2	256	Service Counter	N/A

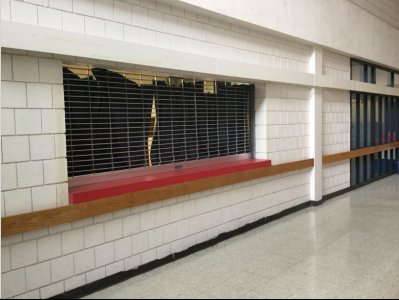
Counter > 36" high	37"	Provide a counter that is 36" max. above the ground or finished floor.	1	660	\$660

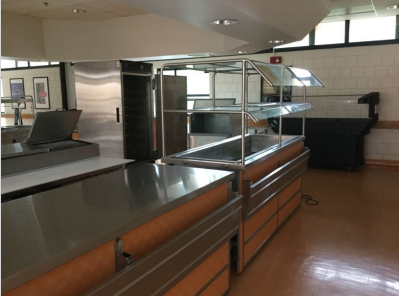
ID	Location	Floor	Room	Element	Type	Photo	Issues	Current Measure	Recommendations	Quantity	Price	Cost Estimation
196	Cafeteria	2		Service Counter	N/A

Counter > 36" high	51"	Ensure anything that is located on the higher shelf is also located at a level that is 36" max. above the ground or finished floor.	1	Labor	\$0
197	School Store	2	251	Service Counter	N/A

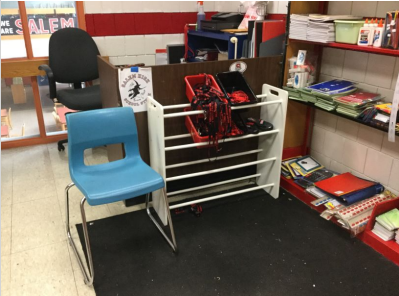
Counter > 36" high	38"	Provide a counter that is 36" max. above the ground or finished floor.	1	660	\$660
198	Library	2	255	Service Counter	N/A

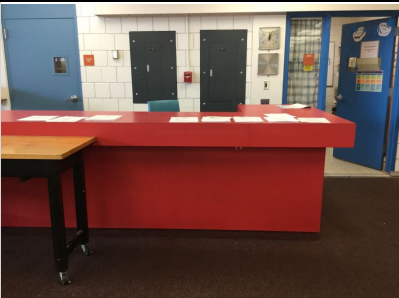
Counter > 36" high	40"	Provide a counter that is 36" max. above the ground or finished floor.	1	660	\$660
Operable Parts												
199	Biology Classroom	1	116	Operable Parts	Other

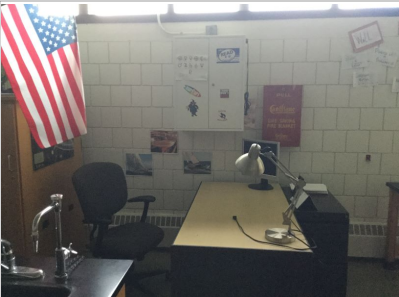
Element not on an accessible route Clear floor space is not provided	- -	Ensure goggles are located on an accessible route. Provide a 30" min. by 48" min. clear floor space at goggle pick up.	1	Labor	\$0

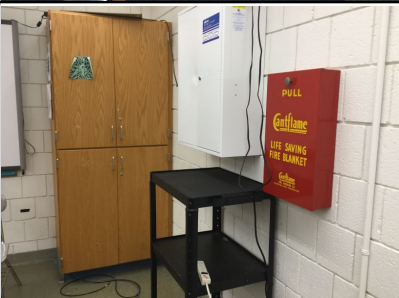
200	Science Classroom	3	314	Operable Parts	Equipment

Clear floor space is not provided	-	Provide a 30" min. by 48" min. clear floor space at goggle pick up.	1	Labor	\$0

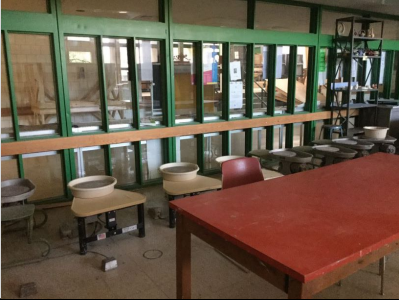
ID	Location	Floor	Room	Element	Type	Photo	Issues	Current Measure	Recommendations	Quantity	Price	Cost Estimation
201	Art Room	1	166	Operable Parts	Other

Clear floor space is not provided	-	Provide a 30" min. by 48" min. clear floor space at pottery wheels.	1	Labor	\$0
202	Automotive Technology Center, Garage	1		Operable Parts	Equipment

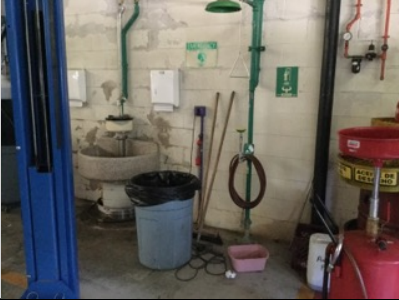
Clear floor space is not provided	-	Provide a 30" min. by 48" min. clear floor space at emergency eyewash station by removing clutter.	1	Labor	\$0
203	Automotive Technology Center, Garage	1		Operable Parts	Equipment
