City of Salem, Massachusetts

PART A – Executive Summary

Part A – Executive Summary

Introduction

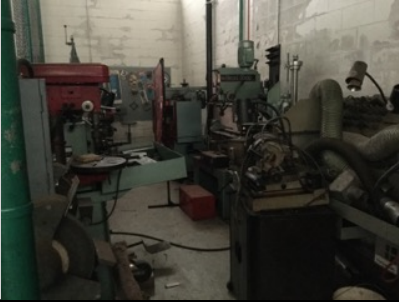
Clear floor space is not provided	-	Provide a 30" min. by 48" min. clear floor space at machines.	1	Labor	\$0
204	Art Room	1	166	Operable Parts	Equipment

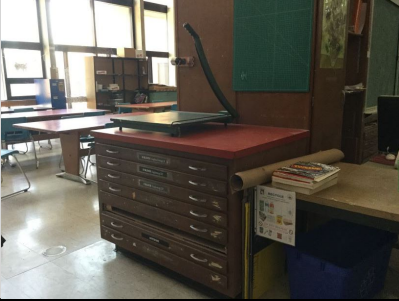
Clear floor space is not provided Reach < 15" or > 48"(forward/side approach)	- 61"	Relocate paper cutter so that controls are between 15"- 48" above finished floor and there is a 30" min. by 48" min. clear floor space.	1	Labor	\$0

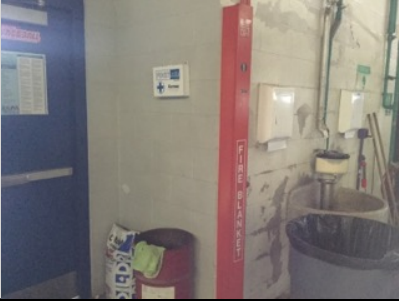
205	Automotive Technology Center, Garage	1		Operable Parts	Equipment

Clear floor space is not provided Side reach > 54"	- 68"	Provide a 30" min. by 48" min. clear floor space at first aid kit. Relocate first aid kit so that controls are between 15" - 48" above finished floor.	1	Labor 192	\$192

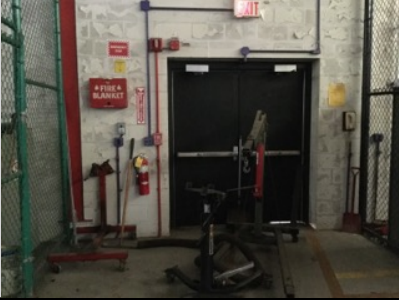
ID	Location	Floor	Room	Element	Type	Photo	Issues	Current Measure	Recommendations	Quantity	Price	Cost Estimation
206	Automotive Technology Center, Garage	1		Operable Parts	Equipment

Clear floor space is not provided Side reach > 54"	- 76.5"	Provide a 30" min. by 48" min. clear floor space at fire blanket and emergency equipment by removing clutter. Relocate fire blanket and emergency equipment so that controls are between 15" - 48" above finished floor.	1	Labor 192	\$192
207	Projection Room	3		Operable Parts	Switch

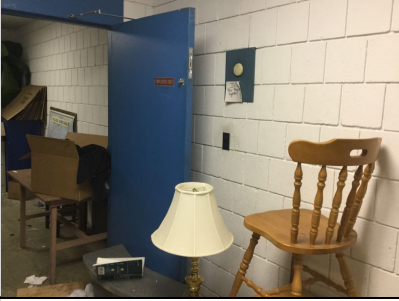
Clear floor space is not provided Side reach if obstruction > 24" deep is > 46" high	- 68.5"	Provide a 30" min. by 48" min. clear floor space at light switch. Ensure that light switch is not higher than 46" above the finished floor.	1	192	\$192
208	English and College Preparation Classroom	3	311	Operable Parts	Other

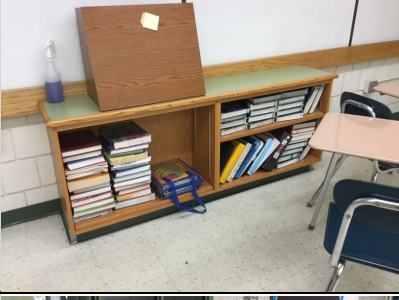
209	Geometry and Calculus Classroom	1	134	Operable Parts	Other

Reach < 15" or > 48"(forward/side approach)	8"	Relocate books so that they are between 15"- 48" above finished floor.	1	Labor	\$0
210	Early Education and Care Room	1	118	Operable Parts	Other

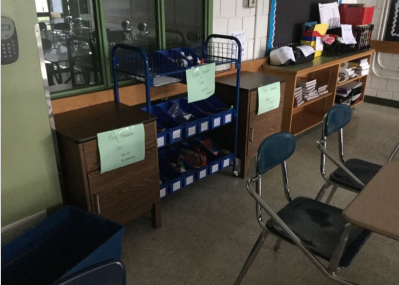
Reach < 15" or > 48"(forward/side approach)	9"	Relocate stored items so that they are between 15"- 48" above finished floor.	1	Labor	\$0

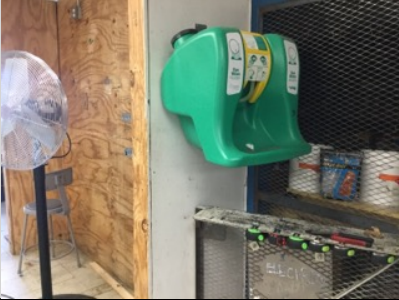
ID	Location	Floor	Room	Element	Type	Photo	Issues	Current Measure	Recommendations	Quantity	Price	Cost Estimation
211	Electrical Class, Emergency Eyewash	B	087	Operable Parts	Other

Reach < 15" or > 48"(forward/side approach)	69"	Relocate emergency eyewash so that controls are between 15"- 48" above finished floor.	1	530	\$530
212	Electrical Class	B	087	Operable Parts	Other

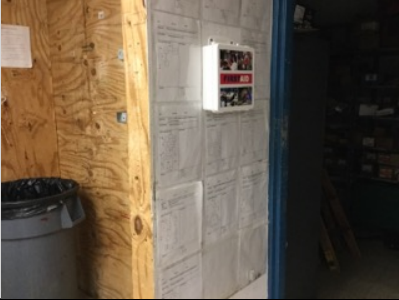
Reach < 15" or > 48"(forward/side approach)	66"	Relocate first aid kit so that controls are between 15"- 48" above finished floor.	1	192	\$192
213	Trainer's Room	B	079	Operable Parts	Other

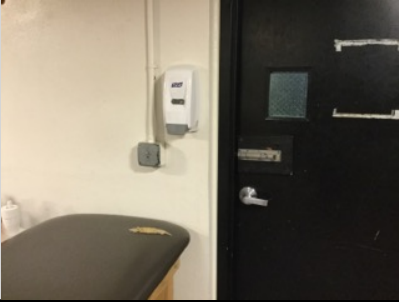
Reach < 15" or > 48"(forward/side approach)	52"	Relocate hand sanitizer so that controls are between 15"- 48" above finished floor.	1	192	\$192
214	Donation Room	1	109	Operable Parts	Other

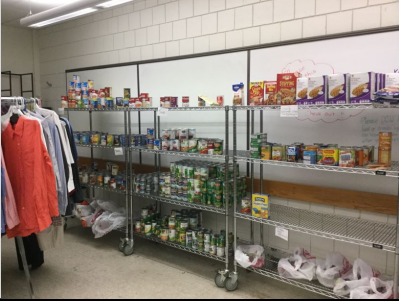
Reach < 15" or > 48"(forward/side approach) Side reach > 54"	10" 59"	Relocate store items so that items are between 15"- 48" above finished floor.	1	Labor	\$0

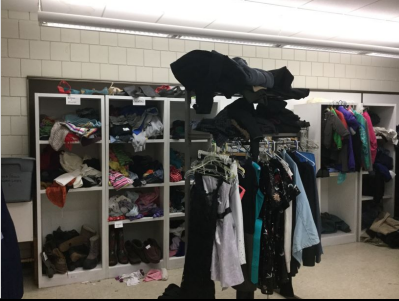
215	Donation Room	1	109	Operable Parts	Other

Reach < 15" or > 48"(forward/side approach) Side reach > 54"	4.5" 72"	Relocate clothes so that items are between 15"- 48" above finished floor.	1	Labor	\$0

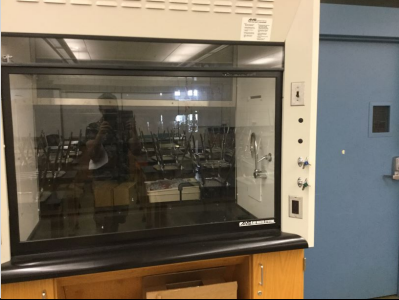
ID	Location	Floor	Room	Element	Type	Photo	Issues	Current Measure	Recommendations	Quantity	Price	Cost Estimation
216	Science Classroom	3	314	Operable Parts	Switch

Side reach > 54"	63"	Relocate fume hood controls so that they are 48" max. above finished floor.	1	192	\$192
217	Costume Room Near Auditorium	3		Operable Parts	Other

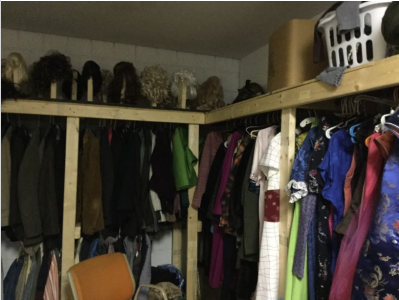
Side reach > 54"	85"	Relocate costumes so that controls are between 15" - 48" above finished floor.	1	Labor	\$0
218	Science Classroom	2	216	Operable Parts	Switch

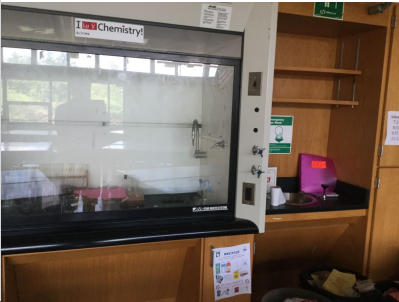
Side reach > 54"	63"	Relocate fume hood controls so that they are 48" max. above finished floor.	1	192	\$192
219	Home Economics/ Special Needs Classroom	1	141	Operable Parts	Other

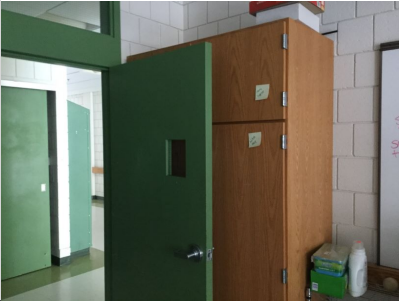
Side reach > 54"	74"	Relocate storage so that items are between 15" - 48" above finished floor.	1	Labor	\$0
220	Independent Living Room	1	133	Operable Parts	Other

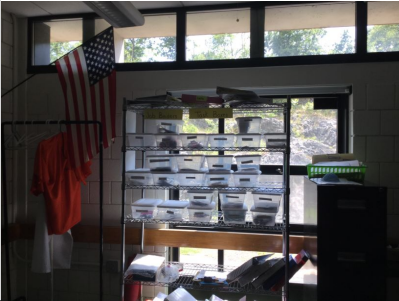
Side reach > 54"	73"	Relocate storage so that controls are between 15" - 48" above finished floor.	1	Labor	\$0

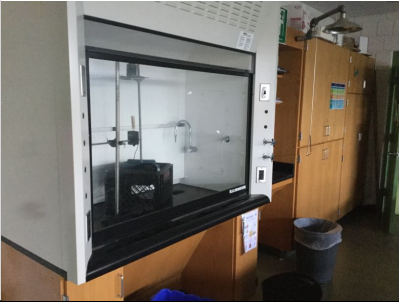
ID	Location	Floor	Room	Element	Type	Photo	Issues	Current Measure	Recommendations	Quantity	Price	Cost Estimation
221	Physics Classroom	1	116	Operable Parts	Switch

Side reach > 54"	63"	Relocate fume hood controls so that they are 48" max. above the finished floor.	1	192	\$192
222	Science Prep Room	1	114	Operable Parts	Switch

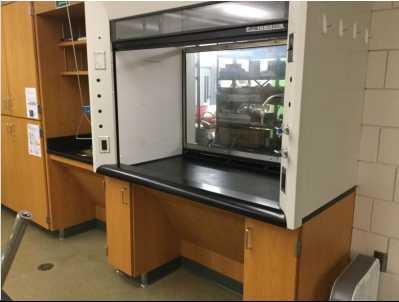
Side reach > 54"	63"	Relocate fume hood controls so that they are between 15" - 48" above finished floor.	1	192	\$192
223	Culinary Arts/Medical Assistance Classroom	2	270	Operable Parts	Other

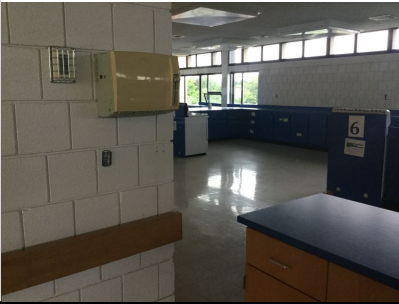
Side reach > 54"	60"	Relocate paper towel dispenser so that controls are between 15" - 48" above finished floor.	1	192	\$192
224	Culinary Arts/Medical Assistance Classroom	2	270	Operable Parts	Other

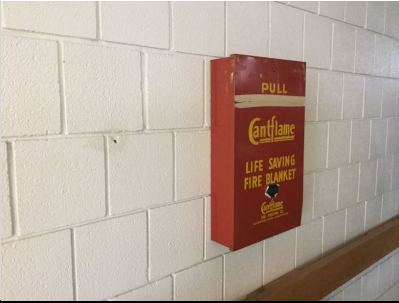
Side reach > 54"	63"	Relocate fire blanket so that controls are between 15" - 48" above finished floor.	1	192	\$192
225	School Store	2	251	Operable Parts	Clothes Rod/Hooks

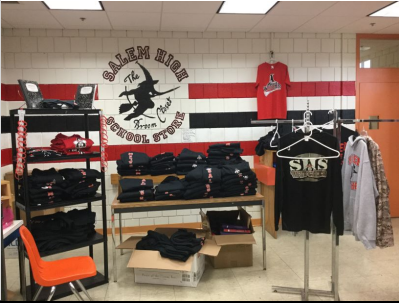
Side reach > 54"	59"	Relocate clothes so that items are between 15" - 48" above finished floor.	1	Labor	\$0

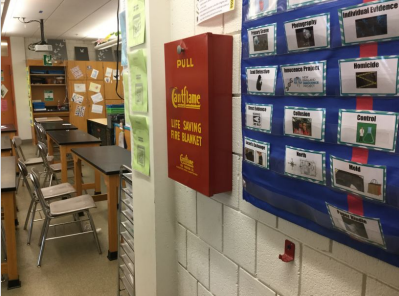
ID	Location	Floor	Room	Element	Type	Photo	Issues	Current Measure	Recommendations	Quantity	Price	Cost Estimation
226	Environmental Science	2	212	Operable Parts	Equipment

Side reach > 54"	63"	Relocate fire blanket so that controls are between 15" - 48" above finished floor.	1	192	\$192
227	Wood Shop	1	174	Operable Parts	Equipment

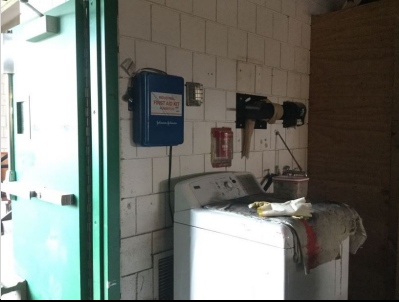
Side reach > 54"	59"	Relocate first aid kit so that controls are between 15" - 48" above finished floor.	1	192	\$192
229	Wood Shop	1	174	Operable Parts	Equipment

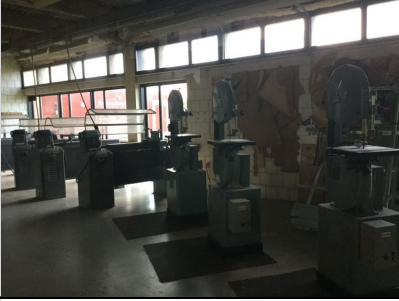
Side reach > 54"	55"	Relocate machine controls so that controls are between 15" - 48" above finished floor.	1	0	\$0
230	Wood Shop	1	174	Operable Parts	Equipment

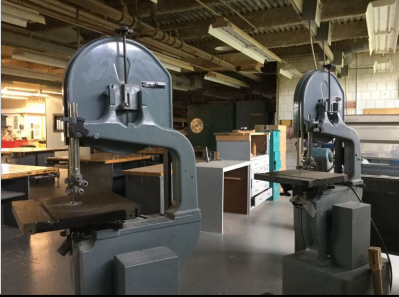
Side reach > 54"	66"	Relocate machine controls so that controls are between 15" - 48" above finished floor.	1	0	\$0

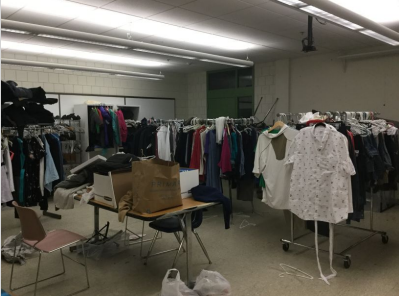
ID	Location	Floor	Room	Element	Type	Photo	Issues	Current Measure	Recommendations	Quantity	Price	Cost Estimation
231	Donation Room	1	109	Operable Parts	Clothes Rod/Hooks

Side reach > 54"	61"	Relocate coat hooks so that controls are between 15" - 48" above finished floor.	1	Labor	\$0
232	Automotive Technology Center Tools Area	1		Operable Parts	Equipment

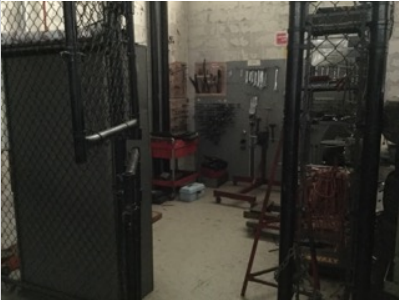
Side reach > 54"	74.5"	Relocate tools so that controls are between 15" - 48" above finished floor.	1	Labor	\$0
233	Automotive Technology Center, Garage	1		Operable Parts	Equipment

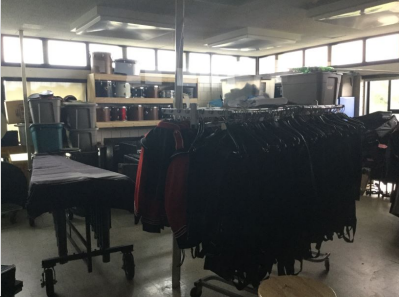
Side reach > 54" No visible fire alarm provided within room	60"	Relocate coat hooks so that controls are between 15" - 48" above finished floor. When fire system is updated, ensure that a visible fire alarm is installed in each room.	1	711	\$711

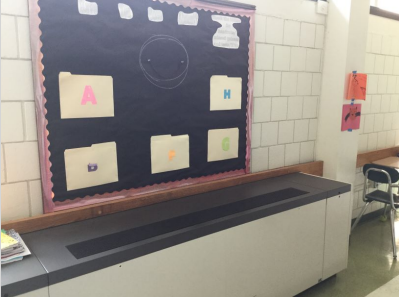
235	Speech Therapy and Social Skills Class	1	129	Operable Parts	Other

Forward reach if obstruction > 20"- 25" deep is > 44" high	56"	Ensure that folders are not higher than 44" above the finished floor.	1	Labor	\$0

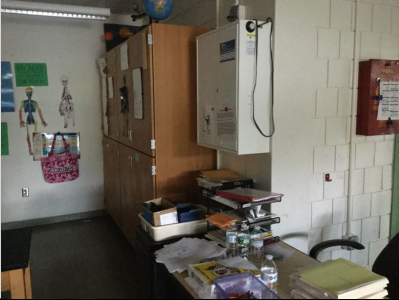
ID	Location	Floor	Room	Element	Type	Photo	Issues	Current Measure	Recommendations	Quantity	Price	Cost Estimation
236	Science Classroom	1	112	Operable Parts	Other

Forward reach if obstruction > 20"- 25" deep is > 44" high	50"	Ensure that goggles are not higher than 44" above the finished floor.	1	192	\$192
237	Auditorium - Backstage	1	191	Operable Parts	Other

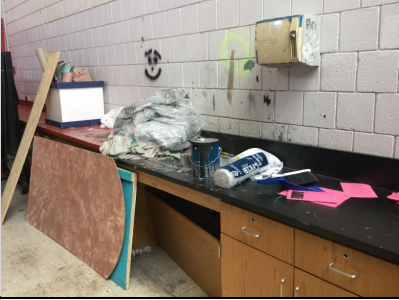
Forward reach if obstruction > 20"- 25" deep is > 44" high	63"	Ensure that paper towel dispenser is not higher than 44" above the finished floor.	1	192	\$192
238	Art Room	1	166	Operable Parts	Other

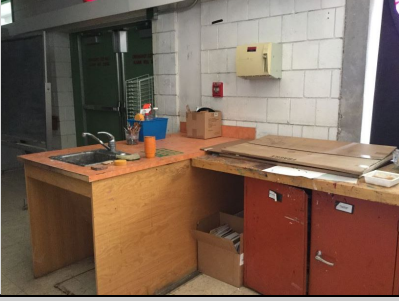
Side reach if obstruction > 24" deep is > 46" high	57"	Ensure that paper towel dispenser is not higher than 46" above the finished floor.	1	192	\$192
Dining or Work Surfaces												
239	Science Classroom	1	112	Dining or Work Surfaces	Work Surface

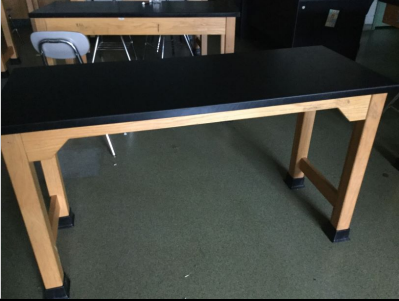
Relocate/swap at least one accessible lab table with inaccessible lab tables in Rooms 116, 216, and 314.	1	Labor	\$0

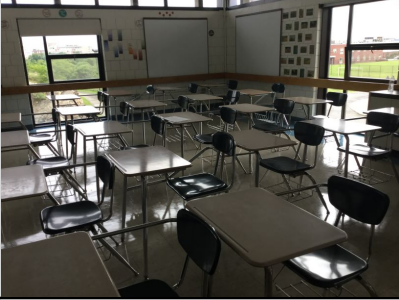
240	History Classroom	3	304	Dining or Work Surfaces	Work Surface

Not on a accessible route At least one or 5% accessible tables not provided	24" -	Ensure work surfaces are located on an accessible route by rearranging desks. Ensure that at least one work surface is accessible.	1	Labor 525	\$525

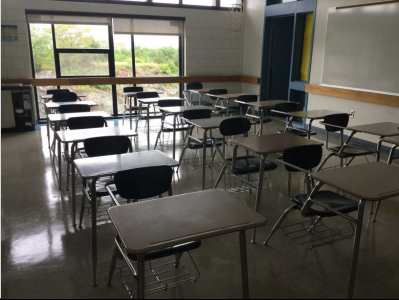
ID	Location	Floor	Room	Element	Type	Photo	Issues	Current Measure	Recommendations	Quantity	Price	Cost Estimation
241	English and College Preparation Classroom	3	311	Dining or Work Surfaces	Work Surface

Not on a accessible route At least one or 5% accessible tables not provided	22" -	Ensure work surfaces are located on an accessible route by rearranging desks. Ensure that at least one work surface is accessible.	1	Labor 525	\$525
242	Latin Classroom	3	335	Dining or Work Surfaces	Work Surface

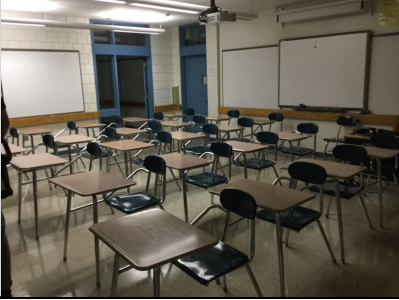
At least one or 5% accessible tables not provided	-	Ensure that at least one work surface is accessible.	1	525	\$525
243	Senior English Classroom	3	339	Dining or Work Surfaces	Work Surface

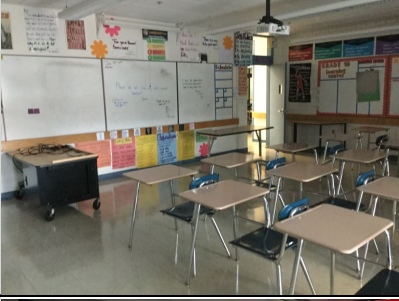
At least one or 5% accessible tables not provided	-	Ensure that at least one work surface is accessible.	1	525	\$525
244	Spanish Classroom	3	318	Dining or Work Surfaces	Work Surface

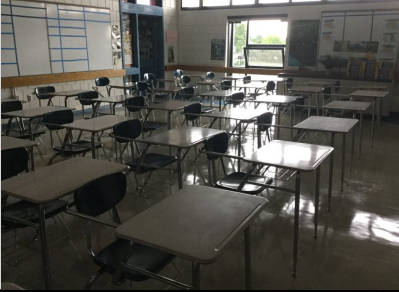
245	French Classroom	3	319	Dining or Work Surfaces	Work Surface

At least one or 5% accessible tables not provided	-	Ensure that at least one work surface is accessible.	1	525	\$525

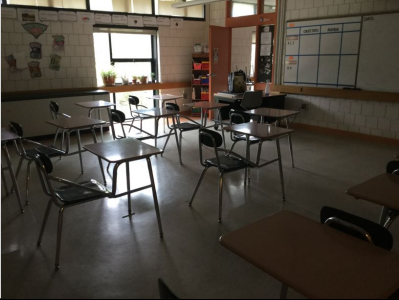
ID	Location	Floor	Room	Element	Type	Photo	Issues	Current Measure	Recommendations	Quantity	Price	Cost Estimation
246	ESL Classroom	2	240	Dining or Work Surfaces	Work Surface

At least one or 5% accessible tables not provided	-	Ensure that at least one work surface is accessible.	1	525	\$525
247	American History Classroom	2	226	Dining or Work Surfaces	Work Surface

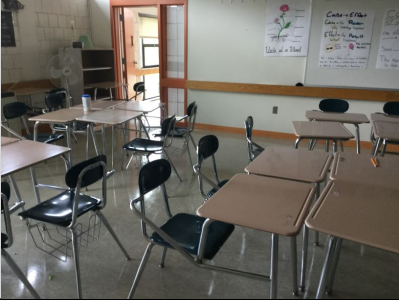
At least one or 5% accessible tables not provided	-	Ensure that at least one work surface is accessible.	1	525	\$525
248	Instructional Media Center	1	155	Dining or Work Surfaces	Work Surface

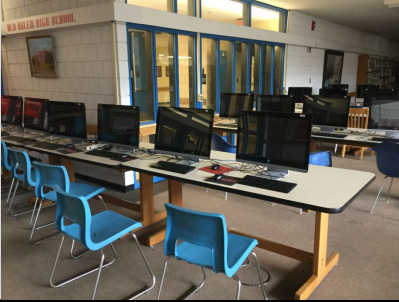
At least one or 5% accessible tables not provided	-	Ensure that at least one work surface is accessible.	1	525	\$525
249	Instructional Media Center	1	155	Dining or Work Surfaces	Work Surface

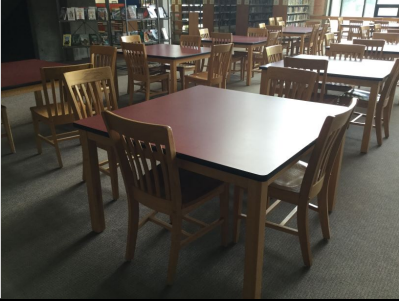
At least one or 5% accessible tables not provided	-	Ensure that at least one work surface is accessible.	1	525	\$525
250	Speech Therapy and Social Skills Class	1	129	Dining or Work Surfaces	Work Surface

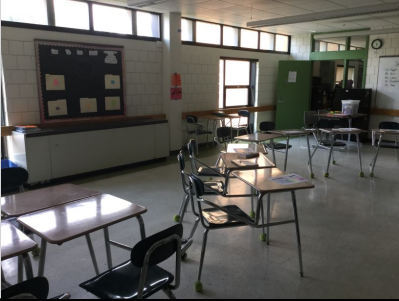
At least one or 5% accessible tables not provided	-	Ensure that at least one work surface is accessible.	1	525	\$525

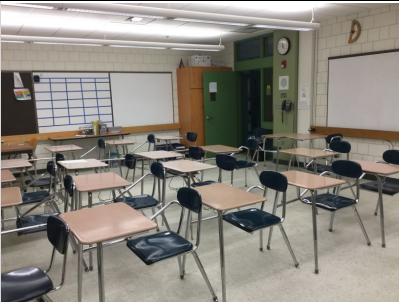
ID	Location	Floor	Room	Element	Type	Photo	Issues	Current Measure	Recommendations	Quantity	Price	Cost Estimation
251	Geometry and Calculus Classroom	1	134	Dining or Work Surfaces	Work Surface

At least one or 5% accessible tables not provided	-	Ensure that at least one work surface is accessible.	1	525	\$525
252	VTC/Special Education Room	1	140	Dining or Work Surfaces	Work Surface

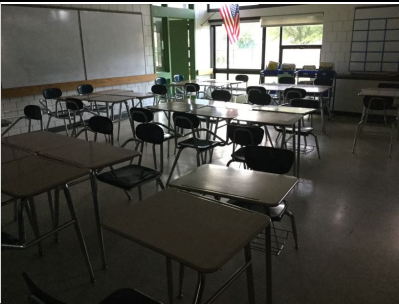
At least one or 5% accessible tables not provided	-	Ensure that at least one work surface is accessible.	1	525	\$525
254	ROTC - Bunker Room	1		Dining or Work Surfaces	Work Surface

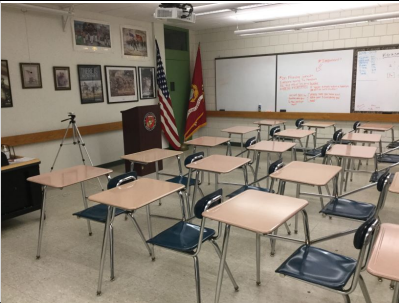
At least one or 5% accessible tables not provided	-	Ensure that at least one work surface is accessible.	1	525	\$525
255	Culinary Arts/Medical Assistance Classroom	2	270	Dining or Work Surfaces	Work Surface

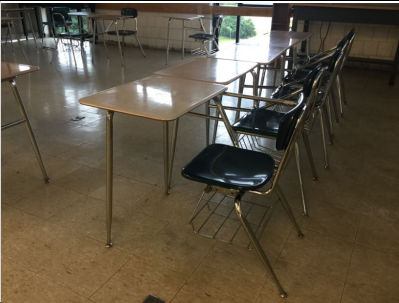
At least one or 5% accessible tables not provided		Ensure that at least one work surface is accessible.	1	525	\$525

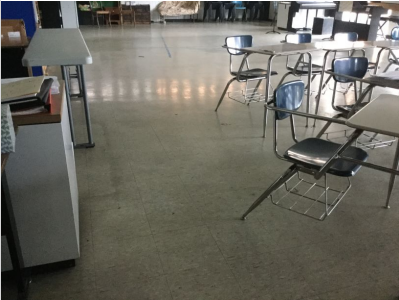
ID	Location	Floor	Room	Element	Type	Photo	Issues	Current Measure	Recommendations	Quantity	Price	Cost Estimation
256	Choir Room	2	285	Dining or Work Surfaces	Work Surface

At least one or 5% accessible tables not provided		Ensure that at least one work surface is accessible.	1	525	\$525
257	Classroom	2	201	Dining or Work Surfaces	Work Surface

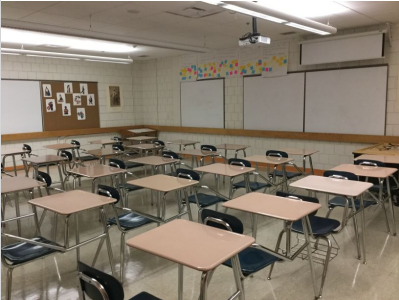
At least one or 5% accessible tables not provided		Ensure that at least one work surface is accessible.	1	525	\$525
258	Library	2	255	Dining or Work Surfaces	Work Surface

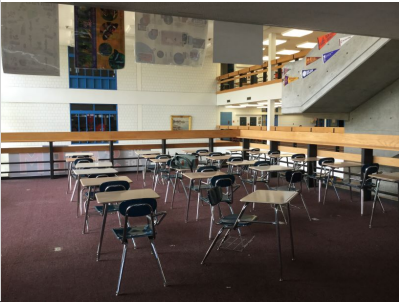
At least one or 5% accessible tables not provided	-	Ensure that at least one work surface is accessible.	1	525	\$525
259	Automotive Technology Center, Classroom	Ext.		Dining or Work Surfaces	Work Surface

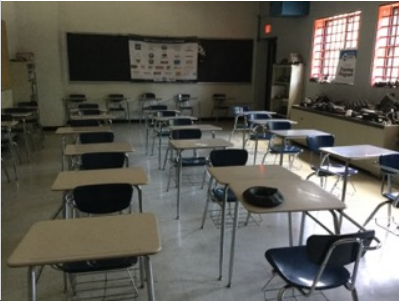
At least one or 5% accessible tables not provided	-	Ensure that at least one work surface is accessible.	1	525	\$525
260	Black Cat Cafe	B		Dining or Work Surfaces	Dining Surface

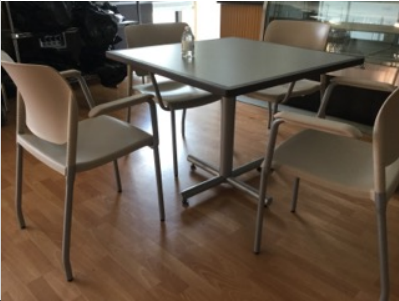
At least one or 5% accessible tables not provided	-	Ensure that at least one dining surface is accessible.	1	825	\$825

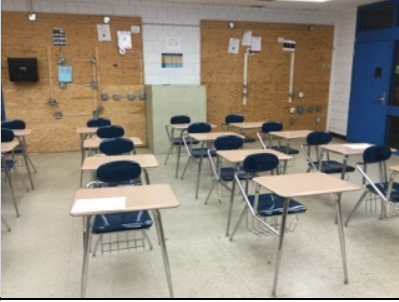
ID	Location	Floor	Room	Element	Type	Photo	Issues	Current Measure	Recommendations	Quantity	Price	Cost Estimation
261	Electrical Class	B	091	Dining or Work Surfaces	Work Surface

At least one or 5% accessible tables not provided	-	Ensure that at least one work surface is accessible.	1	525	\$525
262	Computer Lab	1	101	Dining or Work Surfaces	Work Surface

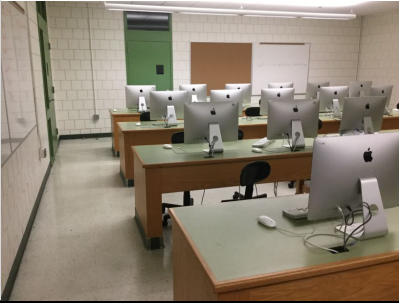
At least one or 5% accessible tables not provided Knee or toe clearance not provided	- 25"	Ensure that at least one work surface is accessible. Provide at least 1 dining or work surface with 27" min. knee and toe clearance.	1	525	\$525
263	Computer Lab	1	182	Dining or Work Surfaces	Work Surface

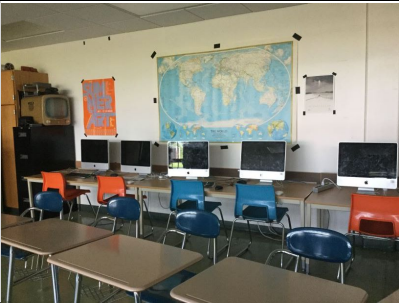
At least one or 5% accessible tables not provided Knee or toe clearance not provided Top of dining/work surface < 28" or > 34"	- 23" 26"	Ensure that at least one work surface is accessible. Provide at least 1 dining or work surface with 27" min. knee and toe clearance. Provide at least one dining or work surface with tops between 28"- 34" above the floor and 27" clear height underneath.	1	525	\$525

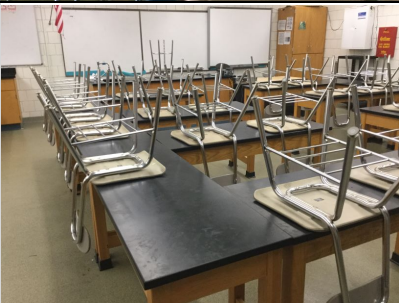
264	Science Classroom	3	314	Dining or Work Surfaces	Work Surface

Knee or toe clearance not provided	25"	Provide at least 1 work surface with 27" min. knee and toe clearance. See ID #239	1	-	\$0
265	Science Classroom	2	216	Dining or Work Surfaces	Work Surface

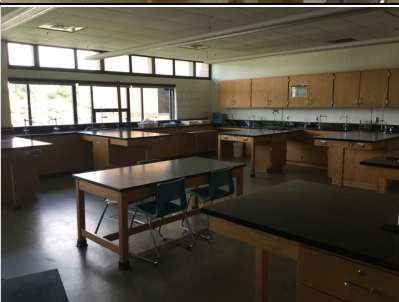
Knee or toe clearance not provided	25"	Provide at least 1 work surface with 27" min. knee and toe clearance. See ID #239	1	-	\$0

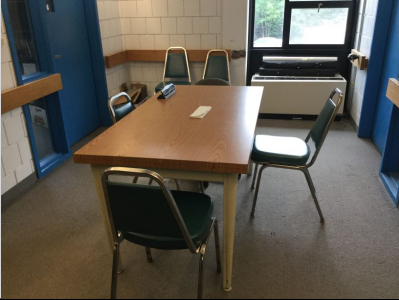
ID	Location	Floor	Room	Element	Type	Photo	Issues	Current Measure	Recommendations	Quantity	Price	Cost Estimation
266	Conference Room	1	158E	Dining or Work Surfaces	Work Surface

Knee or toe clearance not provided	25"	Provide at least 1 work surface with 27" min. knee and toe clearance.	1	525	\$525
267	Conference Room	1	158C	Dining or Work Surfaces	Work Surface

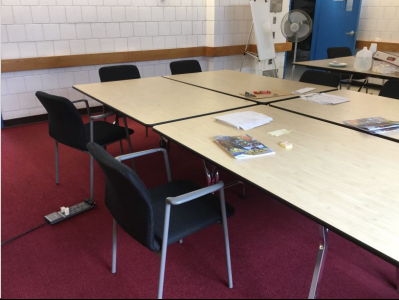
Knee or toe clearance not provided	26"	Provide at least 1 work surface with 27" min. knee and toe clearance.	1	525	\$525
268	Home Economics/ Special Needs Classroom	1	141	Dining or Work Surfaces	Work Surface

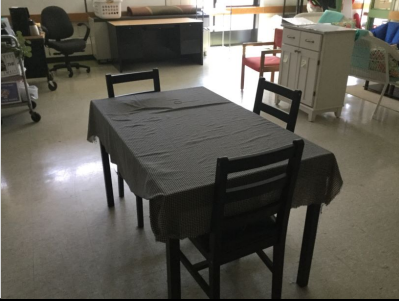
Knee or toe clearance not provided	25"	Provide at least 1 work surface with 27" min. knee and toe clearance.	1	525	\$525
269	Independent Living Room	1	133	Dining or Work Surfaces	Work Surface

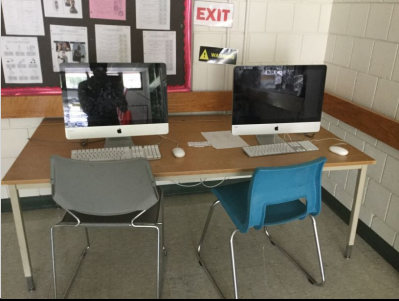
Knee or toe clearance not provided	23"	Provide at least 1 work surface with 27" min. knee and toe clearance.	1	525	\$525

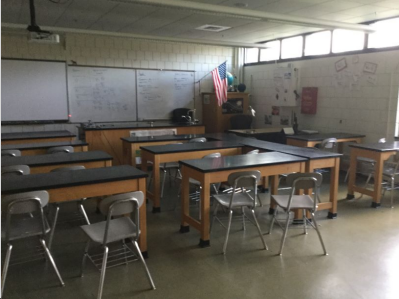
270	Physics Classroom	1	116	Dining or Work Surfaces	Work Surface

Knee or toe clearance not provided	24"	Provide at least 1 work surface with 27" min. knee and toe clearance. See ID 239	1	-	\$0

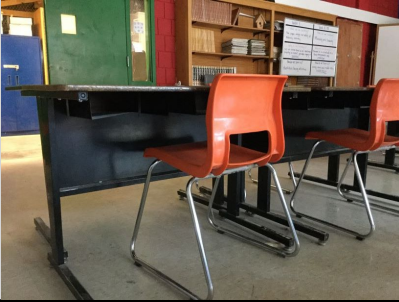
Knee or toe clearance not provided	8" d	Provide at least 1 work surface with 27" min. knee and toe clearance.	1	525	\$525
274	Wood Shop	1	174	Dining or Work Surfaces	Work Surface

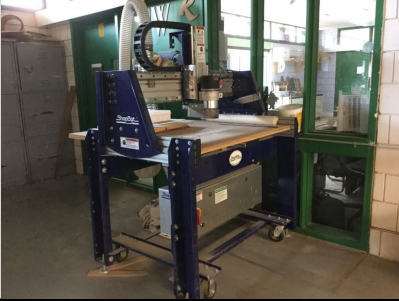
Knee or toe clearance not provided	-	Provide at least 1 work surface with 27" min. knee and toe clearance.	1	525	\$525
275	Automotive Technology Center, Garage Work Benches	1		Dining or Work Surfaces	Work Surface

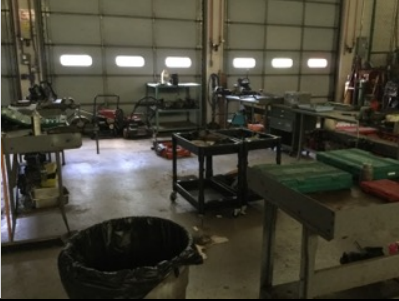
Knee or toe clearance not provided	-	Provide at least 1 work surface with 27" min. knee and toe clearance.	1	525	\$525

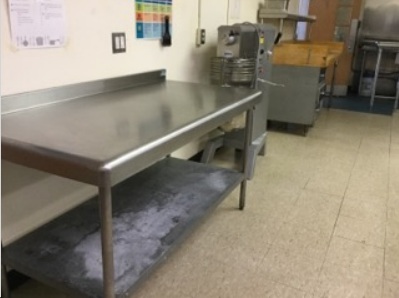
ID	Location	Floor	Room	Element	Type	Photo	Issues	Current Measure	Recommendations	Quantity	Price	Cost Estimation
276	Culinary Arts Class	B	057	Dining or Work Surfaces	Work Surface

Knee or toe clearance not provided	-	Provide at least 1 work surface with 27" min. knee and toe clearance.	1	525	\$525
277	Main Lobby	1		Dining or Work Surfaces	Work Surface

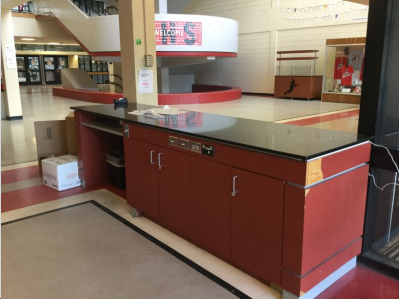
Knee or toe clearance not provided Top of dining/work surface < 28" or > 34"	- 36"	Provide at least 1 work surface with 27" min. knee and toe clearance. Provide at least one dining or work surface with tops between 28"- 34" above the floor and 27" clear height underneath.	1	525	\$525
278	Art Room	1	166	Dining or Work Surfaces	Work Surface

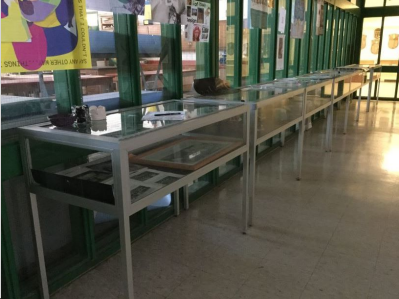
Knee or toe clearance not provided Top of dining/work surface < 28" or > 34"	24" 36"	Provide at least 1 work surface with 27" min. knee and toe clearance. Provide at least one dining or work surface with tops between 28"- 34" above the floor and 27" clear height underneath.	1	525	\$525

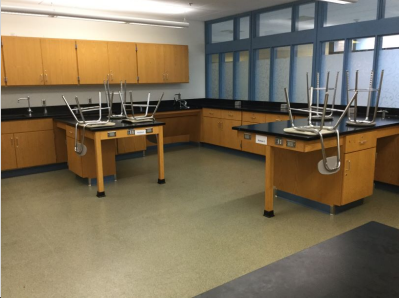
279	Lab Station in Classroom	3	314	Dining or Work Surfaces	Work Surface

Top of dining/work surface < 28" or > 34"	37"	Provide at least one work surface with tops between 28"- 34" above the floor and 27" clear height underneath.	1	525	\$525
280	Science Classroom	2	216	Dining or Work Surfaces	Work Surface

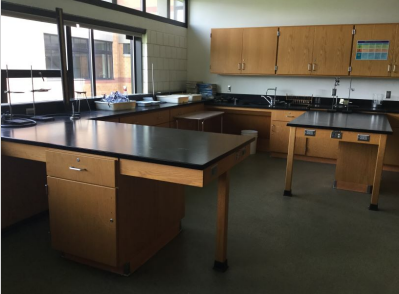
Top of dining/work surface < 28" or > 34"	37"	Provide at least one work surface with tops between 28"- 34" above the floor and 27" clear height underneath.	1	525	\$525

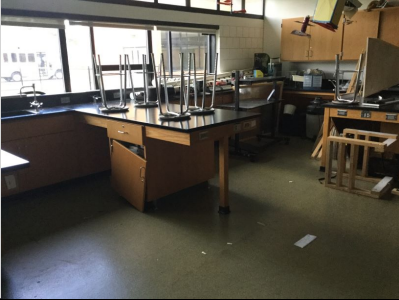
ID	Location	Floor	Room	Element	Type	Photo	Issues	Current Measure	Recommendations	Quantity	Price	Cost Estimation
281	Physics Classroom	1	116	Dining or Work Surfaces	Work Surface

Top of dining/work surface < 28" or > 34"	37"	Provide at least one work surface with tops between 28"- 34" above the floor and 27" clear height underneath.	1	525	\$525
282	Science Prep Room	1	114	Dining or Work Surfaces	Work Surface

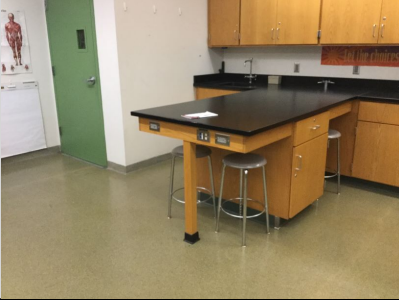
Top of dining/work surface < 28" or > 34"	37"	Provide at least one work surface with tops between 28"- 34" above the floor and 27" clear height underneath.	1	525	\$525
283	Speech	2	256	Dining or Work Surfaces	Work Surface

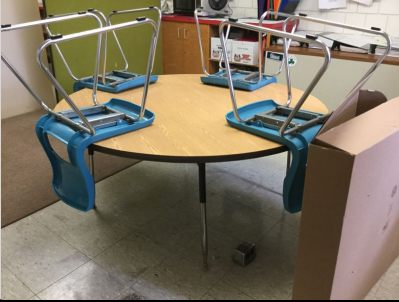
Top of dining/work surface < 28" or > 34"	27"	Provide at least one work surface with top between 28"- 34" above the floor and 27" clear height underneath.	1	525	\$525
284	Music Classroom	2	283	Dining or Work Surfaces	Work Surface

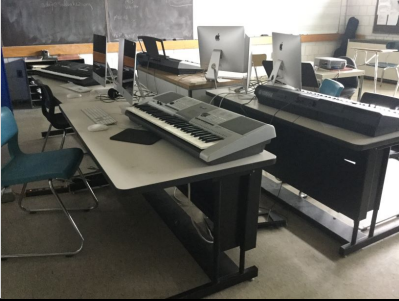
Top of dining/work surface < 28" or > 34" No visible fire alarm provided within room	27"	Provide at least one work surface with tops between 28"- 34" above the floor and 27" clear height underneath. When fire system is updated, ensure that a visible fire alarm is installed in each room.	1	1044	\$1044

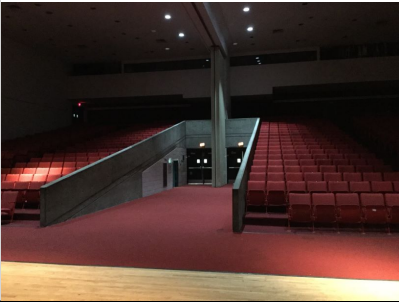
Assembly Area												
285	Auditorium	1	100	Assembly Area	N/A

Number of seats Number of designated wheelchair spaces Companion seat not provided	644 8 -	Provide one companion seat for each wheelchair space. (Reposition accessible seats so all have a companion seat. Four (4) additional companion seats are required.)	4	530	\$2120

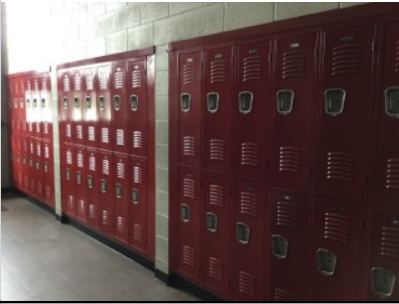
Total # of locker Total # of accessible locker	36 0	Ensure at least one locker is accessible.	1	495	\$495
287	Girls' Locker Room	B		Locker Room	Women's

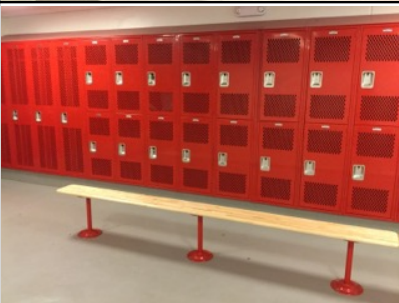
Total # of locker Total # of accessible locker 2% of lockers are not accessible	48 0 -	Ensure 2% of all lockers are accessible .	2	495	\$990
289	Boys' Locker Room	B	074	Locker Room	Men's

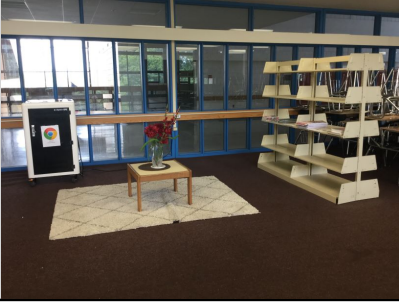
ID	Location	Floor	Room	Element	Type	Photo	Issues	Current Measure	Recommendations	Quantity	Price	Cost Estimation
Libraries												
291	Library	2	255	Libraries	N/A

Card catalogs and magazine displays > 48" high	55"	Locate card catalogs and magazine displays 48" max. above the finished floor.	1	530	\$530
Check-Out Aisles & Retail Areas												
292	School Store	2	251	Check-Out Aisles & Retail Areas	N/A

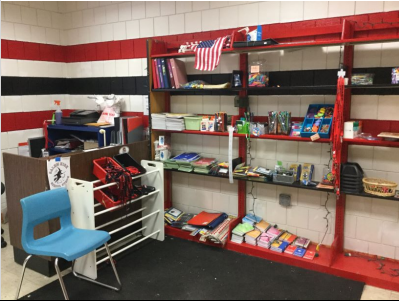
Dispensers or products > 48" high	58.5"	Ensure that dispensing devices are located no higher than 48 inches above finished floor.	1	Labor	\$0
Toilet & Bathing Rooms												
Overall Access												
293	Faculty Lounge	1	185	Overall Access	Toilet Room

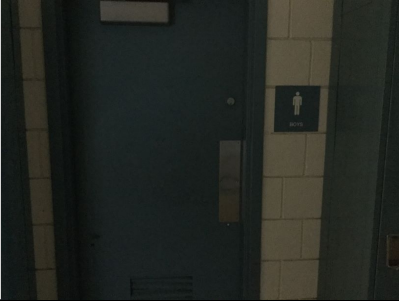
294	Boys' Toilet Room Near Room 359	3		Overall Access	Toilet Room

Sign to accessible toilet not provided	<ul style="list-style-type: none">-	Provide a directional sign indicating the location of the nearest accessible toilet or bathing room.	1	174	\$174

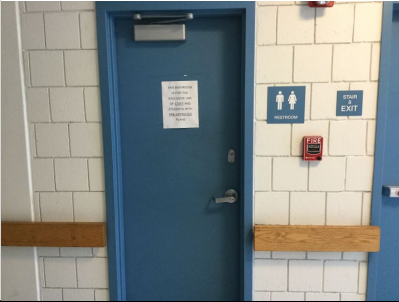
Sign to accessible toilet not provided	-	Provide a directional sign indicating the location of the nearest accessible toilet or bathing room.	1	174	\$174
297	Girls' Toilet Room Near Teacher's Lounge	3		Overall Access	Toilet Room

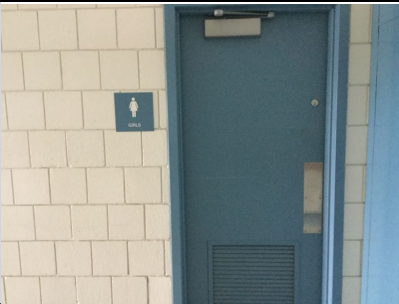
Sign to accessible toilet not provided	-	Provide a directional sign indicating the location of the nearest accessible toilet or bathing room.	1	174	\$174
298	Boys' Toilet Room Near Faculty Lounge	2		Overall Access	Toilet Room

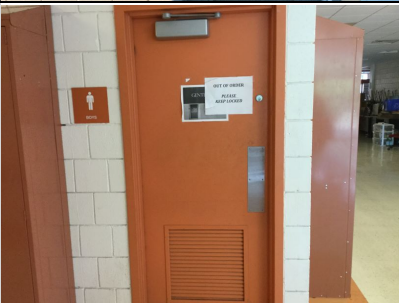
Sign to accessible toilet not provided	-	Provide a directional sign indicating the location of the nearest accessible toilet or bathing room.	1	174	\$174

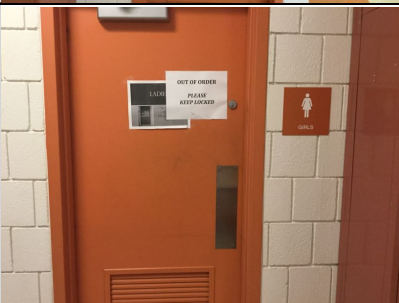
299	Girls' Toilet Room Near Faculty Lounge	2		Overall Access	Toilet Room

Sign to accessible toilet not provided	-	Provide a directional sign indicating the location of the nearest accessible toilet or bathing room.	1	174	\$174

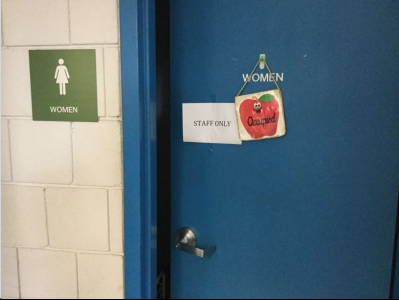
ID	Location	Floor	Room	Element	Type	Photo	Issues	Current Measure	Recommendations	Quantity	Price	Cost Estimation
300	Women's Staff Only Toilet Room	1		Overall Access	Toilet Room

Sign to accessible toilet not provided	-	Provide a directional sign indicating the location of the nearest accessible toilet or bathing room.	1	174	\$174
301	Men's Staff Only Toilet Room	1		Overall Access	Toilet Room

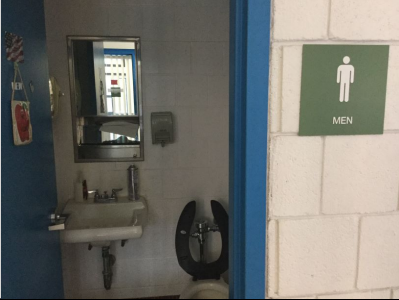
Sign to accessible toilet not provided	-	Provide a directional sign indicating the location of the nearest accessible toilet or bathing room.	1	174	\$174
302	Women's and Men's Staff Only Toilet Room	1		Overall Access	Toilet Room

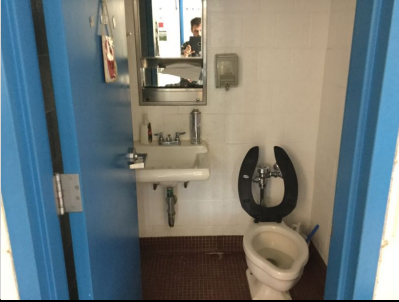
Sign to accessible toilet not provided	-	Provide a directional sign indicating the location of the nearest accessible toilet or bathing room.	1	174	\$174
303	Boys' Toilet Room Near Room 149	1		Overall Access	Toilet Room

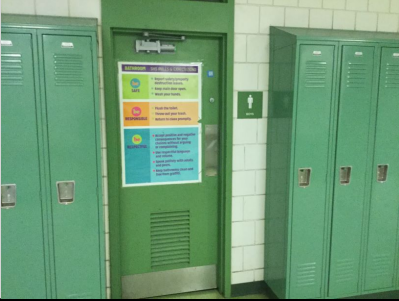
Sign to accessible toilet not provided	-	Provide a directional sign indicating the location of the nearest accessible toilet or bathing room.	1	174	\$174

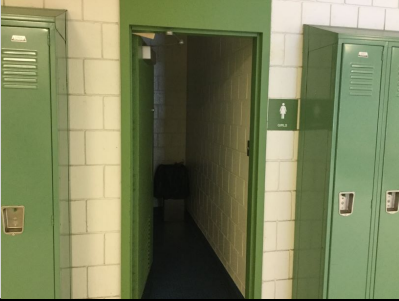
304	Girls' Toilet Room Near Room 149	1		Overall Access	Toilet Room

Sign to accessible toilet not provided	-	Provide a directional sign indicating the location of the nearest accessible toilet or bathing room.	1	174	\$174

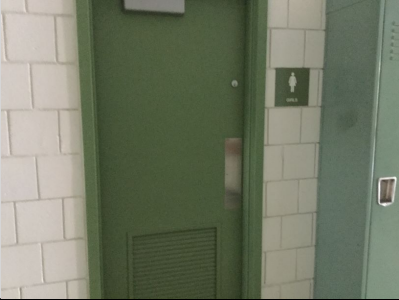
ID	Location	Floor	Room	Element	Type	Photo	Issues	Current Measure	Recommendations	Quantity	Price	Cost Estimation
305	Girls' Toilet Room Near Teen Health Center	1		Overall Access	Toilet Room

Sign to accessible toilet not provided	-	Provide a directional sign indicating the location of the nearest accessible toilet or bathing room.	1	174	\$174
306	Hallway to Music Wing	2	Hall	Overall Access	Toilet Room

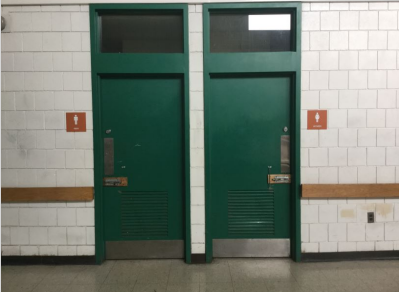
Sign to accessible toilet not provided		Provide a directional sign indicating the location of the nearest accessible toilet or bathing room.	2	174	\$348
307	Girls' Locker Room	B		Overall Access	Toilet Room

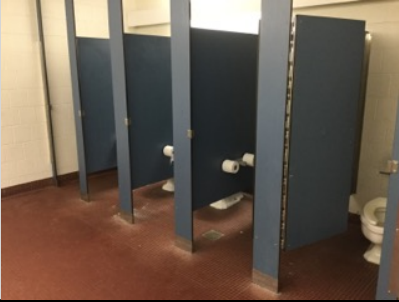
Sign to accessible toilet not provided	-	Provide a directional sign indicating the location of the nearest accessible toilet or bathing room.	1	174	\$174
308	Boys' Locker Room	B	074	Overall Access	Toilet Room

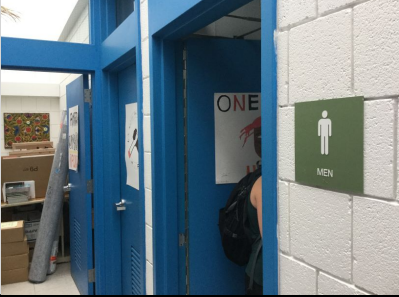
309	Men's and Women's Toilet Room	1	151	Overall Access	Toilet Room

International Symbol of Acc. not provided	-	Provide a sign with the International Symbol of Accessibility.	2	174	\$348

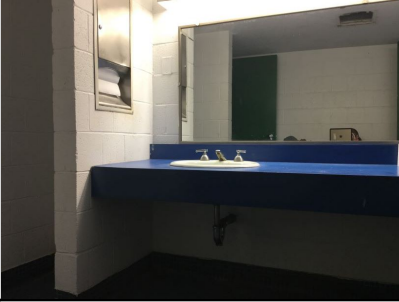
ID	Location	Floor	Room	Element	Type	Photo	Issues	Current Measure	Recommendations	Quantity	Price	Cost Estimation
Lavatory												
310	Boy's Changing Room - Backstage	1	187	Lavatory	N/A

Toe or knee clearances not provided Plumbing underneath is exposed Dispensers not within reach range	23" - 51"	Provide at least one lavatory with knee and toe clearance positioned for a forward approach. Insulate or otherwise configure pipes to prevent contact, for at least one lavatory. Relocate dispenser to 42" max. above the floor.	1	1863	\$1863
311	Girls' Changing Room - Backstage	1	188	Lavatory	N/A

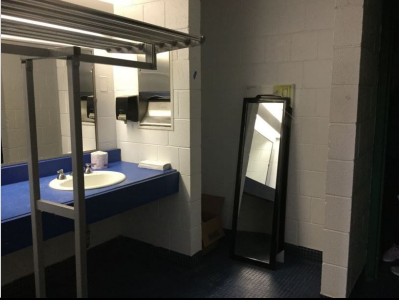
Toe or knee clearances not provided Plumbing underneath is exposed Dispensers not within reach range	23" - 51"	Provide at least one lavatory with knee and toe clearance positioned for a forward approach. Insulate or otherwise configure pipes to prevent contact, for at least one lavatory. Relocate dispenser to 42" max. above the floor.	1	1863	\$1863

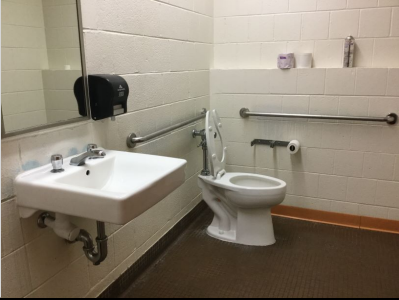
312	Men's Toilet Room	2	Hall C	Lavatory	N/A

Plumbing underneath is exposed	-	Insulate or otherwise configure pipes to prevent contact, for at least one lavatory.	2	69	\$138
313	Automotive Technology Center, Women's Toilet Room	1	104	Lavatory	N/A

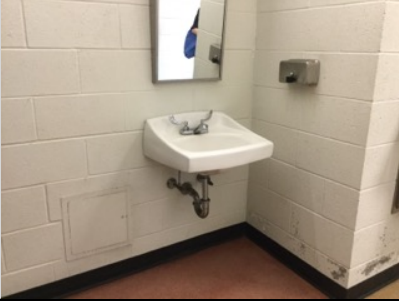
Plumbing underneath is exposed	-	Insulate or otherwise configure pipes to prevent contact, for at least one lavatory.	1	69	\$69
314	Automotive Technology Center, Men's Toilet Room	1	105	Lavatory	N/A

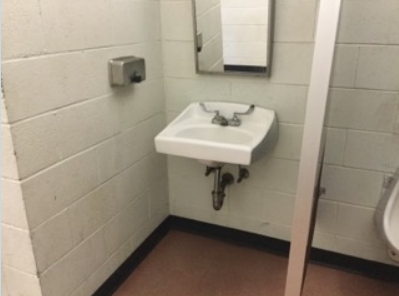
Plumbing underneath is exposed	-	Insulate or otherwise configure pipes to prevent contact, for at least one lavatory.	1	69	\$69

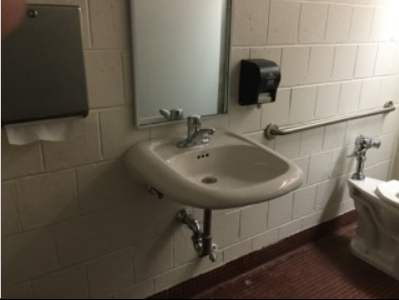
ID	Location	Floor	Room	Element	Type	Photo	Issues	Current Measure	Recommendations	Quantity	Price	Cost Estimation
315	Lobby at Main Entrance, Women's Toilet Room	1		Lavatory	N/A

Plumbing underneath is exposed	-	Insulate or otherwise configure pipes to prevent contact, for at least one lavatory.	1	69	\$69
316	Lobby at Main Entrance, Men's Toilet Room	1		Lavatory	N/A

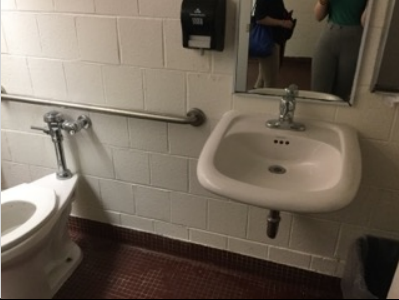
Plumbing underneath is exposed	-	Insulate or otherwise configure pipes to prevent contact, for at least one lavatory.	1	69	\$69
317	Boys' Locker Room	B	074	Lavatory	N/A

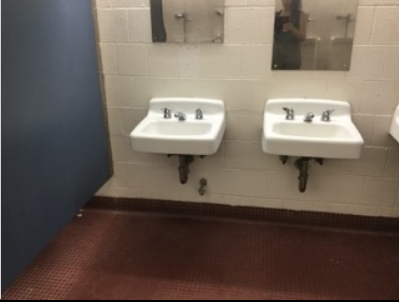
Plumbing underneath is exposed Mirror above lavatory w/reflective surface > 40"	- 42"	Insulate or otherwise configure pipes to prevent contact, for at least one lavatory. Lower mirror so that the bottom surface is at 40" max. above finished floor.	1	261	\$261
318	Gymnasium Area, Women's Public Toilet Room	B		Lavatory	N/A

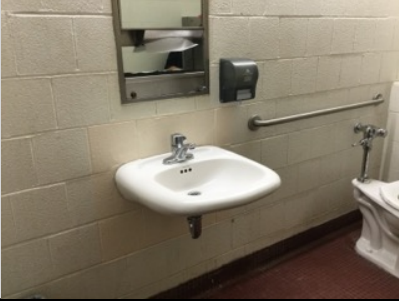
Plumbing underneath is exposed Mirror above lavatory w/reflective surface > 40"	- 54"	Insulate or otherwise configure pipes to prevent contact, for at least one lavatory. Lower mirror so that the bottom surface is at 40" max. above finished floor.	1	261	\$261

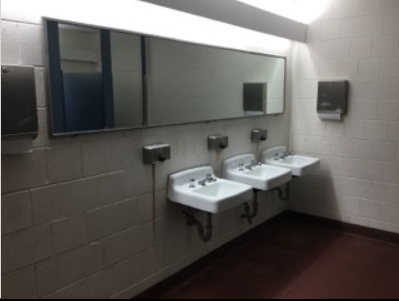
319	Girls' Locker Room	B		Lavatory	N/A

Plumbing underneath is exposed Mirror above lavatory w/reflective surface > 40" Dispensers not within reach range	- 50" 51"	Insulate or otherwise configure pipes to prevent contact, for at least one lavatory. Lower mirror so that the bottom surface is at 40" max. above finished floor. Relocate dispenser to 42" max. above the floor.	1	791	\$791

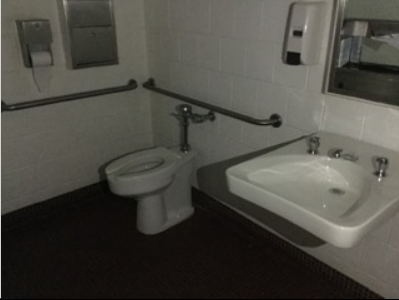
ID	Location	Floor	Room	Element	Type	Photo	Issues	Current Measure	Recommendations	Quantity	Price	Cost Estimation
320	Gymnasium Balcony Area, Women's Toilet Room	1		Lavatory	N/A

Plumbing underneath is exposed Mirror above lavatory w/reflective surface > 40" Dispensers not within reach range	- 54" 51.5"	Insulate or otherwise configure pipes to prevent contact, for at least one lavatory. Lower mirror so that the bottom surface is at 40" max. above finished floor. Relocate dispenser to 42" max. above the floor.	1	791	\$791
321	Gymnasium Balcony Area, Men's Toilet Room	1		Lavatory	N/A

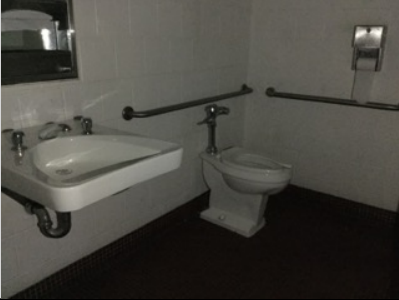
Plumbing underneath is exposed Mirror above lavatory w/reflective surface > 40" Dispensers not within reach range	- 52" 50"	Insulate or otherwise configure pipes to prevent contact, for at least one lavatory. Lower mirror so that the bottom surface is at 40" max. above finished floor. Relocate dispenser to 42" max. above the floor.	1	791	\$791

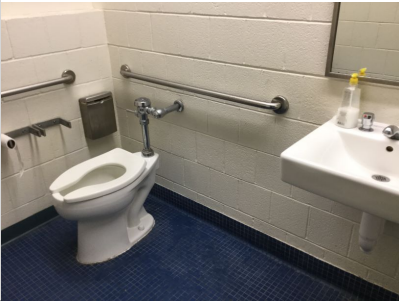
Single-User Toilet												
322	Girls' Accessible Toilet Room Near Room 149	1		Single-User Toilet

Flush control not on open side	-	Relocate the flush control to the open side.	1	281	\$281
323	Girls' Toilet Room Near Room 149	1		Single-User Toilet	N/A

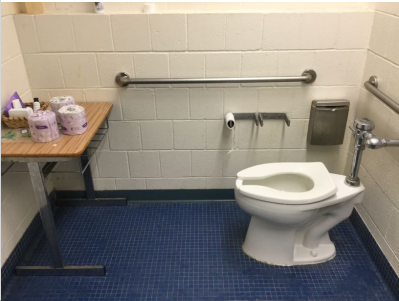
Flush control not on open side Clearance at toilet < 72" clear depth	- -	Relocate the flush control to the open side. Provide a clear floor space that is 72" deep min. by removing table.	1	281	\$281
324	Gymnasium Area, Men's Public Toilet Room	B		Single-User Toilet	N/A

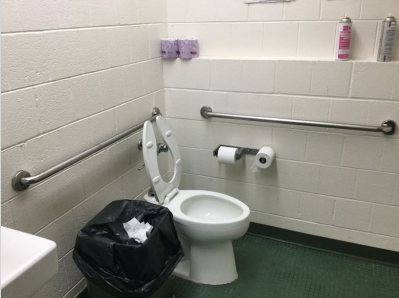
ID	Location	Floor	Room	Element	Type	Photo	Issues	Current Measure	Recommendations	Quantity	Price	Cost Estimation
325	Boys' Accessible Toilet Room Near Room 359	3		Single-User Toilet	N/A

Clearance at toilet < 60" clear width	-	Provide a clear floor space that is 60" wide min. by relocating trash can.	1	Labor	\$0
326	Boys' Accessible Toilet Room Near Room 359	3		Single-User Toilet	N/A

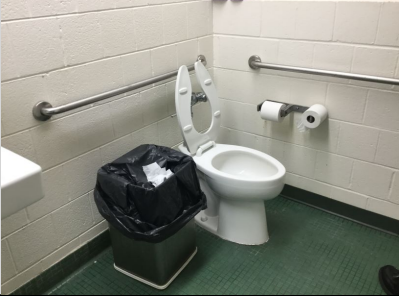
Clearance at toilet < 60" clear width	-	Provide a clear floor space that is 60" wide min. by relocating trash can.	1	Labor	\$0
327	Boys' Accessible Toilet Room Near Teacher's Lounge	3		Single-User Toilet	N/A

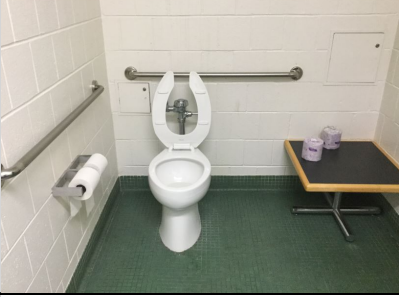
Clearance at toilet < 60" clear width	-	Provide a clear floor space that is 60" wide min. by removing table in the room.	1	Labor	\$0
328	Girls' Accessible Toilet Room Near Teacher's Lounge	3		Single-User Toilet	N/A

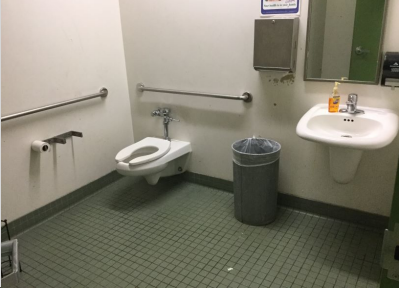
329	Health Suite Toilet Room	1	123	Single-User Toilet	N/A

Clearance at toilet < 60" clear width	-	Provide a clear floor space that is 60" wide min. by relocating trash can.	1	Labor	\$0

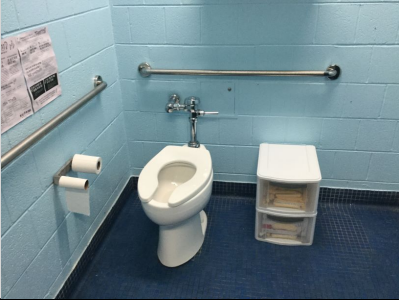
ID	Location	Floor	Room	Element	Type	Photo	Issues	Current Measure	Recommendations	Quantity	Price	Cost Estimation
330	Teen Health Center - Toilet Room	1		Single-User Toilet	N/A

Clearance at toilet < 60" clear width	-	Provide a clear floor space that is 60" wide min. by relocating storage bin.	1	Labor	\$0
331	Girls' Accessible Toilet Room Near Room 359	3		Single-User Toilet	N/A

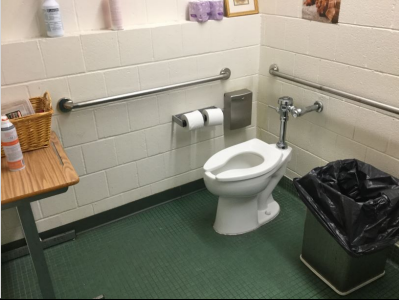
Clearance at toilet < 60" clear width Clearance at toilet < 72" clear depth	- - -	Provide a clear floor space that is 60" wide min. and 72" deep min. by removing desk and relocating trash can.	1	Labor	\$0
332	Gymnasium Area, Women's Public Toilet Room	B		Single-User Toilet	N/A

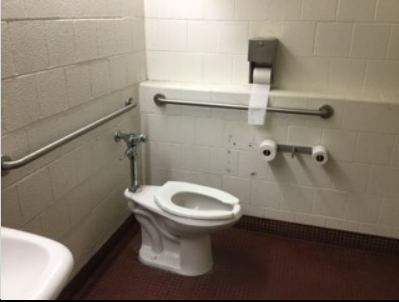
Toilet paper dispenser is not compliant	-	Relocate toilet paper so that it is 15" min. high, located under the grab bar, and between 7" and 9" from the front of the toilet. Replace dispenser if it does not allow continuous paper flow.	1	530	\$530

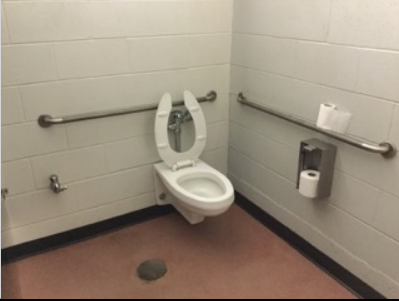
Toilet Compartment												
333	Automotive Technology Center, Men's Toilet Room	1	105	Toilet Compartment	Accessible Compartment

Door has non-compliant hardware Door has malfunctioning self-closing hinge	- -	Ensure locking mechanism is maintained in operable working condition and does not require tight grasping, pinching or twisting of the wrist. Repair hinge.	1	Labor	\$0
334	Gymnasium Balcony Area, Women's Toilet Room	1		Toilet Compartment	Accessible Compartment

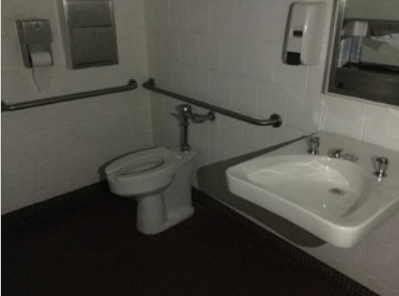
Side grab bar < 42" long Flush control not on open side Non-compliant toilet paper dispenser Centerline < or > 18" (MAAB)	33" - - 23"	Provide a side wall grab bar that is 42" long min. located 12" max. from the rear wall. Provide the flush control on the open side of the toilet (transfer side). Relocate toilet paper so that it is 15" min. high, located under the grab bar, and between 7" and 9" from the front of the toilet. Relocate toilet so the centerline is 18" from the side wall.	1	3617	\$3617
