City of Salem, Massachusetts

PART A – Executive Summary

Part A – Executive Summary

Introduction

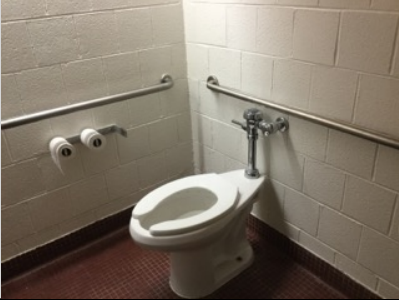
ID	Location	Floor	Room	Element	Type	Photo	Issues	Current Measure	Recommendations	Quantity	Price	Cost Estimation
335	Lobby at Main Entrance, Men's Toilet Room	1		Toilet Compartment	Accessible Compartment

Side grab bar < 42" long Flush control not on open side Centerline < or > 18" (MAAB)	35" - 24"	Provide a side wall grab bar that is 42" long min. located 12" max. from the rear wall. Provide the flush control on the open side of the toilet (transfer side). Relocate toilet so the centerline is 18" from the side wall.	1	2987	\$2987
336	Gymnasium Balcony Area, Men's Toilet Room	1		Toilet Compartment	Accessible Compartment

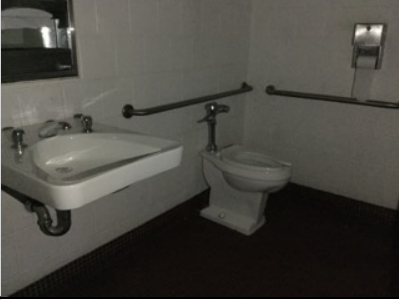
Side grab bar < 42" long Non-compliant toilet paper dispenser Centerline < or > 18" (MAAB)	37" - 24"	Provide a side wall grab bar that is 42" long min. located 12" max. from the rear wall. Relocate toilet paper so that it is 15" min. high, located under the grab bar, and between 7" and 9" from the front of the toilet. Replace dispenser if it does not allow continuous paper flow. Relocate toilet so the centerline is 18" from the side wall.	1	3325	\$3325

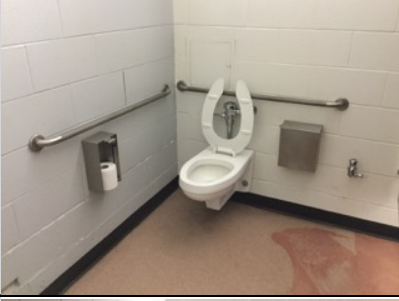
337	Automotive Technology Center, Women's Toilet Room	1	104	Toilet Compartment	Accessible Compartment

Flush control not on open side Coat hook > 48"	- 67"	Provide the flush control on the open side of the toilet (transfer side). Lower coat hook so that it is no higher than 48".	1	305	\$305
338	Lobby at Main Entrance, Women's Toilet Room	1		Toilet Compartment	Accessible Compartment

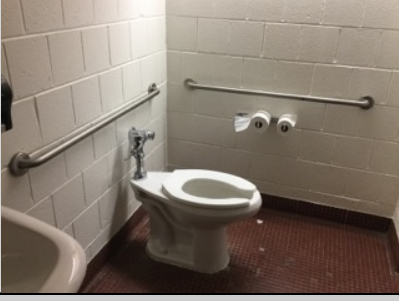
Centerline < or > 18" (MAAB)	24"	Relocate toilet so the centerline is 18" from the side wall.	1	2121	\$2121
Urinal												
339	Boys' Locker Room	B	074	Urinal	N/A

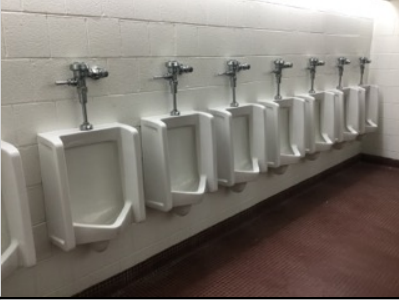
Rim > 15" high (MAAB) Flush control is > 44" high or not properly located	24" 52"	Provide at least one urinal with the rim no higher than 15" above the finished floor. Mount flush control at 44" max. above the finished floor.	1	2717	\$2717

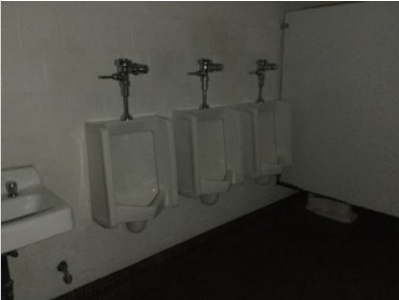
ID	Location	Floor	Room	Element	Type	Photo	Issues	Current Measure	Recommendations	Quantity	Price	Cost Estimation
340	Gymnasium Balcony Area, Men's Toilet Room	1		Urinal	N/A

Rim > 15" high (MAAB) Flush control is > 44" high or not properly located	24" 51"	Provide at least one urinal with the rim no higher than 15" above the finished floor. Mount flush control at 44" max. above the finished floor.	1	2717	\$2717
341	Lobby at Main Entrance, Men's Toilet Room	1		Urinal	N/A

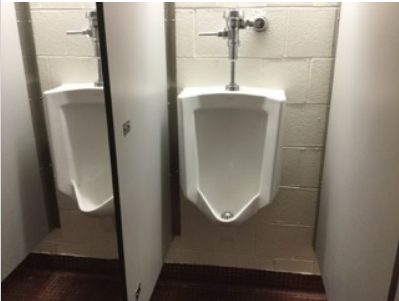
Rim > 15" high (MAAB) Flush control is > 44" high or not properly located Urinal recessed > 24" deep has < 36" clear width	24" 51" 28"	Provide at least one urinal with the rim no higher than 15" above the finished floor. Mount flush control at 44" max. above the finished floor. If urinal is recessed greater than 24" ensure there is a clear width of 36".	1	3190	\$3190
342	Boys' Changing Room - Backstage	1	187	Urinal	N/A

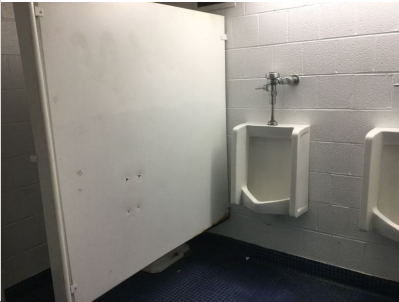
Rim > 15" high (MAAB) Flush control too high or not properly located	- -	Provide at least one urinal with the rim no higher than 15" above the finished floor. Mount flush control at 44" max. above the finished floor.	1	2717	\$2717

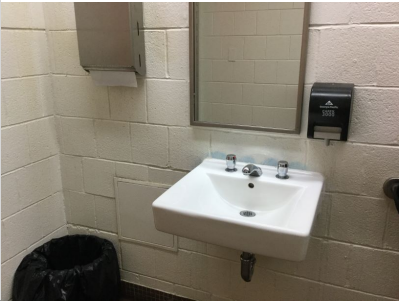
Dispensers												
343	Men's Toilet Room	2	Hall C	Dispensers	Paper Towel Dispenser

Controls > 42" high Clear floor space not provided at accessory	48" -	Relocate so the operable part is 42" max. above the finished floor. Provide a 30" min. by 48" min. clear floor space or relocate dispenser.	2	530	\$1060
Shower Compartment												
344	Girls' Locker Room, Showers	B		Shower Compartment	Transfer Type

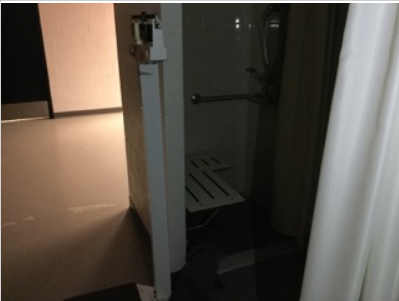
Clear space at transfer shower > 48" x 36"	-	Provide a 48" x 36" clear floor space for a transfer shower by relocating scale.	1	Labor	\$0

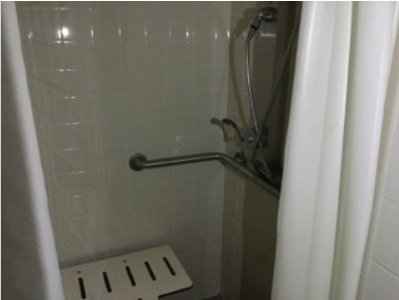
ID	Location	Floor	Room	Element	Type	Photo	Issues	Current Measure	Recommendations	Quantity	Price	Cost Estimation
345	Girls' Locker Room, Showers	B		Shower Compartment	Transfer Type

Seat is not padded (MAAB)	-	Provide a padded shower seat.	1	450	\$450
346	Boys' Locker Room	B	074	Shower Compartment	Transfer Type

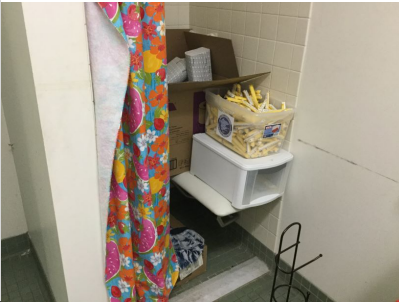
Accessible shower not provided	-	Provide at least one accessible shower.	1	Labor	\$0
Toilet Rooms for Children												
Single-User Toilet												
348	Teen Parent Room/Preschool Toilet Room	1	125	Single-User Toilet	N/A

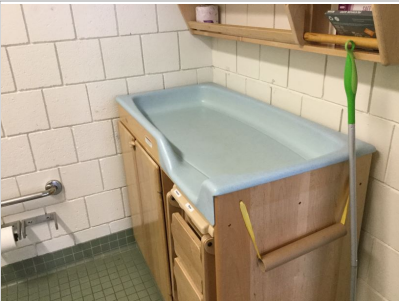
Inadequate maneuvering clearances	-	Provide a clear floor space that is 60" wide min. and 72" deep min. by providing a fold-down baby changing table.	1	Labor	\$0
Lavatory												
349	Teen Parent Room/Preschool Toilet Room	1	125	Lavatory	N/A

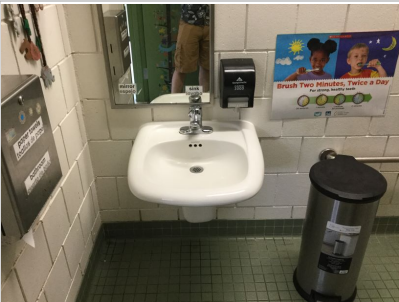
Toe or knee clearances not provided	22"	Provide at least one lavatory with 25" min. knee clearance positioned for a forward approach. Ensure toe clearance is also provided.	1	1265	\$1265

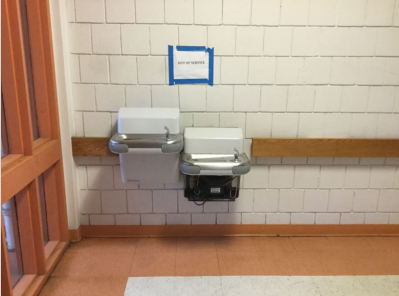
ID	Location	Floor	Room	Element	Type	Photo	Issues	Current Measure	Recommendations	Quantity	Price	Cost Estimation
Additional Access												
Drinking Fountains												
350	Drinking Fountains Near Room 226	2		Drinking Fountains	Hi-Lo

Operable parts malfunctioning	-	Repair or replace drinking fountain to ensure it remains in operable working condition.	1	Labor	\$0
351	Drinking Fountains Near Stairwell 8	1		Drinking Fountains	Hi-Lo

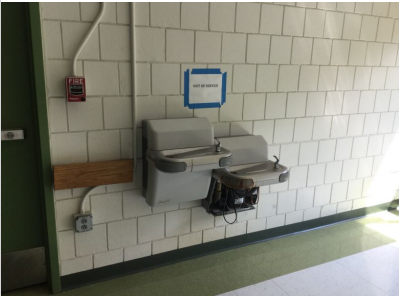
Operable parts malfunctioning	-	Repair or replace drinking fountain to ensure operable parts can be operable with one hand and not require tight grasping, pinching, or twisting of the wrist.	1	Labor	\$0
352	Cafeteria	2		Drinking Fountains	Hi-Lo

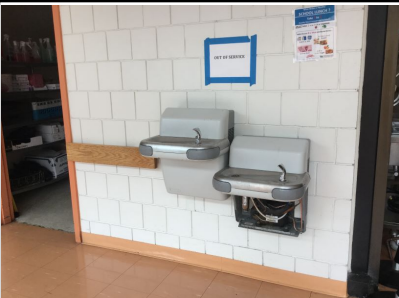
Operable parts malfunctioning	-	Repair or replace drinking fountain to ensure operable parts can be operable with one hand and not require tight grasping, pinching, or twisting of the wrist.	1	Labor	\$0
353	Hall by Stair 3	1	Stair 3	Drinking Fountains	Hi-Lo

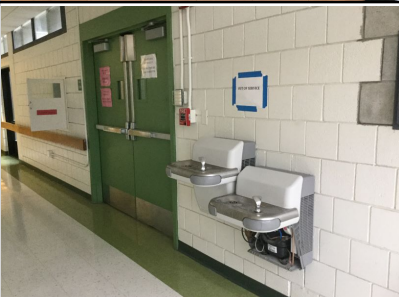
Operable parts malfunctioning	-	Repair or replace drinking fountain to ensure operable parts can be operable with one hand and not require tight grasping, pinching, or twisting of the wrist.	1	Labor	\$0

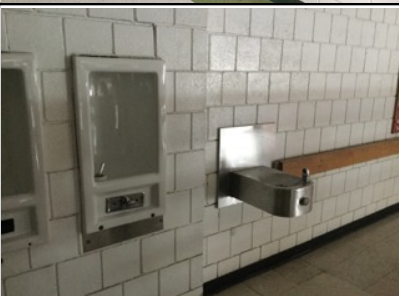
354	Gymnasium Area	B		Drinking Fountains	High

Operable parts malfunctioning	- -	Repair or replace drinking fountain to ensure operable parts can be operable with one hand and not require tight grasping, pinching, or twisting of the wrist.	1	Labor	\$0

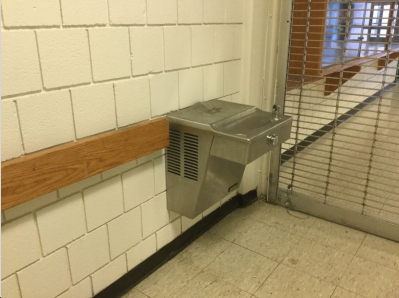
ID	Location	Floor	Room	Element	Type	Photo	Issues	Current Measure	Recommendations	Quantity	Price	Cost Estimation
355	Hall B	1	Hall	Drinking Fountains	Low

Inadequate water flow No drinking fountain provided for standing users Knee or toe clearance not provided	- - 26"	Repair drinking fountain to provide adequate water flow. Provide an additional drinking fountain for standing users or install a Hi-Lo drinking fountain. Provide knee and toe clearance, 27" min. high at drinking fountain for seated users.	1	Labor 3021	\$3021
356	Automotive Technology Center	1		Drinking Fountains	Low

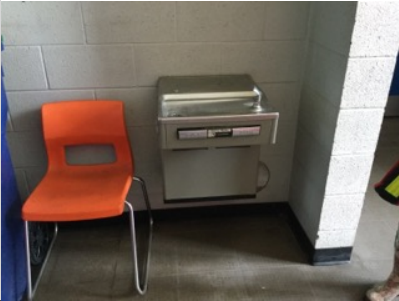
No drinking fountain provided for standing users	-	Provide an additional drinking fountain for standing users.	1	3021	\$3021
357	Girls' Locker Room	B		Drinking Fountains	Low

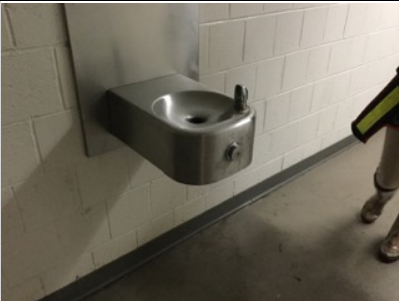
No drinking fountain provided for standing users Seated height fountain does not have cane protection	- -	Provide an additional drinking fountain for standing users. Provide a cane-detectable barrier skirt under the high unit.	1	3689	\$3689

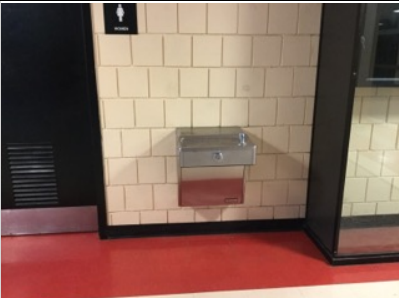
359	Lobby at Main Entrance, Near Toilet Rooms	1		Drinking Fountains	Low

No drinking fountain provided for standing users Knee or toe clearance not provided	- 26"	Install a Hi-Lo drinking fountain.	1	3162	\$3162

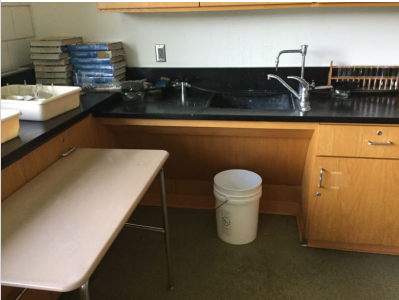
ID	Location	Floor	Room	Element	Type	Photo	Issues	Current Measure	Recommendations	Quantity	Price	Cost Estimation
Sink												
360	Science Classroom	2	216	Sink	Classroom

Clear floor space not provided at sink	-	Provide a 30" by 48" clear floor space positioned for a forward approach by removing table and can.	1	Labor	\$0
361	Science Classroom	2	216	Sink	Classroom

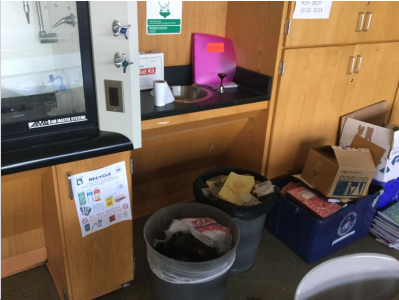
Clear floor space not provided at sink	-	Provide a 30" by 48" clear floor space positioned for a forward approach by removing clutter.	1	Labor	\$0
362	Physics Classroom	1	116	Sink	Classroom

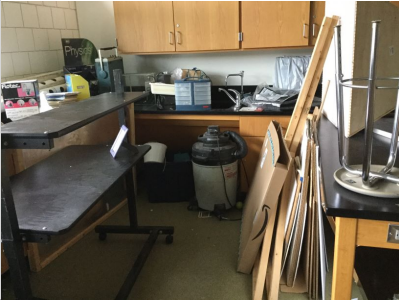
Clear floor space not provided at sink	- -	Provide a 30" by 48" clear floor space positioned for a forward approach by removing clutter.	1	Labor	\$0
363	Physics Classroom	1	116	Sink	Classroom

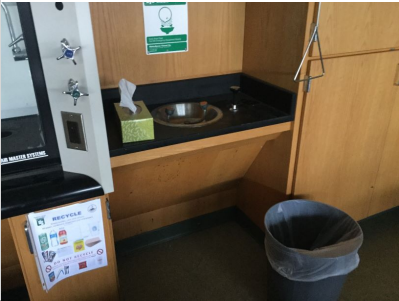
Clear floor space not provided at sink	-	Provide a 30" by 48" clear floor space positioned for a forward approach by removing trash can.	1	Labor	\$0

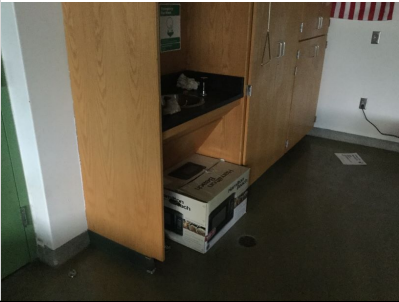
364	Science Classroom	1	112	Sink	Classroom

Toe and knee clearances not provided	-	Ensure there is a 27" knee clearance positioned for a forward approach by removing clutter.	1	Labor	\$0

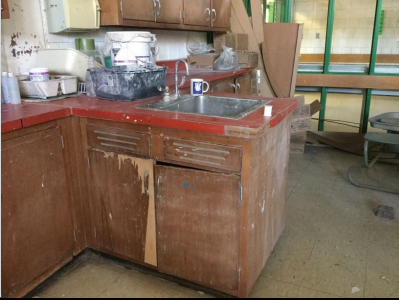
ID	Location	Floor	Room	Element	Type	Photo	Issues	Current Measure	Recommendations	Quantity	Price	Cost Estimation
365	Art Room	1	166	Sink	Classroom

Toe and knee clearances not provided	-	Ensure there is a 27" knee clearance positioned for a forward approach.	1	1265	\$1265
366	Culinary Arts Class	B	057	Sink	Classroom

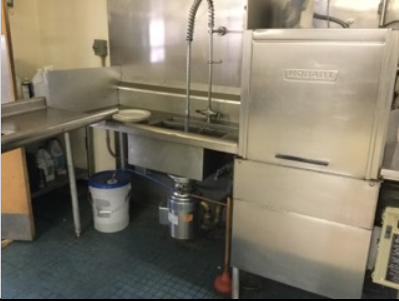
Toe and knee clearances not provided	-	Ensure there is a 27" knee clearance positioned for a forward approach.	1	1265	\$1265
367	Culinary Arts Class	B	057	Sink	Classroom

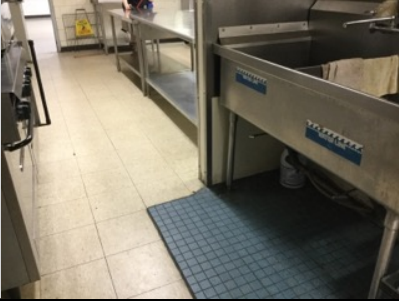
Toe and knee clearances not provided	-	Ensure there is a 27" knee clearance positioned for a forward approach.	1	1265	\$1265
368	Black Cat Cafe, Staff Sink	B		Sink	Other

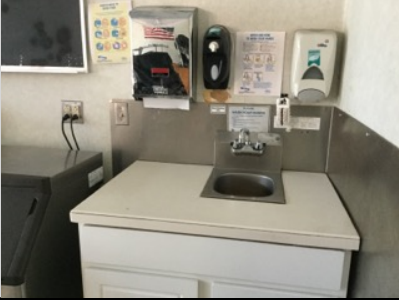
Toe and knee clearances not provided Dispenser not within reach range	- 58"	Ensure there is a 27" knee clearance positioned for a forward approach. Relocate dispenser 48" max. above the finished floor or ground.	1	1795	\$1795

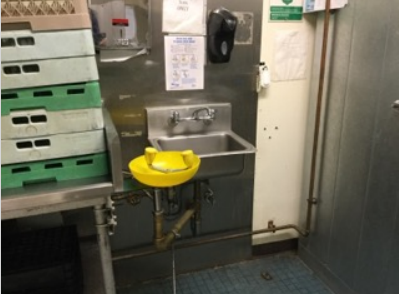
369	Culinary Arts Class	B	057	Sink	Classroom

Exposed plumbing underneath sink Dispenser not within reach range	- 59"	Insulate or otherwise configure pipes at sink. Relocate dispenser 48" max. above the finished floor or ground.	1	599	\$599

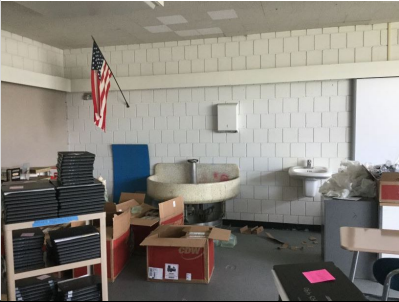
ID	Location	Floor	Room	Element	Type	Photo	Issues	Current Measure	Recommendations	Quantity	Price	Cost Estimation
370	Classroom	1	184	Sink	Classroom

Dispenser not within reach range	-	Relocate dispenser 48" max. above the finished floor or ground.	1	530	\$530
371	Wood Shop	1	174	Sink	Classroom

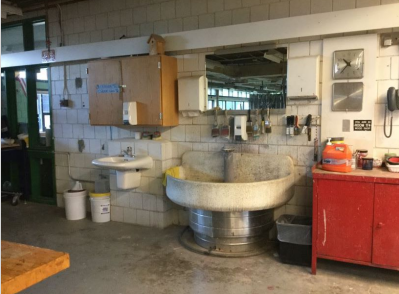
Dispenser not within reach range	53.5"	Relocate dispenser 48" max. above the finished floor or ground.	1	530	\$530
Storage												
372	ROTC - Supply and Uniform Room	1	137A	Storage	N/A

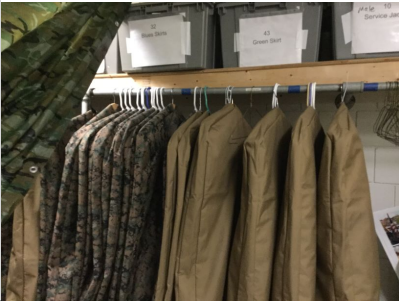
Storage operable parts > 48" high	72"	Lower storage so that operable parts are 48" max. above finished floor.	1	530	\$530
Fire Alarms												
373	Band Room	2	266	Fire Alarms	Classroom

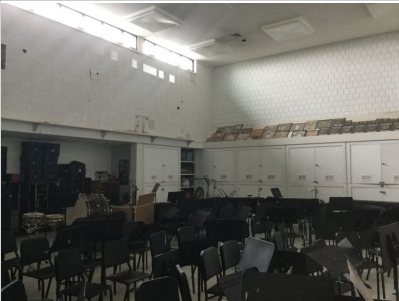
No visible fire alarm provided within room	-	When fire system is updated, ensure that a visible fire alarm is installed in each room.	1	519	\$519
374	Culinary Arts/Medical Assistance Classroom	2	270	Fire Alarms	Classroom

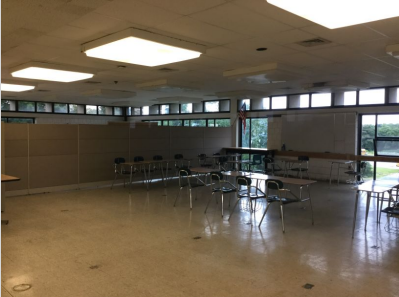
No visible fire alarm provided within room	-	When fire system is updated, ensure that a visible fire alarm is installed in each room.	1	519	\$519

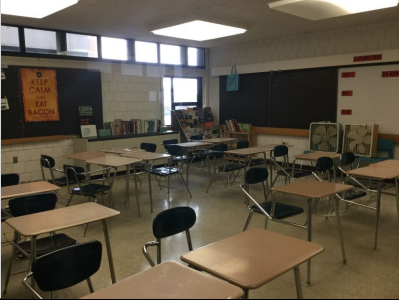
ID	Location	Floor	Room	Element	Type	Photo	Issues	Current Measure	Recommendations	Quantity	Price	Cost Estimation
375	Culinary Arts Classroom	2	280	Fire Alarms	Classroom

No visible fire alarm provided within room	-	When fire system is updated, ensure that a visible fire alarm is installed in each room.	1	519	\$519
376	Orchestra	2	282	Fire Alarms	Classroom

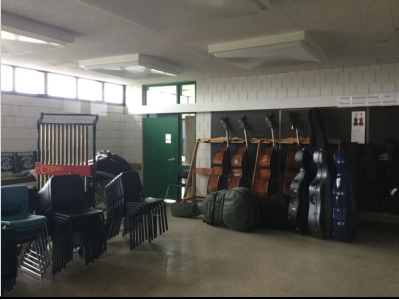
No visible fire alarm provided within room		When fire system is updated, ensure that a visible fire alarm is installed in each room.	1	519	\$519
377	Office	2	281	Fire Alarms	Office

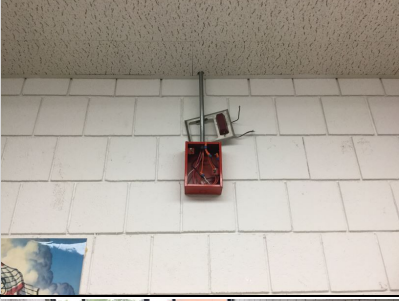
No visible fire alarm provided within room	-	When fire system is updated, ensure that a visible fire alarm is installed in each room.	1	519	\$519
378	Stair 16	2	Stair 16	Fire Alarms	Stair

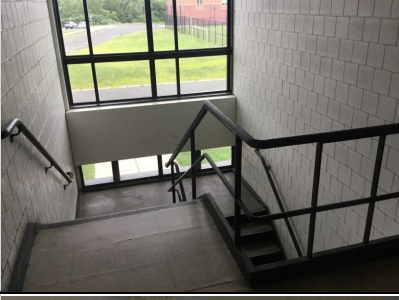
No visible fire alarm provided within room	-	When fire system is updated, ensure that a visible fire alarm is installed in each room.	1	519	\$519
379	Choir Room	2	285	Fire Alarms	Classroom

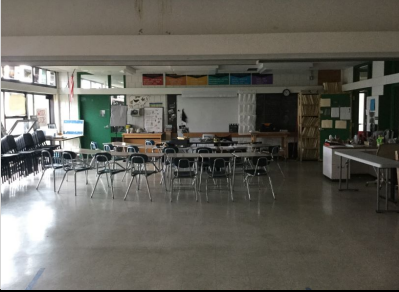
No visible fire alarm provided within room	-	When fire system is updated, ensure that a visible fire alarm is installed in each room.	1	519	\$519

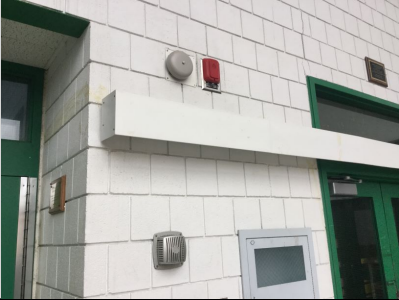
ID	Location	Floor	Room	Element	Type	Photo	Issues	Current Measure	Recommendations	Quantity	Price	Cost Estimation
380	Hall by Band Room	2	266	Fire Alarms	Other

No visible fire alarm provided within room	-	When fire system is updated, ensure that a visible fire alarm is installed in each room.	1	519	\$519
381	Speech	2	256	Fire Alarms	Classroom

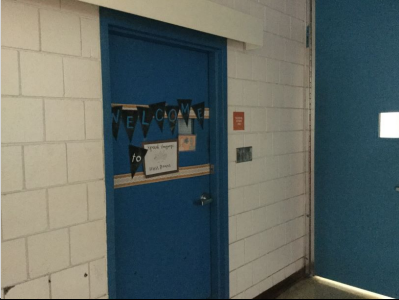
No visible fire alarm provided within room	-	When fire system is updated, ensure that a visible fire alarm is installed in each room.	1	519	\$519
382	Office	2	250B	Fire Alarms	Office

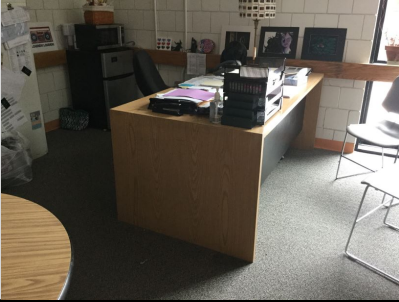
No visible fire alarm provided within room	-	When fire system is updated, ensure that a visible fire alarm is installed in each room.	1	519	\$519
383	Office	2	249C	Fire Alarms	Office

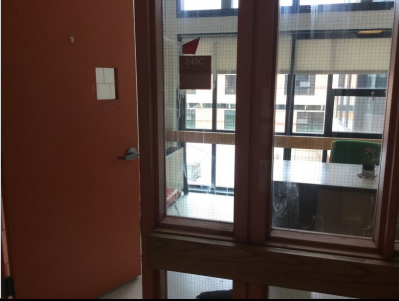
No visible fire alarm provided within room	-	When fire system is updated, ensure that a visible fire alarm is installed in each room.	1	519	\$519
384	Office	2	249E	Fire Alarms	Office

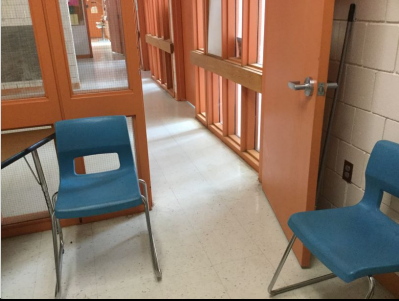
No visible fire alarm provided within room	-	When fire system is updated, ensure that a visible fire alarm is installed in each room.	1	519	\$519

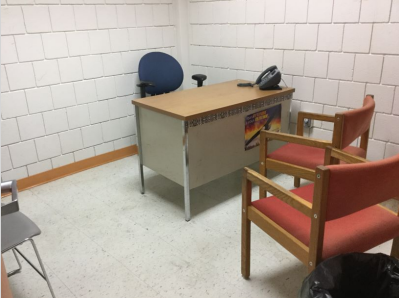
ID	Location	Floor	Room	Element	Type	Photo	Issues	Current Measure	Recommendations	Quantity	Price	Cost Estimation
385	Office	2	249F	Fire Alarms	Office

No visible fire alarm provided within room	-	When fire system is updated, ensure that a visible fire alarm is installed in each room.	1	519	\$519
386	Office	2	249A	Fire Alarms	Office

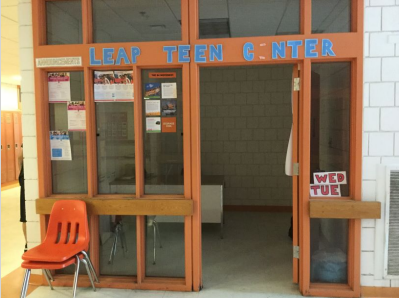
No visible fire alarm provided within room	-	When fire system is updated, ensure that a visible fire alarm is installed in each room.	1	519	\$519
387	Art Room	1	166	Fire Alarms	Classroom

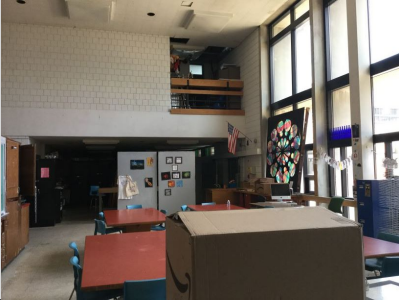
No visible fire alarm provided within room	-	When fire system is updated, ensure that a visible fire alarm is installed in each room.	1	519	\$519
388	Classroom	1	184	Fire Alarms	Classroom

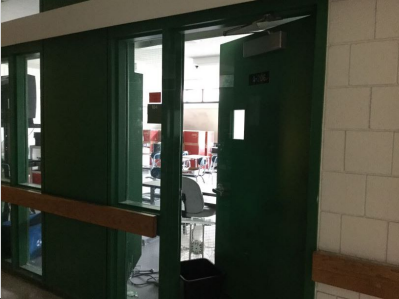
No visible fire alarm provided within room	-	When fire system is updated, ensure that a visible fire alarm is installed in each room.	1	519	\$519
389	Wood Shop Classroom	1	171	Fire Alarms	Classroom

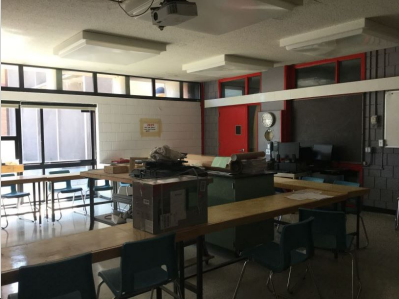
No visible fire alarm provided within room	-	When fire system is updated, ensure that a visible fire alarm is installed in each room.	1	519	\$519

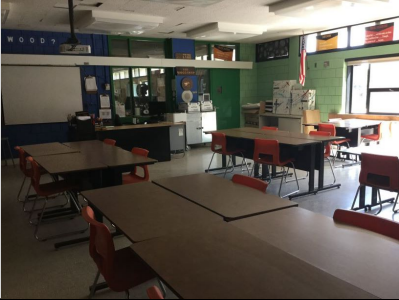
ID	Location	Floor	Room	Element	Type	Photo	Issues	Current Measure	Recommendations	Quantity	Price	Cost Estimation
390	Wood Shop Classroom	1	172	Fire Alarms	Classroom

No visible fire alarm provided within room	-	When fire system is updated, ensure that a visible fire alarm is installed in each room.	1	519	\$519
391	District ELL	1	151	Fire Alarms	Office

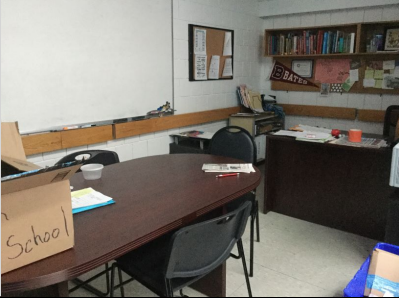
No visible fire alarm provided within room	-	When fire system is updated, ensure that a visible fire alarm is installed in each room.	1	519	\$519
392	Fitness Center	B	062	Fire Alarms	N/A

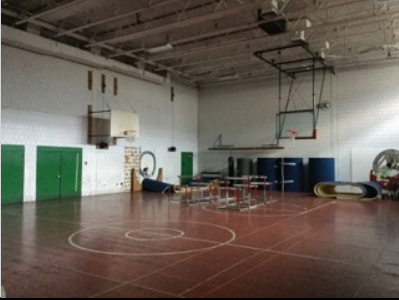
No visible fire alarm provided within room	-	When fire system is updated, ensure that a visible fire alarm is installed in each room.	1	519	\$519
Play and Sport Areas												
Play Areas												
393	Playground Near Exit #44	Ext.		Play Areas	N/A

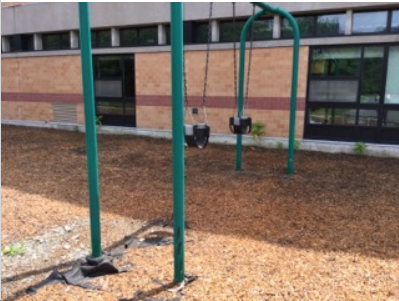
Accessible route not provided to ground level play components	-	Ensure an accessible route is provided to one of each type of ground level play components (Cost based on 215' by 4' wide asphalt route around playground and a 30' long by 5' wide poured in place rubber route to swings.)	1	8633	\$8633

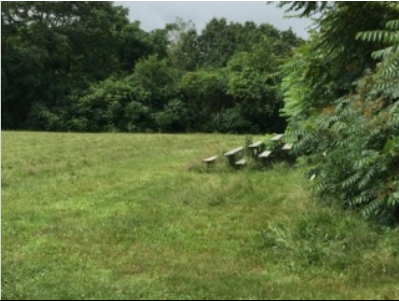
Field												
394	Soccer Field	Ext.		Field	Soccer

Accessible spaces not provided at sidelines seating	-	Provide a 36" x 48" clear floor space at sidelines seating. Ensure bleachers are connected to an accessible route. (Cost based on 100' by 4' wide asphalt route to bleachers an clear floor spaces on each side.)	1	2556	\$2556

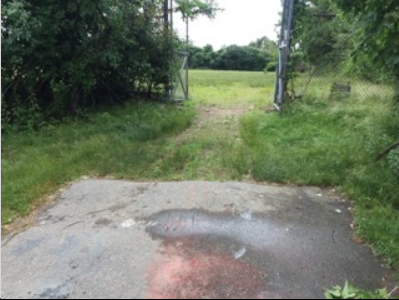
ID	Location	Floor	Room	Element	Type	Photo	Issues	Current Measure	Recommendations	Quantity	Price	Cost Estimation
395	Field Across Doors From Gymnasium	Ext.		Field	Soccer

Field not connected to an accessible route	-	Ensure edge of field is connected to an accessible route. (Cost based on 15' by 4' wide asphalt route to edge of field.)	1	383	\$383
396	Soccer Field	Ext.		Field	Soccer

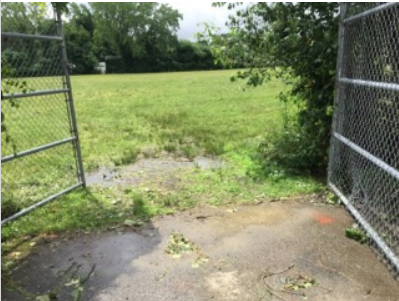
Field not maintained in operable working condition	-	Ensure soccer field is maintained in operable working condition.	1	Labor	\$0
397	Field Across Exits From Gymnasium	Ext.		Field	N/A

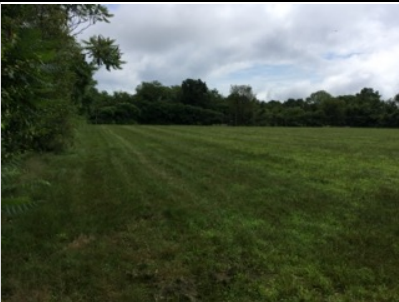
Field not maintained in operable working condition	-	Ensure field is maintained in operable working condition.	1	Labor	\$0
Court												
398	Gymnasium Area, Bleachers	B		Court	Basketball

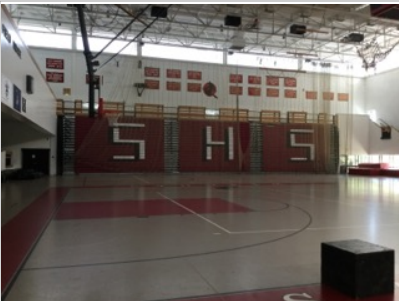
Accessible spaces are not provided at sidelines seating	-	Provide a 36" x 48" clear floor space at sidelines seating.	1	Labor	\$0

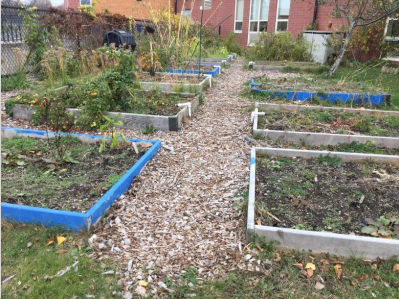
ID	Location	Floor	Room	Element	Type	Photo	Issues	Current Measure	Recommendations	Quantity	Price	Cost Estimation
Approach and Entrance												
Exterior Access Route												
1	Community Garden Southeast Side	Ext		Exterior Access Route	Exterior

Exterior route < 36" wide Surface is not stable, firm, and slip-resistant	29.75" -	Ensure that a clear width of 36" min. is maintained at the accessible route. Repair surface. (Cost based on 50' by 4' wide stone dust path in garden area.)	1	1200	\$1200
2	Ramp to Main Entrance	Ext		Exterior Access Route	Exterior

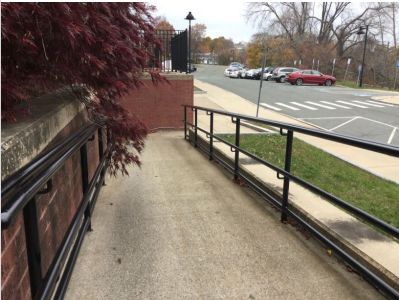
Obstructed by protruding objects	-	Trim low hanging branches in trees.	1	Labor	\$0
3	Benches Near Community Garden	Ext		Exterior Access Route	Exterior

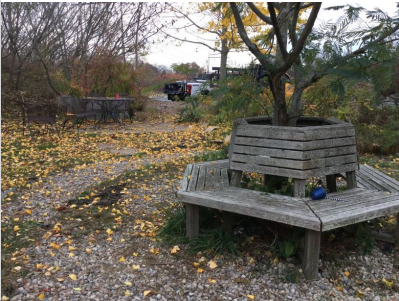
Accessible route not provided	-	Ensure an accessible route is provided. See ID #4 cost.	1	-	\$0
4	Route to Community Garden	Ext		Exterior Access Route	Exterior

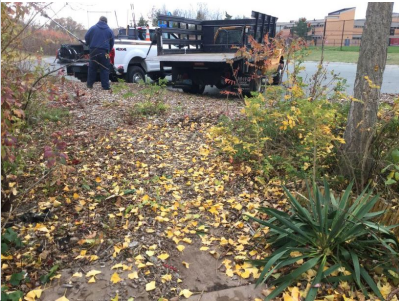
Accessible route not provided	-	Ensure an accessible route is provided. (Cost based on 120' by 4' wide stone dust path to bench, picnic area, and garden.)	1	2880	\$2880

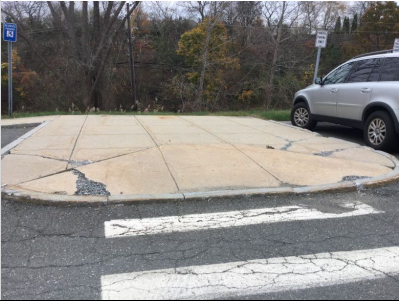
Curb Ramp												
5	Accessible Route to Main Entrance From Parking Lot	Ext		Curb Ramp	N/A

Transition from curb ramp to street not flush Surface not stable, firm and slip-resistant	1" -	Ensure transition from curb ramp to street is flush. Repair surface.	1	155	\$155

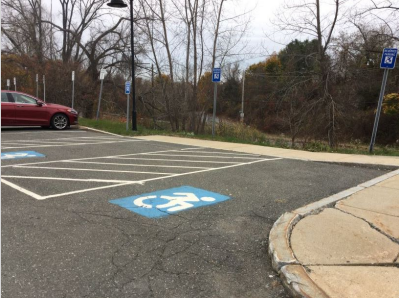
ID	Location	Floor	Room	Element	Type	Photo	Issues	Current Measure	Recommendations	Quantity	Price	Cost Estimation
Off-Street Parking Lot or Garage												
6	Parking Lot	Ext		Off-Street Parking Lot or Garage	N/A

Total # of parking Total # of designated accessible parking spaces Sign does not have the designation "Van Accessible"	79 3 -	Provide One additional car parking space. Add the designation "Van Accessible" to the sign located at the van accessible space.	1	925	\$925
Entrance												
7	Robert J. Geswell Athletic Field	Ext		Entrance	Gate

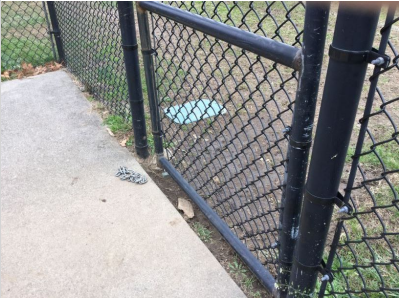
Level changes > 1/4"	3"	Alter change in level to be 1/4" high max.	1	155	\$155
8	Playground Near Kindergarten Wing	Ext		Entrance	Gate

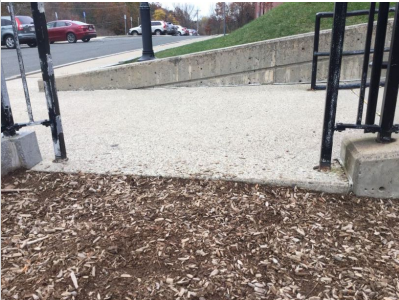
Level changes > 1/4"	1"	Alter change in level to be 1/4" high max.	1	155	\$155
Ramps												
9	Ramp to Main Entrance	Ext		Ramps	Exterior

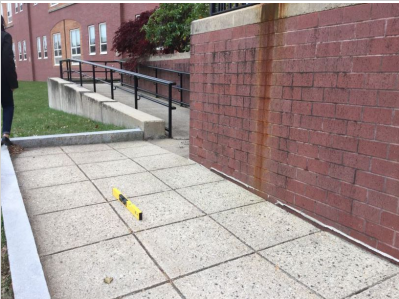
-	Provide handrails with 1 1/4"- 2" circular cross sections or 4"- 6 1/4" non-circular cross sections. Mount handrails between 34"- 38" high above the floor. Provide a lower handrail between 18" to 20" high. (Cost based on two sets of 10' long metal railings.)	4	555	\$2220

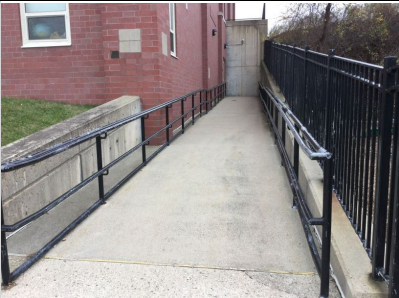
10	Ramp at Exit #10, Near Kindergarten Wing	Ext		Ramps	Exterior

Handrails do not extend 12" past top & bottom	-	Alter handrails to extend horizontally above the landing for 12" min. beyond the top and bottom of ramp runs.	2	600	\$1200

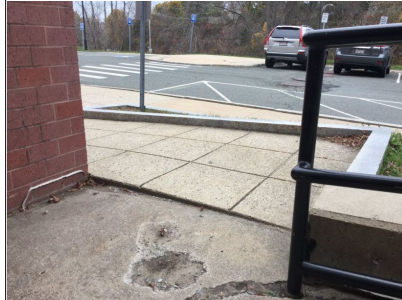
ID	Location	Floor	Room	Element	Type	Photo	Issues	Current Measure	Recommendations	Quantity	Price	Cost Estimation	
11	Ramp to Main Entrance	Ext		Ramps	Exterior

Level changes > 1/4"	-	Alter change in level to be 1/4" high max.	1	155	\$155	
Access to Goods and Services													
Means of Egress													
12	Exit #10, Near Room 172	1		Means of Egress	N/A

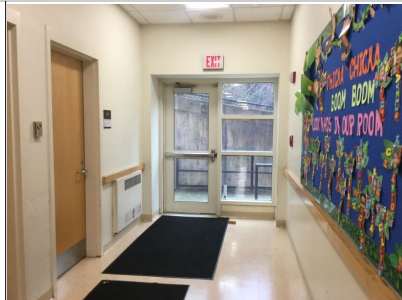
Illuminated sign lacks the International Symbol of Accessibility Tactile exit sign not provided Mat not securely attached	<ul style="list-style-type: none">---	Ensure the illuminated exit sign contains the International Symbol of Accessibility (ISA). Ensure a tactile exit sign with raised characters and braille is provided at exit door. Mount sign between 48"- 60" above finished floor located on the wall adjacent to the latch side of the door. Securely attach mat.	1	274	\$274	
13	Main Entrance, Exit #1	1		Means of Egress	N/A

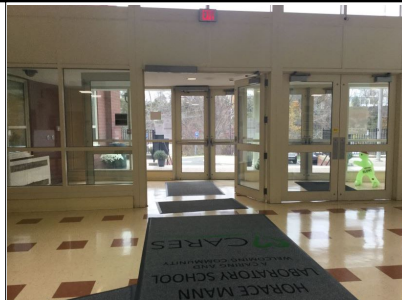
Illuminated sign lacks the International Symbol of Accessibility Tactile exit sign not provided Mat not securely attached	<ul style="list-style-type: none">---	Ensure illuminated exit sign contains the International Symbol of Accessibility (ISA). Ensure tactile exit sign with raised characters and braille is provided at exit door. Mount signs between 48"- 60" above finished floor located on the wall adjacent to the latch side of the door. Securely attach mat.	1	274

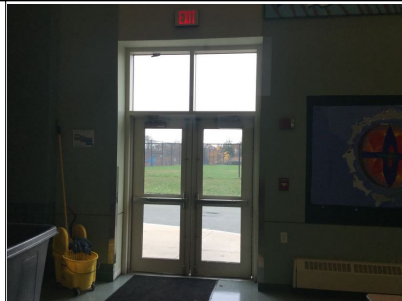
14	Exit #5, From Cafeteria	2	241	Means of Egress	N/A

Illuminated sign lacks the International Symbol of Accessibility Tactile exit sign not provided Mat not securely attached	<ul style="list-style-type: none">---	Ensure illuminated exit sign contains the International Symbol of Accessibility (ISA). Ensure a tactile exit sign with raised characters and braille is provided at exit door. Mount signs between 48"- 60" above finished floor located on the wall adjacent to the latch side of the door. Securely attach mat.	1	274	\$274	
15	Exit #6, Near Cafeteria	2		Means of Egress	N/A

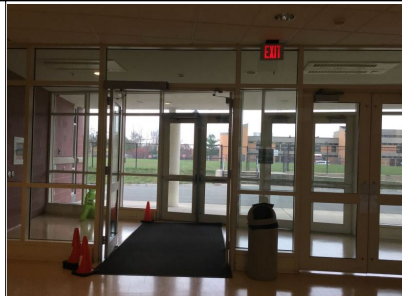
Illuminated sign lacks the International Symbol of Accessibility Tactile exit sign not provided	<ul style="list-style-type: none">---	Ensure illuminated exit sign contains the International Symbol of Accessibility (ISA). Ensure a tactile exit sign with raised characters and braille is provided at exit door. Mount sign between 48"- 60" above finished floor located on the wall adjacent to the latch side of the door.	1	274		\$274

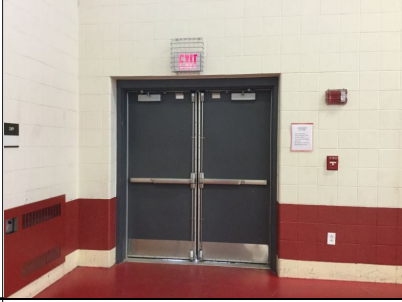
Illuminated sign lacks the International Symbol of Accessibility Tactile exit sign not provided	- -	Ensure illuminated exit sign contains the International Symbol of Accessibility (ISA). Ensure tactile exit sign with raised characters and braille is provided at exit door. Mount sign between 48"- 60" above finished floor located on the wall adjacent to the latch side of the door.	1	274	\$274
17	Exit #7, in Gym	2	261	Means of Egress	N/A

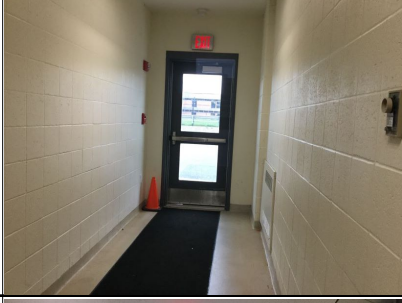
Illuminated sign lacks the International Symbol of Accessibility Tactile exit sign not provided Mat not securely attached	- - -	Ensure illuminated exit sign contains the International Symbol of Accessibility (ISA). Ensure tactile exit sign with raised characters and braille is provided at exit door. Mount sign between 48"- 60" above finished floor located on the wall adjacent to the latch side of the door. Securely attach mat.	1	274	\$274

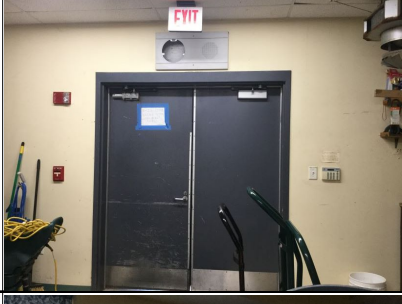
18	Exit #4, Near Cafeteria	2		Means of Egress	N/A

Illuminated sign lacks the International Symbol of Accessibility Tactile exit sign not provided	- -	Ensure illuminated exit sign contains the International Symbol of Accessibility (ISA). Ensure tactile exit sign with raised characters and braille is provided at exit door. Mount sign between 48"- 60" above finished floor located on the wall adjacent to the latch side of the door.	1	274	\$274
19	Exit #3, in Chorus Room	2	207	Means of Egress	N/A

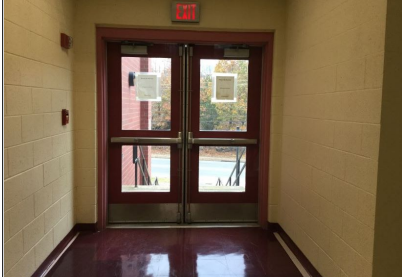
20	Exit #2, Near Pathways Hallway	1		Means of Egress	N/A

Tactile exit sign not provided	- -	Ensure tactile exit sign with raised characters and braille is provided at exit door. Mount sign between 48"- 60" above finished floor located on the wall adjacent to the latch side of the door. Provide a directional sign to the nearest accessible exit.	1	174	\$174

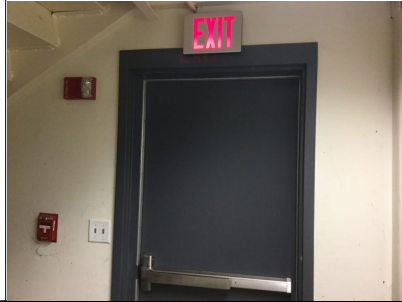
Tactile exit sign not provided	-	Ensure tactile exit sign with raised characters and braille is provided at exit door. Mount sign between 48"- 60" above finished floor located on the wall adjacent to the latch side of the door.	1	174	\$174
Interior Access Route												
22	Speech, Language Pathologist	3	361	Interior Access Route	N/A

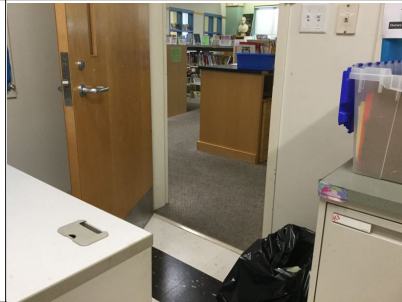
Route < 36" wide	19.5"	Ensure that a clear width of 36" min. is maintained at the accessible route.	1	Labor	\$0
23	Grade 5 ELA/Social Studies Classroom	3	308	Interior Access Route	N/A

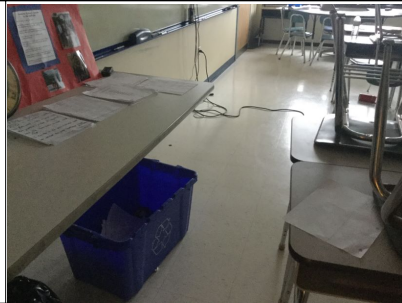
Route < 36" wide	20.25"	Ensure that a clear width of 36" min. is maintained at the accessible route.	1	Labor	
24	Route to Greenhouse	3		Interior Access Route	N/A

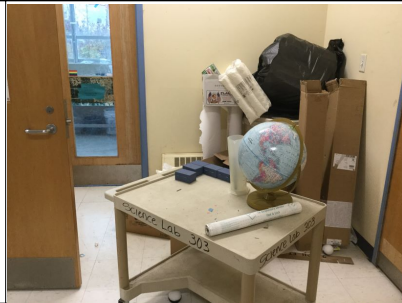
Route < 36" wide	-	Ensure that a clear width of 36" min. is maintained at the accessible route.	1	Labor	\$0

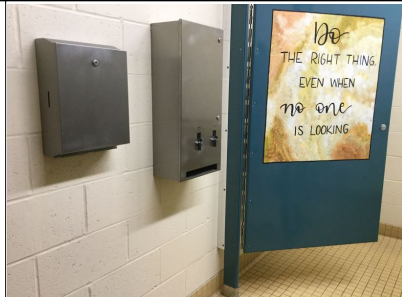
25	All Gender Student Multi-User Toilet Room Near Cafeteria	2		Interior Access Route	N/A

Obstructed by protruding objects	-	Relocate dispenser so it does not protrude into the circulation path.	1	192

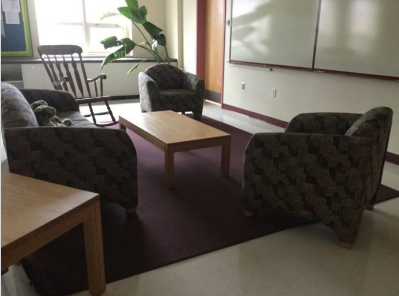
ID	Location	Floor	Room	Element	Type	Photo	Issues	Current Measure	Recommendations	Quantity	Price	Cost Estimation
26	Parent Lounge in Pathways Hallway	1	148	Interior Access Route	N/A

Mat not securely attached	-	Securely attach mat.	1	Labor	\$0
27	Classrooms Throughout the School	1, 2, 3	170, 248, 214, 346, 316, 314, 308	Interior Access Route	N/A

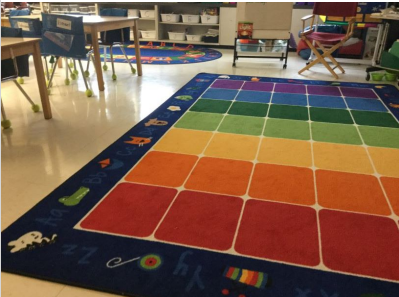
Mat not securely attached	-	Securely attach mats in at least one classroom per grade per topic (i.e. Grade 4 Math/ Science Classroom and Grade 4 ELA/ Social Studies Classroom.)	7	Labor	\$0
28	ESL Classroom, Chorus Room, Inclusion Teacher, Occupational Therapist's Office	2, 3	222, 207, 312, 366	Interior Access Route	N/A

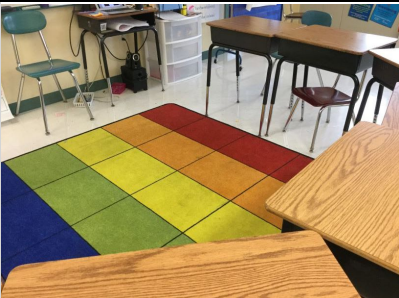
Mat not securely attached	-	Securely attach mat.	4	Labor	\$0
Doors, Doorways, & Gates												
29	Main Office Exit to Nurse's Office	1		Doors, Doorways, & Gates	Circulation

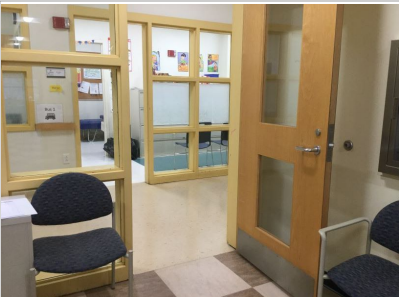
Maneuvering clearance(s) not provided	-	Relocate chair to maintain the maneuvering clearance at the door.	1	Labor	\$0

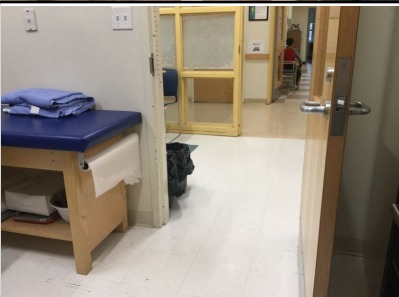
30	Exam Room in Nurse's Office	1	162	Doors, Doorways, & Gates	Other

Maneuvering clearance(s) not provided	-	Relocate exam table to maintain the maneuvering clearance at the door.	1	Labor	\$0

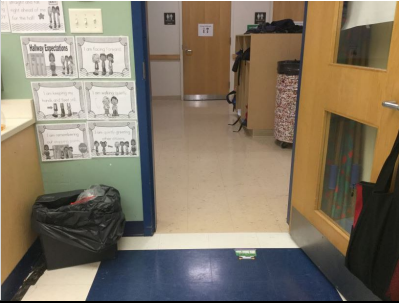
Maneuvering clearance(s) not provided	-	Relocate trash bin to maintain the maneuvering clearance at the door.	1	Labor	\$0
33	Principal's Office	1	157	Doors, Doorways, & Gates	Office

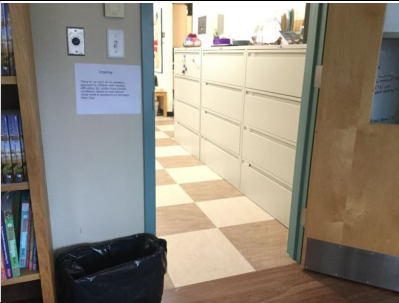
Maneuvering clearance(s) not provided	-	Relocate trash can to maintain the clear floor space at the door.	1	Labor	\$0
34	Parent Lounge in Pathways Hallway	1	148	Doors, Doorways, & Gates	Other

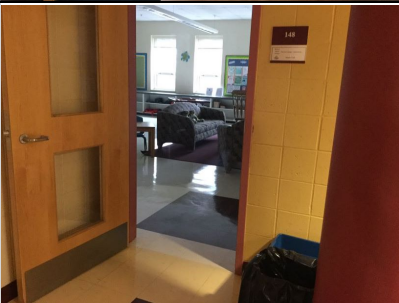
Maneuvering clearance(s) not provided	-	Relocate bin to maintain the maneuvering clearance at the door.	1	Labor	\$0
35	Office	2	256	Doors, Doorways, & Gates	Office

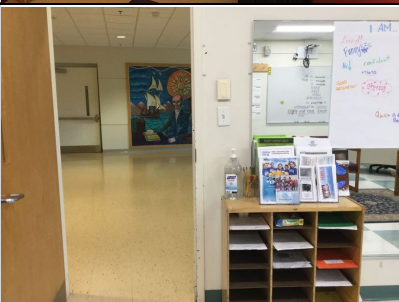
Maneuvering clearance(s) not provided	-	Relocate shelf to maintain the maneuvering clearance at the door.	1	Labor	\$0

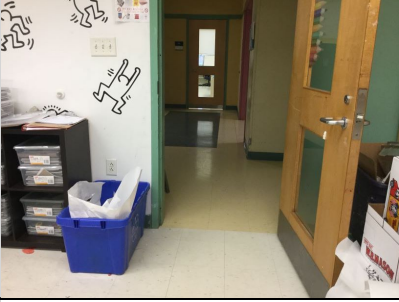
ID	Location	Floor	Room	Element	Type	Photo	Issues	Current Measure	Recommendations	Quantity	Price	Cost Estimation
36	Art Room	2	206	Doors, Doorways, & Gates	Classroom

Maneuvering clearance(s) not provided	-	Relocate trash bin to maintain the maneuvering clearance at the door.	1	Labor	\$0
37	Occupational Therapists Office	3	366	Doors, Doorways, & Gates	Office

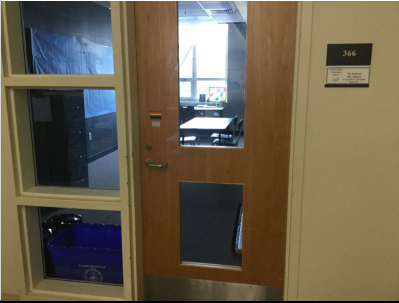
Maneuvering clearance(s) not provided	-	Relocate trash bin to maintain the maneuvering clearance at the door.	1	Labor	\$0
38	Professional Development Room	3	353	Doors, Doorways, & Gates	Classroom

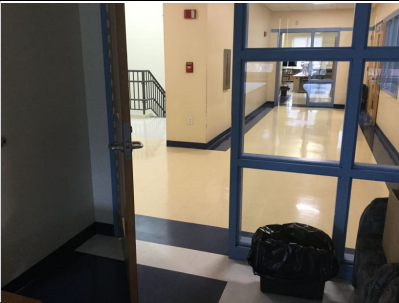
Maneuvering clearance(s) not provided	-	Relocate trash bin to maintain the maneuvering clearance at the door.	1	Labor	\$0
39	All Gender Staff Single-User Toilet Room	3		Doors, Doorways, & Gates	Toilet Room

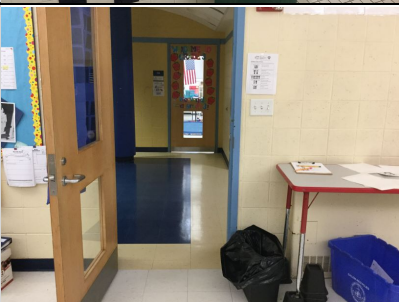
40	Inclusion Teacher	3	344	Doors, Doorways, & Gates	Classroom

Maneuvering clearance(s) not provided	-	Relocate trash bin and table to maintain the maneuvering clearance at the door.	3	Labor	\$0

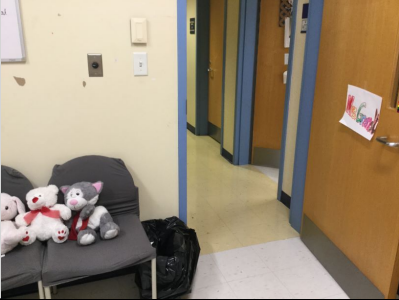
ID	Location	Floor	Room	Element	Type	Photo	Issues	Current Measure	Recommendations	Quantity	Price	Cost Estimation
41	Assistant Principal's Office Inclusion Teacher Science Lab A		324 312 303	Doors, Doorways, & Gates	Office

Maneuvering clearance(s) not provided	-	Relocate one chair and trash bin to maintain the maneuvering clearance at the door.	3	Labor	\$0
42	Greenhouse	3		Doors, Doorways, & Gates	Other

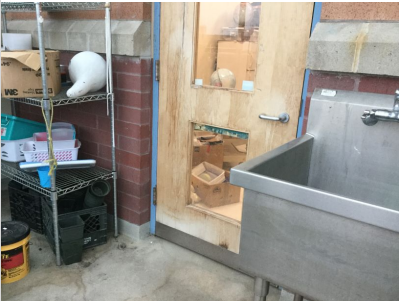
Maneuvering clearance(s) not provided	-	Reverses the swing of the door and relocate shelves to ensure a 18" min. maneuvering clearance is maintained at the door.	1	1413	\$1413
43	ELL Reading Teacher	3	357	Doors, Doorways, & Gates	Office

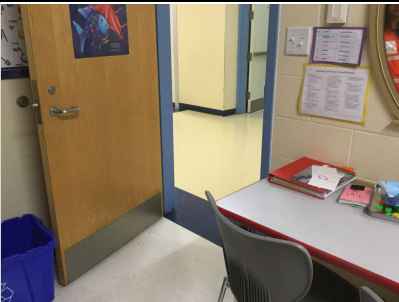
Maneuvering clearance(s) not provided	-	Relocate table to maintain the maneuvering clearance at the door.	1	Labor	\$0
44	All Gender Student Multi-User Toilet Room Near Cafeteria	2		Doors, Doorways, & Gates	Toilet Room

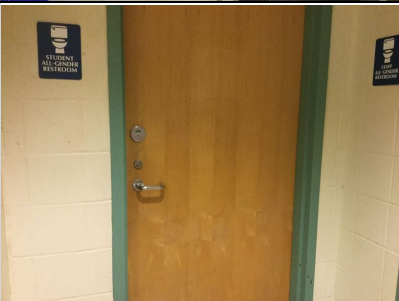
Door requires > 5 lbs. of force to open	15 lbs.	Adjust closers so doors do not require more than 5 pounds of force to open.	1	Labor	\$0

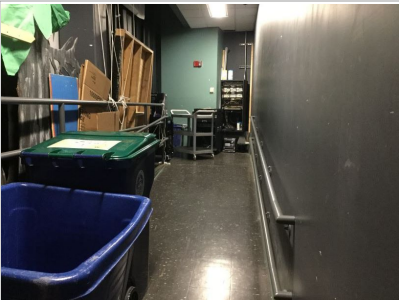
Ramps												
45	Accessible Route to Stage	2	249	Ramps	Interior

Not maintained in operable working condition	-	Ensure the ramp is maintained in operable working condition.	1	Labor	\$0

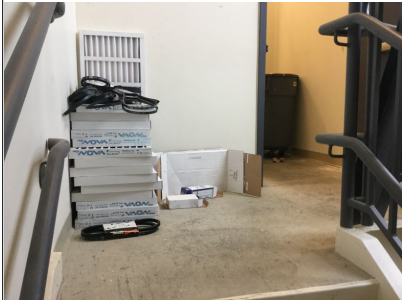
ID	Location	Floor	Room	Element	Type	Photo	Issues	Current Measure	Recommendations	Quantity	Price	Cost Estimation
Stairways												
46	Stair #3 to Exit #8	3		Stairways	Interior

Not maintained in operable working condition	-	Ensure stairs are maintained in operable working condition.	1	Labor	\$0
Elevator												
47	Elevator	1		Elevator	Interior

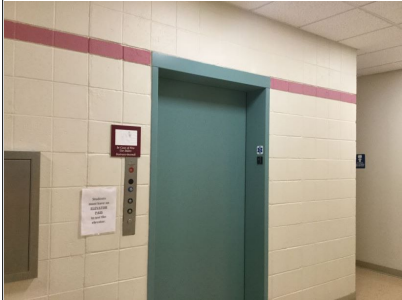
Hoistway signs not on both jambs	-	Provide hoistway signs on both sides of jambs.	3	48	\$144
Signage												
48	Women's Toilet Room in Gym	2	267	Signage	Designation

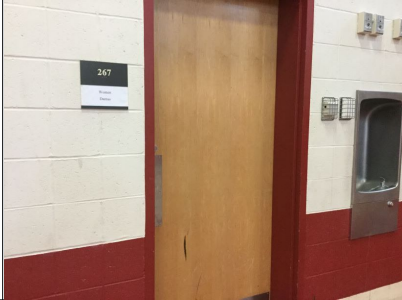
Raised characters not provided Braille not provided International Symbol of Acc. not compliant	- - -	Provide text with raised characters duplicated in braille. Replace sign with a sign containing the International Symbol of Accessibility.	1	174	\$174
49	Men's Toilet Room in Gym	2	261	Signage	Designation

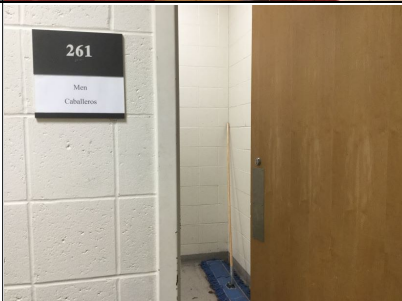
Raised characters not provided Braille not provided International Symbol of Acc. not compliant	- - -	Provide text with raised characters duplicated in braille. Replace sign with a sign containing the International Symbol of Accessibility.	1	174	\$174

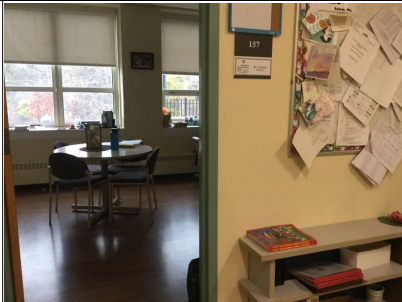
Clear floor space not provided		Remove bookshelf to maintain the 18" min. by 18" min. clear floor space at sign.	1	Labor	\$0

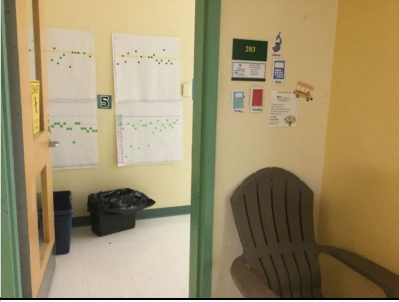
ID	Location	Floor	Room	Element	Type	Photo	Issues	Current Measure	Recommendations	Quantity	Price	Cost Estimation
51	Coaches Room and Art Room	2	203, 206	Signage	Designation

Clear floor space not provided		Relocate chair to maintain the 18" min. by 18" min. clear floor space at the sign.	2	Labor	\$0
52	Nurse's Office	1	165	Signage	Designation

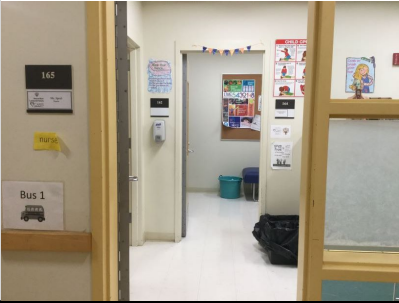
Sign not located on the latch side of the door	-	Locate sign on the wall adjacent to the latch side of the door.	1	Labor	\$0
53	Library	3	360	Signage	Designation

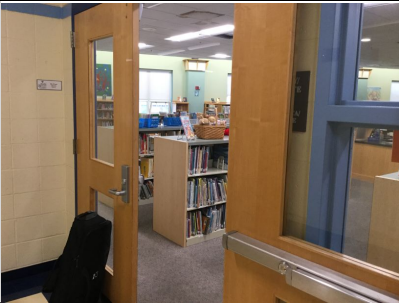
Sign not located on the latch side of the door	-	Locate sign on the wall adjacent to the latch side of the door.	1	Labor	\$0
54	Computer Lab	3	355	Signage	Designation

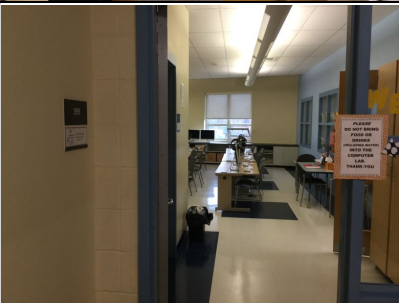
Sign not located on the latch side of the door	-	Locate sign at permanent rooms alongside the door on the latch side.	1	Labor	\$0
55	Professional Development Room	3	353	Signage	Designation

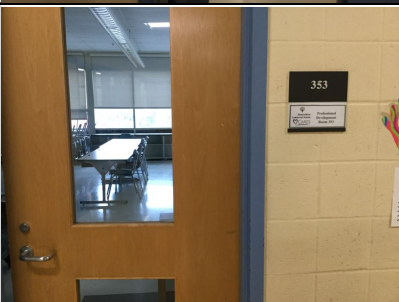
Sign not located on the latch side of the door	-	Locate sign on the wall adjacent to the latch side of the door.	1	Labor	\$0

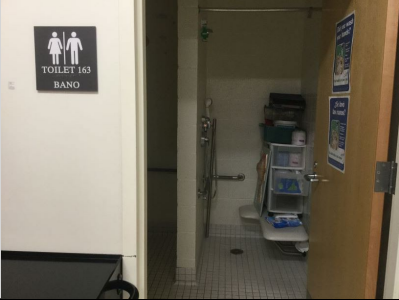
ID	Location	Floor	Room	Element	Type	Photo	Issues	Current Measure	Recommendations	Quantity	Price	Cost Estimation
56	Toilet Room in Nurse's Office	1	163	Signage	Designation

International Symbol of Acc. not compliant	-	Replace sign with a sign containing the International Symbol of Accessibility.	1	174	\$174
57	Staff Toilet Room Near Kindergarten	1	176	Signage	Designation

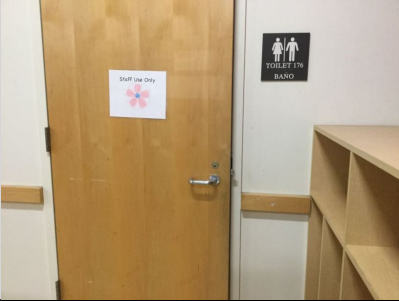
International Symbol of Acc. not compliant	-	Replace sign with a sign containing the International Symbol of Accessibility.	1	174	\$174
Operable Parts												
58	Women's and Men's Toilet Rooms in Gym	2	267, 261	Operable Parts	Other
