City of Salem, Massachusetts

PART A – Executive Summary

Part A – Executive Summary

Introduction

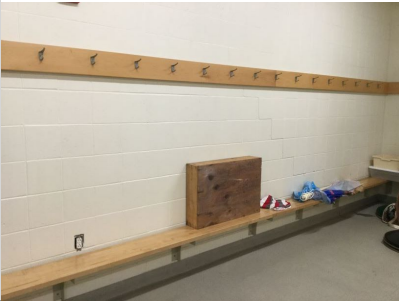
Clear floor space is not provided Side reach > 54"	- 65"	Relocate at least one coat hook so that controls are between 15" - 48" above finished floor.	1	192	\$192
59	Science Lab A	3	303	Operable Parts	Equipment

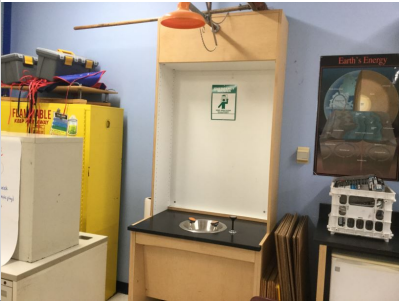
Reach < 15" or > 48"(forward/side approach)	62.75"	Relocate emergency eye wash pull string so that it is between 48" max. above finished floor.	1	192	\$192

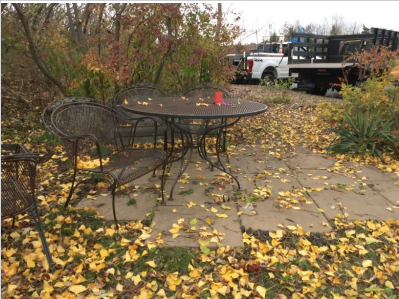
Dining or Work Surfaces												
60	Dining Table Near Garden	Ext		Dining or Work Surfaces	Dining Surface

Not on a accessible route	-	Ensure dining or work surfaces are located on an accessible route. See ID #4 for cost.	1	-	\$0

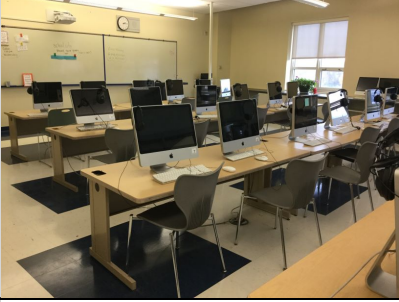
ID	Location	Floor	Room	Element	Type	Photo	Issues	Current Measure	Recommendations	Quantity	Price	Cost Estimation
61	Computer Lab	3	355	Dining or Work Surfaces	Work Surface

At least one or 5% accessible tables not provided Knee or toe clearance not provided	- -	Provide at least 1 work surface with 27" min. knee clearance.	1	525	\$525
62	Kindergarten Classroom	1	170	Dining or Work Surfaces	Work Surface

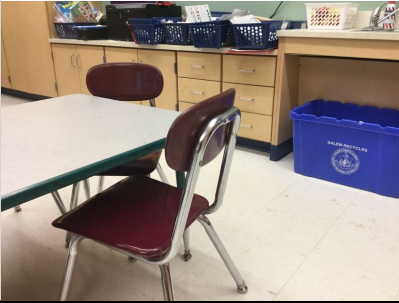
Knee or toe clearance not provided	20"	Adjust to ensure work surface provides a 27" min. knee clearance.	1	Labor	\$0
63	Kindergarten Classroom, Computer Station	1	170	Dining or Work Surfaces	Work Surface

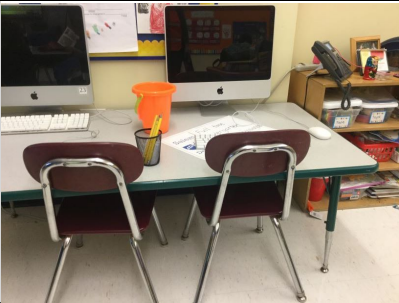
Knee or toe clearance not provided	19"	Adjust to ensure work surface provides a 27" min. knee clearance.	1	Labor	\$0
64	Office	2	256	Dining or Work Surfaces	Work Surface

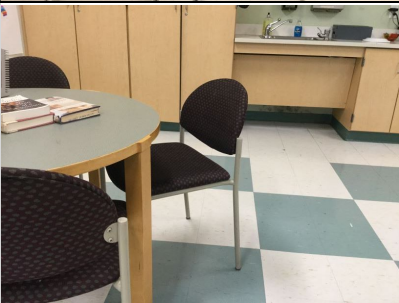
Knee or toe clearance not provided	24"	Provide at least 1 work surface with 27" min. knee clearance.	1	525	\$525

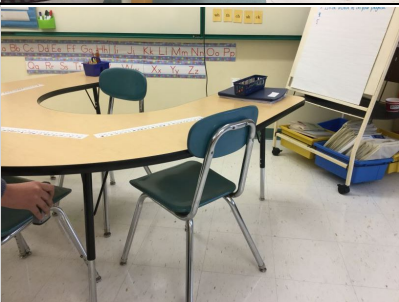
65	Reading Specialist	2	208	Dining or Work Surfaces	Work Surface

Knee or toe clearance not provided	23"	Adjust to ensure work surface provides a 27" min. knee clearance.	1	Labor	\$0

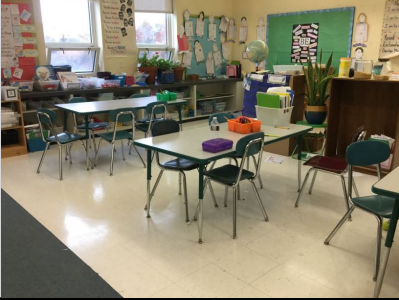
ID	Location	Floor	Room	Element	Type	Photo	Issues	Current Measure	Recommendations	Quantity	Price	Cost Estimation
66	Classrooms Throughout School	2,3	248, 214, 346, 316, 314, 308	Dining or Work Surfaces	Work Surface

Knee or toe clearance not provided	25"	Provide or adjust at least one work surface per grade per classroom topic (i.e. Grade 4 Math/Science Room and Grade 4 ELA/ Social Studies Classroom) so that there is 27" min. knee clearance.	6	Labor	\$0
67	Small Learning Room		328	Dining or Work Surfaces	Work Surface

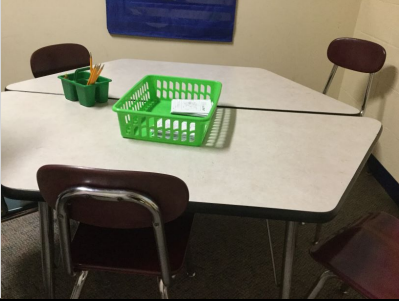
Knee or toe clearance not provided	21.25"	Adjust to ensure work surface provides a 27" min. knee clearance.	1	Labor	\$0
68	Assistant Principal's Office		324	Dining or Work Surfaces	Work Surface

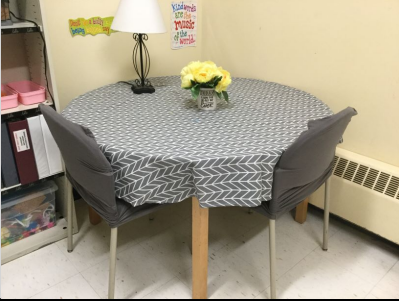
Knee or toe clearance not provided	25.5"	Provide at least 1 work surface with 27" min. knee clearance.	1	525	\$525
69	Science Lab B	3	306	Dining or Work Surfaces	Work Surface

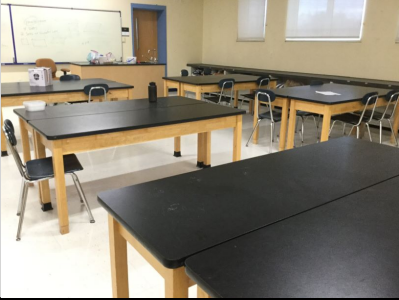
Knee or toe clearance not provided	23.5"	Provide at least 1 work surface with 27" min. knee clearance.	1	525	\$525

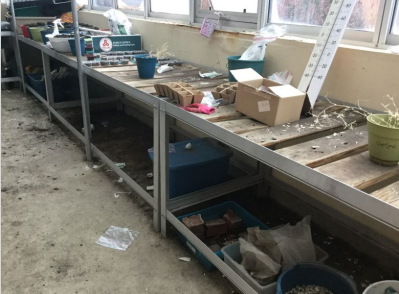
70	Greenhouse	3		Dining or Work Surfaces	Work Surface

Knee or toe clearance not provided	-	Provide at least 1 work surface with 27" min. knee and toe clearance.	1	525	\$525

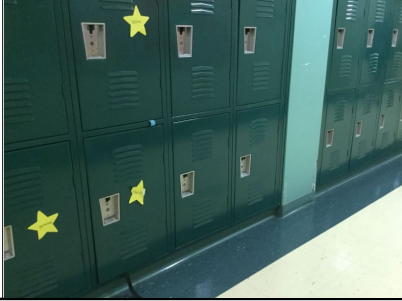
Total # of locker Total # of accessible locker 2% of lockers are not accessible	612 0 -	Provide at least 1 accessible locker (or ensure 2% of all lockers are accessible) .	1	330	\$330
Picnic Tables												
72	Near Garden	Ext		Picnic Tables	N/A

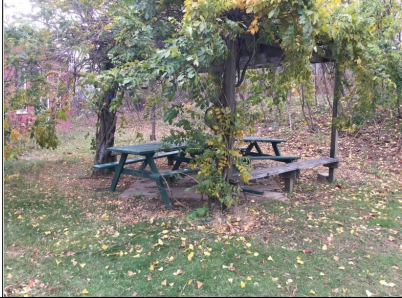
At least 5% accessible spaces not provided Picnic table not on an accessible route	- -	Ensure that at least one picnic table provides knee clearance. Ensure that the picnic table is connected to an accessible route. See ID #4 for cost of route. (Cost based on one accessible picnic table.)	1	1050	\$1050
Toilet & Bathing Rooms												
Overall Access												
73	Toilet Room Near Kindergarten	1	169	Overall Access	Toilet Room

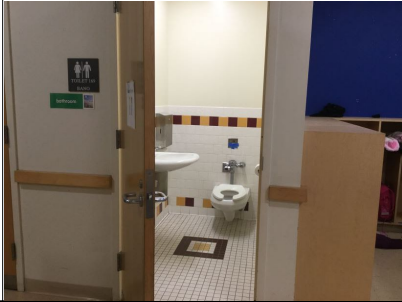
Sign to accessible toilet not provided	-	Provide a directional sign indicating the location of the nearest accessible toilet room.	1	174	\$174

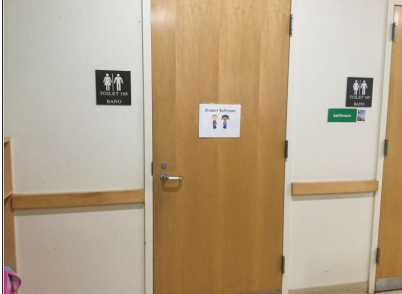
74	Toilet Room Near Kindergarten	1	168	Overall Access	Toilet Room

International Symbol of Acc. not provided	-	Provide a sign with the International Symbol of Accessibility.	1	174	\$174

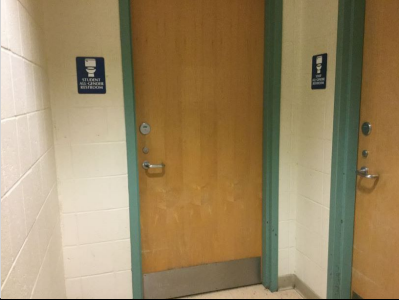
ID	Location	Floor	Room	Element	Type	Photo	Issues	Current Measure	Recommendations	Quantity	Price	Cost Estimation
75	All Gender Student Multi-User Toilet Room Near Cafeteria	2		Overall Access	Toilet Room

International Symbol of Acc. not provided	-	Provide a sign with the International Symbol of Accessibility.	1	174	\$174
76	All Gender Toilet Rooms Throughout School	1,2,3		Overall Access	Toilet Room

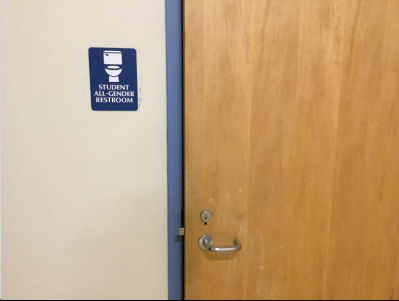
International Symbol of Acc. not provided	-	Provide signs with the International Symbol of Accessibility.	6	174	\$1044
77	Multi-User Boys' and Girls' Toilet Rooms Throughout School	1,2,3		Overall Access	N/A

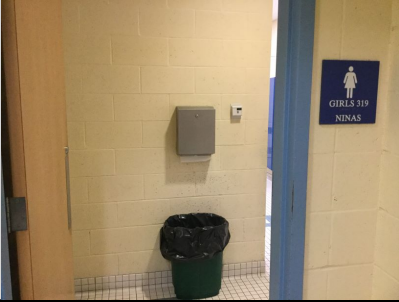
International Symbol of Acc. not provided	-	Provide signs with the International Symbol of Accessibility.	6	174	\$1044
Lavatory												
78	Women's Toilet Room in Gym, Single-User Bathing Room	2	265	Lavatory	N/A

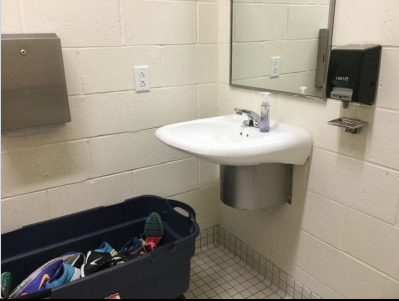
Toe or knee clearances not provided	-	Provide at least one lavatory with knee and toe clearance positioned for a forward approach by relocating shoe bin.	1	Labor	\$0

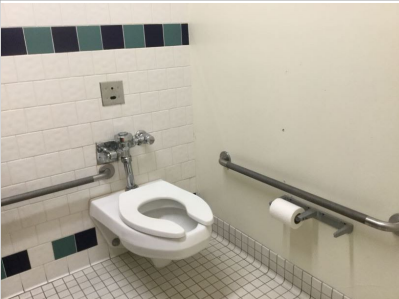
Single-User Toilet												
79	Staff Toilet Room Near Kindergarten	1	176	Single-User Toilet	N/A

Side or rear grab bar < 33" or > 36" high	21"	Mount grab bars 33"- 36" above the floor.	2	192	\$384

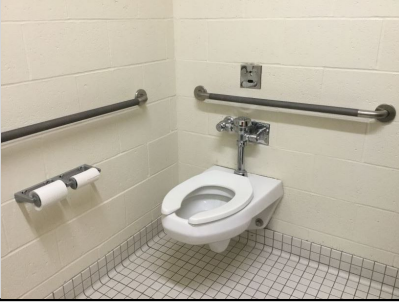
ID	Location	Floor	Room	Element	Type	Photo	Issues	Current Measure	Recommendations	Quantity	Price	Cost Estimation
80	Women's and Men's Toilet Rooms in Gym, Single-User Toilet Rooms	2	265, 263	Single-User Toilet	N/A

Side grab bar < 42" long Rear grab bar < 42" long	38" 39"	Provide a side wall grab bar that is 42" long min. located 12" max. from the rear wall. Provide a rear wall grab bar that is 42" long min. and extends from the toilet 12" min. on one side and 24" min. on the other side (open side).	2	674	\$1348
Toilet Compartment												
81	Boys' Multi-User Toilet Room No Door	3		Toilet Compartment	Accessible Compartment

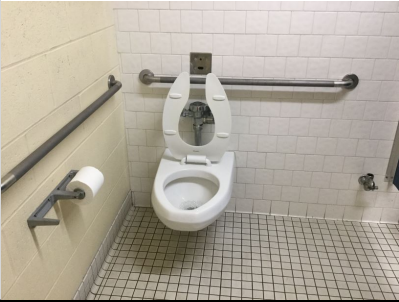
Door has non-compliant hardware	-	Provide hardware that can be operable with one hand and not require tight grasping, pinching, or twisting of the wrist.	1	18	\$18
82	Girls' Toilet Rooms	1,2		Toilet Compartment	Accessible Compartment

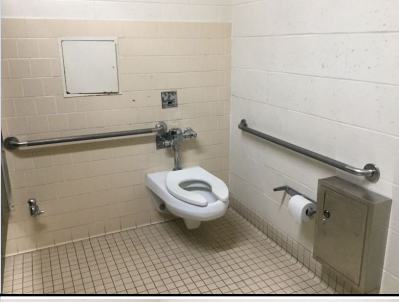
Door has non-compliant hardware Door has malfunctioning self-closing hinge	- -	Provide hardware that can be operable with one hand and not require tight grasping, pinching, or twisting of the wrist. Repair hinge.	1	18	\$18

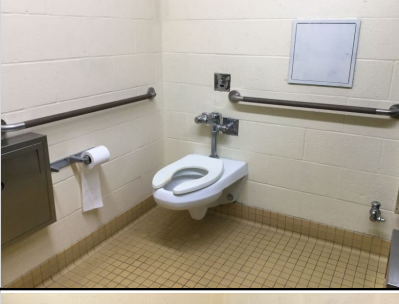
Door has malfunctioning self-closing hinge	-	Repair hinge.	1	Labor	\$0
84	Girls' Multi-User Toilet Room	3		Toilet Compartment	Accessible Compartment

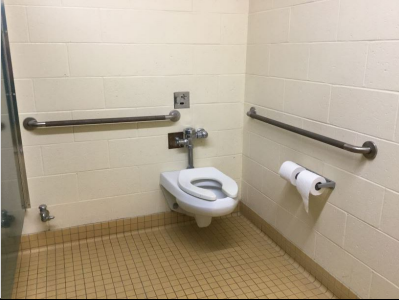
ID	Location	Floor	Room	Element	Type	Photo	Issues	Current Measure	Recommendations	Quantity	Price	Cost Estimation
85	All Gender Staff Multi-User Toilet Room Near Cafeteria	2		Toilet Compartment	Accessible Compartment

Door has malfunctioning self-closing hinge	-	Repair hinge.	1	Labor	\$0
86	Women's Toilet Room in Gym, Accessible Compartment	2	267	Toilet Compartment	Accessible Compartment

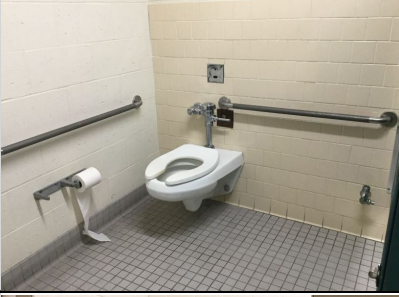
Door has malfunctioning self-closing hinge	-	Repair hinge.	1	Labor	\$0
87	Boys' Toilet Rooms	1,2		Toilet Compartment	Accessible Compartment

Door has malfunctioning self-closing hinge	-	Repair hinge.	1	Labor	\$0
88	Men's Toilet Room in Gym, Accessible Compartment	2	261	Toilet Compartment	Accessible Compartment

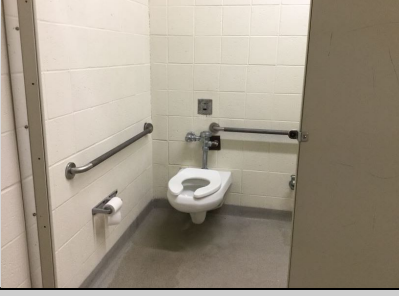
Not maintained in operable working condition	-	Add door to compartment to ensure accessible compartment is maintain in operable working condition.	1	165	\$165
Urinal												
89	All Gender Staff Multi-User Toilet Room Near Cafeteria	2		Urinal	N/A

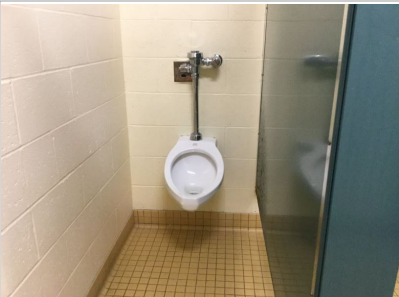
Rim > 17" high Urinal recessed > 24" deep has > 36" clear width	19" 32.5"	Provide an urinal with the rim no higher than 17" above the finished floor. If urinal is recessed greater than 24" ensure there is a clear width of 36".	1	2628	\$2628

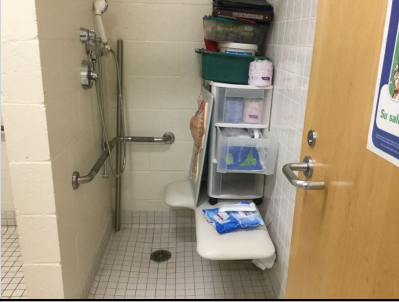
ID	Location	Floor	Room	Element	Type	Photo	Issues	Current Measure	Recommendations	Quantity	Price	Cost Estimation
Shower Compartment												
90	Toilet Room in Nurse's Office	1	163	Shower Compartment	Transfer Type

Clear space not provided at transfer shower Grab bars < 33" > 36" high Seat is not between 17"- 19" high	- 26" 14"	Ensure that a 36" wide min. by a 48" long min. measured from the control wall is provided at the shower. Locate grab bars between 33"- 36" above the finished floor. Mount seat between 17"- 19" above the finished floor. Renovation to this transfer shower might be technically infeasible.	1	-	\$0
91	Women's and Men's Toilet Rooms in Gym, Single-User Bathing Rooms	2	265, 263	Shower Compartment	Transfer Type

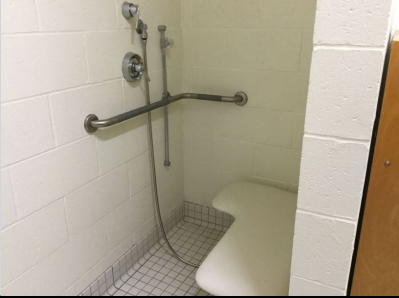
Seat is not between 17"- 19" high Control height < 38" or > 48"	13.5" 52"	Mount seat between 17"- 19" above the finished floor. Relocate controls at 48" max. above the shower floor.	1	384	\$384

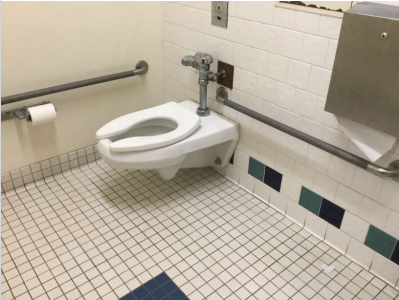
Toilet Rooms for Children												
Single-User Toilet												
92	Toilet Room Near Kindergarten	1	168	Single-User Toilet	N/A

Toilet seat < 12" or > 15" high (K - 3) Centerline < 12" or > 15" (K - 3)	16.5" 18.5"	Install a toilet with a seat between 12"- 15" high above the finished floor. Relocate toilet so that the centerline is between 12" and 15" from the side wall.	1	1625	\$1625
Additional Access												
Drinking Fountains												
93	Near Pathways Hallway	1		Drinking Fountains	High

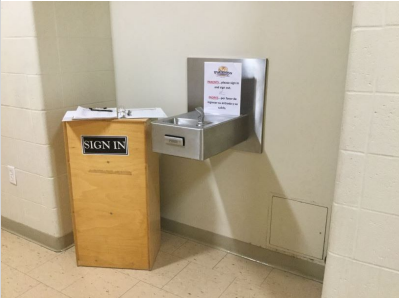
No drinking fountain provided for seated users	-	Provide an additional drinking fountain for seated users.	1	3021	\$3021

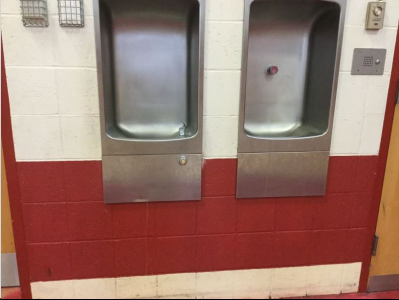
ID	Location	Floor	Room	Element	Type	Photo	Issues	Current Measure	Recommendations	Quantity	Price	Cost Estimation
94	Gym	2		Drinking Fountains	High

No drinking fountain provided for seated users	-	Provide an additional drinking fountain for seated users or install a Hi-Lo drinking fountain.	1	3021	\$3021
95	Cafeteria	2	241	Drinking Fountains	Hi-Lo

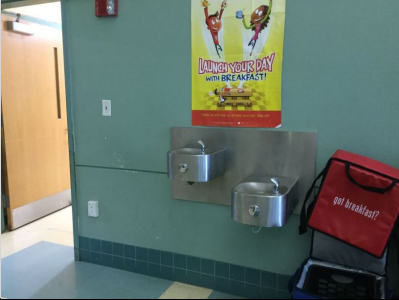
Standing height fountain does not have cane protection	-	Provide a cane-detectable barrier skirt under the high unit.	1	668	\$668
Sink												
96	Exam Room in Nurse's Office	1	166	Sink	N/A

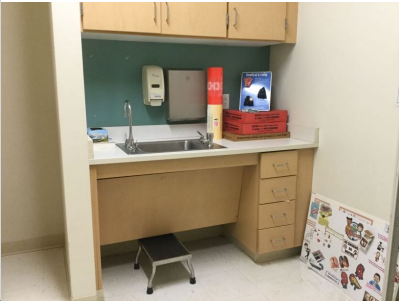
Toe and knee clearances not provided	-	Remove step stool to maintain the 27" min,knee clearance at the sink.	1	Labor	\$0
97	Reading Specialist	2	208	Sink	Classroom

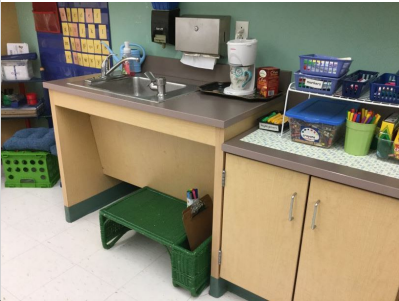
Toe and knee clearances not provided	-	Relocate step stool to maintain the 27" min. knee clearance at the sink.	1	Labor	\$0
98	Band Room	2	211	Sink	Classroom

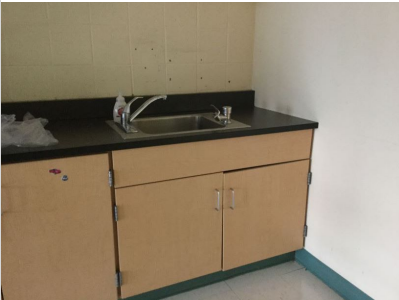
Toe and knee clearances not provided	-	Remove based cabinet to provide a 27" knee clearance positioned for a forward approach.	1	930	\$930

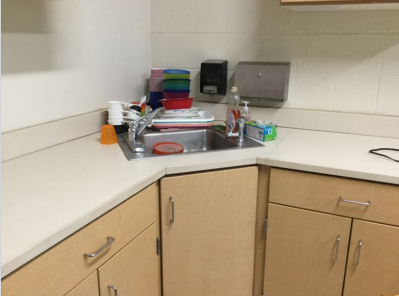
ID	Location	Floor	Room	Element	Type	Photo	Issues	Current Measure	Recommendations	Quantity	Price	Cost Estimation
99	Speech, Language Pathologist	3	361	Sink	N/A

Toe and knee clearances not provided	-	Relocate sink to provide 27" min. knee clearance under the sink with 30" min. width. Ensure the counter is 34" max. above the finished floor.	1	4513	\$4513
100	Greenhouse	3		Sink	Lab

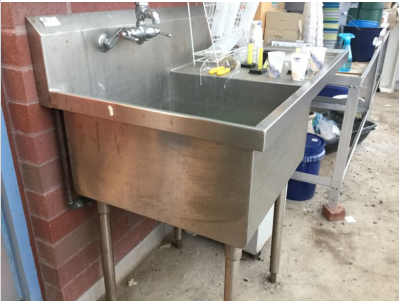
Toe and knee clearances not provided	-	Provide a second sink with 27" knee clearance positioned for a forward approach.	1	1265	\$1265
101	Exam Room in Nurse's Office	1	162	Sink	N/A

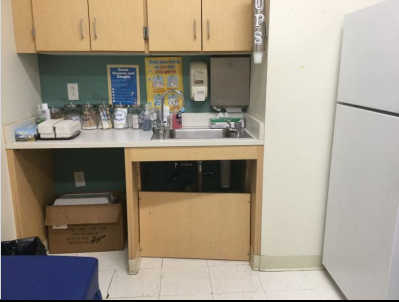
Exposed plumbing underneath sink Dispenser not within reach range	- 51"	Reposition wooden barrier to ensure pipes at sink are insulated. Relocate cup dispenser 48" max. above the finished floor or ground.	1	192	\$192
Sinks for Children's Use												
102	Kindergarten Classroom	1	170	Sinks for Children's Use	Classroom

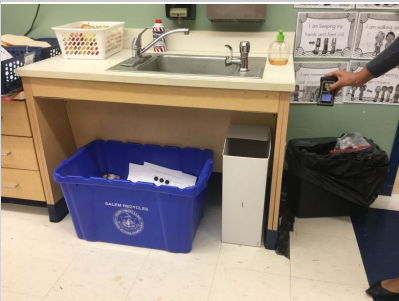
Knee or toe clearance not provided	-	Relocate recycling bin to maintain the 27" min. knee clearance at the sink.	1	Labor	\$0

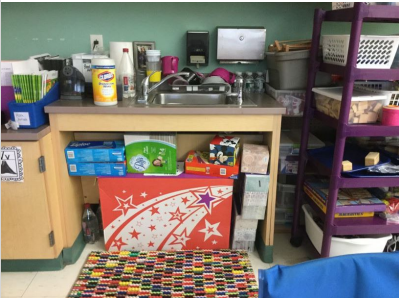
103	Grade 1 and Grade 2 Classrooms	2	248, 214	Sinks for Children's Use	Classroom

Knee or toe clearance not provided	-	Provide at least one sink with 25" knee and toe clearance positioned for a forward approach by removing clutter from under sink.	2	Labor	\$0

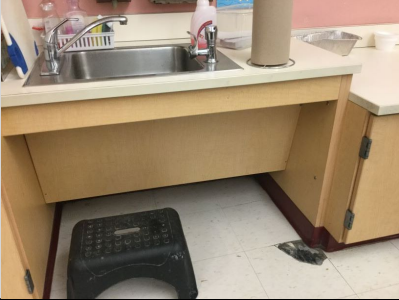
ID	Location	Floor	Room	Element	Type	Photo	Issues	Current Measure	Recommendations	Quantity	Price	Cost Estimation
104	Pathways Classroom	1	140	Sinks for Children's Use	Classroom

Parallel clear space not provided (5 yrs. old or younger)	-	Relocate step stool to maintain the clear floor space at the sink.	1	Labor	\$0
Play and Sport Areas												
Play Areas												
105	Playground Southeast Side of School	Ext		Play Areas	N/A

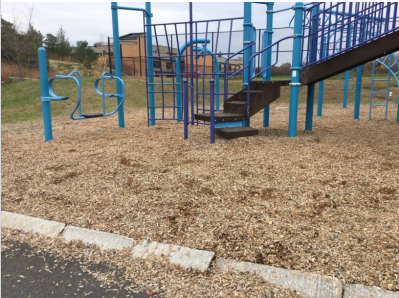
Accessible route not provided to ground level play components	-	Ensure an accessible route is provided to one of each type of ground level play components (Cost based on 115' of 5' wide poured in place rubber routes to play elements.)	1	8050	\$8050
106	Playground Near Kindergarten Wing	Ext		Play Areas	N/A

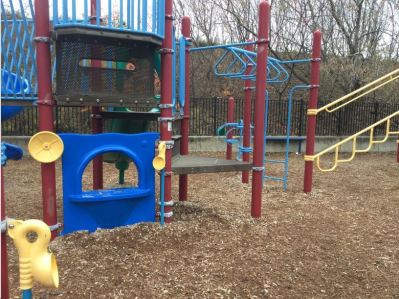
Accessible route not provided to ground level play components	-	Ensure an accessible route is provided to one of each type of ground level play components (Cost based on 145' of 5' wide poured in place rubber to play elements.)	1	10150	\$10150

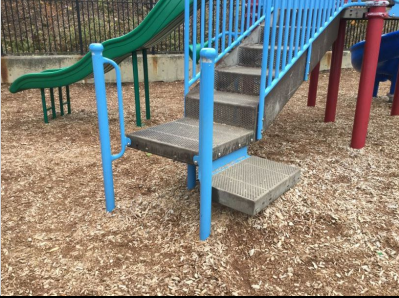
107	Playground Near Kindergarten Wing	Ext		Play Areas	N/A

No compliant transfer system	22.25"	Alteration might be technically infeasible.	1	-	\$0
108	Playground Southeast Side of School	Ext		Play Areas	N/A

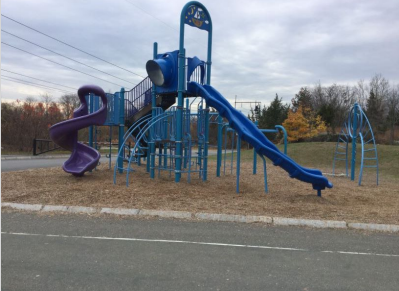
Not connected to an accessible route	-	Provide an accessible route around the playground. (Cost based on 185' of 4' wide, level asphalt surface around playground.)	1	4718	\$4718

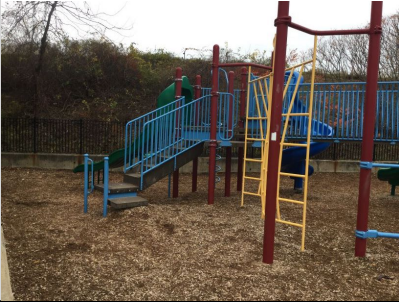
ID	Location	Floor	Room	Element	Type	Photo	Issues	Current Measure	Recommendations	Quantity	Price	Cost Estimation
109	Playground Near Kindergarten Wing	Ext		Play Areas	N/A

Not connected to an accessible route	-	Provide an accessible route around the playground. (Cost based on 210' of 4' wide asphalt path around playground.)	1	5355	\$5355
Benches												
110	Playground Near Kindergarten Wing	Ext		Benches	N/A

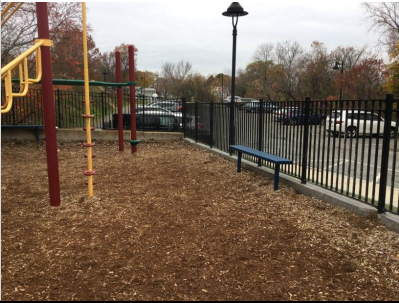
Accessible route not provided	-	Provide an accessible route to at least one of the benches in this area. See ID #111 for cost.	1	-	\$0
Field												
111	Robert J. Geswell Athletic Field	Ext		Field	Soccer

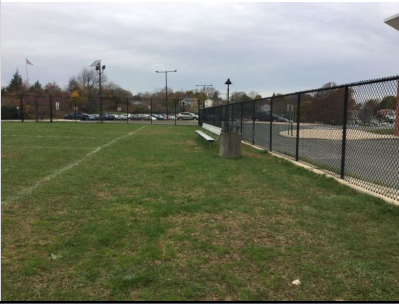
Accessible spaces not provided at sidelines seating Not connected to an accessible route	- -	Provide a 36" min. x 48" min. clear floor space at sidelines seating. Ensure sidelines seating is connected to an accessible route. (Cost based on two concrete clear floor spaces at sidelines seating and 115' concrete route to both benches.)	1	5520	\$5520

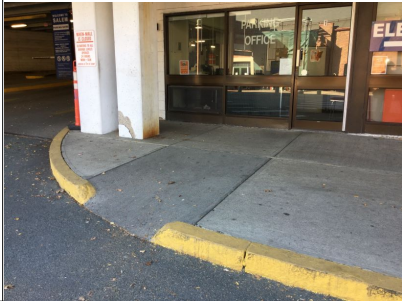
Running slope > 1:12 (8.33%)	18%	Reduce running slope to be no steeper than 1:12 (8.33%).	1	2800	\$2800
Off-Street Parking Lot or Garage												
2	Accessible Parking Spaces	1		Off-Street Parking Lot or Garage	Visitor

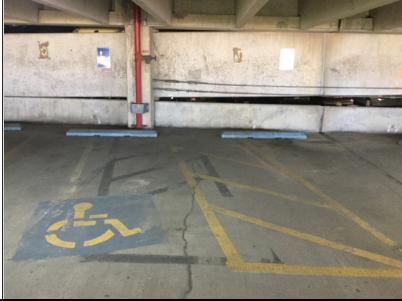
Running slope > 1:12 (8.33%) Curb ramp flares > 1:10 (10%)	8.9% 11%	Reduce running slope to be no steeper than 1:12 (8.33%). Reduce slope at curb ramp flares to be no steeper than 1:10 (10%).	1	2800	\$2800
4	Accessible Parking Spaces	2A		Off-Street Parking Lot or Garage	Visitor

Access aisle < 96" wide at van space	61"	Provide a marked access aisle that is at least 96" wide.	1	338	\$338

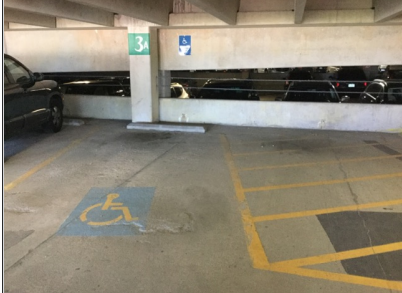
5	Accessible Parking Space	3A		Off-Street Parking Lot or Garage	Visitor

Sign does not have the designation "Van Accessible"	-	Add the designation "Van Accessible" to the sign located at the van accessible space.	1	375	\$375

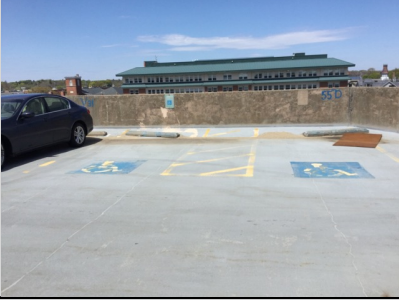
Running slope > 1:12 (8.33%)	15.6%	Reduce running slope to be no steeper than 1:12 (8.33%).	1	2800	\$2800
7	Accessible Parking Spaces	4		Off-Street Parking Lot or Garage	Visitor

Sign not provided	-	Provide a sign with the bottom of the sign 60" min. above the ground and the top 96" max. above the ground.	1	375	\$375
Entrance												
8	Towards Elevators	R		Entrance	N/A

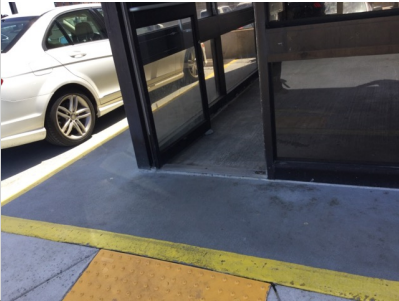
Threshold > 1/2" high	1"	Alter threshold to be 1/2" high max.	1	113	\$113
Access to Goods and Services												
Elevator												
9	Near Pay Machines	1A		Elevator	Interior

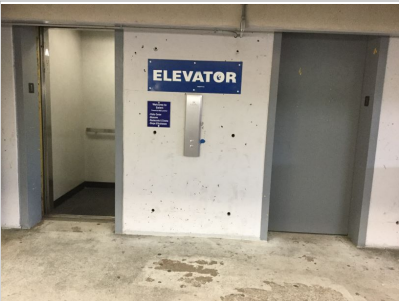
Elevator car dimension not compliant	-	Repair may require major renovation at elevator cab and hoistway and may not be practical until system is replaced.	1	-	\$0

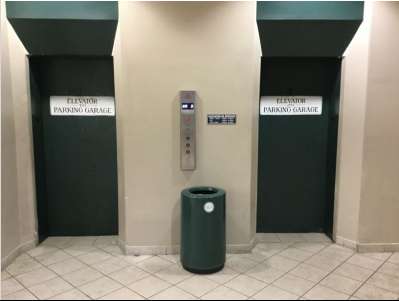
10	Lobby - Mall Level	M		Elevator	Interior

Clear floor space not provided at call buttons	-	Relocate trash can to maintain the clear floor space at call buttons.	1	-	\$0

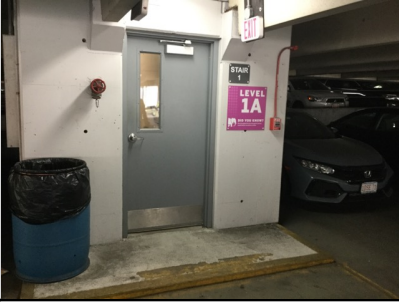
ID	Location	Floor	Room	Element	Type	Photo	Issues	Current Measure	Recommendations	Quantity	Price	Cost Estimation
Signage												
11	Stair #1	1A		Signage	Egress

Raised characters not provided Braille not provided Sign not located on the latch side of the door	- - -	Provide text with raised characters duplicated in braille. Locate sign alongside the door on the latch side.	2	174	\$348
12	Stair #1	2A		Signage	Egress

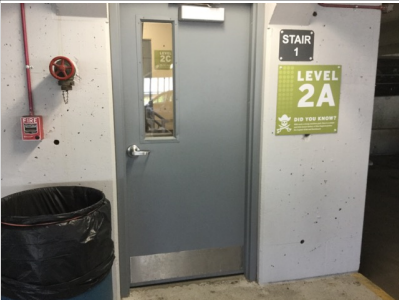
Raised characters not provided Braille not provided Sign not located on the latch side of the door	- - -	Provide text with raised characters duplicated in braille. Locate sign alongside the door on the latch side.	1	174	
13	Stair #3	2A		Signage	Egress

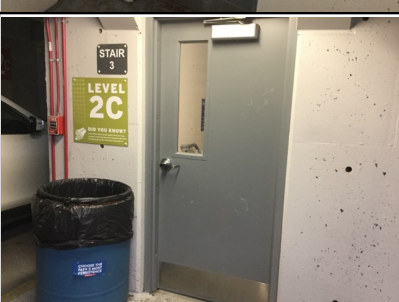
Not provided	-	Provide text with raised characters duplicated in braille. Locate signage alongside the door on the latch side.	1	174	
15	Stair #3	2C		Signage	Egress

Raised characters not provided Braille not provided	- -	Provide text with raised characters duplicated in braille. Relocate trash can to ensure an 18" by 18" clear floor space is provided in front of the sign.	2	116	\$232

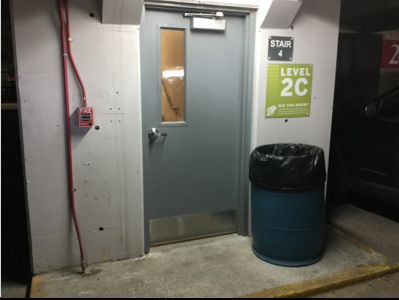
ID	Location	Floor	Room	Element	Type	Photo	Issues	Current Measure	Recommendations	Quantity	Price	Cost Estimation
16	Stair #4	2C		Signage	Egress

Raised characters not provided Braille not provided Sign not located on the latch side of the door	- - -	Provide text with raised characters duplicated in braille. Locate sign at permanent rooms alongside the door on the latch side. Relocate trash can to ensure an 18" by 18" clear floor space is provided in front of the sign.	2	174	\$348
17	Stair #1	3A		Signage	Egress

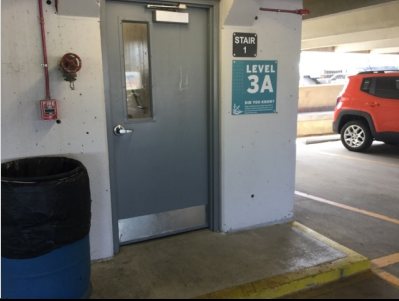
Raised characters not provided Braille not provided Sign not located on the latch side of the door	- - -	Provide text with raised characters duplicated in braille. Locate sign alongside the door on the latch side.	2	174	\$348
18	Stair #3	3A		Signage	Egress

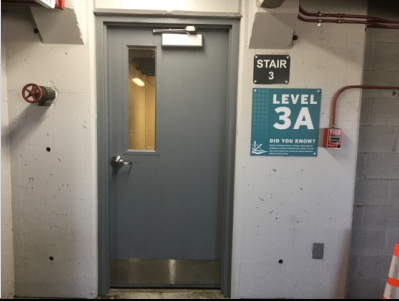
Raised characters not provided Braille not provided Sign not located on the latch side of the door	- - -	Provide text with raised characters duplicated in braille. Locate sign alongside the door on the latch side.	2	174	\$348

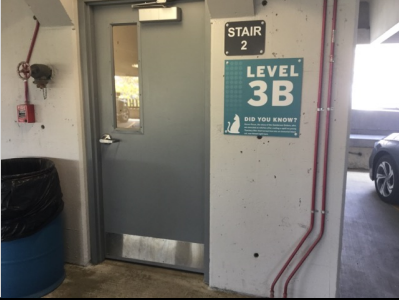
19	Stair #2	3B		Signage	Egress

Raised characters not provided Braille not provided Sign not located on the latch side of the door	- - -	Provide text with raised characters duplicated in braille. Locate sign alongside the door on the latch side.	2	174	\$348
20	Stair #4	3B		Signage	Egress

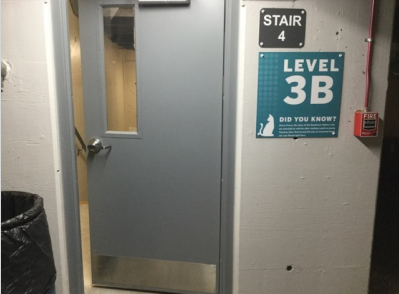
Raised characters not provided Braille not provided Sign not located on the latch side of the door	- - -	Provide text with raised characters duplicated in braille. Locate sign alongside the door on the latch side.	2	174	\$348

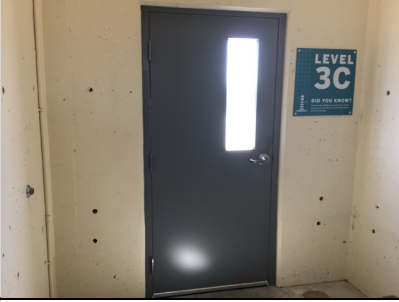
ID	Location	Floor	Room	Element	Type	Photo	Issues	Current Measure	Recommendations	Quantity	Price	Cost Estimation
21	Stair #3	3C		Signage	Egress

Raised characters not provided Braille not provided	- -	Provide text with raised characters duplicated in braille.	2	174	\$348
22	Stair #1	3C		Signage	Egress

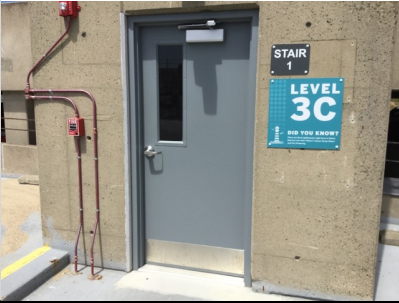
Raised characters not provided Braille not provided Sign not located on the latch side of the door	- - -	Provide text with raised characters duplicated in braille. Locate sign alongside the door on the latch side.	2	174	
23	Stair #2	3C		Signage	Egress

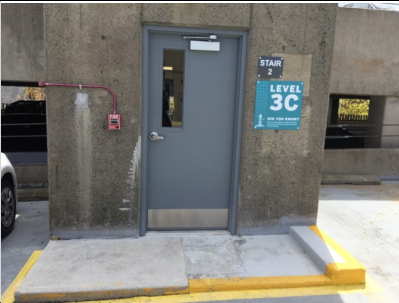
Raised characters not provided Braille not provided Sign not located on the latch side of the door	- - -	Provide text with raised characters duplicated in braille. Locate sign alongside the door on the latch side.	2	174	\$348
24	Stair #4	3C		Signage	Egress

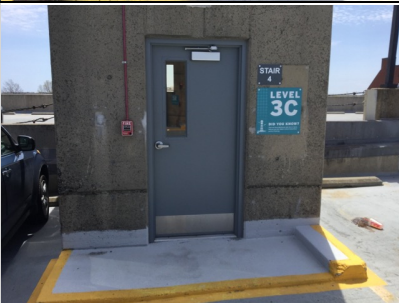
Raised characters not provided Braille not provided Sign not located on the latch side of the door	- - -	Provide text with raised characters duplicated in braille. Locate sign alongside the door on the latch side.	2	174	\$348

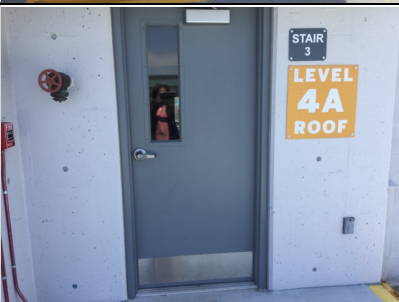
25	Stair #3	4A		Signage	Egress

Raised characters not provided Braille not provided Sign not located on the latch side of the door	- - -	Provide text with raised characters duplicated in braille. Locate sign alongside the door on the latch side.	2	174	\$348

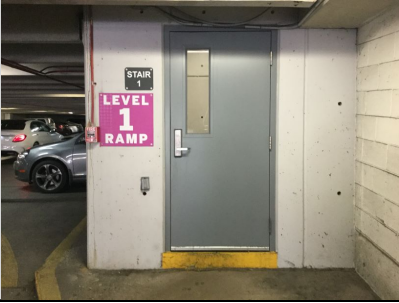
ID	Location	Floor	Room	Element	Type	Photo	Issues	Current Measure	Recommendations	Quantity	Price	Cost Estimation
26	Stair #1	Ext.		Signage	Designation

Raised characters not provided Braille not provided	- -	Provide text with raised characters duplicated in braille. Provide braille.	2	174	\$348

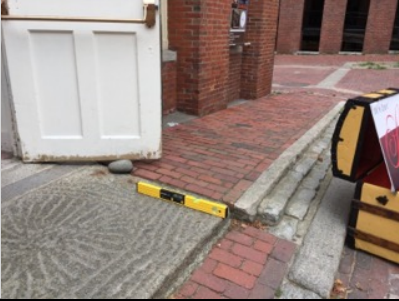
ID	Location	Floor	Room	Element	Type	Photo	Issues	Current Measure	Recommendations	Quantity	Price	Cost Estimation
Approach and Entrance												
Exterior Access Route												
1	Old Town Hall - North Side Entrance	Ext.		Exterior Access Route	Sidewalk

Exterior route < 36" wide	-	Ensure the right leaf is closed to maintain 36" min. width at the accessible route.	1	-	\$0
2	Old Town Hall - North Side	Ext.		Exterior Access Route	Sidewalk

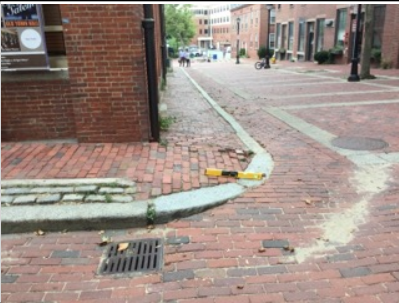
Route not maintained in operable working condition	-	Ensure the accessible route is maintained in operable working conditions.	1	-	\$0
Access to Goods and Services												
Means of Egress												
3	Exit - Near Elevator	1		Means of Egress	N/A

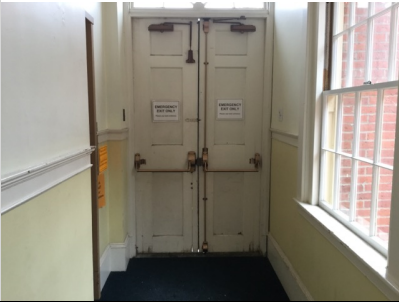
Emergency exit not on an accessible route Directional sign to accessible emergency exit not provided	- -	Provide a directional sign indicating the location of the nearest emergency exit.	2	174	\$348

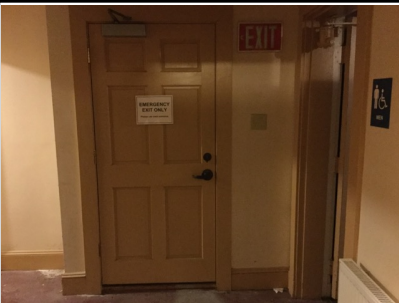
4	Emergency Exit - Near Men's Toilet Room	B		Means of Egress	N/A

Emergency exit not on an accessible route Directional sign to accessible emergency exit not provided	- -	Provide a directional sign indicating the location of the nearest emergency exit.	1	174	\$174

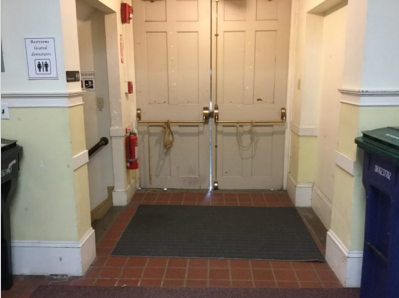
ID	Location	Floor	Room	Element	Type	Photo	Issues	Current Measure	Recommendations	Quantity	Price	Cost Estimation
Interior Access Route												
5	Front Entrance	1		Interior Access Route	N/A

Mat not securely attached	-	Install an ADA-compliant walk-off mat.	1	324	\$324
6	Towards Great Hall	2		Interior Access Route	N/A

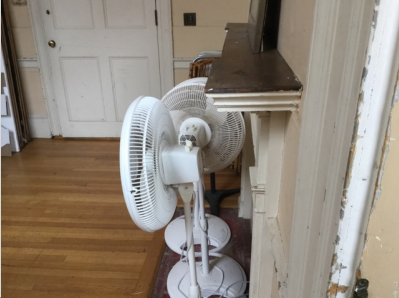
Obstructed by protruding objects	-	Provide a cane-detectable barrier under the fireplace mantel.	2	230	\$460
Doors, Doorways, & Gates												
7	Towards Exhibit Area	1		Doors, Doorways, & Gates	Circulation

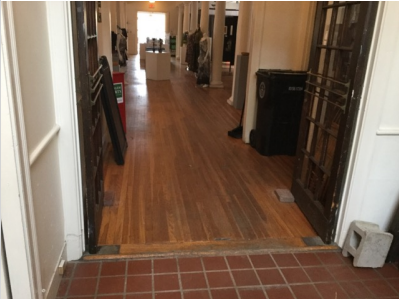
Threshold not beveled	-	Bevel threshold.	1	113	\$113
8	Single-User Toilet Room	2		Doors, Doorways, & Gates	Toilet Room

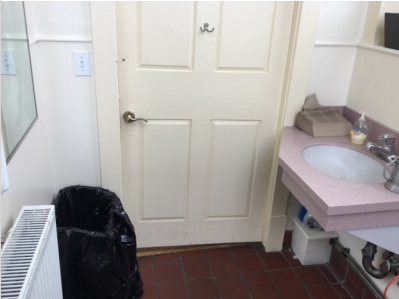
Maneuvering clearance(s) not provided	-	Remove the trash can to maintain the maneuvering clearance at the door.	1	Labor	\$0
9	Great Hall	2		Doors, Doorways, & Gates	Circulation

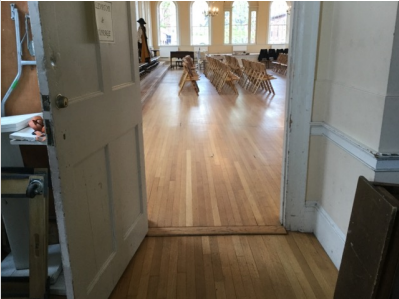
Threshold not beveled	-	Bevel threshold.	1	113	\$113

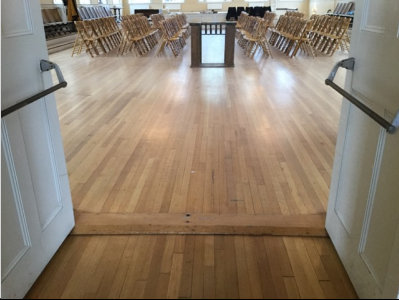
ID	Location	Floor	Room	Element	Type	Photo	Issues	Current Measure	Recommendations	Quantity	Price	Cost Estimation
10	Great Hall	2		Doors, Doorways, & Gates	Other

Threshold not beveled	-	Bevel threshold.	1	113	\$113
11	Towards Great Hall	2		Doors, Doorways, & Gates	Other

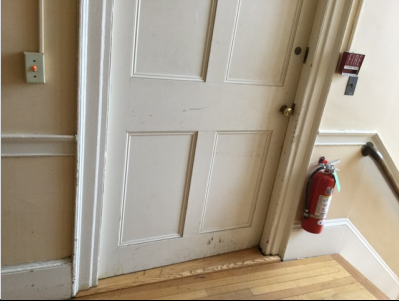
Threshold not beveled Hardware not operable with a closed fist	- -	Bevel threshold. Provide hardware that can be operable with one hand and not require tight grasping, pinching, or twisting of the wrist.	1	476	\$476
12	Towards Great Hall	2		Doors, Doorways, & Gates	Other

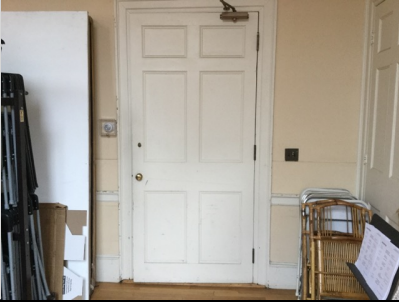
Hardware not operable with a closed fist	-	Provide hardware that can be operable with one hand and not require tight grasping, pinching, or twisting of the wrist.	1	363	\$363
Elevator												
13	Elevator - West Side	1		Elevator	Interior

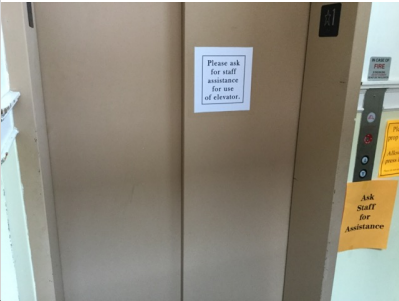
Ensure elevator provides unassisted entry and exit.	1	Labor	\$0
Signage												
14	Exit	1		Signage	Egress

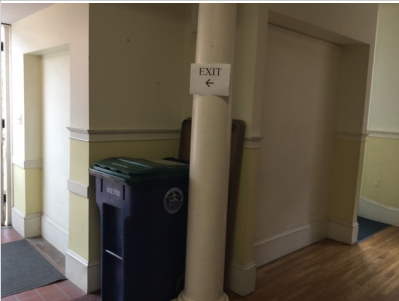
Raised characters not provided Braille not provided	- -	Provide a permanent sign with raised characters duplicated in braille. Locate sign near the emergency exit.	1	174	\$174

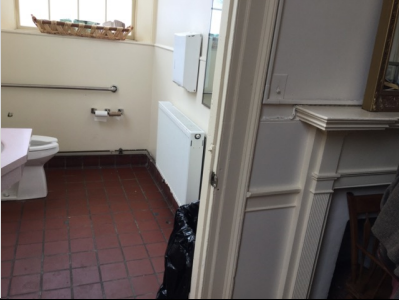
ID	Location	Floor	Room	Element	Type	Photo	Issues	Current Measure	Recommendations	Quantity	Price	Cost Estimation
15	Single-User Toilet Room	2		Signage	Designation

Not provided	-	Provide a sign with raised characters duplicated in braille. Locate sign on the wall adjacent to the latch side of the door. Add the International Symbol of Accessibility (ISA).	1	174	\$174
Assembly Area												
16	Great Hall	2		Assembly Area	N/A

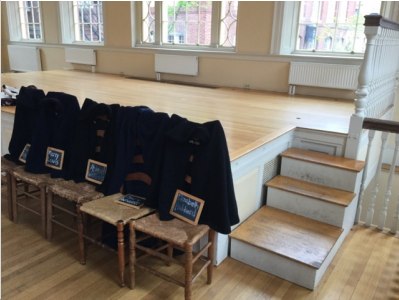
Accessible route to stage not provided	-	Provide an accessible route to the stage. Consider installing a ramp or a lift. (Cost for an interior lift.)	1	16245	\$16245
Toilet & Bathing Rooms												
Lavatory												
17	Single-User Toilet Room	2		Lavatory	N/A

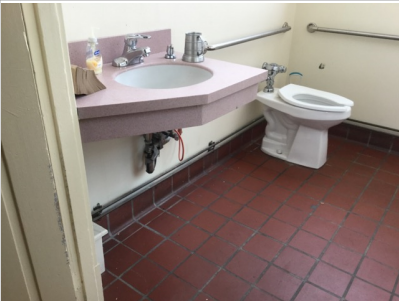
Plumbing underneath is exposed	-	Insulate or otherwise configure pipes to prevent contact, for at least one lavatory.	1	69	\$69
Single-User Toilet												
18	Single-User Toilet Room	2		Single-User Toilet	N/A

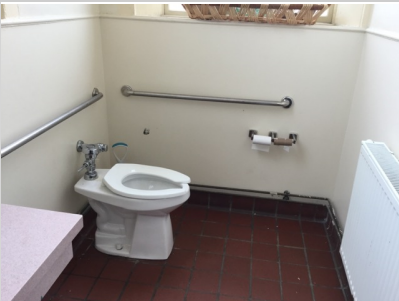
Centerline < or > 18" (MAAB)	22"	Relocate toilet so that the centerline is 18" from the side wall.	1	2121	\$2121

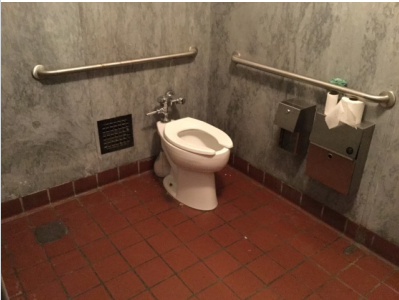
ID	Location	Floor	Room	Element	Type	Photo	Issues	Current Measure	Recommendations	Quantity	Price	Cost Estimation
Toilet Compartment												
19	Women's Toilet Room	B		Toilet Compartment	Accessible Compartment

Door has malfunctioning self-closing hinge	-	Repair hinge.	1	Labor	\$0
Dispensers												
20	Women's Toilet Room	B		Dispensers	Tampon Dispenser

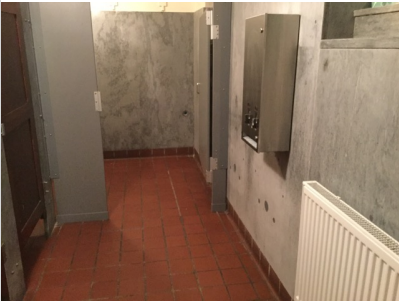
Dispenser acts as a protruding object	7"	Relocate dispenser out of the circulation path.	1	530	\$530

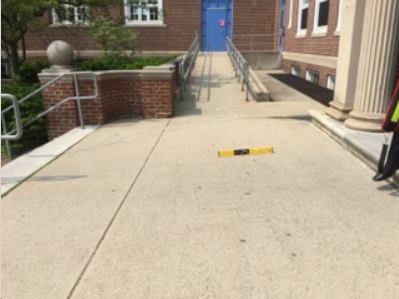
ID	Location	Floor	Room	Element	Type	Photo	Issues	Current Measure	Recommendations	Quantity	Price	Cost Estimation
Approach and Entrance												
Exterior Access Route												
1	At Main Entrance	Ext.		Exterior Access Route	Exterior

Cross slope > 1:50 (2.00%)	6.2%	Reduce cross slope to be no steeper than 1:50 (2.00%). (Cost based on 8' by 4' wide concrete to fix slope.)	1	84	\$84
2	Route to Main Entrance From Parking	Ext.		Exterior Access Route	Exterior

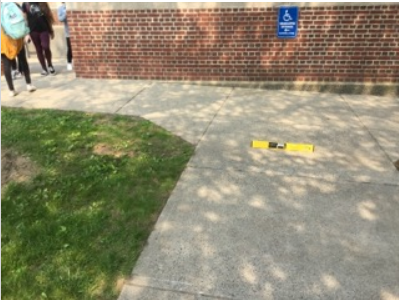
Cross slope > 1:50 (2.00%)	3.3%	Reduce cross slope to be no steeper than 1:50 (2.00%). (Cost based on 4' by 4' concrete to fix slope.)	1	42	\$42
3	Route to Exits #5 and #6	Ext.		Exterior Access Route	Exterior

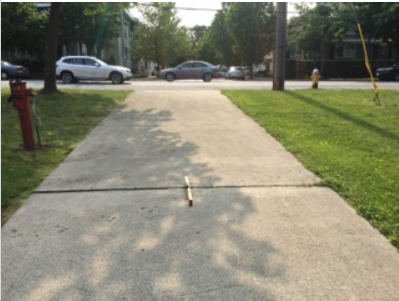
Running slope > 1:20 (5%)	7.6%	Reduce running slope to be no steeper than 1:20 (5%). (Cost based on 10' by 4' wide concrete to fix slope.)	1	105	\$105
4	At Upper Playground	Ext.		Exterior Access Route	Exterior

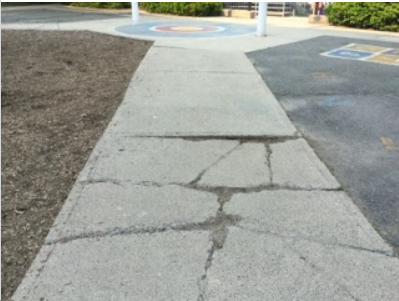
Route not maintained in operable working condition	-	Repair surface to ensure is maintained in operable working condition. (Cost based on 3' by 3' path of concrete.)	1	155	\$155

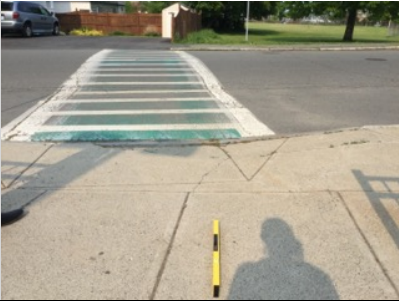
Curb Ramp												
5	East Side Entrance, Near Playgrounds	Ext.		Curb Ramp	Perpendicular

Running slope > 1:12 (8.33%) Landing not provided at top of curb ramp	17.7% 5.7%	Reduce running slope to be no steeper than 1:12 (8.33%). Provide landing at top of curb ramp or reconfigure ramp.	1	2800	\$2800

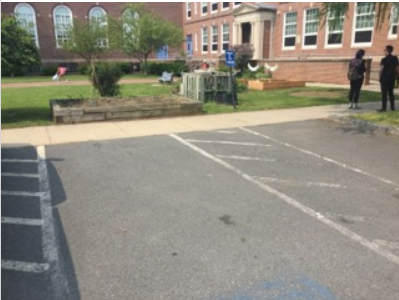
ID	Location	Floor	Room	Element	Type	Photo	Issues	Current Measure	Recommendations	Quantity	Price	Cost Estimation
Off-Street Parking Lot or Garage												
6	Parking Lot	Ext.		Off-Street Parking Lot or Garage	N/A

Total # of parking Total # of designated accessible parking spaces Access aisle < 96" wide at van space Sign does not have the designation "Van Accessible"	17 2 66" -	Provide a marked access aisle that is at least 96" wide. Add the designation "Van Accessible" to the sign located at the van accessible space.	1	600	\$600
Entrance												
7	Exit #1, Main Entrance	Ext.		Entrance	Main Entrance

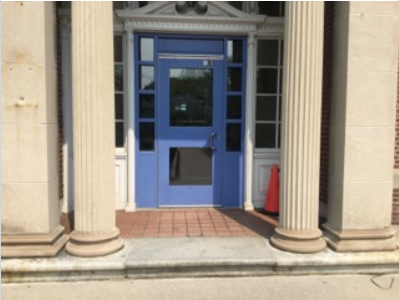
Directional sign to accessible entrance not provided	-	Provide a directional sign indicating the location of the nearest accessible entrance.	1	260	\$260
Emergency Exit												
8	Exit #5	Ext.		Emergency Exit	N/A

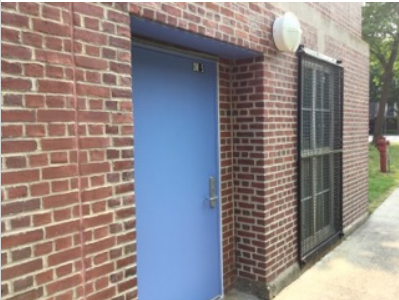
Directional sign to accessible emergency exit not provided		Provide a directional sign on the interior of the door indicating the location of the nearest emergency exit.	1	174	\$174

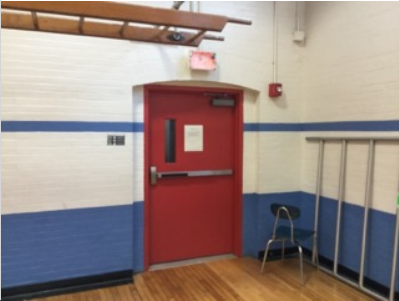
9	Exit From Gym to Stairs	SB	001	Emergency Exit	111

Directional sign to accessible emergency exit not provided	-	Provide a directional sign indicating the location of the nearest emergency exit.	1	174	\$174
10	Exit #4	1		Emergency Exit	N/A

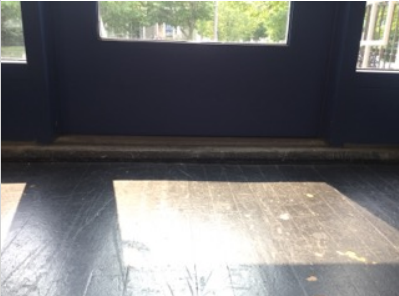
Threshold > 3/4" high	1.5"	Alter threshold to be 3/4" high max.	3	113	\$339

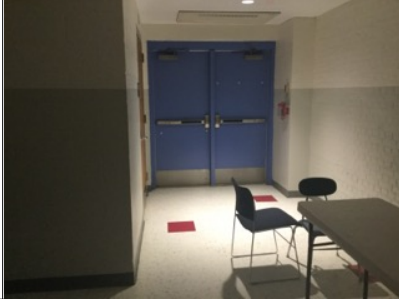
ID	Location	Floor	Room	Element	Type	Photo	Issues	Current Measure	Recommendations	Quantity	Price	Cost Estimation
Access to Goods and Services												
Means of Egress												
11	Exit #8, Near Elevator	B		Means of Egress	N/A

Illuminated exit sign not provided Tactile exit sign not provided	- -	Ensure an illuminated exit sign with the International Symbol of Accessibility (ISA) is provided at exit door. Ensure a tactile exit sign with raised characters and braille is provided at exit door. Mount sign between 48"- 60" above finished floor located on the latch side of the door.	1	274	\$274
12	Route to Accessible Entrance. Exit #2, From Hallway	1		Means of Egress	N/A

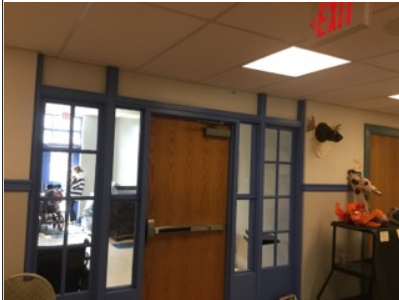
Illuminated sign lacks the International Symbol of Accessibility Tactile exit sign not provided	- -	Ensure illuminated exit sign contains the International Symbol of Accessibility (ISA). Ensure a tactile exit sign with raised characters and braille is provided at exit door. Mount sign between 48"- 60" above finished floor located on the latch side of the door.	1	274	\$274

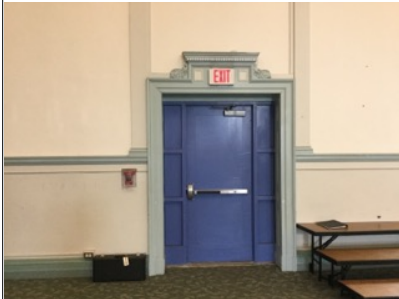
13	Exit #3	1	102	Means of Egress	N/A

Illuminated sign lacks the International Symbol of Accessibility B. Tactile exit sign not provided	- -	Ensure illuminated exit sign contains the International Symbol of Accessibility (ISA). Ensure a tactile exit sign with raised characters and braille is provided at exit door. Mount sign between 48"- 60" above finished floor located on the latch side of the door.	1	274	\$274
14	Exit #13	Ext.		Means of Egress	N/A

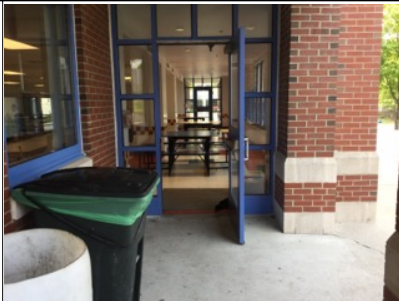
Illuminated sign lacks the International Symbol of Accessibility B. Tactile exit sign not provided	- -	Ensure illuminated exit sign inside contains the International Symbol of Accessibility (ISA). Ensure a tactile exit sign with raised characters and braille is provided on the interior of exit doors. Mount sign between 48"- 60" above finished floor located on the latch side of the door.	1	274	\$274
15	Exit #11	Ext.		Means of Egress	N/A

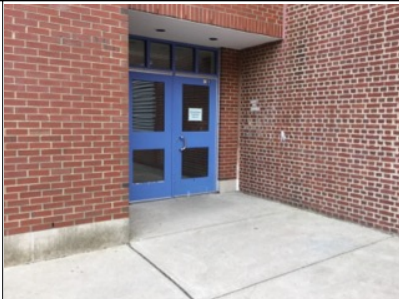
Illuminated sign lacks the International Symbol of Accessibility B. Tactile exit sign not provided	- -	Ensure illuminated exit inside sign contains the International Symbol of Accessibility (ISA). Ensure a tactile exit sign with raised characters and braille is provided on the interior of exit door. Mount sign between 48"- 60" above finished floor located on the latch side of the door.	1	274	\$274

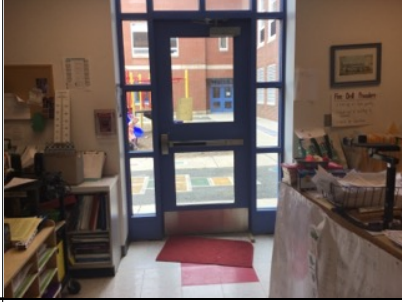
Illuminated sign lacks the International Symbol of Accessibility B. Tactile exit sign not provided	- -	Ensure illuminated exit sign contains the International Symbol of Accessibility (ISA). Ensure a tactile exit sign with raised characters and braille is provided at exit door. Mount sign between 48"- 60" above finished floor located on the latch side of the door.	1	274	\$274
17	Exit #10	B	08	Means of Egress	N/A

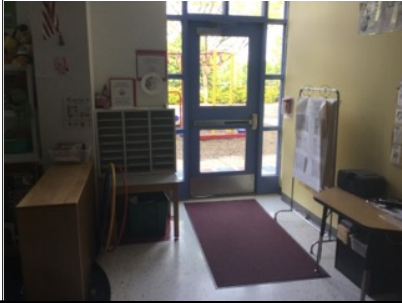
Illuminated sign lacks the International Symbol of Accessibility B. Tactile exit sign not provided	- -	Ensure illuminated exit sign contains the International Symbol of Accessibility (ISA). Ensure a tactile exit sign with raised characters and braille is provided at exit door. Mount sign between 48"- 60" above finished floor located on the latch side of the door.	1	274

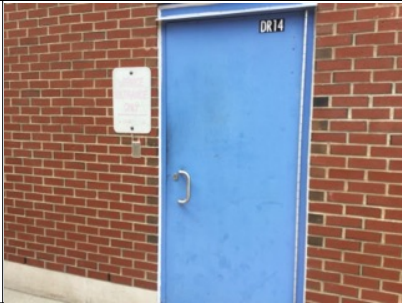
18	Exit #14	Ext.		Means of Egress	N/A

Emergency exit not on an accessible route	-	Provide a directional sign on the interior of the door indicating the location of the nearest emergency exit.	1	174	\$174
19	Exit #4	1		Means of Egress	N/A

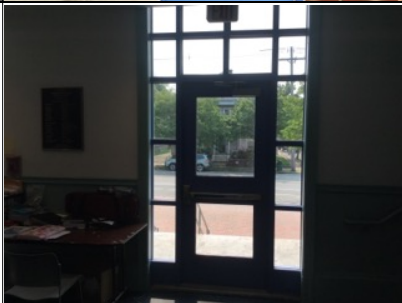
Tactile exit sign not provided Directional sign to accessible emergency exit not provided	- -	Ensure tactile exit signs with raised characters and braille are provided at exit doors. Mount signs between 48"- 60" above finished floor located on the latch side of the door. Provide a directional sign indicating the location of the nearest emergency exit. (Cost based on 3 tactile signs and one directional sign.)	1	696	\$696
20	Exit #16 in Stair #2	1	122	Means of Egress	N/A

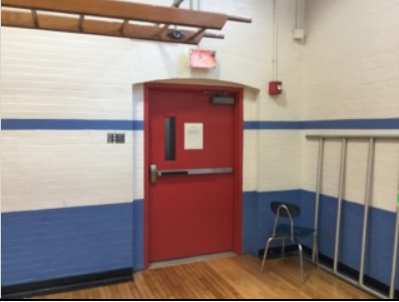
ID	Location	Floor	Room	Element	Type	Photo	Issues	Current Measure	Recommendations	Quantity	Price	Cost Estimation
21	Exit From Gym to Stairs	SB	001	Means of Egress	N/A

Tactile exit sign not provided Directional sign to accessible emergency exit not provided	- -	Ensure a tactile exit sign with raised characters and braille is provided at exit door. Mount sign between 48"- 60" above finished floor located on the latch side of the door. Provide a directional sign indicating the location of the nearest emergency exit.	1	348	\$348
22	Exit #15, Near Kitchen	B		Means of Egress	N/A
