City of Salem, Massachusetts

PART A – Executive Summary

Part A – Executive Summary

Introduction

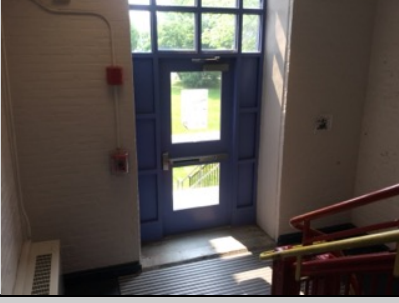
23	Exit #6 in Stair #1	1		Means of Egress	N/A

Tactile exit sign not provided Directional sign to accessible emergency exit not provided Mat not securely attached	- - -	Ensure a tactile exit sign with raised characters and braille is provided at exit door. Mount signs between 48"- 60" above finished floor located on the latch side of the door. Provide a directional sign indicating the location of the nearest emergency exit. Securely attach mat.	1	348	\$348
Interior Access Route												
24	Classroom	1	110	Interior Access Route	N/A

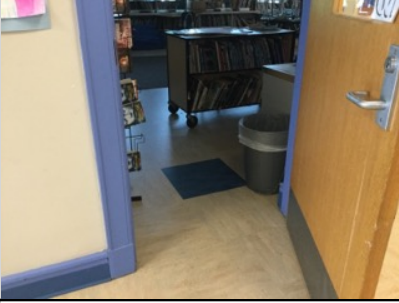
Route < 36" wide	25"	Ensure that a clear width of 36" min. is maintained at the accessible route.	1	Labor	\$0
25	Art Room	1	109	Interior Access Route	N/A

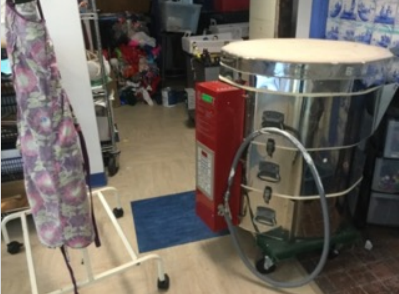
Route < 36" wide	-	Relocate drinking rack to maintain the 36" min. clear width at the accessible route.	1	Labor	\$0

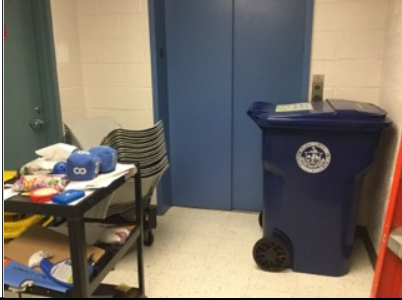
ID	Location	Floor	Room	Element	Type	Photo	Issues	Current Measure	Recommendations	Quantity	Price	Cost Estimation
26	Near Gym and Stair #1	SB		Interior Access Route	N/A

Route < 36" wide	-	Relocate trash bin and other equipment to maintain the 36" min. clear width at the accessible route and the maneuvering clearance at the elevator.	1	Labor	\$0
27	Norman H. Read Discover Center	2	206	Interior Access Route	N/A

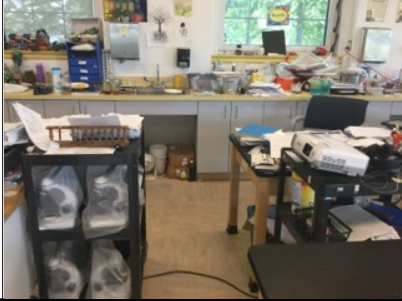
Route < 36" wide	23"	Relocate microscope cart to maintain the 36" min. clear width at the accessible route.	1	Labor	\$0
28	Math Classroom	2	205	Interior Access Route	N/A

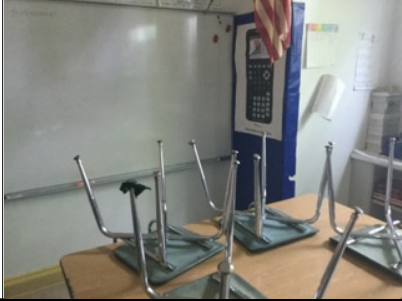
Route < 36" wide	20"	Rearrange desks to ensure the 36" min. clear width is maintained at the accessible route.	1	Labor	\$0
29	One on One Room	2	224	Interior Access Route	N/A

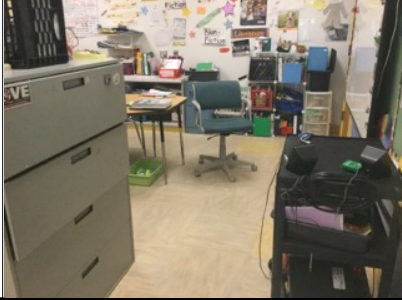
Route < 36" wide	30"	Ensure that a clear width of 36" min. is maintained at the accessible route by relocating cart.	1	Labor	\$0

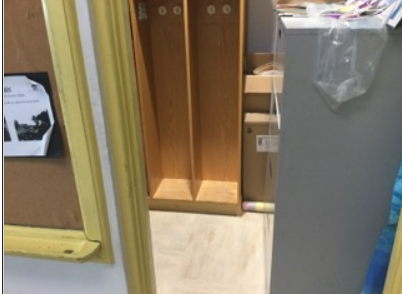
30	Classroom	2	221	Interior Access Route	N/A

Route < 36" wide	18"	Relocate cabinet to ensure the 36" min. clear width is maintained at the accessible route.	1	Labor	\$0

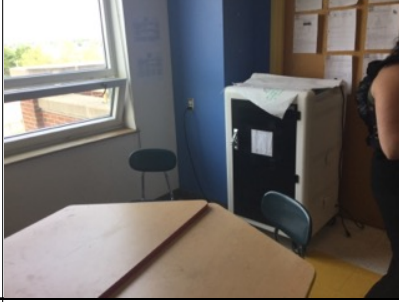
ID	Location	Floor	Room	Element	Type	Photo	Issues	Current Measure	Recommendations	Quantity	Price	Cost Estimation
31	Classroom	2	214	Interior Access Route	N/A

Route < 36" wide	25"	Ensure that a clear width of 36" min. is maintained at the accessible route.	1	Labor	\$0
32	Classroom	1	123	Interior Access Route	N/A

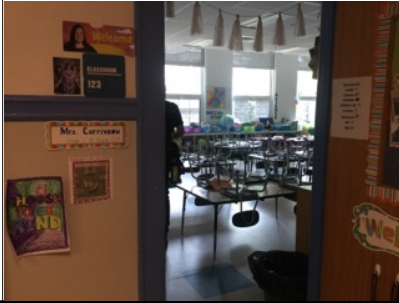
Obstructed by protruding objects	69"	Relocate tassles.	1	Labor	\$0
33	Vestibule With Exit #4	1		Interior Access Route	N/A

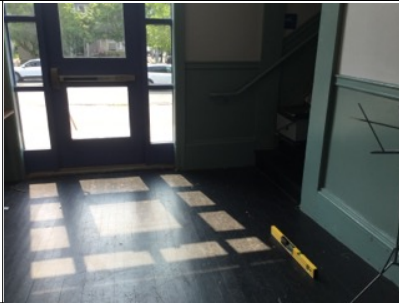
Running slope > 1:20 (5%)	6.5%	While not technically complaint, this space is still usable.	1	-	\$0
34	Routes Into Gym	SB	001	Interior Access Route	N/A

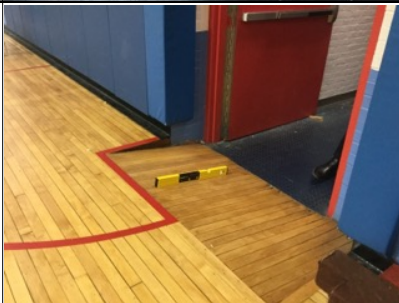
Running slope > 1:20 (5%)	11.9%	Provide compliant handrails with 1 1/4"- 2" circular cross sections. While slope is still technically not compliant, it is generally usable. (Cost based on two handrails per entrance at 3' long.)	2	198	\$396
35	Vestibule With Exit #4	1		Interior Access Route	N/A

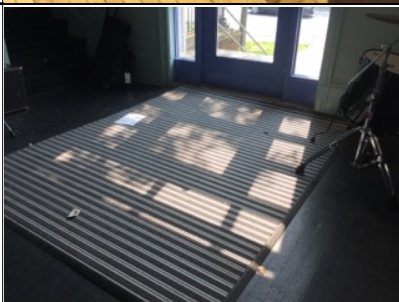
Mat not securely attached	-	Securely attach mats.	2	Labor	\$0

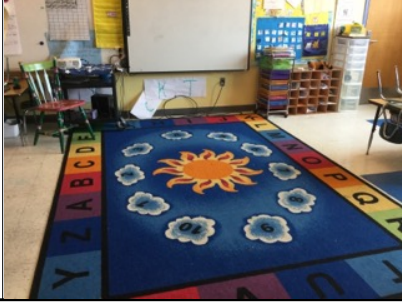
Mat not securely attached	-	Securely attach mats.	19	Labor	\$0
Doors, Doorways, & Gates												
37	Reading Room	1	107	Doors, Doorways, & Gates	Classroom

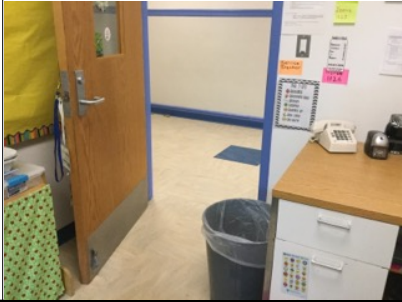
Maneuvering clearance(s) not provided	11"	Relocate trash can and rearrange furniture to maintain the maneuvering clearance at the door.	1	Labor	\$0
38	One on One Room	1	108	Doors, Doorways, & Gates	Classroom

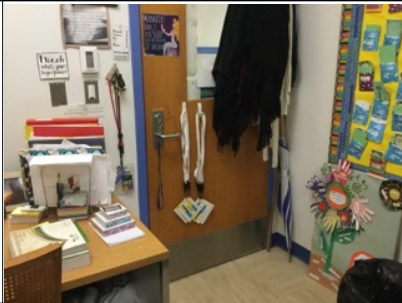
Maneuvering clearance(s) not provided	9.5"	Rearrange furniture to maintain the maneuvering clearance at the door.	1	Labor	\$0
39	Office	1	128	Doors, Doorways, & Gates	Office

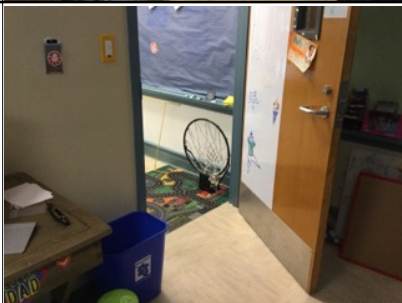
Maneuvering clearance(s) not provided	-	Relocate trash can and desk to maintain the maneuvering clearance at the door.	1	Labor	\$0
40	Cafeteria	B		Doors, Doorways, & Gates	N/A

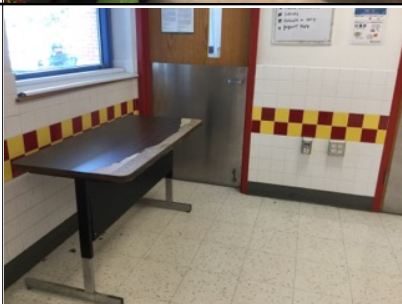
Maneuvering clearance(s) not provided	-	Relocate table to maintain the maneuvering clearance at the door.	1	Labor	\$0

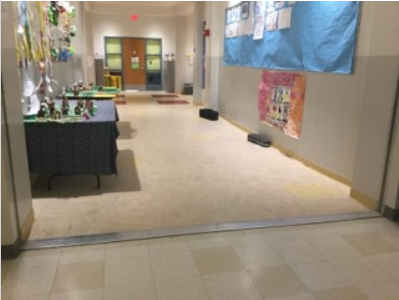
ID	Location	Floor	Room	Element	Type	Photo	Issues	Current Measure	Recommendations	Quantity	Price	Cost Estimation
41	Hallway Near #216	2		Doors, Doorways, & Gates	Circulation

Threshold not beveled	-	Bevel threshold.	1	113	\$113
42	Boys' Toilet Room Near #214	2		Doors, Doorways, & Gates	N/A

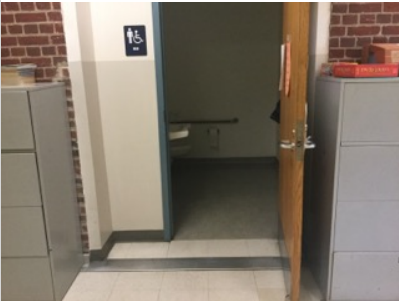
Threshold not beveled	-	Bevel threshold at metal plate near the entrance to the toilet room.	1	113	\$113
43	Music Room	B	018	Doors, Doorways, & Gates	Classroom

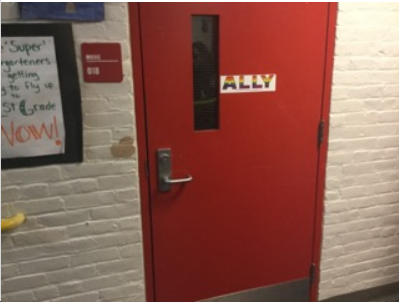
Door requires > 5 lbs. of force to open	17 lbs.	Adjust closer so door does not require more than 5 pounds of force to open.	1	Labor	\$0
Stairways												
44	Stairs to Balcony in Auditorium	1		Stairways	Interior

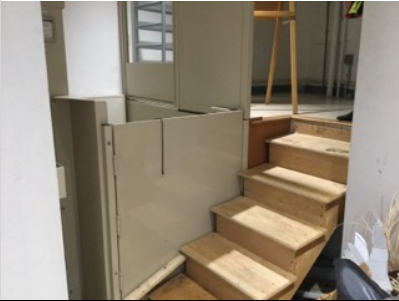
Not in operable working condition	-	Redesign this area to provide a clear floor space at the lift and an accessible route to the stage.	1	-	\$0

The lift that provides users access to the auditorium stage was not in operable working condition at the time of the survey, due to a set of stairs to the auditorium that are in the way of the door at the lower level. The school’s elevator has call buttons that are located higher than the maximum 42” allowed.

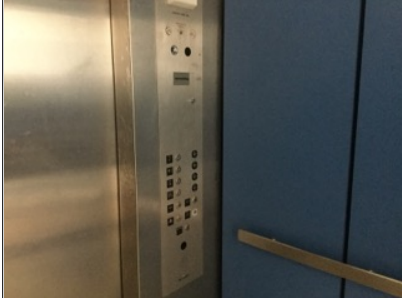
ID	Location	Floor	Room	Element	Type	Photo	Issues	Current Measure	Recommendations	Quantity	Price	Cost Estimation
Elevator												
46	Elevator	1		Elevator	Interior

Emergency communication systems > 48"	65"	Lower the emergency call "Cancel" button to 48" max. above the floor.	1	1446	\$1446
Signage												
47	Classroom	1	122	Signage	Designation

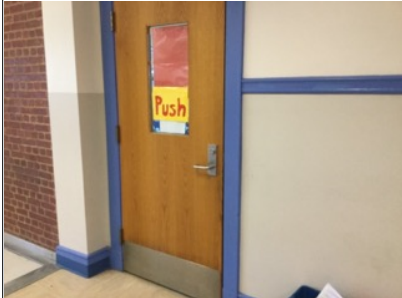
Not provided	-	Provide text with raised characters duplicated in braille. Locate sign alongside the door on the latch side.	1	174	\$174
48	Door to Rooms #127 and #128	1		Signage	Directional

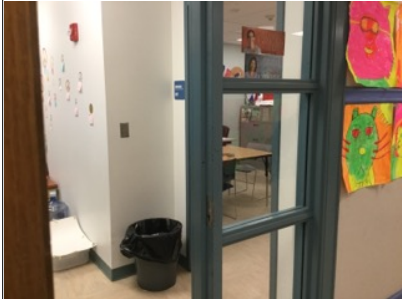
Not provided	-	Provide text with raised characters duplicated in braille. Locate sign alongside the door on the latch side.	1	174	\$174
49	Near Room #111	1		Signage	Designation

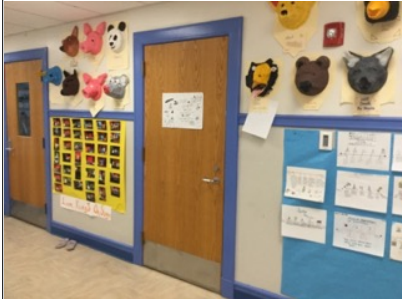
Not provided	-	Provide text with raised characters duplicated in braille. Locate sign alongside the door on the latch side.	1	174	\$174
50	Classroom	1	101	Signage	Designation

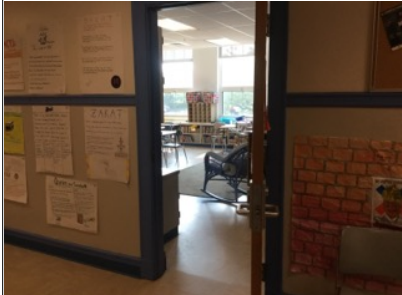
Not provided	-	Provide text with raised characters duplicated in braille. Locate sign alongside the door on the latch side.	1	174	\$174

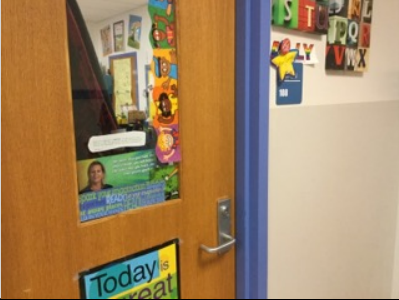
Not maintained in operable working condition	-	Remove paper to ensure sign is usable by people who are blind or low vision.	1	0	\$0
53	Classroom	1	119	Signage	Designation

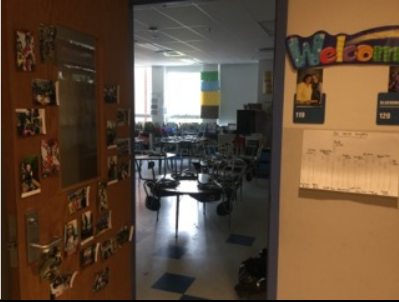
Not maintained in operable working condition	-	Remove paper to ensure sign is usable by people who are blind or low vision.	1	0	\$0
54	Toilet Room Near Room #123	1	123	Signage	Designation

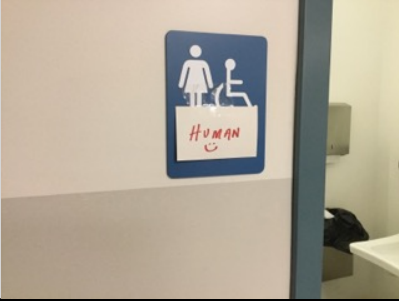
Not maintained in operable working condition	-	Remove paper to ensure sign is usable by people who are blind or low vision.	1	0	\$0
Operable Parts												
55	Norman H. Read Discover Center	2	206	Operable Parts	Other

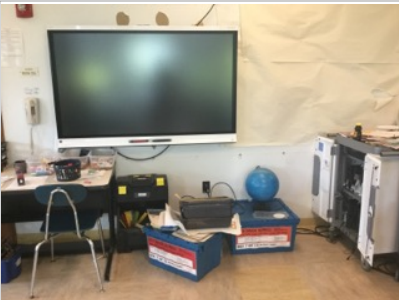
Clear floor space is not provided	-	Ensure a 30" min. by 48" min. clear floor space is provided at smart board.	1	Labor	\$0

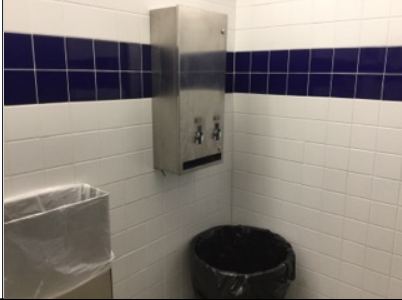
ID	Location	Floor	Room	Element	Type	Photo	Issues	Current Measure	Recommendations	Quantity	Price	Cost Estimation
56	Girls' Toilet Room	1		Operable Parts	Other

Not operable with a closed fist	-	Provide hardware that can be operable with one hand and not require tight grasping, pinching, or twisting of the wrist.	1	150	\$150
Dining or Work Surfaces												
57	Norman H. Read Discover Center	2	206	Dining or Work Surfaces	Work Surface

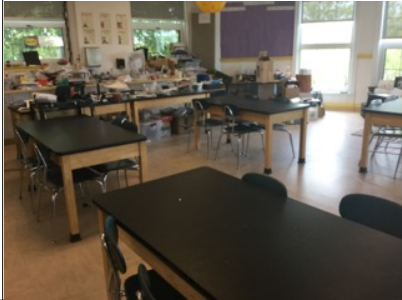
At least one or 5% accessible tables not provided Knee or toe clearance not provided	- 23"	Ensure that at least one work surface is accessible. Provide at least one work surface with 27" min. knee and toe clearance.	1	525	\$525
58	Classroom	2	207	Dining or Work Surfaces	Work Surface

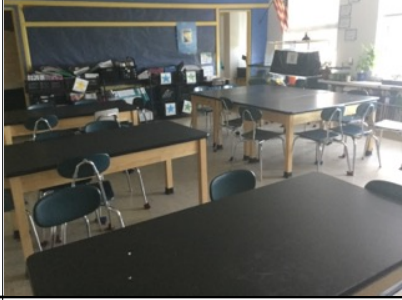
At least one or 5% accessible tables not provided Knee or toe clearance not provided	- 23"	Ensure that at least one work surface is accessible. Provide at least one work surface with 27" min. knee and toe clearance.	1	525	\$525

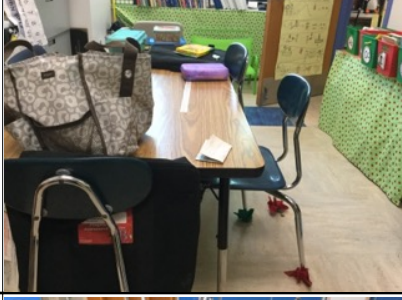
59	Reading Room	1	107	Dining or Work Surfaces	Work Surface

Knee or toe clearance not provided	24"	Adjust work surface to have 27" min. knee and toe clearance.	1	Labor	\$0
60	Classroom	1	120	Dining or Work Surfaces	Work Surface

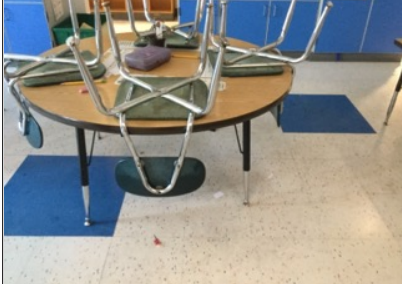
Knee or toe clearance not provided	22.25"	Adjust at least 1 work surface to have 27" min. knee and toe clearance.	1	Labor	\$0

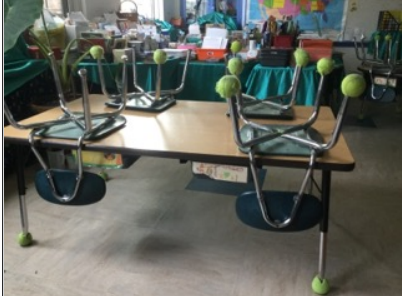
ID	Location	Floor	Room	Element	Type	Photo	Issues	Current Measure	Recommendations	Quantity	Price	Cost Estimation
61	Classroom	1	122	Dining or Work Surfaces	Work Surface

Knee or toe clearance not provided	22"	Adjust at least 1 work surface to have 27" min. knee and toe clearance.	1	Labor	\$0
62	Classroom	1	123	Dining or Work Surfaces	Work Surface

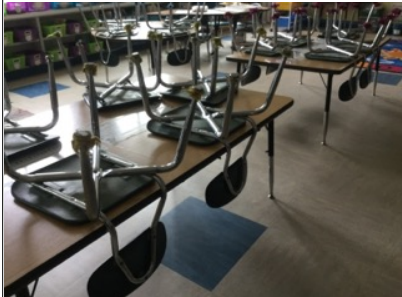
Knee or toe clearance not provided	21.75"	Adjust at least 1 work surface to have 27" min. knee and toe clearance.	1	Labor	\$0
63	Classroom, Chill Zone Desk	2	207	Dining or Work Surfaces	Work Surface

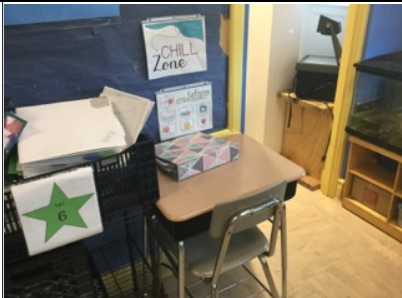
Knee or toe clearance not provided	-	Provide at least 1 work surface with 27" min. knee and toe clearance.	1	525	\$525
64	Classroom	2	221	Dining or Work Surfaces	Work Surface

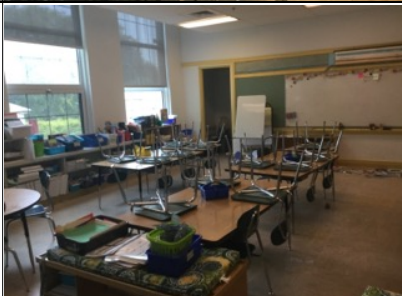
Knee or toe clearance not provided	24"	Adjust at least 1 work surface to have 27" min. knee and toe clearance.	1	Labor	\$0
Picnic Tables												
65	Picnic Tables Near Upper Playground	Ext.		Picnic Tables	N/A

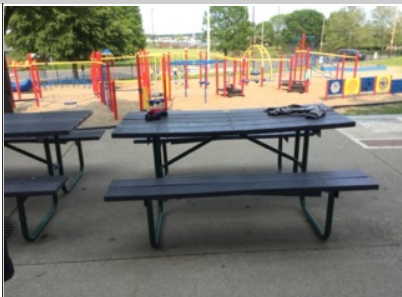
At least 5% accessible spaces not provided	-	Ensure that at least 5% (minimum one) of dining surfaces are accessible.	1	1050	\$1050

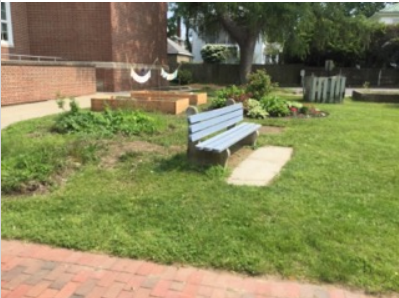
ID	Location	Floor	Room	Element	Type	Photo	Issues	Current Measure	Recommendations	Quantity	Price	Cost Estimation
Benches												
66	Bench Near Main Entrance	Ext.		Benches	N/A

Not connected to an accessible route	-	Ensure that at least one of the benches in this area is on an accessible route.	1	117	\$117
67	Bench Near Playground	Ext.		Benches	N/A

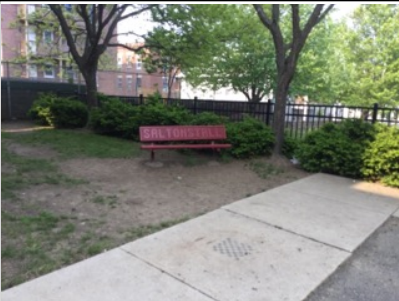
Not connected to an accessible route	-	Ensure bench is located on an accessible route.	1	117	\$117
Toilet & Bathing Rooms												
Lavatory												
68	Toilet Room in Nurse's Office	1	126A	Lavatory	N/A

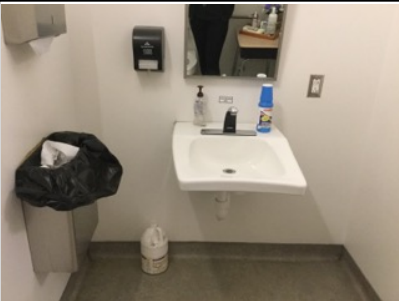
Mirror above lavatory w/reflective surface > 40"	42.25"	Lower mirror so that the bottom surface is at 40" max. above finished floor.	1	192	\$192

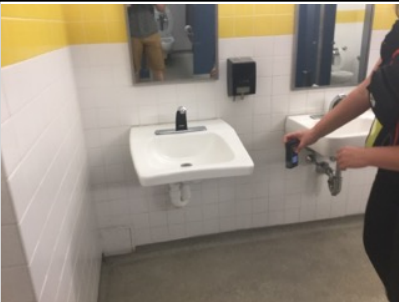
70	Girls' Toilet Room	2		Lavatory	N/A

Mirror above lavatory w/reflective surface > 40"	42"	Lower mirror so that the bottom surface is at 40" max. above finished floor.	1	192	\$192

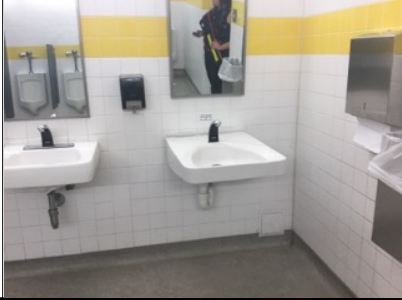
ID	Location	Floor	Room	Element	Type	Photo	Issues	Current Measure	Recommendations	Quantity	Price	Cost Estimation
71	Boys' Toilet Room	2		Lavatory	N/A

Mirror above lavatory w/reflective surface > 40"	42"	Lower mirror so that the bottom surface is at 40" max. above finished floor.	1	192	\$192
72	Girls' Toilet Room Near #221	2		Lavatory	N/A

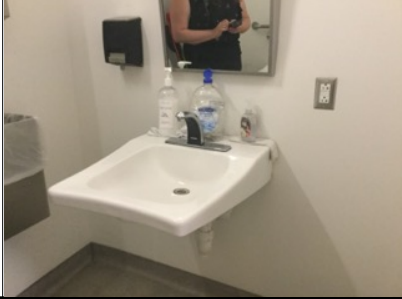
Mirror above lavatory w/reflective surface > 40"	43"	Lower mirror so that the bottom surface is at 40" max. above finished floor.	1	192	\$192
73	Boys' Toilet Room Near #214	2		Lavatory	N/A

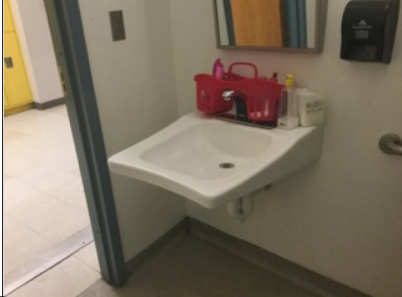
Mirror above lavatory w/reflective surface > 40"	44"	Lower mirror so that the bottom surface is at 40" max. above finished floor.	1	192	\$192
74	Toilet Room	B	024	Lavatory	N/A

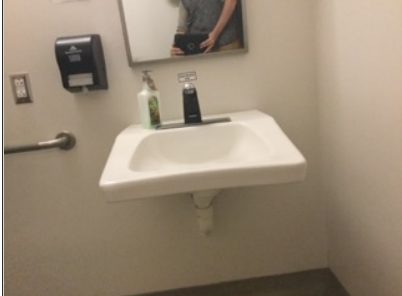
Mirror above lavatory w/reflective surface > 40"	42"	Lower mirror so that the bottom surface is at 40" max. above finished floor.	1	192	\$192
75	Boys' Toilet Room Near Cafeteria	B	028	Lavatory	N/A

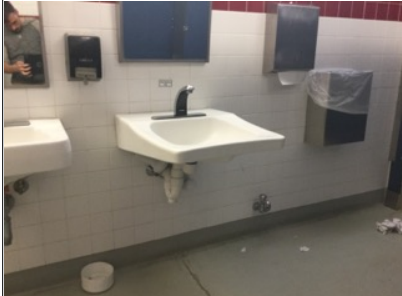
Mirror above lavatory w/reflective surface > 40"	42"	Lower mirror so that the bottom surface is at 40" max. above finished floor.	1	192	\$192

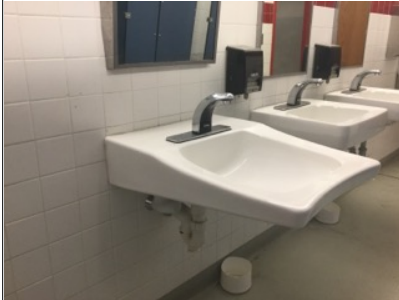
ID	Location	Floor	Room	Element	Type	Photo	Issues	Current Measure	Recommendations	Quantity	Price	Cost Estimation	
76	Girls' Toilet Room Near Cafeteria	B	027	Lavatory	N/A

Mirror above lavatory w/reflective surface > 40"	42"	Lower mirror so that the bottom surface is at 40" max. above finished floor.	1	192	\$192	
Single-User Toilet													
77	Toilet Room in Nurse's Office	1	126A	Single-User Toilet	N/A

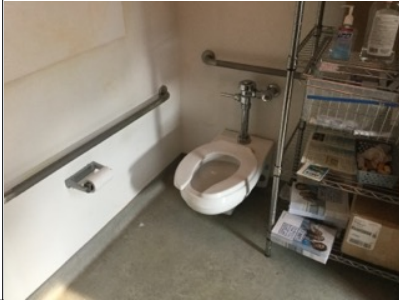
Toilet seat < 17" or > 19" high Flush control not on open side Side or rear grab bar < 33" or > 36" high Clearance at toilet < 60" clear width	15.25" - 23.25" -	Install a toilet with a seat between 17"- 19" high above the finished floor. Relocate the flush control to the open side. Mount grab bars 33"- 36" above the floor. Remove storage to maintain the required 60" min. clear floor at the toilet.	1	2290 Labor		\$2290
78	Toilet Room	B	024	Single-User Toilet	N/A

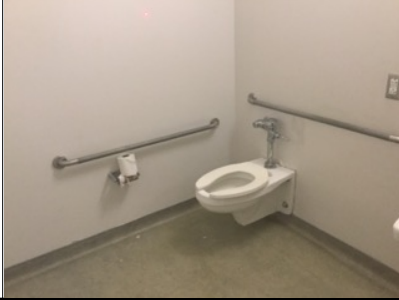
Side or rear grab bar < 33" or > 36" high	24"	Mount side grab bar 33"- 36" above the floor.	1	384		\$384

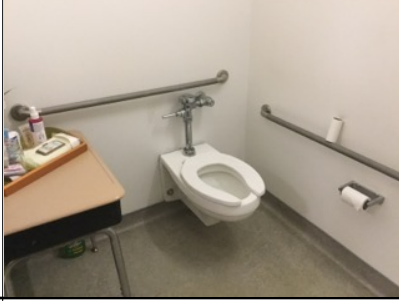
79	Toilet Room Near Room 123	1		Single-User Toilet	N/A

Side or rear grab bar < 33" or > 36" high Clearance at toilet < 60" clear width	25" -	Mount side grab bar 33"- 36" above the finished floor. Remove desk to maintain the 60" min. clear floor space at the toilet.	1	384 Labor		\$384
80	Girls' and Boys' Toilet Rooms Near 221	2		Single-User Toilet	N/A

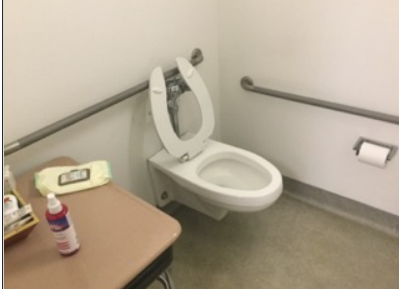
Side or rear grab bar < 33" or > 36" high Clearance at toilet < 60" clear width	26" -	Mount side grab bar 33"- 36" above the finished floor. Remove desk to maintain the 60" min. clear floor space at the toilet.	2	384 Labor	\$768

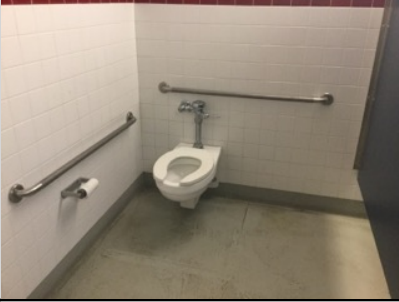
ID	Location	Floor	Room	Element	Type	Photo	Issues	Current Measure	Recommendations	Quantity	Price	Cost Estimation
Toilet Compartment												
81	Boys' Toilet Room Near Cafeteria	B	028	Toilet Compartment	Accessible Compartment

Door has malfunctioning self-closing hinge Side or rear grab bar < 33" or >36" high	- 24"	Repair hinge. Locate side grab bar between 33"- 36" above the finished floor.	1	384	\$384
82	Girls' Toilet Room Near Cafeteria	B	027	Toilet Compartment	Accessible Compartment

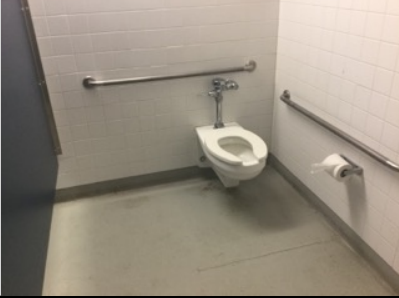
Door has malfunctioning self-closing hinge Side or rear grab bar < 33" or >36" high	- 24"	Repair hinge. Locate side grab bar between 33"- 36" above the finished floor.	1	384	\$384
83	Boys' Toilet Room	1		Toilet Compartment	Accessible Compartment

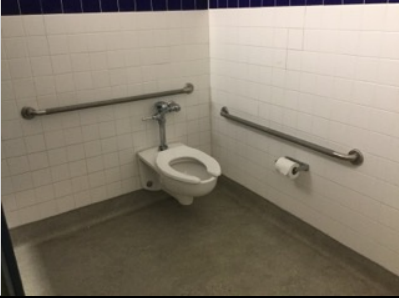
Side or rear grab bar < 33" or >36" high	24.5"	Locate grab bars between 33"- 36" above the finished floor.	1	384	\$384
84	Girls' Toilet Room	2		Toilet Compartment	Accessible Compartment

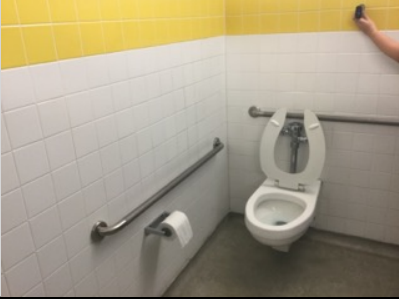
Side or rear grab bar < 33" or >36" high	25"	Locate side grab bar between 33"- 36" above the finished floor.	1	384	\$384

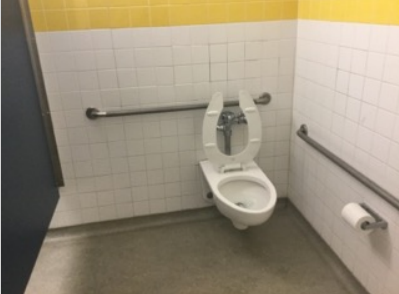
85	Boys' Toilet Room	2		Toilet Compartment	Accessible Compartment

Side or rear grab bar < 33" or >36" high	25"	Locate side grab bar between 33"- 36" above the finished floor.	1	384	\$384

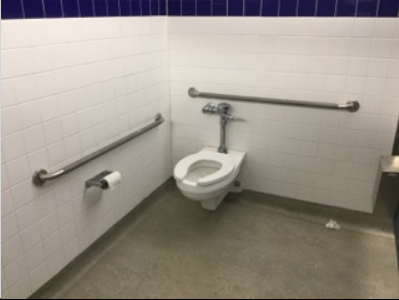
ID	Location	Floor	Room	Element	Type	Photo	Issues	Current Measure	Recommendations	Quantity	Price	Cost Estimation
86	Girls' Toilet Room	1		Toilet Compartment	Accessible Compartment

Side or rear grab bar < 33" or >36" high Coat hook > 48"	24.75" 53"	Locate side grab bar between 33"- 36" above the finished floor. Lower coat hook so that it is no higher than 48".	1	497	\$497
Additional Access												
Drinking Fountains												
87	First Floor Hallway	1		Drinking Fountains	Hi-Lo

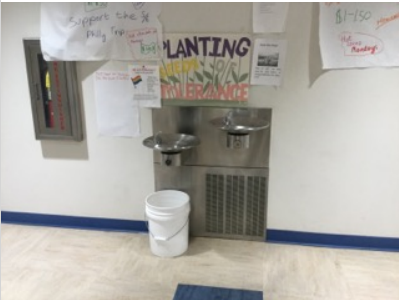
Operable parts malfunctioning Standing height fountain does not have cane protection	- -	Ensure drinking fountain is maintained in working condition. Provide a cane-detectable barrier skirt under the high unit.	1	668	\$668
88	Near Toilet Rooms	2		Drinking Fountains	Hi-Lo

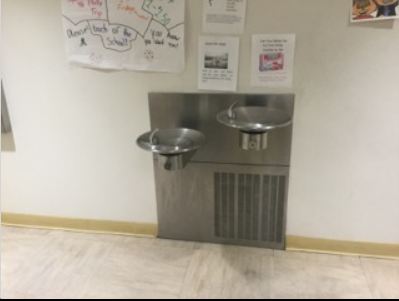
Standing height fountain does not have cane protection	-	Provide a cane-detectable barrier skirt under the high unit.	1	668	\$668

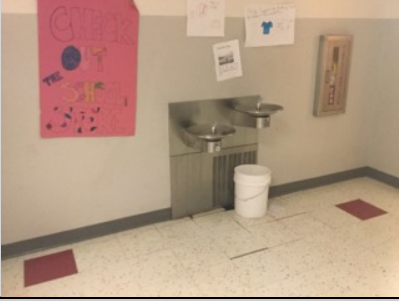
89	Near Toilet Rooms and Cafeteria	B	027	Drinking Fountains	Hi-Lo

Standing height fountain does not have cane protection	-	Provide a cane-detectable barrier skirt under the high unit.	1	668	\$668
Sink												
90	Art Room	1	109	Sink	Classroom

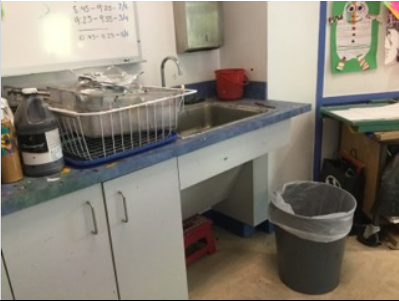
Clear floor space not provided at sink	-	Relocate trash can to maintain the 30" by 48" clear floor space positioned for a forward approach at the sink Note: This design is a good example to use at other classroom sinks throughout the school.	2	0	\$0

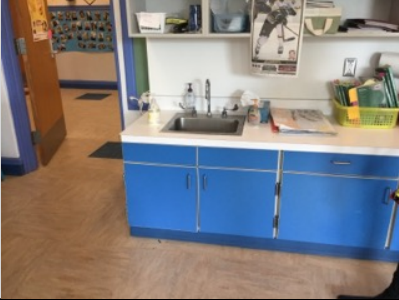
ID	Location	Floor	Room	Element	Type	Photo	Issues	Current Measure	Recommendations	Quantity	Price	Cost Estimation
91	Classrooms Throughout School	1	All	Sink	Classroom

Toe and knee clearances not provided	-	Ensure there is a 27" knee clearance positioned for a forward approach.	8	1265	\$10120
Play and Sport Areas												
Play Areas												
92	Upper Playground	Ext.		Play Areas	N/A

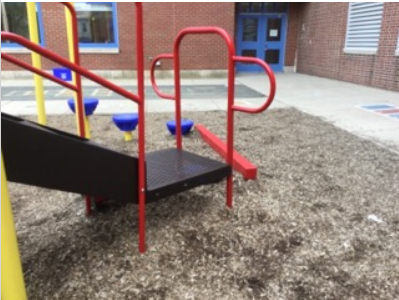
Accessible route not provided to ground level play components Surface not stable, firm, and slip-resistant	-	Ensure an accessible route that is stable, firm and slip-resistant is provided to each play component. (Cost based on 85' by 5' wide poured-in-place rubber.)	1	8925	\$8925
93	Playground, Lower Level	Ext.		Play Areas	N/A

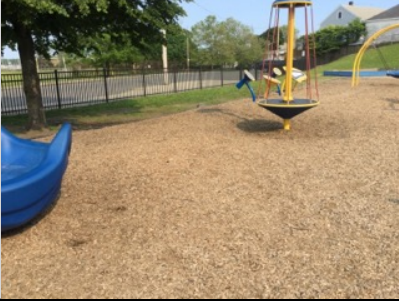
Accessible route not provided to ground level play components Surface not stable, firm, and slip-resistant	-	Ensure an accessible route that is stable, firm and slip-resistant is provided to each play component. (Cost based on 350' by 5' wide poured-in-place rubber.)	1	36750	\$36750

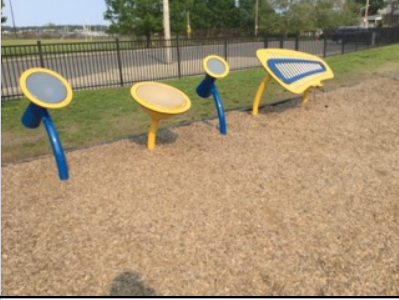
94	Playground, Lower Level	Ext.		Play Areas	N/A

Accessible route not provided to ground level play components Surface not stable, firm, and slip-resistant	-	Ensure an accessible route that is stable, firm and slip-resistant is provided to each play component. See ID #93 for cost.	1	-	\$0
95	Playground, Lower Level	Ext.		Play Areas	N/A

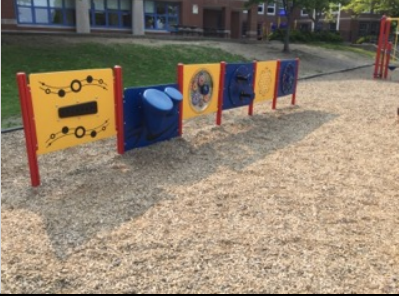
Accessible route not provided to ground level play components Surface not stable, firm, and slip-resistant	-	Ensure an accessible route that is stable, firm and slip-resistant is provided to each play component. See ID #93 for cost.	1	-	\$0

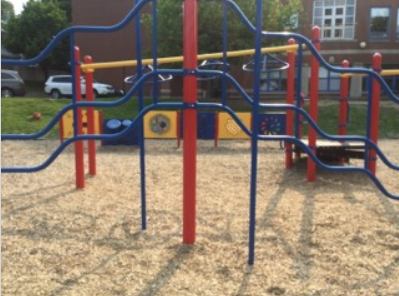
ID	Location	Floor	Room	Element	Type	Photo	Issues	Current Measure	Recommendations	Quantity	Price	Cost Estimation
96	Playground, Lower Level	Ext.		Play Areas	N/A

Accessible route not provided around the playground	-	Provide a 48" min. wide accessible route around the playground. (Cost based on 300' by 4' wide asphalt route around perimeter of playground.)	1	7650	\$7650
97	Route to Playground, Lower Level	Ext.		Play Areas	1

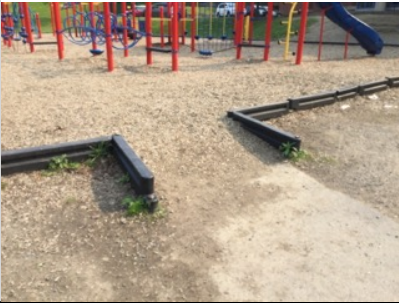
Route not maintained in operable working condition	-	Ensure the accessible route is maintained in operable working condition.	1	Labor	\$0

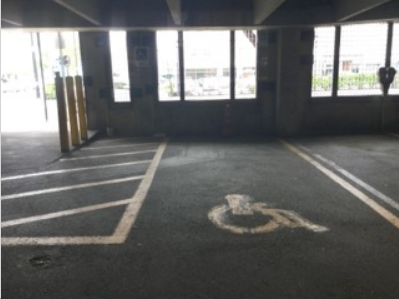
ID	Location	Floor	Room	Element	Type	Photo	Issues	Current Measure	Recommendations	Quantity	Price	Cost Estimation
Approach and Entrance												
Off-Street Parking Lot or Garage												
1	First Floor Accessible Parking	1		Off-Street Parking Lot or Garage	N/A

Vehicle space < 132" wide at van space Sign does not have the designation "Van Accessible"	93.5" -	Provide a van accessible space that is at least 132" wide with a marked access aisle at least 60" wide. Add the designation "Van Accessible" to the sign located at the van accessible space. (Cost based on restriping and a sign.)	1	600	\$600
2	Fourth Floor Accessible Parking by Elevator	4		Off-Street Parking Lot or Garage	N/A

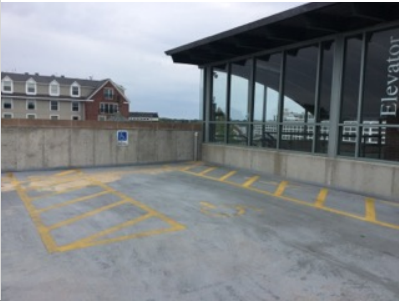
Vehicle space < 132" wide at van space Sign does not have the designation "Van Accessible" Sign bottom < 60" above finished grade	- - -	Provide a van accessible space that is at least 132" wide with a marked access aisle at least 60" wide. Add the designation "Van Accessible" to the sign located at the van accessible space. Locate sign with the bottom of the sign 60" min. and 96" max. above the ground. (Cost based on restriping and a sign.)	1	600	\$600

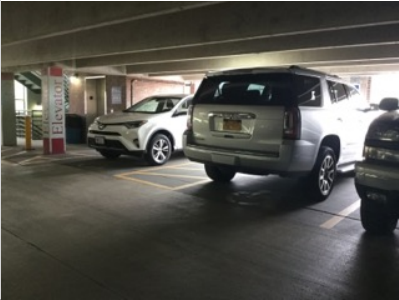
Sign not provided	-	Provide a sign with the International Symbol of Accessibility (ISA) with the bottom of the sign 60" min. above the ground and the top 96" max. above the ground.	1	375	\$375
Access to Goods and Services

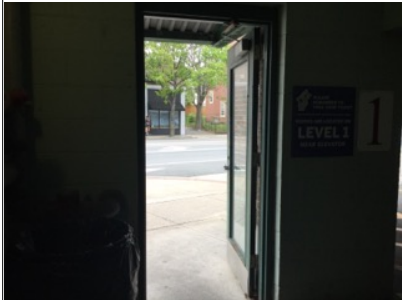
ID	Location	Floor	Room	Element	Type	Photo	Issues	Current Measure	Recommendations	Quantity	Price	Cost Estimation
Means of Egress												
5	First Floor Egress	1		Means of Egress	N/A

Illuminated exit sign not provided Illuminated International Symbol of Accessibility not provided Tactile exit sign not provided	- -	Ensure illuminated exit signs are provided at exits and exit doors. Include an illuminated International Symbol of Accessibility (ISA) on the illuminated exit sign. Ensure tactile exit signs with raised characters and braille are provided at exit doors. Mount signs between 48"- 60" above finished floor located on the latch side of the door.	1	474	\$474
6	Fourth Floor by Elevator	4		Means of Egress	N/A

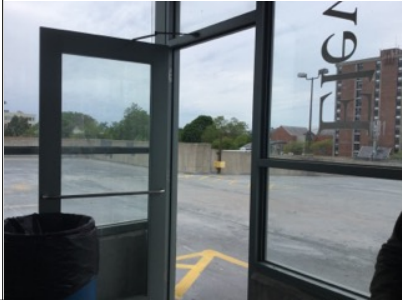
Tactile exit sign not provided	-	Ensure tactile exit signs with raised characters and braille are provided at exit doors. Mount signs between 48"- 60" above finished floor located on the latch side of the door.	1	174	\$174

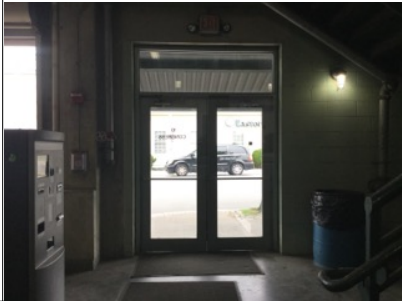
7	First Floor	1		Means of Egress	N/A

Tactile exit sign not provided Illuminated sign lacks the International Symbol of Accessibility Mat not securely attached	-	Ensure tactile exit signs with raised characters and braille are provided at exit doors. Mount signs between 48"- 60" above finished floor located on the latch side of the door. Provide an illuminated International Symbol of Accessibility (ISA) at the illuminated exit sign. Securely attach walk-off mat.	1	324	\$324
8	Fourth Floor by Elevator	4		Means of Egress	N/A

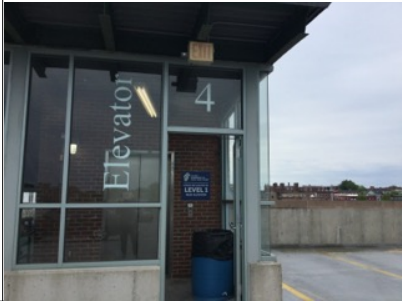
Tactile exit sign not provided Illuminated sign lacks the International Symbol of Accessibility	-	Ensure tactile exit signs with raised characters and braille are provided at exit doors. Mount signs between 48"- 60" above finished floor located on the latch side of the door. Provide an illuminated International Symbol of Accessibility (ISA) at the illuminated exit sign.	1	324	\$324

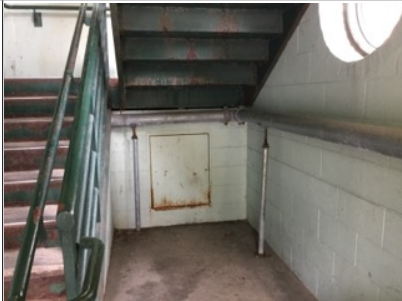
Interior Access Route												
9	Floor 1 Stairwell	1		Interior Access Route	N/A

Obstructed by protruding objects	-	Provide a cane-detectable barrier. (Cost based on a 6'x4' pipe rail under stairs.)	1	720	\$720

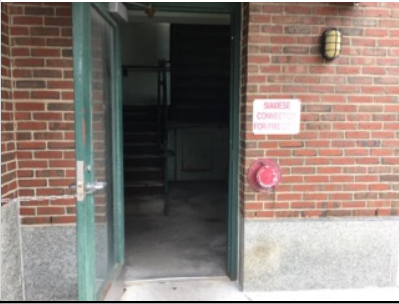
Threshold > 1/2" high	1"	Alter threshold to be 1/2" high max. (Threshold seemed be be not firm and deteriorated.)	1	113	\$113

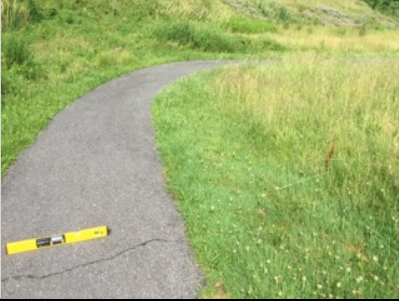
ID	Location	Floor	Room	Element	Type	Photo	Issues	Current Measure	Recommendations	Quantity	Price	Cost Estimation
Approach and Entrance												
Exterior Access Route												
1	Route to Playground	Ext.		Exterior Access Route	Exterior

Cross slope > 1:50 (2.00%) Running slope > 1:20 (5%)	4.5% 11.9%	Reduce cross slope to be no steeper than 1:50 (2.00%). Reduce running slope to be no steeper than 1:20 (5%). (Cost based on 165' by 4' wide asphalt route.)	1	4208	\$4208
2	Exit on North Side of School, Near Baseball Field	Ext.		Exterior Access Route	Exterior

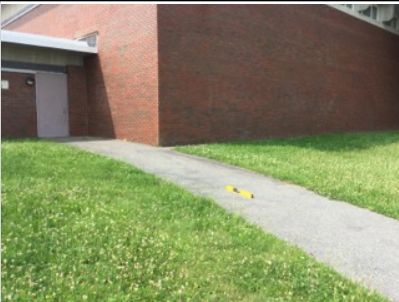
Running slope > 1:20 (5%)	6.9%	Reduce running slope to be no steeper than 1:20 (5%). (Cost based on 30' asphalt to fix slope.)	1	225	\$225
3	Courtyard Garden	1		Exterior Access Route	Exterior

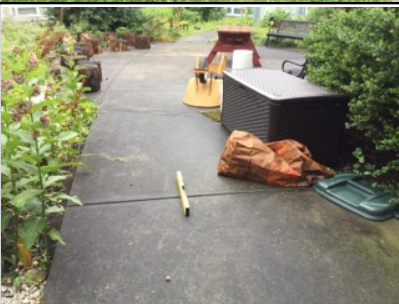
Running slope > 1:20 (5%) Edge protection < 4" high	6.5% -	Provide handrails on both sides. Provide edge protection that prevents the passage of a 4" diameter sphere, where any portion of the sphere is within 4" of the finished floor or ground surface. (Cost based on 10' of handrails on both sides of the walkway and 10' of edge protection on both sides of the walkway.)	2	960	\$1920

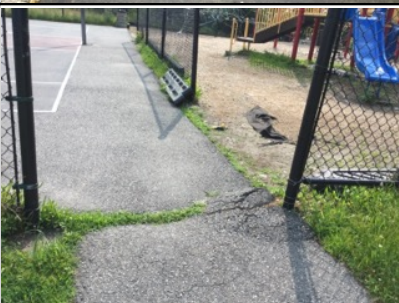
4	Entrance to Playground	Ext.		Exterior Access Route	Exterior

Level changes > 1/4"	-	Alter change in level to be 1/4" high max.	1	27	\$27
5	Westernmost Exit on North Side of School	Ext.		Exterior Access Route	Exterior

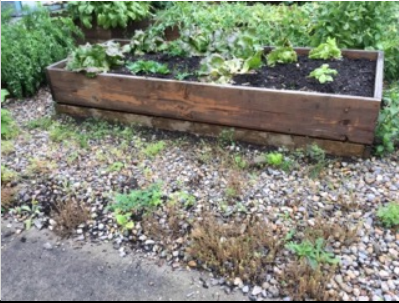
ID	Location	Floor	Room	Element	Type	Photo	Issues	Current Measure	Recommendations	Quantity	Price	Cost Estimation
6	Courtyard Garden	1		Exterior Access Route	Exterior

Accessible route not provided	-	Ensure an accessible route is provided. (Cost based on 4' by 3' asphalt patch to approach bed.)	1	78	\$78
Off-Street Parking Lot or Garage												
7	Southwest Lot Accessible Parking	Ext.		Off-Street Parking Lot or Garage	N/A

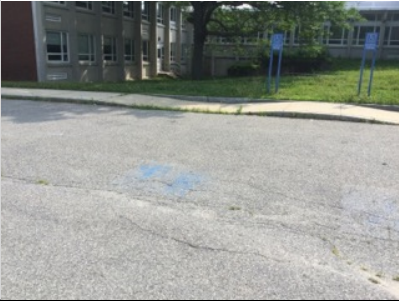
Total # of parking Total # of designated accessible parking spaces Vehicle space < 96" wide at car space Sign does not have the designation "Van Accessible"	12 3 - -	Ensure spaces and access aisles are compliant to ADA 2010:502. Add the designation "Van Accessible" to the sign located at the van accessible space. (Cost based on a Van Accessible sign. Cost to re-stripe spaces not included because lot has been re-striped since survey.)	1	375	\$375
8	Parking Lot at Main Entrance	Ext.		Off-Street Parking Lot or Garage	N/A

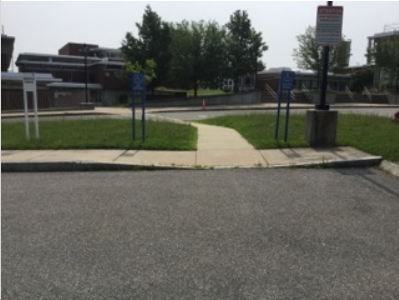
Total # of parking Total # of designated accessible parking spaces Access aisle < 96" wide at van space Sign does not have the designation "Van Accessible"	25 2 - -	Ensure spaces and access aisles are compliant to ADA 2010:502. Add the designation "Van Accessible" to the sign located at the van accessible space. Ensure van space is 132" wide min. and the access aisle is 60" wide min. (Cost based on a Van Accessible sign. Cost to re-stripe spaces not included because lot has been re-striped since survey.)	1	375	\$375

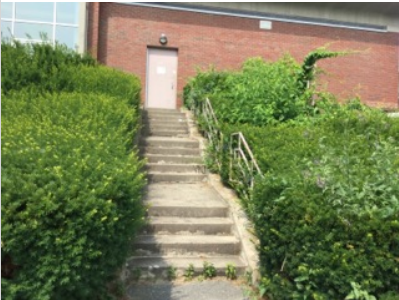
Entrance												
9	YMCA Pick Up Door	Ext.		Entrance	Other

Entrance not on an accessible route	-	Provide a directional sign indicating the location of the nearest accessible entrance.	1	260	\$260
Access to Goods and Services

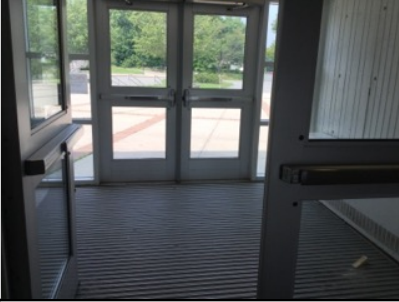
ID	Location	Floor	Room	Element	Type	Photo	Issues	Current Measure	Recommendations	Quantity	Price	Cost Estimation
Means of Egress												
10	Main Entrance	1		Means of Egress	N/A

Illuminated exit sign not provided Tactile exit sign not provided	- -	Ensure illuminated exit signs contain the International Symbol of Accessibility (ISA). Ensure tactile exit signs with raised characters and braille are provided at exit doors. Mount signs between 48"- 60" above finished floor located on the latch side of the door.	1	274	\$274
11	Gym, Exits to North Side of School	B		Means of Egress	N/A

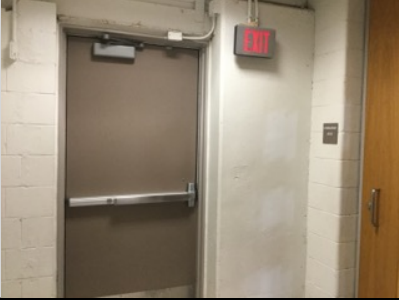
Illuminated exit sign not provided Tactile exit sign not provided	- -	Ensure illuminated exit signs contain the International Symbol of Accessibility (ISA). Ensure tactile exit signs with raised characters and braille are provided at exit doors. Mount signs between 48"- 60" above finished floor located on the latch side of the door.	2	274	\$548

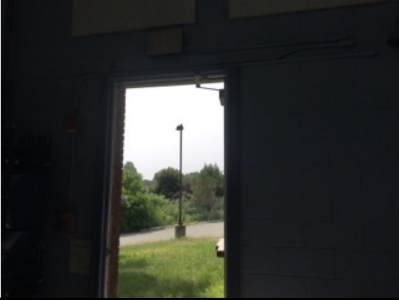
12	Cafeteria Exit, to Southeast Side of School	1	B014	Means of Egress	N/A

Illuminated exit sign not provided Tactile exit sign not provided	- -	Ensure illuminated exit signs contain the International Symbol of Accessibility (ISA). Ensure tactile exit signs with raised characters and braille are provided at exit doors. Mount signs between 48"- 60" above finished floor located on the latch side of the door.	1	274	\$274
13	Exit Near B032	1		Means of Egress	N/A

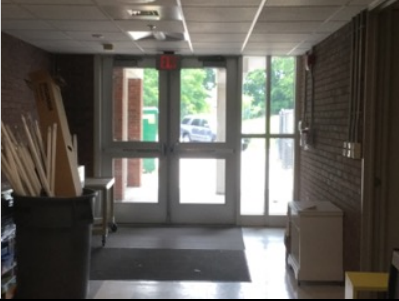
Illuminated exit sign not provided Tactile exit sign not provided	- -	Ensure illuminated exit signs contain the International Symbol of Accessibility (ISA). Ensure tactile exit signs with raised characters and braille are provided at exit doors. Mount signs between 48"- 60" above finished floor located on the latch side of the door.	1	274	\$274
14	Easternmost Exit on South Side of School	1		Means of Egress	N/A

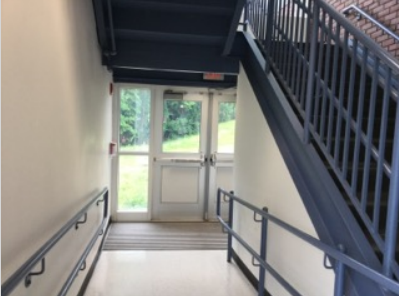
Illuminated exit sign not provided Tactile exit sign not provided	- -	Ensure illuminated exit signs contain the International Symbol of Accessibility (ISA). Ensure tactile exit signs with raised characters and braille are provided at exit doors. Mount signs between 48"- 60" above finished floor located on the latch side of the door.	1	274	\$274

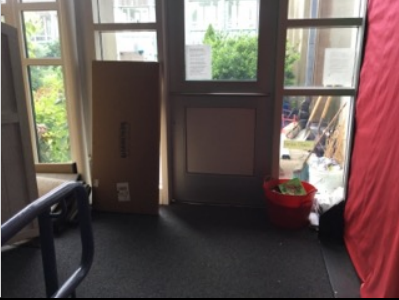
ID	Location	Floor	Room	Element	Type	Photo	Issues	Current Measure	Recommendations	Quantity	Price	Cost Estimation
15	Exits to Courtyard Garden	1	D044, Hallway	Means of Egress	N/A

Illuminated exit sign not provided Tactile exit sign not provided	- -	Ensure illuminated exit signs are provided at exits and exit doors. Ensure tactile exit signs with raised characters and braille are provided at exit doors. Mount signs between 48"- 60" above finished floor located on the latch side of the door.	2	274	\$548
16	Accessible Entrance in Stair 3	1		Means of Egress	N/A

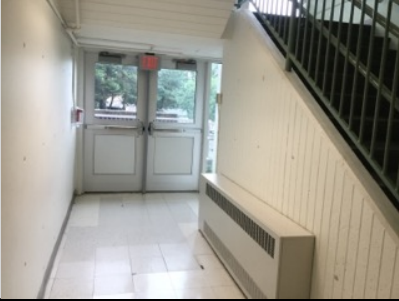
Illuminated exit sign not provided Tactile exit sign not provided	- -	Ensure illuminated exit signs contain the International Symbol of Accessibility (ISA). Ensure tactile exit signs with raised characters and braille are provided at exit doors. Mount signs between 48"- 60" above finished floor located on the latch side of the door.	1	274

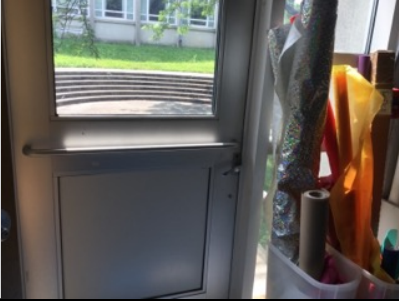
17	Exit to Courtyard on Southwest Side of School	1	C013	Means of Egress	N/A

Illuminated exit sign not provided Tactile exit sign not provided Directional sign to accessible emergency exit not provided	- - -	Ensure illuminated exit signs are provided at exits and exit doors. Ensure tactile exit signs with raised characters and braille are provided at exit doors. Mount signs between 48"- 60" above finished floor located on the latch side of the door. Provide a directional sign indicating the location of the nearest emergency exit.	1	448	\$448
18	Exit Near Gym	B		Means of Egress	N/A

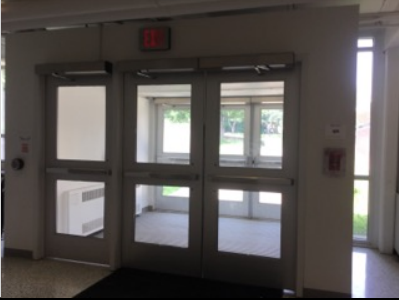
Illuminated exit sign not provided Tactile exit sign not provided Mat not securely attached	- -	Ensure illuminated exit signs contain the International Symbol of Accessibility (ISA). Ensure tactile exit signs with raised characters and braille are provided at exit doors. Mount signs between 48"- 60" above finished floor located on the latch side of the door. Securely attach mat.	1	274	\$274

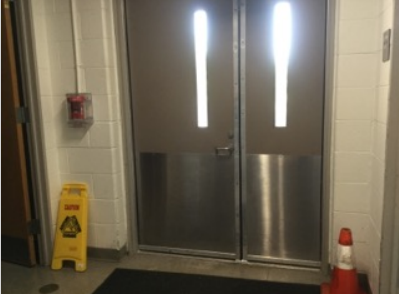
19	Loading Dock Exit	1		Means of Egress	N/A

Illuminated exit sign not provided Tactile exit sign not provided Mat not securely attached	- -	Ensure illuminated exit signs contain the International Symbol of Accessibility (ISA). Ensure tactile exit signs with raised characters and braille are provided at exit doors. Mount signs between 48"- 60" above finished floor located on the latch side of the door. Securely attach mat.	1	274	\$274

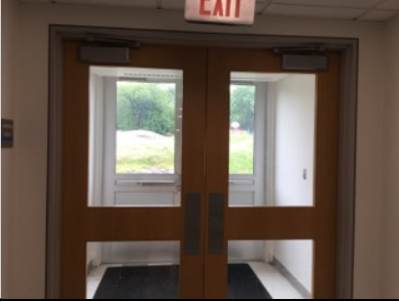
ID	Location	Floor	Room	Element	Type	Photo	Issues	Current Measure	Recommendations	Quantity	Price	Cost Estimation
20	Exit Door Near D036A	1		Means of Egress	N/A

Illuminated exit sign not provided Tactile exit sign not provided Mat not securely attached	- -	Ensure illuminated exit signs contain the International Symbol of Accessibility (ISA). Ensure tactile exit signs with raised characters and braille are provided at exit doors. Mount signs between 48"- 60" above finished floor located on the latch side of the door. Securely attach mat.	1	274	\$274
21	Stair 5, Exit to Southwest Corner of School	1		Means of Egress	N/A

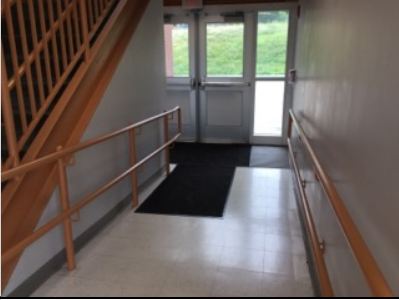
Illuminated exit sign not provided Tactile exit sign not provided Mat not securely attached	- - -	Ensure illuminated exit signs contain the International Symbol of Accessibility (ISA). Ensure tactile exit signs with raised characters and braille are provided at exit doors. Mount signs between 48"- 60" above finished floor located on the latch side of the door. Securely attach mat.	1	274	\$274

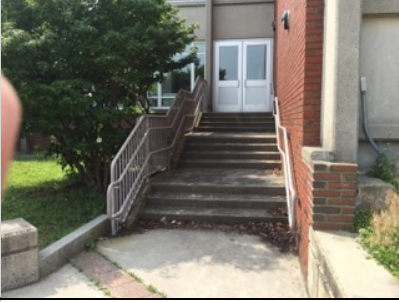
22	Exit East of Main Entrance	Ext.		Means of Egress	N/A

Tactile exit sign not provided Directional sign to accessible emergency exit not provided	- -	Ensure tactile exit signs with raised characters and braille are provided at the interior of exit doors. Mount signs between 48"- 60" above finished floor located on the latch side of the door. Provide a directional sign inside indicating the location of the nearest emergency exit.	1	348	\$348
23	YMCA Pick Up Door	1	B014	Means of Egress	N/A

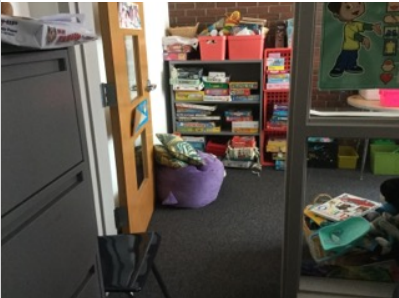
Interior Access Route												
24	Adjustment Councilor	1	B033	Interior Access Route	N/A

Route < 36" wide	23"	Ensure that a clear width of 36" min. is maintained at the accessible route by relocating chairs.	1	Labor	\$0

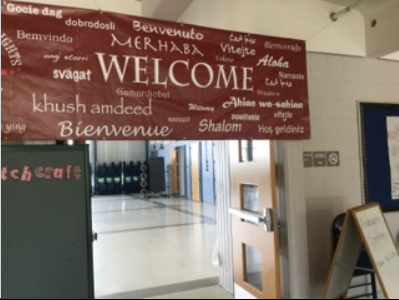
ID	Location	Floor	Room	Element	Type	Photo	Issues	Current Measure	Recommendations	Quantity	Price	Cost Estimation
25	Cafeteria Entrance	1	B014	Interior Access Route	N/A

Obstructed by protruding objects	67"	Relocate banner so that it is at least 80" above the floor.	1	Labor	\$0
26	Inaccessible Route to OT/PT Room	1		Interior Access Route	N/A

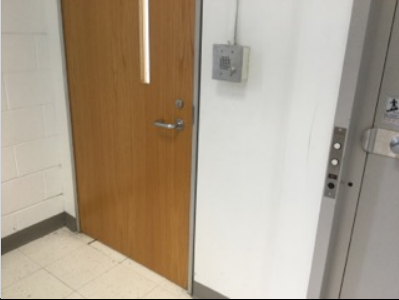
Accessible route not provided	-	Provide a directional sign to the accessible route.	1	174	\$174
27	Media Center	1	D044	Interior Access Route	N/A

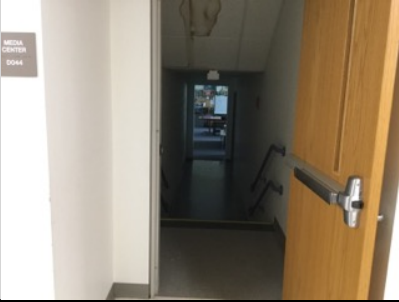
Accessible route not provided	-	Provide a directional sign to the accessible route.	1	174	\$174
28	Classrooms Throughout School	1, 2		Interior Access Route	N/A

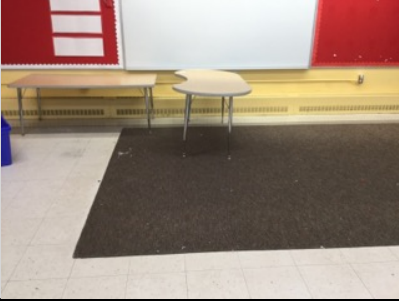
Mat not securely attached	-	Securely attach mats in classrooms throughout the school.	10	Labor	\$0
Doors, Doorways, & Gates												
29	Nurse's Office	1	B046	Doors, Doorways, & Gates	Classroom

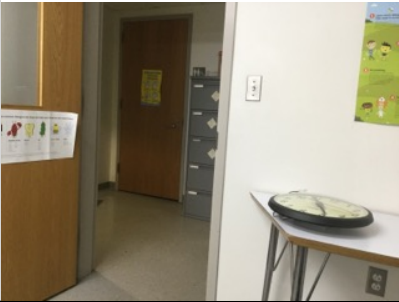
Maneuvering clearance(s) not provided	-	Relocate the table.	1	Labor	\$0

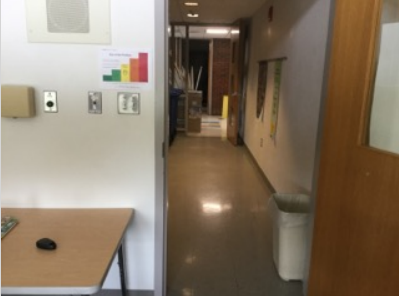
ID	Location	Floor	Room	Element	Type	Photo	Issues	Current Measure	Recommendations	Quantity	Price	Cost Estimation
30	Psychologist's Office	1	B032	Doors, Doorways, & Gates	Office

Maneuvering clearance(s) not provided	-	Relocate the table.	1	Labor	\$0
31	Grade 1 Classroom	1	C004	Doors, Doorways, & Gates	Classroom

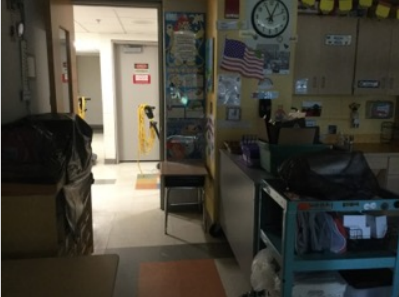
Maneuvering clearance(s) not provided	-	Relocate the table.	1	Labor	\$0
32	Classroom	1	C013	Doors, Doorways, & Gates	Classroom

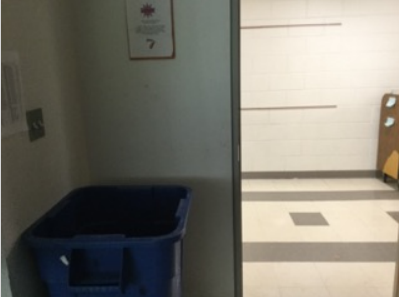
Maneuvering clearance(s) not provided	-	Relocate the table.	1	Labor	\$0
33	Kindergarten Classroom	1	D041	Doors, Doorways, & Gates	Classroom

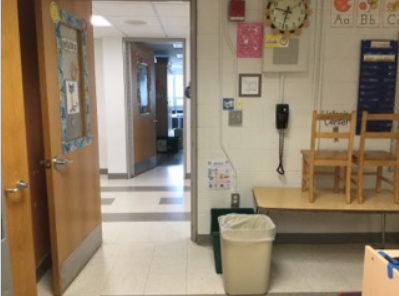
Maneuvering clearance(s) not provided	-	Relocate the table and trash bin.	1	Labor	\$0
34	Classroom	2	D218	Doors, Doorways, & Gates	Classroom
