City of Salem, Massachusetts

PART A – Executive Summary

Part A – Executive Summary

Introduction

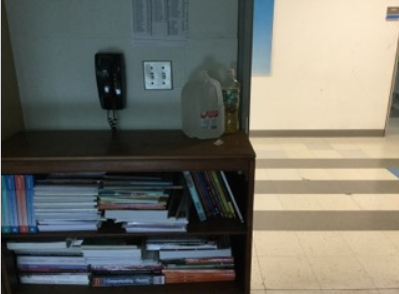
Maneuvering clearance(s) not provided	-	Relocate the bookshelf.	1	Labor	\$0

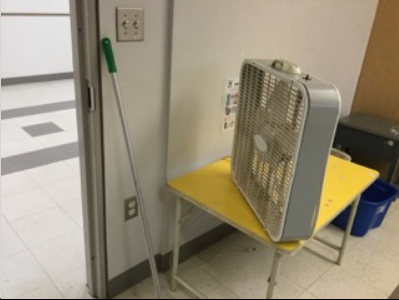
ID	Location	Floor	Room	Element	Type	Photo	Issues	Current Measure	Recommendations	Quantity	Price	Cost Estimation
35	Computer Lab	2	C219	Doors, Doorways, & Gates	Classroom

Maneuvering clearance(s) not provided	-	Relocate the table.	1	Labor	\$0
Ramps												
36	Ramp From Main Office to Classrooms	1		Ramps	Interior

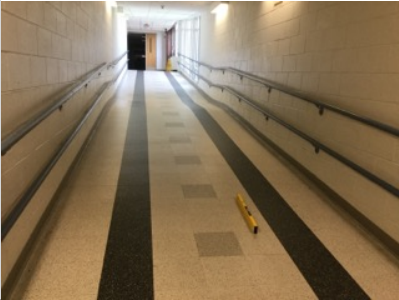
Running slope >1:12 (8.33%)	9.1%	Repair to this ramp might be technically infeasible. While not technically compliant, the ramp is still usable.	1	-	\$0
37	Easternmost Exit on South Side of School			Ramps	Exterior

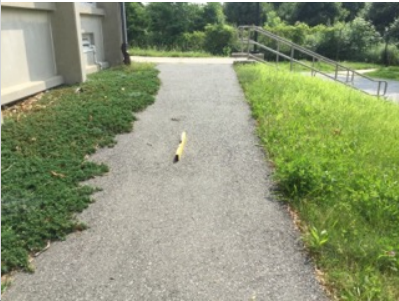
Handrails not provided	-	Provide handrails with 1 1/4"- 2" circular cross sections or 4"- 6 1/4" non-circular cross sections.	1	1980	\$1980
Stairways												
38	YMCA Pick Up Door			Stairways	Exterior

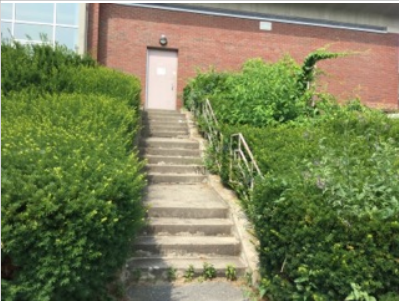
Handrails not continuous where required Handrails not provided	- -	Provide continuous handrails. Ensure handrails are provided on the entirety of both sides of the stairs. (Cost based on two sets of handrails at 15' long, and handrail extensions on both sides to ensure handrails are continuous.)	1	2865	\$2865

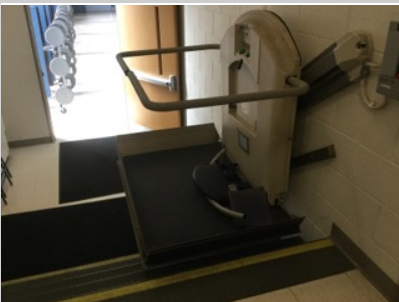
Platform Lift or LULA Elevator												
39	Accessible Route to OT/PT Room and Stage	1		Platform Lift or LULA Elevator	Interior

Not in operable working condition	-	Ensure lift is maintained in operable working condition.	1	Labor	\$0

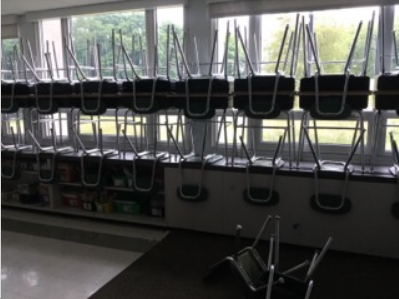
ID	Location	Floor	Room	Element	Type	Photo	Issues	Current Measure	Recommendations	Quantity	Price	Cost Estimation
Dining or Work Surfaces												
40	Classroom	1	D037	Dining or Work Surfaces	Work Surface

At least one or 5% accessible tables not provided	-	Ensure that at least one work surface is accessible.	1	525	\$525
41	OT/PT Room	1		Dining or Work Surfaces	Work Surface

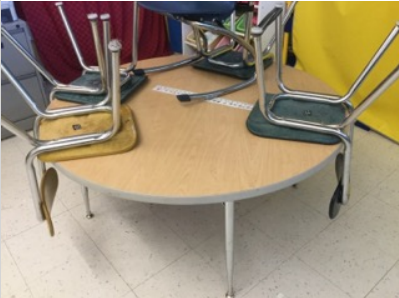
Knee or toe clearance not provided	-	Adjust at least 1 work surface for children so that it has 24" min. knee and toe clearance.	1	Labor	\$0
42	Classrooms Throughout School	1, 2		Dining or Work Surfaces	Work Surface

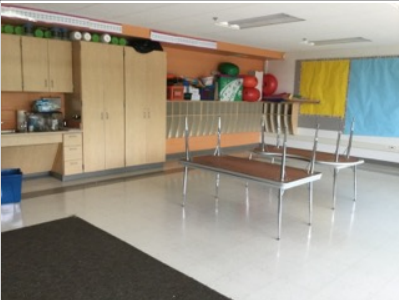
Knee or toe clearance not provided	21"	Adjust at least 1 work surface for children in 1 classroom per grade so that it has 24" min. knee and toe clearance.	6	Labor	\$0
Benches												
43	Courtyard Garden	1		Benches	N/A

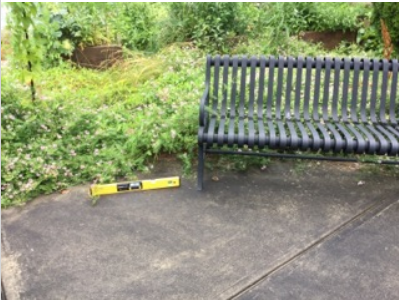
Cross slope > 1:48 (2.08%)	4.0%	Ensure that 20% of benches have a cross slope no greater than 1:50 (2.00%) around the bench and in the clear floor space.	1	135	\$135

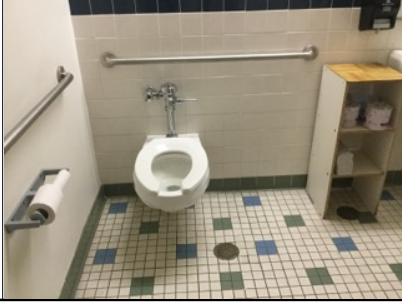
Clearance at toilet < 60" clear width	-	Provide a clear floor space that is 60" wide min. by removing shelf.	1	Labor	\$0
Toilet Compartment												
45	Girls' and Boys' Toilet Rooms Near Cafeteria	1		Toilet Compartment	Accessible Compartment

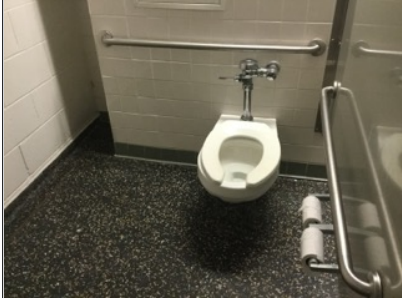
Door with non-compliant hardware Door with malfunctioning self-closing hinge Side or rear grab bar < 25" or > 27" high (Ages 9 - 12)	- - 30"	Provide hardware that can be operable with one hand and not require tight grasping, pinching, or twisting of the wrist. Repair self-closing hinge. Relocate rear grab bar to 25"- 27" above the floor.	2	210	\$420
46	Girls' Toilet Room Near C027	1		Toilet Compartment	Accessible Compartment

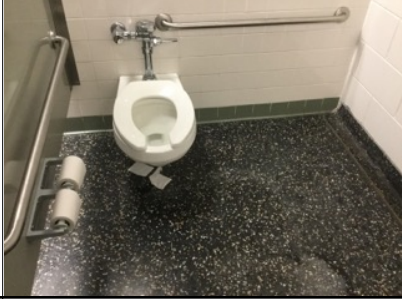
Side or rear grab bar < 42" long	24"	Provide a rear wall grab bar that is 42" long located 6" max. from the interior corner.	1	674	\$674

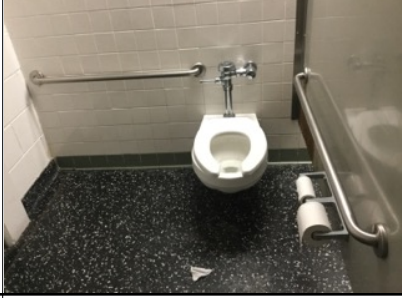
47	Boys' and Girls' Toilet Rooms Near C219	2		Toilet Compartment	Accessible Compartment

Side or rear grab bar < 42" long	- 25.5"	Provide a rear wall grab bar that is 42" long located 6" max. from the interior corner.	2	674	\$1348
48	Boys' Toilet Room Near C017	1		Toilet Compartment	Accessible Compartment

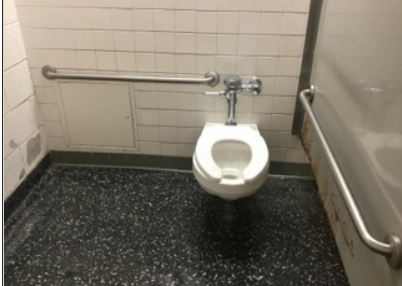
Side or rear grab bar < 42" long Non-compliant toilet paper dispenser	24.5" -	Provide a rear wall grab bar that is 42" long located 6" max. from the interior corner. Provide a toilet paper dispenser. Locate it so that it is between 14"- 19" above the floor and between 7"- 9" in front of the toilet. Ensure dispensers and other devices are not mounted above grab bars.	1	1204	\$1204

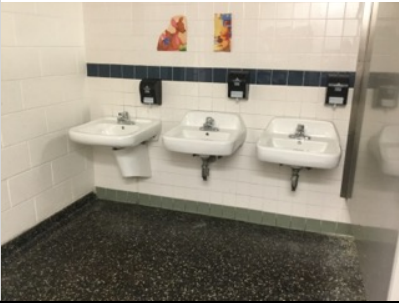
ID	Location	Floor	Room	Element	Type	Photo	Issues	Current Measure	Recommendations	Quantity	Price	Cost Estimation
Lavatory												
49	Girls' Toilet Room Near C027	1		Lavatory	N/A

Exposed plumbing underneath	-	Insulate or otherwise configure pipes to prevent contact, for at least one lavatory.	1	69	\$69
50	Kindergarten Toilet Room	1	D041	Lavatory	N/A

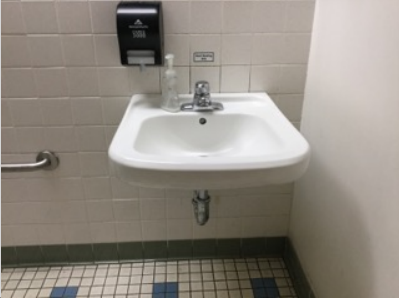
Exposed plumbing underneath	-	Insulate or otherwise configure pipes to prevent contact, for at least one lavatory.	1	69	\$69
51	Boys' and Girls' Toilet Rooms	B		Lavatory	N/A

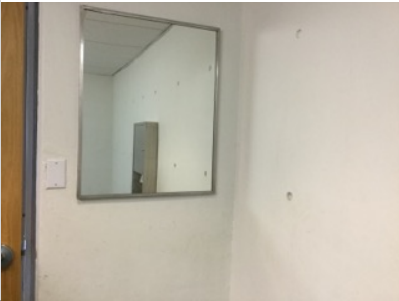
Mirror above lavatory w/reflective surface > 31"	46.5"	Lower mirror so that the bottom surface is at 31" above finished floor.	2	192	\$384
Additional Access												
Drinking Fountains												
52	Near C022	1		Drinking Fountains	Low

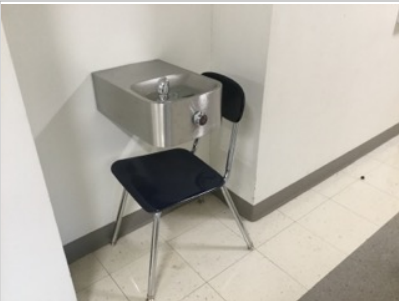
Clear floor space not provided No drinking fountain provided for standing users	- -	Provide a 30" by 48" clear floor space positioned for a forward approach by relocating chair. Provide an additional drinking fountain for standing users or install a Hi-Lo drinking fountain.	1	Labor 3021	\$3021

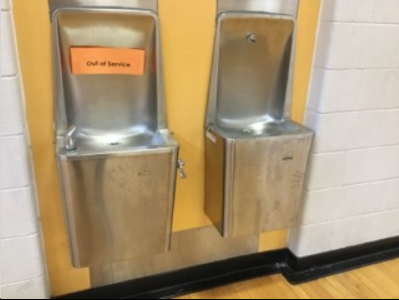
ID	Location	Floor	Room	Element	Type	Photo	Issues	Current Measure	Recommendations	Quantity	Price	Cost Estimation
54	Gym	B		Drinking Fountains	Hi-Lo

Operable parts malfunctioning No drinking fountain provided for seated users	- -	Repair or replace drinking fountain to ensure operable parts are working. Provide an additional drinking fountain for seated users or install a Hi-Lo drinking fountain.	1	Labor 3021	\$3021
55	Near Gym	B		Drinking Fountains	Low

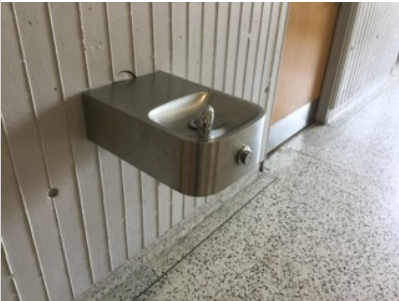
No drinking fountain provided for standing users	-	Provide an additional drinking fountain for standing users.	1	3021	\$3021
56	Hallway D	1		Drinking Fountains	Low

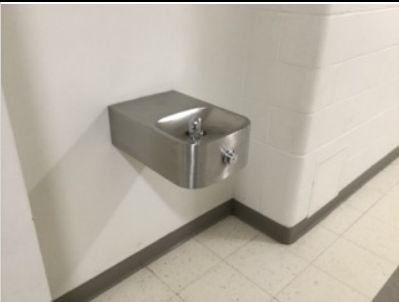
No drinking fountain provided for standing users	-	Provide an additional drinking fountain for standing users.	1	3021	\$3021
Sink												
57	Psychologist's Office	1	B032	Sink	Other

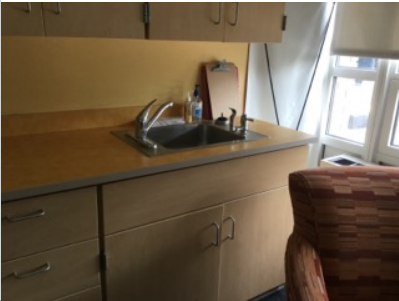
Clear floor space not provided at sink Toe and knee clearances not provided	- -	Provide a 30" by 48" clear floor space positioned for a forward approach. Ensure there is a 27" knee clearance positioned for a forward approach by relocating chair.	1	1265	\$1265

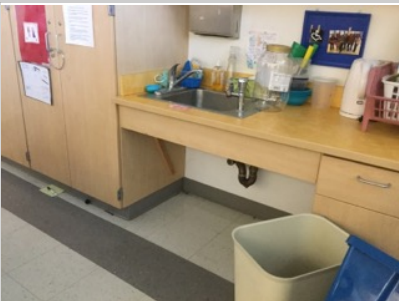
Sinks for Children's Use												
58	OT/PT Room	1		Sinks for Children's Use	Classroom

Exposed plumbing underneath Knee or toe clearance not provided	- 23.75"	Ensure there is a 25" knee clearance positioned for a forward approach. Insulate or otherwise configure pipes at sink.	1	1334	\$1334

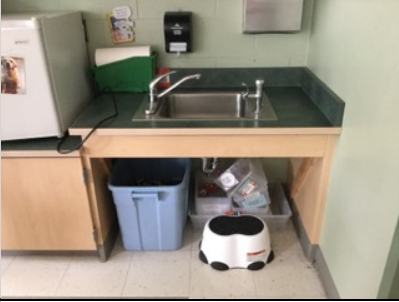
ID	Location	Floor	Room	Element	Type	Photo	Issues	Current Measure	Recommendations	Quantity	Price	Cost Estimation
59	Classroom	1	D025	Sinks for Children's Use	Classroom

Exposed plumbing underneath Knee or toe clearance not provided	- 23"	Insulate or otherwise configure pipes to prevent contact, for at least one sink. Remove clutter under sink.	1	69	\$69
60	Classrooms Throughout School	1, 2		Sinks for Children's Use	Classroom

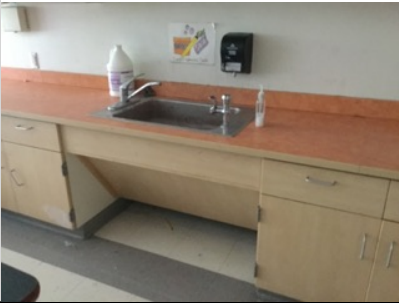
Knee or toe clearance not provided	23"	Provide at least one sink per grade with 25" knee and toe clearance positioned for a forward approach.	6	1265	\$7590
61	STEM Room	1	C009	Sinks for Children's Use	Classroom

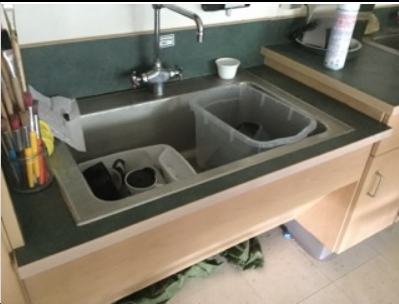
Knee or toe clearance not provided	-	Relocate clutter under sink.	1	Labor	\$0
Play and Sport Areas												
Play Areas												
62	Playground			Play Areas	N/A

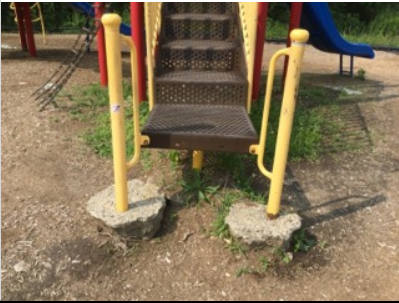
Accessible route not provided to ground level play components No compliant transfer system Surface not stable, firm, and slip-resistant	- - -	Ensure an accessible route is provided to one of each type of ground level play component. Alteration to the transfer system might be technically infeasible. Repair surface and ensure that surface is firm, stable and slip-resistant. (Cost based on 280' of 5' wide poured in place rubber to play components.)	1	29400	\$29400

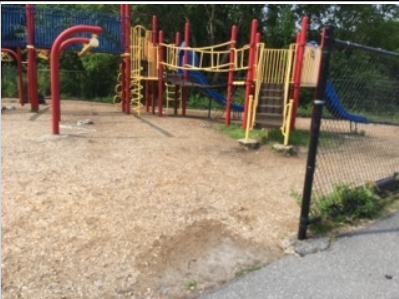
63	Playground	Ext.		Play Areas	N/A

Not connected to an accessible route	-	Provide an accessible route to and around play areas. (Cost based on 300' by 4' wide asphalt route around playground.)	1	7650	\$7650

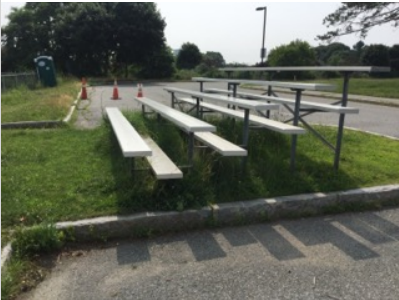
ID	Location	Floor	Room	Element	Type	Photo	Issues	Current Measure	Recommendations	Quantity	Price	Cost Estimation
Field												
64	Baseball Field	Ext.		Field	Baseball

Accessible spaces not provided at sidelines seating Not connected to an accessible route	-	Provide a 36" x 48" clear floor space at sidelines seating. Ensure fan seating is connected to an accessible route. (Cost based on a wheelchair space and 35' by 4' wide stone dust route from curb ramp at baseball field renovation to the accessible space.)	1	918	\$918
65	Baseball Field	Ext.		Field	Baseball

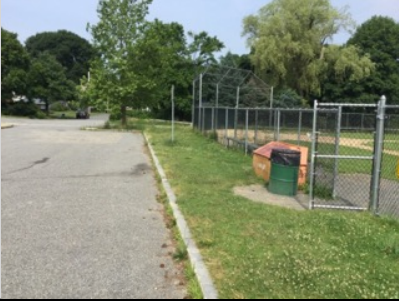
Field not connected to an accessible route	-	Ensure edge of baseball field is connected to an accessible route. (Cost based on one curb ramp, striping at entrance to ensure people do not park in the accessible route, and 60' by 4' wide stone dust route to edge of field as well as maintaining the route to the dugouts.)	1	4465	\$4465

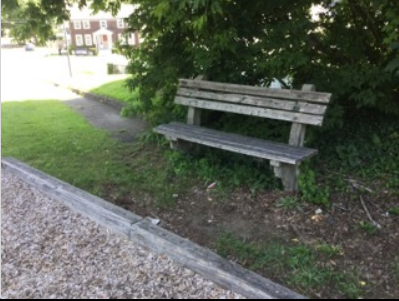
ID	Location	Floor	Room	Element	Type	Photo	Issues	Current Measure	Recommendations	Quantity	Price	Cost Estimation
Approach and Entrance												
Exterior Access Route												
1	Near Playground	Ext.		Exterior Access Route	Exterior

Not connected to an accessible route	-	Locate bench on an accessible route. Recommend having a 36" min. by 48" min. clear floor space adjacent to the bench. See ID #5 for cost.	1	-	\$0
Off-Street Parking Lot or Garage												
2	Parking Near Playground	Ext.		Off-Street Parking Lot or Garage	Visitor

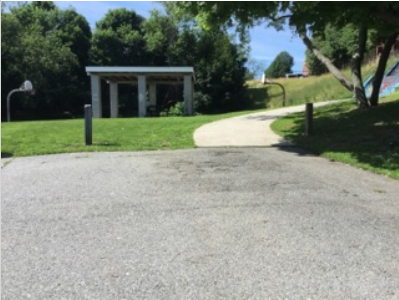
Total # of designated accessible parking spaces	-	Provide a van accessible space that is at least 96" wide with a marked access aisle that is at least 96" wide. Provide a sign with the bottom of the sign 60" min. above the ground and the top 96" max. above the ground. Add the designation "Van Accessible" to the sign.	1	1388	\$1388
Access to Goods and Services

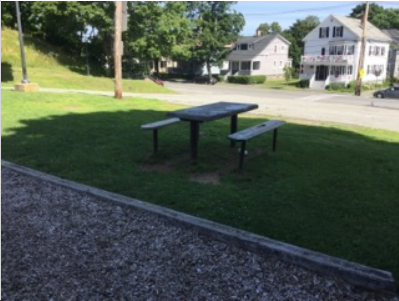
Picnic Tables												
3	Near Playground	Ext.		Picnic Tables	N/A

At least 5% accessible spaces not provided Picnic table not on an accessible route	- -	Provide an accessible picnic table. Ensure the picnic table is on an accessible route.	1	1050	\$1050
Play and Sport Areas												
Play Areas												
4	Playground	Ext.		Play Areas	N/A

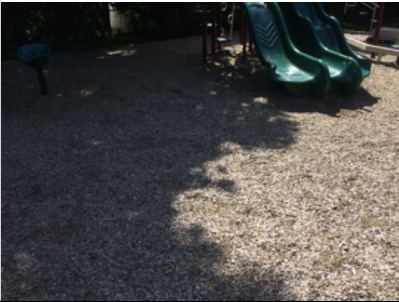
Accessible route not provided to ground level play components Surface not stable, firm, and slip-resistant	- -	Provide an accessible route that is 60" min. wide to each play component in the playground. (Cost for a 177' long by 5' wide poured-in place-rubber.)	1	12390	\$12390

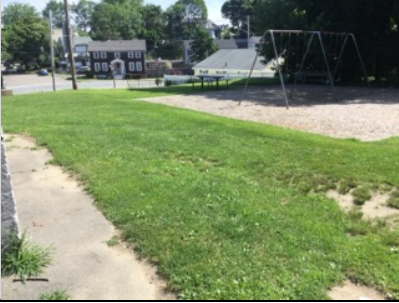
ID	Location	Floor	Room	Element	Type	Photo	Issues	Current Measure	Recommendations	Quantity	Price	Cost Estimation
5	Playground	Ext.		Play Areas	N/A

Not connected to an accessible route Accessible route not provided around the playground	-	Provide a 48" min. wide accessible route around the playground. Provide an accessible route to the playground. (Cost based on 225' long by 4' wide stone dust around the playground and 20' long to the playground.)	1	3920	\$3920

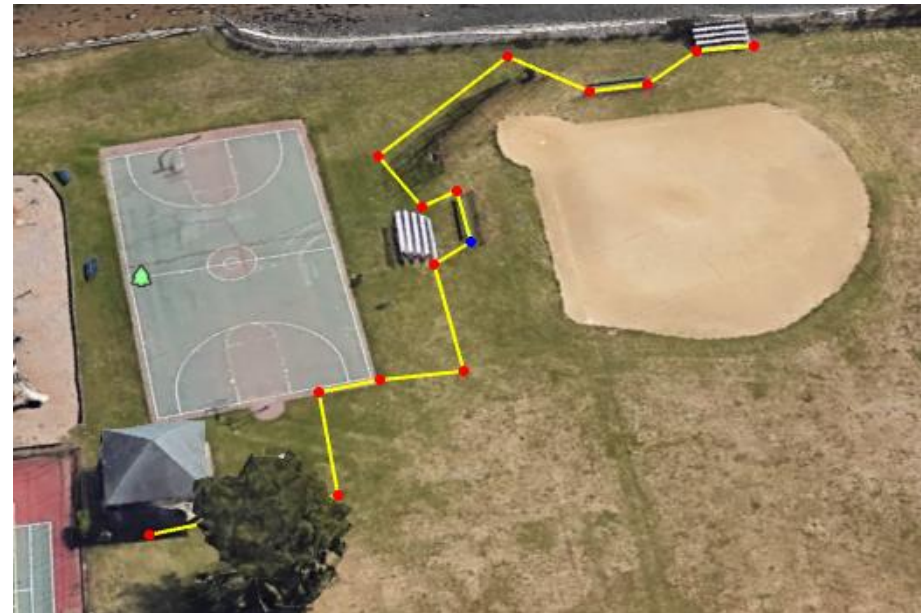
Approximate suggested location for a 48" wide min. x 300' long route connecting existing path at pavilion to park amenities including spectator and team seating at the baseball field and the baseball field itself. (**Note:** Google Earth image does not show newest routes and amenities added as part renovation at Collins Cove Park.)

Field not connected to an accessible route	-	Ensure baseball field and other park amenities are connected to an accessible route. (See Figure 1 in the Report Narrative). (Cost of an accessible route connecting existing path at pavilion to park amenities including spectator and team seating at the baseball field and the baseball field itself.)	1	15600	\$15600

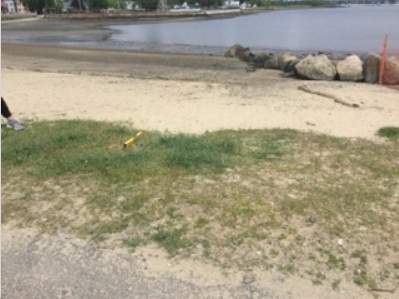
ID	Location	Floor	Room	Element	Type	Photo	Issues	Current Measure	Recommendations	Quantity	Price	Cost Estimation
Value List Missing>												
Beach												
1		Ext.		Beach

Beach route not provided		Provide an accessible beach access route that is firm and stable. Ensure the accessible route extends to the high tide level. (Provide a beach mat that is at least 72" wide and extends to the high tide level.) (Cost based on a 72" wide min. x 33' long beach mat.)	1	1909	\$1909
Approach and Entrance												
Exterior Access Route												
2	Collins Street	Ext.		Exterior Access Route	Sidewalk

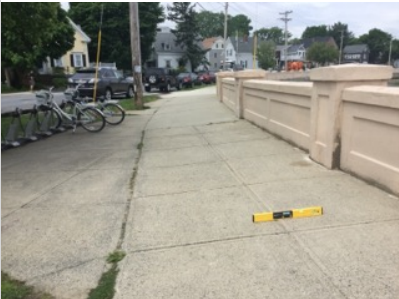
Cross slope > 1:50 (2.00%)	5.2%	Reduce cross slope to be no steeper than 1:50 (2.00%). (Cost based on adding 60' of concrete to reduce slope.)	1	1350	\$1350
3	Webb Street by Beach	Ext.		Exterior Access Route

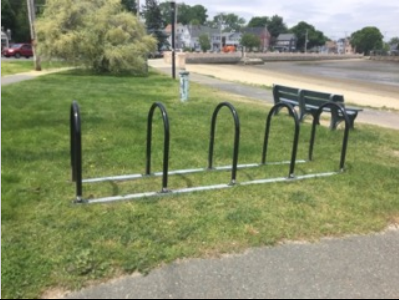
Accessible route not provided	-	Ensure an accessible route is provided to bike rack. Relocate to an accessible route.	1	Labor	\$0

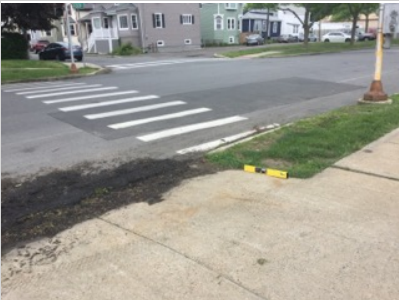
Curb Ramp												
4	By Path to Pavilion and Pickleball Courts	Ext.		Curb Ramp	N/A

Curb ramp not provided	-	Provide a curb ramp at both ends of crosswalk.	2	2800	\$5600

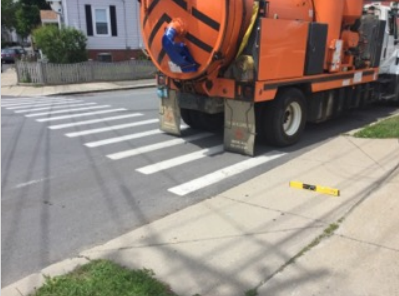
ID	Location	Floor	Room	Element	Type	Photo	Issues	Current Measure	Recommendations	Quantity	Price	Cost Estimation
5	Cross to Arbella Street at South End of Beach Near Staircase to Beach	Ext.		Curb Ramp	Perpendicular

Running slope > 1:12 (8.33%)	9.2	Reduce running slope to be no steeper than 1:12 (8.33%). (Correct curb ramps on both sides of crosswalk.) (Cost based on a new curb ramp on both sides of crosswalk.)	2	2800	\$5600
6	Across From Pickman Street	Ext.		Curb Ramp	Perpendicular

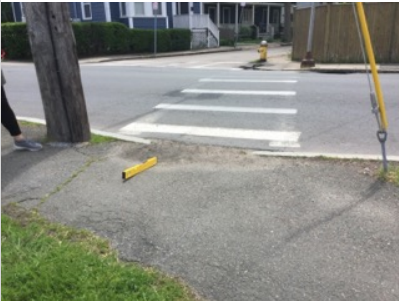
Running slope > 1:12 (8.33%)	13.2%	Reduce running slope to be no steeper than 1:12 (8.33%).	1	2800	\$2800
Access to Goods and Services												
Signage												
7	Stairs to Beach	Ext.		Signage	Directional

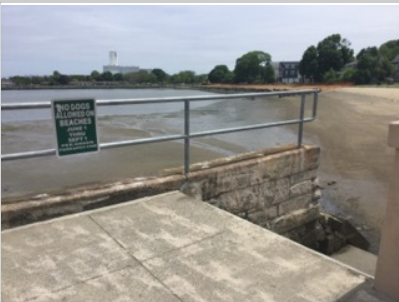
Not provided	-	In order to provide program access, provide signs at both sets of stairs to beach directing visitors to accessible route to beach once beach mat is provided at beach access point near Webb Street.	2	260	\$520

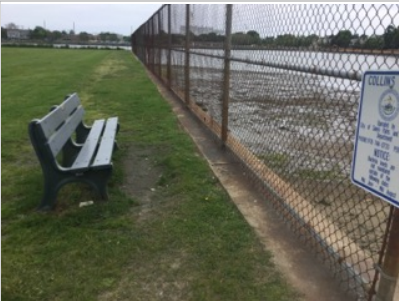
Benches												
8	Near Beach Access Point Across from Barton Road	Ext.		Benches	N/A

No accessible route to 20% of benches	-	Provide an accessible route to 20% of benches in this area. (Cost based on a 48" wide min. 6' long asphalt route to bench.)	1	156	\$156
9	Playground	Ext.		Benches	N/A

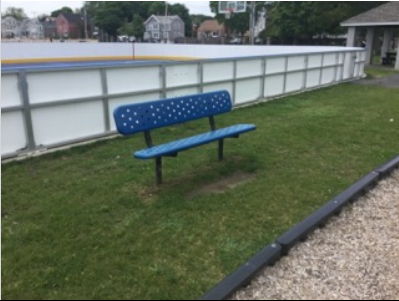
No accessible route to 20% of benches	-	Provide an accessible route to 20% of benches (1 in this case) in this area by the playground. Cost based on a 48" wide min. 30 foot long asphalt route from pavilion area new walkway to bench.)	1	780	\$780

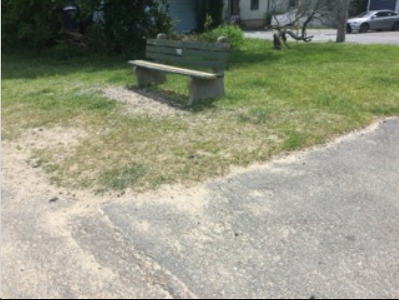
ID	Location	Floor	Room	Element	Type	Photo	Issues	Current Measure	Recommendations	Quantity	Price	Cost Estimation
10	Webb Street by Beach	Ext.		Benches	N/A

No accessible route to 20% of benches	-	Provide an accessible route to 20% of benches (one (1) bench) in this area. (Cost based on a 48" wide min. x 6' asphalt route to bench.)	1	156	\$156
Toilet & Bathing Rooms												
Portable Toilet												
11	Near Pickleball	Ext.		Portable Toilet	N/A

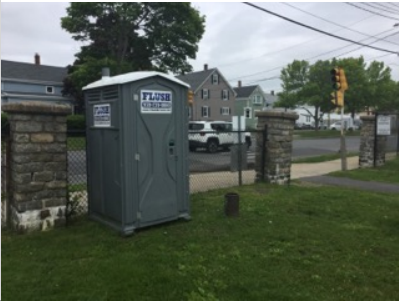
Not located on an accessible route Accessible portable toilets not provided	- -	Locate portable toilet on an accessible route. Ensure that at least 5% of portable toilets are accessible. (Cost based on an accessible portable toilet and a 48" wide min. x 15' long asphalt route.)	1	3840	\$3840
Play and Sport Areas												
Play Areas												
12	Playground	Ext.		Play Areas	N/A

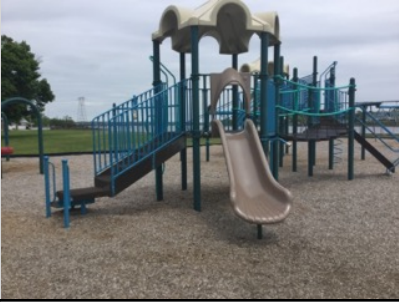
Accessible route not provided to ground level play components	-	Provide an accessible route that is 60" min. to and around each play component in the playground including swing set. (Cost based on a 60" wide min. 275' long poured-in-place rubber accessible route to and around play components including swing set.)	1	19250	\$19250

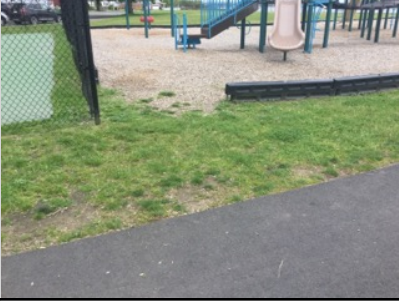
13	Playground	Ext.		Play Areas

Not connected to an accessible route	-	Provide an accessible route to the playground. (Cost based on a 48" wide min. 6' long asphalt route from the existing accessible walkway to the playground entrance.)	1	156	\$156

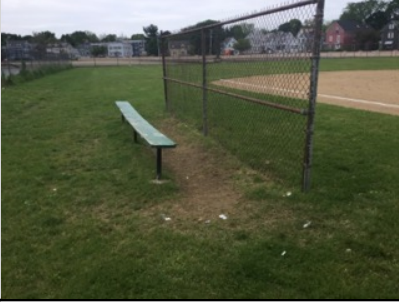
ID	Location	Floor	Room	Element	Type	Photo	Issues	Current Measure	Recommendations	Quantity	Price	Cost Estimation
Field												
14	Baseball	Ext.		Field	Baseball

Accessible spaces not provided at team seating Not on an accessible route	-	Provide a 36" x 48" clear floor space at team seating. Provide an accessible route to team seating. (See ID #17 for cost of an accessible route to team seating including cost of accessible 36" x 48" clear floor space at team seating.)	1	-	\$0
15	Baseball	Ext.		Field	Baseball

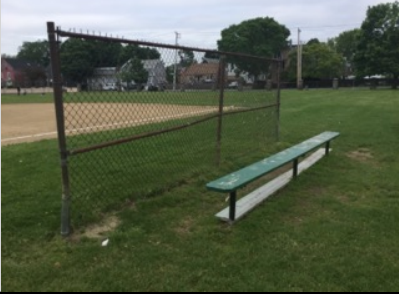
Accessible spaces not provided at team seating Not on an accessible route.	-	Provide a 36" x 48" clear floor space at team seating. Provide an accessible route to team seating. (See ID #17 for cost of an accessible route to team seating including cost of accessible 36" x 48" clear floor space at team seating.)	1	-	\$0
16	Baseball	Ext.		Field	Baseball

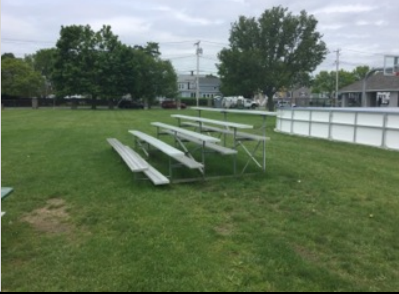
Accessible spaces not provided at sidelines seating Not on an accessible route	-	Provide a 36" x 48" clear floor space at sideline seating. Provide an accessible route to sideline seating. (See ID #17 for cost of an accessible route to sideline seating including cost of accessible 36" x 48" clear floor space at sideline seating.)	1	-	\$0

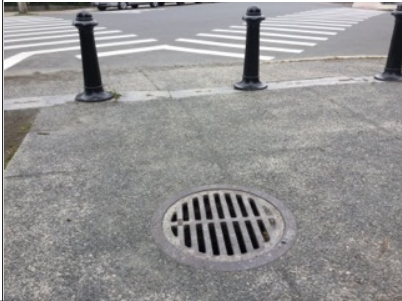
ID	Location	Floor	Room	Element	Type	Photo	Issues	Current Measure	Recommendations	Quantity	Price	Cost Estimation
Approach and Entrance												
Exterior Access Route												
1	Near Forrester Street	Ext.		Exterior Access Route	Walkway

Surface openings > 1/2"	-	Replace or reposition so that openings are 1/2" max. and the long opening dimension is perpendicular to the dominant direction of travel. (Rotate drain cover.)	1	Labor	\$0
2	Across From Williams and Mall Streets	Ext.		Exterior Access Route	Walkway

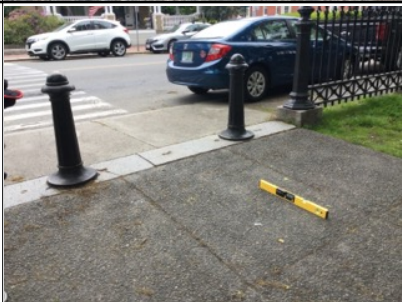
Running slope > 1:20 (5%)	6.4%	Reduce running slope to be no steeper than 1:20 (5%). (Cost for 3' x 3' of concrete to reduce cross slope.)	1	155	\$155
3	Playground	Ext.		Exterior Access Route	Walkway

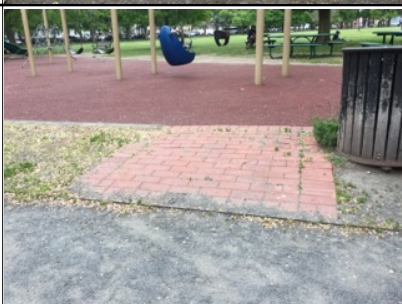
Level changes > 1/4"	.5"	Alter change in level to be 1/4" high max.	1	128	\$128
4	Near Oliver Street	Ext.		Exterior Access Route	Walkway

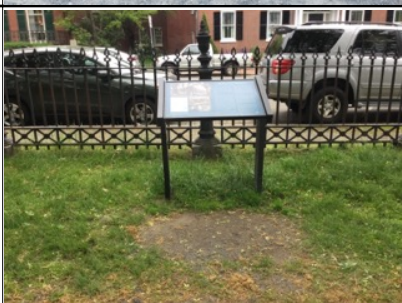
Accessible route not provided	-	Ensure an accessible route is provided. (Cost based on a 48" wide x 6' long concrete path.)	1	276	\$276

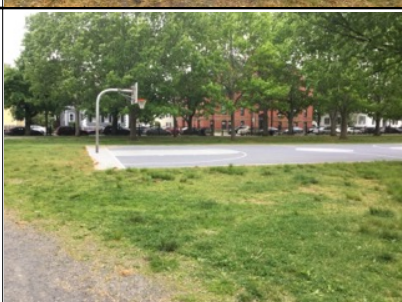
5	Basketball Court	Ext.		Exterior Access Route	Walkway

Accessible route not provided	-	Ensure an accessible route is provided. Provide a 48" wide by 12" long accessible route to the edge of the basketball court.	1	552	\$552

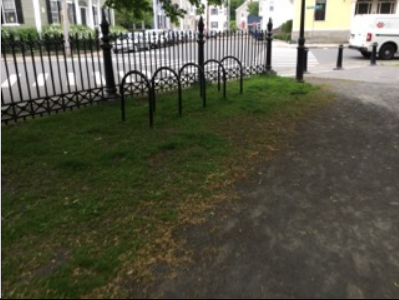
ID	Location	Floor	Room	Element	Type	Photo	Issues	Current Measure	Recommendations	Quantity	Price	Cost Estimation
6	Near Forrester Street	Ext.		Exterior Access Route	Walkway

Accessible route not provided	-	Ensure an accessible route is provided. (Provide a 48" wide x 6' long concrete route to bike rack.)	1	276	\$276
7	Gazebo	Ext.		Exterior Access Route	Walkway

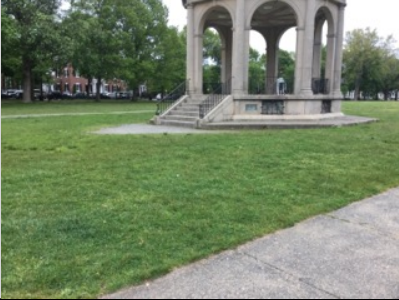
Accessible route not provided	-	Ensure an accessible route is provided to gazebo. (Provide a 48" wide x 30' long concrete route from existing walkway.)	1	1380	\$1380
8	Gazebo	Ext.		Exterior Access Route	Walkway

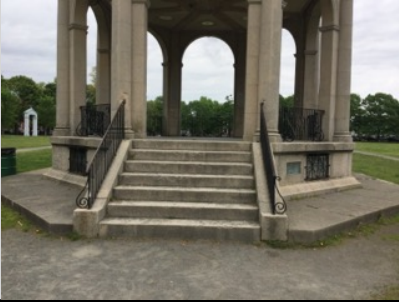
Accessible route not provided	-	In order to provide program access, relocate programs inside gazebo to an accessible location as needed.	1	Labor	\$0
9	Playground Google Earth Image	Ext.		Exterior Access Route	Walkway

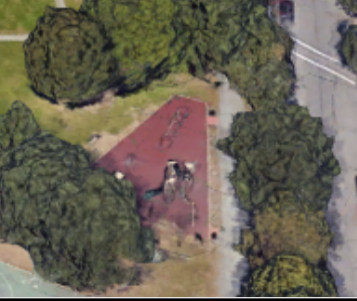
N. Accessible route not provided	- -	Ensure an accessible route is provided. Provide an accessible route 48" wide min. around the exterior of the playground. (Google Earth image.) (Cost based on a 240' long 48" wide min. stone dust path around the exterior of the playground.)	1	5472	\$5472

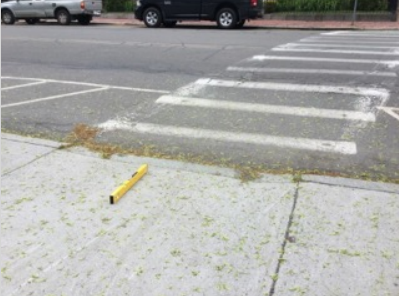
ID	Location	Floor	Room	Element	Type	Photo	Issues	Current Measure	Recommendations	Quantity	Price	Cost Estimation
11	Near Oliver Street	Ext.		Curb Ramp	Perpendicular

Curb ramp not provided Transition from curb ramp to street not flush	- -	Provide a curb ramp at far side of crosswalk. Ensure transition from curb ramp to street at Common is flush or free of changes in level. (Cost based on fixing curb ramp lip at park and providing a curb ramp on the far side of the crosswalk.)	1	2928	\$2928
12	Southwest Entrance, Corner of North and South Washington Streets	Ext.		Curb Ramp	N/A

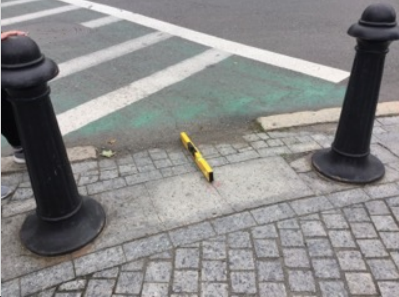
Running slope > 1:12 (8.33%)	12%	Reduce running slope to be no steeper than 1:12 (8.33%). (Cost based an a new curb ramp.)	1	2800	\$2800
13	Near 56 South Washington	Ext.		Curb Ramp	Perpendicular

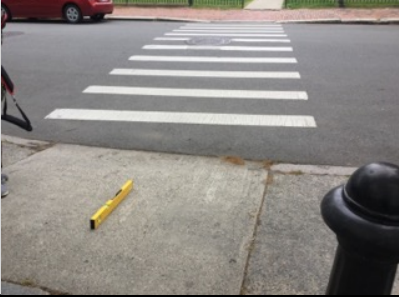
Running slope > 1:12 (8.33%)	15.3%	Reduce running slope to be no steeper than 1:12 (8.33%). (Cost based on a new curb ramp.)	1	2800	\$2800

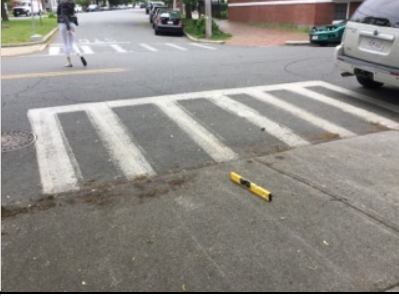
14	Winter Street	Ext.		Curb Ramp	Perpendicular

Running slope > 1:12 (8.33%) Transition from curb ramp to street not flush	10.3% -	Reduce running slope to be no steeper than 1:12 (8.33%). Ensure transition from curb ramp to street is flush or free of changes in level. (Cost based on a new curb ramp.)	1	2800	\$2800
15	North Washington Street Entrance by Brown Street and Witch Museum	Ext.		Curb Ramp	Perpendicular

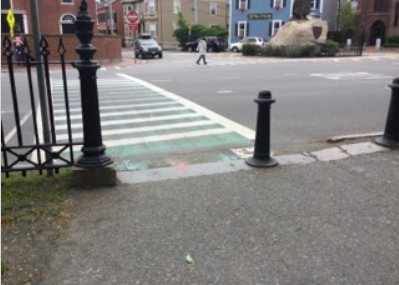
Transition from curb ramp to street not flush	-	Ensure transition from curb ramp to street is flush or free of changes in level. (Cost to patch lip at base of curb ramp.)	1	128	\$128

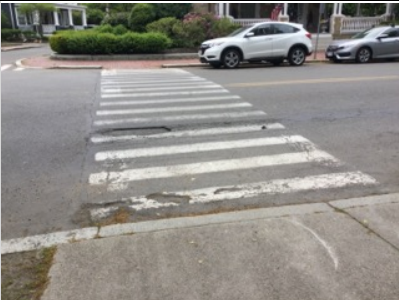
Transition from curb ramp to street not flush	-	Ensure transition from curb ramp to street is flush or free of changes in level. (Cost to patch lip at base of curb ramp.)	1	128	\$128
17	Near Briggs Street	Ext.		Curb Ramp	Parallel

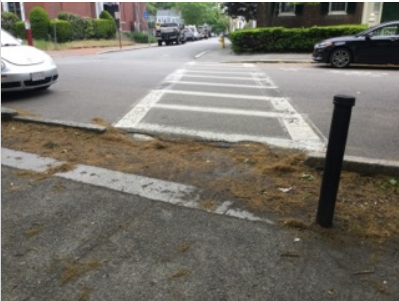
Transition from curb ramp to street not flush	2"	Ensure transition from curb ramp to street is flush or free of changes in level. (Cost to patch lip at base of curb ramp.)	1	128	\$128
18	Near Boardman Street	Ext.		Curb Ramp	Perpendicular

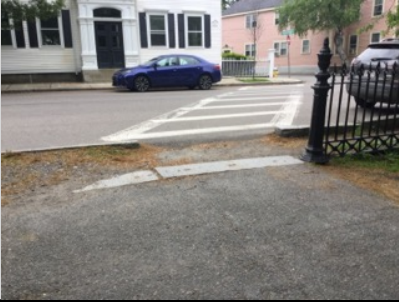
Transition from curb ramp to street not flush	-	Ensure transition from curb ramp to street is flush or free of changes in level. (Cost to patch lip at base of curb ramp.)	1	128	\$128
19	Oliver Street Crosswalk to Salem Common	Ext.		Curb Ramp	N/A

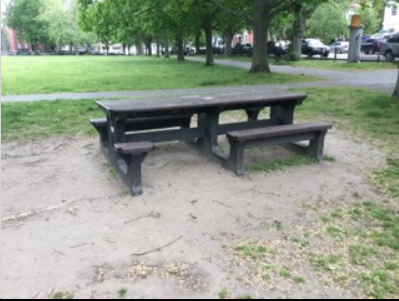
Access to Goods and Services												
Picnic Tables												
20	Picnic Table	Ext.		Picnic Tables	N/A

Picnic table not on an accessible route	-	Ensure that the dining surface is connected to an accessible route. (Provide a 48" wide x 12' long concrete route to accessible portion of picnic table.	1	552	\$552

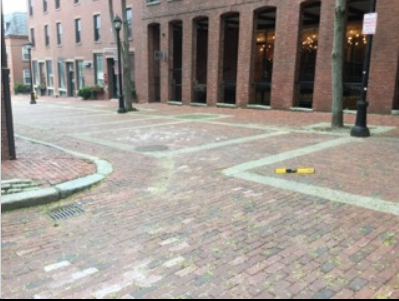
Cross slope > 1:50 (2.00%)	6.6%	Reduce cross slope to be no steeper than 1:50 (2.00%). (Cost based on 5' by 5' concrete to fix the slope and create a level landing at the corner.)	1	188	\$188
2	Northeast Corner of Square	Ext.		Exterior Access Route	Exterior

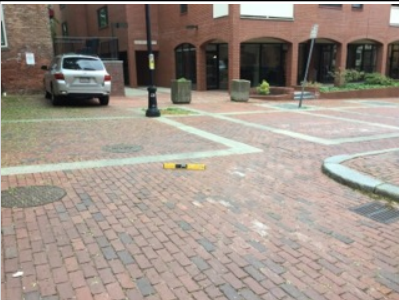
Cross slope > 1:50 (2.00%)	6.0%	Reduce cross slope to be no steeper than 1:50 (2.00%). (Cost based on 5' by 5' concrete to fix the slope and create a level landing at the corner.)	1	188	\$188
3	Tree Enclosure	Ext.		Exterior Access Route	Exterior

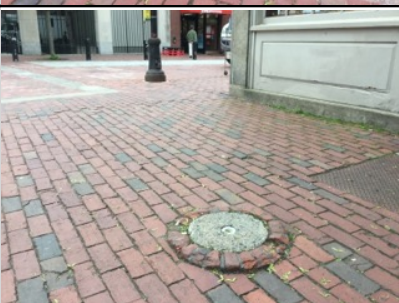
Level changes > 1/4"	1.5"	Alter change in level to be 1/4" high max.	1	27	\$27

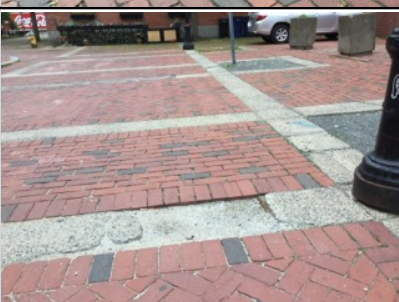
5	East Side of Square	Ext.		Exterior Access Route	Exterior

Level changes > 1/4"	1.5"	Alter change in level to be 1/4" high max.	1	176	\$176

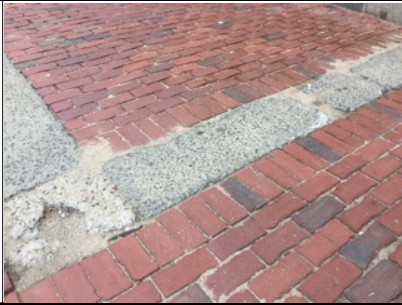
. Route not maintained in operable working condition	-	Ensure the accessible route is maintained in operable working conditions.	1	176	\$176
Curb Ramp												
7	Southeast Corner, Crossing Front Street	Ext.		Curb Ramp	Parallel

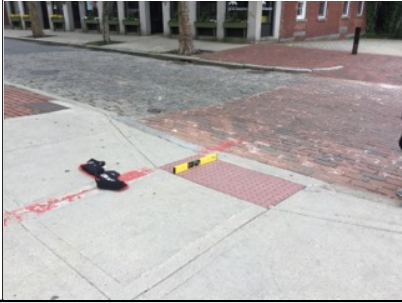
Landing not provided at top of curb ramp	3.5%	Provide landing at top of curb ramp.	1	162	\$162
Access to Goods and Services												
Ramps												
8	Ramp West of "Maria's Sweet Somethings" Restaurant	Ext.		Ramps	Exterior

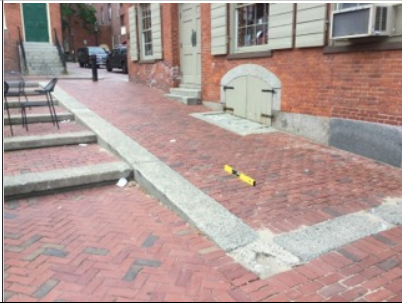
Handrails not provided	-	Provide handrails with 1 1/4"- 2" circular cross sections or 4"- 6 1/4" non-circular cross sections.	1	990	\$990

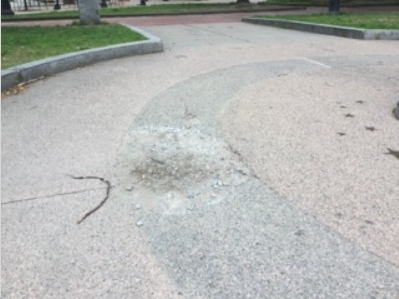
Level changes > 1/4"	2"	Alter change in level to be 1/4" high max. (Cost based on a 3'x3' asphalt patch.)	1	27	\$27
Additional Access												
Drinking Fountains												
2	Essex Street	Ext.		Drinking Fountains	Low

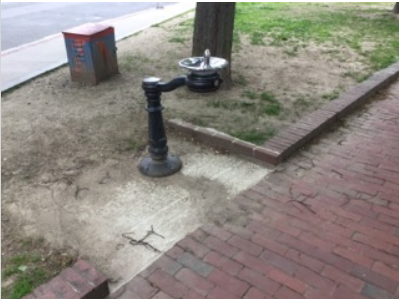
Clear floor space not provided No drinking fountain provided for standing users	- -	Provide a 30" by 48" clear floor space positioned for a forward approach. Provide an additional drinking fountain for standing users or install a Hi-Lo drinking fountain. (Cost based on a new Hi-Lo fountain.)	1	3162	\$3162

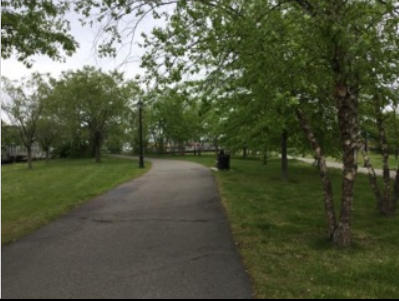
Obstructed by protruding objects	74"	Trim low hanging branches in walkway to 80" min. above the ground.	1	Labor	\$0
2	Dog Waste Bag Dispenser Near North Street Parking Lot	Ext.		Exterior Access Route	Walkway

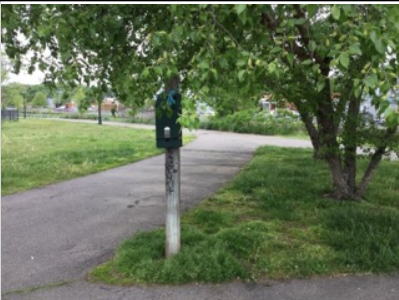
Obstructed by protruding objects	53"	Trim low hanging branches in walkway to 80" min. above the ground.	1	Labor	\$0
3	Bridge Near Flint Street	Ext.		Exterior Access Route	Exterior

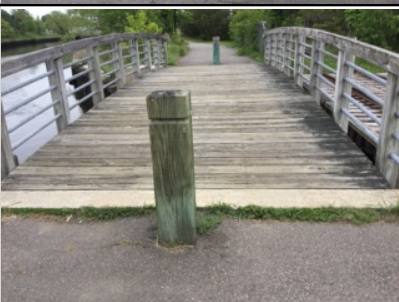
Level changes > 1/4"	2"	Alter change in level to be 1/4" high max. (Cost based on two (2) 3' by 3' concrete patches.)	2	155	\$310
4	Bridge Near Flint Street	Ext.		Exterior Access Route	Exterior

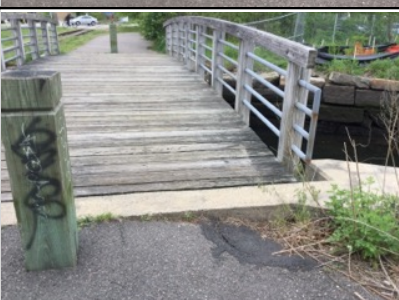
Level changes > 1/4"	6"	Alter change in level to be 1/4" high max. (Cost based on two (2) 3' by 3' concrete patches.)	2	155	\$310

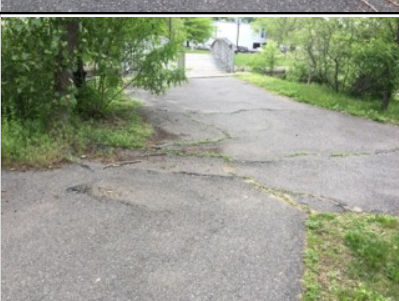
5	Route to Commercial Street Parking Lot Near Bridge	Ext.		Exterior Access Route	Walkway

Level changes > 1/4"	-	Alter change in level to be 1/4" high max. (Cost based on 10' by 6' asphalt path.)	1	390	\$390

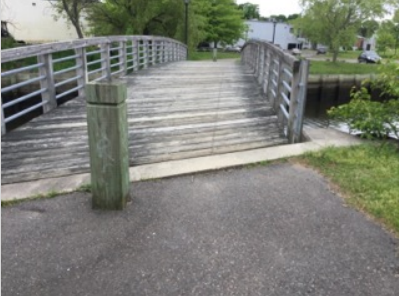
Level changes > 1/4"	2"	Alter change in level to be 1/4" high max. (Cost based on two (2) 3' by 3' concrete patches.)	2	155	\$310
7	Route at Commercial Street Parking Lot	Ext.		Exterior Access Route	Walkway

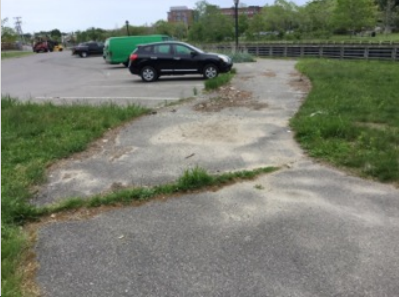
Level changes > 1/4"	-	Alter change in level to be 1/4" high max. (Cost based on 1' by 6' asphalt patch.)	1	54	\$54
8	Route to Pavilion	Ext.		Exterior Access Route	Walkway

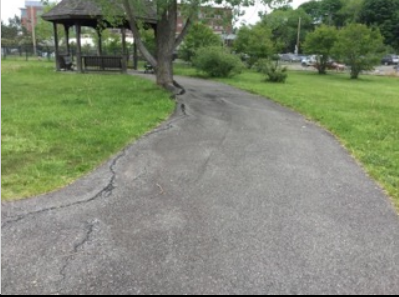
Level changes > 1/4"	-	Alter change in level to be 1/4" high max. (Cost based on 3' by 60' asphalt path.)	1	1170	\$1170
9	Route Near Parking Lot by North Street	Ext.		Exterior Access Route	Walkway

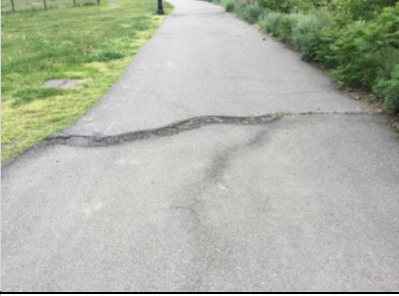
Level changes > 1/4"	4"	Alter change in level to be 1/4" high max. (Cost based on 1' by 6' asphalt patch.)	1	54	\$54

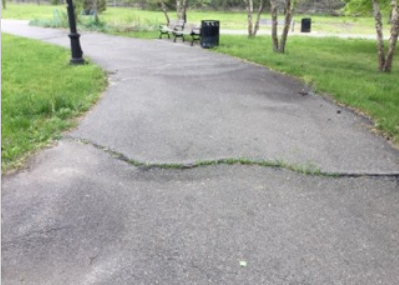
10	Route From Commercial Street Parking Lot Towards North Street Adjacent Parking Lot	Ext.		Exterior Access Route	Walkway

Route not maintained in operable working condition	-	Ensure the accessible route is maintained in operable working conditions. (Cost based on 1' by 6' concrete patch.)	1	54	\$54

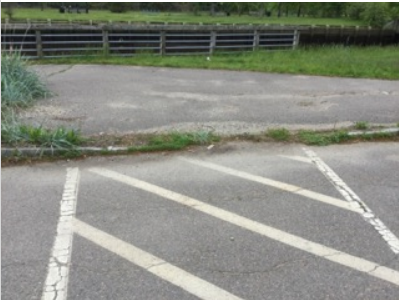
Curb ramp not provided	-	Provide a curb ramp where access aisle meets walkway. (See ID #14.)	1	2800	\$2800
Off-Street Parking Lot or Garage												
12	Flint Street Parking Lot	Ext.		Off-Street Parking Lot or Garage	N/A

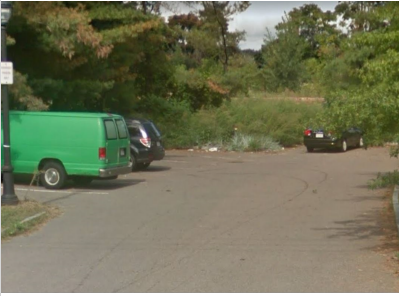
Total # of parking Total # of designated accessible parking spaces Total # of designated van accessible spaces Access aisle not provided Sign not provided Sign does not have the designation "Van Accessible"	9 0 0 - - -	Povide one van accessible parking space. Provide a marked access aisle that is at least 96" wide. Provide a sign with the International Symbol of Accessibility (ISA). Add the designation "Van Accessible" to the sign located at the van accessible space.	1	1388	\$1388

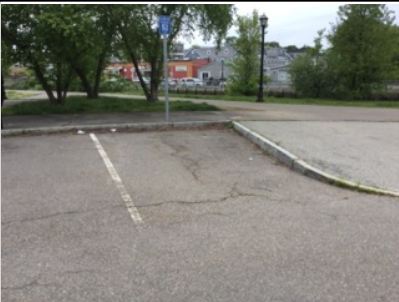
13	North Street Adjacent Parking Lot	Ext.		Off-Street Parking Lot or Garage	N/A

Access aisle not provided Sign does not have the designation "Van Accessible"	- -	Provide a marked access aisle that is at least 96" wide at the van accessible space. Add the designation "Van Accessible" to the sign located at the van accessible space.	1	600	\$600
14	Commercial Street Parking Lot	Ext.		Off-Street Parking Lot or Garage	N/A

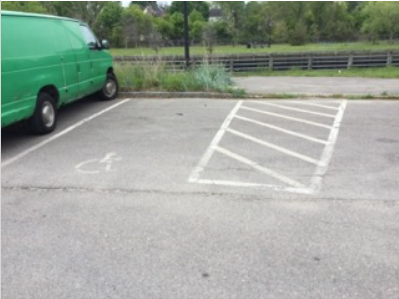
Access aisle < 60" wide at car/van space Access aisle does not adjoin an accessible route Sign not provided Sign does not have the designation "Van Accessible"	56" - - -	Provide a marked access aisle that is at least 96" wide. Ensure the access aisle adjoins an accessible route. (See ID #11 for curb ramp price.) Provide a sign with the International Symbol of Accessibility (ISA). Add the designation "Van Accessible" to the sign located at the van accessible space.	1	600	\$600

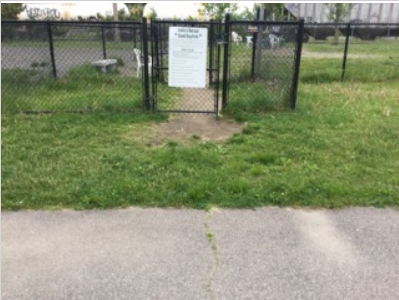
Entrance												
15	Entrance for Small Dog Park	Ext.		Entrance	Main Entrance

Entrance not on an accessible route	-	Provide an accessible route to the entrance. (Cost based on 3' by 15' asphalt path.)	1	293	\$293

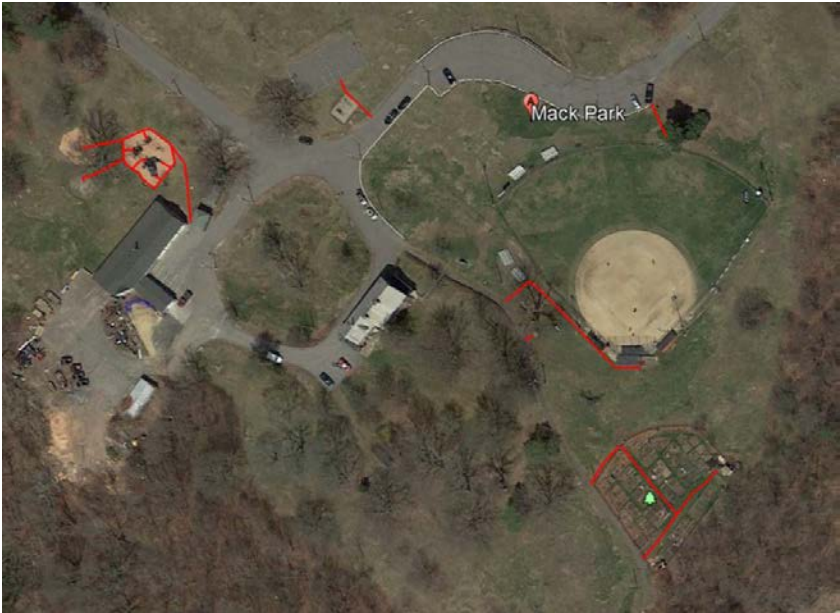
stand, sideline seating and the community garden. Additionally, the community garden lacks accessible routes inside the garden to a variety of flower beds. (See Fig. 1 at the end of this narrative showing suggested accessible routes to amenities.)

Fig. 1 Suggested Location for Exterior Accessible Routes to Amenities in Park

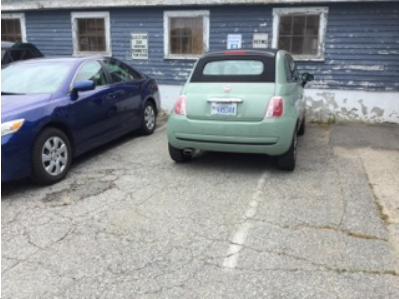
Total # of parking Total # of designated accessible parking spaces Total # of designated van accessible spaces Slope at space and access aisle > 1:50 (2.00%) (MAAB) Access aisle not provided Sign does not have the designation "Van Accessible"	6 - 1 3.5% - -	Reduce slope to be no steeper than 1:50 (2.00%) in all directions. Provide a marked access aisle that is at least 96" wide. Add the designation "Van Accessible" to the sign located at the van accessible space.	1	1032	\$1032
2	Parking Lot Near Baseball Field	Ext.		Off-Street Parking Lot or Garage	N/A

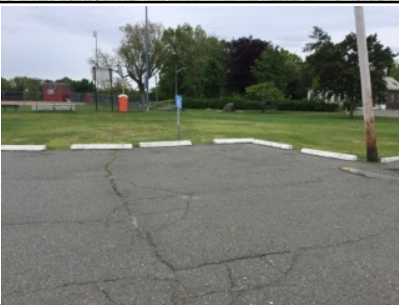
Total # of parking Total # of designated accessible parking spaces Total # of designated van accessible spaces Access aisle not provided Sign does not have the designation "Van Accessible" Sign < 60" above finished grade	25 - 1 - - -	Provide a marked access aisle that is at least 96" wide. Ensure the boundary of the parking space adjoining the access aisle is also striped and is at least 96" wide. Add the designation "Van Accessible" to the sign located at the van accessible space. Ensure the sign is 60" min. and 96" max. above the ground.	1	600	\$600

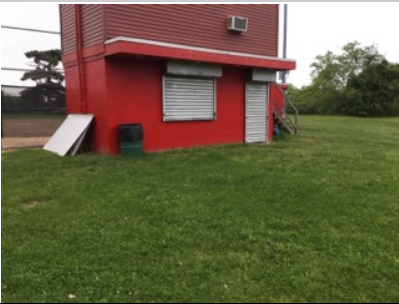
Access to Goods and Services												
Service Counter												
3	Concession Stand for Baseball Field	Ext.		Service Counter	N/A

Not connected to a accessible route	-	Ensure the concession stand and service counter are connected to an accessible route. (Cost based on 185' by 3' wide asphalt route to concession stand, fan seating, baseball field entrance, and clear floor space at sideline seating.)	1	3686	\$3686
Operable Parts												
4	Community Garden	Ext.		Operable Parts	N/A

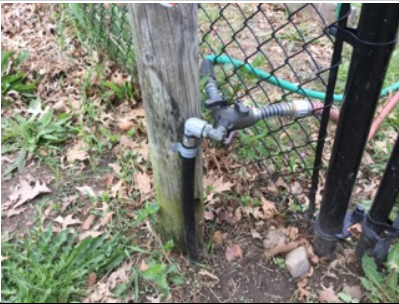
Not operable with a closed fist	-	Provide hardware that does not require tight grasping, pinching, or twisting of the wrist.	1	10	\$10

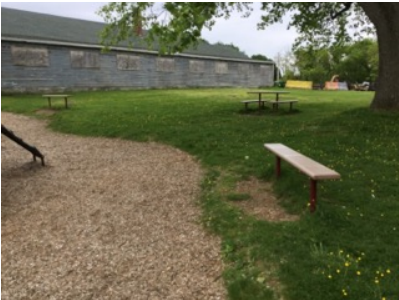
Toe or knee clearance at table not provided Picnic table not on an accessible route	- -	Provide at least one picnic table with toe and knee clearance. Locate picnic table on an accessible route. See ID #18 for cost of route. (Cost based on accessible picnic table.)	1	1050	\$1050
Benches												
6	Benches Near Playground	Ext.		Benches	N/A

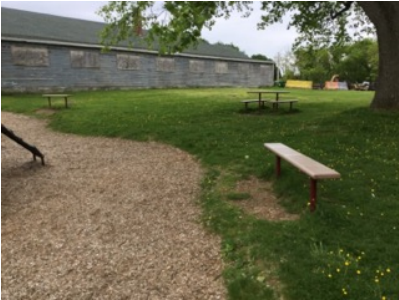
No accessible route to 20% of benches	-	Relocate bench to an accessible route.	1	Labor	\$0
Bike Racks												
7	Bike Rack	Ext.		Bike Racks	N/A

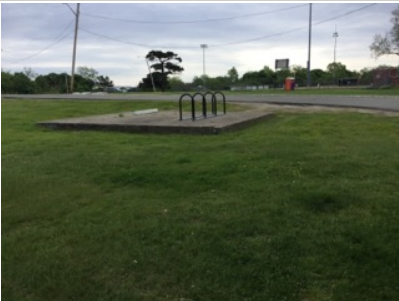
Not connected to an accessible route	-	Ensure bike rack is connected to an accessible route. See ID #20 for cost.	1	-	\$0
Community Gardens Beds												
8	Community Garden			Community Gardens Beds	N/A

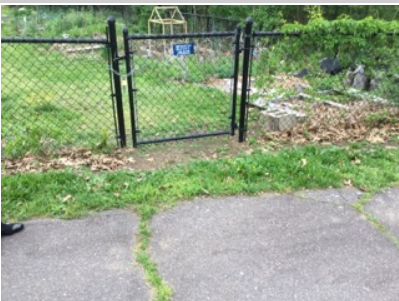
Not connected to an accessible route	28.5%	Provide an accessible route to the community garden. (Cost based on 3' by 3' asphalt patch to fix slope at entrance.)	1	27	\$27

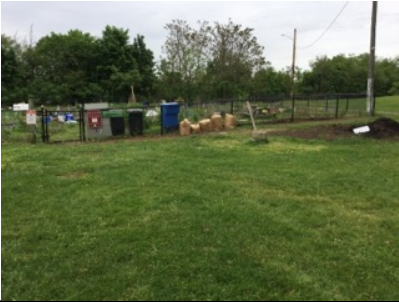
ID	Location	Floor	Room	Element	Type	Photo	Issues	Current Measure	Recommendations	Quantity	Price	Cost Estimation
9	Community Garden	Ext.		Community Gardens Beds	N/A

Not connected to an accessible route	-	Provide an accessible route to the community garden at this gate. (Cost based on 50' x 3' stone dust path.)	1	825	\$825
10	Community Garden	Ext.		Community Gardens Beds	N/A

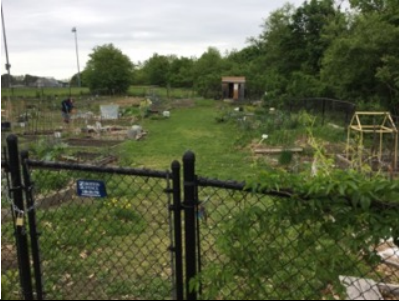
Clear floor space not provided	-	Provide an accessible route through the community garden to a variety of flower beds. (Cost based on 115' by 3' stone dust path through community garden.)	1	1898	\$1898
Toilet & Bathing Rooms												
Lavatory												
11	Women's and Men's Toilet Rooms	1		Lavatory	N/A

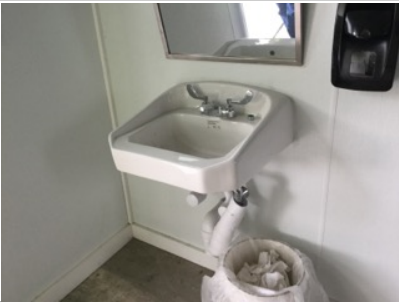
Mirror above lavatory w/reflective surface > 40"	42"	Lower mirror so that the bottom surface is at 40" max. above finished floor.	2	192	\$384
Single-User Toilet												
12	Women's and Men's Toilet Rooms	1		Single-User Toilet	N/A
