City of Salem, Massachusetts

PART A – Executive Summary

Part A – Executive Summary

Introduction

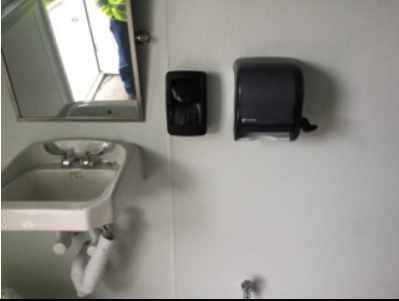
ID	Location	Floor	Room	Element	Type	Photo	Issues	Current Measure	Recommendations	Quantity	Price	Cost Estimation
Dispensers												
13	Women's and Men's Toilet Rooms	1		Dispensers	N/A

Obstructed by protruding object	7"	Relocate paper towel dispenser out of the circulation path.	2	530	\$1060
Additional Access												
Drinking Fountains												
14	Near Baseball Field	Ext.		Drinking Fountains	Seated

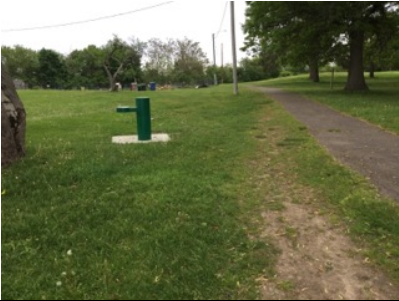
Fountain not on accessible route Clear floor space not provided No drinking fountain provided for standing users	- - -	Ensure drinking fountain is connected to an accessible route. Provide a 30" by 48" clear floor space positioned for a forward approach. Provide an additional drinking fountain for standing users or install a Hi-Lo drinking fountain. (Cost based on 10' by 3' path, clear floor space at fountain, and a fountain for standing users.)	1	3377	\$3377
Play and Sport Areas

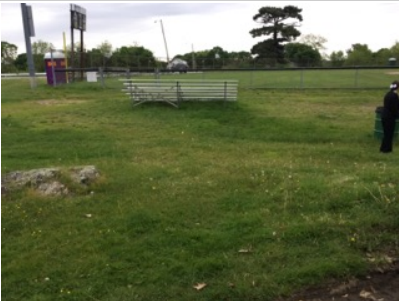
Field												
15	Sideline Seating at Baseball Field	Ext.		Field	Baseball

Accessible spaces not provided at sidelines seating Not connected to an accessible-route	- -	Provide a 36" x 48" clear floor space at sidelines seating. Ensure sidelines seating is connected to an accessible route. See ID #3 for cost.	1	-	\$0
16	Baseball Field	Ext.		Field	Baseball

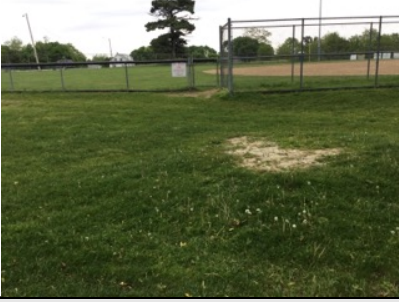
Not connected to an accessible-route	-	Ensure area of sport activity (baseball field) is connected to an accessible route. See ID #3 for cost.	1	-	\$0
Play and Sport Areas

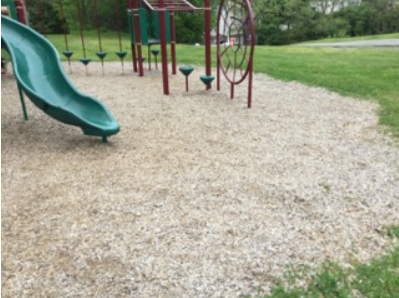
ID	Location	Floor	Room	Element	Type	Photo	Issues	Current Measure	Recommendations	Quantity	Price	Cost Estimation
Play Areas												
17	Playground Near Comfort Station	Ext.		Play Areas	N/A

Accessible route not provided to ground level play components Surface not stable, firm, and slip-resistant	-	Provide an accessible route that is 60" wide min. to each play component in the playground. See ID #19 for cost.	1	-	\$0
18	Playground Near Comfort Station	Ext.		Play Areas	N/A

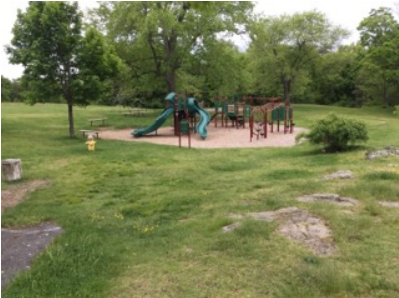
Not connected to an accessible route Accessible route not provided to ground level play components	-	Ensure an accessible route is provided to and around the playground. (Cost based on a total of 150' by 4' wide min. asphalt route to each playground area and 175' by 4' wide asphalt route around the perimeter of the playground.)	1	7388	\$7388
19	Playground Near Comfort Station	Ext.		Play Areas	N/A

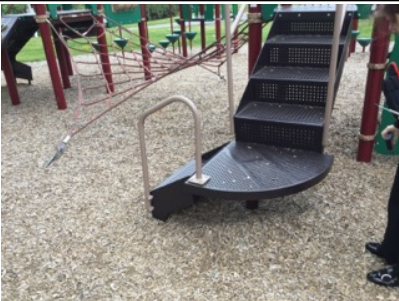
Not connected to an accessible route Accessible route not provided to ground level play components	- -	Provide an accessible route that is 60" min. to each play component in the playground. (Cost based on 100' by 60" wide of poured-in-place rubber to each play component including the swing sets.)	1	7000	\$7000

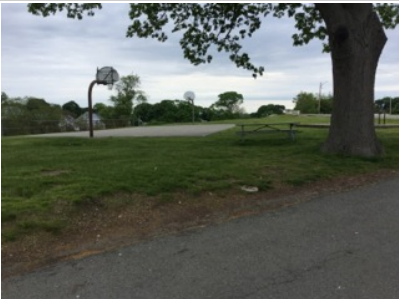
Court												
20	Basketball Court	Ext.		Court	Basketball

Not connected to accessible route	-	Ensure area of sport activity (basketball court) is connected to an accessible route. (Cost based on 50' by 3' wide asphalt path to the basketball court and bike rack.)	1	834	\$834

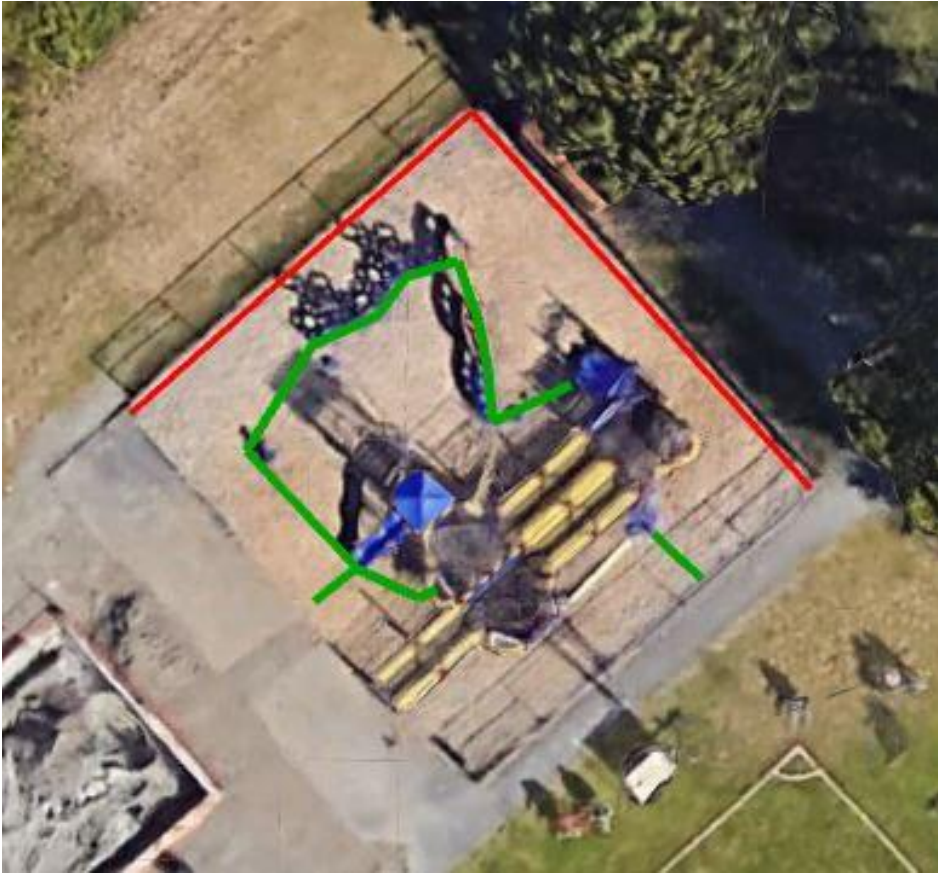
Figure 1:

The following two images (Figure 1 and Figure 2) show suggested locations for 48” min. accessible routes to and around the two (2) playgrounds in McGrath Park (red lines), and for 60” min. accessible routes to each play component in each playground (green lines, poured-in-place rubber recommended).

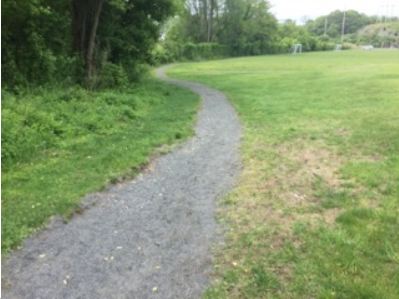
ID	Location	Floor	Room	Element	Type	Photo	Issues	Current Measure	Recommendations	Quantity	Price	Cost Estimation
Approach and Entrance												
Exterior Access Route												
1	North Soccer Field	Ext.		Exterior Access Route	Walkway

Exterior route < 48" wide Surface not stable, firm, and slip-resistant Not maintained in an operable working condition	- - -	Ensure that a clear width of 48" min. is maintained at the accessible route. Ensure the accessible route is maintained in operable working condition. (Cost based on 30' by 4' wide stone dust path.)	1	720	\$720
2	Southwest Side of Parking Lot	Ext.		Exterior Access Route	Sidewalk

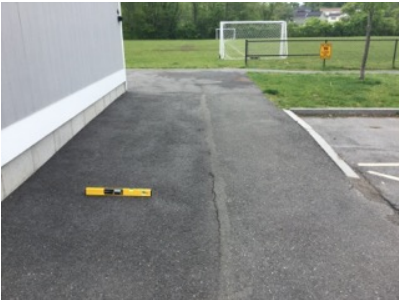
Cross slope > 1:50 (2.00%) (MAAB)	5.1%	Reduce cross slope to be no steeper than 1:50 (2.00%). (Cost based on 20' asphalt to fix slope.)	1	150	\$150
3	South Soccer Field	Ext.		Exterior Access Route	Sidewalk

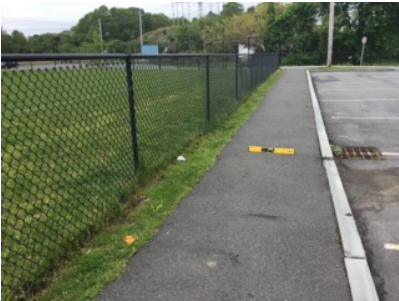
Cross slope > 1:50 (2.00%) (MAAB)	4.6%	Reduce cross slope to be no steeper than 1:50 (2.00%). (Cost based on 15' asphalt to fix slope.)	1	113	\$113

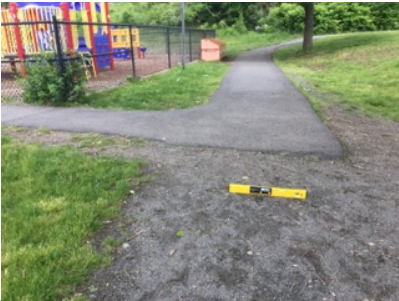
4	East Corner of North Playground	Ext.		Exterior Access Route	Exterior

Cross slope > 1:50 (2.00%) (MAAB) Surface not stable, firm, and slip-resistant	4.2% -	Reduce cross slope to be no steeper than 1:50 (2.00%). Repair surface. (Cost based on 10' stone dust.)	1	255	\$255
5	North Soccer Field	Ext.		Exterior Access Route	Walkway

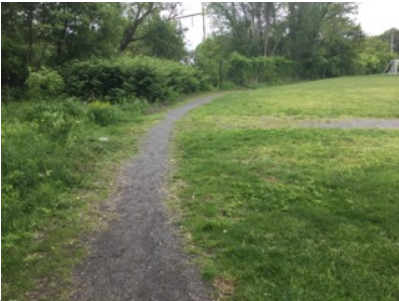
Not maintained in an operable working condition Exterior route < 48" wide	40" -	Ensure that a clear width of 48" min. is maintained at the accessible route. Ensure the accessible route is maintained in operable working condition. (Cost based on 115' by 4' wide stone dust path.)	1	2760	\$2760

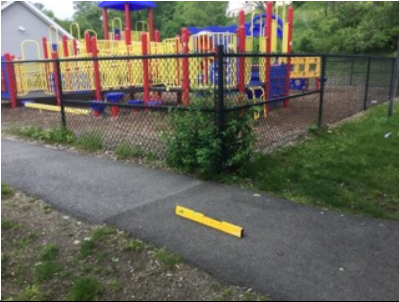
ID	Location	Floor	Room	Element	Type	Photo	Issues	Current Measure	Recommendations	Quantity	Price	Cost Estimation
6	Route to the Farthest Soccer Fields	Ext.		Exterior Access Route	Exterior

Running slope > 1:20 (5.00%)	7.2%	Reduce the running slope to be no steeper than 1:20 (5.00%). (Cost based on 10' asphalt to fix slope.)	1	75	\$75
7	Route to North Soccer Field-Northwest Side	Ext.		Exterior Access Route	Walkway

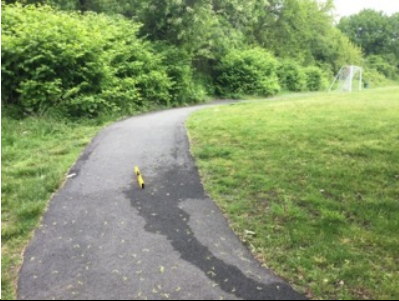
Running slope > 1:20 (5.00%)	11.9%	Reduce the running slope to be no steeper than 1:20 (5.00%). (Cost based on 30' asphalt to reduce slope.)	1	225	\$225
Off-Street Parking Lot or Garage												
8	Parking Lot Near Road	Ext.		Off-Street Parking Lot or Garage	N/A

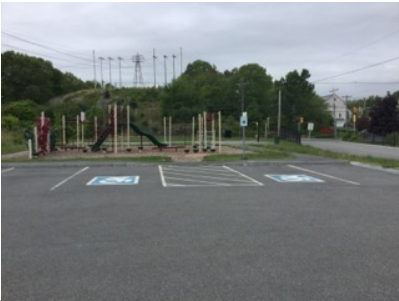
Total # of parking Total # of designated accessible parking spaces Sign not provided Sign does not have the designation "Van Accessible"	36 2 - -	Provide a sign with the bottom of the sign 60" min. above the ground and the top 96" max. above the ground. Add the designation "Van Accessible."	1	375	\$375

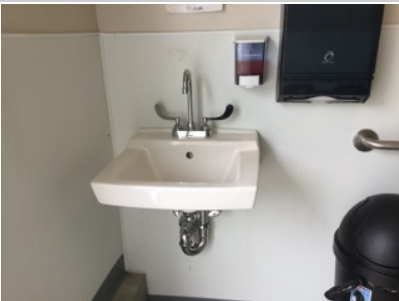
Toilet & Bathing Rooms												
Lavatory												
9	Men's Toilet Room	Ext.		Lavatory	N/A

Exposed plumbing underneath	-	Insulate or otherwise configure pipes to prevent contact at lavatory.	1	69	\$69
10	Women's Toilet Room	Ext.		Lavatory	N/A

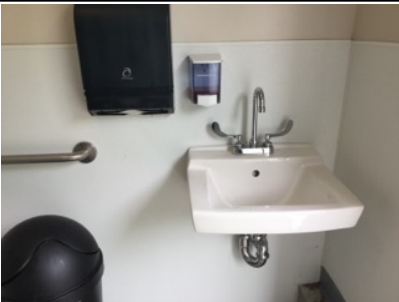
Exposed plumbing underneath	-	Insulate or otherwise configure pipes to prevent contact at lavatory.	1	69	\$69

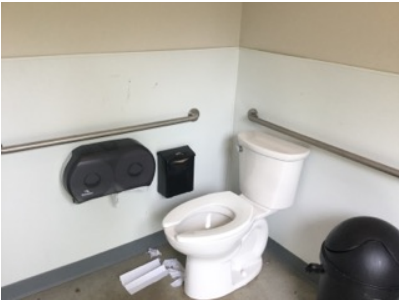
ID	Location	Floor	Room	Element	Type	Photo	Issues	Current Measure	Recommendations	Quantity	Price	Cost Estimation
Toilet Compartment												
11	Women's Toilet Room	Ext.		Toilet Compartment	Accessible Compartment

Flush control not on open side Clearance at toilet < 60" clear width	- -	Provide the flush control on the open side of the toilet (transfer side). Relocate trash can to maintain the 60" min. clear floor space at the toilet.	1	281 Labor	\$281
12	Men's Toilet Room	Ext.		Toilet Compartment	Accessible Compartment

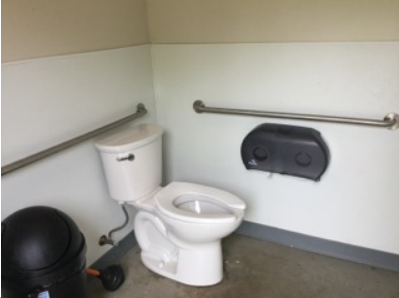
Clearance at toilet < 60" clear width	-	Relocate trash can to maintain the 60" min. clear floor space at the toilet.	1	Labor	\$0
Additional Access												
Drinking Fountains												
13	Concession Stand	Ext.		Drinking Fountains	Seated

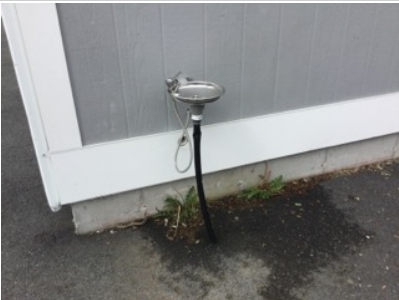
No drinking fountain provided for standing users	-	Install a Hi-Lo drinking fountain.	1	3162	\$3162
Play and Sport Areas

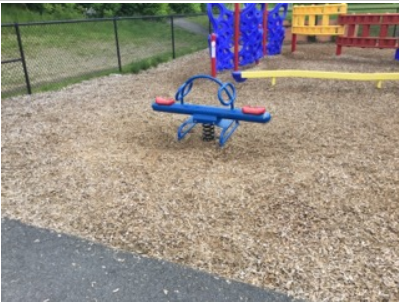
Play Areas												
14	North Playground	Ext.		Play Areas	N/A

Accessible route not provided to ground level play components	-	Ensure an accessible route 48" wide with asphalt is provided around the entirety of the playground. Provide an accessible route that is 60" min. wide to each play component in the playground.	1	11847	\$11847

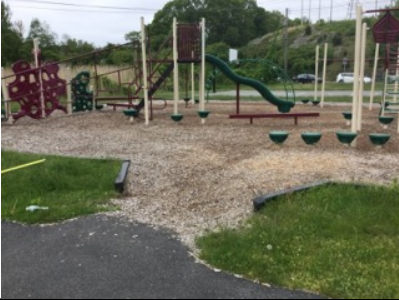
ID	Location	Floor	Room	Element	Type	Photo	Issues	Current Measure	Recommendations	Quantity	Price	Cost Estimation
15	South Playground	Ext.		Play Areas	N/A

Accessible route not provided to ground level play components Surface not stable, firm, and slip-resistant	- -	Ensure an accessible route 48" wide with asphalt is provided around the playground. Provide an accessible route that is 60" min. wide to each play component in the playground.	1	24270	\$24270
Field												
16	North Soccer Field- Team Seating	Ext.		Field	Soccer

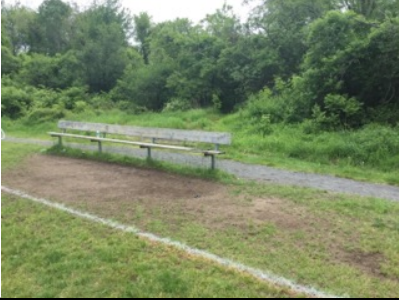
Accessible spaces are not provided at team seating	-	Provide a 36" min. by 48" min. asphalt clear floor space at team seating.	2	234	\$468
17	North Soccer Field	Ext.		Field	Soccer

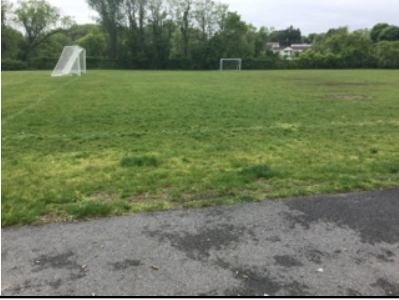
Not connected to an accessible-route	-	Ensure edge of soccer field is connected to an accessible route. (Cost based on 15' by 4' wide stone dust path to edge of field.)	1	360	\$360

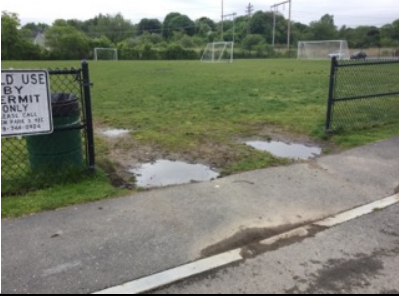
18	South Soccer Field	Ext.		Field	Soccer

Surface not stable, firm, and slip-resistant Does not prevent accumulation of water	- -	Repair surface and ensure water does not accumulate. (Cost based on new curb cut and 12' by 4' wide stone dust route to field.)	1	1785	\$1785

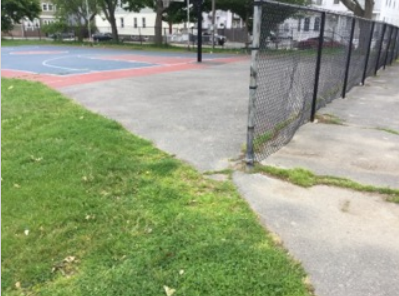
ID	Location	Floor	Room	Element	Type	Photo	Issues	Current Measure	Recommendations	Quantity	Price	Cost Estimation
Approach and Entrance												
Exterior Access Route												
1	Basketball Court	Ext.		Exterior Access Route	Exterior

Exterior route < 48" wide	10"	Ensure that a clear width of 48" min. is maintained at the accessible route. (Cost based on 3' by 3' asphalt patch.)	1	27	\$27
2	Route From Parking Lot to Park	Ext.		Exterior Access Route	Exterior

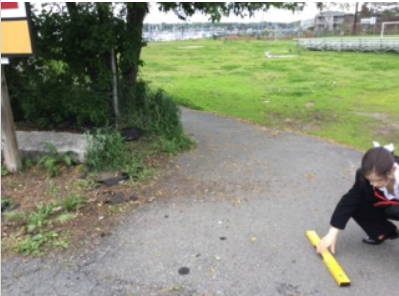
Running slope > 1:20 (5%)	8%	Reduce running slope to be no steeper than 1:20 (5%). (Cost based on adding 6'x4' of asphalt to reduce slope.)	1	180	\$180
3	Route to Parking Lot From Basketball Court	Ext.		Exterior Access Route	Exterior

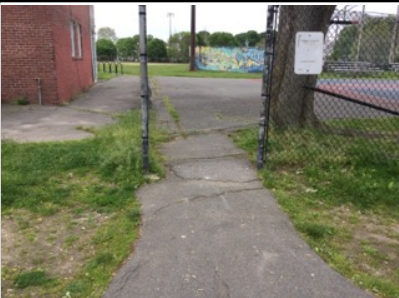
Route not maintained in operable working condition	-	Ensure the accessible route is maintained in operable working condition. (Cost based on 10' asphalt patch.)	1	195	\$195
4	Entrance to First Community Garden Area	Ext.		Exterior Access Route	Exterior

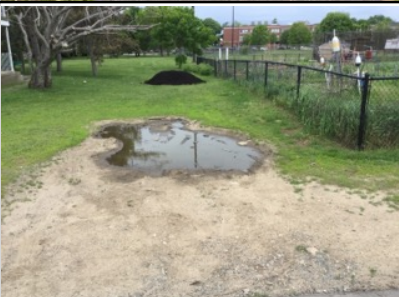
Accessible route not provided	-	Ensure an accessible route is provided to entrance. (Cost based on 60' long 48" wide min. stone dust path to entrance.)	1	1368	\$1368

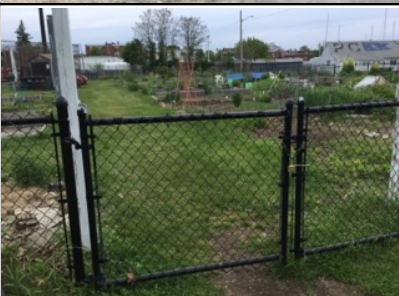
5	First Community Garden Area	Ext.		Exterior Access Route	Exterior

Accessible route not provided	-	Ensure an accessible route is provided inside the community garden. (Cost based on 300' by 4' wide stone dust path throughout the community garden.)	1	6840	\$6840

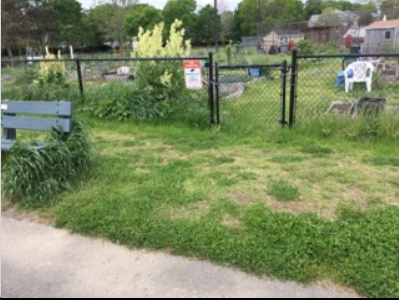
ID	Location	Floor	Room	Element	Type	Photo	Issues	Current Measure	Recommendations	Quantity	Price	Cost Estimation
6	Entrance to Second Community Garden Area	Ext.		Exterior Access Route	Exterior

Accessible route not provided	-	Ensure an accessible route is provided to entrance. (Cost based on 12' long x 48" wide min. stone dust path to gate.)	1	273	\$273
7	Route to Parking Lot From Basketball Court	Ext.		Exterior Access Route	Exterior

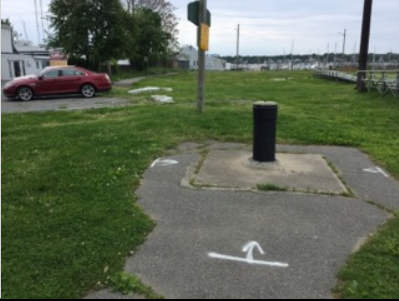
Accessible route not provided	-	Ensure an accessible route is provided. (Cost based on 30' long x 48" wide min. asphalt path connecting this area to the parking lot.)	1	780	\$780
8	Route to Basketball Court	Ext.		Exterior Access Route	Exterior

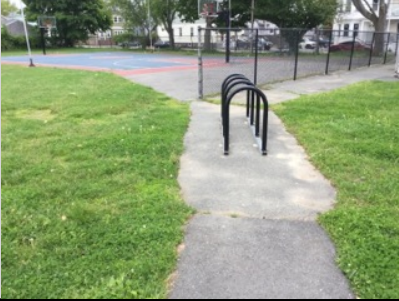
Accessible route not provided	-	Ensure an accessible route is provided. Relocate bike rack to an accessible location to provide an accessible route on walkway. Patch asphalt once bike rack is relocated. (Cost based on a 3'x3' asphalt patch.)	1	27	\$27

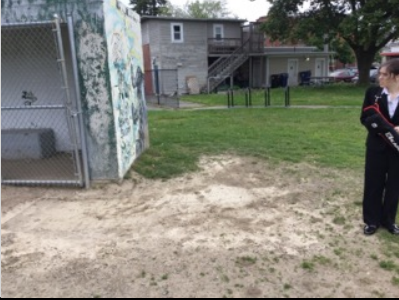
9	Dugouts at Baseball Field	Ext.		Exterior Access Route	Exterior

Accessible route not provided	-	Ensure an accessible route is provided to both dugouts. (Cost based on 240' long by 48" wide stone dust path to both dugouts.)	1	5472	\$5472
10	Second Community Garden Area	Ext.		Exterior Access Route	Exterior

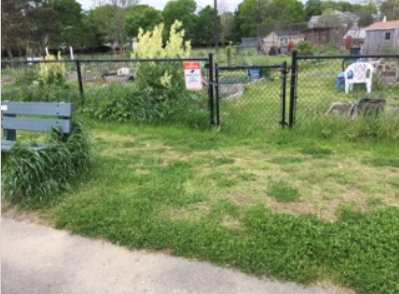
Accessible route not provided	-	Ensure an accessible route is provided is provided inside the second community garden area. (Cost based on a 60' long 48" wide min. stone dust path.)	1	1368	\$1368

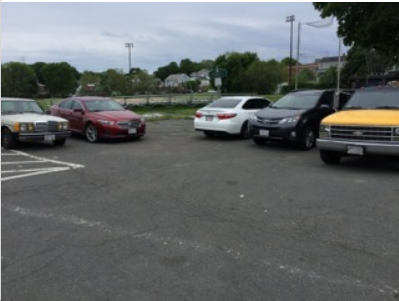
ID	Location	Floor	Room	Element	Type	Photo	Issues	Current Measure	Recommendations	Quantity	Price	Cost Estimation
Off-Street Parking Lot or Garage												
11	Parking Lot on Leavitt Street	Ext.		Off-Street Parking Lot or Garage	N/A

Total # of parking Total # of designated accessible parking spaces Total # of designated van accessible spaces Sign not provided Sign does not have the designation "Van Accessible"	15 0 0 - -	Provide one (1) compliant van accessible parking space and access aisle. Provide a sign with the bottom of the sign 60" min. above the ground and the top 96" max. above the ground. Add the designation "Van Accessible" to the sign located at the van accessible space.	1	1388	\$1388
Access to Goods and Services												
Signage												
12	Men's Toilet Room	1		Signage	Designation

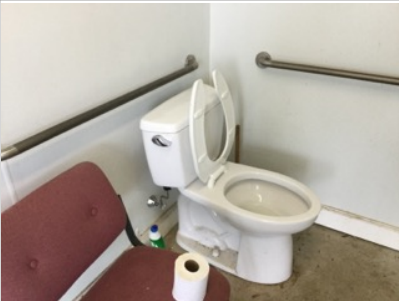
Not provided	-	Remove existing men's room sign and provide a sign designating this single-user toilet room as an all gender toilet room since it is the only toilet room available.	1	174	\$174

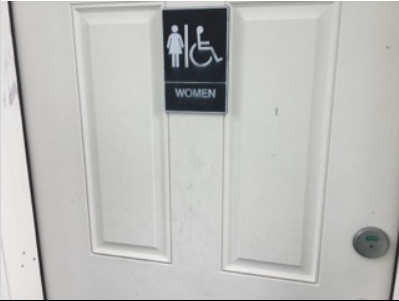
13	Men's and Women's Toilet Rooms	Ext.		Signage	Designation

International Symbol of Acc. not compliant	-	Since the women's toilet room is always locked and never used, remove existing sign from door which indicates that an accessible toilet room is available at this location.	1	Labor	\$0
Picnic Tables												
14	Picnic Table Near Toilet Rooms	Ext.		Picnic Tables	N/A

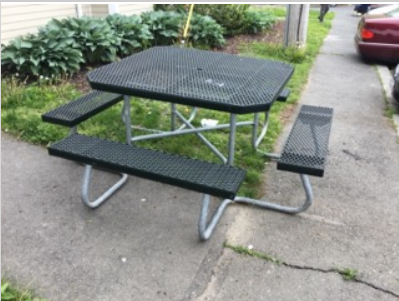
At least 5% accessible spaces not provided	-	Ensure that at least 5% (minimum one) of picnic tables are accessible. (Cost based on one accessible picnic table.)	1	1050	\$1050

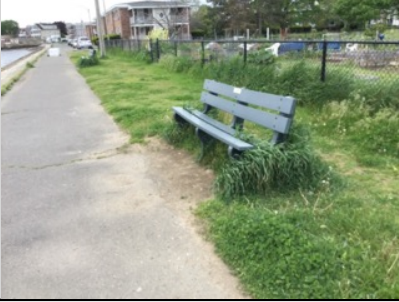
ID	Location	Floor	Room	Element	Type	Photo	Issues	Current Measure	Recommendations	Quantity	Price	Cost Estimation
Benches												
15	Path Along Harbor, East Side of Park	Ext.		Benches	N/A

Shoulder alignment not provided at bench	-	Recommend ensuring that 20% of benches (1) have a clear floor space of 36" wide min. by 48" deep min.	1	68	\$68
Toilet & Bathing Rooms												
Overall Access												
16	Men's Toilet Room	1		Overall Access	Toilet Room

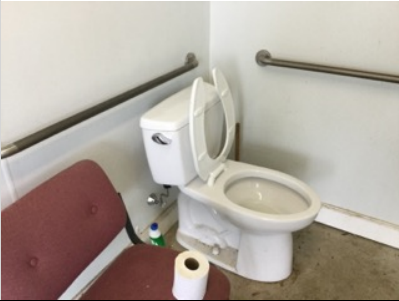
Turning space not provided	-	Remove/relocate chair out of clear floor space at toilet.	1	Labor	\$0
Play and Sport Areas												
Field												
17	Fan Seating at Baseball Field	Ext.		Field	Baseball

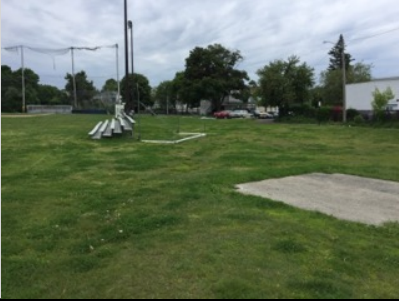
Accessible spaces not provided at sidelines seating Accessible route not provided to sidelines seating Field not connected to an accessible route	- - -	Provide a 36" x 48" clear floor space at sideline seating. Provide an accessible route to sidelines seating. Ensure boundary of baseball field/edge of sport activity is connected to an accessible route. (Cost based on two (2) 3'x4' asphalt patches at seating and 90' long x 48" wide min. asphalt path to sideline seating & edge of sport activity.)	1	2394	\$2394

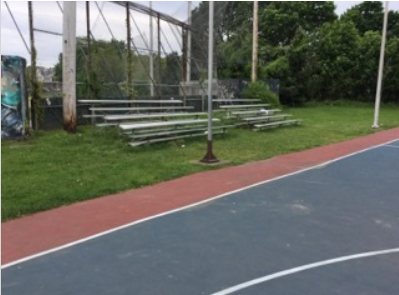
Court												
18	Fan Seating at Basketball Court	Ext.		Court	Basketball

Accessible spaces are not provided at sidelines seating Accessible route not provided to sidelines seating	-	Provide a 36" x 48" clear floor space at sidelines seating. Provide an accessible route to sidelines seating. (Cost based on 12' x 48" wide min. asphalt path to seating and two (2) 3'x4' asphalt patches by seating.)	1	366	\$366

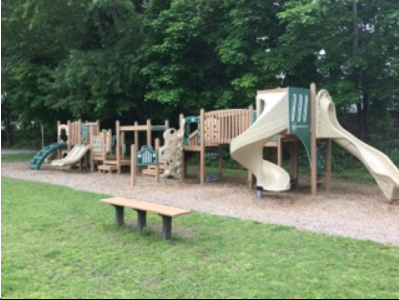
ID	Location	Floor	Room	Element	Type	Photo	Issues	Current Measure	Recommendations	Quantity	Price	Cost Estimation
10	Playground	Ext.		Benches	N/A

20% of benches have clear space < 36" x 48"	- -	Ensure that 20% of benches have a clear floor space of 36" wide min. by 48" deep min. (Cost is for a level asphalt patch alongside bench. Ensure asphalt patch joins exterior asphalt path along perimeter of playground.)	1	27	\$27
Play and Sport Areas												
Play Areas												
11	Swing Set by Picnic Pavilion	Ext.		Play Areas	N/A

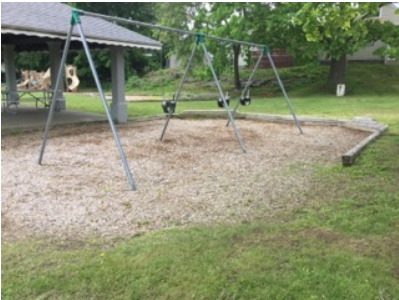
Accessible route not provided to ground level play components	-	Provide an accessible route that is 60" wide min. to each play component in the playground (swing set). (Cost based on 60" wide x 30' long route from entrance to and along the swings, poured in place rubber.)	1	2100	\$2100
12	Second Swing Set	Ext.		Play Areas	N/A

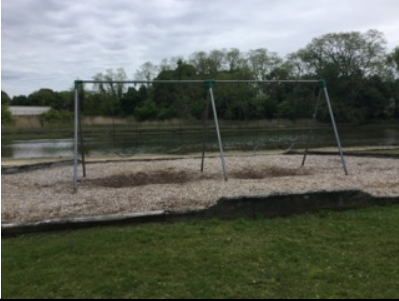
Accessible route not provided to ground level play components	-	Provide an accessible route that is 60" wide min. to each play component in the playground (swing set). Ensure transition from rubber to exterior accessible route at edge of swings is 1/4" max. (Cost based on 60" wide x 40' long route from entrance to and along the swings, poured in place rubber.)	1	2800	\$2800

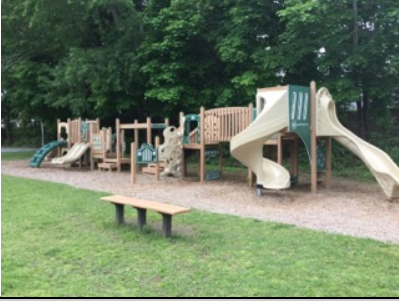
13	Playground	Ext.		Play Areas

Accessible route not provided to ground level play components	-	Provide an accessible route that is 60" wide min. to each play component in the playground. Ensure transition from rubber to exterior accessible route at edge of playground is 1/4" max. (Cost based on 60" wide x 80' long route from entrance to playground area and along the playground, poured in place rubber.)	1	5600	\$5600
Court												
14	Basketball Court	Ext.		Court	Basketball

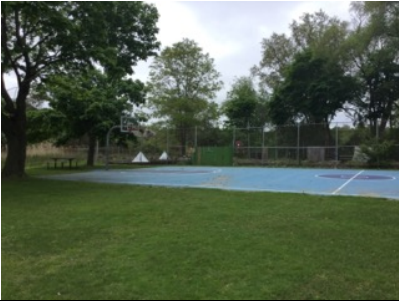
Not connected to accessible route	-	Ensure basketball court is connected to an accessible route from park entrance at Lincoln Road. Provide a 48" wide min. accessible route through the center of the park connecting to the basketball court with a 1:20 (5.00%) max. running slope and a 1:50 (2.00%) max. cross slope. (Cost based on a 48" wide min. x 200' long asphalt path to the edge of the basketball court.)	1	5100	\$5100

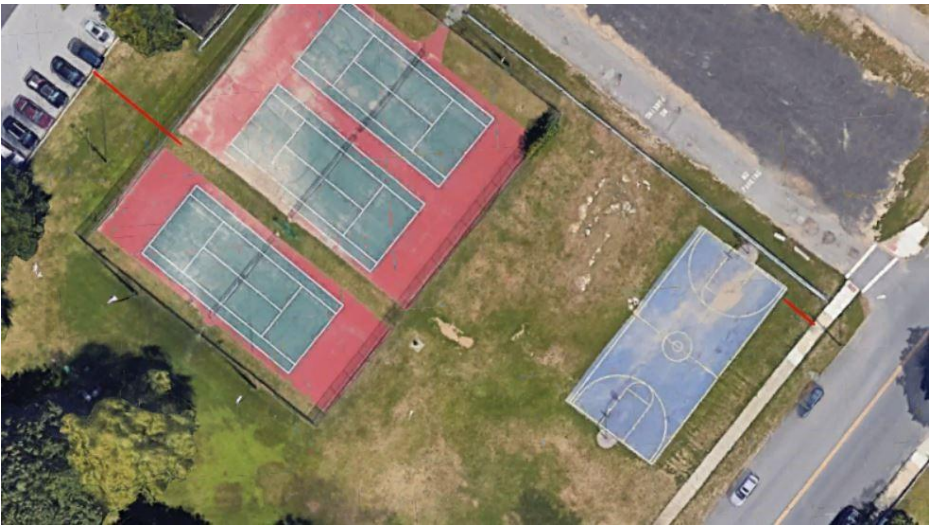
Note: IHCD recommends using tables such as this to ensure an accessible and inclusive experience for park visitors.

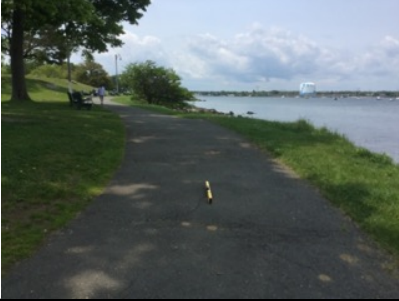
ID	Location	Floor	Room	Element	Type	Photo	Issues	Current Measure	Recommendations	Quantity	Price	Cost Estimation
Approach and Entrance												
Exterior Access Route												
1	Northwest Side of Park	Ext.		Exterior Access Route	Exterior

Cross slope > 1:50 (2.00%)	4.2%	Reduce cross slope to be no steeper than 1:50 (2.00%). (Cost based on 100' asphalt to fix cross slope.)	1	750	\$750
2	Route to Pavilion on North End of Park	Ext.		Exterior Access Route	Exterior

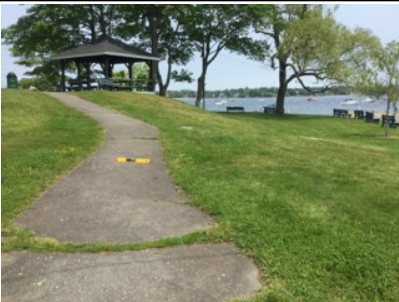
Cross slope > 1:50 (2.00%) (MAAB) Running slope > 1:20 (5.00%)	8.3% 17.4%	Reduce cross slope to be no steeper than 1:50 (2.00%). Recommend reducing running slope to be no steeper than 1:20 (5%). (Cost based on 80' asphalt to fix cross slope.)	1	600	\$600
3	Route to Hatch Shell	Ext.		Exterior Access Route	Exterior

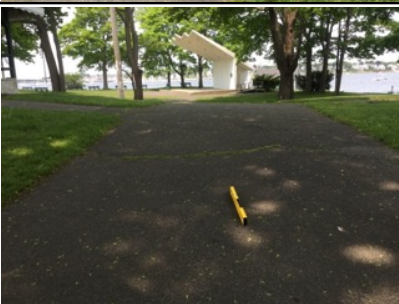
Running slope > 1:20 (5%)	8.4%	Reduce running slope to be no steeper than 1:20 (5%). (Cost based on 120' asphalt to hatch shell.)	1	2340	\$2340

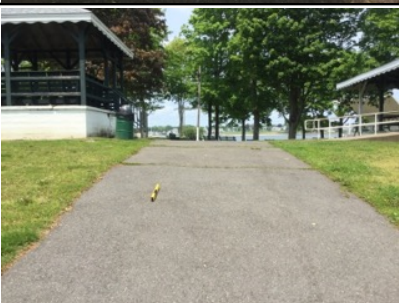
4	Route From Parking to Pavilions Near Center of the Park	Ext.		Exterior Access Route	Exterior

Running slope > 1:20 (5%)	14.6%	Reduce running slope to be no steeper than 1:20 (5%). (Cost based on 75' asphalt to pavilion.)	1	1463	\$1463
5	Pavilion on North End of Park	Ext.		Exterior Access Route	Exterior

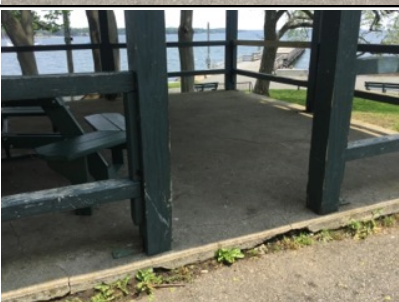
Level changes > 1/4"	4"	Alter change in level to be 1/4" high max.	1	155	\$155

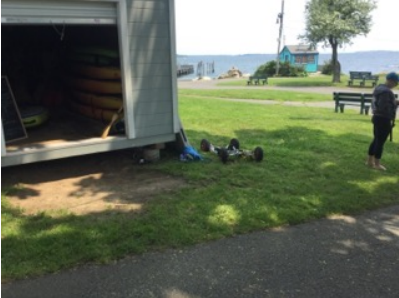
ID	Location	Floor	Room	Element	Type	Photo	Issues	Current Measure	Recommendations	Quantity	Price	Cost Estimation
6	Canoe Shed	Ext.		Exterior Access Route	Exterior

Accessible route not provided	-	Ensure an accessible route is provided. (Cost based on 15' asphalt to canoe rental area.)	1	293	\$293
7	Route to Clam Shack	Ext.		Exterior Access Route	Exterior

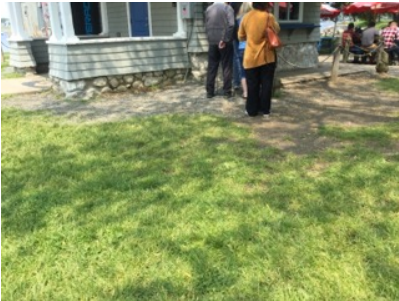
Accessible route not provided	-	Ensure an accessible route is provided. (Cost based on 15' concrete to service window.)	1	518	\$518
8	Route to Dead Horse Beach	Ext.		Exterior Access Route	Exterior

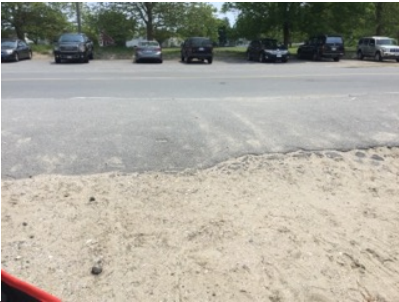
Running slope > 1:20 (5.00%)	15%	Reduce the running slope to be no steeper than 1:20 (5.00%). (Cost based on 10' asphalt.)	1	195	\$195
Beach Access Routes												
9	Dead Horse Beach	Ext.		Beach Access Routes	Removable

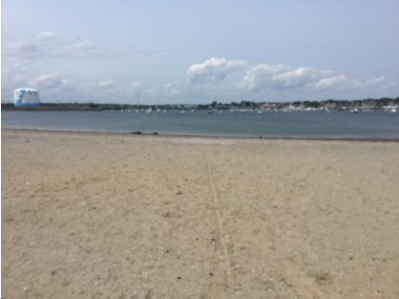
Beach route not provided	-	Provide an accessible route that is firm and stable. Ensure the accessible route extends to the high tide level. (Cost based on a 125' long by 72" wide beach mat.)	1	5821	\$5821

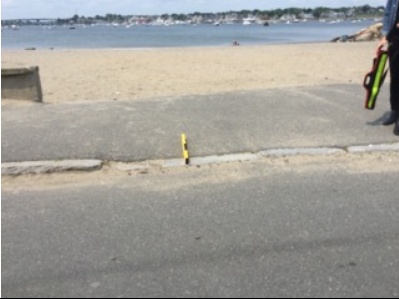
Curb Ramp												
10	Route to Dead Horse Beach From Parking Lot	Ext.		Curb Ramp	Parallel

Running slope > 1:12 (8.33%) Transition from curb ramp to street not flush	9.4% -	Reduce running slope to be no steeper than 1:12 (8.33%). Ensure transition from curb ramp to street is flush or free of changes in level.	1	2800	\$2800

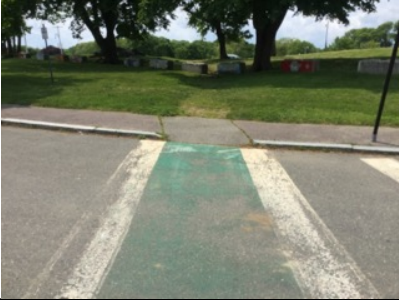
ID	Location	Floor	Room	Element	Type	Photo	Issues	Current Measure	Recommendations	Quantity	Price	Cost Estimation
11	Southern Crosswalk From North Half of Park to South Half of Park	Ext.		Curb Ramp	Parallel

Running slope > 1:12 (8.33%) Landing not provided at top of curb ramp	14.1% 5.3%	Reduce running slope to be no steeper than 1:12 (8.33%). Provide landing at top of curb ramp or reconfigure ramp.	1	2800	\$2800
Entrance												
12	Alternate Entrance to Pavilion With Ramp Near Center of Park	Ext.		Entrance	N/A

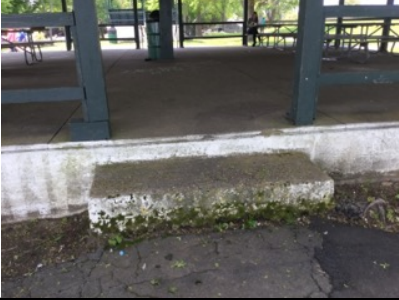
Directional sign to accessible entrance not provided	-	Provide a directional sign indicating the location of the nearest accessible entrance.	1	260	\$260
Off-Street Parking Lot or Garage												
13	Parking Lot - Dead Horse Beach	Ext.		Off-Street Parking Lot or Garage	N/A

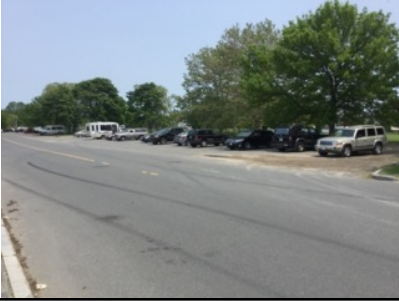
Total # of parking Total # of designated accessible parking spaces Access aisle not provided Sign not provided Sign does not have the designation "Van Accessible"	45 0 - - -	Provide one (1) car accessible space and one (1) van accessible space. Provide a marked access aisle that is at least 96" wide for both spaces to use. Provide a sign with the bottom of the sign 60" min. above the ground and the top 96" max. above the ground. Add the designation "Van Accessible" to the sign located at the van accessible space.	2	1388	\$2776

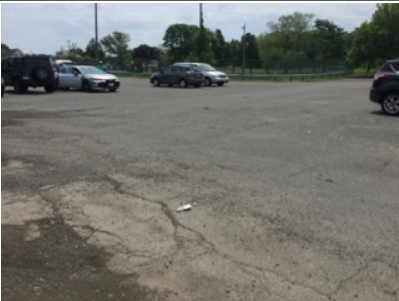
14	Parking Lot North of Tennis Courts	Ext.		Off-Street Parking Lot or Garage	N/A

Total # of parking Total # of designated accessible parking spaces Access aisle not provided Sign not provided Sign does not have the designation "Van Accessible"	56 0 - - -	Provide one (1) van accessible space and two (2) car accessible spaces. Provide two (2) marked access aisles. Provide three (3) signs with the bottom of the signs 60" min. above the ground and the top 96" max. above the ground. Add the designation "Van Accessible" to the sign located at the van accessible space.	3	1388	\$4164
15	Metered Parking Lot Near Arcade	Ext.		Off-Street Parking Lot or Garage	N/A

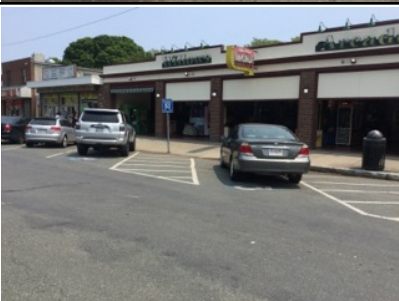
Total # of parking Total # of designated accessible parking spaces Sign does not have the designation "Van Accessible"	97 4 -	Add the designation "Van Accessible" to the sign located at the van accessible space.	1	375	\$375

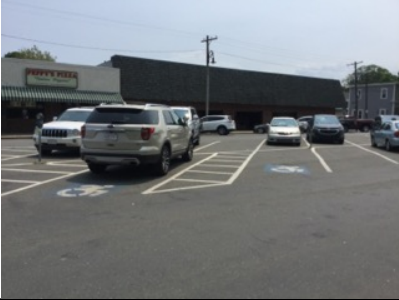
ID	Location	Floor	Room	Element	Type	Photo	Issues	Current Measure	Recommendations	Quantity	Price	Cost Estimation
16	Metered Parking Lot Near Arcade	Ext.		Off-Street Parking Lot or Garage	N/A

Access aisle < 60" wide at car/van space Sign not provided	57" -	Provide a marked access aisle that is at least 60" wide. Provide a sign with the bottom of the sign 60" min. above the ground and the top 96" max. above the ground.	1	600	\$600
Access to Goods and Services												
Ramps												
17	Hatch Shell	Ext.		Ramps	Exterior

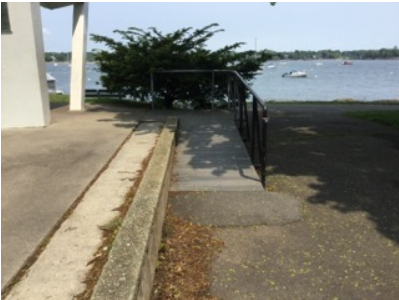
Ramp < 48" wide (MAAB) Handrails do not extend 12" past top & bottom	41" -	Widen ramp so that the clear width is 48" min. Alter handrails to extend horizontally above the landing for 12" min. beyond the top and bottom of ramp runs. Ensure handrails are provided on both sides. (Cost based on one set of metal handrail extensions and widening a 10' long ramp.)	1	4262	\$4262

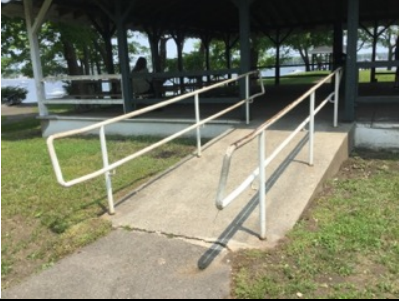
18	Route to Pavilion With Ramp Near Center of Park	Ext.		Ramps	Exterior

Running slope >1:12 (8.33%) Landing not as wide as ramp.	10.8% -	While the running slope is technically not compliant, it is still usable. Alter so the landing is at least as wide as the ramp. (Cost based on widening bottom of ramp.)	1	48	\$48
19	Route to Toilet Rooms	Ext.		Ramps	Exterior

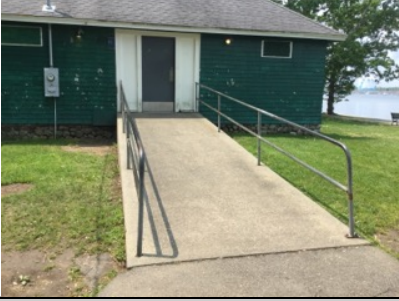
Running slope >1:12 (8.33%) Landing has a slope > 1:50 (2.00%) (MAAB)	9.2% 9.2%	Reduce running slope to be no steeper than 1:12 (8.33%). Alter so that the slope in all directions is no greater than 1:50 (2.00%).	1	9251	\$9251
Signage												
20	Toilet Rooms, Main Entrance	Ext.		Signage	Designation

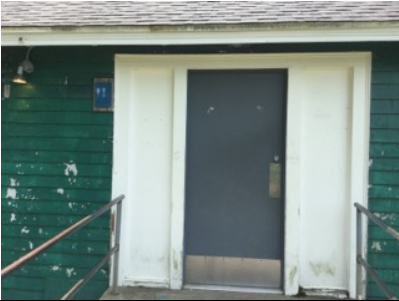
Raised characters not provided Braille not provided Sign not located on the latch side of the door	- - -	Provide text with raised characters duplicated in braille. Locate sign alongside the door on the latch side.	1	174	\$174

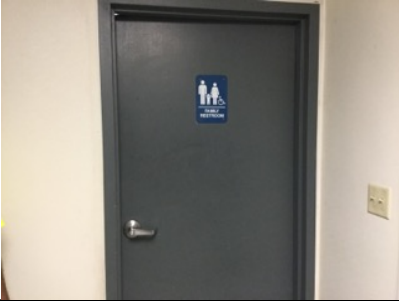
ID	Location	Floor	Room	Element	Type	Photo	Issues	Current Measure	Recommendations	Quantity	Price	Cost Estimation
21	Family Toilet Room	1		Signage	Designation

Raised characters < 48" or > 60 " above ground Sign not located on the latch side of the door	62" -	Mount sign so that the baseline of the lowest tactile character is 48" min. above finished floor and the baseline of the highest tactile character is 60" max. above finished floor. Locate sign alongside the door on the latch side.	1	Labor	\$0
22	Women's Toilet Room	1		Signage	Designation

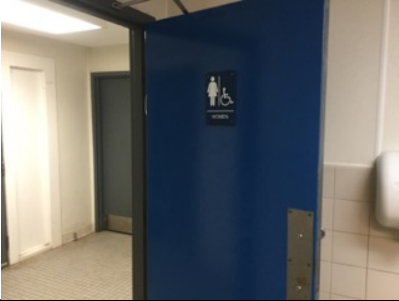
Raised characters < 48" or > 60 " above ground Sign not located on the latch side of the door	61.5" -	Mount sign so that the baseline of the lowest tactile character is 48" min. above finished floor and the baseline of the highest tactile character is 60" max. above finished floor. Locate sign alongside the door on the latch side.	1	Labor	\$0

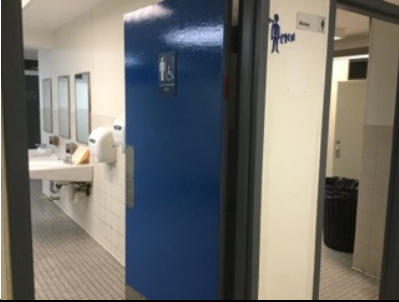
23	Men's Toilet Room	1		Signage	Designation

Raised characters < 48" or > 60 " above ground Sign not located on the latch side of the door	61" -	Mount sign so that the baseline of the lowest tactile character is 48" min. above finished floor and the baseline of the highest tactile character is 60" max. above finished floor. Locate sign alongside the door on the latch side.	1	Labor	\$0
Service Counter												
24	Clam Shack	Ext.		Service Counter	N/A

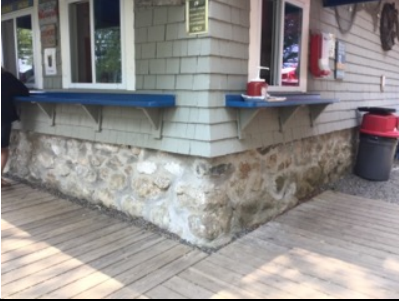
Counter > 36" high	43.25"	Provide a counter that is 36" max. above the ground.	1	660	\$660
25	Restaurant Ordering Window	Ext.		Service Counter	N/A

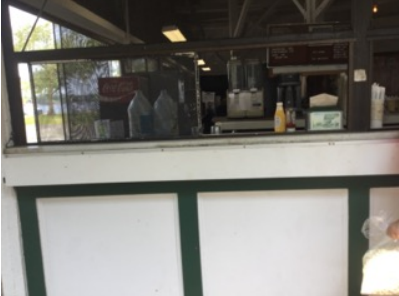
Counter > 36" high	48.5"	Provide a counter that is 36" max. above the ground.	1	660	\$660

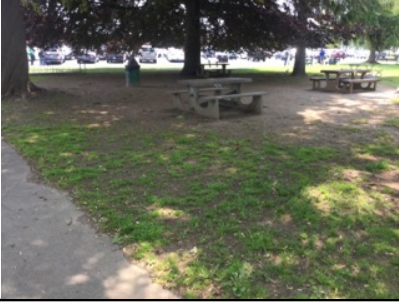
ID	Location	Floor	Room	Element	Type	Photo	Issues	Current Measure	Recommendations	Quantity	Price	Cost Estimation
Picnic Tables												
26	Picnic Area Across From Dairy Palace	Ext.		Picnic Tables	N/A

Toe or knee clearance at table not provided Picnic table not on an accessible route	- -	Provide at least one picnic table with toe and knee clearance. Locate picnic table on an accessible route. (Cost based on one accessible picnic table and 30' asphalt to picnic area.)	1	1635	\$1635
27	Picnic Area South of Tennis Courts	Ext.		Picnic Tables	N/A

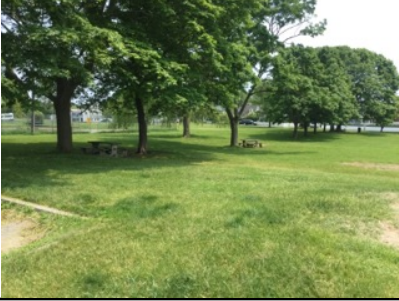
Toe or knee clearance at table not provided Picnic table not on an accessible route	- -	Provide at least one picnic table with toe and knee clearance. Locate picnic table on an accessible route. (Cost based on one accessible picnic table and 30' asphalt path to picnic area.)	1	1635	\$1635
28	Picnic Area North of Concession Stand	Ext.		Picnic Tables	N/A

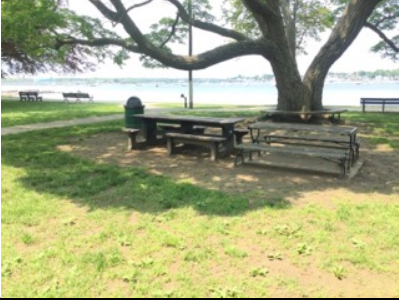
Picnic table not on an accessible route	-	Ensure that the picnic table is connected to an accessible route. (Cost based on 15' asphalt to accessible table.)	1	293	\$293

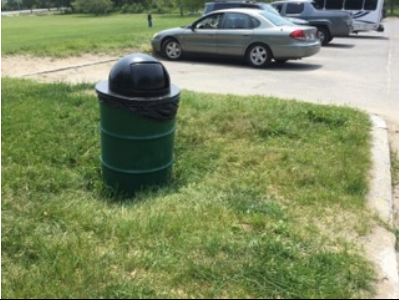
Trash / Recycling												
29	South of Tennis Courts, Near Parking Lot for Dead Horse Beach	Ext.		Trash / Recycling	N/A

Trash container not connected to an accessible route	-	Ensure trash container is located on an accessible route.	1	Labor	\$0
Toilet & Bathing Rooms

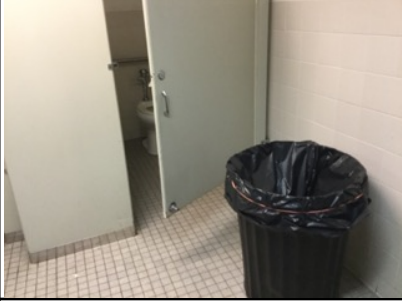
ID	Location	Floor	Room	Element	Type	Photo	Issues	Current Measure	Recommendations	Quantity	Price	Cost Estimation
Overall Access												
30	Women's Toilet Room	1		Overall Access	Toilet Room

Maneuvering clearance(s) not provided	-	Remove the trash container to maintain the maneuvering clearance at the door.	1	Labor	\$0
31	Women's Toilet Room	1		Overall Access	Toilet Room

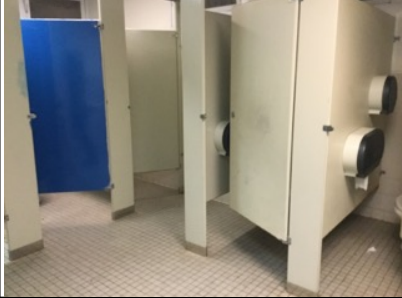
6 fixtures, but no ambulatory compartment provided	-	Provide one ambulatory accessible compartment.	1	1539	\$1539
Lavatory												
32	Family Toilet Room	1		Lavatory	N/A

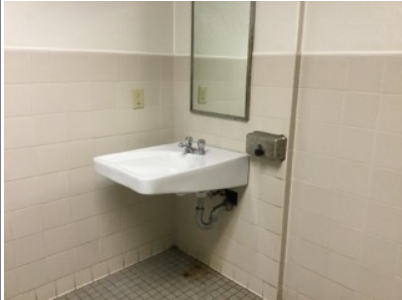
Plumbing underneath is exposed	-	Insulate or otherwise configure pipes to prevent contact, for at least one lavatory.	1	69	\$69
Single-User Toilet												
33	Family Toilet Room	1		Single-User Toilet	N/A

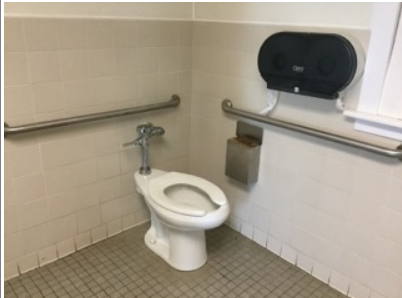
Toilet paper dispenser is not compliant	-	Relocate toilet paper so that it is 15" min. high, located under the grab bar, and between 7" and 9" from the front of the toilet.	1	530	\$530

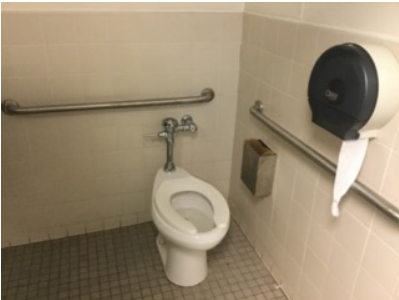
ID	Location	Floor	Room	Element	Type	Photo	Issues	Current Measure	Recommendations	Quantity	Price	Cost Estimation
Toilet Compartment												
34	Women's Toilet Room	1		Toilet Compartment	Accessible Compartment

Door has malfunctioning self-closing hinge Non-compliant toilet paper dispenser	- -	Repair hinge. Relocate toilet paper so that it is 15" min. high, located under the grab bar, and between 7" and 9" from the front of the toilet.	1	530	\$530
35	Men's Toilet Room	1		Toilet Compartment	Accessible Compartment

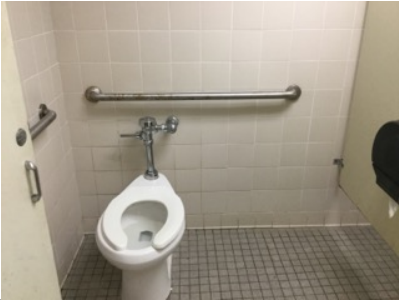
Door with malfunctioning self-closing hinge Flush control not on open side Non-compliant toilet paper dispenser	- - -	Repair hinge. Provide the flush control on the open side of the toilet (transfer side). Relocate toilet paper to the opposite wall. Ensure toilet paper is 15" min. high, located under the grab bar, and between 7" and 9" from the front of the toilet.	1	810	\$810

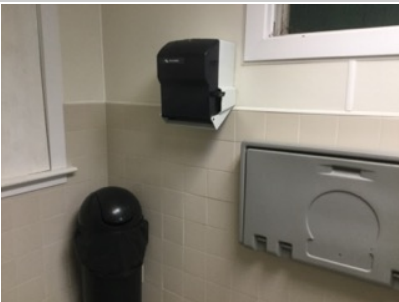
Dispensers												
36	Family Toilet Room	1		Dispensers	N/A

Controls > 42" high	55.75"	Relocate paper towel dispenser so the operable part is 42" max. above the finished floor.	1	530	\$530
37	Women's Toilet Room	1		Dispensers	N/A

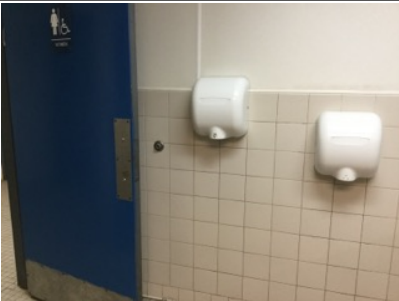
Dispenser acts as a protruding object	6"	Relocate hand dryer dispensers so they do not protrude into the circulation path.	2	530	\$1060
38	Men's Toilet Room	1		Dispensers	N/A

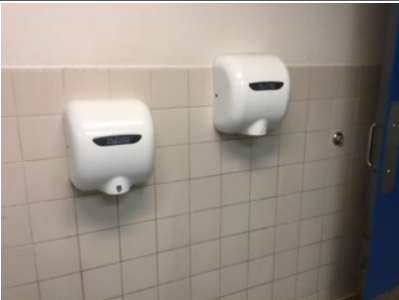
Dispenser acts as a protruding object	6"	Relocate hand dryer dispensers so they do not protrude into the circulation path.	2	530	\$1060
Additional Access

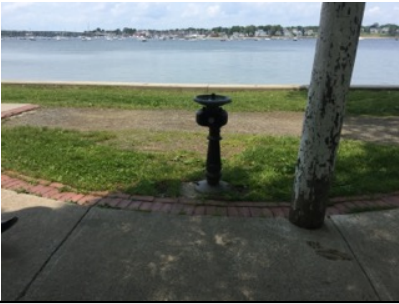
Operable parts malfunctioning No drinking fountain provided for standing users	- -	Repair or replace drinking fountain to ensure operable parts can be operable with one hand and not require tight grasping, pinching, or twisting of the wrist. Provide an additional drinking fountain for standing users or install a Hi-Lo drinking fountain.	1	3162	\$3162
Play and Sport Areas												
Court												
40	Basketball Court	Ext.		Court	Basketball

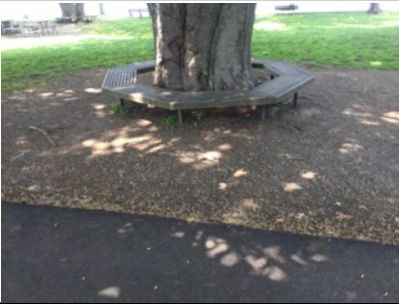
Recommend providing an accessible bench in this area.	1	-	\$0

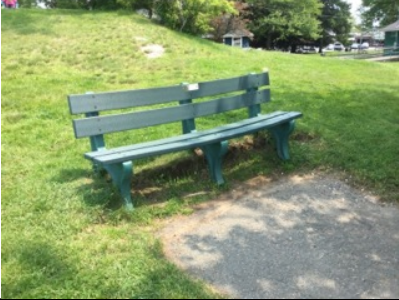
ID	Location	Floor	Room	Element	Type	Photo	Issues	Current Measure	Recommendations	Quantity	Price	Cost Estimation
43	Benches Throughout Park	Ext.		Benches	N/A

Recommend having a clear floor space of 36" wide min. by 48" deep min. adjacent to the benches around the park.	1	-	\$0
N/A												
44	Route to Hatch Shell	Ext.		N/A	N/A

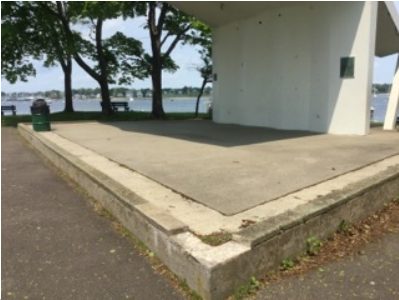
Ensure the route to Hatch Shell is maintained in operable working condition.	1	-	\$0
45	Canoe Shed	Ext.		N/A	N/A

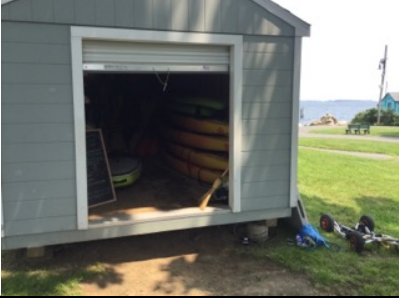
Recommend providing permanent informational sign about canoe and kayak rentals in the park.	1	-	\$0
46	Tennis Courts	Ext.		N/A	N/A

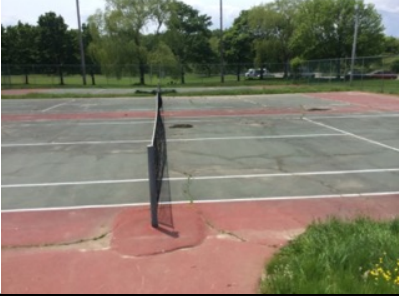
Recommend replacing tennis court surface.	1	-	\$0
Picnic Tables												
47	Pavilion on North End of Park	Ext.		Picnic Tables	N/A

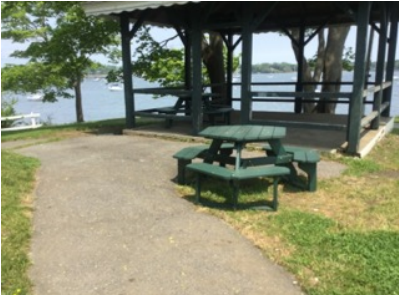
Recommend providing directional signage indicating the location of the nearest accessible picnic table (in this case, at the Pavilion with ramp near center of park).	1	0	\$0

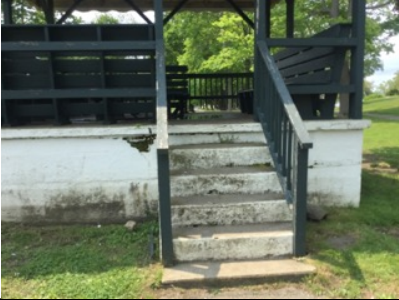
ID	Location	Floor	Room	Element	Type	Photo	Issues	Current Measure	Recommendations	Quantity	Price	Cost Estimation
48	Route to Pavilion Opposite Pavilion With Ramp Near Center of Park	Ext.		Picnic Tables	N/A

Recommend providing directional signage indicating the location of the nearest accessible picnic table (in this case, at the Pavilion with ramp near center of park).	2	0	\$0
49	Pavilion on Southwest Side of Park	Ext.		Picnic Tables	N/A

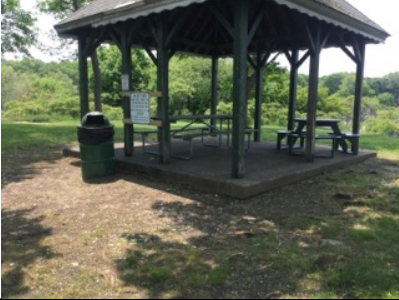
Recommend providing directional signage indicating the location of the nearest accessible picnic table (in this case, where IHCD recommends providing one near the tennis courts.)	1	0	\$0
50	Pavilion on Northeast Side of Park	Ext.		Picnic Tables	N/A

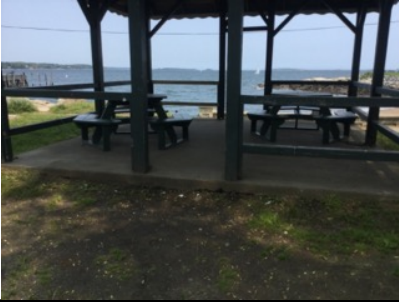
Recommend providing directional signage indicating the location of the nearest accessible picnic table (in this case, at the Pavilion with ramp near center of park.)	1	0	\$0
Waysides

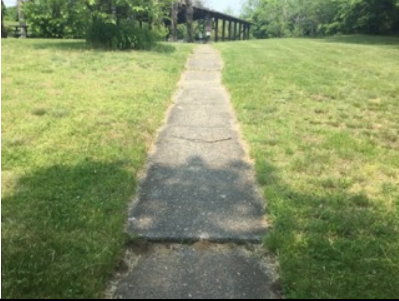
ID	Location	Floor	Room	Element	Type	Photo	Issues	Current Measure	Recommendations	Quantity	Price	Cost Estimation
Approach and Entrance												
Exterior Access Route												
1	Route From Main Parking Area to Picnic Pavilion	Ext.		Exterior Access Route	Walkway

Exterior route < 48" wide Surface openings > 1/2"	30" -	Ensure that a clear width of 48" min. is maintained at the accessible route. Repair surface openings. (Cost estimate based on repaving 125'x48" path.)	1	3138	\$3138
2	Route From Main Parking Area to Waikiki Beach	Ext.		Exterior Access Route	Walkway

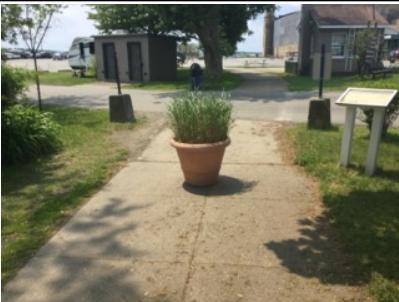
Exterior route < 48" wide	31"	Remove or relocate potted plant to ensure that a clear width of 48" min. is maintained in the the accessible route.	1	Labor	\$0
3	Route to Playground From Main Parking Area	Ext.		Exterior Access Route	Walkway

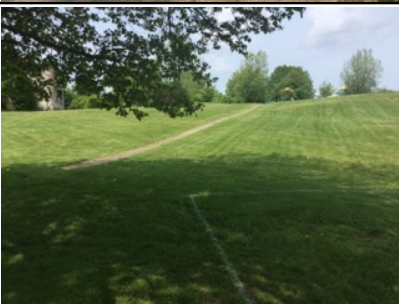
Exterior route < 48" wide Running slope > 1:20 (5%)	28" 15%	Ensure that a clear width of 48" min. is maintained in the accessible route with a running slope of 1:20 (5.00%) max. and a cross slope of 1:50 (2.00%) max. (Cost estimate based on 200'x48" wide min. asphalt route.)	1	4800	\$4800
