City of Salem, Massachusetts

PART A – Executive Summary

Part A – Executive Summary

Introduction

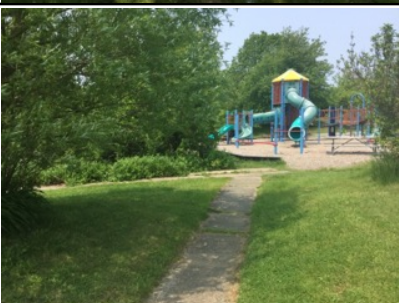
4	Route to Playground From Main Parking Area	Ext.		Exterior Access Route	Walkway

Obstructed by protruding objects	-	Trim low hanging tree branches.	1	Labor	\$0
5	Waikiki Beach Comfort Station	Ext.		Exterior Access Route	Walkway

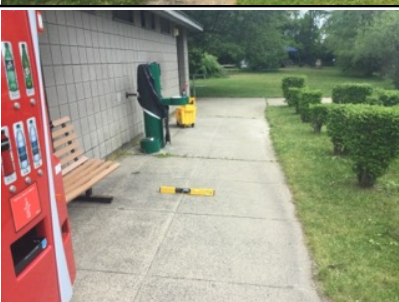
Cross slope > 1:50 (2.00%)	7.0%	Reduce cross slope to be no steeper than 1:50 (2.00%). (Cost estimate based on regrading 30' long section of walkway.)	1	900	\$900

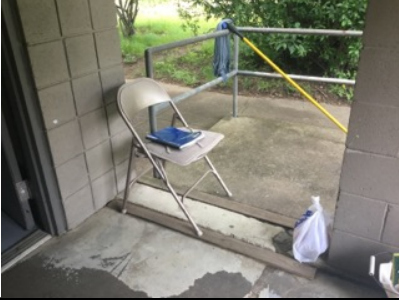
ID	Location	Floor	Room	Element	Type	Photo	Issues	Current Measure	Recommendations	Quantity	Price	Cost Estimation
6	Waikiki Beach Comfort Station	Ext.		Exterior Access Route	Exterior

Level changes > 1/4"	2"	Alter change in level to be 1/4" high max.	2	206	\$412
7	Route to Concrete Camping Area	Ext.		Exterior Access Route	Walkway

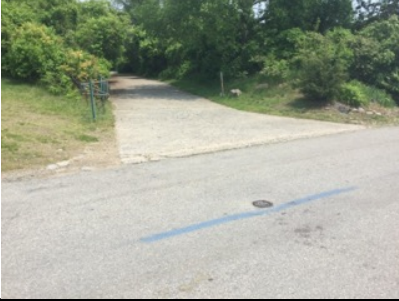
Level changes > 1/4"	2"	Alter change in level to be 1/4" high max. (Cost estimate based on patching 25' x 2' asphalt patch.)	1	213	\$213
8	Route to Waikiki Beach From Main Parking Area	Ext.		Exterior Access Route	Walkway

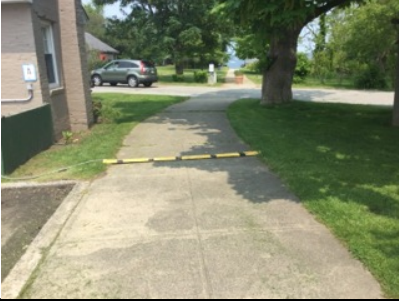
Level changes > 1/4"	2"	Bury cables or otherwise relocate or redesign cable crossing to a height of 1/4" max.	1	Labor	\$0
9	Access to Fort Pickering From Main Parking Area	Ext.		Exterior Access Route	Walkway

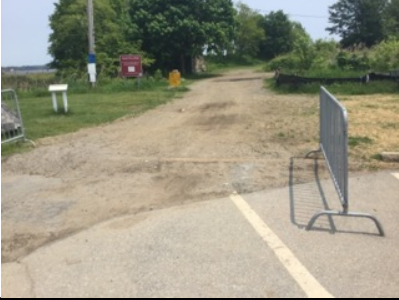
Level changes > 1/4" Surface is not stable, firm, and slip-resistant Does not prevent accumulation of water	1.5" - -	Repair transition so that changes in level are 1/4" high max. Provide a surface that is stable, firm, and slip resistant and is at least 48" wide. (Cost estimate based on the installation of a 325'x48" wide min. stone dust path connecting Fort Pickering entrance and the main parking area.)	1	5200	\$5200

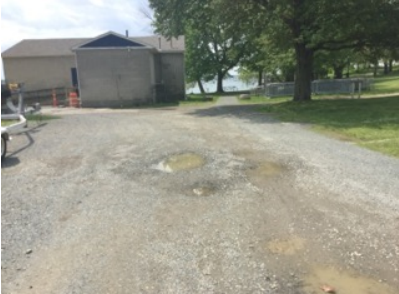
10	Main Parking Area	Ext.		Exterior Access Route	Exterior

Route not maintained in operable working condition Accessible route not provided	-	Ensure an accessible route is provided behind Harbormaster's office. (Cost based on a 48" wide min. 120' long stone dust path.)	1	4104	\$4104

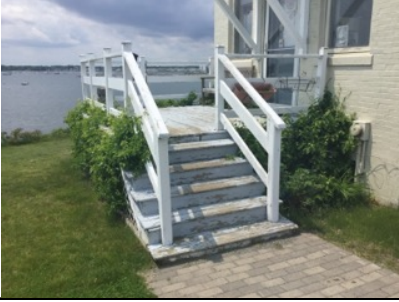
ID	Location	Floor	Room	Element	Type	Photo	Issues	Current Measure	Recommendations	Quantity	Price	Cost Estimation
11	Harbormaster's Office	Ext.		Exterior Access Route	Exterior

Accessible route not provided	-	Providing an accessible route to the Harbormaster's Office may prove technically infeasible. For program access, provide alternative means of allowing members of the public to interact with the Harbormaster as needed.	1	0	\$0
12	Concrete Camping Area	Ext.		Exterior Access Route	Exterior

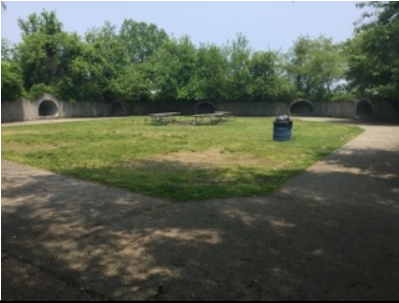
Accessible route not provided	-	Ensure an accessible route is provided. (Cost estimate based on a 50'x48" wide min. stone dust path.)	1	1200	\$1200
13	Route From Main Parking Area to Picnic Pavilion	Ext.		Exterior Access Route	Exterior

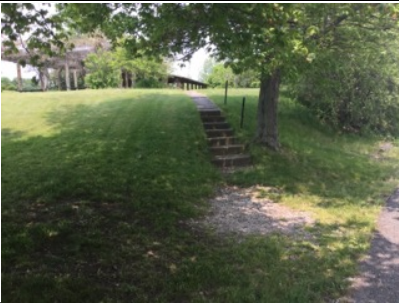
Accessible route not provided		Provide a sign directing users to the the accessible route to the bandstand parking lot.	1	173	\$173
14	Gazebo Near Boat Launch	Ext.		Exterior Access Route	Exterior

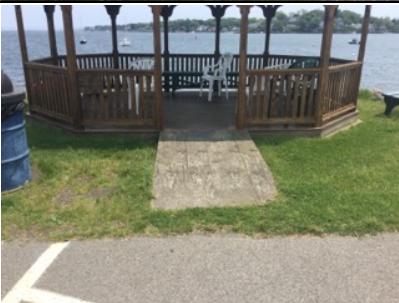
Accessible route not provided	-	Ensure an accessible route is provided. (Cost estimate based on the installation of an asphalt patch connecting parking lot to gazebo.)	1	52	\$52

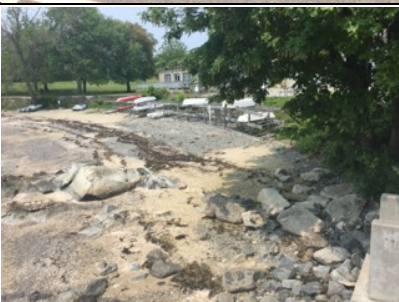
15	Canoe Launch	Ext.		Exterior Access Route	Exterior

Accessible route not provided	-	Ensure an accessible route is provided. (Cost estimate based on a compliant 30' concrete ramp and 48" wide min. asphalt path connecting canoe launch to the main parking area.)	1	10450	\$10450

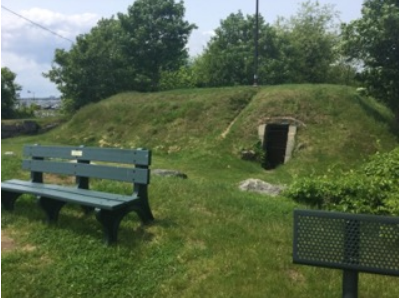
ID	Location	Floor	Room	Element	Type	Photo	Issues	Current Measure	Recommendations	Quantity	Price	Cost Estimation
16	Fort Pickering Waterfront	Ext.		Exterior Access Route	Exterior

Accessible route not provided	-	Ensure accessible route is provided. (Cost estimate based on the installation of 180' x 48" wide min. stone dust path connecting amenities on the waterfront to an accessible route.)	1	4380	\$4380
17	Fort Pickering Old Entrances	Ext.		Exterior Access Route	Exterior

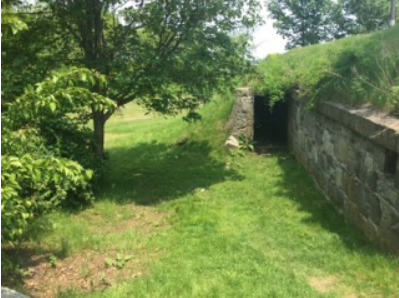
Accessible route not provided	-	Ensure accessible route is provided. (Cost estimate based on 250' x 48" wide min. stone dust path creating accessible routes to major points of interest at Fort Pickering.)	1	6000	\$6000
18	Route From Playground Parking	Ext.		Exterior Access Route	Exterior

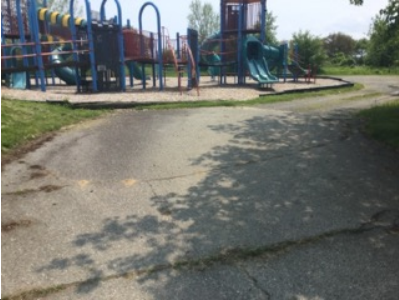
Accessible route not provided	-	Ensure an accessible route is provided around exterior of playground. (Cost based on 255' long x 48" wide min. stone dust path around playground perimeter.)	1	6503	\$6503

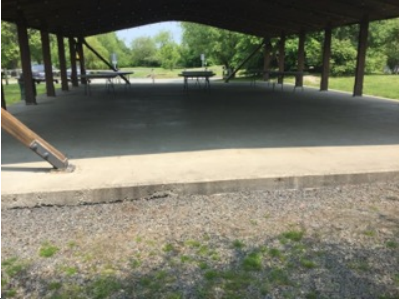
19	Bandstand Near Picnic Pavilion	Ext.		Exterior Access Route	Exterior

Accessible route not provided	-	Ensure an accessible route is provided. Provide a 48" wide min. x 10' long cement path with a max. running slope of 1:20 (5.00%) and a max. cross slope of 1:50 (2.00%).	1	194	\$194
Beach Access Routes												
20	Waikiki Beach Head	Ext.		Beach Access Routes	Removable

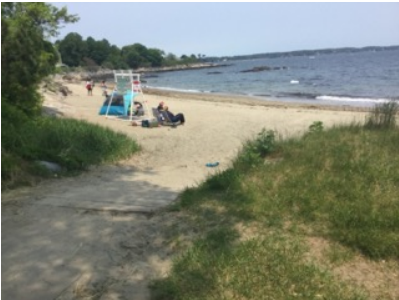
Beach route not provided	- -	Provide an accessible route that is firm and stable. Ensure the accessible route extends to the high tide level. (Cost estimate based on 72" wide min. x 55' long beach mat.)	1	2475	\$2475

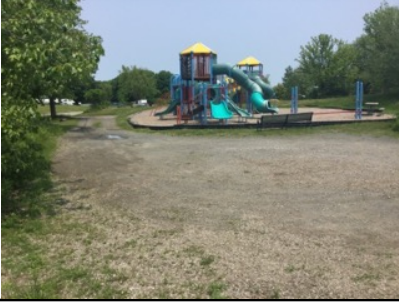
ID	Location	Floor	Room	Element	Type	Photo	Issues	Current Measure	Recommendations	Quantity	Price	Cost Estimation
Off-Street Parking Lot or Garage												
21	Playground Parking Lot	Ext.		Off-Street Parking Lot or Garage	Visitor

Total # of parking Total # of designated accessible parking spaces Total # of designated van accessible spaces	8 - -	Provide a van accessible parking space, access aisle and sign with the International Symbol of Accessibility and the words "Van Accessible". Mount sign 60" min. and 96" max. above the ground.	1	925	\$925
22	Harbormaster Parking Lot	Ext.		Off-Street Parking Lot or Garage	Visitor

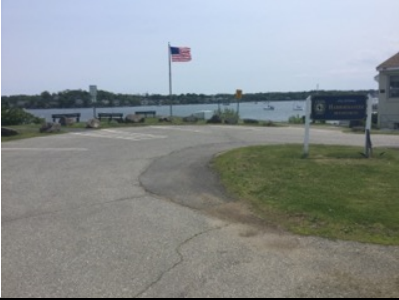
Total # of parking Total # of designated accessible parking spaces Total # of designated van accessible spaces Sign not provided Sign does not have the designation "Van Accessible"	3 - 1 - -	Provide a sign with the International Symbol of Accessibility (ISA). Mount the bottom of the sign 60" min. above the ground and the top 96" max. above the ground. Add the designation "Van Accessible" to the sign located at the van accessible space.	1	375	\$375

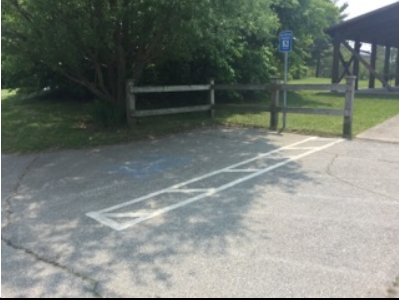
23	Bandstand Parking Area	Ext.		Off-Street Parking Lot or Garage	Visitor

Total # of parking Total # of designated accessible parking spaces Total # of designated van accessible spaces Access aisle < 60" wide at car/van space Sign does not have the designation "Van Accessible"	4 2 - 24" -	Provide a 96" wide min. access aisle. Provide a sign with the words "Van Accessible" mounted 60" min. and 96" max. above the ground.	1	600	\$600
24	Main Parking Area Near Main Office	Ext.		Off-Street Parking Lot or Garage	Visitor

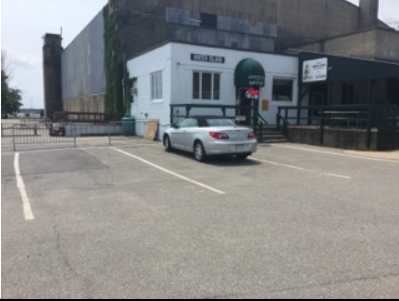
Total # of parking Total # of designated accessible parking spaces Total # of designated van accessible spaces Access aisle does not adjoin an accessible route	99 3 2 -	Relocate one of the two van accessible spaces so it is on the shortest accessible route to the accessible entrance at the main park office. (Re-stripe, relocate International Symbol of Accessibility (ISA) sign and sign with the words "Van Accessible".) Mount signs 60" min. and 96" max. above the ground.	1	925	\$925

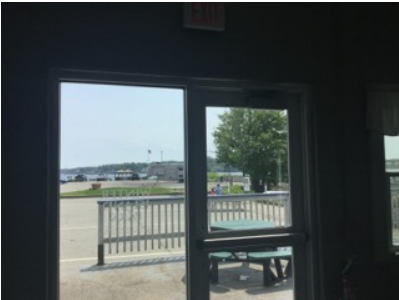
ID	Location	Floor	Room	Element	Type	Photo	Issues	Current Measure	Recommendations	Quantity	Price	Cost Estimation
Emergency Exit												
26	Function Hall	1		Emergency Exit	Main Exit

Emergency exit not on an accessible route Directional sign to accessible emergency exit not provided	- -	Provide a directional sign indicating the location of the nearest accessible emergency exit.	2	173	\$346
27	Function Hall Accessible Exit	1		Emergency Exit	Accessible Exit

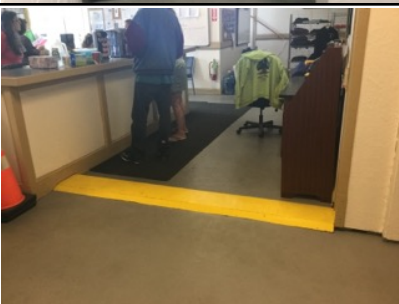
Level changes > 1/4"	5"	Reduce level change to 1/4" max. Relocate cables.	1	Labor	\$0

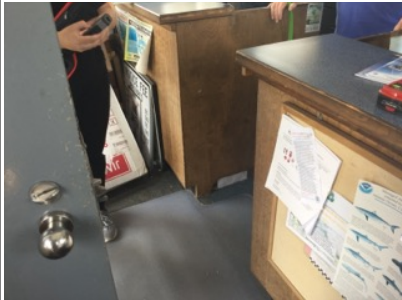
ID	Location	Floor	Room	Element	Type	Photo	Issues	Current Measure	Recommendations	Quantity	Price	Cost Estimation
Doors, Doorways, & Gates												
31	Harbormaster's Office	1		Doors, Doorways, & Gates	Main Entrance

Maneuvering clearance(s) not provided Threshold > 1/2" high	- -	Providing proper maneuvering clearances may prove technically infeasible. Consider alternative locations where members of the public may interact with the Harbormaster. Provide door hardware that can be operated without tight pinching, grasping, or twisting of the wrist.	1	242	\$242
Ramps												
32	Function Hall Accessible Exit	Ext.		Ramps	Exterior

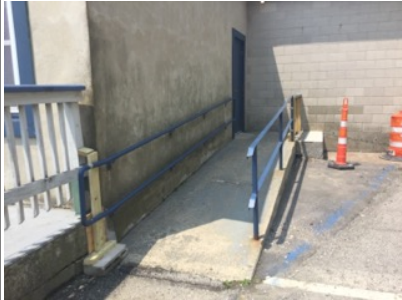
Handrails do not extend 12" past top & bottom Not maintained in operable working condition	- -	Alter handrails to extend horizontally above the landing for 12" min. beyond the bottom of ramp run on one side. Ensure the ramp is maintained in operable working condition. Patch transition at bottom ramp landing.	1	1734	\$1734

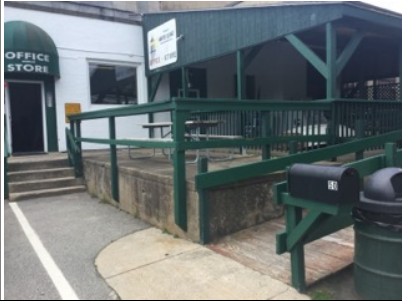
33	Ramp to Main Office	Ext.		Ramps	N/A

Handrails have non-compliant cross section	-	Provide handrails on both sides with 1 1/4"- 2" circular cross sections or 4"- 6 1/4" non-circular cross sections at between 34"-38" (upper handrail) and 18"-20" (lower handrail).	1	5190	\$5190
34	Men's Comfort Station	Ext.		Ramps	Exterior

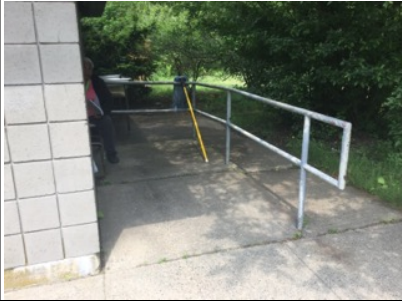
Handrails not provided	-	Provide handrails on one side with 1 1/4"- 2" circular cross sections or 4"- 6 1/4" non-circular cross sections at between 34"-38" (upper handrail) and 18"-20" (lower handrail).	1	1665	\$1665
35	Women's Comfort Station	Ext.		Ramps	Exterior

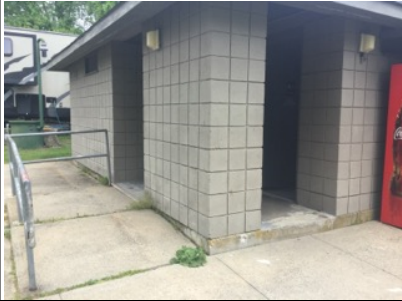
Handrails not provided on one side. Handrails not provided	-	Provide handrails on one side with 1 1/4"- 2" circular cross sections or 4"- 6 1/4" non-circular cross sections at between 34"-38" (upper handrail) and 18"-20" (lower handrail).	1	1665	\$1665

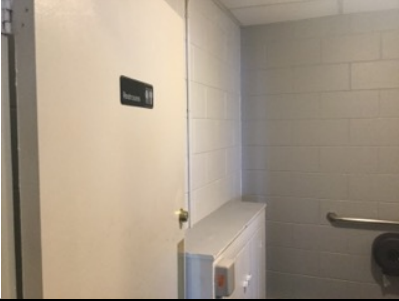
ID	Location	Floor	Room	Element	Type	Photo	Issues	Current Measure	Recommendations	Quantity	Price	Cost Estimation
Signage												
36	Function Hall Toilet Room (Left)	1		Signage	Designation

Raised characters not provided Braille not provided Sign not located on the latch side of the door International Symbol of Acc. not compliant	- - - -	Provide text with raised characters duplicated in braille. Locate sign at permanent rooms alongside the door on the latch side. Replace sign with a sign containing the International Symbol of Accessibility (ISA).	1	173	\$173
37	Women's Toilet Room & Changing Room	1		Signage	Designation

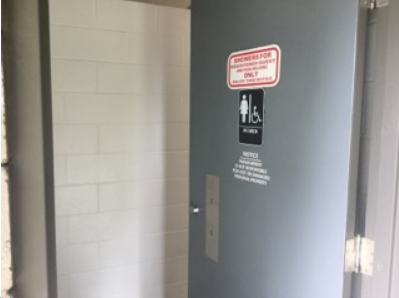
Sign not located on the latch side of the door	-	Locate sign at permanent rooms alongside the door on the latch side.	2	Labor	\$0
38	Men's Toilet Room & Changing Room	1		Signage	Designation

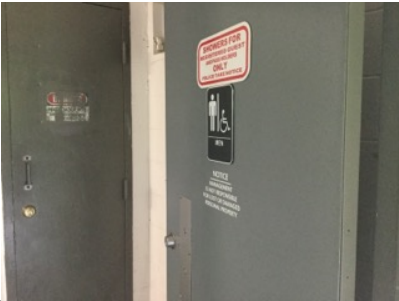
Sign not located on the latch side of the door	-	Locate sign at permanent rooms alongside the door on the latch side.	2	Labor	\$0

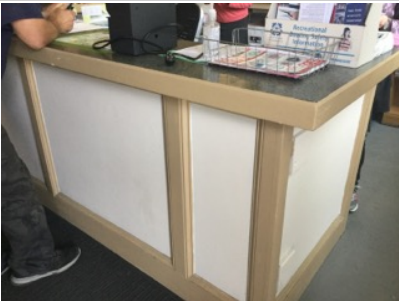
Service Counter												
39	Main Office	1		Service Counter	N/A

Counter > 36" high	42"	Provide a counter that is 36" max. above the ground.	1	660	\$660
Operable Parts												
40	Route to Waikiki Beach	Ext.		Operable Parts	Bike Rack

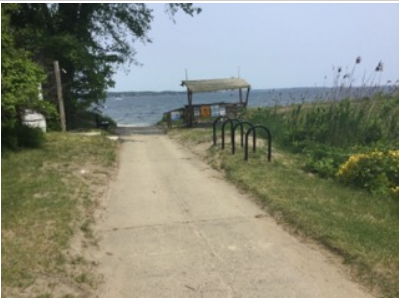
Element not on an accessible route	-	Ensure bike rack is located on an accessible route. (Cost estimate based on providing stone dust to, around and underneath bike rack.)	1	288	\$288

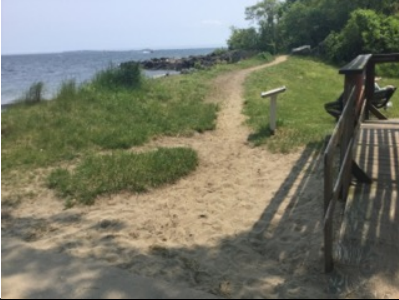
ID	Location	Floor	Room	Element	Type	Photo	Issues	Current Measure	Recommendations	Quantity	Price	Cost Estimation
41	Waikiki Beach Head Wayside	Ext.		Operable Parts	Wayside

Element not on an accessible route	-	Ensure waysides are located on an accessible route. (Relocate wayside.)	1	Labor	\$0
42	Coast Guard Wayside	Ext.		Operable Parts	Wayside

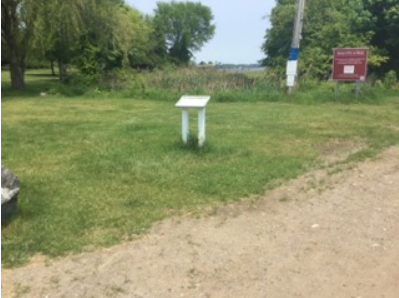
Element not on an accessible route	-	Ensure waysides are located on an accessible route. (Relocate wayside.)	1	Labor	\$0
43	Winter Island Wayside Near Bandstand	Ext.		Operable Parts	Wayside

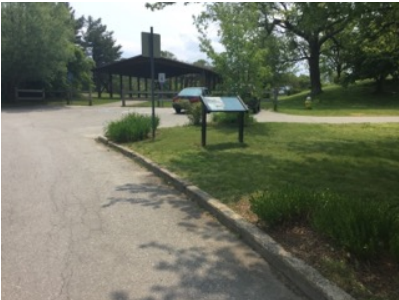
Element not on an accessible route	-	Ensure waysides are located on an accessible route. (Relocate wayside.)	1	Labor	\$0
44	Sail Salem Garage	Ext.		Operable Parts	First Aid

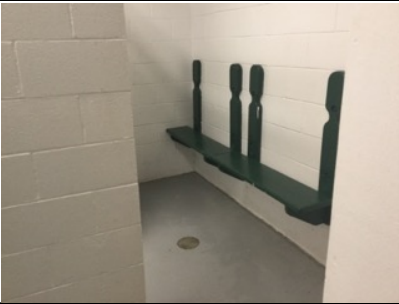
Bench not on an accessible route Bench < 20" or > 24" deep	- 10"	Locate accessible bench on an accessible route. Provide a bench that is 20"- 24" deep max. (Cost estimate based on installation of a new bench.)	1	150	\$150
Picnic Tables												
47	Picnic Pavilion	Ext.		Picnic Tables	N/A

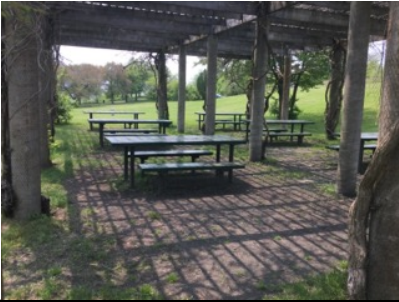
At least 5% accessible spaces not provided Surface not stable, firm and slip-resistant Picnic table not on an accessible route		Ensure that at least one (1) picnic table is accessible. Provide 48" wide min. 30' long accessible route through picnic pavilion and past the accessible picnic table. (Cost based on a new accessible picnic table and a stone dust path through the picnic area.)	1	1735	\$1735
48	Route to Harbormaster's Office From Main Parking Area	Ext.		Picnic Tables	N/A

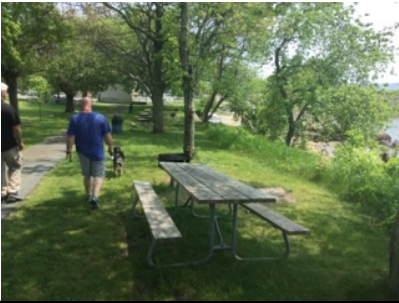
At least 5% accessible spaces not provided Picnic table not on an accessible route	- -	Ensure that at least one (1) picnic table is accessible. Ensure that the picnic table is located on an accessible route. (Cost based on a new accessible picnic table and a 48" wide min. x 6' long stone dust path to picnic table.)	1	1187	\$1187

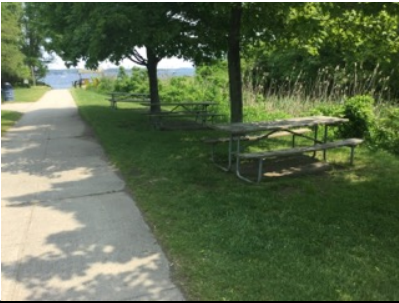
At least 5% accessible spaces not provided Picnic table not on an accessible route	- -	Ensure that at least one (1) picnic table is accessible. Ensure that the picnic table is on an accessible route. (Cost based on a new accessible picnic table and a 48" wide min. x 6' long stone dust path to picnic table.)	1	1187	\$1187
50	Route to Harbormaster's Office From Main Parking Area	Ext.		Picnic Tables	N/A

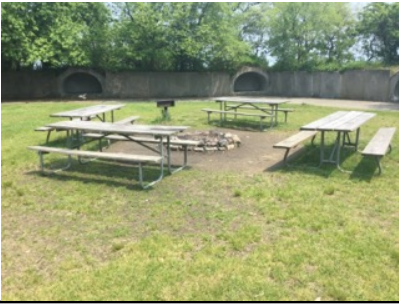
Toe or knee clearance at table not provided Picnic table not on an accessible route	- -	Provide at least one (1) accessible picnic table with toe and knee clearance. Locate picnic table on an accessible route. (Cost based on an accessible picnic table and a 48" wide min. x 6' stone dust path.)	1	2078	\$2078

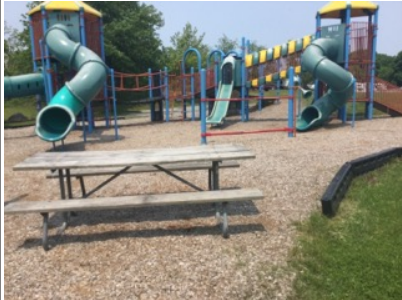
Picnic table not on an accessible route	-	Relocate picnic table to an accessible route.	1	Labor	\$0
Toilet & Bathing Rooms												
Overall Access												
52	Function Hall Toilet Room (Right)	1		Overall Access	Toilet Room

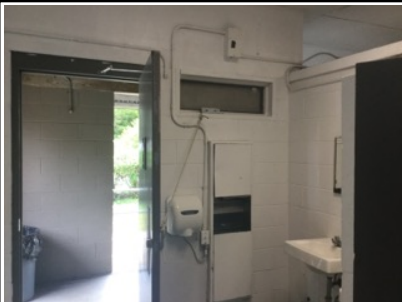
6 fixtures, but no ambulatory compartment provided	-	Provide one ambulatory accessible compartment.	1	1539	\$1539
Lavatory												
54	Women's Comfort Station	1		Lavatory	N/A

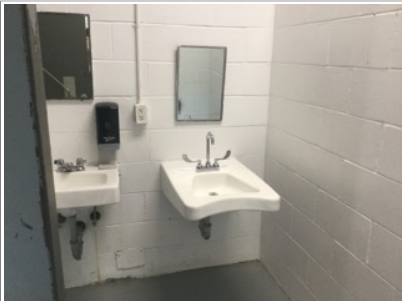
Plumbing underneath is exposed Mirror above lavatory w/reflective surface > 40"	- 42"	Insulate or otherwise configure pipes to prevent contact for at least one lavatory. Lower mirror so that the bottom surface is at 40" max. above finished floor.	1	261	\$261

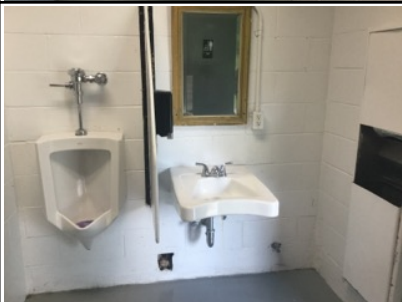
55	Men's Comfort Station	1		Lavatory	N/A

Plumbing underneath is exposed Mirror above lavatory w/reflective surface > 40"	- 43"	Insulate or otherwise configure pipes to prevent contact for at least one lavatory. Lower mirror so that the bottom surface is at 40" max. above finished floor.	1	261	\$261

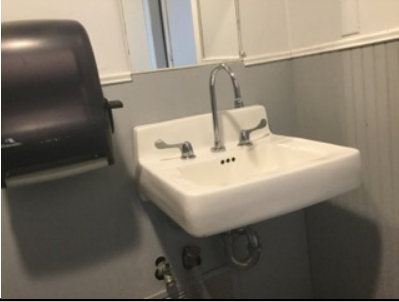
Plumbing underneath is exposed Mirror above lavatory w/reflective surface > 40"	- 46"	Insulate or otherwise configure pipes to prevent contact for at least one lavatory. Lower mirror so that the bottom surface is at 40" max. above finished floor.	1	261	\$261
Single-User Toilet												
57	Function Hall Toilet Room (Left)	1		Single-User Toilet	N/A

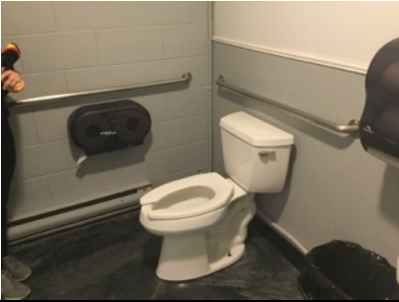
Centerline < or > 18" (MAAB)	26"	Relocate toilet so that the centerline is 18" from the side wall.	1	2121	\$2121
58	Function Hall Toilet Room (Left)	1		Single-User Toilet	N/A

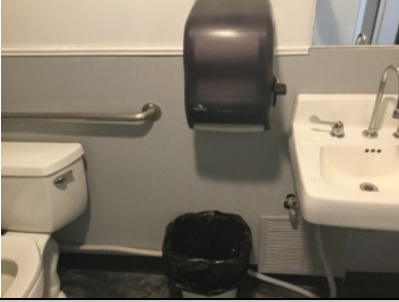
Clearance at toilet < 60" clear width	-	Remove or relocate paper towel dispenser out of clear floor space at toilet.	1	192	\$192
Toilet Compartment												
59	Men's Comfort Station	1		Toilet Compartment	Accessible Compartment

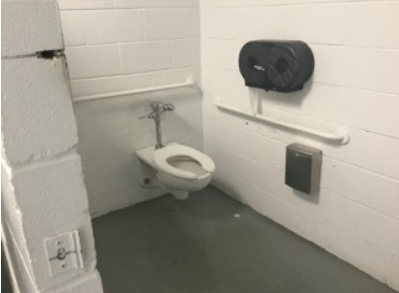
60	Women's Comfort Station	1		Toilet Compartment	Accessible Compartment

Door has malfunctioning self-closing hinge Side or rear grab bar < 33" or >36" high Non-compliant toilet paper dispenser	- 31" -	Repair self-closing hinge at compartment door. Locate side grab bar between 33"- 36" above the finished floor (both should be at same height.) Relocate toilet paper dispenser so that it is 15" min high, located under the grab bar, and between 7" and 9" from the front of the toilet.	1	722	\$722

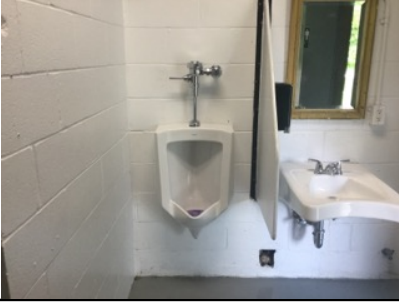
Rim > 15" high (MAAB) Urinal recessed > 24" has > 36" clear width	23" 32"	Provide at least one urinal with the rim no higher than 15" above the finished floor. Remove or relocate partition to ensure there is a clear width of 36" min.	1	2628	\$2628
Dispensers												
62	Women's Comfort Station	1		Dispensers	N/A

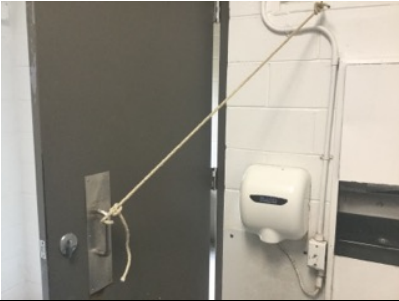
Clear floor space not provided at accessory Obstructed by protruding objects	-	Provide a 30" min. x 48" min. clear floor space or relocate dispenser. (Remove ropes and provide an alternative means of holding the door open.)	1	Labor	\$0
Shower Compartment												
63	Women's Changing Room	1		Shower Compartment	Roll-In Type

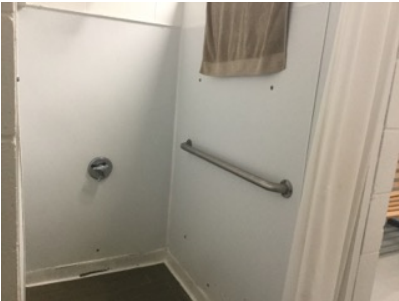
Grab bars not provided Control height < 38" or > 48" Shower spray hose < 59" long	- 30" -	Provide compliant grab bars on the walls adjacent to the controls. Relocate controls at 48" max. above the finished floor. Provide a spray unit with a hose 59" long min.	1	1057	\$1057

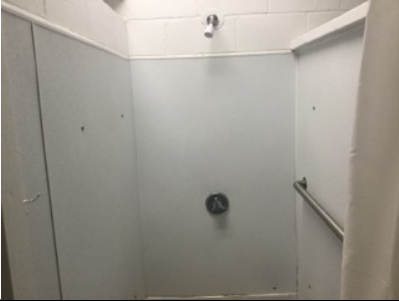
64	Men's Changing Room	1		Shower Compartment	N/A

Accessible shower not provided	-	Provide at least one accessible shower.	1	1387	\$1387
Additional Access

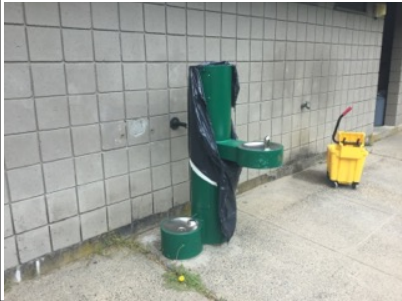
Operable parts malfunctioning No drinking fountain provided for seated users Standing height fountain does not have cane protection	- - -	Provide a drinking fountain for seated users. (Cost based on a new Hi-Lo fountain).	1	3162	\$3162
Play and Sport Areas												
Play Areas												
66	Playground	1		Play Areas	N/A

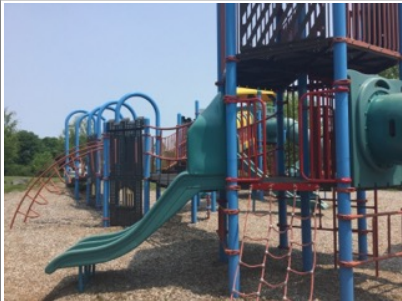
Accessible route < 60" wide at ground level	-	Ensure the clear width of the accessible routes is 60" minimum. (Cost estimate based on a 10 ft. long x 60" wide min. accessible route that connects each play element - poured in place rubber.)	1	720	\$720

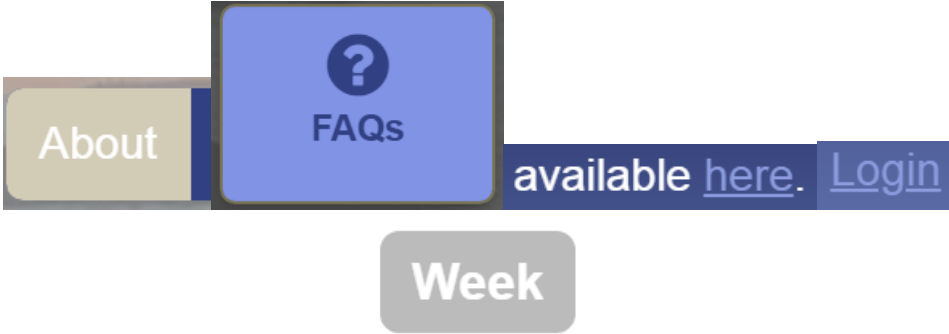
General Content	Color Contrast Pseudo Classes	<p>Background Users with low vision or older users depend on high contrast link text to distinguish and read link text on a webpage. This text should also be high contrast for different pseudo classes, such as focus and hover.</p> <p>Current Link text across the website often lightens when it receives mouse hover, which in some areas creates an insufficient color contrast. Examples of link text that does not meet criteria include:</p> <ul style="list-style-type: none">Home page- Navigation bar items: 1.6:1Home page- "FAQs" in "Salem Action Center": 3.3:1Footer content- "here" link on color gradient: 2.8:1Footer content- "Login" link on color gradient: 2.1.1Calendar page- Calendar view buttons (e.g. "Week"): 1.9:1 <p>Recommendation Ensure the contrast ratio between link text on hover and the background is at least 4.5:1 and 3:1 for large text. Areas containing gradients with varying color contrast should be fixed so that all link content receiving mouse hover on the gradient has a sufficient color contrast.</p>	Low-vision, 65+ WCAG 2.1 1.4.3 Contrast (Minimum)
