***Strategies: preservation and restoration***

For Charter Street Cemetery markers can be prioritized into four technical categories:

CONDITION ASSESSMENT Inspected by: IS+MJ 3/31/2016

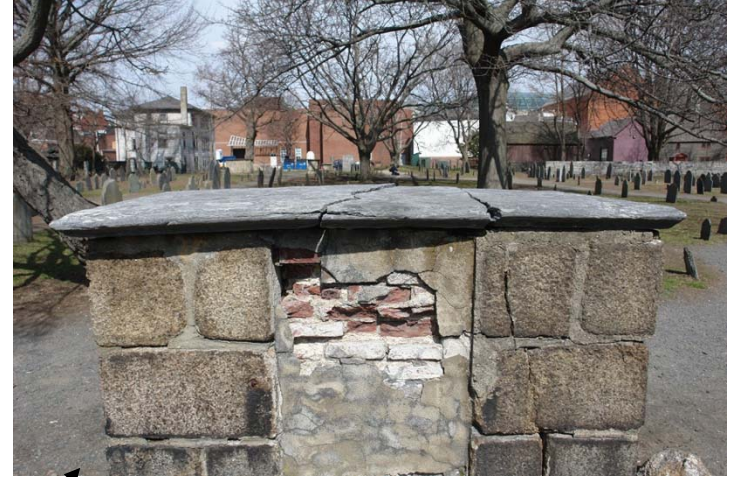
*G7.1 Lynde Tomb. An example of priority “1”. Highly visible, deteriorating tomb with loose top fragments*

**1.0 Hazardous**--requires immediate action; included are tombs with loose tops and those which are excessively deteriorating.

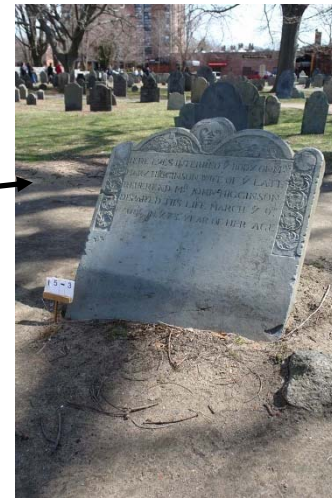
*I5.3 Higginson, extremely tilted, along-side path*

**1.5 Unstable deterioration**—requires treatment as soon as possible; included are excessively tilted, fractured and unstable, fragments vulnerable to theft and trip hazards

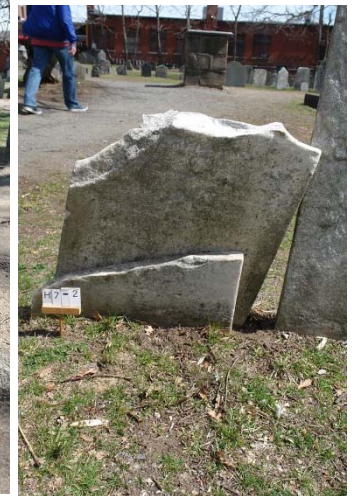
*H7.2 Loose fragments are vulnerable to theft, alongside path*

D6.3	Beadle	Thomas	1	Reset off pathway		
D6.1		Turner	1	Tomb	Secure top	Consolidate
F1.1		Fisk	1	Tomb	Secure top	Consolidate
F2.2		Derby	1	Tomb	Secure top	Repoint (2)
I5.2		Wainwright	1	Tomb	Secure top	stucco failure
I6.1	Bradstreet	Simon	1	Tomb	Secure top	stucco failure
G4.1		Gedney	1	Tomb	Stucco Failure	Consolidate
G4.2		Bartlett	1	Tomb	Stucco Failure	
G7.1		Lynde	1	Tomb	Top Failure	Missing plaques
H7.4	Seldon	Capt. Robert	1		Fractured	
E7.2	Grafton	Jehoadan	1.5	Tilt	Fracture	
E2.1	Brown	John	1.5	Tilt		
I5.3	Higginson	Mary	1.5	Tilt		
J8.1	Barnard	Samuel	1.5	Tilt		
C5.3	Hollingworth	William and Elianor	1.5		Fracture	
J8.2	Clover	Susanah	1.5		Fracture	Metal
F5.1	Chatwel (?)	Nicholas	1.5		Fractured	Metal
H1.1	Millet	Elizabeth	1.5		Fractured	
J10.1	n.a.		1.5		Fractured	Restorable?
J3.1		Beckett	1.5		Fractured	New base
C7.2	Willard	Josiah	1.5		Fragment	Investigate
D4.1	n.a.		1.5		Fragment	Investigate
H7.2	n.a.		1.5		Fragment	Investigate

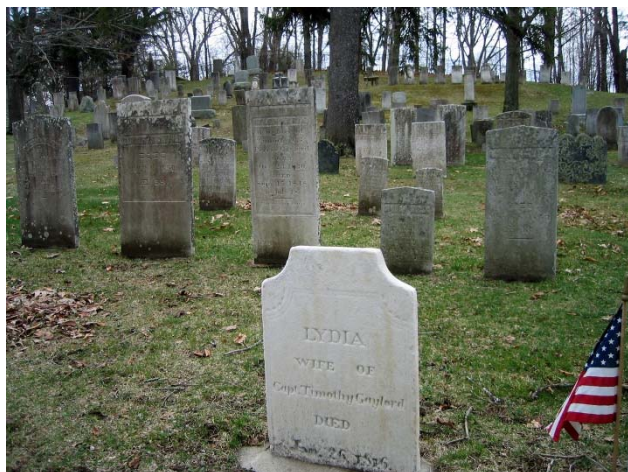
*The cleaning of one marble inappropriately stands out; and cleaning all the stones would be historically incorrect.*

Cleaning of marble markers should be limited to those requiring structural adhesions. General cleaning of marbles would make the markers appear very white and the cemetery would appear historically inaccurate.

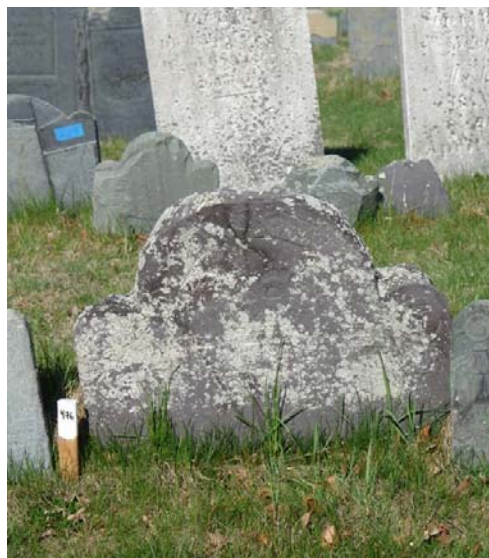
*Typical slate marker, benefitting from cleaning*

Removal of biofilm is with D/2 Biological Solution. It is an aqueous antibacterial solution that also aids in the removal of algae, fungi and other organisms. After application and scrubbing with soft brushes, surfaces are fully rinsed with water. Stubborn, well-attached growths will slowly release their grip in a short amount of time and the stone will appear cleaner.

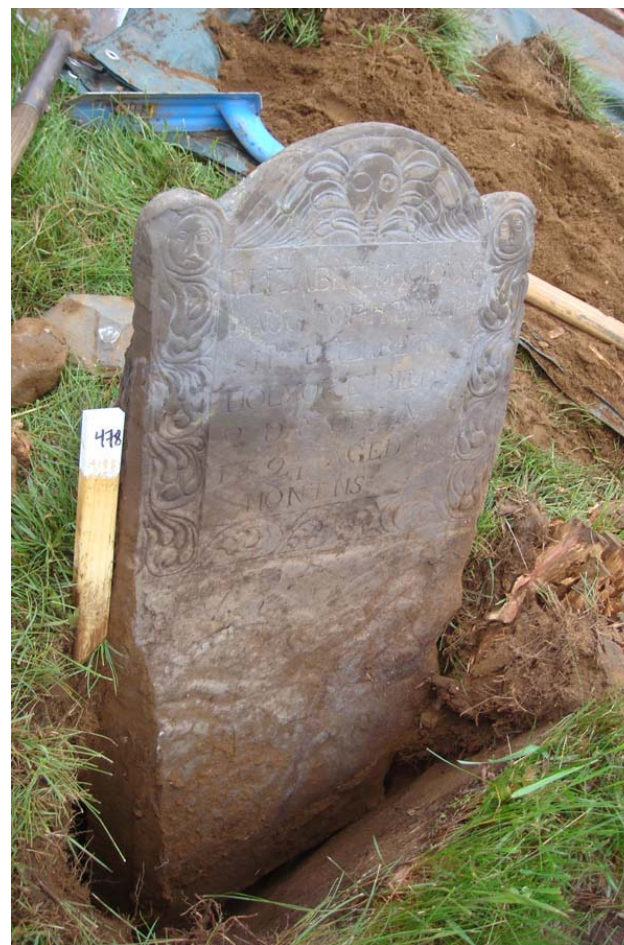
*18th century markers often have as much below the ground as above. Only upon excavating this marker for resetting does the very massive below grade portion become apparent..*

Breaks at, or just below grade are very common. Most of these markers will require new bases, since the success of below and near grade repair with structural adhesives is limited.

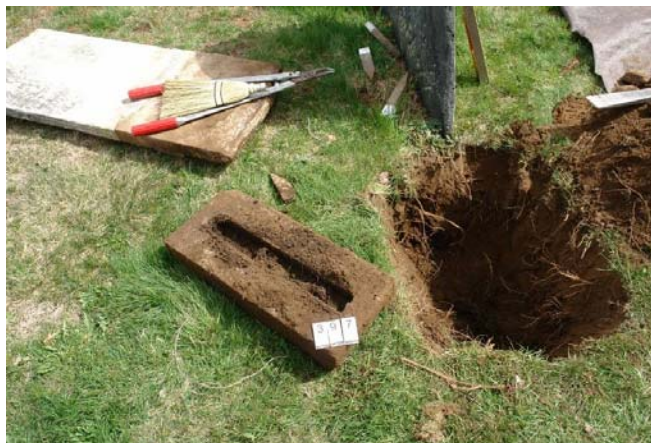
*Old base removed and inspected for soundness*

Older bases should be carefully excavated, examined for soundness and reset level at a higher elevation and aligned with adjacent markers.

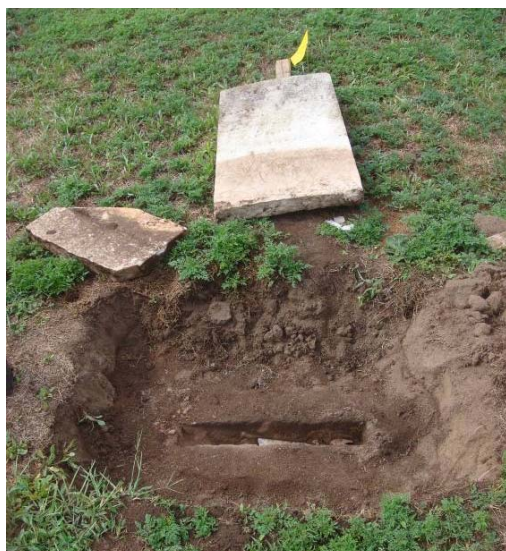
*When excavating for resetting often original, or old bases are discovered*

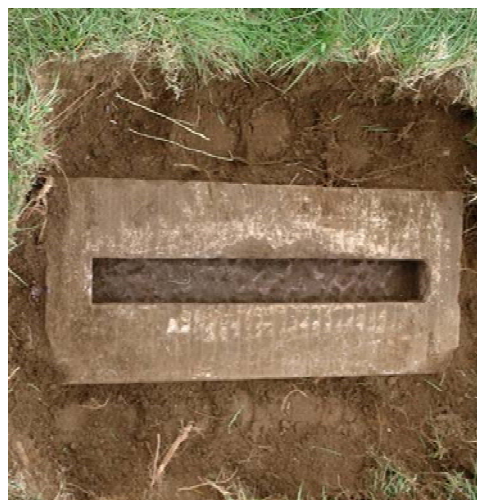
*Old base reset higher and aligned with adjacent markers*

Gravestones that required insertion into existing bases are to be set with a relatively weak cement/lime-based grout (3:2:9) with fine aggregates (000), made fluid with a high-range water reducer which ensures a complete fill. This mix is poured into the base slot. Stones to be braced for a minimum of three days to limit movement during curing of the grout.

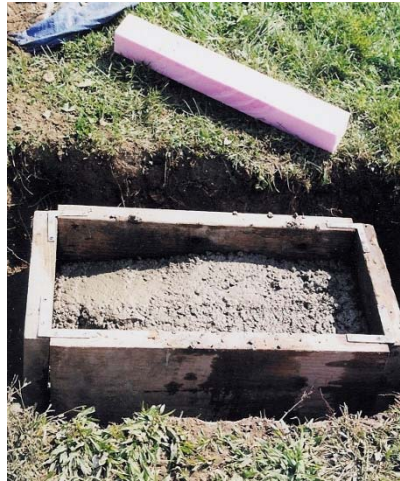
*Formwork for new base*

New below grade bases are made on site by casting in the ground with concrete. The casting is generally 9 to 12 inches deep, and 12 inches greater in thickness and 6 inches wider than the stone itself. The finished top surface of the base should be entirely below grade.

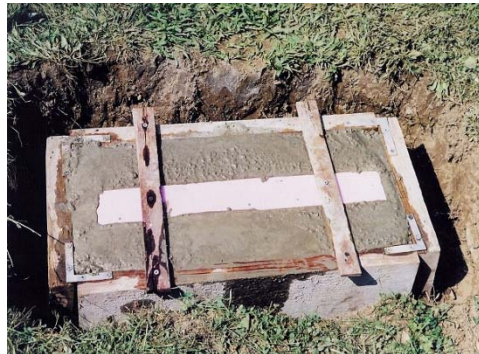
*Poured base with form insert for setting slot*

A form insert for a 1-inch deep setting slot, 1/2 inch wider and 1 inch thicker than the stone, is positioned in the concrete, in line with adjacent markers.

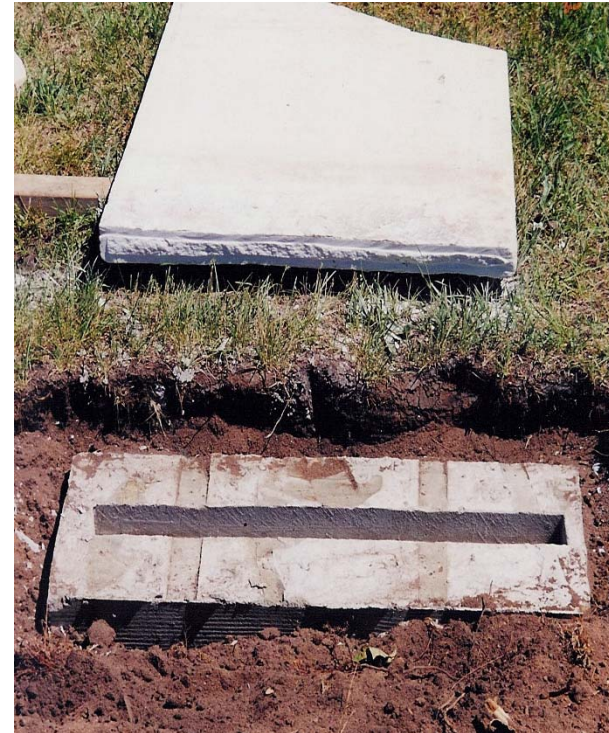
*New base ready for resetting*

After the base has cured, the form is removed, and the area backfilled. The gravestone is reset into the slot using a cement/lime mortar (3:2:8) with 00 or 000 sand, made fluid with a high-range water reducer which ensures a complete fill.

After stones are set plumb and level, and braced for a minimum of three days, topsoil is added to re-grade the disturbed area..

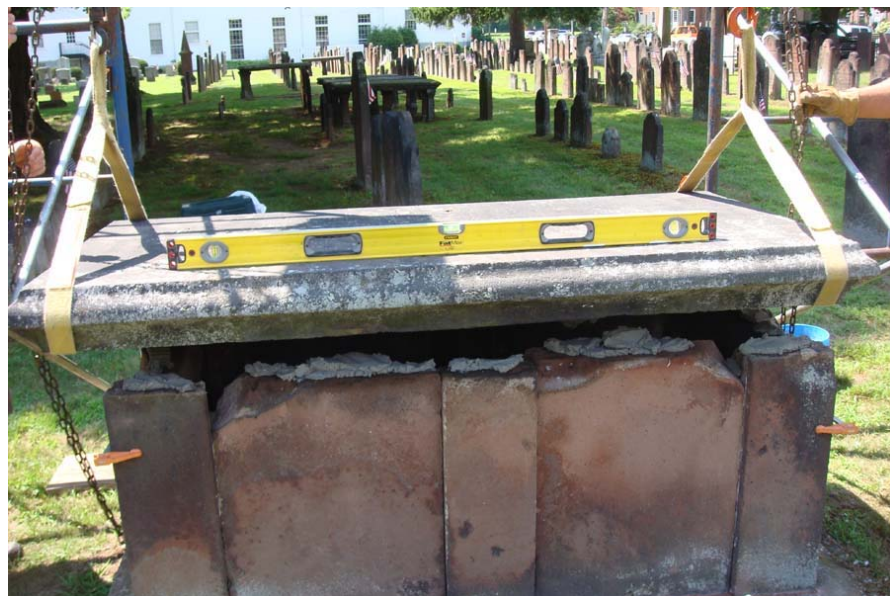
*Example of re-setting a large ledger top with mortar onto tomb base with the aid of scaffolding and chain hoists*

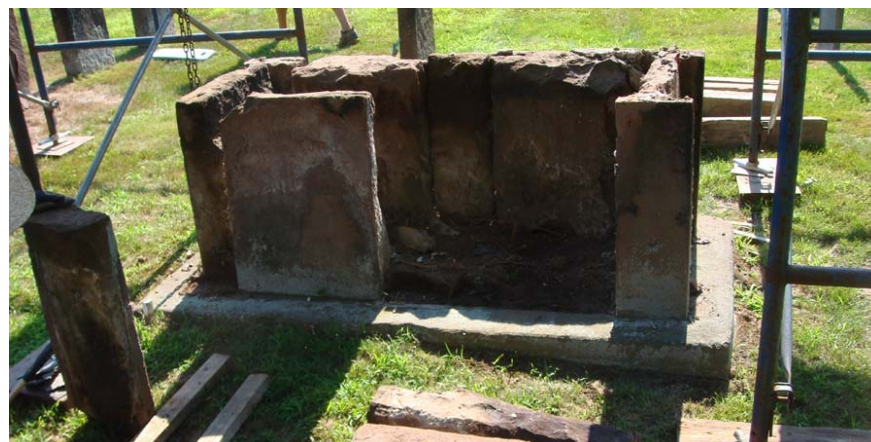
*When necessary, the tomb is taken apart and re-constructed.*

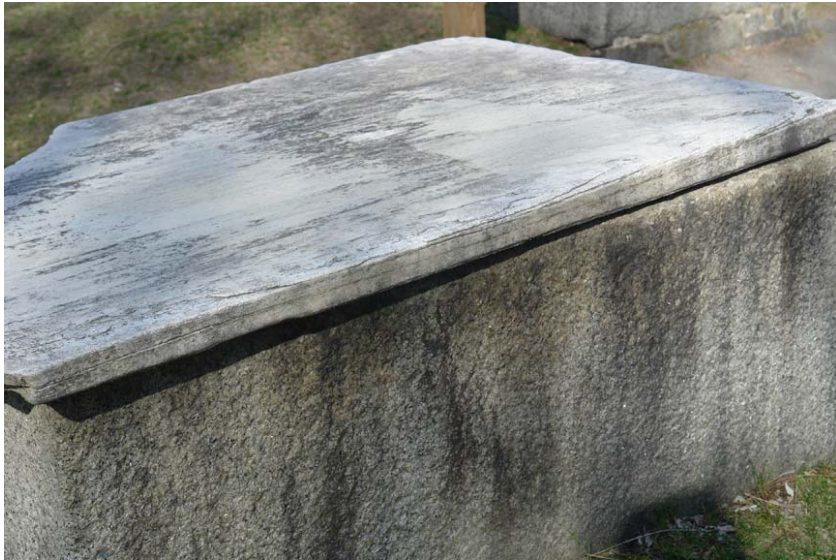
*F1.1 Fisk Tomb This loose top can be secured to the solid granite base with a structural adhesive . There is little reason for it to ever be removed.*

If there is little or no likelihood of removing the top in the future, the top can be set using a structural adhesive (Abatron 55-22)

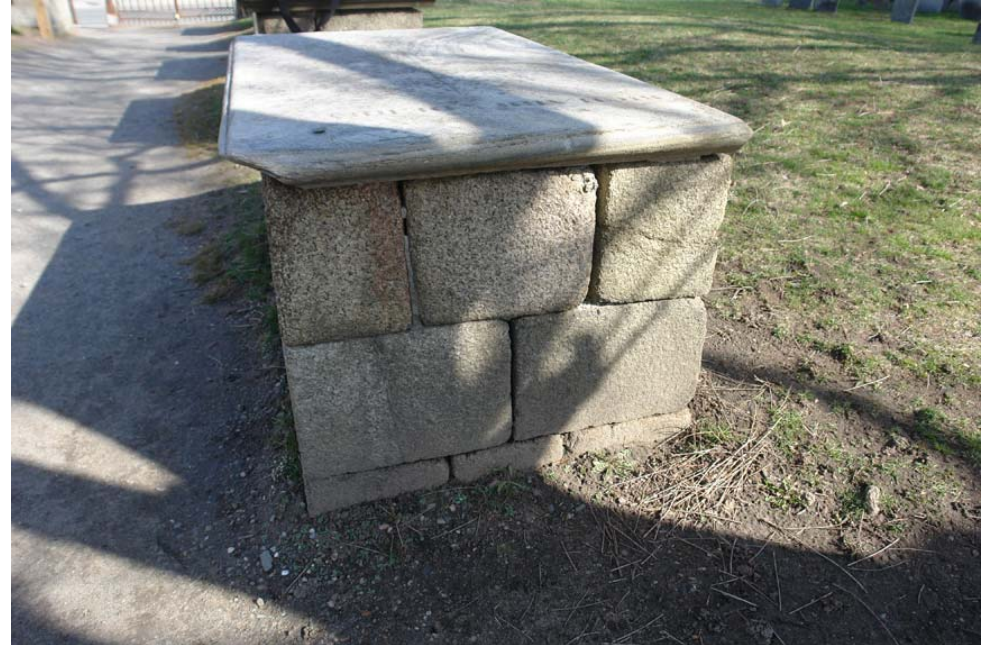
*F2.2 Derby Tomb. This top will be reset with a pozzolanic hydraulic lime (typically #600 PHLc70 by Voidspan). The mortar can be removed if the tomb has to be dismantled in the future*

If the tops of table tombs are loose they present a hazard to inquisitive passerby's and should be made secure. If it is likely that the tomb will be taken apart sometime in the future a pigmented pozzolanic hydraulic lime (typically #600 PHLc70 by Voidspan) is used to set the ledger top.

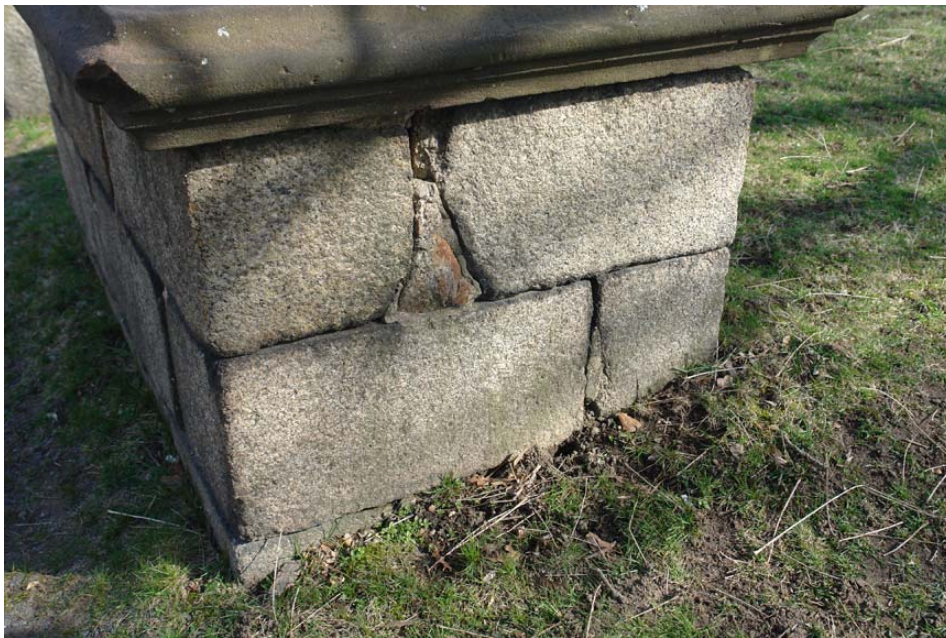
*F2.1 Mason Tomb with open joints*

Open and failed joints in the granite block bases should be cleaned of loose material and sand re-pointed with a 1:1:6 mix with masonry sand, or with #200 Mortar Binder (Voidspan) with masonry sand

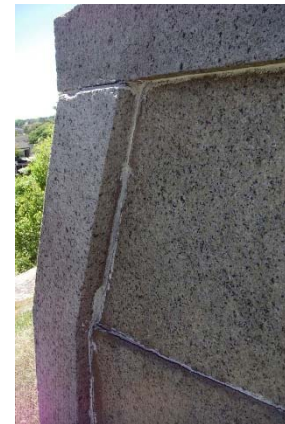
*Old mortar and caulk*

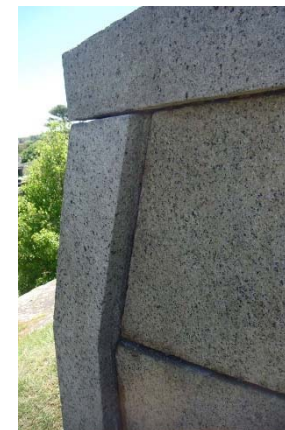
*Joints cleaned with hand tools*

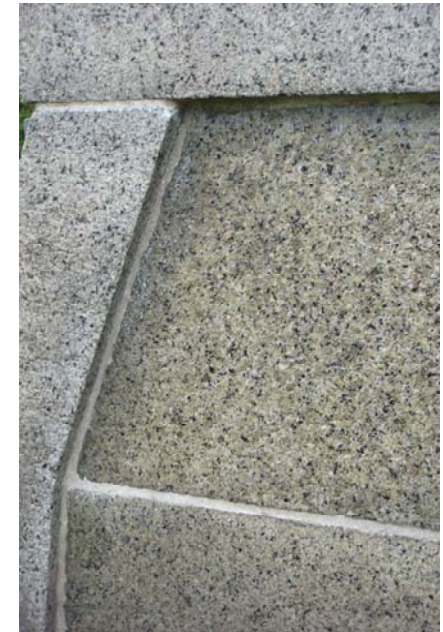
*Example showing  
repointing with 1:1:6  
with masonry sand*

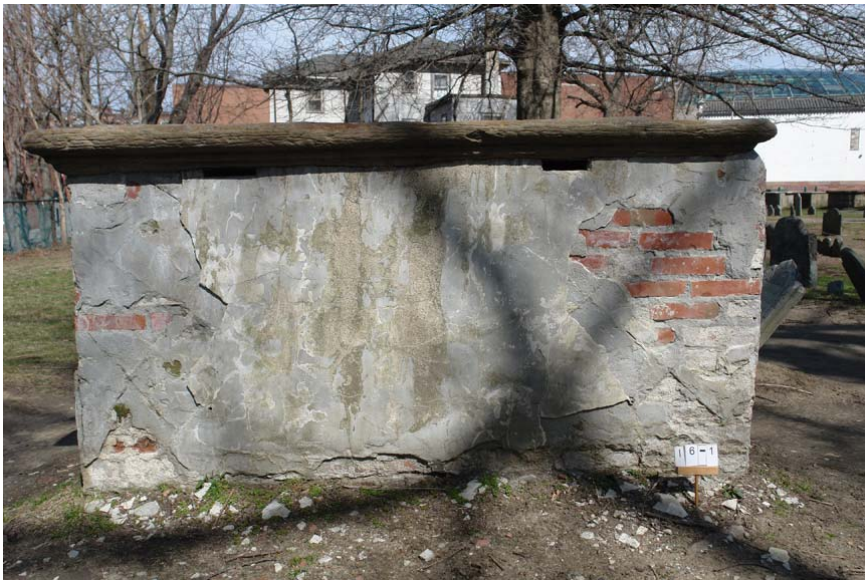
*16.1 Bradstreet Tomb . Deteriorating stucco and loose top*

All existing loose, failing or spalling stucco is to be removed and a bonding agent applied to all surfaces. Applications of stucco (1:1:6 with masonry sand) are applied and repeated when required.

If only stucco patching is necessary, entire base to be white-washed.

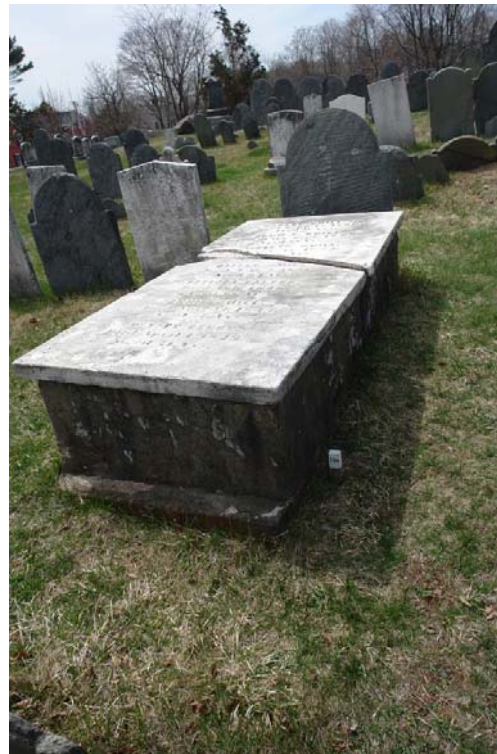
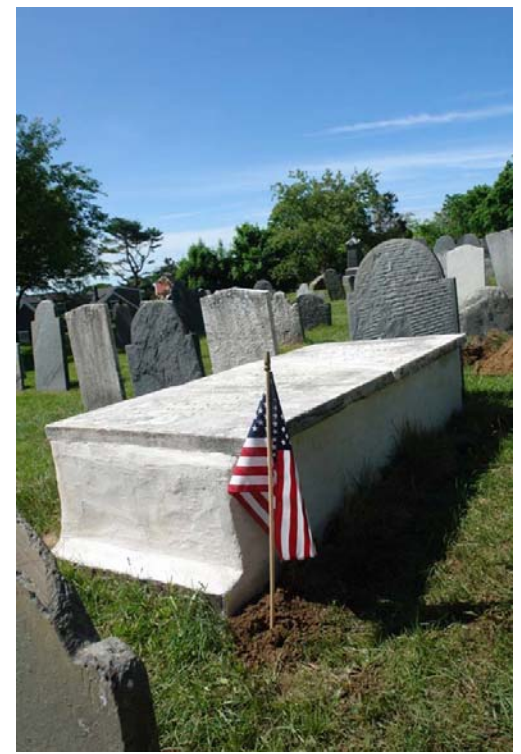
*Before and after, New stucco applied to base (top restored)*

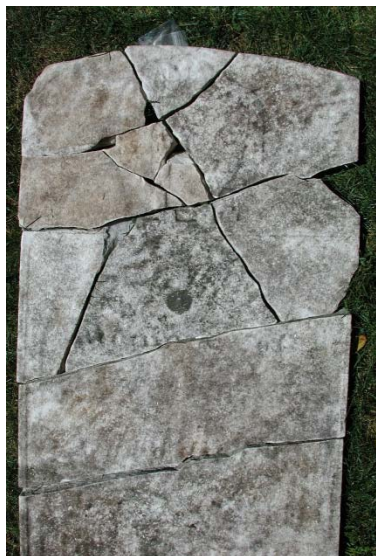
*Marble gravestone, before and after restoration*

Most broken markers can be re-assembled with structural adhesives, without pinning. Bonding is dependent upon the soundness, cleanness and conformation of the fractured surfaces, factors often associated with the age of the break.

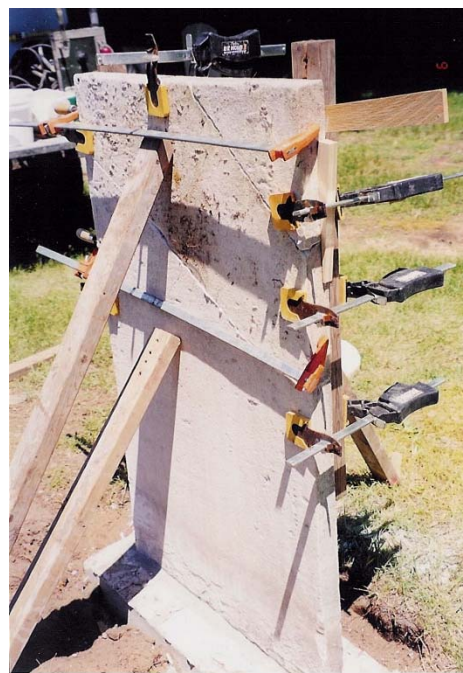
**Example of bracing and clamping**

The properly-aligned fragments are joined with clamps, and braced during curing, which is typically a period of several days. Any extra epoxy flowing from clamped joints should be left to partially cure for 24 hrs before attempting removal, and carefully chipped off. The slight gap created is concealed with a crack filler.

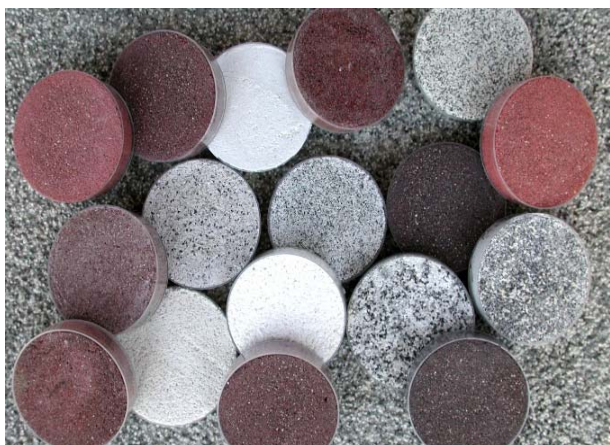
*Examples of cement-lime repair mortars*

Losses designated for treatment can be filled with a pigmented cement/lime mortar, using colored aggregates.

The mortar color and texture should be matched to that of the unsoiled stone. If the stone has not been cleaned, artificial "soiling" of the cured mortar surfaces can be done by a variety of means, including use of potassium silicate paint systems, such as Silin (Cathedral Stone Products, Inc.), or a diluted acrylic wash with alkali-stable pigments.

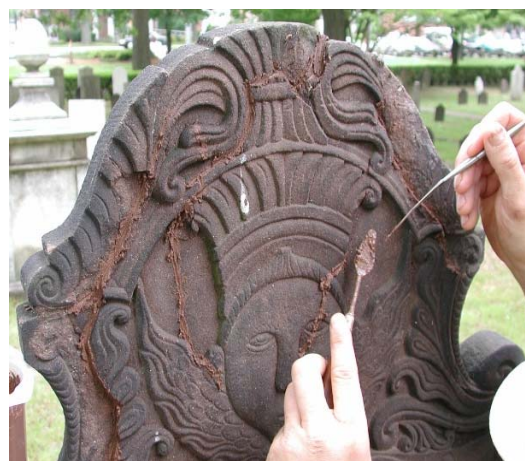
*Filling cracks in a sandstone  
with a pigmented crack filler*

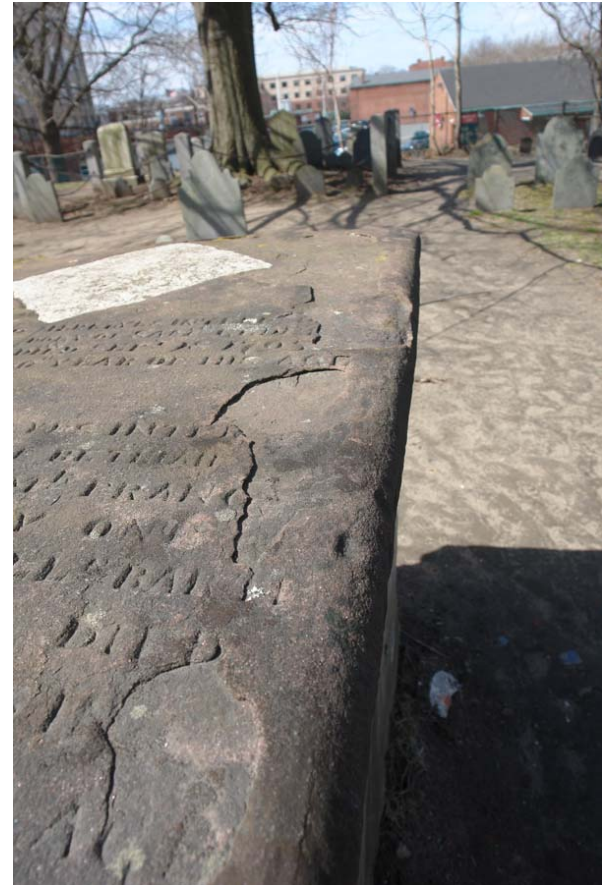
*G4.1 Gedney Tomb. The top should be consolidated and after sufficient curing, losses and cracks filled with the appropriate materials.*

**Sandstones:** The consolidation product used is a catalyzed ethyl silicate formulation (Conservare OH100, by ProSoCo, Inc.), following all manufacturer's instructions and safety precautions. Because of the thin delaminations, most sandstone markers do not require the recommended 3 full "cycles"; one cycle is usually sufficient.

**Marbles:** Marbles requiring consolidation should first be treated with HCT, a hydroxylating conversion treatment (Prosoco Inc) which protects and strengthens weathered surfaces. If required, marbles can be additionally consolidated with one cycle of OH100.

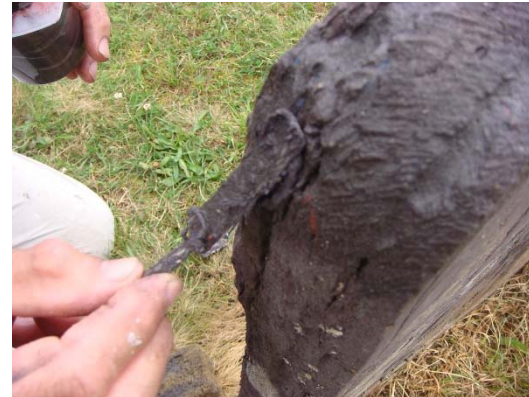
*Filling top cavities with a pigmented crack filler by Sto. Excess material to be immediately wiped off with damp sponging*

In “capping” a marker with delaminations, the voids are usually filled along the top side of the marker only. The sides are kept open to allow the escape of any water that may enter the interior. A pigmented flexible crack filler by STO can be used to fill openings up to 1/8” wide.

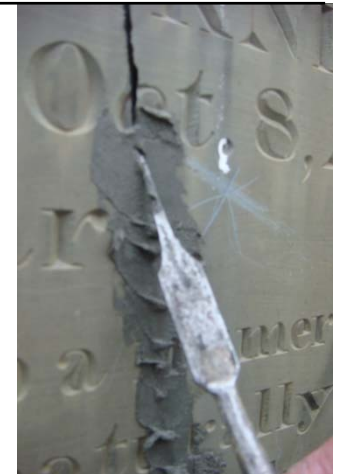
*A pigmented Sto Crack Filler being tooled into an open face crack*

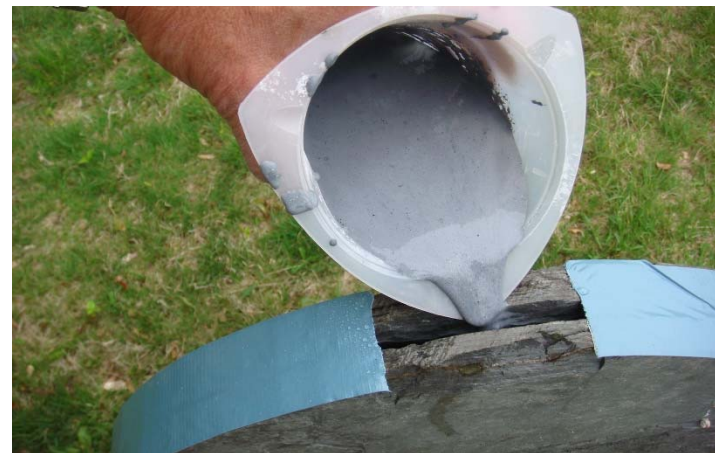
*Filling voids with a pigmented flowable grout (VoidSpan PHLc)*

For larger voids, a pigmented PHLc Grout ( a pozolanic hydraulic lime manufactured by VoidSpan) can be used as a flowable grout.

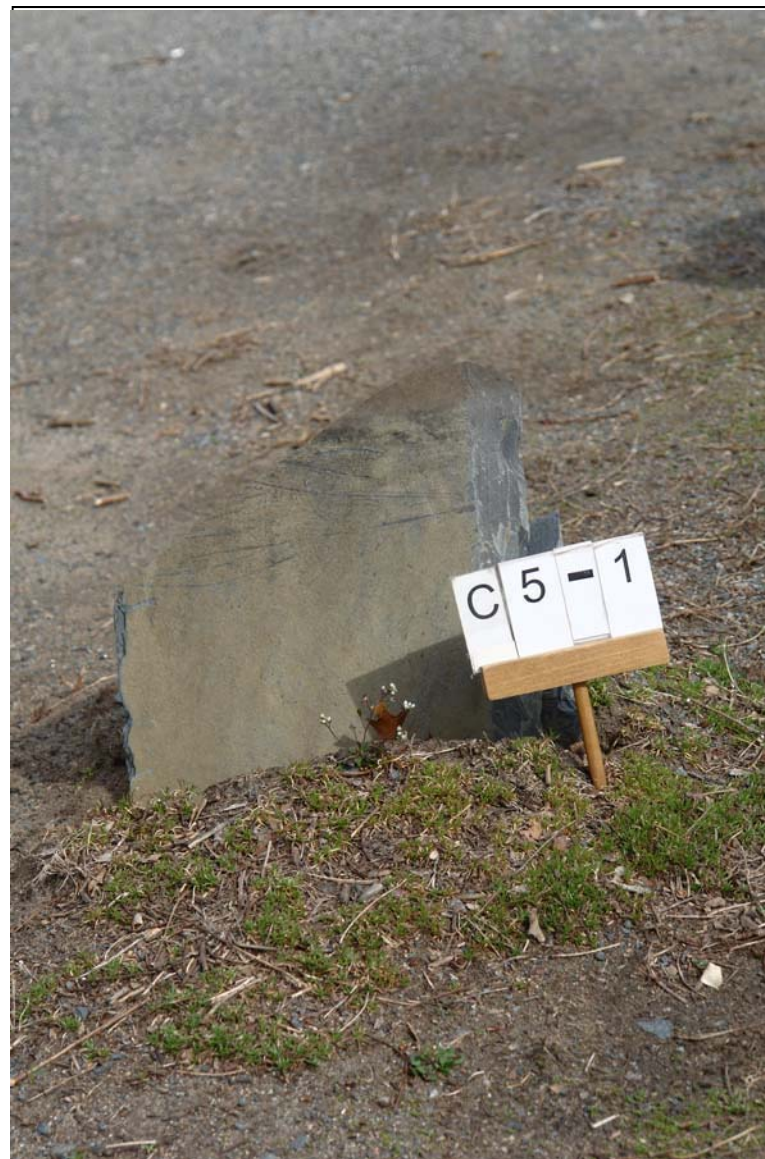
Marker# **C5.1**

Delaminating	Clean all voids Fill voids and cracks caused by delaminations
--------------	---

1. Treat all open voids with D/2 biological solution and scrub with nylon brushes. Repeat as necessary. Rinse with water. Flush interior voids with water and remove any lichens and/or debris with hand tools.
2. After full drying, all voids caused by splitting or delaminations at top edge of marker filled with a pigmented Sto Crack Filler using injection syringes and/or trowels. Voids along the lower sides of monument typically left open to allow escape of any water which may enter.
3. Excess crack filler immediately removed with damp sponging.
4. Large voids filled with a pigmented PHLc flowable grout, mist with water and cover for 3 days min.

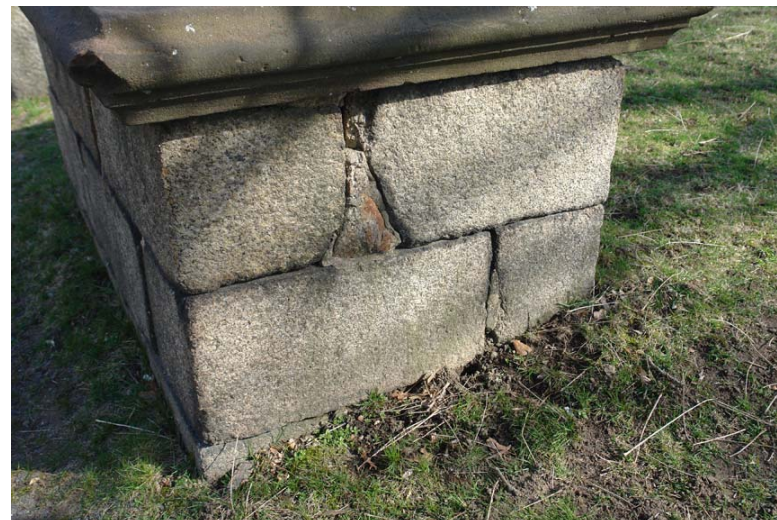
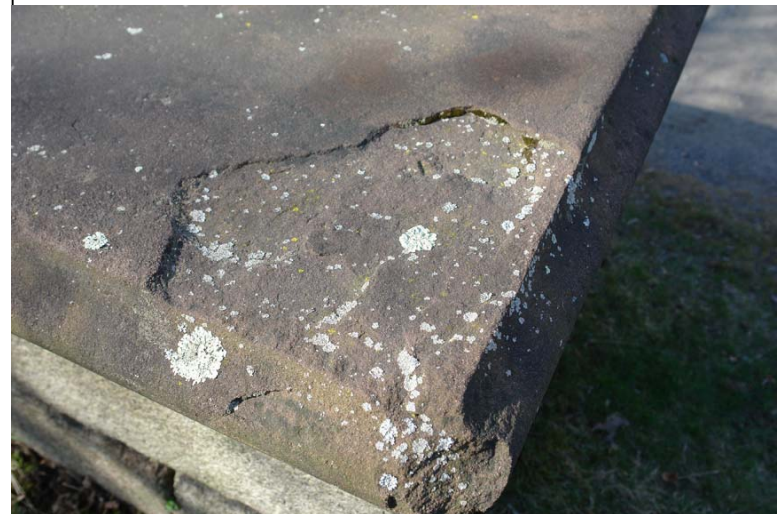
Marker# **F2.1**

Top loose from base  
Mortar joints failing  
Lower granite block out of  
plane  
Conservation Priority: 1

Secure top to base  
Repoint failed joints  
Investigate lower block

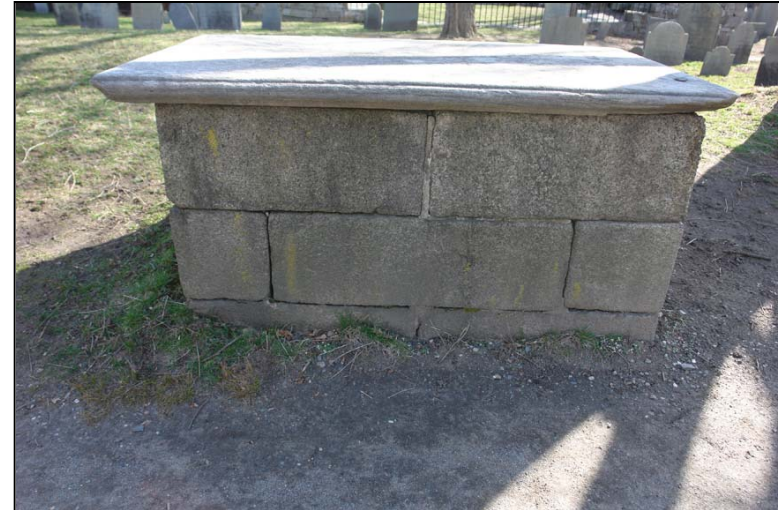
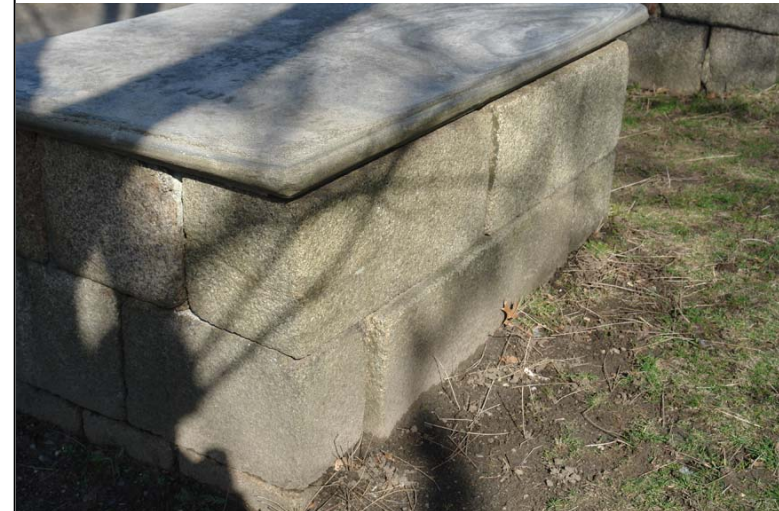
Marker# **F2.2**

Delaminating	Clean all voids Fill voids and cracks caused by delaminations
--------------	--

1. Treat all open voids with D/2 biological solution and scrub with nylon brushes. Repeat as necessary. Rinse with water . Flush interior voids with water and remove any lichens and/or debris with hand tools.
2. After full drying, all voids caused by splitting or delaminations at top edge of marker filled with a pigmented Sto Crack Filler using injection syringes and/or trowels. Voids along the lower sides of monument typically left open to allow escape of any water which may enter.
3. Excess crack filler immediately removed with damp sponging.
4. Large voids filled with a pigmented PHLc flowable grout, mist with water and cover for 3 days min.
