CITY OF SALEM, MASSACHUSETTS

DEPARTMENT OF PLANNING AND COMMUNITY DEVELOPMENT

I am writing to inform the Association that the Department of Planning and Community Development and Departments of Parks and Recreation are working together to continue to restore the Common Fence as outlined in the Common Fence Restoration Condition Assessment Report (See [Part 1](#) and [Part 2](#)).

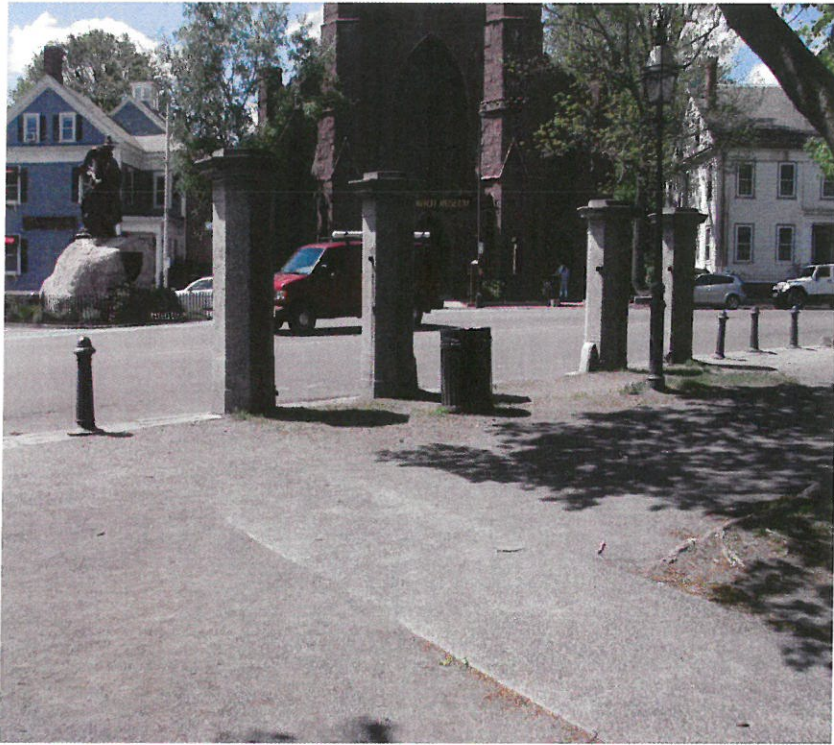
Before and After Examples Phase I Restoration

In both examples above, fence sections were completely missing and were recast in the original form. (Photos: CBI Consulting)

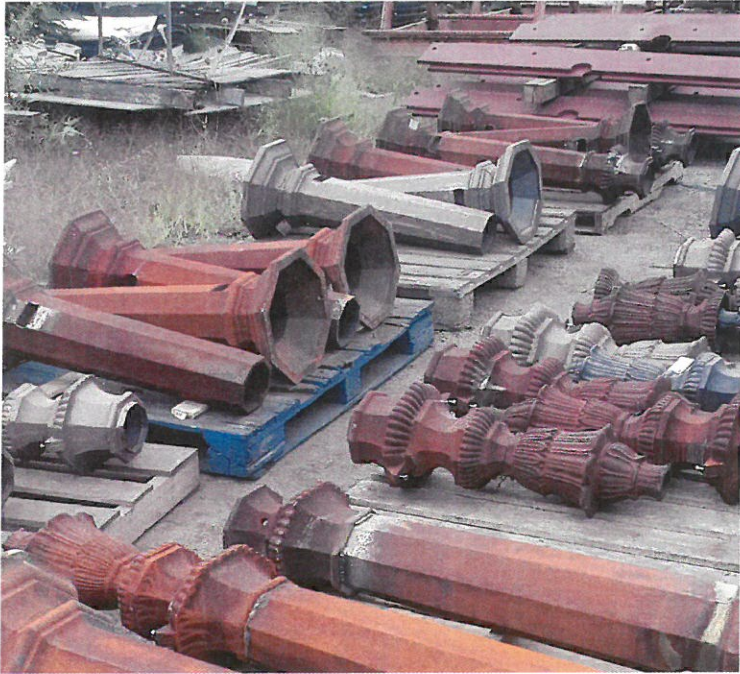
The restoration process includes securing a specialized foundry through a public bid process. In the past, the City has contracted with DeAngelis Iron Work, Inc. to restore and also remake missing fence sections. Below are pictures from Phase I and Phase II restoration in progress at the foundry (now complete).

Original cast iron pieces are labeled, mapped, and then removed from the Common and taken to the foundry. At the foundry, the fence sections sandblasted to remove paint, repairs are made to the metal and then painted. The goal is to always keep as much of the original fabric of the fence as possible.

In Phase I of this restoration project, the foundry made molds to match the original design of the fence to be able to recast all components of the fence in the extreme case that an entire fence section is missing or components are damaged beyond repair. Generally, each fence section is made of a top rail, bottom decorative rail and individual pickets with alternative patterns of diamonds and spades. When an entire fence section is recast, all of these components are cast separately and then joined by a metal worker as shown above. The same is done for the decorative fence posts. Each fence post has three components: a base, decorative middle and pineapple shaped top. The decorative fence posts are held together by being welded at the seams and further reinforced by a metal rod that is capped by the decorative pineapple top. Restoration of the fence is a particular specialty and extremely labor intensive.

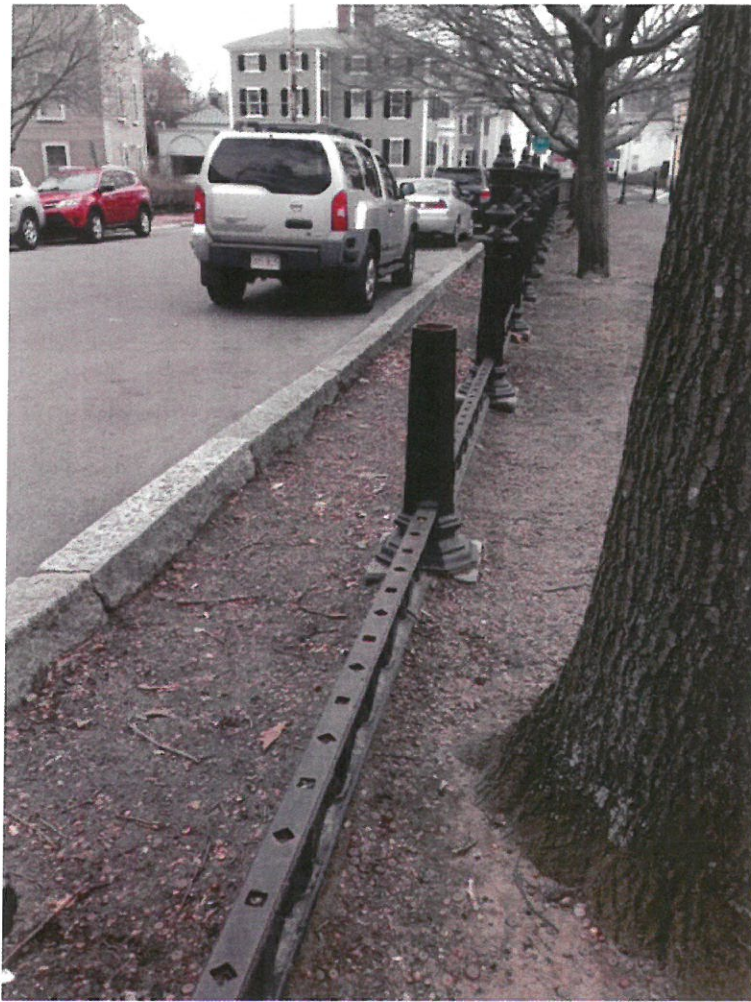
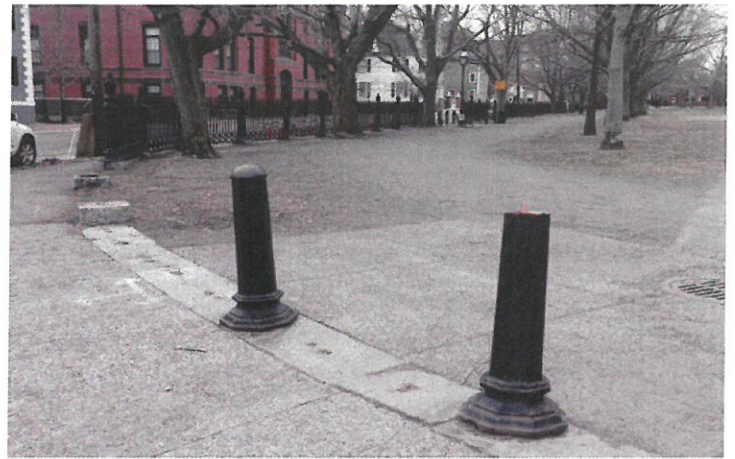
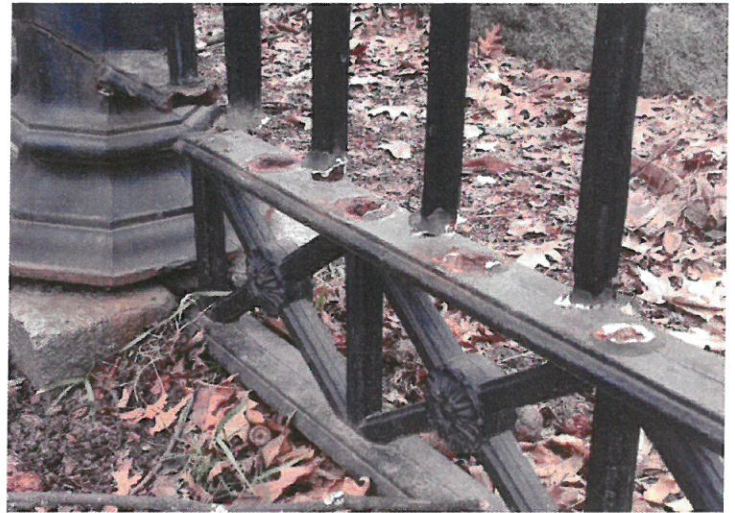
Above images (Photos: City of Salem): Missing fence sections along Washington Square East, bollards and fence section in need of repair and replacement at the Washington Street South entrance and severe structural damage to the existing fence example.

At this time, the City has secured CBI Consulting to assist the City to establish a scope of restoration work for Phase 3 to provide an updated site plan, recommendations, budget, scope of work and bid documentation to restore as many fence sections as funds will allow. For Phase III, the City is particularly interested in restoring the fence along Washington Square East and the entrance at Washington Square South along the playground (see images above).
