- Due diligence investigations conducted in November 2018 in prep for Gallows Hill Park renovation project.
- Slightly elevated levels of arsenic detected in shallow soils on western portion of "Mansell Field" area, situated east of main Gallows Hill Park area.

CITY OF SALEM - MANSELL FIELD PROJECT PAGE

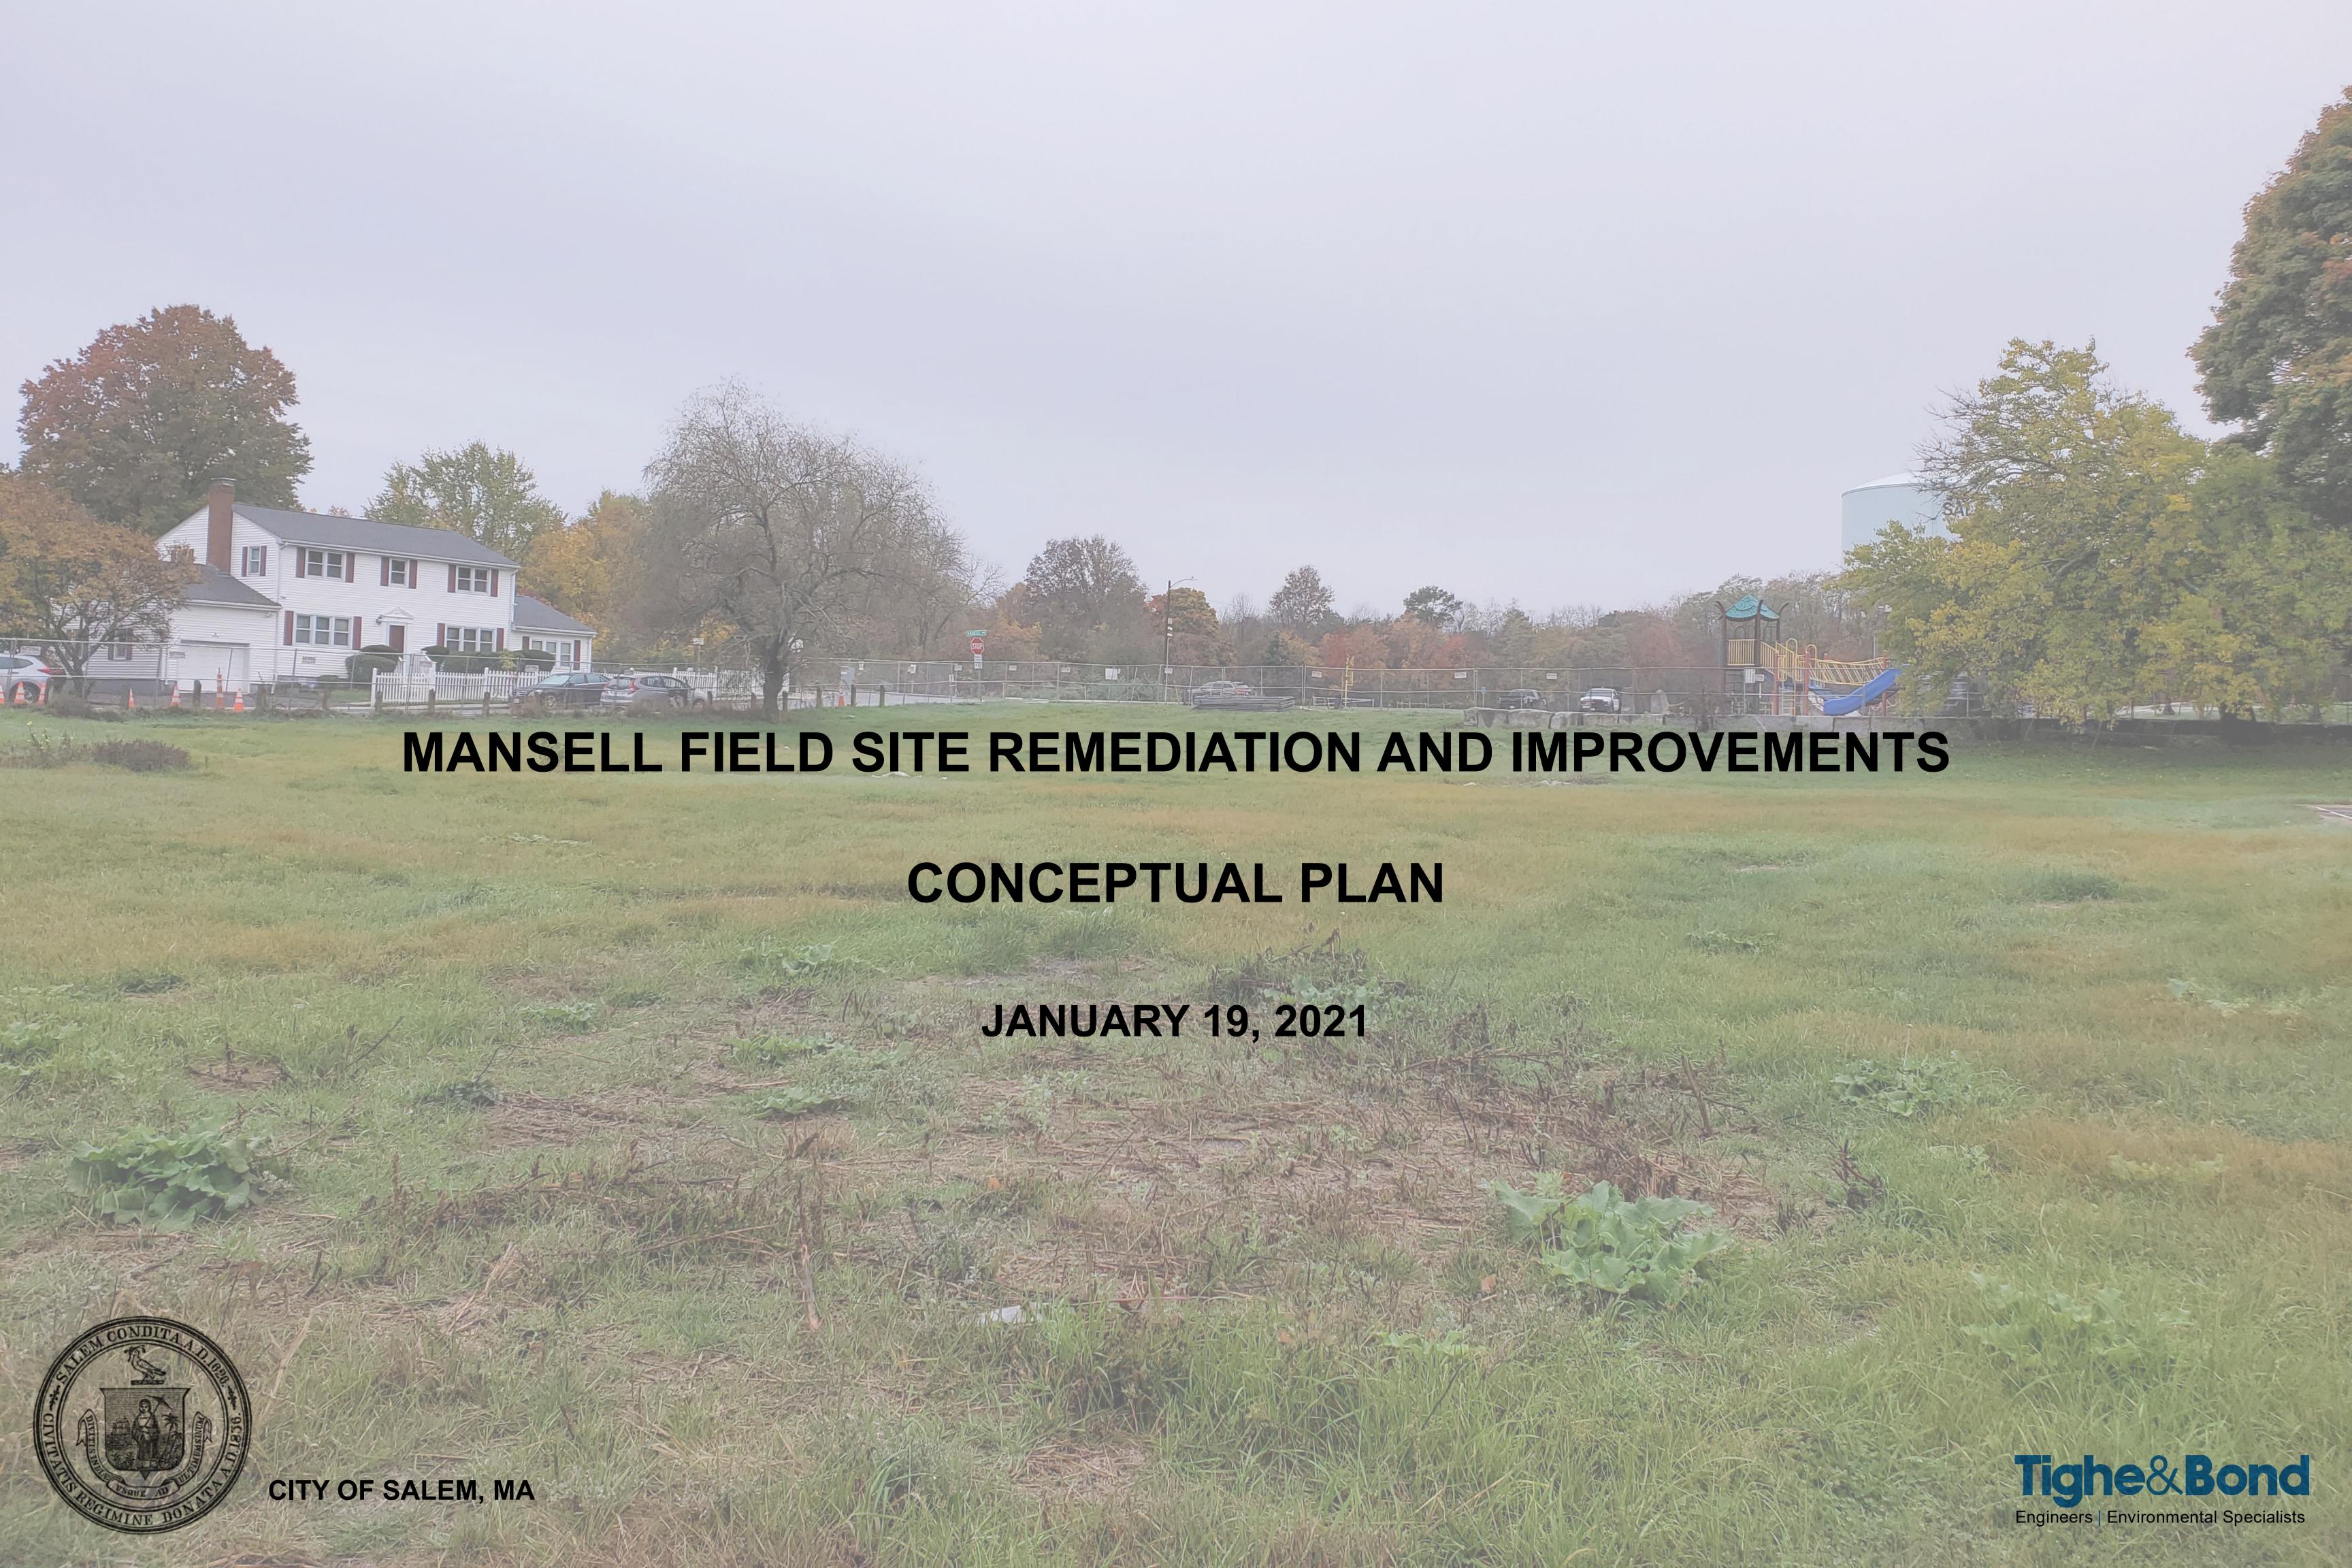
- Site history research indicated former tannery facility located on eastern portion of Mansell Field area circa late 1800s to early 1900s. City took ownership of Mansell Field area parcel in 1940.

- Mansell Field area contains basketball court and a grass covered area that is slightly sloped and not very "functional" field area. A 36-inch reinforced concrete pipe (RCP) stormwater line/ culverted stream crosses Mansell Field area.

- Further investigations indicated more elevated arsenic levels in shallow soils on central portion of Mansell Field area; triggered Imminent Hazard condition under MCP regulations and MassDEP immediately notified.

- Six-foot high chain link construction fence installed to restrict access for general public to Mansell Field.
- Delineation of site contamination has been completed; included sampling soils across Mansell Field parcel as well as other portions of Gallows Hill Park and on neighboring properties.
