# Forest River Park Pool Evaluation

City of Salem, Massachusetts  
93 Washington Street  
Salem, MA 01970

October 2017

## **ENGINEER'S REPORT**

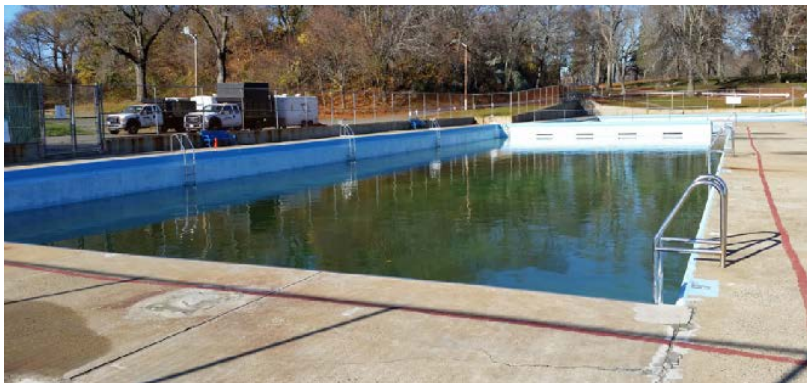
Figure C: Photo of Current Lap Pool

The main pool layout configuration is split into two separate portions. The long lap lane portion of the pool is approximately 65-feet wide by 187-feet long with depths from 3.0-feet on the north side of the lap lanes, sloping to depth of 9-feet in the south end of the pool. The pool

is used for general swim recreation, swim lessons, lap swim and is not used for competition swimming. A photo of the lap pool area can be seen in Figure C above.

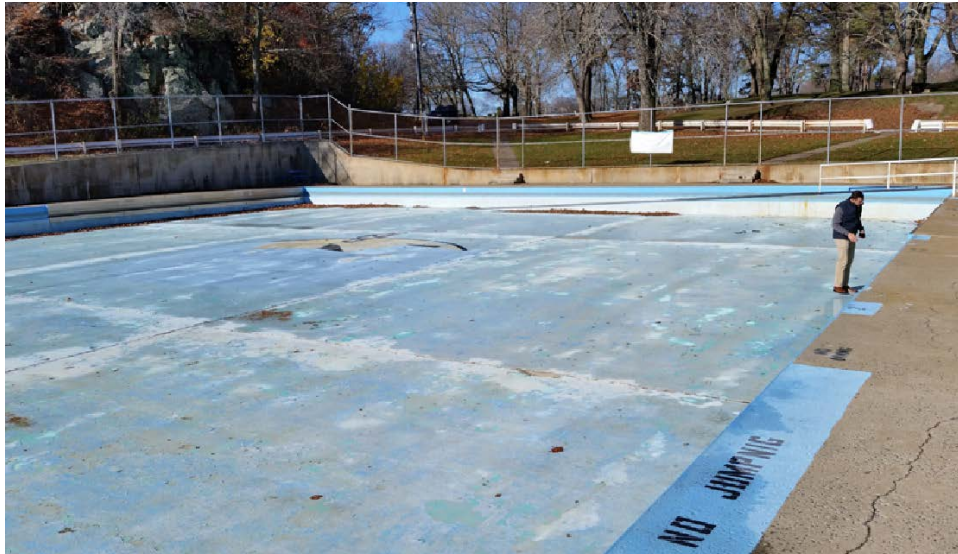
Figure D: Photo of Wading Pool

The pool also contains a shallow children area (Figure D). This section of the pool is approximately 50-feet wide by 60-feet long, with depths of 1'-9" deep to depths of 3 FT. This section of the pool has a ramp system that allows patrons to enter the pool. The entire pool approximately has a surface area of approximately 15,150 square feet, contains 610,000 gallons of water, with 724 linear feet of perimeter. Water flows from the children's pool into the lap pool through the gate area and a series of weirs at the base of the dividing wall between the two pool areas.
