COLUMBUS AVENUE SEAWALL

PROJECT REVIEW - NEIGHBORHOOD SUBCOMMITTEE MEETING JULY 28, 2020

GZA GeoEnvironmental, Inc.

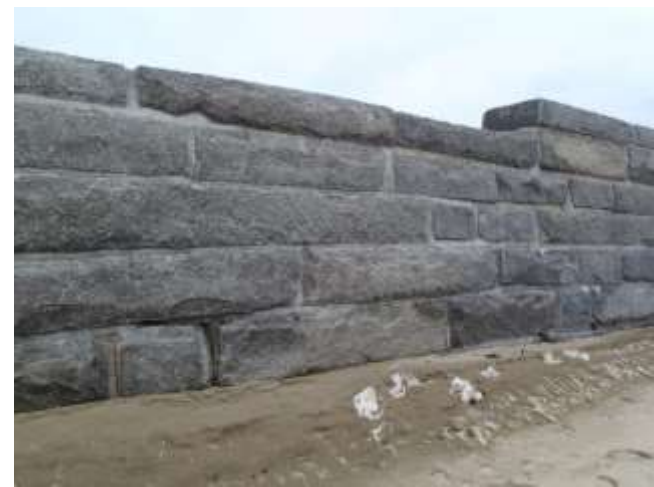
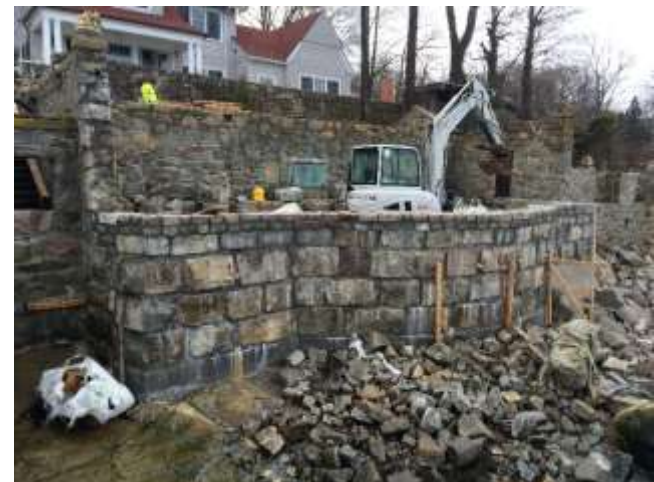
➤ Alt No. 2B – Reconstruct with Large Cut Granite Stone

- Medium upfront cost
- Increased flood protection
- Aesthetics- stone masonry

- Routine maintenance/upkeep
- Material availability

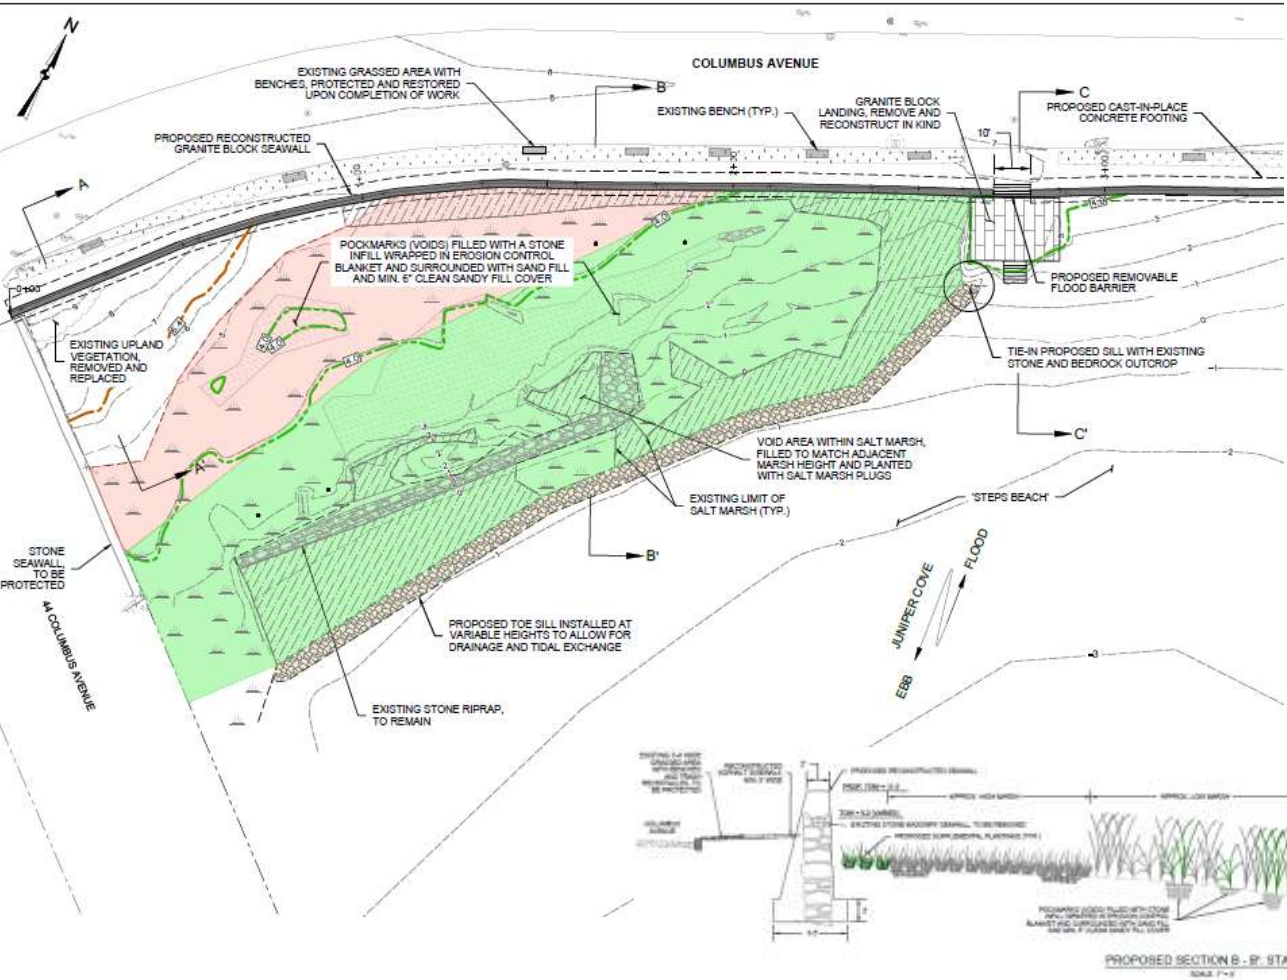
- Partly desiccated with “pockmark” voids throughout
- Erosion and undermining along seaward edge

Living Shoreline Design:

- New seaward sill
- Sand nourishment fill to raise grades and fill voids
- New and supplemental salt marsh plantings (*Spartina patens* and *Spartina alterniflora*)

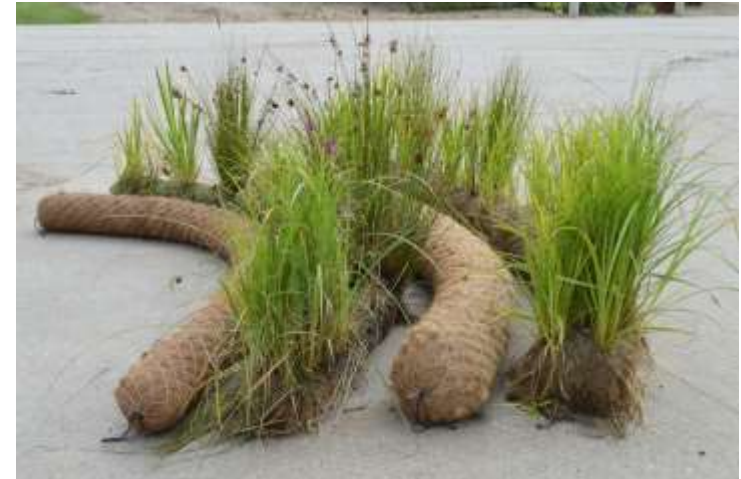
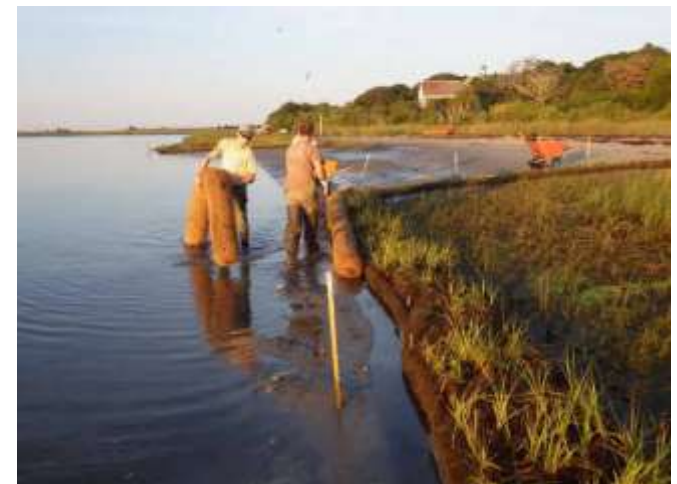
➤ Toe Sill – Coir Roll

- Natural and biodegradable material
- Promotes vegetation growth – plant directly into coir roll
- Absorbs wave energy with minimal reflection
- Easy installation

- Temporary protection (2-5 years)
- Minimal protection against waves and ice impacts
- Additional maintenance (resetting, anchoring, or replacement)

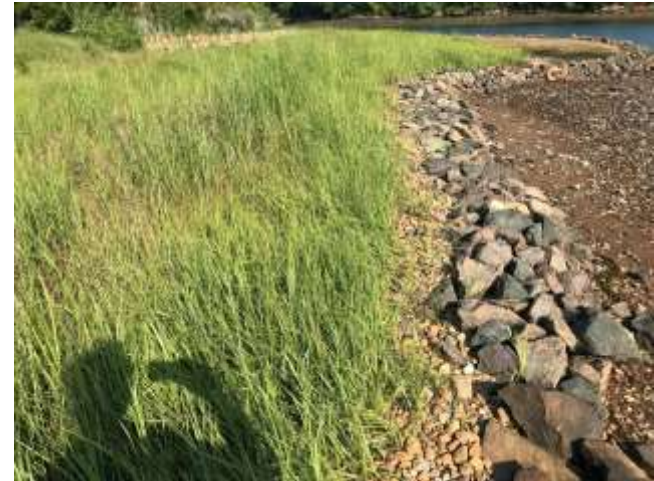
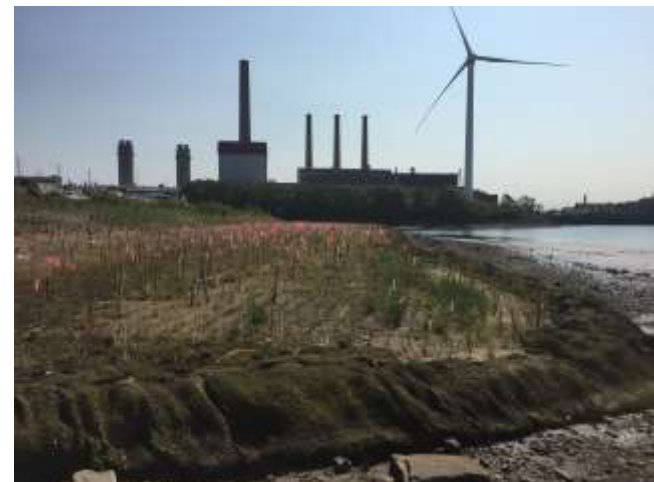
➤ Toe Sill – Stone Sill

- Long-term protection
- Increased protection against waves and ice impacts
- Easy to moderate installation

- Less natural- hard armoring
- Possible wave reflection and scour

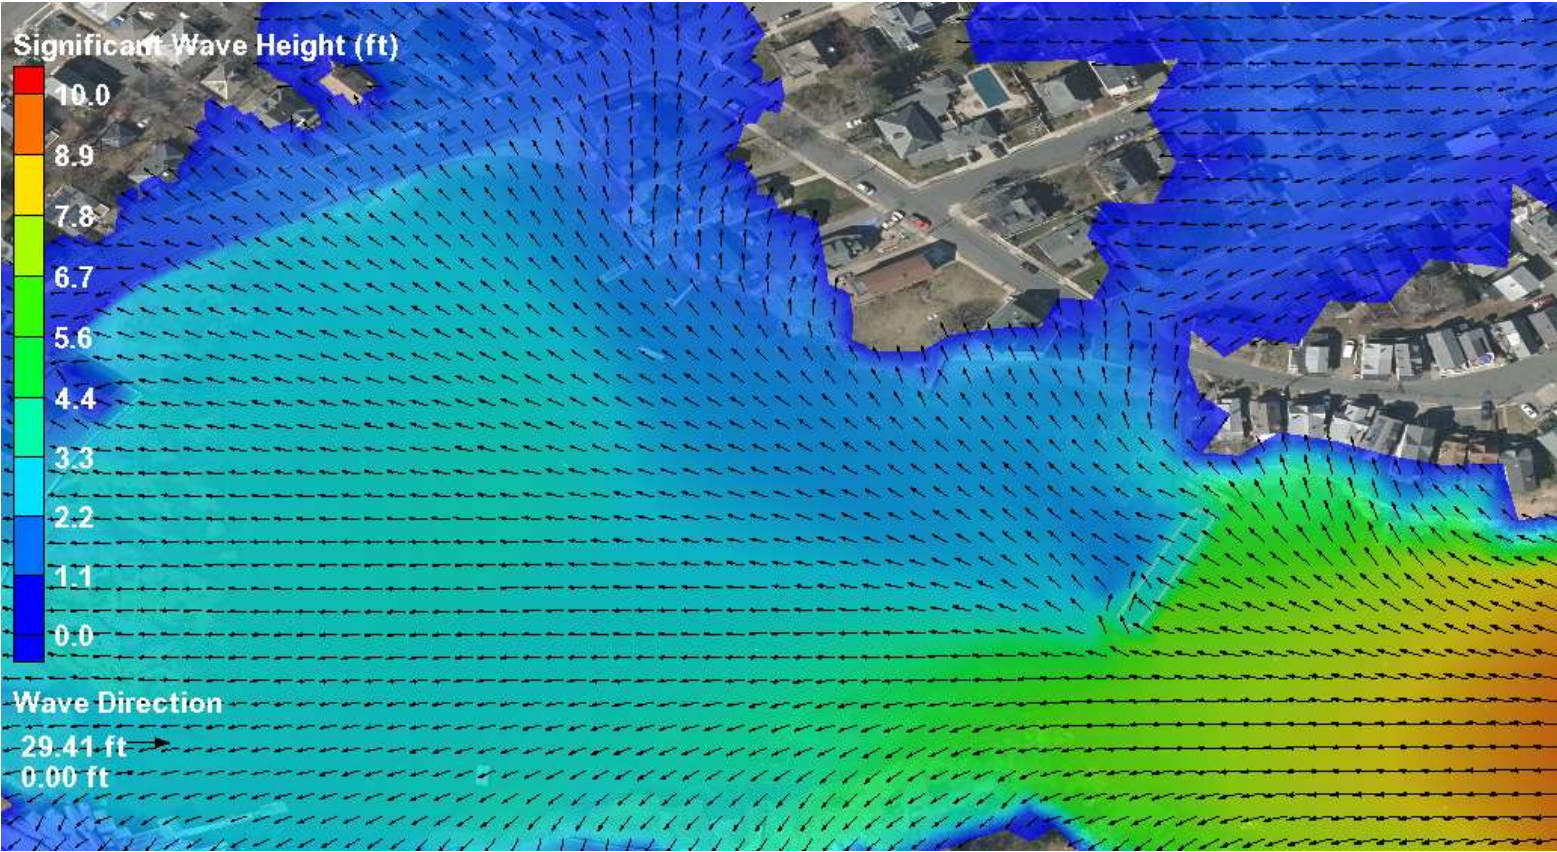
Figure 8. Revetment height: El. 8' – Scenario 1

1. Wave heights at seawall generally range from 2' to 2.4' except at the NE corner at 1.5'.
2. Additional wave runup contributing to wall overtopping at NE corner with sand build-up, however $\leq 0.5'$.
3. Overtopping of seawall at El. 11 and 12 due to wave runup.
4. Existing breakwater only minimally attenuates incoming waves.
