## FOREST RIVER CONSERVATION AREA TRAIL ASSESSMENT

Produced for the Conservation Commission  
of the City of Salem, MA

February 2016

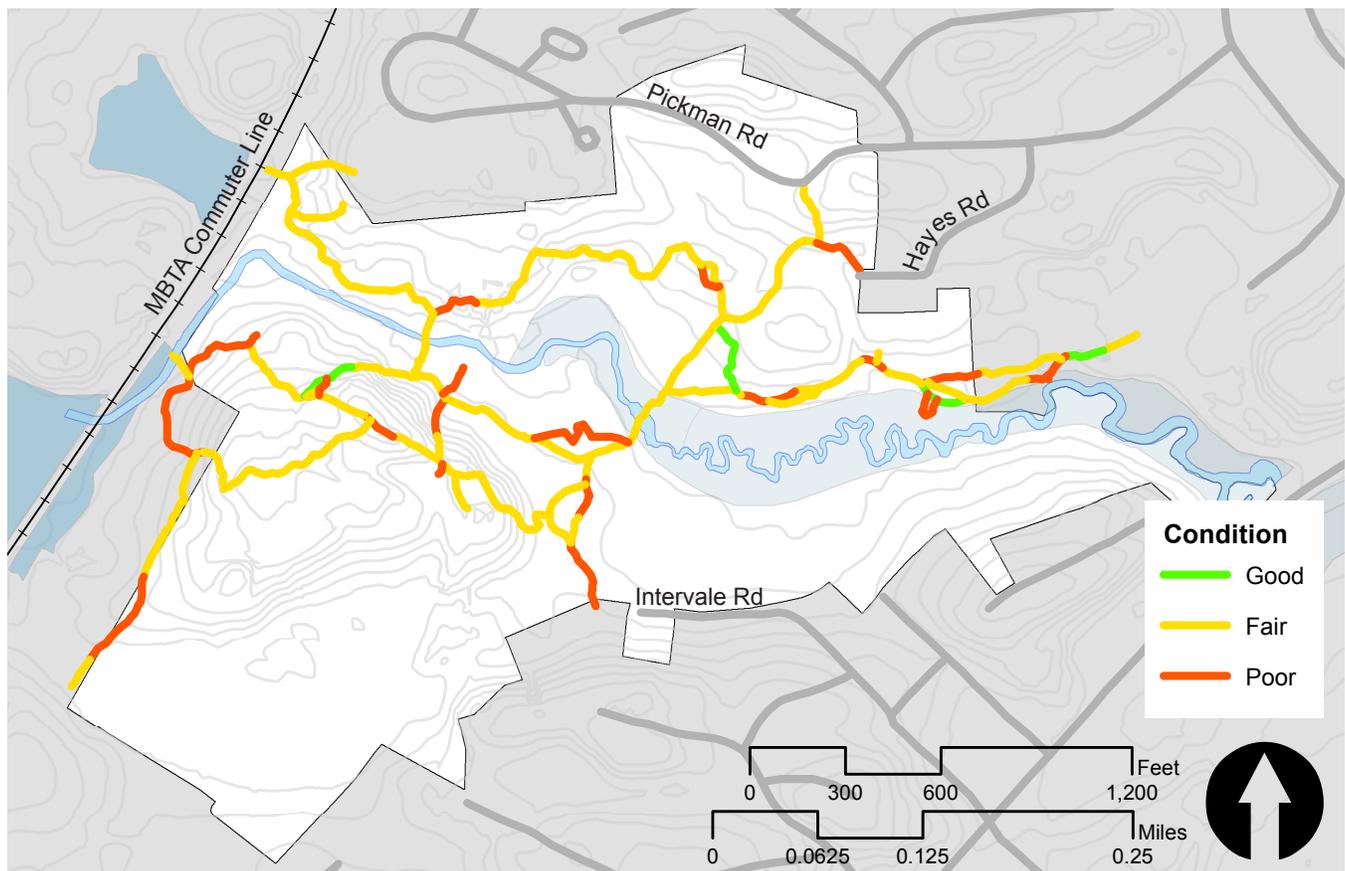
October 2015 Trail Conditions. Seventy percent (70%) of trails are in fair condition.

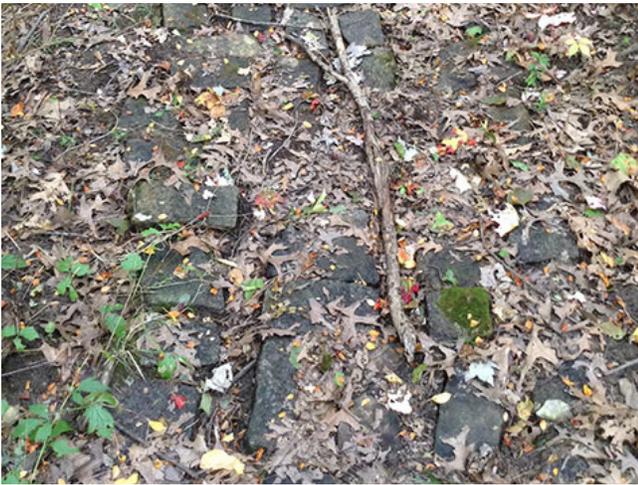
*Cobblestones at eastern base of Eagle Hill*

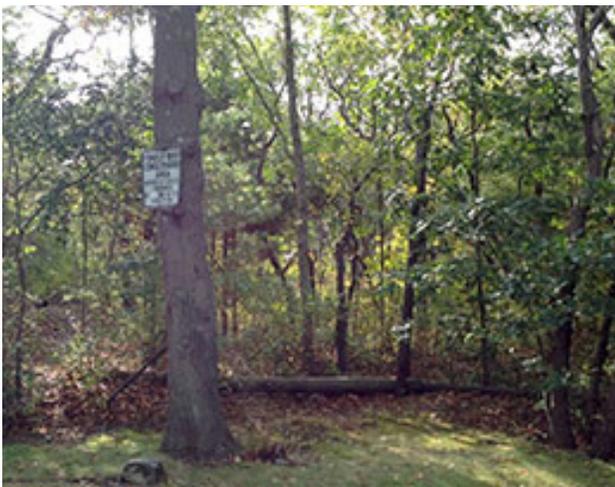
*Pickman Road Entrance with rules sign and utility pole*

Aluminum painted signs advertising \$50 fines are dotted throughout the property and located at both the Salem State and Pickman Road entrances. All clearly forbid motorized vehicles, but the bottom text has been vandalized on most every sign with white paint. One sign advertises No Hunting - No Fires, but according to a newspaper editorial other signs say No Camping - No Bikes. The effectiveness of the fine statements has not been determined as part of this assessment, and the signs lend a forbidding air to the site.

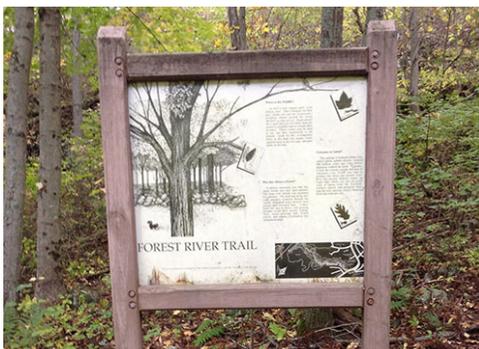
*Eagle Hill interpretive sign*

Three graphic interpretive signs provide information on the history and ecology of Forest River Conservation Area. The signs are 6 feet high with wood frames and glass covering black and white text and graphics. The frames are sturdy but worn-looking, and one of the legs on the sign closest to Salem State is splitting. Leaves and insects have infiltrated the glass on each sign to varying extents. The signs are legible, and the graphic style fits the character of the surroundings, but the trail map is not accurate nor adequately informative.

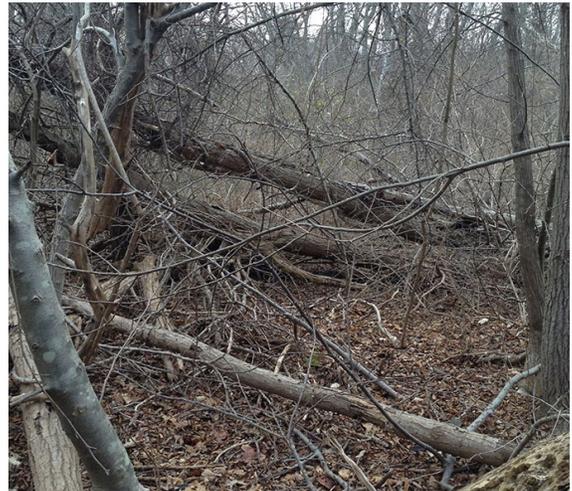
*Extensive clearing would be needed*

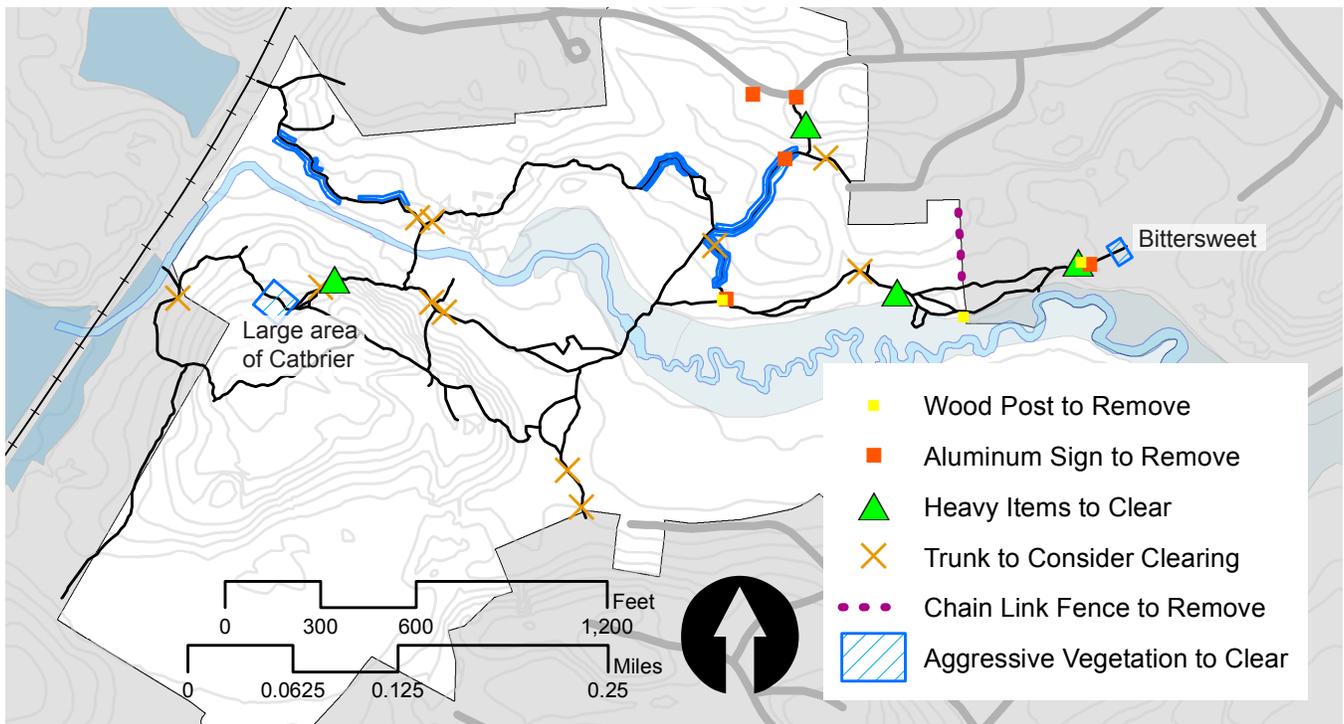
Consider working with Salem State to establish a less visible property boundary than the current 6' high chain link fence that stretches back toward a residence about 250 feet. Consider painting dots on trunks of trees or forming a line of boulders after removing at least the most visible length of the fence (150').
