**City of Salem,  
Massachusetts**

December 2019

# Salem City Hall

## City of Salem ADA Transition Plan

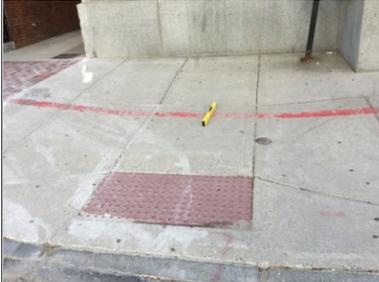
ID	Location	Floor	Room	Element	Type	Photo	Issues	Current Measure	Recommendations	Quantity	Price	Cost Estimation
<b>Approach and Entrance</b>												
<b>Exterior Access Route</b>												
1	Near Main Entrance	Ext.		Exterior Access Route	Sidewalk

Cross slope > 1:50 (2.00%)	5.2%	Reduce cross slope to be no steeper than 1:50 (2.00%).	1	648	\$648
2	Main Entrance	1		Exterior Access Route	Sidewalk

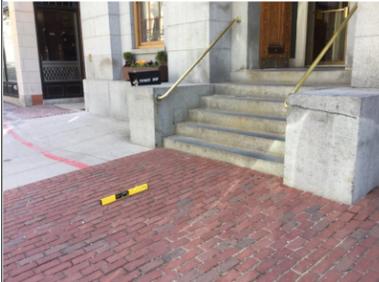
Cross slope > 1:50 (2.00%)	5.7%	Reduce cross slope to be no steeper than 1:50 (2.00%).	1	1125	\$1125
3	Near Main Entrance	Ext.		Exterior Access Route	Sidewalk

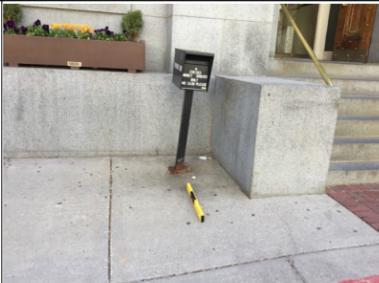
Running slope > 1:20 (5%)	9.9%	Reduce running slope to be no steeper than 1:20 (5.00%).  See ID #2	1	0	\$0
<b>Entrance</b>												
4	Accessible Entrance	Ext.		Entrance	Secondary Entrance

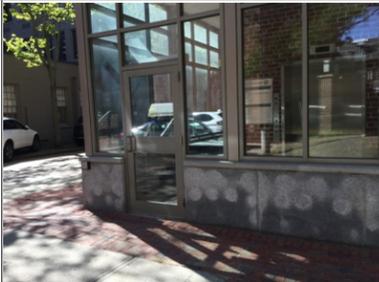
International Symbol of Accessibility not provided	-	Provide the International Symbol of Accessibility.	1	260	\$260
5	Towards City Hall Offices			Entrance	Secondary Entrance

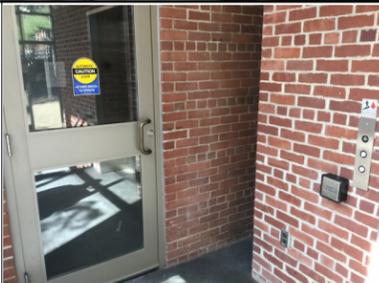
International Symbol of Accessibility not provided	-	Provide the International Symbol of Accessibility.	1	260	\$260

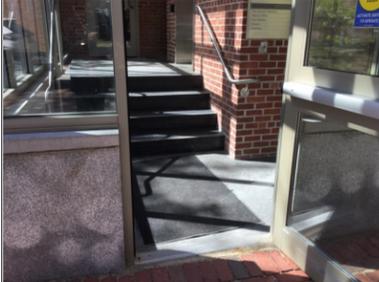
ID	Location	Floor	Room	Element	Type	Photo	Issues	Current Measure	Recommendations	Quantity	Price	Cost Estimation
6	Accessible Entrance	Ext.		Entrance	Secondary Entrance

Mat not securely attached	-	Install an ADA-compliant walk-off mat.	1	486	\$486
7	Main Entrance	1	2	Entrance	Main Entrance

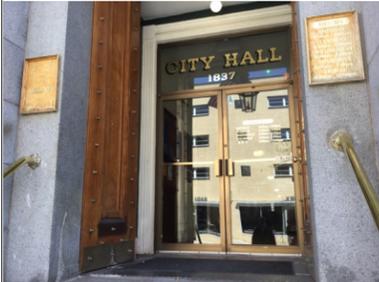
Mat not securely attached	-	Install an ADA-compliant walk-off mat.	1	486	\$486
<b>Access to Goods and Services</b>												
<b>Interior Access Route</b>												
8	Council's Chambers	2		Interior Access Route	N/A

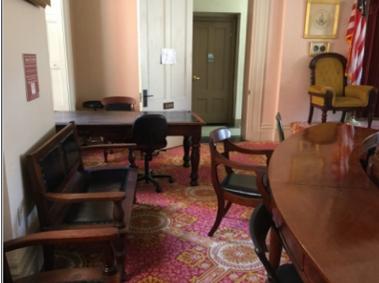
Route < 36" wide	31"	Relocate furniture to ensure a clear width of 36" min. is maintained at the accessible route.	1	Labor	\$0
9	Near Elevator			Interior Access Route	N/A

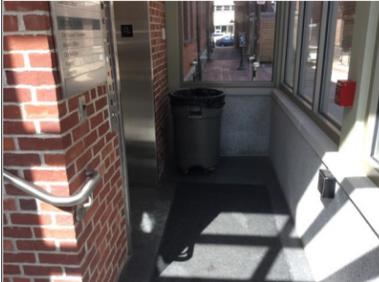
Mat not securely attached		Install an ADA-compliant walk-off mat.	1	486	\$486
<b>Doors, Doorways, &amp; Gates</b>												
10	Towards City Hall Offices			Doors, Doorways, & Gates	Circulation

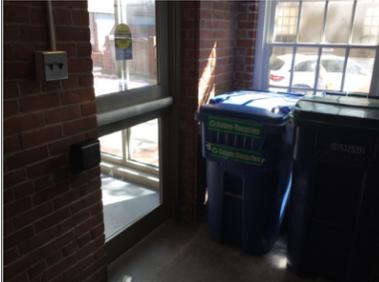
Clear width at door < 32"	31"	Relocate trash can to maintain the maneuvering clearance at the door.	1	Labor	\$0

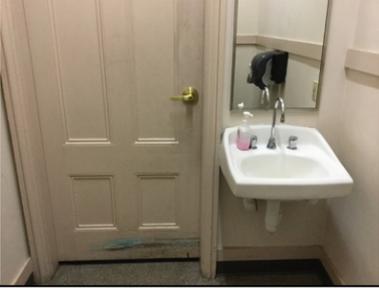
ID	Location	Floor	Room	Element	Type	Photo	Issues	Current Measure	Recommendations	Quantity	Price	Cost Estimation
11	Single-User Toilet Room	2		Doors, Doorways, & Gates	Toilet Room

Maneuvering clearance(s) not provided	-	Provide an automatic door opener.	1	2295	\$2295
12	City Council Ante Room	2		Doors, Doorways, & Gates	Office

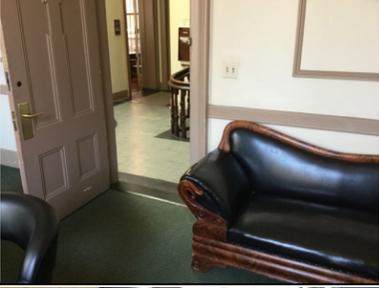
Maneuvering clearance(s) not provided	-	Relocate furniture to maintain the maneuvering clearance at the door.	1	Labor	\$0
13	Elections and Registrations Office	1	5	Doors, Doorways, & Gates	Office

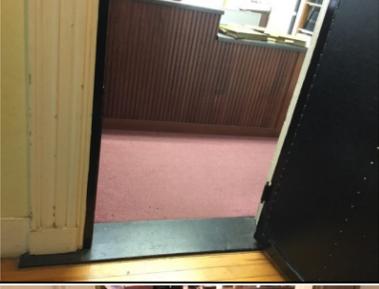
Threshold not beveled	-	Bevel threshold.	1	113	\$113
14	Legal Department	2	10	Doors, Doorways, & Gates	Office

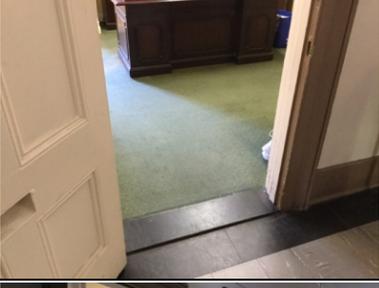
Threshold not beveled	-	Bevel threshold.	1	113	\$113
15	Legal Department	2	10	Doors, Doorways, & Gates	Office

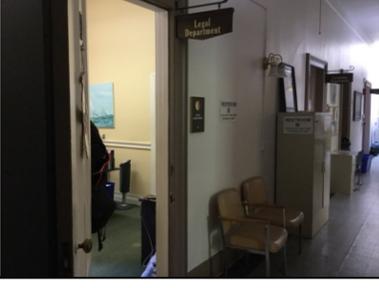
Hardware not operable with a closed fist	-	Provide hardware that can be operable with one hand and not require tight grasping, pinching, or twisting of the wrist.	1	363	\$363

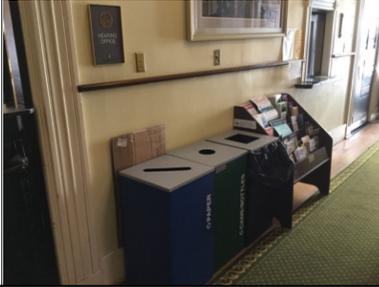
ID	Location	Floor	Room	Element	Type	Photo	Issues	Current Measure	Recommendations	Quantity	Price	Cost Estimation
<b>Signage</b>												
16	Hearing Office	1	4	Signage	Designation

Clear floor space is not provided	-	Relocate trash cans to provide an 18" by 18" clear floor space at the sign.	1	Labor	\$0
17	Legal Department	2	10	Signage	Designation

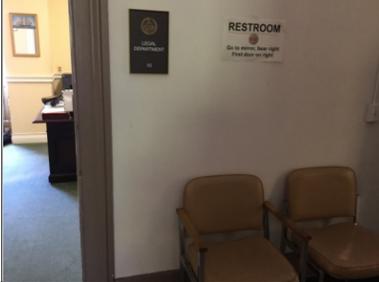
Clear floor space is not provided		Relocate chairs to provide an 18" by 18" clear floor space at the sign.	1	Labor	\$0
18	Licensing Department	2	8	Signage	Designation

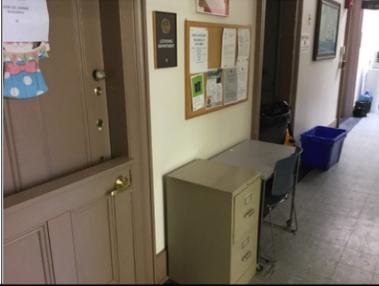
Clear floor space is not provided		Relocate cabinet to provide an 18" by 18" clear floor space at the sign.	1	Labor	\$0
19	Near Council's Chambers	2		Signage	Designation

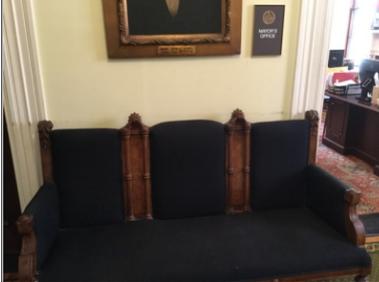
Clear floor space is not provided		Relocate chairs to provide an 18" by 18" clear floor space at the sign.	1	Labor	\$0
20	Assessor's Office	1	6	Signage	Designation

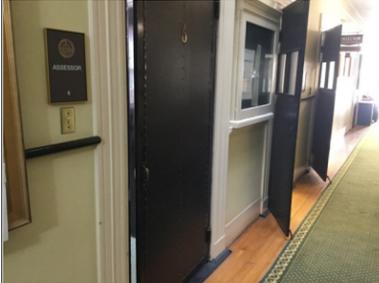
Raised characters < 48" or > 60" above ground	63"	Mount signs so that the baseline of the lowest tactile character is 48" min. above finish floor and the baseline of the highest tactile character is 60" max. above finish floor.	1	Labor	\$0

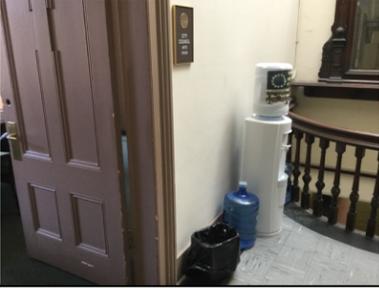
ID	Location	Floor	Room	Element	Type	Photo	Issues	Current Measure	Recommendations	Quantity	Price	Cost Estimation
21	City Council Ante Room	2		Signage	Designation

Sign not located on the latch side of the door	- -	Locate sign at permanent rooms alongside the door on the latch side. Ensure an 18" by 18" clear floor space is maintained at the sign.	1	Labor	\$0
22	Licensing Department	2	8	Signage	Informational

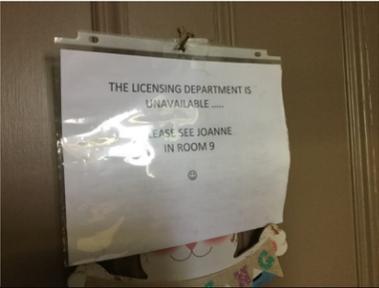
Non glare finish and contrast not provided	-	Provide signs with a non-glare finish with characters that have a high contrast to the background.	1	174	\$174
23	Council's Chambers	2		Signage	Informational

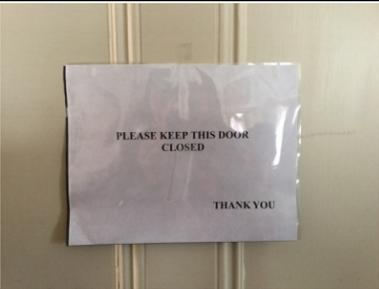
Non glare finish and contrast not provided	-	Provide signs with a non-glare finish with characters that have a high contrast to the background.	1	174	\$174
24	City Clerk - General Office	1	3	Signage	Directional

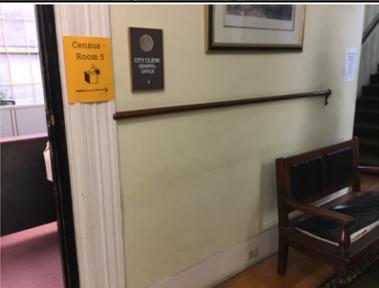
Text size non-compliant	-	Ensure that character size complies with the Character Height Table 703.5.5 in the ADA 2010 Standards.	1	174	\$174

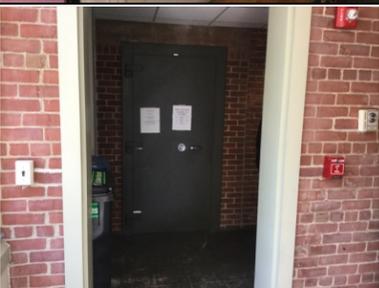
25		2		Signage	Directional

Text size non-compliant	-	Ensure that character size complies with the Character Height Table 703.5.5 in the ADA 2010 Standards.	1	174	\$174

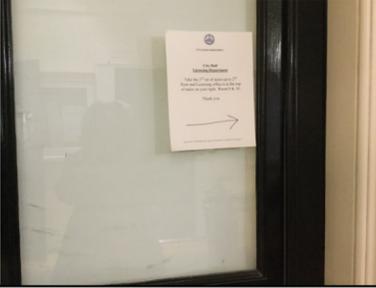
ID	Location	Floor	Room	Element	Type	Photo	Issues	Current Measure	Recommendations	Quantity	Price	Cost Estimation
26	Licensing Department	1		Signage	Directional

Text size non-compliant	-	Ensure that character size complies with the Character Height Table 703.5.5 in the ADA 2010 Standards.	1	174	\$174
<b>Service Counter</b>												
27	Elections and Registrations Office	1	5	Service Counter	N/A

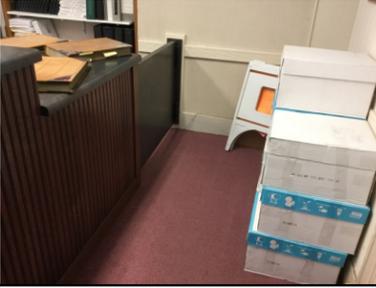
Route < 36" wide	-	Remove boxes to maintain a clear width of 36" min. is maintained at the accessible route.	1	Labor	\$0
28	City Clerk - General Office	1	3	Service Counter	N/A

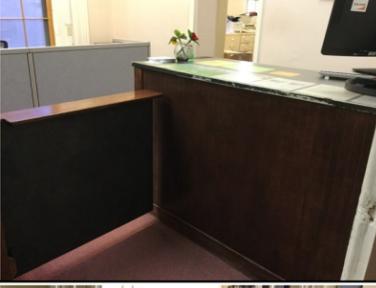
Counter > 36" high	41"	Provide a counter that is 36" max. above the ground or finish floor.	1	660	\$660
29	Hearing Office	1	4	Service Counter	N/A

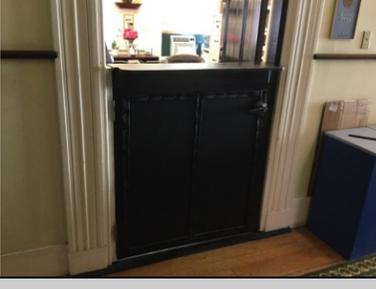
Counter > 36" high	49"	Provide a counter that is 36" max. above the ground or finish floor.	1	660	\$660
<b>Operable Parts</b>												
30	Across From Hearing Office	1		Operable Parts	Other

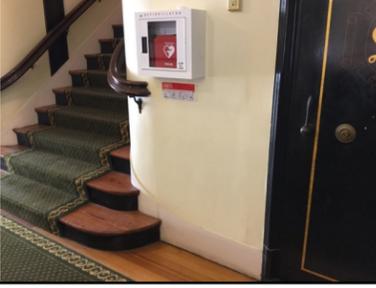
Reach < 15" or > 48"(forward/side approach)	59"	Relocate AED so that controls are 48" max. above finish floor.	1	192	\$192

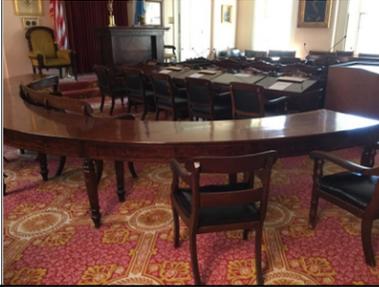
ID	Location	Floor	Room	Element	Type	Photo	Issues	Current Measure	Recommendations	Quantity	Price	Cost Estimation
<b>Dining or Work Surfaces</b>												
31	Council's Chambers	2		Dining or Work Surfaces	Work Surface

Knee or toe clearance not provided	23"	Provide a work surface with 27" min. knee clearance.	1	825	\$825
32	City Council Ante Room	2		Dining or Work Surfaces	Work Surface

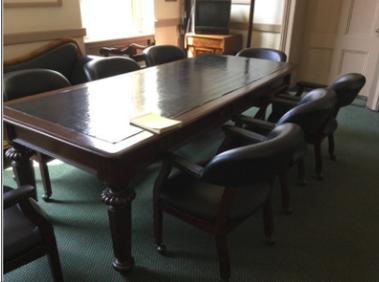
Knee or toe clearance not provided	23"	Provide a work surface with 27" min. knee clearance.	1	825	\$825
<b>Toilet &amp; Bathing Rooms</b>												
<b>Single-User Toilet</b>												
33	Single-User Toilet Room	2		Single-User Toilet	N/A

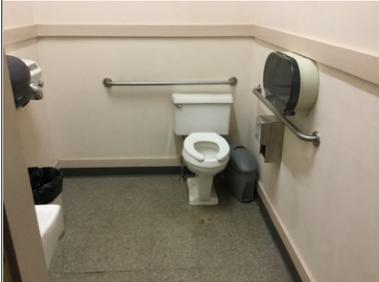
Toilet paper dispenser is not compliant	-	Relocate toilet paper dispenser so that it is 15" min. high, located below the grab bar, and between 7" and 9" from the front of the toilet.	1	530	\$530

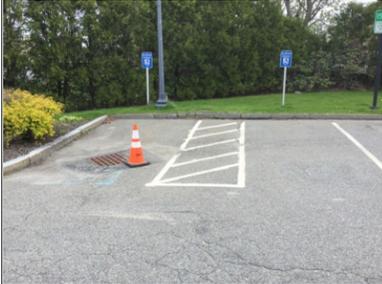
ID	Location	Floor	Room	Element	Type	Photo	Issues	Current Measure	Recommendations	Quantity	Price	Cost Estimation
<b>Approach and Entrance</b>												
<b>Off-Street Parking Lot or Garage</b>												
1	Parking Lot	1		Off-Street Parking Lot or Garage	Visitor

Vehicle space < 96" wide at car space Access aisle < 96" wide at van space Sign does not have the designation "Van Accessible" Sign bottom < 60" above finished grade Sign top > 96" above finished grade	80" 62" - 51"	Provide an accessible space that is at least 96" wide with a marked access aisle that is at least 96" wide. Add the designation "Van Accessible" to the sign located at the van accessible space. Locate sign with between 60" and 96" above the ground.	1	600	\$600
<b>Entrance</b>												
2	Main Entrance	Ext.		Entrance	Main Entrance

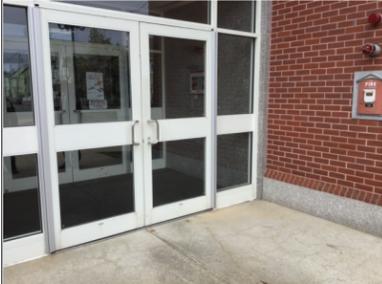
Door requires >15 lbs. of force to open	18 lbs	Adjust closers so doors do not require more than 15 pounds of force.	1	Labor	\$0

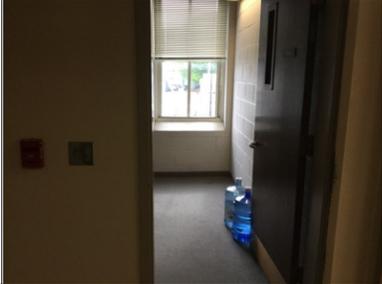
<b>Access to Goods and Services</b>												
<b>Means of Egress</b>												
3	Stairway			Means of Egress	N/A

Tactile exit sign not provided	-	Ensure tactile exit signs with raised characters and braille are provided at exit doors. Mount signs between 48"- 60" above finish floor located on the latch side of the door.	1	174	\$174
4	Stairway	1		Means of Egress	N/A

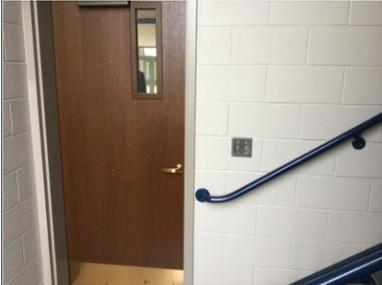
Tactile exit sign not provided	-	Ensure tactile exit signs with raised characters and braille are provided at exit doors. Mount signs between 48"- 60" above finish floor located on the latch side of the door.	1	174	\$174

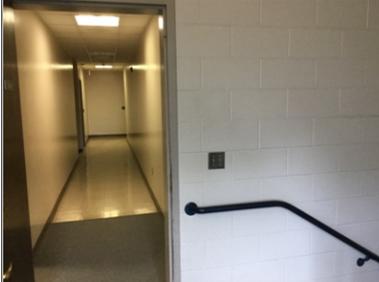
ID	Location	Floor	Room	Element	Type	Photo	Issues	Current Measure	Recommendations	Quantity	Price	Cost Estimation
5	Stairway	2		Means of Egress	N/A

Tactile exit sign not provided	-	Ensure tactile exit signs with raised characters and braille are provided at exit doors. Mount signs between 48"- 60" above finish floor located on the latch side of the door.	1	174	\$174
6	Stairway	2		Means of Egress	N/A

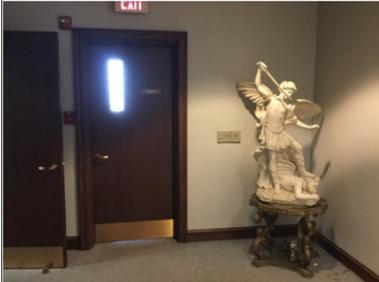
Tactile exit sign not provided	-	Ensure tactile exit signs with raised characters and braille are provided at exit doors. Mount signs between 48"- 60" above finish floor located on the latch side of the door.	1	174	\$174
7	Stairway	2		Means of Egress	N/A

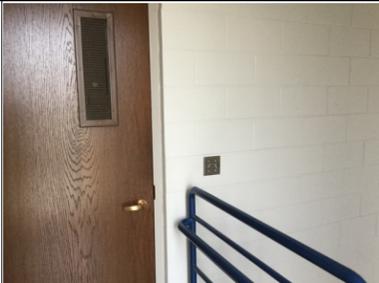
Tactile exit sign not provided	-	Ensure tactile exit signs with raised characters and braille are provided at exit doors. Mount signs between 48"- 60" above finish floor located on the latch side of the door.	1	174	\$174
<b>Interior Access Route</b>

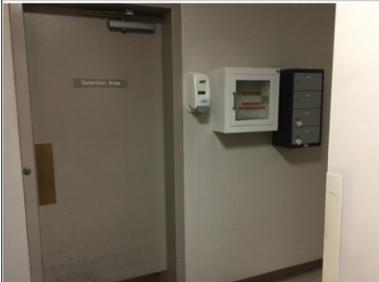
8	Detention Area	1		Interior Access Route	N/A

Obstructed by protruding objects	-	Relocate AED cabinet.	1	192	\$192
<b>Doors, Doorways, &amp; Gates</b>												
9	Licensing Office	1		Doors, Doorways, & Gates	Office

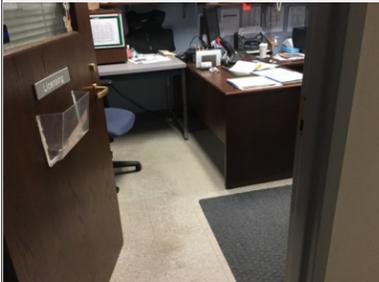
Clear width at door < 32"	-	Ensure door opens 90 degrees.	1	Labor	\$0

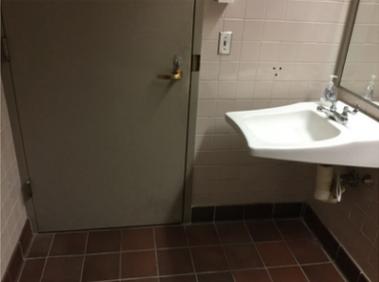
ID	Location	Floor	Room	Element	Type	Photo	Issues	Current Measure	Recommendations	Quantity	Price	Cost Estimation
10	Men's Toilet Room	1		Doors, Doorways, & Gates	Toilet Room

Maneuvering clearance(s) not provided	-	See ID #12	1	0	\$0
11	Women's Toilet Room	1		Doors, Doorways, & Gates	Toilet Room

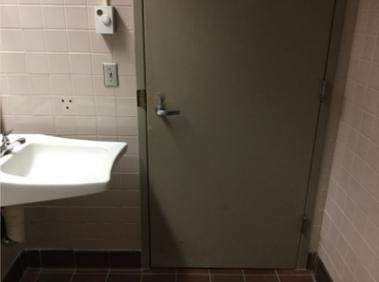
Maneuvering clearance(s) not provided	-	See ID #12	1	0	\$0
12	Women's Toilet Room	1		Doors, Doorways, & Gates	Toilet Room

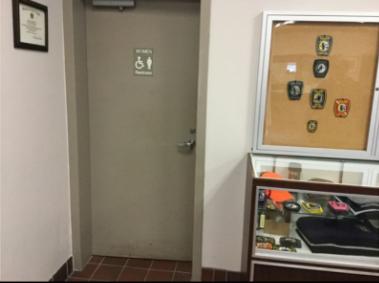
Maneuvering clearance not provided at recess > 6"	10"	Install an automatic door opener.	2	2295	\$4590
13	Main Entrance	1		Doors, Doorways, & Gates	Other

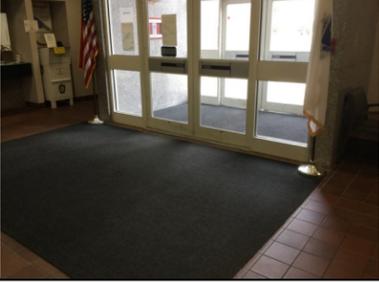
Mat not securely attached Door requires > 5 lbs. of force to open	- 17 lbs	Install an ADA-compliant walk-off mat. Adjust closers so doors do not require more than 5 pounds of force to open.	1	486	\$486
<b>Elevator</b>												
14	Lobby	1		Elevator	Interior

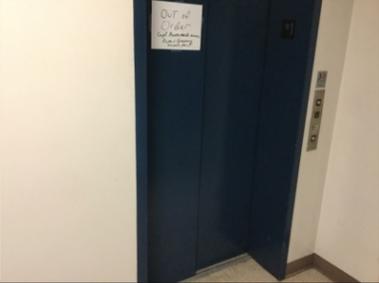
Elevator not maintained in operable working condition	-	Ensure elevator is maintained in operable working condition.	1	0	\$0

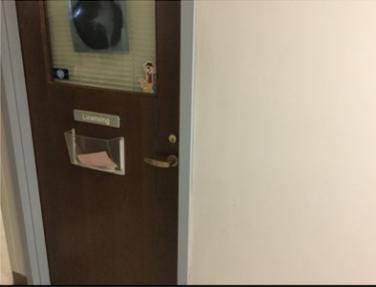
ID	Location	Floor	Room	Element	Type	Photo	Issues	Current Measure	Recommendations	Quantity	Price	Cost Estimation
<b>Signage</b>												
15	Licensing Office	1		Signage	Designation

Raised characters not provided Braille misplaced Sign not located on the latch side of the door	- - -	Provide text with raised characters duplicated in braille. Position braille below the corresponding text. If text is multi-lined place braille below the entire text. Locate sign alongside the door on the latch side.	1	174	\$174
16	Interview Room	1		Signage	Designation

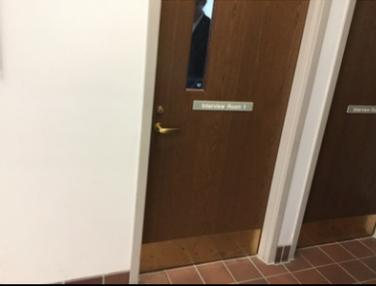
Braille not provided Sign not located on the latch side of the door	- -	Provide braille. Locate sign alongside the door on the latch side.	2	174	\$348
17	Men's Toilet Room & Women's Toilet Room	1		Signage	Designation

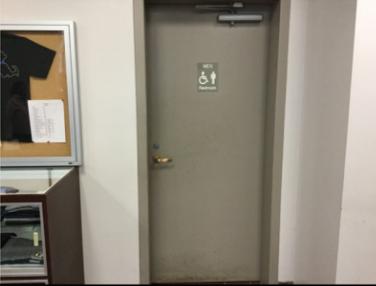
Braille not provided Sign not located on the latch side of the door	- -	Provide braille. Locate sign alongside the door on the latch side.	2	174	\$348

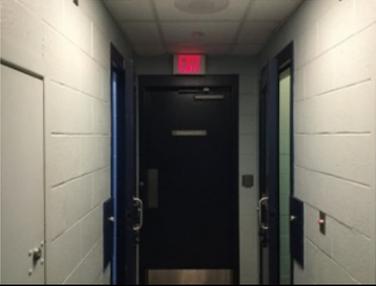
18	Detention Area	1		Signage	Egress

Sign not located on the latch side of the door	-	Locate sign at permanent rooms alongside the door on the latch side.	1	Labor	\$0
19	Auditorium	2		Signage	Egress

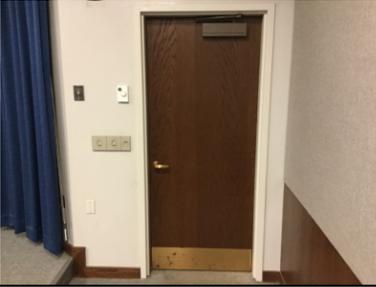
Not provided	-	Locate sign on the latch side.	1	174	\$174

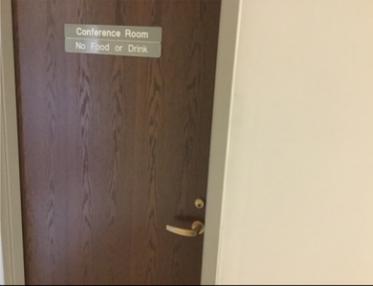
ID	Location	Floor	Room	Element	Type	Photo	Issues	Current Measure	Recommendations	Quantity	Price	Cost Estimation
20	Conference Room	2		Signage	Designation

Raised characters not provided Braille not provided Sign not located on the latch side of the door	- - -	Provide text with raised characters duplicated in braille. Locate signs alongside the door on the latch side.	1	174	\$174
21	Chief Police	2		Signage	Designation

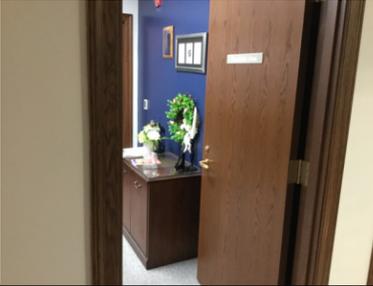
Raised characters not provided Braille not provided Sign not located on the latch side of the door	- - -	Provide text with raised characters duplicated in braille. Locate sign alongside the door on the latch side.	1	174	\$174
<b>Assembly Area</b>												
22	Auditorium	2		Assembly Area	N/A

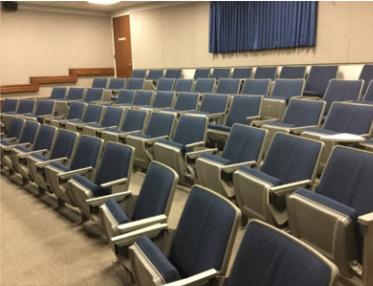
Number of seats Number of designated wheelchair spaces Minimum # wheelchair spaces not provided Assistive listening devices not provided	60 - - -	Provide four (4) wheelchair spaces; two (2) in the middle and one (1) at each end of the front row. If audible communication is integral to the use of the space, provide an assistive listening system.	1	10143	\$10143

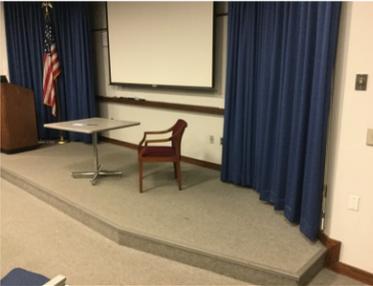
23	Auditorium	2		Assembly Area	N/A

Accessible route to stage not provided	-	Provide a portable ramp as needed.	1	450	\$450
<b>Detention Facilities</b>												
24	Holding Cell	1		Detention Facilities	Men's

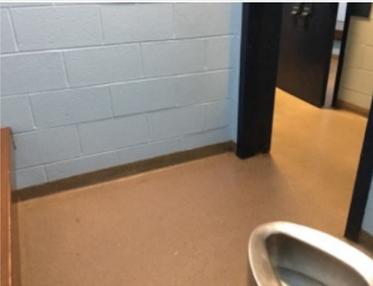
Mobility cell lacks 60" turning space	-	Ensure that a 60" turning space is provided.	1	0	\$0

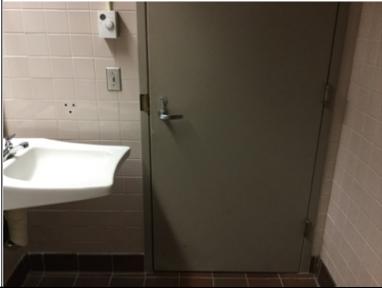
Audible and visible alarms not provided	-	When fire system is updated, ensure that a visible and audible fire alarm is installed.	2	519	\$1038
<b>Single-User Toilet</b>												
27	Women's Toilet Room	1		Single-User Toilet	N/A

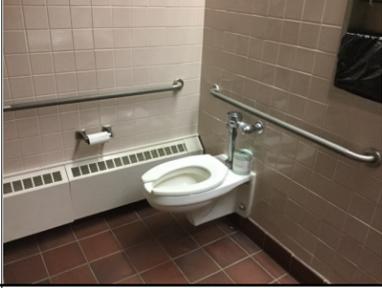
Flush control not on open side	-	Relocate the flush control to the open side.	1	281	\$281
28	Men's Toilet Room	1		Single-User Toilet	N/A

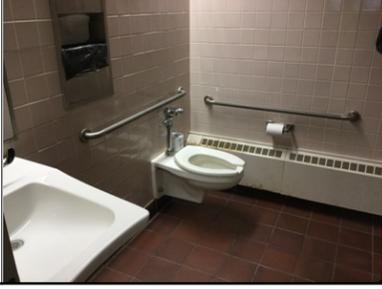
Side or rear grab bar < 33" or > 36" high	34"	Mount grab bars 33"- 36" above the floor.	1	192	\$192

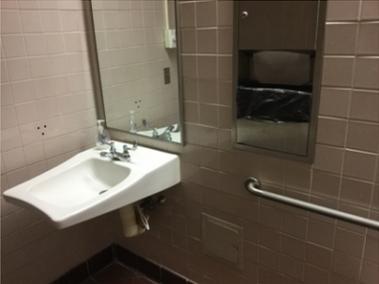
ID	Location	Floor	Room	Element	Type	Photo	Issues	Current Measure	Recommendations	Quantity	Price	Cost Estimation
<b>Dispensers</b>												
29	Men's Toilet Room and Women's Toilet Room	1		Dispensers	Paper Towel Dispenser

Controls > 42" high	56"	Relocate paper towel dispenser so the operable part is 42" max. above the finish floor.	2	530	\$1060

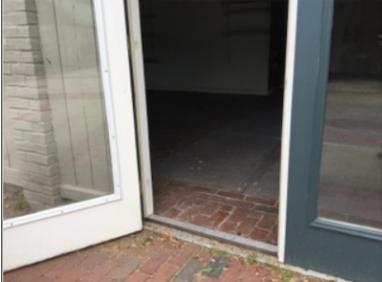
ID	Location	Floor	Room	Element	Type	Photo	Issues	Current Measure	Recommendations	Quantity	Price	Cost Estimation
1	Main Entrance			Entrance	Main Entrance

Clear width at door is < 32" Threshold not beveled	- -	Keep both doors open as needed to provide program access. Bevel threshold.	1	113	\$113
2	Artist's Row	1		Signage	Egress

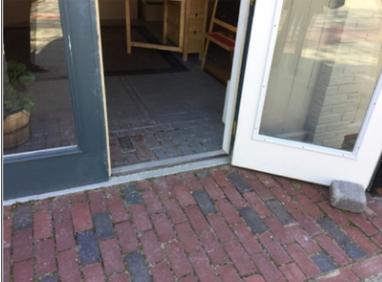
ID	Location	Floor	Room	Element	Type	Photo	Issues	Current Measure	Recommendations	Quantity	Price	Cost Estimation
1	Main Entrance	1		Entrance	Main Entrance

Threshold not beveled	-	Bevel threshold.  See Catalog for Artist Row #5 for egress sign.	1	113	\$113
2	Building #2	1		Service Counter	N/A

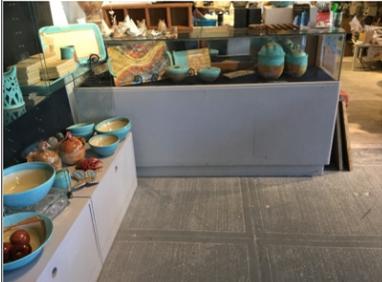
Counter > 36" high	40"	Provide a counter that is 36" max. above the ground or finished floor.	1	660	\$660
3	Route From Parking Lot	Ext.		Exterior Access Route	Walkway

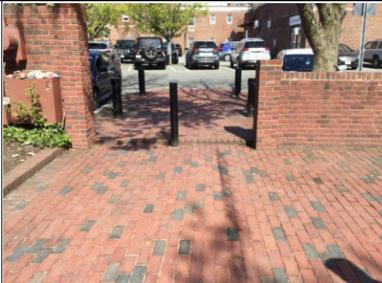
Level changes > 1/4"	2"	Alter change in level to be 1/4" high max.	1	-	\$0

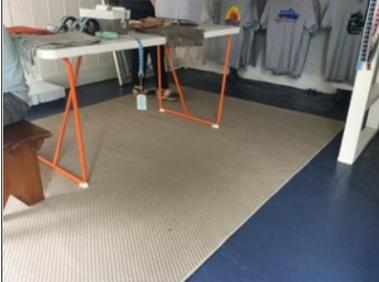
ID	Location	Floor	Room	Element	Type	Photo	Issues	Current Measure	Recommendations	Quantity	Price	Cost Estimation
1	Artist's Row	1		Interior Access Route	N/A

Mat not securely attached		Ensure mat is securely attached.	1	Labor	\$0
2	Entrance/Exit	1		Signage	Egress

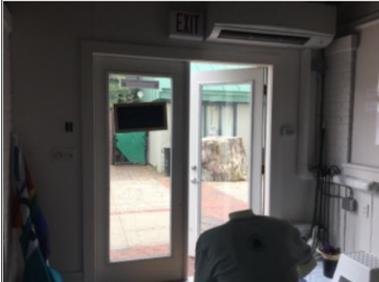
Raised characters not provided Braille not provided	- -	Provide a sign with raised characters duplicated in braille. Ensure sign is locate alongside the door on the latch side.  (Applies to all buildings.)	4	174	\$696
3	Main Entrance	1		Entrance	Main Entrance

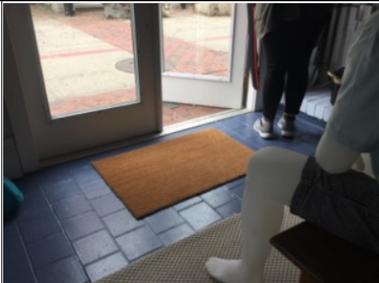
Mat not securely attached	-	Ensure mat is securely attached.	1	Labor	\$0

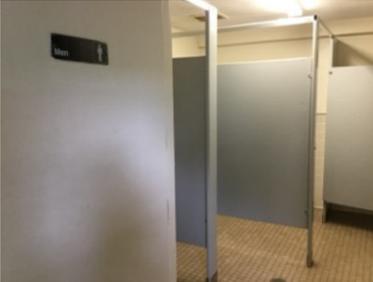
ID	Location	Floor	Room	Element	Type	Photo	Issues	Current Measure	Recommendations	Quantity	Price	Cost Estimation
<b>Access to Goods and Services</b>												
<b>Signage</b>												
1	Men's Toilet Room	1		Signage	Designation

Raised characters not provided Braille not provided Sign not located on the latch side of the door	- - -	Provide text with raised characters duplicated in braille. Locate sign at permanent rooms alongside the door on the latch side.	1	174	\$174
2	Women's Toilet Room	1		Signage	Designation

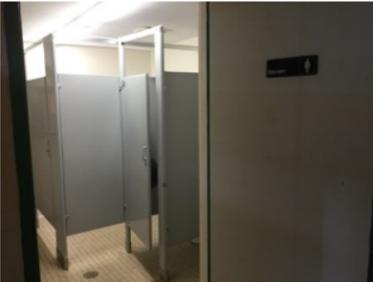
Raised characters not provided Braille not provided Sign not located on the latch side of the door	- - -	Provide text with raised characters duplicated in braille. Locate sign at permanent rooms alongside the door on the latch side.	1	174	\$174
<b>Toilet &amp; Bathing Rooms</b>												
<b>Lavatory</b>												
3	Men's Toilet Room			Lavatory	N/A

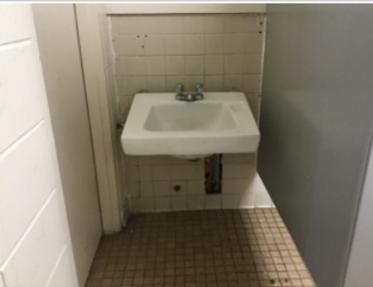
Route < 36" wide Toe or knee clearances not provided Plumbing underneath is exposed	31" 24" -	Remove partition to ensure that a clear width of 36" min. is maintained at the accessible route to the lavatory. Provide a lavatory with knee and toe clearance positioned for a forward approach. Insulate or otherwise configure pipes to prevent contact at lavatory.	1	1526	\$1526

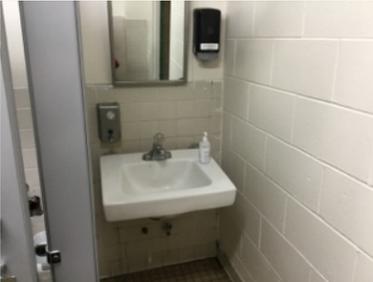
4	Women's Toilet Room			Lavatory	N/A

Route < 36" wide Toe or knee clearances not provided Plumbing underneath is exposed Mirror above lavatory w/reflective surface > 40"	- 24" 47.5"	Relocate partition to ensure that a clear width of 36" min. is maintained at the accessible route. Provide a lavatory with knee and toe clearance positioned for a forward approach. Insulate or otherwise configure pipes to prevent contact at lavatory. Lower mirror so that the bottom surface is at 40" max. above finished floor.	1	1718	\$1718

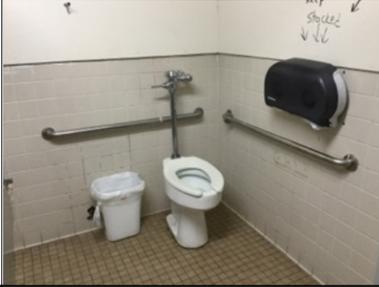
ID	Location	Floor	Room	Element	Type	Photo	Issues	Current Measure	Recommendations	Quantity	Price	Cost Estimation
<b>Toilet Compartment</b>												
5	Men's Toilet Room	1		Toilet Compartment	Accessible Compartment

Door has malfunctioning self-closing hinge Side or rear grab bar < 33" or >36" high Non-compliant toilet paper dispenser Coat hook > 48"	- 30" - 60"	Repair hinge. Locate grab bars between 33"- 36" above the finished floor. Relocate toilet paper so that it is 15" min. high, located under the grab bar, and between 7" and 9" from the front of the toilet below the side grab bar. Lower coat hook so that it is no higher than 48".	1	1237	\$1237
6	Women's Toilet Room	1		Toilet Compartment	Accessible Compartment

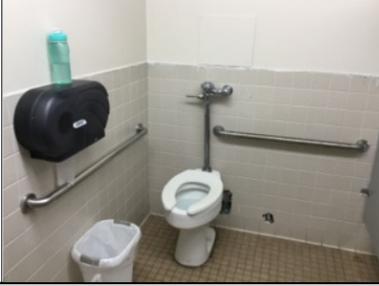
Side or rear grab bar < 33" or >36" high Flush control not on open side Non-compliant toilet paper dispenser Coat hook > 48"	30" - - 63"	Locate grab bars between 33"- 36" above the finished floor. Provide the flush control on the open side of the toilet (transfer side). Relocate toilet paper so that it is 15" min. high, located under the grab bar, and between 7" and 9" from the front of the toilet below the side grab bar. Lower coat hook so that it is no higher than 48".	1	1518	\$1518

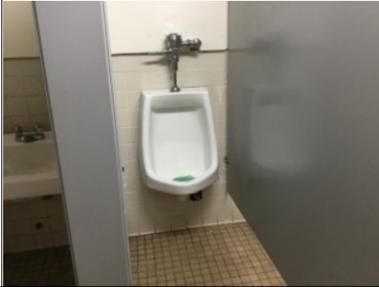
<b>Urinal</b>												
7	Men's Toilet Room	1		Urinal	N/A

Rim > 17" high Flush control is > 44" high or not properly located Urinal recessed > 24" deep has < 36" clear width	20" 47" 25"	Provide an urinal with the rim no higher than 17" above the finished floor. Mount flush control at 44" max. above the finished floor. Remove partition to ensure there is a clear width of 36".	1	2628	\$2628
<b>Dispensers</b>												
8	Men's Toilet Room			Dispensers	Other

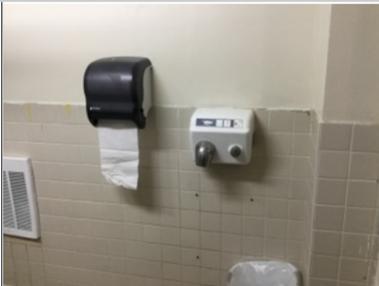
Controls > 42" high Dispenser acts as a protruding object	44" -	Relocate so the operable part is 42" max. above the finished floor. Ensure paper towel dispenser does not protrude into the circulation path.	1	530	\$530
9	Women's Toilet Room	1		Dispensers	Paper Towel Dispenser

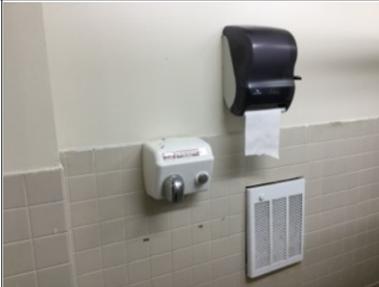
Controls > 42" high Dispenser acts as a protruding object	58" -	Relocate so the operable part is 42" max. above the finished floor. Ensure paper towel dispenser does not protrude into the circulation path.	1	530	\$530

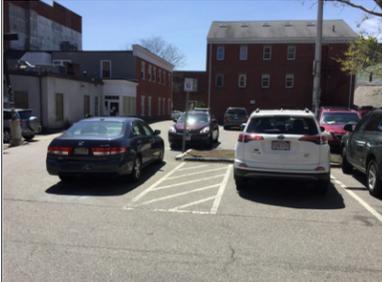
ID	Location	Floor	Room	Element	Type	Photo	Issues	Current Measure	Recommendations	Quantity	Price	Cost Estimation
<b>Approach and Entrance</b>												
<b>Off-Street Parking Lot or Garage</b>												
1	Parking By Annex	Ext		Off-Street Parking Lot or Garage	N/A

Total # of parking Total # of designated accessible parking spaces Total # of designated van accessible spaces Vehicle space < 132" wide at van space Sign does not have the designation "Van Accessible"	20 1 - -	Provide a van accessible space that is 96" wide min. with an access aisle that is 96" wide min. Add the designation "Van Accessible" to the sign located at the van accessible space. Mount the sign 60" min. and 96" max. aff.  (Cost for re-striping and a "Van Accessible" sign.)	1	600	\$600
2	Parking Sewell Street Lot	Ext		Off-Street Parking Lot or Garage	N/A

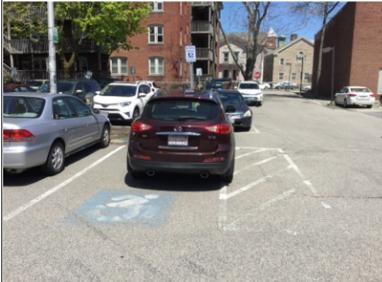
Total # of parking Total # of designated accessible parking spaces Total # of designated van accessible spaces	60 4 -	Provide a van accessible space that is 96" wide min. with an access aisle that is 96" wide min. Add the designation "Van Accessible" to the sign located at the van accessible space. Mount the sign 60" min. and 96" max. aff.  (Cost for re-striping and a "Van Accessible" sign.)	1	600	\$600

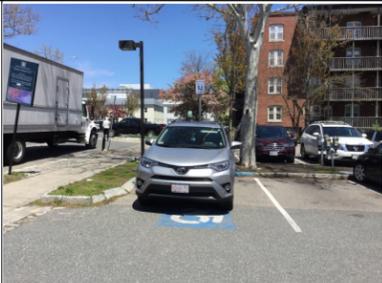
3	Parking Sewell Street	Ext		Off-Street Parking Lot or Garage	N/A

Access aisle not provided	-	Provide a marked access aisle that is 60" wide min. (At both the photographed space and second identical space behind the photographed location.)  (Cost for re-striping to provide access aisles.)	2	225	\$450
<b>Access to Goods and Services</b>												
<b>Means of Egress</b>												
4	Large Meeting Room	1	106	Means of Egress	N/A

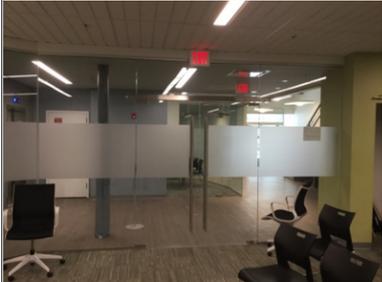
Tactile exit sign not provided	-	Ensure tactile exit signs with raised characters and braille are provided at exit doors. Mount signs between 48"- 60" above finish floor located on the latch side of the door.	1	174	\$174

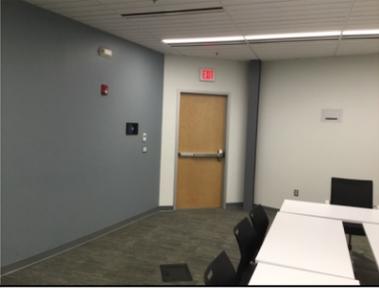
ID	Location	Floor	Room	Element	Type	Photo	Issues	Current Measure	Recommendations	Quantity	Price	Cost Estimation
5	Large Meeting Room	1	106	Means of Egress	N/A

Tactile exit sign not provided	-	Ensure tactile exit signs with raised characters and braille are provided at exit doors. Mount signs between 48"- 60" above finish floor located on the latch side of the door.	1	174	\$174
6	Planning	2		Means of Egress	N/A

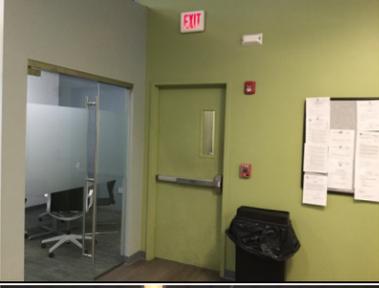
Tactile exit sign not provided	-	Ensure tactile exit signs with raised characters and braille are provided at exit doors. Mount signs between 48"- 60" above finish floor located on the latch side of the door.	1	174	\$174
7	Parking Entrance	1		Means of Egress	N/A

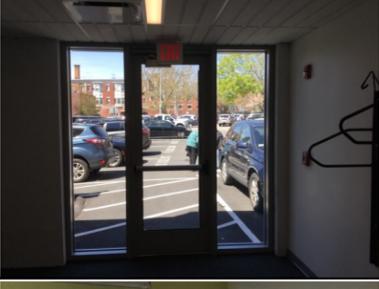
Tactile exit sign not provided International Symbol of Acc. not provided	-	Ensure tactile exit signs with raised characters and braille are provided at exit doors. Mount signs between 48"- 60" above finish floor located on the latch side of the door. Provide the International Symbol of Accessibility	1	174	\$174

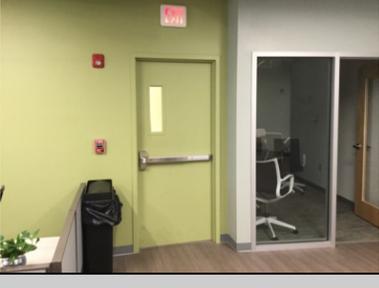
8	Third Floor Lobby	3		Means of Egress	N/A

Tactile exit sign not provided International Symbol of Acc. not provided	-	Ensure tactile exit signs with raised characters and braille are provided at exit doors. Mount signs between 48"- 60" above finish floor located on the latch side of the door. Provide International Symbol of Accessibility	1	174	\$174
<b>Interior Access Route</b>												
9		1		Interior Access Route	N/A

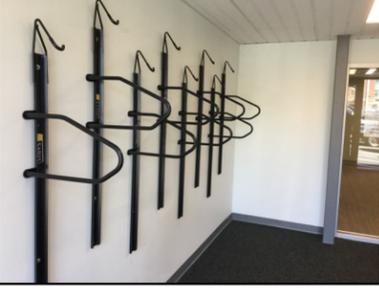
Obstructed by protruding objects	51"	Provide a cane detectable barrier 27" max. aff before the first / leading bike rack.	1	230	\$230

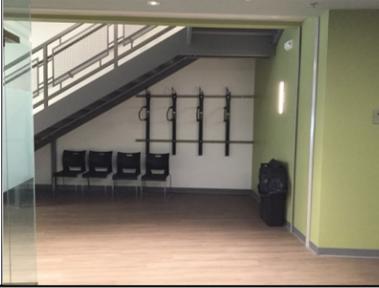
ID	Location	Floor	Room	Element	Type	Photo	Issues	Current Measure	Recommendations	Quantity	Price	Cost Estimation
10	Lobby	1		Interior Access Route	N/A

Obstructed by protruding objects	-	Relocate bike rack. (Descending stair less than 80" aff.) Provide a cane detectable barrier below stairs.  (Cost bases on a 6' long 27" max. high pipe rail under stairs.)	1	720	\$720
<b>Doors, Doorways, &amp; Gates</b>												
11	Egress to Parking	1		Doors, Doorways, & Gates	Emergency Egress

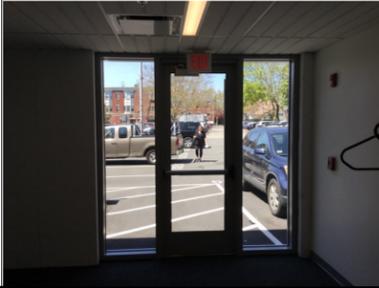
Door requires > 5 lbs. of force to open	25 lbs.	Adjust closers so doors do not require more than 5 pounds of force to open.	1	Labor	\$0
<b>Stairways</b>												
12	Entrance Lobby	1		Stairways	Interior

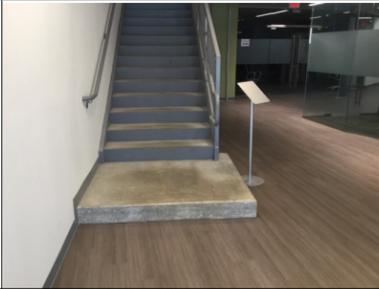
Handrails do not extend 12" from stairs Handrails not continuous where required	- -	Top: Ensure handrails extend horizontally above the landing for 12" min. beginning above the first riser nosing. Bottom: Ensure handrails extend to one tread depth beyond the last riser. Provide continuous handrails. (Cost based on one wall mounted and one free standing metal railing at landing.)	1	1074	\$1074

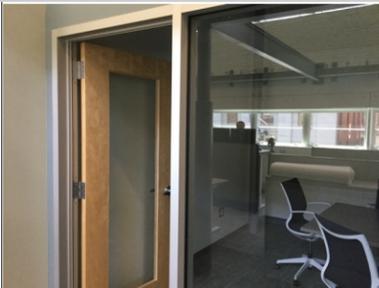
<b>Signage</b>												
13	Small Meeting Room	2		Signage	Designation

Not provided	-	Locate signage with raised characters and braille alongside the door on the latch side.	1	174	\$174
14	Engineering Conference Room	2		Signage	Designation

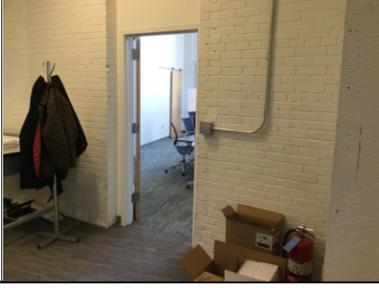
Not provided	-	Locate signage with raised characters and braille alongside the door on the latch side.	1	174	\$174

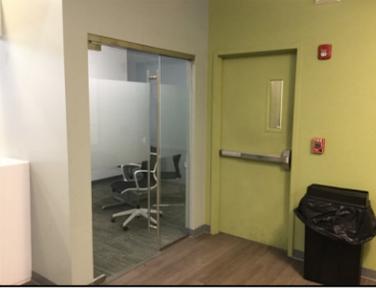
ID	Location	Floor	Room	Element	Type	Photo	Issues	Current Measure	Recommendations	Quantity	Price	Cost Estimation
15	Planning Lobby Conference Room	2		Signage	Designation

Not provided	-	Locate signage with raised characters and braille alongside the door on the latch side.	1	174	\$174
16	Health Conference Room	3		Signage	Designation

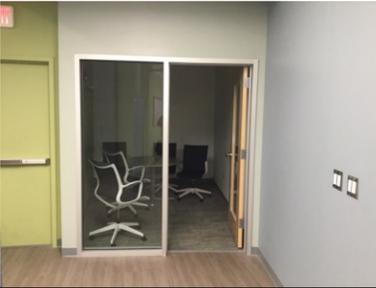
Not provided	-	Locate signage with raised characters and braille alongside the door on the latch side.	1	174	\$174
17	Conference Room	3		Signage	Designation

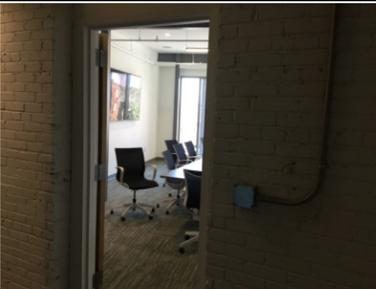
Not provided	-	Locate signage with raised characters and braille alongside the door on the latch side.	1	174	\$174
18	Large Meeting Room	1	106	Signage	Designation

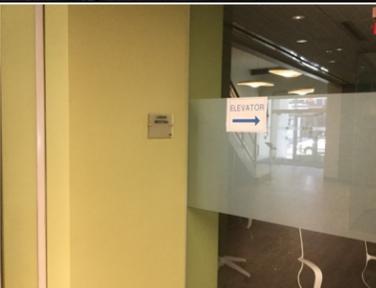
Raised characters not provided Braille not provided	- -	Mount signs so that the baseline of the lowest tactile character is 48" min. above finish floor and the baseline of the highest tactile character is 60" max. above finish floor. Provide braille for room number.	1	174	\$174

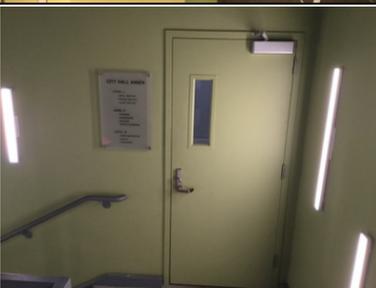
19	Floor 2 Stairwell	2		Signage	Designation

Raised characters not provided Braille not provided	- -	Provide text with raised characters duplicated in braille indicating floor number in stairwell. (Sign in photo is a directory.)	3	174	\$522

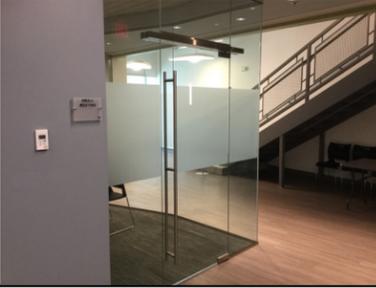
ID	Location	Floor	Room	Element	Type	Photo	Issues	Current Measure	Recommendations	Quantity	Price	Cost Estimation
20	Small Meeting Room	1	102	Signage	Designation

Raised characters < 48" or > 60" above ground Braille not provided	63.5" -	Mount signs so that the baseline of the lowest tactile character is 48" min. above finish floor and the baseline of the highest tactile character is 60" max. above finish floor. Provide braille for room number.	1	174	\$174
21	Medium Meeting Room	1	107	Signage	Designation

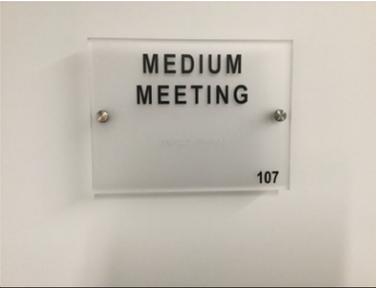
Braille not provided	-	Provide braille for room number.	1	174	\$174
22	Wellness Room	3		Signage	Designation

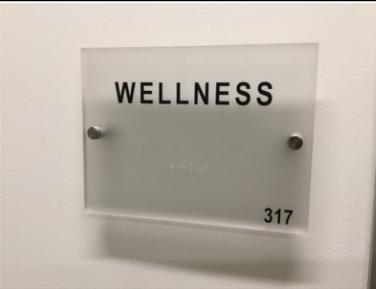
Braille not provided	-	Provide braille for room number.	1	174	\$174
<b>Service Counter</b>												
23	Health Reception	3		Service Counter	N/A

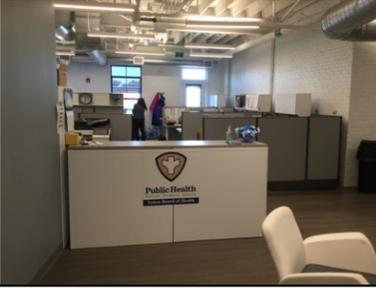
Counter > 36" high	42"	Provide a counter that is 36" max. above the ground or finish floor.	1	660	\$660
24	Planning	2		Service Counter	N/A

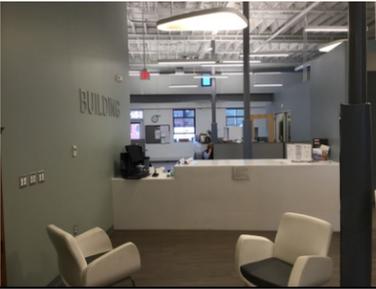
Service counter not clear and usable.		Keep accessible counter clear of stored objects.	1	Labor	\$0

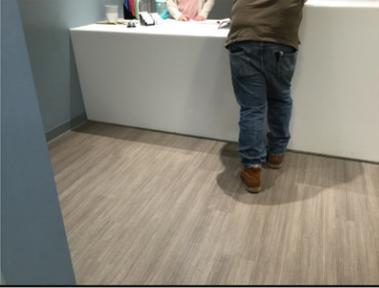
ID	Location	Floor	Room	Element	Type	Photo	Issues	Current Measure	Recommendations	Quantity	Price	Cost Estimation
25	Engineering	2		Service Counter	N/A

Service counter not clear and usable.		Keep accessible counter clear of stored objects.	1	Labor	\$0
<b>Assembly Area</b>												
26	Large Meeting Room	1	106	Assembly Area	N/A

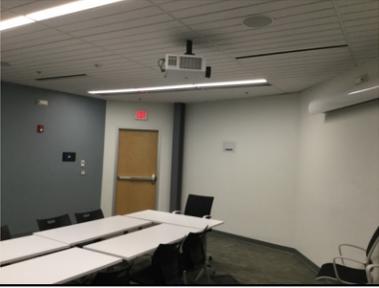
Assistive listening devices not provided	-	If audible communication is integral to the use of the space, provide an assistive listening system.	1	0	\$0
27	Medium Meeting Room	1	107	Assembly Area	N/A

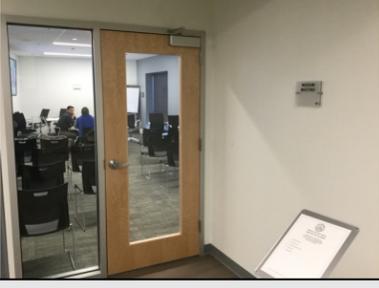
Assistive listening devices not provided	-	If audible communication is integral to the use of the space, provide an assistive listening system.	1	0	\$0
<b>Toilet &amp; Bathing Rooms</b>												
<b>Overall Access</b>												
28	Men's and Women's	3		Overall Access	Toilet Room

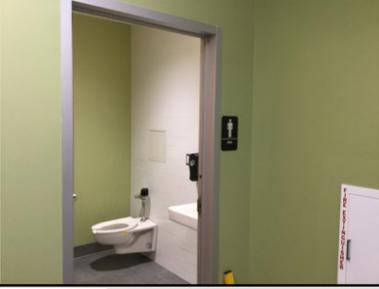
Sign to accessible toilet not provided	-	Provide a directional sign indicating the location of the nearest accessible toilet room.	2	174	\$348

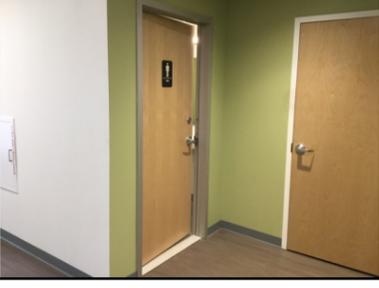
29	Men's	1		Overall Access	Toilet Room

International Symbol of Acc. not provided	-	Provide a sign with the International Symbol of Accessibility.	1	174	\$174

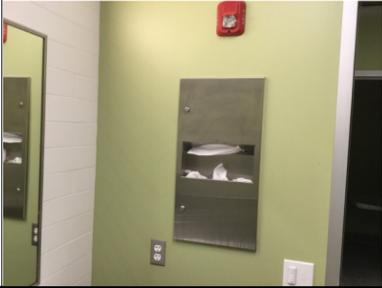
Controls > 42" high	60.5"	Relocate so the operable part is 42" max. above the finish floor. (Lower paper towel access.)	1	530	\$530
32	Women's	1		Dispensers	Paper Towel Dispenser

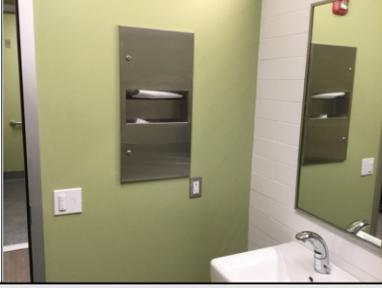
Controls > 42" high	61"	Relocate so the operable part is 42" max. above the finish floor. (Lower paper towel access.)	1	530	\$530
<b>Additional Access</b>												
<b>Drinking Fountains</b>												
33	Hallway	1		Drinking Fountains	Low

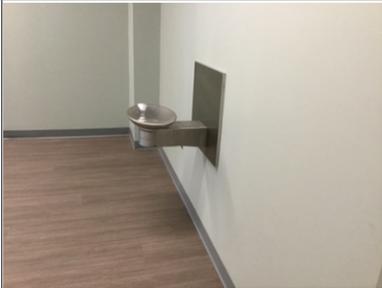
No drinking fountain provided for standing users	-	Provide an additional drinking fountain for standing users or install a hi-lo drinking fountain.  (Cost for a new wall-mounted fountain for a standing user.)	1	3021	\$3021

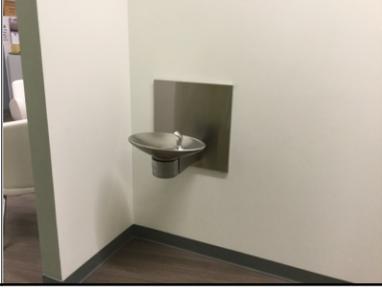
34	Near Wellness	3		Drinking Fountains	Low

No drinking fountain provided for standing users	-	Provide an additional drinking fountain for standing users or install a hi-lo drinking fountain.  (Cost for a new wall-mounted fountain for a standing user.)	1	3021	\$3021

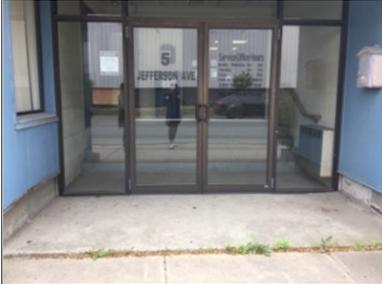
ID	Location	Floor	Room	Element	Type	Photo	Issues	Current Measure	Recommendations	Quantity	Price	Cost Estimation
<b>Approach and Entrance</b>												
<b>Exterior Access Route</b>												
1	5 Jefferson Street Entrance	Ext.		Exterior Access Route	Exterior

Level changes > 1/4"	-	Alter change in level to be 1/4" high max.  (Cost based on a 3'x 9' concrete patch.)	1	464	\$464
<b>Curb Ramp</b>												
2	Crosswalk Near DPW at U-Haul	Ext.		Curb Ramp	N/A

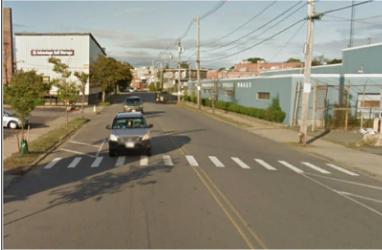
Curb ramp not provided	-	Provide a curb ramp at both sides of crosswalk.  Note: Google Earth image.  (Cost based on curb ramps in a concrete sidewalk.)	2	2800	\$5600
<b>Off-Street Parking Lot or Garage</b>												
3	Employee Parking	Ext.		Off-Street Parking Lot or Garage	Employee

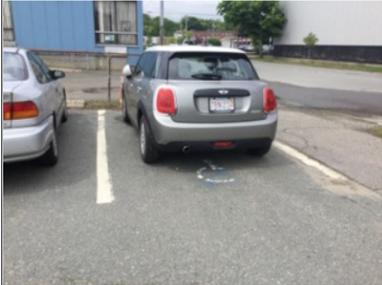
Total # of parking Total # of designated accessible parking spaces Total # of designated van accessible spaces Access aisle not provided Sign not provided Sign does not have the designation "Van Accessible"	24 - - - -	Provide a van accessible parking space 132" wide min. with a marked access aisle 60" wide min. Provide a sign with the International Symbol of Accessibility (ISA) 60" min. above the ground and the top 96" max. above the ground. Add the designation "Van Accessible" to the sign located at the van accessible space. (Cost based on re-striping and a sign.)	1	600	\$600

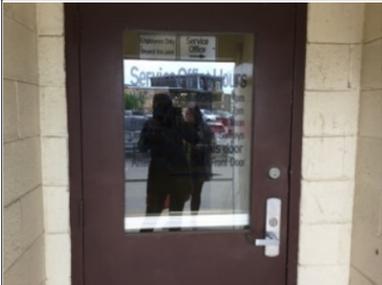
<b>Entrance</b>												
4	Northeast Entrance at Ramp	Ext.		Entrance	N/A

Entrance not on an accessible route when locked.	-	In order to provide program access at this entrance, which is the only accessible entrance and is locked after 3:-00 PM, either install an intercom system at this entrance, or keep this entrance open at all times that the office is open to the public.	1	Labor	\$0

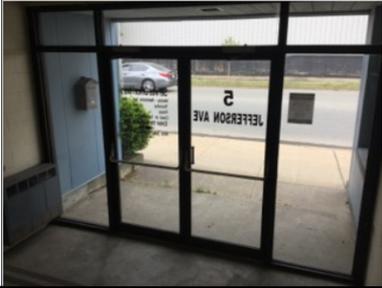
Emergency exit not on an accessible route Directional sign to accessible emergency exit not provided Tactile exit sign not provided	- -	Provide a directional sign indicating the location of the nearest accessible emergency exit. Ensure tactile exit signs with raised characters and braille are provided at exit doors. Mount signs between 48"- 60" above finished floor located on the latch side of the door.  (Cost based on two (2) signs.)	2	174	\$348
<b>Access to Goods and Services</b>

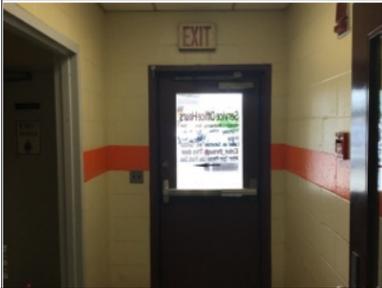
<b>Means of Egress</b>												
7	Northeast Accessible Exit to Ramp	1		Means of Egress	N/A

Illuminated exit sign not provided Tactile exit sign not provided	- -	Ensure illuminated International Symbol of Accessibility (ISA) sign is provided at accessible exit doors. Ensure tactile exit signs with raised characters and braille are provided at exit doors. Mount signs between 48"- 60" above finished floor located on the latch side of the door. (Cost based on illuminated ISA sign and tactile exit sign.)	1	324	\$324
<b>Interior Access Route</b>												
8	Employee Timecard Area	1		Interior Access Route	N/A

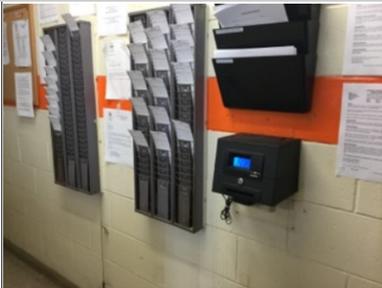
Obstructed by protruding objects	41"	Provide a cane-detectable barrier.	1	230	\$230

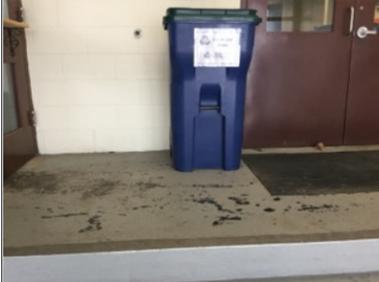
ID	Location	Floor	Room	Element	Type	Photo	Issues	Current Measure	Recommendations	Quantity	Price	Cost Estimation
9	Light Bulb Drop-Off	1		Interior Access Route	N/A

Accessible route not provided	-	Light bulb recycling bin not on an accessible route. Relocate bin to an accessible location or provide assistance with bulb disposal as needed.	1	Labor	\$0
<b>Doors, Doorways, &amp; Gates</b>												
10	Service Office	1		Doors, Doorways, & Gates	Office

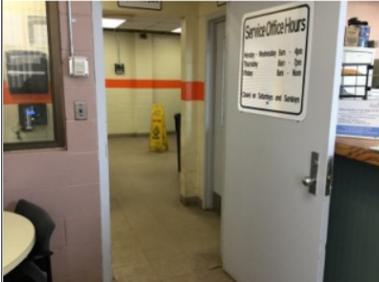
Hardware not operable with a closed fist	-	Provide hardware that can be operable with one hand and not require tight grasping, pinching, or twisting of the wrist.	1	363	\$363
<b>Ramps</b>												
11	Northeast Accessible Entrance and Egress Ramp	Ext.		Ramps	Exterior

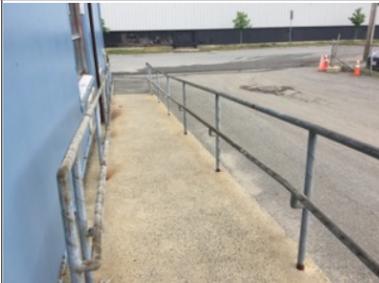
Ramp < 48" wide	40"	If ramp is renovated, widen ramp so that the clear width is 48" min. Ramp is usable but not compliant.	1	-	\$0
<b>Stairways</b>												
12	Interior at 5 Jefferson Street Entrance	1		Stairways	Interior

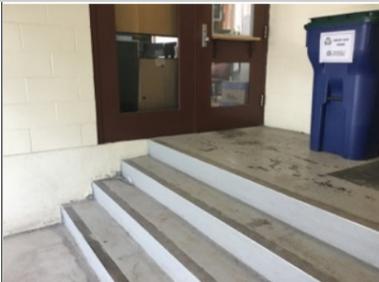
Handrail not provided on both sides	-	Provide handrail on one side.  (Cost based on one (1) 6' long wall-mounted wooden handrail at \$33 a foot.)	1	198	\$198
