**City of Salem,  
Massachusetts**

December 2019

# Salem City Hall

## City of Salem ADA Transition Plan

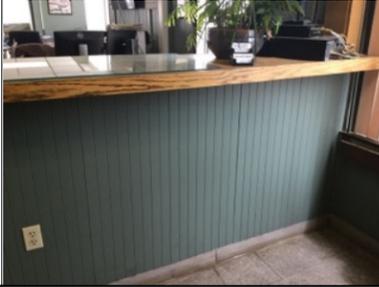
Counter > 36" high	45.5	Provide a counter that is 36" max. above the ground or finished floor.	1	660	\$660
<b>Dining or Work Surfaces</b>												
14	Service Office	1		Dining or Work Surfaces	Work Surface

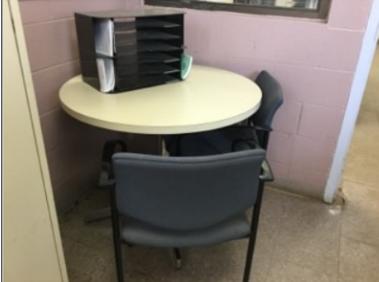
Knee or toe clearance not provided	-	Provide at least one (1) work surface with toe clearance. (Existing table does have sufficient knee clearance in excess of 27".)	1	525	\$525

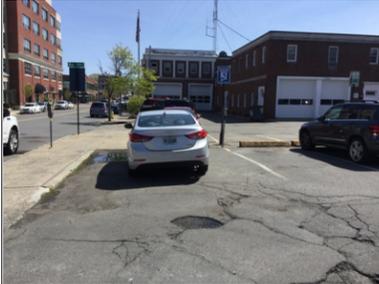
Total # of parking Total # of designated accessible parking spaces Total # of designated van accessible spaces Access aisle not provided Access aisle < 96" wide at van space Sign does not have the designation "Van Accessible"	26 2 - - - -	Provide a van accessible parking space 132" wide min. and a marked access aisle 60" wide min. Add the designation "Van Accessible" to the sign located at the van accessible space.  (Cost based on a sign and re-striping.)	1	600	\$600
2	Employee Parking - Google Maps Image	1	101	Off-Street Parking Lot or Garage	Employee

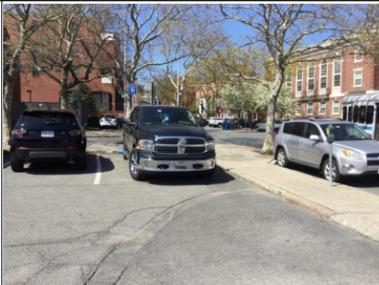
3	Klop Alley Parking Lot	1	101	Off-Street Parking Lot or Garage	Visitor

Access aisle not provided	-	Provide a marked access aisle that is at least 60" wide at the car accessible parking space.  (Cost based on re-striping.)	1	225	\$225
<b>Entrance</b>												
4	Main Entrance at Parking	1	101	Entrance	Main Entrance

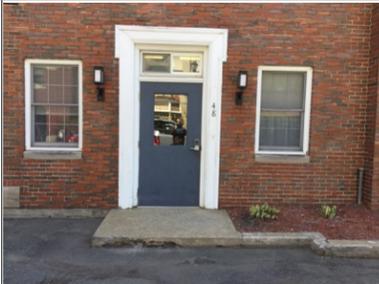
Entrance not on an accessible route ISA sign not provided.	6"	Provide a 48" wide min. x 6' long min. concrete walkway to door landing at main entrance. Ensure walkway has a running slope that does not exceed 1:20 (5.00%) and a cross slope that does not exceed 1:50 (2.00%). Provide sign with the International Symbol of Accessibility (ISA).	1	536	\$536
5	Lafayette and Newbury	Ext.		Entrance	Secondary Entrance

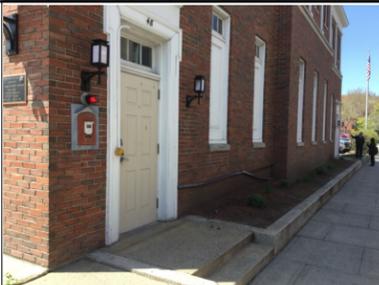
Entrance not on an accessible route Directional sign to accessible entrance not provided	- -	Provide a directional sign indicating the location of the nearest accessible entrance.	1	260	\$260

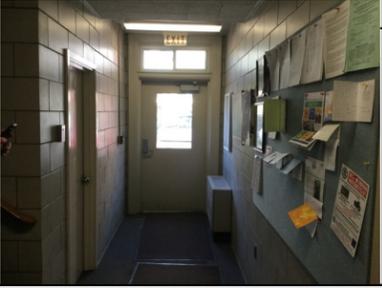
Maneuvering clearance(s) not provided Tactile exit sign not provided Illuminated ISA not provided.	-	Provide an automatic door opener. Ensure tactile exit signs with raised characters and braille are provided at exit doors. Mount signs between 48"- 60" above finished floor located on the latch side of the door. Add an illuminated International Symbol of Accessibility (ISA) to the illuminated exit sign.	1	2619	\$2619

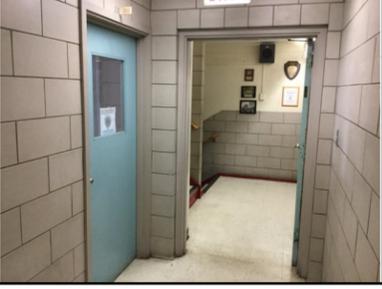
Hardware not operable with a closed fist Not provided Raised characters not provided	-	Provide hardware that can be operable with one hand and not require tight grasping, pinching, or twisting of the wrist. Locate signage alongside the door on the latch side. Provide text with raised characters duplicated in braille.  (Cost based on accessible door hardware and sign.)	1	537	\$537

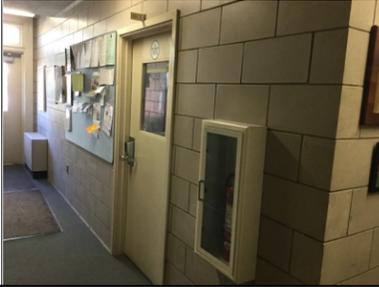
Not provided Raised characters not provided	- -	Locate signage alongside the door on the latch side. Provide text with raised characters duplicated in braille.	1	174	\$174
11	Conference Room	2		Signage

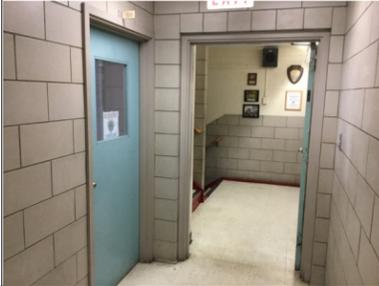
Not provided Raised characters not provided	- - -	Locate signage alongside the door on the latch side. Provide text with raised characters duplicated in braille.	1	174	\$174
<b>Service Counter</b>												
12	Admin and Chief's Office	1	101	Service Counter	N/A

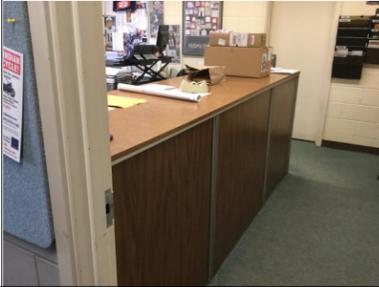
Counter > 36" high	-	Provide a counter that is 36" max. above the ground or finished floor.	1	660	\$660
<b>Toilet &amp; Bathing Rooms</b>												
<b>Overall Access</b>												
13	Men's Toilet Room	1		Overall Access	Toilet Room

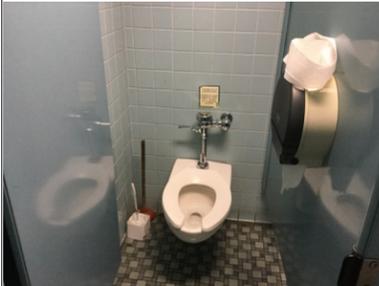
Accessible plumbing fixtures or stalls not provided	-	Provide one accessible wheelchair stall.	1	4637	\$4637

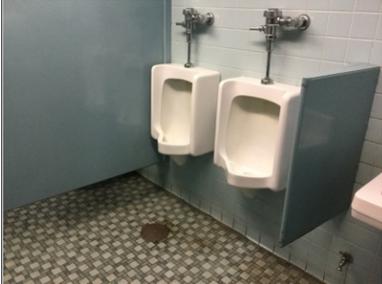
Rim > 15" high (MAAB)	24"	Provide at least one urinal with the rim no higher than 15" above the finished floor.	1	2436	\$2436
<b>Dispensers</b>												
16	Admin and Chief's Office	1		Dispensers	Paper Towel Dispenser

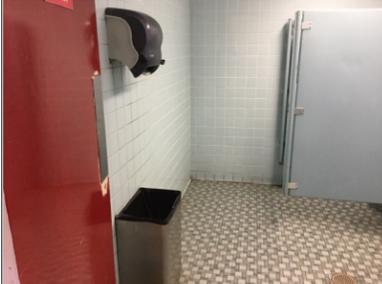
Controls > 42" high	-	Relocate so the operable part is 42" max. above the finished floor.	1	530	\$530
<b>Additional Access</b>												
<b>Drinking Fountains</b>

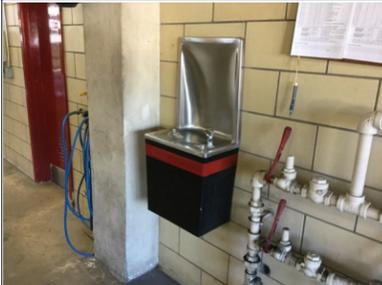
17	First Floor	1		Drinking Fountains	High

No drinking fountain provided for seated users	-	Provide an additional drinking fountain for seated users.  (Cost based on a new low wall mounted drinking fountain.)	1	3021	\$3021

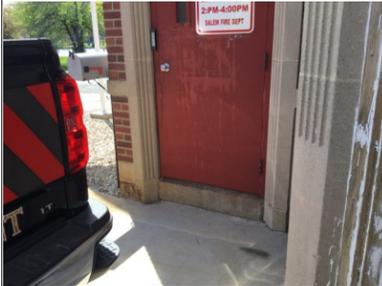
Accessible entrance not provided	-		1		\$0
<b>Access to Goods and Services</b>												
<b>Stairways</b>												
2	From 1st Floor to 2nd Floor	2		Stairways	Interior

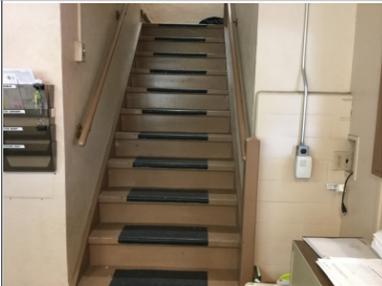
Accessible route not provided	-		1		\$0
<b>Toilet &amp; Bathing Rooms</b>												
<b>Overall Access</b>												
3	Toilet Room	1		Overall Access	Toilet Room

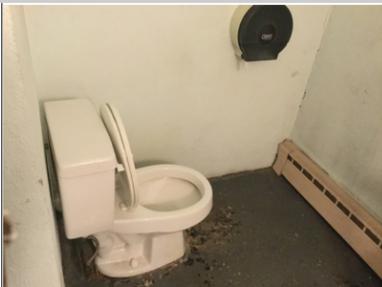
Accessible plumbing fixtures or stalls not provided	-		1	0	\$0
4	Toilet Room	2		Overall Access	Toilet Room

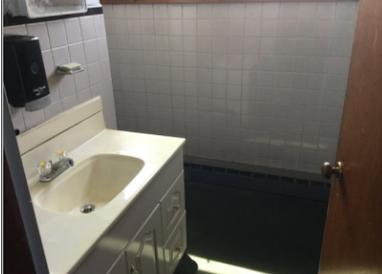
Accessible plumbing fixtures or stalls not provided	-		1	0	\$0

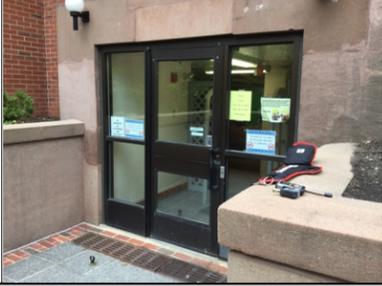
International Symbol of Accessibility not provided	-	Provide the International Symbol of Accessibility.	1	260	\$260
<b>Emergency Exit</b>												
2	Emergency Exit	G		Emergency Exit	N/A

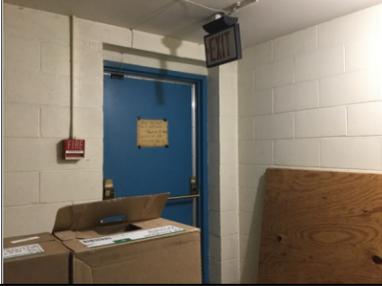
Directional sign to accessible emergency exit not provided	-	Provide a directional sign indicating the location of the nearest accessible emergency exit.	1	174	\$174
<b>Access to Goods and Services</b>												
<b>Means of Egress</b>												
3	Emergency Exit to Children's Area	G		Means of Egress	N/A

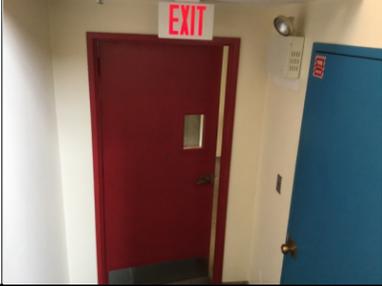
Tactile exit sign not provided	-	Ensure tactile exit signs with raised characters and braille are provided at exit doors. Mount signs between 48"- 60" above finish floor located on the latch side of the door.	1	174	\$174

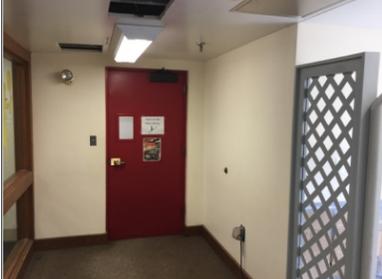
4	Emergency Exit	G		Means of Egress	N/A

Tactile exit sign not provided	-	Ensure tactile exit signs with raised characters and braille are provided at exit doors. Mount signs between 48"- 60" above finish floor located on the latch side of the door.	1	174	\$174

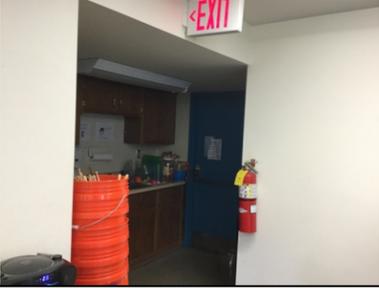
ID	Location	Floor	Room	Element	Type	Photo	Issues	Current Measure	Recommendations	Quantity	Price	Cost Estimation
5	Children Exit Near Sink	G		Means of Egress	N/A

Tactile exit sign not provided	-	Ensure tactile exit signs with raised characters and braille are provided at exit doors. Mount signs between 48"- 60" above finish floor located on the latch side of the door.	1	174	\$174
6	Children Emergency Exit	G		Means of Egress	N/A

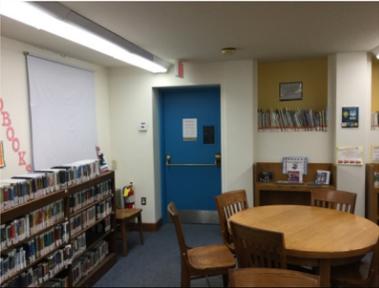
Tactile exit sign not provided	-	Ensure tactile exit signs with raised characters and braille are provided at exit doors. Mount signs between 48"- 60" above finish floor located on the latch side of the door.	1	174	\$174
7	First Floor Stacks Exit to Stairs	1		Means of Egress	N/A

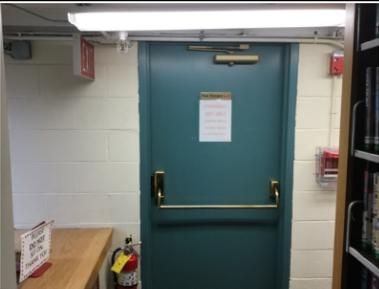
Tactile exit sign not provided	-	Ensure tactile exit signs with raised characters and braille are provided at exit doors. Mount signs between 48"- 60" above finish floor located on the latch side of the door.	1	174	\$174

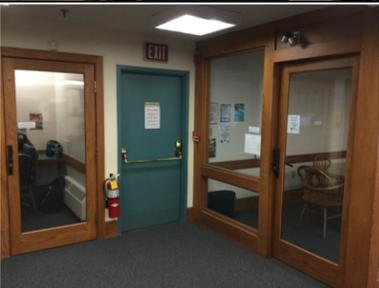
8	Exit Near Study Room	2		Means of Egress	N/A

Tactile exit sign not provided	-	Ensure tactile exit signs with raised characters and braille are provided at exit doors. Mount signs between 48"- 60" above finish floor located on the latch side of the door.	1	174	\$174
9	Exit Behind Reference	2		Means of Egress	N/A

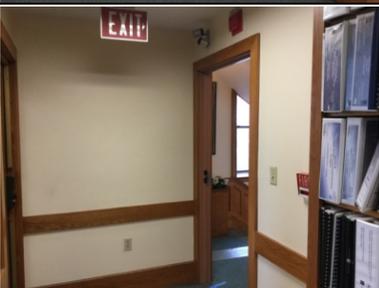
Tactile exit sign not provided	-	Ensure tactile exit signs with raised characters and braille are provided at exit doors. Mount signs between 48"- 60" above finish floor located on the latch side of the door.	1	174	\$174

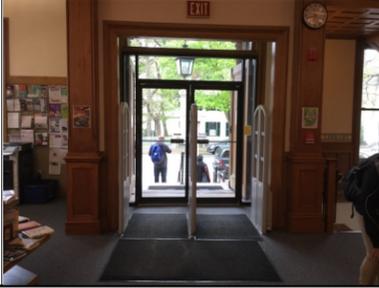
ID	Location	Floor	Room	Element	Type	Photo	Issues	Current Measure	Recommendations	Quantity	Price	Cost Estimation
10	Main Entrance	1		Means of Egress	N/A

Tactile exit sign not provided	-	Ensure tactile exit signs with raised characters and braille are provided at exit doors. Mount signs between 48"- 60" above finish floor located on the latch side of the door.	1	174	\$174
<b>Interior Access Route</b>												
11	Children	G		Interior Access Route	N/A

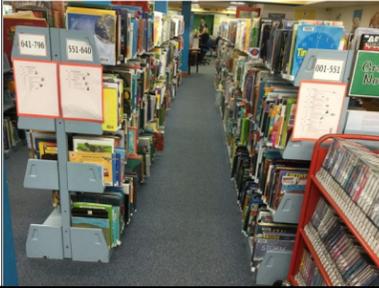
Route < 36" wide	33"	Ensure that a clear width of 36" min. is maintained at the accessible route.	1	Labor	\$0
12	Children Near Sink	G		Interior Access Route	N/A

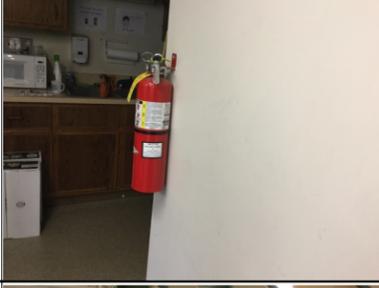
Obstructed by protruding objects	33.5"	Relocate fire extinguisher out of circulation path, lower extinguisher to 27" max. above the finished floor or provide a cane detectable barrier.	1	230	\$230
13	Emergency Exit	G		Interior Access Route	N/A

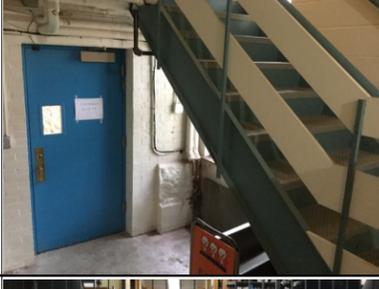
Obstructed by protruding objects	-	Provide a cane detectable barrier under stairs.  (Cost for a 6'x4' pipe rail under stairs.)	1	720	\$720

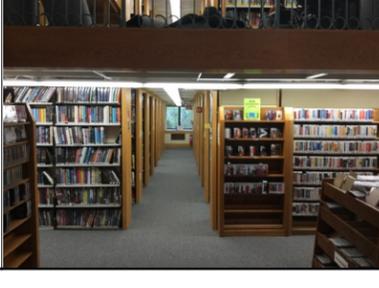
14	Floor 1	1		Interior Access Route	N/A

Obstructed by protruding objects	77"	Provide color contrast and / or padding.	1	Labor	\$0

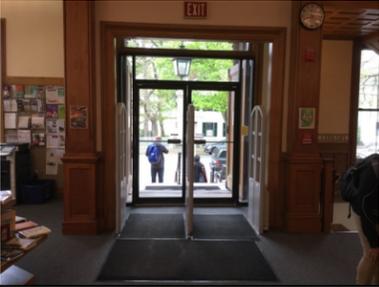
ID	Location	Floor	Room	Element	Type	Photo	Issues	Current Measure	Recommendations	Quantity	Price	Cost Estimation
<b>Doors, Doorways, &amp; Gates</b>												
15	Main Entrance	1		Doors, Doorways, & Gates	N/A

Mat not securely attached	-	Securely attach walk-off mat.	1	Labor	\$0
16	Ground Floor Exit to Ramp	G		Doors, Doorways, & Gates	Emergency Egress

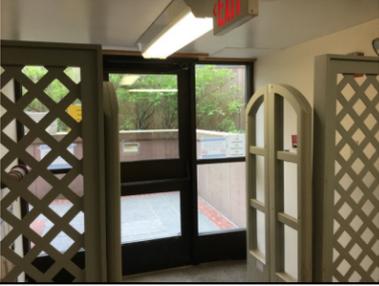
Mat not securely attached Illuminated International Symbol of Accessibility (ISA) not provided	-	Securely attach walk-off mat. Provide an illuminated International Symbol of Accessibility (ISA) sign.	1	150	\$150
17	Exit Towards Ramp	G		Doors, Doorways, & Gates	Emergency Egress

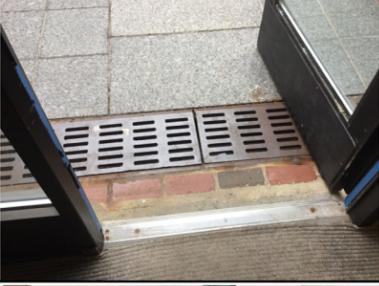
Threshold > 1/2" high	1"	Alter threshold to be 1/2" high max.	1	113	\$113
18	Single-User Toilet Room	1	E	Doors, Doorways, & Gates	Toilet Room

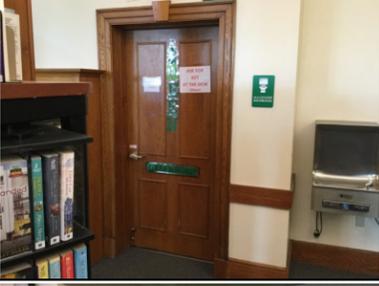
Door requires > 5 lbs. of force to open	18 lbs.	Adjust closers so doors do not require more than 5 pounds of force to open.	1	Labor	\$0

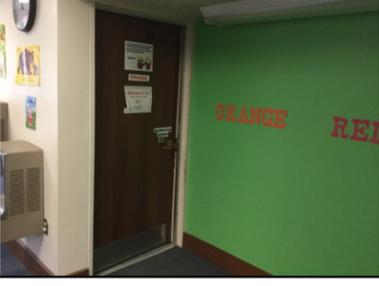
19	Orange Single-User Toilet Room	G		Doors, Doorways, & Gates	Toilet Room

Door requires > 5 lbs. of force to open	20 lbs.	Adjust closers so doors do not require more than 5 pounds of force to open.	1	Labor	\$0

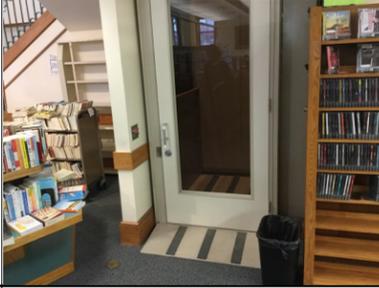
ID	Location	Floor	Room	Element	Type	Photo	Issues	Current Measure	Recommendations	Quantity	Price	Cost Estimation
20	Lift to Mezzanine	1		Doors, Doorways, & Gates	N/A

Door requires > 5 lbs. of force to open	17 lbs.	Adjust closers so doors do not require more than 5 pounds of force to open.	1	Labor	\$0
21	Single-User Toilet Room by Elevator	1		Doors, Doorways, & Gates	Toilet Room

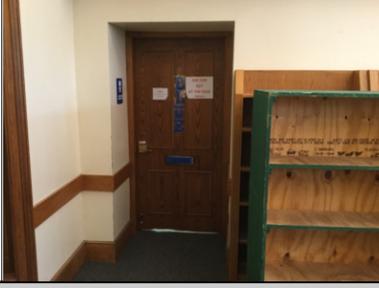
Door requires > 5 lbs. of force to open	15 lbs.	Adjust closers so doors do not require more than 5 pounds of force to open.	1	Labor	\$0
<b>Ramps</b>												
22	Ramp	2		Ramps	Interior

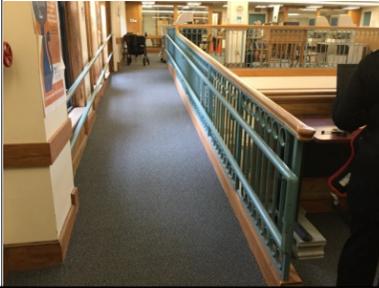
No lower handrail 18"-20" high provided Handrails not continuous where required	-	Provide continuous handrails for the length of ramp runs. (Provide continuous lower and upper handrails on one side.)  (Cost based on two 5' sections of metal handrail at \$56 a foot.)	1	560	\$560
23	Exterior Ramp	G		Ramps	Exterior

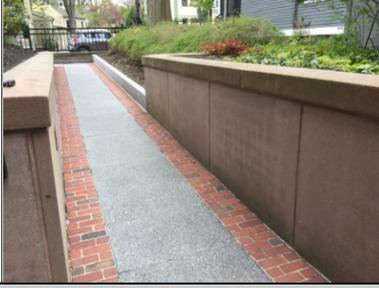
Handrails not provided	-	Provide upper handrails between 34"- 38" high above the ground and lower handrails between 18" to 20" above the ground on both sides of ramp, all with 1 1/4"- 2" circular cross sections or a 4"- 6 1/4" non-circular cross sections.  (Cost based on 4 30' sections of metal railing.)	1	6660	\$6660

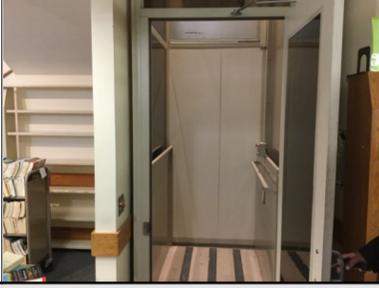
<b>Platform Lift or LULA Elevator</b>												
24	Lift to Mezzanine	G		Platform Lift or LULA Elevator	Interior

36" x 48" clear floor space not provided (if end door)	34"	Providing a 36" by 48" clear floor space might be technically infeasible. (34"x46" provided). Not compliant, but usable.	1	-	\$0
<b>Toilet &amp; Bathing Rooms</b>

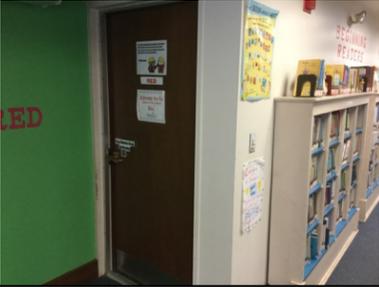
ID	Location	Floor	Room	Element	Type	Photo	Issues	Current Measure	Recommendations	Quantity	Price	Cost Estimation
<b>Overall Access</b>												
25	Red Single-User Toilet Room	G		Overall Access	Toilet Room

International Symbol of Acc. not provided	-	Provide a sign with raised characters and braille and the International Symbol of Accessibility mounted on the latch side of the door.	1	174	\$174
26	Orange Single-User Toilet Room	G		Overall Access	Toilet Room

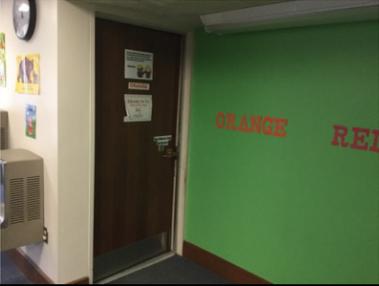
International Symbol of Acc. not provided	-	Provide a sign with raised characters and braille and the International Symbol of Accessibility mounted on the latch side of the door.	1	174	\$174
<b>Lavatory</b>												
27	Orange Single-User Toilet Room	G		Lavatory	N/A

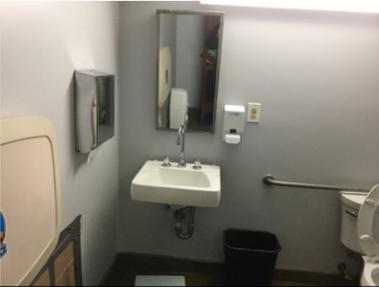
Plumbing underneath is exposed	-	Insulate or otherwise configure pipes to prevent contact, for at least one lavatory.	1	69	\$69
28	Red Single-User Toilet Room	G		Lavatory	N/A

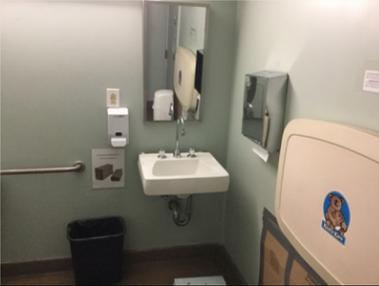
Plumbing underneath is exposed	-	Insulate or otherwise configure pipes to prevent contact, for at least one lavatory.	1	69	\$69

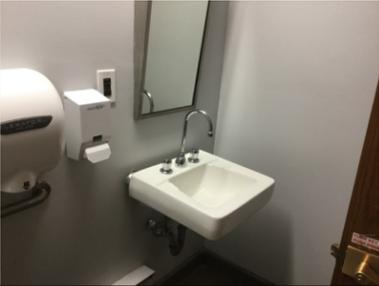
29	Single-User Toilet Room by Elevator	1		Lavatory	N/A

Plumbing underneath is exposed	-	Insulate or otherwise configure pipes to prevent contact, for at least one lavatory.	1	69	\$69

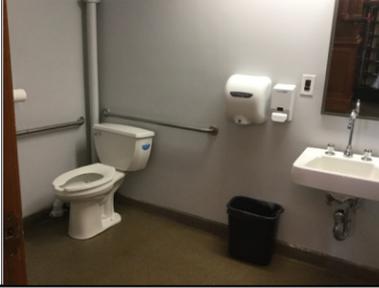
ID	Location	Floor	Room	Element	Type	Photo	Issues	Current Measure	Recommendations	Quantity	Price	Cost Estimation
30	Single-User Toilet Room	1	E	Lavatory	N/A

Plumbing underneath is exposed Mirror above lavatory w/reflective surface > 40"	- 42"	Insulate or otherwise configure pipes to prevent contact, for at least one lavatory. Lower mirror so that the bottom surface is at 40" max. above finished floor.	1	261	\$261
<b>Single-User Toilet</b>												
31	Single-User Toilet Room	1	E	Single-User Toilet	N/A

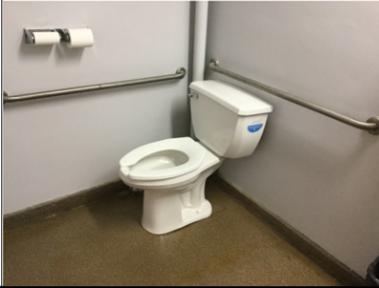
Flush control not on open side Side or rear grab bar < 33" or > 36" high Toilet paper dispenser is not compliant	- 30.5" -	Relocate the flush control to the open side. Mount grab bars 33"- 36" above the floor. Relocate toilet paper so that it is 15" min high, located under the grab bar, and between 7" and 9" from the front of the toilet. Replace dispenser if it does not allow continuous paper flow.	1	1003	\$1003

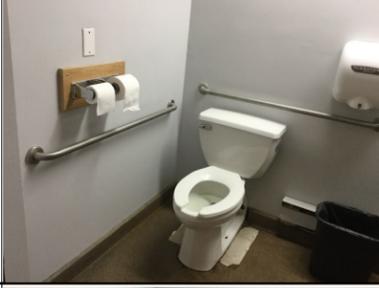
32	Single-User Toilet Room by Elevator	1		Single-User Toilet	N/A

Flush control not on open side Clearance at toilet < 60" clear width Toilet paper dispenser is not compliant	- - -	Relocate the flush control to the open side. Provide a clear floor space that is 60" wide min. (Relocate trash can and hand dryer.) Relocate toilet paper dispenser so that it is 15" min high, located under the grab bar, and between 7" and 9" from the front of the toilet.	1	1341	\$1341
33	Red Single-User Toilet Room	G		Single-User Toilet	N/A

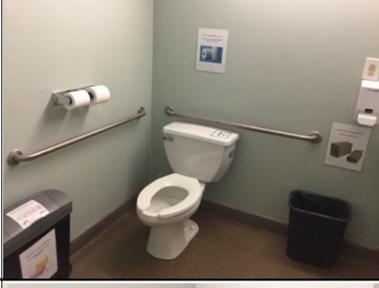
Flush control not on open side Toilet paper dispenser is not compliant	- -	Relocate the flush control to the open side. Relocate toilet paper so that it is 15" min high, located under the grab bar, and between 7" and 9" from the front of the toilet. Replace dispenser if it does not allow continuous paper flow.	1	811	\$811
34	Orange Single-User Toilet Room	G		Single-User Toilet	N/A

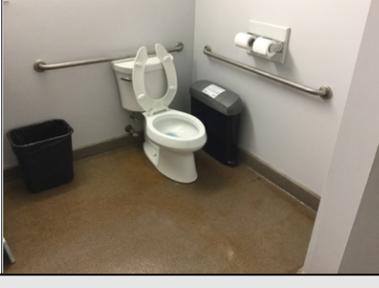
Toilet paper dispenser is not compliant	-	Relocate toilet paper so that it is 15" min high, located under the grab bar, and between 7" and 9" from the front of the toilet. Replace dispenser if it does not allow continuous paper flow.	1	530	\$530

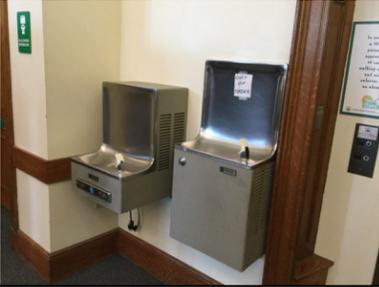
ID	Location	Floor	Room	Element	Type	Photo	Issues	Current Measure	Recommendations	Quantity	Price	Cost Estimation
<b>Drinking Fountains</b>												
35	Water Fountains Near Toilet Room	1		Drinking Fountains	N/A

Knee or toe clearance not provided	20"	Provide knee and toe clearance, 27" min. high at both drinking fountains.  (Cost based on a new Hi-Lo fountain.)	1	3162	\$3162
36	Near Orange Toilet Room	G		Drinking Fountains	N/A

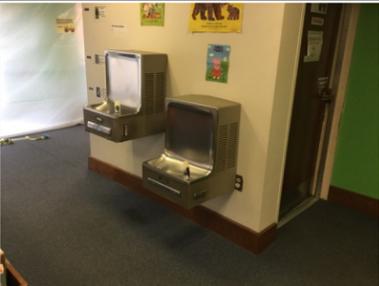
Knee or toe clearance not provided	16"	Provide knee and toe clearance, 27" min. high at both drinking fountains.  (Cost based on a new Hi-Lo fountain.)	1	3162	\$3162
37	By Second Floor Interior Ramp	2		Drinking Fountains	N/A

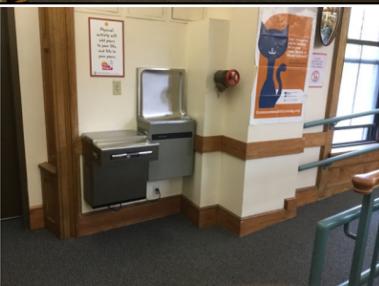
Knee or toe clearance not provided	9"	Provide knee and toe clearance, 27" min. high at both drinking fountains.  (Cost based on a new Hi-Lo fountain.)	1	3162	\$3162

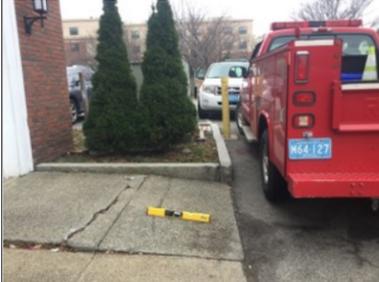
ID	Location	Floor	Room	Element	Type	Photo	Issues	Current Measure	Recommendations	Quantity	Price	Cost Estimation
<b>Approach and Entrance</b>												
<b>Exterior Access Route</b>												
1	Approach to Main Entrance	Ext		Exterior Access Route	Exterior

Cross slope > 1:50 (2.00%) Running slope > 1:20 (5%)	5.2% 13.7%	Reduce cross slope to be no steeper than 1:50 (2.00%). Reduce running slope to be no steeper than 1:20 (5%).  (Cost for adding concrete to correct running and cross slope.)	1	135	\$135
2	Approach to Main Entrance	Ext		Exterior Access Route	Exterior

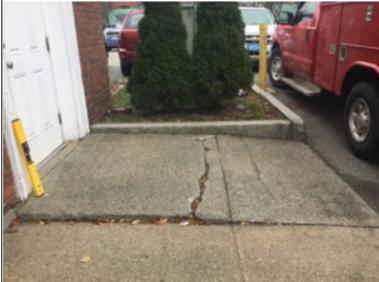
Level changes > 1/4"	2"	Alter change in level to be 1/4" high max. (Bevel edge when repairing door landing.)  (Cost included in ID #5.)	1	-	\$0
<b>Off-Street Parking Lot or Garage</b>												
3	Electrical Department Parking	Ext		Off-Street Parking Lot or Garage	N/A

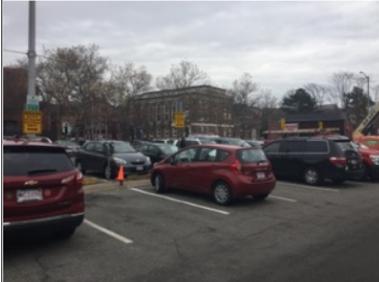
Total # of parking Total # of designated accessible parking spaces Total # of designated van accessible spaces Access aisle < 96" wide at van space Sign not provided Sign does not have the designation "Van Accessible"	8 - - - -	Provide a marked access aisle that is at least 96" wide. Provide a sign with the International Symbol of Accessibility with the bottom of the sign 60" min. above the ground and the top 96" max. above the ground. Add the designation "Van Accessible" to the sign located at the van accessible space.	1	600	\$600

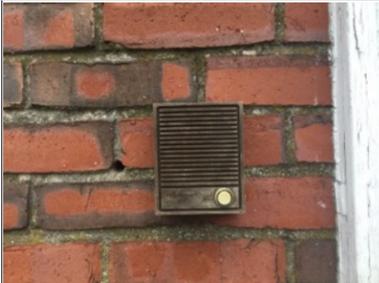
<b>Access to Goods and Services</b>												
<b>Means of Egress</b>												
4	Main Entrance Intercom	Ext		Means of Egress	N/A

Two-way emergency communication not provided	-	Ensure a two-way communication system is in operable working condition. (At time of survey, the intercom was broken.)	1	Labor	\$0

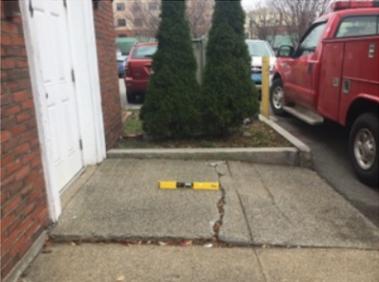
ID	Location	Floor	Room	Element	Type	Photo	Issues	Current Measure	Recommendations	Quantity	Price	Cost Estimation
<b>Doors, Doorways, &amp; Gates</b>												
5	Main Entrance Door Landing	Ext		Doors, Doorways, & Gates	Other

Maneuvering clearance at door > 1:50 (2.00%)	6.8%	Alter so that the slope of the door landing in all directions is no greater than 1:50 (2.00%).  (Cost for adding concrete to correct running and cross slope.)	1	135	\$135
6	Electrical Department Office	2		Doors, Doorways, & Gates	Circulation

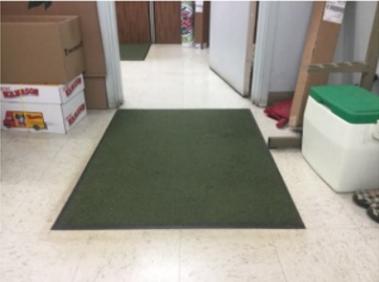
Mat not securely attached	-	Securely attach mat.	1	Labor	\$0
7	Main Entrance Door Threshold	Ext		Doors, Doorways, & Gates	Other

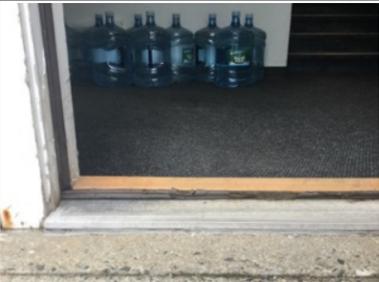
Threshold > 1/2" high	2"	Alter threshold to be 1/2" high max.	1	75	\$75
8	Main Entrance Door	Ext		Doors, Doorways, & Gates	Other

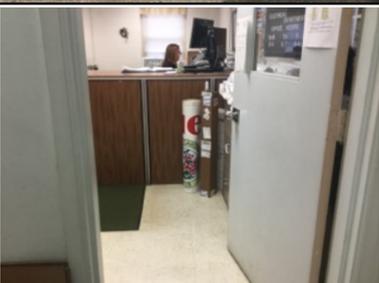
9	Electrical Department Office Door	2		Doors, Doorways, & Gates	Office

Hardware not operable with a closed fist	-	Provide hardware that can be operable with one hand and not require tight grasping, pinching, or twisting of the wrist.	1	363	\$363

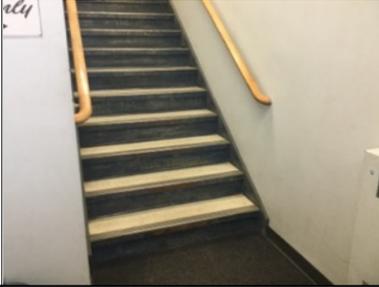
ID	Location	Floor	Room	Element	Type	Photo	Issues	Current Measure	Recommendations	Quantity	Price	Cost Estimation
<b>Stairways</b>												
10	First Staircase to Electrical Department Office	1		Stairways	Interior

Handrails do not extend 12" from stairs	-	Top: Ensure handrails extend horizontally above the landing for 12" min. beginning above the first riser nosing. Bottom: Ensure handrails extend to one tread depth beyond the last riser. Extended handrails can wrap around a wall.  (Cost based on 4 wooden railing extensions.)	4	249	\$996
11	Second Staircase to Electrical Department Office	2		Stairways	Interior

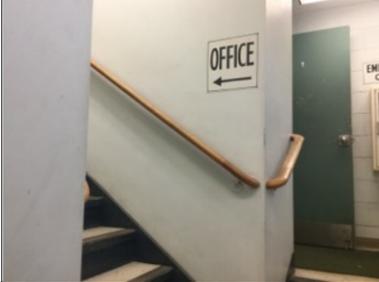
Handrails do not extend 12" from stairs	-	Top: Ensure handrails extend horizontally above the landing for 12" min. beginning above the first riser nosing. Bottom: Ensure handrails extend to one tread depth beyond the last riser.  (Cost based on 3 wooden railing extensions.)	3	249	\$747

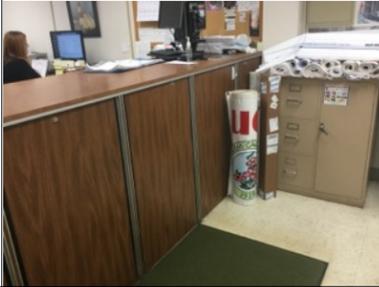
<b>Service Counter</b>												
12	Electrical Department Office	2		Service Counter	N/A

Counter > 36" high	43"	Provide a counter that is 36" max. above the ground or finished floor.	1	660	\$660
<b>Operable Parts</b>												
13	Main Entrance Intercom	Ext		Operable Parts	Other

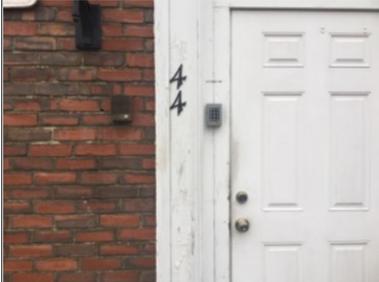
Reach < 15" or > 48"(forward/side approach)	62" -	Relocate intercom so that controls are between 15"- 48" above finished floor.	1	192	\$192

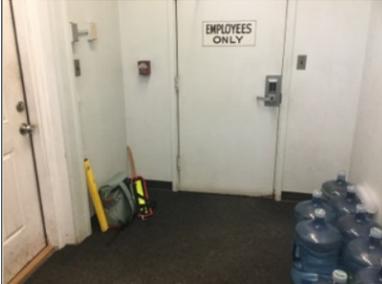
ID	Location	Floor	Room	Element	Type	Photo	Issues	Current Measure	Recommendations	Quantity	Price	Cost Estimation
Dining or Work Surfaces												
14	First Floor Lobby	1		Dining or Work Surfaces	Work Surface

At least one or 5% accessible tables not provided	-	In order to provide program access, place an accessible work surface with 27" min. knee clearance on the ground floor so visitors who can't access the second floor can review forms onsite.	1	525	\$525

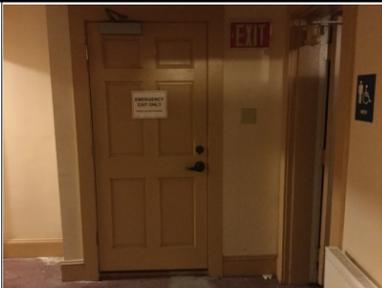
4	Emergency Exit - Near Men's Toilet Room	B		Means of Egress	N/A

Emergency exit not on an accessible route Directional sign to accessible emergency exit not provided	- -	Provide a directional sign indicating the location of the nearest emergency exit.	1	174	\$174

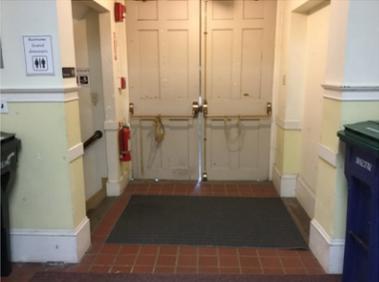
ID	Location	Floor	Room	Element	Type	Photo	Issues	Current Measure	Recommendations	Quantity	Price	Cost Estimation
<b>Interior Access Route</b>												
5	Front Entrance	1		Interior Access Route	N/A

Mat not securely attached	-	Install an ADA-compliant walk-off mat.	1	324	\$324
6	Towards Great Hall	2		Interior Access Route	N/A

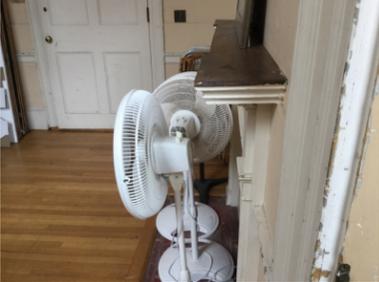
Obstructed by protruding objects	-	Provide a cane-detectable barrier under the fireplace mantel.	2	230	\$460
<b>Doors, Doorways, &amp; Gates</b>												
7	Towards Exhibit Area	1		Doors, Doorways, & Gates	Circulation

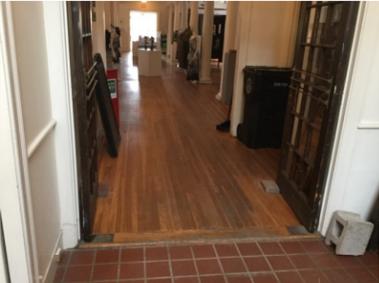
Threshold not beveled	-	Bevel threshold.	1	113	\$113
8	Single-User Toilet Room	2		Doors, Doorways, & Gates	Toilet Room

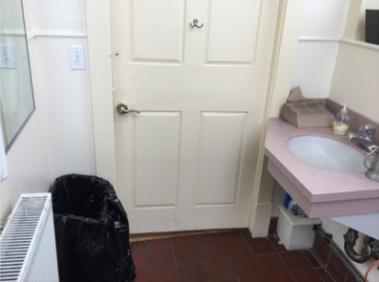
Maneuvering clearance(s) not provided	-	Remove the trash can to maintain the maneuvering clearance at the door.	1	Labor	\$0
9	Great Hall	2		Doors, Doorways, & Gates	Circulation

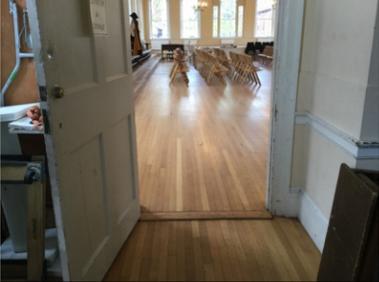
Threshold not beveled	-	Bevel threshold.	1	113	\$113

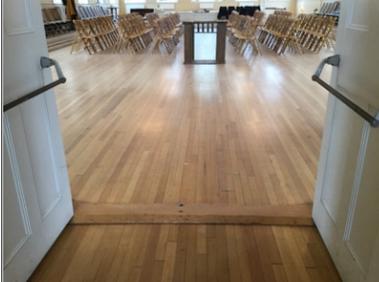
ID	Location	Floor	Room	Element	Type	Photo	Issues	Current Measure	Recommendations	Quantity	Price	Cost Estimation
10	Great Hall	2		Doors, Doorways, & Gates	Other

Threshold not beveled	-	Bevel threshold.	1	113	\$113
11	Towards Great Hall	2		Doors, Doorways, & Gates	Other

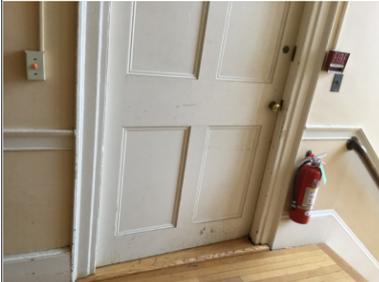
Threshold not beveled Hardware not operable with a closed fist	- -	Bevel threshold. Provide hardware that can be operable with one hand and not require tight grasping, pinching, or twisting of the wrist.	1	476	\$476
12	Towards Great Hall	2		Doors, Doorways, & Gates	Other

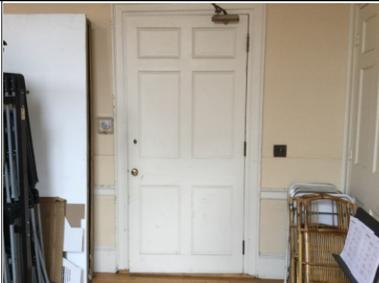
Hardware not operable with a closed fist	-	Provide hardware that can be operable with one hand and not require tight grasping, pinching, or twisting of the wrist.	1	363	\$363
<b>Elevator</b>												
13	Elevator - West Side	1		Elevator	Interior

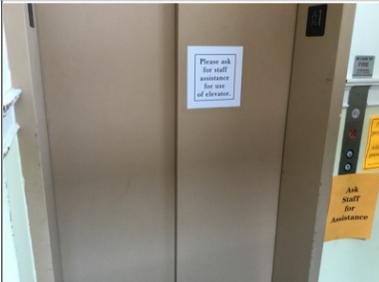
Ensure elevator provides unassisted entry and exit.	1	Labor	\$0
<b>Signage</b>												
14	Exit	1		Signage	Egress

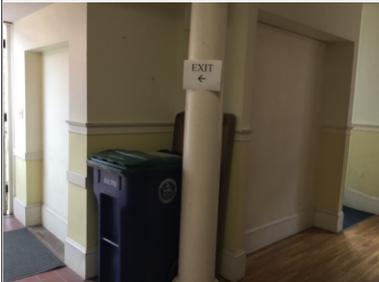
Raised characters not provided Braille not provided	- -	Provide a permanent sign with raised characters duplicated in braille. Locate sign near the emergency exit.	1	174	\$174

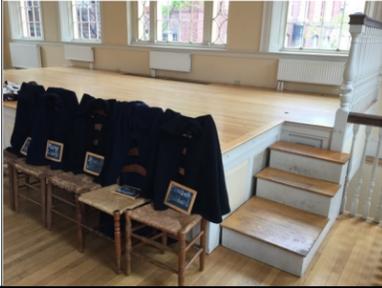
Accessible route to stage not provided	-	Provide an accessible route to the stage. Consider installing a ramp or a lift.  (Cost for an interior lift.)	1	16245	\$16245
<b>Toilet &amp; Bathing Rooms</b>												
<b>Lavatory</b>												
17	Single-User Toilet Room	2		Lavatory	N/A

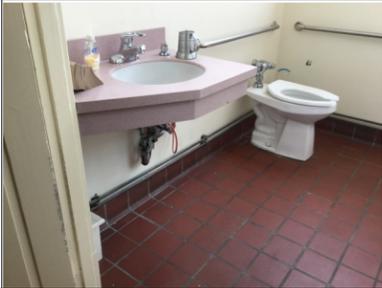
Plumbing underneath is exposed	-	Insulate or otherwise configure pipes to prevent contact, for at least one lavatory.	1	69	\$69
<b>Single-User Toilet</b>												
18	Single-User Toilet Room	2		Single-User Toilet	N/A

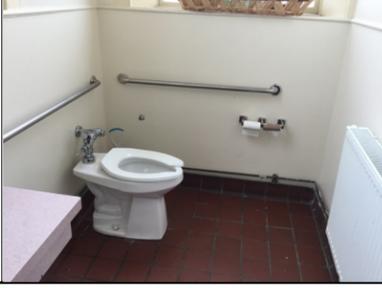
Centerline < or > 18" (MAAB)	22"	Relocate toilet so that the centerline is 18" from the side wall.	1	2121	\$2121

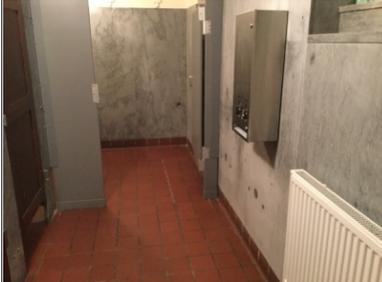
Dispenser acts as a protruding object	7"	Relocate dispenser out of the circulation path.	1	530	\$530

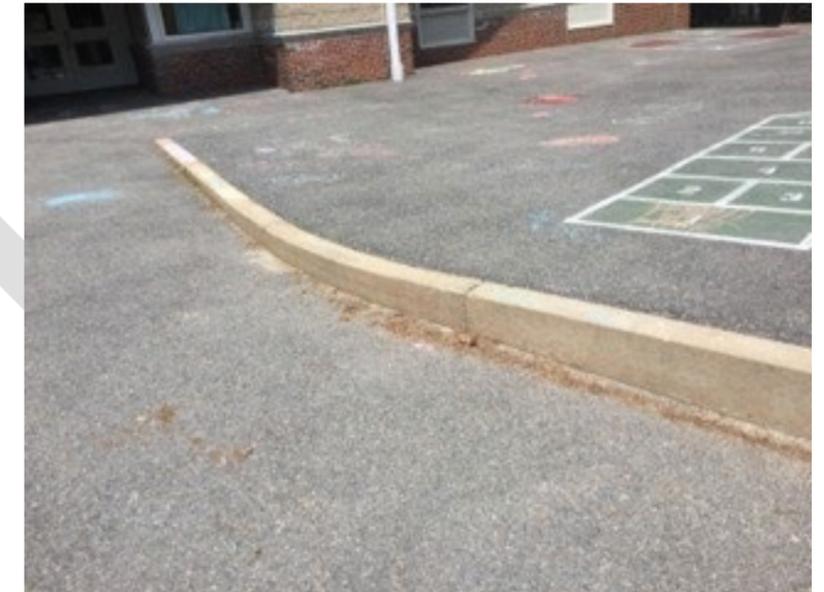
**Fig. 1** Tripping Hazard on South Playground

of the playground act as a serious tripping and safety hazard (see Fig. 1). As it is in the middle of the playground, children might be running from one side to the other and could fall if they are not fully aware of the curbs. IHCD strongly recommends looking into a possible solution to this issue, such as redesigning the area or using more poured in place rubber.

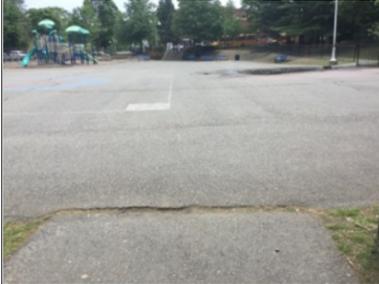
ID	Location	Floor	Room	Element	Type	Photo	Issues	Current Measure	Recommendations	Quantity	Price	Cost Estimation
<b>Approach and Entrance</b>												
<b>Exterior Access Route</b>												
1	Route to Basketball Court 2	Ext.		Exterior Access Route	Exterior

Surface openings > 1/2"	3"	Repair surface.	1	27	\$27
2	Bike Rack Near Basketball Court 1	Ext.		Exterior Access Route	Exterior

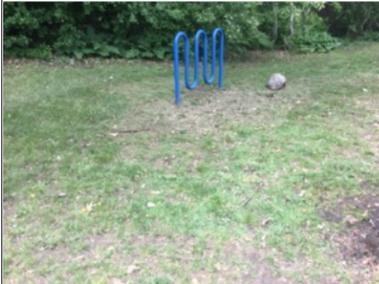
Accessible route not provided	-	Ensure an accessible route is provided.  (Cost based on 15' by 4' wide asphalt route to bike rack.)	1	383	\$383
<b>Curb Ramp</b>												
3	Southeast Corner of School	Ext.		Curb Ramp	N/A

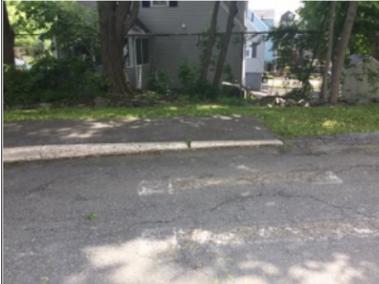
Curb ramp not provided	-	Provide a curb ramp at intersection.	1	2800	\$2800
<b>Off-Street Parking Lot or Garage</b>												
4	Parking Lot on West Side of School	Ext.		Off-Street Parking Lot or Garage	N/A

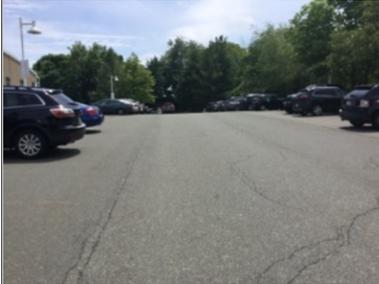
Total # of parking Total # of designated accessible parking spaces Access aisle not provided Sign not provided Sign does not have the designation "Van Accessible"	58 0 - - -	Provide two (2) car accessible spaces and one (1) van accessible space. Provide a marked access aisle that is at least 60" wide. for the car spaces to share and one that is 96" wide for the van space. Provide a sign with the bottom of the sign 60" min. above the ground and the top 96" max. above the ground. Add the designation "Van Accessible" at the van accessible space.	3	1388	\$4164

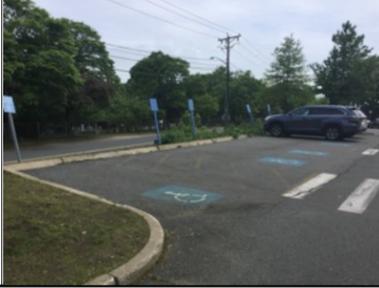
ID	Location	Floor	Room	Element	Type	Photo	Issues	Current Measure	Recommendations	Quantity	Price	Cost Estimation
5	Accessible Parking Spaces Near Main Entrance	Ext.		Off-Street Parking Lot or Garage	N/A

Access aisle < 96" wide at van space Sign does not have the designation "Van Accessible"	93" -	Provide a marked access aisle that is at least 96" wide. Add the designation "Van Accessible" to the sign located at the van accessible space.	1	600	\$600
<b>Entrance</b>												
6	Stairs to Basketball Courts and Playground on North Side of School	Ext.		Entrance	N/A

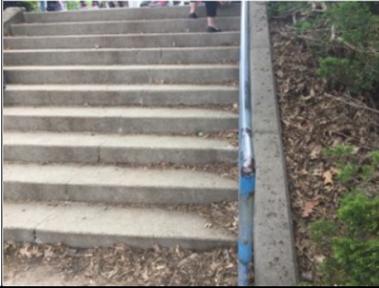
Directional sign to accessible entrance not provided	-	Provide a directional sign indicating the location of the nearest accessible entrance.	1	260	\$260
<b>Access to Goods and Services</b>												
<b>Means of Egress</b>												
7	Emergency Exit 9	Ext.		Means of Egress	N/A

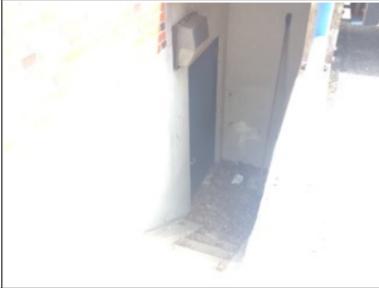
Tactile exit sign not provided Directional sign to accessible emergency exit not provided	- -	Ensure tactile exit signs on the interior of the door have raised characters and braille are provided at exit doors. Mount signs between 48"- 60" above finished floor located on the latch side of the door. Provide a directional sign on the inside indicating the location of the nearest accessible emergency exit.	1	348	\$348

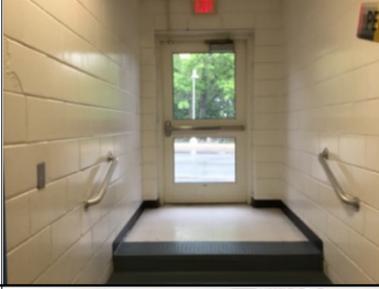
8	Emergency Exit 14, Near Cafeteria	B		Means of Egress	N/A

Tactile exit sign not provided Directional sign to accessible emergency exit not provided	- -	Ensure tactile exit signs with raised characters and braille are provided at exit doors. Mount signs between 48"- 60" above finished floor located on the latch side of the door. Provide a directional sign indicating the location of the nearest accessible emergency exit.	1	348	\$348
9	Route to Emergency Exit 4	1		Means of Egress	N/A

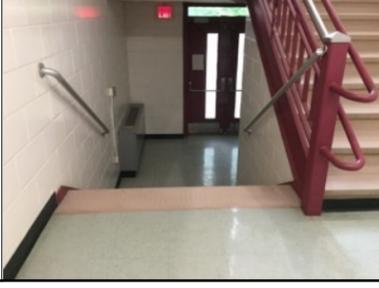
Tactile exit sign not provided Directional sign to accessible emergency exit not provided	- -	Ensure tactile exit signs with raised characters and braille are provided at exit doors. Mount signs between 48"- 60" above finished floor located on the latch side of the door. Provide a directional sign indicating the location of the nearest accessible emergency exit.	1	348	\$348

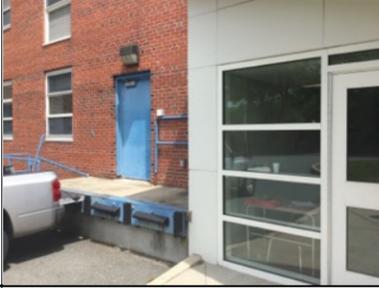
ID	Location	Floor	Room	Element	Type	Photo	Issues	Current Measure	Recommendations	Quantity	Price	Cost Estimation
10	Emergency Exit 8	Ext.		Means of Egress	N/A

Tactile exit sign not provided Illuminated exit sign lacks International Symbol of Accessibility.	- -	Ensure tactile exit signs on the interior of the door have raised characters and braille are provided at exit doors. Mount signs between 48"- 60" above finished floor located on the latch side of the door. Ensure illuminated exit sign inside contains the International Symbol of Accessibility (ISA).	1	274	\$274
11	Emergency Exit 15	Ext.		Means of Egress	N/A

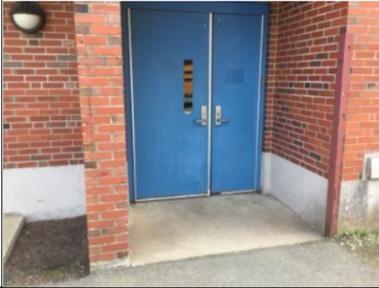
Tactile exit sign not provided Illuminated exit sign lacks International Symbol of Accessibility.	- -	Ensure tactile exit signs on the interior of the door have raised characters and braille are provided at exit doors. Mount signs between 48"- 60" above finished floor located on the latch side of the door. Ensure illuminated exit sign inside contains the International Symbol of Accessibility (ISA).	1	274	\$274

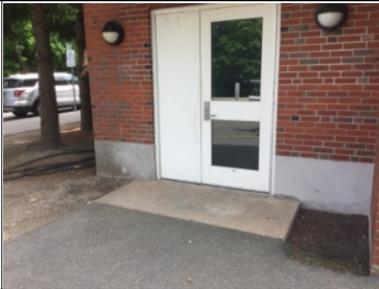
12	Emergency Exit 16	Ext.		Means of Egress	N/A

Tactile exit sign not provided Illuminated exit sign lacks International Symbol of Accessibility.	- -	Ensure tactile exit signs on the interior of the door have raised characters and braille are provided at exit doors. Mount signs between 48"- 60" above finished floor located on the latch side of the door. Ensure illuminated exit sign inside contains the International Symbol of Accessibility (ISA).	1	274	\$274
13	Emergency Exit 11	B	012	Means of Egress	N/A

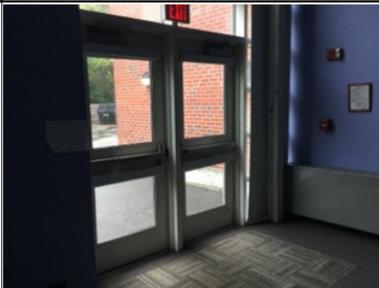
Tactile exit sign not provided Illuminated exit sign lacks International Symbol of Accessibility.	- -	Ensure tactile exit signs with raised characters and braille are provided at exit doors. Mount signs between 48"- 60" above finished floor located on the latch side of the door. Ensure illuminated exit sign contains the International Symbol of Accessibility (ISA).	1	274	\$274
14	Emergency Exit 12, Near Stage	B		Means of Egress	N/A

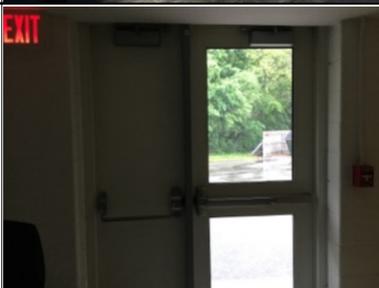
Tactile exit sign not provided Illuminated exit sign lacks International Symbol of Accessibility.	- -	Ensure tactile exit signs with raised characters and braille are provided at exit doors. Mount signs between 48"- 60" above finished floor located on the latch side of the door. Ensure illuminated exit sign contains the International Symbol of Accessibility (ISA).	1	274	\$274

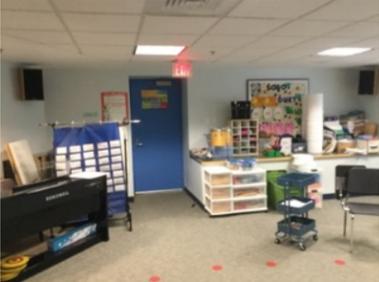
ID	Location	Floor	Room	Element	Type	Photo	Issues	Current Measure	Recommendations	Quantity	Price	Cost Estimation
15	Emergency Exit 10, in Music Room	1	130	Means of Egress	N/A

Tactile exit sign not provided Illuminated exit sign lacks International Symbol of Accessibility.	- -	Ensure tactile exit signs with raised characters and braille are provided at exit doors. Mount signs between 48"- 60" above finished floor located on the latch side of the door. Ensure illuminated exit sign contains the International Symbol of Accessibility (ISA).	1	274	\$274
16	Emergency Exit 7	1		Means of Egress	N/A

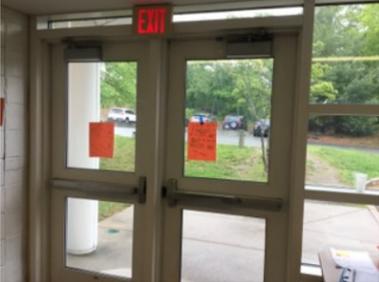
Tactile exit sign not provided Illuminated exit sign lacks International Symbol of Accessibility.	- -	Ensure tactile exit signs with raised characters and braille are provided at exit doors. Mount signs between 48"- 60" above finished floor located on the latch side of the door. Ensure illuminated exit sign contains the International Symbol of Accessibility (ISA).	1	274	\$274

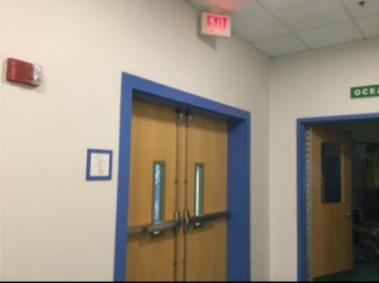
17	Route to Emergency Exit 5	1		Means of Egress	N/A

Tactile exit sign not provided Illuminated exit sign lacks International Symbol of Accessibility.	- -	Ensure tactile exit signs with raised characters and braille are provided at exit doors. Mount signs between 48"- 60" above finished floor located on the latch side of the door. Ensure illuminated exit sign contains the International Symbol of Accessibility (ISA).	1	274	\$274
18	Emergency Exit 5	1		Means of Egress	N/A

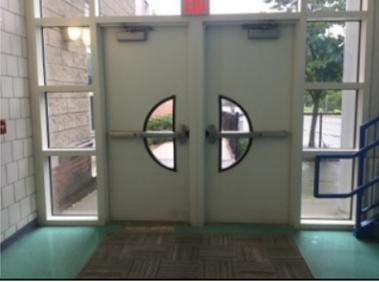
Tactile exit sign not provided Illuminated exit sign lacks International Symbol of Accessibility.	- -	Ensure tactile exit signs with raised characters and braille are provided at exit doors. Mount signs between 48"- 60" above finished floor located on the latch side of the door. Ensure illuminated exit sign contains the International Symbol of Accessibility (ISA).	1	274	\$274
19	Emergency Exit 6	1		Means of Egress	N/A

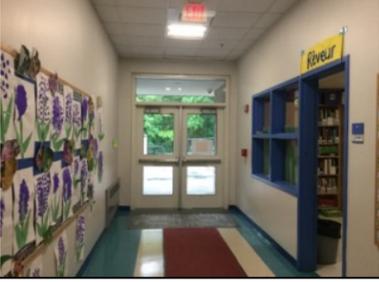
Tactile exit sign not provided Illuminated exit sign lacks International Symbol of Accessibility.	- - -	Ensure tactile exit signs with raised characters and braille are provided at exit doors. Mount signs between 48"- 60" above finished floor located on the latch side of the door. Ensure illuminated exit sign contains the International Symbol of Accessibility (ISA).	1	274	\$274

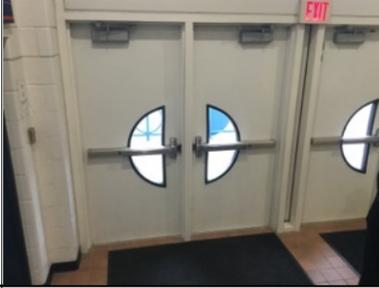
ID	Location	Floor	Room	Element	Type	Photo	Issues	Current Measure	Recommendations	Quantity	Price	Cost Estimation
20	Main Entrance, Exit 1	1		Means of Egress	N/A

Tactile exit sign not provided Illuminated exit sign lacks International Symbol of Accessibility.	- -	Ensure tactile exit signs with raised characters and braille are provided at exit doors. Mount signs between 48"- 60" above finished floor located on the latch side of the door. Ensure illuminated exit sign contains the International Symbol of Accessibility (ISA).	1	274	\$274
21	Exit From Gym to Emergency Exit 12 in Basement	1		Means of Egress	N/A

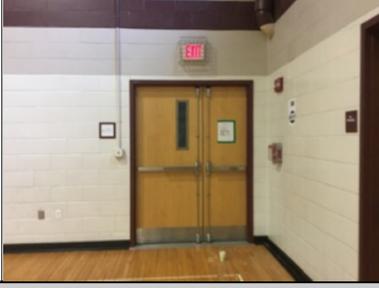
Directional sign to accessible emergency exit not provided	-	Provide a directional sign indicating the location of the nearest accessible emergency exit.	1	174	\$174
<b>Interior Access Route</b>												
22	Classroom, Book Nook	2	202	Interior Access Route	N/A

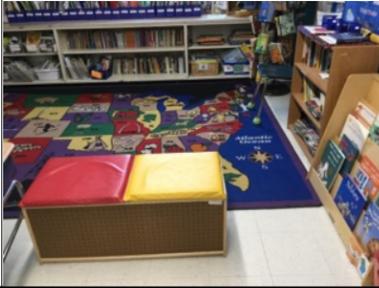
Route < 36" wide	30" -	Ensure that a clear width of 36" min. is maintained at the accessible route.	1	Labor	\$0

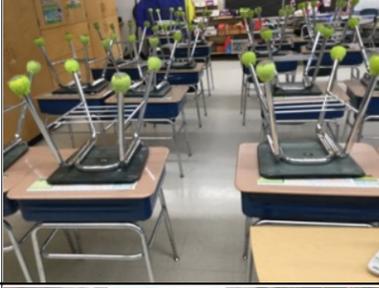
23	Classroom	2	202	Interior Access Route	N/A

Route < 36" wide	19"	Ensure that a clear width of 36" min. is maintained at the accessible route.	1	Labor	\$0
24	Classroom	2	205	Interior Access Route	N/A

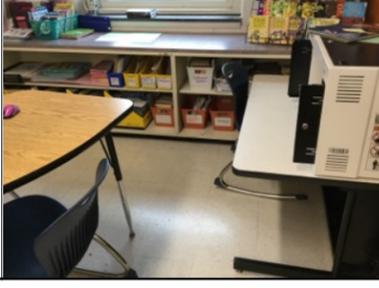
Route < 36" wide	17.5"	Ensure that a clear width of 36" min. is maintained at the accessible route.	1	Labor	\$0

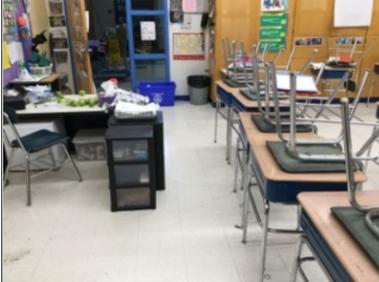
ID	Location	Floor	Room	Element	Type	Photo	Issues	Current Measure	Recommendations	Quantity	Price	Cost Estimation
25	Classroom, Fifth Grade	2	210	Interior Access Route	N/A

Route < 36" wide	25"	Ensure that a clear width of 36" min. is maintained at the accessible route.	1	Labor	\$0
26	Classroom	2	209	Interior Access Route	N/A

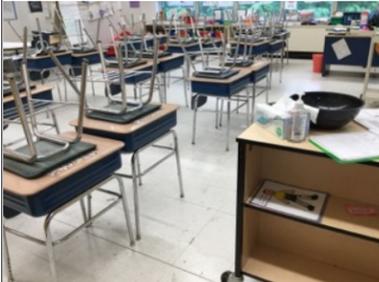
Route < 36" wide	28"	Ensure that a clear width of 36" min. is maintained at the accessible route.	1	Labor	\$0
27	Classroom, Fourth Grade	2	217	Interior Access Route	N/A

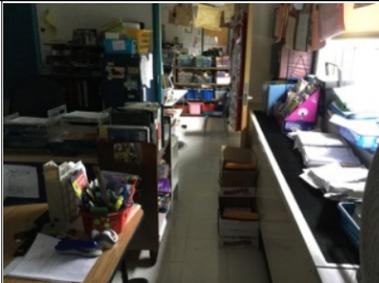
Route < 36" wide	28"	Ensure that a clear width of 36" min. is maintained at the accessible route.	1	Labor	\$0
28	ELA Classroom	2	206	Interior Access Route	N/A

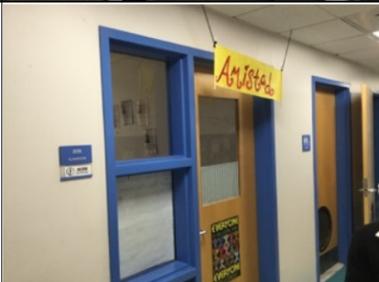
Obstructed by protruding objects	76"	Relocate sign in doorway so that it is at least 80" above the finished floor.	1	Labor	\$0
29	Main Office	1	100	Interior Access Route	N/A

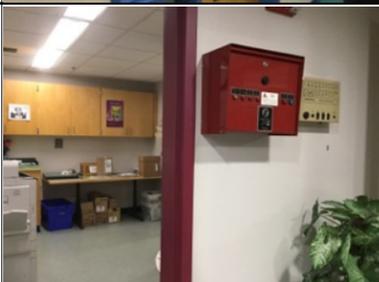
Obstructed by protruding objects	7"	Relocate object out of circulation path.	1	530	\$530

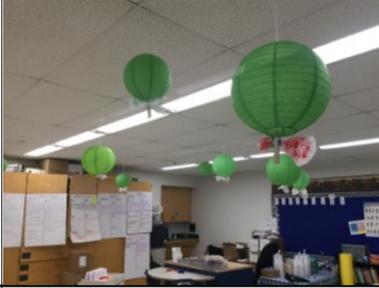
ID	Location	Floor	Room	Element	Type	Photo	Issues	Current Measure	Recommendations	Quantity	Price	Cost Estimation
30	Classroom	1	107	Interior Access Route	N/A

Obstructed by protruding objects	69"	Relocate lanterns so that that are at least 80" above the finished floor.	1	Labor	\$0
31	Classrooms Throughout School	2, 1, B	203, 205, 209, 213, 215, 217, 05, 104, 107, 110	Interior Access Route	N/A
