**City of Salem,  
Massachusetts**

December 2019

# Salem City Hall

## City of Salem ADA Transition Plan

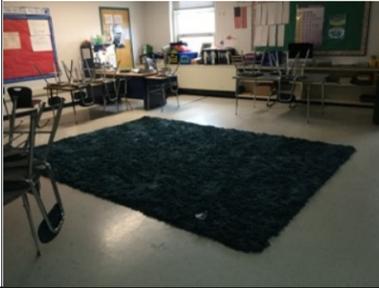
Mat not securely attached	-	Securely attach mats.	16	Labor	\$0
<b>Doors, Doorways, &amp; Gates</b>												
32	Main Office Into Hallway	1	100	Doors, Doorways, & Gates	N/A

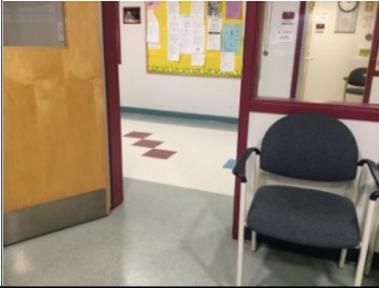
Maneuvering clearance(s) not provided	-	Remove the chair away from the required maneuvering clearance at the door.	1	Labor	\$0
33	Health Suite	1	127	Doors, Doorways, & Gates	N/A

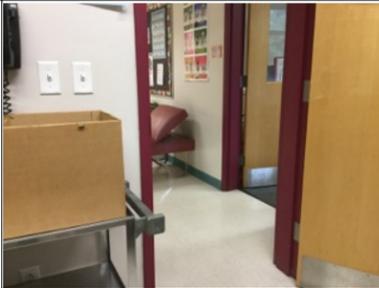
Maneuvering clearance(s) not provided	-	Relocate the cart away from the required maneuvering clearance at the door.	1	Labor	\$0
34	Toilet Room Near 127	1		Doors, Doorways, & Gates	Toilet Room

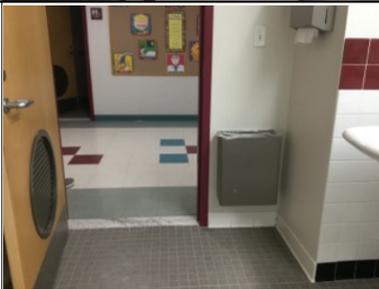
Maneuvering clearance(s) not provided	-	Relocate trash can to another wall at the same height away from the required maneuvering clearance at the door.	1	530	\$530

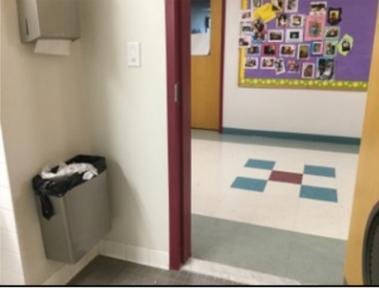
ID	Location	Floor	Room	Element	Type	Photo	Issues	Current Measure	Recommendations	Quantity	Price	Cost Estimation
35	Toilet Room Near 127	1		Doors, Doorways, & Gates	Toilet Room

Maneuvering clearance(s) not provided	14"	While not technically compliant, this doorway is still usable.	1	-	\$0
36	Classroom	1	104	Doors, Doorways, & Gates	Classroom

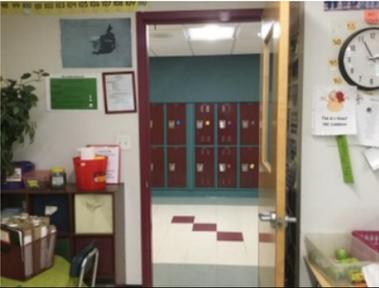
Maneuvering clearance(s) not provided	-	Relocate the cabinet away from the required maneuvering clearance at the door.	1	Labor	\$0
37	Classroom, First Grade	1	119	Doors, Doorways, & Gates	Classroom

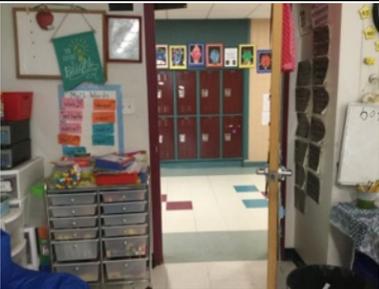
Maneuvering clearance(s) not provided	-	Relocate the cabinet away from the required maneuvering clearance at the door.	1	Labor	\$0
38	Locker Room Entrance	1		Doors, Doorways, & Gates	N/A

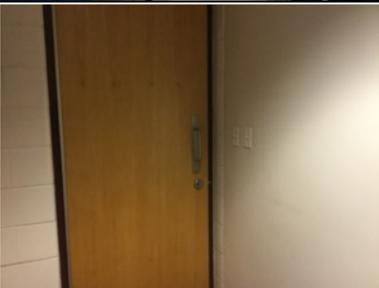
Maneuvering clearance(s) not provided	-	Provide an automatic door opener.	1	2295	\$2295
<b>Ramps</b>												
39	Ramp to Emergency Exit 7	1		Ramps	Interior

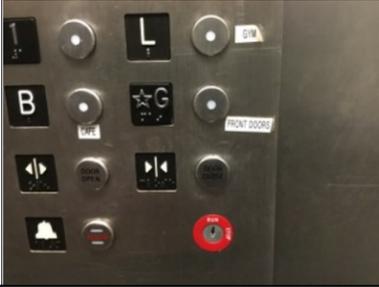
ID	Location	Floor	Room	Element	Type	Photo	Issues	Current Measure	Recommendations	Quantity	Price	Cost Estimation
<b>Elevator</b>												
40	Elevator	1		Elevator	Interior

Raised characters / braille not provided on cabin controls	-	Ensure that raised character and braille designations are placed immediately to the left of the control button to which the designations apply. Ensure they align with the currently used floor plan.	1	360	\$360
<b>Signage</b>												
41	Bilingual Reading Room	2	207	Signage	Designation

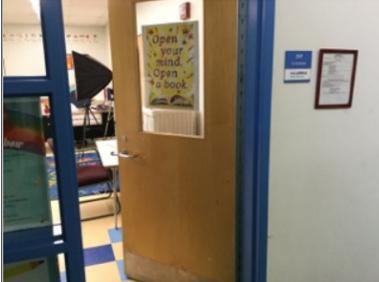
Sign not located on the latch side of the door	-	Locate sign at permanent rooms alongside the door on the latch side.	1	Labor	\$0
42	Art Room	2	208	Signage	Designation

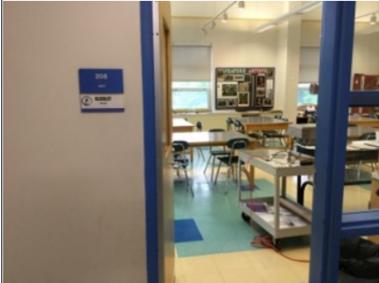
Sign not located on the latch side of the door	-	Locate sign at permanent rooms alongside the door on the latch side.	1	Labor	\$0
43	Art Room to Kiln Room	2	208	Signage	Designation

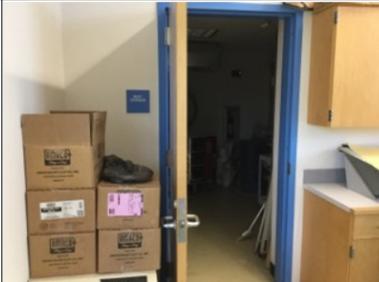
Sign not located on the latch side of the door	-	Locate sign at permanent rooms alongside the door on the latch side.	1	Labor	\$0

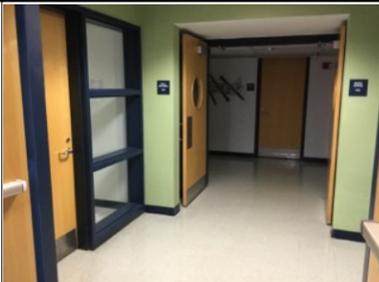
44	Music Ensemble Room and Music Office	B	009, 013	Signage	Designation

Sign not located on the latch side of the door	-	Locate sign at permanent rooms alongside the door on the latch side.	2	Labor	\$0

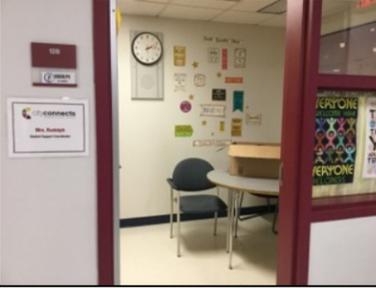
ID	Location	Floor	Room	Element	Type	Photo	Issues	Current Measure	Recommendations	Quantity	Price	Cost Estimation
45	Office	1	128	Signage	Designation

Sign not located on the latch side of the door	-	Locate sign at permanent rooms alongside the door on the latch side.	1	Labor	\$0
46	Boys' Toilet Room	1		Signage	Designation

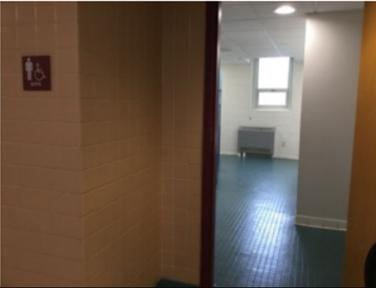
Sign not located on the latch side of the door	-	Locate sign at permanent rooms alongside the door on the latch side.	1	Labor	\$0
47	Classroom	1	113	Signage	Designation

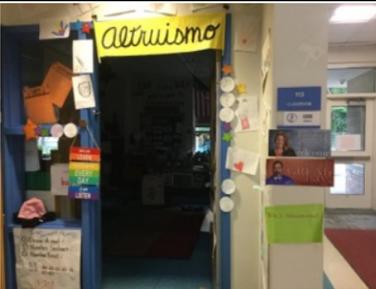
Sign not located on the latch side of the door	-	Locate sign at permanent rooms alongside the door on the latch side.	1	Labor	\$0
48	Classroom	1	108	Signage	Designation

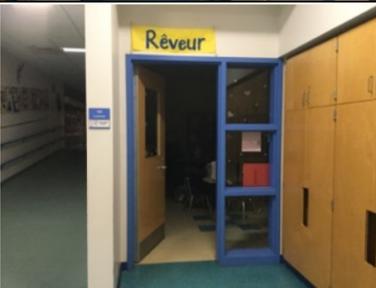
Sign not located on the latch side of the door	-	Locate sign at permanent rooms alongside the door on the latch side.	1	Labor	\$0
<b>Service Counter</b>												
49	Main Office	1	100	Service Counter	N/A

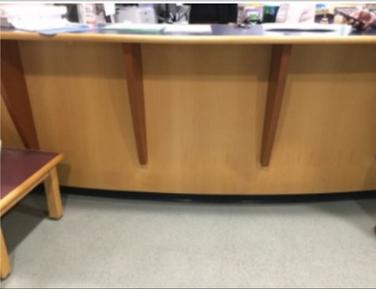
Counter > 36" high	42"	Provide a counter that is 36" max. above the ground or finished floor.	1	660	\$660

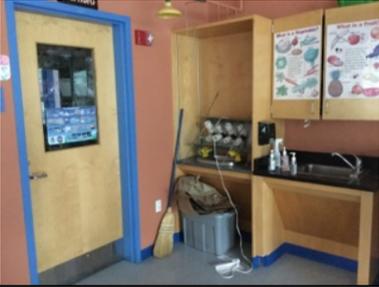
ID	Location	Floor	Room	Element	Type	Photo	Issues	Current Measure	Recommendations	Quantity	Price	Cost Estimation
<b>Operable Parts</b>												
50	Emergency Shower	2	211	Operable Parts	Other

Clear floor space is not provided	-	Provide a 30" min. by 48" min. clear floor space at emergency eye wash station.	1	Labor	\$0
51	Classroom, Book Nook	2	202	Operable Parts	Other

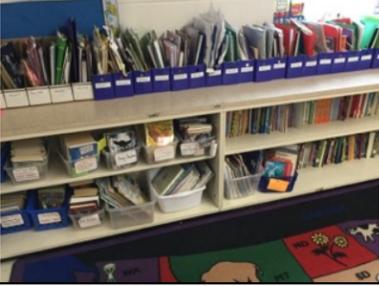
Reach < 15" or > 48"(forward/side approach)	5"	Relocate books so that controls are between 15"- 48" above finished floor.	1	Labor	\$0
52	Classroom	2	209	Operable Parts	Other

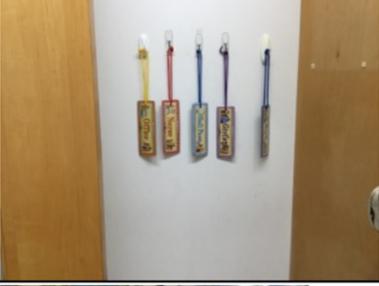
Reach < 15" or > 48"(forward/side approach)	64"	Relocate hooks so that controls are between 15"- 48" above finished floor.	1	Labor	\$0
53	Classroom, Third Grade	2	213	Operable Parts	Other

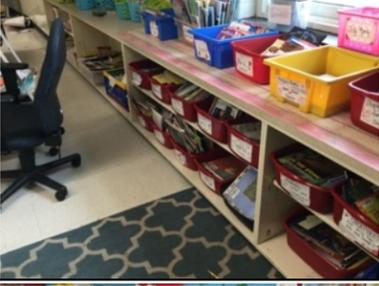
Reach < 15" or > 48"(forward/side approach)	5"	Relocate books so that controls are between 15"- 48" above finished floor.	1	Labor	\$0
54	Classroom, Fourth Grade	2	215	Operable Parts	Other

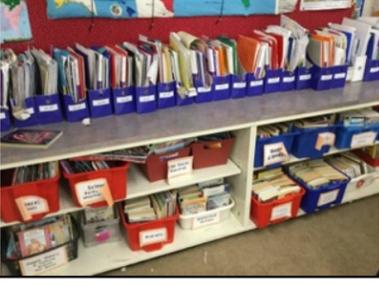
Reach < 15" or > 48"(forward/side approach)	5"	Relocate books so that controls are between 15"- 48" above finished floor.	1	Labor	\$0

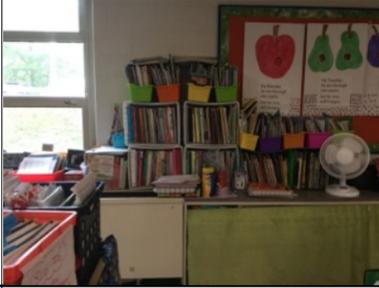
ID	Location	Floor	Room	Element	Type	Photo	Issues	Current Measure	Recommendations	Quantity	Price	Cost Estimation
55	Classroom, First Grade	1	119	Operable Parts	Other

Reach < 15" or > 48"(forward/side approach)	68"	Relocate books so that controls are between 15"- 48" above finished floor.	1	Labor	\$0
56	Boys' and Girls' Locker Rooms	1		Operable Parts	Other

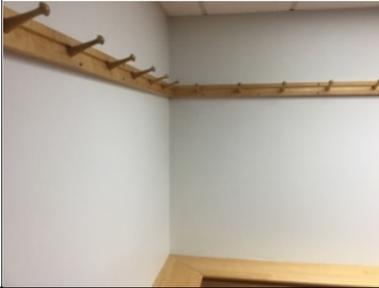
Reach < 15" or > 48"(forward/side approach)	66.5"	Relocate at least one hook per room so that controls are between 15"- 48" above finished floor.	2	192	\$384
<b>Dining or Work Surfaces</b>												
57	Classrooms Throughout School	2, 1, B	202, 210, 213, 215, 217, 005	Dining or Work Surfaces	Work Surface

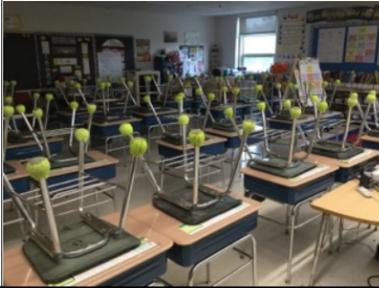
At least one or 5% accessible tables not provided	-	Ensure that at least one work surface per room is accessible with 27" minimum knee and toe clearance.	6	525	\$3150
58	Classrooms Throughout School	2, 1	203, 124, 104, 118, 107	Dining or Work Surfaces	Work Surface

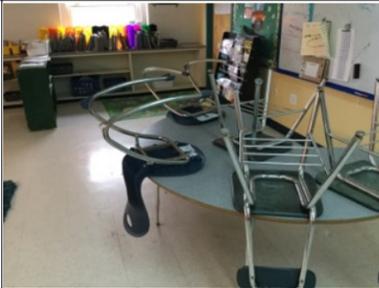
Knee or toe clearance not provided	24"	Adjust at least 1 work surface per room so that they have 27" min. knee and toe clearance.	5	Labor	\$0

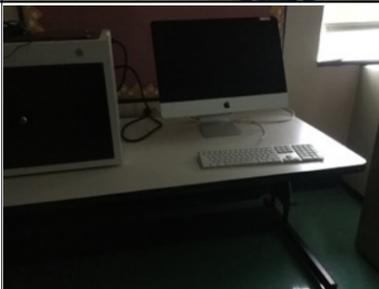
59	Classroom	1	110	Dining or Work Surfaces	Work Surface

Knee or toe clearance not provided	22.5"	Adjust work surface so that it has 27" min. knee and toe clearance.	1	Labor	\$0

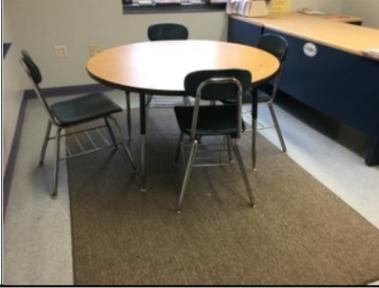
Knee or toe clearance not provided Mat not securely attached	26" -	Adjust table so that it has minimum 27" knee clearance underneath. Securely attach mat.	1	Labor	\$0
<b>Picnic Tables</b>												
61	North Side of School	Ext.		Picnic Tables	N/A

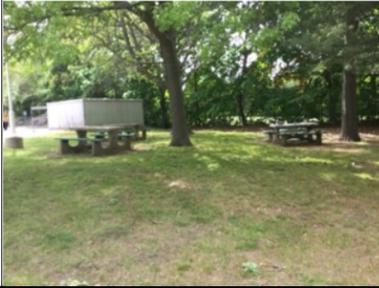
At least 5% accessible spaces not provided Picnic table not on an accessible route	- -	Ensure that at least 5% (minimum one) of dining surfaces are accessible. Ensure that the dining surface is connected to an accessible route.  (Cost based on an accessible picnic table and a 15' by 4' wide asphalt path to the picnic area.)	1	1433	\$1433
<b>Toilet &amp; Bathing Rooms</b>												
<b>Lavatory</b>												
62	Girls' Toilet Room	1		Lavatory	N/A

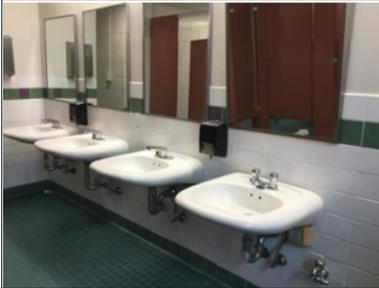
Toe or knee clearances not provided Plumbing underneath is exposed	25" -	Provide at least one lavatory with knee and toe clearance positioned for a forward approach. Insulate or otherwise configure pipes to prevent contact, for at least one lavatory.	1	1334	\$1334

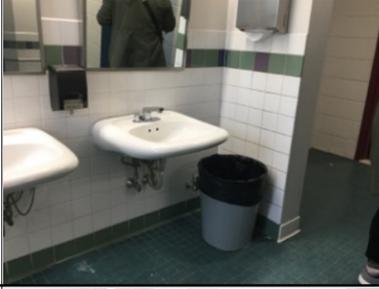
63	Boys' Toilet Room	1		Lavatory	N/A

Toe or knee clearances not provided Plumbing underneath is exposed	24.5" -	Provide at least one lavatory with knee and toe clearance positioned for a forward approach. Insulate or otherwise configure pipes to prevent contact, for at least one lavatory.	1	1334	\$1334
64	Toilet Room Near 109	1	113	Lavatory	N/A

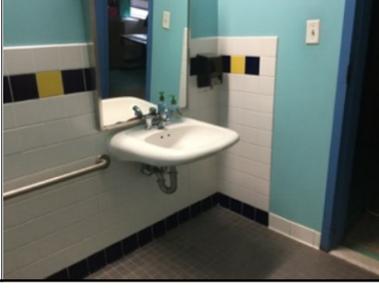
Toe or knee clearances not provided Plumbing underneath is exposed	25.5" -	Provide at least one lavatory with knee and toe clearance positioned for a forward approach. Insulate or otherwise configure pipes to prevent contact, for at least one lavatory.	1	1334	\$1334

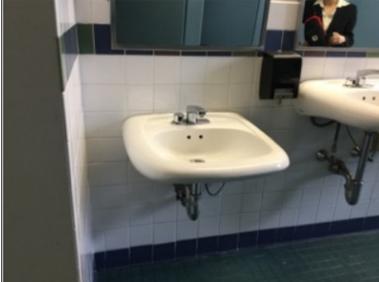
Plumbing underneath is exposed	-	Insulate or otherwise configure pipes to prevent contact, for at least one lavatory.	1	69	\$69
66	Boys' Toilet Room	2		Lavatory	N/A

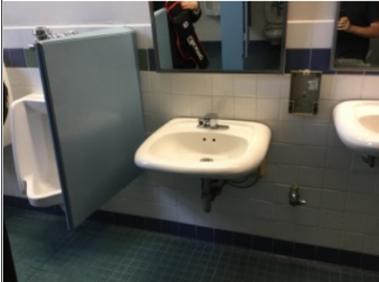
Plumbing underneath is exposed	-	Insulate or otherwise configure pipes to prevent contact, for at least one lavatory.	1	69	\$69
67	Girls' Toilet Room	B		Lavatory	N/A

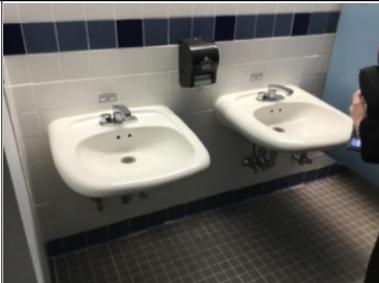
Plumbing underneath is exposed	-	Insulate or otherwise configure pipes to prevent contact, for at least one lavatory.	1	69	\$69
68	Health Suite, Toilet Room	1	127	Lavatory	N/A

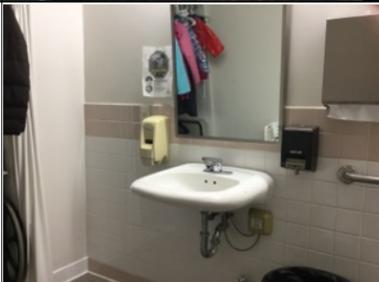
Plumbing underneath is exposed	-	Insulate or otherwise configure pipes to prevent contact, for at least one lavatory.	1	69	\$69
69	Toilet Room in 116	1	116	Lavatory	N/A

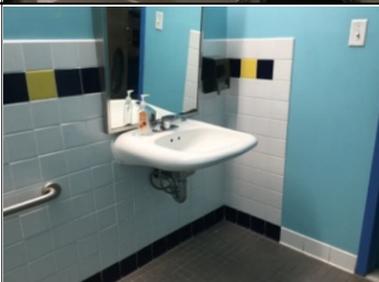
Plumbing underneath is exposed	-	Insulate or otherwise configure pipes to prevent contact, for at least one lavatory.	1	69	\$69

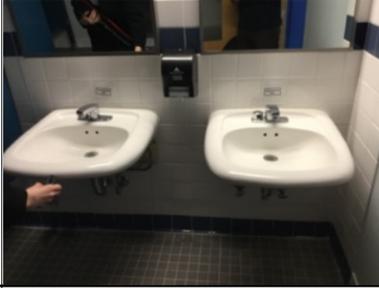
Plumbing underneath is exposed Mirror above lavatory w/reflective surface > 40"	- 42"	Insulate or otherwise configure pipes to prevent contact, for at least one lavatory. Lower mirror so that the bottom surface is at 40" max. above finished floor.	1	261	\$261
71	Women's Toilet Room Near 218	2		Lavatory	N/A

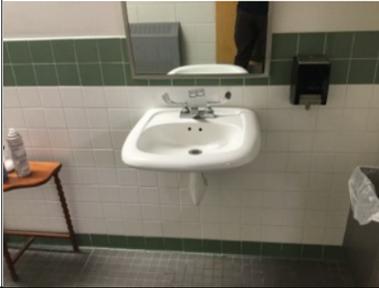
Mirror above lavatory w/reflective surface > 40"	42"	Lower mirror so that the bottom surface is at 40" max. above finished floor.	1	192	\$192
72	Men's Toilet Room Near 218	2		Lavatory	N/A

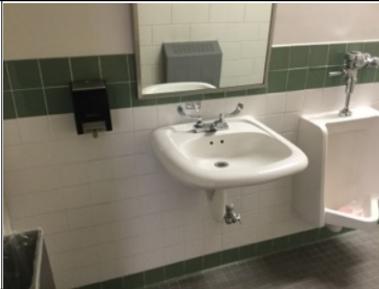
Mirror above lavatory w/reflective surface > 40"	42"	Lower mirror so that the bottom surface is at 40" max. above finished floor.	1	192	\$192
<b>Single-User Toilet</b>												
73	Women's Toilet Room Near 218	2		Single-User Toilet	N/A

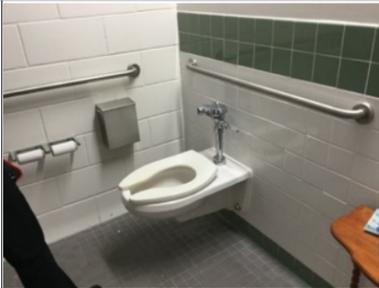
Centerline < or > 18" (MAAB)	20"	Relocate toilet so that the centerline is 18" from the side wall.	1	2121	\$2121

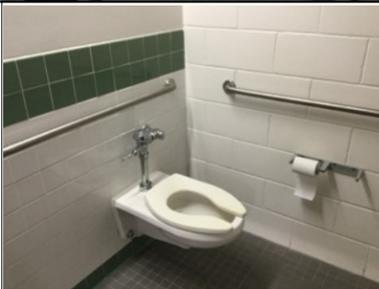
74	Men's Toilet Room Near 218	2		Single-User Toilet	N/A

Centerline < or > 18" (MAAB)	20"	Relocate toilet so that the centerline is 18" from the side wall.	1	2121	\$2121

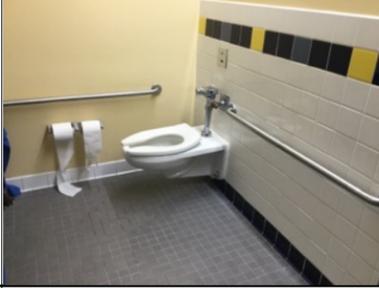
Centerline < or > 18" (MAAB) Side or rear grab bar < 33" or > 36" high	15" 22"	Relocate toilet so that the centerline is 18" from the side wall. Mount grab bars 33"- 36" above the floor.	1	2313	\$2313
76	Toilet Room in 115	1	115	Single-User Toilet	N/A

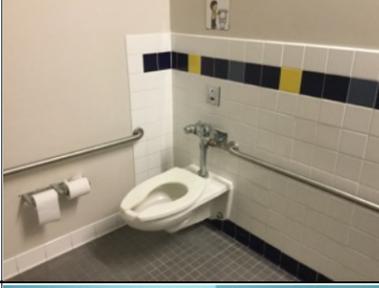
Centerline < or > 18" (MAAB) Side or rear grab bar < 33" or > 36" high	15" 22"	Relocate toilet so that the centerline is 18" from the side wall. Mount grab bars 33"- 36" above the floor.	1	2313	\$2313
77	Toilet Room in 116	1	116	Single-User Toilet	N/A

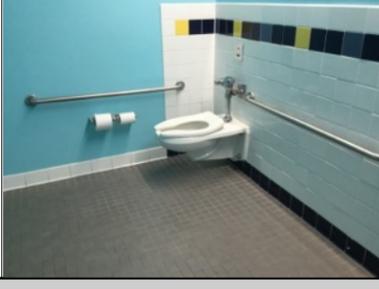
Centerline < or > 18" (MAAB) Side or rear grab bar < 33" or > 36" high	15" 24"	Relocate toilet so that the centerline is 18" from the side wall. Mount grab bars 33"- 36" above the floor.	1	2313	\$2313
<b>Toilet Compartment</b>

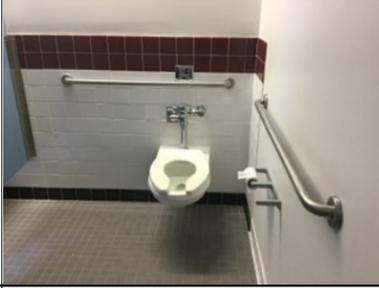
78	Girls' Locker Room Toilet Room	1		Toilet Compartment	Accessible Compartment

Door has malfunctioning self-closing hinge	-	Repair hinge.	1	Labor	\$0
79	Boys' Toilet Room	B		Toilet Compartment	Accessible Compartment

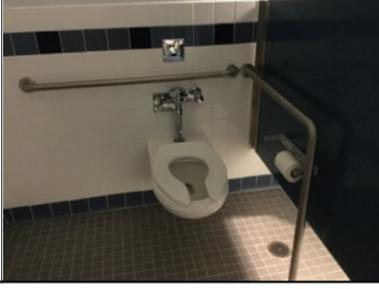
Side grab bar < 42" long	30"	Provide a side wall grab bar that is 42" long min. located 12" max. from the rear wall.	1	674	\$674

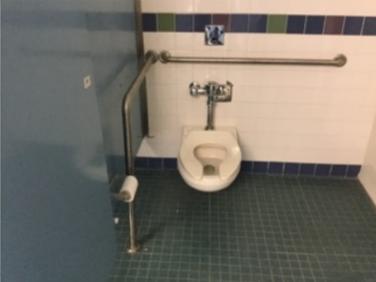
Side grab bar < 42" long Non-compliant toilet paper dispenser	30" -	Provide a side wall grab bar that is 42" long min. located 12" max. from the rear wall. Relocate toilet paper so that it is 15" min. high, located under the grab bar, and between 7" and 9" from the front of the toilet. Replace dispenser if it does not allow continuous paper flow.	1	1204	\$1204
81	Boys' Toilet Room	2		Toilet Compartment	Accessible Compartment

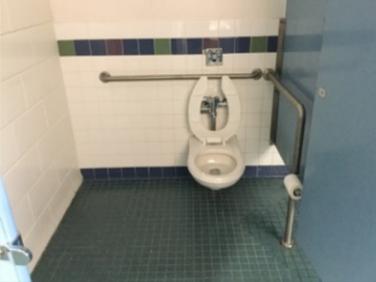
Side grab bar < 42" long Non-compliant toilet paper dispenser	30" -	Provide a side wall grab bar that is 42" long min. located 12" max. from the rear wall. Relocate toilet paper so that it is 15" min. high, located under the grab bar, and between 7" and 9" from the front of the toilet. Replace dispenser if it does not allow continuous paper flow.	1	1204	\$1204

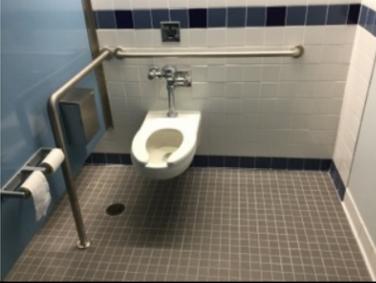
82	Girls' Toilet Room	B		Toilet Compartment	Accessible Compartment

Side grab bar < 42" long Non-compliant toilet paper dispenser	30" -	Provide a side wall grab bar that is 42" long min. located 12" max. from the rear wall. Relocate toilet paper so that it is 15" min. high, located under the grab bar, and between 7" and 9" from the front of the toilet. Replace dispenser if it does not allow continuous paper flow.	1	1204	\$1204
83	Girls' Toilet Room	1		Toilet Compartment	Accessible Compartment

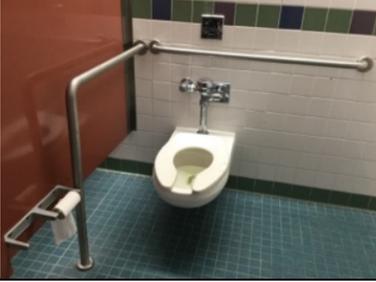
Side grab bar < 42" long Non-compliant toilet paper dispenser	31" -	Provide a side wall grab bar that is 42" long min. located 12" max. from the rear wall. Relocate toilet paper so that it is 15" min. high, located under the grab bar, and between 7" and 9" from the front of the toilet. Replace dispenser if it does not allow continuous paper flow.	1	1204	\$1204
84	Boys' Toilet Room	1		Toilet Compartment	Accessible Compartment

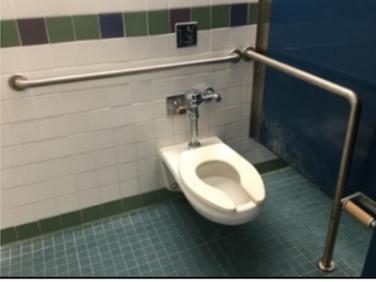
Side grab bar < 42" long Non-compliant toilet paper dispenser	31" -	Provide a side wall grab bar that is 42" long min. located 12" max. from the rear wall. Relocate toilet paper so that it is 15" min. high, located under the grab bar, and between 7" and 9" from the front of the toilet. Replace dispenser if it does not allow continuous paper flow.	1	1204	\$1204

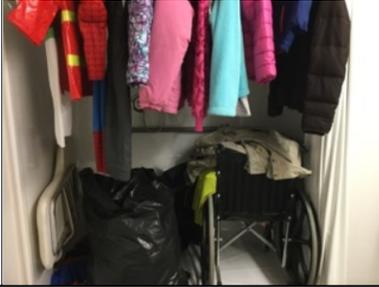
Accessible shower not provided	-	Provide at least one accessible shower by ensuring it is maintained in operable working condition and is free of clutter.	1	Labor	\$0
<b>Additional Access</b>												
<b>Drinking Fountains</b>												
86	Gym	1		Drinking Fountains	High

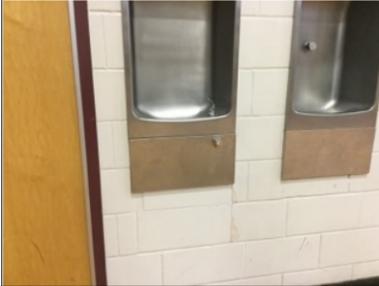
Inadequate water flow No drinking fountain provided for seated users	- -	Install a Hi-Lo drinking fountain.	1	3162	\$3162
87	Drinking Fountains Near Main Staircase	B	005	Drinking Fountains	Hi-Lo

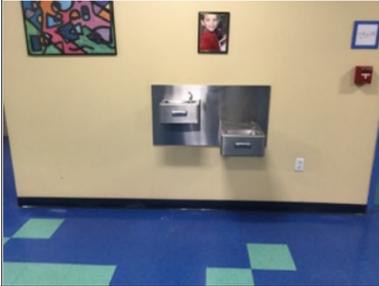
Standing height fountain does not have cane protection	-	Provide a cane-detectable barrier skirt under the high unit.	1	668	\$668
<b>Sink</b>												
88	Classroom	2	202	Sink	Classroom

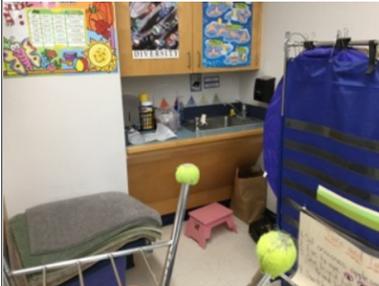
Clear floor space not provided at sink Sink not on a accessible route	- -	Provide a 30" by 48" clear floor space positioned for a forward approach. Ensure the sink is on an accessible route.	1	Labor	\$0

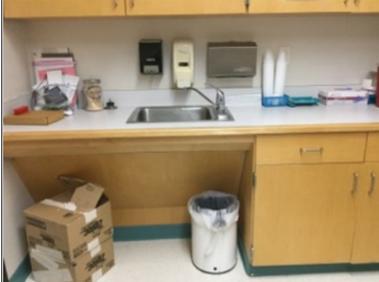
Toe and knee clearances not provided	-	Ensure there is a 27" knee clearance positioned for a forward approach by removing clutter.	2	Labor	\$0
90	Classrooms Throughout School	2, 1	210, 208, 213, 215, 130, 104, 119, 118	Sink	Classroom

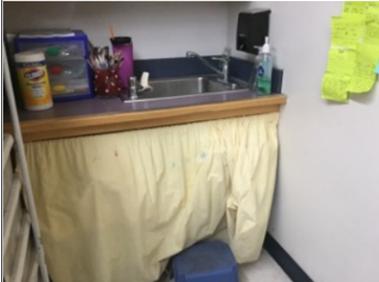
Toe and knee clearances not provided	-	Ensure there is a 27" knee clearance positioned for a forward approach by removing storage and other clutter under the sink. Ensure sinks have a minimum 30" by 48" clear floor space as well.	8	Labor	\$0
91	Bilingual Reading Room	2	207	Sink	Classroom

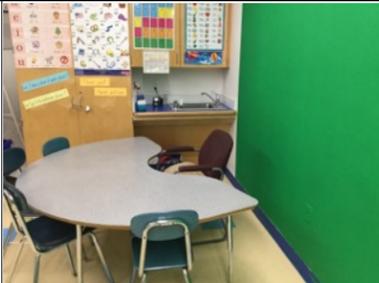
Sink not on a accessible route	-	Ensure the sink is on an accessible route.	1	Labor	\$0
<b>Play and Sport Areas</b>												
<b>Play Areas</b>												
92	Playground on North Side of School	Ext.		Play Areas	N/A

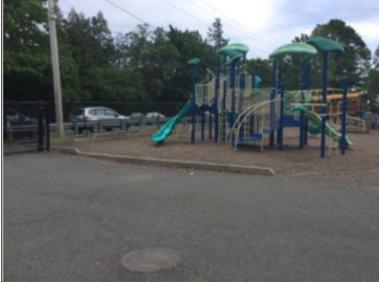
Accessible route not provided to ground level play components	-	Ensure an accessible route is provided to one of each type of ground level play components  (Cost based on 250' by 4' wide asphalt route around playground as well as 1880' by 5' wide poured in place rubber route to play components.)	1	25275	\$25275

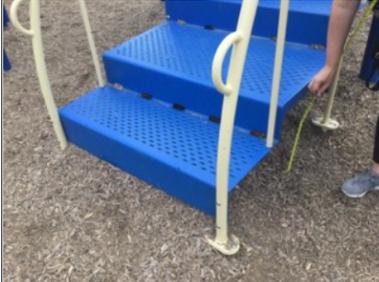
93	Playground on North Side of School	Ext.		Play Areas	N/A

No compliant transfer system	-	Alteration might be technically infeasible.	1	-	\$0

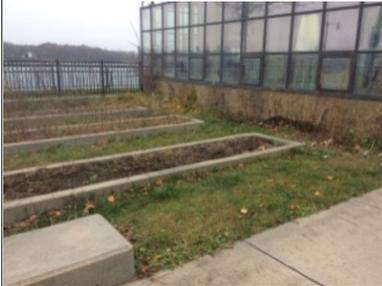
ID	Location	Floor	Room	Element	Type	Photo	Issues	Current Measure	Recommendations	Quantity	Price	Cost Estimation
<b>Approach and Entrance</b>												
<b>Exterior Access Route</b>												
1	Community Garden	Ext.		Exterior Access Route	Exterior

Accessible route not provided	-	Ensure an accessible route is provided.  (Cost based on 45' by 4' wide stone dust path to and around community garden.)	1	1080	\$1080
<b>Off-Street Parking Lot or Garage</b>												
2	Parking Lot	Ext.		Off-Street Parking Lot or Garage	N/A

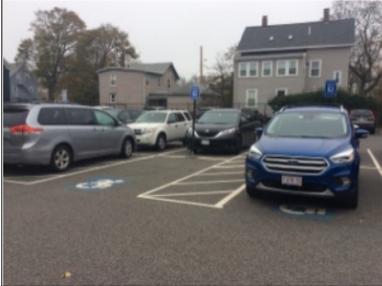
Total # of parking Total # of designated accessible parking spaces Sign does not have the designation "Van Accessible" Total # of designated van accessible spaces	50 2 1 -	Add the designation "Van Accessible" to the sign located at the van accessible space.	1	375	\$375
<b>Entrance</b>												
3	Main Entrance	Ext.		Entrance	Main Entrance

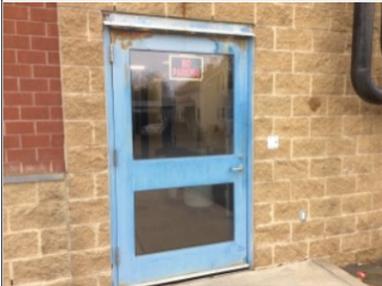
<b>Access to Goods and Services</b>												
<b>Means of Egress</b>												
4	Exit #9	Ext.		Means of Egress	N/A

Illuminated exit sign not provided	-	Ensure illuminated exit sign on the interior of the door contains the International Symbol of Accessibility (ISA).	1	150	\$150

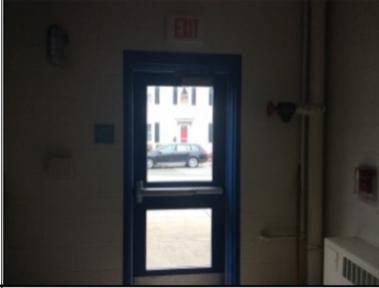
ID	Location	Floor	Room	Element	Type	Photo	Issues	Current Measure	Recommendations	Quantity	Price	Cost Estimation
5	Exit #6 in Stair #2	1		Means of Egress	N/A

Illuminated exit sign not provided	-	Ensure illuminated exit signs contain the International Symbol of Accessibility (ISA).	1	150	\$150
6	Exit #3 in Kindergarten Classroom	1	109	Means of Egress	N/A

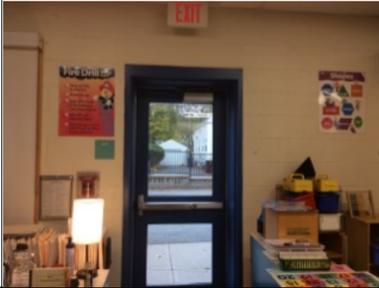
Illuminated exit sign not provided	-	Ensure illuminated exit signs contain the International Symbol of Accessibility (ISA).	1	150	\$150
7	Exit #2 in Kindergarten Classroom	1	102	Means of Egress	N/A

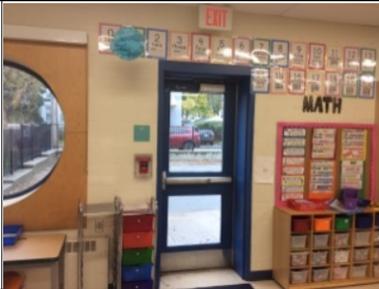
Illuminated exit sign not provided	-	Ensure illuminated exit signs contain the International Symbol of Accessibility (ISA).	1	150	\$150
8	Exit #5 in Greenhouse	1		Means of Egress	N/A

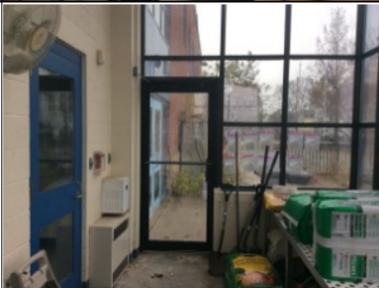
Illuminated exit sign not provided Tactile exit sign not provided	- -	Ensure illuminated exit signs are provided at exits and exit doors. Ensure it contains the International Symbol of Accessibility (ISA). Ensure tactile exit signs with raised characters and braille are provided at exit doors. Mount signs between 48"- 60" above finished floor located on the latch side of the door.	1	324	\$324

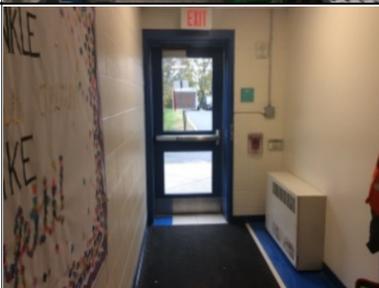
9	Exit #11	1		Means of Egress	N/A

Illuminated exit sign not provided Mat not securely attached	- -	Ensure illuminated exit signs contain the International Symbol of Accessibility (ISA). Securely attach mat.	1	150	\$150

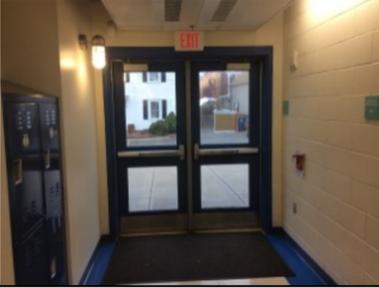
ID	Location	Floor	Room	Element	Type	Photo	Issues	Current Measure	Recommendations	Quantity	Price	Cost Estimation
10	Exit #8	1		Means of Egress	N/A

Illuminated exit sign not provided Mat not securely attached	- -	Ensure illuminated exit signs contain the International Symbol of Accessibility (ISA). Securely attach mat.	1	150	\$150
11	Exit #4 in Stair #1	1		Means of Egress	N/A

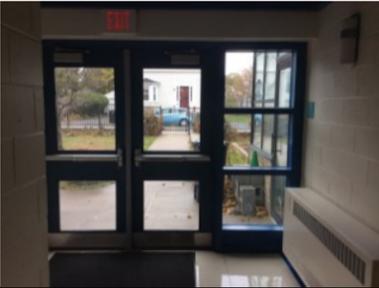
Illuminated exit sign not provided Mat not securely attached	- -	Ensure illuminated exit signs contain the International Symbol of Accessibility (ISA). Securely attach mat.	1	150	\$150
<b>Interior Access Route</b>												
12	Inclusion Classroom	2	260	Interior Access Route	N/A

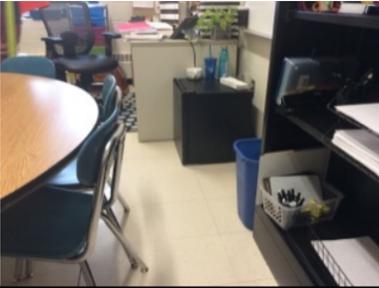
Route < 36" wide	22"	Ensure that a clear width of 36" min. is maintained at the accessible route.	1	Labor	\$0
13	Reading Room	2	261	Interior Access Route	N/A

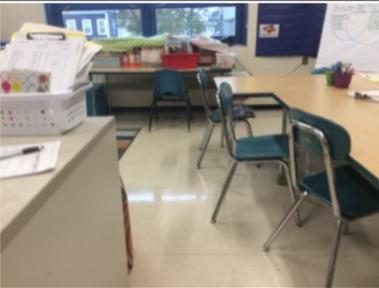
Route < 36" wide	29"	Ensure that a clear width of 36" min. is maintained at the accessible route.	1	Labor	\$0

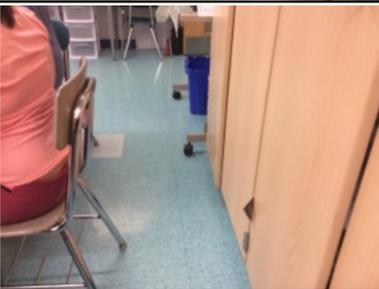
14	Grade 3 Classroom	2	222	Interior Access Route	N/A

Route < 36" wide	18"	Ensure that a clear width of 36" min. is maintained at the accessible route.	1	Labor	\$0

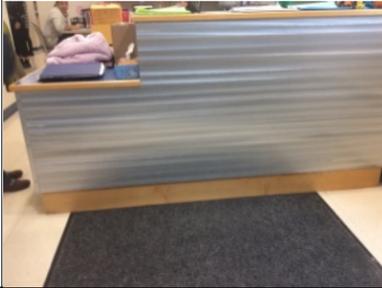
Mat not securely attached	-	Securely attach mat.	1	Labor	\$0
17	Special Education Room	1	175	Interior Access Route	N/A

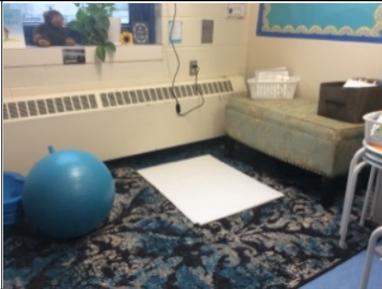
Mat not securely attached	-	Securely attach mat.	1	Labor	\$0
18	Classrooms Throughout the School	1	127, 222	Interior Access Route	N/A

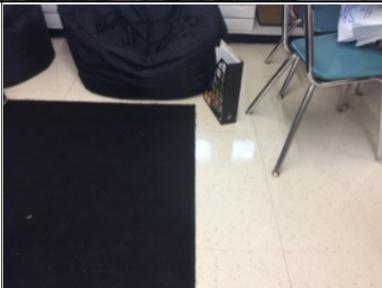
Mat not securely attached	-	Securely attach mats.	2	Labor	\$0
19	Math/Marine Environmental Lab	1	113	Interior Access Route	N/A

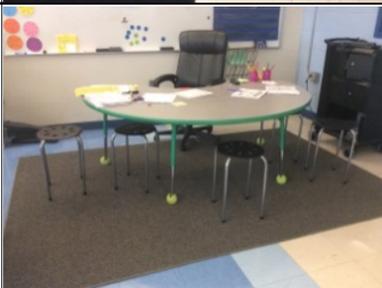
Mat not securely attached	-	Securely attach mat.	1	Labor	\$0

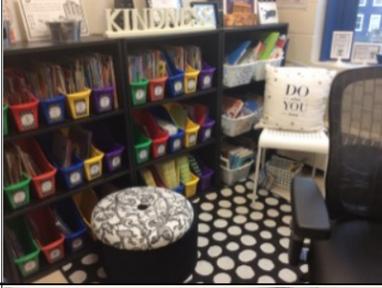
Mat not securely attached	-	Securely attach mat.	1	Labor	\$0
22	Reading Room	2	261	Interior Access Route	N/A

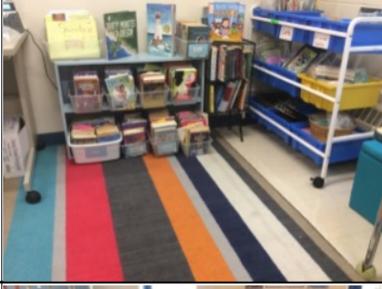
Mat not securely attached	-	Securely attach mat.	1	Labor	\$0
23	Music Room	2	270	Interior Access Route	N/A

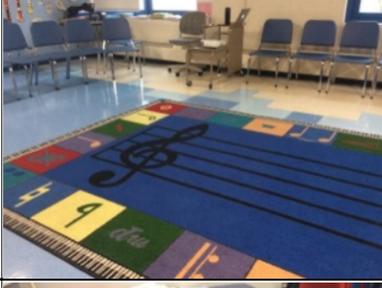
Mat not securely attached	-	Securely attach mat.	1	Labor	\$0
24	Faculty/ FLEX Room	2	235	Interior Access Route	N/A

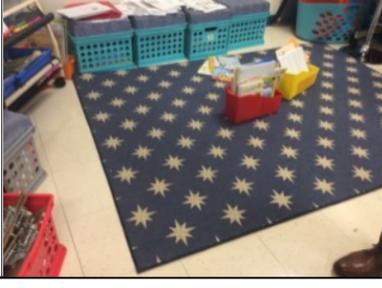
Mat not securely attached	-	Securely attach mat.	1	Labor	\$0

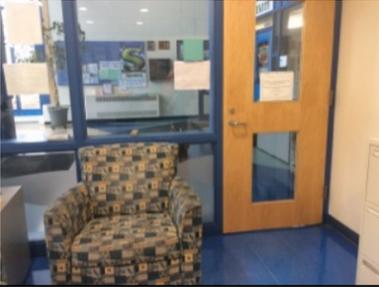
ID	Location	Floor	Room	Element	Type	Photo	Issues	Current Measure	Recommendations	Quantity	Price	Cost Estimation
<b>Doors, Doorways, &amp; Gates</b>												
25	Main Office	1	164	Doors, Doorways, & Gates	Office

Maneuvering clearance(s) not provided	14.75"	Move chair to the left in this image so as to maintain maneuvering clearance of at least 18" on the pull side of the door.	1	Labor	\$0
26	Health Suite	1	170	Doors, Doorways, & Gates	Office

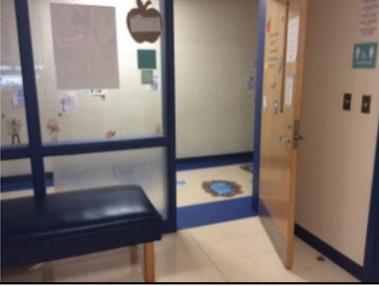
Maneuvering clearance(s) not provided	13.25"	Move bed to the left in this image so as to maintain maneuvering clearance of at least 18" on the pull side of the door.	1	Labor	\$0
27	Health Suite, Bathing Room	1	170	Doors, Doorways, & Gates	Toilet Room

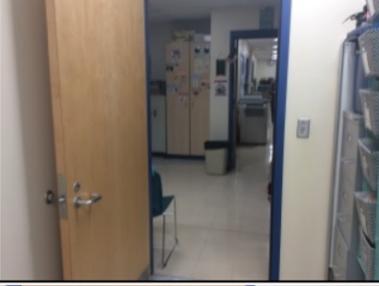
Maneuvering clearance(s) not provided	13.5"	Remove the clutter in the shower compartment so as to maintain maneuvering clearance of at least 18" on the pull side of the door.	1	Labor	\$0
28	Men's Staff Toilet Room	1		Doors, Doorways, & Gates	Toilet Room

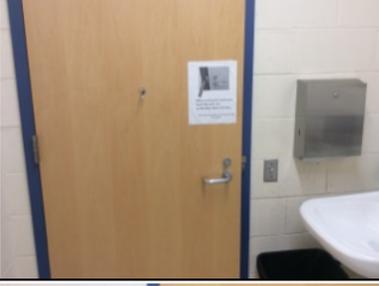
Maneuvering clearance(s) not provided	6"	Provide an automatic door opener.	1	2295	\$2295

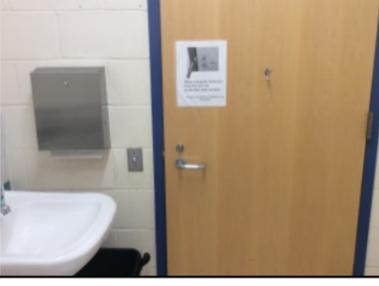
29	Women's Staff Toilet Room	1		Doors, Doorways, & Gates	Toilet Room

Maneuvering clearance(s) not provided	6"	Provide an automatic door opener.	1	2295	\$2295

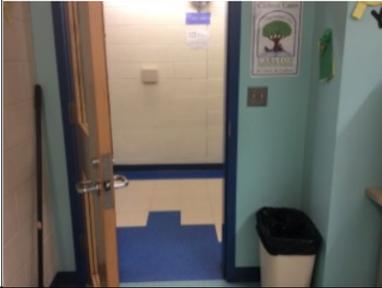
Maneuvering clearance(s) not provided	-	Relocate trash bins.	4	Labor	\$0
32	Grades 2 and 3 and Grade 1 Math (FLEX Classroom)	1	125	Doors, Doorways, & Gates	Classroom

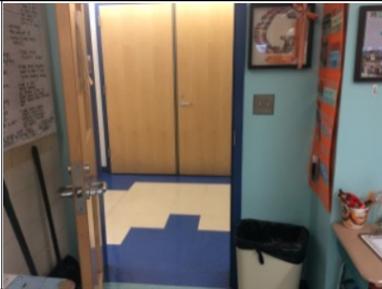
Maneuvering clearance(s) not provided	-	Relocate trash bin.	1	Labor	\$0
33	Kindergarten Classroom	1	109	Doors, Doorways, & Gates	Classroom

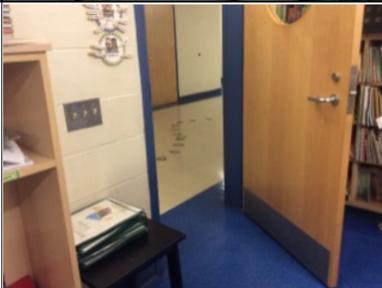
Maneuvering clearance(s) not provided	-	Relocate table.	1	Labor	\$0
34	Speech and Language Room	2	253	Doors, Doorways, & Gates	Office

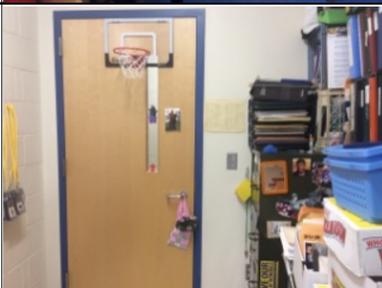
Maneuvering clearance(s) not provided	15.5"	Rearrange room so as to maintain maneuvering clearance of at least 18" on the pull side of the door.	1	Labor	\$0

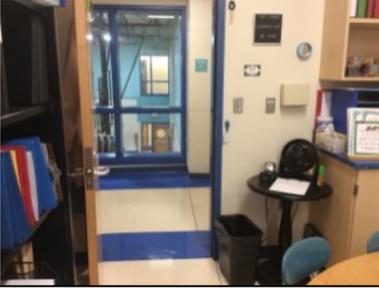
ID	Location	Floor	Room	Element	Type	Photo	Issues	Current Measure	Recommendations	Quantity	Price	Cost Estimation
35	Inclusion Classroom	2	260	Doors, Doorways, & Gates	Classroom

Maneuvering clearance(s) not provided	-	Relocate clutter so as to maintain maneuvering clearance of at least 18" on the pull side of the door.	1	Labor	\$0
36	Reading Room	2	261	Doors, Doorways, & Gates	Classroom

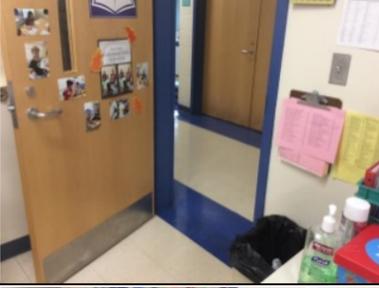
Maneuvering clearance(s) not provided	-	Rearrange room so as to maintain maneuvering clearance of at least 18" on the pull side of the door.	1	Labor	\$0
37	Literacy Coach	2	262	Doors, Doorways, & Gates	Classroom

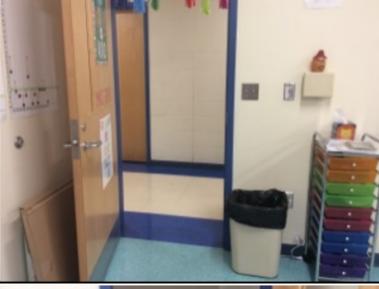
Maneuvering clearance(s) not provided	-	Relocate trash bin and storage bin.	1	Labor	\$0
38	OT Room	2	264	Doors, Doorways, & Gates	Classroom

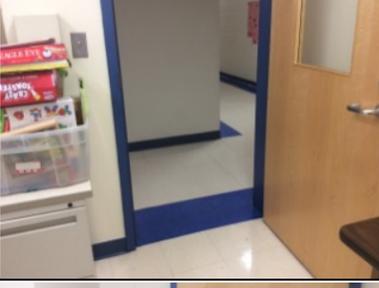
Maneuvering clearance(s) not provided	-	Rearrange room so as to maintain maneuvering clearance of at least 18" on the pull side of the door.	1	Labor	\$0

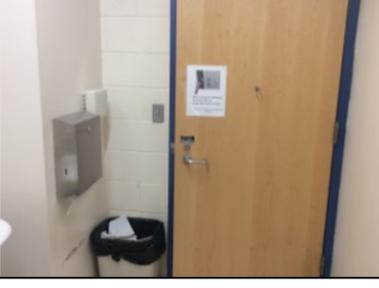
39	Women's Staff Toilet Room	2		Doors, Doorways, & Gates	Toilet Room

Maneuvering clearance(s) not provided	14.75"	Provide an automatic door opener.	1	2295	\$2295

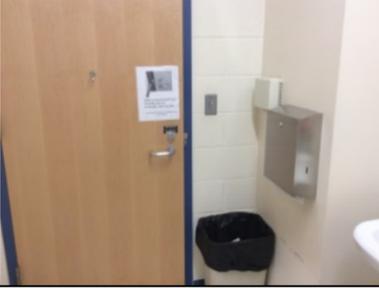
ID	Location	Floor	Room	Element	Type	Photo	Issues	Current Measure	Recommendations	Quantity	Price	Cost Estimation
40	All Gender Toilet Room Near 223	2		Doors, Doorways, & Gates	Toilet Room

Maneuvering clearance(s) not provided	12.5"	Provide an automatic door opener.	1	2295	\$2295
41	Art Room	2	213	Doors, Doorways, & Gates	Classroom

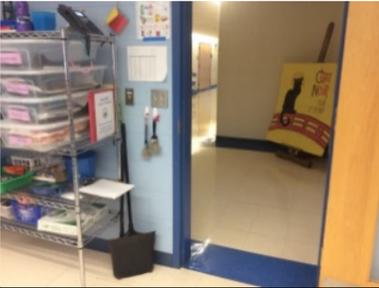
Maneuvering clearance(s) not provided	14.5"	Rearrange room so as to maintain maneuvering clearance of at least 18" on the pull side of the door.	1	Labor	\$0
42	Distance Learning Room	2	206	Doors, Doorways, & Gates	Classroom

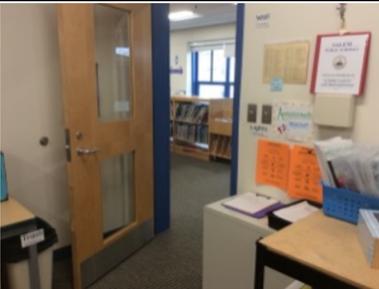
Maneuvering clearance(s) not provided	-	Rearrange room so as to maintain maneuvering clearance of at least 18" on the pull side of the door.	1	Labor	\$0
43	Music Room	2	270	Doors, Doorways, & Gates	Classroom

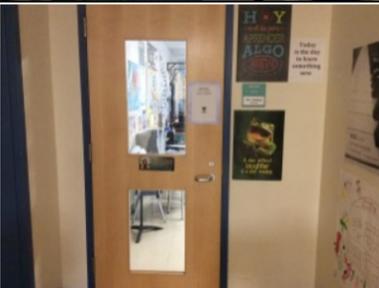
Door requires > 5 lbs. of force to open	11 lbs.	Adjust closers so doors do not require more than 5 pounds of force to open.	1	Labor	\$0

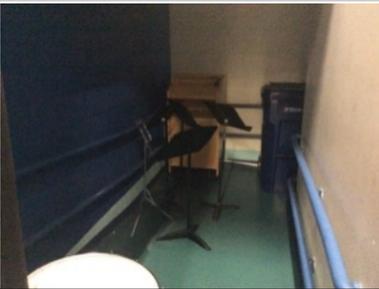
<b>Ramps</b>												
44	Cafetorium, Route to Stage	1	133	Ramps	Interior

Not maintained in operable working condition	-	Ensure the ramp is maintained in operable working condition by remove stored items from ramp.	1	Labor	\$0

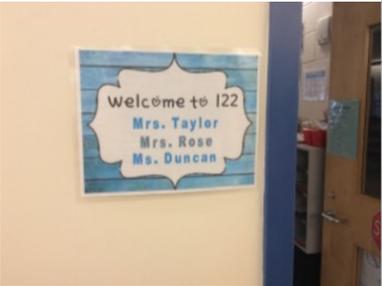
ID	Location	Floor	Room	Element	Type	Photo	Issues	Current Measure	Recommendations	Quantity	Price	Cost Estimation
<b>Signage</b>												
45	Classroom	1	122	Signage	Designation

Raised characters not provided Braille not provided	- -	Provide text with raised characters duplicated in braille.	1	174	\$174
46	All Gender Toilet Room Near 223	2		Signage	Designation

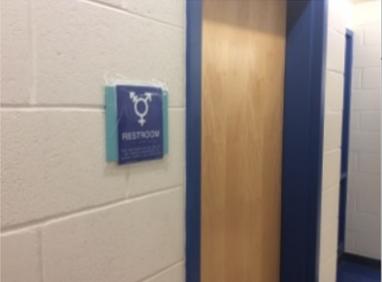
Raised characters not provided Braille not provided International Symbol of Acc. not compliant	- - -	Provide text with raised characters duplicated in braille for All Gender toilet room sign. Provide sign with raised characters and braille containing the International Symbol of Accessibility (ISA).	2	174	\$348
47	Practice Room in Music Room	2	272	Signage	Designation

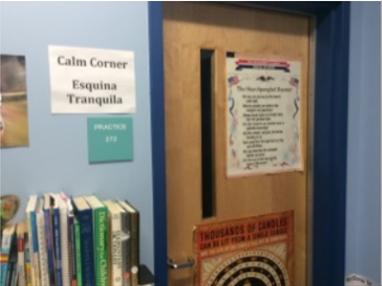
Designation sign does not reflect current use		Provide accurate designation sign with raised characters and braille mounted on the latch side of the door. (Designation sign does not reflect long term use of room. It reads "Practice", but the room is being used as storage and as a "Calm Corner").	1	174	\$174

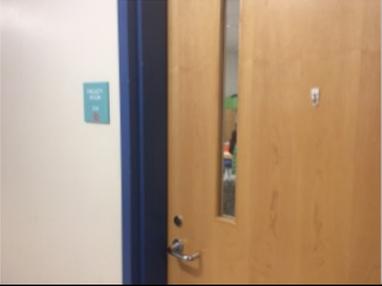
48	Faculty/ FLEX Room	2	235	Signage	Designation

Designation sign does not reflect current use		Provide accurate designation sign with raised characters and braille mounted on the latch side of the door. (Designation sign does not reflect long term use of room. It reads "Faculty", but the room is being used as a classroom for multiple grades.)	1	174	\$174
<b>Operable Parts</b>												
49	Near Main Entrance	Ext.		Operable Parts	Other

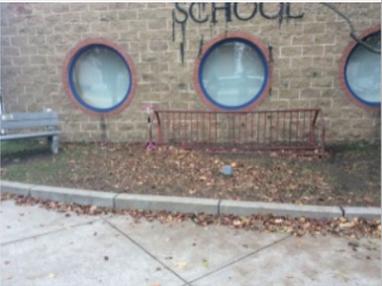
Element not on an accessible route	-	Ensure bike rack is located on an accessible route.	1	Labor	\$0

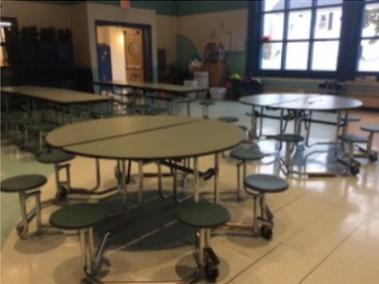
ID	Location	Floor	Room	Element	Type	Photo	Issues	Current Measure	Recommendations	Quantity	Price	Cost Estimation
<b>Dining or Work Surfaces</b>												
50	Cafetorium	1	133	Dining or Work Surfaces	Dining Surface

At least one or 5% accessible tables not provided	-	Ensure that at least one dining surface is accessible.	1	825	\$825
51	Grades 1 and 2 Classroom	1	127, 222	Dining or Work Surfaces	Work Surface

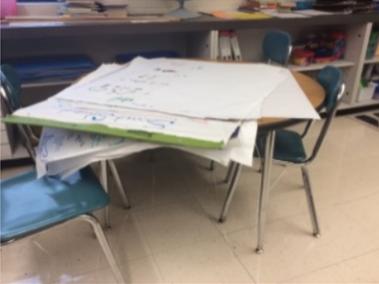
Knee or toe clearance not provided	22.25"	Adjust at least 1 work surface per room so that it has 24" min. knee and toe clearance.	2	Labor	\$0
52	Greenhouse in Math/ Environmental Lab	1	113	Dining or Work Surfaces	Work Surface

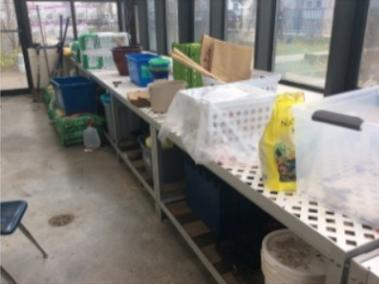
Knee or toe clearance not provided	-	Provide at least 1 work surface with 24" min. knee and toe clearance.	1	525	\$525
53	Kindergarten Classroom	1	109	Dining or Work Surfaces	Work Surface

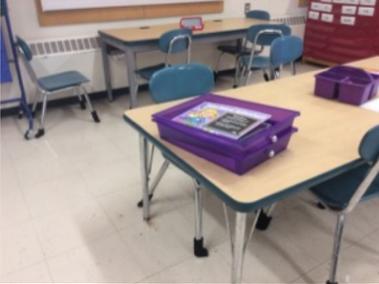
Knee or toe clearance not provided	19.75"	Adjust at least 1 work surface so that it has 24" min. knee and toe clearance.	1	Labor	\$0

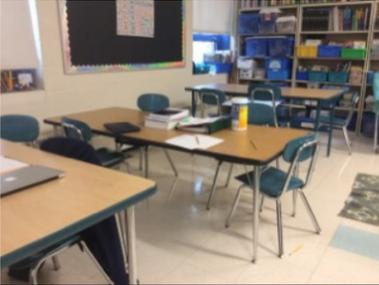
54	Small Classroom	2	252	Dining or Work Surfaces	Work Surface

Knee or toe clearance not provided	22.25"	Adjust at least 1 work surface so that it has 24" min. knee and toe clearance.	1	Labor	\$0

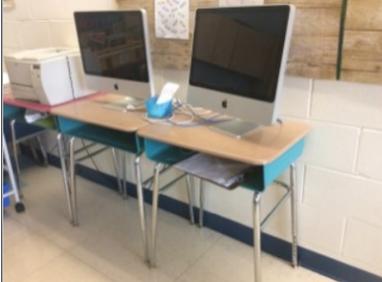
ID	Location	Floor	Room	Element	Type	Photo	Issues	Current Measure	Recommendations	Quantity	Price	Cost Estimation
55	Grades 4 and 5 Classroom	2	227	Dining or Work Surfaces	Work Surface

Knee or toe clearance not provided	23"	Provide at least 1 work surface with 24" min. knee and toe clearance.	1	525	\$525
56	Reading Area in Library	2	205	Dining or Work Surfaces	Work Surface

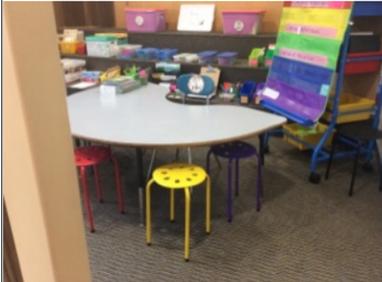
Knee or toe clearance not provided	23"	Adjust at least 1 work surface so that it has 24" min. knee and toe clearance.	1	Labor	\$0
<b>Benches</b>												
57	Near Main Entrance	Ext.		Benches	N/A

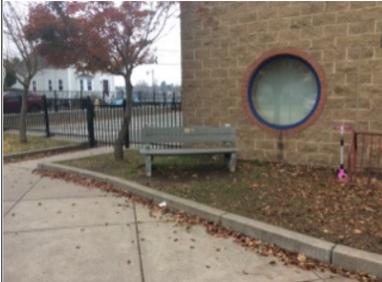
No accessible route to 20% of benches	-	Relocate 20% of benches (1) to an accessible route.	1	Labor	\$0
<b>Toilet &amp; Bathing Rooms</b>												
<b>Lavatory</b>												
58	Men's Staff Toilet Room	1		Lavatory	N/A

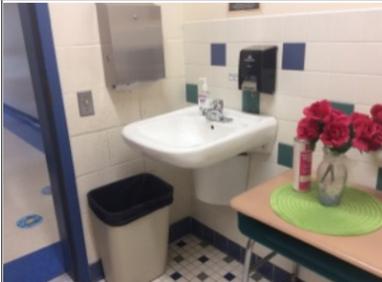
Clear floor space not provided at lavatory	-	Provide at least one lavatory with a 30" min. by 48" min. clear floor space positioned for a forward approach. Relocate clutter.	1	Labor	\$0

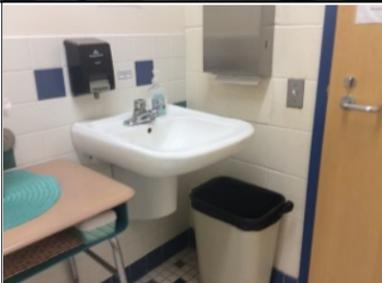
59	Women's Staff Toilet Room	1		Lavatory	N/A

Clear floor space not provided at lavatory	-	Provide at least one lavatory with a 30" min. by 48" min. clear floor space positioned for a forward approach. Relocate clutter.	1	Labor	\$0

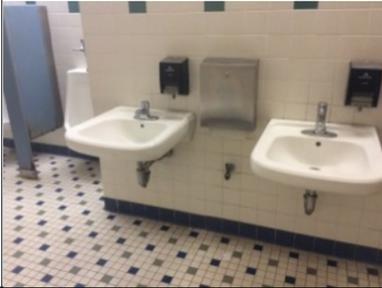
Plumbing underneath is exposed	-	Insulate or otherwise configure pipes to prevent contact, for at least one lavatory.	1	69	\$69
62	Girls' Toilet Room	1		Lavatory	N/A

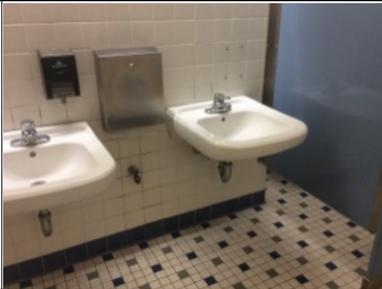
Plumbing underneath is exposed	-	Insulate or otherwise configure pipes to prevent contact, for at least one lavatory.	1	69	\$69
63	Girls' Toilet Room	2		Lavatory	N/A

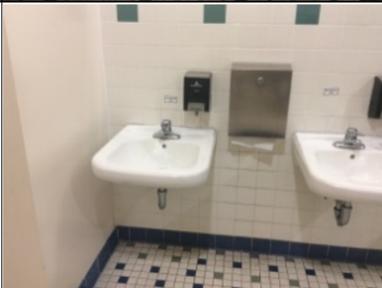
Plumbing underneath is exposed	-	Insulate or otherwise configure pipes to prevent contact, for at least one lavatory.	1	69	\$69
<b>Single-User Toilet</b>

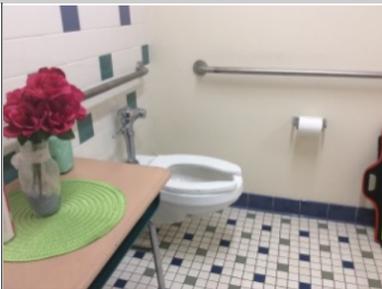
64	Men's Staff Toilet Room	1		Single-User Toilet	N/A

Clearance at toilet < 60" clear width	-	Provide a clear floor space that is 60" wide min. and/or provide sign to accessible toilet. (Relocate desk.)	1	Labor	\$0

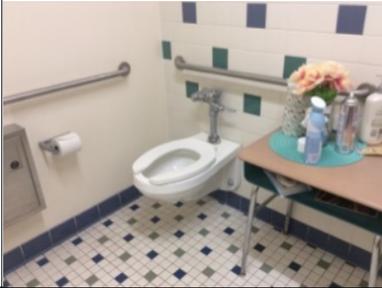
Clearance at toilet < 60" clear width	-	Provide a clear floor space that is 60" wide min. and/or provide sign to accessible toilet. (Relocate desk.)	1	Labor	\$0
67	All Gender Toilet Room Near 223	2		Single-User Toilet	N/A

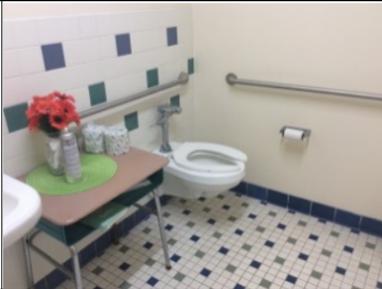
Clearance at toilet < 60" clear width	-	Provide a clear floor space that is 60" wide min. and/or provide sign to accessible toilet. (Relocate desk.)	1	Labor	\$0
68	Health Suite, Bathing Room	1	170	Single-User Toilet	N/A

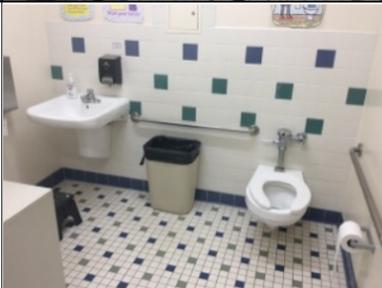
Clearance at toilet < 72" clear depth	49.5"	Remove storage unit.	1	Labor	\$0

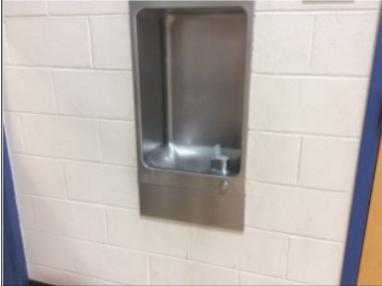
No drinking fountain provided for seated users	-	Provide an additional drinking fountain for seated users or install a Hi-Lo drinking fountain.	1	3021	\$3021
<b>Sink</b>												
77	Faculty/ FLEX Room	2	235	Sink	Classroom

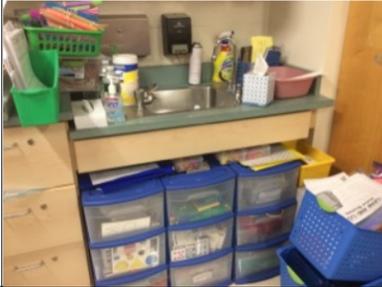
Clear floor space not provided at sink	-	Provide a 30" by 48" clear floor space positioned for a forward approach by removing clutter.	1	Labor	\$0

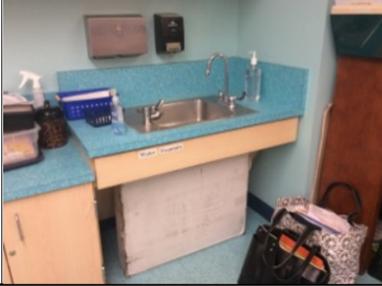
78	Classrooms Throughout School	1	127, 125, 227, 222	Sink	Classroom

Clear floor space not provided at sink Toe and knee clearances not provided	- 23.5"	Provide a 30" by 48" clear floor space positioned for a forward approach by removing clutter. Ensure there is a 25" knee clearance positioned for a forward approach.	4	1265	\$5060

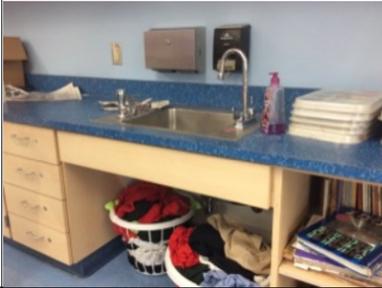
Clear floor space not provided at sink Toe and knee clearances not provided Exposed plumbing underneath sink	- 23.5" -	Provide a 30" by 48" clear floor space positioned for a forward approach by removing clutter. Ensure there is a 25" knee clearance positioned for a forward approach. Insulate or otherwise configure pipes at sink.	1	1334	\$1334
81	Music Room	2	270	Sink	Classroom

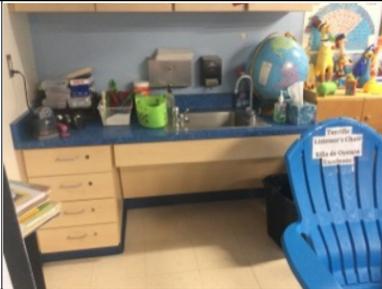
Toe and knee clearances not provided	23.5"	Ensure there is a 25" knee clearance positioned for a forward approach.	1	1265	\$1265
