**City of Salem,  
Massachusetts**

December 2019

# Salem City Hall

## City of Salem ADA Transition Plan

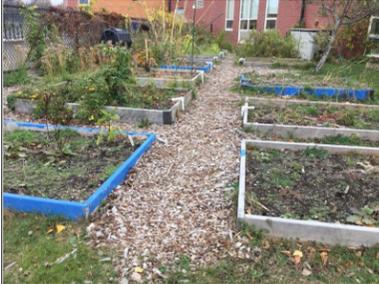
ID	Location	Floor	Room	Element	Type	Photo	Issues	Current Measure	Recommendations	Quantity	Price	Cost Estimation
<b>Approach and Entrance</b>												
<b>Exterior Access Route</b>												
1	Community Garden Southeast Side	Ext		Exterior Access Route	Exterior

Exterior route < 36" wide Surface is not stable, firm, and slip-resistant	29.75" -	Ensure that a clear width of 36" min. is maintained at the accessible route. Repair surface.  (Cost based on 50' by 4' wide stone dust path in garden area.)	1	1200	\$1200
2	Ramp to Main Entrance	Ext		Exterior Access Route	Exterior

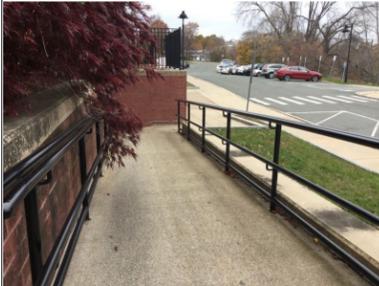
Obstructed by protruding objects	-	Trim low hanging branches in trees.	1	Labor	\$0
3	Benches Near Community Garden	Ext		Exterior Access Route	Exterior

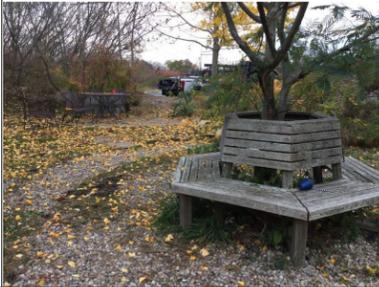
Accessible route not provided	-	Ensure an accessible route is provided.  See ID #4 cost.	1	-	\$0
4	Route to Community Garden	Ext		Exterior Access Route	Exterior

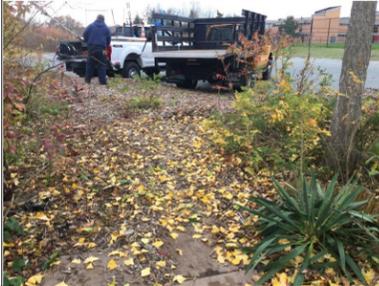
Accessible route not provided	-	Ensure an accessible route is provided.  (Cost based on 120' by 4' wide stone dust path to bench, picnic area, and garden.)	1	2880	\$2880

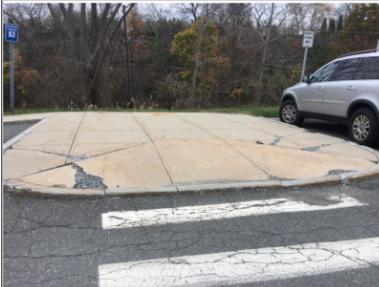
<b>Curb Ramp</b>												
5	Accessible Route to Main Entrance From Parking Lot	Ext		Curb Ramp	N/A

Transition from curb ramp to street not flush Surface not stable, firm and slip-resistant	1" -	Ensure transition from curb ramp to street is flush. Repair surface.	1	155	\$155

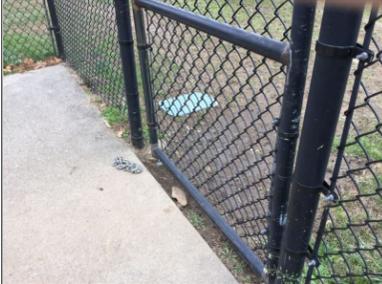
Level changes > 1/4"	3"	Alter change in level to be 1/4" high max.	1	155	\$155
8	Playground Near Kindergarten Wing	Ext		Entrance	Gate

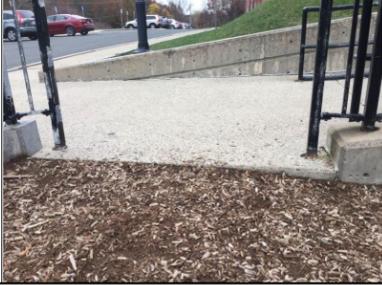
Level changes > 1/4"	1"	Alter change in level to be 1/4" high max.	1	155	\$155
<b>Ramps</b>												
9	Ramp to Main Entrance	Ext		Ramps	Exterior

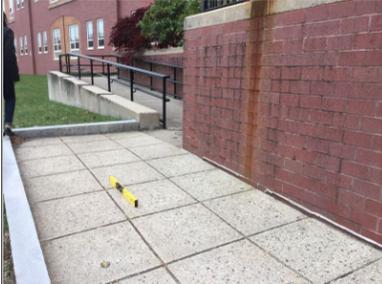
-	Provide handrails with 1 1/4"- 2" circular cross sections or 4"- 6 1/4" non-circular cross sections. Mount handrails between 34"- 38" high above the floor. Provide a lower handrail between 18" to 20" high. (Cost based on two sets of 10' long metal railings.)	4	555	\$2220

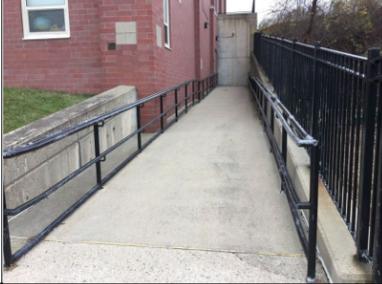
10	Ramp at Exit #10, Near Kindergarten Wing	Ext		Ramps	Exterior

Handrails do not extend 12" past top & bottom	-	Alter handrails to extend horizontally above the landing for 12" min. beyond the top and bottom of ramp runs.	2	600	\$1200

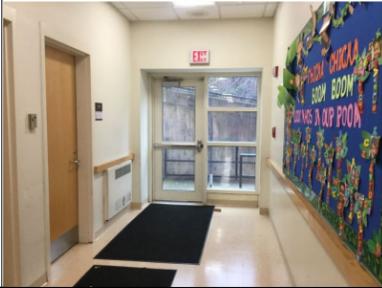
Illuminated sign lacks the International Symbol of Accessibility Tactile exit sign not provided Mat not securely attached	- - -	Ensure the illuminated exit sign contains the International Symbol of Accessibility (ISA). Ensure a tactile exit sign with raised characters and braille is provided at exit door. Mount sign between 48"- 60" above finished floor located on the wall adjacent to the latch side of the door. Securely attach mat.	1	274	\$274
13	Main Entrance, Exit #1	1		Means of Egress	N/A

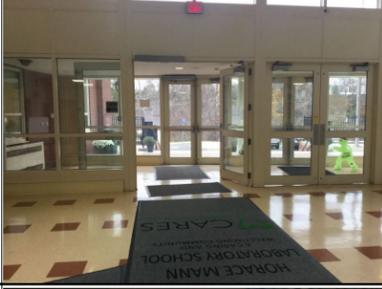
Illuminated sign lacks the International Symbol of Accessibility Tactile exit sign not provided Mat not securely attached	- - -	Ensure illuminated exit sign contains the International Symbol of Accessibility (ISA). Ensure tactile exit sign with raised characters and braille is provided at exit door. Mount signs between 48"- 60" above finished floor located on the wall adjacent to the latch side of the door. Securely attach mat.	1	274	\$274

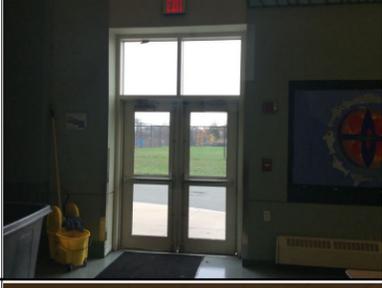
14	Exit #5, From Cafeteria	2	241	Means of Egress	N/A

Illuminated sign lacks the International Symbol of Accessibility Tactile exit sign not provided Mat not securely attached	- - -	Ensure illuminated exit sign contains the International Symbol of Accessibility (ISA). Ensure a tactile exit sign with raised characters and braille is provided at exit door. Mount signs between 48"- 60" above finished floor located on the wall adjacent to the latch side of the door. Securely attach mat.	1	274	\$274
15	Exit #6, Near Cafeteria	2		Means of Egress	N/A

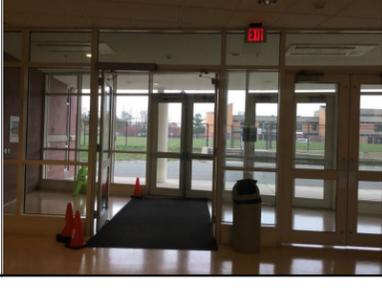
Illuminated sign lacks the International Symbol of Accessibility Tactile exit sign not provided	- - -	Ensure illuminated exit sign contains the International Symbol of Accessibility (ISA). Ensure a tactile exit sign with raised characters and braille is provided at exit door. Mount sign between 48"- 60" above finished floor located on the wall adjacent to the latch side of the door.	1	274	\$274

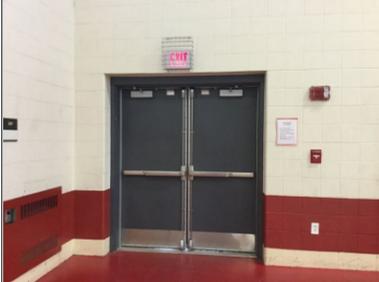
ID	Location	Floor	Room	Element	Type	Photo	Issues	Current Measure	Recommendations	Quantity	Price	Cost Estimation
16	Exit #9, in Gym	2		Means of Egress	N/A

Illuminated sign lacks the International Symbol of Accessibility Tactile exit sign not provided	- -	Ensure illuminated exit sign contains the International Symbol of Accessibility (ISA). Ensure tactile exit sign with raised characters and braille is provided at exit door. Mount sign between 48"- 60" above finished floor located on the wall adjacent to the latch side of the door.	1	274	\$274
17	Exit #7, in Gym	2	261	Means of Egress	N/A

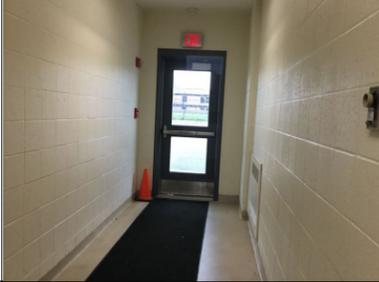
Illuminated sign lacks the International Symbol of Accessibility Tactile exit sign not provided Mat not securely attached	- - -	Ensure illuminated exit sign contains the International Symbol of Accessibility (ISA). Ensure tactile exit sign with raised characters and braille is provided at exit door. Mount sign between 48"- 60" above finished floor located on the wall adjacent to the latch side of the door. Securely attach mat.	1	274	\$274

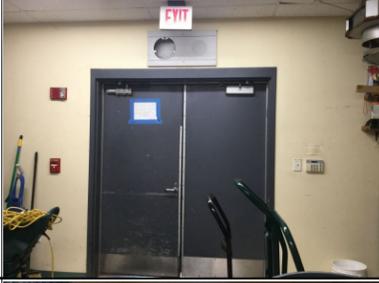
18	Exit #4, Near Cafeteria	2		Means of Egress	N/A

Illuminated sign lacks the International Symbol of Accessibility Tactile exit sign not provided	- -	Ensure illuminated exit sign contains the International Symbol of Accessibility (ISA). Ensure tactile exit sign with raised characters and braille is provided at exit door. Mount sign between 48"- 60" above finished floor located on the wall adjacent to the latch side of the door.	1	274	\$274
19	Exit #3, in Chorus Room	2	207	Means of Egress	N/A

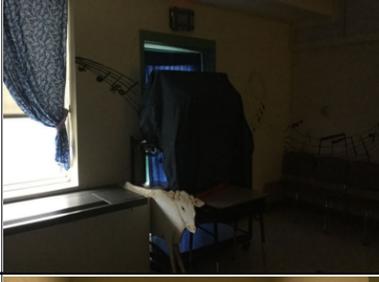
Illuminated sign lacks the International Symbol of Accessibility Tactile exit sign not provided	- -	Ensure illuminated exit sign contains the International Symbol of Accessibility (ISA). Ensure tactile exit sign with raised characters and braille is provided at exit door. Mount sign between 48"- 60" above finished floor located on the wall adjacent to the latch side of the door.	1	274	\$274

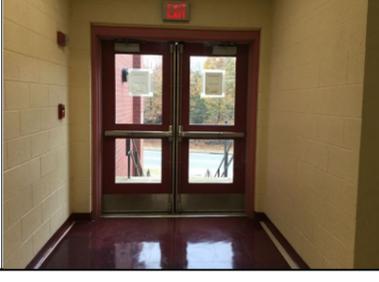
20	Exit #2, Near Pathways Hallway	1		Means of Egress	N/A

Tactile exit sign not provided	- -	Ensure tactile exit sign with raised characters and braille is provided at exit door. Mount sign between 48"- 60" above finished floor located on the wall adjacent to the latch side of the door. Provide a directional sign to the nearest accessible exit.	1	174	\$174

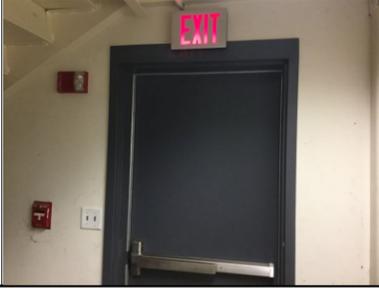
ID	Location	Floor	Room	Element	Type	Photo	Issues	Current Measure	Recommendations	Quantity	Price	Cost Estimation
21	Exit #8, Emergency Exit in Stair #3	2		Means of Egress	N/A

Tactile exit sign not provided	-	Ensure tactile exit sign with raised characters and braille is provided at exit door. Mount sign between 48"- 60" above finished floor located on the wall adjacent to the latch side of the door.	1	174	\$174
<b>Interior Access Route</b>												
22	Speech, Language Pathologist	3	361	Interior Access Route	N/A

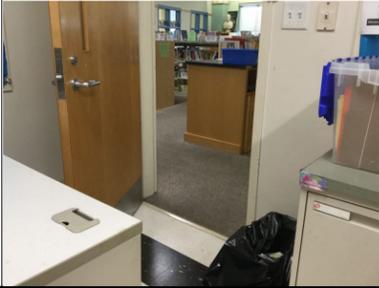
Route < 36" wide	19.5"	Ensure that a clear width of 36" min. is maintained at the accessible route.	1	Labor	\$0
23	Grade 5 ELA/Social Studies Classroom	3	308	Interior Access Route	N/A

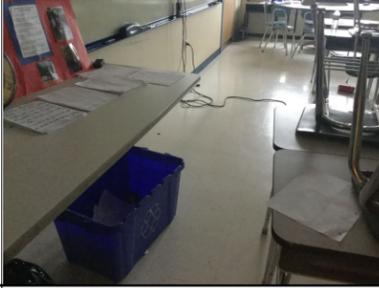
Route < 36" wide	20.25"	Ensure that a clear width of 36" min. is maintained at the accessible route.	1	Labor	\$0
24	Route to Greenhouse	3		Interior Access Route	N/A

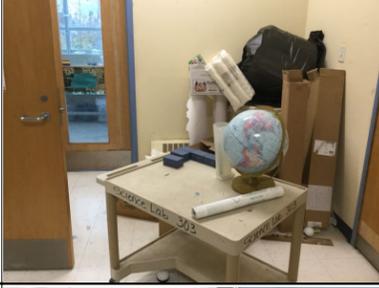
Route < 36" wide	-	Ensure that a clear width of 36" min. is maintained at the accessible route.	1	Labor	\$0

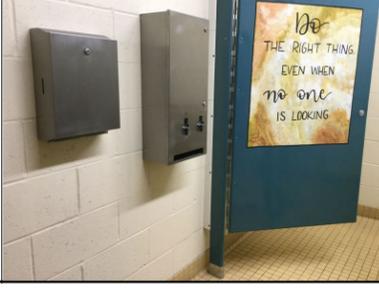
25	All Gender Student Multi-User Toilet Room Near Cafeteria	2		Interior Access Route	N/A

Obstructed by protruding objects	-	Relocate dispenser so it does not protrude into the circulation path.	1	192	\$192

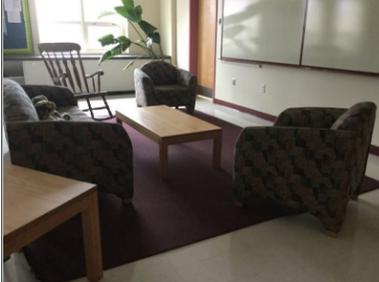
ID	Location	Floor	Room	Element	Type	Photo	Issues	Current Measure	Recommendations	Quantity	Price	Cost Estimation
26	Parent Lounge in Pathways Hallway	1	148	Interior Access Route	N/A

Mat not securely attached	-	Securely attach mat.	1	Labor	\$0
27	Classrooms Throughout the School	1, 2, 3	170, 248, 214, 346, 316, 314, 308	Interior Access Route	N/A

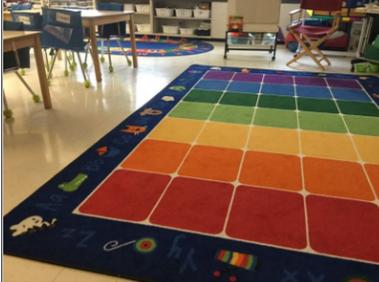
Mat not securely attached	-	Securely attach mats in at least one classroom per grade per topic (i.e. Grade 4 Math/ Science Classroom and Grade 4 ELA/ Social Studies Classroom.)	7	Labor	\$0
28	ESL Classroom, Chorus Room, Inclusion Teacher, Occupational Therapist's Office	2, 3	222, 207, 312, 366	Interior Access Route	N/A

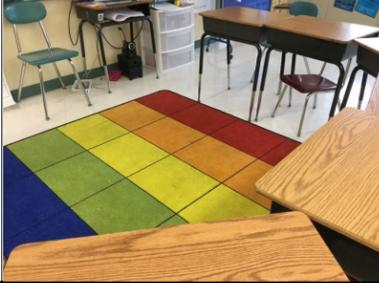
Mat not securely attached	-	Securely attach mat.	4	Labor	\$0
<b>Doors, Doorways, &amp; Gates</b>												
29	Main Office Exit to Nurse's Office	1		Doors, Doorways, & Gates	Circulation

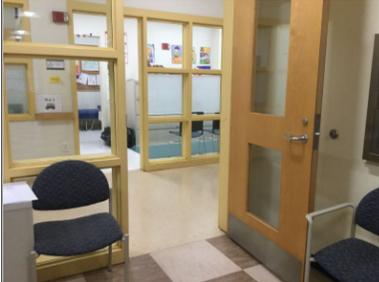
Maneuvering clearance(s) not provided	-	Relocate chair to maintain the maneuvering clearance at the door.	1	Labor	\$0

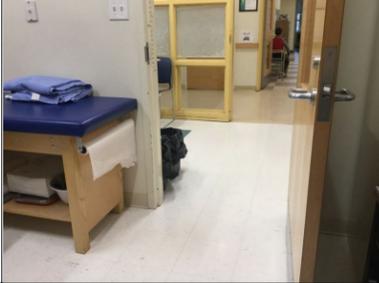
30	Exam Room in Nurse's Office	1	162	Doors, Doorways, & Gates	Other

Maneuvering clearance(s) not provided	-	Relocate exam table to maintain the maneuvering clearance at the door.	1	Labor	\$0

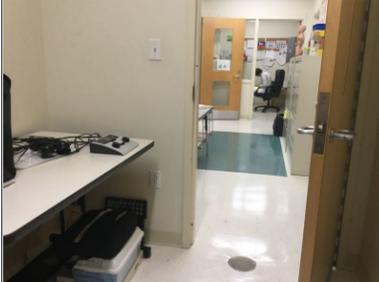
ID	Location	Floor	Room	Element	Type	Photo	Issues	Current Measure	Recommendations	Quantity	Price	Cost Estimation
31	Exam Room in Nurse's Office	1	167	Doors, Doorways, & Gates	Other

Maneuvering clearance(s) not provided	-	Relocate table to maintain the maneuvering clearance at the door.	1	Labor	\$0
32	Kindergarten Classroom	1	170	Doors, Doorways, & Gates	Classroom

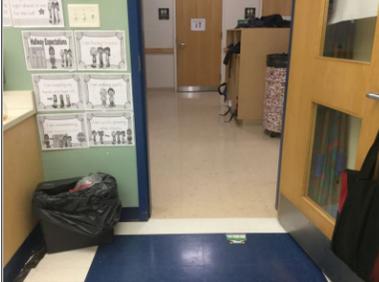
Maneuvering clearance(s) not provided	-	Relocate trash bin to maintain the maneuvering clearance at the door.	1	Labor	\$0
33	Principal's Office	1	157	Doors, Doorways, & Gates	Office

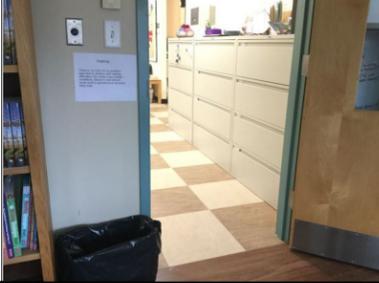
Maneuvering clearance(s) not provided	-	Relocate trash can to maintain the clear floor space at the door.	1	Labor	\$0
34	Parent Lounge in Pathways Hallway	1	148	Doors, Doorways, & Gates	Other

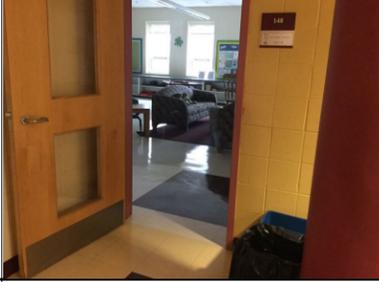
Maneuvering clearance(s) not provided	-	Relocate bin to maintain the maneuvering clearance at the door.	1	Labor	\$0
35	Office	2	256	Doors, Doorways, & Gates	Office

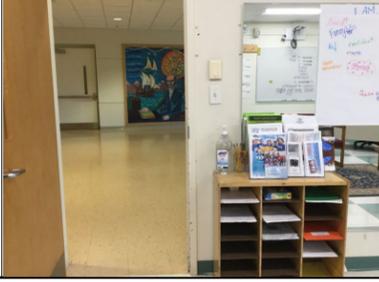
Maneuvering clearance(s) not provided	-	Relocate shelf to maintain the maneuvering clearance at the door.	1	Labor	\$0

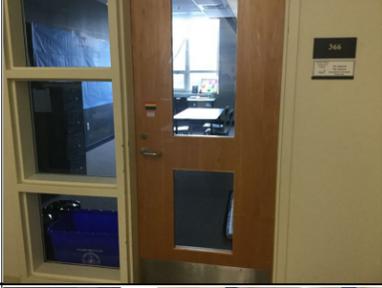
Maneuvering clearance(s) not provided	-	Relocate trash bin to maintain the maneuvering clearance at the door.	1	Labor	\$0
38	Professional Development Room	3	353	Doors, Doorways, & Gates	Classroom

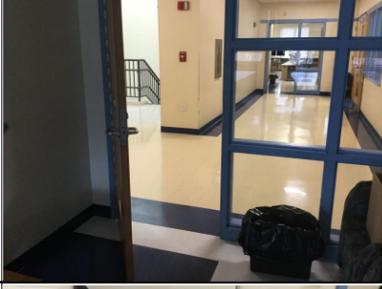
Maneuvering clearance(s) not provided	-	Relocate trash bin to maintain the maneuvering clearance at the door.	1	Labor	\$0
39	All Gender Staff Single-User Toilet Room	3		Doors, Doorways, & Gates	Toilet Room

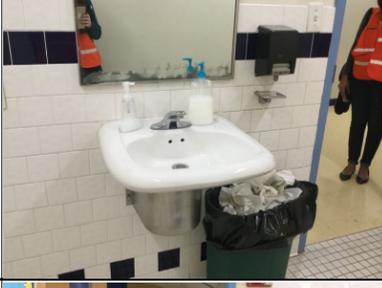
Maneuvering clearance(s) not provided	-	Relocate trash bin to maintain the maneuvering clearance at the door.	1	Labor	\$0

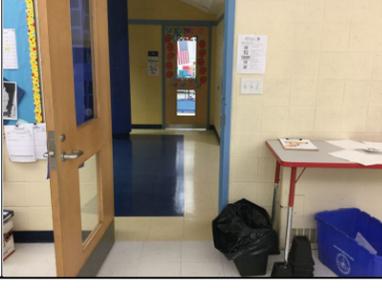
40	Inclusion Teacher	3	344	Doors, Doorways, & Gates	Classroom

Maneuvering clearance(s) not provided	-	Relocate trash bin and table to maintain the maneuvering clearance at the door.	3	Labor	\$0

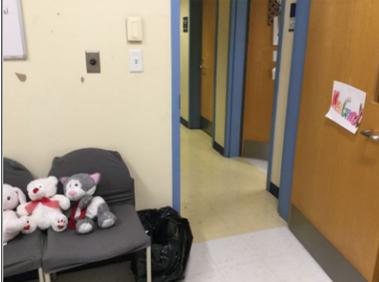
ID	Location	Floor	Room	Element	Type	Photo	Issues	Current Measure	Recommendations	Quantity	Price	Cost Estimation
41	Assistant Principal's Office Inclusion Teacher Science Lab A		324 312 303	Doors, Doorways, & Gates	Office

Maneuvering clearance(s) not provided	-	Relocate one chair and trash bin to maintain the maneuvering clearance at the door.	3	Labor	\$0
42	Greenhouse	3		Doors, Doorways, & Gates	Other

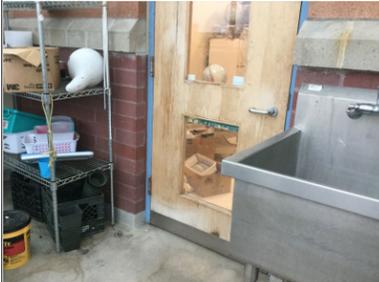
Maneuvering clearance(s) not provided	-	Revers the swing of the door and relocate shelves to ensure a 18" min. maneuvering clearance is maintained at the door.	1	1413	\$1413
43	ELL Reading Teacher	3	357	Doors, Doorways, & Gates	Office

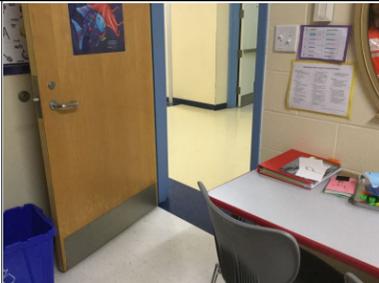
Maneuvering clearance(s) not provided	-	Relocate table to maintain the maneuvering clearance at the door.	1	Labor	\$0
44	All Gender Student Multi-User Toilet Room Near Cafeteria	2		Doors, Doorways, & Gates	Toilet Room

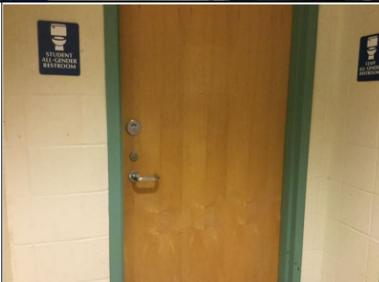
Door requires > 5 lbs. of force to open	15 lbs.	Adjust closers so doors do not require more than 5 pounds of force to open.	1	Labor	\$0

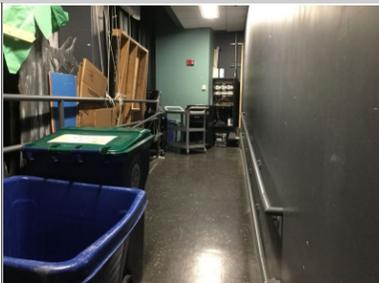
<b>Ramps</b>												
45	Accessible Route to Stage	2	249	Ramps	Interior

Not maintained in operable working condition	-	Ensure the ramp is maintained in operable working condition.	1	Labor	\$0

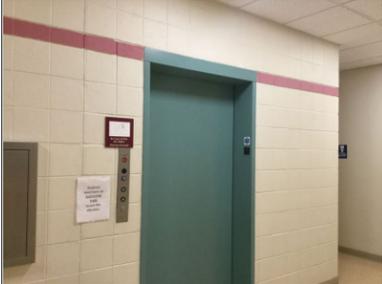
Hoistway signs not on both jambs	-	Provide hoistway signs on both sides of jambs.	3	48	\$144
<b>Signage</b>												
48	Women's Toilet Room in Gym	2	267	Signage	Designation

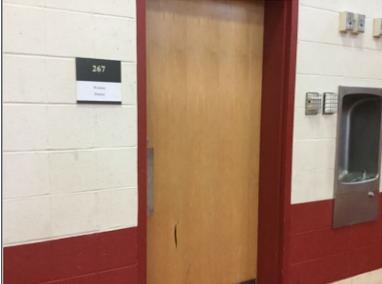
Raised characters not provided Braille not provided International Symbol of Acc. not compliant	- - -	Provide text with raised characters duplicated in braille. Replace sign with a sign containing the International Symbol of Accessibility.	1	174	\$174
49	Men's Toilet Room in Gym	2	261	Signage	Designation

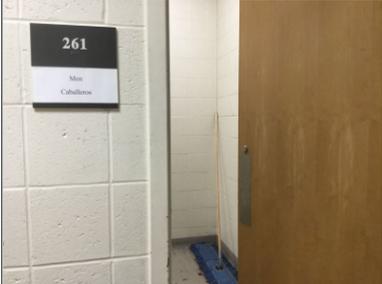
Raised characters not provided Braille not provided International Symbol of Acc. not compliant	- - -	Provide text with raised characters duplicated in braille. Replace sign with a sign containing the International Symbol of Accessibility.	1	174	\$174

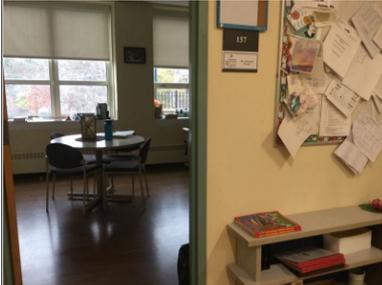
50	Principal's Office	1	157	Signage	Designation

Clear floor space not provided		Remove bookshelf to maintain the 18" min. by 18" min. clear floor space at sign.	1	Labor	\$0

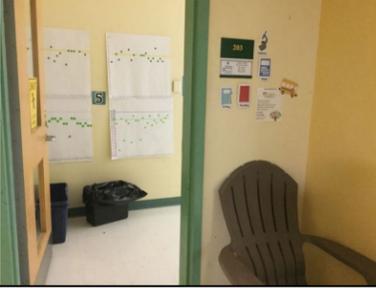
ID	Location	Floor	Room	Element	Type	Photo	Issues	Current Measure	Recommendations	Quantity	Price	Cost Estimation
51	Coaches Room and Art Room	2	203, 206	Signage	Designation

Clear floor space not provided		Relocate chair to maintain the 18" min. by 18" min. clear floor space at the sign.	2	Labor	\$0
52	Nurse's Office	1	165	Signage	Designation

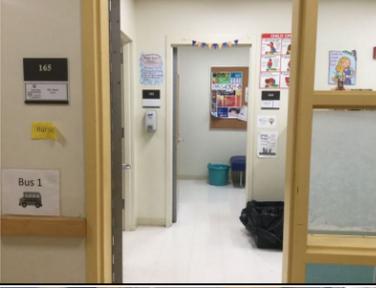
Sign not located on the latch side of the door	-	Locate sign on the wall adjacent to the latch side of the door.	1	Labor	\$0
53	Library	3	360	Signage	Designation

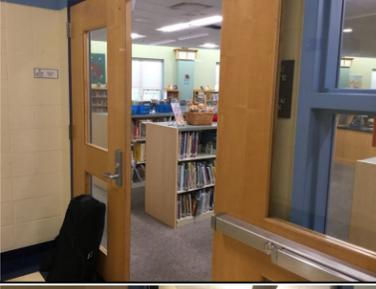
Sign not located on the latch side of the door	-	Locate sign on the wall adjacent to the latch side of the door.	1	Labor	\$0
54	Computer Lab	3	355	Signage	Designation

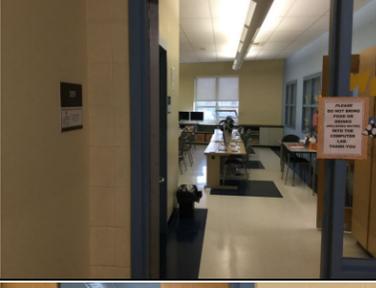
Sign not located on the latch side of the door	-	Locate sign at permanent rooms alongside the door on the latch side.	1	Labor	\$0
55	Professional Development Room	3	353	Signage	Designation

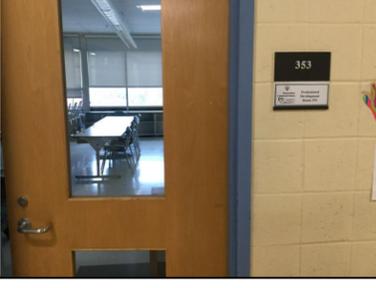
Sign not located on the latch side of the door	-	Locate sign on the wall adjacent to the latch side of the door.	1	Labor	\$0

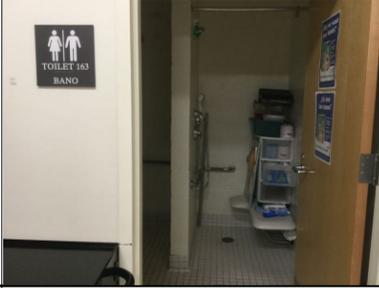
ID	Location	Floor	Room	Element	Type	Photo	Issues	Current Measure	Recommendations	Quantity	Price	Cost Estimation
56	Toilet Room in Nurse's Office	1	163	Signage	Designation

International Symbol of Acc. not compliant	-	Replace sign with a sign containing the International Symbol of Accessibility.	1	174	\$174
57	Staff Toilet Room Near Kindergarten	1	176	Signage	Designation

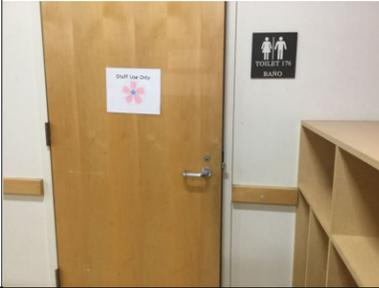
International Symbol of Acc. not compliant	-	Replace sign with a sign containing the International Symbol of Accessibility.	1	174	\$174
<b>Operable Parts</b>												
58	Women's and Men's Toilet Rooms in Gym	2	267, 261	Operable Parts	Other

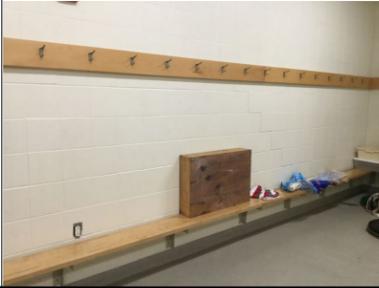
Clear floor space is not provided Side reach > 54"	- 65"	Relocate at least one coat hook so that controls are between 15" - 48" above finished floor.	1	192	\$192
59	Science Lab A	3	303	Operable Parts	Equipment

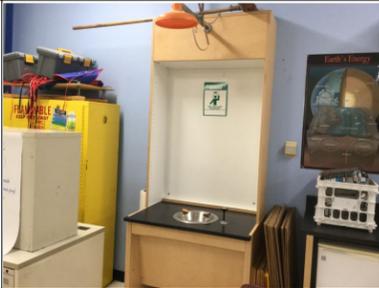
Reach < 15" or > 48"(forward/side approach)	62.75"	Relocate emergency eye wash pull string so that it is between 48" max. above finished floor.	1	192	\$192

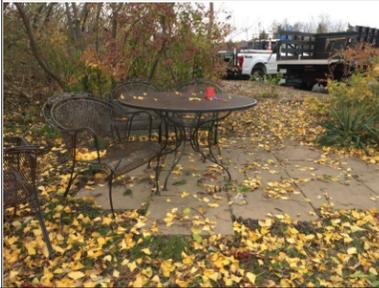
<b>Dining or Work Surfaces</b>												
60	Dining Table Near Garden	Ext		Dining or Work Surfaces	Dining Surface

Not on a accessible route	-	Ensure dining or work surfaces are located on an accessible route.  See ID #4 for cost.	1	-	\$0

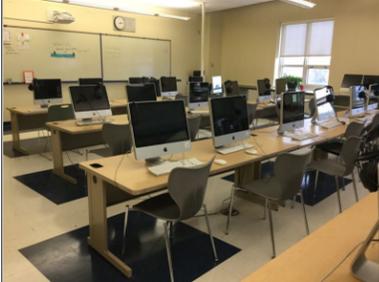
ID	Location	Floor	Room	Element	Type	Photo	Issues	Current Measure	Recommendations	Quantity	Price	Cost Estimation
61	Computer Lab	3	355	Dining or Work Surfaces	Work Surface

At least one or 5% accessible tables not provided Knee or toe clearance not provided	- -	Provide at least 1 work surface with 27" min. knee clearance.	1	525	\$525
62	Kindergarten Classroom	1	170	Dining or Work Surfaces	Work Surface

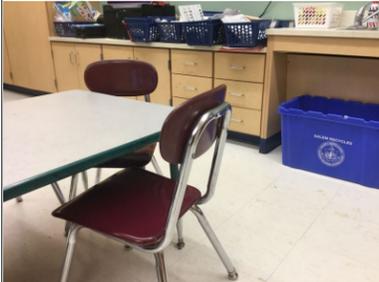
Knee or toe clearance not provided	20"	Adjust to ensure work surface provides a 27" min. knee clearance.	1	Labor	\$0
63	Kindergarten Classroom, Computer Station	1	170	Dining or Work Surfaces	Work Surface

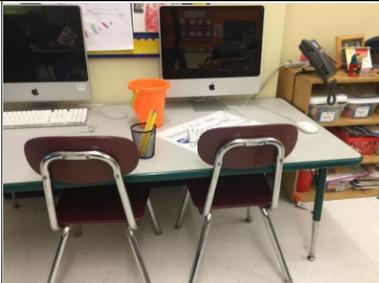
Knee or toe clearance not provided	19"	Adjust to ensure work surface provides a 27" min. knee clearance.	1	Labor	\$0
64	Office	2	256	Dining or Work Surfaces	Work Surface

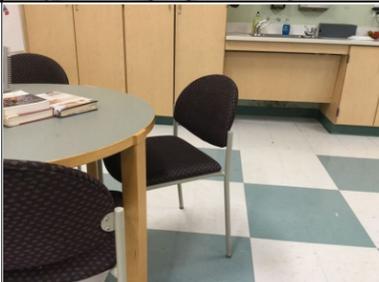
Knee or toe clearance not provided	24"	Provide at least 1 work surface with 27" min. knee clearance.	1	525	\$525

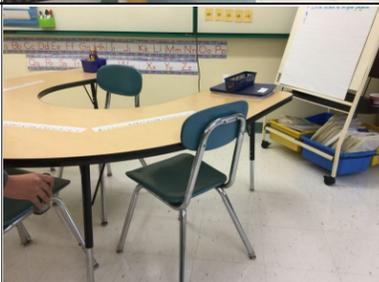
65	Reading Specialist	2	208	Dining or Work Surfaces	Work Surface

Knee or toe clearance not provided	23"	Adjust to ensure work surface provides a 27" min. knee clearance.	1	Labor	\$0

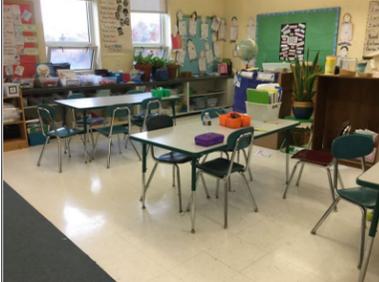
ID	Location	Floor	Room	Element	Type	Photo	Issues	Current Measure	Recommendations	Quantity	Price	Cost Estimation
66	Classrooms Throughout School	2,3	248, 214, 346, 316, 314, 308	Dining or Work Surfaces	Work Surface

Knee or toe clearance not provided	25"	Provide or adjust at least one work surface per grade per classroom topic (i.e. Grade 4 Math/Science Room and Grade 4 ELA/ Social Studies Classroom) so that there is 27" min. knee clearance.	6	Labor	\$0
67	Small Learning Room		328	Dining or Work Surfaces	Work Surface

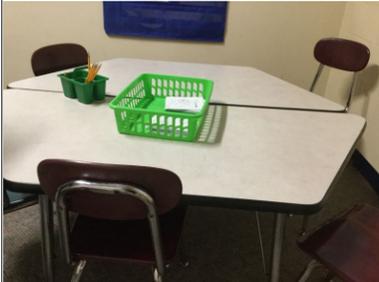
Knee or toe clearance not provided	21.25"	Adjust to ensure work surface provides a 27" min. knee clearance.	1	Labor	\$0
68	Assistant Principal's Office		324	Dining or Work Surfaces	Work Surface

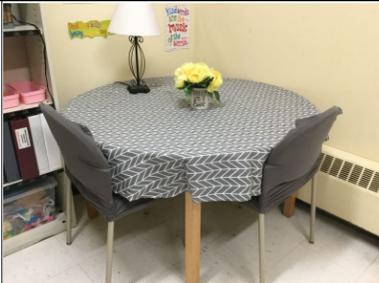
Knee or toe clearance not provided	25.5"	Provide at least 1 work surface with 27" min. knee clearance.	1	525	\$525
69	Science Lab B	3	306	Dining or Work Surfaces	Work Surface

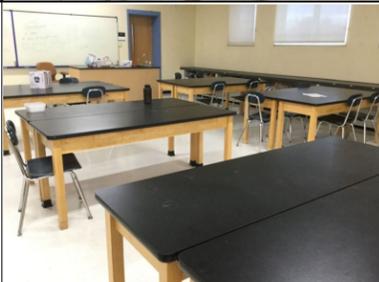
Knee or toe clearance not provided	23.5"	Provide at least 1 work surface with 27" min. knee clearance.	1	525	\$525

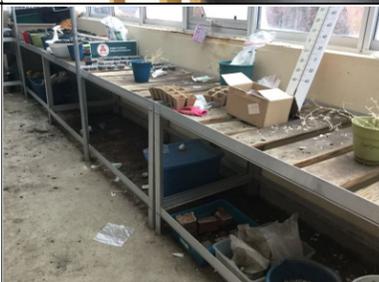
70	Greenhouse	3		Dining or Work Surfaces	Work Surface

Knee or toe clearance not provided	-	Provide at least 1 work surface with 27" min. knee and toe clearance.	1	525	\$525

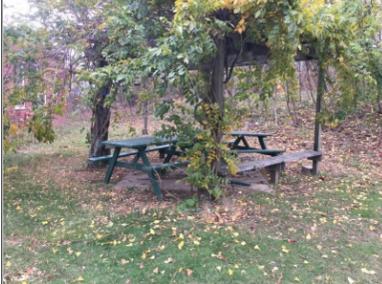
At least 5% accessible spaces not provided Picnic table not on an accessible route	- -	Ensure that at least one picnic table provides knee clearance. Ensure that the picnic table is connected to an accessible route.  See ID #4 for cost of route. (Cost based on one accessible picnic table.)	1	1050	\$1050
<b>Toilet &amp; Bathing Rooms</b>												
<b>Overall Access</b>												
73	Toilet Room Near Kindergarten	1	169	Overall Access	Toilet Room

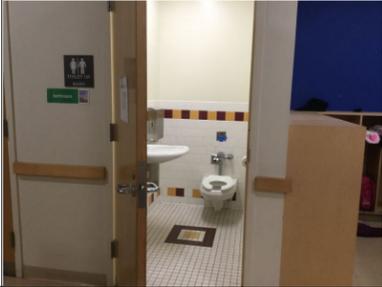
Sign to accessible toilet not provided	-	Provide a directional sign indicating the location of the nearest accessible toilet room.	1	174	\$174

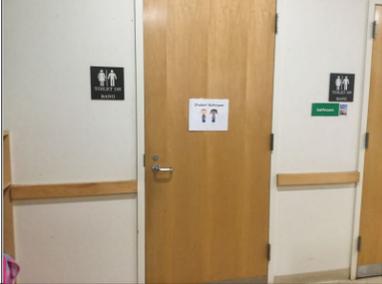
74	Toilet Room Near Kindergarten	1	168	Overall Access	Toilet Room

International Symbol of Acc. not provided	-	Provide a sign with the International Symbol of Accessibility.	1	174	\$174

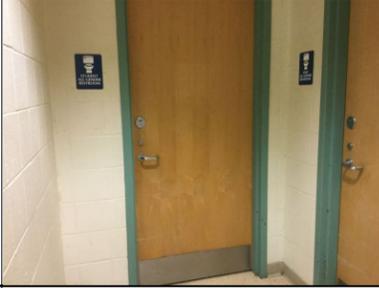
ID	Location	Floor	Room	Element	Type	Photo	Issues	Current Measure	Recommendations	Quantity	Price	Cost Estimation
75	All Gender Student Multi-User Toilet Room Near Cafeteria	2		Overall Access	Toilet Room

International Symbol of Acc. not provided	-	Provide a sign with the International Symbol of Accessibility.	1	174	\$174
76	All Gender Toilet Rooms Throughout School	1,2,3		Overall Access	Toilet Room

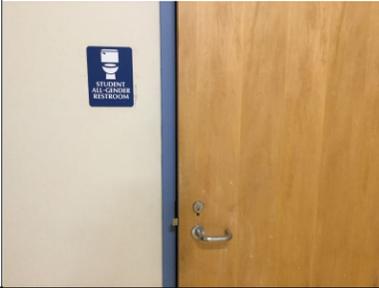
International Symbol of Acc. not provided	-	Provide signs with the International Symbol of Accessibility.	6	174	\$1044
77	Multi-User Boys' and Girls' Toilet Rooms Throughout School	1,2,3		Overall Access	N/A

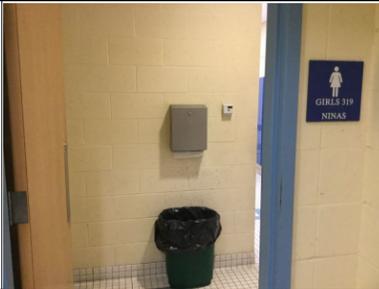
International Symbol of Acc. not provided	-	Provide signs with the International Symbol of Accessibility.	6	174	\$1044
<b>Lavatory</b>												
78	Women's Toilet Room in Gym, Single-User Bathing Room	2	265	Lavatory	N/A

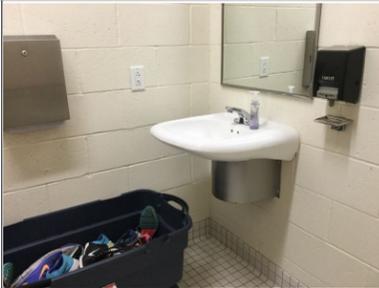
Toe or knee clearances not provided	-	Provide at least one lavatory with knee and toe clearance positioned for a forward approach by relocating shoe bin.	1	Labor	\$0

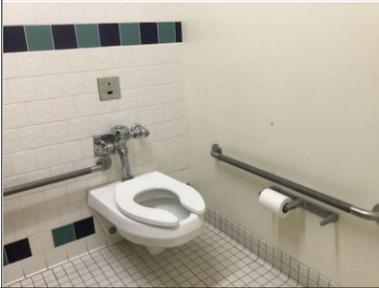
<b>Single-User Toilet</b>												
79	Staff Toilet Room Near Kindergarten	1	176	Single-User Toilet	N/A

Side or rear grab bar < 33" or > 36" high	21"	Mount grab bars 33"- 36" above the floor.	2	192	\$384

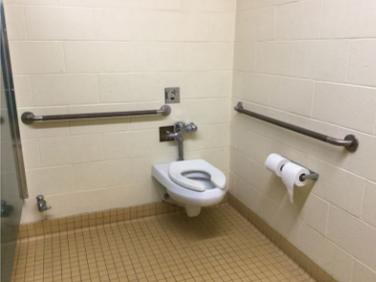
ID	Location	Floor	Room	Element	Type	Photo	Issues	Current Measure	Recommendations	Quantity	Price	Cost Estimation
85	All Gender Staff Multi-User Toilet Room Near Cafeteria	2		Toilet Compartment	Accessible Compartment

Door has malfunctioning self-closing hinge	-	Repair hinge.	1	Labor	\$0
86	Women's Toilet Room in Gym, Accessible Compartment	2	267	Toilet Compartment	Accessible Compartment

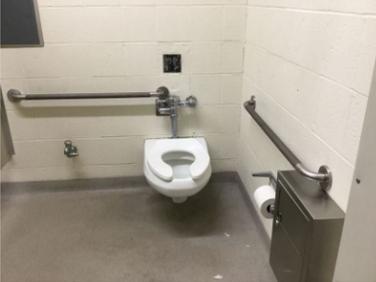
Door has malfunctioning self-closing hinge	-	Repair hinge.	1	Labor	\$0
87	Boys' Toilet Rooms	1,2		Toilet Compartment	Accessible Compartment

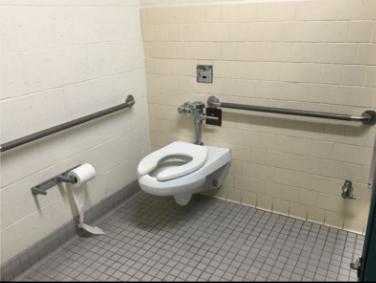
Door has malfunctioning self-closing hinge	-	Repair hinge.	1	Labor	\$0
88	Men's Toilet Room in Gym, Accessible Compartment	2	261	Toilet Compartment	Accessible Compartment

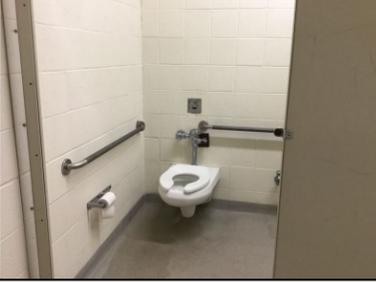
Not maintained in operable working condition	-	Add door to compartment to ensure accessible compartment is maintain in operable working condition.	1	165	\$165
<b>Urinal</b>

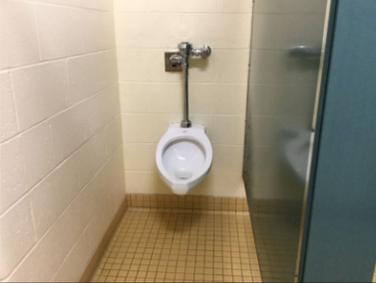
89	All Gender Staff Multi-User Toilet Room Near Cafeteria	2		Urinal	N/A

Rim > 17" high Urinal recessed > 24" deep has > 36" clear width	19" 32.5"	Provide an urinal with the rim no higher than 17" above the finished floor. If urinal is recessed greater than 24" ensure there is a clear width of 36".	1	2628	\$2628

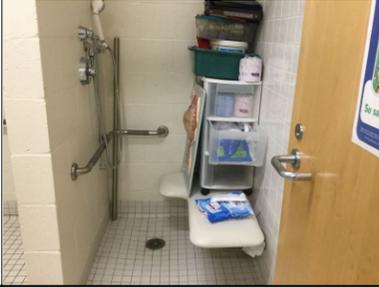
ID	Location	Floor	Room	Element	Type	Photo	Issues	Current Measure	Recommendations	Quantity	Price	Cost Estimation
<b>Shower Compartment</b>												
90	Toilet Room in Nurse's Office	1	163	Shower Compartment	Transfer Type

Clear space not provided at transfer shower Grab bars < 33" > 36" high Seat is not between 17"- 19" high	- 26" 14"	Ensure that a 36" wide min. by a 48" long min. measured from the control wall is provided at the shower. Locate grab bars between 33"- 36" above the finished floor. Mount seat between 17"- 19" above the finished floor.  Renovation to this transfer shower might be technically infeasible.	1	-	\$0
91	Women's and Men's Toilet Rooms in Gym, Single-User Bathing Rooms	2	265, 263	Shower Compartment	Transfer Type

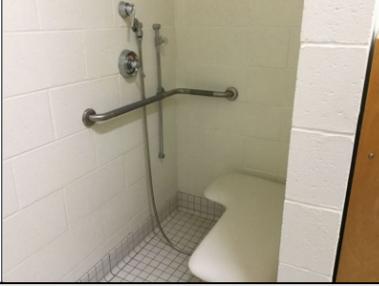
Seat is not between 17"- 19" high Control height < 38" or > 48"	13.5" 52"	Mount seat between 17"- 19" above the finished floor. Relocate controls at 48" max. above the shower floor.	1	384	\$384

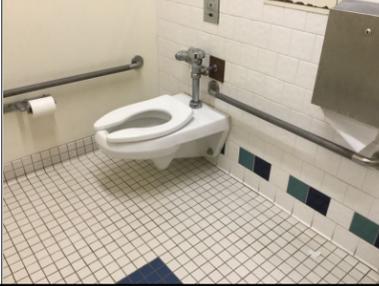
Toilet seat < 12" or > 15" high (K - 3) Centerline < 12" or > 15" (K - 3)	16.5" 18.5"	Install a toilet with a seat between 12"- 15" high above the finished floor. Relocate toilet so that the centerline is between 12" and 15" from the side wall.	1	1625	\$1625
<b>Additional Access</b>												
<b>Drinking Fountains</b>												
93	Near Pathways Hallway	1		Drinking Fountains	High

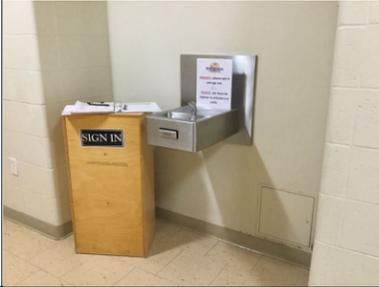
No drinking fountain provided for seated users	-	Provide an additional drinking fountain for seated users.	1	3021	\$3021

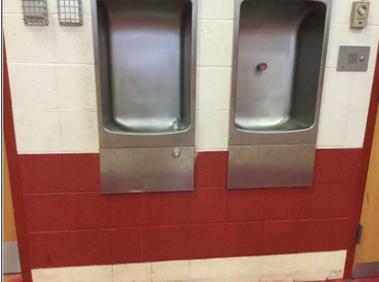
ID	Location	Floor	Room	Element	Type	Photo	Issues	Current Measure	Recommendations	Quantity	Price	Cost Estimation
94	Gym	2		Drinking Fountains	High

No drinking fountain provided for seated users	-	Provide an additional drinking fountain for seated users or install a Hi-Lo drinking fountain.	1	3021	\$3021
95	Cafeteria	2	241	Drinking Fountains	Hi-Lo

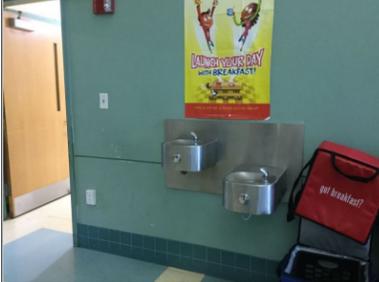
Standing height fountain does not have cane protection	-	Provide a cane-detectable barrier skirt under the high unit.	1	668	\$668
<b>Sink</b>												
96	Exam Room in Nurse's Office	1	166	Sink	N/A

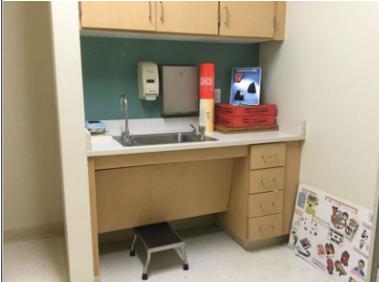
Toe and knee clearances not provided	-	Remove step stool to maintain the 27" min, knee clearance at the sink.	1	Labor	\$0
97	Reading Specialist	2	208	Sink	Classroom

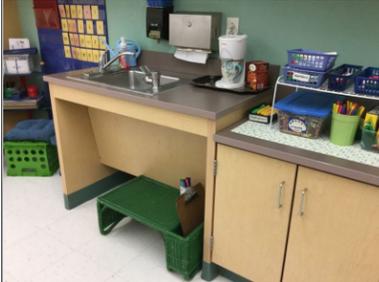
Toe and knee clearances not provided	-	Relocate step stool to maintain the 27" min. knee clearance at the sink.	1	Labor	\$0
98	Band Room	2	211	Sink	Classroom

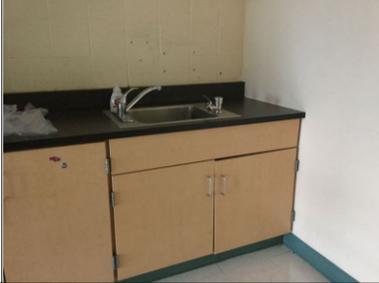
Toe and knee clearances not provided	-	Remove based cabinet to provide a 27" knee clearance positioned for a forward approach.	1	930	\$930

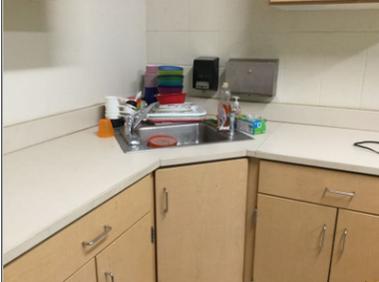
ID	Location	Floor	Room	Element	Type	Photo	Issues	Current Measure	Recommendations	Quantity	Price	Cost Estimation
99	Speech, Language Pathologist	3	361	Sink	N/A

Toe and knee clearances not provided	-	Relocate sink to provide 27" min. knee clearance under the sink with 30" min. width. Ensure the counter is 34" max. above the finished floor.	1	4513	\$4513
100	Greenhouse	3		Sink	Lab

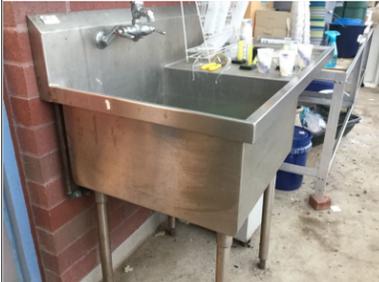
Toe and knee clearances not provided	-	Provide a second sink with 27" knee clearance positioned for a forward approach.	1	1265	\$1265
101	Exam Room in Nurse's Office	1	162	Sink	N/A

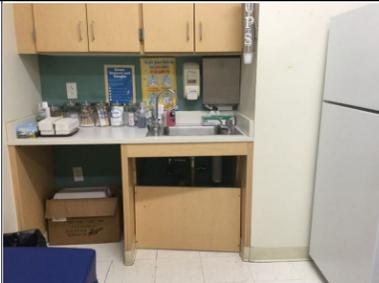
Exposed plumbing underneath sink Dispenser not within reach range	- 51"	Reposition wooden barrier to ensure pipes at sink are insulated. Relocate cup dispenser 48" max. above the finished floor or ground.	1	192	\$192
<b>Sinks for Children's Use</b>												
102	Kindergarten Classroom	1	170	Sinks for Children's Use	Classroom

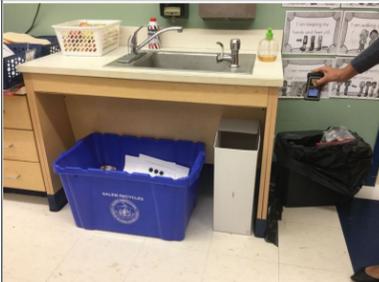
Knee or toe clearance not provided	-	Relocate recycling bin to maintain the 27" min. knee clearance at the sink.	1	Labor	\$0

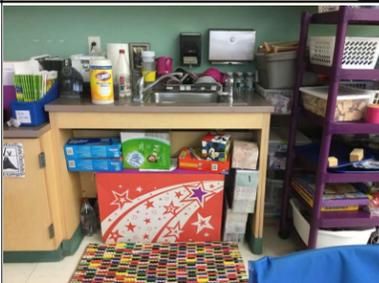
103	Grade 1 and Grade 2 Classrooms	2	248, 214	Sinks for Children's Use	Classroom

Knee or toe clearance not provided	-	Provide at least one sink with 25" knee and toe clearance positioned for a forward approach by removing clutter from under sink.	2	Labor	\$0

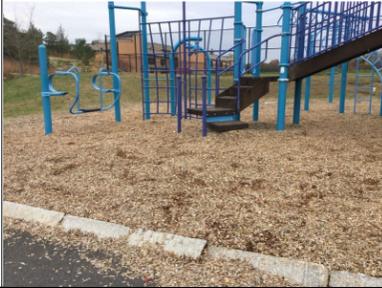
Accessible route not provided to ground level play components	-	Ensure an accessible route is provided to one of each type of ground level play components  (Cost based on 115' of 5' wide poured in place rubber routes to play elements.)	1	8050	\$8050
106	Playground Near Kindergarten Wing	Ext		Play Areas	N/A

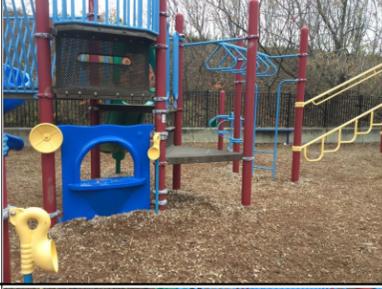
Accessible route not provided to ground level play components	-	Ensure an accessible route is provided to one of each type of ground level play components  (Cost based on 145' of 5' wide poured in place rubber to play elements.)	1	10150	\$10150

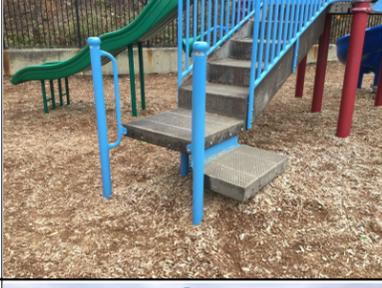
107	Playground Near Kindergarten Wing	Ext		Play Areas	N/A

No compliant transfer system	22.25"	Alteration might be technically infeasible.	1	-	\$0
108	Playground Southeast Side of School	Ext		Play Areas	N/A

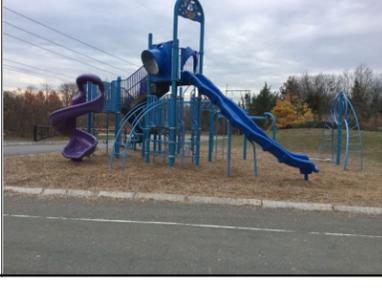
Not connected to an accessible route	-	Provide an accessible route around the playground.  (Cost based on 185' of 4' wide, level asphalt surface around playground.)	1	4718	\$4718

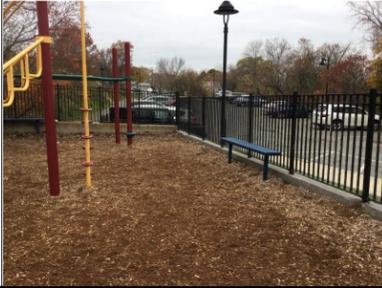
Accessible route not provided	-	Provide an accessible route to at least one of the benches in this area.  See ID #111 for cost.	1	-	\$0
<b>Field</b>												
111	Robert J. Geswell Athletic Field	Ext		Field	Soccer

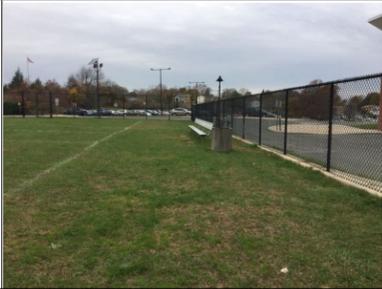
Accessible spaces not provided at sidelines seating Not connected to an accessible route	- -	Provide a 36" min. x 48" min. clear floor space at sidelines seating. Ensure sidelines seating is connected to an accessible route.  (Cost based on two concrete clear floor spaces at sidelines seating and 115' concrete route to both benches.)	1	5520	\$5520

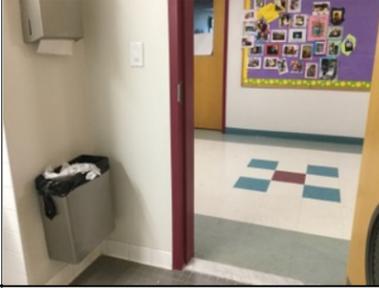
Maneuvering clearance(s) not provided	14"	While not technically compliant, this doorway is still usable.	1	-	\$0
36	Classroom	1	104	Doors, Doorways, & Gates	Classroom

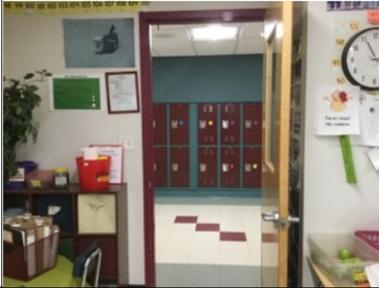
Maneuvering clearance(s) not provided	-	Relocate the cabinet away from the required maneuvering clearance at the door.	1	Labor	\$0
37	Classroom, First Grade	1	119	Doors, Doorways, & Gates	Classroom

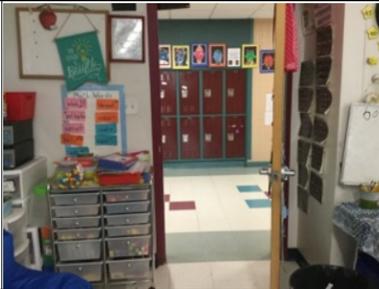
Maneuvering clearance(s) not provided	-	Relocate the cabinet away from the required maneuvering clearance at the door.	1	Labor	\$0
38	Locker Room Entrance	1		Doors, Doorways, & Gates	N/A

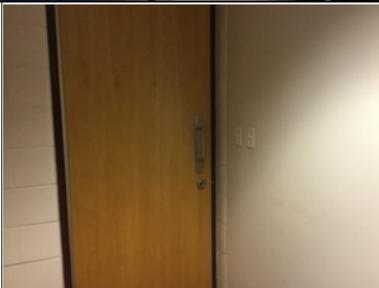
Maneuvering clearance(s) not provided	-	Provide an automatic door opener.	1	2295	\$2295
<b>Ramps</b>												
39	Ramp to Emergency Exit 7	1		Ramps	Interior

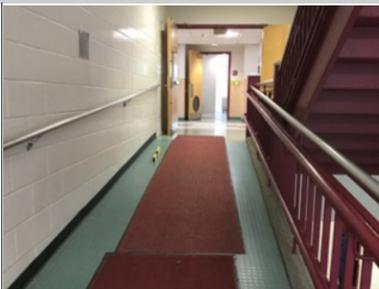
Running slope >1:12 (8.33%) Mat not securely attached	9.8% -	Repair to this ramp might be technically infeasible. Securely attach mat.	1	Labor	\$0

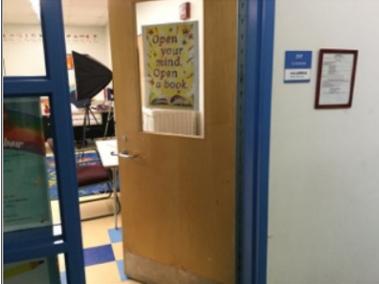
Sign not located on the latch side of the door	-	Locate sign at permanent rooms alongside the door on the latch side.	1	Labor	\$0
42	Art Room	2	208	Signage	Designation

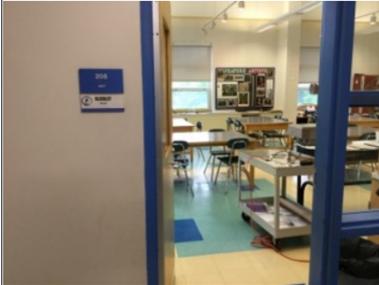
Sign not located on the latch side of the door	-	Locate sign at permanent rooms alongside the door on the latch side.	1	Labor	\$0
43	Art Room to Kiln Room	2	208	Signage	Designation

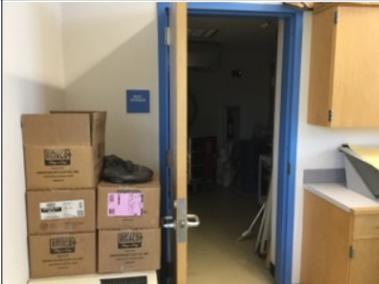
Sign not located on the latch side of the door	-	Locate sign at permanent rooms alongside the door on the latch side.	1	Labor	\$0

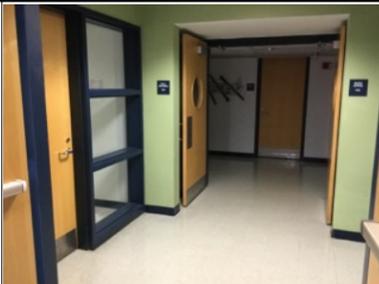
44	Music Ensemble Room and Music Office	B	009, 013	Signage	Designation

Sign not located on the latch side of the door	-	Locate sign at permanent rooms alongside the door on the latch side.	2	Labor	\$0

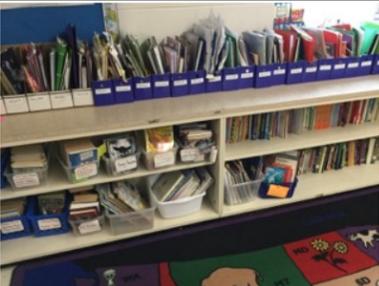
Reach < 15" or > 48"(forward/side approach)	5"	Relocate books so that controls are between 15"- 48" above finished floor.	1	Labor	\$0
52	Classroom	2	209	Operable Parts	Other

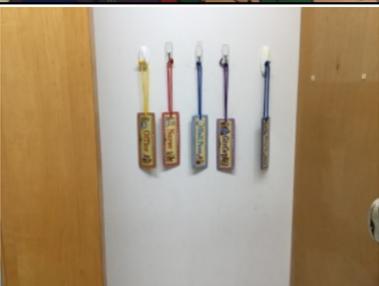
Reach < 15" or > 48"(forward/side approach)	64"	Relocate hooks so that controls are between 15"- 48" above finished floor.	1	Labor	\$0
53	Classroom, Third Grade	2	213	Operable Parts	Other

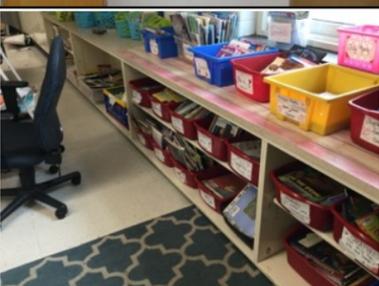
Reach < 15" or > 48"(forward/side approach)	5"	Relocate books so that controls are between 15"- 48" above finished floor.	1	Labor	\$0
54	Classroom, Fourth Grade	2	215	Operable Parts	Other

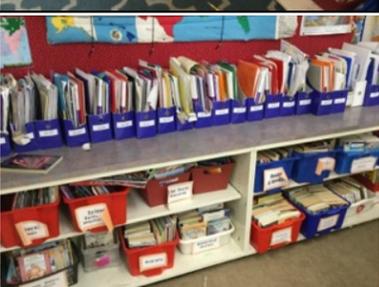
Reach < 15" or > 48"(forward/side approach)	5"	Relocate books so that controls are between 15"- 48" above finished floor.	1	Labor	\$0

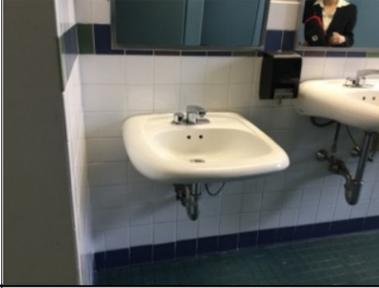
Plumbing underneath is exposed	-	Insulate or otherwise configure pipes to prevent contact, for at least one lavatory.	1	69	\$69
66	Boys' Toilet Room	2		Lavatory	N/A

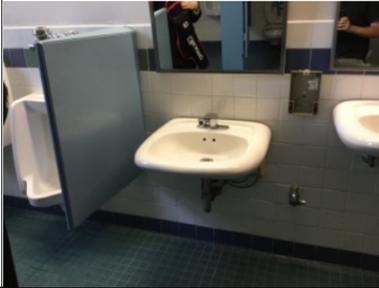
Plumbing underneath is exposed	-	Insulate or otherwise configure pipes to prevent contact, for at least one lavatory.	1	69	\$69
67	Girls' Toilet Room	B		Lavatory	N/A

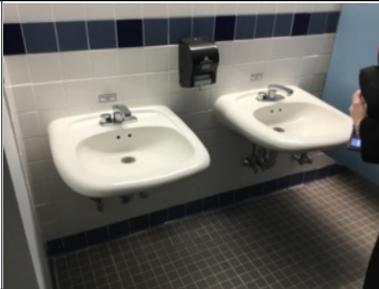
Plumbing underneath is exposed	-	Insulate or otherwise configure pipes to prevent contact, for at least one lavatory.	1	69	\$69
68	Health Suite, Toilet Room	1	127	Lavatory	N/A

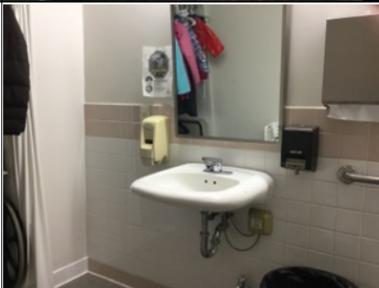
Plumbing underneath is exposed	-	Insulate or otherwise configure pipes to prevent contact, for at least one lavatory.	1	69	\$69
69	Toilet Room in 116	1	116	Lavatory	N/A

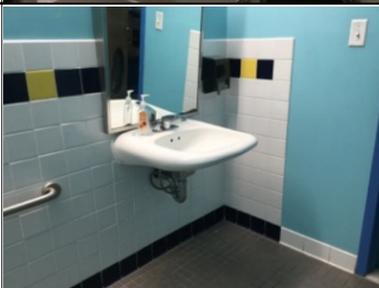
Plumbing underneath is exposed	-	Insulate or otherwise configure pipes to prevent contact, for at least one lavatory.	1	69	\$69

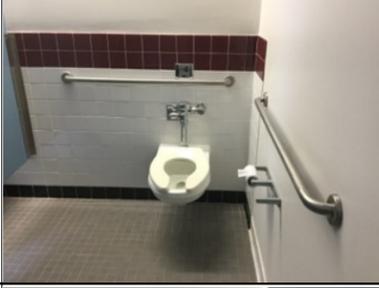
78	Girls' Locker Room Toilet Room	1		Toilet Compartment	Accessible Compartment

Door has malfunctioning self-closing hinge	-	Repair hinge.	1	Labor	\$0
79	Boys' Toilet Room	B		Toilet Compartment	Accessible Compartment

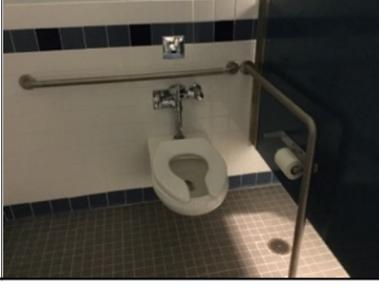
Side grab bar < 42" long	30"	Provide a side wall grab bar that is 42" long min. located 12" max. from the rear wall.	1	674	\$674

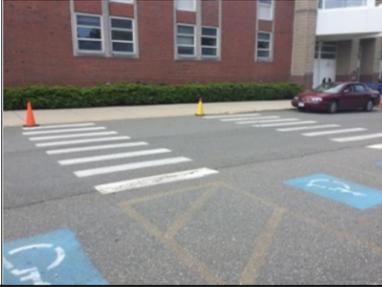
Good example of inclusive design solution that ensures easy access into the building.	1	-	\$0
N/A												
95	Benches Near Playground on South Side of School	Ext.		N/A	N/A

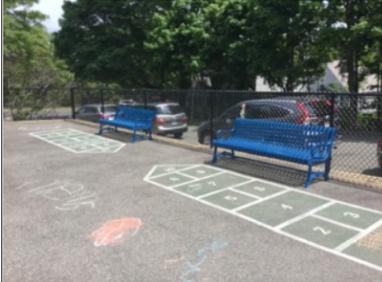
Consider relocating benches so that shoulder alignment is available by ensuring that the 30" by 48" clear floor space spans at least 12" back from the back of the benches.	1	0	\$0
96	Emergency Exit 10	Ext.		N/A	N/A

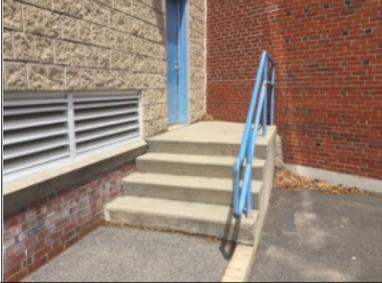
Consider providing informational sign on the inside of the door indicating the conditions of the exit on the exterior (stairs leading away from building.)	1	0	\$0
97	Emergency Exit 12	Ext.		N/A	N/A

- At Emergency Exit #10, consider providing an informational sign on the inside of the door indicating the conditions of the exit on the exterior (stairs leading away from building).

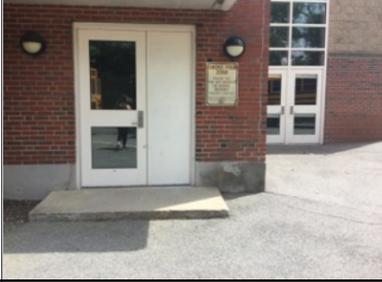
Recommend repairing surface so that transition from concrete safety area to asphalt is flush.	1	0	\$0
98	Emergency Exit 13	Ext.		N/A	N/A

- At Emergency Exit #12 and 13, recommend repairing surface so that transition from concrete safety area to asphalt is flush.
- In Room 005, consider providing additional seating that is on an accessible route.

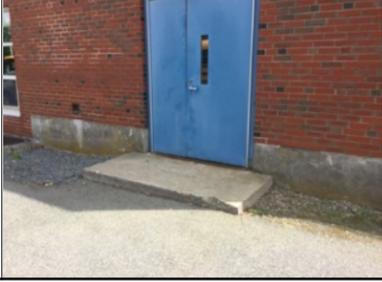
Recommend repairing surface so that transition from concrete safety area to asphalt is flush.	1	0	\$0

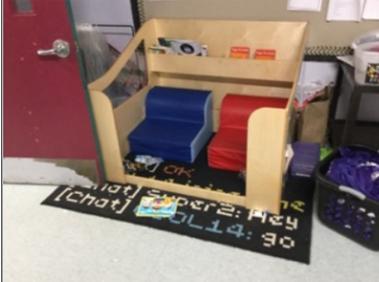
Consider providing additional seating that is on an accessible route.	1	0	\$0
100	Music Room	B	012	N/A	N/A

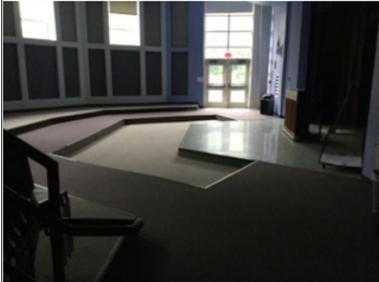
Consider providing handrails and edge protection.	1	0	\$0
101	Music Room	B	012	N/A	N/A

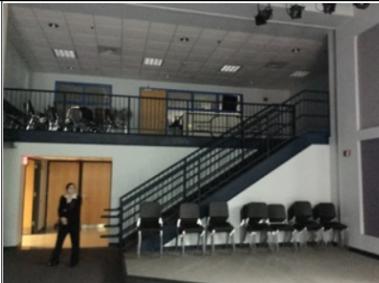
Consider providing directional signage indicating the location of the accessible route to the second floor practice area.	1	0	\$0
102	Old Elevator Near Center of School			N/A	N/A
