**City of Salem,  
Massachusetts**

December 2019

# Salem City Hall

## City of Salem ADA Transition Plan

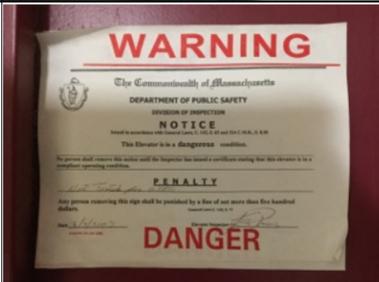
While this notice is posted on some of the old elevator doors, IHCD recommends posting them on all three floors to ensure that the public is aware that the elevator is out of service.  IHCD also recommends providing directional signage indicating the location of the working elevator on all three floors.	1	0	\$0
103	Stairs Throughout School	1		N/A	N/A

- While there is a notice posted on some of the old elevator doors, IHCD recommends posting the notices on all three floors to ensure that the public is aware that the elevator is out of service. IHCD also recommends providing

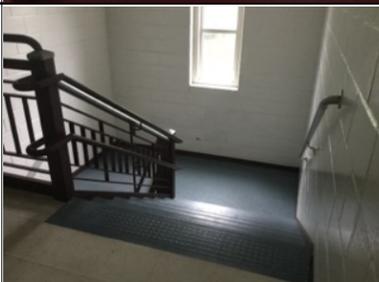
Recommend ensuring that in all stairwells, all sets of handrails have extensions that go 12" beyond the last top riser and one tread depth past the bottom riser.	1	0	\$0

- directional signage indicating the location of the working elevator on all three floors.
- Recommend ensuring that in all stairwells, all sets of handrails have extensions that extend 12" beyond the last top riser and one tread depth past the bottom riser.

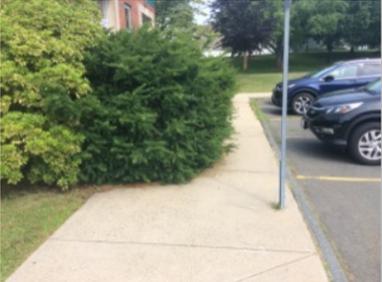
Exterior route < 48" wide	25"	Ensure that a clear width of 48" min. is maintained at the accessible route by trimming trees.	1	Labor	\$0
2	Crossing at Exit to Early Childhood Drop Off Area, Along Memorial Drive	Ext.		Exterior Access Route	Exterior

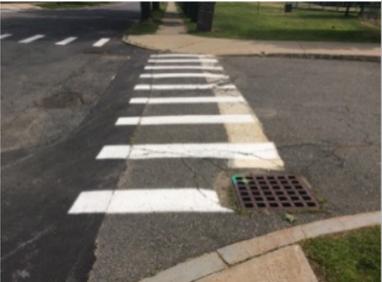
Surface openings > 1/2"	-	Replace or reposition so that openings are 1/2" max. and the long opening dimension is perpendicular to the dominant direction of travel.	1	1238	\$1238
3	Exit #3	Ext.		Exterior Access Route	Exterior

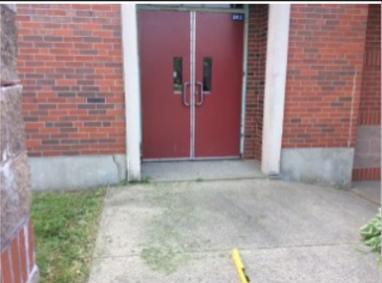
Level changes > 1/4"	1.5"	Alter change in level to be 1/4" high max.	1	155	\$155
4	Route to Parking Lot From Memorial Drive	Ext.		Exterior Access Route	Exterior

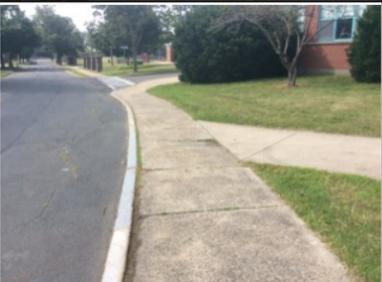
Level changes > 1/4"	2"	Alter change in level to be 1/4" high max. (Cost based on 20' of concrete.)	1	690	\$690

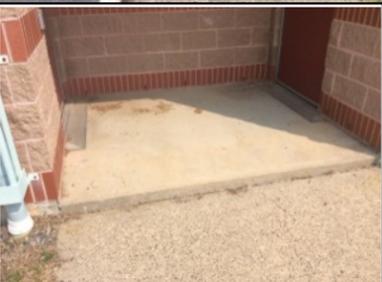
5	Exits #10 and #11	Ext.		Exterior Access Route	Exterior

Level changes > 1/4"	3"	Alter change in level to be 1/4" high max.	1	155	\$155

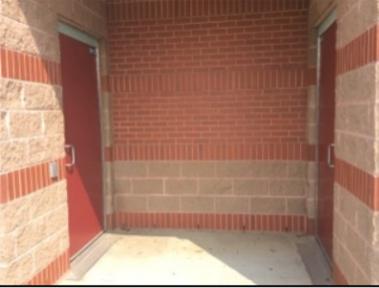
ID	Location	Floor	Room	Element	Type	Photo	Issues	Current Measure	Recommendations	Quantity	Price	Cost Estimation
6	Exits #12 and #13	Ext.		Exterior Access Route	Exterior

Level changes > 1/4"	3.5"	Alter change in level to be 1/4" high max.	2	155	\$310
7	Near Exit #14, Route to Playground	Ext.		Exterior Access Route	Exterior

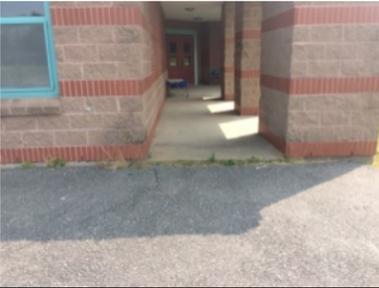
Level changes > 1/4"	3"	Alter change in level to be 1/4" high max.	1	155	\$155
8	Exits #15 and #16	Ext.		Exterior Access Route	Exterior

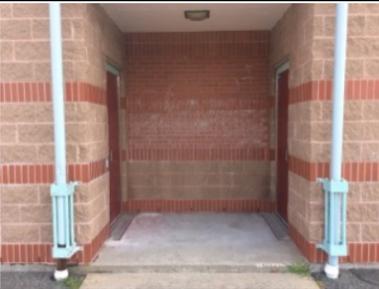
Level changes > 1/4"	3"	Alter change in level to be 1/4" high max.	1	155	\$155
9	Exits #17 and #18	Ext.		Exterior Access Route	Exterior

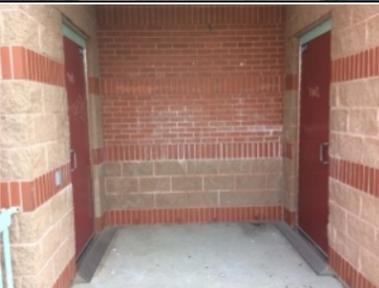
Level changes > 1/4"	3"	Alter change in level to be 1/4" high max.	1	155	\$155
10	North of Crossing at Exit to Early Childhood Drop Off Area, Along Memorial Drive	Ext.		Exterior Access Route	Exterior

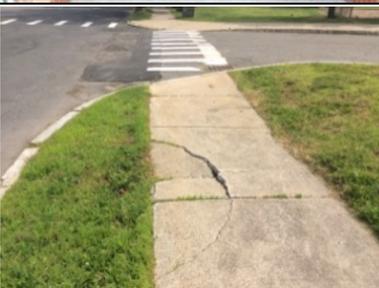
Surface is not stable, firm, and slip-resistant	-	Repair surface.	1	155	\$155

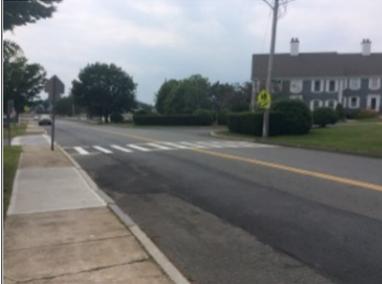
ID	Location	Floor	Room	Element	Type	Photo	Issues	Current Measure	Recommendations	Quantity	Price	Cost Estimation
<b>Curb Ramp</b>												
11	Crossing Szetela Lane to Settlers Way	1		Curb Ramp	N/A

Curb ramp not provided	-	Provide a curb ramp at intersection.	2	2800	\$5600
12	Main Entrance, Exit #2	Ext.		Curb Ramp	N/A

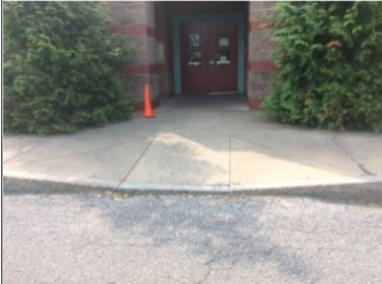
Transition from curb ramp to street not flush	3"	Ensure transition from curb ramp to street is flush or free of changes in level.	1	128	\$128
<b>Off-Street Parking Lot or Garage</b>												
13	Parking Lot Northeast Side	Ext.		Off-Street Parking Lot or Garage	N/A

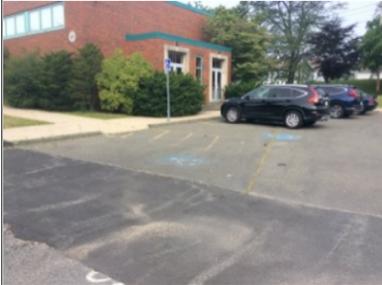
Total # of parking Total # of designated accessible parking spaces Total # of designated van accessible spaces Access aisle < 96" wide at van space Sign not provided Sign does not have the designation "Van Accessible"	23 2 0 90" - -	Provide a marked access aisle that is at least 96" wide. Provide a sign with the bottom of the sign 60" min. above the ground and the top 96" max. above the ground. Add the designation "Van Accessible" to the sign located at the van accessible space.	1	600	\$600

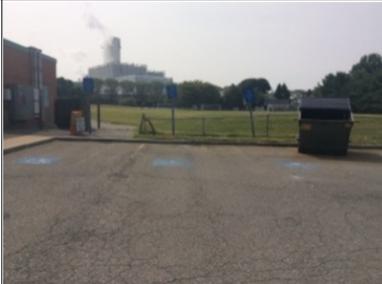
14	Parking Lot West Side	Ext.		Off-Street Parking Lot or Garage	N/A

Total # of parking Total # of designated accessible parking spaces Total # of designated van accessible spaces Access aisle < 96" wide at van space Sign does not have the designation "Van Accessible" Surface not stable, firm, and slip-resistant	75 3 0 48" - -	Provide a marked access aisle that is at least 96" wide. Add the designation "Van Accessible" to the sign located at the van accessible space. Relocate dumpster.	1	600	\$600
<b>Passenger Loading Zones</b>												
15	Early Childhood Center Drop Off Zone	Ext.		Passenger Loading Zones	N/A

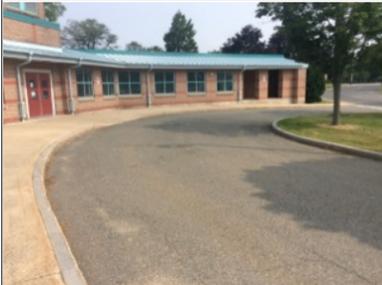
Zone not connected to an accessible route	-	Ensure the passenger loading zone is connected to an accessible route by providing curb ramp.	1	2800	\$2800

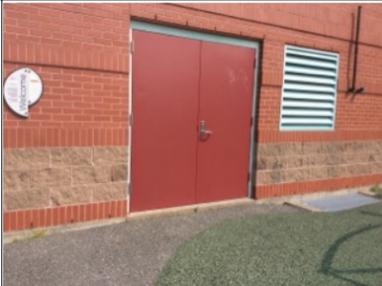
Threshold > 1/2" high	2"	While not technically compliant, this exit could still be usable if the threshold is altered. Alter threshold to be 1/2" high max.	1	155	\$155
<b>Access to Goods and Services</b>												
<b>Means of Egress</b>												
18	Main Entrance, Exit #2	Ext.		Means of Egress	N/A

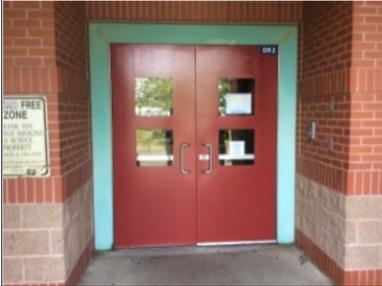
Illuminated exit sign not provided Tactile exit sign not provided	- -	Ensure illuminated exit signs on the interior of the door contain the International Symbol of Accessibility (ISA). Ensure tactile exit signs with raised characters and braille are provided at the interior of exit doors. Mount signs between 48"- 60" above finished floor located on the latch side of the door.	1	274	\$274

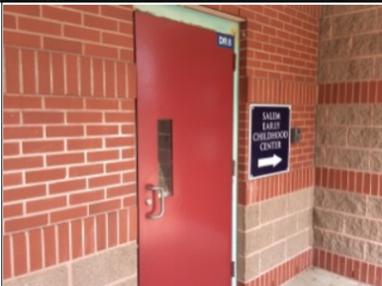
19	Exit #8	Ext.		Means of Egress	N/A

Illuminated exit sign not provided Tactile exit sign not provided	- -	Ensure illuminated exit signs on the interior of the door contain the International Symbol of Accessibility (ISA). Ensure tactile exit signs with raised characters and braille are provided at the interior of exit doors. Mount signs between 48"- 60" above finished floor located on the latch side of the door.	1	274	\$274
20	Exit #9	Ext.		Means of Egress	N/A

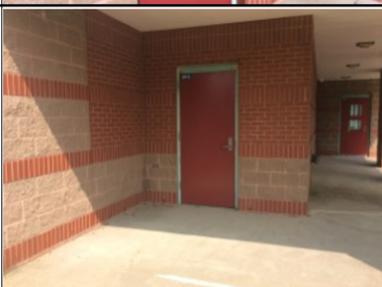
Illuminated exit sign not provided Tactile exit sign not provided	- -	Ensure illuminated exit signs on the interior of the door contain the International Symbol of Accessibility (ISA). Ensure tactile exit signs with raised characters and braille are provided at the interior of exit doors. Mount signs between 48"- 60" above finished floor located on the latch side of the door.	1	274	\$274

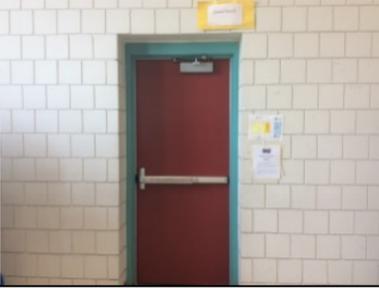
ID	Location	Floor	Room	Element	Type	Photo	Issues	Current Measure	Recommendations	Quantity	Price	Cost Estimation
21	Exit #1	1		Means of Egress	N/A

Illuminated exit sign not provided Tactile exit sign not provided	- -	Ensure illuminated exit signs contain the International Symbol of Accessibility (ISA). Ensure tactile exit signs with raised characters and braille are provided at exit doors. Mount signs between 48"- 60" above finished floor located on the latch side of the door.	1	274	\$274
22	Exit #20 From Gym	1		Means of Egress	N/A

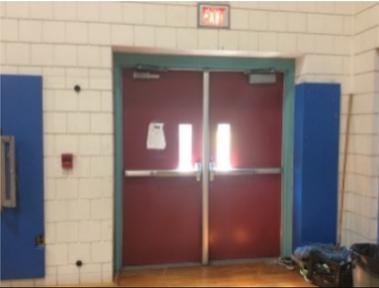
Illuminated exit sign not provided Tactile exit sign not provided	- -	Ensure illuminated exit signs contain the International Symbol of Accessibility (ISA). Ensure tactile exit signs with raised characters and braille are provided at exit doors. Mount signs between 48"- 60" above finished floor located on the latch side of the door.	1	274	\$274
23	Emergency Exits From Classrooms to Central Courtyard	Ext.		Means of Egress	N/A

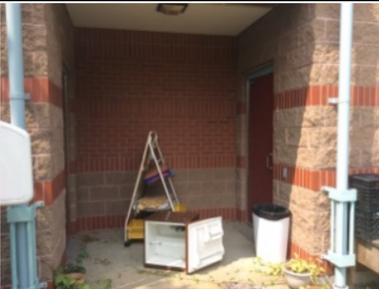
Illuminated exit sign not provided Tactile exit sign not provided	- -	Ensure illuminated exit signs on the interior of the door contain the International Symbol of Accessibility (ISA). Ensure tactile exit signs with raised characters and braille are provided at the interior of exit doors. Mount signs between 48"- 60" above finished floor located on the latch side of the door.	12	274	\$3288

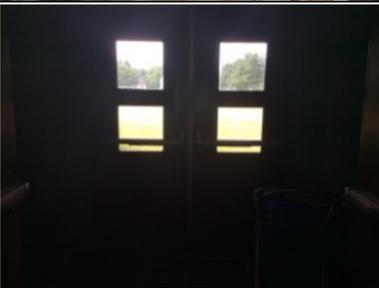
24	Exit #14	1		Means of Egress	N/A

Illuminated exit sign not provided Tactile exit sign not provided	- -	Ensure illuminated exit signs contain the International Symbol of Accessibility (ISA). Ensure tactile exit signs with raised characters and braille are provided at exit doors. Mount signs between 48"- 60" above finished floor located on the latch side of the door.	1	274	\$274
25	Emergency Exits #10, #11, #12, #13, #15, #16, #17, #18 in Classrooms	1	04	Means of Egress	N/A

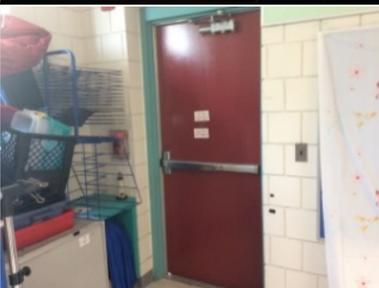
Illuminated exit sign not provided Tactile exit sign not provided	- -	Ensure illuminated exit signs contain the International Symbol of Accessibility (ISA). Ensure tactile exit signs with raised characters and braille are provided at exit doors. Mount signs between 48"- 60" above finished floor located on the latch side of the door.	8	274	\$2192

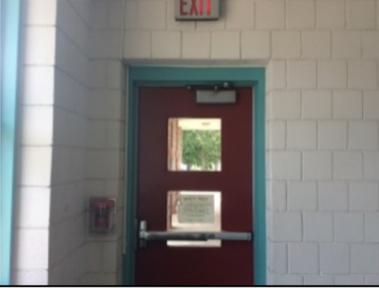
ID	Location	Floor	Room	Element	Type	Photo	Issues	Current Measure	Recommendations	Quantity	Price	Cost Estimation
26	Exit #7	1		Means of Egress	N/A

Illuminated exit sign not provided Tactile exit sign not provided	- -	Ensure illuminated exit signs contain the International Symbol of Accessibility (ISA). Ensure tactile exit signs with raised characters and braille are provided at exit doors. Mount signs between 48"- 60" above finished floor located on the latch side of the door.	1	274	\$274
27	Exit #6	1		Means of Egress	N/A

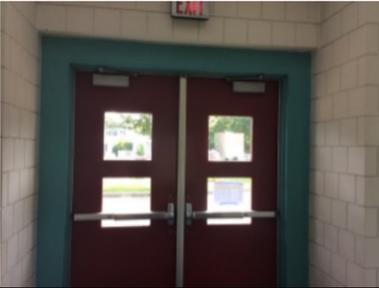
Illuminated exit sign not provided Tactile exit sign not provided	- -	Ensure illuminated exit signs contain the International Symbol of Accessibility (ISA). Ensure tactile exit signs with raised characters and braille are provided at exit doors. Mount signs between 48"- 60" above finished floor located on the latch side of the door.	1	274	\$274
28	Exit #5	1		Means of Egress	N/A

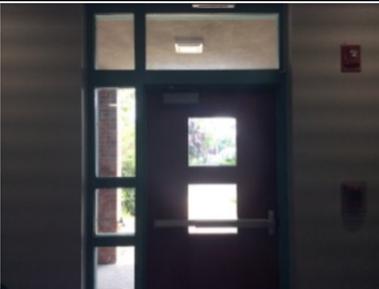
Illuminated exit sign not provided Tactile exit sign not provided	- -	Ensure illuminated exit signs contain the International Symbol of Accessibility (ISA). Ensure tactile exit signs with raised characters and braille are provided at exit doors. Mount signs between 48"- 60" above finished floor located on the latch side of the door.	1	274	\$274

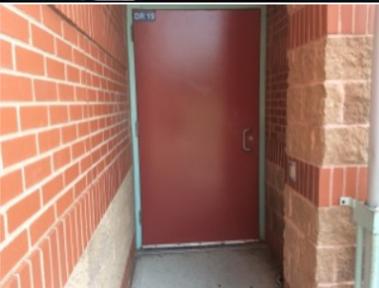
29	Exit #19	1	119	Means of Egress	N/A

Illuminated exit sign not provided Tactile exit sign not provided	- -	Ensure illuminated exit signs on the interior of the door contain the International Symbol of Accessibility (ISA). Ensure tactile exit signs with raised characters and braille are provided at the interior of exit doors. Mount signs between 48"- 60" above finished floor located on the latch side of the door.	1	274	\$274
30	Exit #22	1		Means of Egress	N/A

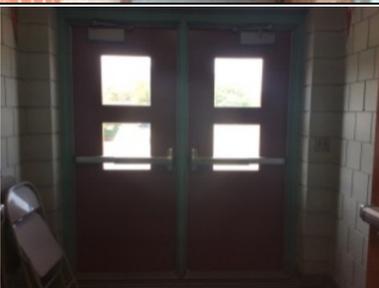
Illuminated exit sign not provided Tactile exit sign not provided Threshold > 1/2" high	- - 2"	Ensure illuminated exit signs contain the International Symbol of Accessibility (ISA). Ensure tactile exit signs with raised characters and braille are provided at exit doors. Mount signs between 48"- 60" above finished floor located on the latch side of the door. Alter threshold to be 1/2" high max.	1	487	\$487

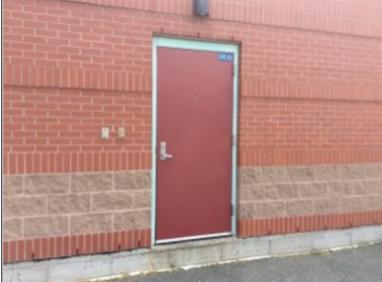
ID	Location	Floor	Room	Element	Type	Photo	Issues	Current Measure	Recommendations	Quantity	Price	Cost Estimation
31	Exit #23	Ext.		Means of Egress	N/A

Tactile exit sign not provided Emergency exit not on an accessible route	- -	Ensure tactile exit signs with raised characters and braille are provided at the interior of exit doors. Mount signs between 48"- 60" above finished floor located on the latch side of the door. Provide a directional sign inside indicating the location of the nearest accessible emergency exit.	1	348	\$348
32	Library Exits 4	1		Means of Egress	N/A

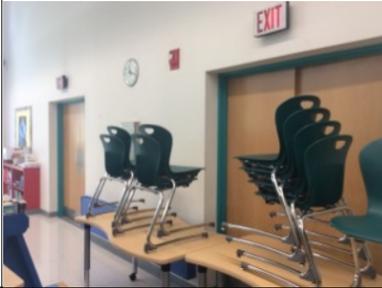
Tactile exit sign not provided Emergency exit not on an accessible route	- -	Ensure tactile exit signs with raised characters and braille are provided at exit doors. Mount signs between 48"- 60" above finished floor located on the latch side of the door. Provide a directional sign indicating the location of the nearest accessible emergency exit.	1	348	\$348

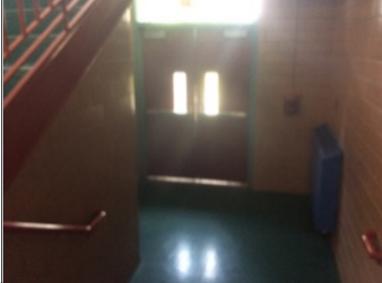
33	Exit #3	1		Means of Egress	N/A

Tactile exit sign not provided Emergency exit not on an accessible route	- -	Ensure tactile exit signs with raised characters and braille are provided at exit doors. Mount signs between 48"- 60" above finished floor located on the latch side of the door. Provide a directional sign indicating the location of the nearest accessible emergency exit.	1	348	\$348
<b>Interior Access Route</b>												
34	Classroom Throughout School	1		Interior Access Route	N/A

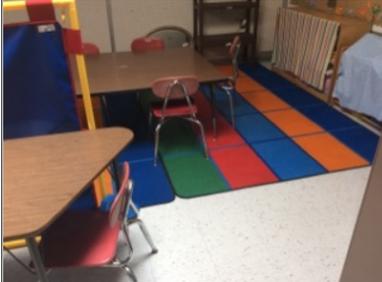
Mat not securely attached		Ensure mats in classrooms throughout the school are securely attached.	6	Labor	\$0
35	OT/PT Room	1	125	Interior Access Route	N/A

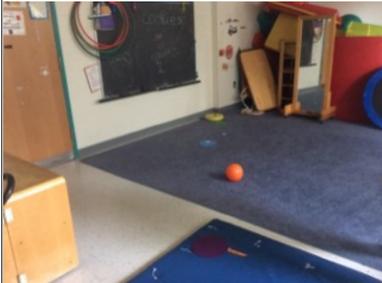
Mat not securely attached	-	Securely attach mat.	1	Labor	\$0

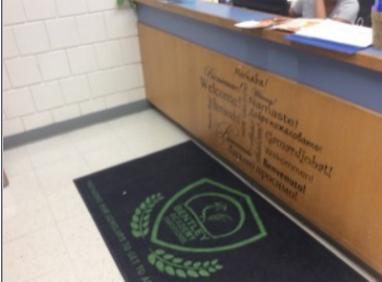
ID	Location	Floor	Room	Element	Type	Photo	Issues	Current Measure	Recommendations	Quantity	Price	Cost Estimation
36	Main Office	1		Interior Access Route	N/A

Mat not securely attached	-	Securely attach mat.	1	Labor	\$0
37	Reading Specialist	1	132	Interior Access Route	N/A

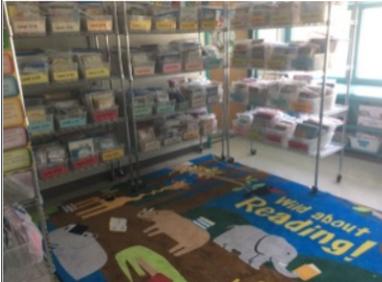
Mat not securely attached	-	Securely attach mat.	1	Labor	\$0
<b>Doors, Doorways, &amp; Gates</b>												
38	OT/PT Room Office	1	125	Doors, Doorways, & Gates	Office

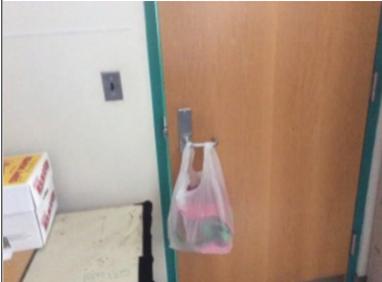
Maneuvering clearance(s) not provided	-	Relocate furniture.	1	Labor	\$0
39	Music Room	1	120	Doors, Doorways, & Gates	Classroom

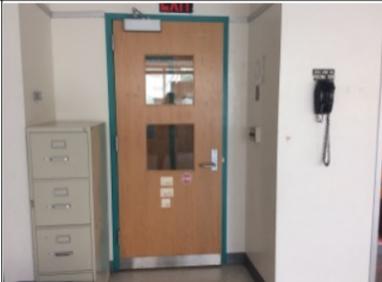
Maneuvering clearance not provided at recess > 8"	29"	Install an automatic door opener.	1	2295	\$2295
40	Classroom	2	219	Doors, Doorways, & Gates	Classroom

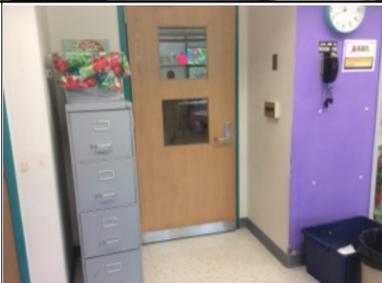
Maneuvering clearance not provided at recess > 8"	29"	Install an automatic door opener.	1	2295	\$2295

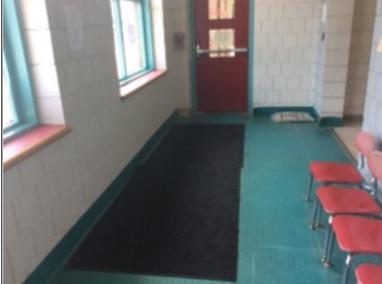
ID	Location	Floor	Room	Element	Type	Photo	Issues	Current Measure	Recommendations	Quantity	Price	Cost Estimation
41	Exit #7	1		Doors, Doorways, & Gates	Emergency Egress

Mat not securely attached	-	Securely attach mat.	2	Labor	\$0
42	Exit #6	1		Doors, Doorways, & Gates	Emergency Egress

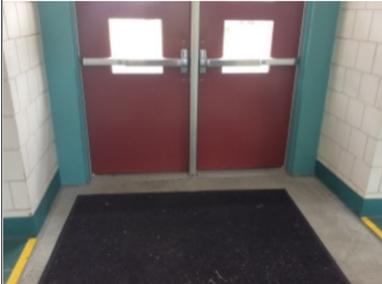
Mat not securely attached	-	Securely attach mat.	1	Labor	\$0
<b>Signage</b>												
43	City Connects Coordinator	1	123	Signage	Designation

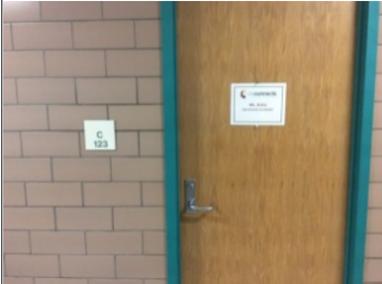
Raised characters not provided Braille not provided	- -	Provide text with raised characters duplicated in braille.	1	174	\$174
44	EOC Office	1	106	Signage	Designation

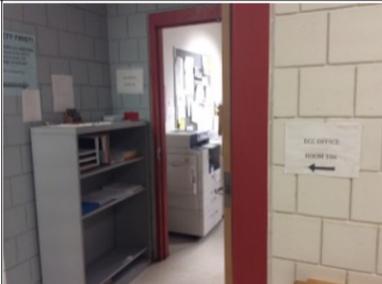
Raised characters not provided Braille not provided Sign not located on the latch side of the door	- - -	Provide text with raised characters duplicated in braille. Locate sign at permanent rooms alongside the door on the latch side.	1	174 Labor	\$174
45	Main Office	1		Signage	Designation

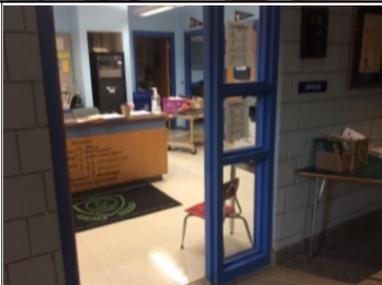
Braille not provided	-	Provide braille.	1	174	\$174

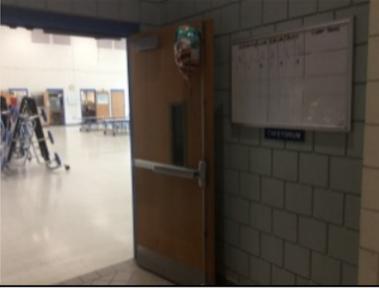
Braille not provided	-	Provide braille.	1	174	\$174
47	Men's Toilet Room Near Main Entrance	1		Signage	Designation

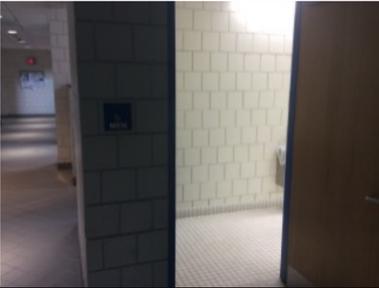
Braille not provided	-	Provide braille.	1	174	\$174
48	Women's Toilet Room Near Main Entrance	1		Signage	Designation

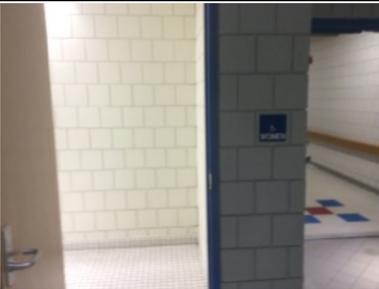
Braille not provided	-	Provide braille.	1	174	\$174
49	Classrooms Throughout School	1		Signage	Designation

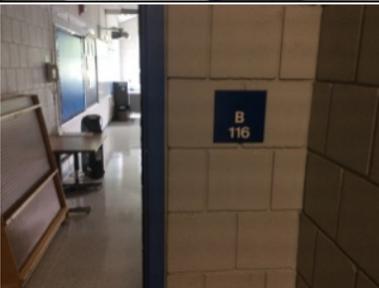
Braille not provided	-	Provide braille.	44	174	\$7656
50	Boys' Toilet Room in Classroom	1	B115	Signage	Designation

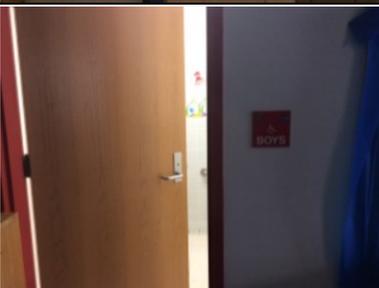
Braille not provided	-	Provide braille.	1	174	\$174

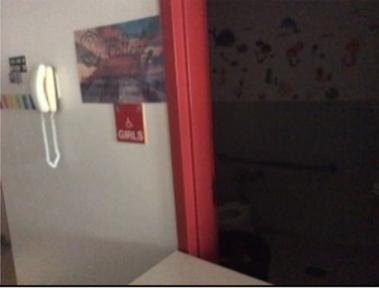
Braille not provided	-	Provide braille.	1	174	\$174
52	Health Office	1	127	Signage	Designation

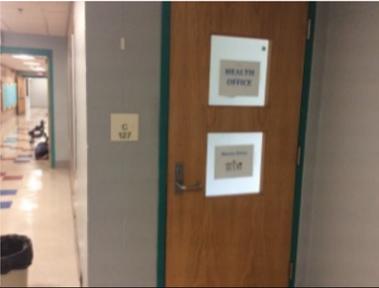
Braille not provided	-	Provide braille.	1	174	\$174
53	Chairperson's Office	1	129	Signage	Designation

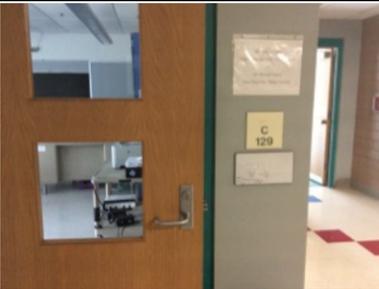
Braille not provided	-	Provide braille.	1	174	\$174
54	Women's Toilet Room Near Library	1		Signage	Designation

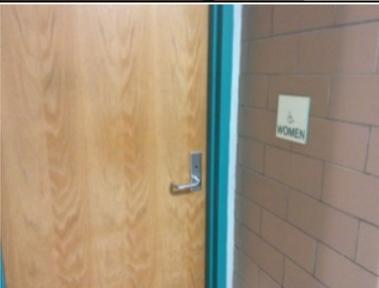
Braille not provided	-	Provide braille.	1	174	\$174
55	Men's Toilet Room Near Library	1		Signage	Designation

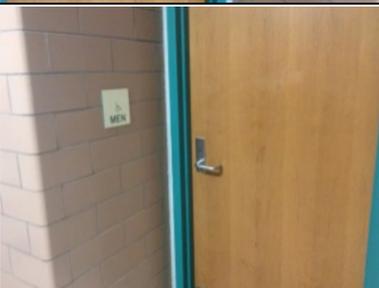
Braille not provided	-	Provide braille.	1	174	\$174

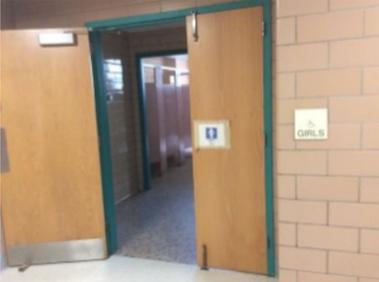
Braille not provided	-	Provide braille.	1	174	\$174
57	Reading Specialist	1	132	Signage	Designation

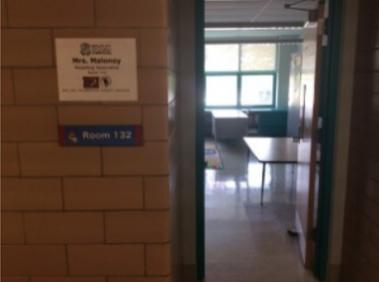
Braille not provided	-	Provide braille.	1	174	\$174
58	Health Office	1	119	Signage	Designation

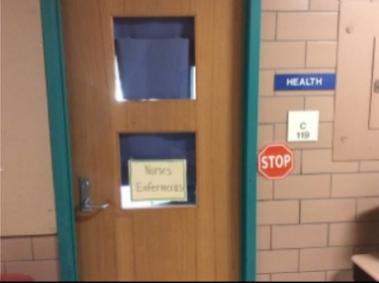
Braille not provided	-	Provide braille.	1	174	\$174
59	Music Room	1	120	Signage	Designation

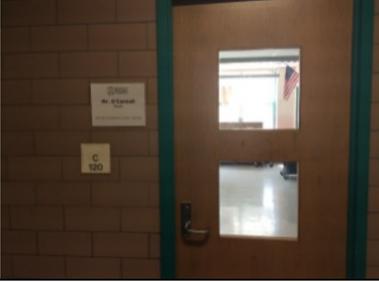
Braille not provided	-	Provide braille.	1	174	\$174
60	Art Room	2	217	Signage	Designation

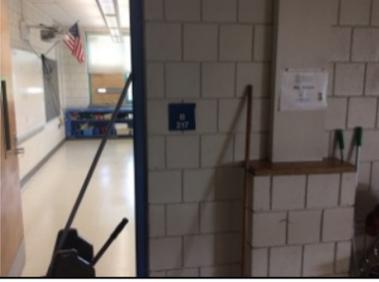
Braille not provided	-	Provide braille.	1	174	\$174

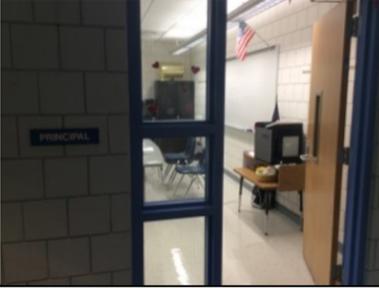
Braille not provided Sign not located on the latch side of the door	- -	Provide braille. Locate sign at permanent rooms alongside the door on the latch side.	1	174 Labor	\$174
62	Boys' Multi-User Toilet Room Near Library	1		Signage	Designation

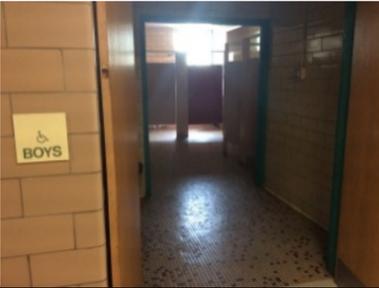
Braille not provided Sign not located on the latch side of the door	- -	Provide braille. Locate sign at permanent rooms alongside the door on the latch side.	1	174 Labor	\$174
63	Girls' Multi-User Toilet Room Second Floor	2		Signage	Designation

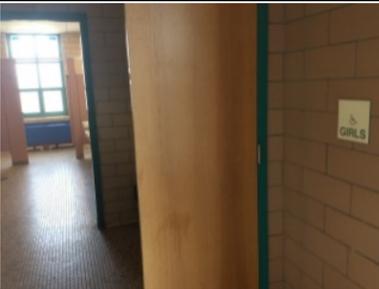
Braille not provided Sign not located on the latch side of the door	- -	Provide braille. Locate sign at permanent rooms alongside the door on the latch side.	1	174 Labor	\$174
64	Girls' Toilet Room in Gym	1		Signage	Designation

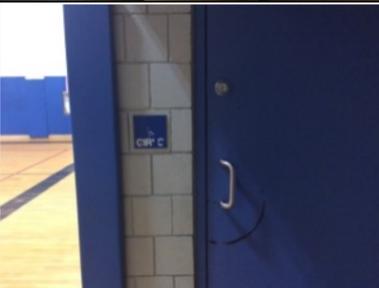
Braille not provided International Symbol of Acc. not compliant	- -	Provide braille. Replace sign with a sign containing the International Symbol of Accessibility.	1	174	\$174

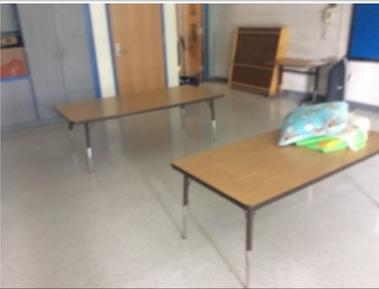
Knee or toe clearance not provided	21"	Adjust at least 1 work surface per classroom per grade to provide 25" min. knee and toe clearance.	6	Labor	\$0

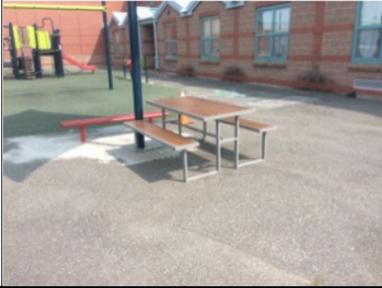
At least 5% accessible spaces not provided	-	Ensure that at least 5% (minimum one) of dining surfaces are accessible.	1	1050	\$1050
<b>Toilet &amp; Bathing Rooms</b>												
<b>Lavatory</b>												
68	Women's Toilet Room Near Library	1		Lavatory	N/A

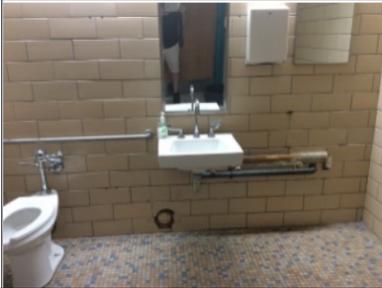
Plumbing underneath is exposed	-	Insulate or otherwise configure pipes to prevent contact, for at least one lavatory.	1	69	\$69
69	Men's Toilet Room Near Library	1		Lavatory	N/A

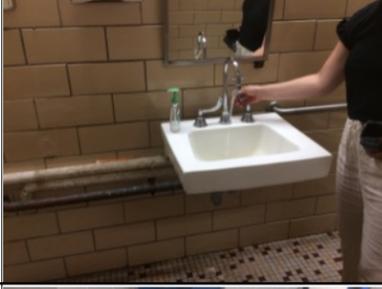
Plumbing underneath is exposed	-	Insulate or otherwise configure pipes to prevent contact, for at least one lavatory.	1	69	\$69

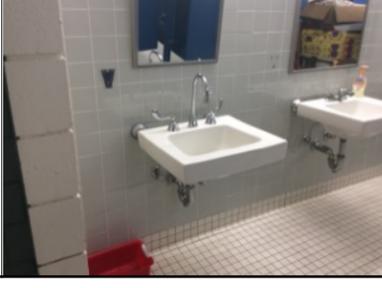
Plumbing underneath is exposed Mirror above lavatory w/reflective surface > 40"	- 42"	Insulate or otherwise configure pipes to prevent contact, for at least one lavatory. Lower mirror so that the bottom surface is at 40" max. above finished floor.	2	261	\$522

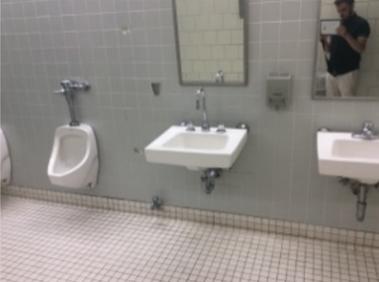
Plumbing underneath is exposed Mirror above lavatory w/reflective surface > 40"	- 42"	Insulate or otherwise configure pipes to prevent contact, for at least one lavatory. Lower mirror so that the bottom surface is at 40" max. above finished floor.	1	261	\$261
72	Women's Toilet Room Near Main Entrance	1		Lavatory	N/A

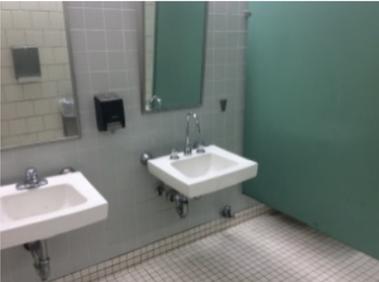
Plumbing underneath is exposed Mirror above lavatory w/reflective surface > 40"	- 42"	Insulate or otherwise configure pipes to prevent contact, for at least one lavatory. Lower mirror so that the bottom surface is at 40" max. above finished floor.	1	261	\$261
73	Girls' Multi-User Toilet Room Near Library	1		Lavatory	N/A

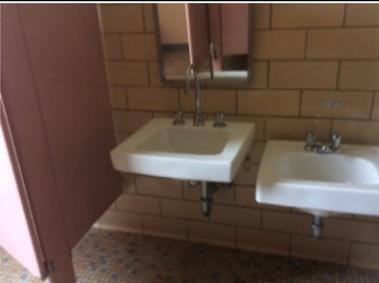
Plumbing underneath is exposed Mirror above lavatory w/reflective surface > 40"	- 42"	Insulate or otherwise configure pipes to prevent contact, for at least one lavatory. Lower mirror so that the bottom surface is at 40" max. above finished floor.	1	261	\$261

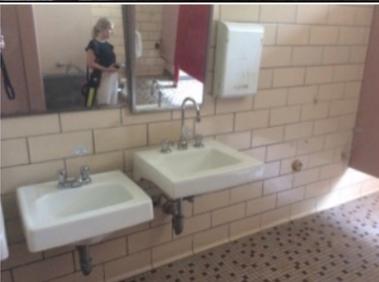
Plumbing underneath is exposed Mirror above lavatory w/reflective surface > 40"	- 42"	Insulate or otherwise configure pipes to prevent contact, for at least one lavatory. Lower mirror so that the bottom surface is at 40" max. above finished floor.	1	261	\$261
75	Girls' Multi-User Toilet Room Second Floor	2		Lavatory	N/A

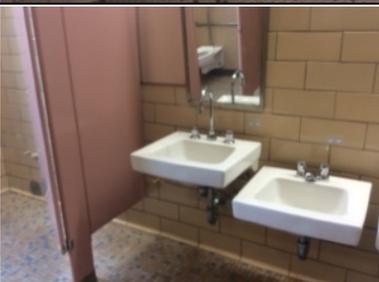
Plumbing underneath is exposed Mirror above lavatory w/reflective surface > 40"	- 43"	Insulate or otherwise configure pipes to prevent contact, for at least one lavatory. Lower mirror so that the bottom surface is at 40" max. above finished floor.	1	261	\$261

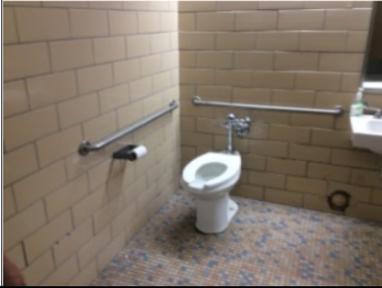
Flush control not on open side	-	Relocate the flush control to the open/transfer side.	1	281	\$281
<b>Toilet Compartment</b>												
78	Girls' and Boys' Toilet Rooms in Gym	1		Toilet Compartment	Accessible Compartment

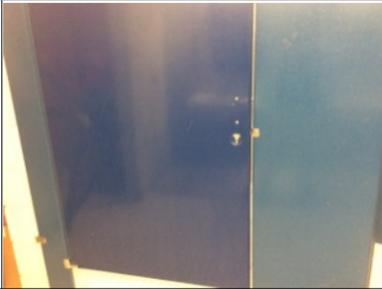
Door has non-compliant hardware	-	Provide hardware that can be operable with one hand and not require tight grasping, pinching, or twisting of the wrist.	2	18	\$36

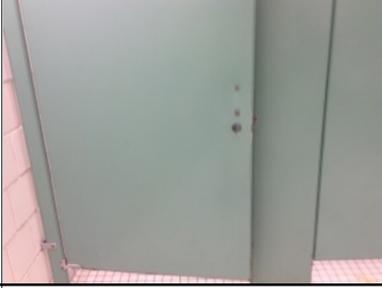
Door has non-compliant hardware	-	Provide hardware that can be operable with one hand and not require tight grasping, pinching, or twisting of the wrist.	1	18	\$18
80	Girls' and Boys' Multi-User Toilet Rooms Second Floor	2		Toilet Compartment	Accessible Compartment

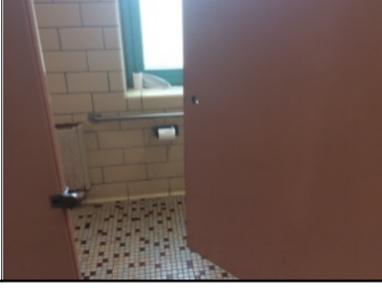
Door has non-compliant hardware	-	Provide hardware that can be operable with one hand and not require tight grasping, pinching, or twisting of the wrist.	1	18	\$18

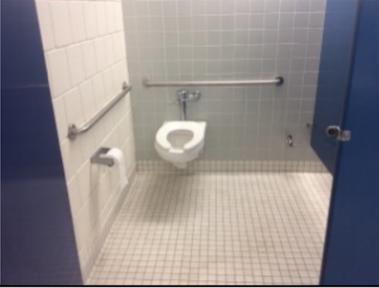
Toilet seat <17" or > 19" high Side or rear grab bar < 33" or >36" high Flush control not on open side	21" 31" -	Install a toilet with a seat height 17"- 19" above the floor. Locate grab bars between 33"- 36" above the finished floor. Provide the flush control on the open side of the toilet (transfer side).	2	2098	\$4196
82	Boys' Multi-User Toilet Room Near Library	1		Toilet Compartment	Accessible Compartment

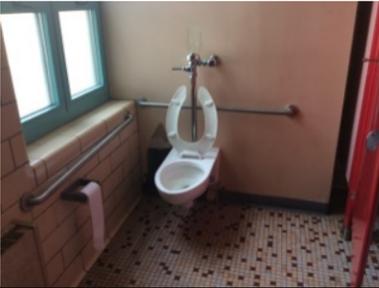
Side or rear grab bar < 33" or >36" high Flush control not on open side	29" -	Locate grab bars between 33"- 36" above the finished floor. Provide the flush control on the open side of the toilet (transfer side).	1	473	\$473
83	Boys' Multi-User Toilet Room Second Floor	2		Toilet Compartment	Accessible Compartment

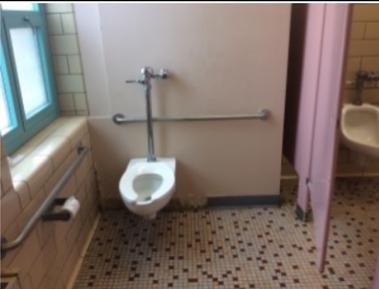
Side or rear grab bar < 33" or >36" high Flush control not on open side	29" -	Locate grab bars between 33"- 36" above the finished floor. Provide the flush control on the open side of the toilet (transfer side).	1	473	\$473

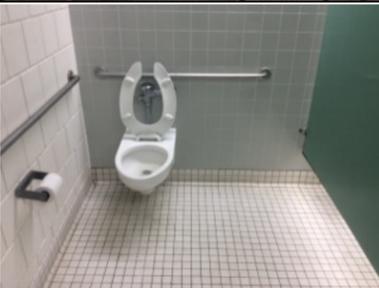
Flush control not on open side	-	Provide the flush control on the open side of the toilet (transfer side).	1	281	\$281
<b>Urinal</b>												
85	Boys' Multi-User Toilet Room Near Library	1		Urinal	N/A

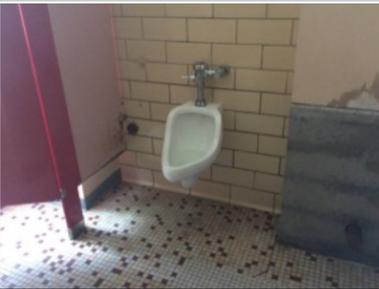
Rim > 15" high (MAAB)	20"	Provide at least one urinal with the rim no higher than 15" above the finished floor.	1	2436	\$2436

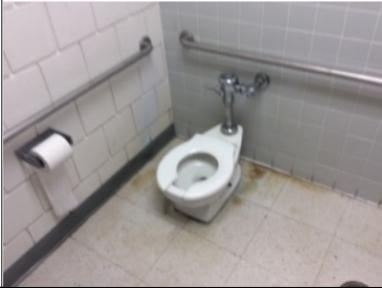
Flush control not on open side Centerline < or > 11" (Pre-K) Side or rear grab bar < 18" or > 20" high (Pre-K)	- 19" 25"	Move the flush control to the open/transfer side. Mount flush control between 20" - 30" above the floor. Relocate toilet so that the centerline is 11" from the side wall. Locate grab bar between 18"- 20" above the floor.	1	2594	\$2594
88	Boys' Toilet Room in Classroom	1	B115	Single-User Toilet	N/A

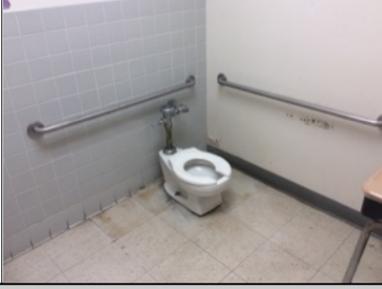
Centerline < or > 11" (Pre-K) Side or rear grab bar < 18" or > 20" high (Pre-K)	19" 25"	Relocate toilet so that the centerline is 11" from the side wall. Locate grab bar between 18"- 20" above the floor.	1	2313	\$2313

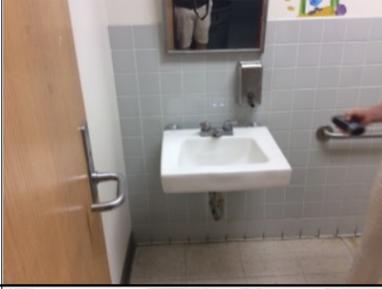
<b>Lavatory</b>												
89	Boys' Toilet Room in Classroom	1	B115	Lavatory	N/A

Exposed plumbing underneath Mirror above lavatory w/reflective surface > 31"	- 43"	Insulate or otherwise configure pipes to prevent contact, for at least one lavatory. Lower mirror so that the bottom surface is at 31" above finished floor.	1	261	\$261
90	Girls' Toilet Room in Classroom	1	B115	Lavatory	N/A

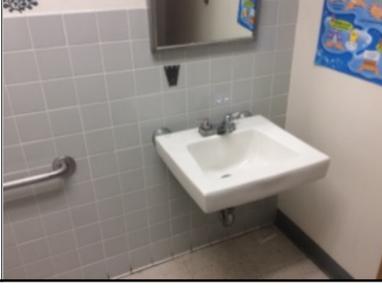
Exposed plumbing underneath Mirror above lavatory w/reflective surface > 31"	- 41"	Insulate or otherwise configure pipes to prevent contact, for at least one lavatory. Lower mirror so that the bottom surface is at 31" above finished floor.	1	261	\$261

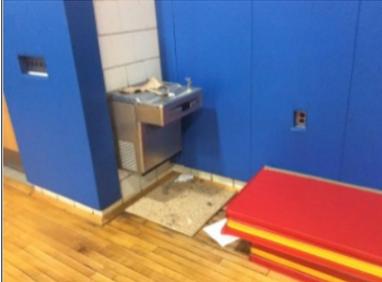
Clear floor space not provided No drinking fountain provided for standing users	- -	Provide a 30" by 48" clear floor space positioned for a forward approach by removing clutter. Provide an additional drinking fountain for standing users or install a Hi-Lo drinking fountain.	1	Labor 3021	\$3021
92	Near Main Entrance	1		Drinking Fountains	Low

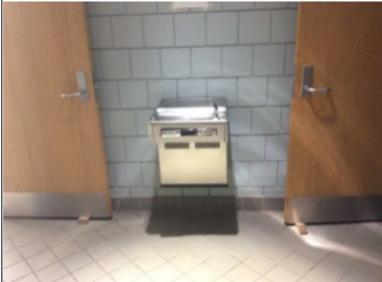
No drinking fountain provided for standing users	-	Provide an additional drinking fountain for standing users or install a Hi-Lo drinking fountain.	1	3021	\$3021
93	Near Room 110	1		Drinking Fountains	Low

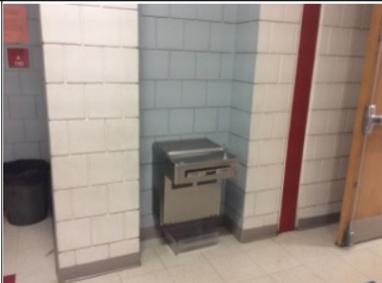
No drinking fountain provided for standing users	-	Provide an additional drinking fountain for standing users or install a Hi-Lo drinking fountain.	1	3162	\$3162

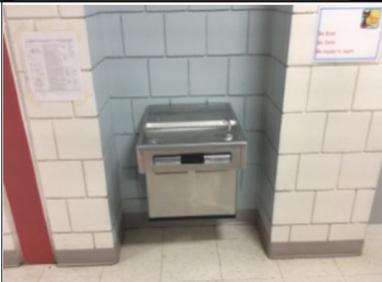
94	Near Early Childhood Center Office	1		Drinking Fountains	Low

No drinking fountain provided for standing users	-	Provide an additional drinking fountain for standing users or install a Hi-Lo drinking fountain.	1	3162	\$3162
95	Near Library	1		Drinking Fountains	Low

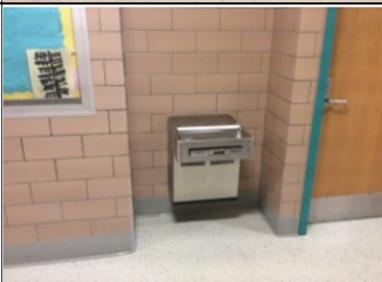
No drinking fountain provided for standing users	-	Provide an additional drinking fountain for standing users or install a Hi-Lo drinking fountain.	1	3162	\$3162

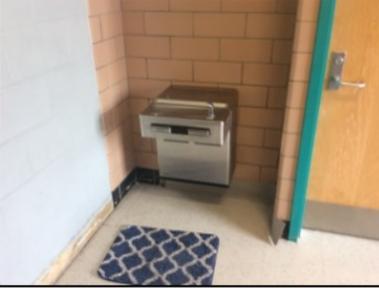
No drinking fountain provided for standing users	-	Provide an additional drinking fountain for standing users or install a Hi-Lo drinking fountain.	1	3162	\$3162
<b>Sink</b>												
97	Health Office	1	119	Sink	N/A

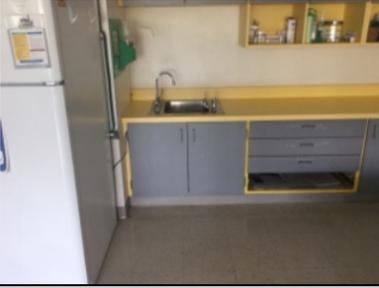
Toe and knee clearances not provided	-	Ensure there is a 27" knee clearance positioned for a forward approach.	1	1265	\$1265
<b>Sinks for Children's Use</b>												
98	Music Room	1	120	Sinks for Children's Use	Classroom

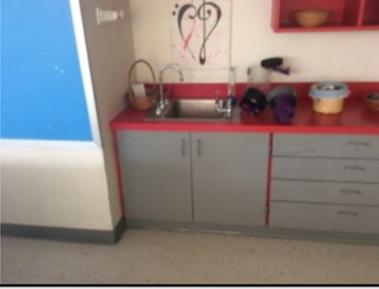
Knee or toe clearance not provided	-	Provide at least one sink with 25" knee and toe clearance positioned for a forward approach.	1	1265	\$1265
<b>Play and Sport Areas</b>												
<b>Play Areas</b>												
99	Kindergarten Playground	Ext.		Play Areas	N/A

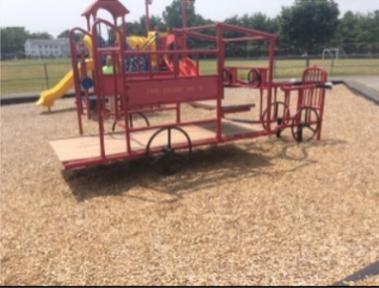
Accessible route not provided to ground level play components Not connected to an accessible route	- -	Ensure an accessible route is provided to one of each type of ground level play components Provide an accessible route to and around play areas.  (Cost based on 80' by 5' wide poured in place rubber routes to play components.)	1	8400	\$8400

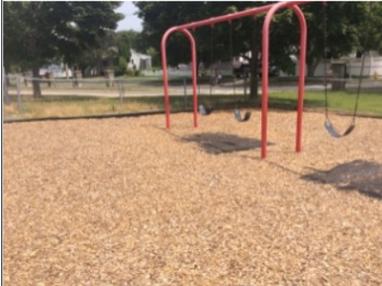
Not connected to an accessible route Accessible route not provided to ground level play components	- -	Ensure an accessible route is provided to swings. Provide an accessible route to play areas.  (Cost based on 115' by 4' wide asphalt around play area and 55' by 5' wide poured in place rubber route to swings.)	1	8708	\$8708

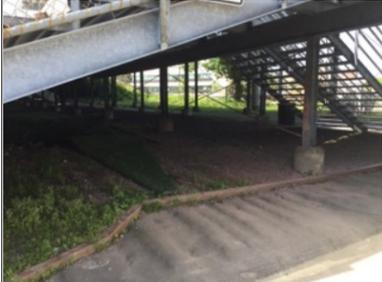
Accessible route not provided	-	Redesign this area to provide an accessible route to the lift.	1	-	\$0
2	Athletic Field, Route to Toilet Rooms			Exterior Access Route	Exterior

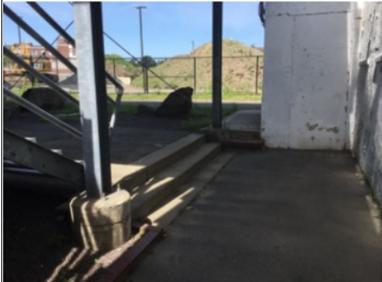
Accessible route not provided	-	Redesign this area to provide an accessible route to the lift.	1	-	\$0
<b>Stairs</b>												
3	Stairs Towards Broad Street	Ext.		Stairs	Exterior

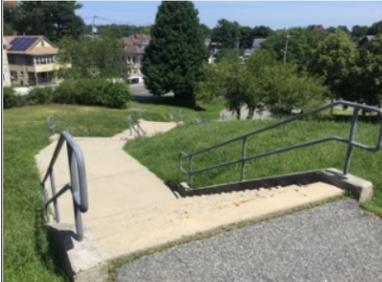
Stairs not maintained in operable working condition		Ensure stairs are maintained in operable working condition.	1	Labor	\$0
<b>Curb Ramp</b>												
4	Towards Playground	Ext.		Curb Ramp	N/A

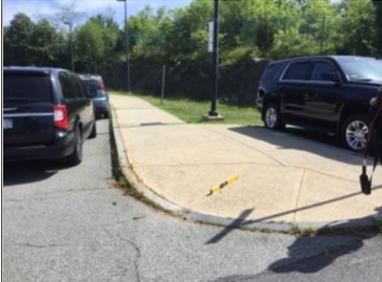
Running slope > 1:12 (8.33%)	13.5%	Reduce running slope to be no steeper than 1:12 (8.33%).	1	2800	\$2800

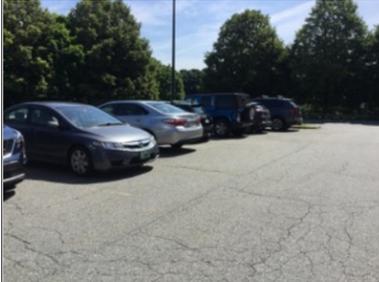
Total # of parking Total # of designated accessible parking spaces	24 -	Provide a van accessible space that is at least 96" wide with a marked access aisle that is at least 96" wide. Provide a sign with the bottom of the sign 60" min. above the ground and the top 96" max. above the ground. Add the designation "Van Accessible" to the sign.	1	1388	\$1388
6	Staff Parking Lot, South Side of School	Ext.		Off-Street Parking Lot or Garage	Employee

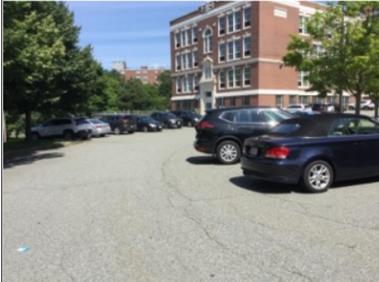
Total # of parking Total # of designated accessible parking spaces	20 -	Provide a van accessible space that is at least 96" wide with a marked access aisle that is at least 96" wide. Provide a sign with the bottom of the sign 60" min. above the ground and the top 96" max. above the ground. Add the designation "Van Accessible" to the sign.	1	1388	\$1388

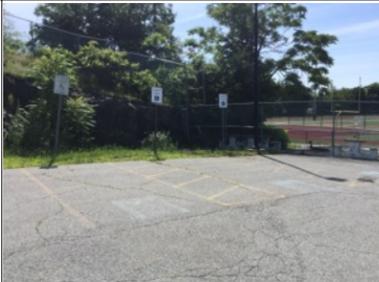
7	Parking Near Athletic Field	Ext.		Off-Street Parking Lot or Garage	Visitor

Total # of parking Total # of designated accessible parking spaces Access aisle < 96" wide at van space	59 3 64"	Provide two marked access aisle that are at least 96" wide.	1	225	\$225
8	Parking - North Side	Ext.		Off-Street Parking Lot or Garage	Employee

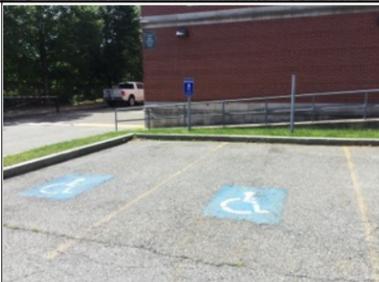
Access aisle not provided Sign bottom < 60" above finished grade	- 41"	Provide a marked access aisle that is at least 96" wide. Locate sign with the bottom of the sign 60" above the ground and the top 96" max. above the ground. Add the designation "Van Accessible" to the sign.	1	225	\$225
9	Staff Parking Lot	Ext.		Off-Street Parking Lot or Garage	Employee

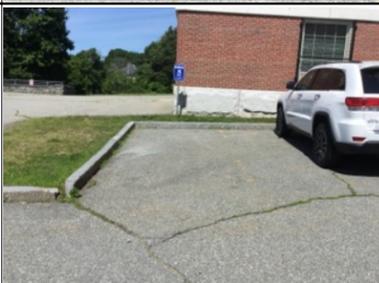
Access aisle < 96" wide at van space Sign bottom < 60" above finished grade	60" 45"	Provide a marked access aisle that is at least 96" wide. Locate sign with the bottom of the sign 60" above the ground and the top of the sign 96" above the ground.	1	225	\$225

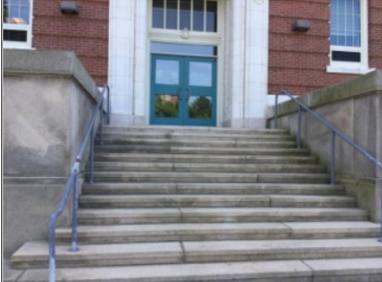
Entrance not on an accessible route Directional sign to accessible entrance not provided	- -	Provide a directional sign indicating the location of the nearest accessible entrance.	1	260	\$260
12	Main Entrance	Ext.		Entrance	Main Entrance

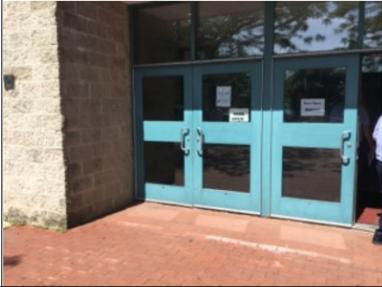
International Symbol of Accessibility not provided	-	Provide the International Symbol of Accessibility.	1	260	\$260
<b>Stairs</b>												
13	Stairs Towards Highland Avenue	Ext.		Stairs	N/A

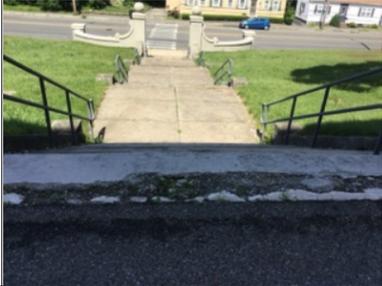
Not maintained in operable working condition	-	Ensure stairs are maintained in operable working condition.	1	-	\$0

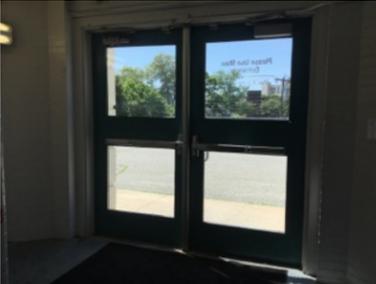
Illuminated exit sign not provided Tactile exit sign not provided	-	Ensure an illuminated exit sign with the International Symbol of Accessibility (ISA) is provided at exit door. Ensure a tactile exit sign with raised characters and braille is provided at exit door. Mount sign between 48"- 60" above finished floor located on the latch side of the door.	1	274	\$274
15	Main Entrance	1		Means of Egress	N/A

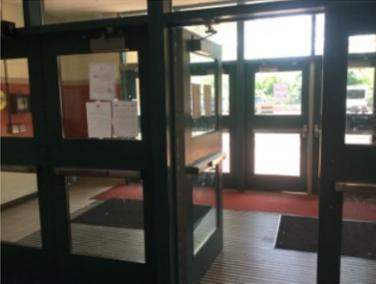
Illuminated exit sign not provided Tactile exit sign not provided	- -	Ensure an illuminated exit sign with the International Symbol of Accessibility (ISA) is provided at exit door. Ensure a tactile exit sign with raised characters and braille is provided at exit door. Mount sign between 48"- 60" above finished floor located on the latch side of the door.	1	274	\$274

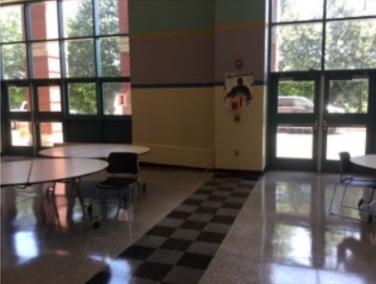
16	Exits #24 and #25 (Cafeteria)	1		Means of Egress	N/A

Illuminated exit sign not provided Tactile exit sign not provided	- -	Ensure illuminated exit signs with the International Symbol of Accessibility (ISA) are provided at exit doors. Ensure tactile exit signs with raised characters and braille is provided at exit door. Mount sign between 48"- 60" above finished floor located on the latch side of the door.	2	274	\$548
17	Exit #2	1		Means of Egress	N/A

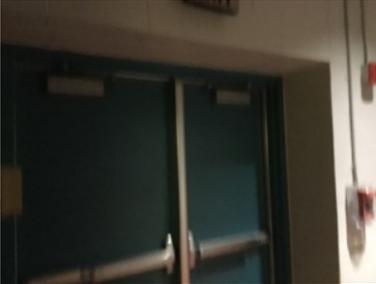
Illuminated exit sign not provided Tactile exit sign not provided	- -	Ensure illuminated exit signs with the International Symbol of Accessibility (ISA) are provided at exit doors. Ensure tactile exit signs with raised characters and braille is provided at exit door. Mount sign between 48"- 60" above finished floor located on the latch side of the door.	1	274	\$274
18	Exit #7	1		Means of Egress	N/A

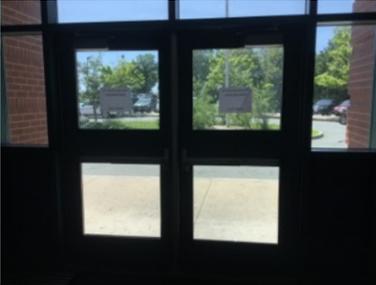
Illuminated exit sign not provided Tactile exit sign not provided	- -	Ensure an illuminated exit sign with the International Symbol of Accessibility (ISA) is provided at exit door. Ensure a tactile exit sign with raised characters and braille is provided at exit door. Mount sign between 48"- 60" above finished floor located on the latch side of the door.	1	274	\$274

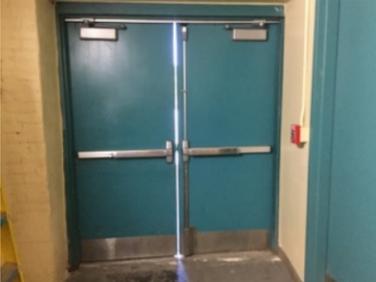
Illuminated exit sign not provided Tactile exit sign not provided	- -	Ensure an illuminated exit sign with the International Symbol of Accessibility (ISA) is provided at exit door. Ensure a tactile exit sign with raised characters and braille is provided at exit door. Mount sign between 48"- 60" above finished floor located on the latch side of the door.	1	274	\$274
20	Exit #17	Ext.		Means of Egress	N/A

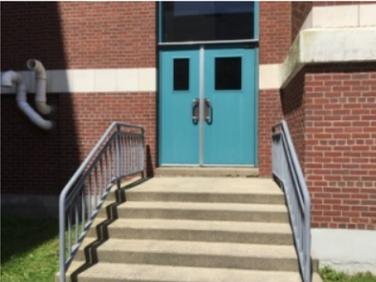
Emergency exit not on an accessible route		Provide a directional sign on the interior indicating the location of the nearest emergency exit. Ensure a tactile exit sign with raised characters and braille is provided at exit door. Mount sign between 48"- 60" above finished floor located on the latch side of the door.	1	174	\$174
21	Exit #16	1		Means of Egress	N/A

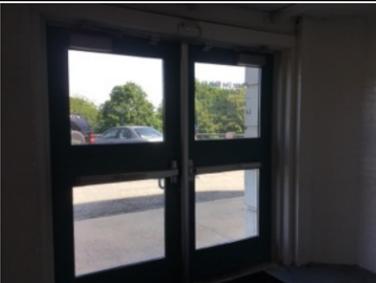
Emergency exit not on an accessible route Directional sign to accessible emergency exit not provided Tactile exit sign not provided	- - -	Provide a directional sign indicating the location of the nearest emergency exit. Ensure a tactile exit sign with raised characters and braille is provided at exit door. Mount sign between 48"- 60" above finished floor located on the latch side of the door.	1	174	\$174

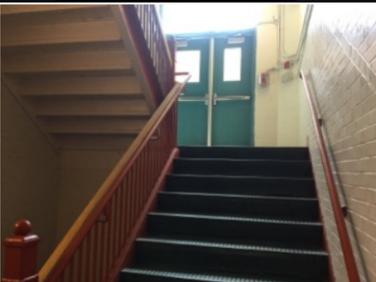
22	Stair F Exit #17	1	Stair F	Means of Egress	N/A

Emergency exit not on an accessible route Directional sign to accessible emergency exit not provided Tactile exit sign not provided	- - -	Provide a directional sign indicating the location of the nearest emergency exit. Ensure a tactile exit sign with raised characters and braille is provided at exit door. Mount sign between 48"- 60" above finished floor located on the latch side of the door.	1	174	\$174
23	Exit #14	1		Means of Egress	N/A

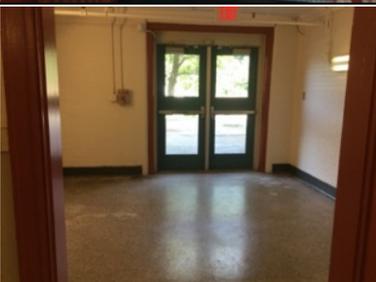
Emergency exit not on an accessible route Directional sign to accessible emergency exit not provided Tactile exit sign not provided	- - -	Provide a directional sign indicating the location of the nearest emergency exit. Ensure a tactile exit sign with raised characters and braille is provided at exit door. Mount sign between 48"- 60" above finished floor located on the latch side of the door.	2	174	\$348

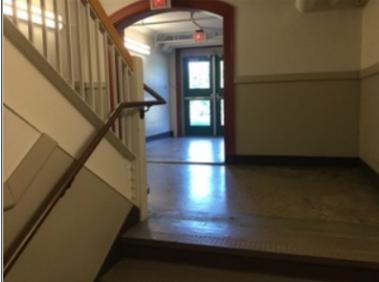
ID	Location	Floor	Room	Element	Type	Photo	Issues	Current Measure	Recommendations	Quantity	Price	Cost Estimation
24	Exit #12	1		Means of Egress	N/A

Emergency exit not on an accessible route Directional sign to accessible emergency exit not provided Tactile exit sign not provided		Provide a directional sign indicating the location of the nearest emergency exit. Ensure a tactile exit sign with raised characters and braille is provided at exit door. Mount sign between 48"- 60" above finished floor located on the latch side of the door.	1	174	\$174
25	Exit #10	1	117	Means of Egress	N/A
