**City of Salem,  
Massachusetts**

December 2019

# Salem City Hall

## City of Salem ADA Transition Plan

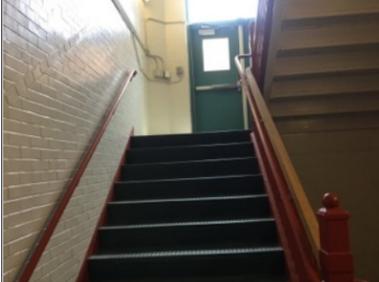
Emergency exit not on an accessible route Directional sign to accessible emergency exit not provided Tactile exit sign not provided		Provide a directional sign indicating the location of the nearest emergency exit. Ensure a tactile exit sign with raised characters and braille is provided at exit door. Mount sign between 48"- 60" above finished floor located on the latch side of the door.	1	174	\$174

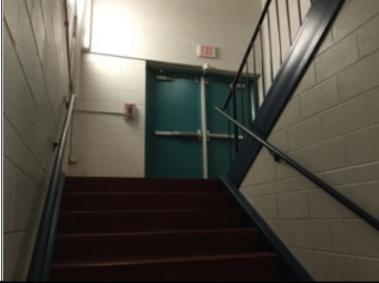
26	Exit #9	1		Means of Egress	N/A

Emergency exit not on an accessible route Directional sign to accessible emergency exit not provided Tactile exit sign not provided	- -	Provide a directional sign indicating the location of the nearest emergency exit. Ensure a tactile exit sign with raised characters and braille is provided at exit door. Mount sign between 48"- 60" above finished floor located on the latch side of the door.	1	174	\$174
27	Exit #9	2		Means of Egress	N/A

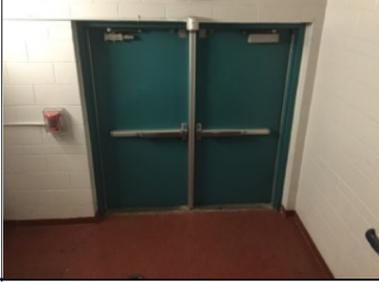
Emergency exit not on an accessible route Directional sign to accessible emergency exit not provided Tactile exit sign not provided	-	Provide a directional sign indicating the location of the nearest emergency exit. Ensure a tactile exit sign with raised characters and braille is provided at exit door. Mount sign between 48"- 60" above finished floor located on the latch side of the door.	1	174	\$174
28	Exit #22			Means of Egress	90

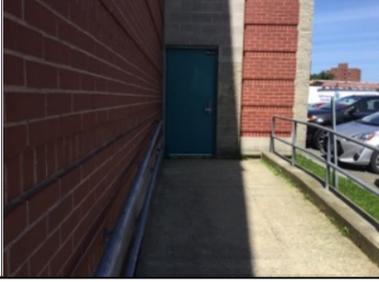
Tactile exit sign not provided	- -	Ensure a tactile exit sign with raised characters and braille is provided on the interior at exit door. Mount sign between 48"- 60" above finished floor located on the latch side of the door. Ensure an illuminated exit sign with the International Symbol of Accessibility (ISA) is provided at exit door.	1	274	\$274

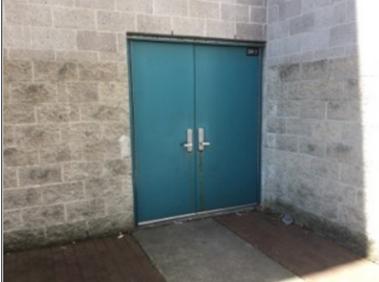
ID	Location	Floor	Room	Element	Type	Photo	Issues	Current Measure	Recommendations	Quantity	Price	Cost Estimation
29	Exit #2	Ext.		Means of Egress	N/A

Tactile exit sign not provided	-	Ensure tactile exit signs on the interior with raised characters and braille are provided at exit doors. Mount signs between 48"- 60" above finished floor located on the latch side of the door. Ensure an illuminated exit signs with the International Symbol of Accessibility (ISA) are provided at exit door.	1	274	\$274
30	Exits #3, #4, #5, and #6			Means of Egress	N/A

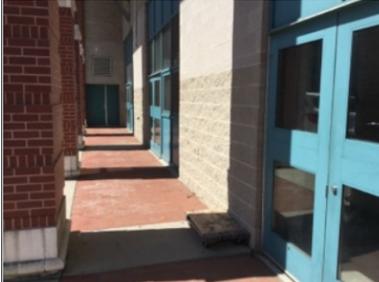
Tactile exit sign not provided	-	Ensure tactile exit signs on the interior with raised characters and braille are provided at exit doors. Mount signs between 48"- 60" above finished floor located on the latch side of the door. Ensure an illuminated exit signs with the International Symbol of Accessibility (ISA) are provided at exit door.	4	274	\$1096

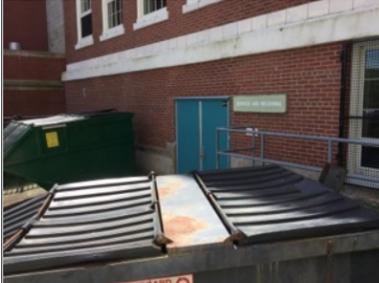
31	Exit #18			Means of Egress	N/A

Tactile exit sign not provided		Ensure a tactile exit sign on the interior with raised characters and braille is provided at exit door. Mount sign between 48"- 60" above finished floor located on the latch side of the door. Ensure an illuminated exit sign with the International Symbol of Accessibility (ISA) is provided at exit door.	1	274	\$274
32	Exits #19, #20			Means of Egress	N/A

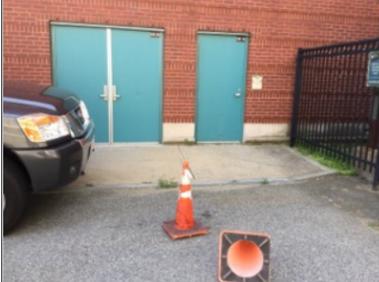
Tactile exit sign not provided	-	Ensure tactile exit signs with raised characters and braille are provided at exit doors. Mount signs between 48"- 60" above finished floor located on the latch side of the door. Ensure an illuminated exit signs with the International Symbol of Accessibility (ISA) are provided at exit doors.	2	274	\$548
33	Exit #21			Means of Egress	N/A

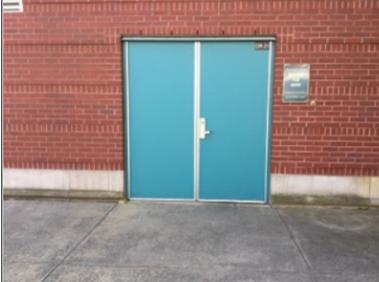
Tactile exit sign not provided	-	Ensure a tactile exit sign on the interior with raised characters and braille is provided at exit door. Mount sign between 48"- 60" above finished floor located on the latch side of the door. Ensure an illuminated exit sign with the International Symbol of Accessibility (ISA) is provided at exit door.	1	274	\$274

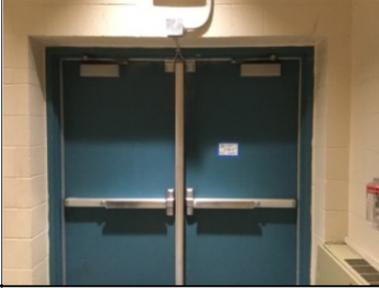
ID	Location	Floor	Room	Element	Type	Photo	Issues	Current Measure	Recommendations	Quantity	Price	Cost Estimation
34	Exit #23	1		Means of Egress	N/A

Tactile exit sign not provided	- -	Ensure an illuminated exit sign with the International Symbol of Accessibility (ISA) is provided at exit door. Ensure a tactile exit sign with raised characters and braille is provided at exit door. Mount sign between 48"- 60" above finished floor located on the latch side of the door.	1	274	\$274
35	Stairwells I & J	2		Means of Egress	N/A

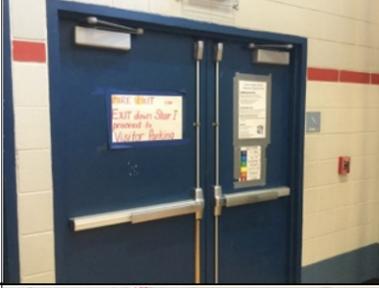
Directional sign to accessible emergency exit not provided	-	Provide a directional sign indicating the location of the nearest accessible emergency exit.	2	174	\$348
36	Stairwell H	2		Means of Egress	N/A

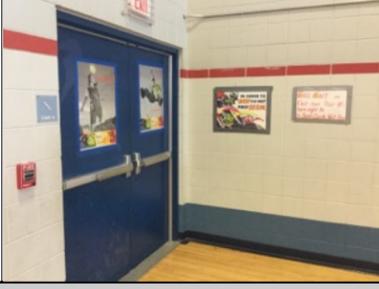
Directional sign to accessible emergency exit not provided	-	Provide a directional sign indicating the location of the nearest accessible emergency exit.	1	174	\$174

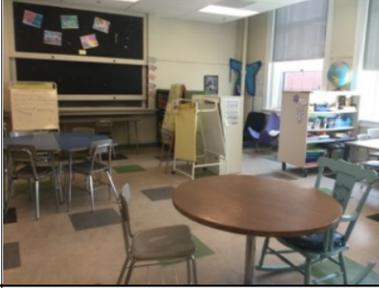
<b>Interior Access Route</b>												
37	Classroom	3	310	Interior Access Route

Route < 36" wide	29.75"	Ensure that a clear width of 36" min. is maintained at the accessible route.	1	Labor	\$0
38	Near Girls' Toilet Room	3		Interior Access Route	N/A

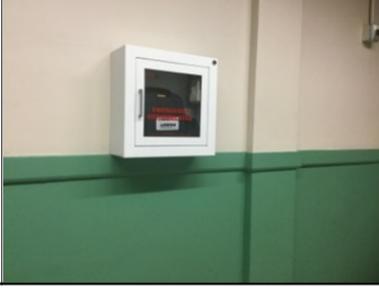
Obstructed by protruding objects	7"	Relocate AED so it does not protrude into the circulation path.	1	128	\$128

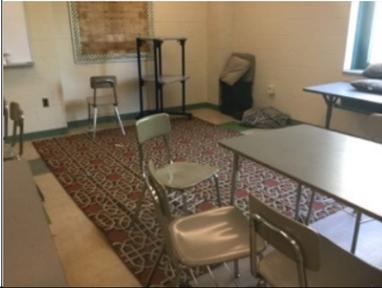
Mat not securely attached	-	Ensure walk-off mat is securely attached.	1	Labor	\$0
<b>Doors, Doorways, &amp; Gates</b>												
41	Classroom	3	334	Doors, Doorways, & Gates	Classroom

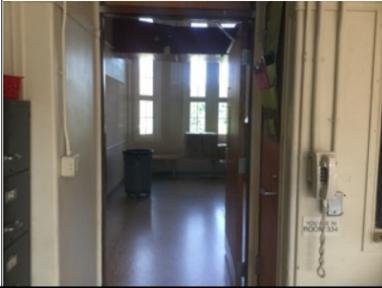
Maneuvering clearance(s) not provided	-	Keep door open as needed.	1	Labor	\$0
42	Boys' Toilet Room - Near Room #327	3		Doors, Doorways, & Gates	Toilet Room

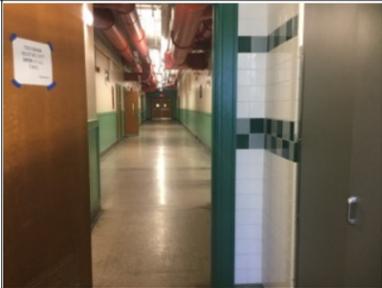
Maneuvering clearance(s) not provided	14.5"	Provide an automatic door opener.	1	2295	\$2295
43	Multi-Purpose Room	3	338	Doors, Doorways, & Gates	Classroom

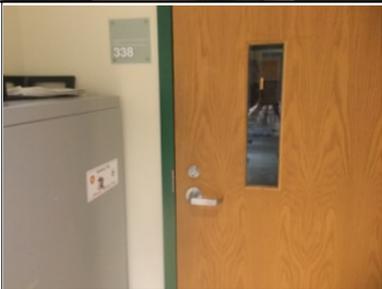
Maneuvering clearance(s) not provided	6"	Relocate cabinet to maintain the 18" min. maneuvering clearance at the door.	1	Labor	\$0

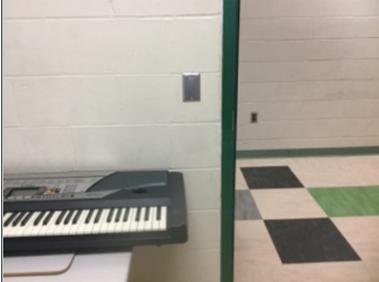
ID	Location	Floor	Room	Element	Type	Photo	Issues	Current Measure	Recommendations	Quantity	Price	Cost Estimation
44	Music Room	3	343	Doors, Doorways, & Gates	Classroom

Maneuvering clearance(s) not provided	-	Remove piano keyboard to maintain the maneuvering clearance at the door.	1	Labor	\$0
45	Assistant Superintendent's Office	2	226	Doors, Doorways, & Gates	N/A

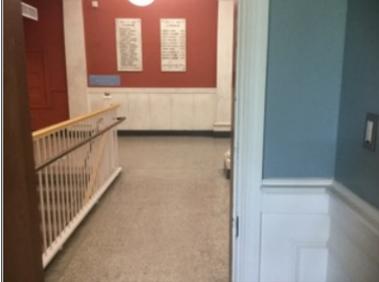
Maneuvering clearance(s) not provided		Keep door open as needed.	1	Labor	\$0
46	Assistant Superintendent's Office	2	226	Doors, Doorways, & Gates

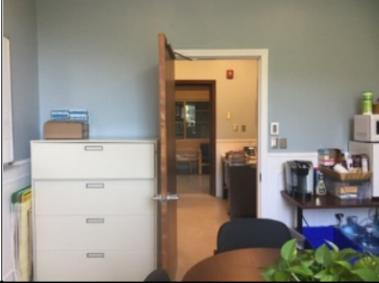
Maneuvering clearance(s) not provided	-	Relocate table to maintain the maneuvering clearance at the door.	1	Labor	\$0
47	Superintendent's Office	2	222	Doors, Doorways, & Gates	Office

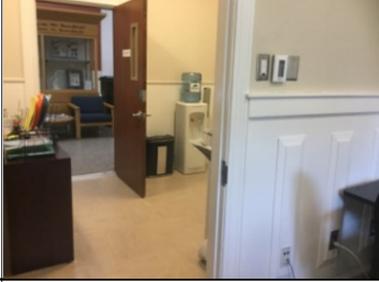
Maneuvering clearance(s) not provided	-	Relocate table to maintain the maneuvering clearance at the door.	1	Labor	\$0
48	Director of Nursing Office	1	129	Doors, Doorways, & Gates	Office

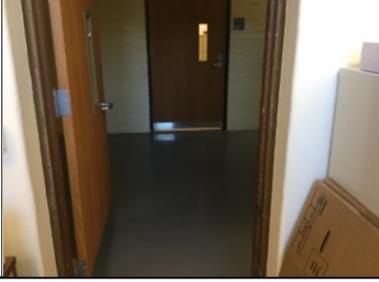
Maneuvering clearance(s) not provided	-	Ensure the maneuvering clearance is maintained at the door.	1	Labor	\$0

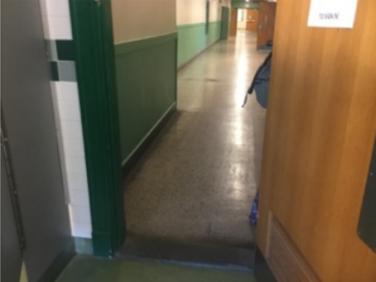
ID	Location	Floor	Room	Element	Type	Photo	Issues	Current Measure	Recommendations	Quantity	Price	Cost Estimation
49	Girls' Toilet Room - Near Room #321	3		Doors, Doorways, & Gates	Toilet Room

Maneuvering clearance(s) not provided Threshold not beveled	11.5" -	Provide an automatic door opener. Bevel threshold.	1	2408	\$2408
50	Exit #14	1		Doors, Doorways, & Gates	Emergency Egress

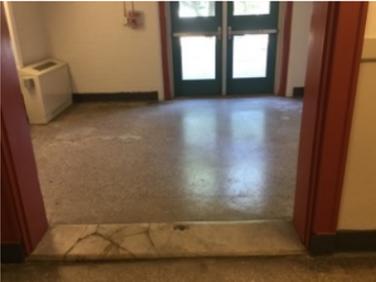
Threshold > 1/2" high	2"	Alter threshold to be 1/2" high max.	1	113	\$113
51	Classroom	4	431	Doors, Doorways, & Gates	Circulation

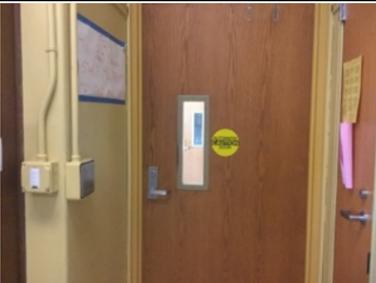
Automatic door opener not operable	-	Repair or replace the door opener.	1	2295	\$2295
52	Classroom	4	432	Doors, Doorways, & Gates

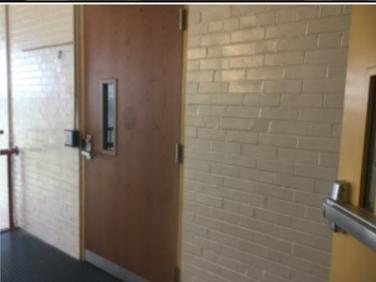
Automatic door opener not operable	-	Repair or replace the door opener.	1	2295	\$2295
53	Nurse's Room	3	317	Doors, Doorways, & Gates	Office

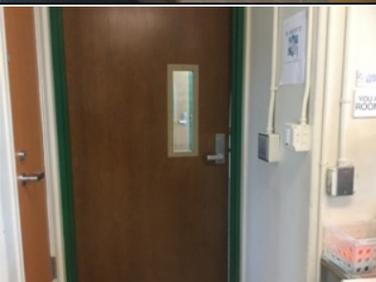
Automatic door opener not operable	-	Repair or replace the door opener.	1	2295	\$2295

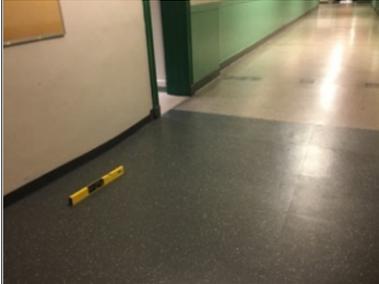
ID	Location	Floor	Room	Element	Type	Photo	Issues	Current Measure	Recommendations	Quantity	Price	Cost Estimation
<b>Ramps</b>												
54	Hallway - Near Room #337	3		Ramps	Interior

Handrails not provided at both sides if rise is > 6"	-	Provide handrails on both sides.	4	834	\$3336
55	Near Room #310	3		Ramps	Interior

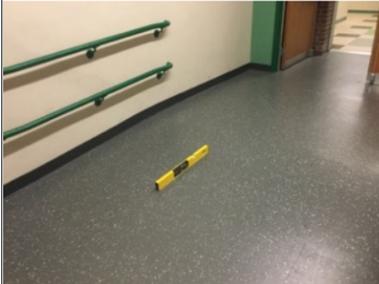
No lower handrail 18"-20" high provided	-	Provide a lower handrail between 18" to 20" high.	1	834	\$834
<b>Stairways</b>												
56	Towards Bleachers From Toilet Rooms	Ext		Stairways	Exterior

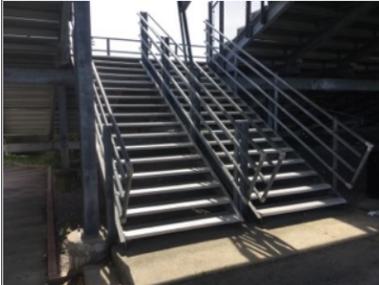
Stair has open risers	-	Ensure stairs have closed risers.  (Cost for fill in of 16 risers.)	2	1968	\$3936
<b>Elevator</b>												
57	Elevator	3		Elevator	Interior

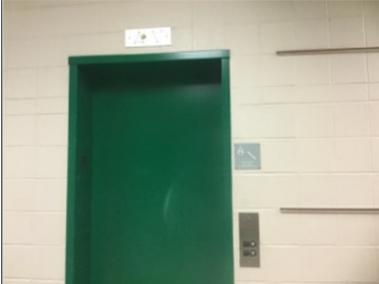
Elevator not independently operable (requires key)		Ensure elevator provides unassisted entry and exit.	1	-	\$0

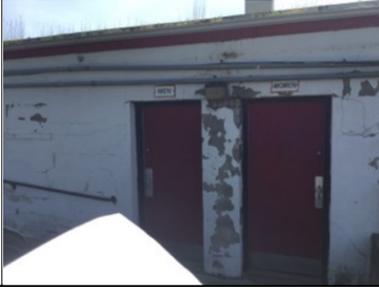
ID	Location	Floor	Room	Element	Type	Photo	Issues	Current Measure	Recommendations	Quantity	Price	Cost Estimation
<b>Signage</b>												
58	Men's and Women's Toilet Rooms	Ext.		Signage	Designation

Raised characters not provided Braille not provided Sign not located on the latch side of the door	- - -	Provide text with raised characters duplicated in braille. Locate sign alongside doors on the latch side.	2	260	\$520
59	Mechanical Drawing	1	103	Signage	Designation

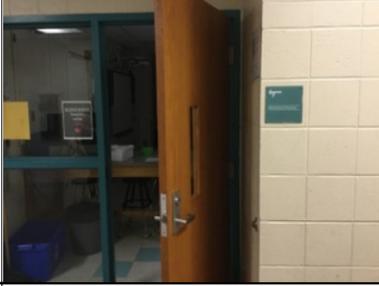
Raised characters not provided Braille not provided Sign not located on the latch side of the door	- - -	Provide text with raised characters duplicated in braille. Locate sign alongside the door on the latch side.	1	174	\$174
60	Classroom	3	334	Signage	Designation

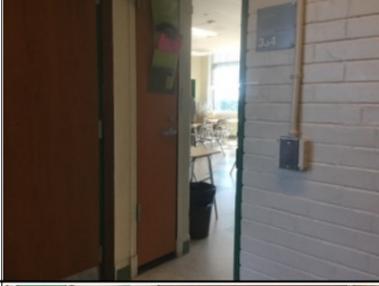
Braille not provided	-	Provide braille.	1	174	\$174
61	Classroom	4	422	Signage	Designation

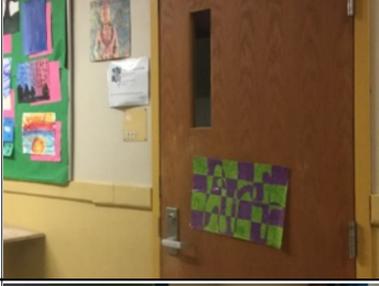
Braille not provided	-	Provide braille.	1	174	\$174
62	Boys' Toilet Room - Near Cafeteria	1		Signage	Designation

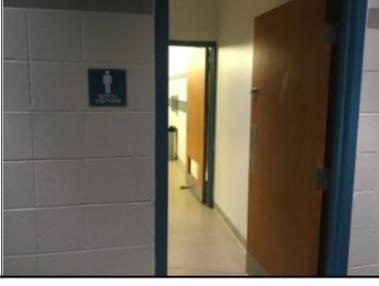
Braille not provided International Symbol of Acc. not provided	- -	Provide braille. Provide a sign with the International Symbol of Accessibility.	1	174	\$174

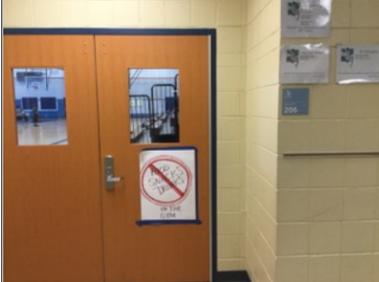
ID	Location	Floor	Room	Element	Type	Photo	Issues	Current Measure	Recommendations	Quantity	Price	Cost Estimation
63	Gym	2	206	Signage	Designation

Braille not provided Sign not located on the latch side of the door	- -	Provide braille. Locate sign at permanent rooms alongside the door on the latch side.	1	174	\$174
64	Classroom	4	423	Signage	Designation

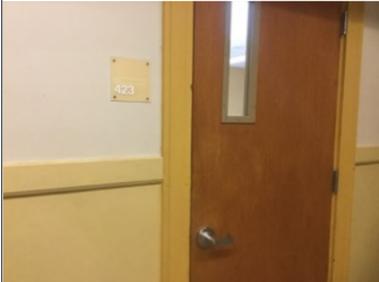
Braille misplaced	-	Position braille below the corresponding text. If text is multi-lined place braille below the entire text.	1	174	\$174
65	Girls' Toilet Room - Near Room #321	3		Signage	Designation

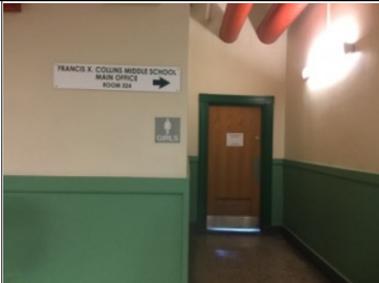
Braille misplaced	-	Position braille below the corresponding text. If text is multi-lined place braille below the entire text.	1	174	\$174
66	Stair B	3		Signage	Egress

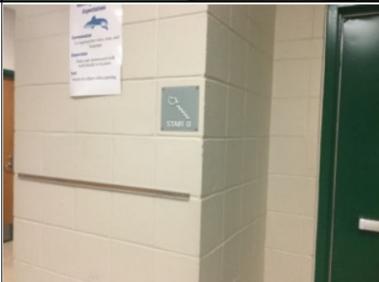
Braille misplaced	-	Position braille below the corresponding text. If text is multi-lined place braille below the entire text.	1	174	\$174
67	Boys' Toilet Room - Near Room #327	3		Signage	Designation

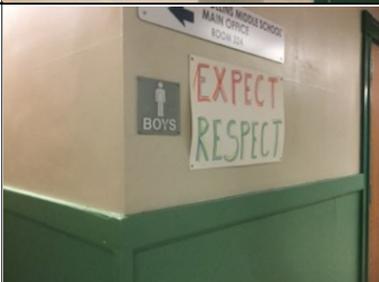
Braille misplaced Sign not located on the latch side of the door	- -	Position braille below the corresponding text. If text is multi-lined place braille below the entire text. Locate sign alongside the door on the latch side.	1	174	\$174

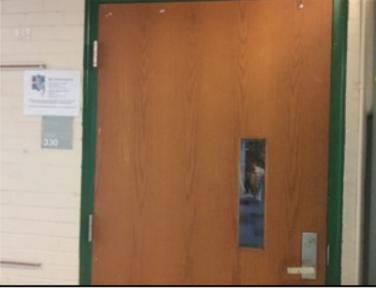
Sign not located on the latch side of the door	-	Locate sign at permanent rooms alongside the door on the latch side.	1	Labor	\$0
69	Technology Education	1	104	Signage	Designation

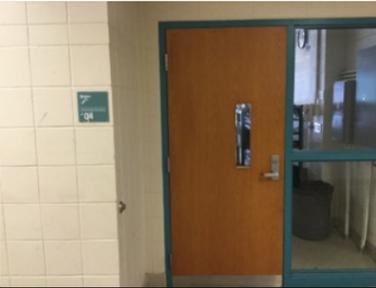
Sign not located on the latch side of the door	-	Locate sign alongside the door on the latch side.	1	Labor	\$0
70	Classroom	1	105	Signage	Designation

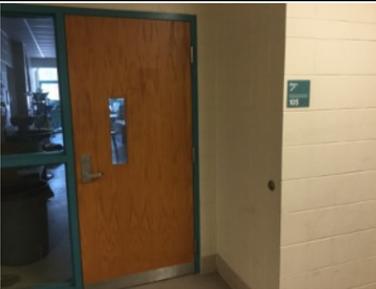
Sign not located on the latch side of the door	-	Locate sign alongside the door on the latch side.	1	Labor	\$0
71	Fitness Room	1	107	Signage	Designation

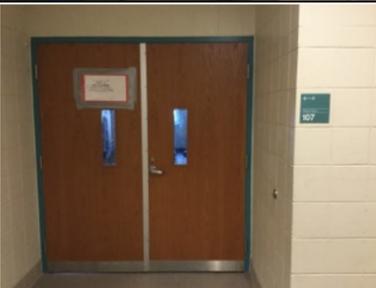
Sign not located on the latch side of the door	-	Locate sign at permanent rooms alongside the door on the latch side on the inactive leaf.	1	Labor	\$0
72	Computer Lab	2	225	Signage	Designation

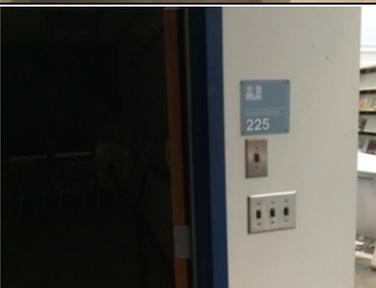
Sign not located on the latch side of the door	-	Locate sign alongside the door on the latch side.	1	Labor	\$0

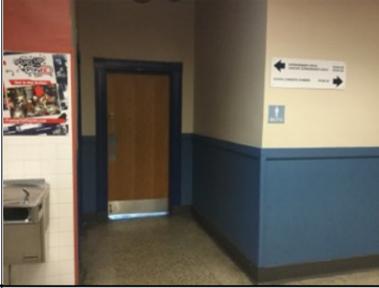
Sign not located on the latch side of the door	-	Locate sign at permanent rooms alongside the door on the latch side.	2	Labor	\$0
74	Committee Chamber	2	227	Signage	Designation

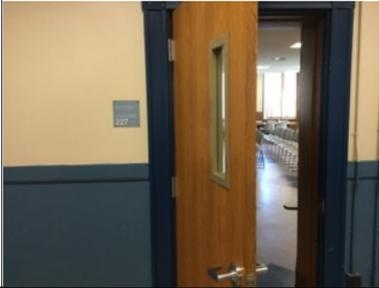
Sign not located on the latch side of the door	-	Locate sign alongside the door on the latch side.	1	Labor	\$0
75	Girls' Toilet Room Near Cafeteria	1		Signage	Designation

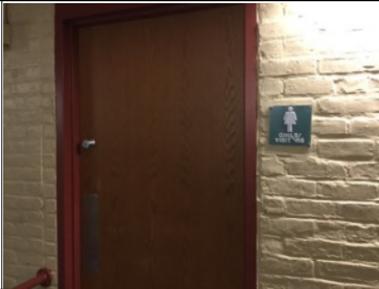
Sign not located on the latch side of the door International Symbol of Acc. not provided	- -	Locate sign at permanent rooms alongside the door on the latch side. Provide a sign with the International Symbol of Accessibility.	1	174	\$174
76	Green Room	1		Signage	Designation

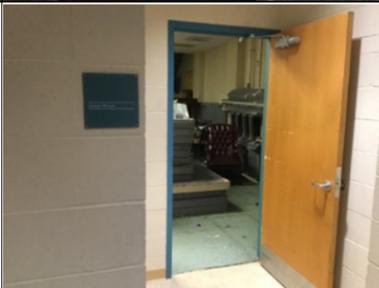
Sign not maintained in operable working condition	-	Provide a sign with raised characters duplicated in braille. Locate sign alongside doors on the latch side.	1	174	\$174

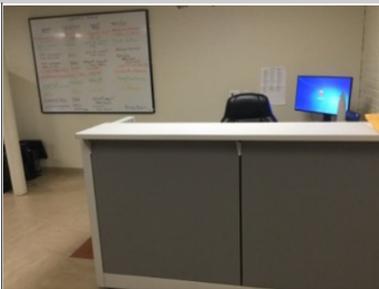
<b>Service Counter</b>												
77	Data Technology Lab	1	127	Service Counter	N/A

Counter > 36" high	44"	Provide a counter that is 36" max. above the ground or finished floor.	1	660	\$660

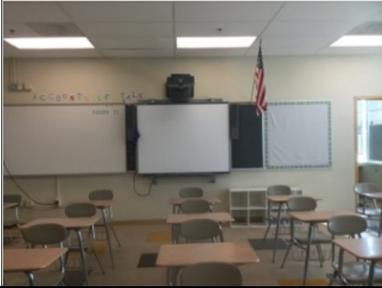
At least one or 5% accessible tables not provided Knee or toe clearance not provided	- -	Ensure that at least one dining or work surface is accessible. Provide at least 1 dining or work surface with 27" min. knee and toe clearance.	1	525	\$525
80	Classroom	4	433	Dining or Work Surfaces	Work Surface

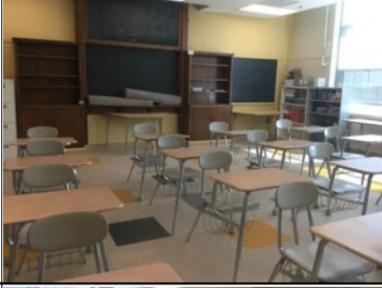
At least one or 5% accessible tables not provided Knee or toe clearance not provided	- -	Ensure that at least one dining or work surface is accessible. Provide at least 1 dining or work surface with 27" min. knee and toe clearance.	1	525	\$525

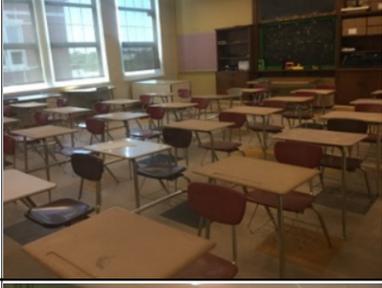
81	Classroom	4	430	Dining or Work Surfaces	Work Surface

At least one or 5% accessible tables not provided Knee or toe clearance not provided	- -	Ensure that at least one dining or work surface is accessible. Provide at least 1 dining or work surface with 27" min. knee and toe clearance.	1	525	\$525
82	Classroom	3	321	Dining or Work Surfaces	Work Surface

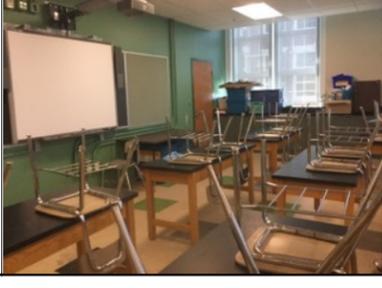
At least one or 5% accessible tables not provided Knee or toe clearance not provided	- 24"	Provide at least one work surface with 27" min. knee and toe clearance.	1	525	\$525

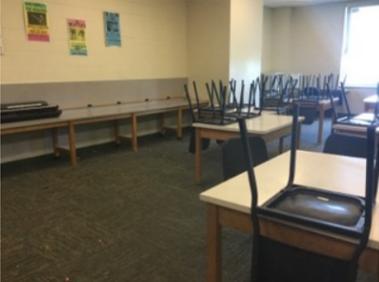
At least one or 5% accessible tables not provided Knee or toe clearance not provided	- 23.5"	Provide at least 1 work surface with 27" min. knee and toe clearance.	1	525	\$525
84	Computer Lab	2	225	Dining or Work Surfaces	Work Surface

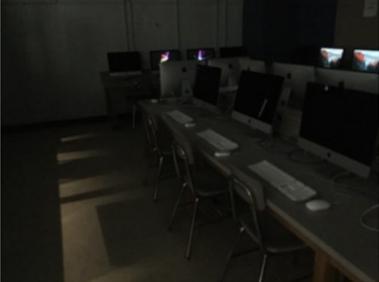
At least one or 5% accessible tables not provided Knee or toe clearance not provided	- 23"	Ensure that at least one work surface is accessible. Provide at least one work surface with 27" min. knee and toe clearance.	1	525	\$525
85	Library	2		Dining or Work Surfaces	Work Surface

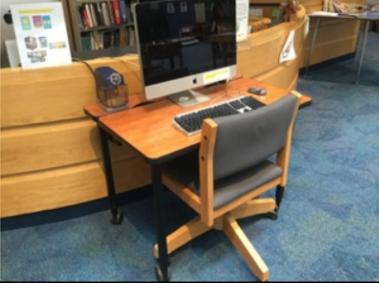
At least one or 5% accessible tables not provided Knee or toe clearance not provided	- 25"	Provide a work surface with 27" min. knee and toe clearance.	1	525	\$525
86	Library	2	238	Dining or Work Surfaces	Work Surface

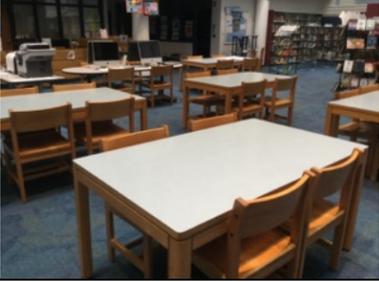
At least one or 5% accessible tables not provided Knee or toe clearance not provided	- 25"	Ensure that at least one work surface is accessible. Provide at least one work surface with 27" min. knee and toe clearance.	1	525	\$525

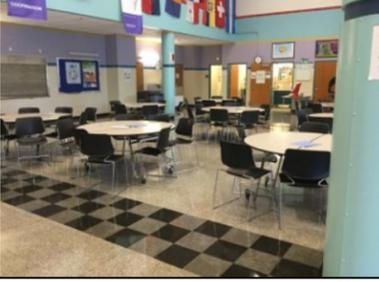
87	Cafeteria	1		Dining or Work Surfaces	Dining Surface

At least one or 5% accessible tables not provided Top of dining/work surface < 28" or > 34"	- 25"	Ensure that at least one dining surface is accessible. Provide at least one dining surface with top between 28"- 34" above the floor and 27" clear height underneath.	1	825	\$825

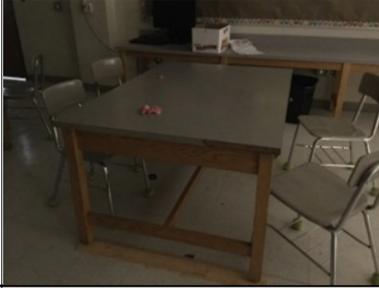
At least one or 5% accessible tables not provided Top of dining/work surface < 28" or > 34"	- 23"	Ensure that at least one work surface is accessible. Provide at least one work surface with top between 28"- 34" above the floor and 27" clear height underneath.	1	525	\$525
89	Classroom	4	422 426	Dining or Work Surfaces	Work Surface

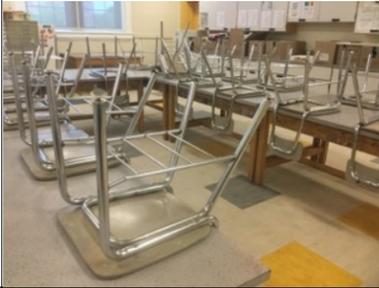
Knee or toe clearance not provided	23.75"	Provide at least 1 work surface with 27" min. knee and toe clearance.	2	525	\$1050
90	Research Room	3	323	Dining or Work Surfaces	Work Surface

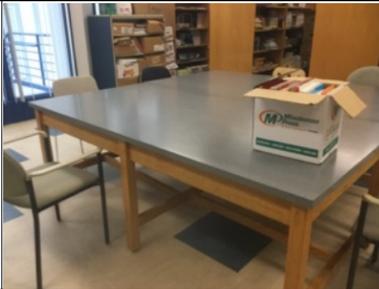
Knee or toe clearance not provided	23.5"	Provide at least one work surface with 27" min. knee and toe clearance.	1	525	\$525
<b>Assembly Area</b>												
91	Auditorium	2		Assembly Area	N/A

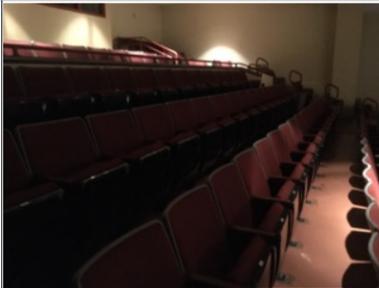
Number of seats Minimum # wheelchair spaces not provided Designated aisle seats < 5%	370 - -	Provide six (6) wheelchair accessible spaces. At least 5% of the total number of aisle seats provided must be identified by a sign or marker and have folding or retractable armrests.  (Cost to remove six (6) seats.)	1	1152	\$1152

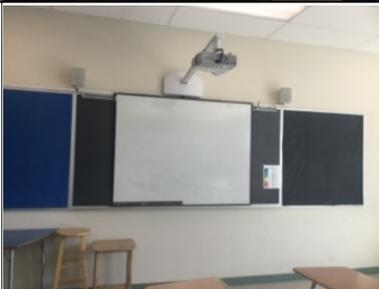
92	Classroom	3	334	Assembly Area	N/A

Assistive listening devices not provided	-	If audible communication is integral to the use of the space, provide an assistive listening system.  (Cost for a capacity of 50 or less.)	1	1821	\$1821

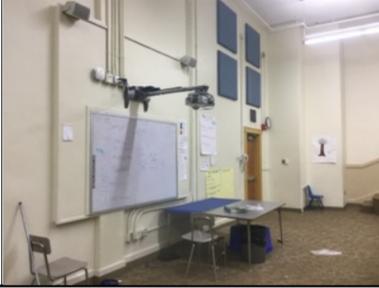
Assistive listening devices not provided	-	If audible communication is integral to the use of the space, provide an assistive listening system.  (Cost for a capacity of 50 or less.)	1	1821	\$1821
<b>Lockers</b>												
94	Near Room #411	4		Lockers	N/A

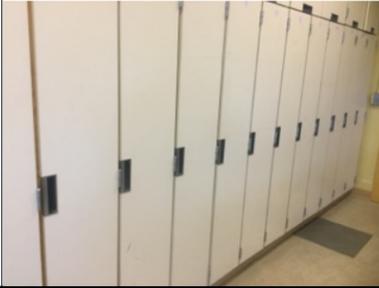
Total # of locker Total # of accessible locker	- -	Ensure that at least (5%) or one locker is accessible.	1	495	\$495
<b>Emergency Shower</b>												
95	Lab	3	321	Emergency Shower	N/A

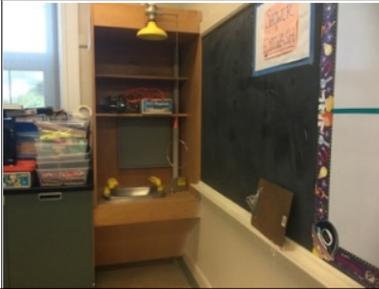
Emergency shower out of reach range	66"	Lower the shower pull to 48" max.	1	Labor	\$0
<b>Picnic Tables</b>												
96	North Side of Athletic Field	Ext.		Picnic Tables	N/A

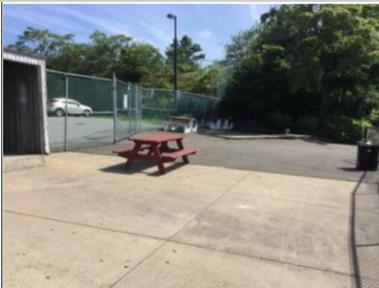
At least 5% accessible spaces not provided	-	Ensure that at least 5% (minimum one) of dining surfaces are accessible.	1	1050	\$1050

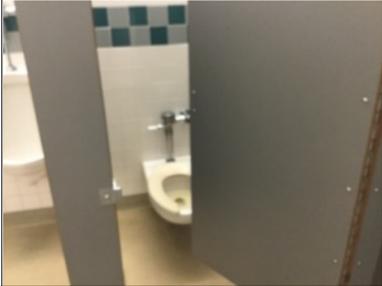
6 fixtures, but no ambulatory compartment provided	-	Provide one ambulatory accessible compartment.	1	2259	\$2259
<b>Lavatory</b>												
99	Girls' Toilet Room Near Cafeteria	1		Lavatory	N/A

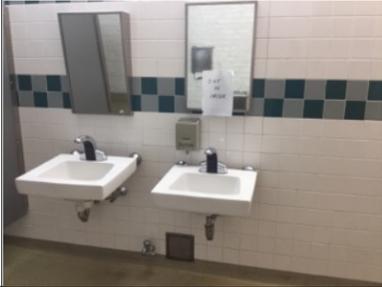
Toe or knee clearances not provided Mirror above lavatory w/reflective surface > 40"	22" 44.5"	Provide at least one lavatory with knee and toe clearance positioned for a forward approach. Lower mirror so that the bottom surface is at 40" max. above finished floor.	1	1457	\$1457

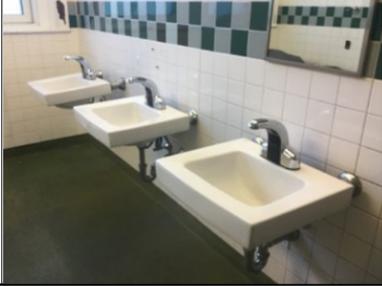
100	Boys' Toilet Room - Near Room #327	3		Lavatory	N/A

Plumbing underneath is exposed Mirror above lavatory w/reflective surface > 40"	- 44"	Insulate or otherwise configure pipes to prevent contact, for at least one lavatory. Lower mirror so that the bottom surface is at 40" max. above finished floor.	1	261	\$261

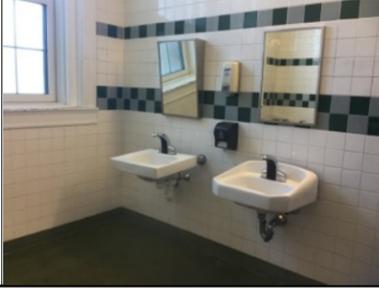
Mirror above lavatory w/reflective surface > 40"	43"	Lower mirror so that the bottom surface is at 40" max. above finished floor.	1	192	\$192
<b>Single-User Toilet</b>												
102	Toilet Room - Nurse's Room	3	320	Single-User Toilet	N/A

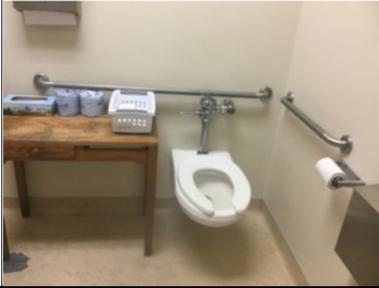
Clearance at toilet < 60" clear width	-	Remove table to maintain the 60" min. clear floor space at the toilet.	1	Labor	\$0
<b>Toilet Compartment</b>												
103	Girls' Toilet Room - Near Room #321	3		Toilet Compartment	Accessible Compartment

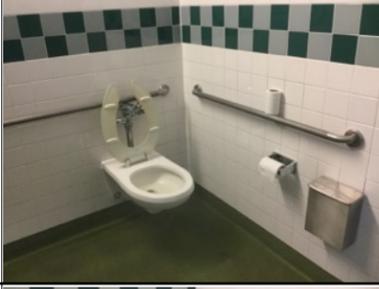
Door has malfunctioning self-closing hinge	-	Repair hinge.	1	Labor	\$0
104	Girls' Toilet Room - Near Room #302	3		Toilet Compartment	Accessible Compartment

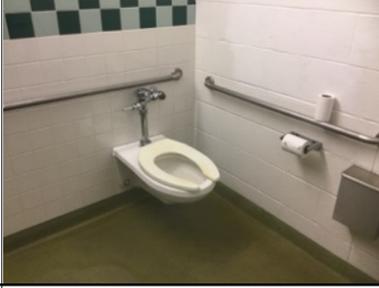
Door has malfunctioning self-closing hinge	-	Repair hinge.	1	Labor	\$0
105	Boys' Toilet Room - Near Room #302	3		Toilet Compartment	Accessible Compartment

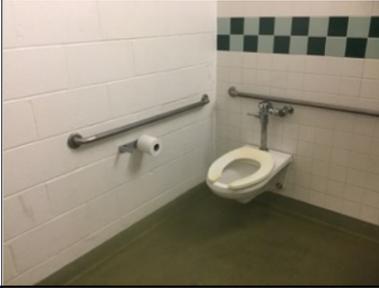
Door has malfunctioning self-closing hinge Flush control not on open side	- -	Repair hinge. Provide the flush control on the open side of the toilet (transfer side).	1	281	\$281

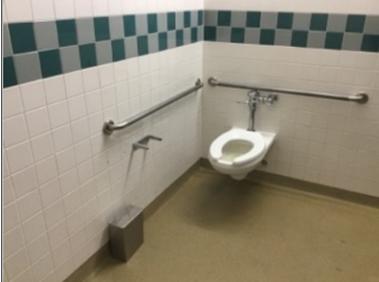
ID	Location	Floor	Room	Element	Type	Photo	Issues	Current Measure	Recommendations	Quantity	Price	Cost Estimation
106	Girls' Toilet Room Near Cafeteria	1		Toilet Compartment	Accessible Compartment

Flush control not on open side	-	Provide the flush control on the open side of the toilet (transfer side).	1	281	\$281
107	Girls' Toilet Room - Near Room #302	3		Toilet Compartment	Accessible Compartment

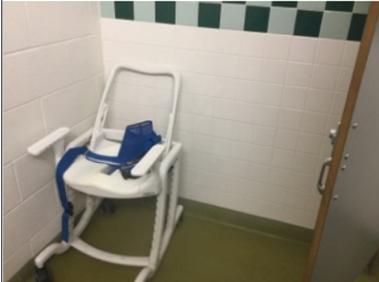
Clearance at toilet < 72" clear depth (MAAB)	-	Remove chair to maintain the required 72" depth clear floor space.	1	Labor	\$0
108	Boys' Toilet Room - Near Room #327	3		Toilet Compartment	Accessible Compartment

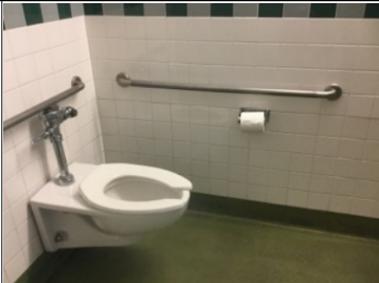
Centerline < or > 18" (MAAB)	19.5"	Relocate toilet so the centerline is 18" from the side wall.	1	2121	\$2121
<b>Shower Compartment</b>												
109	Toilet Room - Nurse's Room	3	320	Shower Compartment	Roll-In Type

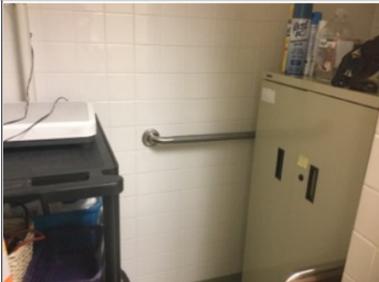
Not maintained in operable working condition		Remove cabinet and other items to ensure the shower is maintained in operable working condition.	1	Labor	\$0

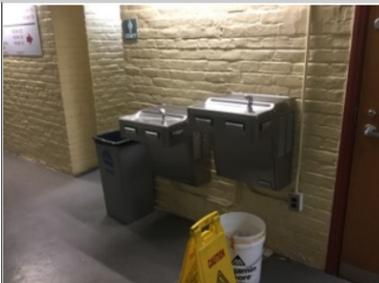
<b>Additional Access</b>												
<b>Drinking Fountains</b>												
110	Near Room #121	1		Drinking Fountains	N/A

Drinking fountains not maintained in operable working condition	-	Ensure drinking fountains are maintained in operable working condition.	1	-	\$0

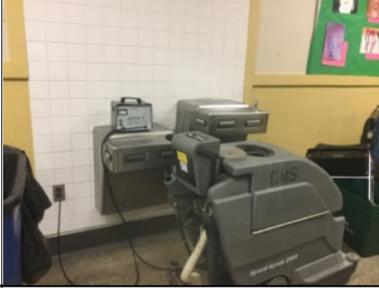
ID	Location	Floor	Room	Element	Type	Photo	Issues	Current Measure	Recommendations	Quantity	Price	Cost Estimation
111	Near Room #413	4		Drinking Fountains	Low

Spout > 36" high (wheelchair users)	38.5"	Lower drinking fountain for seated users so that the spout is 36" max. above the finished floor or ground.	1	1521	\$1521
112	Fountain Near Front Atrium	2	226	Drinking Fountains	Low

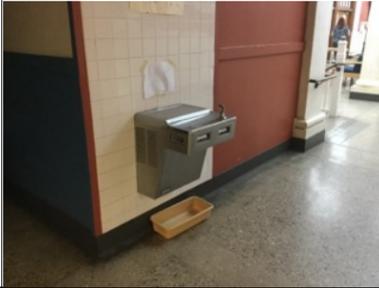
No drinking fountain provided for standing users	-	Provide an additional drinking fountain for standing users or install a Hi-Lo drinking fountain.	1	3021	\$3021
113	Near Room #127	1		Drinking Fountains	High

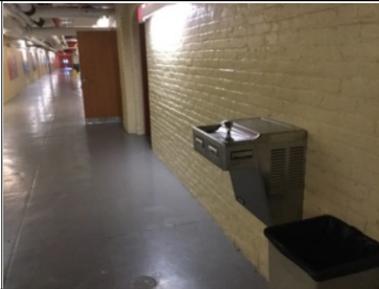
No drinking fountain provided for seated users	-	Provide an additional drinking fountain for seated users or install a Hi-Lo drinking fountain.	1	3021	\$3021
<b>Sink</b>												
114	Classroom	3	345	Sink	Classroom

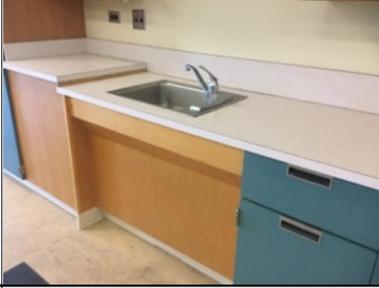
Toe and knee clearances not provided	-	Remove wooden panel to provide a 27" knee clearance positioned for a forward approach and insulate or otherwise configure pipes at sink.	1	930	\$930

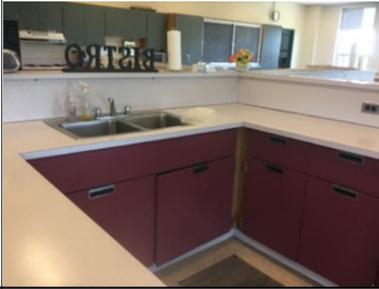
115	Kitchen Classroom	3	347	Sink

Toe and knee clearances not provided	-	Remove wooden panel to provide a 27" knee clearance positioned for a forward approach and insulate or otherwise configure pipes at sink.	1	930	\$930

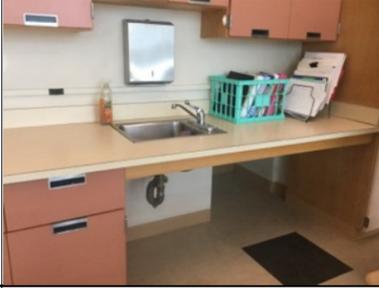
ID	Location	Floor	Room	Element	Type	Photo	Issues	Current Measure	Recommendations	Quantity	Price	Cost Estimation
116	Classroom	4	433	Sink	Classroom

Exposed plumbing underneath sink	-	Insulate or otherwise configure pipes at sink.  (Insulate pipes at one sink per-grade.)	3	69	\$207
117	Band Room	3	340	Sink

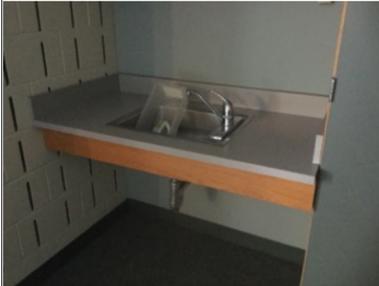
Exposed plumbing underneath sink	-	Insulate or otherwise configure pipes at sink.	1	69	\$69

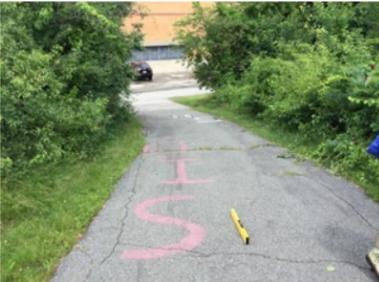
Cross slope > 1:50 (2.00%) Running slope > 1:20 (5%)	3.5% 10.6%	Reduce cross slope to be no steeper than 1:50 (2.00%). Reduce running slope to be no steeper than 1:20 (5%).  (Cost based on 265' by 4" wide asphalt route to field.)	1	6758	\$6758
3	Route to Exits #4, #5, #6, #7	Ext.		Exterior Access Route	Exterior

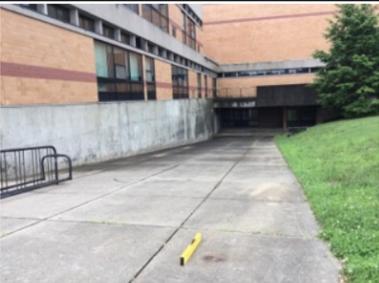
Running slope > 1:20 (5%)	9.8%	While not technically compliant, this area is still usable.	1	0	\$0
4	Tennis Courts	Ext.		Exterior Access Route	Exterior

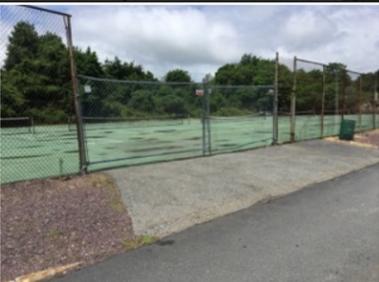
Running slope > 1:20 (5%)	14.1%	Provide an accessible route to the tennis courts that has a running slope no steeper than 1:20 (5%).  See ID #1 for route placement.  (Cost based on 65' by 4' wide asphalt route.)	1	1658	\$1658

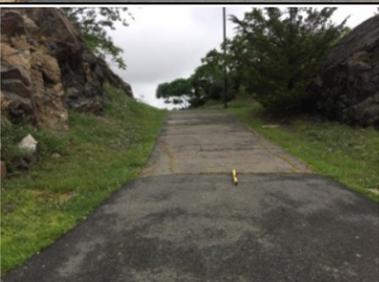
5	Route to Parking From Main Entrance	Ext.		Exterior Access Route	Exterior

Running slope > 1:20 (5%) Level changes > 1/4"	16.8% -	Provide signs indicating the direction of the nearest accessible route to the parking areas.	1	260	\$260

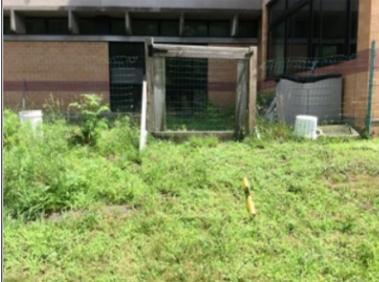
ID	Location	Floor	Room	Element	Type	Photo	Issues	Current Measure	Recommendations	Quantity	Price	Cost Estimation
6	Route to Community Garden	Ext.		Exterior Access Route	Exterior

Running slope > 1:20 (5%) Surface is not stable, firm, and slip-resistant	30% -	Create an alternative entrance on the north side of the community garden.  See ID #9 for cost.	1	-	\$0
7	Route to Veteran's Memorial Fieldhouse	Ext.		Exterior Access Route	Exterior

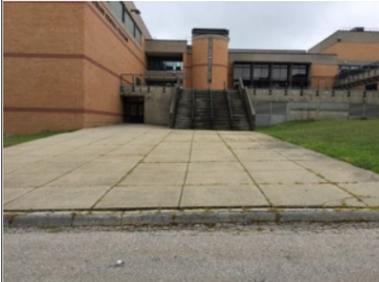
Level changes > 1/4"	6"	Alter change in level to be 1/4" high max.	1	155	\$155
8	Route to Exit #26	Ext.		Exterior Access Route	Exterior

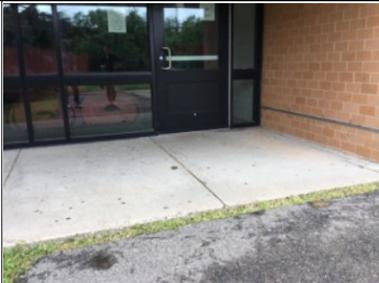
Level changes > 1/4"	3"	Alter change in level to be 1/4" high max.	1	155	\$155
9	Exit #37, Potential Route to Community Garden	Ext.		Exterior Access Route	Exterior

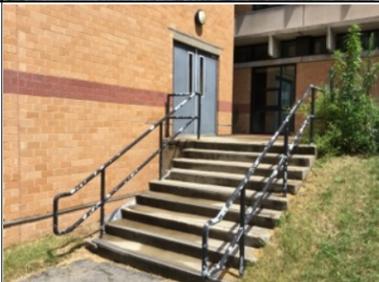
Surface is not stable, firm, and slip-resistant	-	Use this exit to provide an accessible route to the community garden.  (Cost based on 15' asphalt path to community garden and new entry gate.)	1	483	\$483

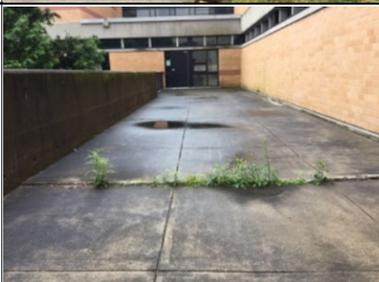
10	Route to Exit #3	Ext.		Exterior Access Route	Exterior

Does not prevent accumulation of water Route not maintained in operable working condition	- -	Repair surface. Ensure the accessible route is maintained in operable working conditions.	1	155	\$155

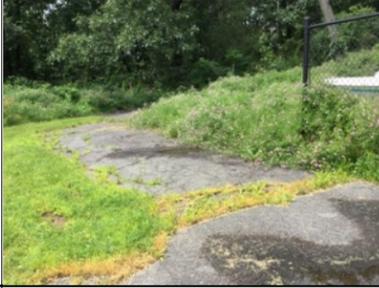
ID	Location	Floor	Room	Element	Type	Photo	Issues	Current Measure	Recommendations	Quantity	Price	Cost Estimation
11	Route to Basketball Court Near Veteran's Memorial Fieldhouse Parking Lot	Ext.		Exterior Access Route	Exterior

Route not maintained in operable working condition	-	Ensure the accessible route is maintained in operable working conditions.  (Cost based on 185' by 4' wide asphalt route to basketball court.)	1	4718	\$4718
12	Route to Outdoor Classroom	Ext.		Exterior Access Route	Exterior

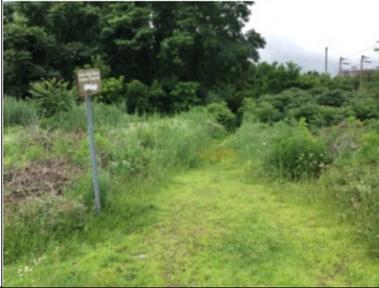
Accessible route not provided	-	Ensure an accessible route is provided.  See ID #13 for cost.	1	-	\$0
13	Outdoor Classroom	Ext.		Exterior Access Route	Exterior

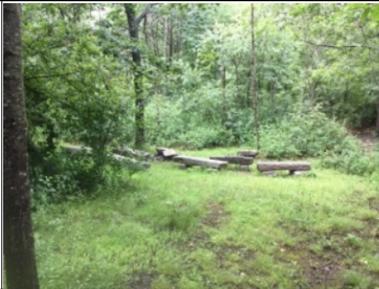
Accessible route not provided	-	Ensure an accessible route is provided.  (Cost based on 300' by 4' wide stone dust route to outdoor classroom.)	1	7200	\$7200
14	Community Garden Near Exit #36	Ext.		Exterior Access Route	Exterior

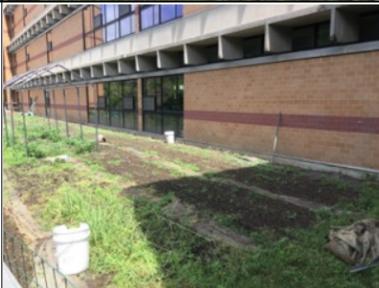
Accessible route not provided	-	Ensure an accessible route is provided.  (Cost based on 90' by 4' wide stone dust route in garden.)	1	2160	\$2160

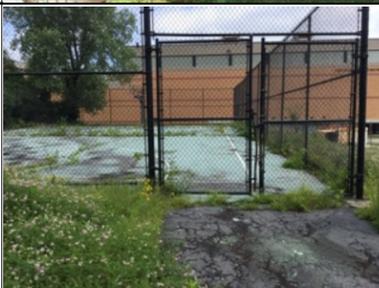
15	Basketball Court Near Veteran's Memorial Fieldhouse Parking Lot	Ext.		Exterior Access Route	613

Accessible route not provided	-	Ensure an accessible route is provided.  See ID #11 for cost.	1	-	\$0

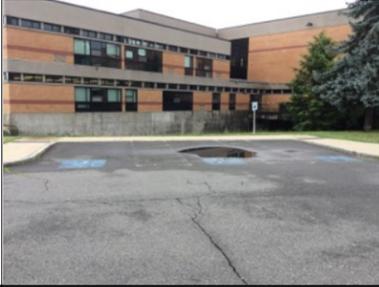
ID	Location	Floor	Room	Element	Type	Photo	Issues	Current Measure	Recommendations	Quantity	Price	Cost Estimation
<b>Off-Street Parking Lot or Garage</b>												
16	Accessible Parking Near Main Entrance	Ext.		Off-Street Parking Lot or Garage	N/A

Total # of parking Total # of designated accessible parking spaces Total # of designated van accessible spaces Vehicle space < 132" wide at van space Sign not provided Sign bottom < 60" above finished grade	3 3 0 118" - 53"	Provide a van accessible space that is at least 132" wide. Provide two (2) additional signs with the bottom of the sign 60" min. above the ground and the top 96" max. above the ground. Ensure sign at the van accessible space has the designation "Van Accessible." Locate existing sign with the bottom of the sign 60" above the ground.	1	975 Labor	\$975
17	Accessible Parking Near Exit #8	Ext.		Off-Street Parking Lot or Garage	N/A

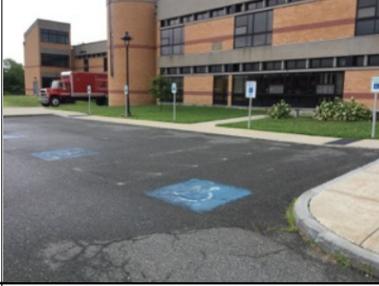
Total # of parking Total # of designated accessible parking spaces Total # of designated van accessible spaces Sign bottom < 60" above finished grade	5 4 1 47.75"	Locate sign with the bottom of the sign 60" above the ground.	1	Labor	\$0

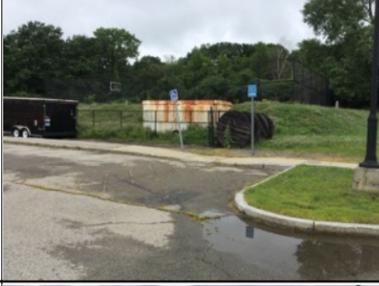
18	Veteran's Memorial Fieldhouse Parking Lot	Ext.		Off-Street Parking Lot or Garage	N/A

Total # of parking Total # of designated accessible parking spaces Total # of designated van accessible spaces Sign does not have the designation "Van Accessible"	85 3 0 -	Restripe parking lot so that accessible spaces and aisles are compliant with ADA 2010: 503. Ensure at least one of them is of a compliant van space size. Add the designation "Van Accessible" to the sign located at the van accessible space.	1	600	\$600
19	Parking Lot Near Tennis Courts	Ext.		Off-Street Parking Lot or Garage	N/A

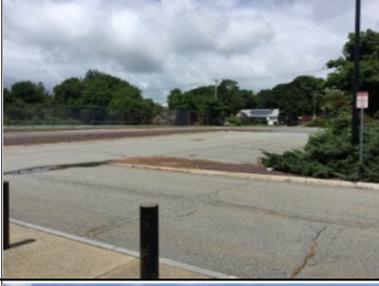
Total # of parking Total # of designated accessible parking spaces Access aisle not provided Sign not provided Sign does not have the designation "Van Accessible"	62 0 - - -	Provide two (2) car accessible spaces and one (1) van accessible space. Provide a marked access aisle that is at least 60" wide at the car space and 96" wide at the van space. Provide signs with the bottom of the sign 60" min. above the ground and the top 96" max. above the ground. Add the designation "Van Accessible" to the van accessible space.	3	1388	\$4164

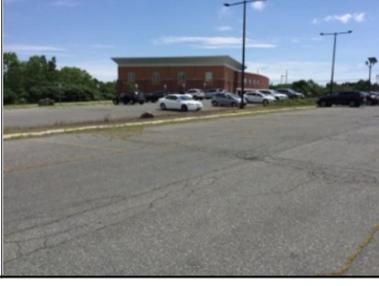
20	Parking Lot Near Main Entrance, Shared With Horace Mann School	Ext.		Off-Street Parking Lot or Garage	N/A

Total # of parking Total # of designated accessible parking spaces Access aisle not provided Sign not provided Sign does not have the designation "Van Accessible"	110 0 - - -	Provide four (4) car accessible spaces and one (1) van accessible space. Provide a marked access aisle that is at least 60" wide at the car spaces and 96" wide at the van space. Provide signs with the bottom of the sign 60" min. above the ground and the top 96" max. above the ground. Add the designation "Van Accessible" to the van accessible space.	4	1388	\$5552

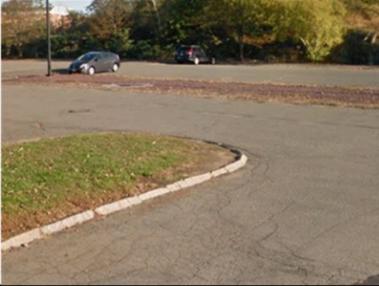
ID	Location	Floor	Room	Element	Type	Photo	Issues	Current Measure	Recommendations	Quantity	Price	Cost Estimation
21	Parking Lot on North Side of School	Ext.		Off-Street Parking Lot or Garage	N/A

Total # of parking Total # of designated accessible parking spaces Access aisle not provided Sign not provided Sign does not have the designation "Van Accessible"	106 0 - - -	Provide four (4) car accessible spaces and one (1) van accessible space. Provide a marked access aisle that is at least 60" wide at the car spaces and 96" wide at the van space. Provide signs with the bottom of the sign 60" min. above the ground and the top 96" max. above the ground. Add the designation "Van Accessible" to the van accessible space.	4	1388	\$5552
<b>Entrance</b>												
22	Storage Doors Off of Gymnasium	Ext.		Entrance	N/A

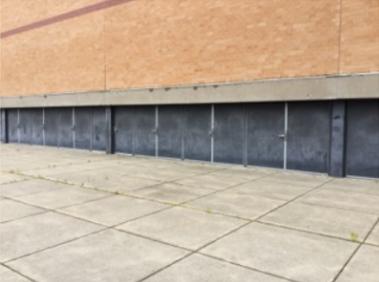
Directional sign to accessible entrance not provided	-	Provide a directional sign indicating the location of the nearest accessible entrance.	1	260	\$260

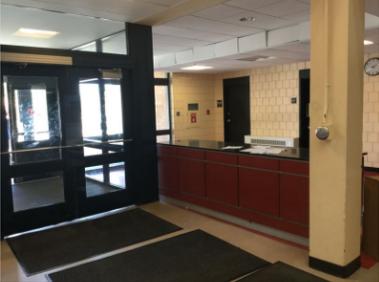
23	Main Lobby	1		Entrance	Main Entrance

Mat not securely attached Automatic door opener not operable Automatic door opener > 48" above the floor surface	- - 49"	Securely attach mat. Repair or replace the door opener. Lower automatic door opener to 48" max. above ground.	1	2295 Labor	\$2295
24	Playground Near Exit #44	Ext.		Entrance	Gate

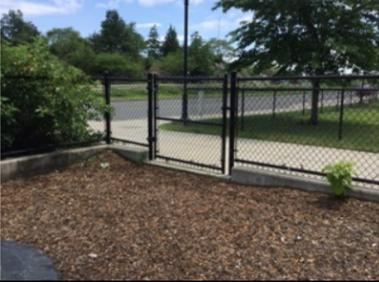
Threshold > 3/4" high	2"	Alter threshold to be 3/4" high max.	1	113	\$113
<b>Emergency Exit</b>												
25	Exits #11 and #12, Wood Shop	1	174	Emergency Exit	N/A

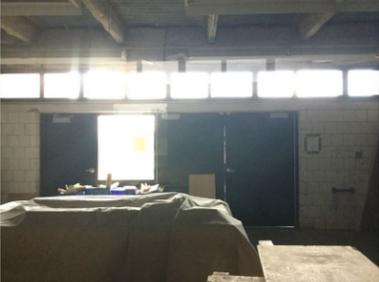
Illuminated exit sign not provided Tactile exit sign not provided	- -	Ensure illuminated exit signs are provided at exits and exit doors. Ensure it contains the International Symbol of Accessibility (ISA). Ensure tactile exit signs with raised characters and braille are provided at exit doors. Mount signs between 48"- 60" above finished floor located on the latch side of the door.	1	274	\$274

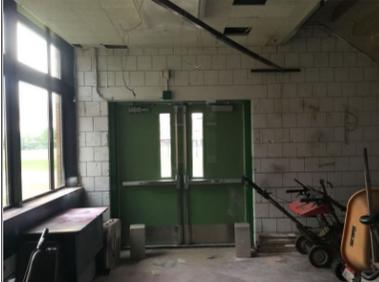
ID	Location	Floor	Room	Element	Type	Photo	Issues	Current Measure	Recommendations	Quantity	Price	Cost Estimation
26	Exit #13, in Stairwell 14	1	174	Emergency Exit	N/A

<p>Illuminated exit sign not provided Tactile exit sign not provided Directional sign to accessible emergency exit not provided</p>	- -	<p>Ensure illuminated exit signs are provided at exits and exit doors. Ensure tactile exit signs with raised characters and braille are provided at exit doors. Mount signs between 48"- 60" above finished floor located on the latch side of the door. Provide a directional sign indicating the location of the nearest emergency exit.</p>	1	448	\$448
27	Exits #4, #5, #6	Ext.		Emergency Exit	N/A

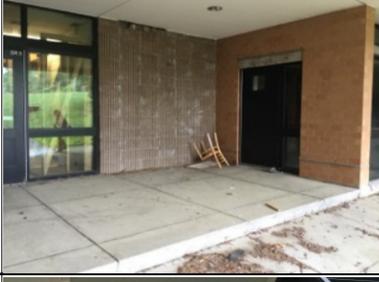
Emergency exit not on an accessible route	-	<p>Renovate area so that there is an accessible route away from the building.  (Cost based on 6' long ramp that is 48" wide and had handrails.)</p>	1	1269	\$1269

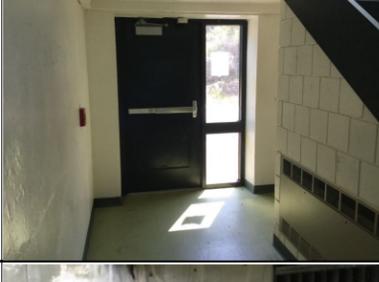
28	Exit #38, in Stairwell 7	1		Emergency Exit	N/A

<p>Emergency exit not on an accessible route Tactile exit sign not provided</p>	- -	<p>Provide a directional sign indicating the location of the nearest emergency exit. Ensure tactile exit signs with raised characters and braille are provided at exit doors. Mount signs between 48"- 60" above finished floor located on the latch side of the door.</p>	1	348	\$348
29	Exit #7	Ext.		Emergency Exit	N/A

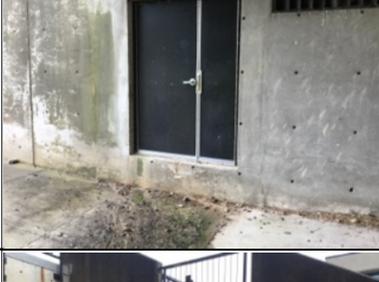
<p>Emergency exit not on an accessible route Tactile exit sign not provided</p>	-	<p>Provide a directional sign indicating the location of the nearest emergency exit on the interior of the door. Ensure tactile exit signs on the interior with raised characters and braille are provided at exit doors. Mount signs between 48"- 60" above finished floor located on the latch side of the door.</p>	1	348	\$348
30	Veteran's Memorial Fieldhouse, Exit #22	Ext.		Emergency Exit	N/A

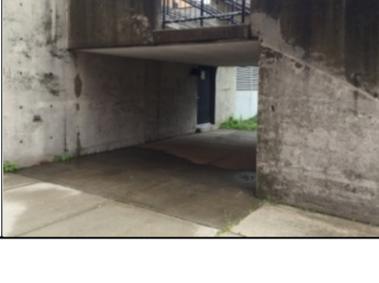
<p>Emergency exit not on an accessible route Tactile exit sign not provided</p>	- 6"	<p>Provide a directional sign indicating the location of the nearest emergency exit on the interior of the door. Ensure tactile exit signs on the interior with raised characters and braille are provided at exit doors. Mount signs between 48"- 60" above finished floor located on the latch side of the door.</p>	1	348	\$348

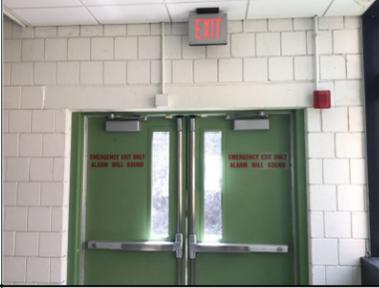
ID	Location	Floor	Room	Element	Type	Photo	Issues	Current Measure	Recommendations	Quantity	Price	Cost Estimation
31	Exit #36, in Stairwell 9	1		Emergency Exit	N/A

Illuminated exit sign lacks the International Symbol of Accessibility. Tactile exit sign not provided	- -	Ensure illuminated exit sign contains the International Symbol of Accessibility (ISA). Ensure tactile exit signs with raised characters and braille are provided at exit doors. Mount signs between 48"- 60" above finished floor located on the latch side of the door.	1	274	\$274
32	Exit #37, in Stairwell 8	1		Emergency Exit	N/A

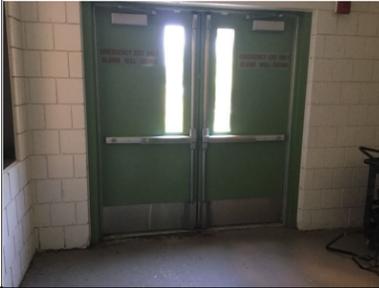
Illuminated exit sign lacks the International Symbol of Accessibility. Tactile exit sign not provided	- -	Ensure illuminated exit sign contains the International Symbol of Accessibility (ISA). Ensure tactile exit signs with raised characters and braille are provided at exit doors. Mount signs between 48"- 60" above finished floor located on the latch side of the door.	1	274	\$274
