**City of Salem,  
Massachusetts**

December 2019

# Salem City Hall

## City of Salem ADA Transition Plan

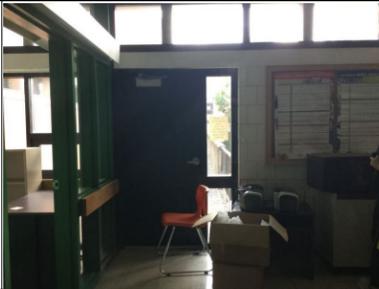
33	Exit #3, Faculty Lounge	1	185	Emergency Exit	N/A

Illuminated exit sign lacks the International Symbol of Accessibility. Tactile exit sign not provided Threshold > 3/4" high	- - 3"	Ensure illuminated exit sign contains the International Symbol of Accessibility (ISA). Ensure tactile exit signs with raised characters and braille are provided at exit doors. Mount signs between 48"- 60" above finished floor located on the latch side of the door. Alter threshold to be 3/4" high max.	1	387	\$387
34	Exit #14, Wood Shop	1	174	Emergency Exit	N/A

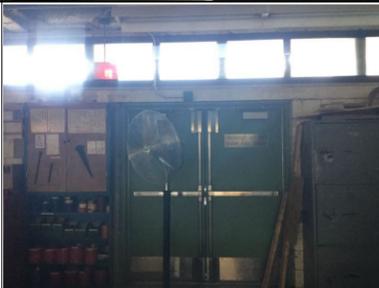
Illuminated exit sign lacks the International Symbol of Accessibility. Tactile exit sign not provided	- -	Ensure illuminated exit sign contains the International Symbol of Accessibility (ISA). Ensure tactile exit signs with raised characters and braille are provided at exit doors. Mount signs between 48"- 60" above finished floor located on the latch side of the door.	1	274	\$274

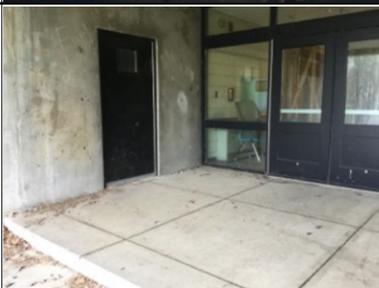
35	Exit #6	Ext.		Emergency Exit	N/A

Illuminated exit sign lacks the International Symbol of Accessibility. Tactile exit sign not provided	- -	Ensure illuminated exit sign on the interior contains the International Symbol of Accessibility (ISA). Ensure tactile exit signs on the interior with raised characters and braille are provided at exit doors. Mount signs between 48"- 60" above finished floor located on the latch side of the door.	1	274	\$274

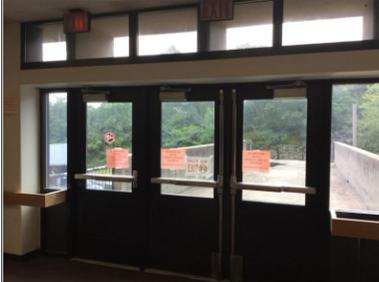
ID	Location	Floor	Room	Element	Type	Photo	Issues	Current Measure	Recommendations	Quantity	Price	Cost Estimation
36	Exit #33, in Instructional Media Center	1	155	Emergency Exit	N/A

Tactile exit sign not provided Emergency exit not on an accessible route	- -	Ensure tactile exit signs with raised characters and braille are provided at exit doors. Mount signs between 48"- 60" above finished floor located on the latch side of the door. Provide a directional sign indicating the location of the nearest emergency exit.	1	274	\$274
37	Fitness Center - Exit #29	B	062	Emergency Exit	N/A

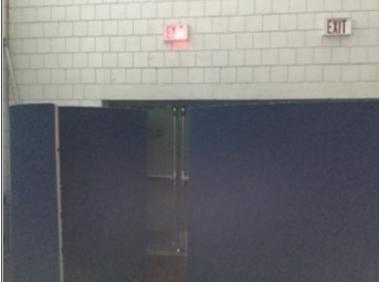
Tactile exit sign not provided Emergency exit not on an accessible route	- -	Ensure tactile exit signs with raised characters and braille are provided at exit doors. Mount signs between 48"- 60" above finished floor located on the latch side of the door. Provide a directional sign indicating the location of the nearest emergency exit.	1	348	\$348

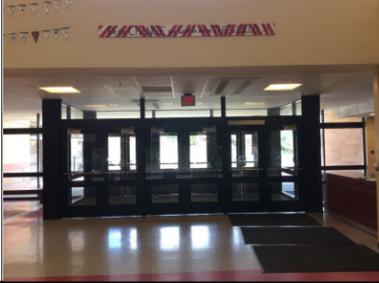
38	Exit #1, Main Lobby	1		Emergency Exit	N/A

Tactile exit sign not provided Illuminated exit sign lacks the International Symbol of Accessibility.	- -	Ensure tactile exit signs with raised characters and braille are provided at exit doors. Mount signs between 48"- 60" above finished floor located on the latch side of the door. Ensure illuminated exit sign contains the International Symbol of Accessibility (ISA).	1	274	\$274
39	Exit #48, Stair 2	1	Stair 2	Emergency Exit	N/A

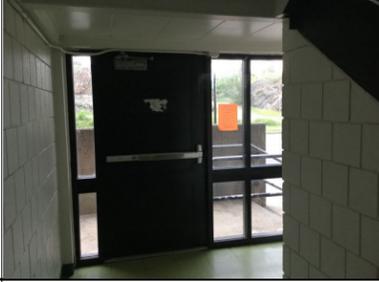
Tactile exit sign not provided Illuminated exit sign lacks the International Symbol of Accessibility.	- -	Ensure illuminated exit sign contains the International Symbol of Accessibility (ISA). Ensure tactile exit signs with raised characters and braille are provided at exit doors. Mount signs between 48"- 60" above finished floor located on the latch side of the door.	1	274	\$274
40	Exit #2, Auditorium	1	100	Emergency Exit	N/A

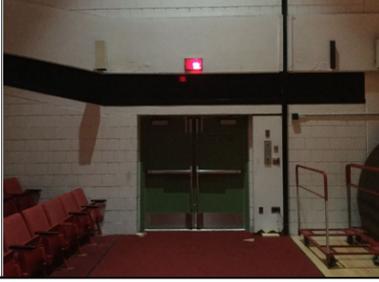
Tactile exit sign not provided Illuminated exit sign lacks the International Symbol of Accessibility. Threshold > 3/4" high	- - 3"	Ensure tactile exit signs with raised characters and braille are provided at exit doors. Mount signs between 48"- 60" above finished floor located on the latch side of the door. Ensure illuminated exit sign contains the International Symbol of Accessibility (ISA). Alter threshold to be 3/4" high max.	1	387	\$387

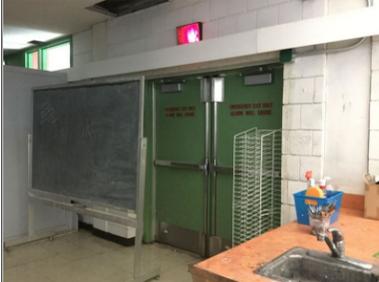
ID	Location	Floor	Room	Element	Type	Photo	Issues	Current Measure	Recommendations	Quantity	Price	Cost Estimation
41	Exit #20, Art Room	1	166	Emergency Exit	N/A

Tactile exit sign not provided Illuminated exit sign lacks the International Symbol of Accessibility.	- -	Ensure tactile exit signs with raised characters and braille are provided at exit doors. Mount signs between 48"- 60" above finished floor located on the latch side of the door Ensure illuminated exit sign contains the International Symbol of Accessibility (ISA).	1	274	\$274
42	Exits #8 and #9, in Stairwell 15 and Stairwell 16	1		Emergency Exit	N/A

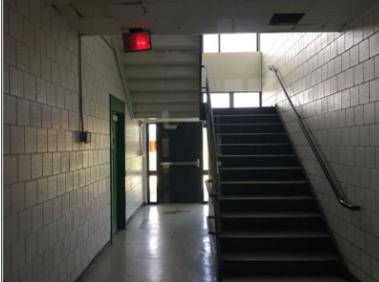
Tactile exit sign not provided Illuminated exit sign lacks the International Symbol of Accessibility.	- -	Ensure tactile exit signs with raised characters and braille are provided at exit doors. Mount signs between 48"- 60" above finished floor located on the latch side of the door. Ensure illuminated exit sign contains the International Symbol of Accessibility (ISA).	2	274	\$548

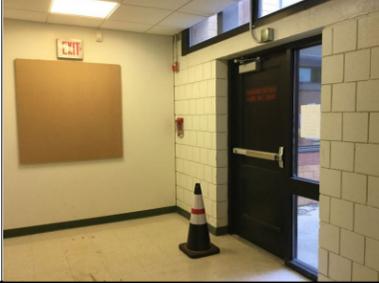
43	Exit #10, Hall by Wood Shop			Emergency Exit	N/A

Tactile exit sign not provided Illuminated exit sign lacks the International Symbol of Accessibility.	-	Ensure tactile exit signs with raised characters and braille are provided at exit doors. Mount signs between 48"- 60" above finished floor located on the latch side of the door. Ensure the illuminated exit sign contains the International Symbol of Accessibility (ISA).	1	274	\$274
44	Wood Shop, Route to Exit	1	174	Emergency Exit	N/A

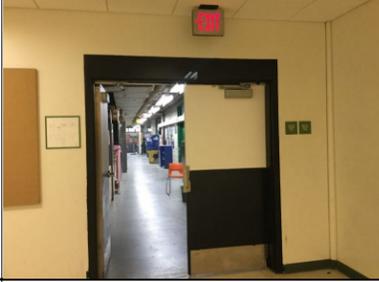
Tactile exit sign not provided Illuminated exit sign lacks the International Symbol of Accessibility.	-	Ensure tactile exit signs with raised characters and braille are provided at exit doors. Mount signs between 48"- 60" above finished floor located on the latch side of the door. Ensure illuminated exit sign contains the International Symbol of Accessibility (ISA).	1	274	\$274
45	Exit to Courtyard From Cafeteria, First Floor	1		Emergency Exit	N/A

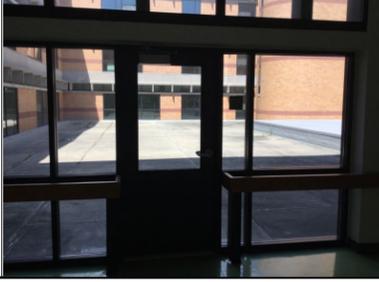
Tactile exit sign not provided Illuminated exit sign lacks the International Symbol of Accessibility.	-	Ensure tactile exit signs with raised characters and braille are provided at exit doors. Mount signs between 48"- 60" above finished floor located on the latch side of the door. Ensure illuminated exit sign contains the International Symbol of Accessibility (ISA).	1	274	\$274

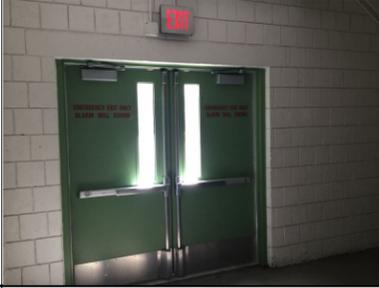
ID	Location	Floor	Room	Element	Type	Photo	Issues	Current Measure	Recommendations	Quantity	Price	Cost Estimation
46	Exit #43, in Stairwell 6	1		Emergency Exit	N/A

Tactile exit sign not provided Illuminated exit sign lacks the International Symbol of Accessibility.	- -	Ensure tactile exit signs with raised characters and braille are provided at exit doors. Mount signs between 48"- 60" above finished floor located on the latch side of the door. Ensure illuminated exit sign contains the International Symbol of Accessibility (ISA).	1	274	\$274
47	Exit #44, Adjacent to Stairwell 6	1		Emergency Exit	N/A

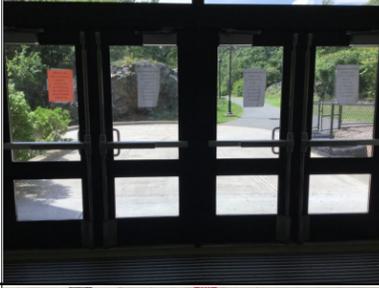
Tactile exit sign not provided Illuminated exit sign lacks the International Symbol of Accessibility.	- -	Ensure tactile exit signs with raised characters and braille are provided at exit doors. Mount signs between 48"- 60" above finished floor located on the latch side of the door. Ensure illuminated exit sign contains the International Symbol of Accessibility (ISA).	1	274	\$274

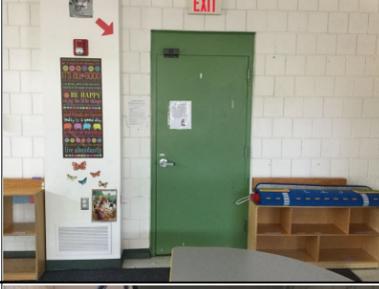
48	To Exit #45, Teen Parent Room/ Preschool	1	125	Emergency Exit	N/A

Tactile exit sign not provided Illuminated exit sign lacks the International Symbol of Accessibility.	- -	Ensure tactile exit signs with raised characters and braille are provided at exit doors. Mount signs between 48"- 60" above finished floor located on the latch side of the door. Ensure illuminated exit sign contains the International Symbol of Accessibility (ISA).	1	274	\$274
49	Exit #45, in Stairwell 5	1		Emergency Exit	N/A

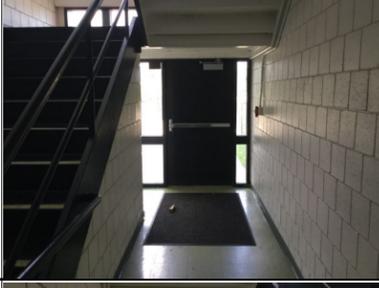
Tactile exit sign not provided Illuminated exit sign lacks the International Symbol of Accessibility.	- -	Ensure tactile exit signs with raised characters and braille are provided at exit doors. Mount signs between 48"- 60" above finished floor located on the latch side of the door. Ensure illuminated exit sign contains the International Symbol of Accessibility (ISA).	1	274	\$274
50	Exit #46, in Stairwell 4	1		Emergency Exit	N/A

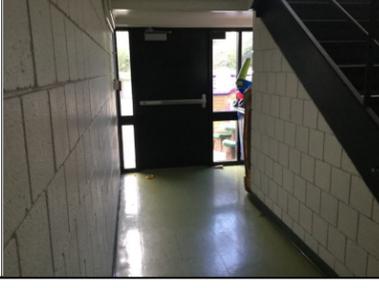
Tactile exit sign not provided Illuminated exit sign lacks the International Symbol of Accessibility.	- -	Ensure tactile exit signs with raised characters and braille are provided at exit doors. Mount signs between 48"- 60" above finished floor located on the latch side of the door. Ensure illuminated exit sign contains the International Symbol of Accessibility (ISA).	1	274	\$274

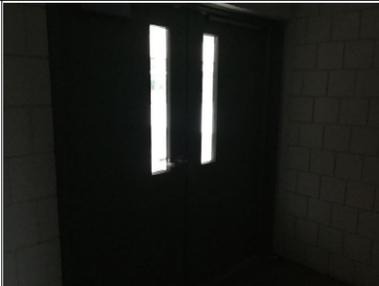
ID	Location	Floor	Room	Element	Type	Photo	Issues	Current Measure	Recommendations	Quantity	Price	Cost Estimation
51	Exit in Stairwell 10 to Courtyard	1		Emergency Exit	N/A

Tactile exit sign not provided Illuminated exit sign lacks the International Symbol of Accessibility.	- -	Ensure tactile exit signs with raised characters and braille are provided at exit doors. Mount signs between 48"- 60" above finished floor located on the latch side of the door. Ensure illuminated exit sign contains the International Symbol of Accessibility (ISA).	1	274	\$274
52	Exit #47	Ext.		Emergency Exit	N/A

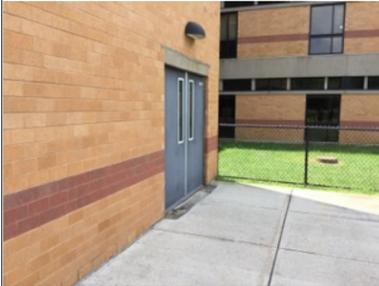
Tactile exit sign not provided Illuminated exit sign lacks the International Symbol of Accessibility.	- -	Ensure tactile exit signs on the interior with raised characters and braille are provided at exit doors. Mount signs between 48"- 60" above finished floor located on the latch side of the door. Ensure illuminated exit sign contains the International Symbol of Accessibility (ISA).	1	274	\$274

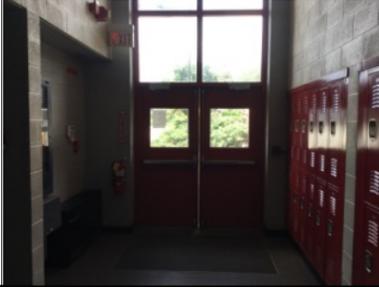
53	Automotive Technology Center, Main Entrance	1		Emergency Exit	N/A

Tactile exit sign not provided Illuminated exit sign lacks the International Symbol of Accessibility.	- -	Ensure tactile exit signs with raised characters and braille are provided at exit doors. Mount signs between 48"- 60" above finished floor located on the latch side of the door. Ensure illuminated exit sign contains the International Symbol of Accessibility (ISA).	1	274	\$274
54	Exit #31, Black Cat Cafe	B		Emergency Exit	N/A

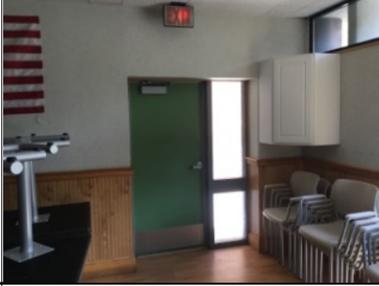
Tactile exit sign not provided Illuminated exit sign lacks the International Symbol of Accessibility.	- -	Ensure tactile exit signs with raised characters and braille are provided at exit doors. Mount signs between 48"- 60" above finished floor located on the latch side of the door. Ensure illuminated exit sign contains the International Symbol of Accessibility (ISA).	1	274	\$274
55	Exit #27, Gym	B		Emergency Exit	N/A

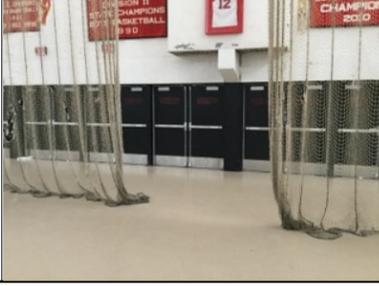
Tactile exit sign not provided Illuminated exit sign lacks the International Symbol of Accessibility.	- -	Ensure tactile exit signs with raised characters and braille are provided at exit doors. Mount signs between 48"- 60" above finished floor located on the latch side of the door. Ensure illuminated exit sign contains the International Symbol of Accessibility (ISA).	1	274	\$274

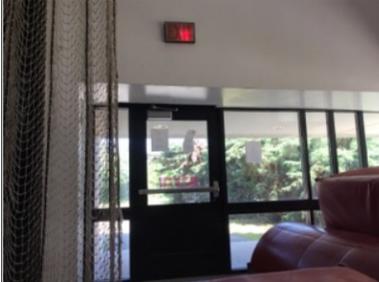
ID	Location	Floor	Room	Element	Type	Photo	Issues	Current Measure	Recommendations	Quantity	Price	Cost Estimation
56	Exit #26, Gym	B		Emergency Exit	N/A

Tactile exit sign not provided Illuminated exit sign lacks the International Symbol of Accessibility.	- -	Ensure tactile exit signs with raised characters and braille are provided at exit doors. Mount signs between 48"- 60" above finished floor located on the latch side of the door. Ensure illuminated exit sign contains the International Symbol of Accessibility (ISA).	1	274	\$274
57	Exit #25	B		Emergency Exit	N/A

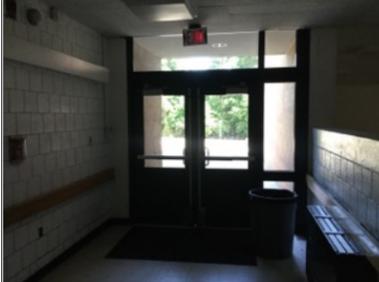
Tactile exit sign not provided Illuminated exit sign lacks the International Symbol of Accessibility.	- -	Ensure tactile exit signs with raised characters and braille are provided at exit doors. Mount signs between 48"- 60" above finished floor located on the latch side of the door. Ensure illuminated exit sign contains the International Symbol of Accessibility (ISA).	1	274	\$274

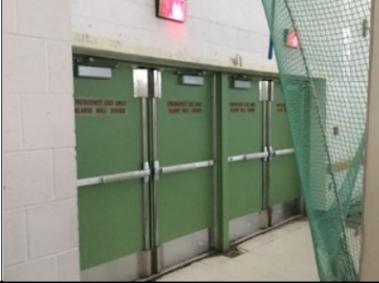
58	Exit #24, Gymnasium Balcony Area	1		Emergency Exit	N/A

Tactile exit sign not provided Illuminated exit sign lacks the International Symbol of Accessibility. Threshold > 3/4" high	- -	Ensure tactile exit signs with raised characters and braille are provided at exit doors. Mount signs between 48"- 60" above finished floor located on the latch side of the door. Ensure illuminated exit sign contains the International Symbol of Accessibility (ISA). Alter threshold to be 3/4" high max.	1	387	\$387
59	Exit #23	1		Emergency Exit	N/A

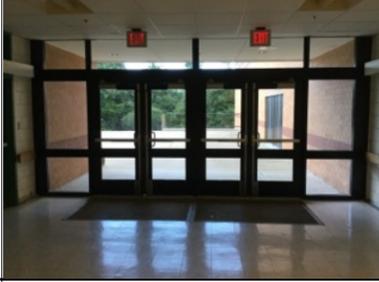
Tactile exit sign not provided Illuminated exit sign lacks the International Symbol of Accessibility.	- -	Ensure tactile exit signs with raised characters and braille are provided at exit doors. Mount signs between 48"- 60" above finished floor located on the latch side of the door. Ensure illuminated exit sign contains the International Symbol of Accessibility (ISA).	1	274	\$274

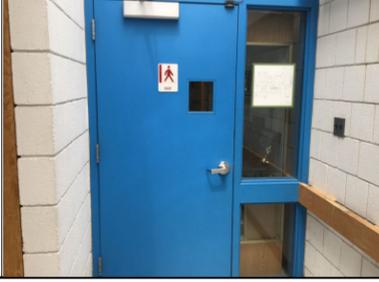
60	Exit From Main Office to Hallway	1	158C	Emergency Exit	N/A

Directional sign to accessible emergency exit not provided	-	Provide a directional sign indicating the location of the nearest emergency exit.	1	174	\$174

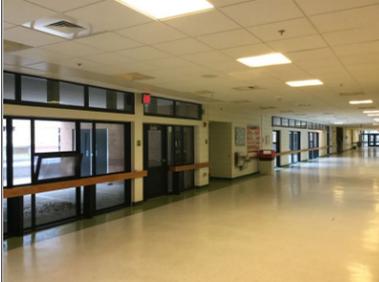
ID	Location	Floor	Room	Element	Type	Photo	Issues	Current Measure	Recommendations	Quantity	Price	Cost Estimation
61	Hall D, Exit to Courtyard	1	Hall D	Emergency Exit	N/A

International Symbol of Acc. not provided Tactile exit sign not provided	- -	Ensure illuminated exit sign contains the International Symbol of Accessibility (ISA). Ensure tactile exit signs with raised characters and braille are provided at exit doors. Mount signs between 48"- 60" above finished floor located on the latch side of the door.	1	274	\$274
62	Exit #4, Electrical Class	B	087	Emergency Exit	N/A

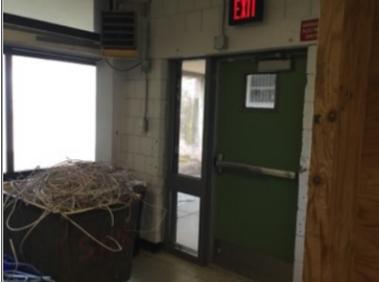
International Symbol of Acc. not provided Tactile exit sign not provided	- -	Ensure illuminated exit sign contains the International Symbol of Accessibility (ISA). Ensure tactile exit signs with raised characters and braille are provided at exit doors. Mount signs between 48"- 60" above finished floor located on the latch side of the door.	1	274	\$274

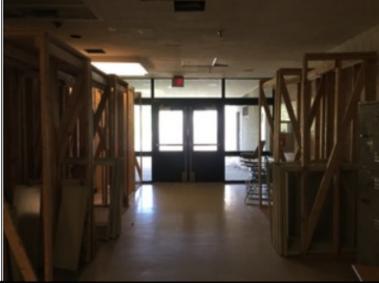
63	Exit #5	B		Emergency Exit	N/A

International Symbol of Acc. not provided Tactile exit sign not provided	- -	Ensure illuminated exit sign contains the International Symbol of Accessibility (ISA). Ensure tactile exit signs with raised characters and braille are provided at exit doors. Mount signs between 48"- 60" above finished floor located on the latch side of the door.	1	274	\$274
64	Automotive Technology Center, Classroom	Ext.		Emergency Exit	N/A

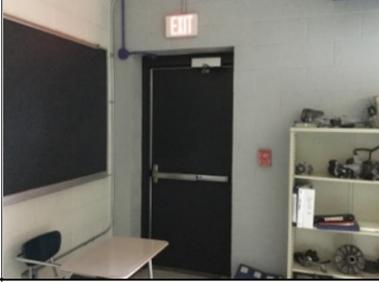
Maneuvering clearance(s) not provided Tactile exit sign not provided Illuminated exit sign lacks the International Symbol of Accessibility.	- - -	Provide an automatic door opener. Ensure tactile exit signs with raised characters and braille are provided at exit doors. Mount signs between 48"- 60" above finished floor located on the latch side of the door. Ensure illuminated exit sign contains the International Symbol of Accessibility (ISA).	1	2569	\$2569

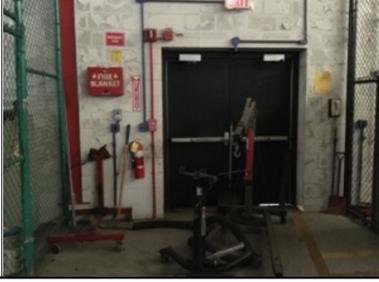
65	Automotive Technology Center, Garage Emergency Exit	1		Emergency Exit	N/A

Maneuvering clearance(s) not provided Tactile exit sign not provided Illuminated exit sign lacks the International Symbol of Accessibility.	- - -	Remove clutter in front of emergency exit. Ensure tactile exit signs with raised characters and braille are provided at exit doors. Mount signs between 48"- 60" above finished floor located on the latch side of the door. Ensure illuminated exit sign contains the International Symbol of Accessibility (ISA).	1	Labor 274	\$274

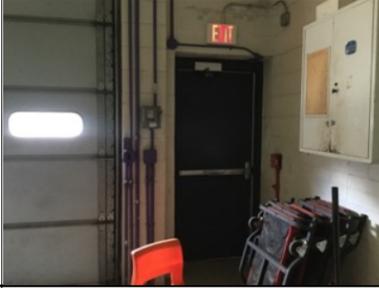
ID	Location	Floor	Room	Element	Type	Photo	Issues	Current Measure	Recommendations	Quantity	Price	Cost Estimation
66	Automotive Technology Center, Garage	1		Emergency Exit	N/A

Maneuvering clearance(s) not provided Tactile exit sign not provided Illuminated exit sign lacks the International Symbol of Accessibility.	- -	Provide an automatic door opener. Ensure tactile exit signs with raised characters and braille are provided at exit doors. Mount signs between 48"- 60" above finished floor located on the latch side of the door. Ensure illuminated exit sign contains the International Symbol of Accessibility (ISA).	1	2569	\$2569
67	Exit #30	B		Emergency Exit	N/A

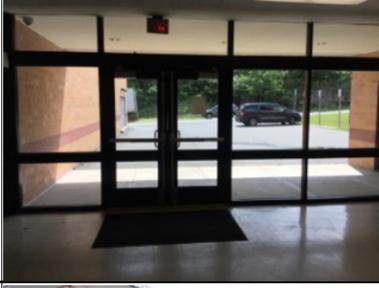
Mat not securely attached Tactile exit sign not provided Illuminated exit sign lacks the International Symbol of Accessibility.	- -	Securely attach mat. Ensure tactile exit signs with raised characters and braille are provided at exit doors. Mount signs between 48"- 60" above finished floor located on the latch side of the door. Ensure illuminated exit sign contains the International Symbol of Accessibility (ISA).	1	274	\$274

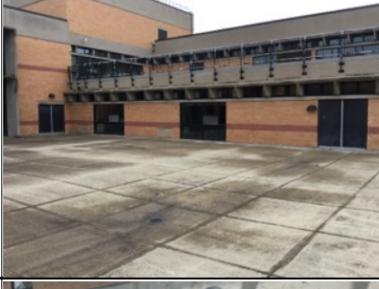
68	Exits #14, #16, #17, and #20 Emergency Exits at Top of Stairs at Veteran's Memorial Fieldhouse	Ext.		Emergency Exit	N/A

Threshold > 3/4" high	3"	Alter thresholds to be no more than 1/2" max.	4	113	\$452
69	Exit #38	Ext.		Emergency Exit	N/A

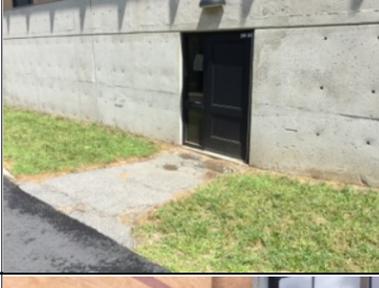
Threshold > 3/4" high	3"	Alter threshold to be no more than 1/2" max.	1	113	\$113
70	Exit #21 at Top of Stairs at Veteran's Memorial Fieldhouse	Ext.		Emergency Exit	N/A

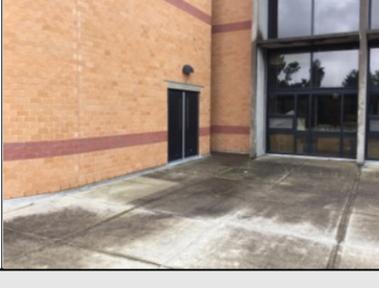
Threshold > 3/4" high Tactile exit sign not provided Illuminated exit sign lacks the International Symbol of Accessibility.	3" - -	Alter threshold to be 3/4" high max. Ensure tactile exit signs on the interior with raised characters and braille are provided at exit doors. Mount signs between 48"- 60" above finished floor located on the latch side of the door. Ensure illuminated exit sign contains the International Symbol of Accessibility (ISA).	1	387	\$387

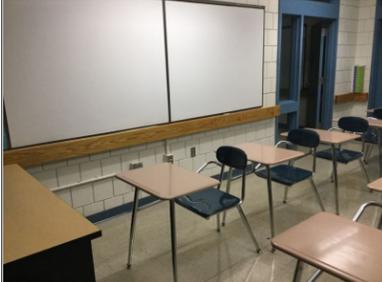
Route < 36" wide	31"	Ensure that a clear width of 36" min. is maintained at the accessible route.	1	Labor	\$0
73	Spanish Classroom	3	318	Interior Access Route	N/A

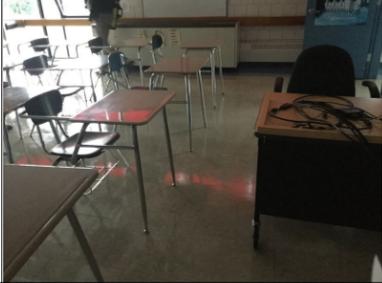
Route < 36" wide	21"	Ensure that a clear width of 36" min. is maintained at the accessible route.	1	Labor	\$0
74	French Classroom	3	319	Interior Access Route	N/A

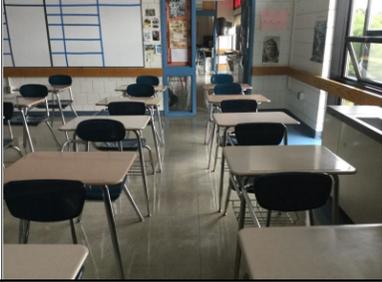
Route < 36" wide	27"	Ensure that a clear width of 36" min. is maintained at the accessible route.	1	Labor	\$0

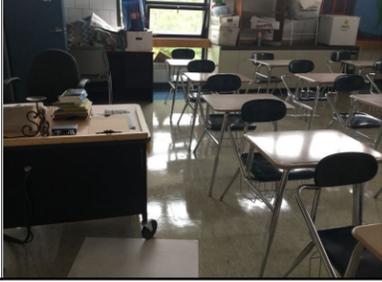
75	Spanish 3 Classroom	3	325	Interior Access Route	N/A

Route < 36" wide	20"	Ensure that a clear width of 36" min. is maintained at the accessible route.	1	Labor	\$0

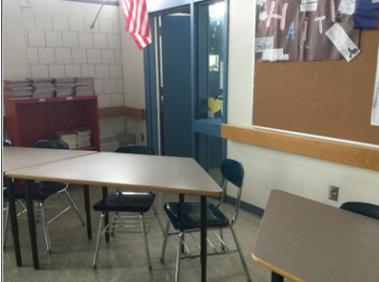
ID	Location	Floor	Room	Element	Type	Photo	Issues	Current Measure	Recommendations	Quantity	Price	Cost Estimation
76	French 3 Classroom	3	326	Interior Access Route	N/A

Route < 36" wide	9"	Ensure that a clear width of 36" min. is maintained at the accessible route.	1	Labor	\$0
77	Business Department Computer Lab	3	330	Interior Access Route	N/A

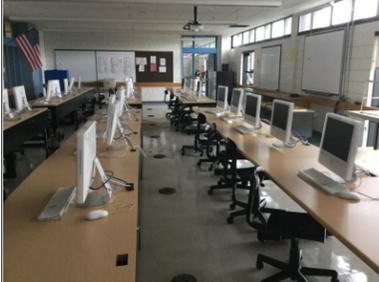
Route < 36" wide	34"	Ensure that a clear width of 36" min. is maintained at the accessible route.	1	Labor	\$0
78	Hydroponics Lab	3	348	Interior Access Route	N/A

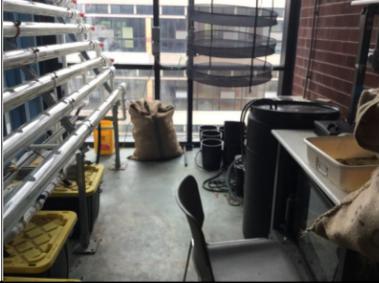
Route < 36" wide	22"	Ensure that a clear width of 36" min. is maintained at the accessible route.	1	Labor	\$0
79	Economics Class	2	232	Interior Access Route	N/A

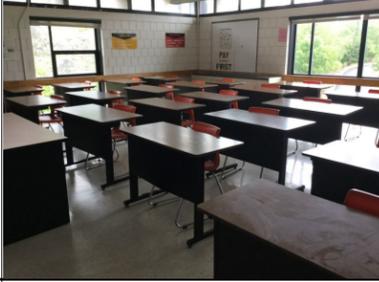
Route < 36" wide	21"	Ensure that a clear width of 36" min. is maintained at the accessible route.	1	Labor	\$0
80	Economics Class	2	232	Interior Access Route	N/A

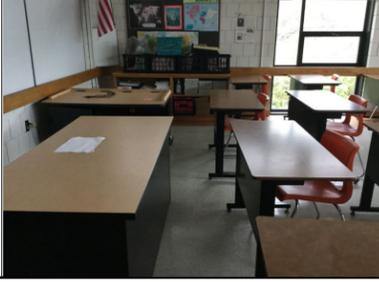
Route < 36" wide	18"	Ensure that a clear width of 36" min. is maintained at the accessible route.	1	Labor	\$0

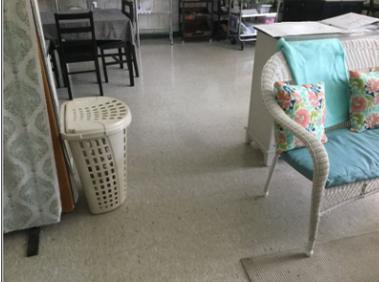
ID	Location	Floor	Room	Element	Type	Photo	Issues	Current Measure	Recommendations	Quantity	Price	Cost Estimation
81	Home Economics/ Special Needs Classroom	1	141	Interior Access Route	N/A

Route < 36" wide	28.5"	Ensure that a clear width of 36" min. is maintained at the accessible route.	1	Labor	\$0
82	Geometry and Calculus Classroom	1	134	Interior Access Route	N/A

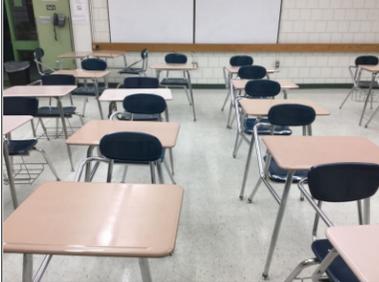
Route < 36" wide	28"	Ensure that a clear width of 36" min. is maintained at the accessible route.	1	Labor	\$0
83	Science Classroom	1	112	Interior Access Route	N/A

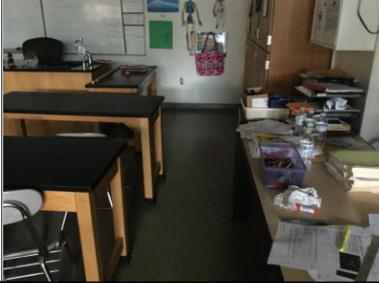
Route < 36" wide	25"	Ensure that a clear width of 36" min. is maintained at the accessible route.	1	Labor	\$0
84	ROTC - Supply and Uniform Room	1	137A	Interior Access Route	N/A

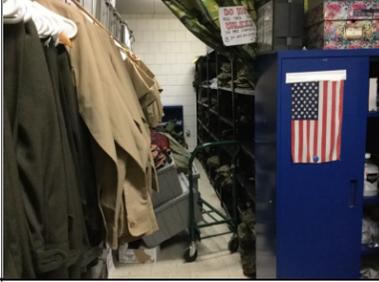
Route < 36" wide	33"	Ensure that a clear width of 36" min. is maintained at the accessible route.	1	Labor	\$0
85	ROTC - Bunker Room	1		Interior Access Route	N/A

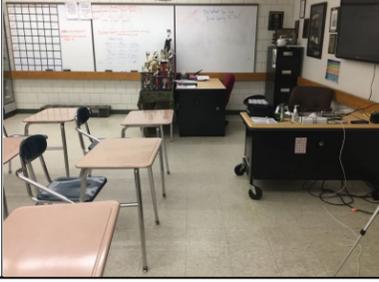
Route < 36" wide	28"	Ensure that a clear width of 36" min. is maintained at the accessible route by rearranging classroom set up.	1	Labor	\$0

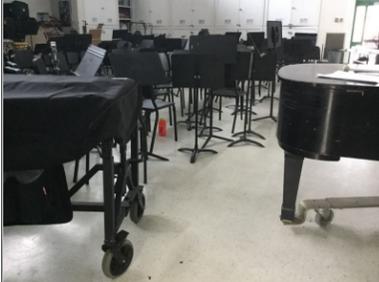
ID	Location	Floor	Room	Element	Type	Photo	Issues	Current Measure	Recommendations	Quantity	Price	Cost Estimation
86	Band Room	2	266	Interior Access Route	N/A

Route < 36" wide	31"	Ensure that a clear width of 36" min. is maintained at the accessible route.	1	Labor	\$0
87	Band Room	2	266	Interior Access Route	N/A

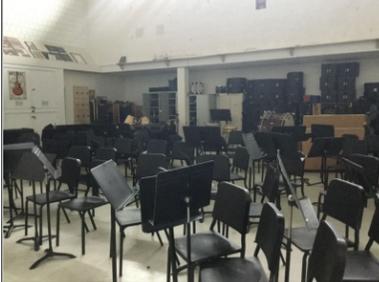
Route < 36" wide		Ensure that a clear width of 36" min. is maintained at the accessible route.	1	Labor	\$0
88	Auditorium	1	100	Interior Access Route	N/A

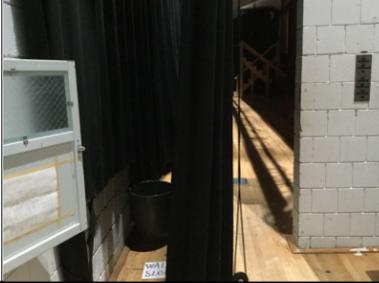
Route < 36" wide		Ensure that a clear width of 36" min. is maintained at the accessible route.	1	Labor	\$0
89	Wood Shop	1	174	Interior Access Route	N/A

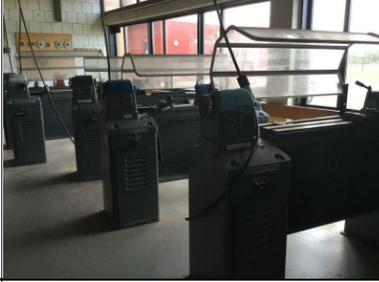
Route < 36" wide	30"	Ensure that a clear width of 36" min. is maintained at the accessible route.	1	Labor	\$0
90	Automotive Technology Center, Classroom	1	107	Interior Access Route	N/A

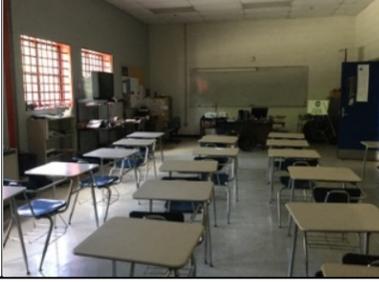
Route < 36" wide	22"	Ensure that a clear width of 36" min. is maintained at the accessible route.	1	Labor	\$0

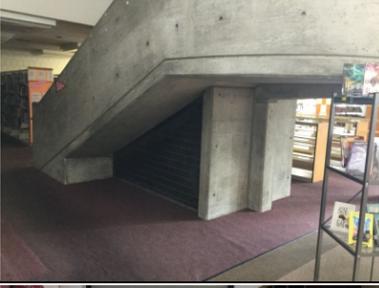
Obstructed by protruding objects	65"	Provide a cane-detectable barrier.	1	720	\$720
93	Mailbox Near Athletic Offices	1		Interior Access Route	N/A

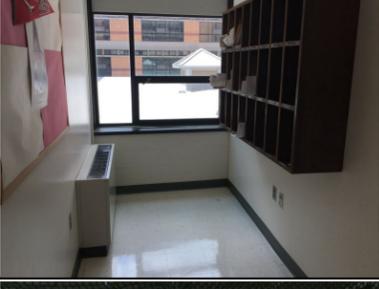
Obstructed by protruding objects	-	Provide a cane-detectable barrier.	1	230	\$230
94	ROTC Office Block	1	137	Interior Access Route	N/A

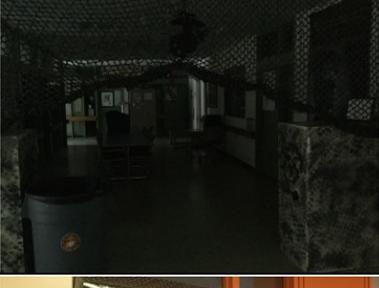
Obstructed by protruding objects	-	Remove netting on ceiling.	1	Labor	\$0
95	Classroom	2	212	Interior Access Route	N/A

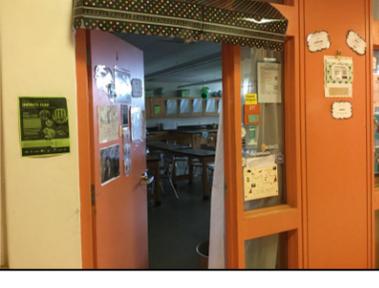
Obstructed by protruding objects	75"	Relocate paper border so that it is at least 80" above the finished floor.	1	Labor	\$0

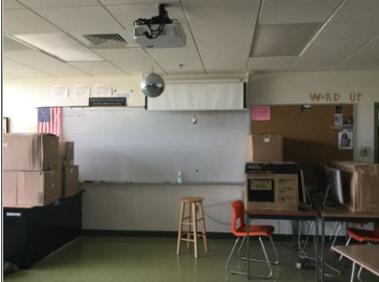
ID	Location	Floor	Room	Element	Type	Photo	Issues	Current Measure	Recommendations	Quantity	Price	Cost Estimation
96	Computer Lab	1	182	Interior Access Route	N/A

Obstructed by protruding objects	73"	Relocate disco ball so that it is at least 80" above the finished floor.	1	Labor	\$0
97	Automotive Technology Center, Women's Toilet Room	1	104	Interior Access Route	N/A

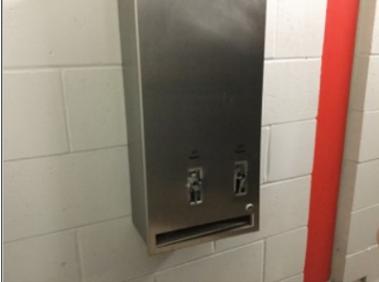
Obstructed by protruding objects	-	Remove tampon dispenser.	1	192	\$192
98	Visiting Team Room 2	B	074	Interior Access Route	N/A

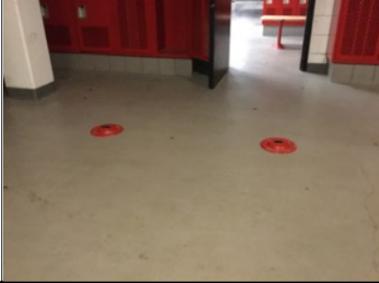
Level changes > 1/4"	-	Alter change in level to be 1/4" high max.	1	155	\$155
99	Laboratory	2	248	Interior Access Route	N/A

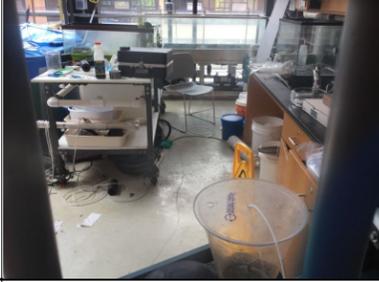
Surface not stable, firm, and slip-resistant	-	Relocate cables and other clutter.	1	Labor	\$0
100	Library	2	255	Interior Access Route	N/A

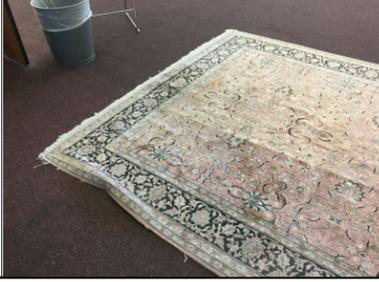
Surface not stable, firm, and slip-resistant	-	Remove rug or secure to floor.	1	Labor	\$0

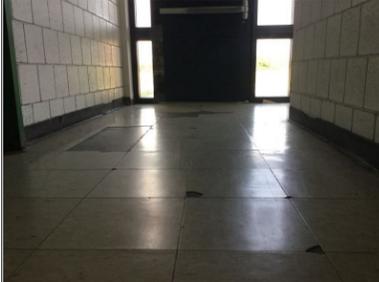
ID	Location	Floor	Room	Element	Type	Photo	Issues	Current Measure	Recommendations	Quantity	Price	Cost Estimation
101	Stair 16	1	Stair 16	Interior Access Route	N/A

Surface not stable, firm, and slip-resistant		Repair surface.	1	155	\$155
102	ROTC Office	1	137G	Interior Access Route	N/A

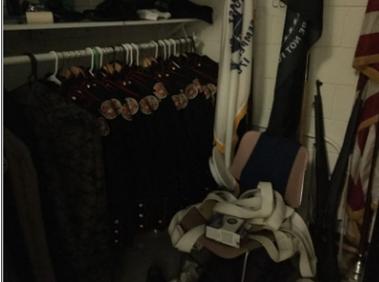
Accessible route not provided	-	Provide an accessible route that is at least 36" wide.	1	Labor	\$0
103	Home Economics/ Special Needs Classroom	1	141	Interior Access Route	N/A

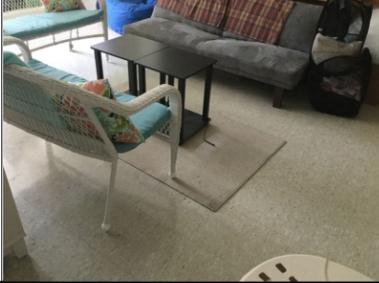
Mat not securely attached	-	Securely attach mat.	1	Labor	\$0
104	Home Economics/ Special Needs Classroom	1	141	Interior Access Route	N/A

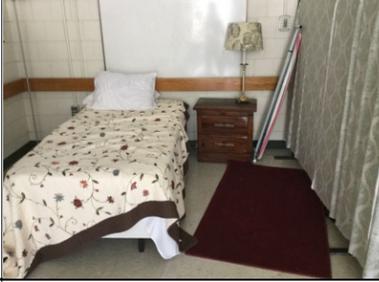
Mat not securely attached	-	Securely attach mat.	1	Labor	\$0
105	Life Skills/Post High School/ OT PT	1	131	Interior Access Route	N/A

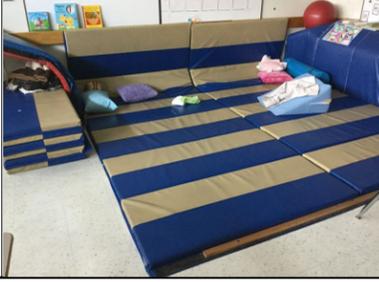
Mat not securely attached	-	Securely attach mat.	1	Labor	\$0

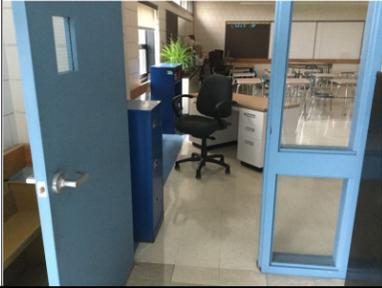
Clear width at door < 32"	30"	Ensure doorway is at least 32" wide by relocating cabinet.	1	Labor	\$0
108	Spanish 3 Classroom, Route to Room 326	3	325	Doors, Doorways, & Gates	Circulation

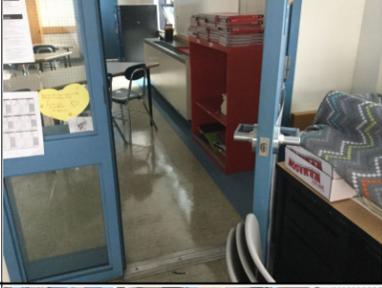
Clear width at door < 32"	28"	Remove obstructions.	1	Labor	\$0
109	Hydroponics Lab	3	348	Doors, Doorways, & Gates	Classroom

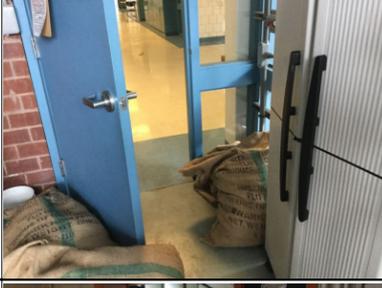
Clear width at door < 32"	18"	Remove obstructions.	1	Labor	\$0
110	ESL Classroom, Route to Room 233	2	240	Doors, Doorways, & Gates	Circulation

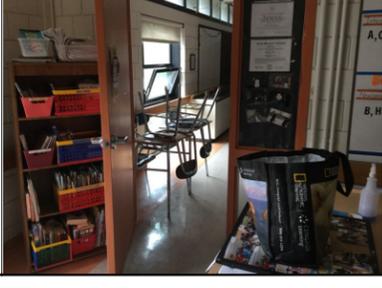
Clear width at door < 32"	24"	Remove obstructions.	1	Labor	\$0

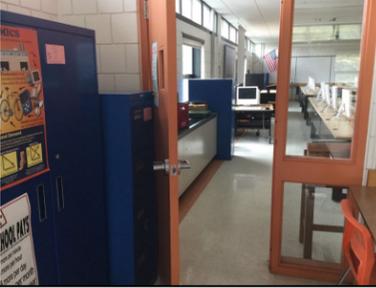
ID	Location	Floor	Room	Element	Type	Photo	Issues	Current Measure	Recommendations	Quantity	Price	Cost Estimation
111	Economics Class, Route to Computer Lab	2	232	Doors, Doorways, & Gates	Circulation

Clear width at door < 32"	30"	Remove obstructions	1	Labor	\$0
112	Door Between Rooms 140 and 134	1	140	Doors, Doorways, & Gates	Circulation

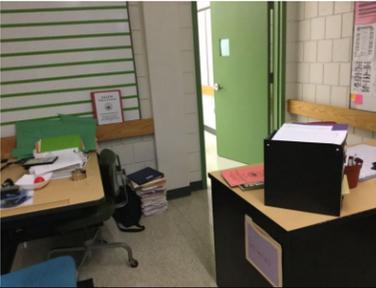
Clear width at door < 32"	28"	Relocate obstructions.	1	Labor	\$0
113	Language Classroom	3	324	Doors, Doorways, & Gates	Classroom

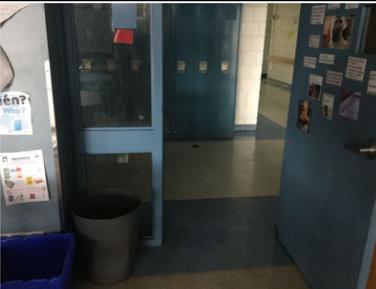
Maneuvering clearance(s) not provided	-	Remove the trash cans.	1	Labor	\$0
114	French 3 Classroom	3	326	Doors, Doorways, & Gates	Classroom

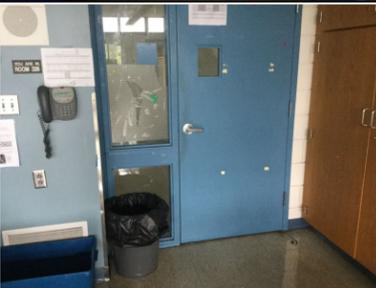
Maneuvering clearance(s) not provided	-	Remove the trash cans.	1	Labor	\$0
115	ESL Classroom	2	240	Doors, Doorways, & Gates	Classroom

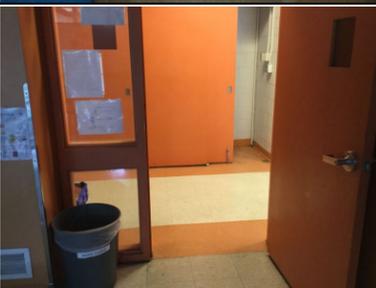
Maneuvering clearance(s) not provided	-	Remove the trash cans.	1	Labor	\$0

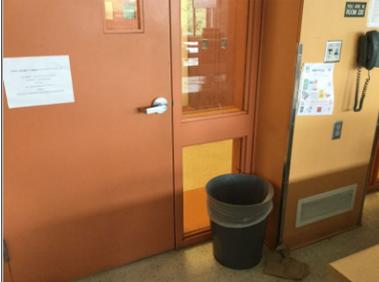
ID	Location	Floor	Room	Element	Type	Photo	Issues	Current Measure	Recommendations	Quantity	Price	Cost Estimation
116	Computer Lab	2	230	Doors, Doorways, & Gates	Classroom

Maneuvering clearance(s) not provided	-	Remove the trash cans.	1	Labor	\$0
117	Exit From Instructional Media Center to Hallway	1	155	Doors, Doorways, & Gates	Other

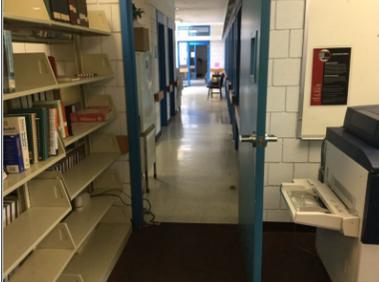
Maneuvering clearance(s) not provided	4"	Remove or relocate the bookshelf on the Instructional Media Center side and display case on the hallway side.	2	Labor	\$0
118	Conference Room	1	158G	Doors, Doorways, & Gates	Office

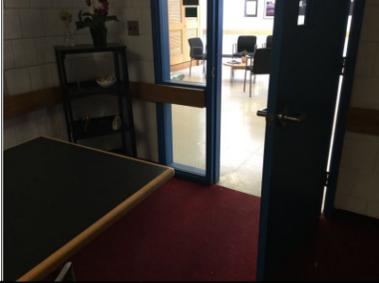
Maneuvering clearance(s) not provided	-	Rearrange the room so that the table is not in the maneuvering clearance at the door.	1	Labor	\$0
119	Additional Entrance to Main Office Area	1		Doors, Doorways, & Gates	Other

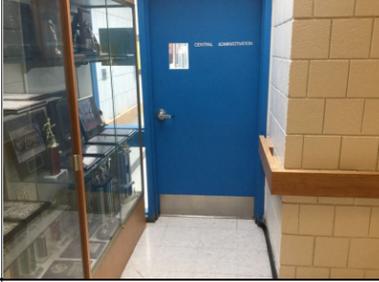
Maneuvering clearance(s) not provided	4"	Remove or relocate the display case.	1	Labor	\$0
120	Office	1	150B	Doors, Doorways, & Gates	Other

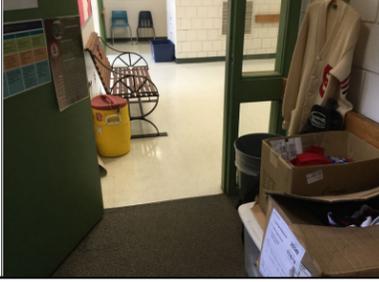
Maneuvering clearance(s) not provided	-	Remove the obstructions.	1	Labor	\$0

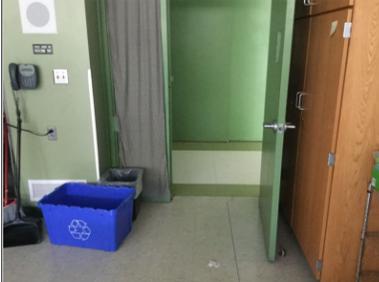
ID	Location	Floor	Room	Element	Type	Photo	Issues	Current Measure	Recommendations	Quantity	Price	Cost Estimation
121	Home Economics/ Special Needs Classroom	1	141	Doors, Doorways, & Gates	Classroom

Maneuvering clearance(s) not provided	-	Remove the trash can.	1	Labor	\$0
122	Door Between Rooms 128 and 129	1	129	Doors, Doorways, & Gates	Circulation

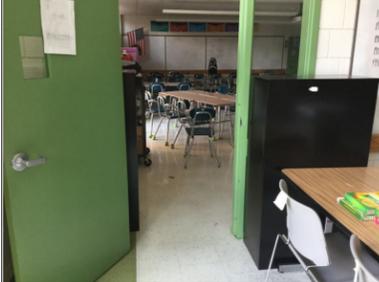
Maneuvering clearance(s) not provided	-	Remove the obstructions.	1	Labor	\$0
123	Teen Parent Room/ Preschool Toilet Room	1	125	Doors, Doorways, & Gates	Toilet Room

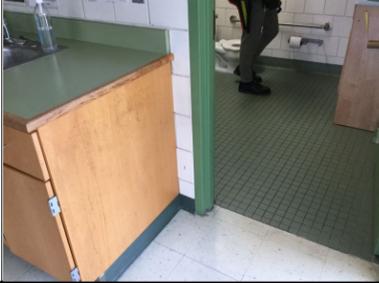
Maneuvering clearance(s) not provided	6"	Provide an automatic door opener.	1	2295	\$2295
124	Band Teacher's Office	2	279	Doors, Doorways, & Gates	Office

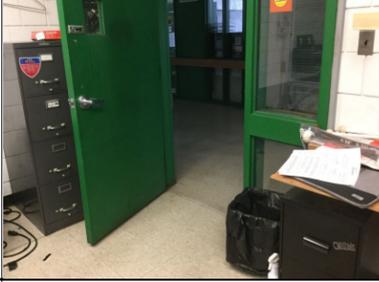
Maneuvering clearance(s) not provided		Remove trash can to provide at least 18" wide maneuvering clearance.	1	Labor	\$0
125	Orchestra	2	282	Doors, Doorways, & Gates	Classroom

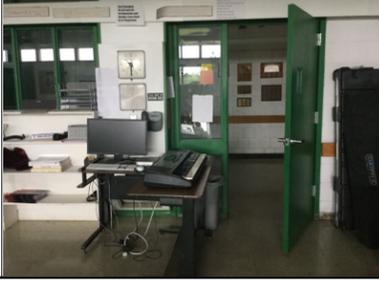
Maneuvering clearance(s) not provided		Remove the desk to provide at least 18" wide maneuvering clearance.	1	Labor	\$0

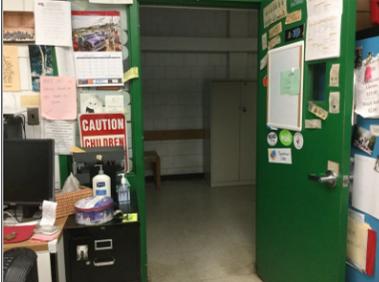
ID	Location	Floor	Room	Element	Type	Photo	Issues	Current Measure	Recommendations	Quantity	Price	Cost Estimation
126	Office	2	281	Doors, Doorways, & Gates	Office

Maneuvering clearance(s) not provided		Remove the file cabinet to provide at least 18" wide maneuvering clearance.	1	Labor	\$0
127	Office	2	250B	Doors, Doorways, & Gates	Meeting Room

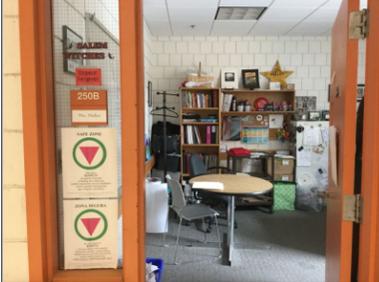
Maneuvering clearance(s) not provided	16"	Provide an automatic door opener.	1	2295	\$2295
128	Office	2	249F	Doors, Doorways, & Gates	Office

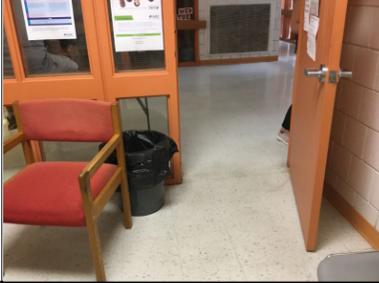
Maneuvering clearance(s) not provided		Remove trash can and chair to provide at least 18" wide maneuvering clearance.	1	Labor	\$0
129	Women's Toilet Room	2	Hall C	Doors, Doorways, & Gates	Toilet Room

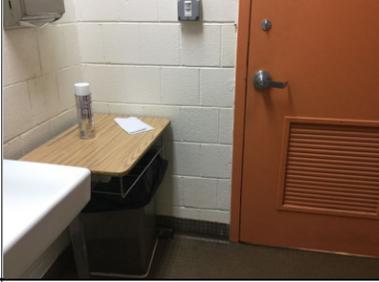
Maneuvering clearance(s) not provided	15"	Remove desk to provide at least 18" wide maneuvering clearance.	1	Labor	\$0
130	Classroom	2	210	Doors, Doorways, & Gates	Classroom

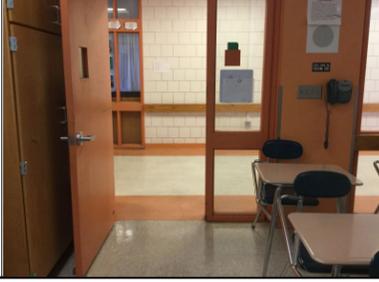
Maneuvering clearance(s) not provided	16"	Provide an automatic door opener.	1	2295	\$2295

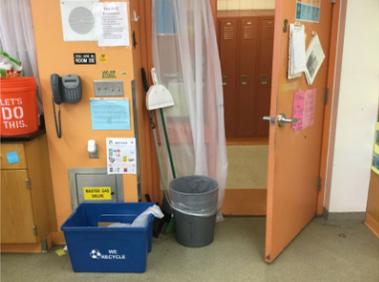
ID	Location	Floor	Room	Element	Type	Photo	Issues	Current Measure	Recommendations	Quantity	Price	Cost Estimation
131	Environmental Science	2	212	Doors, Doorways, & Gates	Classroom

Maneuvering clearance(s) not provided	-	Remove trash can to provide at least 18" wide maneuvering clearance.	1	Labor	\$0
132	Gymnasium Balcony Area, Men's Toilet Room	1		Doors, Doorways, & Gates	Toilet Room

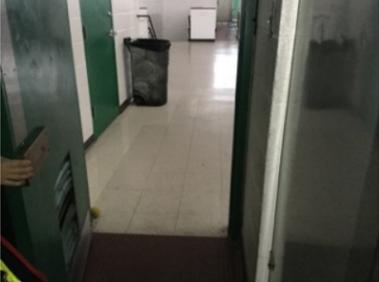
Maneuvering clearance(s) not provided	-	Provide an automatic door opener.	1	2295	\$2295
133	Science Classroom	2	216	Doors, Doorways, & Gates	Classroom

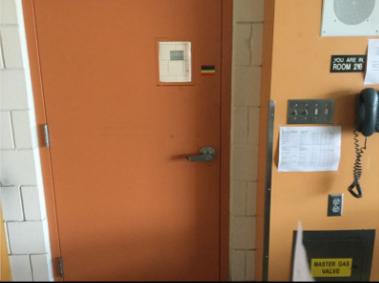
Maneuvering clearance not provided at recess > 8"	7"	Install an automatic door opener.	1	2295	\$2295
134	Color Guard Closet	2		Doors, Doorways, & Gates	Other

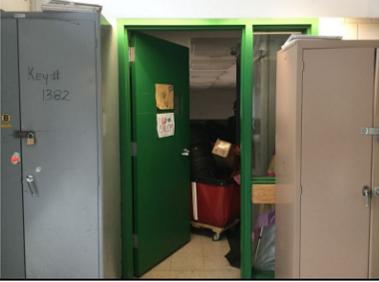
Maneuvering clearance not provided at recess > 8"	9"	Install an automatic door opener.	1	2295	\$2295
135	School Store	2	251	Doors, Doorways, & Gates	Other

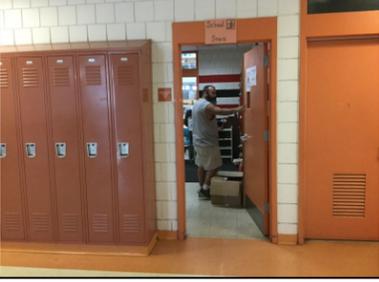
Maneuvering clearance not provided at recess > 8"	11"	Install an automatic door opener.	1	2295	\$2295

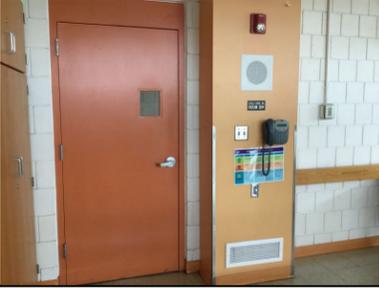
ID	Location	Floor	Room	Element	Type	Photo	Issues	Current Measure	Recommendations	Quantity	Price	Cost Estimation
136	Classroom	2	204	Doors, Doorways, & Gates	Classroom

Maneuvering clearance not provided at recess > 8"	4"	Install an automatic door opener.	1	2295	\$2295
137	Lobby at Main Entrance, Women's Toilet Room	1		Doors, Doorways, & Gates	Toilet Room

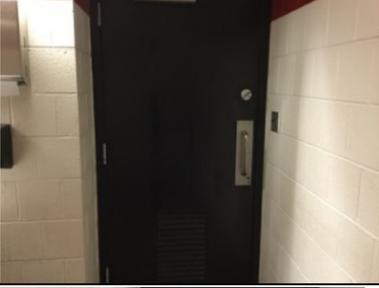
Maneuvering clearance not provided at recess > 8"	-	Install an automatic door opener.	1	2295	\$2295
138	Lobby at Main Entrance, Men's Toilet Room	1		Doors, Doorways, & Gates	Toilet Room

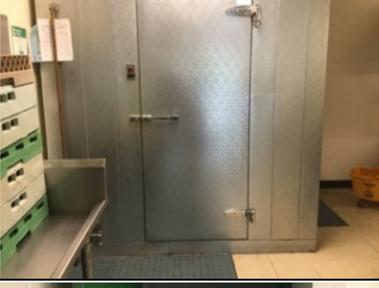
Maneuvering clearance not provided at recess > 8"	-	Install an automatic door opener.	1	2295	\$2295
139	Culinary Arts Class	B	057	Doors, Doorways, & Gates	Other

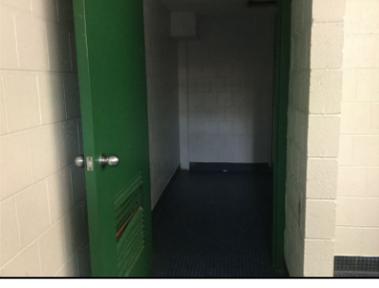
Threshold > 1/2" high	4"	Alter threshold to be 1/2" high max.	1	113	\$113
140	Boys' Changing Room - Backstage	1	187	Doors, Doorways, & Gates	Toilet Room

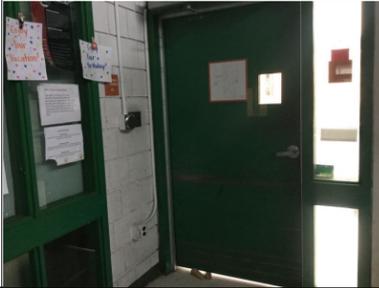
Automatic door opener not operable		Repair or replace the door opener.	1	2295	\$2295
142	Band Room (West Door)	2	266	Doors, Doorways, & Gates	Classroom

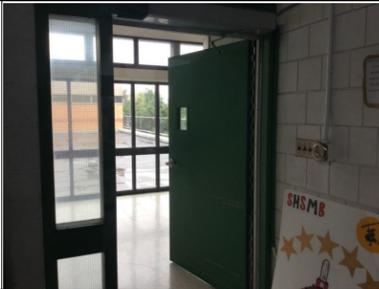
Automatic door opener > 48" above the floor surface	50"	Lower automatic door opener to 48" max. above ground.	1	Labor	\$0
143	Band Room (East Door)	2	266	Doors, Doorways, & Gates	Classroom

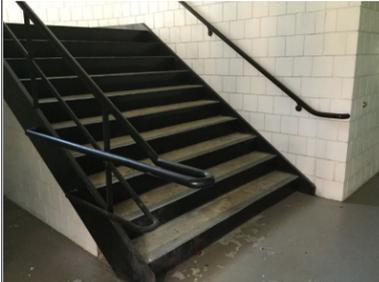
Handrails do not extend 12" from stairs	-	Ensure handrails extend to one tread depth beyond the last riser for the lower railing to ensure that the upper railing extension does not protrude as a protruding object.	1	600	\$600
147	Stairwell 8	1		Stairways	Interior

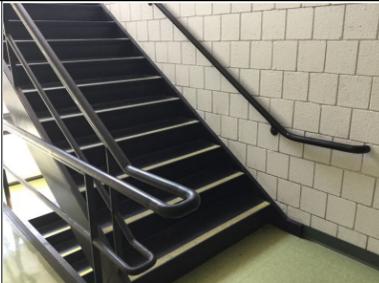
Handrails do not extend 12" from stairs	-	Ensure handrails extend to one tread depth beyond the last riser for the lower railing to ensure that the upper railing extension does not protrude as a protruding object.	1	600	\$600
148	Stairwell 7	1		Stairways	Interior

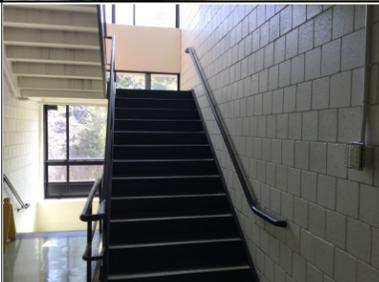
149	Stairwell 7	1		Stairways	Interior

Handrails do not extend 12" from stairs	-	Ensure handrails extend to one tread depth beyond the last riser for the lower railing to ensure that the upper railing extension does not protrude as a protruding object.	1	600	\$600
150	Stairwell 6	1		Stairways	Interior

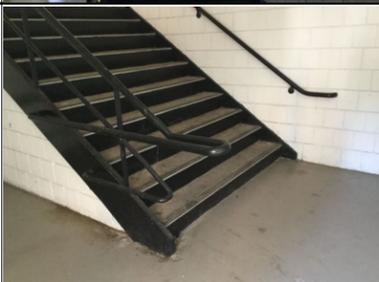
Handrails do not extend 12" from stairs	-	Ensure handrails extend to one tread depth beyond the last riser for the lower railing to ensure that the upper railing extension does not protrude as a protruding object.	1	600	\$600

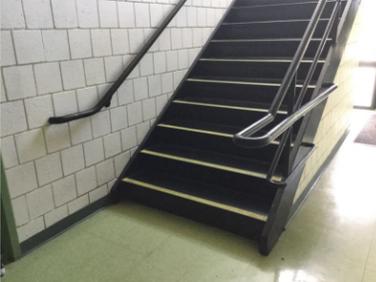
Handrails do not extend 12" from stairs	-	Ensure handrails extend to one tread depth beyond the last riser for the lower railing to ensure that the upper railing extension does not protrude as a protruding object.	1	600	\$600
152	Stairwell 5	1		Stairways	Interior

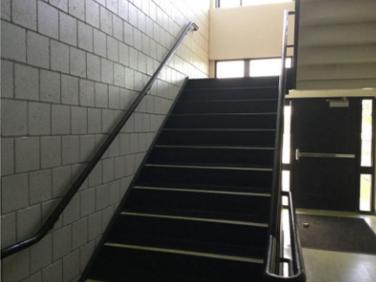
Handrails do not extend 12" from stairs	-	Ensure handrails extend to one tread depth beyond the last riser for the lower railing to ensure that the upper railing extension does not protrude as a protruding object.	1	600	\$600
153	Stairwell 4	1		Stairways	Interior

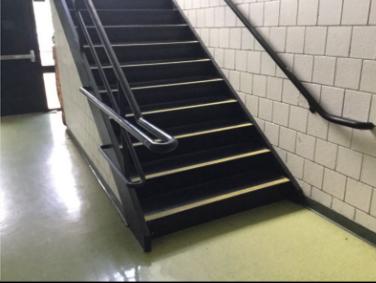
Handrails do not extend 12" from stairs	-	Ensure handrails extend to one tread depth beyond the last riser for the lower railing to ensure that the upper railing extension does not protrude as a protruding object.	1	600	\$600

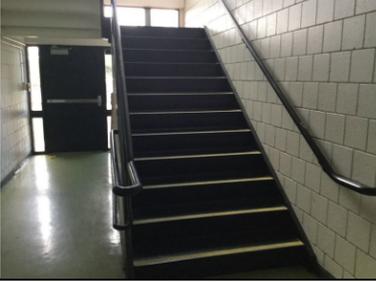
154	Stairwell 4	1		Stairways	Interior

Handrails do not extend 12" from stairs	-	Ensure handrails extend to one tread depth beyond the last riser for the lower railing to ensure that the upper railing extension does not protrude as a protruding object.	1	600	\$600
155	Stairwell 10	1		Stairways	Interior

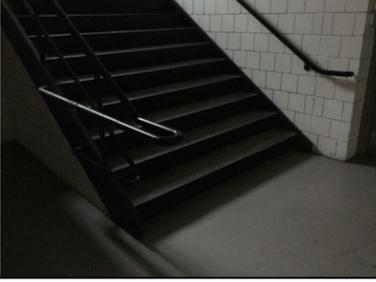
Handrails do not extend 12" from stairs	-	Ensure handrails extend to one tread depth beyond the last riser for the lower railing to ensure that the upper railing extension does not protrude as a protruding object.	1	600	\$600

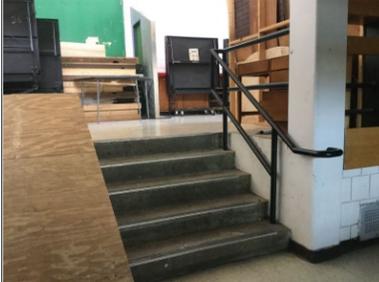
Handrails do not extend 12" from stairs	-	Ensure handrails extend horizontally above the landing for 12" min. beginning above the first riser nosing.	1	107	\$107
157	Auditorium	1	100	Stairways	Interior

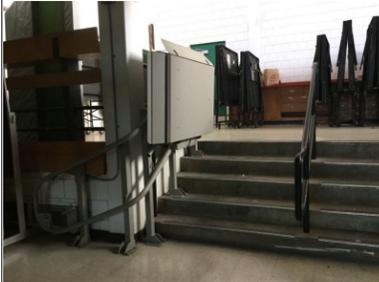
Not in operable working condition		Ensure lift is maintained in operable working condition.	1	Labor	\$0
159	Auditorium	1	100	Platform Lift or LULA Elevator	Interior

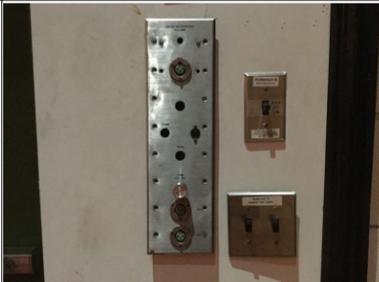
Not independently operable	-	Adjust controls to be independently operable or provide a new lift.	1	Labor	\$0

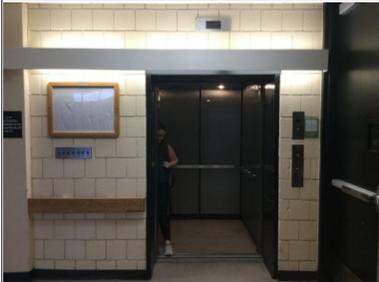
Elevator call buttons > 42" (MAAB)	48"	Lower call buttons to 42" max. above the finished floor.	1	1446	\$1446

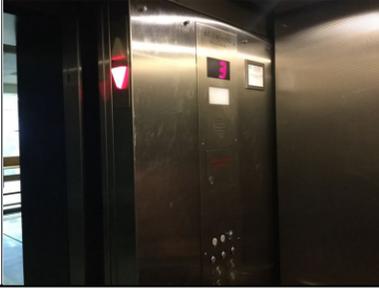
Audible hall signals not provided		Add audible hall signals.  Note: Audible hall signals exist but were very faint and may not be audible to people who are deaf or are hard of hearing.	1	1329	\$1329
<b>Signage</b>												
162	Office	1		Signage	Designation

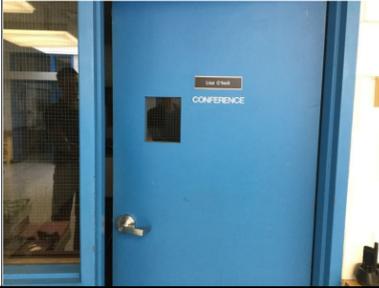
Not provided	-	Locate signage in raised characters in braille alongside the door on the latch side. Ensure it matches the long term use of this room.	1	174	\$174
163	Conference Room	1	158G	Signage	Designation

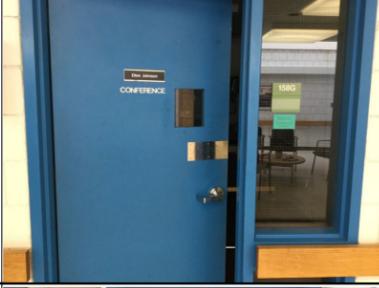
Not provided	-	Locate signage in raised characters and braille alongside the door on the latch side. Ensure it matches the long term purpose of the room.	1	174	\$174
164	Additional Entrance to Main Office Area	1		Signage	Designation
