**City of Salem,  
Massachusetts**

December 2019

# Salem City Hall

## City of Salem ADA Transition Plan

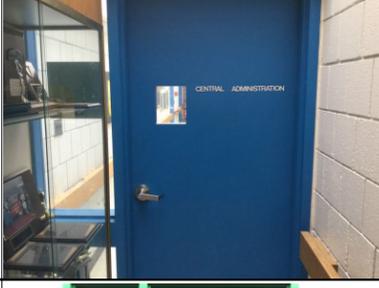
Not provided	-	Locate signage alongside the door on the latch side.	1	174	\$174

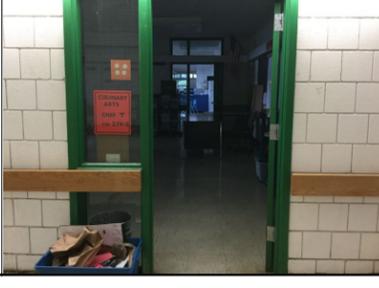
165	Culinary Arts Classroom	2	280	Signage	Designation

Not provided		Locate signage alongside the door on the latch side.	1	174	\$174

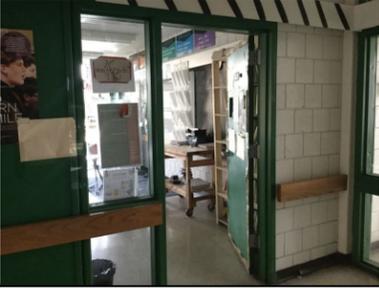
Not provided		Locate signage alongside the door on the latch side.	1	174	\$174
167	Donation Room	1	109	Signage	Designation

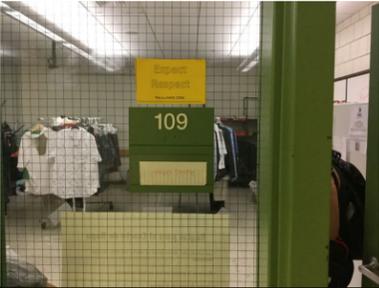
Not provided		Locate signage with correct information alongside the door on the latch side.	1	174	\$174
168	Principal's Office	1	158D	Signage	Designation

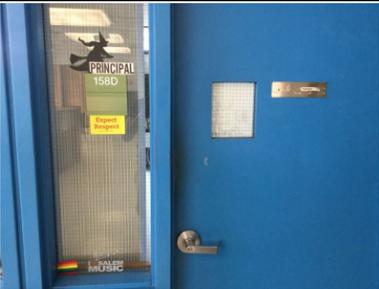
Raised characters not provided	-	Provide text with raised characters duplicated in braille. Ensure sign reflects the long term usage of this room.	1	174	\$174
169	Office	1		Signage	Designation

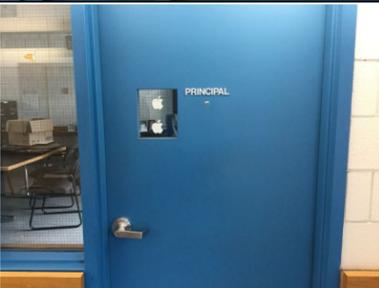
Raised characters not provided Braille not provided Sign not located on the latch side of the door	- - -	Provide text with raised characters duplicated in braille. Locate sign at permanent rooms alongside the door on the latch side. Ensure signage reflects the long term use of this room.	1	174	\$174

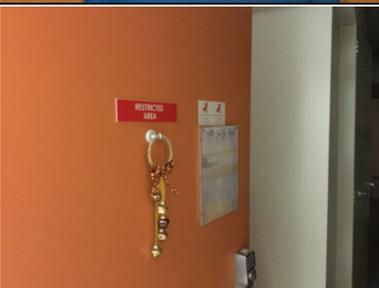
170	Environmental Science Closet	2	215	Signage	Informational

Raised characters not provided Braille not provided Sign not located on the latch side of the door	- - -	Provide text with raised characters duplicated in braille. Locate sign at permanent rooms alongside the door on the latch side.	1	174 Labor	\$174

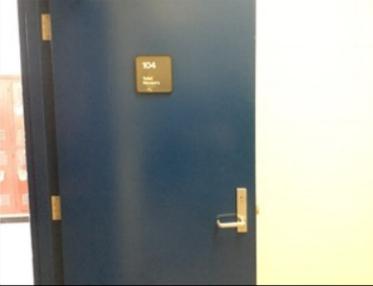
Raised characters not provided Braille not provided Sign not located on the latch side of the door International Symbol of Acc. not compliant	- - - -	Provide text with raised characters duplicated in braille. Locate sign at permanent rooms alongside the door on the latch side. Replace sign with a sign containing the International Symbol of Accessibility.	1	174	\$174
172	Automotive Technology Center, Men's Toilet Room	1	105	Signage	Designation

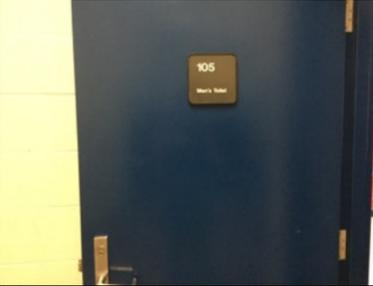
Raised characters not provided Braille not provided Sign not located on the latch side of the door International Symbol of Acc. not compliant	- - - -	Provide text with raised characters duplicated in braille. Locate sign at permanent rooms alongside the door on the latch side. Replace sign with a sign containing the International Symbol of Accessibility.	1	174	\$174

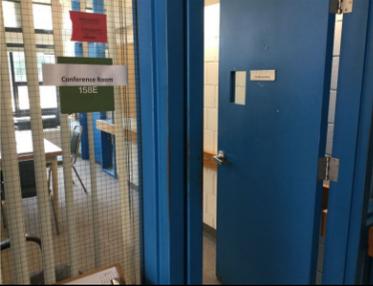
Raised characters not provided Braille misplaced	- -	Provide text with raised characters duplicated in braille. Ensure braille and raised characters match the long term purpose of this room.	1	174	\$174
175	Office	2	284	Signage	Designation

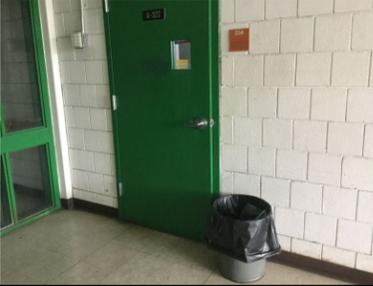
Raised characters < 48" or > 60" above ground	61"	Mount signs so that the baseline of the lowest tactile character is 48" min. above finished floor and the baseline of the highest tactile character is 60" max. above finished floor.	1	Labor	\$0

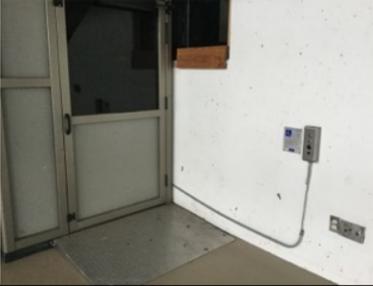
Braille not provided	-	Provide braille.	1	174	\$174
177	Projection Room	3		Signage	Designation

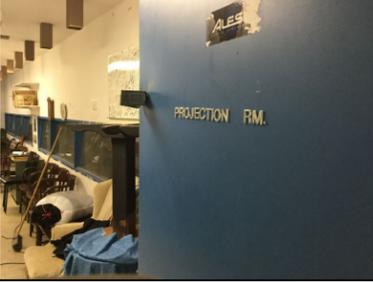
Braille not provided Sign not located on the latch side of the door	- -	Provide braille. Locate all signage at permanent rooms alongside the door on the latch side.	1	174 Labor	\$174
178	Conference Room	1	158E	Signage	Designation

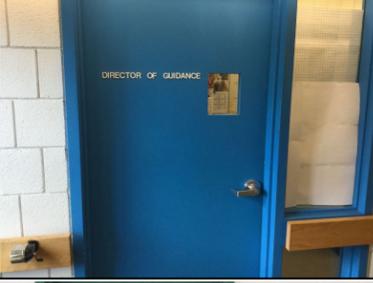
Braille not provided Sign not located on the latch side of the door	- -	Provide braille. Locate sign at permanent rooms alongside the door on the latch side.	1	174	\$174
179	Gymnasium Balcony Area, Women's Toilet Room	1		Signage	Designation

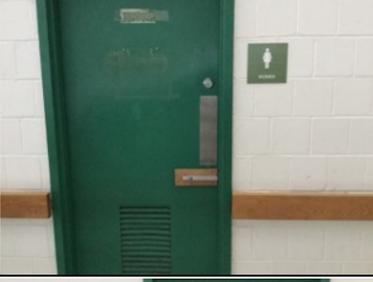
Braille not provided International Symbol of Acc. not compliant	- -	Provide braille. Replace sign with a sign containing the International Symbol of Accessibility.	1	174	\$174

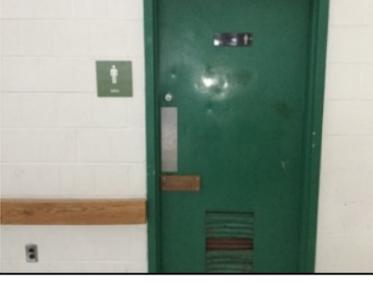
180	Gymnasium Balcony Area, Men's Toilet Room	1		Signage	Designation

Braille not provided International Symbol of Acc. not compliant	- -	Provide braille. Replace sign with a sign containing the International Symbol of Accessibility.	1	174	\$174

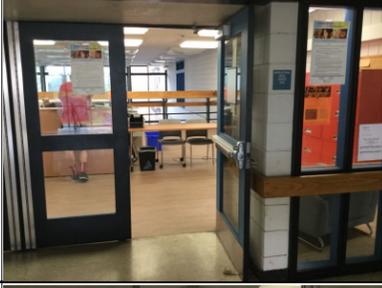
Sign not located on the latch side of the door	-	Locate sign at permanent rooms alongside the door on the latch side.	1	Labor	\$0
183	Instructional Media Center	1	155	Signage	Designation

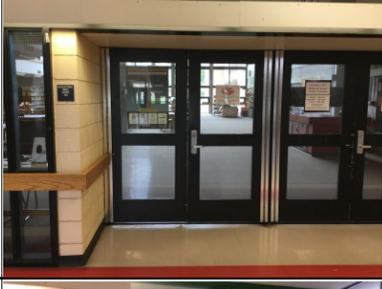
Sign not located on the latch side of the door	-	Locate sign at permanent rooms alongside the door on the latch side.	1	Labor	\$0
184	Culinary Arts/Medical Assistance Classroom	2	270	Signage	Designation

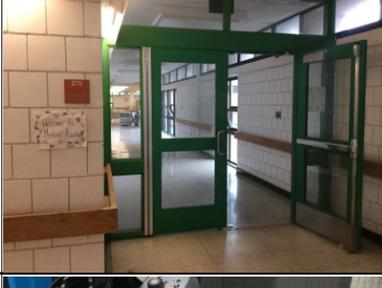
Sign not located on the latch side of the door		Locate sign at permanent rooms alongside the door on the latch side.	1	Labor	\$0

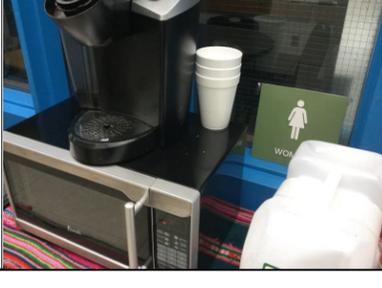
185	District ELL	1	151	Signage	Designation

Sign not located on the latch side of the door		Locate sign at permanent rooms alongside the door on the latch side.	1	Labor	\$0

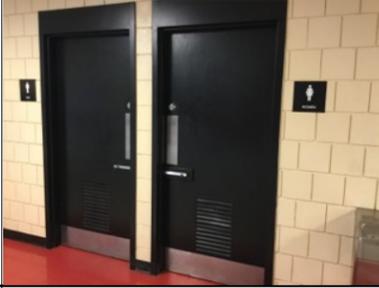
Sign not located on the latch side of the door International Symbol of Acc. not compliant	- -	Locate sign at permanent rooms alongside the door on the latch side. Replace sign with a sign containing the International Symbol of Accessibility.	1	Labor 174	\$174
187	Lobby at Main Entrance, Men's Toilet Room	1		Signage	Designation

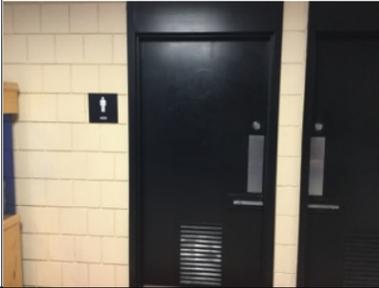
Sign not located on the latch side of the door International Symbol of Acc. not compliant	- -	Locate sign at permanent rooms alongside the door on the latch side. Replace sign with a sign containing the International Symbol of Accessibility.	1	Labor 174	\$174
188	Boys' Toilet Room Near Teacher's Lounge	3		Signage	Designation

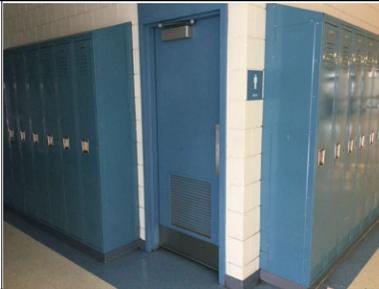
Sign not located on the latch side of the door Directional sign to access. toilet not provided	- -	Locate sign at permanent rooms alongside the door on the latch side. Provide a sign indicating the location of the nearest accessible toilet room.	1	Labor 174	\$174

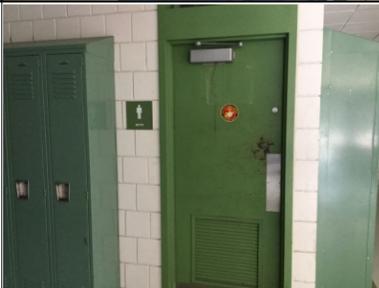
189	Boys' Toilet Room Near Teen Health Center	1		Signage	Designation

Sign not located on the latch side of the door Directional sign to access. toilet not provided	- -	Locate sign at permanent rooms alongside the door on the latch side. Provide a sign indicating the location of the nearest accessible toilet room.	1	Labor 174	\$174
190	Cafeteria, Third Floor	3	343	Signage	Designation

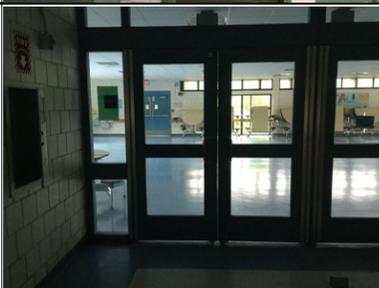
Sign not located on the latch side of the door	-	Ensure designation sign is located on the right side of this set of doors.	1	Labor	\$0

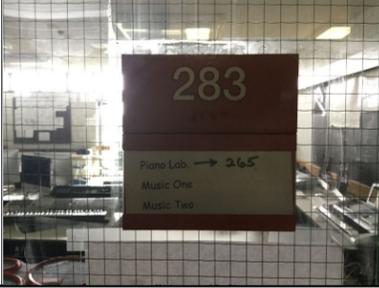
Text size non-compliant		Ensure that character size complies with the Character Height Table 703.5.5 in the ADA 2010 Standards.	1	174	\$174
<b>Service Counter</b>												
192	Instructional Media Center	3	355	Service Counter	N/A

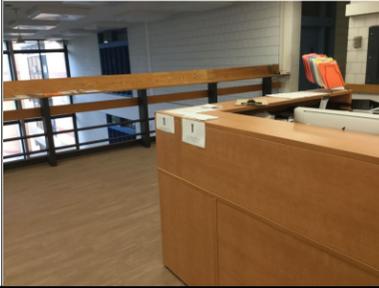
Counter > 36" high	44"	Provide a counter that is 36" max. above the ground or finished floor.	1	660	\$660
193	Instructional Media Center	1	155	Service Counter	N/A

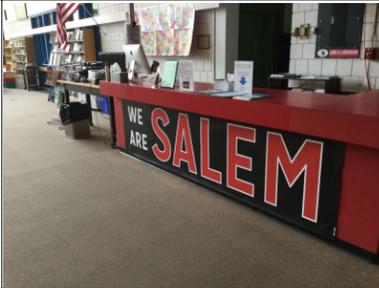
Counter > 36" high	40"	Provide a counter that is 36" max. above the ground or finished floor.	1	660	\$660
194	Speech	2	256	Service Counter	N/A

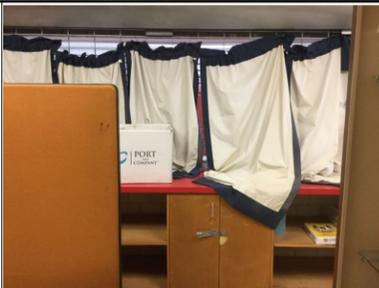
Counter > 36" high	37"	Provide a counter that is 36" max. above the ground or finished floor.	1	660	\$660
195	Hallway by Speech Room	2	256	Service Counter	N/A

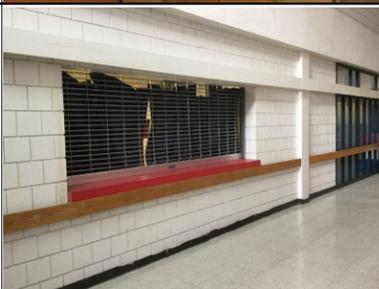
Counter > 36" high	37"	Provide a counter that is 36" max. above the ground or finished floor.	1	660	\$660

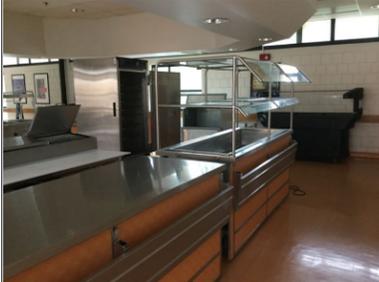
Counter > 36" high	51"	Ensure anything that is located on the higher shelf is also located at a level that is 36" max. above the ground or finished floor.	1	Labor	\$0
197	School Store	2	251	Service Counter	N/A

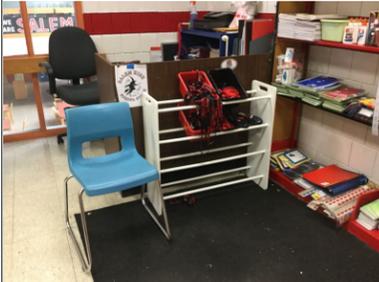
Counter > 36" high	38"	Provide a counter that is 36" max. above the ground or finished floor.	1	660	\$660
198	Library	2	255	Service Counter	N/A

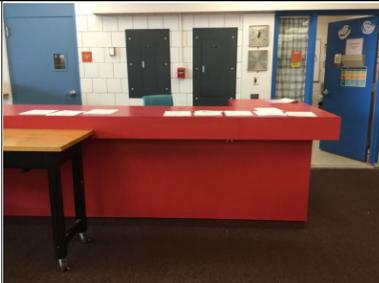
Counter > 36" high	40"	Provide a counter that is 36" max. above the ground or finished floor.	1	660	\$660
<b>Operable Parts</b>												
199	Biology Classroom	1	116	Operable Parts	Other

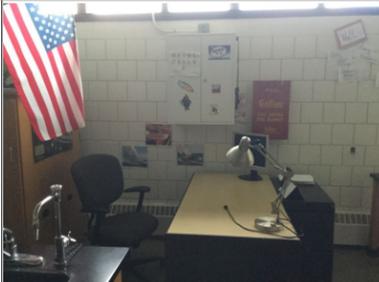
Element not on an accessible route Clear floor space is not provided	- -	Ensure goggles are located on an accessible route. Provide a 30" min. by 48" min. clear floor space at goggle pick up.	1	Labor	\$0

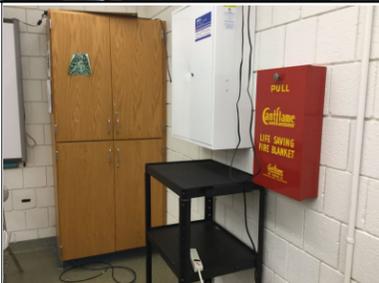
200	Science Classroom	3	314	Operable Parts	Equipment

Clear floor space is not provided	-	Provide a 30" min. by 48" min. clear floor space at goggle pick up.	1	Labor	\$0

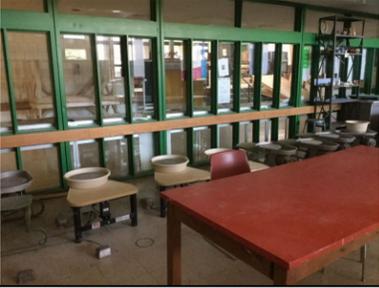
Clear floor space is not provided	-	Provide a 30" min. by 48" min. clear floor space at pottery wheels.	1	Labor	\$0
202	Automotive Technology Center, Garage	1		Operable Parts	Equipment

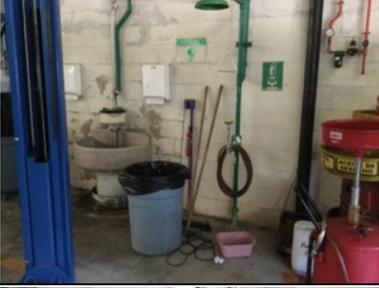
Clear floor space is not provided	-	Provide a 30" min. by 48" min. clear floor space at emergency eyewash station by removing clutter.	1	Labor	\$0
203	Automotive Technology Center, Garage	1		Operable Parts	Equipment

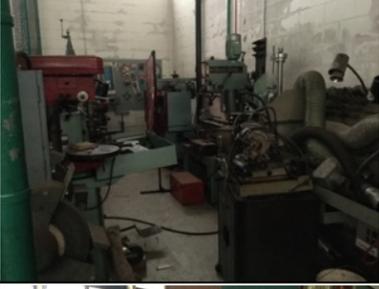
Clear floor space is not provided	-	Provide a 30" min. by 48" min. clear floor space at machines.	1	Labor	\$0
204	Art Room	1	166	Operable Parts	Equipment

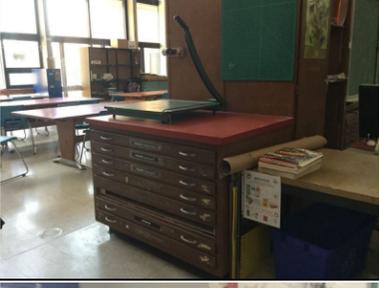
Clear floor space is not provided Reach < 15" or > 48"(forward/side approach)	- 61"	Relocate paper cutter so that controls are between 15"- 48" above finished floor and there is a 30" min. by 48" min. clear floor space.	1	Labor	\$0

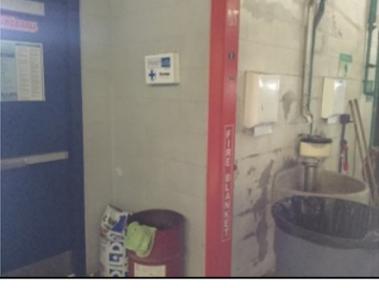
205	Automotive Technology Center, Garage	1		Operable Parts	Equipment

Clear floor space is not provided Side reach > 54"	- 68"	Provide a 30" min. by 48" min. clear floor space at first aid kit. Relocate first aid kit so that controls are between 15" - 48" above finished floor.	1	Labor 192	\$192

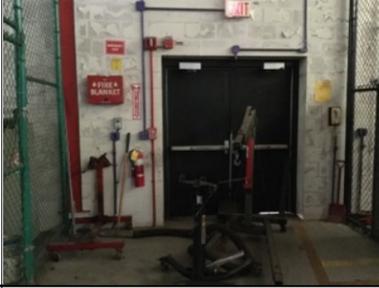
Clear floor space is not provided Side reach > 54"	- 76.5"	Provide a 30" min. by 48" min. clear floor space at fire blanket and emergency equipment by removing clutter. Relocate fire blanket and emergency equipment so that controls are between 15" - 48" above finished floor.	1	Labor 192	\$192
207	Projection Room	3		Operable Parts	Switch

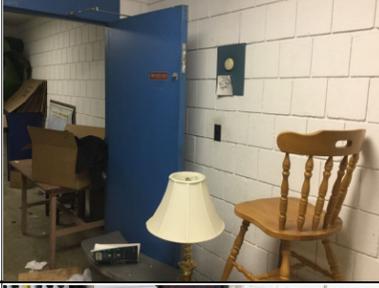
Clear floor space is not provided Side reach if obstruction > 24" deep is > 46" high	- 68.5"	Provide a 30" min. by 48" min. clear floor space at light switch. Ensure that light switch is not higher than 46" above the finished floor.	1	192	\$192
208	English and College Preparation Classroom	3	311	Operable Parts	Other

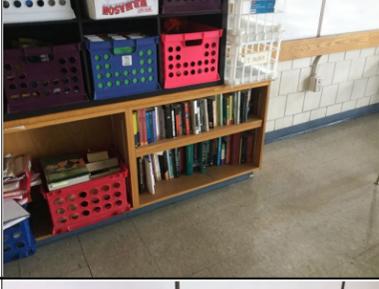
Reach < 15" or > 48"(forward/side approach)	8"	Relocate books so that controls are between 15"- 48" above finished floor.	1	Labor	\$0

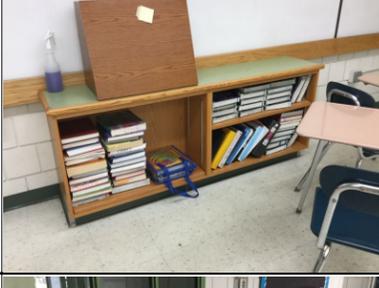
209	Geometry and Calculus Classroom	1	134	Operable Parts	Other

Reach < 15" or > 48"(forward/side approach)	8"	Relocate books so that they are between 15"- 48" above finished floor.	1	Labor	\$0
210	Early Education and Care Room	1	118	Operable Parts	Other

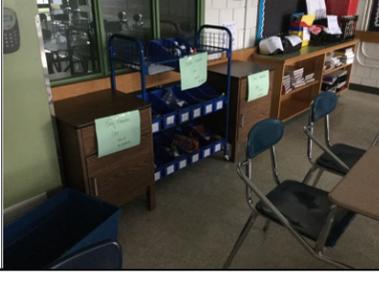
Reach < 15" or > 48"(forward/side approach)	9"	Relocate stored items so that they are between 15"- 48" above finished floor.	1	Labor	\$0

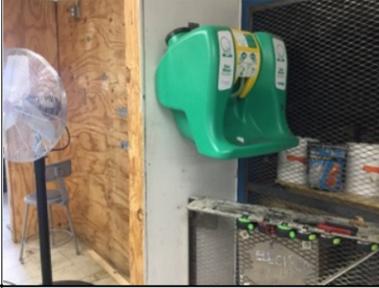
Reach < 15" or > 48"(forward/side approach)	69"	Relocate emergency eyewash so that controls are between 15"- 48" above finished floor.	1	530	\$530
212	Electrical Class	B	087	Operable Parts	Other

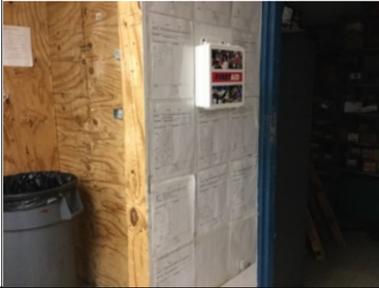
Reach < 15" or > 48"(forward/side approach)	66"	Relocate first aid kit so that controls are between 15"- 48" above finished floor.	1	192	\$192
213	Trainer's Room	B	079	Operable Parts	Other

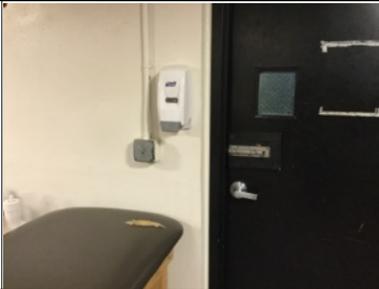
Reach < 15" or > 48"(forward/side approach)	52"	Relocate hand sanitizer so that controls are between 15"- 48" above finished floor.	1	192	\$192
214	Donation Room	1	109	Operable Parts	Other

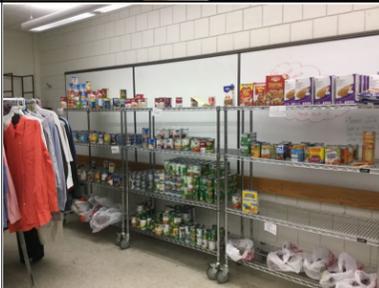
Reach < 15" or > 48"(forward/side approach) Side reach > 54"	10" 59"	Relocate store items so that items are between 15"- 48" above finished floor.	1	Labor	\$0

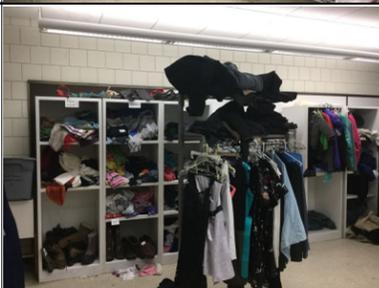
215	Donation Room	1	109	Operable Parts	Other

Reach < 15" or > 48"(forward/side approach) Side reach > 54"	4.5" 72"	Relocate clothes so that items are between 15"- 48" above finished floor.	1	Labor	\$0

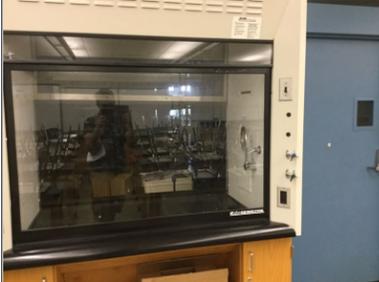
Side reach > 54"	63"	Relocate fume hood controls so that they are 48" max. above finished floor.	1	192	\$192
217	Costume Room Near Auditorium	3		Operable Parts	Other

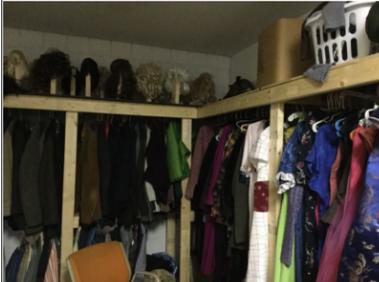
Side reach > 54"	85"	Relocate costumes so that controls are between 15" - 48" above finished floor.	1	Labor	\$0
218	Science Classroom	2	216	Operable Parts	Switch

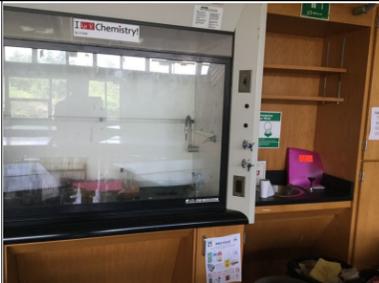
Side reach > 54"	63"	Relocate fume hood controls so that they are 48" max. above finished floor.	1	192	\$192
219	Home Economics/ Special Needs Classroom	1	141	Operable Parts	Other

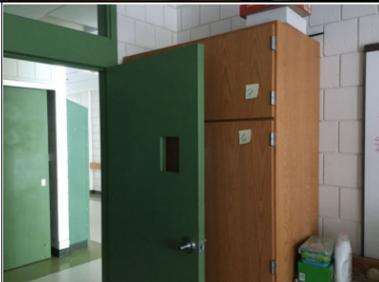
Side reach > 54"	74"	Relocate storage so that items are between 15" - 48" above finished floor.	1	Labor	\$0
220	Independent Living Room	1	133	Operable Parts	Other

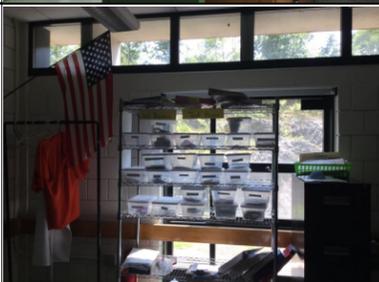
Side reach > 54"	73"	Relocate storage so that controls are between 15" - 48" above finished floor.	1	Labor	\$0

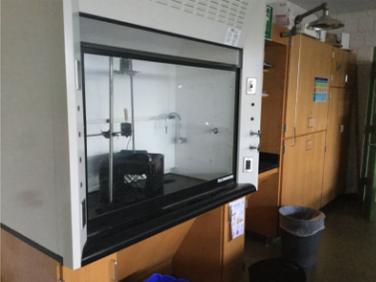
ID	Location	Floor	Room	Element	Type	Photo	Issues	Current Measure	Recommendations	Quantity	Price	Cost Estimation
221	Physics Classroom	1	116	Operable Parts	Switch

Side reach > 54"	63"	Relocate fume hood controls so that they are 48" max. above the finished floor.	1	192	\$192
222	Science Prep Room	1	114	Operable Parts	Switch

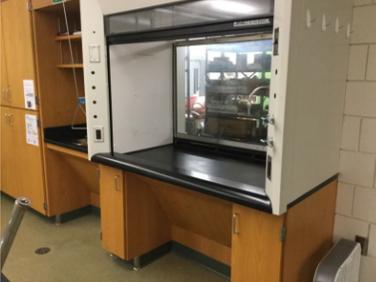
Side reach > 54"	63"	Relocate fume hood controls so that they are between 15" - 48" above finished floor.	1	192	\$192
223	Culinary Arts/Medical Assistance Classroom	2	270	Operable Parts	Other

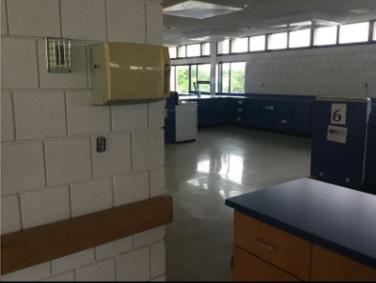
Side reach > 54"	60"	Relocate paper towel dispenser so that controls are between 15" - 48" above finished floor.	1	192	\$192
224	Culinary Arts/Medical Assistance Classroom	2	270	Operable Parts	Other

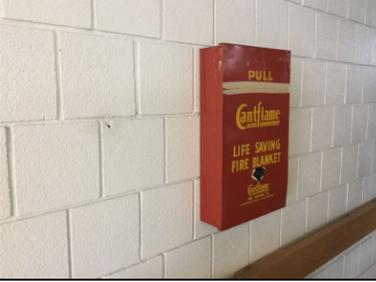
Side reach > 54"	63"	Relocate fire blanket so that controls are between 15" - 48" above finished floor.	1	192	\$192
225	School Store	2	251	Operable Parts	Clothes Rod/Hooks

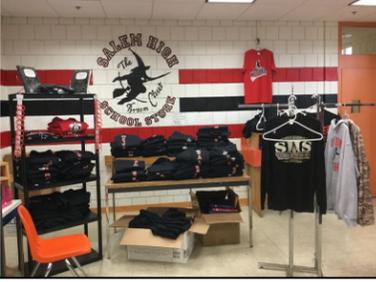
Side reach > 54"	59"	Relocate clothes so that items are between 15" - 48" above finished floor.	1	Labor	\$0

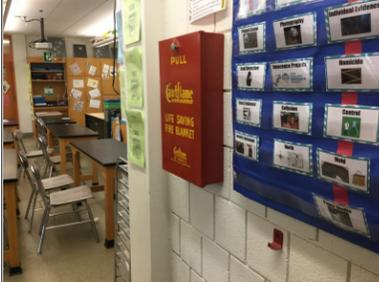
ID	Location	Floor	Room	Element	Type	Photo	Issues	Current Measure	Recommendations	Quantity	Price	Cost Estimation
226	Environmental Science	2	212	Operable Parts	Equipment

Side reach > 54"	63"	Relocate fire blanket so that controls are between 15" - 48" above finished floor.	1	192	\$192
227	Wood Shop	1	174	Operable Parts	Equipment

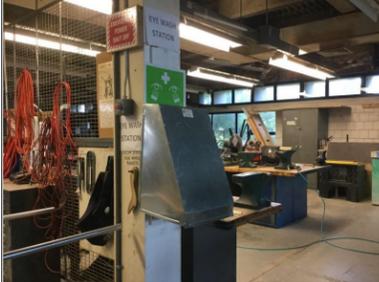
Side reach > 54"	60"	Relocate emergency button so that controls are between 15" - 48" above finish floor.	1	192	\$192
228	Next to Stair 14	1	174	Operable Parts	Other

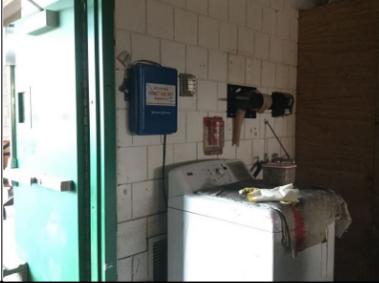
Side reach > 54"	59"	Relocate first aid kit so that controls are between 15" - 48" above finished floor.	1	192	\$192
229	Wood Shop	1	174	Operable Parts	Equipment

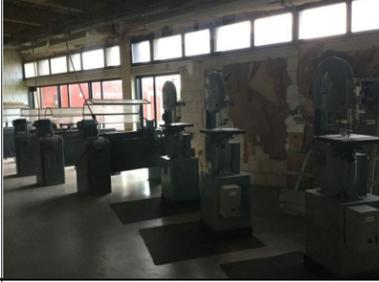
Side reach > 54"	55"	Relocate machine controls so that controls are between 15" - 48" above finished floor.	1	0	\$0
230	Wood Shop	1	174	Operable Parts	Equipment

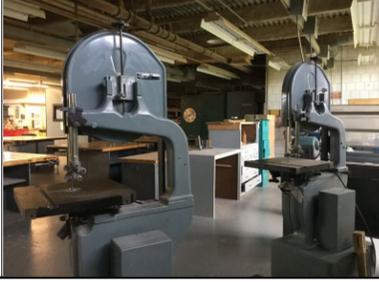
Side reach > 54"	66"	Relocate machine controls so that controls are between 15" - 48" above finished floor.	1	0	\$0

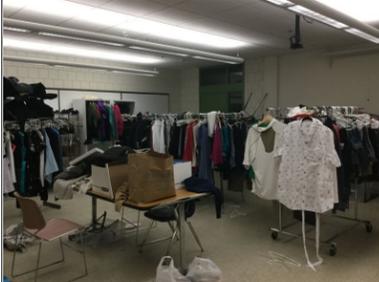
ID	Location	Floor	Room	Element	Type	Photo	Issues	Current Measure	Recommendations	Quantity	Price	Cost Estimation
231	Donation Room	1	109	Operable Parts	Clothes Rod/Hooks

Side reach > 54"	61"	Relocate coat hooks so that controls are between 15" - 48" above finished floor.	1	Labor	\$0
232	Automotive Technology Center Tools Area	1		Operable Parts	Equipment

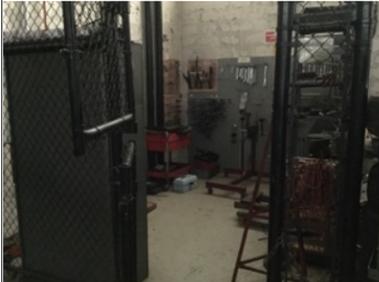
Side reach > 54"	74.5"	Relocate tools so that controls are between 15" - 48" above finished floor.	1	Labor	\$0
233	Automotive Technology Center, Garage	1		Operable Parts	Equipment

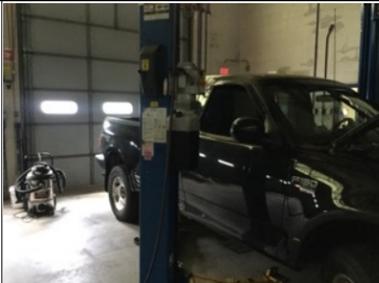
Side reach > 54"	70"	Relocate car lift buttons so that controls are between 15" - 48" above finished floor.	1	0	\$0
234	Band Storage Room	2	284	Operable Parts	Clothes Rod/Hooks

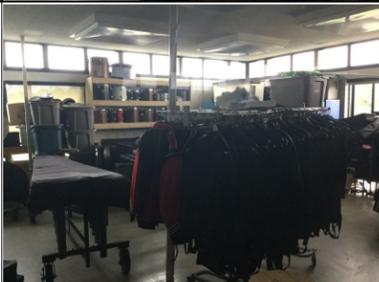
Side reach > 54" No visible fire alarm provided within room	60"	Relocate coat hooks so that controls are between 15" - 48" above finished floor. When fire system is updated, ensure that a visible fire alarm is installed in each room.	1	711	\$711

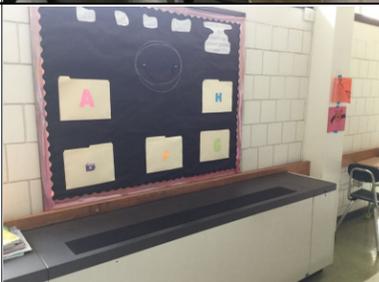
235	Speech Therapy and Social Skills Class	1	129	Operable Parts	Other

Forward reach if obstruction > 20"- 25" deep is > 44" high	56"	Ensure that folders are not higher than 44" above the finished floor.	1	Labor	\$0

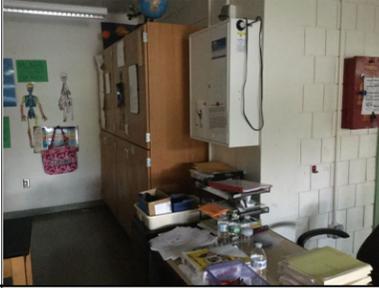
ID	Location	Floor	Room	Element	Type	Photo	Issues	Current Measure	Recommendations	Quantity	Price	Cost Estimation
236	Science Classroom	1	112	Operable Parts	Other

Forward reach if obstruction > 20"- 25" deep is > 44" high	50"	Ensure that goggles are not higher than 44" above the finished floor.	1	192	\$192
237	Auditorium - Backstage	1	191	Operable Parts	Other

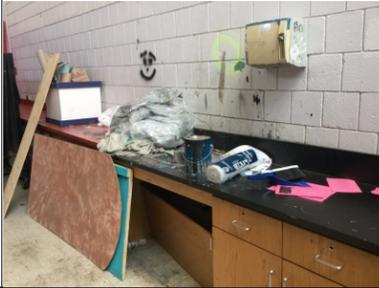
Forward reach if obstruction > 20"- 25" deep is > 44" high	63"	Ensure that paper towel dispenser is not higher than 44" above the finished floor.	1	192	\$192
238	Art Room	1	166	Operable Parts	Other

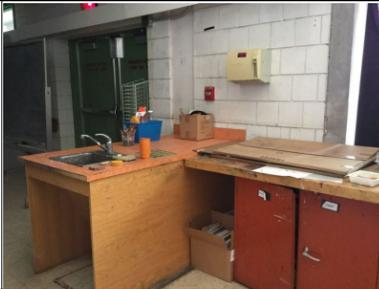
Side reach if obstruction > 24" deep is > 46" high	57"	Ensure that paper towel dispenser is not higher than 46" above the finished floor.	1	192	\$192
<b>Dining or Work Surfaces</b>												
239	Science Classroom	1	112	Dining or Work Surfaces	Work Surface

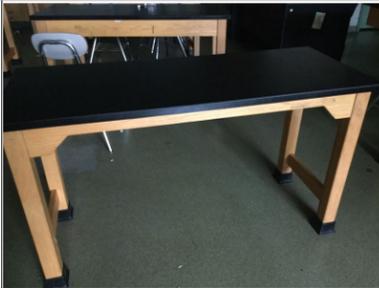
Relocate/swap at least one accessible lab table with inaccessible lab tables in Rooms 116, 216, and 314.	1	Labor	\$0

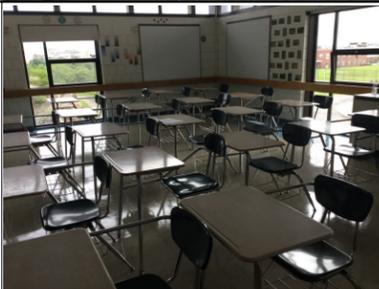
240	History Classroom	3	304	Dining or Work Surfaces	Work Surface

Not on a accessible route At least one or 5% accessible tables not provided	24" -	Ensure work surfaces are located on an accessible route by rearranging desks. Ensure that at least one work surface is accessible.	1	Labor 525	\$525

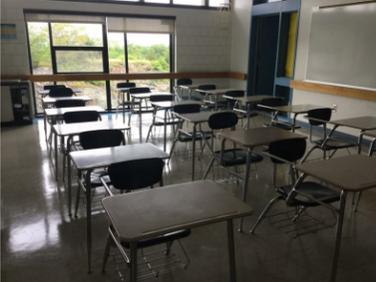
ID	Location	Floor	Room	Element	Type	Photo	Issues	Current Measure	Recommendations	Quantity	Price	Cost Estimation
241	English and College Preparation Classroom	3	311	Dining or Work Surfaces	Work Surface

Not on a accessible route At least one or 5% accessible tables not provided	22" -	Ensure work surfaces are located on an accessible route by rearranging desks. Ensure that at least one work surface is accessible.	1	Labor 525	\$525
242	Latin Classroom	3	335	Dining or Work Surfaces	Work Surface

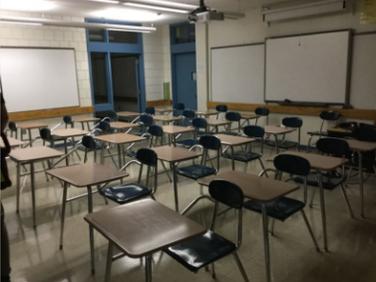
At least one or 5% accessible tables not provided	-	Ensure that at least one work surface is accessible.	1	525	\$525
243	Senior English Classroom	3	339	Dining or Work Surfaces	Work Surface

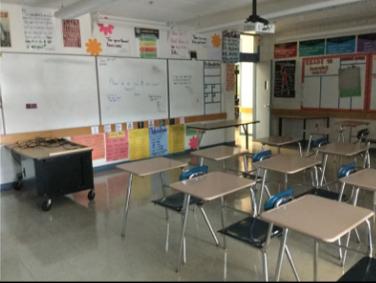
At least one or 5% accessible tables not provided	-	Ensure that at least one work surface is accessible.	1	525	\$525
244	Spanish Classroom	3	318	Dining or Work Surfaces	Work Surface

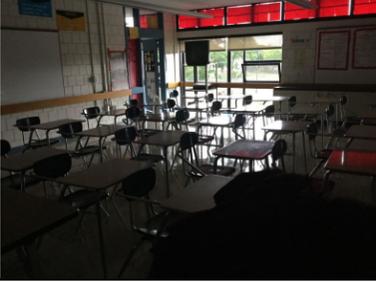
At least one or 5% accessible tables not provided	-	Ensure that at least one work surface is accessible.	1	525	\$525

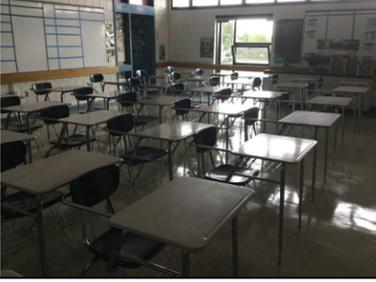
245	French Classroom	3	319	Dining or Work Surfaces	Work Surface

At least one or 5% accessible tables not provided	-	Ensure that at least one work surface is accessible.	1	525	\$525

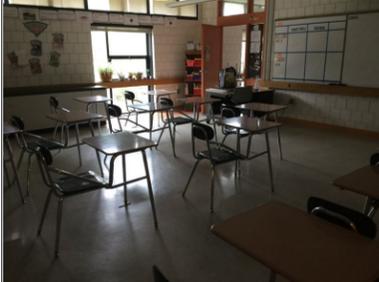
ID	Location	Floor	Room	Element	Type	Photo	Issues	Current Measure	Recommendations	Quantity	Price	Cost Estimation
246	ESL Classroom	2	240	Dining or Work Surfaces	Work Surface

At least one or 5% accessible tables not provided	-	Ensure that at least one work surface is accessible.	1	525	\$525
247	American History Classroom	2	226	Dining or Work Surfaces	Work Surface

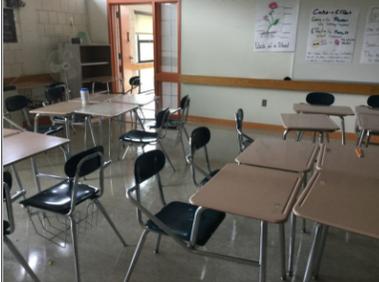
At least one or 5% accessible tables not provided	-	Ensure that at least one work surface is accessible.	1	525	\$525
248	Instructional Media Center	1	155	Dining or Work Surfaces	Work Surface

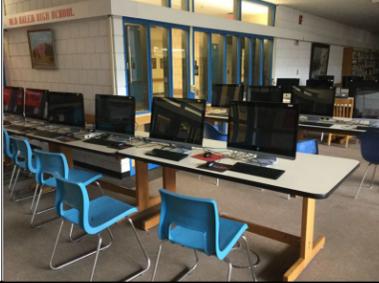
At least one or 5% accessible tables not provided	-	Ensure that at least one work surface is accessible.	1	525	\$525
249	Instructional Media Center	1	155	Dining or Work Surfaces	Work Surface

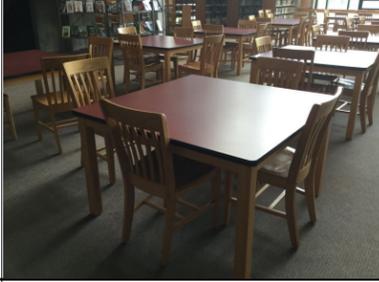
At least one or 5% accessible tables not provided	-	Ensure that at least one work surface is accessible.	1	525	\$525
250	Speech Therapy and Social Skills Class	1	129	Dining or Work Surfaces	Work Surface

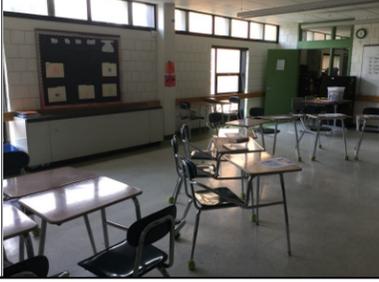
At least one or 5% accessible tables not provided	-	Ensure that at least one work surface is accessible.	1	525	\$525

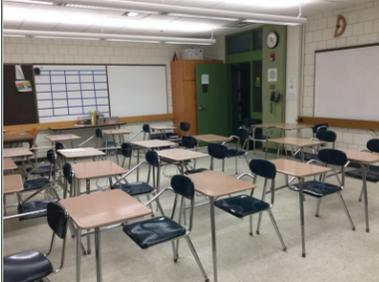
ID	Location	Floor	Room	Element	Type	Photo	Issues	Current Measure	Recommendations	Quantity	Price	Cost Estimation
251	Geometry and Calculus Classroom	1	134	Dining or Work Surfaces	Work Surface

At least one or 5% accessible tables not provided	-	Ensure that at least one work surface is accessible.	1	525	\$525
252	VTC/Special Education Room	1	140	Dining or Work Surfaces	Work Surface

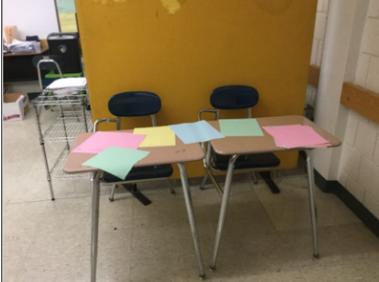
At least one or 5% accessible tables not provided	-	Ensure that at least one work surface is accessible.	1	525	\$525
253	Early Education and Care Room	1	118	Dining or Work Surfaces	Work Surface

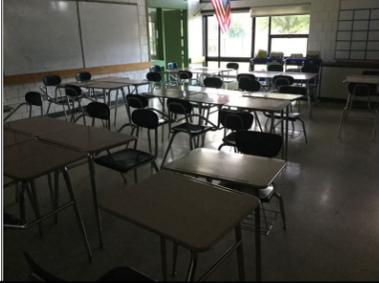
At least one or 5% accessible tables not provided	-	Ensure that at least one work surface is accessible.	1	525	\$525
254	ROTC - Bunker Room	1		Dining or Work Surfaces	Work Surface

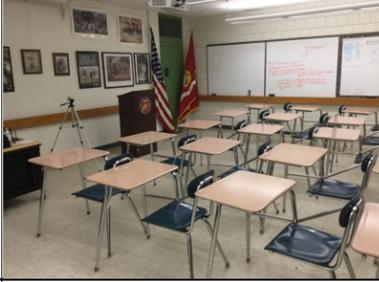
At least one or 5% accessible tables not provided	-	Ensure that at least one work surface is accessible.	1	525	\$525
255	Culinary Arts/Medical Assistance Classroom	2	270	Dining or Work Surfaces	Work Surface

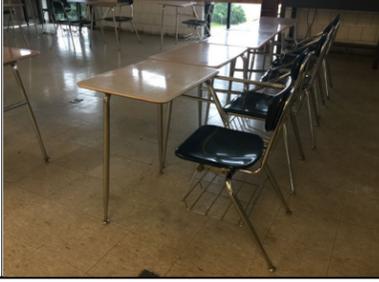
At least one or 5% accessible tables not provided		Ensure that at least one work surface is accessible.	1	525	\$525

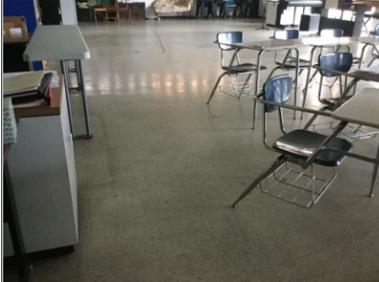
ID	Location	Floor	Room	Element	Type	Photo	Issues	Current Measure	Recommendations	Quantity	Price	Cost Estimation
256	Choir Room	2	285	Dining or Work Surfaces	Work Surface

At least one or 5% accessible tables not provided		Ensure that at least one work surface is accessible.	1	525	\$525
257	Classroom	2	201	Dining or Work Surfaces	Work Surface

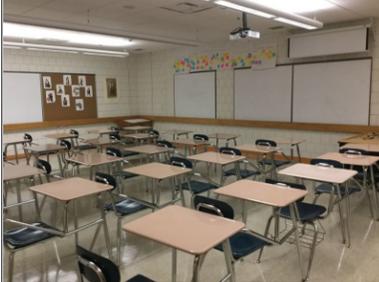
At least one or 5% accessible tables not provided		Ensure that at least one work surface is accessible.	1	525	\$525
258	Library	2	255	Dining or Work Surfaces	Work Surface

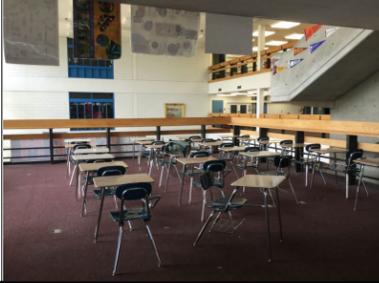
At least one or 5% accessible tables not provided	-	Ensure that at least one work surface is accessible.	1	525	\$525
259	Automotive Technology Center, Classroom	Ext.		Dining or Work Surfaces	Work Surface

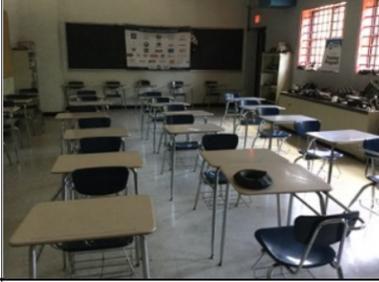
At least one or 5% accessible tables not provided	-	Ensure that at least one work surface is accessible.	1	525	\$525
260	Black Cat Cafe	B		Dining or Work Surfaces	Dining Surface

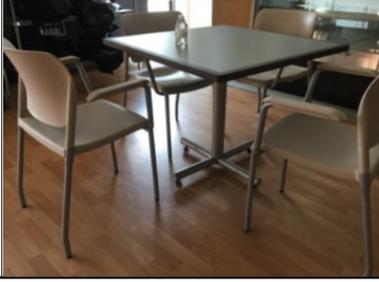
At least one or 5% accessible tables not provided	-	Ensure that at least one dining surface is accessible.	1	825	\$825

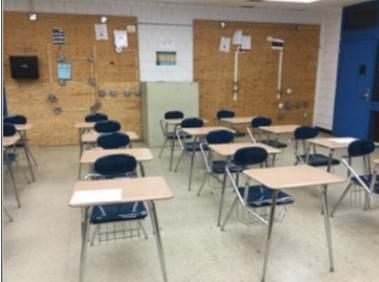
ID	Location	Floor	Room	Element	Type	Photo	Issues	Current Measure	Recommendations	Quantity	Price	Cost Estimation
261	Electrical Class	B	091	Dining or Work Surfaces	Work Surface

At least one or 5% accessible tables not provided	-	Ensure that at least one work surface is accessible.	1	525	\$525
262	Computer Lab	1	101	Dining or Work Surfaces	Work Surface

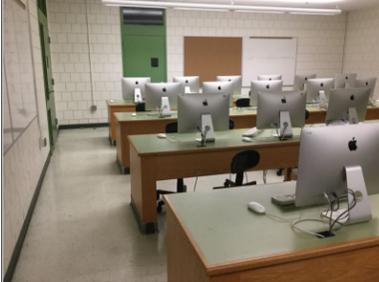
At least one or 5% accessible tables not provided Knee or toe clearance not provided	- 25"	Ensure that at least one work surface is accessible. Provide at least 1 dining or work surface with 27" min. knee and toe clearance.	1	525	\$525
263	Computer Lab	1	182	Dining or Work Surfaces	Work Surface

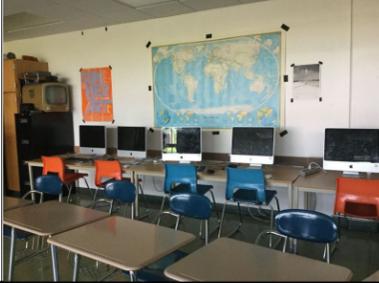
At least one or 5% accessible tables not provided Knee or toe clearance not provided Top of dining/work surface < 28" or > 34"	- 23" 26"	Ensure that at least one work surface is accessible. Provide at least 1 dining or work surface with 27" min. knee and toe clearance. Provide at least one dining or work surface with tops between 28"- 34" above the floor and 27" clear height underneath.	1	525	\$525

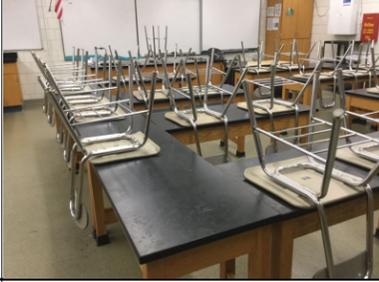
264	Science Classroom	3	314	Dining or Work Surfaces	Work Surface

Knee or toe clearance not provided	25"	Provide at least 1 work surface with 27" min. knee and toe clearance.  See ID #239	1	-	\$0
265	Science Classroom	2	216	Dining or Work Surfaces	Work Surface

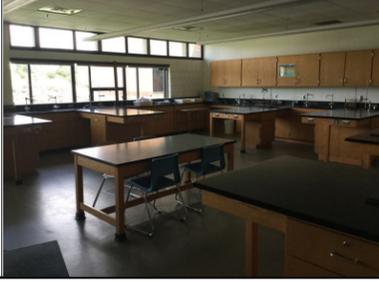
Knee or toe clearance not provided	25"	Provide at least 1 work surface with 27" min. knee and toe clearance.  See ID #239	1	-	\$0

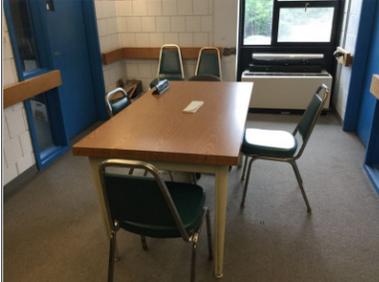
ID	Location	Floor	Room	Element	Type	Photo	Issues	Current Measure	Recommendations	Quantity	Price	Cost Estimation
266	Conference Room	1	158E	Dining or Work Surfaces	Work Surface

Knee or toe clearance not provided	25"	Provide at least 1 work surface with 27" min. knee and toe clearance.	1	525	\$525
267	Conference Room	1	158C	Dining or Work Surfaces	Work Surface

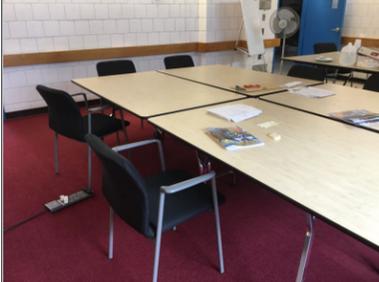
Knee or toe clearance not provided	26"	Provide at least 1 work surface with 27" min. knee and toe clearance.	1	525	\$525
268	Home Economics/ Special Needs Classroom	1	141	Dining or Work Surfaces	Work Surface

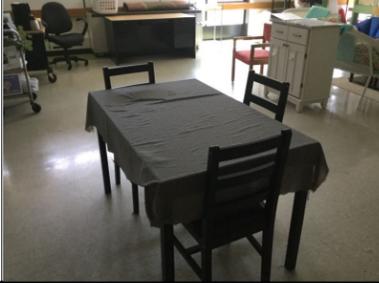
Knee or toe clearance not provided	25"	Provide at least 1 work surface with 27" min. knee and toe clearance.	1	525	\$525
269	Independent Living Room	1	133	Dining or Work Surfaces	Work Surface

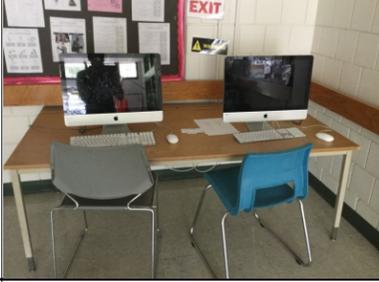
Knee or toe clearance not provided	23"	Provide at least 1 work surface with 27" min. knee and toe clearance.	1	525	\$525

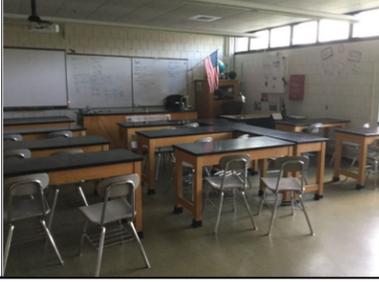
270	Physics Classroom	1	116	Dining or Work Surfaces	Work Surface

Knee or toe clearance not provided	24"	Provide at least 1 work surface with 27" min. knee and toe clearance.  See ID 239	1	-	\$0

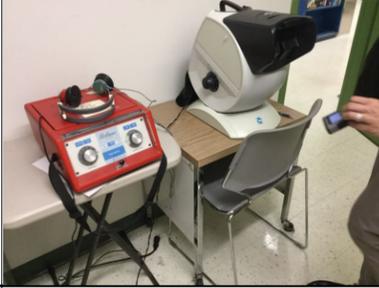
ID	Location	Floor	Room	Element	Type	Photo	Issues	Current Measure	Recommendations	Quantity	Price	Cost Estimation
271	Health Suite Eye Exam	1	123c	Dining or Work Surfaces	Work Surface

Knee or toe clearance not provided	25"	Provide at least 1 work surface with 27" min. knee and toe clearance.	1	525	\$525
272	Music Practice Rooms	2	265	Dining or Work Surfaces	Work Surface

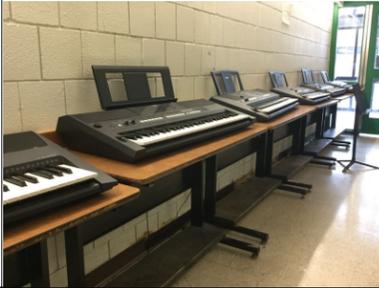
Knee or toe clearance not provided		Provide at least 1 work surface with 27" min. knee and toe clearance.	1	525	\$525
273	Wood Shop Classroom	1	172	Dining or Work Surfaces	Work Surface

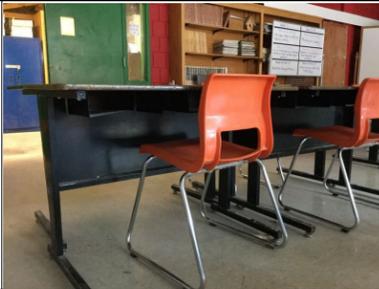
Knee or toe clearance not provided	8" d	Provide at least 1 work surface with 27" min. knee and toe clearance.	1	525	\$525
274	Wood Shop	1	174	Dining or Work Surfaces	Work Surface

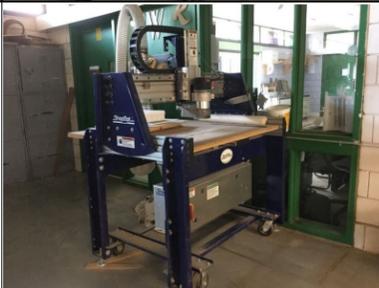
Knee or toe clearance not provided	-	Provide at least 1 work surface with 27" min. knee and toe clearance.	1	525	\$525
275	Automotive Technology Center, Garage Work Benches	1		Dining or Work Surfaces	Work Surface

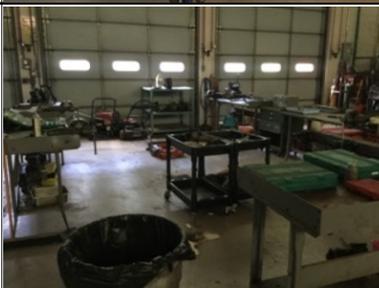
Knee or toe clearance not provided	-	Provide at least 1 work surface with 27" min. knee and toe clearance.	1	525	\$525

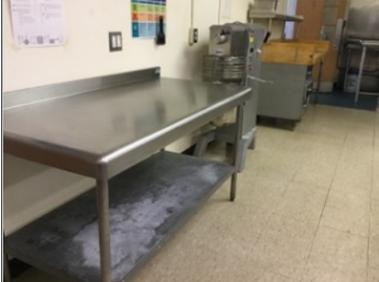
ID	Location	Floor	Room	Element	Type	Photo	Issues	Current Measure	Recommendations	Quantity	Price	Cost Estimation
276	Culinary Arts Class	B	057	Dining or Work Surfaces	Work Surface

Knee or toe clearance not provided	-	Provide at least 1 work surface with 27" min. knee and toe clearance.	1	525	\$525
277	Main Lobby	1		Dining or Work Surfaces	Work Surface

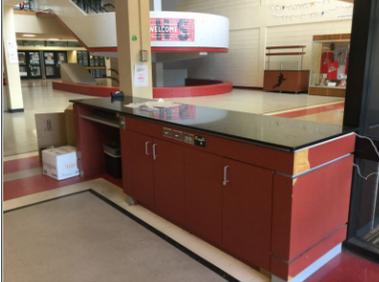
Knee or toe clearance not provided Top of dining/work surface < 28" or > 34"	- 36"	Provide at least 1 work surface with 27" min. knee and toe clearance. Provide at least one dining or work surface with tops between 28"- 34" above the floor and 27" clear height underneath.	1	525	\$525
278	Art Room	1	166	Dining or Work Surfaces	Work Surface

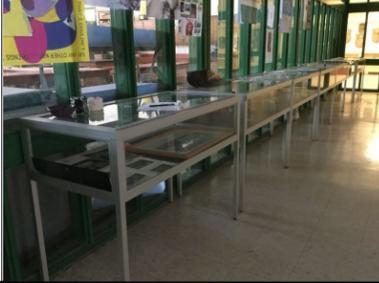
Knee or toe clearance not provided Top of dining/work surface < 28" or > 34"	24" 36"	Provide at least 1 work surface with 27" min. knee and toe clearance. Provide at least one dining or work surface with tops between 28"- 34" above the floor and 27" clear height underneath.	1	525	\$525

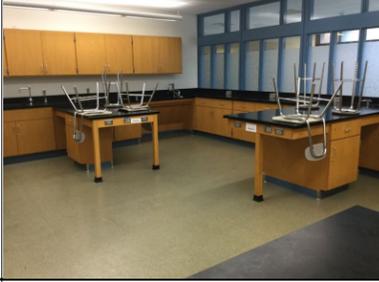
279	Lab Station in Classroom	3	314	Dining or Work Surfaces	Work Surface

Top of dining/work surface < 28" or > 34"	37"	Provide at least one work surface with tops between 28"- 34" above the floor and 27" clear height underneath.	1	525	\$525
280	Science Classroom	2	216	Dining or Work Surfaces	Work Surface

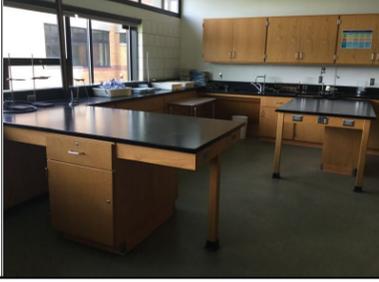
Top of dining/work surface < 28" or > 34"	37"	Provide at least one work surface with tops between 28"- 34" above the floor and 27" clear height underneath.	1	525	\$525

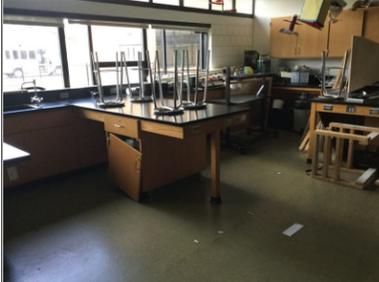
ID	Location	Floor	Room	Element	Type	Photo	Issues	Current Measure	Recommendations	Quantity	Price	Cost Estimation
281	Physics Classroom	1	116	Dining or Work Surfaces	Work Surface

Top of dining/work surface < 28" or > 34"	37"	Provide at least one work surface with tops between 28"- 34" above the floor and 27" clear height underneath.	1	525	\$525
282	Science Prep Room	1	114	Dining or Work Surfaces	Work Surface

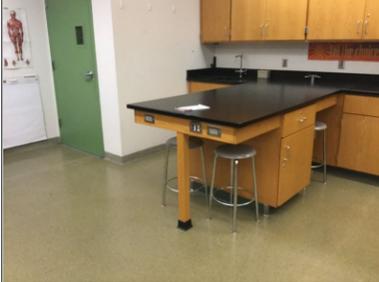
Top of dining/work surface < 28" or > 34"	37"	Provide at least one work surface with tops between 28"- 34" above the floor and 27" clear height underneath.	1	525	\$525
283	Speech	2	256	Dining or Work Surfaces	Work Surface

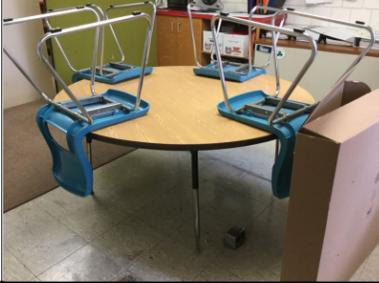
Top of dining/work surface < 28" or > 34"	27"	Provide at least one work surface with top between 28"- 34" above the floor and 27" clear height underneath.	1	525	\$525
284	Music Classroom	2	283	Dining or Work Surfaces	Work Surface

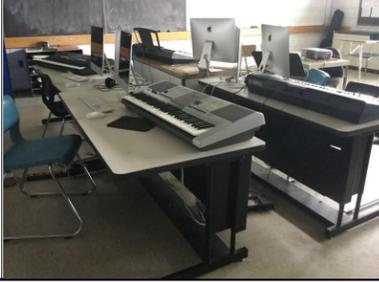
Top of dining/work surface < 28" or > 34" No visible fire alarm provided within room	27"	Provide at least one work surface with tops between 28"- 34" above the floor and 27" clear height underneath. When fire system is updated, ensure that a visible fire alarm is installed in each room.	1	1044	\$1044

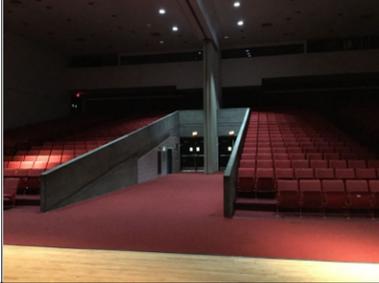
<b>Assembly Area</b>												
285	Auditorium	1	100	Assembly Area	N/A

Number of seats Number of designated wheelchair spaces Companion seat not provided	644 8 -	Provide one companion seat for each wheelchair space. (Reposition accessible seats so all have a companion seat. Four (4) additional companion seats are required.)	4	530	\$2120

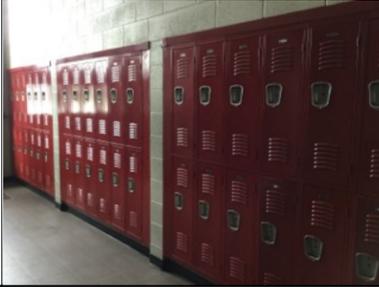
ID	Location	Floor	Room	Element	Type	Photo	Issues	Current Measure	Recommendations	Quantity	Price	Cost Estimation
<b>Locker Room</b>												
286	Automotive Technology Center	1		Locker Room	N/A

Total # of locker Total # of accessible locker	36 0	Ensure at least one locker is accessible.	1	495	\$495
287	Girls' Locker Room	B		Locker Room	Women's

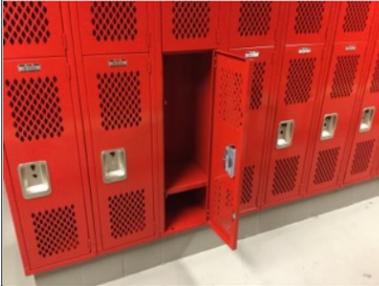
Total # of locker Total # of accessible locker 2% of lockers are not accessible	413 6 -	Ensure 2% of all lockers are accessible .	2	495	\$990
288	Visiting Team Rooms 1 and 2	B		Locker Room	N/A

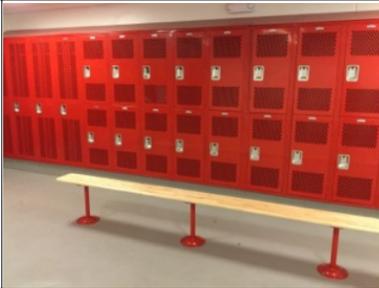
Total # of locker Total # of accessible locker 2% of lockers are not accessible	48 0 -	Ensure 2% of all lockers are accessible .	2	495	\$990
289	Boys' Locker Room	B	074	Locker Room	Men's

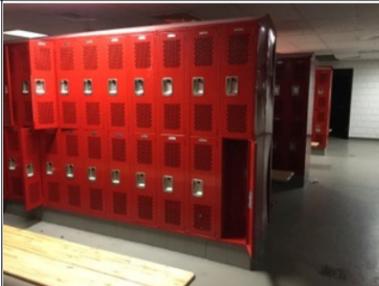
Total # of locker Total # of accessible locker 2% of lockers are not accessible	415 0 -	Ensure 2% of all lockers are accessible .	8	495	\$3960
<b>Laboratory</b>

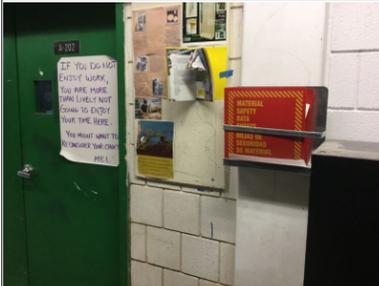
290	Wood Shop	1	174	Laboratory

Accessories > 48"	54"	Lower controls and operable parts to 48" max. above the floor.	1	192	\$192

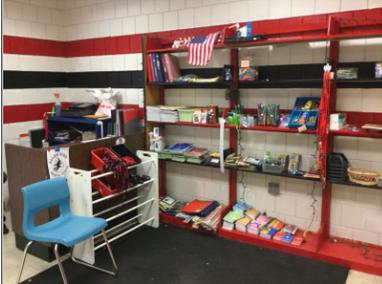
Dispensers or products > 48" high	58.5"	Ensure that dispensing devices are located no higher than 48 inches above finished floor.	1	Labor	\$0
<b>Toilet &amp; Bathing Rooms</b>												
<b>Overall Access</b>												
293	Faculty Lounge	1	185	Overall Access	Toilet Room

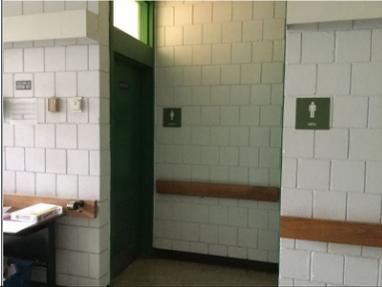
Accessible plumbing fixtures or stalls not provided Sign to accessible toilet not provided Audible and visible alarms not provided	- - -	Provide one accessible wheelchair stall. Provide a directional sign indicating the location of the nearest accessible toilet or bathing room. When fire system is updated, ensure that a visible and audible fire alarm is installed.  (Cost estimate based on accessible wheelchair stall, directional sign, and visible and audible fire alarm.)	1	5330	\$5330

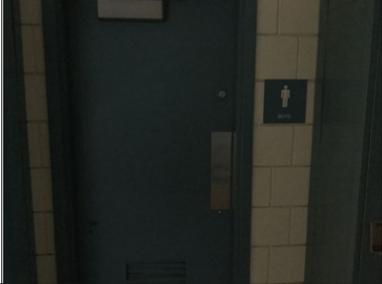
294	Boys' Toilet Room Near Room 359	3		Overall Access	Toilet Room

Sign to accessible toilet not provided	-	Provide a directional sign indicating the location of the nearest accessible toilet or bathing room.	1	174	\$174

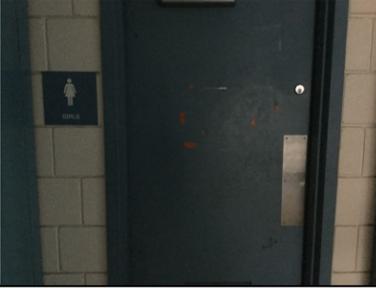
ID	Location	Floor	Room	Element	Type	Photo	Issues	Current Measure	Recommendations	Quantity	Price	Cost Estimation
295	Girls' Toilet Room Near Room 359	3		Overall Access	Toilet Room

Sign to accessible toilet not provided	-	Provide a directional sign indicating the location of the nearest accessible toilet or bathing room.	1	174	\$174
296	Staff Toilet Room in Cafeteria, Third Floor	3		Overall Access	Toilet Room

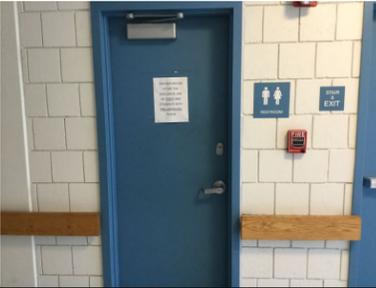
Sign to accessible toilet not provided	-	Provide a directional sign indicating the location of the nearest accessible toilet or bathing room.	1	174	\$174
297	Girls' Toilet Room Near Teacher's Lounge	3		Overall Access	Toilet Room

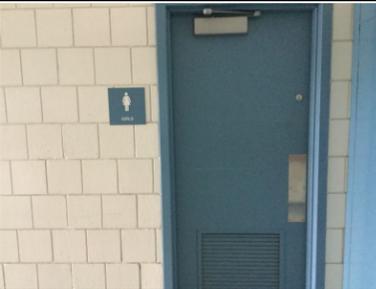
Sign to accessible toilet not provided	-	Provide a directional sign indicating the location of the nearest accessible toilet or bathing room.	1	174	\$174
298	Boys' Toilet Room Near Faculty Lounge	2		Overall Access	Toilet Room
