**City of Salem,  
Massachusetts**

December 2019

# Salem City Hall

## City of Salem ADA Transition Plan

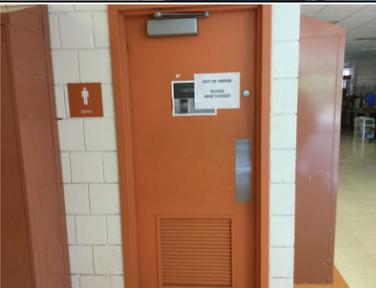
Sign to accessible toilet not provided	-	Provide a directional sign indicating the location of the nearest accessible toilet or bathing room.	1	174	\$174

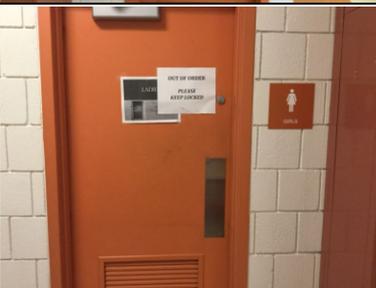
299	Girls' Toilet Room Near Faculty Lounge	2		Overall Access	Toilet Room

Sign to accessible toilet not provided	-	Provide a directional sign indicating the location of the nearest accessible toilet or bathing room.	1	174	\$174

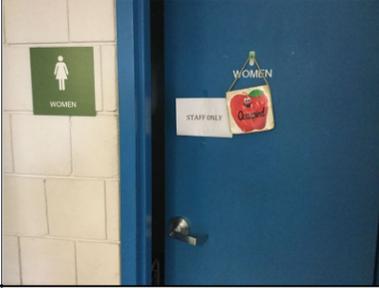
ID	Location	Floor	Room	Element	Type	Photo	Issues	Current Measure	Recommendations	Quantity	Price	Cost Estimation
300	Women's Staff Only Toilet Room	1		Overall Access	Toilet Room

Sign to accessible toilet not provided	-	Provide a directional sign indicating the location of the nearest accessible toilet or bathing room.	1	174	\$174
301	Men's Staff Only Toilet Room	1		Overall Access	Toilet Room

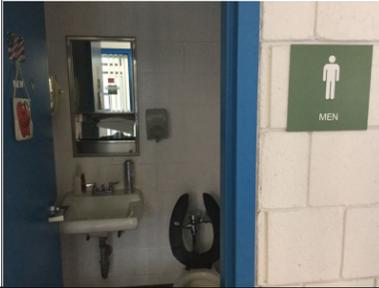
Sign to accessible toilet not provided	-	Provide a directional sign indicating the location of the nearest accessible toilet or bathing room.	1	174	\$174
302	Women's and Men's Staff Only Toilet Room	1		Overall Access	Toilet Room

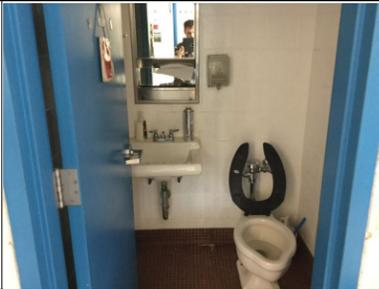
Sign to accessible toilet not provided	-	Provide a directional sign indicating the location of the nearest accessible toilet or bathing room.	1	174	\$174
303	Boys' Toilet Room Near Room 149	1		Overall Access	Toilet Room

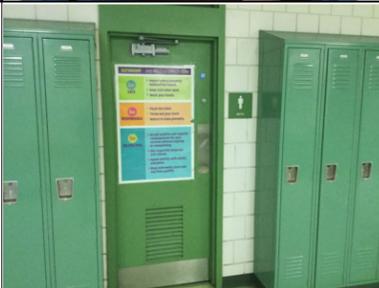
Sign to accessible toilet not provided	-	Provide a directional sign indicating the location of the nearest accessible toilet or bathing room.	1	174	\$174

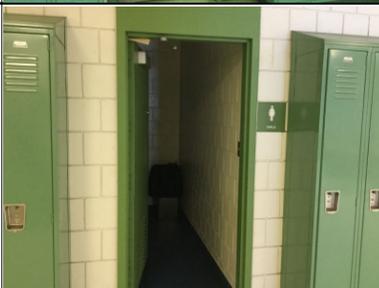
304	Girls' Toilet Room Near Room 149	1		Overall Access	Toilet Room

Sign to accessible toilet not provided	-	Provide a directional sign indicating the location of the nearest accessible toilet or bathing room.	1	174	\$174

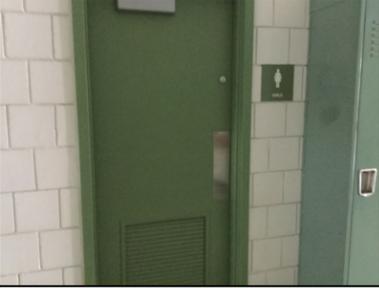
ID	Location	Floor	Room	Element	Type	Photo	Issues	Current Measure	Recommendations	Quantity	Price	Cost Estimation
305	Girls' Toilet Room Near Teen Health Center	1		Overall Access	Toilet Room

Sign to accessible toilet not provided	-	Provide a directional sign indicating the location of the nearest accessible toilet or bathing room.	1	174	\$174
306	Hallway to Music Wing	2	Hall	Overall Access	Toilet Room

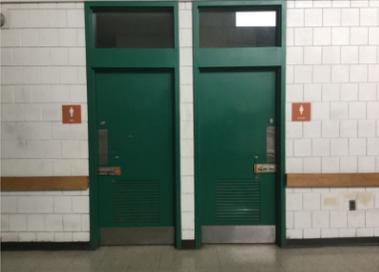
Sign to accessible toilet not provided		Provide a directional sign indicating the location of the nearest accessible toilet or bathing room.	2	174	\$348
307	Girls' Locker Room	B		Overall Access	Toilet Room

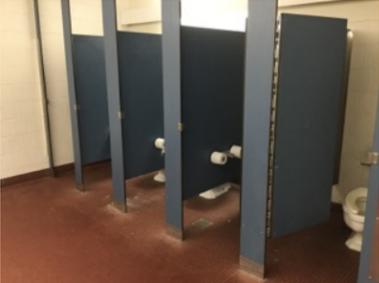
Sign to accessible toilet not provided	-	Provide a directional sign indicating the location of the nearest accessible toilet or bathing room.	1	174	\$174
308	Boys' Locker Room	B	074	Overall Access	Toilet Room

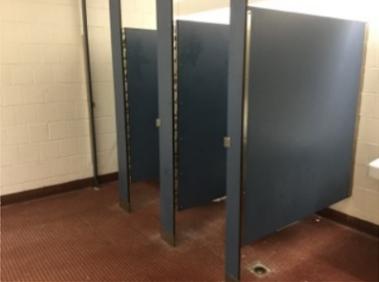
Sign to accessible toilet not provided	-	Provide a directional sign indicating the location of the nearest accessible toilet or bathing room.	1	174	\$174

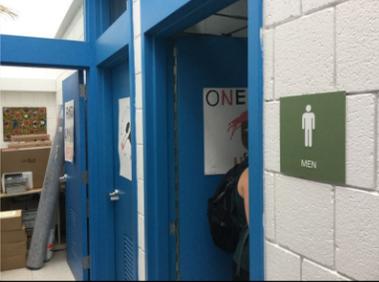
309	Men's and Women's Toilet Room	1	151	Overall Access	Toilet Room

International Symbol of Acc. not provided	-	Provide a sign with the International Symbol of Accessibility.	2	174	\$348

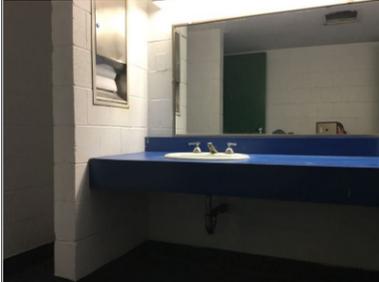
ID	Location	Floor	Room	Element	Type	Photo	Issues	Current Measure	Recommendations	Quantity	Price	Cost Estimation
<b>Lavatory</b>												
310	Boys' Changing Room - Backstage	1	187	Lavatory	N/A

Toe or knee clearances not provided Plumbing underneath is exposed Dispensers not within reach range	23" - 51"	Provide at least one lavatory with knee and toe clearance positioned for a forward approach. Insulate or otherwise configure pipes to prevent contact, for at least one lavatory. Relocate dispenser to 42" max. above the floor.	1	1863	\$1863
311	Girls' Changing Room - Backstage	1	188	Lavatory	N/A

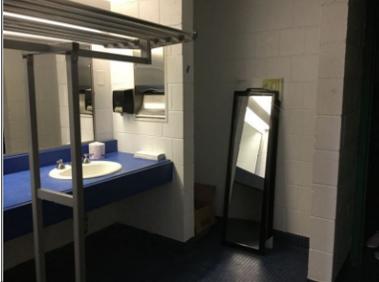
Toe or knee clearances not provided Plumbing underneath is exposed Dispensers not within reach range	23" - 51"	Provide at least one lavatory with knee and toe clearance positioned for a forward approach. Insulate or otherwise configure pipes to prevent contact, for at least one lavatory. Relocate dispenser to 42" max. above the floor.	1	1863	\$1863

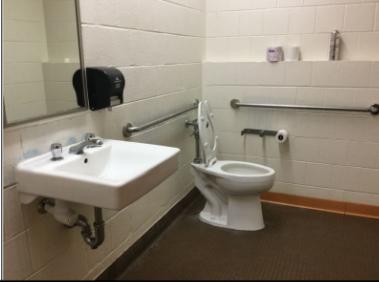
312	Men's Toilet Room	2	Hall C	Lavatory	N/A

Plumbing underneath is exposed	-	Insulate or otherwise configure pipes to prevent contact, for at least one lavatory.	2	69	\$138
313	Automotive Technology Center, Women's Toilet Room	1	104	Lavatory	N/A

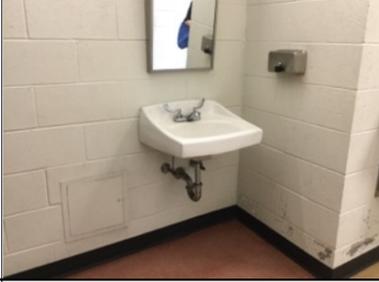
Plumbing underneath is exposed	-	Insulate or otherwise configure pipes to prevent contact, for at least one lavatory.	1	69	\$69
314	Automotive Technology Center, Men's Toilet Room	1	105	Lavatory	N/A

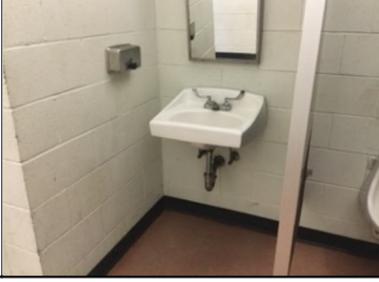
Plumbing underneath is exposed	-	Insulate or otherwise configure pipes to prevent contact, for at least one lavatory.	1	69	\$69

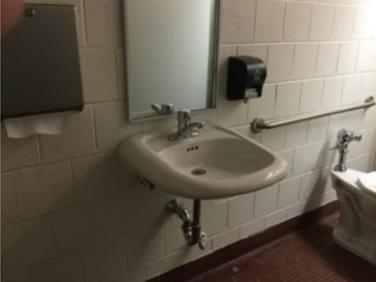
ID	Location	Floor	Room	Element	Type	Photo	Issues	Current Measure	Recommendations	Quantity	Price	Cost Estimation
315	Lobby at Main Entrance, Women's Toilet Room	1		Lavatory	N/A

Plumbing underneath is exposed	-	Insulate or otherwise configure pipes to prevent contact, for at least one lavatory.	1	69	\$69
316	Lobby at Main Entrance, Men's Toilet Room	1		Lavatory	N/A

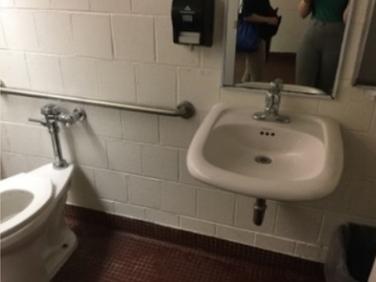
Plumbing underneath is exposed	-	Insulate or otherwise configure pipes to prevent contact, for at least one lavatory.	1	69	\$69
317	Boys' Locker Room	B	074	Lavatory	N/A

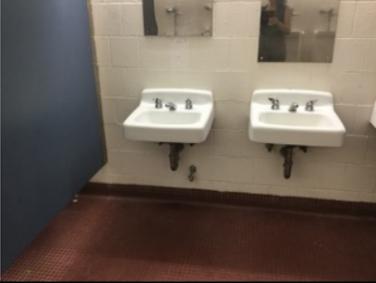
Plumbing underneath is exposed Mirror above lavatory w/reflective surface > 40"	- 42"	Insulate or otherwise configure pipes to prevent contact, for at least one lavatory. Lower mirror so that the bottom surface is at 40" max. above finished floor.	1	261	\$261
318	Gymnasium Area, Women's Public Toilet Room	B		Lavatory	N/A

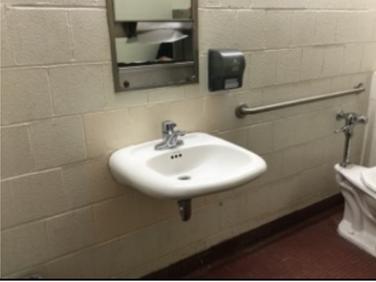
Plumbing underneath is exposed Mirror above lavatory w/reflective surface > 40"	- 54"	Insulate or otherwise configure pipes to prevent contact, for at least one lavatory. Lower mirror so that the bottom surface is at 40" max. above finished floor.	1	261	\$261

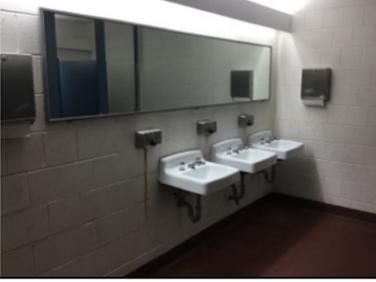
319	Girls' Locker Room	B		Lavatory	N/A

Plumbing underneath is exposed Mirror above lavatory w/reflective surface > 40" Dispensers not within reach range	- 50" 51"	Insulate or otherwise configure pipes to prevent contact, for at least one lavatory. Lower mirror so that the bottom surface is at 40" max. above finished floor. Relocate dispenser to 42" max. above the floor.	1	791	\$791

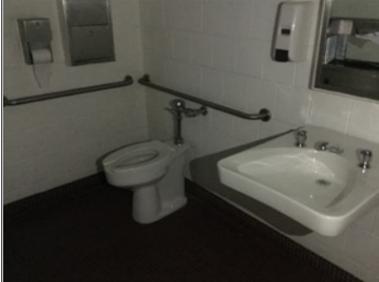
ID	Location	Floor	Room	Element	Type	Photo	Issues	Current Measure	Recommendations	Quantity	Price	Cost Estimation
320	Gymnasium Balcony Area, Women's Toilet Room	1		Lavatory	N/A

Plumbing underneath is exposed Mirror above lavatory w/reflective surface > 40" Dispensers not within reach range	- 54" 51.5"	Insulate or otherwise configure pipes to prevent contact, for at least one lavatory. Lower mirror so that the bottom surface is at 40" max. above finished floor. Relocate dispenser to 42" max. above the floor.	1	791	\$791
321	Gymnasium Balcony Area, Men's Toilet Room	1		Lavatory	N/A

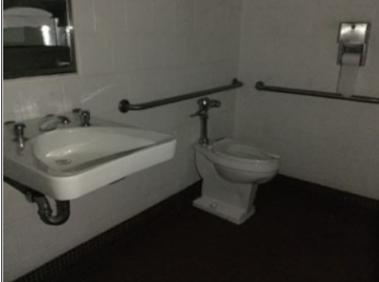
Plumbing underneath is exposed Mirror above lavatory w/reflective surface > 40" Dispensers not within reach range	- 52" 50"	Insulate or otherwise configure pipes to prevent contact, for at least one lavatory. Lower mirror so that the bottom surface is at 40" max. above finished floor. Relocate dispenser to 42" max. above the floor.	1	791	\$791

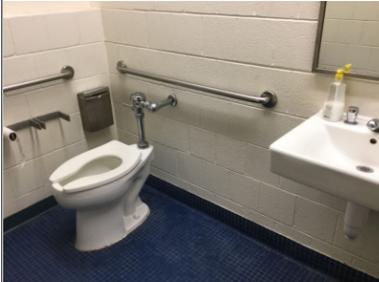
<b>Single-User Toilet</b>												
322	Girls' Accessible Toilet Room Near Room 149	1		Single-User Toilet

Flush control not on open side	-	Relocate the flush control to the open side.	1	281	\$281
323	Girls' Toilet Room Near Room 149	1		Single-User Toilet	N/A

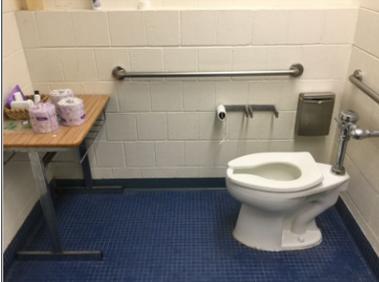
Flush control not on open side Clearance at toilet < 72" clear depth	- -	Relocate the flush control to the open side. Provide a clear floor space that is 72" deep min. by removing table.	1	281	\$281
324	Gymnasium Area, Men's Public Toilet Room	B		Single-User Toilet	N/A

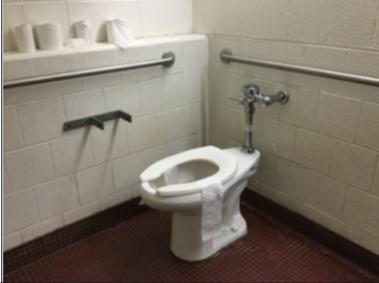
Flush control not on open side Toilet paper dispenser is not compliant	- -	Relocate the flush control to the open side. Relocate toilet paper so that it is 15" min. high, located under the grab bar, and between 7" and 9" from the front of the toilet. Replace dispenser if it does not allow continuous paper flow.	1	722	\$722

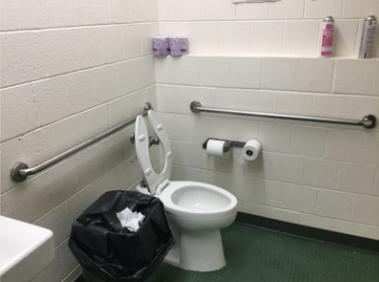
ID	Location	Floor	Room	Element	Type	Photo	Issues	Current Measure	Recommendations	Quantity	Price	Cost Estimation
325	Boys' Accessible Toilet Room Near Room 359	3		Single-User Toilet	N/A

Clearance at toilet < 60" clear width	-	Provide a clear floor space that is 60" wide min. by relocating trash can.	1	Labor	\$0
326	Boys' Accessible Toilet Room Near Room 359	3		Single-User Toilet	N/A

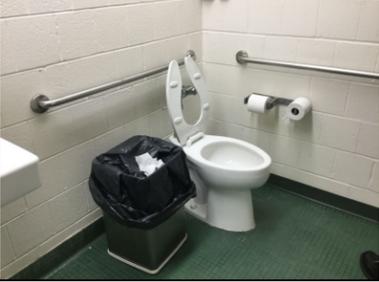
Clearance at toilet < 60" clear width	-	Provide a clear floor space that is 60" wide min. by relocating trash can.	1	Labor	\$0
327	Boys' Accessible Toilet Room Near Teacher's Lounge	3		Single-User Toilet	N/A

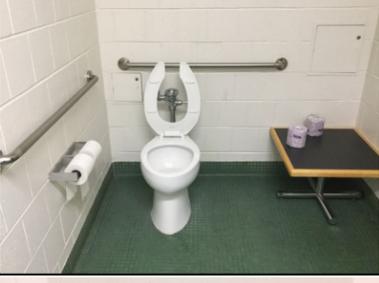
Clearance at toilet < 60" clear width	-	Provide a clear floor space that is 60" wide min. by removing table in the room.	1	Labor	\$0
328	Girls' Accessible Toilet Room Near Teacher's Lounge	3		Single-User Toilet	N/A

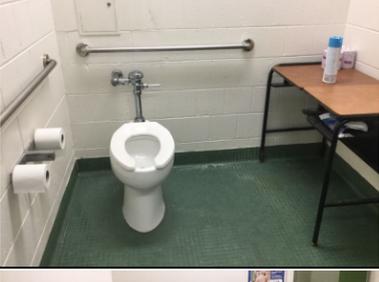
Clearance at toilet < 60" clear width	-	Provide a clear floor space that is 60" wide min. by removing table in the room.	1	Labor	\$0

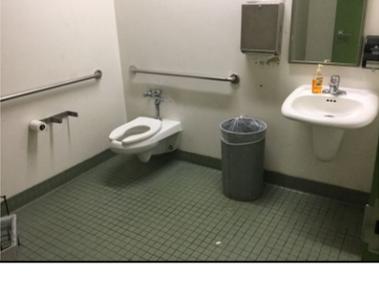
329	Health Suite Toilet Room	1	123	Single-User Toilet	N/A

Clearance at toilet < 60" clear width	-	Provide a clear floor space that is 60" wide min. by relocating trash can.	1	Labor	\$0

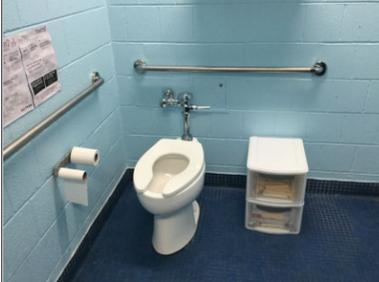
ID	Location	Floor	Room	Element	Type	Photo	Issues	Current Measure	Recommendations	Quantity	Price	Cost Estimation
330	Teen Health Center - Toilet Room	1		Single-User Toilet	N/A

Clearance at toilet < 60" clear width	-	Provide a clear floor space that is 60" wide min. by relocating storage bin.	1	Labor	\$0
331	Girls' Accessible Toilet Room Near Room 359	3		Single-User Toilet	N/A

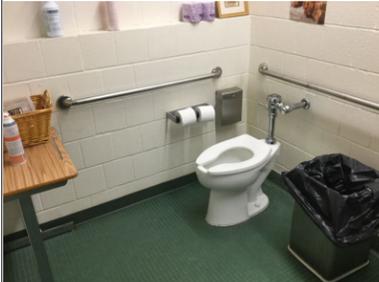
Clearance at toilet < 60" clear width Clearance at toilet < 72" clear depth	- - -	Provide a clear floor space that is 60" wide min. and 72" deep min. by removing desk and relocating trash can.	1	Labor	\$0
332	Gymnasium Area, Women's Public Toilet Room	B		Single-User Toilet	N/A

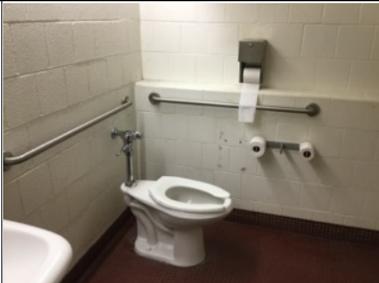
Toilet paper dispenser is not compliant	-	Relocate toilet paper so that it is 15" min. high, located under the grab bar, and between 7" and 9" from the front of the toilet. Replace dispenser if it does not allow continuous paper flow.	1	530	\$530

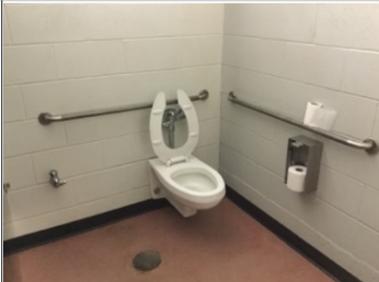
<b>Toilet Compartment</b>												
333	Automotive Technology Center, Men's Toilet Room	1	105	Toilet Compartment	Accessible Compartment

Door has non-compliant hardware Door has malfunctioning self-closing hinge	- -	Ensure locking mechanism is maintained in operable working condition and does not require tight grasping, pinching or twisting of the wrist. Repair hinge.	1	Labor	\$0
334	Gymnasium Balcony Area, Women's Toilet Room	1		Toilet Compartment	Accessible Compartment

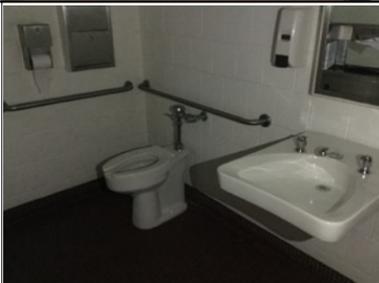
Side grab bar < 42" long Flush control not on open side Non-compliant toilet paper dispenser Centerline < or > 18" (MAAB)	33" - - 23"	Provide a side wall grab bar that is 42" long min. located 12" max. from the rear wall. Provide the flush control on the open side of the toilet (transfer side). Relocate toilet paper so that it is 15" min. high, located under the grab bar, and between 7" and 9" from the front of the toilet. Relocate toilet so the centerline is 18" from the side wall.	1	3617	\$3617

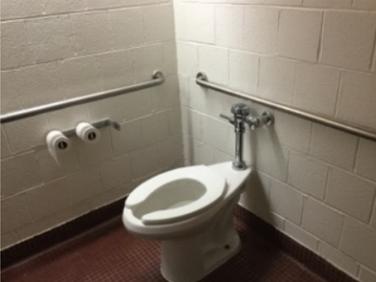
ID	Location	Floor	Room	Element	Type	Photo	Issues	Current Measure	Recommendations	Quantity	Price	Cost Estimation
335	Lobby at Main Entrance, Men's Toilet Room	1		Toilet Compartment	Accessible Compartment

Side grab bar < 42" long Flush control not on open side Centerline < or > 18" (MAAB)	35" - 24"	Provide a side wall grab bar that is 42" long min. located 12" max. from the rear wall. Provide the flush control on the open side of the toilet (transfer side). Relocate toilet so the centerline is 18" from the side wall.	1	2987	\$2987
336	Gymnasium Balcony Area, Men's Toilet Room	1		Toilet Compartment	Accessible Compartment

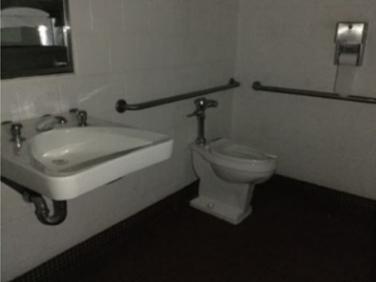
Side grab bar < 42" long Non-compliant toilet paper dispenser Centerline < or > 18" (MAAB)	37" - 24"	Provide a side wall grab bar that is 42" long min. located 12" max. from the rear wall. Relocate toilet paper so that it is 15" min. high, located under the grab bar, and between 7" and 9" from the front of the toilet. Replace dispenser if it does not allow continuous paper flow. Relocate toilet so the centerline is 18" from the side wall.	1	3325	\$3325

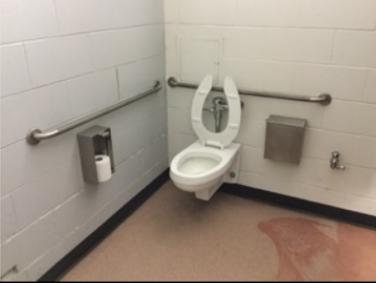
337	Automotive Technology Center, Women's Toilet Room	1	104	Toilet Compartment	Accessible Compartment

Flush control not on open side Coat hook > 48"	- 67"	Provide the flush control on the open side of the toilet (transfer side). Lower coat hook so that it is no higher than 48".	1	305	\$305
338	Lobby at Main Entrance, Women's Toilet Room	1		Toilet Compartment	Accessible Compartment

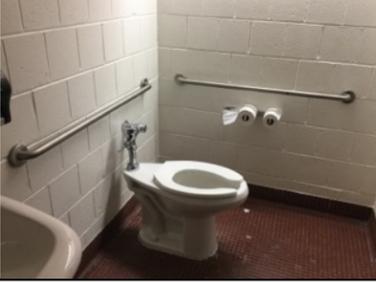
Centerline < or > 18" (MAAB)	24"	Relocate toilet so the centerline is 18" from the side wall.	1	2121	\$2121
<b>Urinal</b>												
339	Boys' Locker Room	B	074	Urinal	N/A

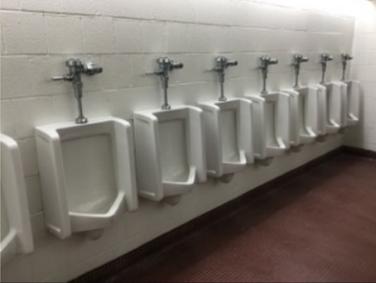
Rim > 15" high (MAAB) Flush control is > 44" high or not properly located	24" 52"	Provide at least one urinal with the rim no higher than 15" above the finished floor. Mount flush control at 44" max. above the finished floor.	1	2717	\$2717

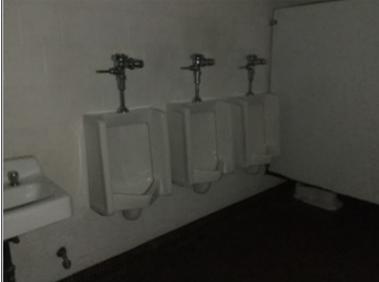
Rim > 15" high (MAAB) Flush control is > 44" high or not properly located	24" 51"	Provide at least one urinal with the rim no higher than 15" above the finished floor. Mount flush control at 44" max. above the finished floor.	1	2717	\$2717
341	Lobby at Main Entrance, Men's Toilet Room	1		Urinal	N/A

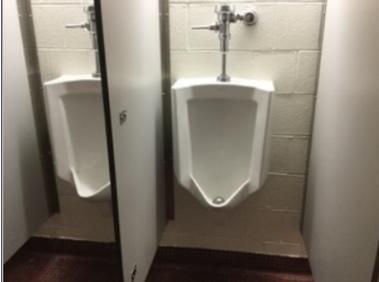
Rim > 15" high (MAAB) Flush control is > 44" high or not properly located Urinal recessed > 24" deep has < 36" clear width	24" 51" 28"	Provide at least one urinal with the rim no higher than 15" above the finished floor. Mount flush control at 44" max. above the finished floor. If urinal is recessed greater than 24" ensure there is a clear width of 36".	1	3190	\$3190
342	Boys' Changing Room - Backstage	1	187	Urinal	N/A

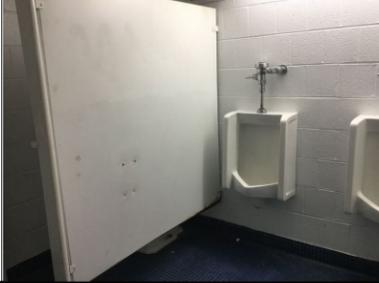
Rim > 15" high (MAAB) Flush control too high or not properly located	- -	Provide at least one urinal with the rim no higher than 15" above the finished floor. Mount flush control at 44" max. above the finished floor.	1	2717	\$2717

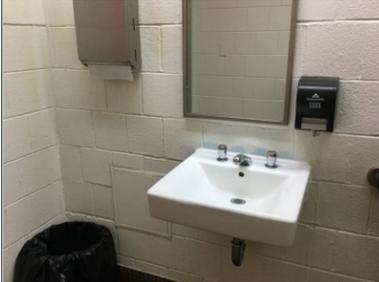
<b>Dispensers</b>												
343	Men's Toilet Room	2	Hall C	Dispensers	Paper Towel Dispenser

Controls > 42" high Clear floor space not provided at accessory	48" -	Relocate so the operable part is 42" max. above the finished floor. Provide a 30" min. by 48" min. clear floor space or relocate dispenser.	2	530	\$1060
<b>Shower Compartment</b>												
344	Girls' Locker Room, Showers	B		Shower Compartment	Transfer Type

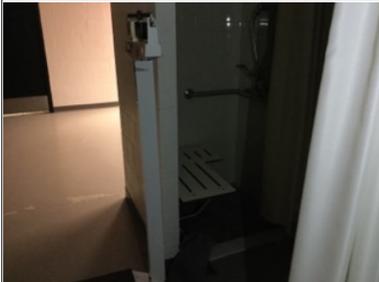
Clear space at transfer shower > 48" x 36"	-	Provide a 48" x 36" clear floor space for a transfer shower by relocating scale.	1	Labor	\$0

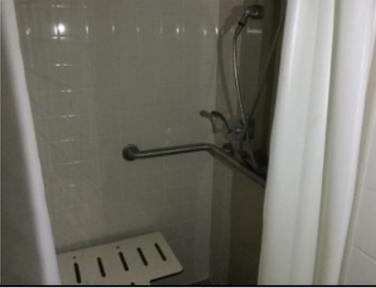
Seat is not padded (MAAB)	-	Provide a padded shower seat.	1	450	\$450
346	Boys' Locker Room	B	074	Shower Compartment	Transfer Type

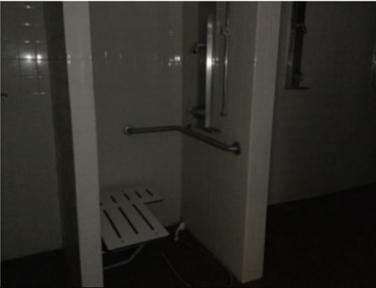
Seat is not padded (MAAB)	-	Provide a padded shower seat.	1	450	\$450
347	Health Suite Toilet Room	1	123	Shower Compartment	Transfer Type

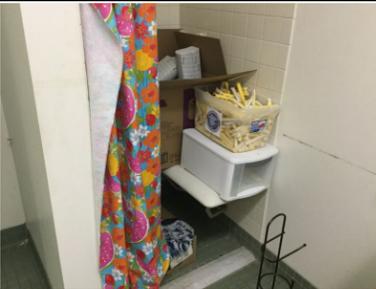
Accessible shower not provided	-	Provide at least one accessible shower.	1	Labor	\$0
<b>Toilet Rooms for Children</b>												
<b>Single-User Toilet</b>												
348	Teen Parent Room/ Preschool Toilet Room	1	125	Single-User Toilet	N/A

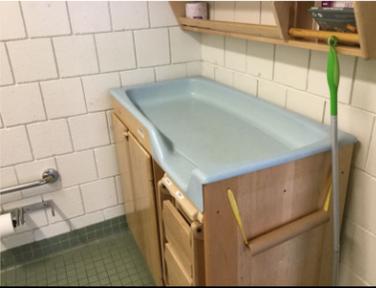
Inadequate maneuvering clearances	-	Provide a clear floor space that is 60" wide min. and 72" deep min. by providing a fold-down baby changing table.	1	Labor	\$0
<b>Lavatory</b>												
349	Teen Parent Room/ Preschool Toilet Room	1	125	Lavatory	N/A

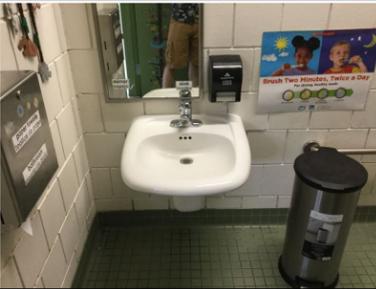
Toe or knee clearances not provided	22"	Provide at least one lavatory with 25" min. knee clearance positioned for a forward approach. Ensure toe clearance is also provided.	1	1265	\$1265

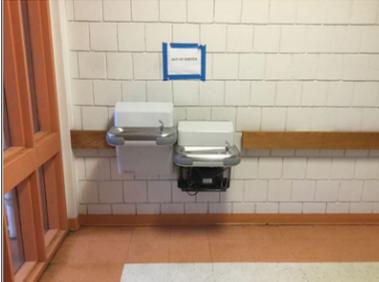
Operable parts malfunctioning	-	Repair or replace drinking fountain to ensure it remains in operable working condition.	1	Labor	\$0
351	Drinking Fountains Near Stairwell 8	1		Drinking Fountains	Hi-Lo

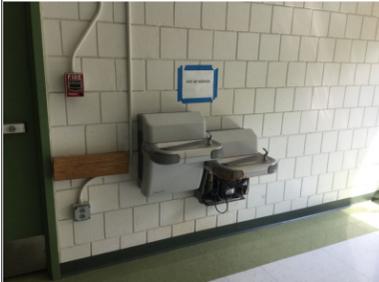
Operable parts malfunctioning	-	Repair or replace drinking fountain to ensure operable parts can be operable with one hand and not require tight grasping, pinching, or twisting of the wrist.	1	Labor	\$0
352	Cafeteria	2		Drinking Fountains	Hi-Lo

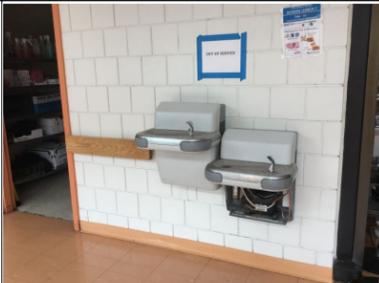
Operable parts malfunctioning	-	Repair or replace drinking fountain to ensure operable parts can be operable with one hand and not require tight grasping, pinching, or twisting of the wrist.	1	Labor	\$0

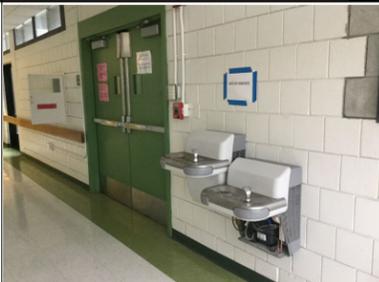
353	Hall by Stair 3	1	Stair 3	Drinking Fountains	Hi-Lo

Operable parts malfunctioning	-	Repair or replace drinking fountain to ensure operable parts can be operable with one hand and not require tight grasping, pinching, or twisting of the wrist.	1	Labor	\$0
354	Gymnasium Area	B		Drinking Fountains	High

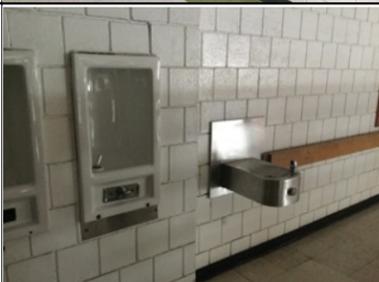
Operable parts malfunctioning	- -	Repair or replace drinking fountain to ensure operable parts can be operable with one hand and not require tight grasping, pinching, or twisting of the wrist.	1	Labor	\$0

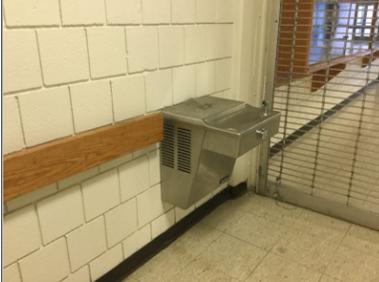
Inadequate water flow No drinking fountain provided for standing users Knee or toe clearance not provided	- - 26"	Repair drinking fountain to provide adequate water flow. Provide an additional drinking fountain for standing users or install a Hi-Lo drinking fountain. Provide knee and toe clearance, 27" min. high at drinking fountain for seated users.	1	Labor 3021	\$3021
356	Automotive Technology Center	1		Drinking Fountains	Low

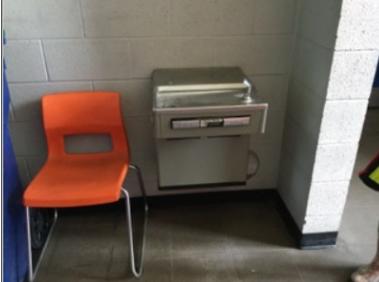
No drinking fountain provided for standing users	-	Provide an additional drinking fountain for standing users.	1	3021	\$3021
357	Girls' Locker Room	B		Drinking Fountains	Low

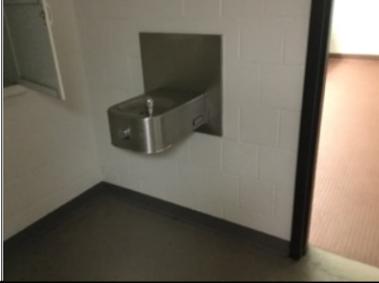
No drinking fountain provided for standing users	-	Provide an additional drinking fountain for standing users.	1	3021	\$3021

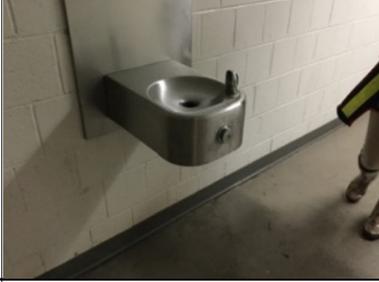
358	Boys' Locker Room	B	074	Drinking Fountains	Low

No drinking fountain provided for standing users Seated height fountain does not have cane protection	- -	Provide an additional drinking fountain for standing users. Provide a cane-detectable barrier skirt under the high unit.	1	3689	\$3689
359	Lobby at Main Entrance, Near Toilet Rooms	1		Drinking Fountains	Low

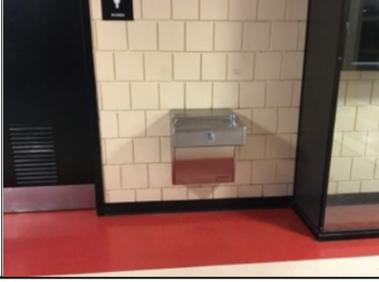
No drinking fountain provided for standing users Knee or toe clearance not provided	- 26"	Install a Hi-Lo drinking fountain.	1	3162	\$3162

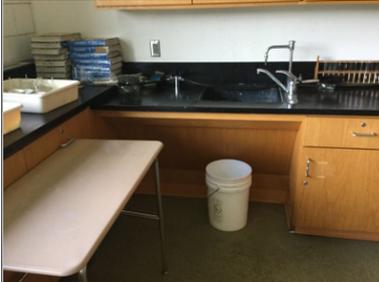
Clear floor space not provided at sink	-	Provide a 30" by 48" clear floor space positioned for a forward approach by removing table and can.	1	Labor	\$0
361	Science Classroom	2	216	Sink	Classroom

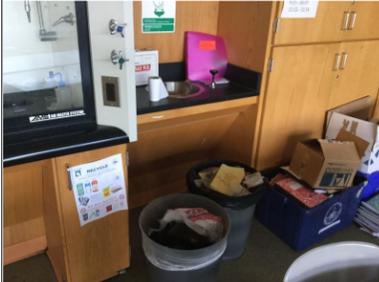
Clear floor space not provided at sink	-	Provide a 30" by 48" clear floor space positioned for a forward approach by removing clutter.	1	Labor	\$0
362	Physics Classroom	1	116	Sink	Classroom

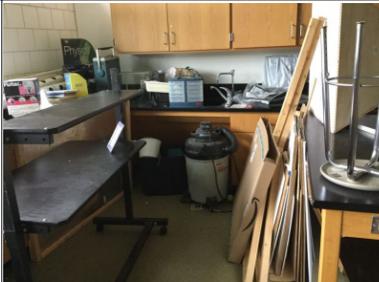
Clear floor space not provided at sink	- -	Provide a 30" by 48" clear floor space positioned for a forward approach by removing clutter.	1	Labor	\$0
363	Physics Classroom	1	116	Sink	Classroom

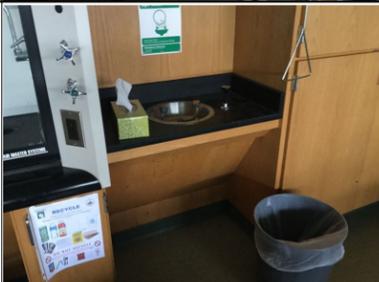
Clear floor space not provided at sink	-	Provide a 30" by 48" clear floor space positioned for a forward approach by removing trash can.	1	Labor	\$0

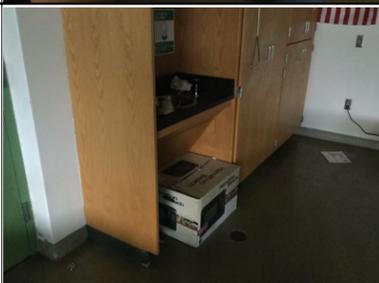
364	Science Classroom	1	112	Sink	Classroom

Toe and knee clearances not provided	-	Ensure there is a 27" knee clearance positioned for a forward approach by removing clutter.	1	Labor	\$0

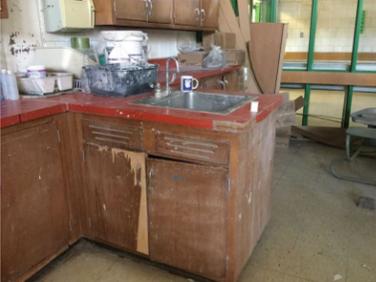
Toe and knee clearances not provided	-	Ensure there is a 27" knee clearance positioned for a forward approach.	1	1265	\$1265
366	Culinary Arts Class	B	057	Sink	Classroom

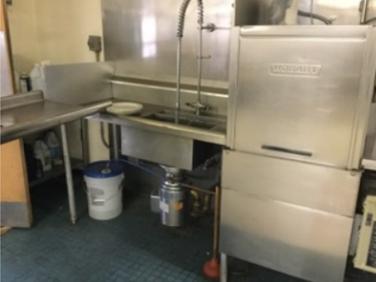
Toe and knee clearances not provided	-	Ensure there is a 27" knee clearance positioned for a forward approach.	1	1265	\$1265
367	Culinary Arts Class	B	057	Sink	Classroom

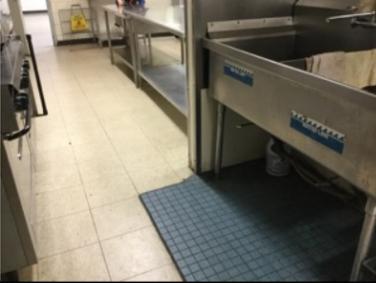
Toe and knee clearances not provided	-	Ensure there is a 27" knee clearance positioned for a forward approach.	1	1265	\$1265
368	Black Cat Cafe, Staff Sink	B		Sink	Other

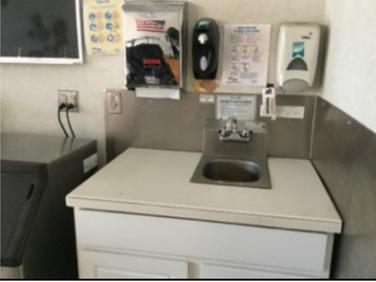
Toe and knee clearances not provided Dispenser not within reach range	- 58"	Ensure there is a 27" knee clearance positioned for a forward approach. Relocate dispenser 48" max. above the finished floor or ground.	1	1795	\$1795

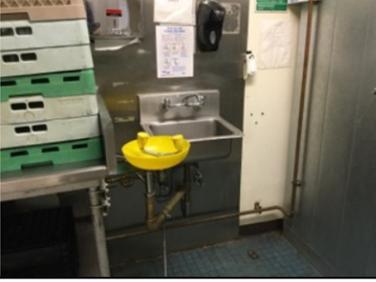
369	Culinary Arts Class	B	057	Sink	Classroom

Exposed plumbing underneath sink Dispenser not within reach range	- 59"	Insulate or otherwise configure pipes at sink. Relocate dispenser 48" max. above the finished floor or ground.	1	599	\$599

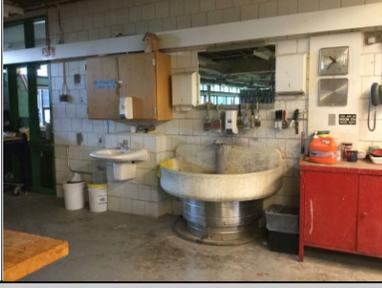
Dispenser not within reach range	53.5"	Relocate dispenser 48" max. above the finished floor or ground.	1	530	\$530
<b>Storage</b>												
372	ROTC - Supply and Uniform Room	1	137A	Storage	N/A

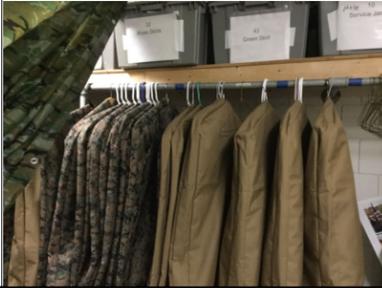
Storage operable parts > 48" high	72"	Lower storage so that operable parts are 48" max. above finished floor.	1	530	\$530
<b>Fire Alarms</b>												
373	Band Room	2	266	Fire Alarms	Classroom

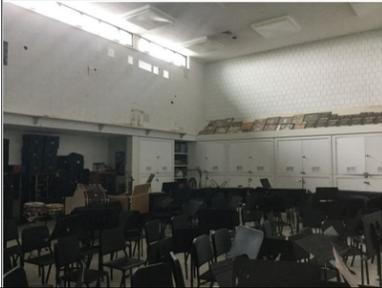
No visible fire alarm provided within room	-	When fire system is updated, ensure that a visible fire alarm is installed in each room.	1	519	\$519
374	Culinary Arts/Medical Assistance Classroom	2	270	Fire Alarms	Classroom

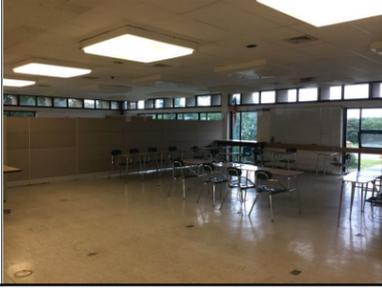
No visible fire alarm provided within room	-	When fire system is updated, ensure that a visible fire alarm is installed in each room.	1	519	\$519

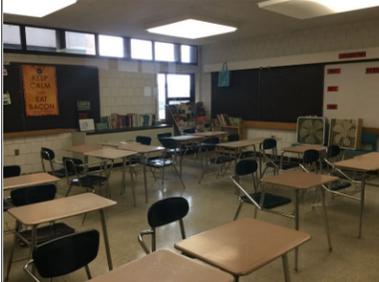
No visible fire alarm provided within room	-	When fire system is updated, ensure that a visible fire alarm is installed in each room.	1	519	\$519
376	Orchestra	2	282	Fire Alarms	Classroom

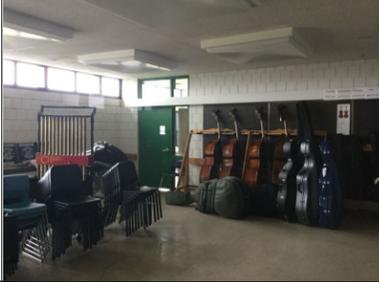
No visible fire alarm provided within room		When fire system is updated, ensure that a visible fire alarm is installed in each room.	1	519	\$519
377	Office	2	281	Fire Alarms	Office

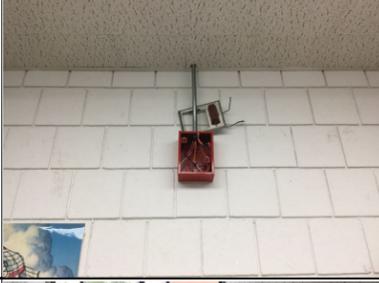
No visible fire alarm provided within room	-	When fire system is updated, ensure that a visible fire alarm is installed in each room.	1	519	\$519
378	Stair 16	2	Stair 16	Fire Alarms	Stair

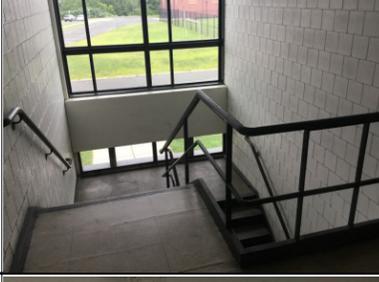
No visible fire alarm provided within room	-	When fire system is updated, ensure that a visible fire alarm is installed in each room.	1	519	\$519
379	Choir Room	2	285	Fire Alarms	Classroom

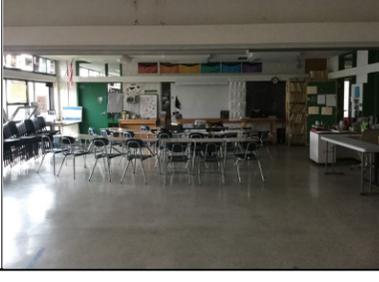
No visible fire alarm provided within room	-	When fire system is updated, ensure that a visible fire alarm is installed in each room.	1	519	\$519

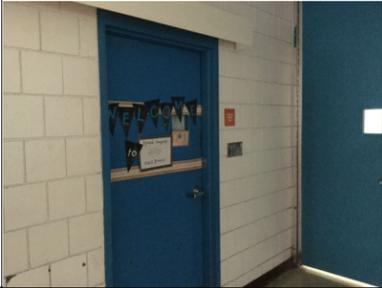
No visible fire alarm provided within room	-	When fire system is updated, ensure that a visible fire alarm is installed in each room.	1	519	\$519
382	Office	2	250B	Fire Alarms	Office

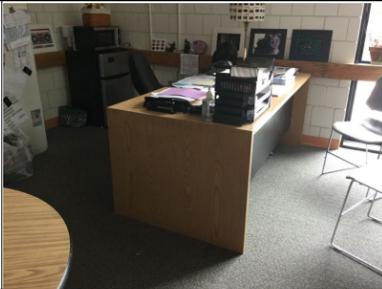
No visible fire alarm provided within room	-	When fire system is updated, ensure that a visible fire alarm is installed in each room.	1	519	\$519
383	Office	2	249C	Fire Alarms	Office

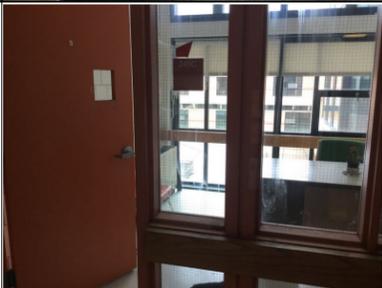
No visible fire alarm provided within room	-	When fire system is updated, ensure that a visible fire alarm is installed in each room.	1	519	\$519
384	Office	2	249E	Fire Alarms	Office

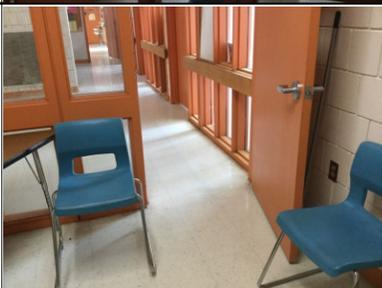
No visible fire alarm provided within room	-	When fire system is updated, ensure that a visible fire alarm is installed in each room.	1	519	\$519

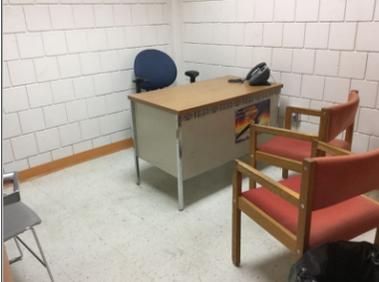
ID	Location	Floor	Room	Element	Type	Photo	Issues	Current Measure	Recommendations	Quantity	Price	Cost Estimation
385	Office	2	249F	Fire Alarms	Office

No visible fire alarm provided within room	-	When fire system is updated, ensure that a visible fire alarm is installed in each room.	1	519	\$519
386	Office	2	249A	Fire Alarms	Office

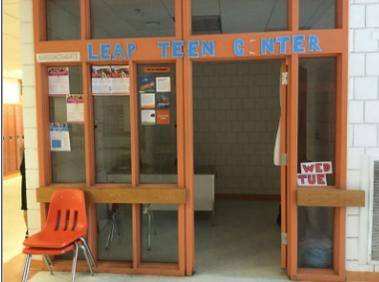
No visible fire alarm provided within room	-	When fire system is updated, ensure that a visible fire alarm is installed in each room.	1	519	\$519
387	Art Room	1	166	Fire Alarms	Classroom

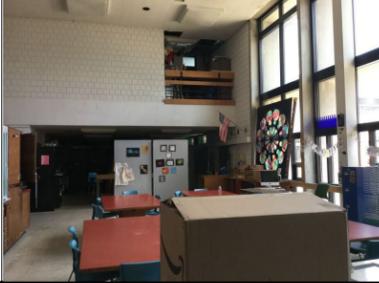
No visible fire alarm provided within room	-	When fire system is updated, ensure that a visible fire alarm is installed in each room.	1	519	\$519
388	Classroom	1	184	Fire Alarms	Classroom

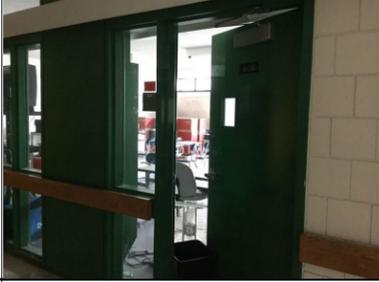
No visible fire alarm provided within room	-	When fire system is updated, ensure that a visible fire alarm is installed in each room.	1	519	\$519
389	Wood Shop Classroom	1	171	Fire Alarms	Classroom

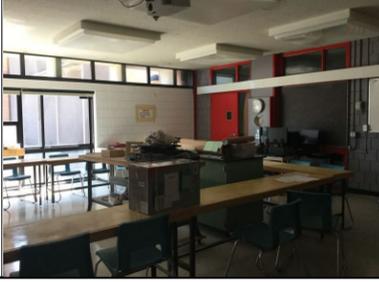
No visible fire alarm provided within room	-	When fire system is updated, ensure that a visible fire alarm is installed in each room.	1	519	\$519

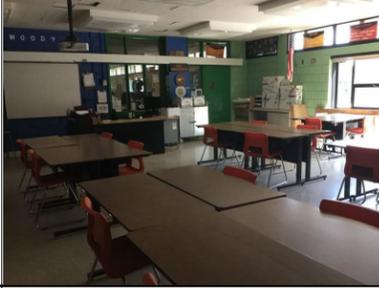
ID	Location	Floor	Room	Element	Type	Photo	Issues	Current Measure	Recommendations	Quantity	Price	Cost Estimation
390	Wood Shop Classroom	1	172	Fire Alarms	Classroom

No visible fire alarm provided within room	-	When fire system is updated, ensure that a visible fire alarm is installed in each room.	1	519	\$519
391	District ELL	1	151	Fire Alarms	Office

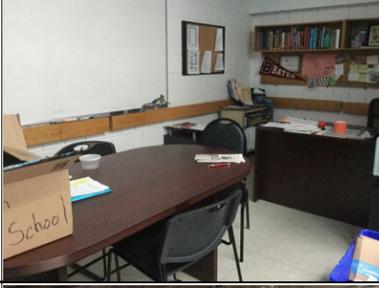
No visible fire alarm provided within room	-	When fire system is updated, ensure that a visible fire alarm is installed in each room.	1	519	\$519
392	Fitness Center	B	062	Fire Alarms	N/A

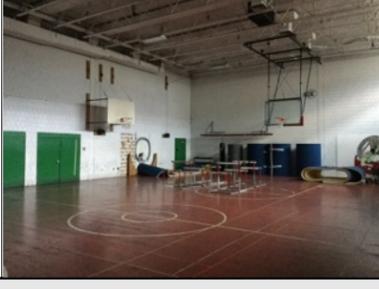
No visible fire alarm provided within room	-	When fire system is updated, ensure that a visible fire alarm is installed in each room.	1	519	\$519
<b>Play and Sport Areas</b>												
<b>Play Areas</b>												
393	Playground Near Exit #44	Ext.		Play Areas	N/A

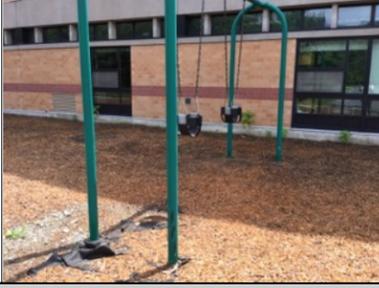
Accessible route not provided to ground level play components	-	Ensure an accessible route is provided to one of each type of ground level play components  (Cost based on 215' by 4' wide asphalt route around playground and a 30' long by 5' wide poured in place rubber route to swings.)	1	8633	\$8633

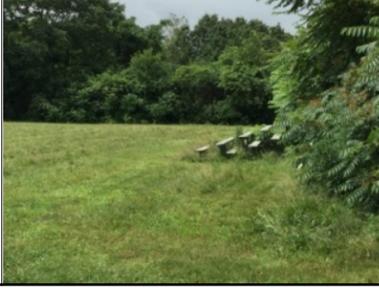
<b>Field</b>												
394	Soccer Field	Ext.		Field	Soccer

Accessible spaces not provided at sidelines seating	-	Provide a 36" x 48" clear floor space at sidelines seating. Ensure bleachers are connected to an accessible route.  (Cost based on 100' by 4' wide asphalt route to bleachers an clear floor spaces on each side.)	1	2556	\$2556

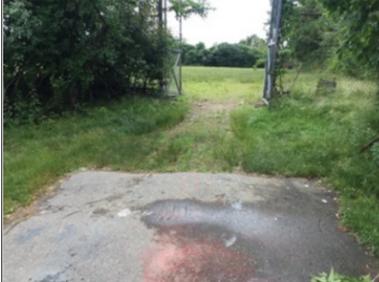
ID	Location	Floor	Room	Element	Type	Photo	Issues	Current Measure	Recommendations	Quantity	Price	Cost Estimation
395	Field Across Doors From Gymnasium	Ext.		Field	Soccer

Field not connected to an accessible route	-	Ensure edge of field is connected to an accessible route.  (Cost based on 15' by 4' wide asphalt route to edge of field.)	1	383	\$383
396	Soccer Field	Ext.		Field	Soccer

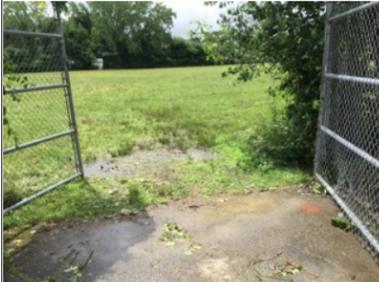
Field not maintained in operable working condition	-	Ensure soccer field is maintained in operable working condition.	1	Labor	\$0
397	Field Across Exits From Gymnasium	Ext.		Field	N/A

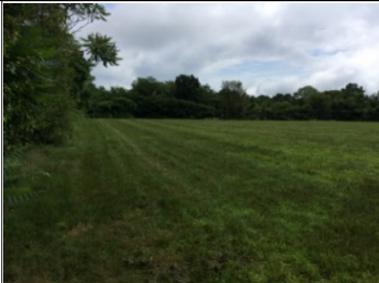
Field not maintained in operable working condition	-	Ensure field is maintained in operable working condition.	1	Labor	\$0
<b>Court</b>												
398	Gymnasium Area, Bleachers	B		Court	Basketball

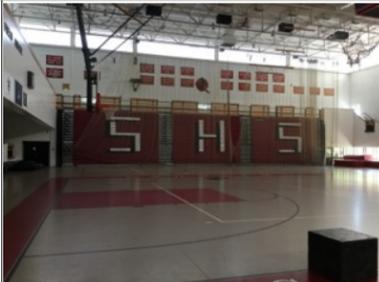
Accessible spaces are not provided at sidelines seating	-	Provide a 36" x 48" clear floor space at sidelines seating.	1	Labor	\$0

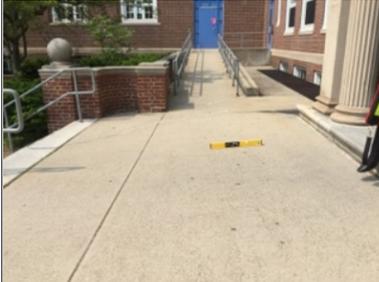
ID	Location	Floor	Room	Element	Type	Photo	Issues	Current Measure	Recommendations	Quantity	Price	Cost Estimation
<b>Approach and Entrance</b>												
<b>Exterior Access Route</b>												
1	At Main Entrance	Ext.		Exterior Access Route	Exterior

Cross slope > 1:50 (2.00%)	6.2%	Reduce cross slope to be no steeper than 1:50 (2.00%).  (Cost based on 8' by 4' wide concrete to fix slope.)	1	84	\$84
2	Route to Main Entrance From Parking	Ext.		Exterior Access Route	Exterior

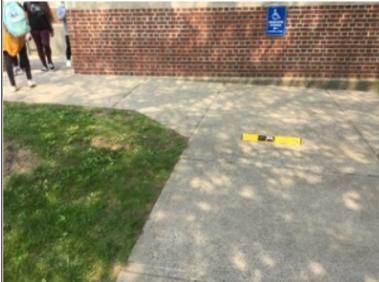
Cross slope > 1:50 (2.00%)	3.3%	Reduce cross slope to be no steeper than 1:50 (2.00%).  (Cost based on 4' by 4' concrete to fix slope.)	1	42	\$42
3	Route to Exits #5 and #6	Ext.		Exterior Access Route	Exterior

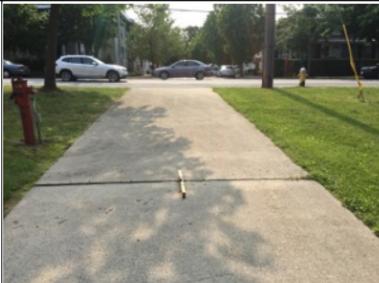
Running slope > 1:20 (5%)	7.6%	Reduce running slope to be no steeper than 1:20 (5%).  (Cost based on 10' by 4' wide concrete to fix slope.)	1	105	\$105
4	At Upper Playground	Ext.		Exterior Access Route	Exterior

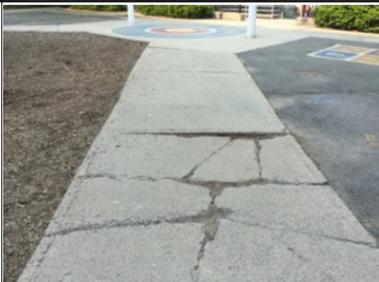
Route not maintained in operable working condition	-	Repair surface to ensure is maintained in operable working condition.  (Cost based on 3' by 3' path of concrete.)	1	155	\$155

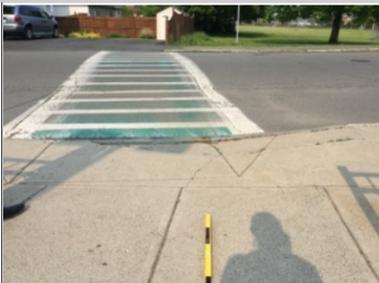
<b>Curb Ramp</b>												
5	East Side Entrance, Near Playgrounds	Ext.		Curb Ramp	Perpendicular

Running slope > 1:12 (8.33%) Landing not provided at top of curb ramp	17.7% 5.7%	Reduce running slope to be no steeper than 1:12 (8.33%). Provide landing at top of curb ramp or reconfigure ramp.	1	2800	\$2800

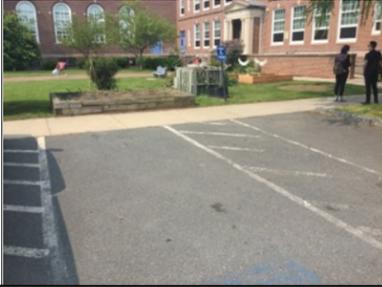
ID	Location	Floor	Room	Element	Type	Photo	Issues	Current Measure	Recommendations	Quantity	Price	Cost Estimation
<b>Off-Street Parking Lot or Garage</b>												
6	Parking Lot	Ext.		Off-Street Parking Lot or Garage	N/A

Total # of parking Total # of designated accessible parking spaces Access aisle < 96" wide at van space Sign does not have the designation "Van Accessible"	17 2 66" -	Provide a marked access aisle that is at least 96" wide. Add the designation "Van Accessible" to the sign located at the van accessible space.	1	600	\$600
<b>Entrance</b>												
7	Exit #1, Main Entrance	Ext.		Entrance	Main Entrance

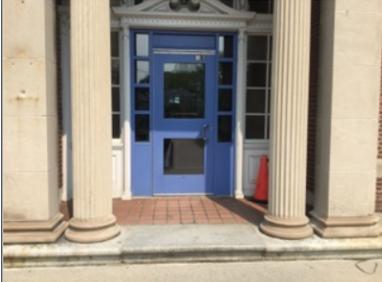
Directional sign to accessible entrance not provided	-	Provide a directional sign indicating the location of the nearest accessible entrance.	1	260	\$260
<b>Emergency Exit</b>												
8	Exit #5	Ext.		Emergency Exit	N/A

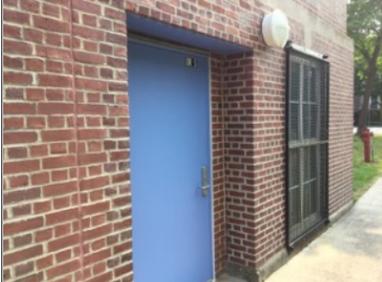
Directional sign to accessible emergency exit not provided		Provide a directional sign on the interior of the door indicating the location of the nearest emergency exit.	1	174	\$174

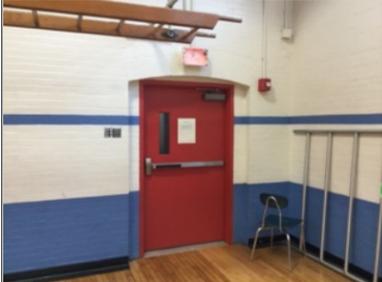
9	Exit From Gym to Stairs	SB	001	Emergency Exit	111

Directional sign to accessible emergency exit not provided	-	Provide a directional sign indicating the location of the nearest emergency exit.	1	174	\$174
10	Exit #4	1		Emergency Exit	N/A

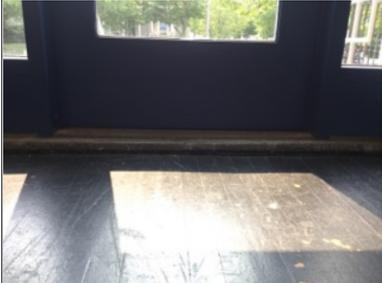
Threshold > 3/4" high	1.5"	Alter threshold to be 3/4" high max.	3	113	\$339

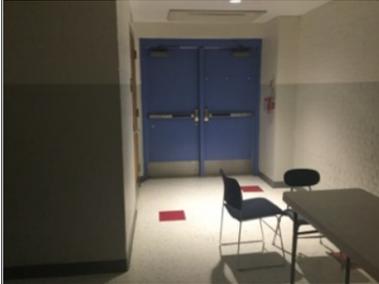
ID	Location	Floor	Room	Element	Type	Photo	Issues	Current Measure	Recommendations	Quantity	Price	Cost Estimation
<b>Access to Goods and Services</b>												
<b>Means of Egress</b>												
11	Exit #8, Near Elevator	B		Means of Egress	N/A

Illuminated exit sign not provided Tactile exit sign not provided	- -	Ensure an illuminated exit sign with the International Symbol of Accessibility (ISA) is provided at exit door. Ensure a tactile exit sign with raised characters and braille is provided at exit door. Mount sign between 48"- 60" above finished floor located on the latch side of the door.	1	274	\$274
12	Route to Accessible Entrance. Exit #2, From Hallway	1		Means of Egress	N/A

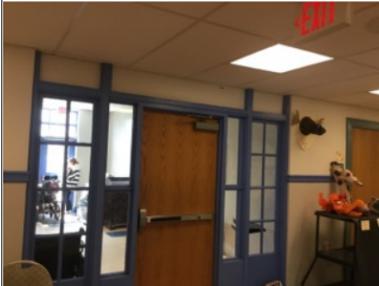
Illuminated sign lacks the International Symbol of Accessibility Tactile exit sign not provided	- -	Ensure illuminated exit sign contains the International Symbol of Accessibility (ISA). Ensure a tactile exit sign with raised characters and braille is provided at exit door. Mount sign between 48"- 60" above finished floor located on the latch side of the door.	1	274	\$274

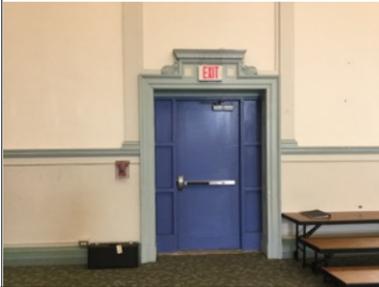
13	Exit #3	1	102	Means of Egress	N/A

Illuminated sign lacks the International Symbol of Accessibility B. Tactile exit sign not provided	- -	Ensure illuminated exit sign contains the International Symbol of Accessibility (ISA). Ensure a tactile exit sign with raised characters and braille is provided at exit door. Mount sign between 48"- 60" above finished floor located on the latch side of the door.	1	274	\$274
14	Exit #13	Ext.		Means of Egress	N/A

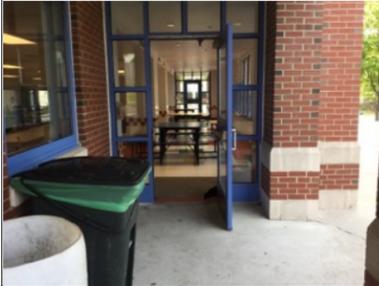
Illuminated sign lacks the International Symbol of Accessibility B. Tactile exit sign not provided	- -	Ensure illuminated exit sign inside contains the International Symbol of Accessibility (ISA). Ensure a tactile exit sign with raised characters and braille is provided on the interior of exit doors. Mount sign between 48"- 60" above finished floor located on the latch side of the door.	1	274	\$274
15	Exit #11	Ext.		Means of Egress	N/A

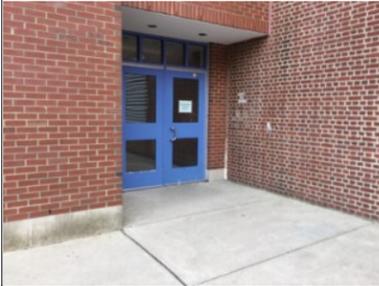
Illuminated sign lacks the International Symbol of Accessibility B. Tactile exit sign not provided	- -	Ensure illuminated exit inside sign contains the International Symbol of Accessibility (ISA). Ensure a tactile exit sign with raised characters and braille is provided on the interior of exit door. Mount sign between 48"- 60" above finished floor located on the latch side of the door.	1	274	\$274

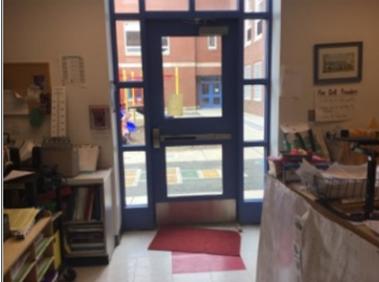
ID	Location	Floor	Room	Element	Type	Photo	Issues	Current Measure	Recommendations	Quantity	Price	Cost Estimation
16	Exit #9	B	07	Means of Egress	N/A

Illuminated sign lacks the International Symbol of Accessibility B. Tactile exit sign not provided	- -	Ensure illuminated exit sign contains the International Symbol of Accessibility (ISA). Ensure a tactile exit sign with raised characters and braille is provided at exit door. Mount sign between 48"- 60" above finished floor located on the latch side of the door.	1	274	\$274
17	Exit #10	B	08	Means of Egress	N/A

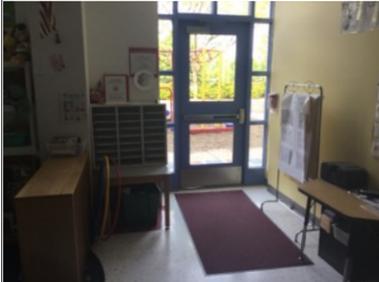
Illuminated sign lacks the International Symbol of Accessibility B. Tactile exit sign not provided	- -	Ensure illuminated exit sign contains the International Symbol of Accessibility (ISA). Ensure a tactile exit sign with raised characters and braille is provided at exit door. Mount sign between 48"- 60" above finished floor located on the latch side of the door.	1	274	\$274

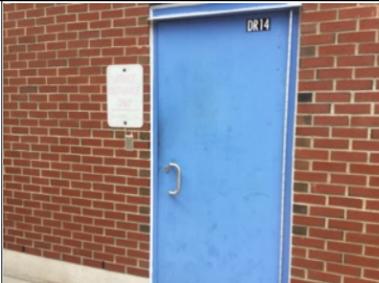
18	Exit #14	Ext.		Means of Egress	N/A

Emergency exit not on an accessible route	-	Provide a directional sign on the interior of the door indicating the location of the nearest emergency exit.	1	174	\$174
19	Exit #4	1		Means of Egress	N/A

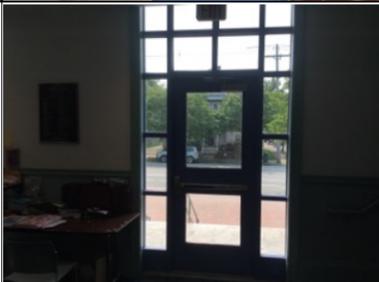
Tactile exit sign not provided Directional sign to accessible emergency exit not provided	- -	Ensure tactile exit signs with raised characters and braille are provided at exit doors. Mount signs between 48"- 60" above finished floor located on the latch side of the door. Provide a directional sign indicating the location of the nearest emergency exit.  (Cost based on 3 tactile signs and one directional sign.)	1	696	\$696
20	Exit #16 in Stair #2	1	122	Means of Egress	N/A

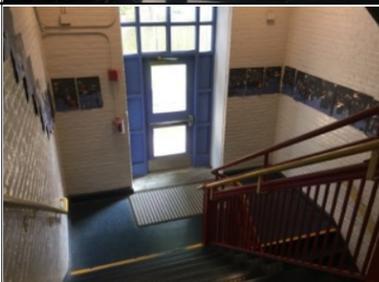
Tactile exit sign not provided Directional sign to accessible emergency exit not provided	- -	Ensure a tactile exit sign with raised characters and braille is provided at exit door. Mount sign between 48"- 60" above finished floor located on the latch side of the door. Provide a directional sign indicating the location of the nearest emergency exit.	1	348	\$348

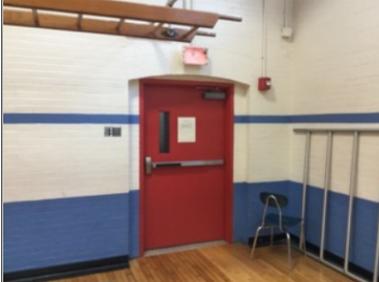
ID	Location	Floor	Room	Element	Type	Photo	Issues	Current Measure	Recommendations	Quantity	Price	Cost Estimation
21	Exit From Gym to Stairs	SB	001	Means of Egress	N/A

Tactile exit sign not provided Directional sign to accessible emergency exit not provided	- -	Ensure a tactile exit sign with raised characters and braille is provided at exit door. Mount sign between 48"- 60" above finished floor located on the latch side of the door. Provide a directional sign indicating the location of the nearest emergency exit.	1	348	\$348
22	Exit #15, Near Kitchen	B		Means of Egress	N/A

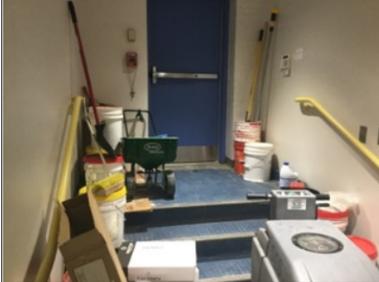
Tactile exit sign not provided Directional sign to accessible emergency exit not provided	- -	Ensure a tactile exit sign with raised characters and braille is provided at exit door. Mount sign between 48"- 60" above finished floor located on the latch side of the door. Provide a directional sign indicating the location of the nearest emergency exit.	1	348	\$348
