**City of Salem,  
Massachusetts**

December 2019

# Salem City Hall

## City of Salem ADA Transition Plan

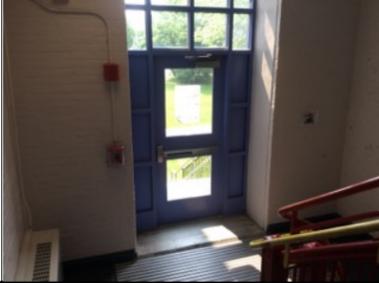
23	Exit #6 in Stair #1	1		Means of Egress	N/A

Tactile exit sign not provided Directional sign to accessible emergency exit not provided Mat not securely attached	- - -	Ensure a tactile exit sign with raised characters and braille is provided at exit door. Mount signs between 48"- 60" above finished floor located on the latch side of the door. Provide a directional sign indicating the location of the nearest emergency exit. Securely attach mat.	1	348	\$348
<b>Interior Access Route</b>												
24	Classroom	1	110	Interior Access Route	N/A

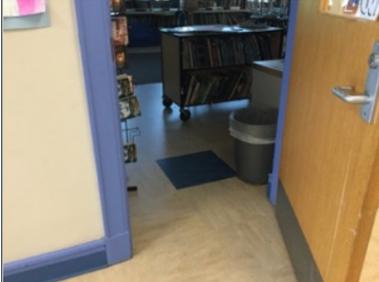
Route < 36" wide	25"	Relocate book stand and trash can to maintain the 36" min. clear width at the accessible route.	1	Labor	\$0
25	Art Room	1	109	Interior Access Route	N/A

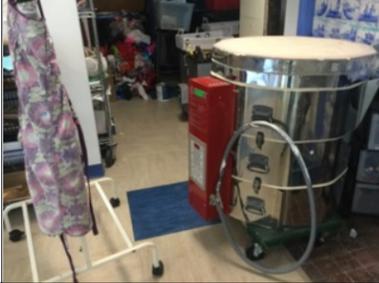
Route < 36" wide	-	Relocate drinking rack to maintain the 36" min. clear width at the accessible route.	1	Labor	\$0

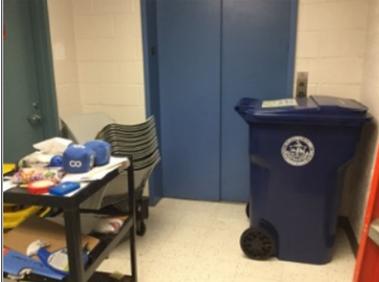
Route < 36" wide	-	Relocate trash bin and other equipment to maintain the 36" min. clear width at the accessible route and the maneuvering clearance at the elevator.	1	Labor	\$0
27	Norman H. Read Discover Center	2	206	Interior Access Route	N/A

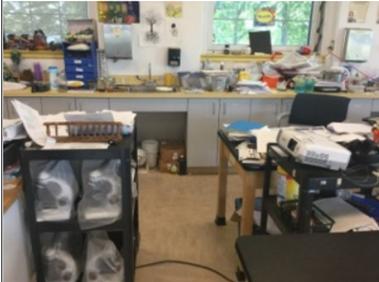
Route < 36" wide	23"	Relocate microscope cart to maintain the 36" min. clear width at the accessible route.	1	Labor	\$0
28	Math Classroom	2	205	Interior Access Route	N/A

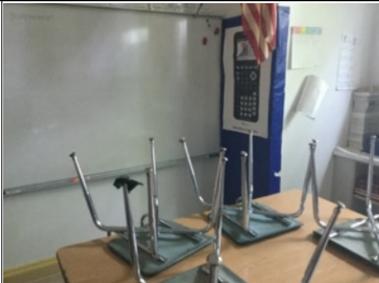
Route < 36" wide	20"	Rearrange desks to ensure the 36" min. clear width is maintained at the accessible route.	1	Labor	\$0
29	One on One Room	2	224	Interior Access Route	N/A

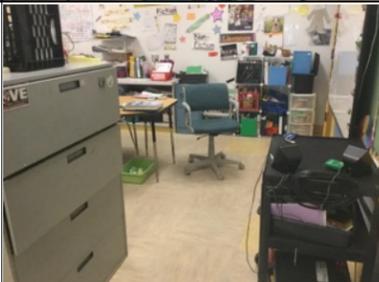
Route < 36" wide	30"	Ensure that a clear width of 36" min. is maintained at the accessible route by relocating cart.	1	Labor	\$0

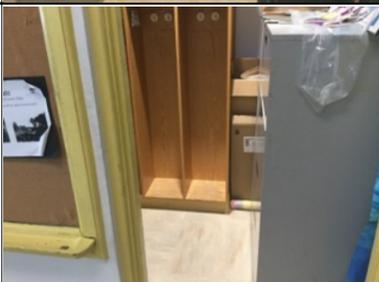
30	Classroom	2	221	Interior Access Route	N/A

Route < 36" wide	18"	Relocate cabinet to ensure the 36" min. clear width is maintained at the accessible route.	1	Labor	\$0

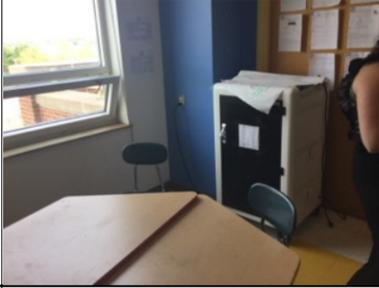
Route < 36" wide	25"	Ensure that a clear width of 36" min. is maintained at the accessible route.	1	Labor	\$0
32	Classroom	1	123	Interior Access Route	N/A

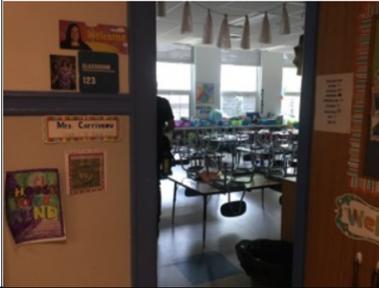
Obstructed by protruding objects	69"	Relocate tassles.	1	Labor	\$0
33	Vestibule With Exit #4	1		Interior Access Route	N/A

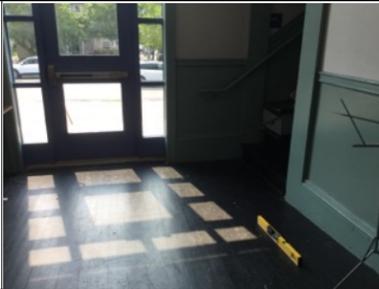
Running slope > 1:20 (5%)	6.5%	While not technically compliant, this space is still usable.	1	-	\$0
34	Routes Into Gym	SB	001	Interior Access Route	N/A

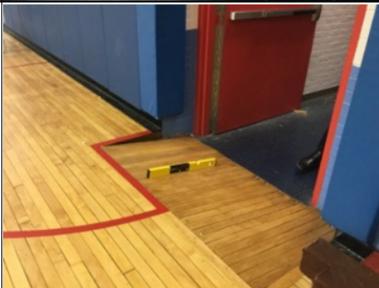
Running slope > 1:20 (5%)	11.9%	Provide compliant handrails with 1 1/4"- 2" circular cross sections. While slope is still technically not compliant, it is generally usable.  (Cost based on two handrails per entrance at 3' long.)	2	198	\$396
35	Vestibule With Exit #4	1		Interior Access Route	N/A

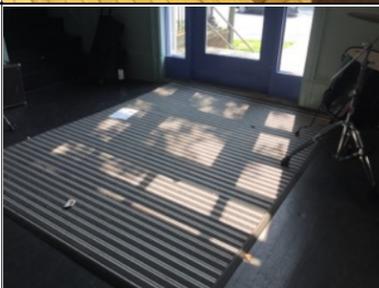
Mat not securely attached	-	Securely attach mats.	2	Labor	\$0

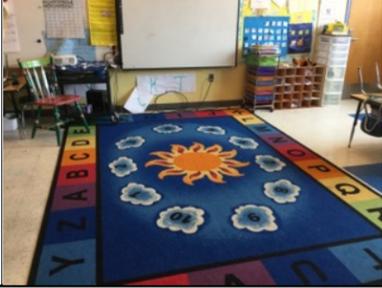
Mat not securely attached	-	Securely attach mats.	19	Labor	\$0
<b>Doors, Doorways, &amp; Gates</b>												
37	Reading Room	1	107	Doors, Doorways, & Gates	Classroom

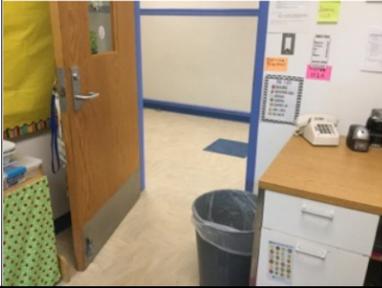
Maneuvering clearance(s) not provided	11"	Relocate trash can and rearrange furniture to maintain the maneuvering clearance at the door.	1	Labor	\$0
38	One on One Room	1	108	Doors, Doorways, & Gates	Classroom

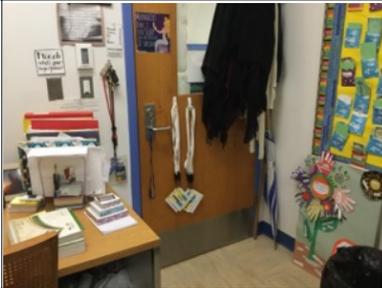
Maneuvering clearance(s) not provided	9.5"	Rearrange furniture to maintain the maneuvering clearance at the door.	1	Labor	\$0
39	Office	1	128	Doors, Doorways, & Gates	Office

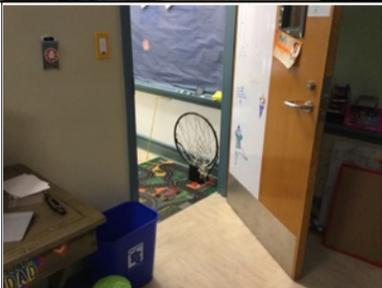
Maneuvering clearance(s) not provided	-	Relocate trash can and desk to maintain the maneuvering clearance at the door.	1	Labor	\$0
40	Cafeteria	B		Doors, Doorways, & Gates	N/A

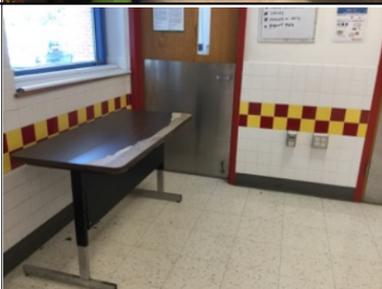
Maneuvering clearance(s) not provided	-	Relocate table to maintain the maneuvering clearance at the door.	1	Labor	\$0

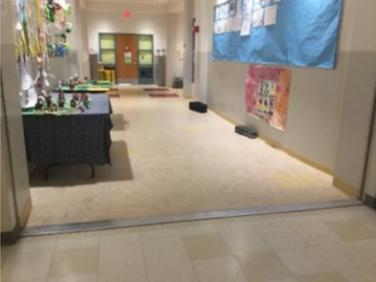
Threshold not beveled	-	Bevel threshold.	1	113	\$113
42	Boys' Toilet Room Near #214	2		Doors, Doorways, & Gates	N/A

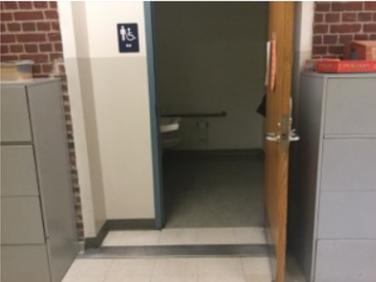
Threshold not beveled	-	Bevel threshold at metal plate near the entrance to the toilet room.	1	113	\$113
43	Music Room	B	018	Doors, Doorways, & Gates	Classroom

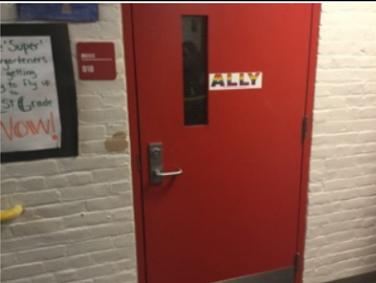
Door requires > 5 lbs. of force to open	17 lbs.	Adjust closer so door does not require more than 5 pounds of force to open.	1	Labor	\$0
<b>Stairways</b>												
44	Stairs to Balcony in Auditorium	1		Stairways	Interior

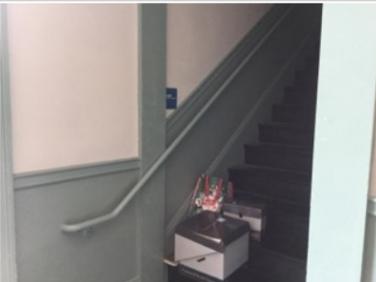
Not maintained in operable working condition	-	Remove storage from stairs to ensure stairs are maintained in operable working condition.	1	Labor	\$0
<b>Platform Lift or LULA Elevator</b>												
45	Lift to Stage	1		Platform Lift or LULA Elevator	Interior

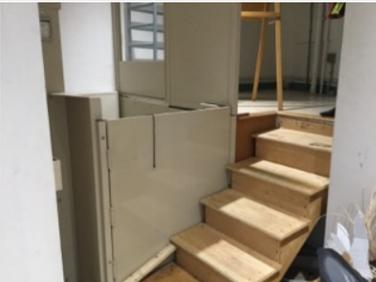
The lift that provides users access to the auditorium stage was not in operable working condition at the time of the survey, due to a set of stairs to the auditorium that are in the way of the door at the lower level. The school's elevator has call buttons that are located higher than the maximum 42" allowed.

Not in operable working condition	-	Redesign this area to provide a clear floor space at the lift and an accessible route to the stage.	1	-	\$0

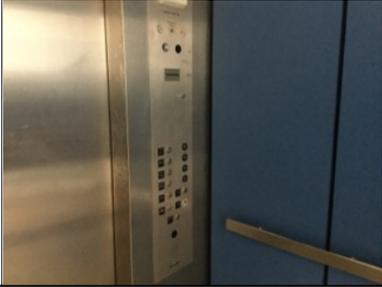
Emergency communication systems > 48"	65"	Lower the emergency call "Cancel" button to 48" max. above the floor.	1	1446	\$1446
<b>Signage</b>												
47	Classroom	1	122	Signage	Designation

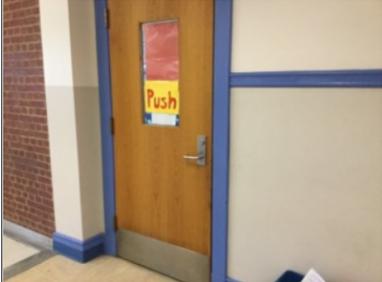
Not provided	-	Provide text with raised characters duplicated in braille. Locate sign alongside the door on the latch side.	1	174	\$174
48	Door to Rooms #127 and #128	1		Signage	Directional

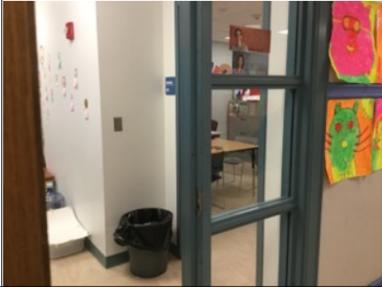
Not provided	-	Provide text with raised characters duplicated in braille. Locate sign alongside the door on the latch side.	1	174	\$174
49	Near Room #111	1		Signage	Designation

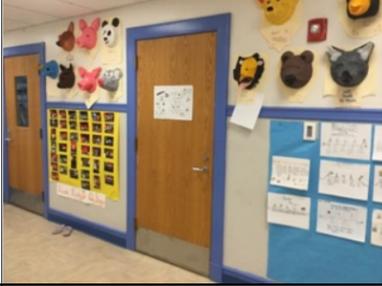
Not provided	-	Provide text with raised characters duplicated in braille. Locate sign alongside the door on the latch side.	1	174	\$174
50	Classroom	1	101	Signage	Designation

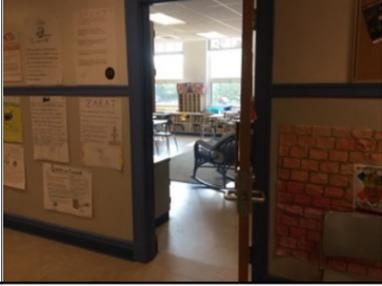
Not provided	-	Provide text with raised characters duplicated in braille. Locate sign alongside the door on the latch side.	1	174	\$174

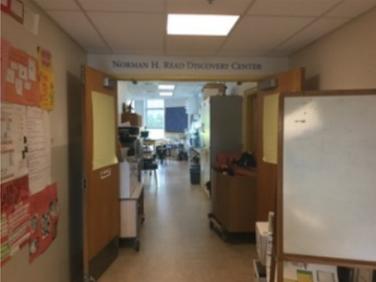
Text size non-compliant	-	Ensure that character size complies with the Character Height Table 703.5.5 in the ADA 2010 Standards.	1	174	\$174
52	One on One Room	1	108	Signage	Designation

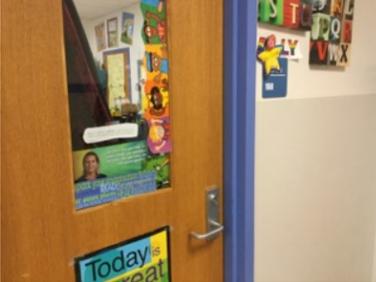
Not maintained in operable working condition	-	Remove paper to ensure sign is usable by people who are blind or low vision.	1	0	\$0
53	Classroom	1	119	Signage	Designation

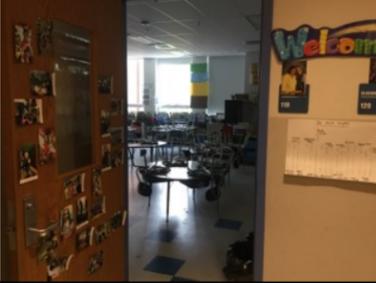
Not maintained in operable working condition	-	Remove paper to ensure sign is usable by people who are blind or low vision.	1	0	\$0
54	Toilet Room Near Room #123	1	123	Signage	Designation

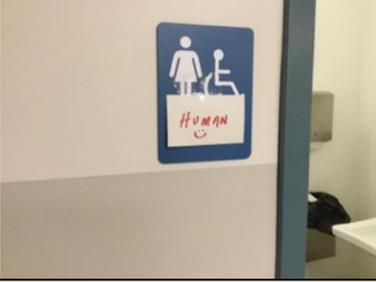
Not maintained in operable working condition	-	Remove paper to ensure sign is usable by people who are blind or low vision.	1	0	\$0
<b>Operable Parts</b>

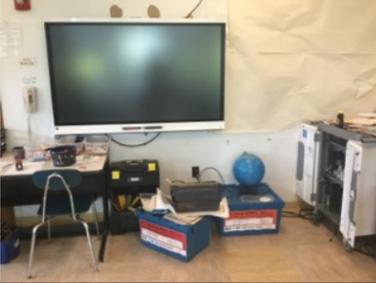
55	Norman H. Read Discover Center	2	206	Operable Parts	Other

Clear floor space is not provided	-	Ensure a 30" min. by 48" min. clear floor space is provided at smart board.	1	Labor	\$0

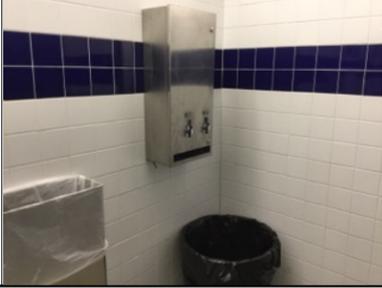
Not operable with a closed fist	-	Provide hardware that can be operable with one hand and not require tight grasping, pinching, or twisting of the wrist.	1	150	\$150
<b>Dining or Work Surfaces</b>												
57	Norman H. Read Discover Center	2	206	Dining or Work Surfaces	Work Surface

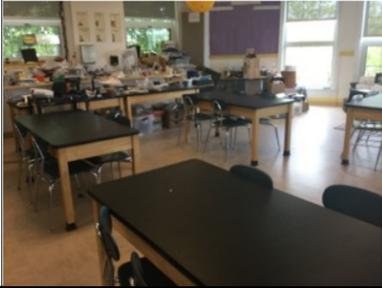
At least one or 5% accessible tables not provided Knee or toe clearance not provided	- 23"	Ensure that at least one work surface is accessible. Provide at least one work surface with 27" min. knee and toe clearance.	1	525	\$525
58	Classroom	2	207	Dining or Work Surfaces	Work Surface

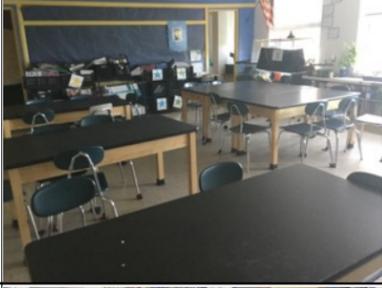
At least one or 5% accessible tables not provided Knee or toe clearance not provided	- 23"	Ensure that at least one work surface is accessible. Provide at least one work surface with 27" min. knee and toe clearance.	1	525	\$525

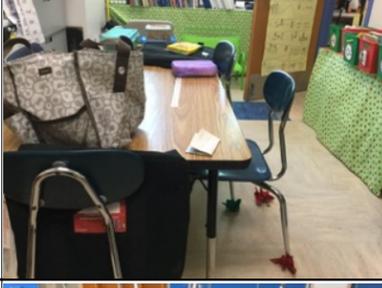
59	Reading Room	1	107	Dining or Work Surfaces	Work Surface

Knee or toe clearance not provided	24"	Adjust work surface to have 27" min. knee and toe clearance.	1	Labor	\$0
60	Classroom	1	120	Dining or Work Surfaces	Work Surface

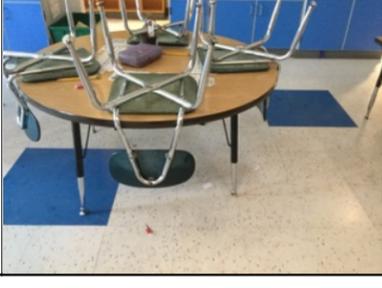
Knee or toe clearance not provided	22.25"	Adjust at least 1 work surface to have 27" min. knee and toe clearance.	1	Labor	\$0

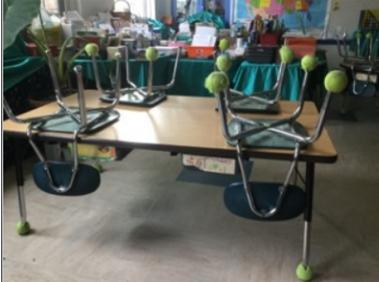
Knee or toe clearance not provided	22"	Adjust at least 1 work surface to have 27" min. knee and toe clearance.	1	Labor	\$0
62	Classroom	1	123	Dining or Work Surfaces	Work Surface

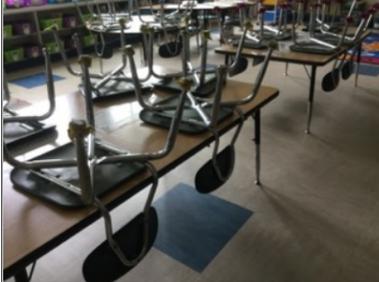
Knee or toe clearance not provided	21.75"	Adjust at least 1 work surface to have 27" min. knee and toe clearance.	1	Labor	\$0
63	Classroom, Chill Zone Desk	2	207	Dining or Work Surfaces	Work Surface

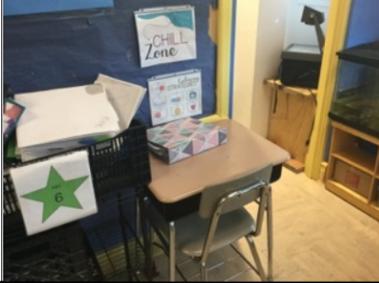
Knee or toe clearance not provided	-	Provide at least 1 work surface with 27" min. knee and toe clearance.	1	525	\$525
64	Classroom	2	221	Dining or Work Surfaces	Work Surface

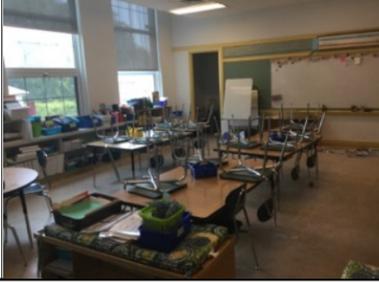
Knee or toe clearance not provided	24"	Adjust at least 1 work surface to have 27" min. knee and toe clearance.	1	Labor	\$0
<b>Picnic Tables</b>												
65	Picnic Tables Near Upper Playground	Ext.		Picnic Tables	N/A

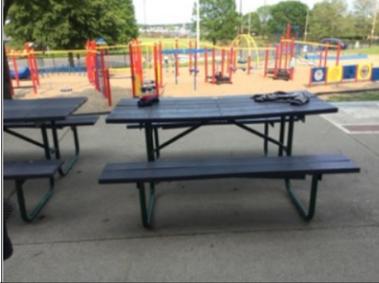
At least 5% accessible spaces not provided	-	Ensure that at least 5% (minimum one) of dining surfaces are accessible.	1	1050	\$1050

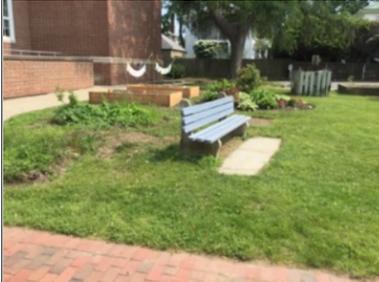
ID	Location	Floor	Room	Element	Type	Photo	Issues	Current Measure	Recommendations	Quantity	Price	Cost Estimation
<b>Benches</b>												
66	Bench Near Main Entrance	Ext.		Benches	N/A

Not connected to an accessible route	-	Ensure that at least one of the benches in this area is on an accessible route.	1	117	\$117
67	Bench Near Playground	Ext.		Benches	N/A

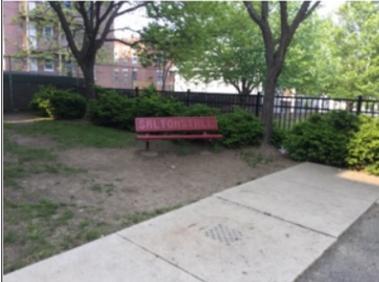
Not connected to an accessible route	-	Ensure bench is located on an accessible route.	1	117	\$117
<b>Toilet &amp; Bathing Rooms</b>												
<b>Lavatory</b>												
68	Toilet Room in Nurse's Office	1	126A	Lavatory	N/A

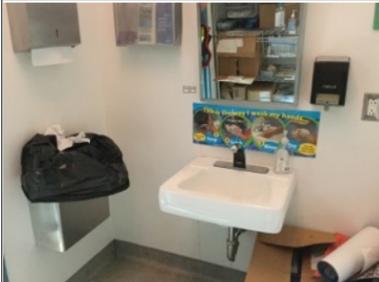
Toe or knee clearances not provided Dispensers not within reach range	22" 52.5"	Provide a lavatory with knee and toe clearance positioned for a forward approach. Relocate dispenser to 42" max. above the finished floor.	1	1795	\$1795
69	Toilet Room Near Room #123	1		Lavatory	N/A

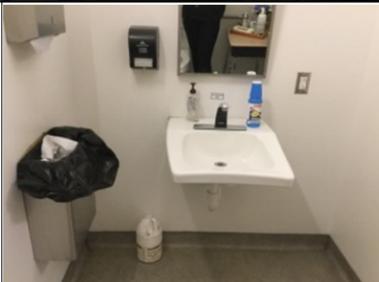
Mirror above lavatory w/reflective surface > 40"	42.25"	Lower mirror so that the bottom surface is at 40" max. above finished floor.	1	192	\$192

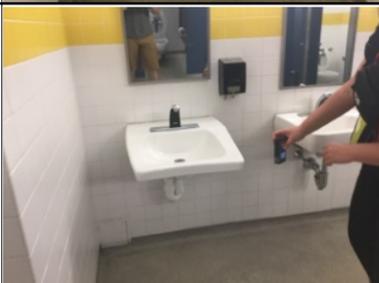
70	Girls' Toilet Room	2		Lavatory	N/A

Mirror above lavatory w/reflective surface > 40"	42"	Lower mirror so that the bottom surface is at 40" max. above finished floor.	1	192	\$192

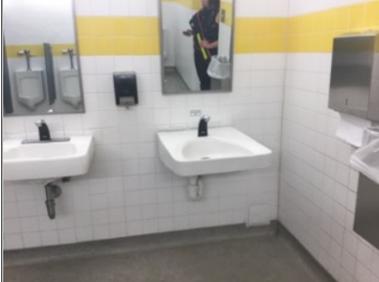
ID	Location	Floor	Room	Element	Type	Photo	Issues	Current Measure	Recommendations	Quantity	Price	Cost Estimation
71	Boys' Toilet Room	2		Lavatory	N/A

Mirror above lavatory w/reflective surface > 40"	42"	Lower mirror so that the bottom surface is at 40" max. above finished floor.	1	192	\$192
72	Girls' Toilet Room Near #221	2		Lavatory	N/A

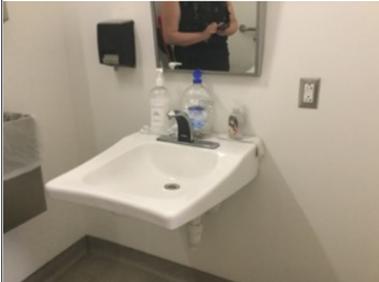
Mirror above lavatory w/reflective surface > 40"	43"	Lower mirror so that the bottom surface is at 40" max. above finished floor.	1	192	\$192
73	Boys' Toilet Room Near #214	2		Lavatory	N/A

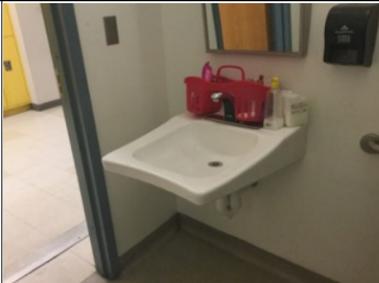
Mirror above lavatory w/reflective surface > 40"	44"	Lower mirror so that the bottom surface is at 40" max. above finished floor.	1	192	\$192
74	Toilet Room	B	024	Lavatory	N/A

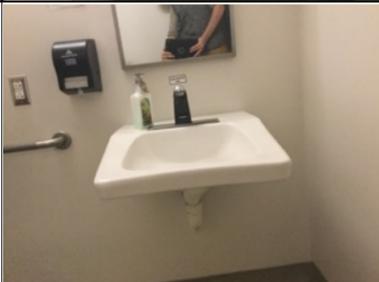
Mirror above lavatory w/reflective surface > 40"	42"	Lower mirror so that the bottom surface is at 40" max. above finished floor.	1	192	\$192
75	Boys' Toilet Room Near Cafeteria	B	028	Lavatory	N/A

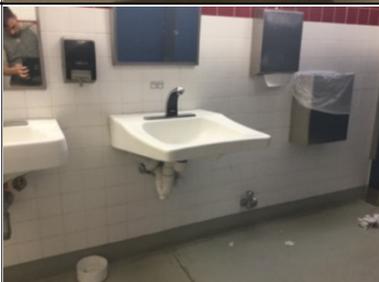
Mirror above lavatory w/reflective surface > 40"	42"	Lower mirror so that the bottom surface is at 40" max. above finished floor.	1	192	\$192

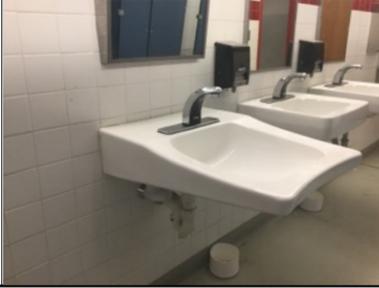
ID	Location	Floor	Room	Element	Type	Photo	Issues	Current Measure	Recommendations	Quantity	Price	Cost Estimation
76	Girls' Toilet Room Near Cafeteria	B	027	Lavatory	N/A

Mirror above lavatory w/reflective surface > 40"	42"	Lower mirror so that the bottom surface is at 40" max. above finished floor.	1	192	\$192
<b>Single-User Toilet</b>												
77	Toilet Room in Nurse's Office	1	126A	Single-User Toilet	N/A

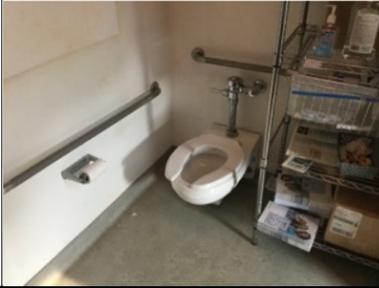
Toilet seat < 17" or > 19" high Flush control not on open side Side or rear grab bar < 33" or > 36" high Clearance at toilet < 60" clear width	15.25" - 23.25" -	Install a toilet with a seat between 17"- 19" high above the finished floor. Relocate the flush control to the open side. Mount grab bars 33"- 36" above the floor. Remove storage to maintain the required 60" min. clear floor at the toilet.	1	2290 Labor	\$2290
78	Toilet Room	B	024	Single-User Toilet	N/A

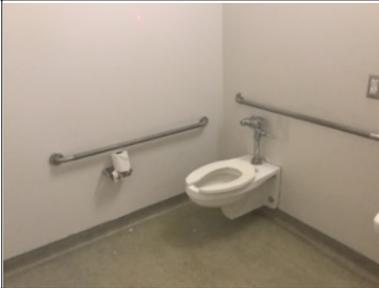
Side or rear grab bar < 33" or > 36" high	24"	Mount side grab bar 33"- 36" above the floor.	1	384	\$384

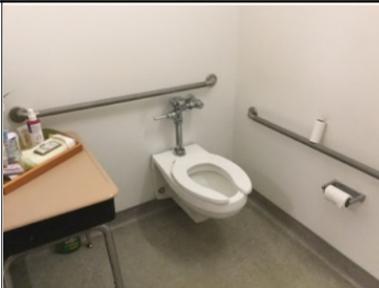
79	Toilet Room Near Room 123	1		Single-User Toilet	N/A

Side or rear grab bar < 33" or > 36" high Clearance at toilet < 60" clear width	25" -	Mount side grab bar 33"- 36" above the finished floor. Remove desk to maintain the 60" min. clear floor space at the toilet.	1	384 Labor	\$384
80	Girls' and Boys' Toilet Rooms Near 221	2		Single-User Toilet	N/A

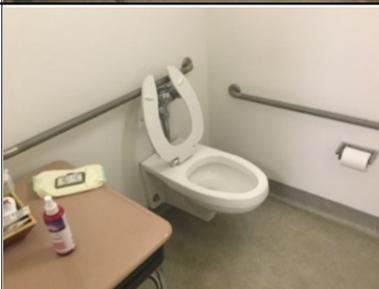
Side or rear grab bar < 33" or > 36" high Clearance at toilet < 60" clear width	26" -	Mount side grab bar 33"- 36" above the finished floor. Remove desk to maintain the 60" min. clear floor space at the toilet.	2	384 Labor	\$768

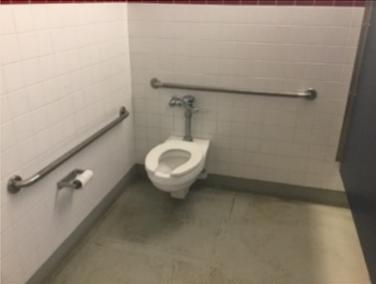
ID	Location	Floor	Room	Element	Type	Photo	Issues	Current Measure	Recommendations	Quantity	Price	Cost Estimation
<b>Toilet Compartment</b>												
81	Boys' Toilet Room Near Cafeteria	B	028	Toilet Compartment	Accessible Compartment

Door has malfunctioning self-closing hinge Side or rear grab bar < 33" or >36" high	- 24"	Repair hinge. Locate side grab bar between 33"- 36" above the finished floor.	1	384	\$384
82	Girls' Toilet Room Near Cafeteria	B	027	Toilet Compartment	Accessible Compartment

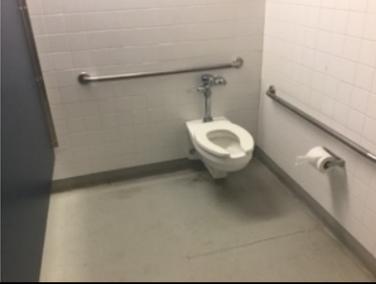
Door has malfunctioning self-closing hinge Side or rear grab bar < 33" or >36" high	- 24"	Repair hinge. Locate side grab bar between 33"- 36" above the finished floor.	1	384	\$384
83	Boys' Toilet Room	1		Toilet Compartment	Accessible Compartment

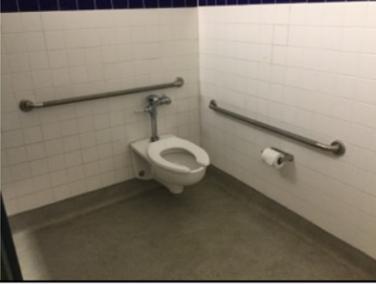
Side or rear grab bar < 33" or >36" high	24.5"	Locate grab bars between 33"- 36" above the finished floor.	1	384	\$384
84	Girls' Toilet Room	2		Toilet Compartment	Accessible Compartment

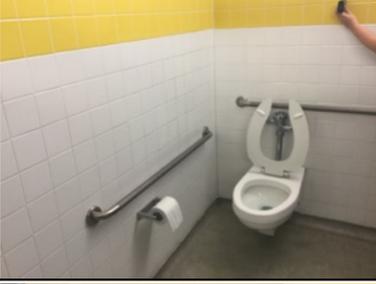
Side or rear grab bar < 33" or >36" high	25"	Locate side grab bar between 33"- 36" above the finished floor.	1	384	\$384

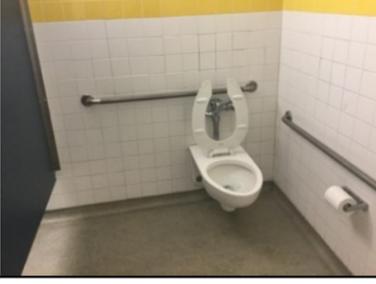
85	Boys' Toilet Room	2		Toilet Compartment	Accessible Compartment

Side or rear grab bar < 33" or >36" high	25"	Locate side grab bar between 33"- 36" above the finished floor.	1	384	\$384

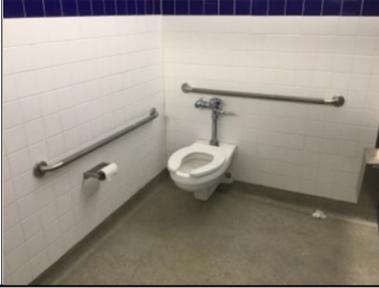
ID	Location	Floor	Room	Element	Type	Photo	Issues	Current Measure	Recommendations	Quantity	Price	Cost Estimation
86	Girls' Toilet Room	1		Toilet Compartment	Accessible Compartment

Side or rear grab bar < 33" or >36" high Coat hook > 48"	24.75" 53"	Locate side grab bar between 33"- 36" above the finished floor. Lower coat hook so that it is no higher than 48".	1	497	\$497
<b>Additional Access</b>												
<b>Drinking Fountains</b>												
87	First Floor Hallway	1		Drinking Fountains	Hi-Lo

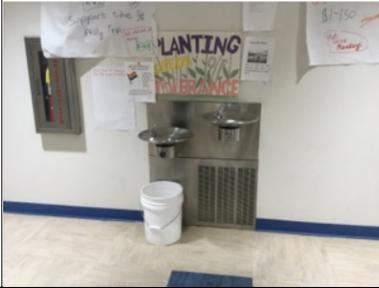
Operable parts malfunctioning Standing height fountain does not have cane protection	- -	Ensure drinking fountain is maintained in working condition. Provide a cane-detectable barrier skirt under the high unit.	1	668	\$668
88	Near Toilet Rooms	2		Drinking Fountains	Hi-Lo

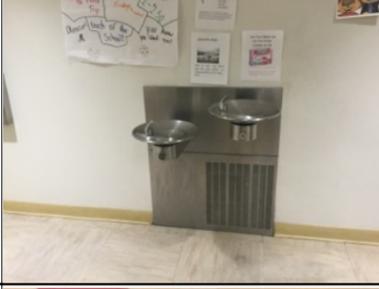
Standing height fountain does not have cane protection	-	Provide a cane-detectable barrier skirt under the high unit.	1	668	\$668

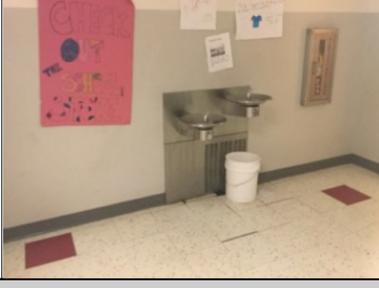
89	Near Toilet Rooms and Cafeteria	B	027	Drinking Fountains	Hi-Lo

Standing height fountain does not have cane protection	-	Provide a cane-detectable barrier skirt under the high unit.	1	668	\$668
<b>Sink</b>												
90	Art Room	1	109	Sink	Classroom

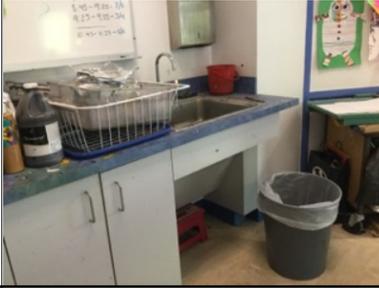
Clear floor space not provided at sink	-	Relocate trash can to maintain the 30" by 48" clear floor space positioned for a forward approach at the sink  Note: This design is a good example to use at other classroom sinks throughout the school.	2	0	\$0

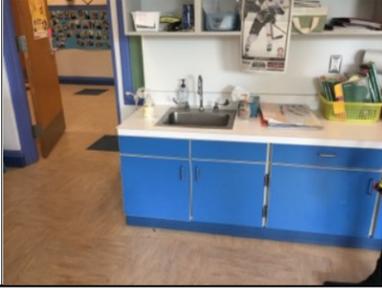
ID	Location	Floor	Room	Element	Type	Photo	Issues	Current Measure	Recommendations	Quantity	Price	Cost Estimation
91	Classrooms Throughout School	1	All	Sink	Classroom

Toe and knee clearances not provided	-	Ensure there is a 27" knee clearance positioned for a forward approach.	8	1265	\$10120
<b>Play and Sport Areas</b>												
<b>Play Areas</b>												
92	Upper Playground	Ext.		Play Areas	N/A

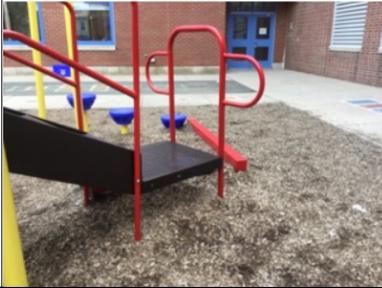
Accessible route not provided to ground level play components Surface not stable, firm, and slip-resistant	-	Ensure an accessible route that is stable, firm and slip-resistant is provided to each play component.  (Cost based on 85' by 5' wide poured-in-place rubber.)	1	8925	\$8925
93	Playground, Lower Level	Ext.		Play Areas	N/A

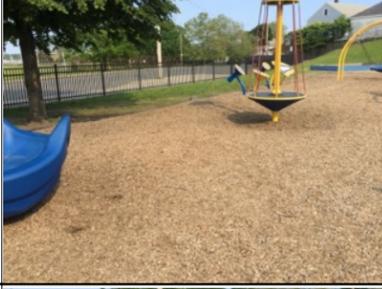
Accessible route not provided to ground level play components Surface not stable, firm, and slip-resistant	-	Ensure an accessible route that is stable, firm and slip-resistant is provided to each play component.  (Cost based on 350' by 5' wide poured-in-place rubber.)	1	36750	\$36750

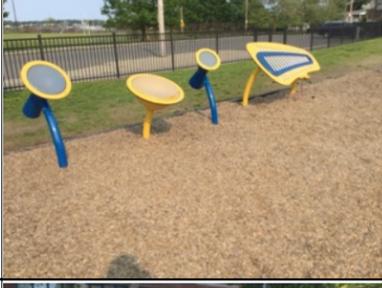
94	Playground, Lower Level	Ext.		Play Areas	N/A

Accessible route not provided to ground level play components Surface not stable, firm, and slip-resistant	-	Ensure an accessible route that is stable, firm and slip-resistant is provided to each play component.  See ID #93 for cost.	1	-	\$0
95	Playground, Lower Level	Ext.		Play Areas	N/A

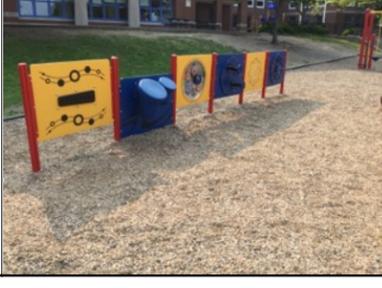
Accessible route not provided to ground level play components Surface not stable, firm, and slip-resistant	-	Ensure an accessible route that is stable, firm and slip-resistant is provided to each play component.  See ID #93 for cost.	1	-	\$0

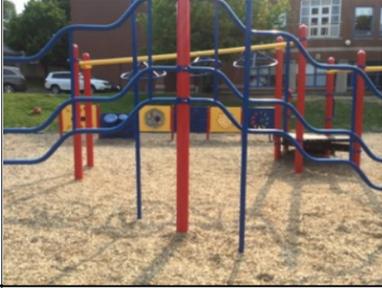
ID	Location	Floor	Room	Element	Type	Photo	Issues	Current Measure	Recommendations	Quantity	Price	Cost Estimation
96	Playground, Lower Level	Ext.		Play Areas	N/A

Accessible route not provided around the playground	-	Provide a 48" min. wide accessible route around the playground.  (Cost based on 300' by 4' wide asphalt route around perimeter of playground.)	1	7650	\$7650
97	Route to Playground, Lower Level	Ext.		Play Areas	1

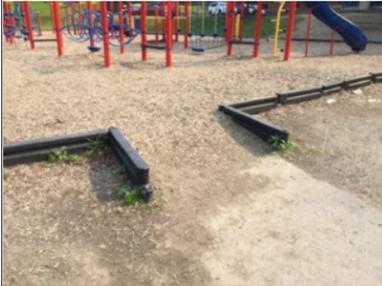
Route not maintained in operable working condition	-	Ensure the accessible route is maintained in operable working condition.	1	Labor	\$0

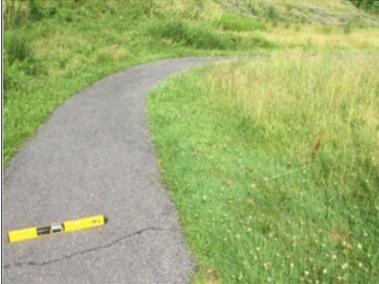
ID	Location	Floor	Room	Element	Type	Photo	Issues	Current Measure	Recommendations	Quantity	Price	Cost Estimation
<b>Approach and Entrance</b>												
<b>Exterior Access Route</b>												
1	Route to Playground	Ext.		Exterior Access Route	Exterior

Cross slope > 1:50 (2.00%) Running slope > 1:20 (5%)	4.5% 11.9%	Reduce cross slope to be no steeper than 1:50 (2.00%). Reduce running slope to be no steeper than 1:20 (5%).  (Cost based on 165' by 4' wide asphalt route.)	1	4208	\$4208
2	Exit on North Side of School, Near Baseball Field	Ext.		Exterior Access Route	Exterior

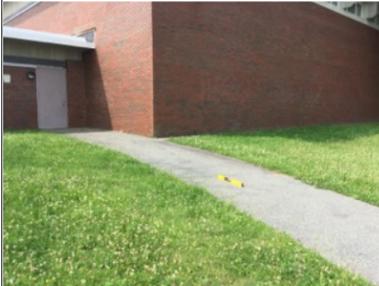
Running slope > 1:20 (5%)	6.9%	Reduce running slope to be no steeper than 1:20 (5%).  (Cost based on 30' asphalt to fix slope.)	1	225	\$225
3	Courtyard Garden	1		Exterior Access Route	Exterior

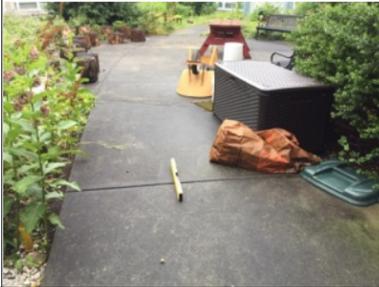
Running slope > 1:20 (5%) Edge protection < 4" high	6.5% -	Provide handrails on both sides. Provide edge protection that prevents the passage of a 4" diameter sphere, where any portion of the sphere is within 4" of the finished floor or ground surface.  (Cost based on 10' of handrails on both sides of the walkway and 10' of edge protection on both sides of the walkway.)	2	960	\$1920

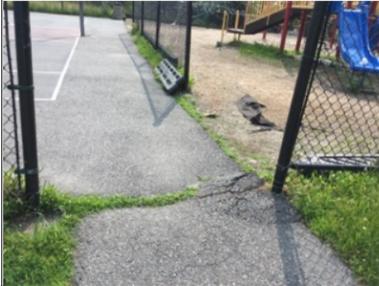
4	Entrance to Playground	Ext.		Exterior Access Route	Exterior

Level changes > 1/4"	-	Alter change in level to be 1/4" high max.	1	27	\$27
5	Westernmost Exit on North Side of School	Ext.		Exterior Access Route	Exterior

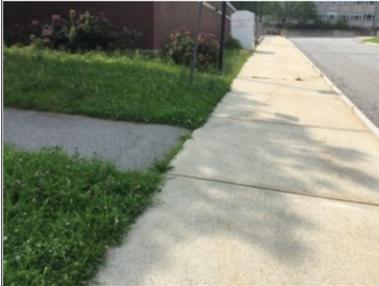
Level changes > 1/4"	0.5"	Alter change in level to be 1/4" high max.	1	27	\$27

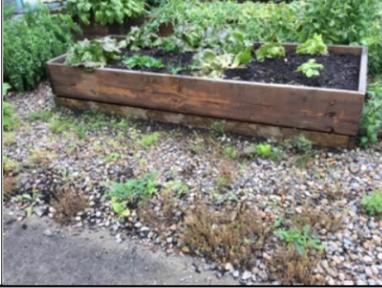
ID	Location	Floor	Room	Element	Type	Photo	Issues	Current Measure	Recommendations	Quantity	Price	Cost Estimation
6	Courtyard Garden	1		Exterior Access Route	Exterior

Accessible route not provided	-	Ensure an accessible route is provided.  (Cost based on 4' by 3' asphalt patch to approach bed.)	1	78	\$78
<b>Off-Street Parking Lot or Garage</b>												
7	Southwest Lot Accessible Parking	Ext.		Off-Street Parking Lot or Garage	N/A

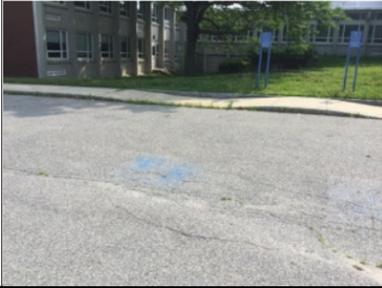
Total # of parking Total # of designated accessible parking spaces Vehicle space < 96" wide at car space Sign does not have the designation "Van Accessible"	12 3 - -	Ensure spaces and access aisles are compliant to ADA 2010:502. Add the designation "Van Accessible" to the sign located at the van accessible space.  (Cost based on a Van Accessible sign. Cost to re-stripe spaces not included because lot has been re-striped since survey.)	1	375	\$375
8	Parking Lot at Main Entrance	Ext.		Off-Street Parking Lot or Garage	N/A

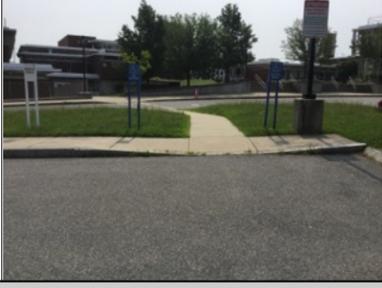
Total # of parking Total # of designated accessible parking spaces Access aisle < 96" wide at van space Sign does not have the designation "Van Accessible"	25 2 - -	Ensure spaces and access aisles are compliant to ADA 2010:502. Add the designation "Van Accessible" to the sign located at the van accessible space. Ensure van space is 132" wide min. and the access aisle is 60" wide min.  (Cost based on a Van Accessible sign. Cost to re-stripe spaces not included because lot has been re-striped since survey.)	1	375	\$375

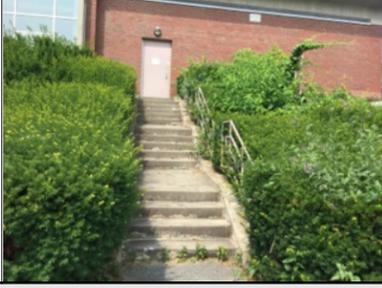
<b>Entrance</b>												
9	YMCA Pick Up Door	Ext.		Entrance	Other

Entrance not on an accessible route	-	Provide a directional sign indicating the location of the nearest accessible entrance.	1	260	\$260
<b>Access to Goods and Services</b>

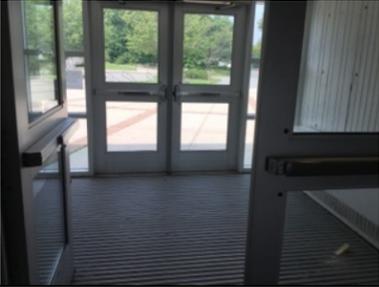
ID	Location	Floor	Room	Element	Type	Photo	Issues	Current Measure	Recommendations	Quantity	Price	Cost Estimation
<b>Means of Egress</b>												
10	Main Entrance	1		Means of Egress	N/A

Illuminated exit sign not provided Tactile exit sign not provided	- -	Ensure illuminated exit signs contain the International Symbol of Accessibility (ISA). Ensure tactile exit signs with raised characters and braille are provided at exit doors. Mount signs between 48"- 60" above finished floor located on the latch side of the door.	1	274	\$274
11	Gym, Exits to North Side of School	B		Means of Egress	N/A

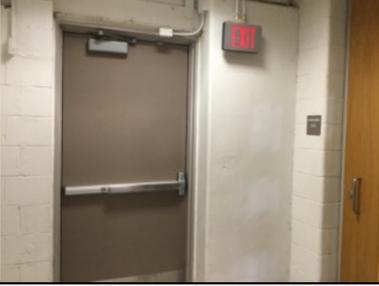
Illuminated exit sign not provided Tactile exit sign not provided	- -	Ensure illuminated exit signs contain the International Symbol of Accessibility (ISA). Ensure tactile exit signs with raised characters and braille are provided at exit doors. Mount signs between 48"- 60" above finished floor located on the latch side of the door.	2	274	\$548

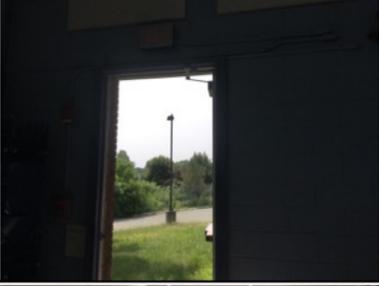
12	Cafeteria Exit, to Southeast Side of School	1	B014	Means of Egress	N/A

Illuminated exit sign not provided Tactile exit sign not provided	- -	Ensure illuminated exit signs contain the International Symbol of Accessibility (ISA). Ensure tactile exit signs with raised characters and braille are provided at exit doors. Mount signs between 48"- 60" above finished floor located on the latch side of the door.	1	274	\$274
13	Exit Near B032	1		Means of Egress	N/A

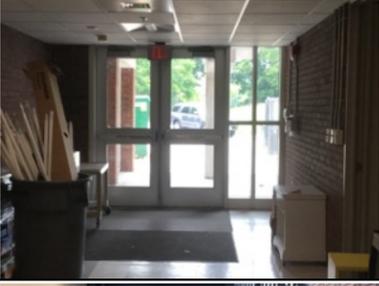
Illuminated exit sign not provided Tactile exit sign not provided	- -	Ensure illuminated exit signs contain the International Symbol of Accessibility (ISA). Ensure tactile exit signs with raised characters and braille are provided at exit doors. Mount signs between 48"- 60" above finished floor located on the latch side of the door.	1	274	\$274
14	Easternmost Exit on South Side of School	1		Means of Egress	N/A

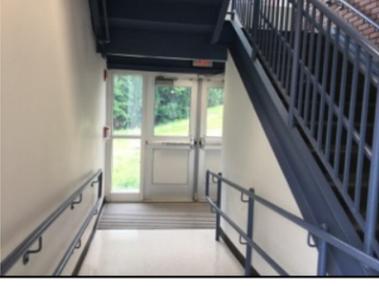
Illuminated exit sign not provided Tactile exit sign not provided	- -	Ensure illuminated exit signs contain the International Symbol of Accessibility (ISA). Ensure tactile exit signs with raised characters and braille are provided at exit doors. Mount signs between 48"- 60" above finished floor located on the latch side of the door.	1	274	\$274

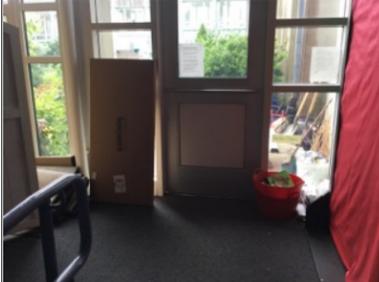
ID	Location	Floor	Room	Element	Type	Photo	Issues	Current Measure	Recommendations	Quantity	Price	Cost Estimation
15	Exits to Courtyard Garden	1	D044, Hallway	Means of Egress	N/A

Illuminated exit sign not provided Tactile exit sign not provided	- -	Ensure illuminated exit signs are provided at exits and exit doors. Ensure tactile exit signs with raised characters and braille are provided at exit doors. Mount signs between 48"- 60" above finished floor located on the latch side of the door.	2	274	\$548
16	Accessible Entrance in Stair 3	1		Means of Egress	N/A

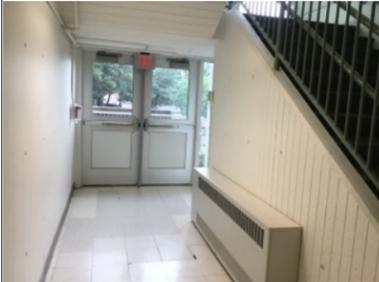
Illuminated exit sign not provided Tactile exit sign not provided	- -	Ensure illuminated exit signs contain the International Symbol of Accessibility (ISA). Ensure tactile exit signs with raised characters and braille are provided at exit doors. Mount signs between 48"- 60" above finished floor located on the latch side of the door.	1	274	\$274

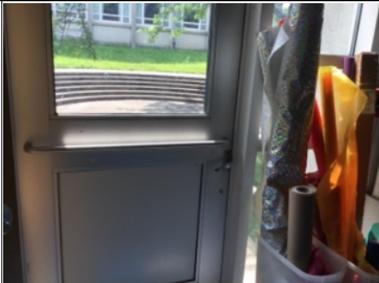
17	Exit to Courtyard on Southwest Side of School	1	C013	Means of Egress	N/A

Illuminated exit sign not provided Tactile exit sign not provided Directional sign to accessible emergency exit not provided	- - -	Ensure illuminated exit signs are provided at exits and exit doors. Ensure tactile exit signs with raised characters and braille are provided at exit doors. Mount signs between 48"- 60" above finished floor located on the latch side of the door. Provide a directional sign indicating the location of the nearest emergency exit.	1	448	\$448
18	Exit Near Gym	B		Means of Egress	N/A

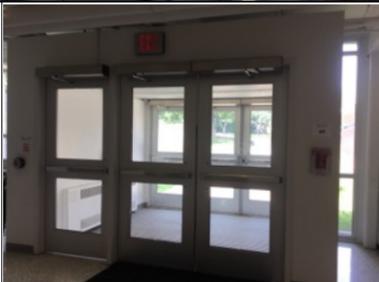
Illuminated exit sign not provided Tactile exit sign not provided Mat not securely attached	- -	Ensure illuminated exit signs contain the International Symbol of Accessibility (ISA). Ensure tactile exit signs with raised characters and braille are provided at exit doors. Mount signs between 48"- 60" above finished floor located on the latch side of the door. Securely attach mat.	1	274	\$274

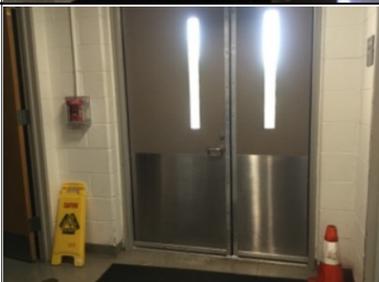
19	Loading Dock Exit	1		Means of Egress	N/A

Illuminated exit sign not provided Tactile exit sign not provided Mat not securely attached	- -	Ensure illuminated exit signs contain the International Symbol of Accessibility (ISA). Ensure tactile exit signs with raised characters and braille are provided at exit doors. Mount signs between 48"- 60" above finished floor located on the latch side of the door. Securely attach mat.	1	274	\$274

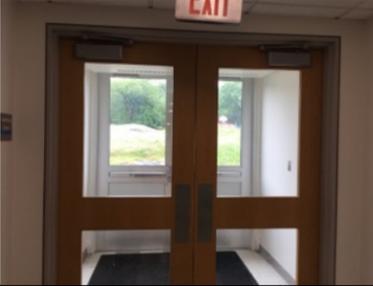
ID	Location	Floor	Room	Element	Type	Photo	Issues	Current Measure	Recommendations	Quantity	Price	Cost Estimation
20	Exit Door Near D036A	1		Means of Egress	N/A

<ul style="list-style-type: none"> <li>Illuminated exit sign not provided</li> <li>Tactile exit sign not provided</li> <li>Mat not securely attached</li> </ul>	<ul style="list-style-type: none"> <li>-</li> <li>-</li> </ul>	<ul style="list-style-type: none"> <li>Ensure illuminated exit signs contain the International Symbol of Accessibility (ISA).</li> <li>Ensure tactile exit signs with raised characters and braille are provided at exit doors. Mount signs between 48"- 60" above finished floor located on the latch side of the door.</li> <li>Securely attach mat.</li> </ul>	1	274	\$274
21	Stair 5, Exit to Southwest Corner of School	1		Means of Egress	N/A

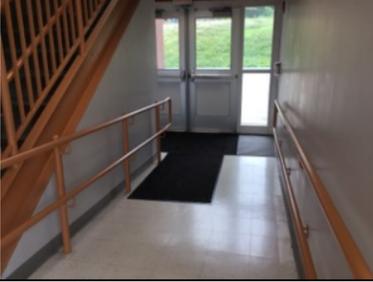
<ul style="list-style-type: none"> <li>Illuminated exit sign not provided</li> <li>Tactile exit sign not provided</li> <li>Mat not securely attached</li> </ul>	<ul style="list-style-type: none"> <li>-</li> <li>-</li> <li>-</li> </ul>	<ul style="list-style-type: none"> <li>Ensure illuminated exit signs contain the International Symbol of Accessibility (ISA).</li> <li>Ensure tactile exit signs with raised characters and braille are provided at exit doors. Mount signs between 48"- 60" above finished floor located on the latch side of the door.</li> <li>Securely attach mat.</li> </ul>	1	274	\$274

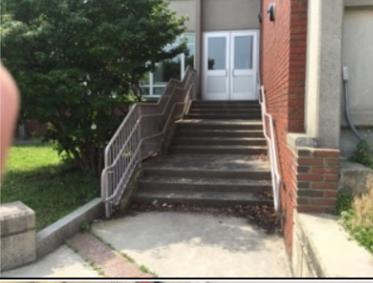
22	Exit East of Main Entrance	Ext.		Means of Egress	N/A

<ul style="list-style-type: none"> <li>Tactile exit sign not provided</li> <li>Directional sign to accessible emergency exit not provided</li> </ul>	<ul style="list-style-type: none"> <li>-</li> <li>-</li> </ul>	<ul style="list-style-type: none"> <li>Ensure tactile exit signs with raised characters and braille are provided at the interior of exit doors. Mount signs between 48"- 60" above finished floor located on the latch side of the door.</li> <li>Provide a directional sign inside indicating the location of the nearest emergency exit.</li> </ul>	1	348	\$348
23	YMCA Pick Up Door	1	B014	Means of Egress	N/A

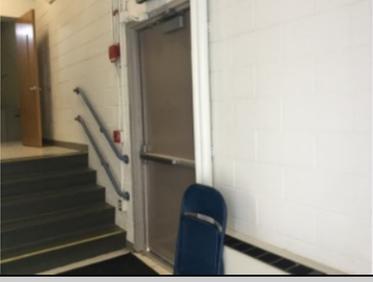
<ul style="list-style-type: none"> <li>Tactile exit sign not provided</li> <li>Directional sign to accessible emergency exit not provided</li> <li>Mat not securely attached</li> </ul>	<ul style="list-style-type: none"> <li>-</li> <li>-</li> <li>-</li> </ul>	<ul style="list-style-type: none"> <li>Ensure tactile exit signs with raised characters and braille are provided at the interior of exit doors. Mount signs between 48"- 60" above finished floor located on the latch side of the door.</li> <li>Provide a directional sign inside indicating the location of the nearest accessible emergency exit.</li> <li>Securely attach mat.</li> </ul>	1	348	\$348

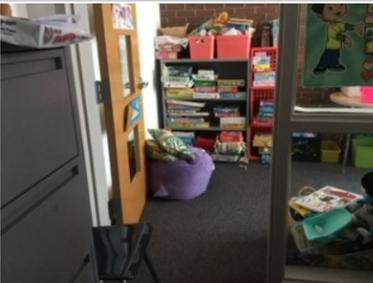
<b>Interior Access Route</b>												
24	Adjustment Councilor	1	B033	Interior Access Route	N/A

Route < 36" wide	23"	Ensure that a clear width of 36" min. is maintained at the accessible route by relocating chairs.	1	Labor	\$0

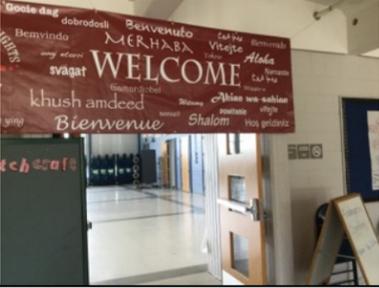
ID	Location	Floor	Room	Element	Type	Photo	Issues	Current Measure	Recommendations	Quantity	Price	Cost Estimation
25	Cafeteria Entrance	1	B014	Interior Access Route	N/A

Obstructed by protruding objects	67"	Relocate banner so that it is at least 80" above the floor.	1	Labor	\$0
26	Inaccessible Route to OT/PT Room	1		Interior Access Route	N/A

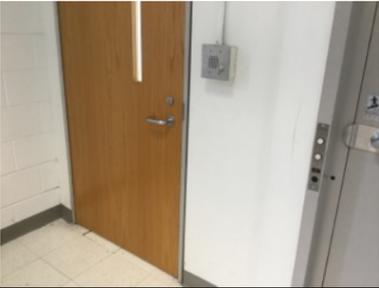
Accessible route not provided	-	Provide a directional sign to the accessible route.	1	174	\$174
27	Media Center	1	D044	Interior Access Route	N/A

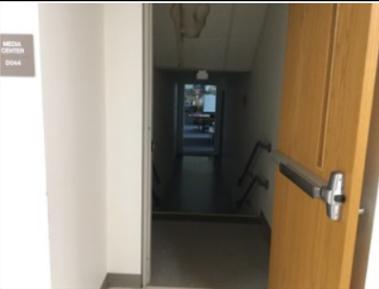
Accessible route not provided	-	Provide a directional sign to the accessible route.	1	174	\$174
28	Classrooms Throughout School	1, 2		Interior Access Route	N/A

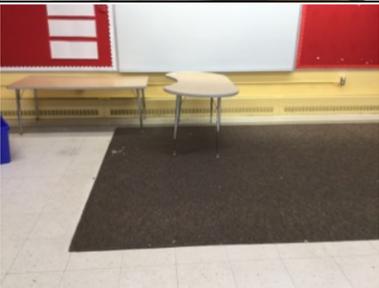
Mat not securely attached	-	Securely attach mats in classrooms throughout the school.	10	Labor	\$0
<b>Doors, Doorways, &amp; Gates</b>												
29	Nurse's Office	1	B046	Doors, Doorways, & Gates	Classroom

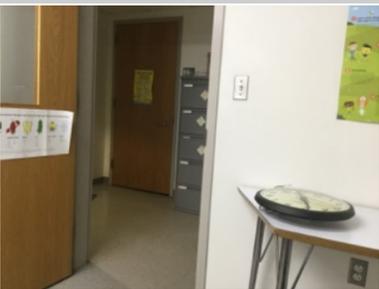
Maneuvering clearance(s) not provided	-	Relocate the table.	1	Labor	\$0

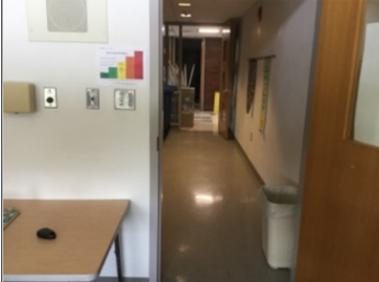
ID	Location	Floor	Room	Element	Type	Photo	Issues	Current Measure	Recommendations	Quantity	Price	Cost Estimation
30	Psychologist's Office	1	B032	Doors, Doorways, & Gates	Office

Maneuvering clearance(s) not provided	-	Relocate the table.	1	Labor	\$0
31	Grade 1 Classroom	1	C004	Doors, Doorways, & Gates	Classroom

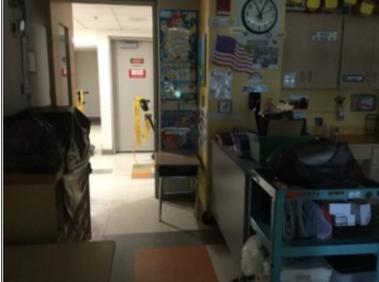
Maneuvering clearance(s) not provided	-	Relocate the table.	1	Labor	\$0
32	Classroom	1	C013	Doors, Doorways, & Gates	Classroom

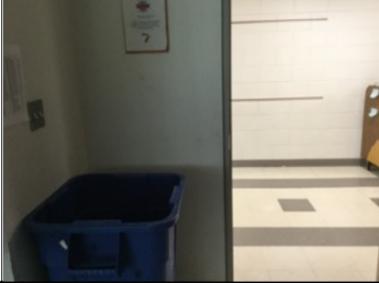
Maneuvering clearance(s) not provided	-	Relocate the table.	1	Labor	\$0
33	Kindergarten Classroom	1	D041	Doors, Doorways, & Gates	Classroom

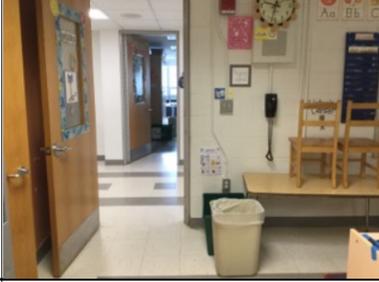
Maneuvering clearance(s) not provided	-	Relocate the table and trash bin.	1	Labor	\$0
34	Classroom	2	D218	Doors, Doorways, & Gates	Classroom

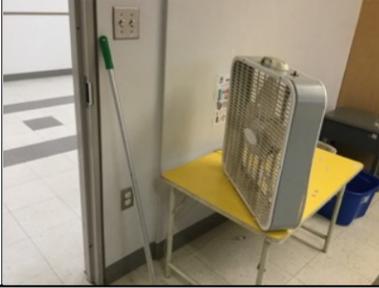
ID	Location	Floor	Room	Element	Type	Photo	Issues	Current Measure	Recommendations	Quantity	Price	Cost Estimation
35	Computer Lab	2	C219	Doors, Doorways, & Gates	Classroom

Maneuvering clearance(s) not provided	-	Relocate the table.	1	Labor	\$0
<b>Ramps</b>												
36	Ramp From Main Office to Classrooms	1		Ramps	Interior

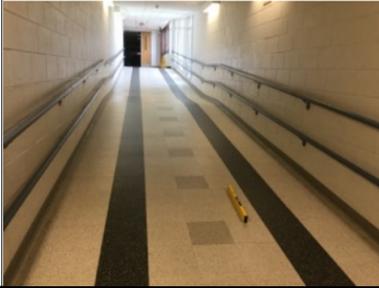
Running slope >1:12 (8.33%)	9.1%	Repair to this ramp might be technically infeasible. While not technically compliant, the ramp is still usable.	1	-	\$0
37	Easternmost Exit on South Side of School			Ramps	Exterior

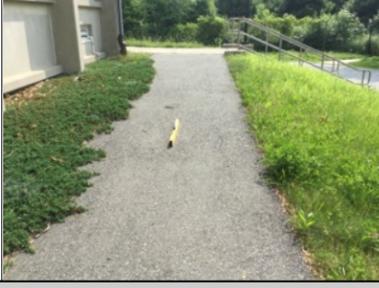
Handrails not provided	-	Provide handrails with 1 1/4" - 2" circular cross sections or 4" - 6 1/4" non-circular cross sections.	1	1980	\$1980
<b>Stairways</b>												
38	YMCA Pick Up Door			Stairways	Exterior

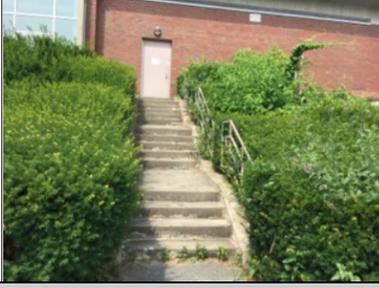
Handrails not continuous where required Handrails not provided	- -	Provide continuous handrails. Ensure handrails are provided on the entirety of both sides of the stairs.  (Cost based on two sets of handrails at 15' long, and handrail extensions on both sides to ensure handrails are continuous.)	1	2865	\$2865

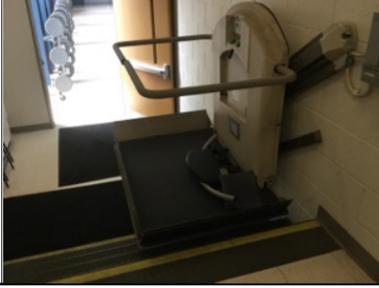
<b>Platform Lift or LULA Elevator</b>												
39	Accessible Route to OT/PT Room and Stage	1		Platform Lift or LULA Elevator	Interior

Not in operable working condition	-	Ensure lift is maintained in operable working condition.	1	Labor	\$0

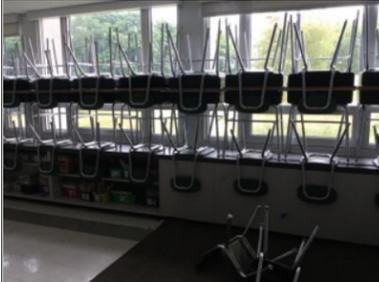
ID	Location	Floor	Room	Element	Type	Photo	Issues	Current Measure	Recommendations	Quantity	Price	Cost Estimation
<b>Dining or Work Surfaces</b>												
40	Classroom	1	D037	Dining or Work Surfaces	Work Surface

At least one or 5% accessible tables not provided	-	Ensure that at least one work surface is accessible.	1	525	\$525
41	OT/PT Room	1		Dining or Work Surfaces	Work Surface

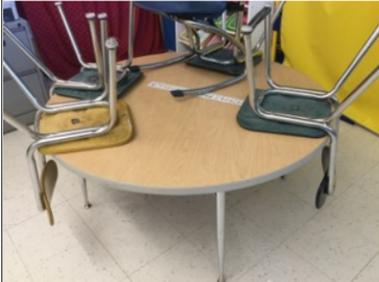
Knee or toe clearance not provided	-	Adjust at least 1 work surface for children so that it has 24" min. knee and toe clearance.	1	Labor	\$0
42	Classrooms Throughout School	1, 2		Dining or Work Surfaces	Work Surface

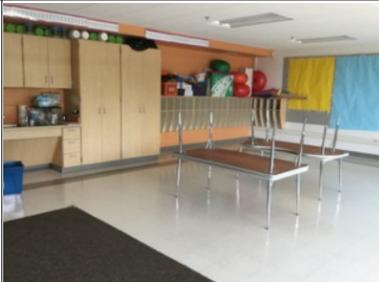
Knee or toe clearance not provided	21"	Adjust at least 1 work surface for children in 1 classroom per grade so that it has 24" min. knee and toe clearance.	6	Labor	\$0
<b>Benches</b>												
43	Courtyard Garden	1		Benches	N/A

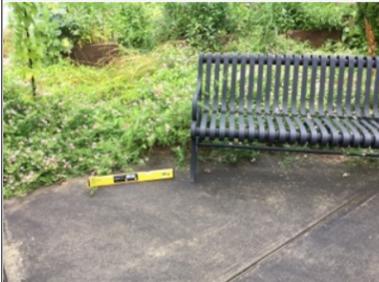
Cross slope > 1:48 (2.08%)	4.0%	Ensure that 20% of benches have a cross slope no greater than 1:50 (2.00%) around the bench and in the clear floor space.	1	135	\$135

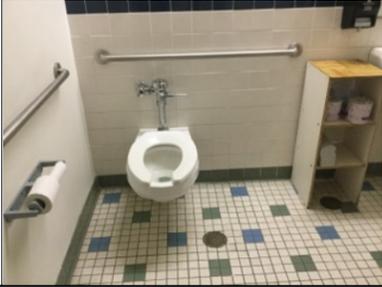
ID	Location	Floor	Room	Element	Type	Photo	Issues	Current Measure	Recommendations	Quantity	Price	Cost Estimation
<b>Single-User Toilet</b>												
44	Toilet Room in Nurse's Office	1		Single-User Toilet	N/A

Clearance at toilet < 60" clear width	-	Provide a clear floor space that is 60" wide min. by removing shelf.	1	Labor	\$0
<b>Toilet Compartment</b>												
45	Girls' and Boys' Toilet Rooms Near Cafeteria	1		Toilet Compartment	Accessible Compartment

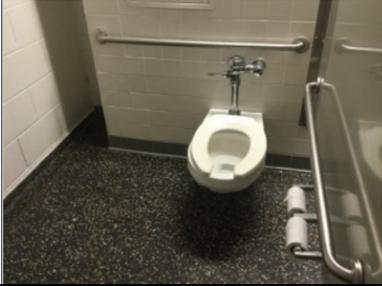
Door with non-compliant hardware Door with malfunctioning self-closing hinge Side or rear grab bar < 25" or > 27" high (Ages 9 - 12)	- - 30"	Provide hardware that can be operable with one hand and not require tight grasping, pinching, or twisting of the wrist. Repair self-closing hinge. Relocate rear grab bar to 25"- 27" above the floor.	2	210	\$420
46	Girls' Toilet Room Near C027	1		Toilet Compartment	Accessible Compartment

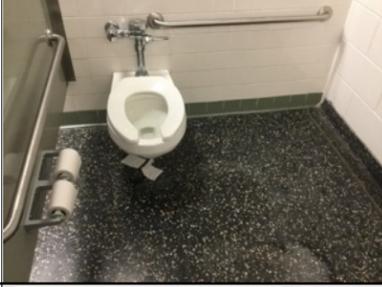
Side or rear grab bar < 42" long	24"	Provide a rear wall grab bar that is 42" long located 6" max. from the interior corner.	1	674	\$674

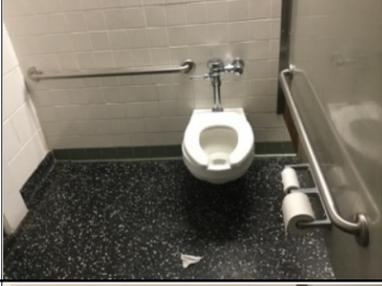
47	Boys' and Girls' Toilet Rooms Near C219	2		Toilet Compartment	Accessible Compartment

Side or rear grab bar < 42" long	- 25.5"	Provide a rear wall grab bar that is 42" long located 6" max. from the interior corner.	2	674	\$1348
48	Boys' Toilet Room Near C017	1		Toilet Compartment	Accessible Compartment
